Gully Inventory Map	Legend		\mathbf{T}
Area #1	LMRWD Boundary (not official)	FEMA Floodway	\mathbb{N}
Lower Minnesota River Watershed District	City/Township Boundary	100-Year FEMA Floodplain	T
Watershed Management Plan	Gully Inventory Locations	500-Year FEMA Floodplain	Not to Scale

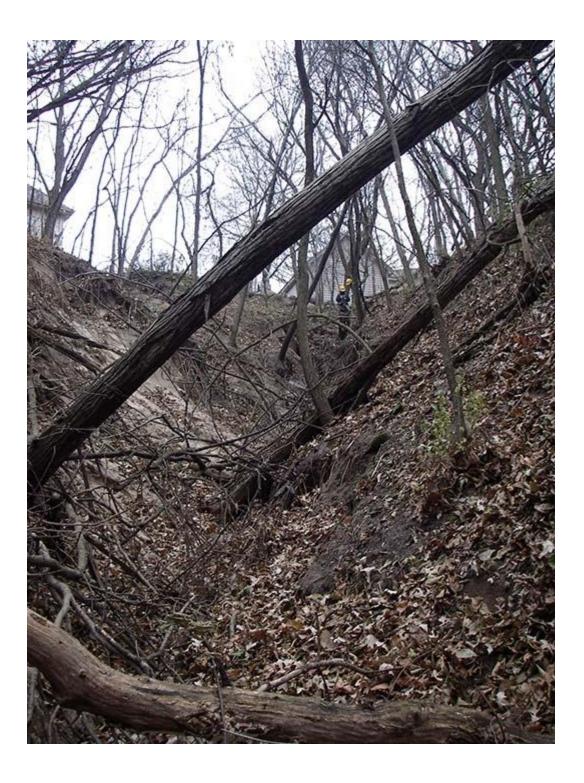
Tree debris; exposed soil.

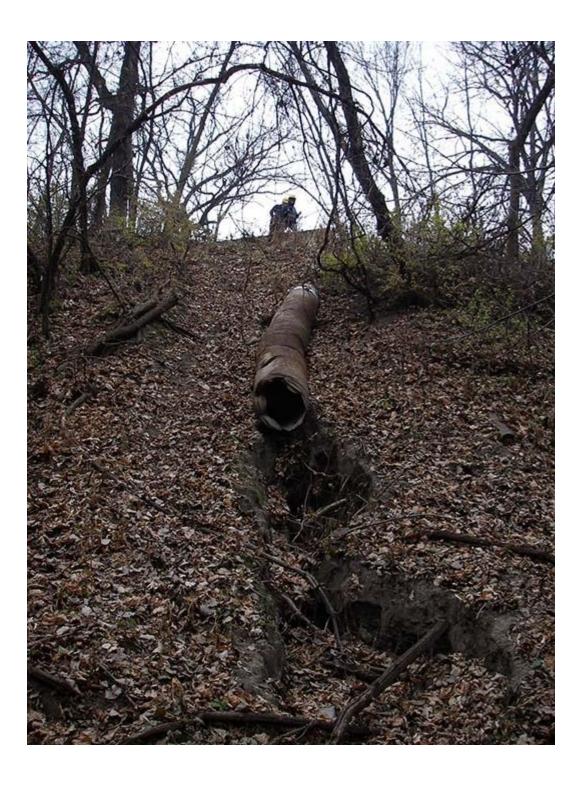
Drain pipe

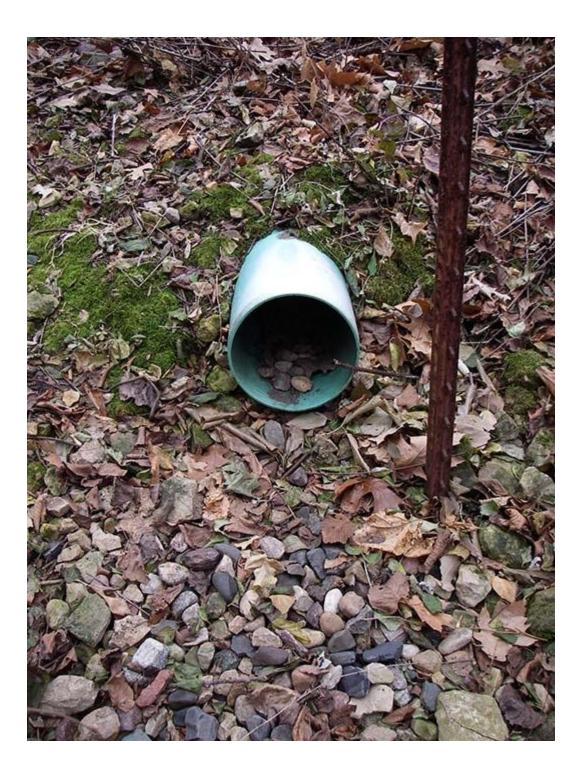
Drain pipe

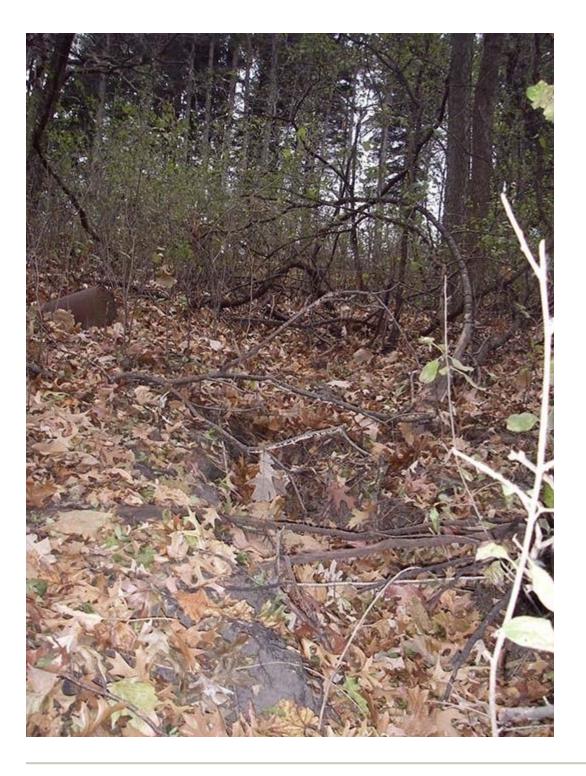
Gully bank erosion from parking lot

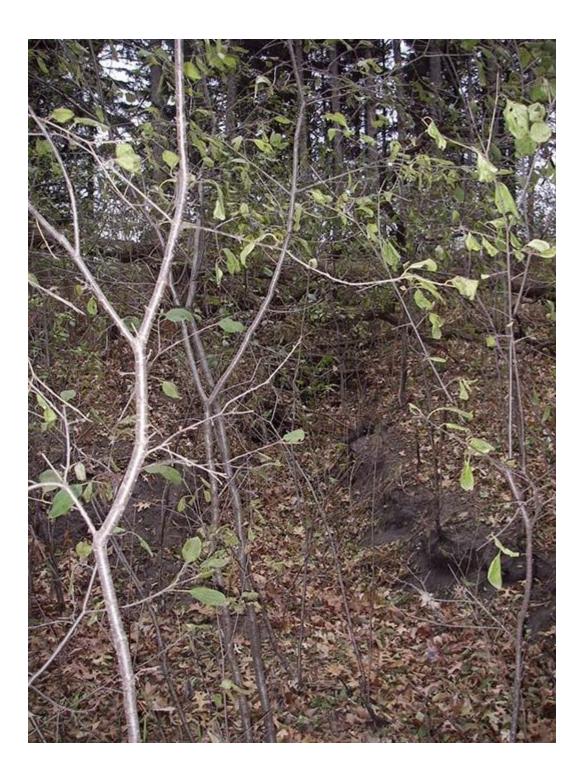
Gully bank erosion from parking lot

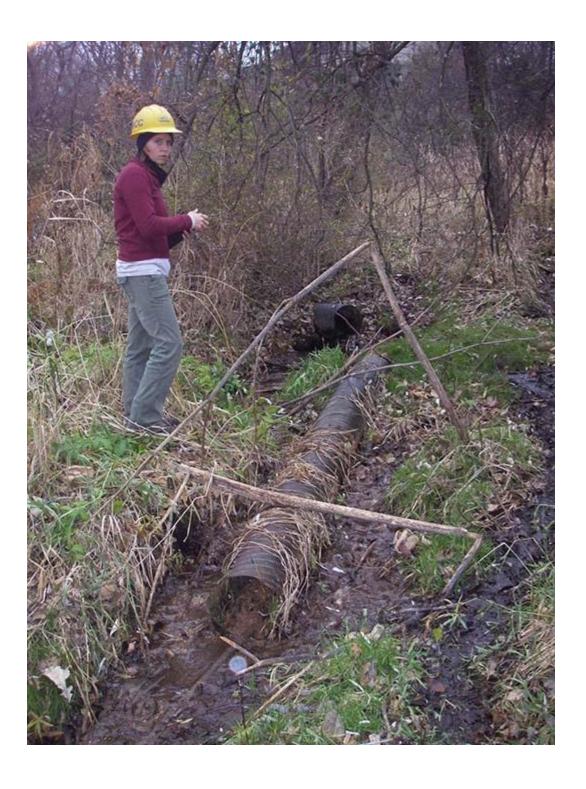
Drain pipe outlet

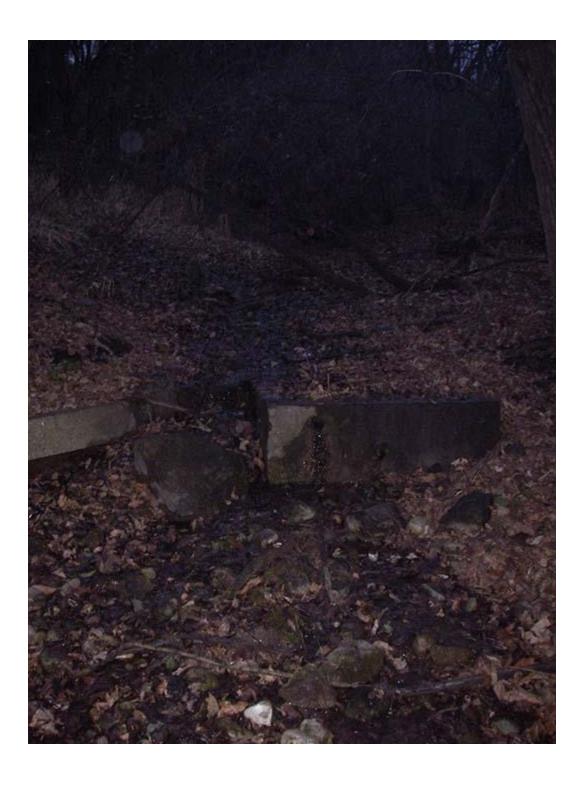
Outlet pipe

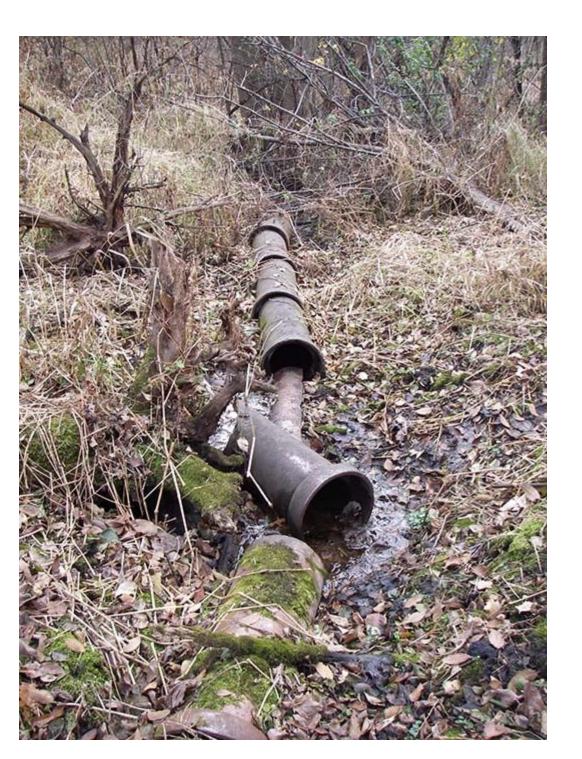
40 ft. of broken clay pipe along a long spring

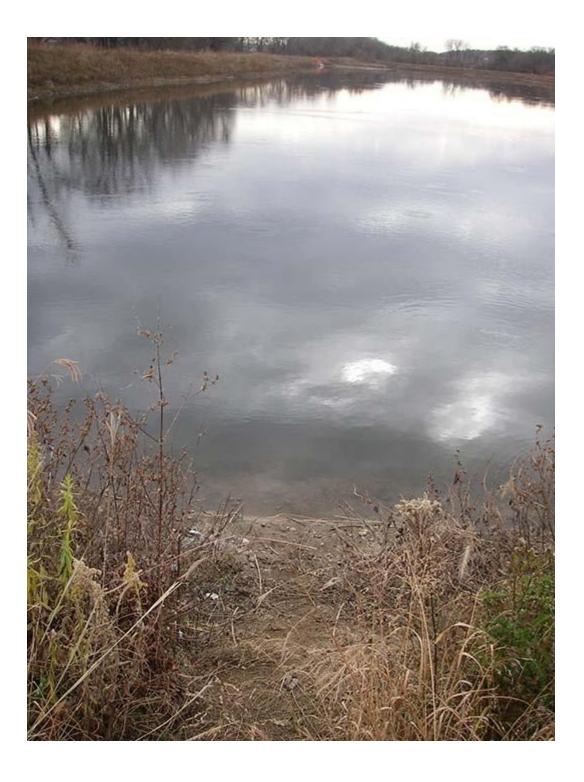
Pipe underwater

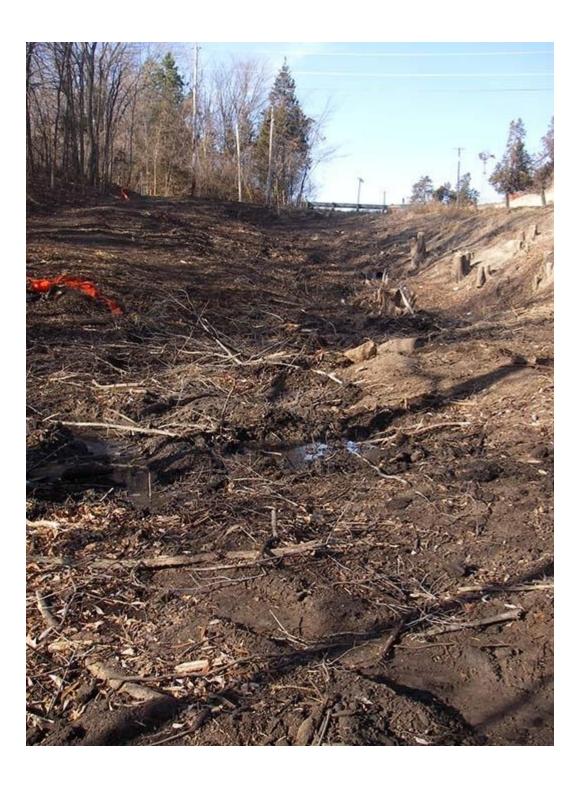
construction/erosion, standing water

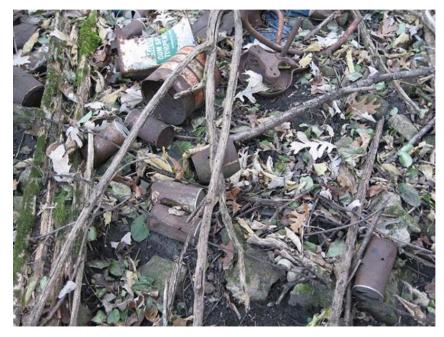
All pictures - Large dump site; lots of bottles, cans, metal containers, misc. metals (rusted); old style of cans indicate they've been here

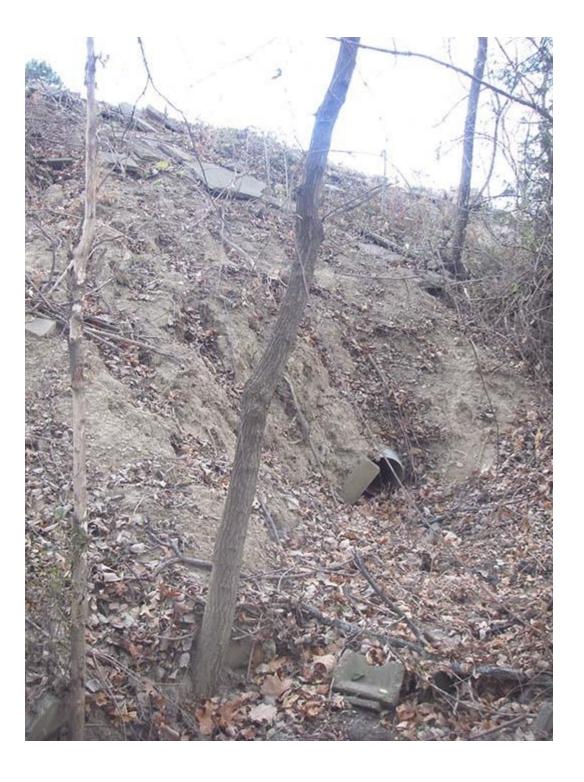
Drain pipe from trailer park & erosion

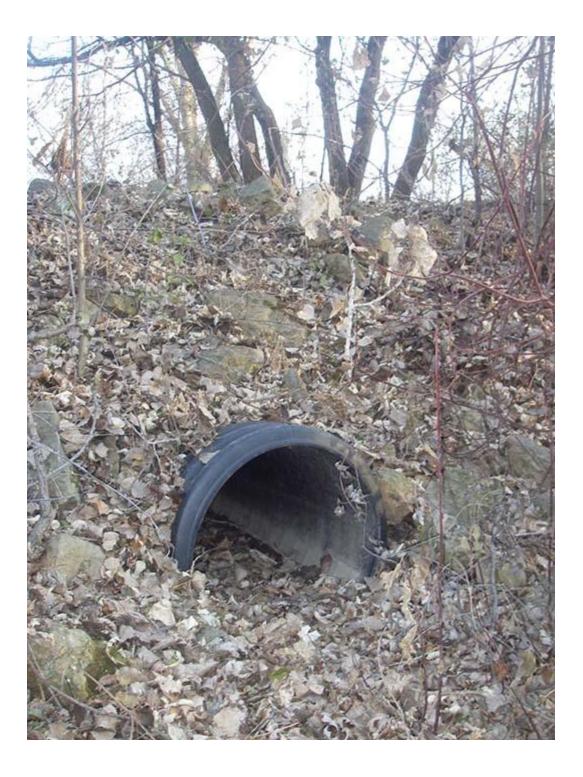
Drain pipe

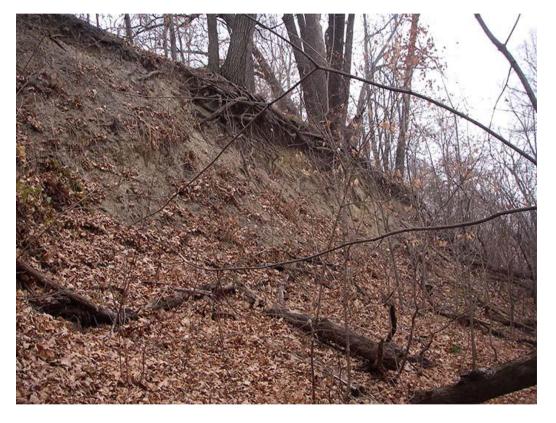
Extreme soil erosion

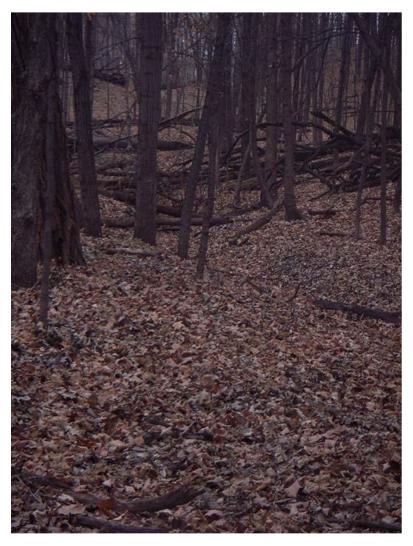
End of gully; severe erosion throughout gully/near newer housing development; is erosion caused by construction?

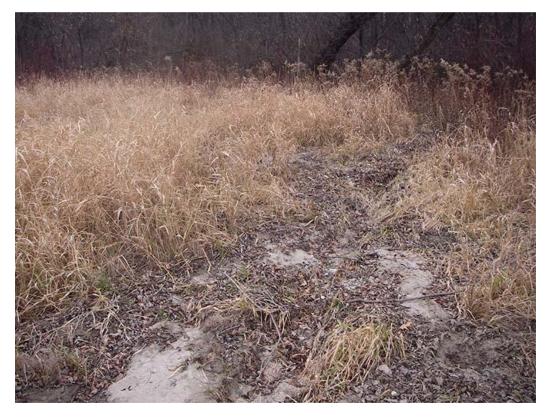
End of gully; severe erosion throughout gully/near newer housing development; is erosion caused by construction?

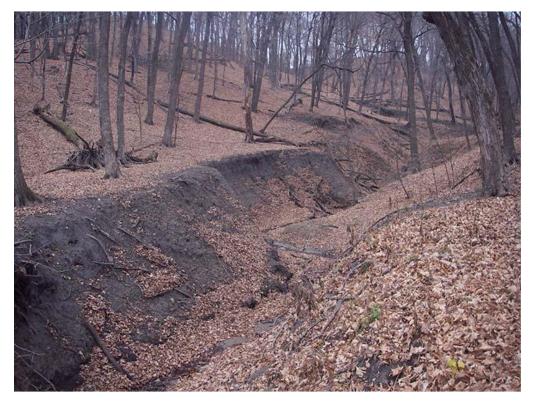
Severe erosion throughout gully/near newer housing development; is erosion caused by construction? Moderate erosion

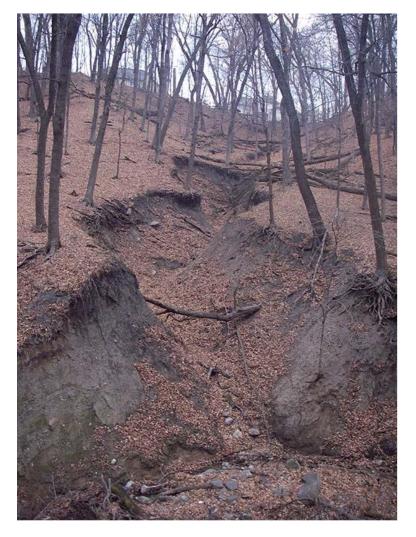
Branch of gully; severe erosion throughout gully/near newer housing development; is erosion caused by construction?

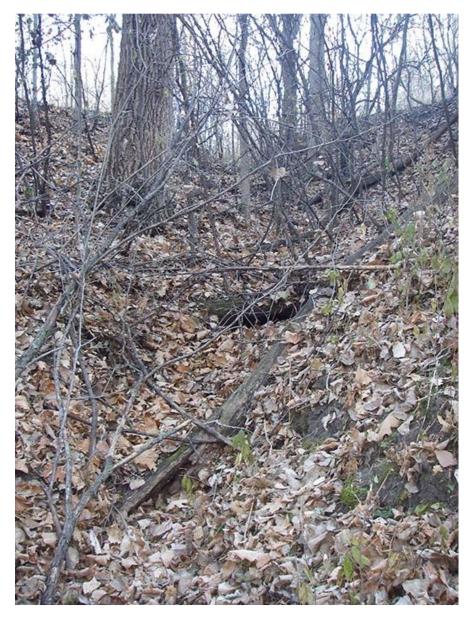
Severe erosion throughout gully/near newer housing development; is erosion caused by construction?

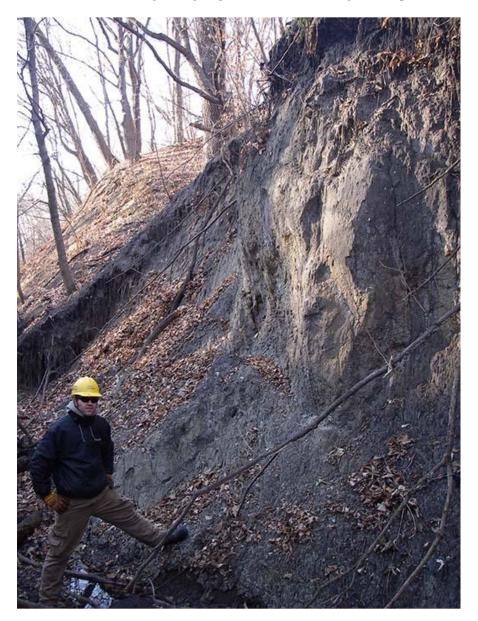
Severe erosion throughout gully/near newer housing development; is erosion caused by construction?

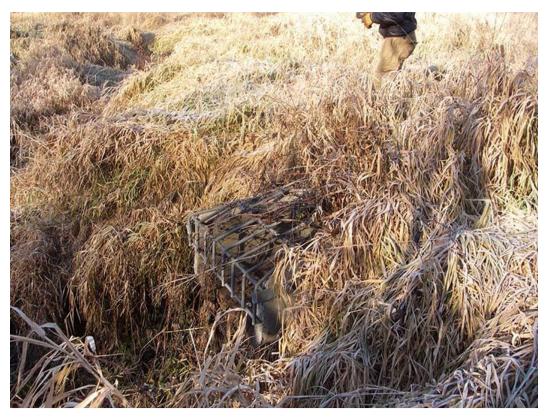
Drain pipe; severe erosion throughout gully/near newer housing development; is erosion caused by construction?

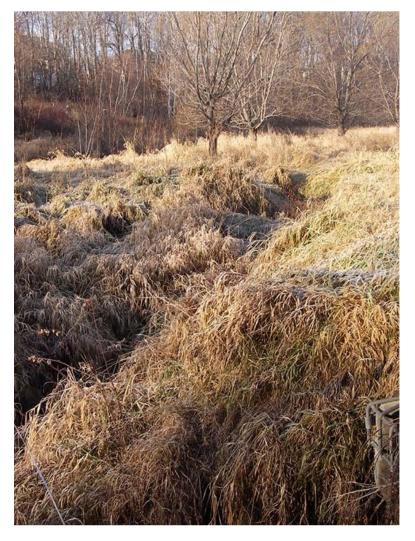
Start of gully; severe erosion throughout gully/near newer housing development; is erosion caused by construction?

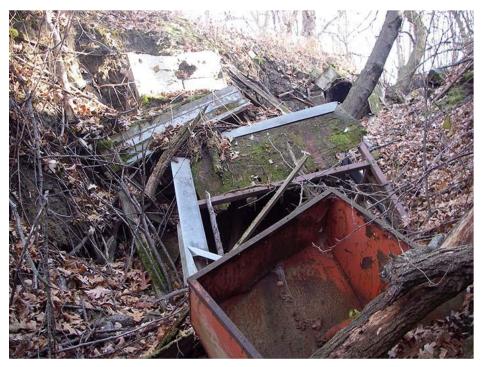
Garbage in branch at start; severe erosion throughout gully/near newer housing development; is erosion caused by construction?

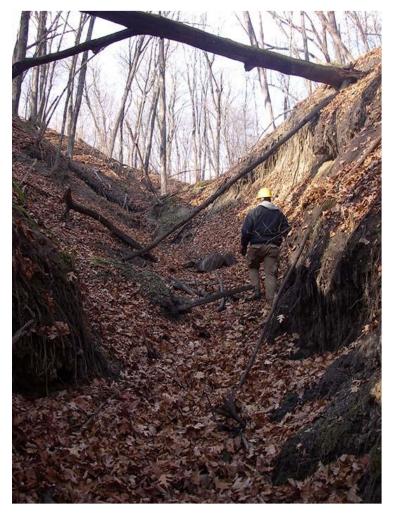
Branch w/moderate to severe erosion throughout gully/near newer housing development; is erosion caused by construction?

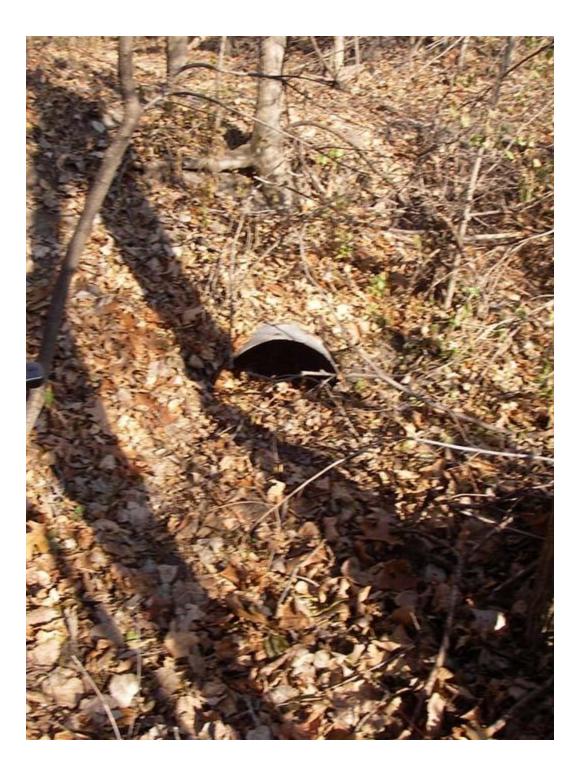
Drain pipe

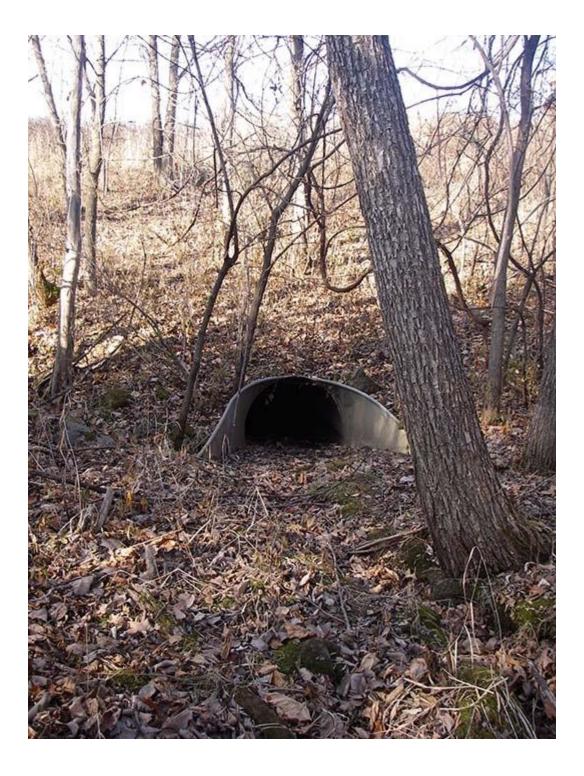
Start and drain pipe

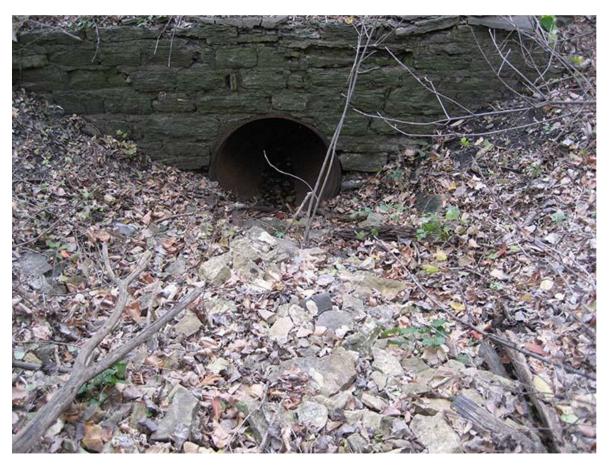
Culvert coming down from trail above; lots of loose rock; looking down at culvert; moderate erosion.

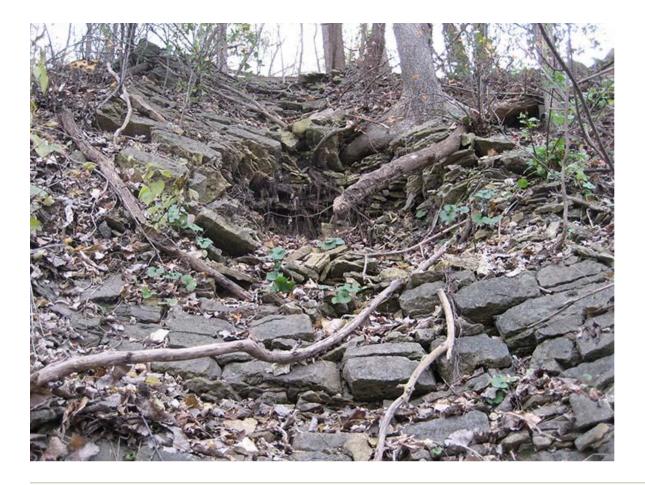
Looking up to where water comes down into culvert.

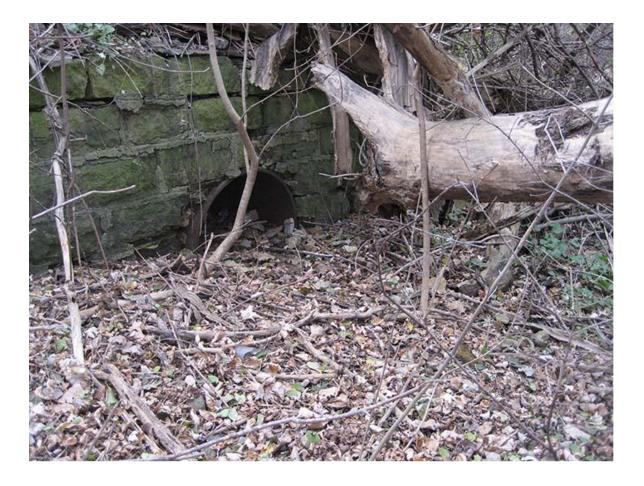
Culvert on lower side; half full with loose rock; minimal erosion.

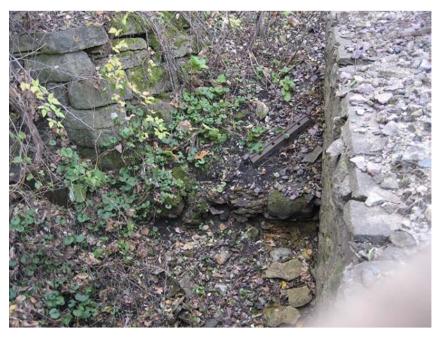
Sides next to culvert are beginning to erode; minimal erosion.

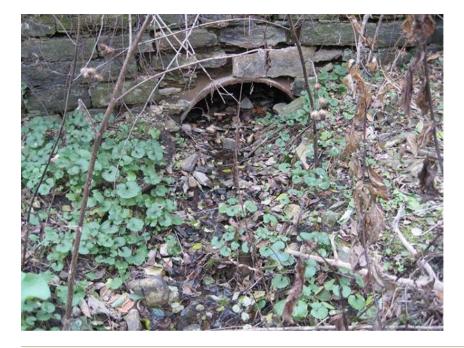
River side of culvert has cut away the stream bank along the river; culvert has lots of loose rock in culvert; moderate to major erosion.

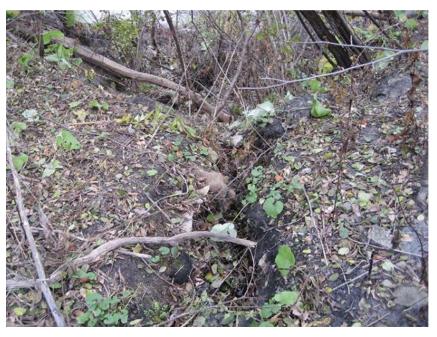
River side of culvert has cut away the stream bank along the river; culvert has lots of loose rock in culvert; moderate to major erosion.

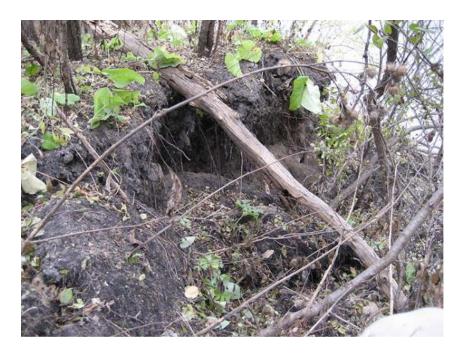
River side of culvert has cut away the stream bank along the river; culvert has lots of loose rock in culvert; moderate to major erosion.

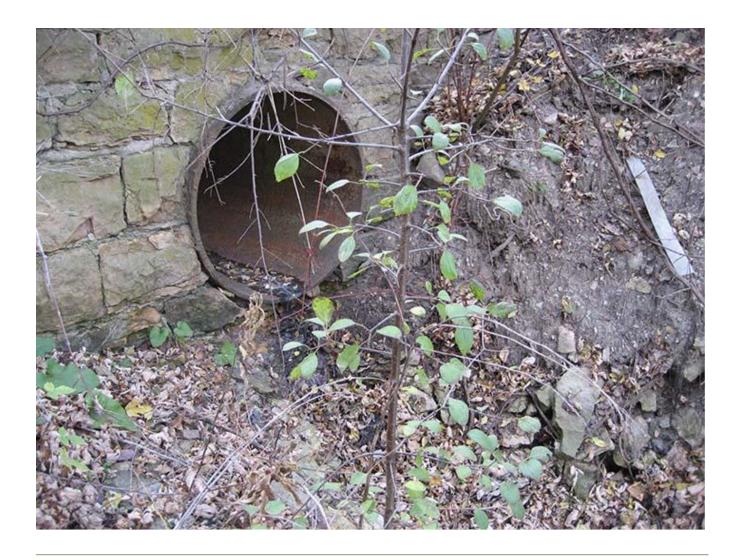
Lower side of culvert.

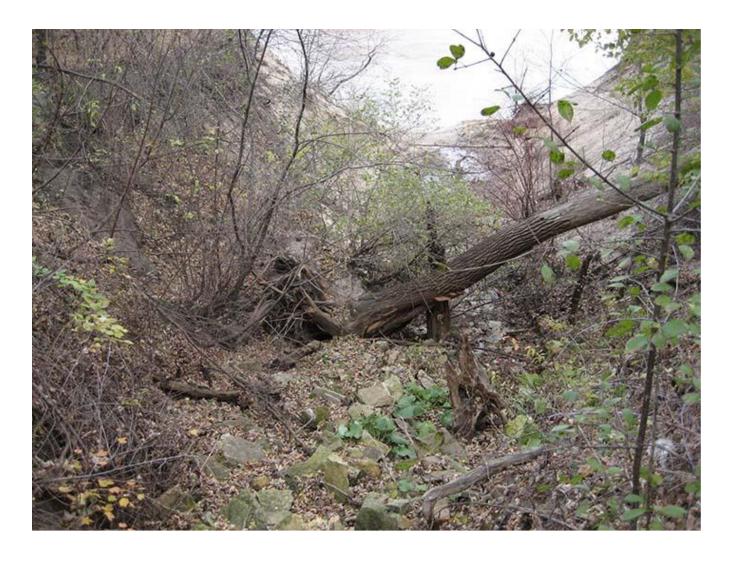
Major erosion; sides cut out all the way to the river; loose rock and exposed soil.

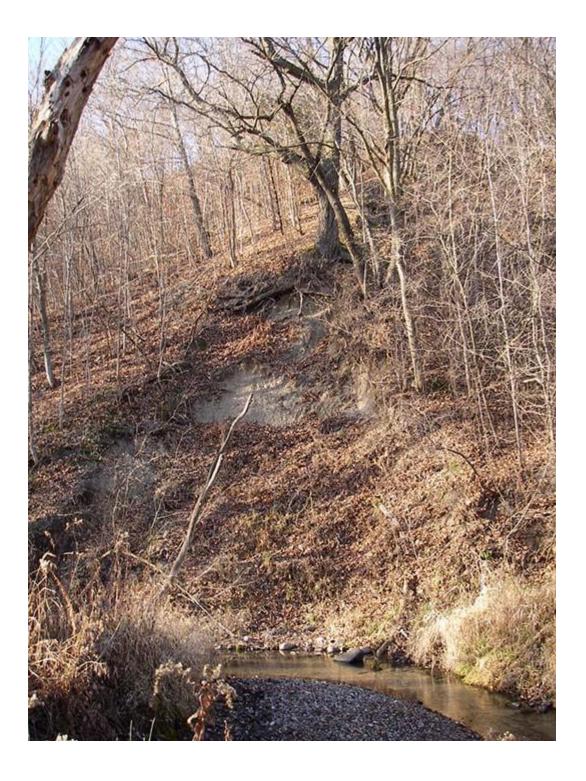
Steep erosion into creek

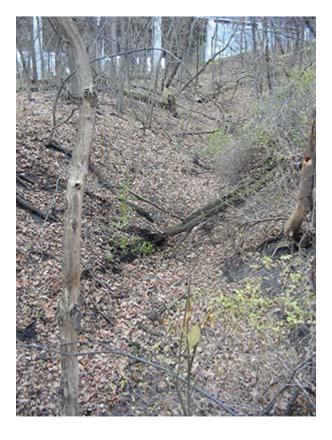
Gully/spring, cut fairly deep w/steep banks along west side/loose soil

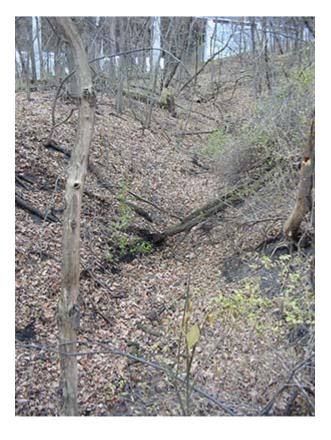
Gully/spring, cut fairly deep w/steep banks along west side/loose soil

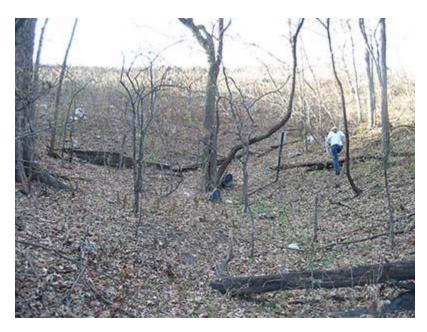
Top of gully-small broken retaining wall, top of gully looks fine, garbage, TV

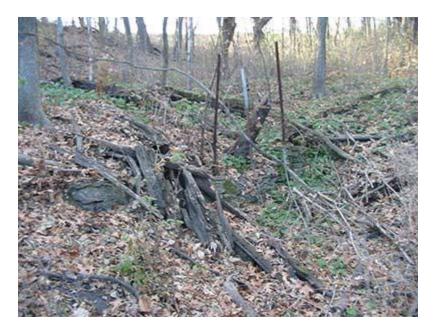
Old foundation

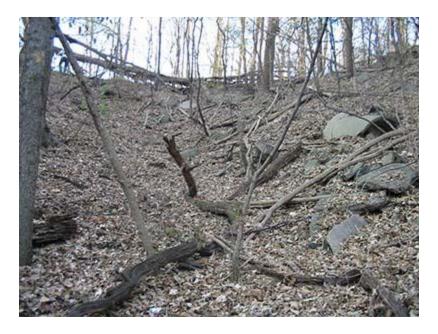
Top of gully, lots of broken concrete/4587 erosion cut

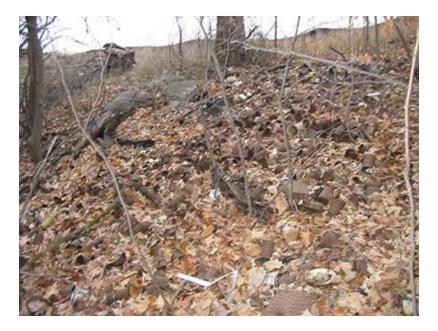
Pile of rusty cans

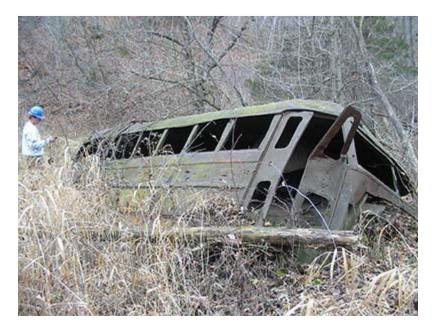
Rusty bus
