Technical Memorandum

Re: East Chaska Creek Restoration—Final Walk-Through

Re: East Chaska Creek Restoration—Construction Update

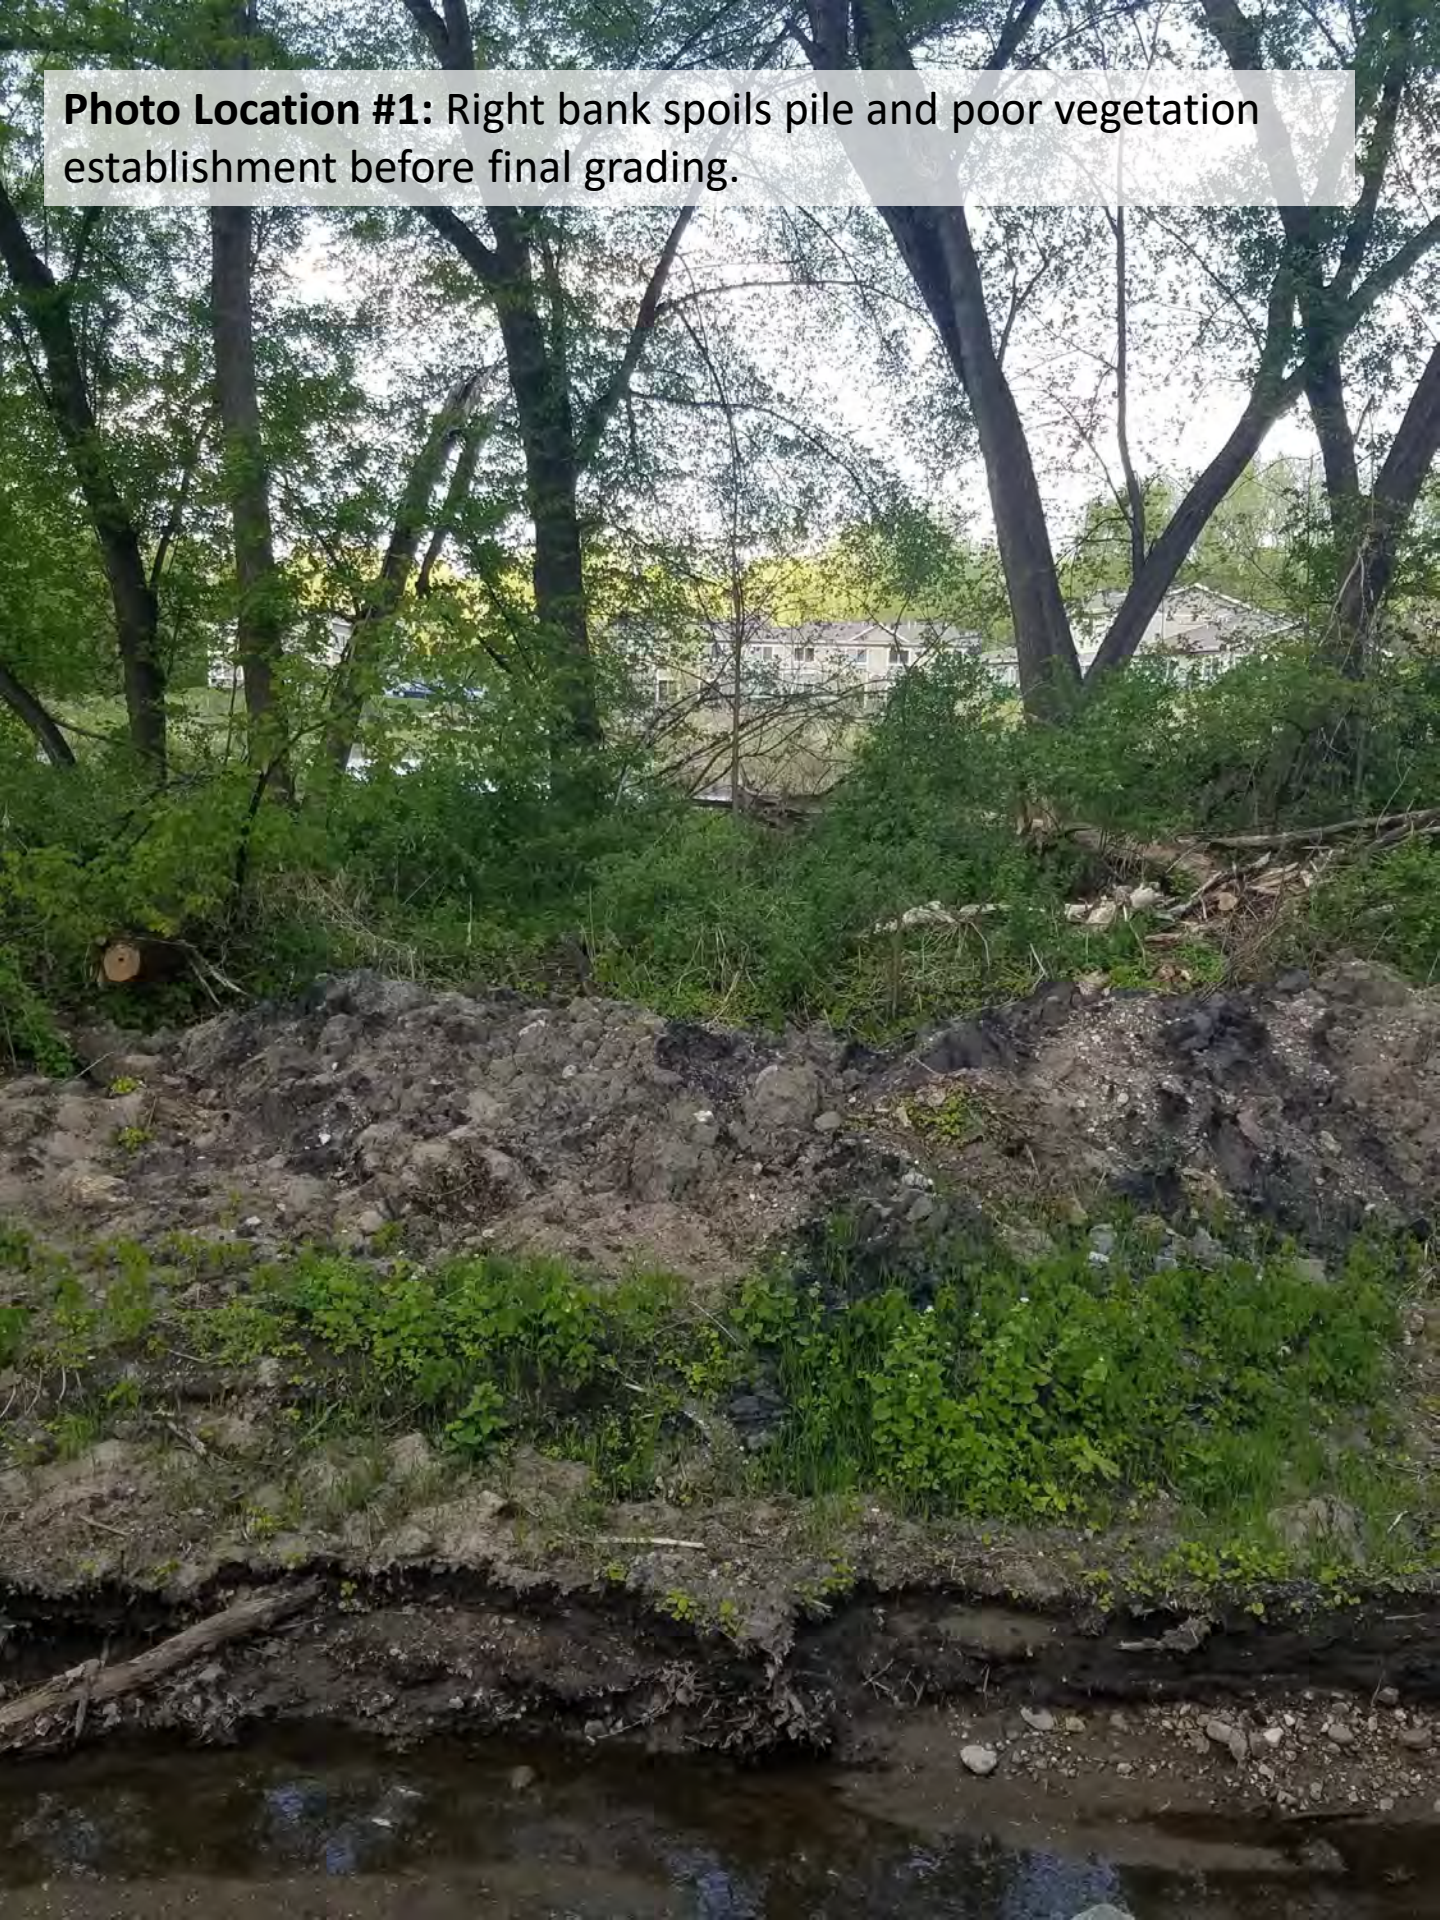
During the site walk, it was apparent that the dormant seed placed in March to stabilize the disturbed areas had a poor germination rate and that the frozen material placed on the banks gave a bumpy and rather messy appearance (Attachment 1, Photos 1 and 3).

Photo Location #1: Right bank spoils pile and poor vegetation establishment before final grading.

After discussion with the City and Blackstone, Barr directed Blackstone to return to the site to compact the lumpy areas and reseed if necessary. The City has provided stakes indicating where plants (red twig dogwood and swamp white oak) will be placed. Several banks were noted to be too steep, especially near the City stormwater outfall, and Blackstone said its crew would return and flatten the slope to prevent further erosion.

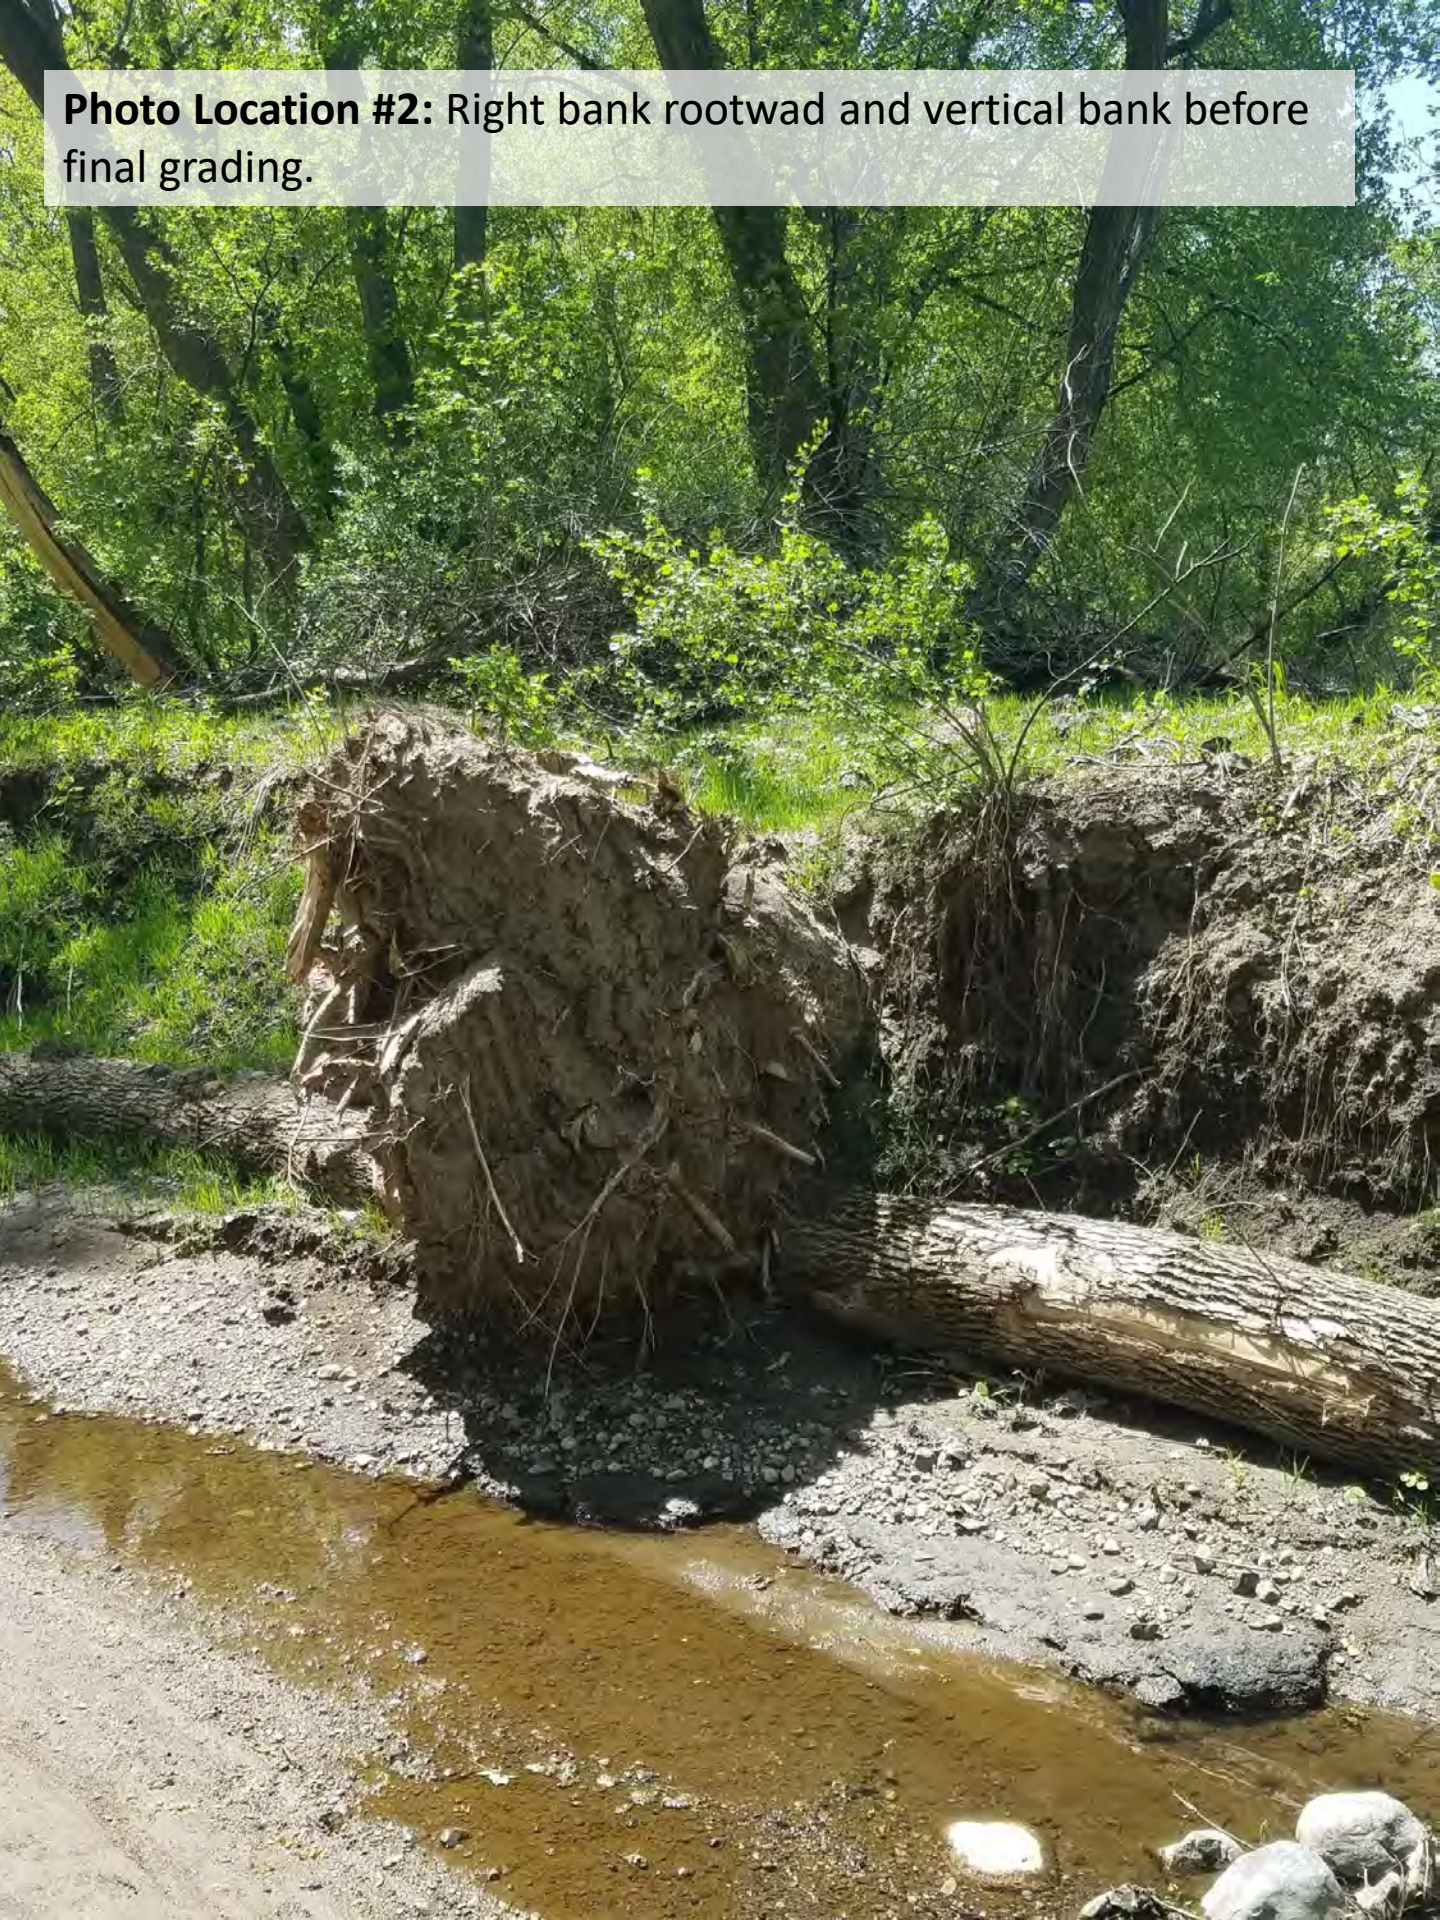
Several of the in-channel rock structures appeared to have caused bank erosion as a result of improper elevations of the header rocks and/or footer logs. These locations were noted by Barr and will be reviewed by the design engineer to determine what actions need to be taken (Attachment 1, Photos 2, 4, and 5).

Photo Location #2: Right bank rootwad and vertical bank before final grading.

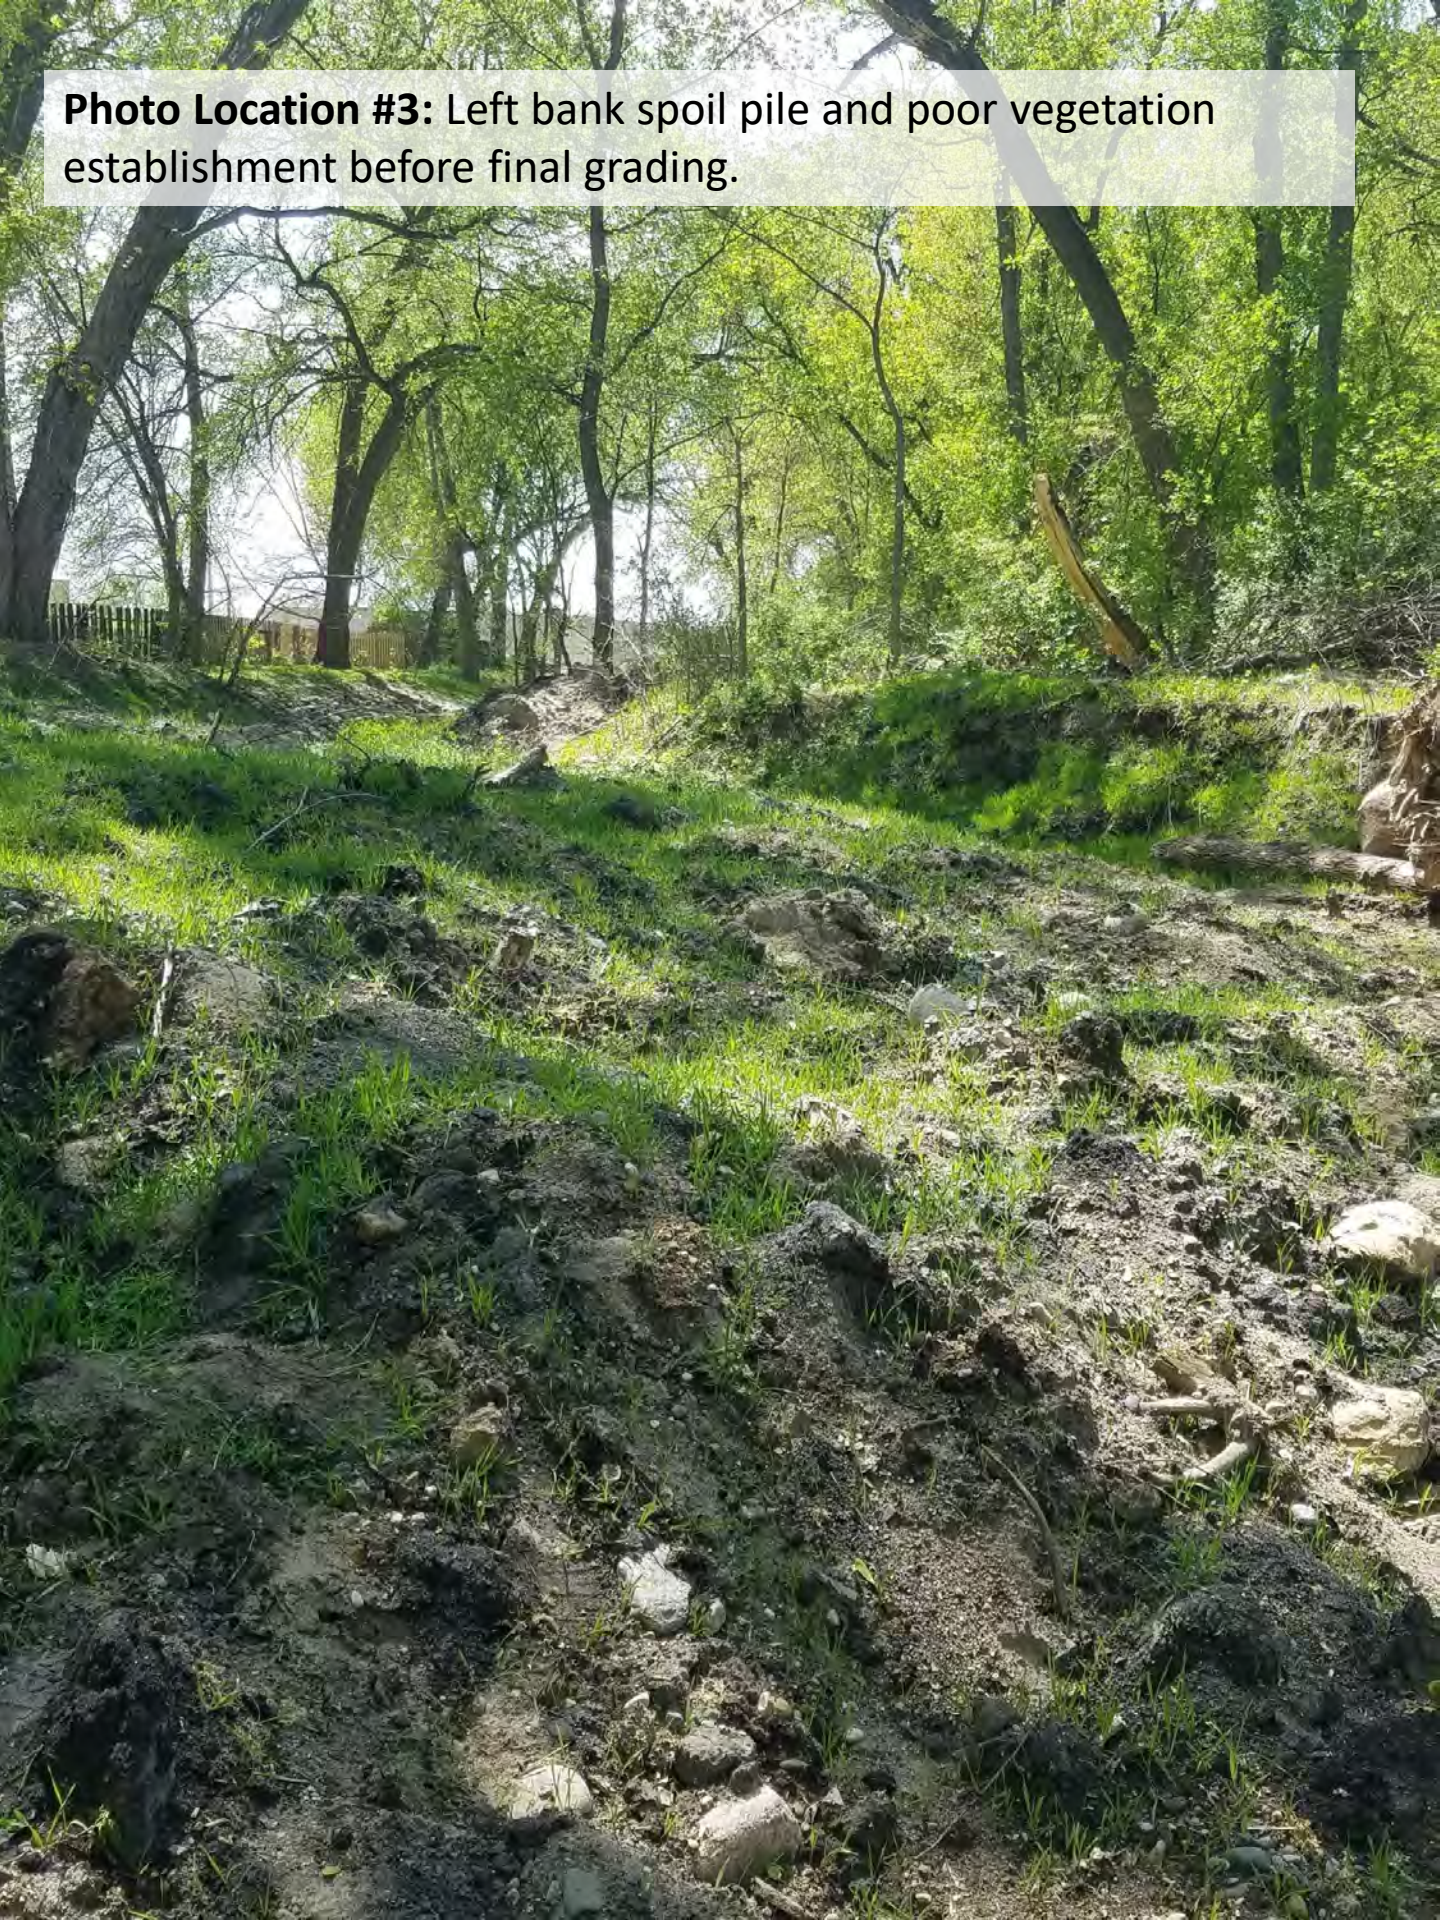
Photo Location #3: Left bank spoil pile and poor vegetation establishment before final grading.

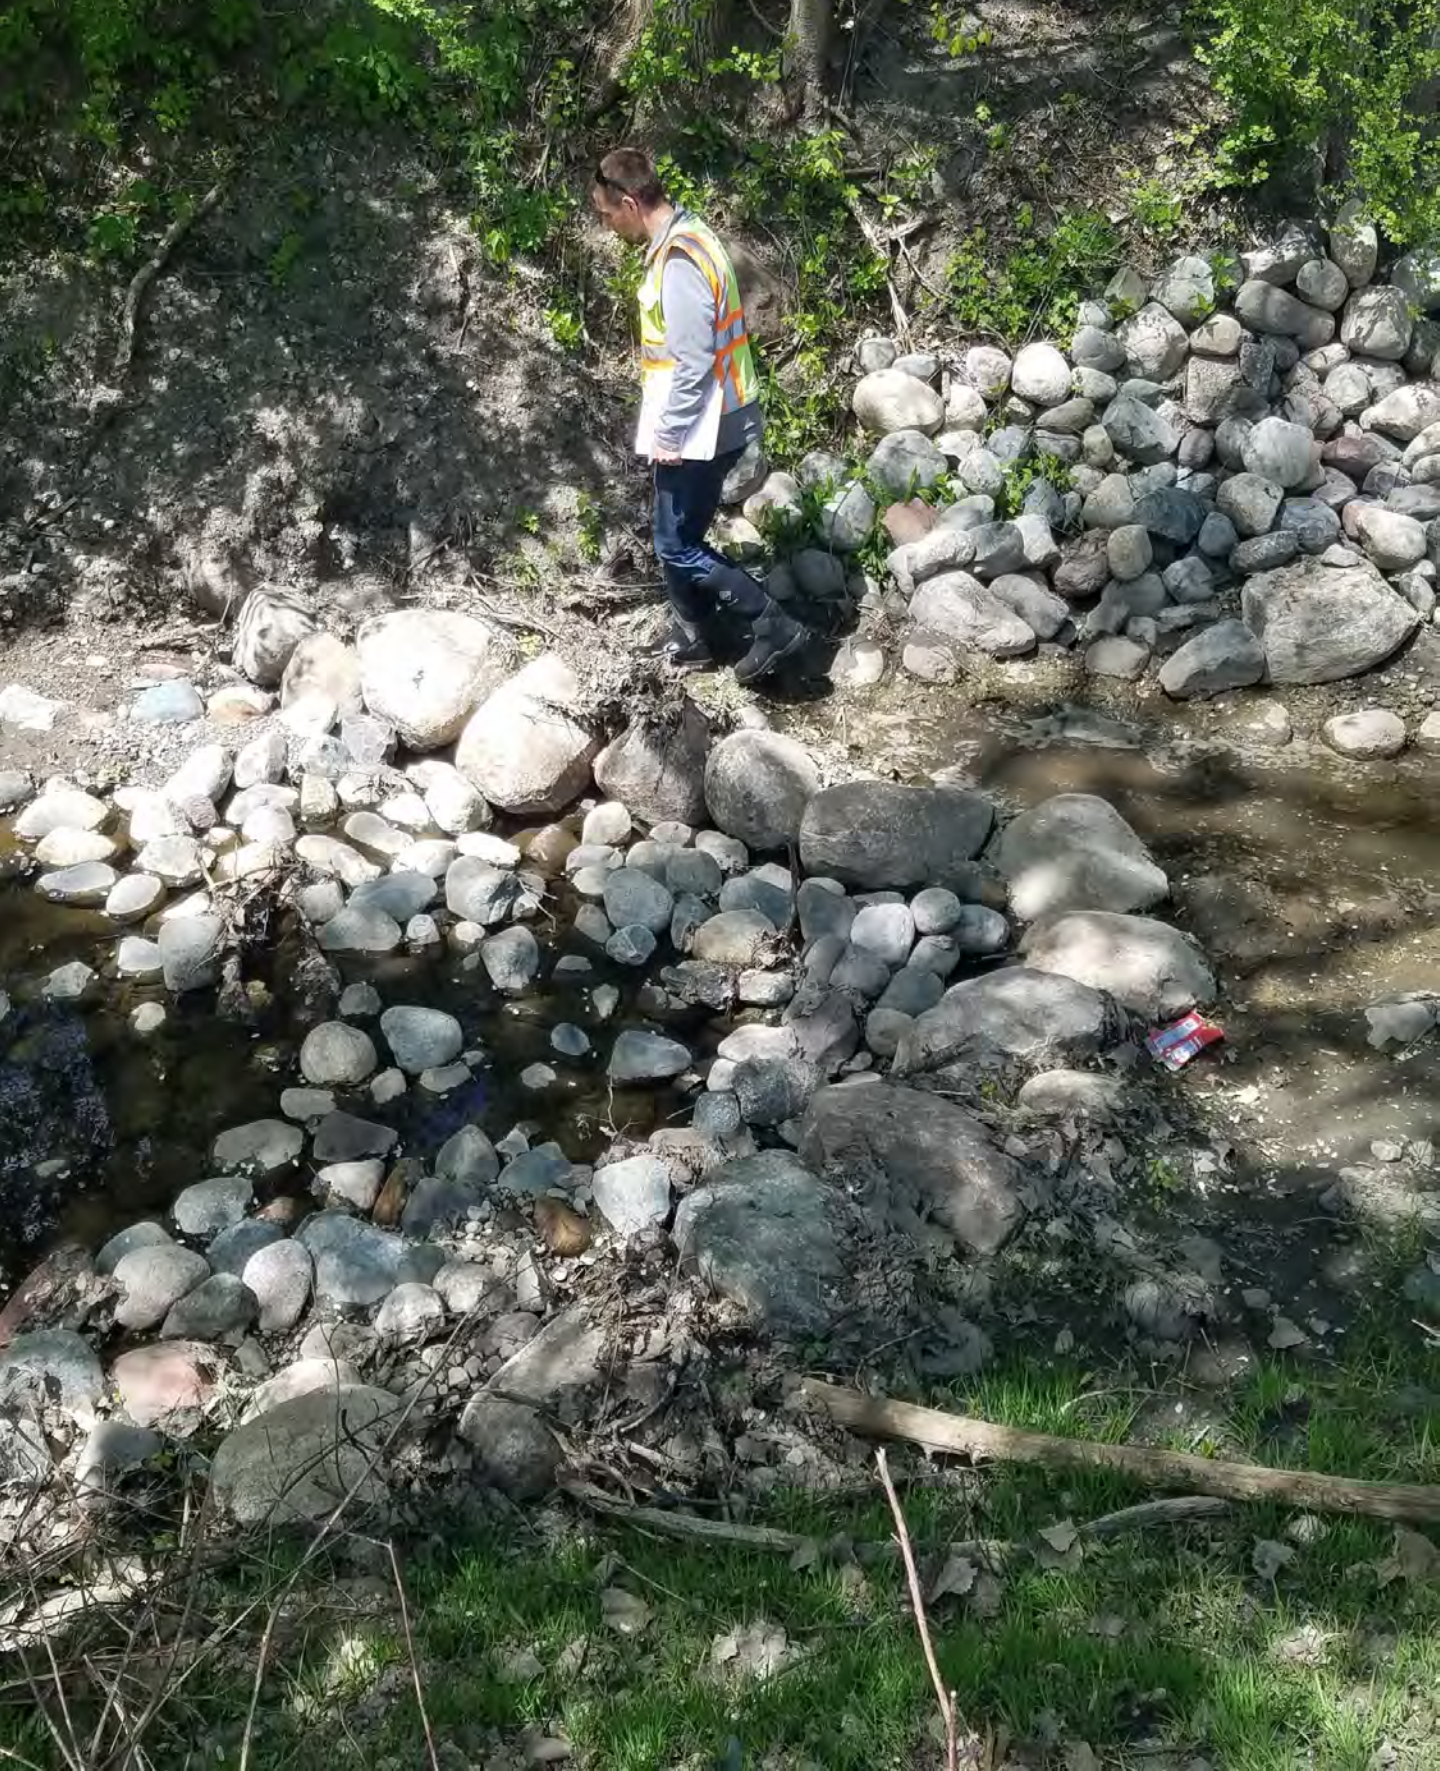
Photo Location #4: Example of right bank erosion at cross vane.

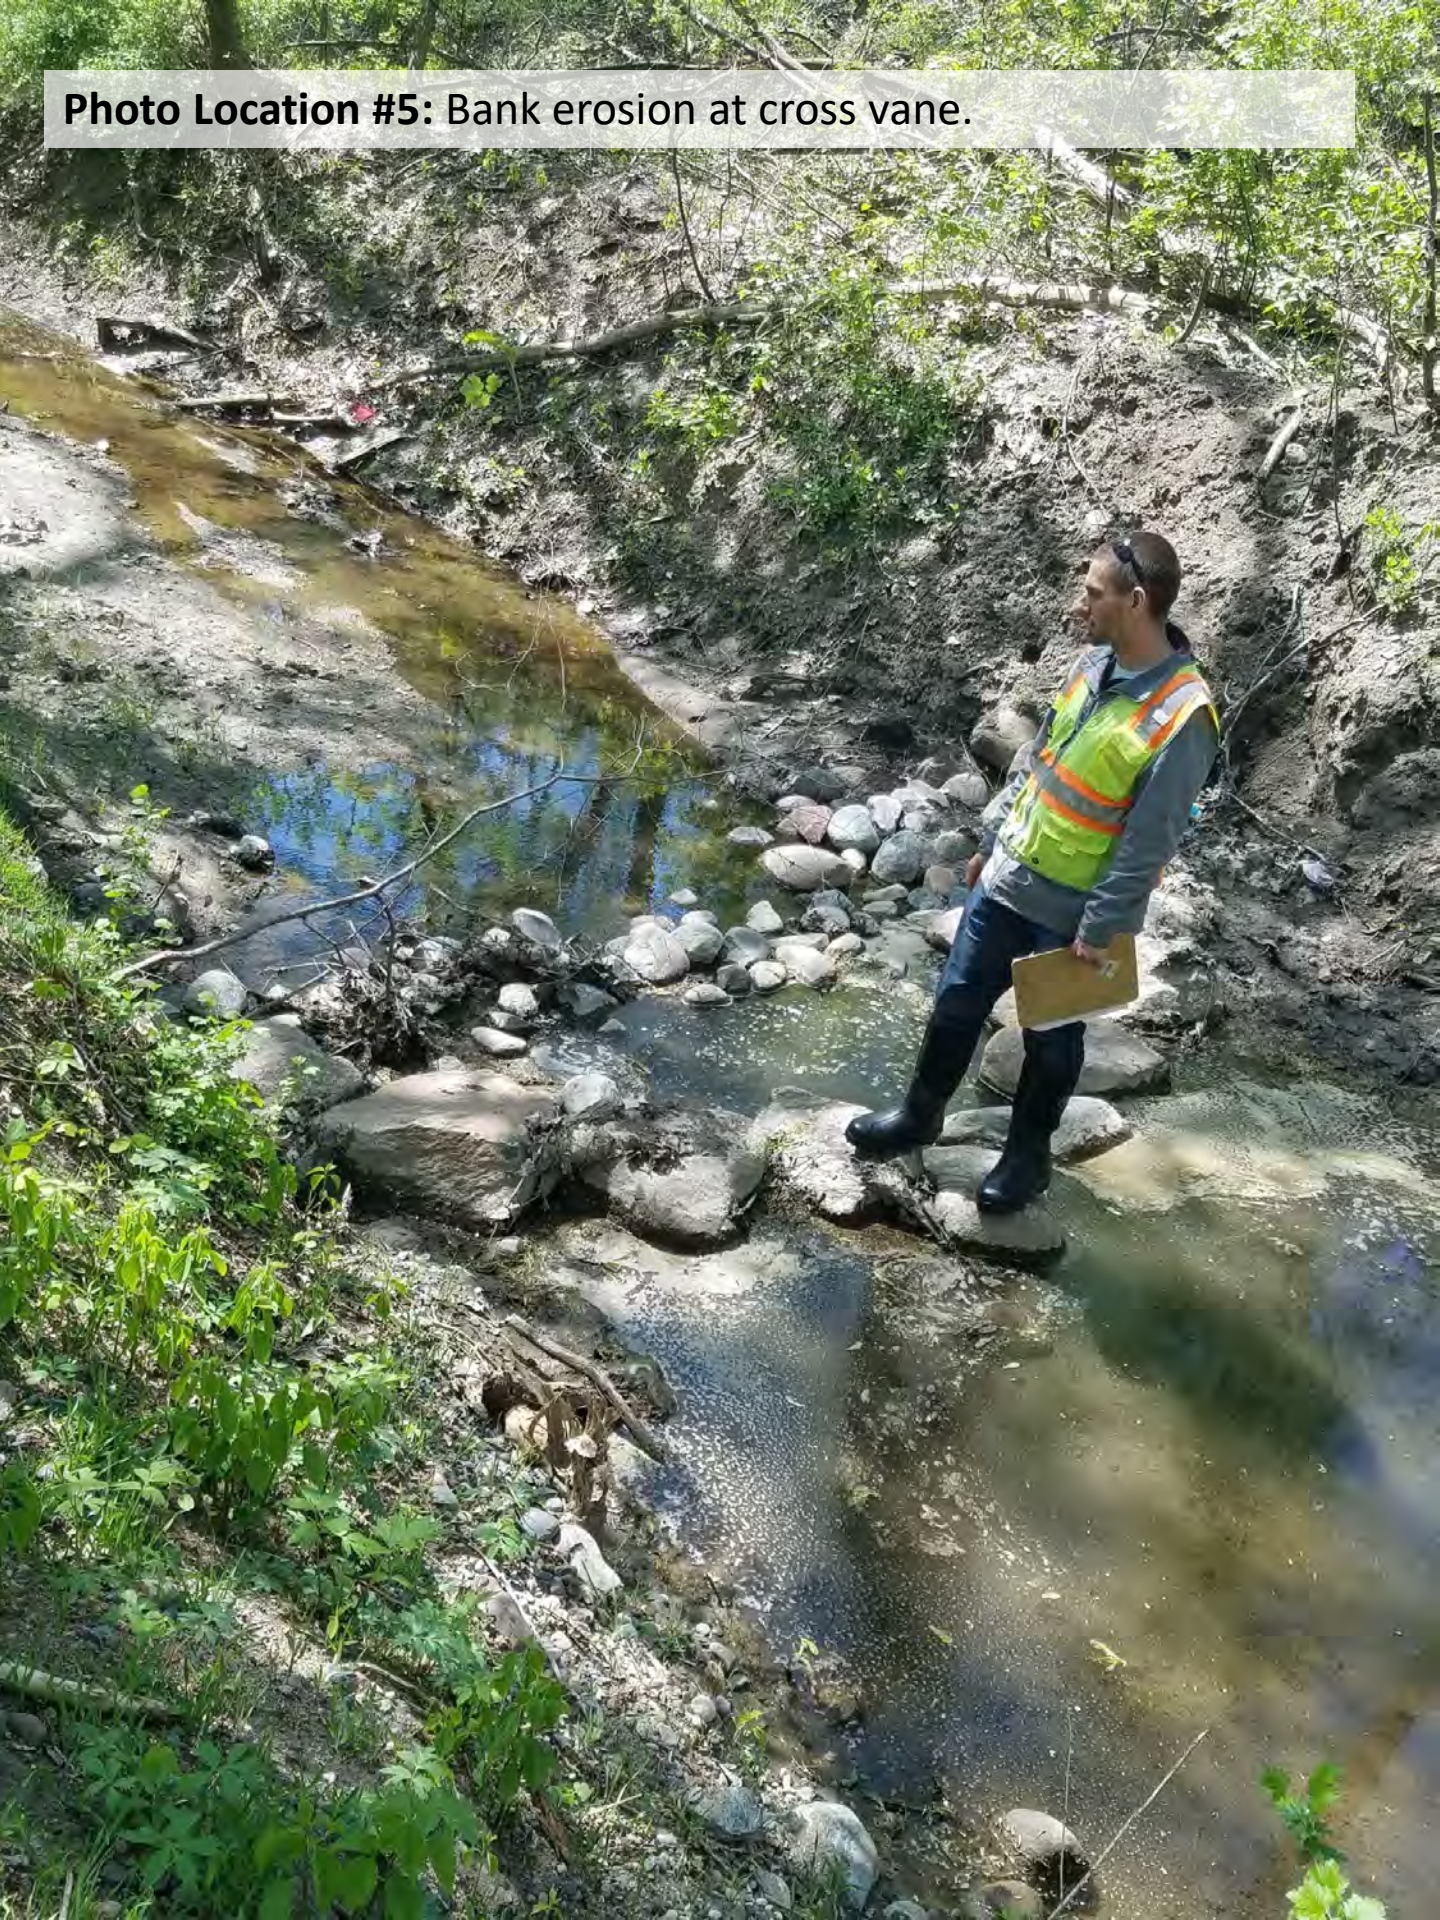
Photo Location #5: Bank erosion at cross vane.

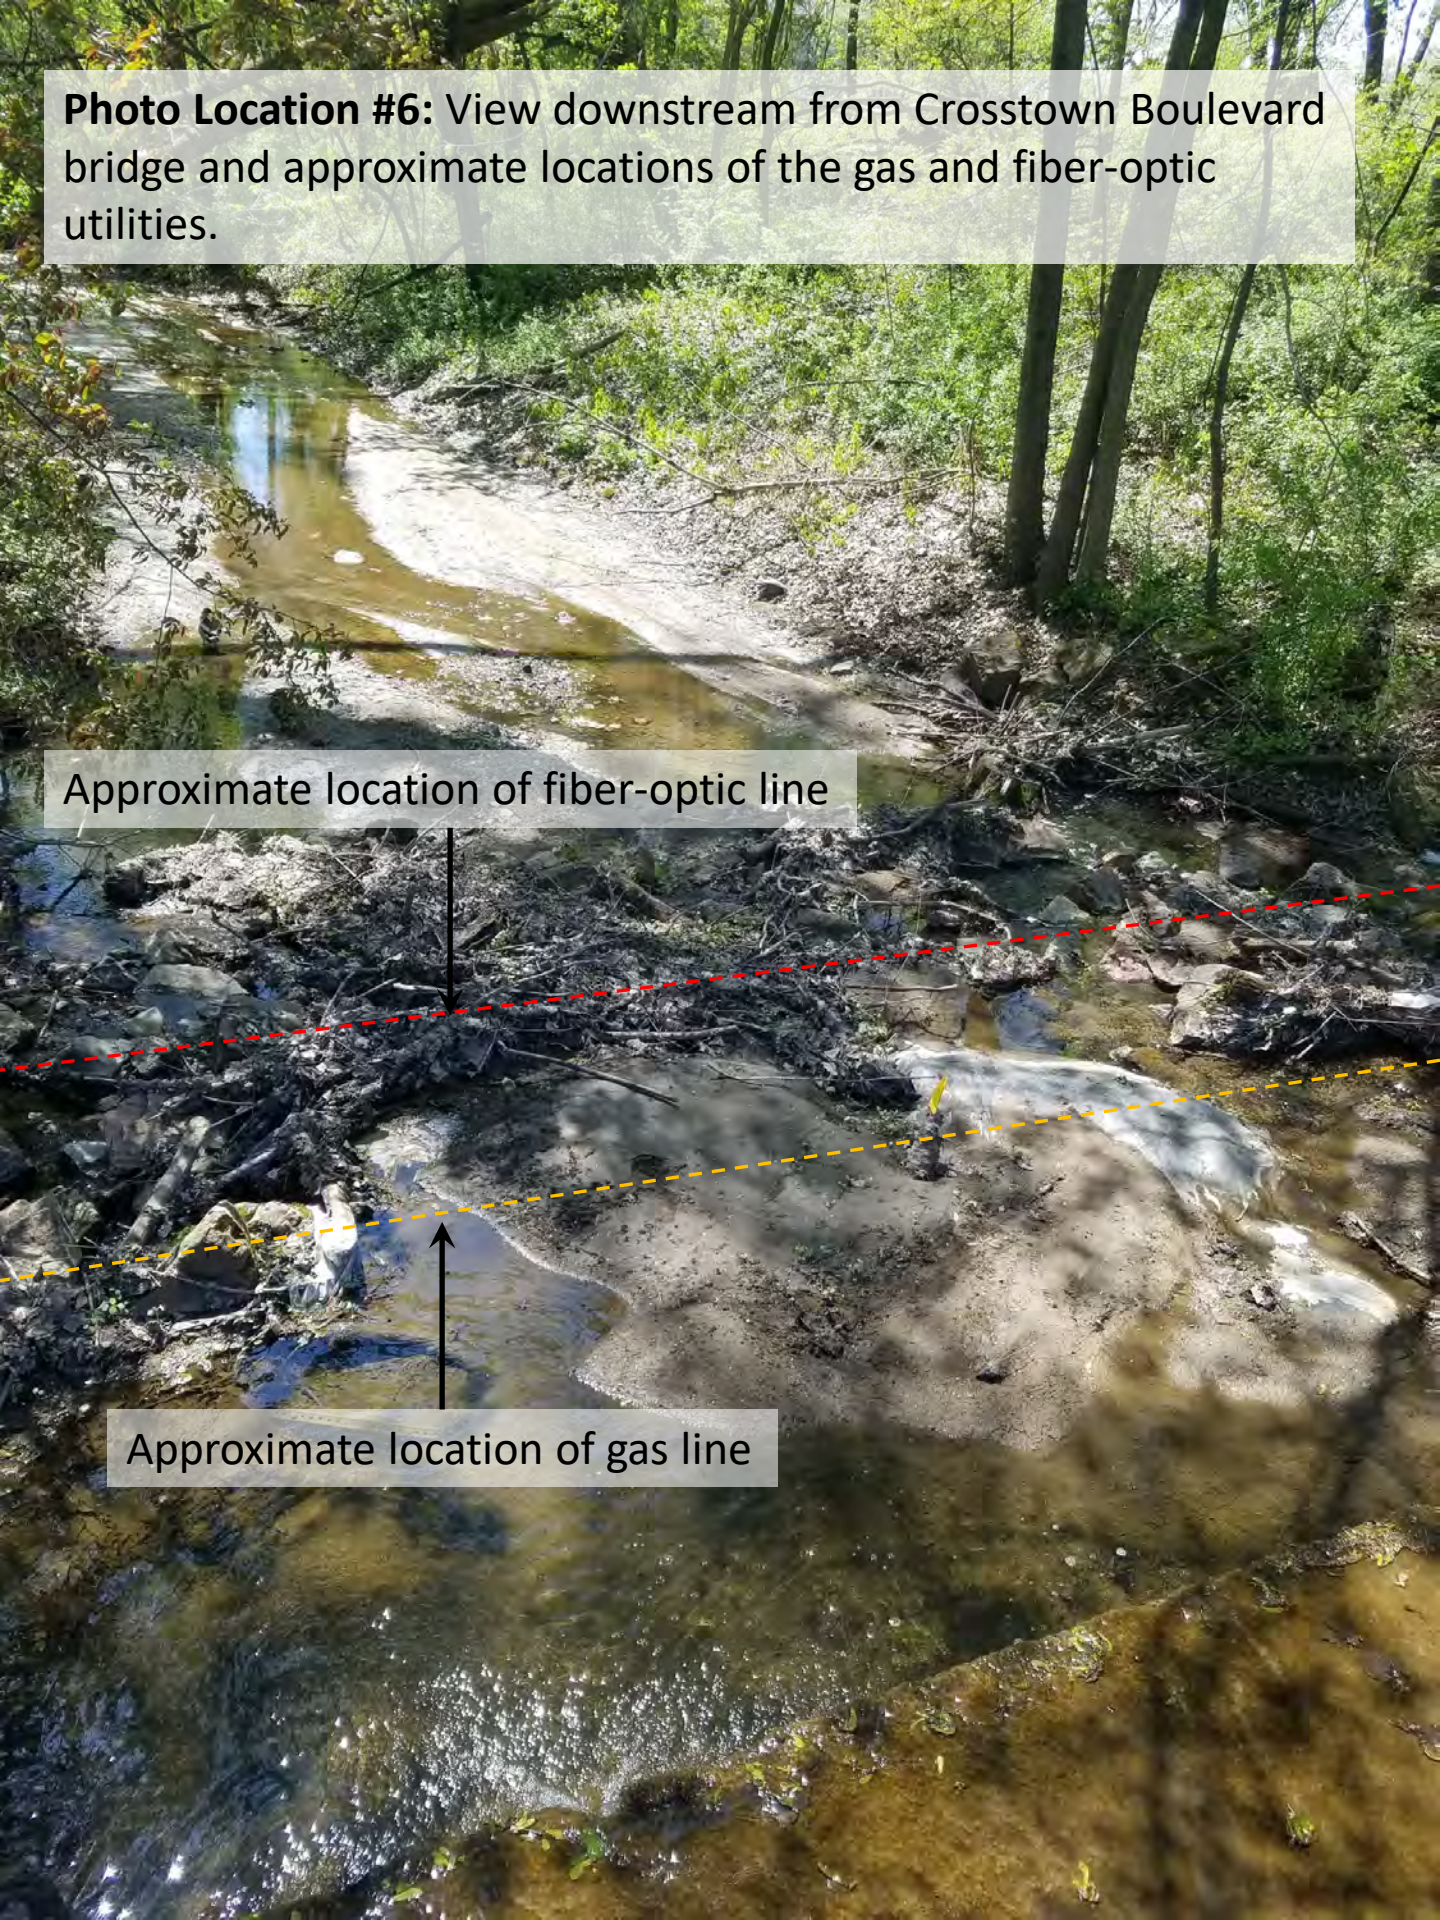
At Crosstown Boulevard, the previous utility locate flag showing the location of the high-pressure gas main downstream from the bridge was still present (Attachment 1, Photo 6). Given the location of the main directly underneath the proposed plunge pool, it was agreed that the plunge pool would be shifted downstream, past the gas main, so that no excavation would occur immediately on top of the main. Sand, filter fabric, and salvaged riprap would be placed on top of the gas main location to extend the bridge apron elevation beyond the gas main, at which point the plunge pool and final boulder weir could be constructed.

Photo Location #6: View downstream from Crosstown Boulevard bridge and approximate locations of the gas and fiber-optic utilities.

Approximate location of fiber-optic line

Approximate location of gas line

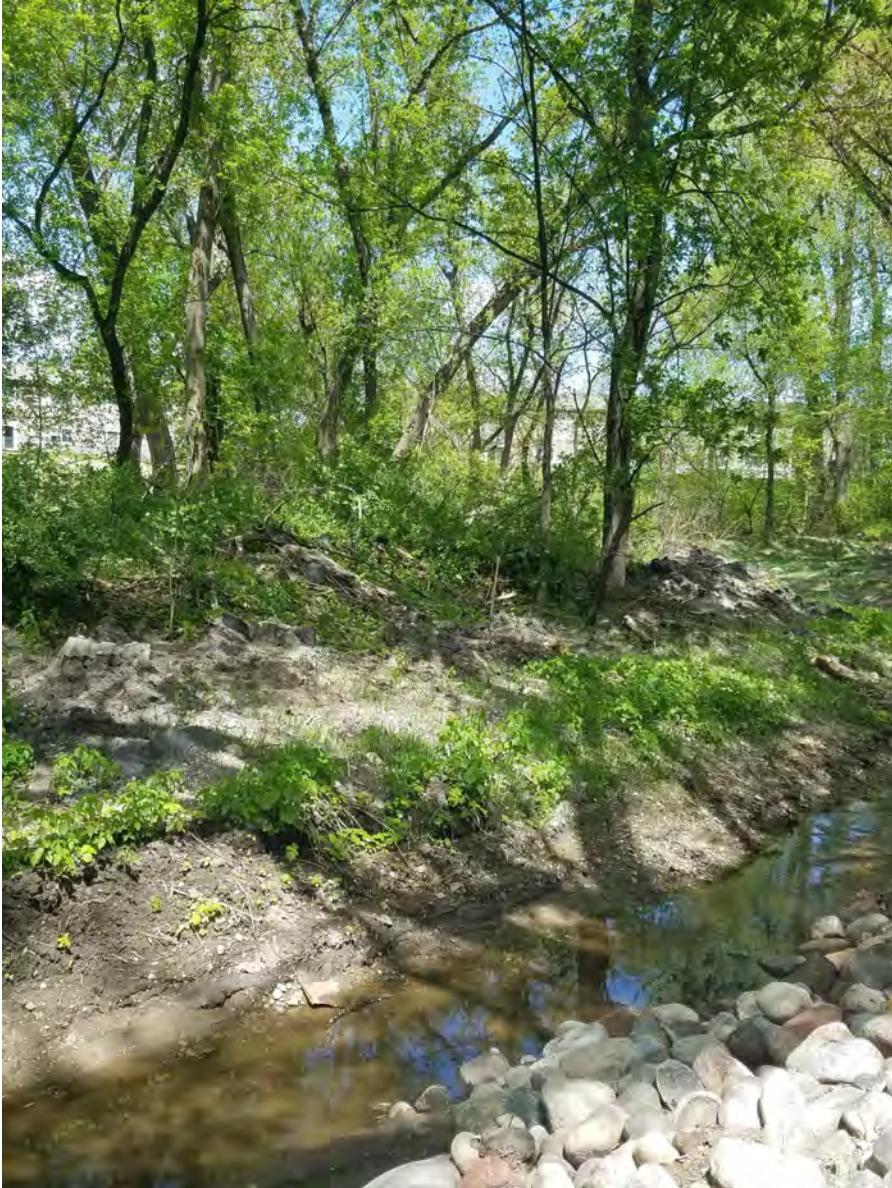
Final Walk Through—Area I

- Areas 1 and 3: Dormant seed placed in March to stabilize the disturbed areas had a poor germination rate, and the frozen material placed on the banks produced a bumpy and rather messy appearance (Attachment 1, Areas 1 and 3 photos).

May 6, 2021—Looking upstream at right bank and spoil pile.

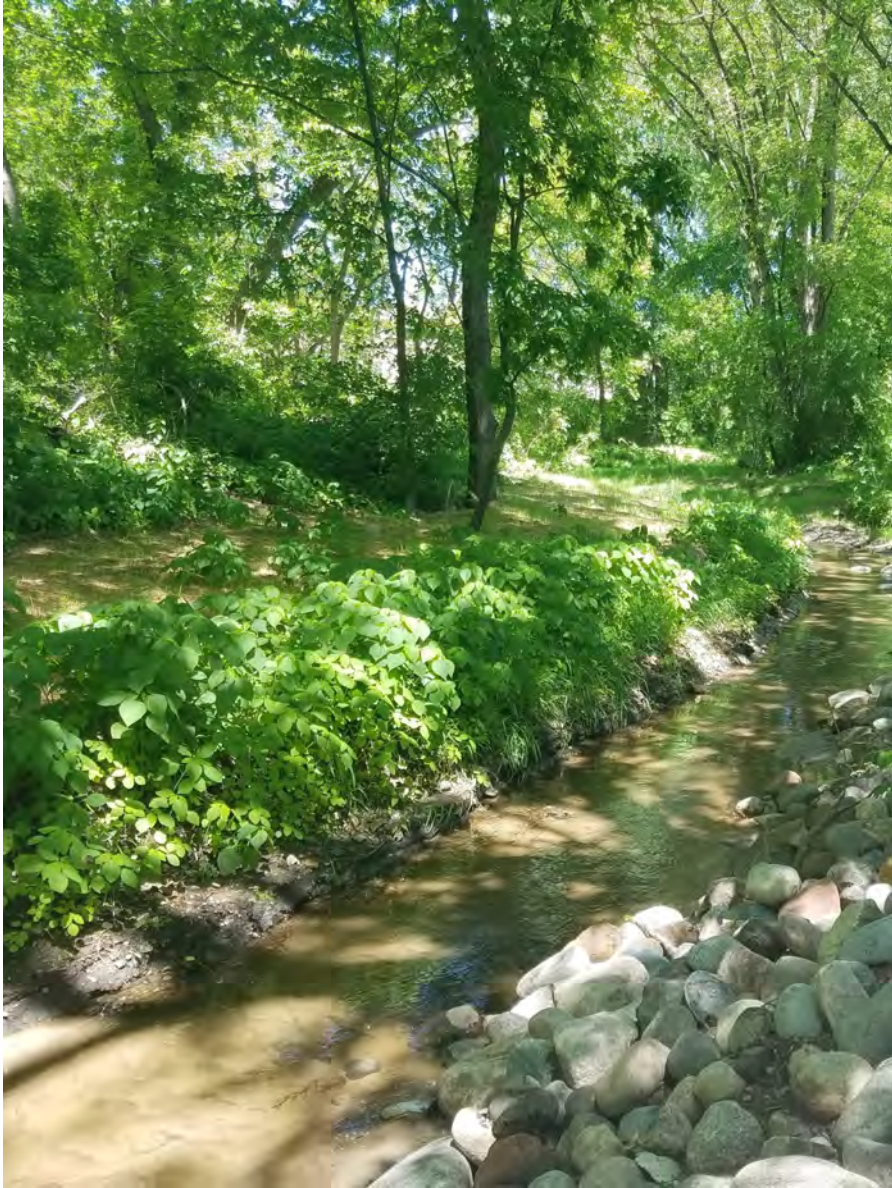
May 28, 2021—Looking upstream at additional grading and erosion control measures placed on right bank.

- *Blackstone has since regraded these areas, provided additional erosion control blankets, and reseeded.*
- Area 2: The right bank was noted to be too steep, especially near the city stormwater outfall and rootwad stream feature.

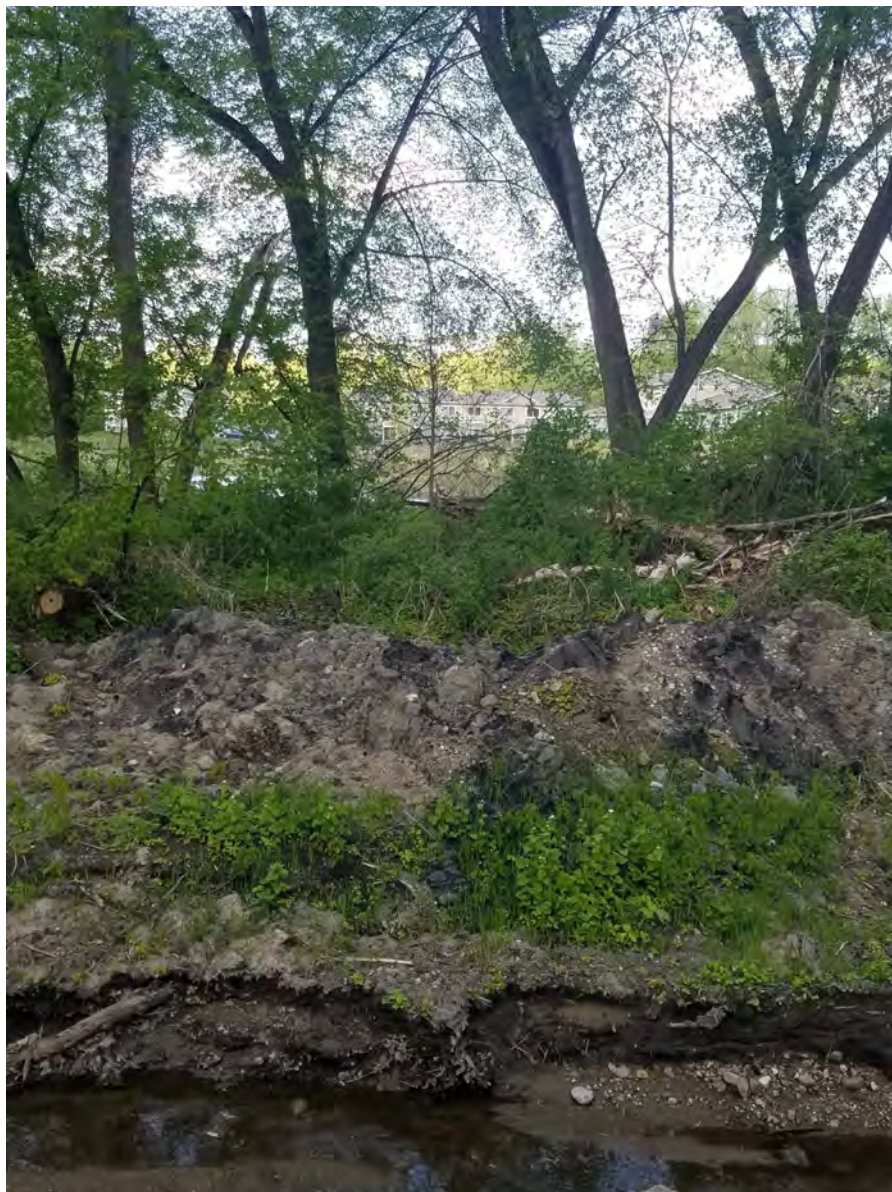
Final Walk Through—Area I

May 6, 2021—Right bank spoils pile and poor vegetation establishment before final grading.

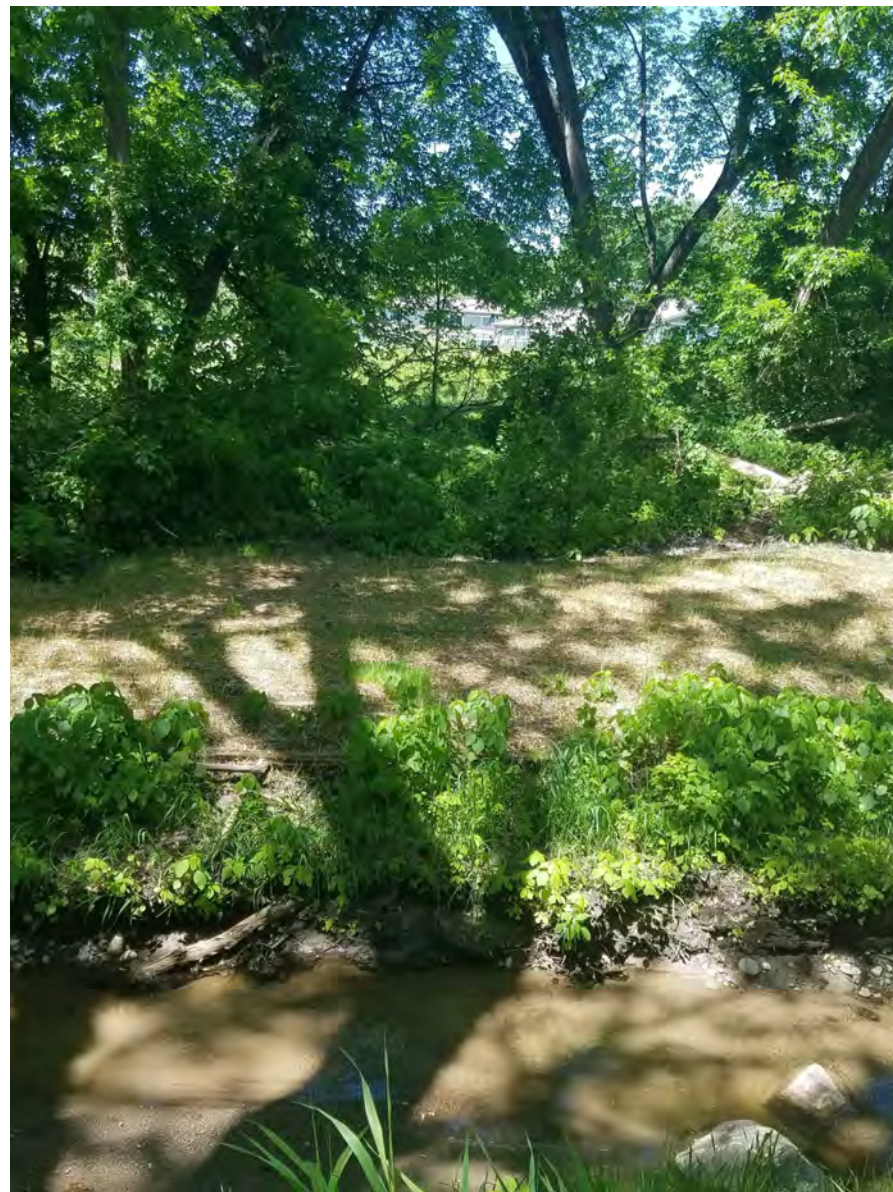
May 28, 2021—Spoils pile removed and erosion control blanket and seeding provided on right bank

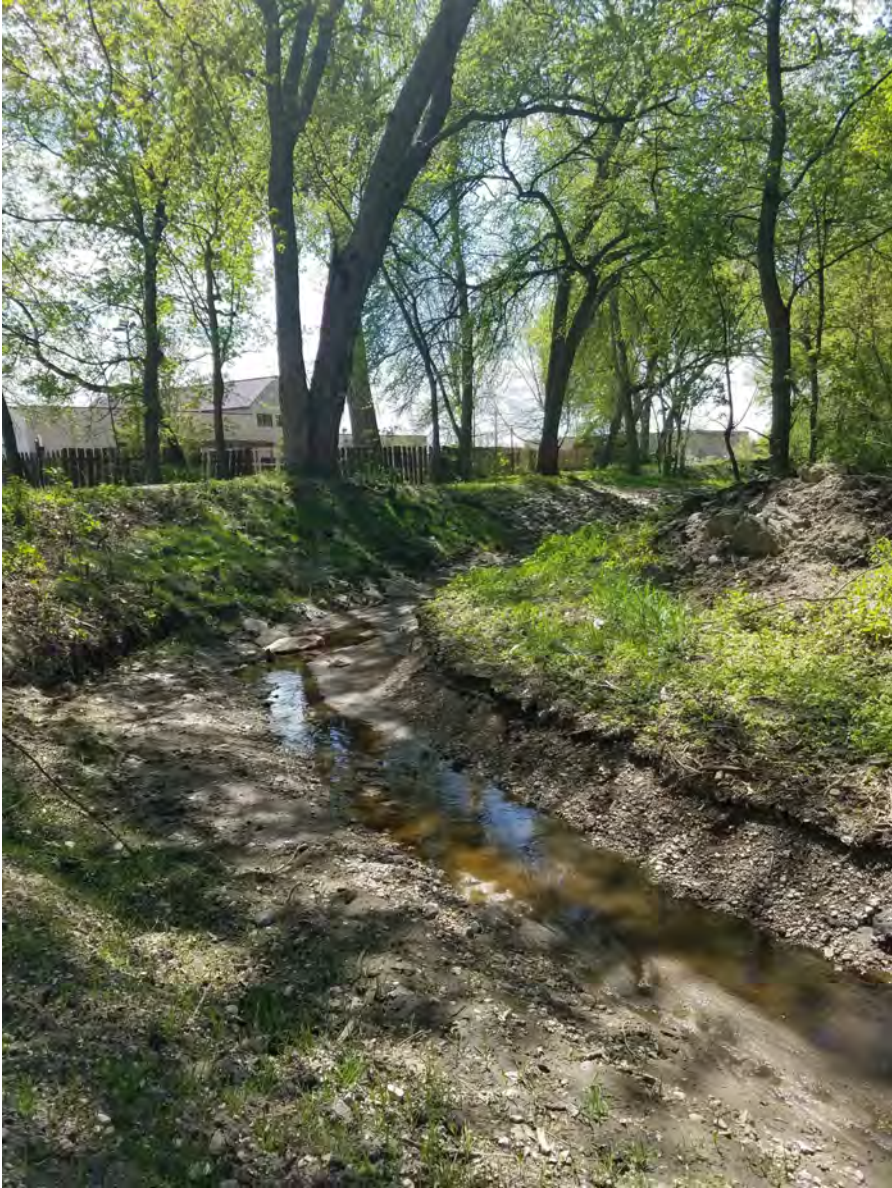
Final Walk Through—Area I

May 6, 2021—Looking downstream at right bank spoils pile and poor vegetation establishment before final grading.
