Technical Memorandum

Re: East Chaska Creek Restoration—Final Walk-Through

Re: East Chaska Creek Restoration—Construction Update

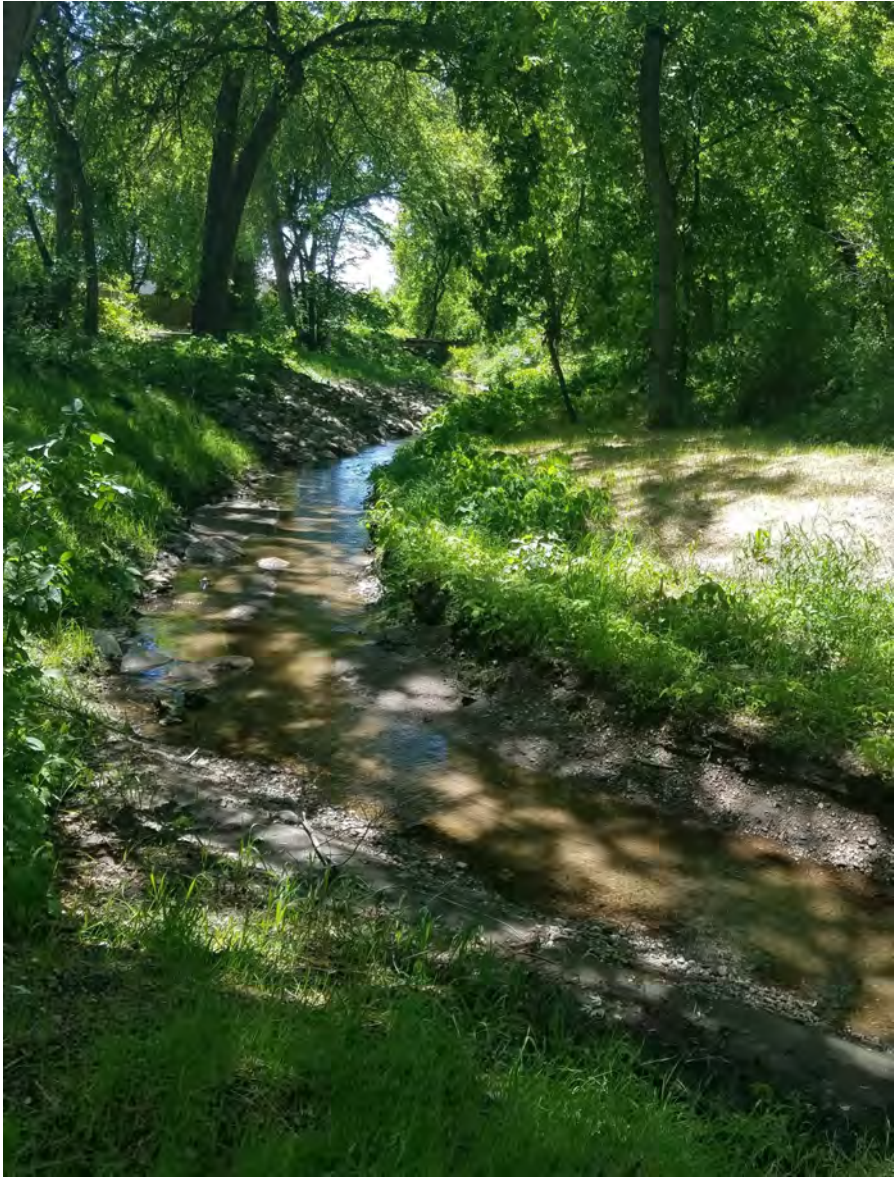
May 28, 2021—Spoils pile removed and erosion control blanket and seeding provided on right bank

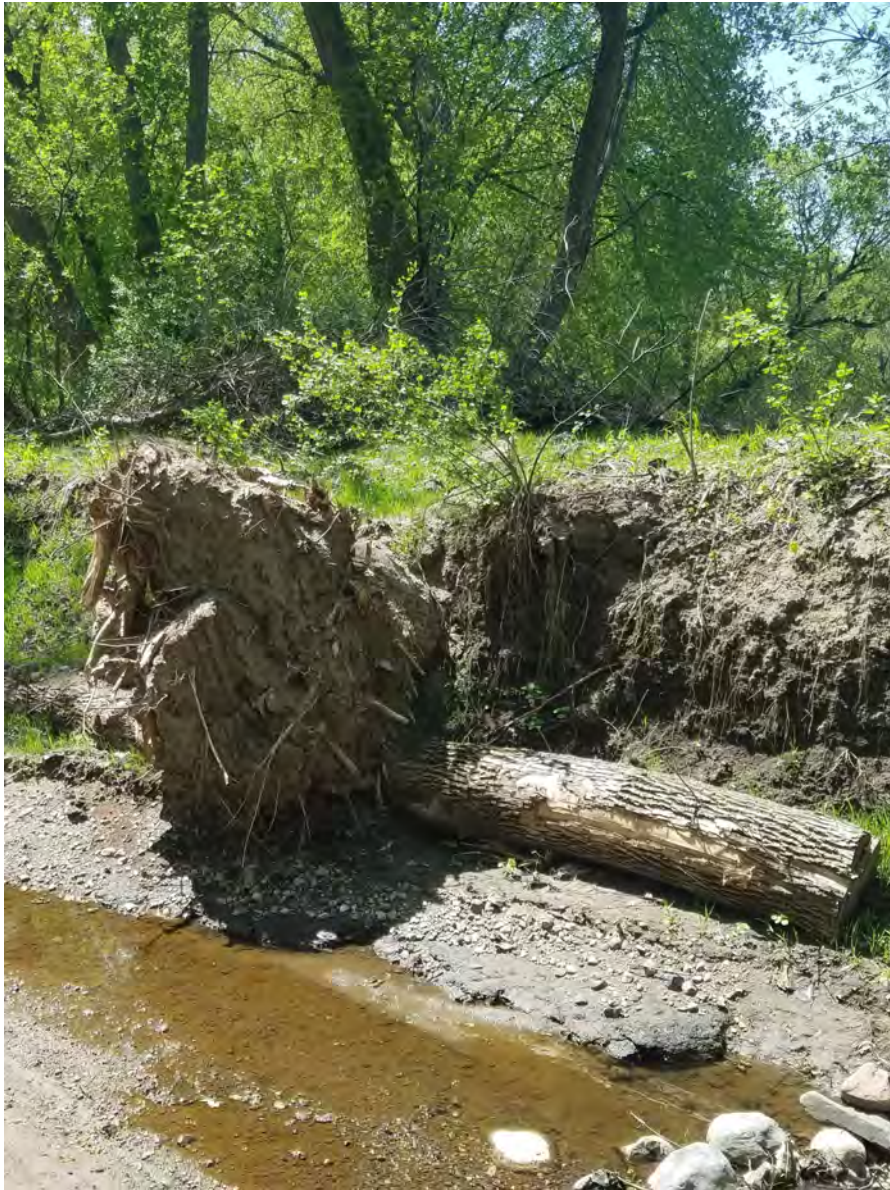
Final Walk Through—Area 2

- *Blackstone has since regraded these areas, provided additional erosion control blankets, and reseeded.*
- Area 2: The right bank was noted to be too steep, especially near the city stormwater outfall and rootwad stream feature.

May 6, 2021—Right bank rootwad and vertical bank.

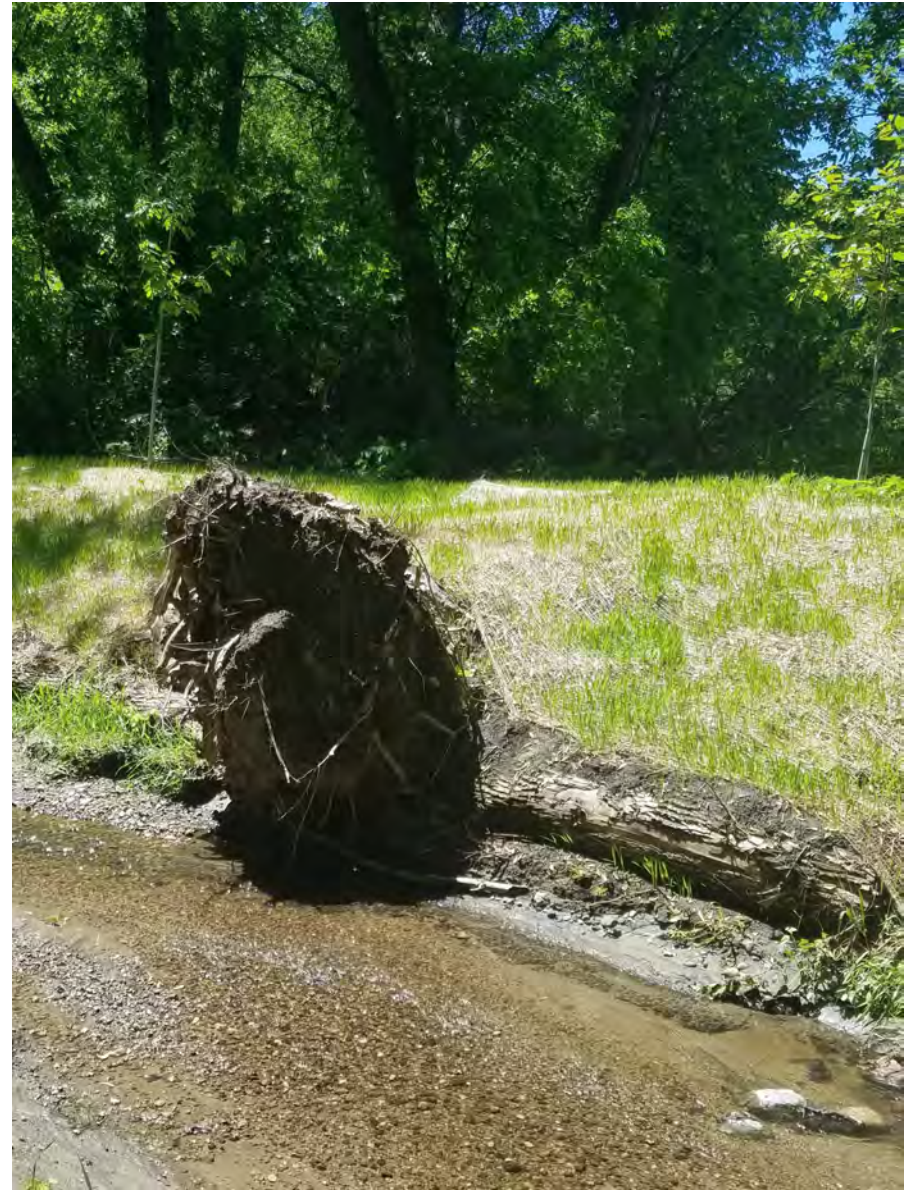
May 28, 2021—Right bank re-graded and additional stabilization/erosion control measures installed. Trees planted on upper right bank.

- *The right bank at the stormwater outfall has been corrected by Blackstone (Attachment 1, Area 2 photo).*
- Areas 2 and 3: The footer long underneath the rootwads appeared to be placed too high.

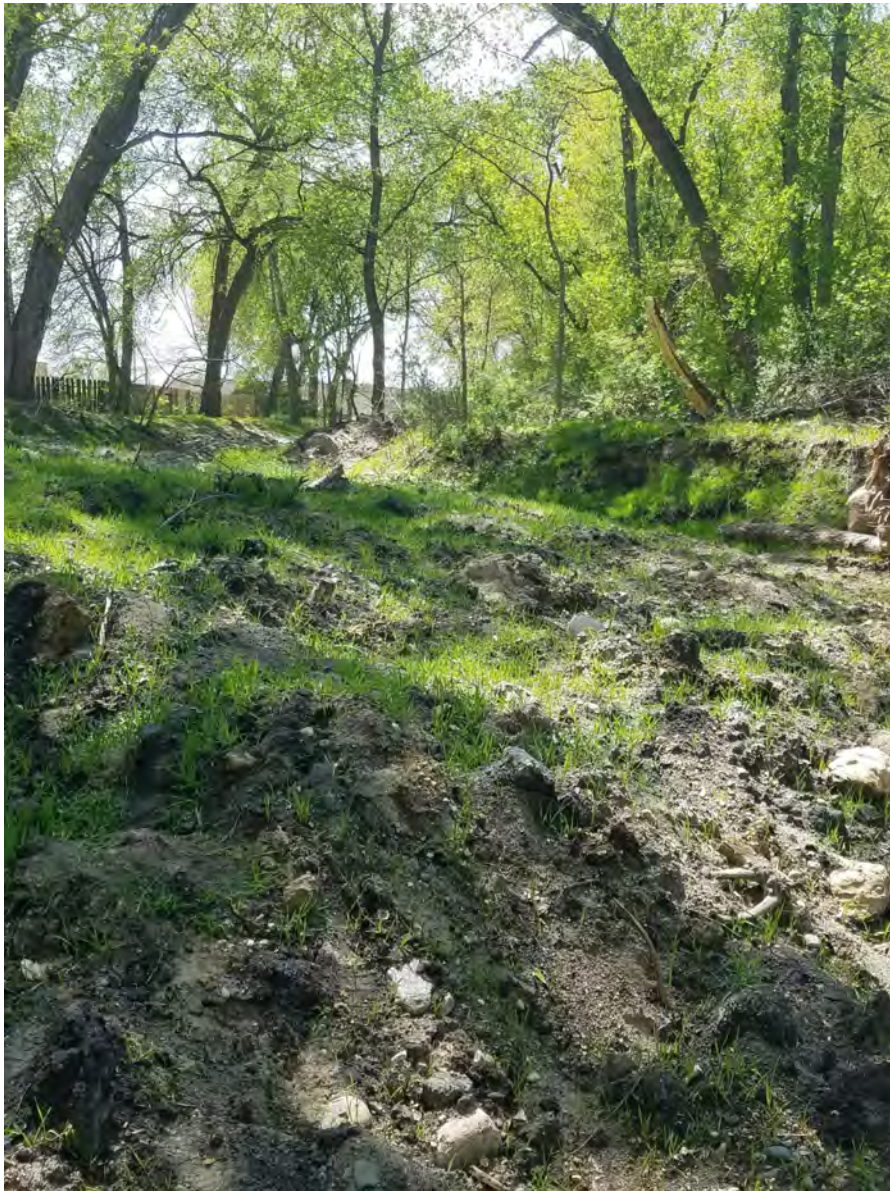
Final Walk Through—Area 3

May 6, 2021—Left bank spoil pile and poor vegetation establishment before final grading.

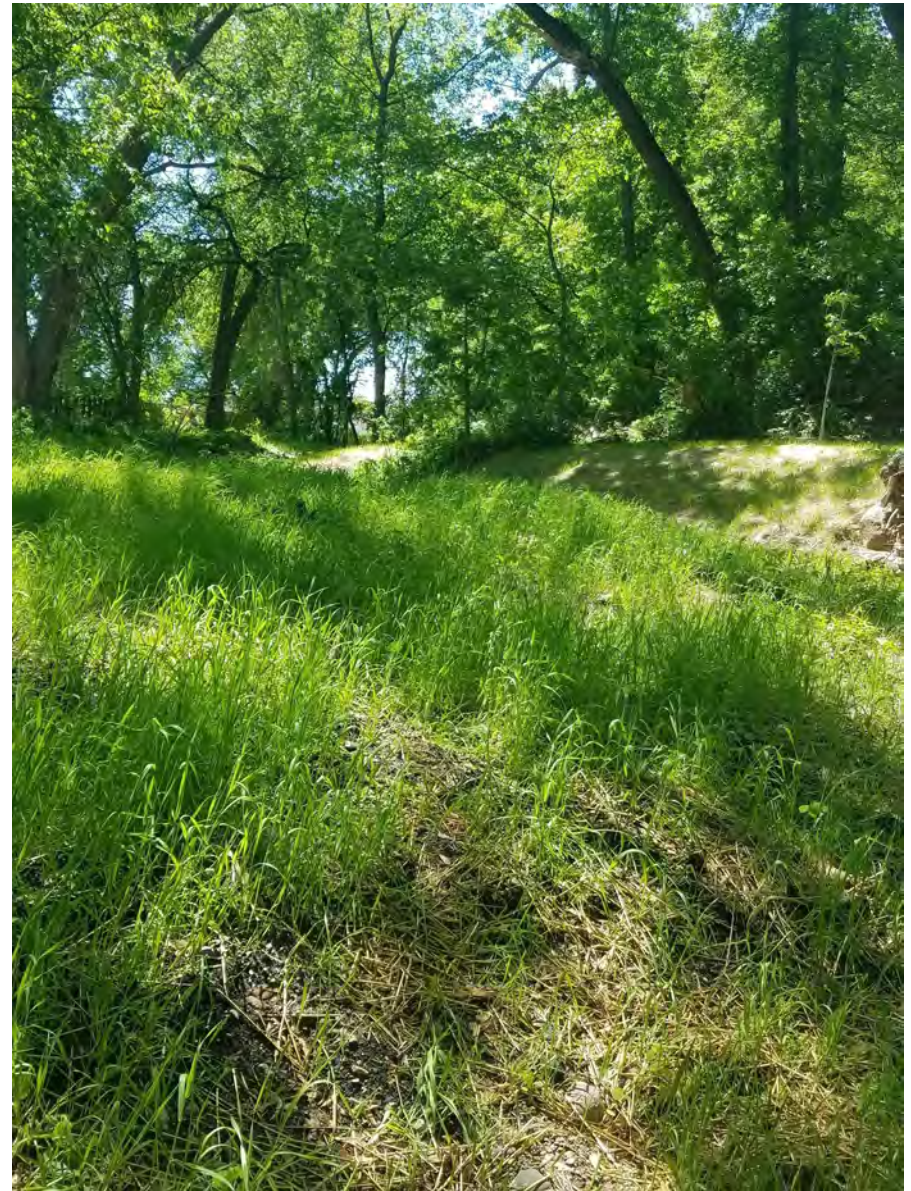
May 28, 2021—Left and right banks re-graded and additional stabilization/erosion control measures installed. Trees planted on upper right bank.

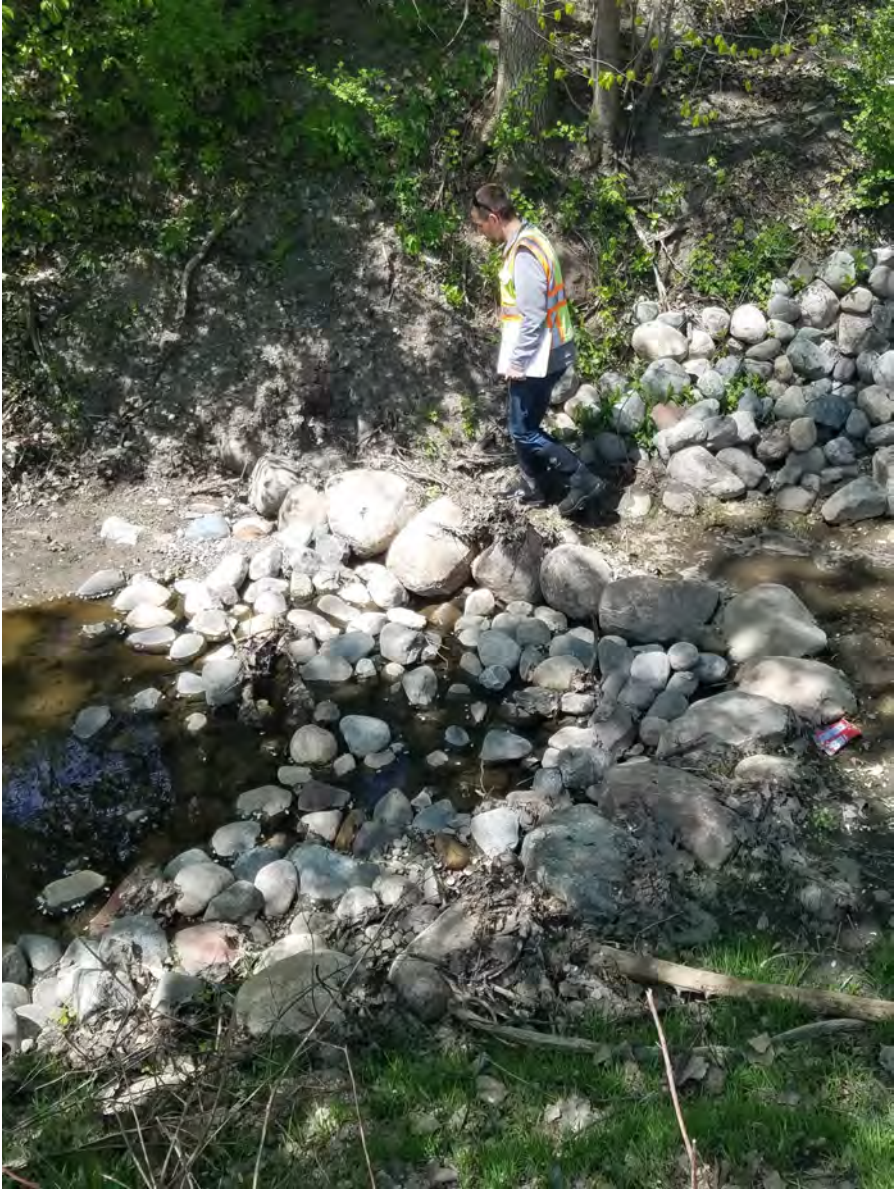
Final Walk Through—Area 4

- Areas 4 and 5: The two constructed cross-vane structures appeared to have caused bank erosion as a result of improper elevations of the header rocks.

May 6, 2021—Example of right bank erosion at cross vane and incorrect placement of upstream cross vane boulders creating a stagnant pool upstream.

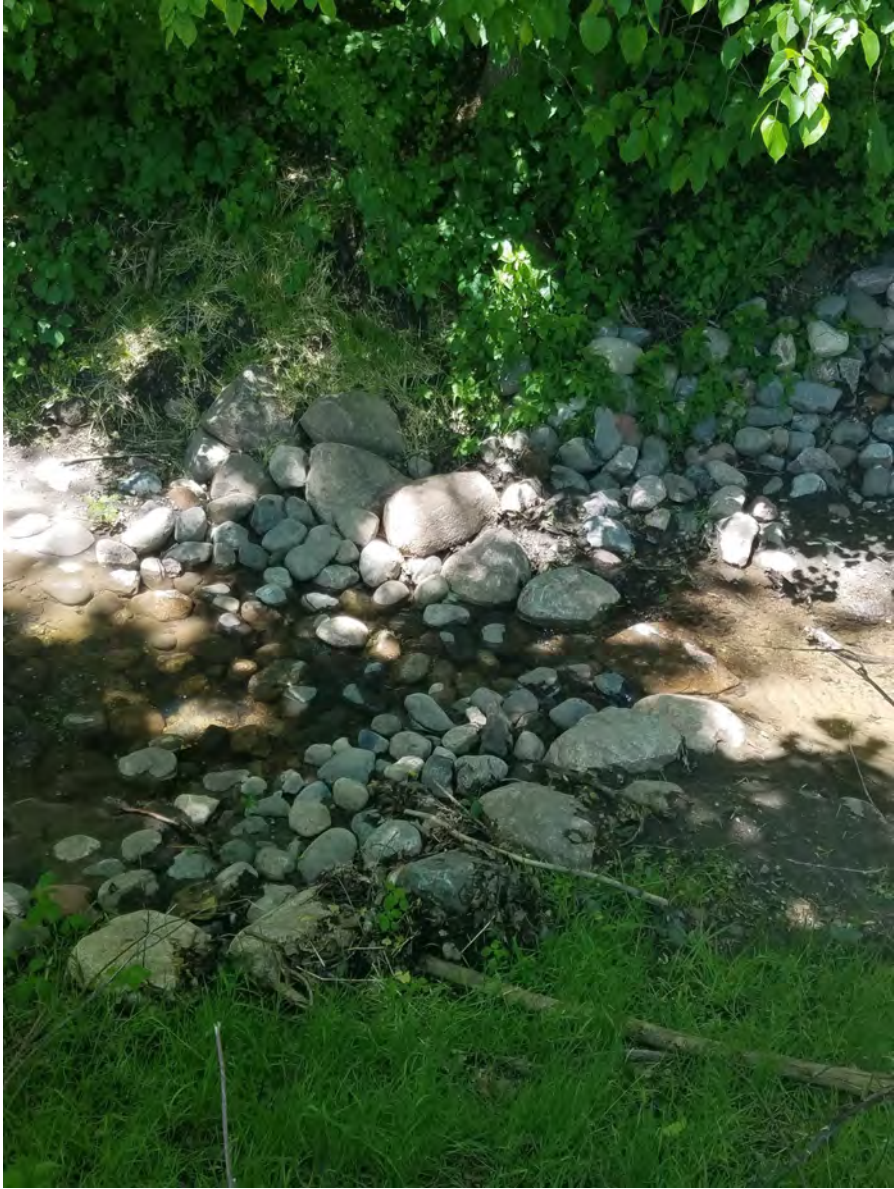
May 28, 2021—Additional riprap placed on right bank; upstream cross vane boulders lowered allowing water to flow more freely.

- *These locations have since been adjusted by Blackstone (Attachment 1, Areas 4 and 5 photos).*
- Area 6: The plunge pool and cross-vane at Crosstown Boulevard conflict with the existing high-pressure gas main and fiber-optic line.

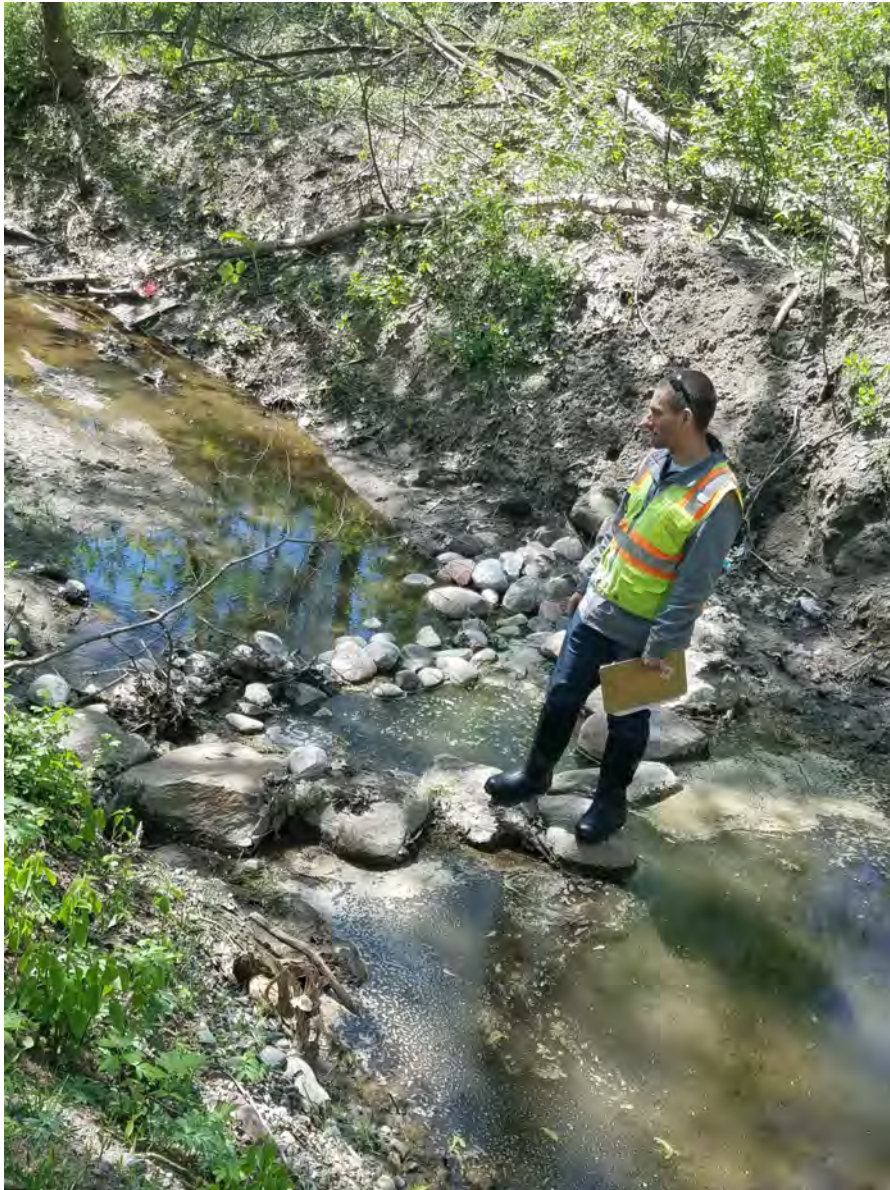
Final Walk Through—Area 5

May 6, 2021—Bank erosion at cross vane and incorrect placement of upstream cross vane boulders, creating a stagnant pool upstream.

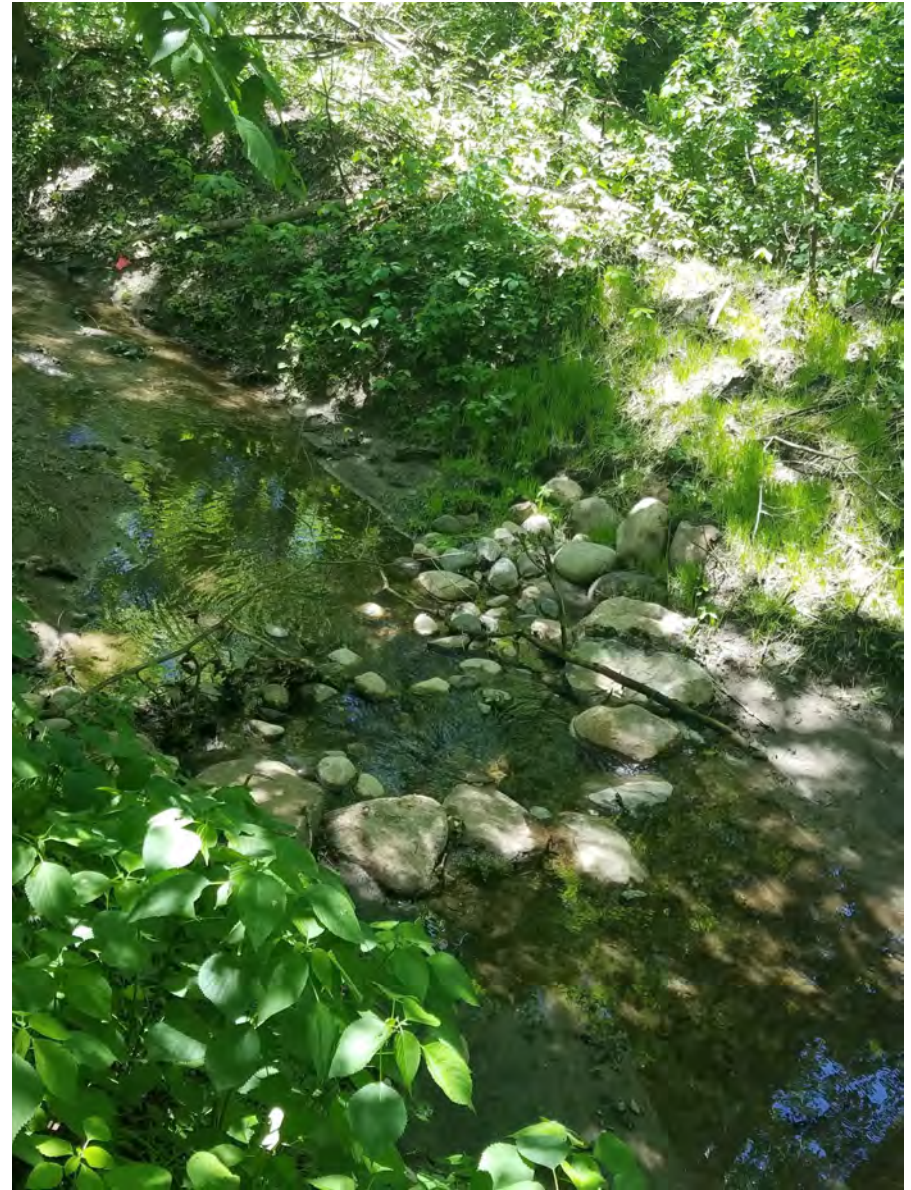
May 28, 2021—Additional riprap placed on both banks, as well as erosion control blanket; upstream cross vane boulders lowered allowing water to flow more freely.

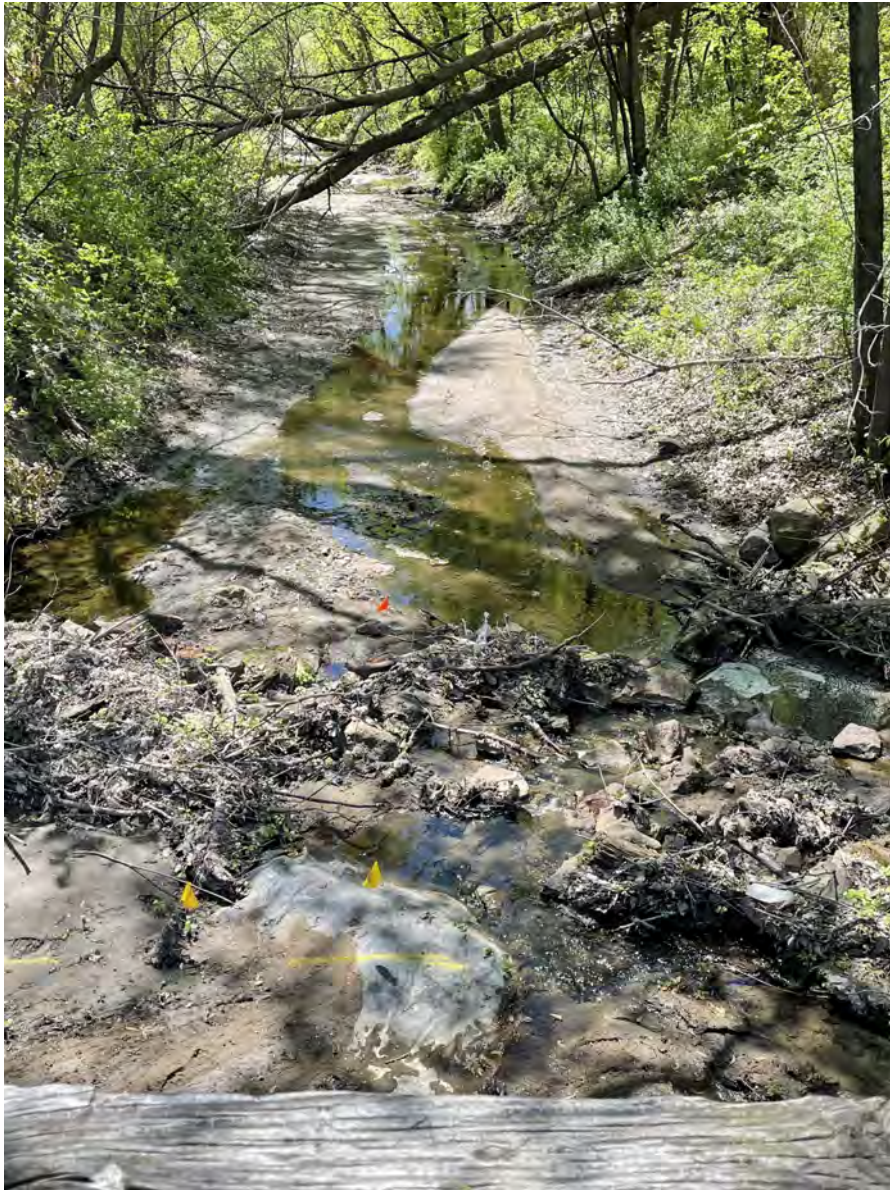
Final Walk Through—Area 6

At Crosstown Boulevard, the utility location surveys showed the location of a high-pressure gas main and fiber-optic line downstream from the bridge. Because of the utilities, Barr adjusted the proposed design to extend the riprap protection at the bridge apron downstream past the fiber-optic line, then to construct the plunge pool so no excavation would occur immediately on top of the gas main or fiber-optic line. The final cross-vane weir was eliminated from the proposed design after Barr reviewed the channel hydraulics with the modifications and determined this additional grade control structure was not necessary. Barr has also confirmed that although the design has been modified from the originally permitted conditions, the changes are minor and do not affect the original permit terms.

May 7, 2021—View downstream from Crosstown Boulevard bridge with utility locations (yellow = gas, orange = fiber optic), prior to construction.

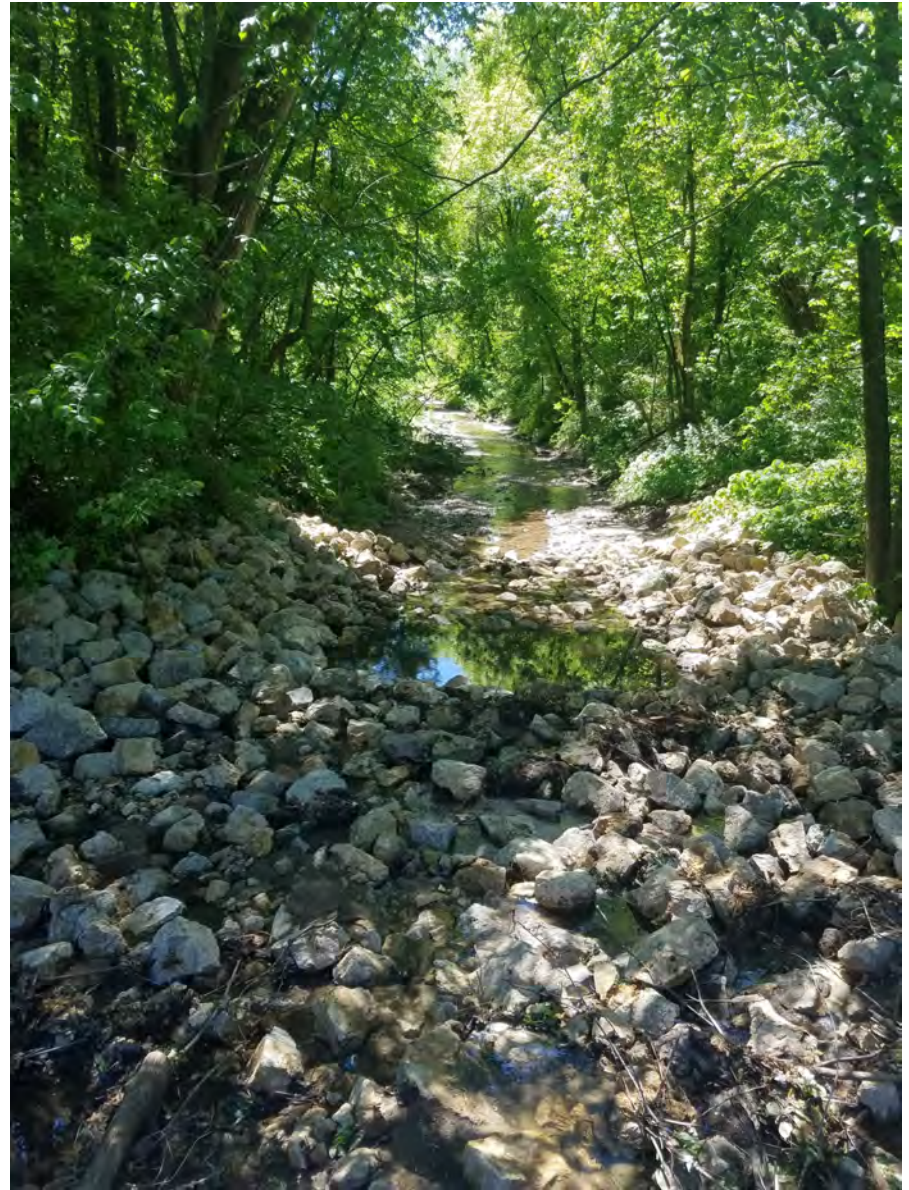
May 28, 2021—Final constructed riprap flume and plunge pool; fallen trees removed from channel.

- *This area has been constructed by Blackstone following design modifications discussed in the following section of this memo.*
- General: The city provided stakes indicating where plants (red twig dogwood and swamp white oak) were to be placed.

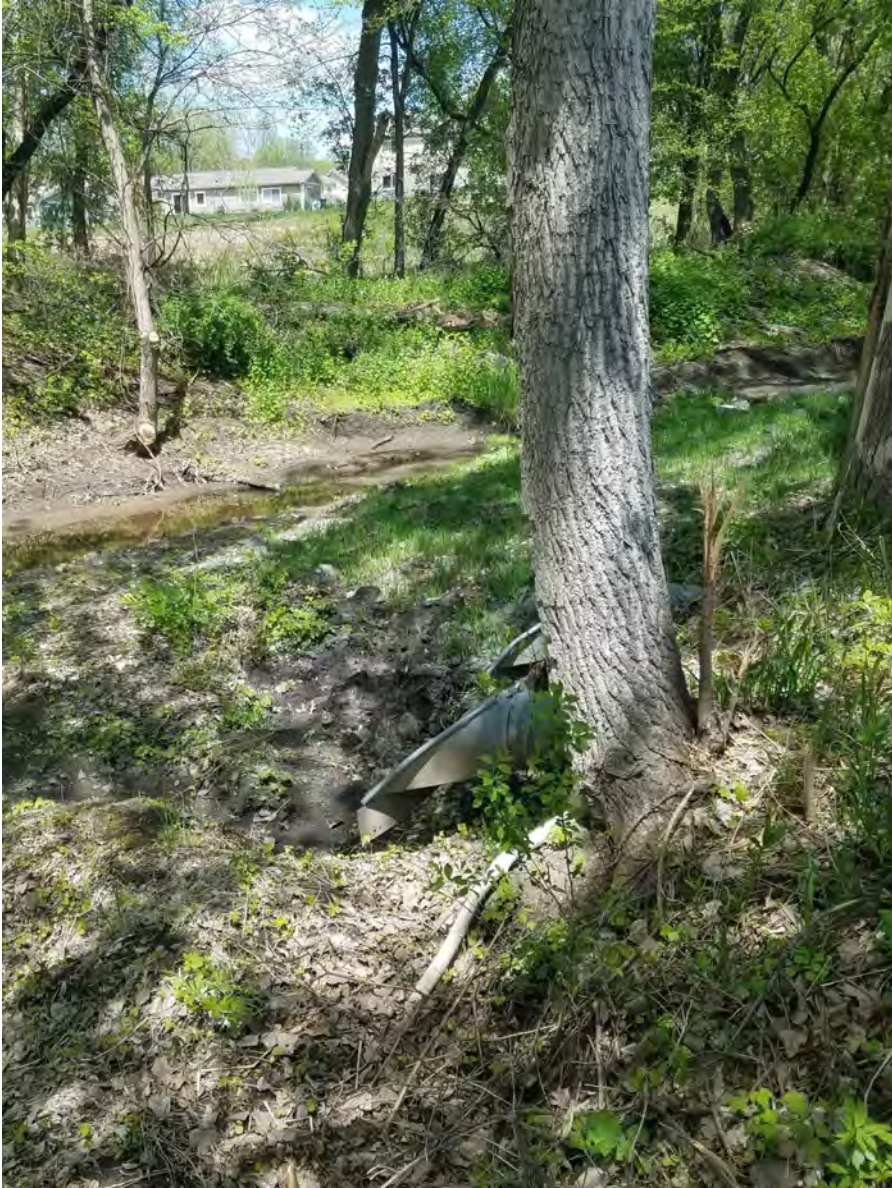
Final Walk Through—Photo Location 7

May 6, 2021—Hanging pipe outfalls outside the project limits.

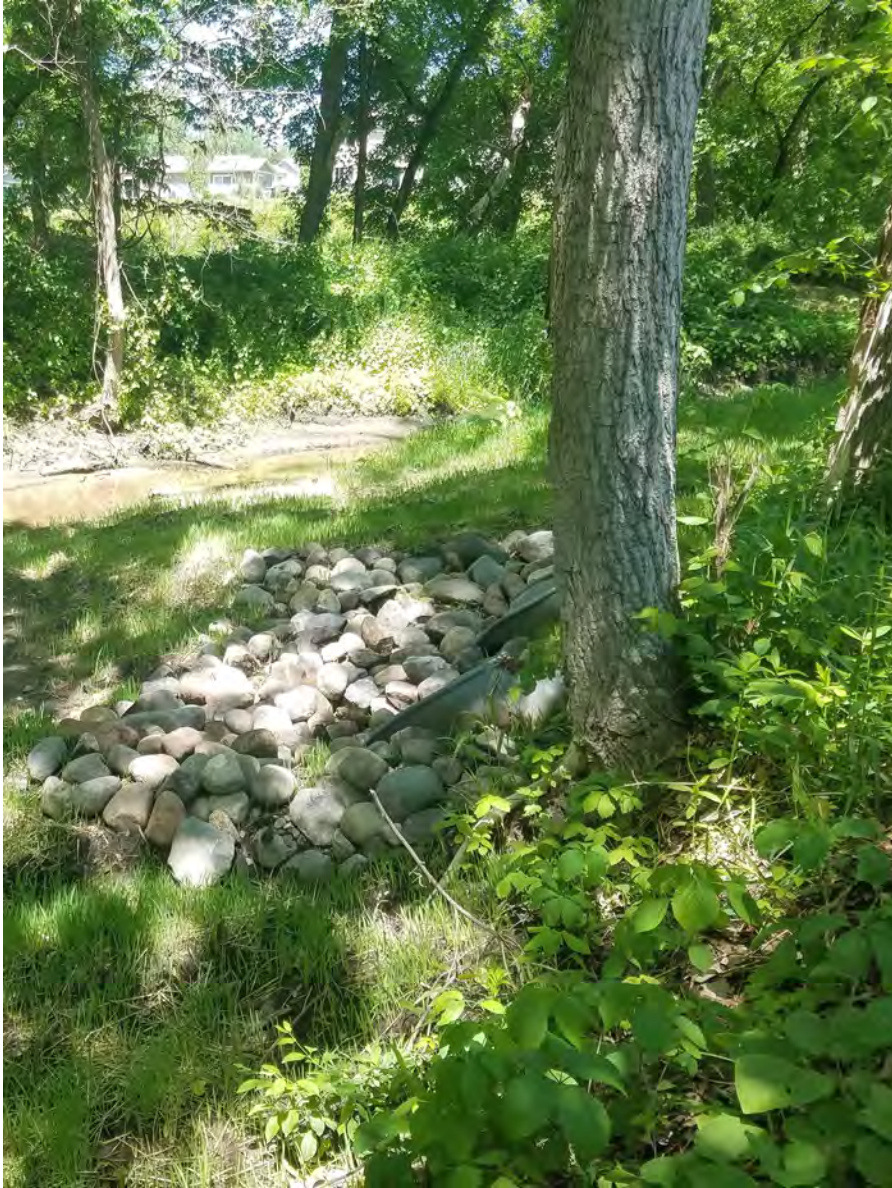
May 28, 2021—Additional riprap placed.

- Area 7: Two storm outfalls were found to be hanging during the May 6 site walk. The locations were discussed, and it was noted the area was outside the project limits.
 - *Riprap has been placed under the stormwater outfalls, and additional seeding appears to have been placed.*
- Area 8: Left bank erosion had previously been stabilized by the city with concrete to protect the trail. This was discussed in the field, but it was observed that this area was not part of the East Chaska Creek project; Blackstone noted if additional material was left over, it could be placed in this area.
 - *Riprap has been placed along the left bank, filling in the undercut areas.*

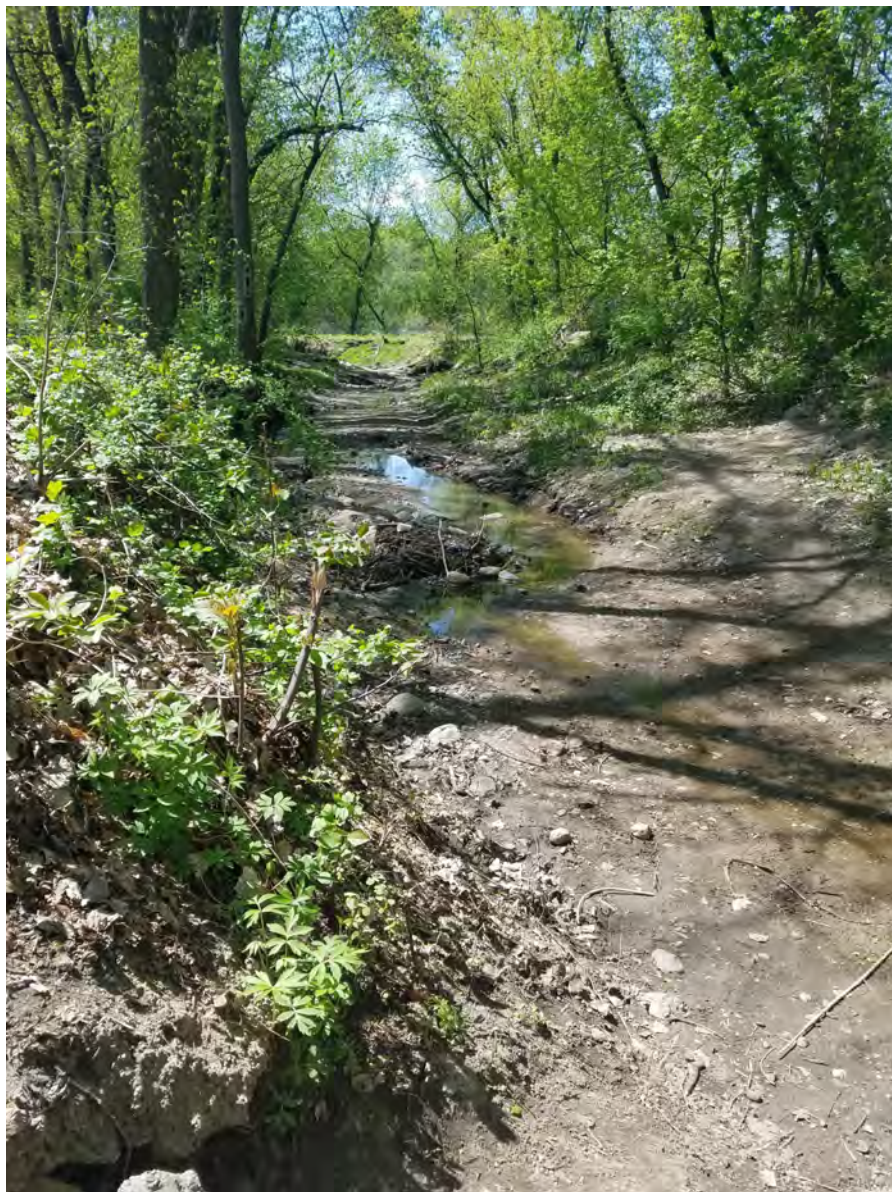
Final Walk Through—Area 8

May 6, 2021—Existing left bank erosion; while located within the project limits, this area was not part of the East Chaska Creek Stabilization Project.

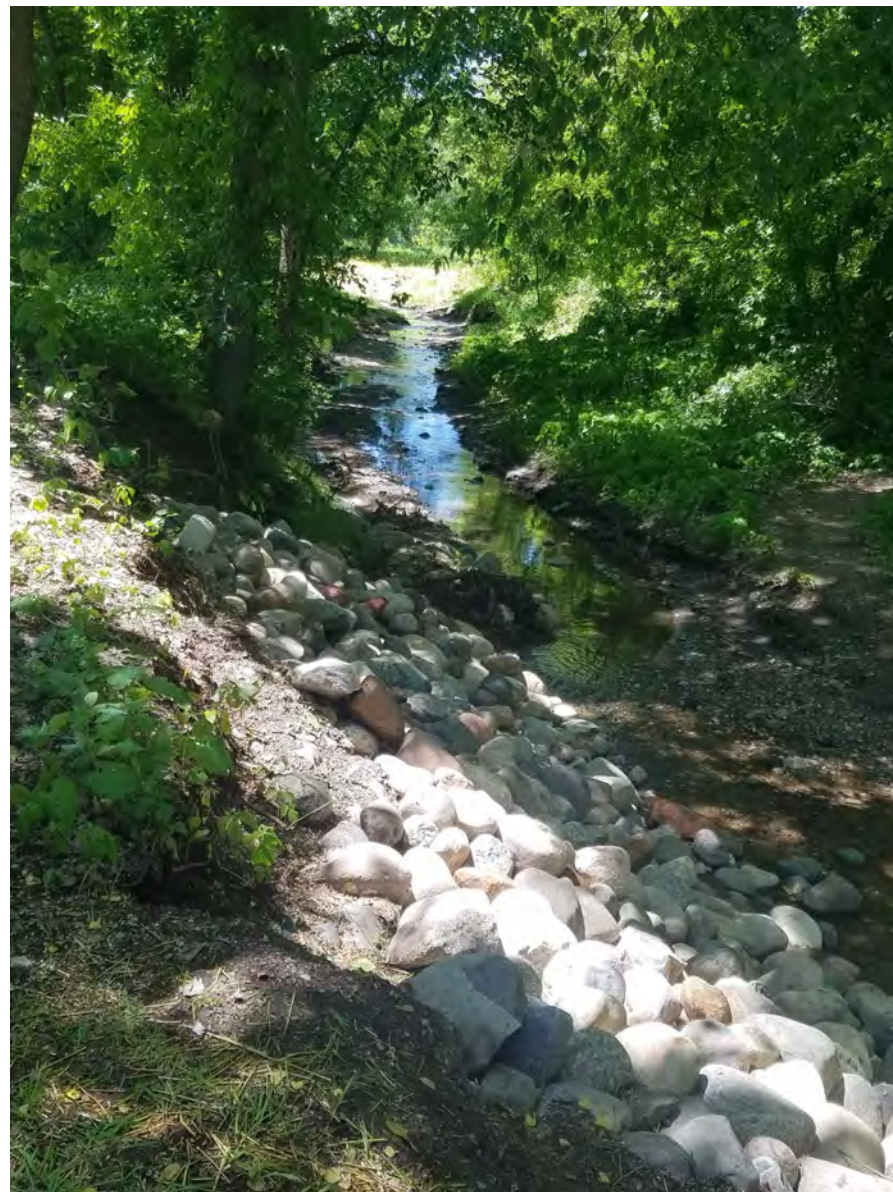
May 28, 2021—Additional riprap placed.
