2021 GULLY INVENTORY AND CONDITION ASSESSMENT, VOLUME 2

July 15, 2022

Lower Minnesota River Watershed District
Gully Inventory and Condition Assessment, Volume 2
Chaska, Minnesota

Revision 0
July 15, 2022

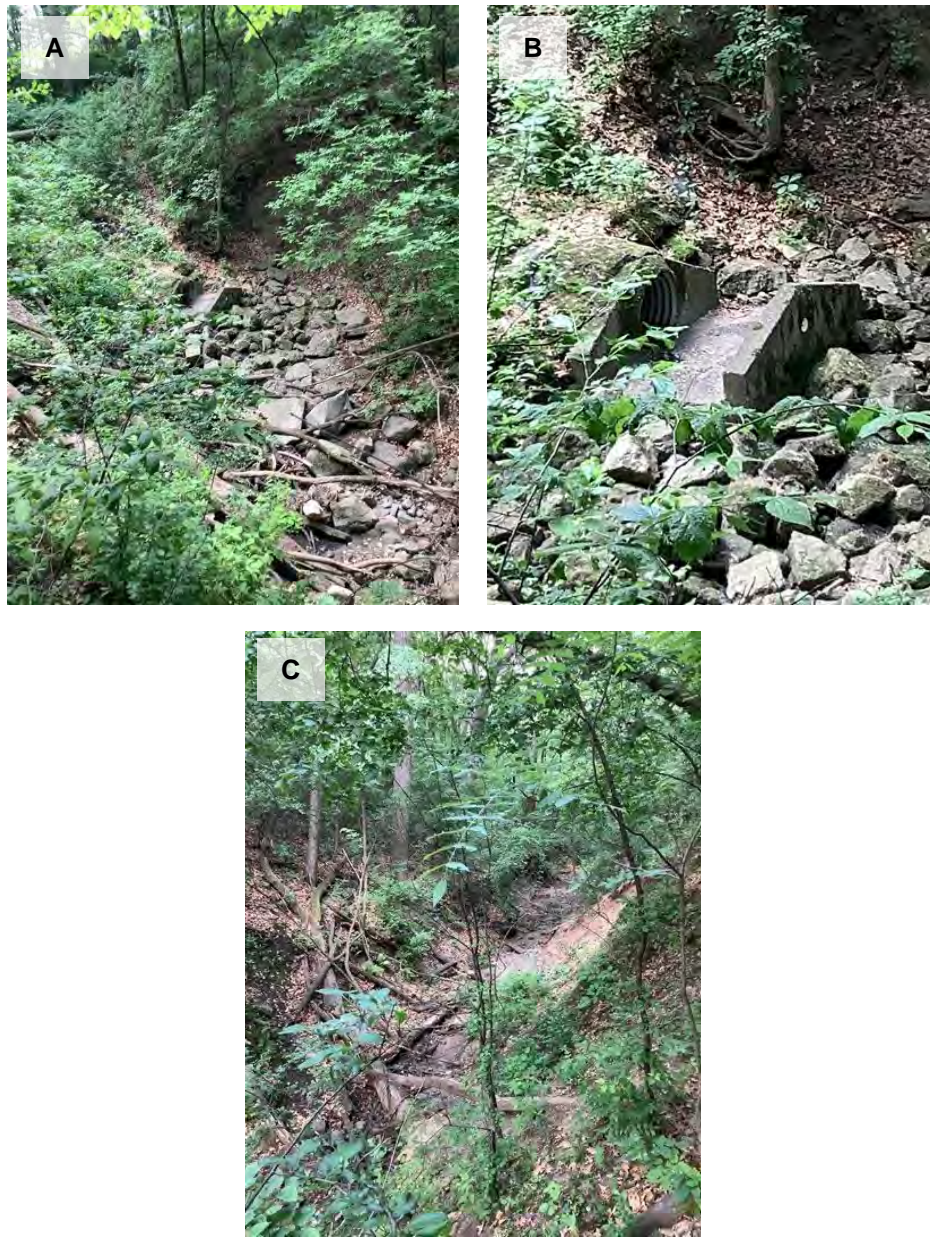
Figure 4: Photos of Gully 06:08-01:06 A) Upstream view of gully, B) Upstream view of pipe, C) Downstream view of gully

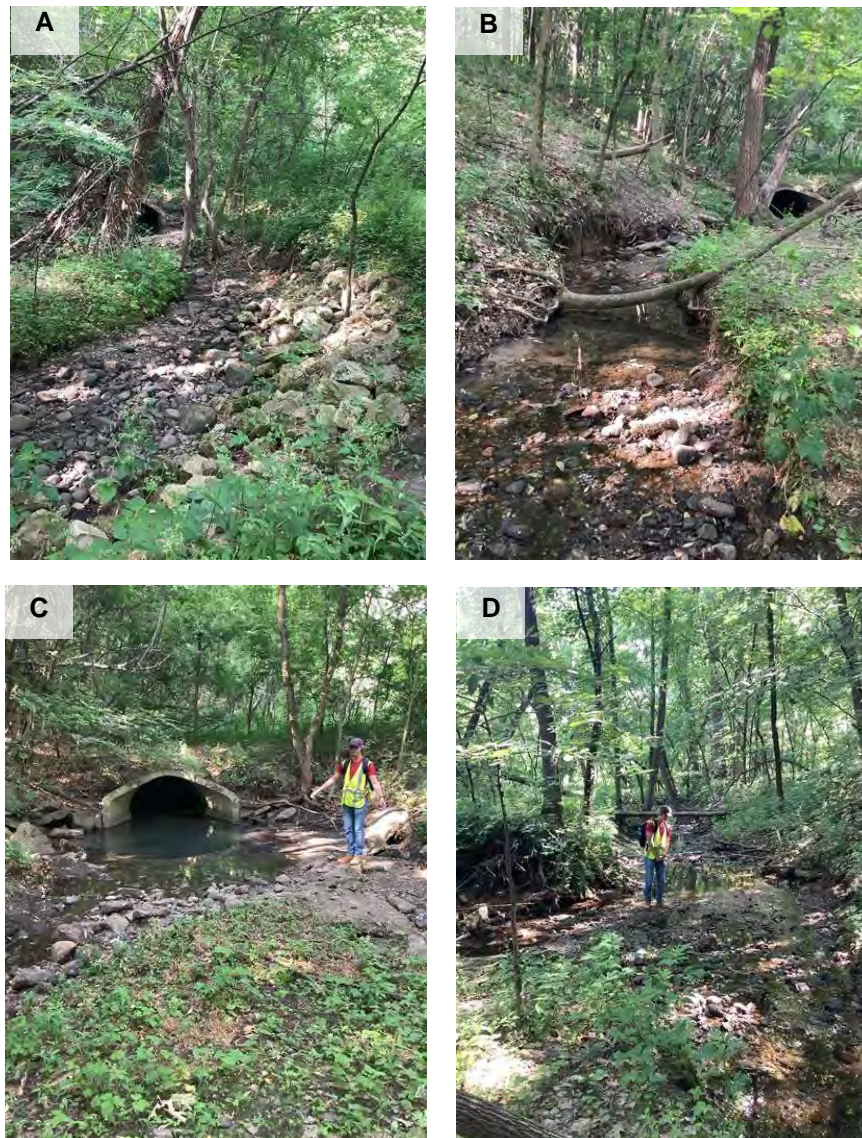
Figure 9: Photos of Gully 06:23-09:32 A) Upstream view of left bank, B) Upstream view of right bank, C) Upstream view of pipe outfall, D) Downstream view of where gully reconnects

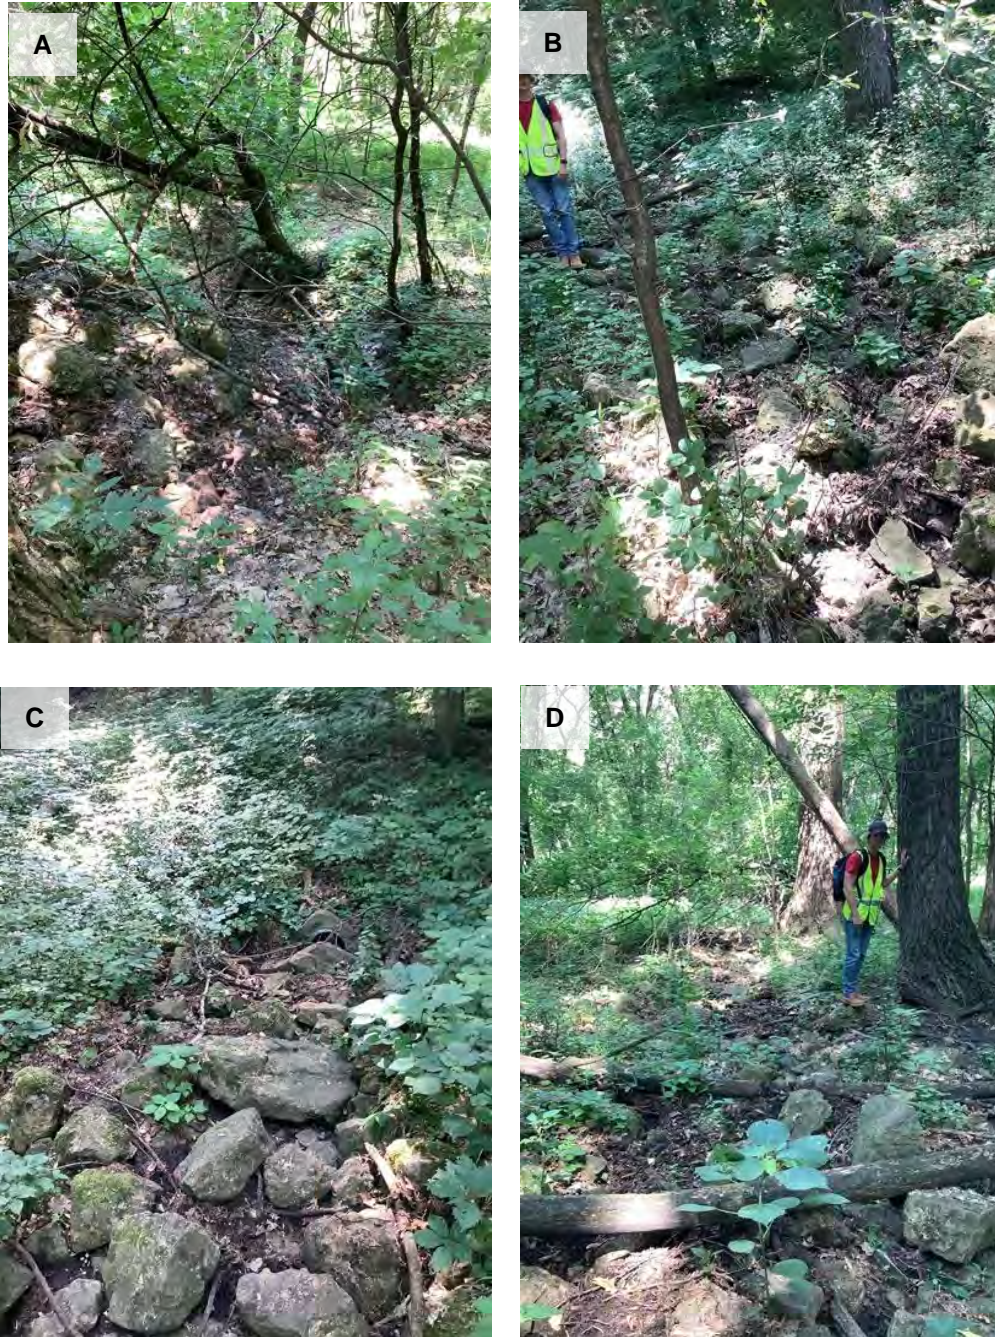
This gully was located north of 27th Avenue South at the bottom of a very steep slope. This site was long but shallow, with some riprap armoring (Figure 17). The gully began from a small pipe that was heavily armored and stable. Approximately 50 feet downstream, the gully slope steepened, and the degradation became severe, with very little vegetation on the banks and gully bottom. The gully banks are steep, forming a V-shape. There were trees leaning over the channel, and the banks were slumping. This site scored a 34 for erosion potential, placing it in the moderate erosion category; however, when combined with the Tier 1 impact zone, this gully was classified as a high-risk site. This gully discharged into an area that was inaccessible because of a homeless encampment. This site should be revisited to confirm the severity of the overall gully erosion.

Figure 17: Photos of Gully 06:23-11:37 A) Downstream view of gully, B) Upstream view of gully, C) Upstream view of pipe, D) Downstream view past pipe outfall

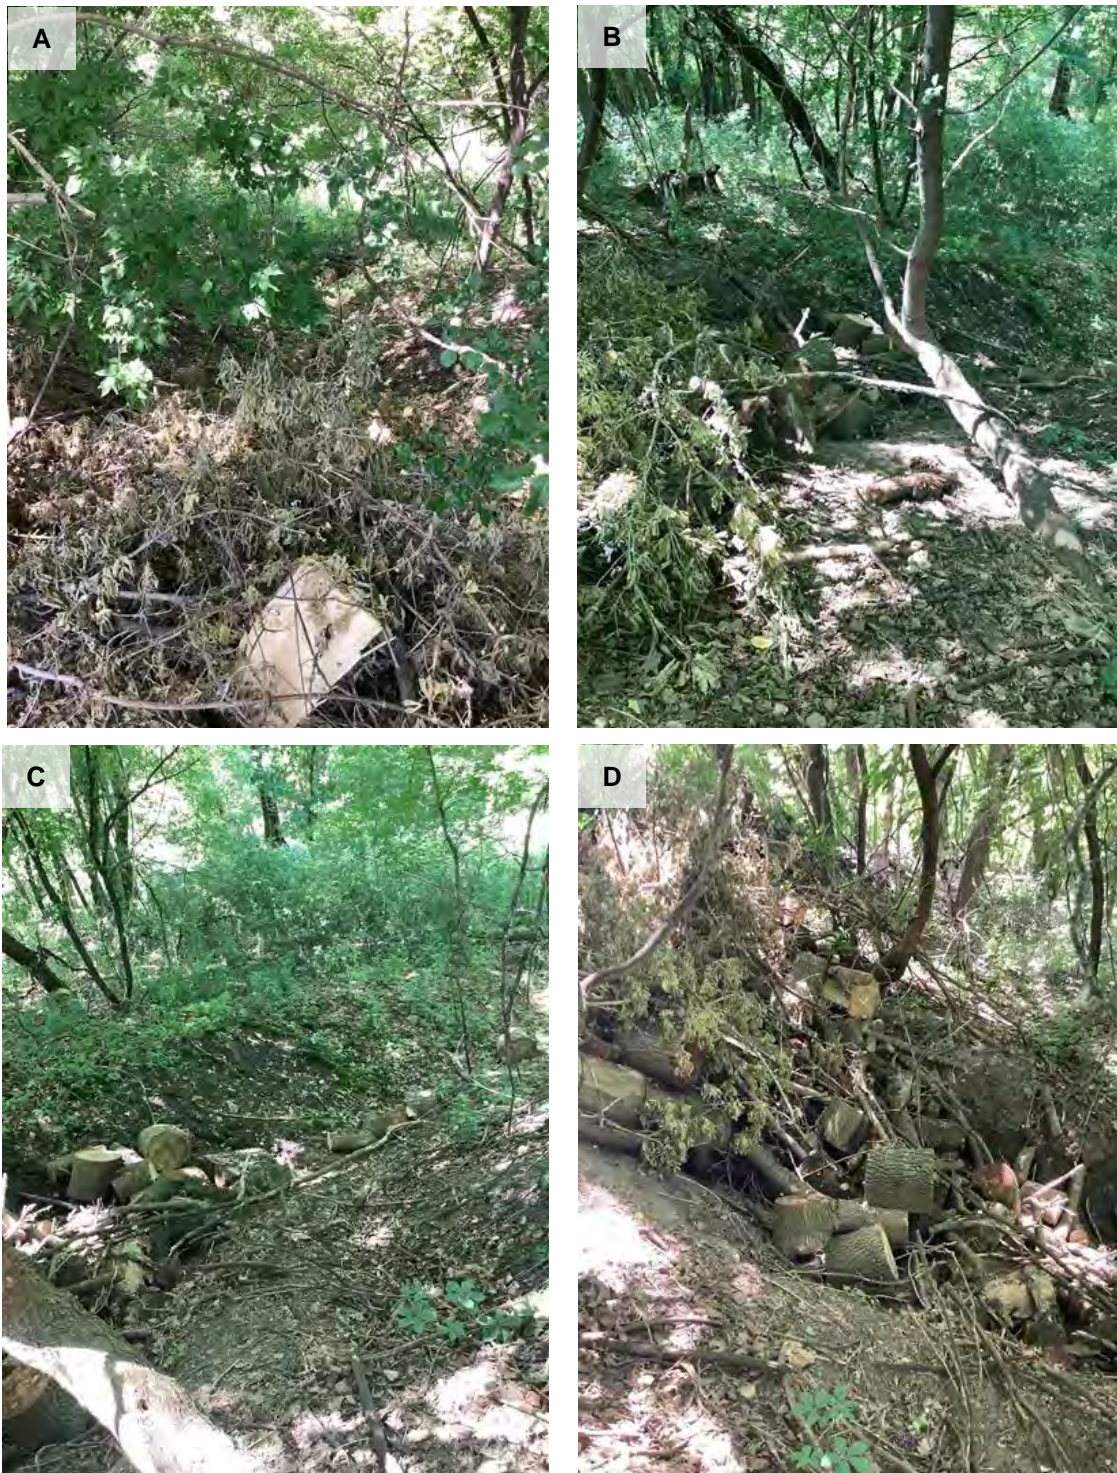
This site was located north of Wurthington Heights Road behind a resident's yard (Figure 23). There was no water present in the medium-sized V-shaped gully. Some vegetation lined the bottom and banks, which were composed of silt and clay (Figure 24). The resident said that this gully has been getting worse over the years, and he has dumped truckloads of dirt, branches, cut-up tree trunks, cement, and other yard waste into the gully to try and prevent it from further eroding into his property. The degradation was severe, and there were trees leaning over the channel and slumping banks. The gully scored a 35 for moderate erosion potential and when combined with the Tier I impact zone, is considered at high risk for future erosion and should be further reviewed and studied to prevent further degradation to the remaining viable trout habitat in Kennaley's Creek.

Figure 24. Photos of Gully 06:22-01:45. A) Downstream view from top of gully, B) Downstream view of headcut of gully filled with log chopping, C) Downstream view of entire gully, D) Upstream view of yard waste thrown in gully to prevent erosion

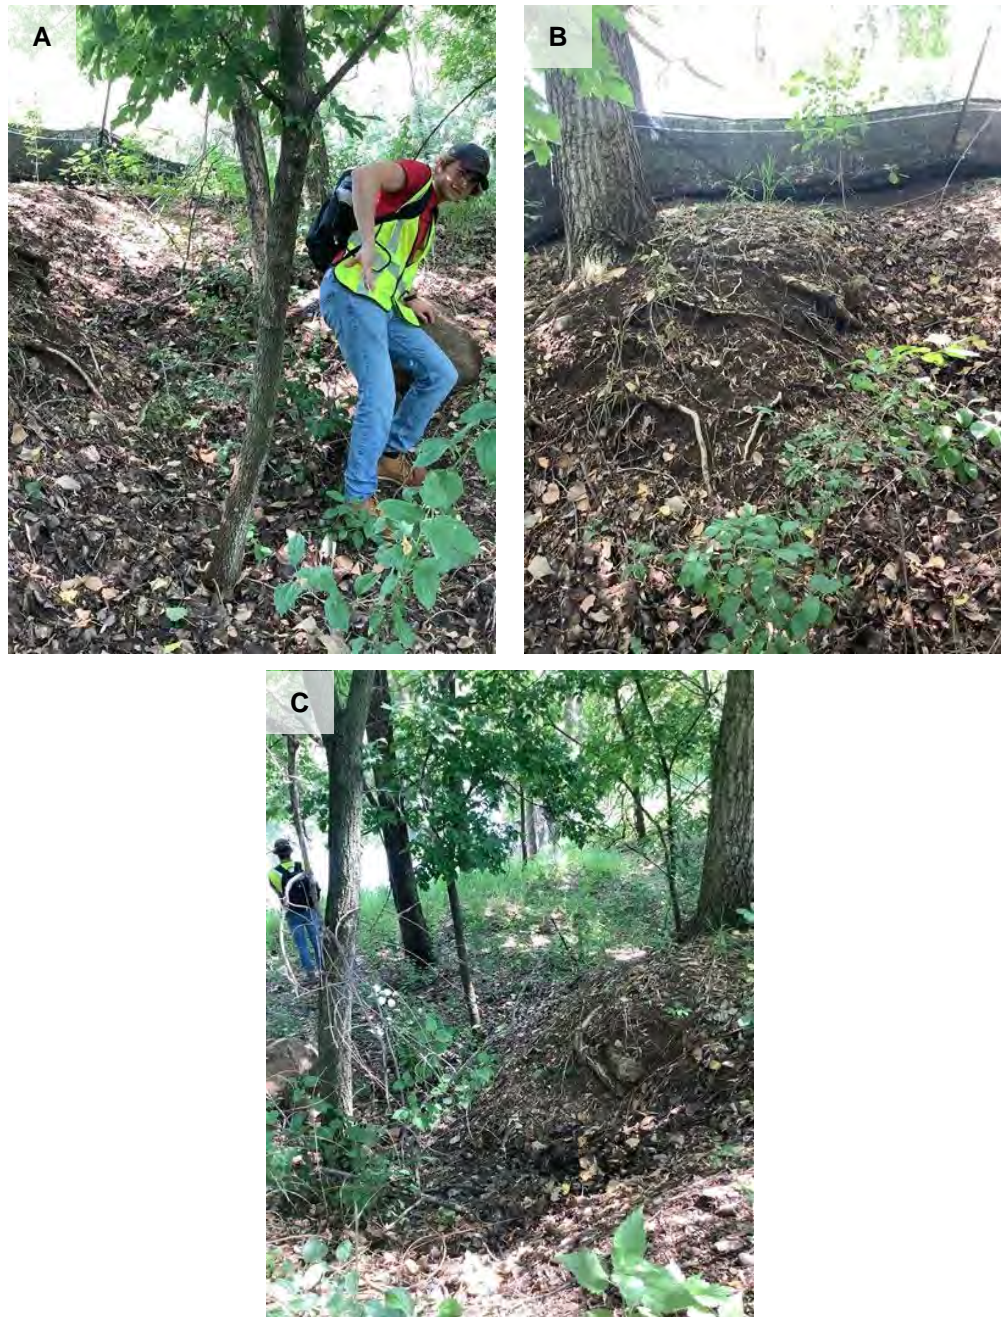
This site was located west of the Cedar Bluffs Business Center and north of Gully 06:28–10:53 (Figure 23), a moderate erosion potential gully. This gully was located on a constructed slope leading down to a pond. There was almost no vegetation in this gully besides one large and several small trees (Figure 25). Although the gully was short and shallow, the bottom and banks had no vegetation besides a couple of trees and was actively eroding. There was no water in the gully or visible pipes draining into this site. The degradation was severe, exposing half of one tree's root ball; trees were leaning in, and there was slumping of the banks. The gully scored a 35 for moderate erosion potential; and when combined with the Tier I impact zone, the gully is considered to be at high risk of future erosion and should be further reviewed and studied to prevent further degradation to the remaining viable trout habitat in Kennaley's Creek.

Figure 25. Pictures of Gully 06:28–10:59. A) Upstream view of the gully, B) Upstream view of left bank where severe degradation is visible, C) Downstream view of gully. A pond can be seen in the background.

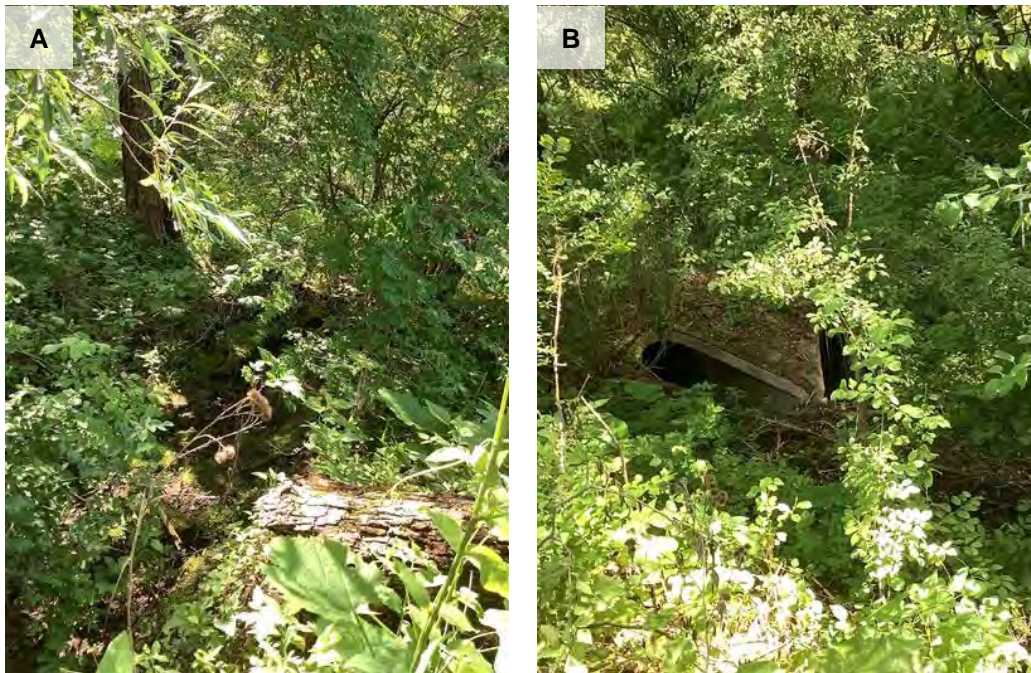
This gully is located east of the intersection of Plant Road and Comanche Road (Figure 23). The gully had a medium depth, and the bottom was moderately wide but quite long. The bottom of the gully had no vegetation, but the banks each had heavy vegetation (Figure 27). The gully took a general U-shape, and there were fallen trees throughout. There appeared to be severe degradation and moderate slumping of trees. Evidence of high groundwater or dry weather stormwater flows were observed; the gully bottom was very wet despite the absence of rain during the past week. The gully scored a 31 for moderate erosion potential, and when combined with the Tier I impact zone because of its location within the SSOD, the gully is considered to be at high risk of future erosion and should be further reviewed and studied to prevent additional degradation to the steep slopes or continued release of sediment to the Minnesota River.

Figure 27. Photos of Gully 06:10-10:04. A) Upstream view of the gully, B) Downstream view of the pipes at the beginning of the gully

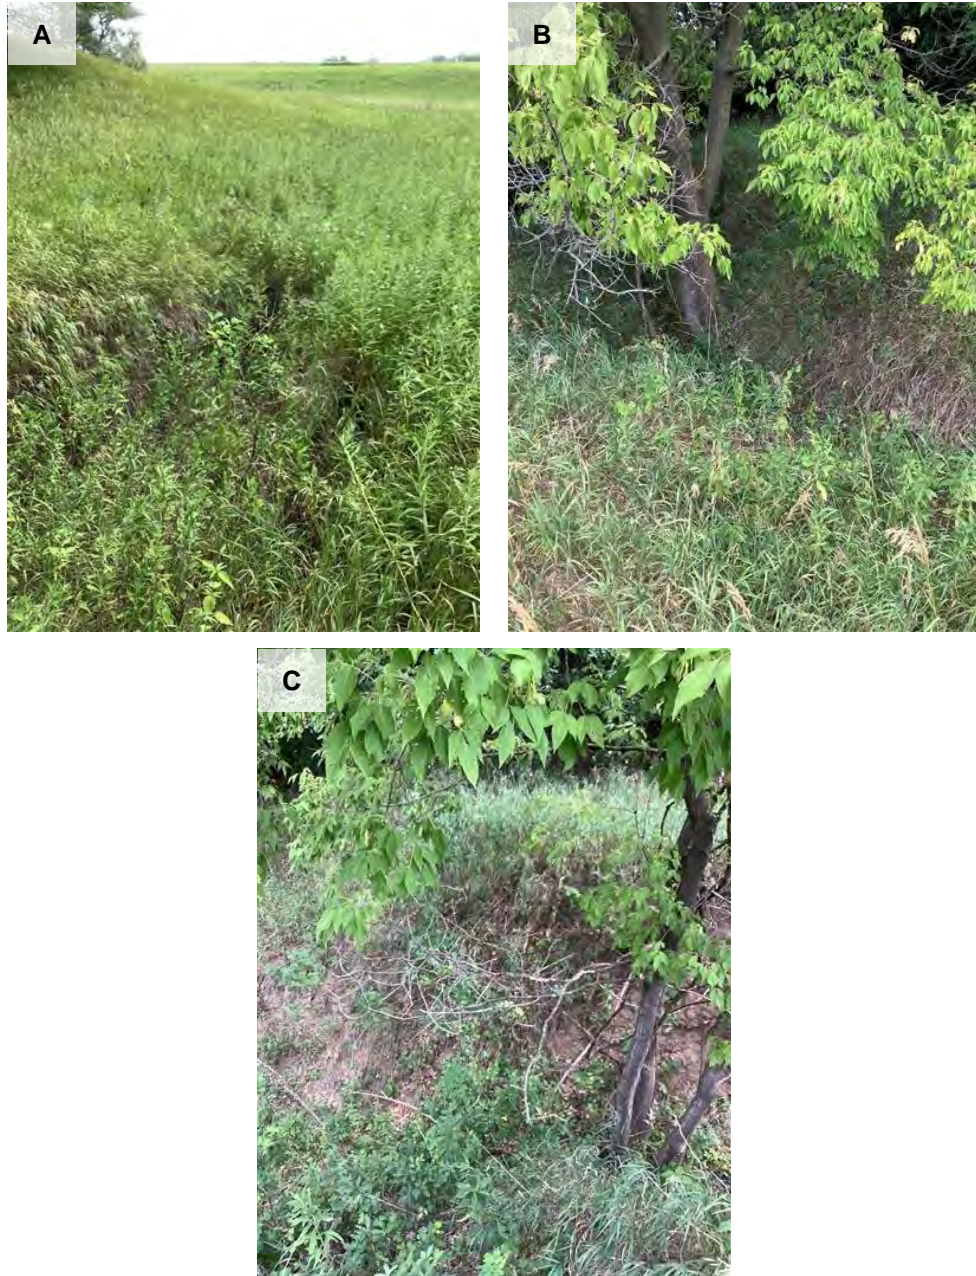
Figure 29. Photos of Gully 07:21-11:58. A) Upstream view of gully headcut, B) Downstream view of right bank, C) Upstream view of right bank from further downstream

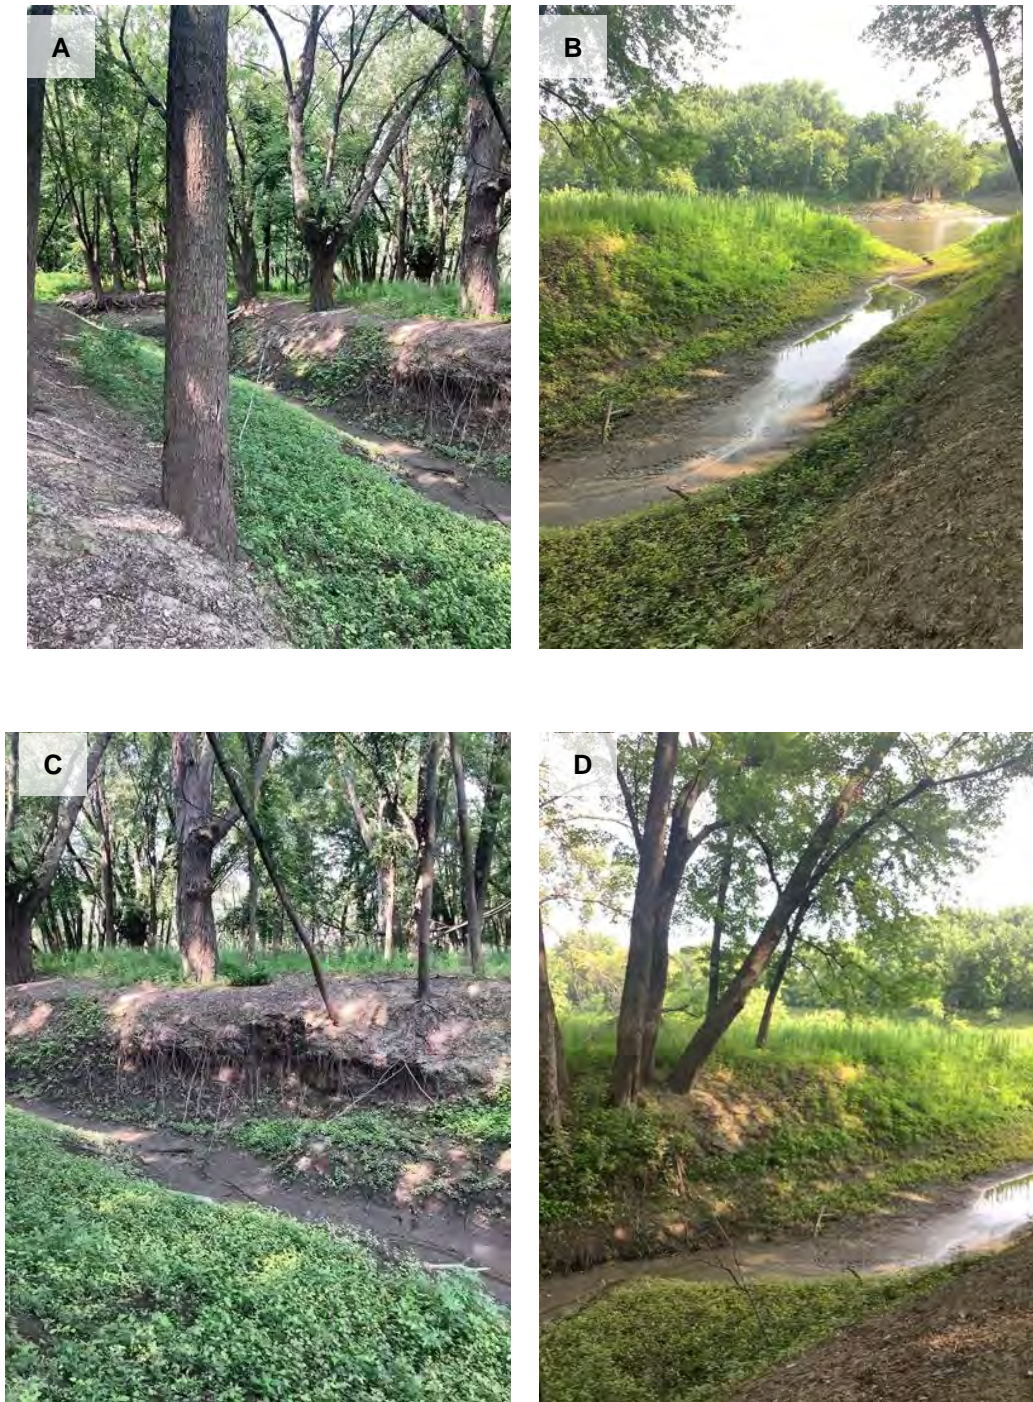
Figure 32: Photos of Gully 07:12-10:13. A) Upstream view of gully, B) Downstream view of confluence with Minnesota River, C) View of severe degradation on left bank, D) View of leaning trees on right bank

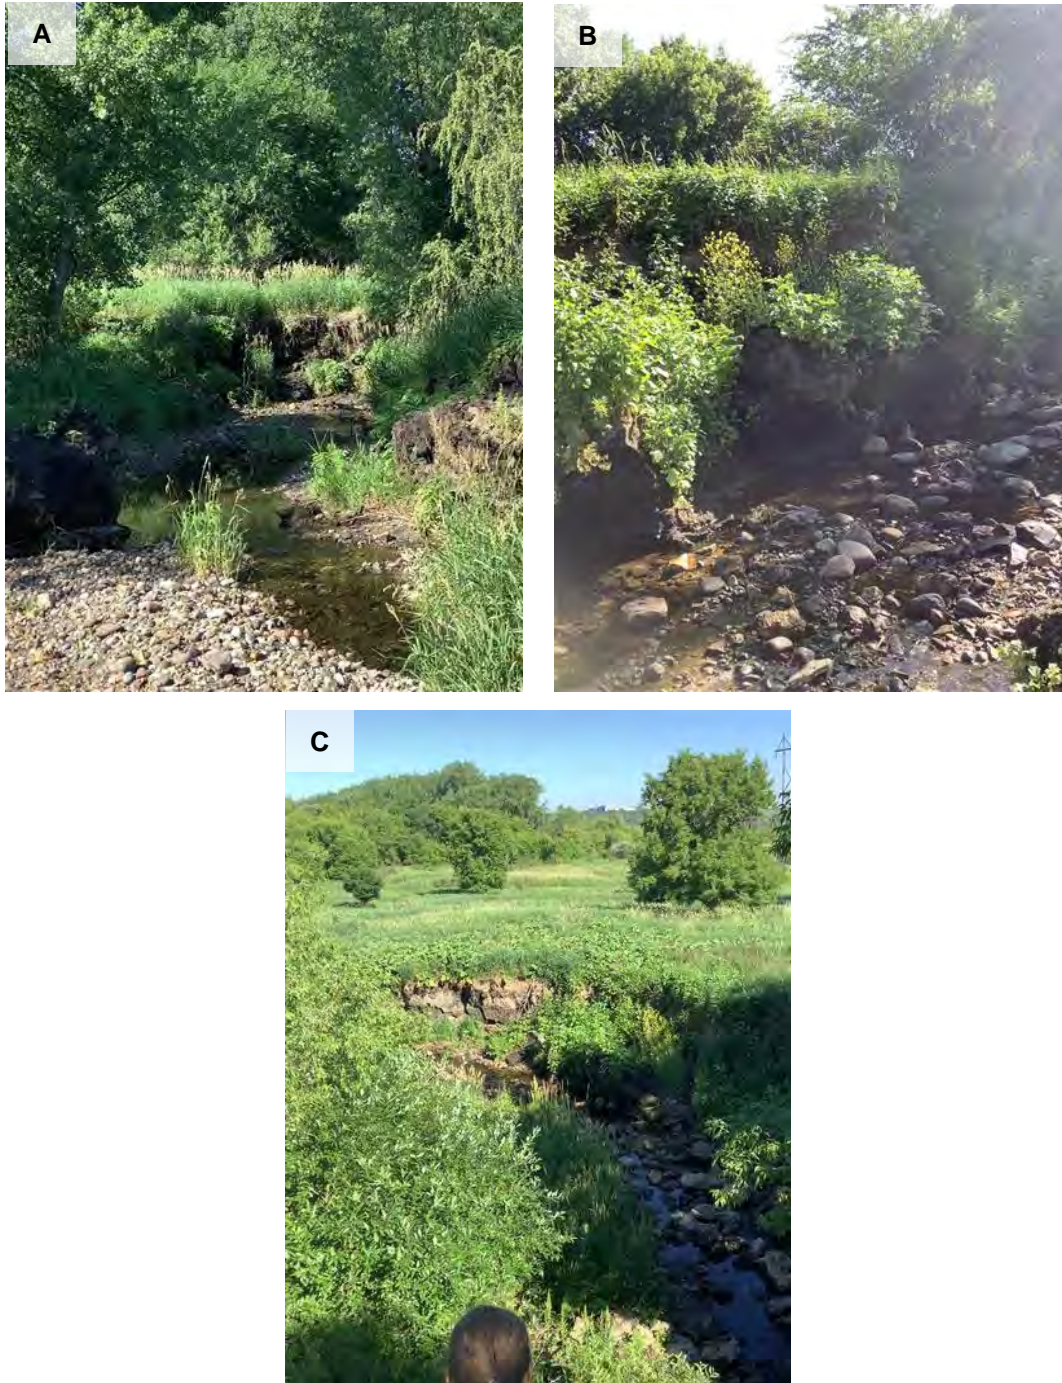
Figure 35: Photos of Gully 06:16-09:07. A) Downstream view of the left bank, B) Upstream view of the right bank showing severe slumping, C) Downstream view of the right bank from a higher perspective

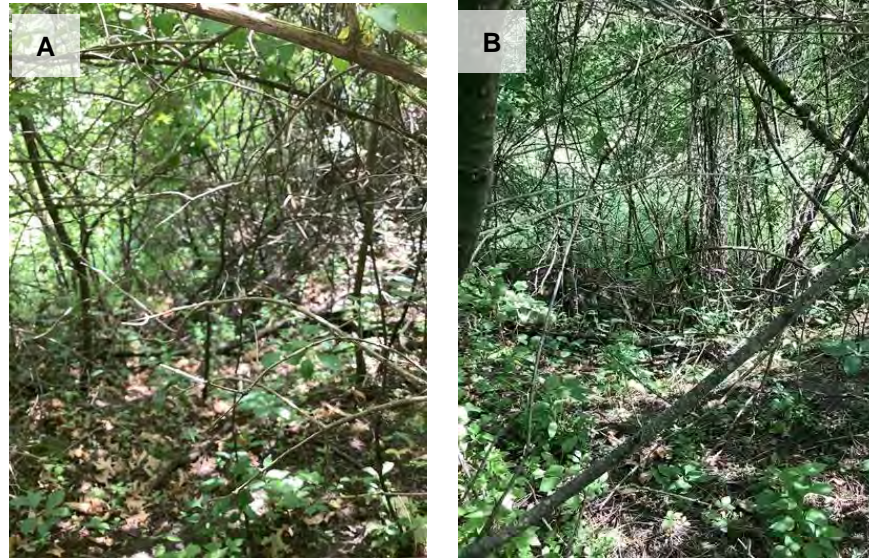
Figure 38: Photos of Gully 06:09-10:55. A) Downstream view of gully, vegetation makes picture difficult to make out. B) Downstream view of gully from right bank

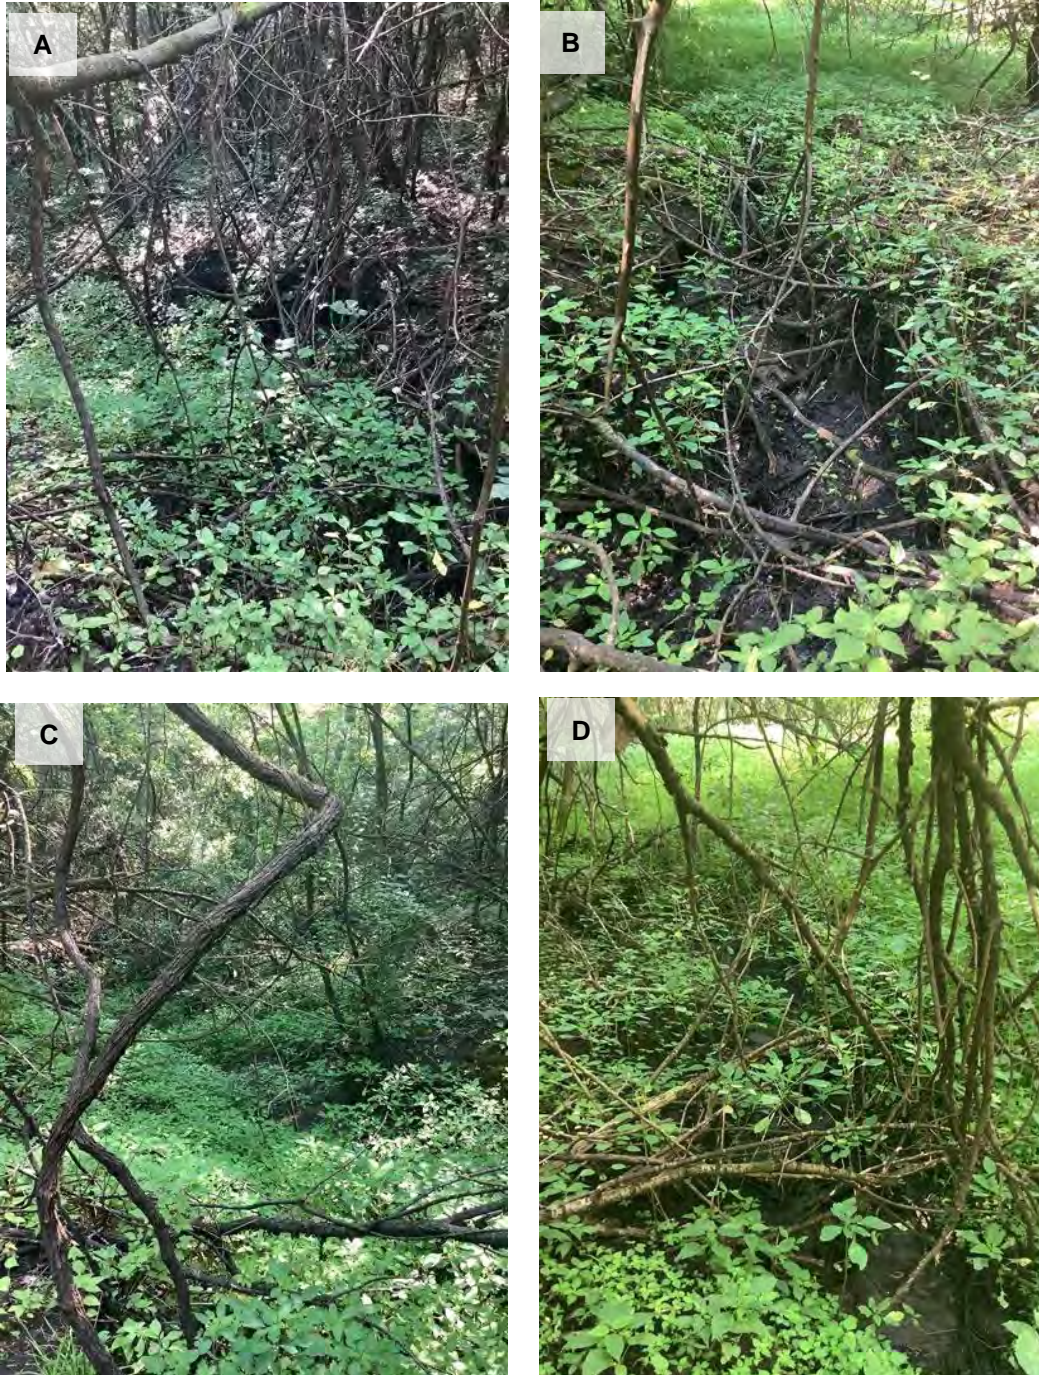
Gully 07:19–09:52 is located in the Savage Fen HVRA and at the end of Vernon Avenue South. The silt channel had some seeps at the bottom of its long, shallow, and medium-width gully. The gully began very narrow and shallow; and then approximately 30 feet down from the headcut, it sloped down and got deeper, wider, and more severe. The bottom had heavy vegetation although the banks had only some vegetation with an acute V-shape. The degradation was severe, and aggradation was moderate. Some trees were leaning over the channel, and there were many dead, fallen branches along with some slumping on the banks. The gully received a score of 32, placing it in the moderate erosion potential category. Combined with the Tier I impact zone, it is a high-risk gully that should be monitored or considered for future mitigation efforts.

Figure 40: Photos of Gully 07:19-09:52. A) Downstream view of where the gully widens, B) Upstream view of increasing severity, C) Downstream view of gully, D) Upstream view of beginning of gully

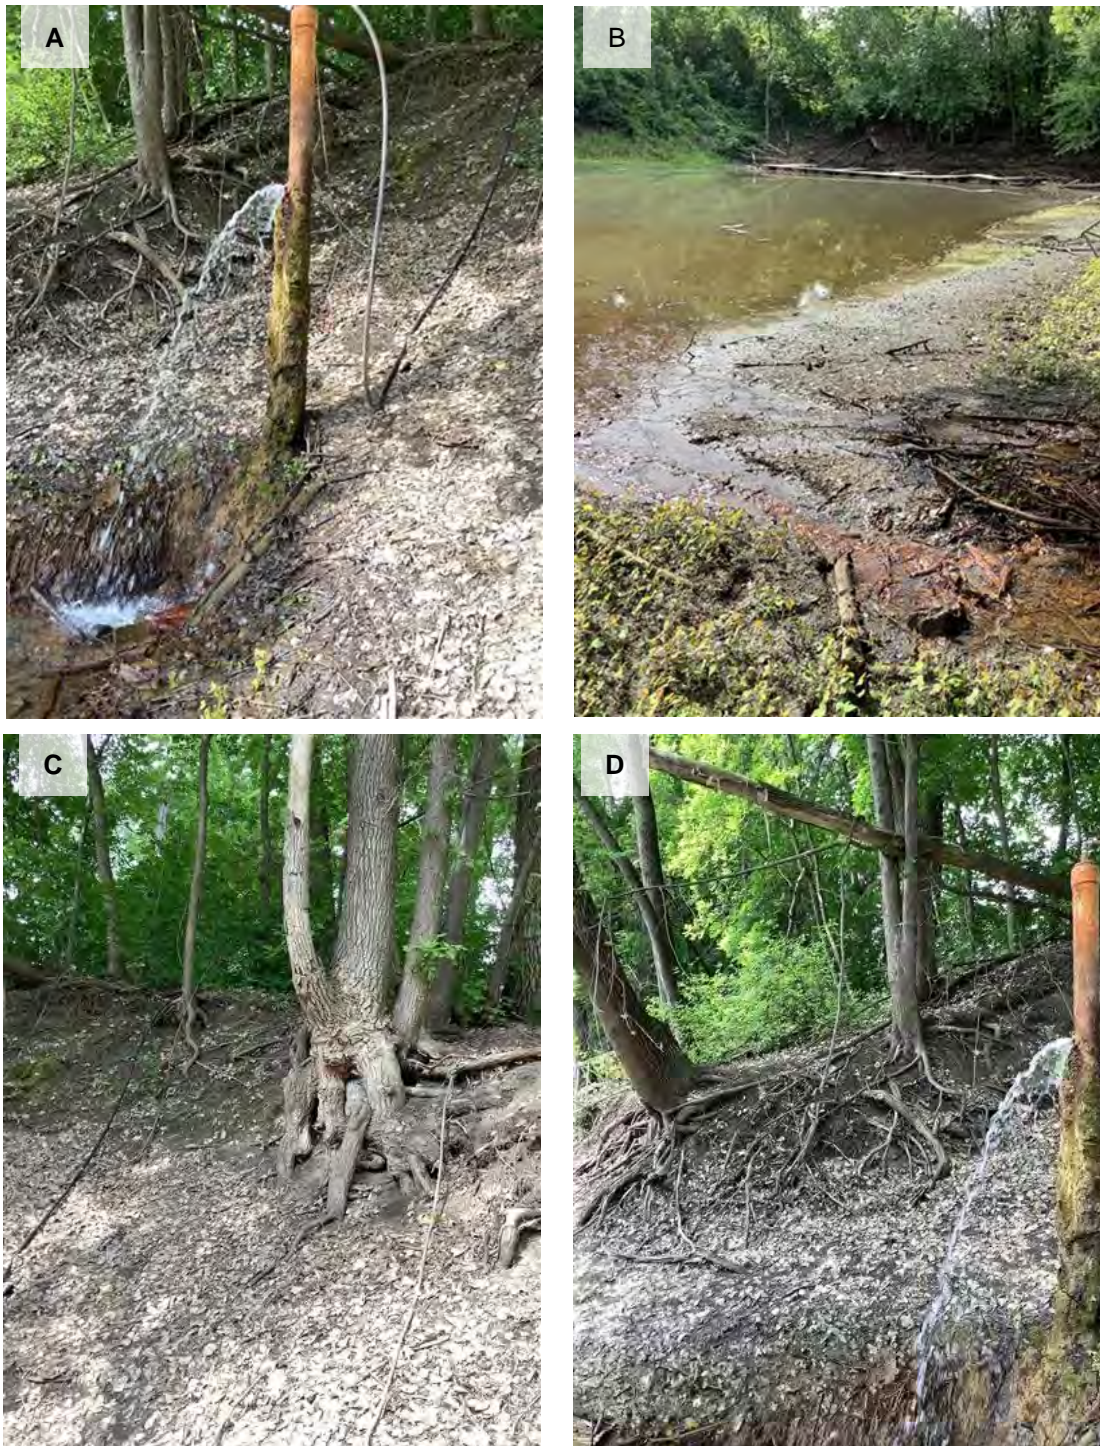
Figure 44: Photos of Gully 07:08-09:58. A) Upstream view of high flow of water exiting pipe, B) Downstream view of water draining into this pond area where the gully flows, C) Upstream view of the left bank, D) Upstream view of the right bank

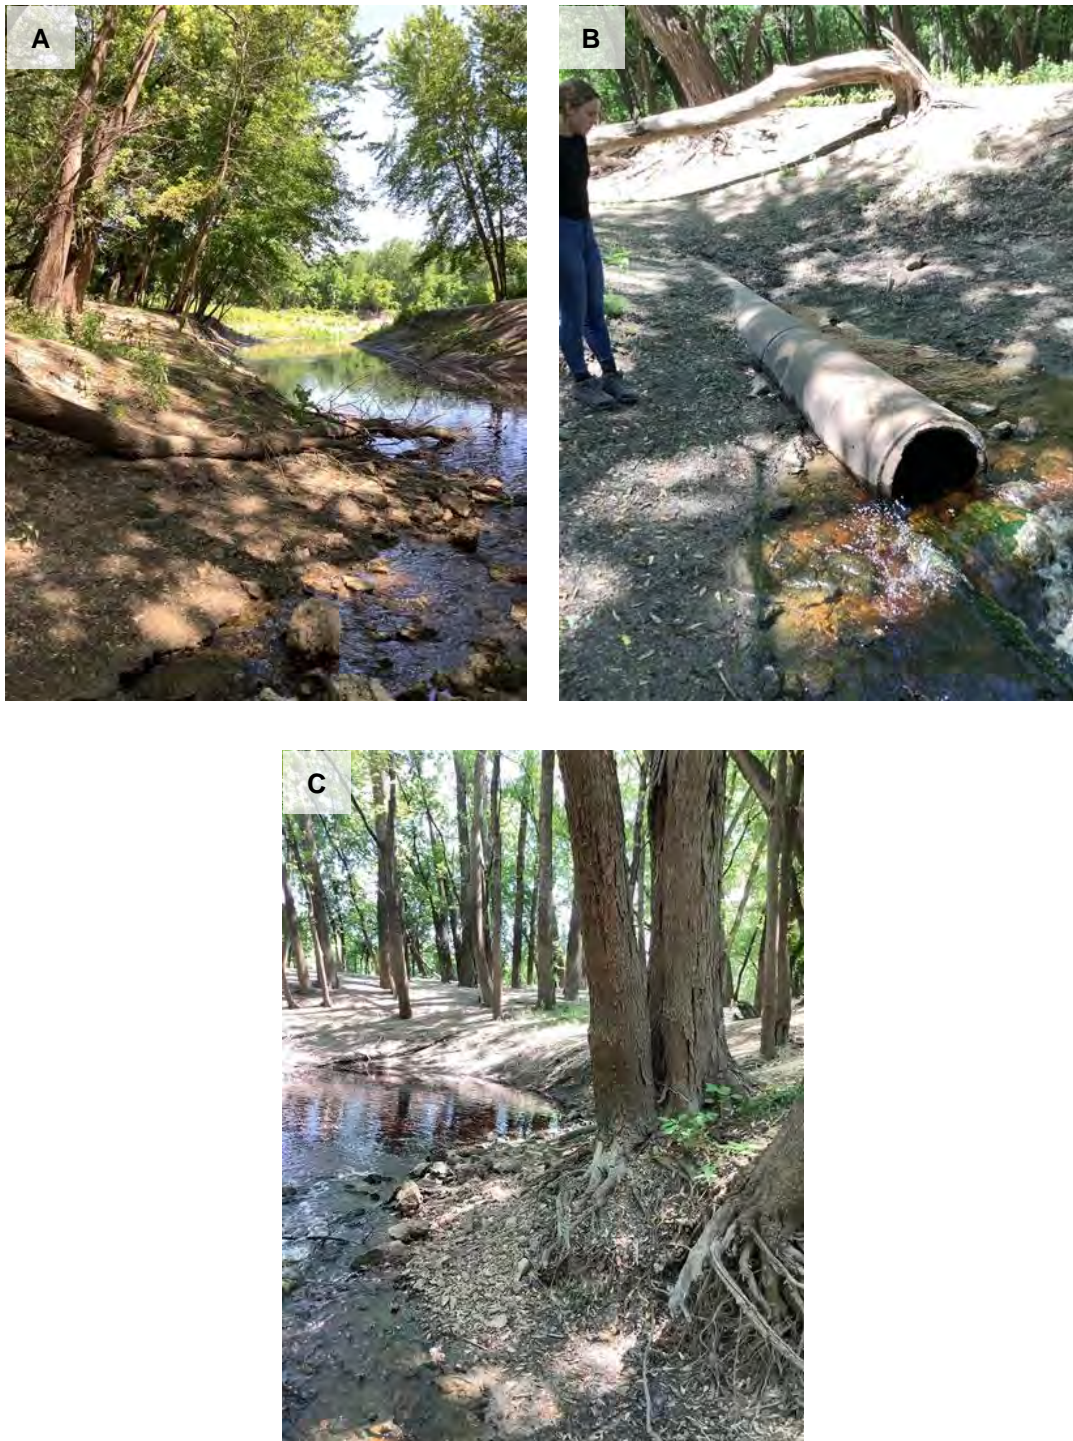
Figure 46: Photos of Gully 06:03-11:34. A) Downstream view of left gully bank, B) Upstream view of pipe with constant, high flow of water exiting the pipe, C) Downstream view of the right gully bank
