<b>Gully ID:</b> 07:15-11:41	<b>MAP</b>

<b>Date &amp; Time:</b> July 15, 2021 11:41 AM	
<b>Location:</b> Burnsville	
<b>Weather:</b> Sunny <b>Storm/Rainfall Event in the Past 24 Hours?</b> Yes-High Intensity	
<b>GULLY INFORMATION</b>	
<b>Calculated Erosion Potential:</b>	Low
<b>Approximate Depth:</b>	3-Medium (3'-15')
<b>Approximate Bottom Width:</b>	1-Wide (>5')
<b>Approximate Gully Length:</b>	3-Medium (50'-100')
<b>Condition of Gully Bottom:</b>	1-Heavy Vegetation
<b>Condition of Gully Banks:</b>	1-Heavy Vegetation
<b>Gully Bank Angles:</b>	3-Mid-Range (45 to 90 degrees)
<b>Gully Shape:</b>	1-Trapezoid
<b>Gully Material:</b>	Silt/Clay

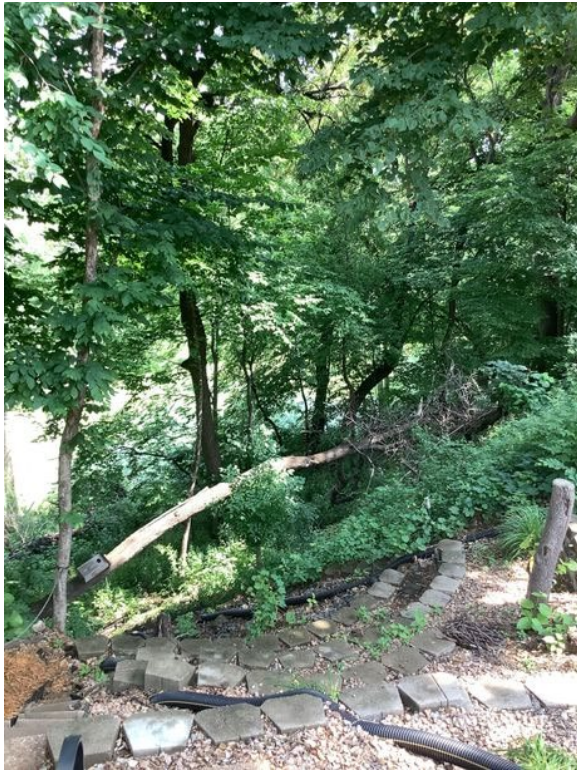
**Photo 1 Image**

<b>Seep:</b>	0-No	
<b>Stormwater Runoff:</b>	1-Yes	
<b>Stormwater Inputs:</b>	0-None	
<b>Fallen Trees:</b>	1-Yes	
<b>Degradation:</b>	5-Severe	
<b>Aggradation:</b>	1-Low	
<b>Slumping:</b>	1-Yes	
<b>Additional Notes:</b>	<p>Classification? Moderate</p> <p>Presence of Water? No</p> <p>Quantity of Water?</p> <p>Notes/Comments: Very severe gully eroding into the back yard of a residential property. Has run off pipes and large fallen trees.</p>

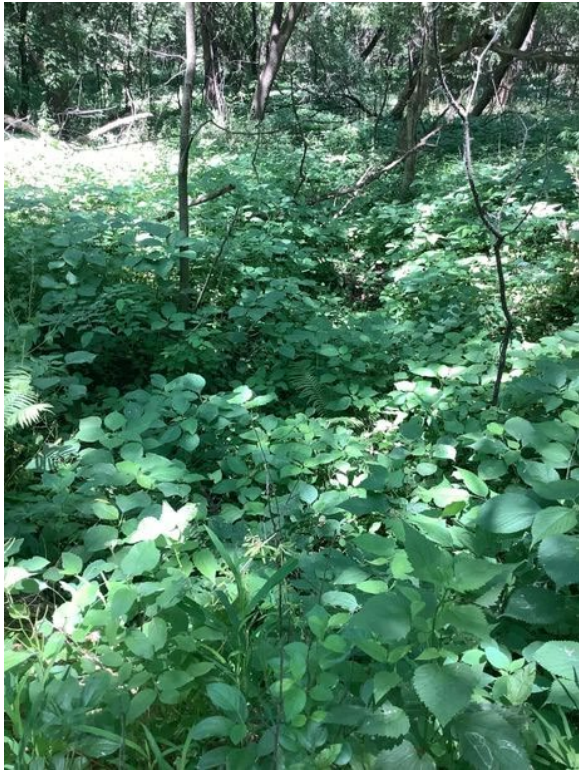
**Photo 1 Image**

<b>Seep:</b>	0-No	
<b>Stormwater Runoff:</b>	0-No	
<b>Stormwater Inputs:</b>		
<b>Fallen Trees:</b>	0-No	
<b>Degradation:</b>	3-Moderate	
<b>Aggradation:</b>	1-Low	
<b>Slumping:</b>	1-Yes	
<b>Additional Notes:</b>	<p>Classification? Low</p> <p>Presence of Water? No</p> <p>Quantity of Water?</p> <p>Notes/Comments: Gully behind neighborhood connects into the left bank of another gully downstream</p>

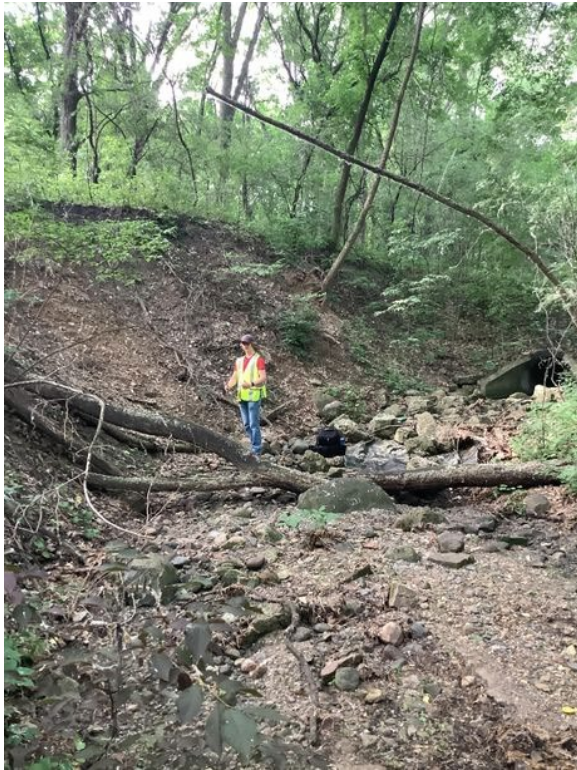
**Photo 1 Image**

<b>Seep:</b>	0-No	
<b>Stormwater Runoff:</b>	1-Yes	
<b>Stormwater Inputs:</b>	1-Dripping	
<b>Fallen Trees:</b>	1-Yes	
<b>Degradation:</b>	5-Severe	
<b>Aggradation:</b>	0-None	
<b>Slumping:</b>	1-Yes	
<b>Additional Notes:</b>	<p>Classification? Moderate</p> <p>Presence of Water? Yes</p> <p>Quantity of Water? Puddles/Stagnant</p> <p>Notes/Comments: Large gully upstream of smaller gully in black dog park. Pipe is dripping and we can hear a water flow, but there isn't any water actively flowing through the gully. The bottom has lots of fallen branches and is made of rocks and gravel.</p>

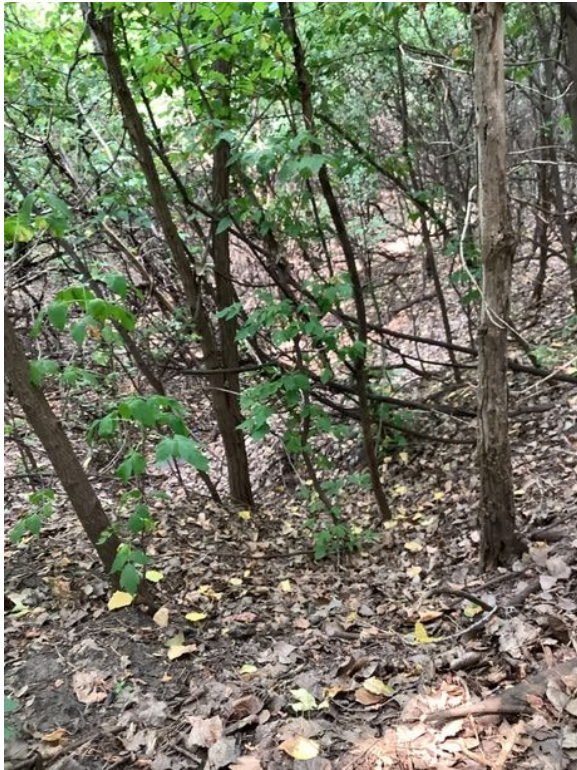
**Photo 1 Image**

<b>Seep:</b>	0-No	
<b>Stormwater Runoff:</b>	0-No	
<b>Stormwater Inputs:</b>		
<b>Fallen Trees:</b>	1-Yes	
<b>Degradation:</b>		3-Moderate
<b>Aggradation:</b>		0-None
<b>Slumping:</b>		0-No
<b>Additional Notes:</b>	<p>Classification? Moderate</p> <p>Presence of Water? No</p> <p>Quantity of Water?</p> <p>Notes/Comments: Small gully which runs into the right bank of a large gully. No greenery but trees in bottom for vegetation</p>

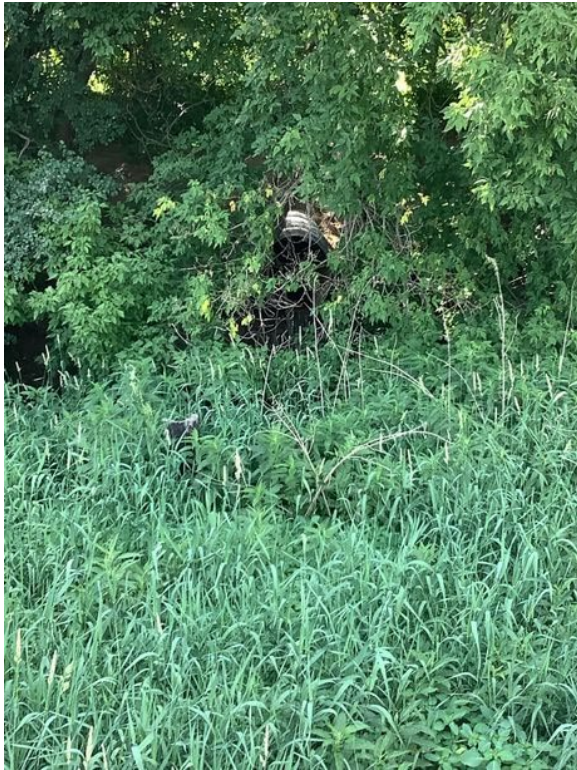
View downstream from pipe. Left bank is armored but right bank has lots of slumping and degradation

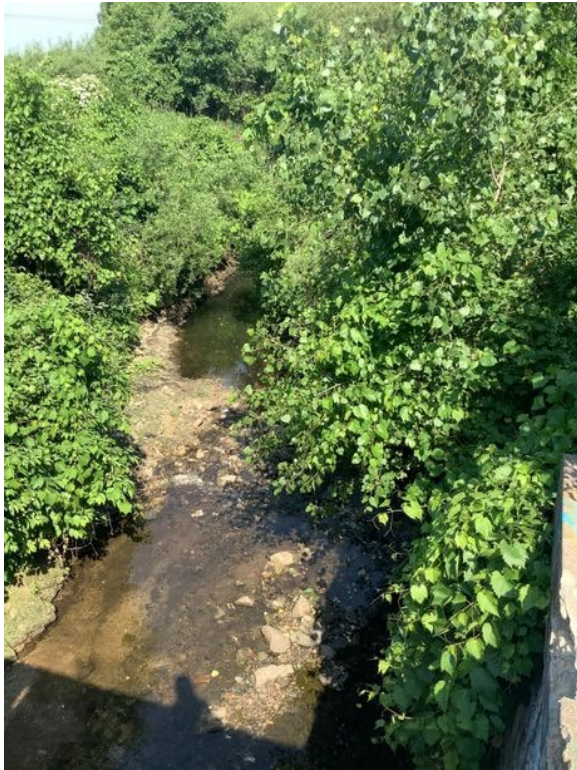
Left bank view under railroad bridge showing signs of lots of degradation.
