<p>Gully ID: 07:07-11:46</p>	<p style="text-align: center;">MAP</p>

<p>Date & Time: July 7, 2021 11:46 AM</p>	
<p>Location: Shakopee</p>	
<p>Weather: Cloudy</p> <p>Storm/Rainfall Event in the Past 24 Hours? Yes-Low Intensity</p>	
GULLY INFORMATION	
<p>Calculated Erosion Potential:</p>	<p>Moderate</p>
<p>Approximate Depth:</p>	<p>1-Shallow (<3')</p>
<p>Approximate Bottom Width:</p>	<p>3-Medium (1'-5')</p>
<p>Approximate Gully Length:</p>	<p>5-Long (>100')</p>
<p>Condition of Gully Bottom:</p>	<p>5-Bare Soil</p>
<p>Condition of Gully Banks:</p>	<p>1-Heavy Vegetation</p>
<p>Gully Bank Angles:</p>	<p>3-Mid-Range (45 to 90 degrees)</p>
<p>Gully Shape:</p>	<p>3-U-Shaped</p>
<p>Gully Material:</p>	<p>Gravel/Cobble/Boulders</p>

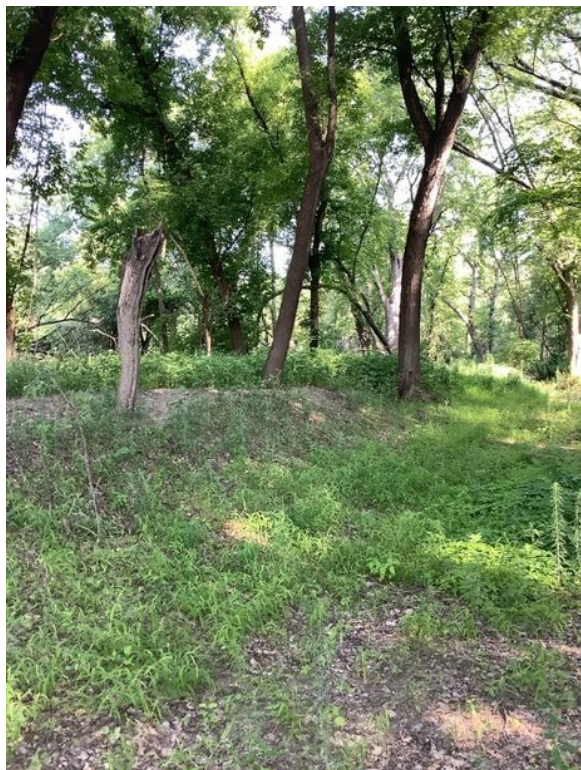
Photo 1 Image

Seep:	0-No	
Stormwater Runoff:	0-No	
Stormwater Inputs:		
Fallen Trees:	0-No	
Degradation:		1-Low
Aggradation:		1-Low
Slumping:		1-Yes
Additional Notes:	<p>Classification? Moderate</p> <p>Presence of Water? No</p> <p>Quantity of Water?</p> <p>Notes/Comments: Some slumping and pistol shaped trees, meets with next gully at end, more vegetation on left bank than right</p>

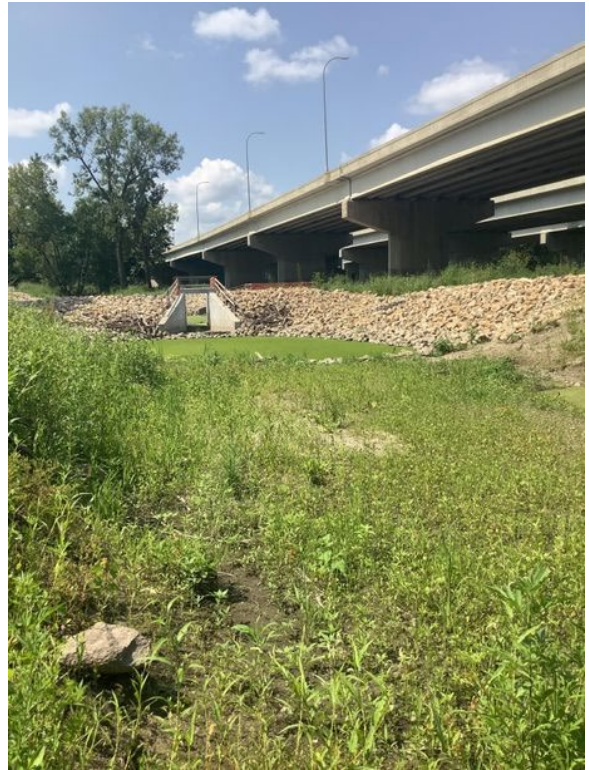
Photo 4 Image

Seep:	0-No	
Stormwater Runoff:	1-Yes	
Stormwater Inputs:	0-None	
Fallen Trees:	1-Yes	
Degradation:	5-Severe	
Aggradation:	0-None	
Slumping:	1-Yes	
Additional Notes:	<p>Classification? Moderate</p> <p>Presence of Water? Yes</p> <p>Quantity of Water? Puddles/Stagnant</p> <p>Notes/Comments: Gully downstream of dam system that connects three streams into this one heading towards the MN river. Very little stagnant water, upstream the water is covered in green algae suggesting it hasn't had much flow recently.</p>

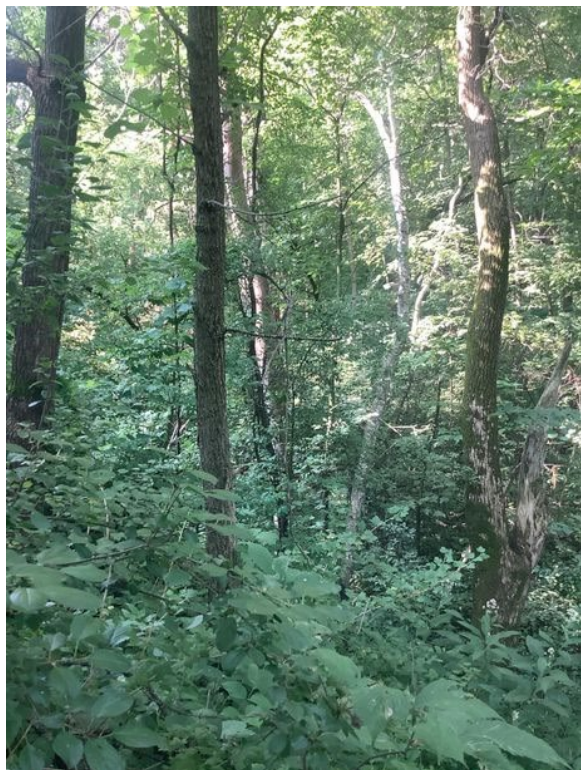
Photo 1 Image

Seep:	0-No	
Stormwater Runoff:	0-No	
Stormwater Inputs:		
Fallen Trees:	1-Yes	
Degradation:		3-Moderate
Aggradation:		0-None
Slumping:		0-No
Additional Notes:	<p>Classification? Moderate</p> <p>Presence of Water? No</p> <p>Quantity of Water?</p> <p>Notes/Comments: Gully in the woods running along the side of the road. The base opens up to a large building on private property so it could only be accessed from the side so pictures were not the best. on the left bank there were some trees with exposed roots.</p>

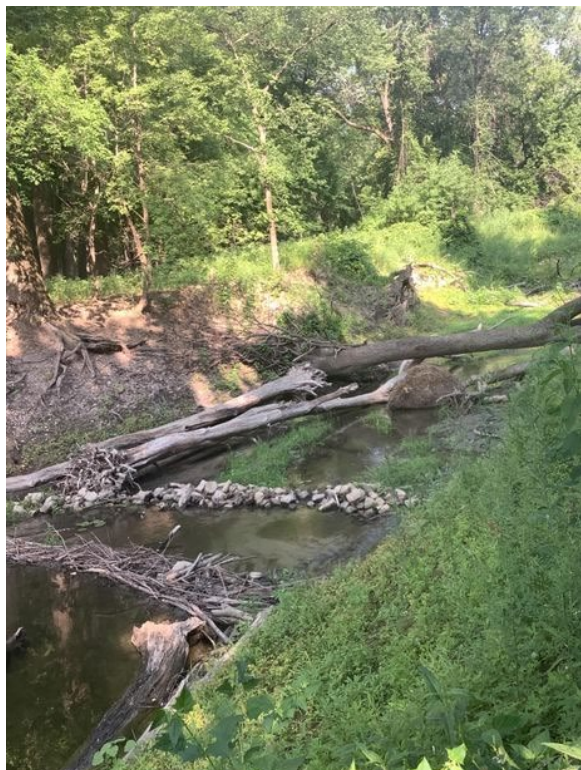
Photo 1 Image

Seep:	0-No	
Stormwater Runoff:	1-Yes	
Stormwater Inputs:	3-Low Flow	
Fallen Trees:	1-Yes	
Degradation:	5-Severe	
Aggradation:	1-Low	
Slumping:	1-Yes	
Additional Notes:	<p>Classification? High</p> <p>Presence of Water? Yes</p> <p>Quantity of Water? Trickle/Slow Moving</p> <p>Notes/Comments: Gully located downstream of a dam that looks fairly new. This gully has very steep banks with severe degradation. There is armoring upstream around the area by the dam, but once the armoring ends the banks get very steep.</p>

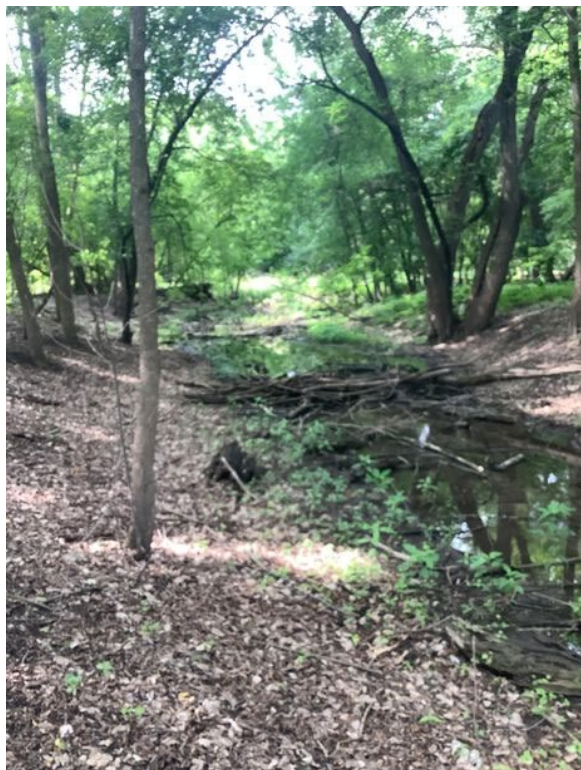
Photo 1 Image

Seep:	0-No	
Stormwater Runoff:	0-No	
Stormwater Inputs:		
Fallen Trees:	1-Yes	
Degradation:		3-Moderate
Aggradation:		1-Low
Slumping:		0-No
Additional Notes:	<p>Classification? Moderate</p> <p>Presence of Water? Yes</p> <p>Quantity of Water? Trickle/Slow Moving</p> <p>Notes/Comments: Stream in bottom of gully which runs through a series of pipes and into the river, this is the first section of the gully. There are lots of fallen and dead branches in the gully bottom</p>

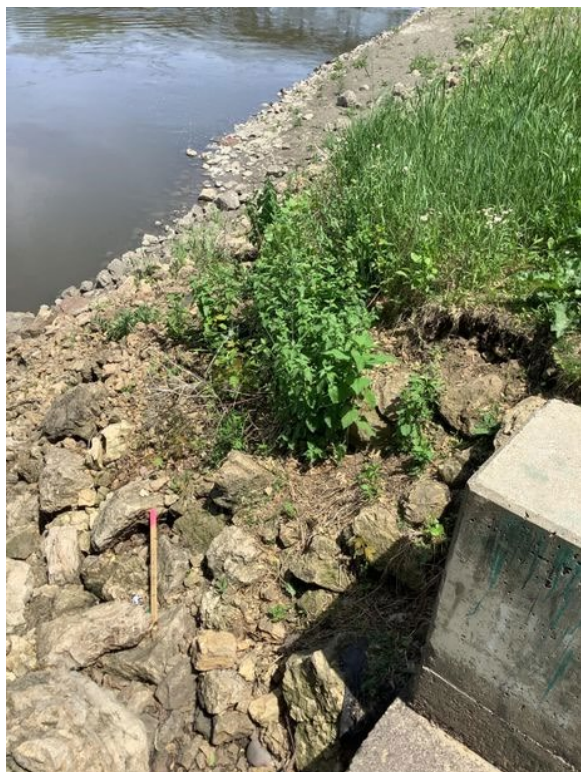
Photo1 View Direction: View Downstream

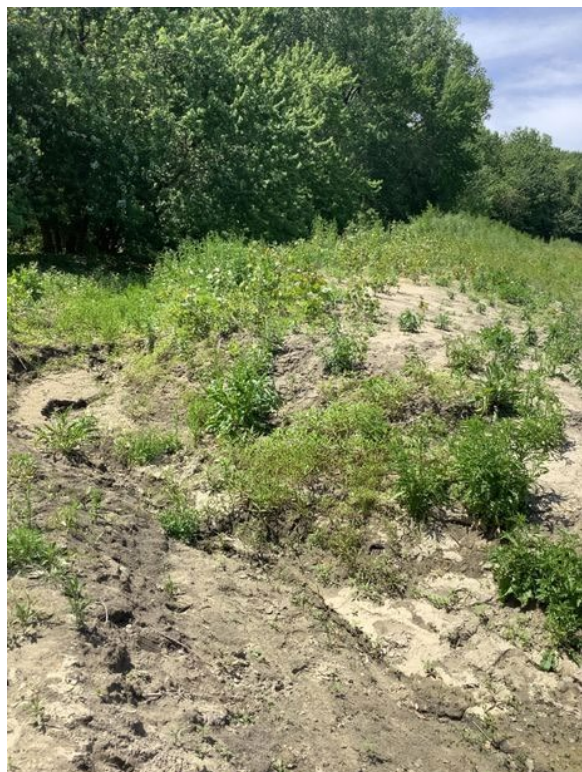
Photo1 View Direction: View Upstream

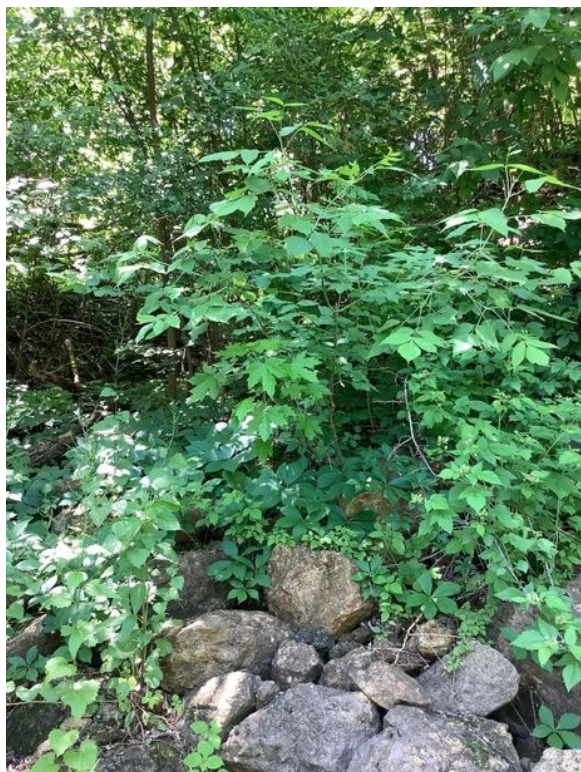
Photo1 View Direction: View Upstream

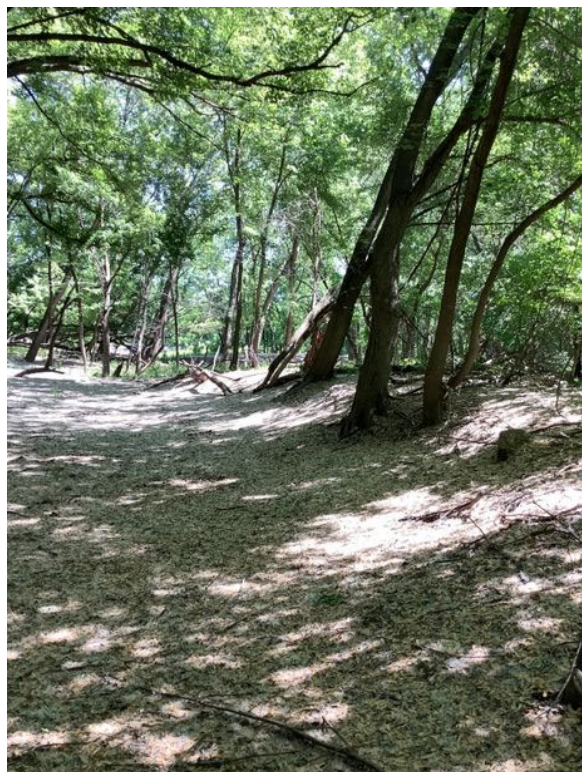
Photo1 View Direction: View Downstream

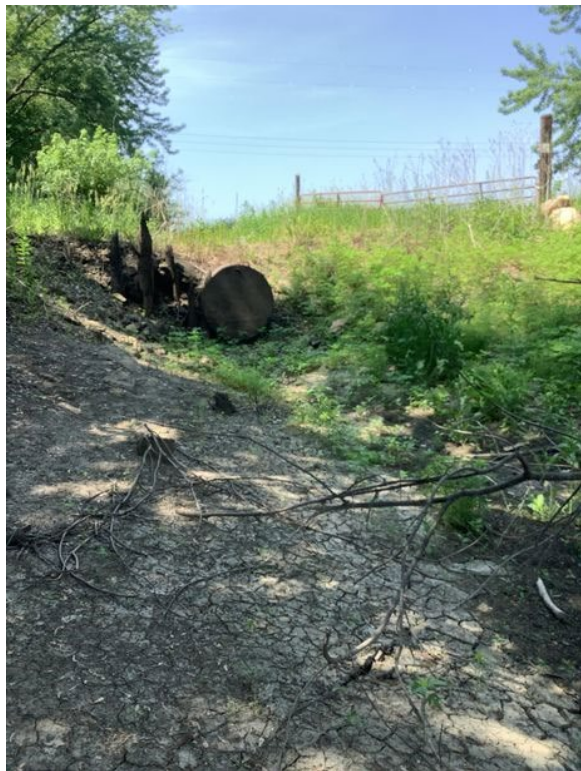
Photo1 View Direction: View Upstream

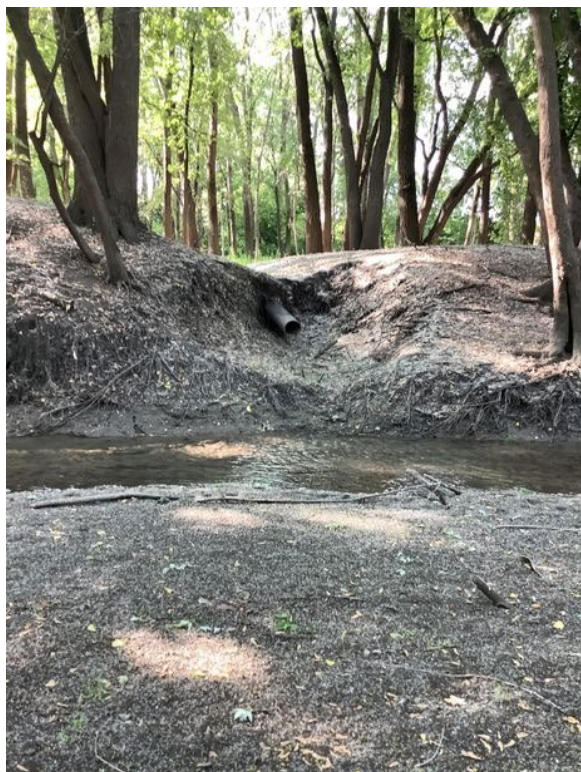
Photo1 View Direction: View Upstream

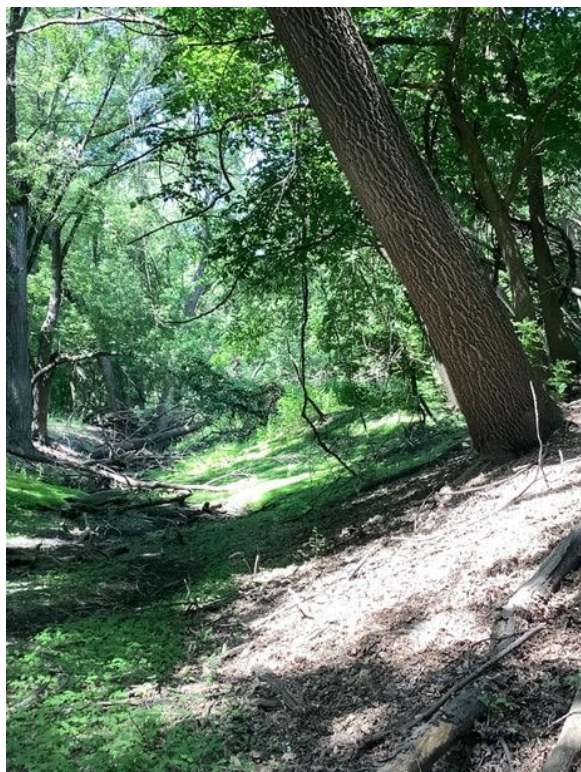
Photo1 View Direction: View Upstream
