Appendix K: Lower Minnesota River Watershed District: Gully Inventory

Gully Inventory Map
 Area #1
 Lower Minnesota River Watershed District
 Watershed Management Plan

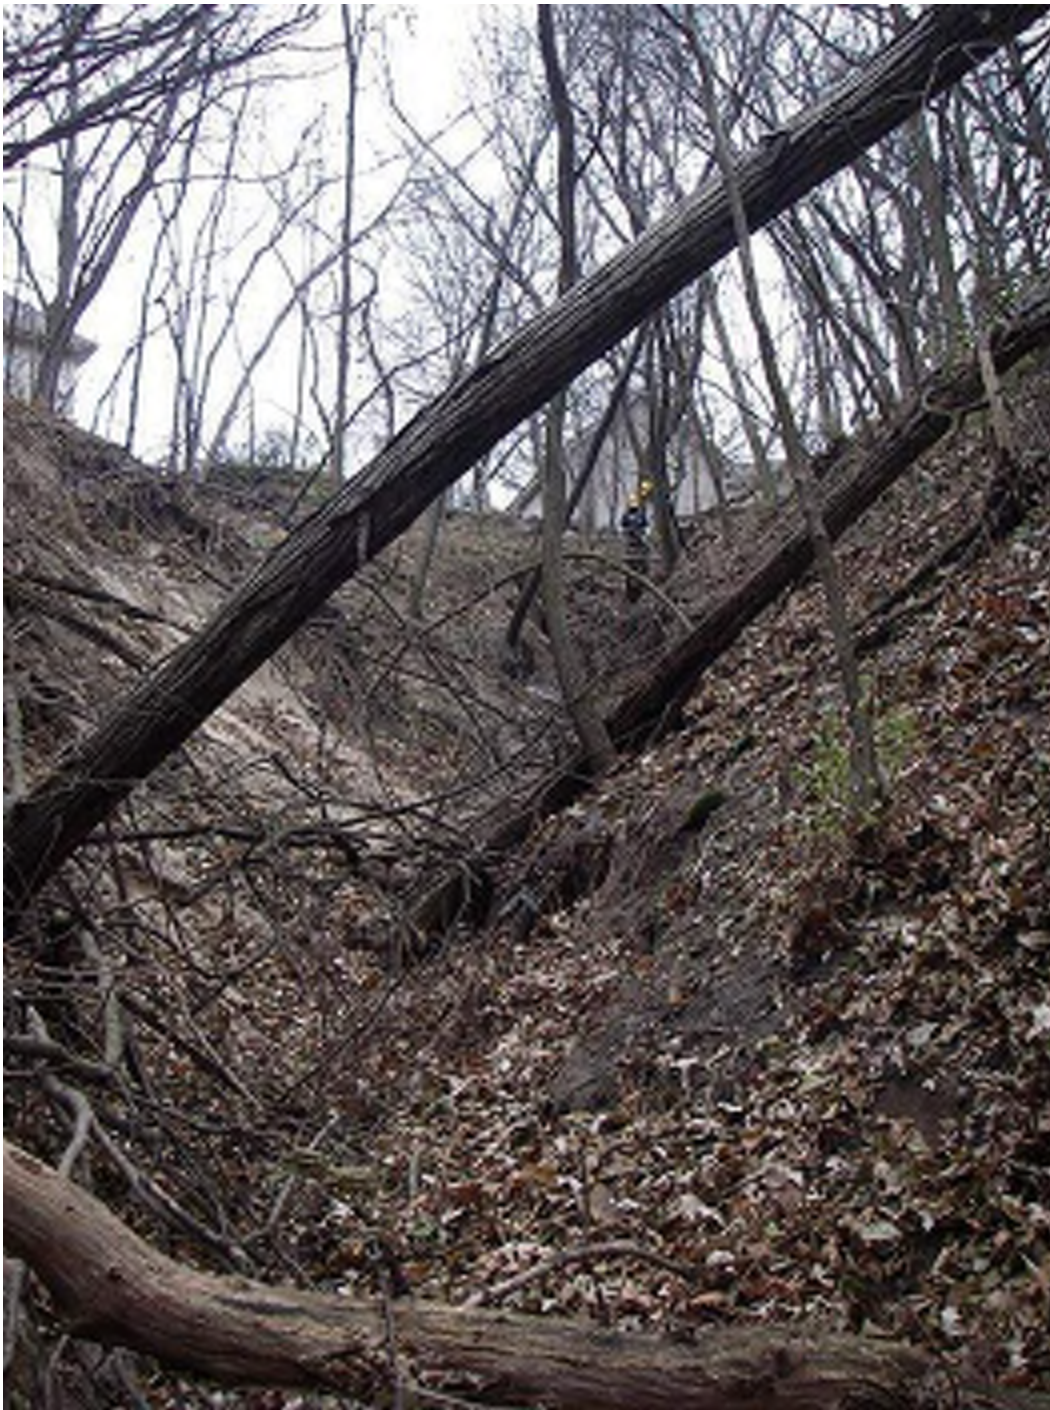
Waypoint 1

Pronounced soil erosion.

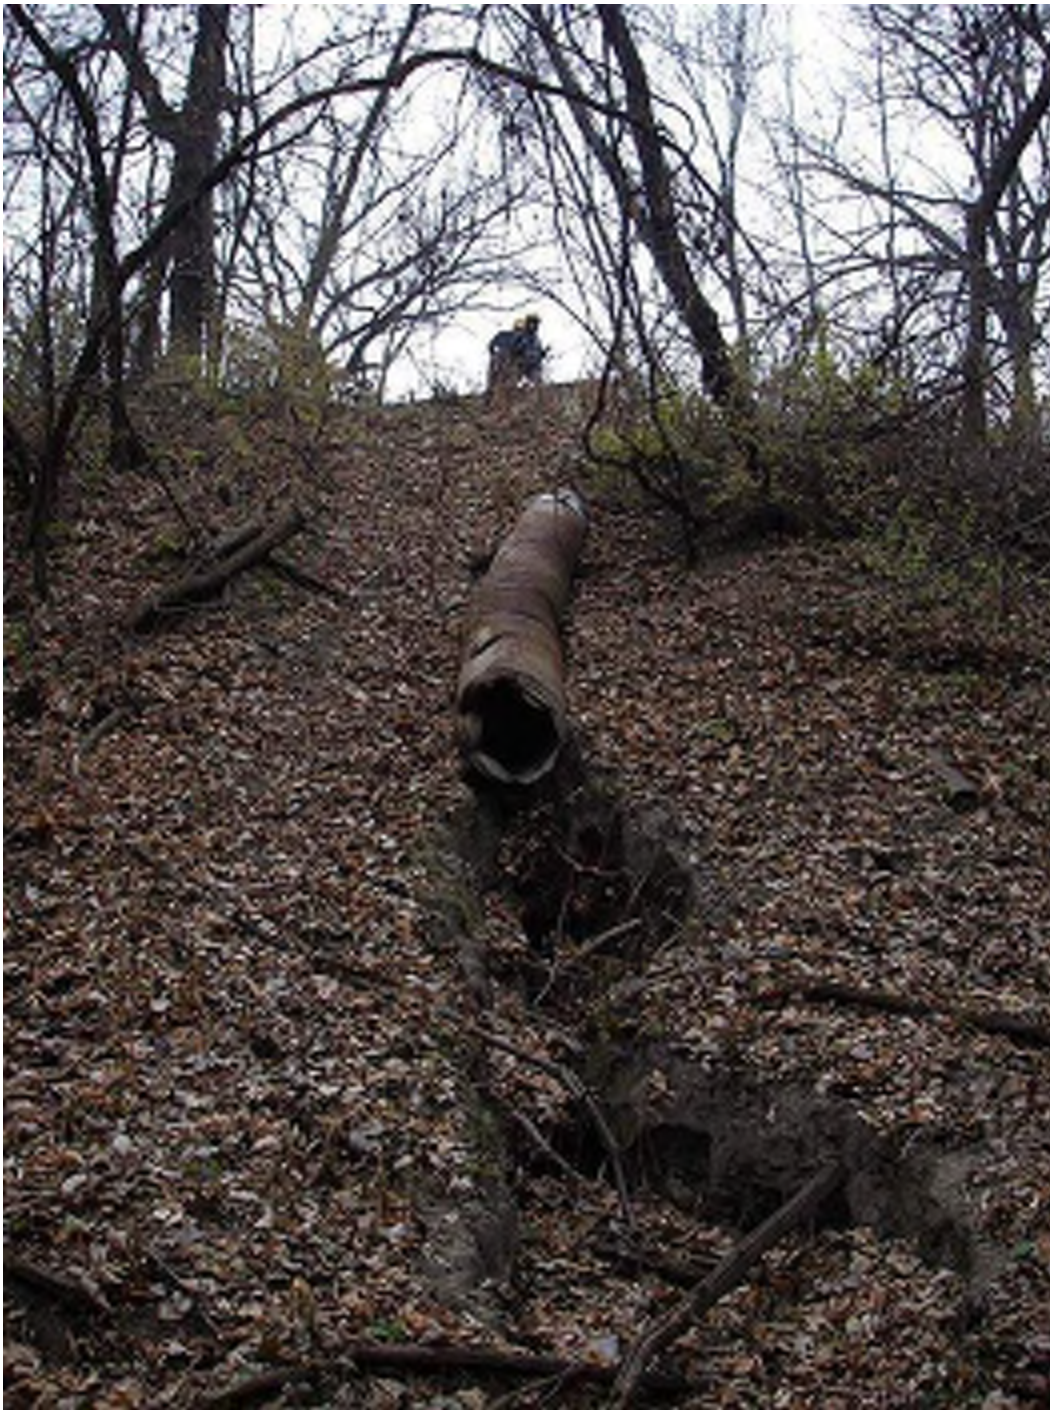
Waypoint 5

Drain pipe

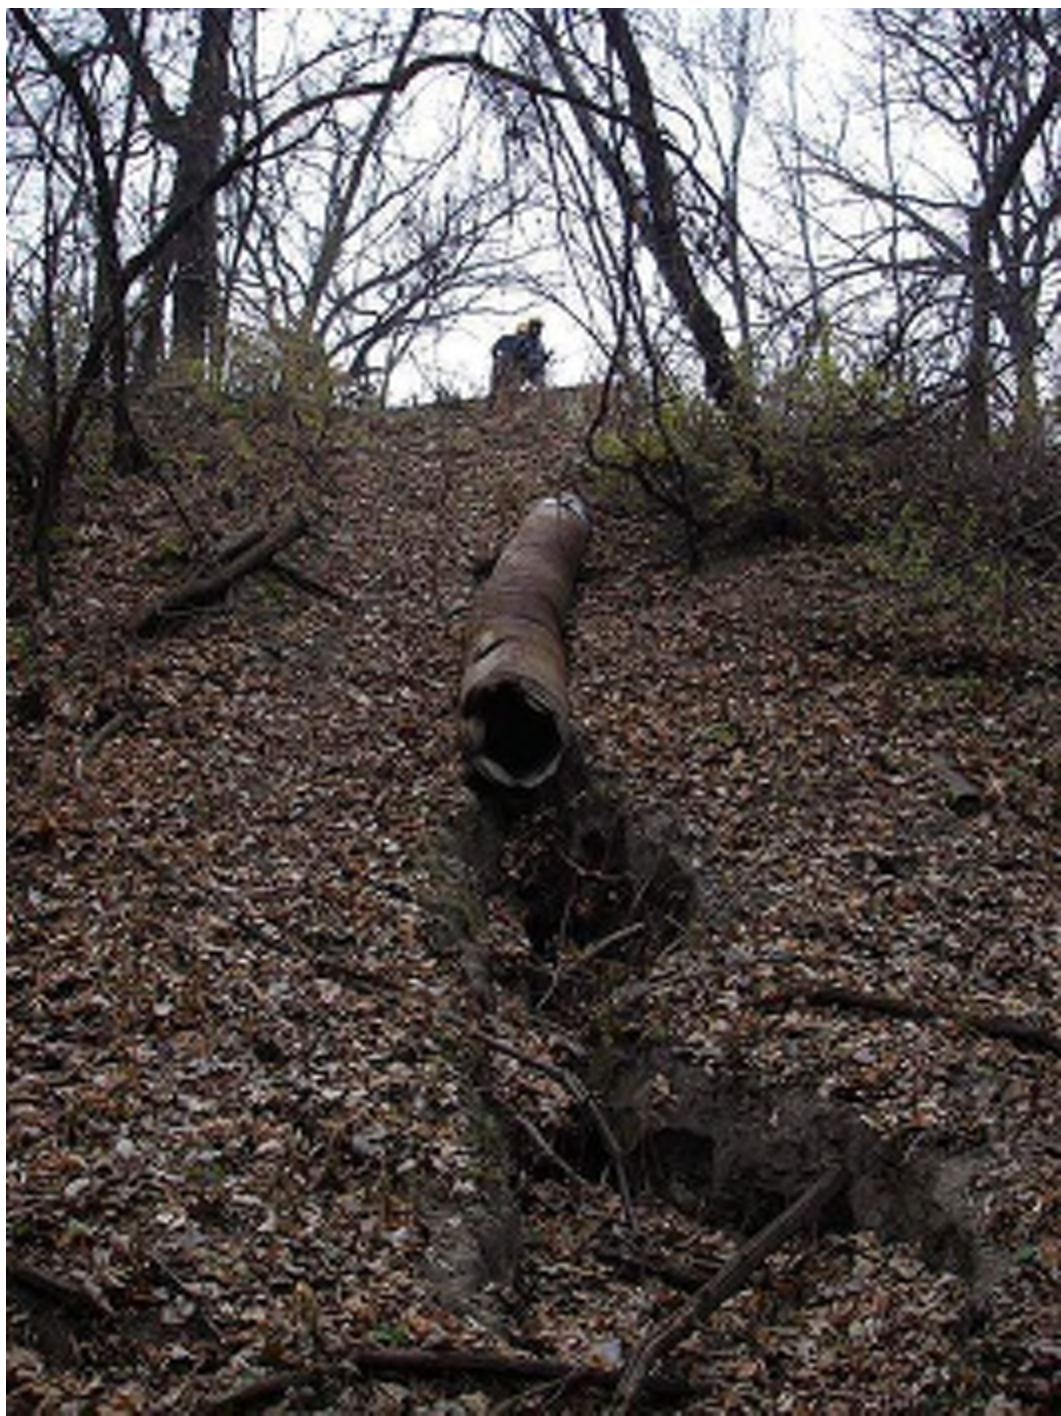
Waypoint 6

Drain pipe

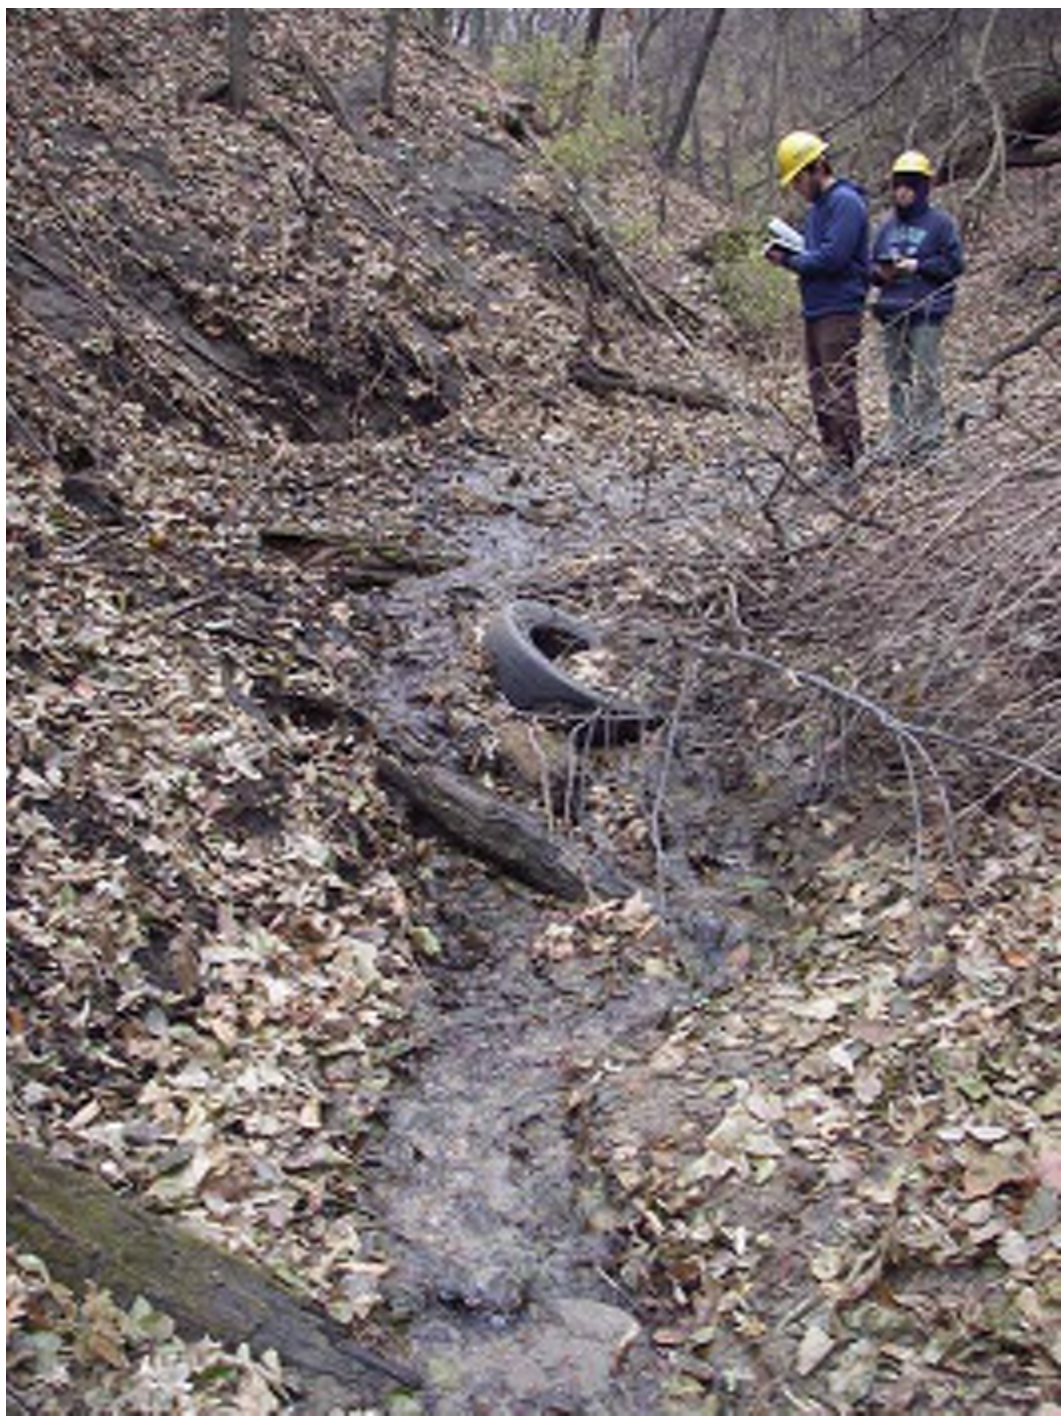
Waypoint 7

Spring/groundwater seeping

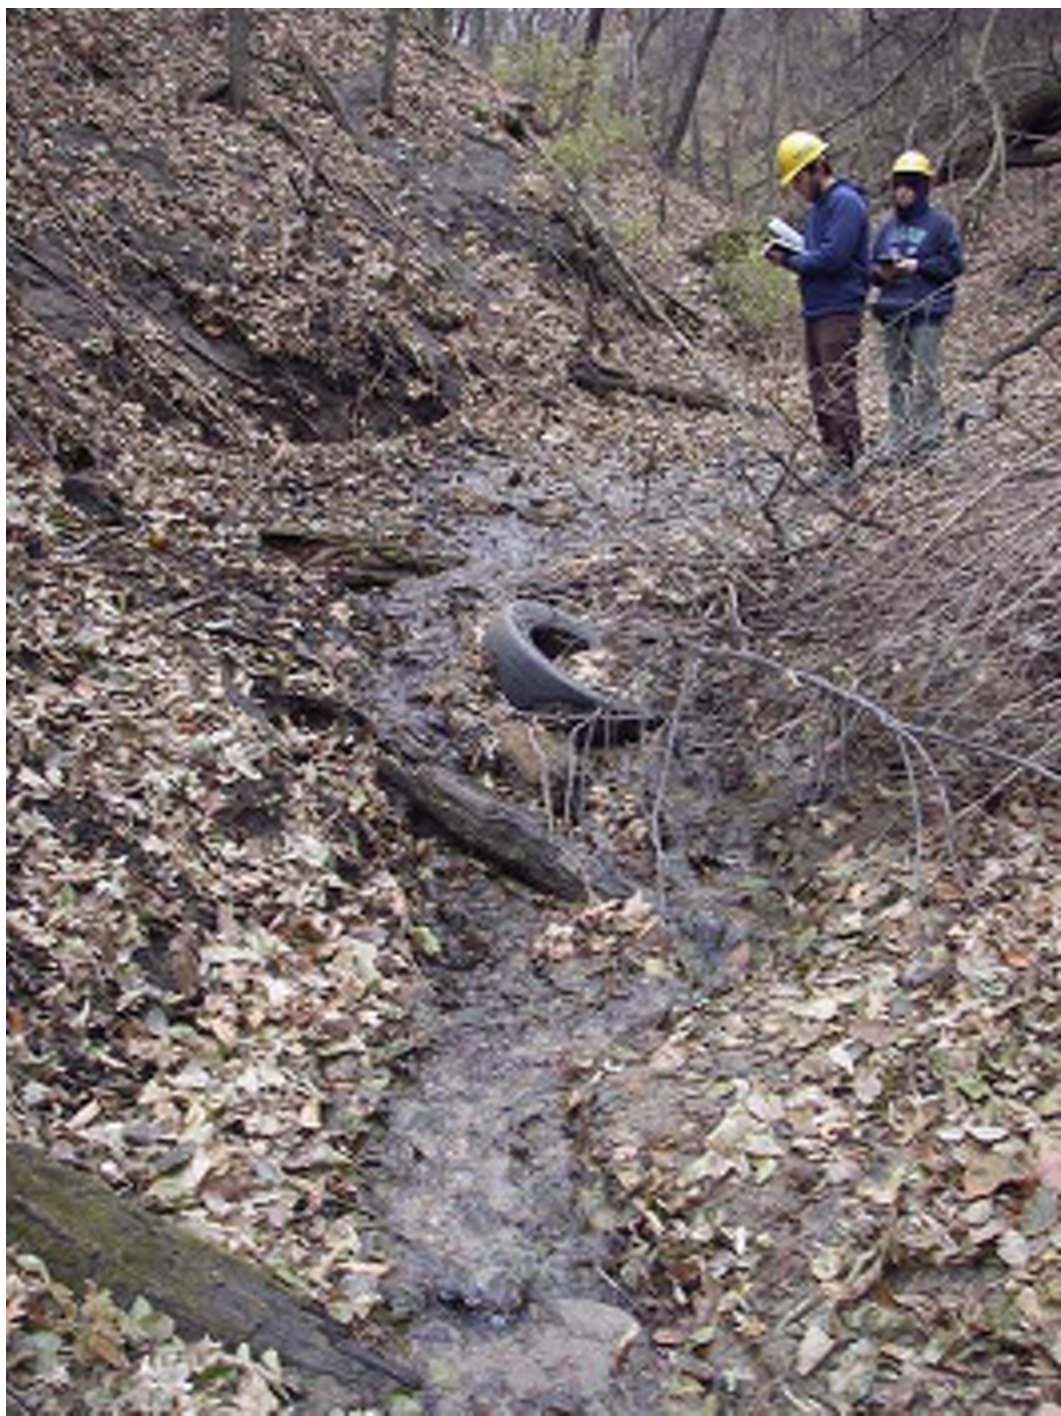
Waypoint 8

Spring/groundwater seeping

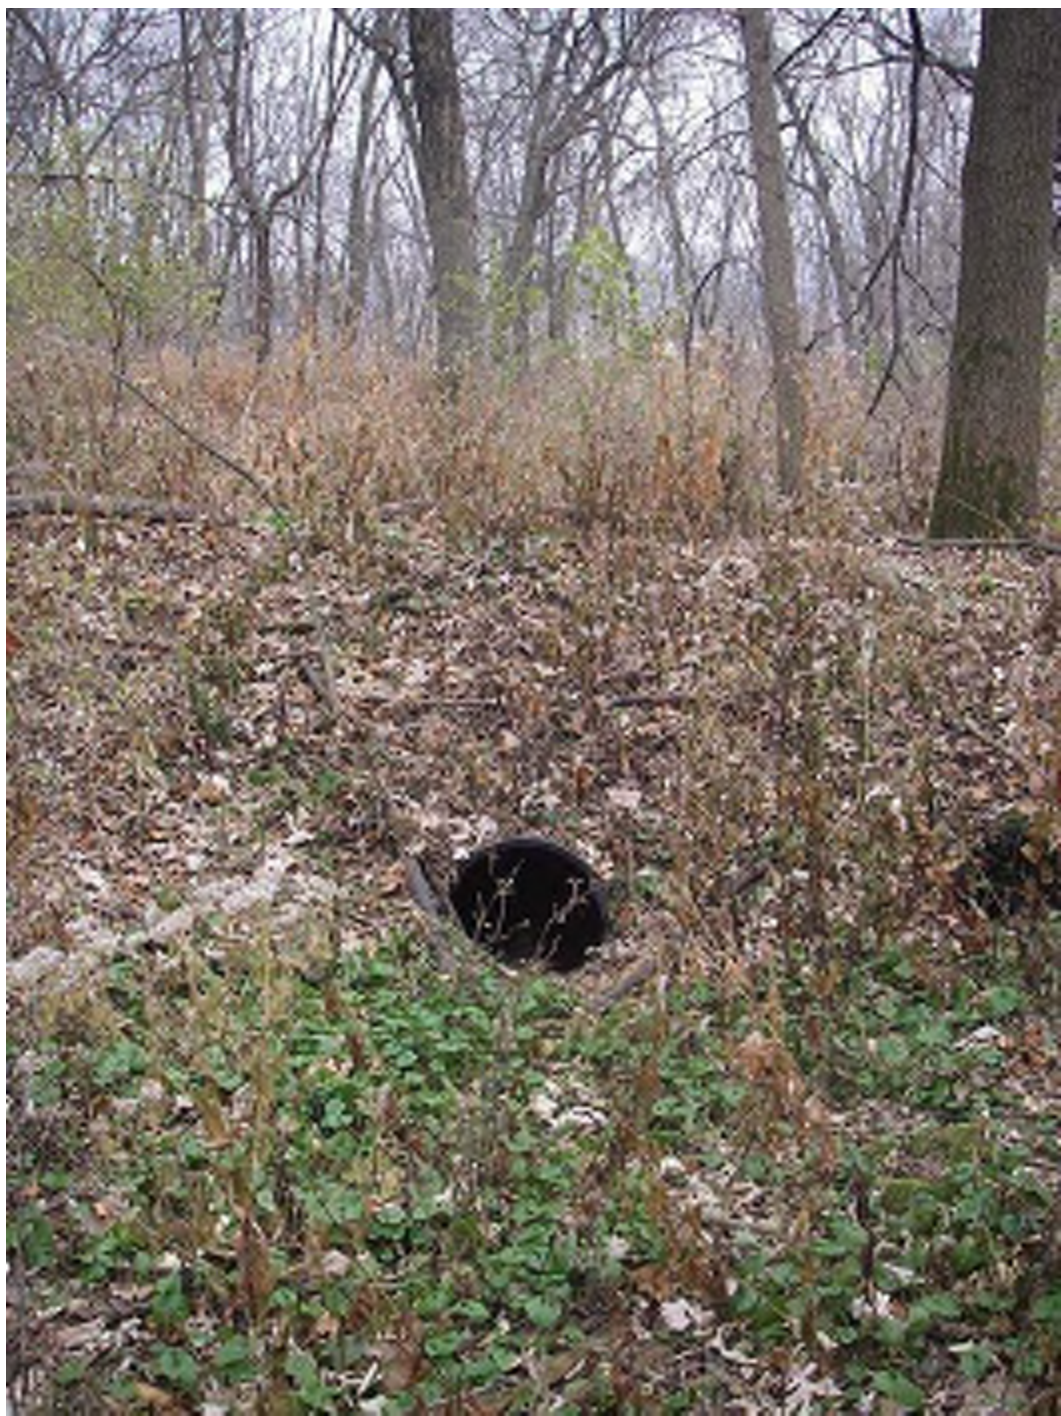
Waypoint 20

Drain pipe entrance for 018 WP

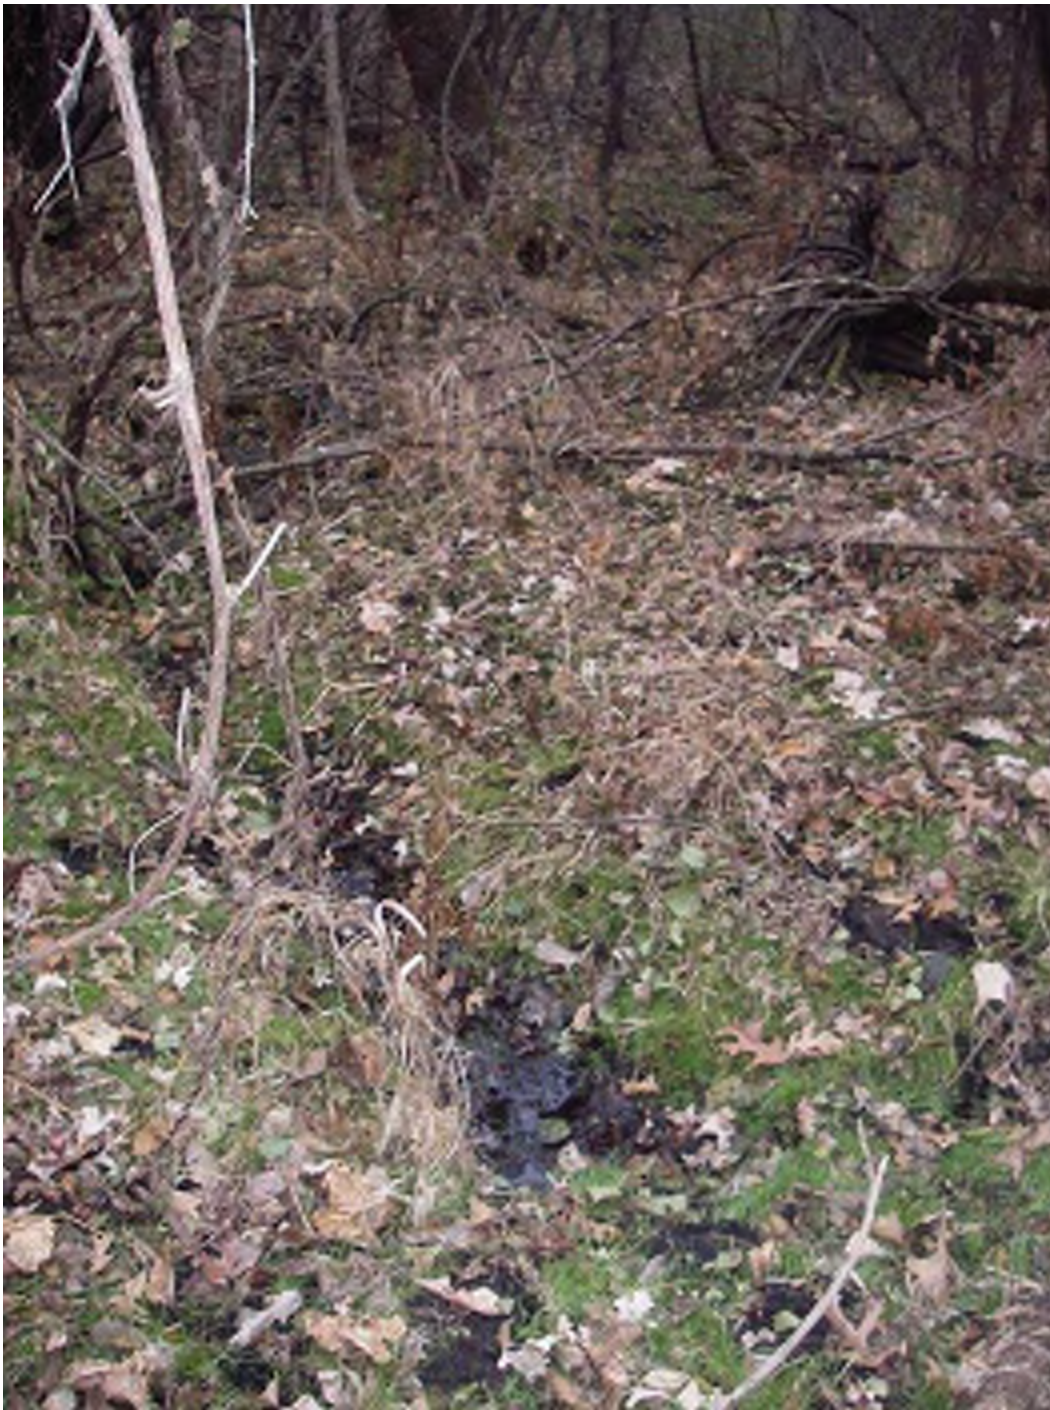
Waypoint 27

Spring & small channel leading to wetland

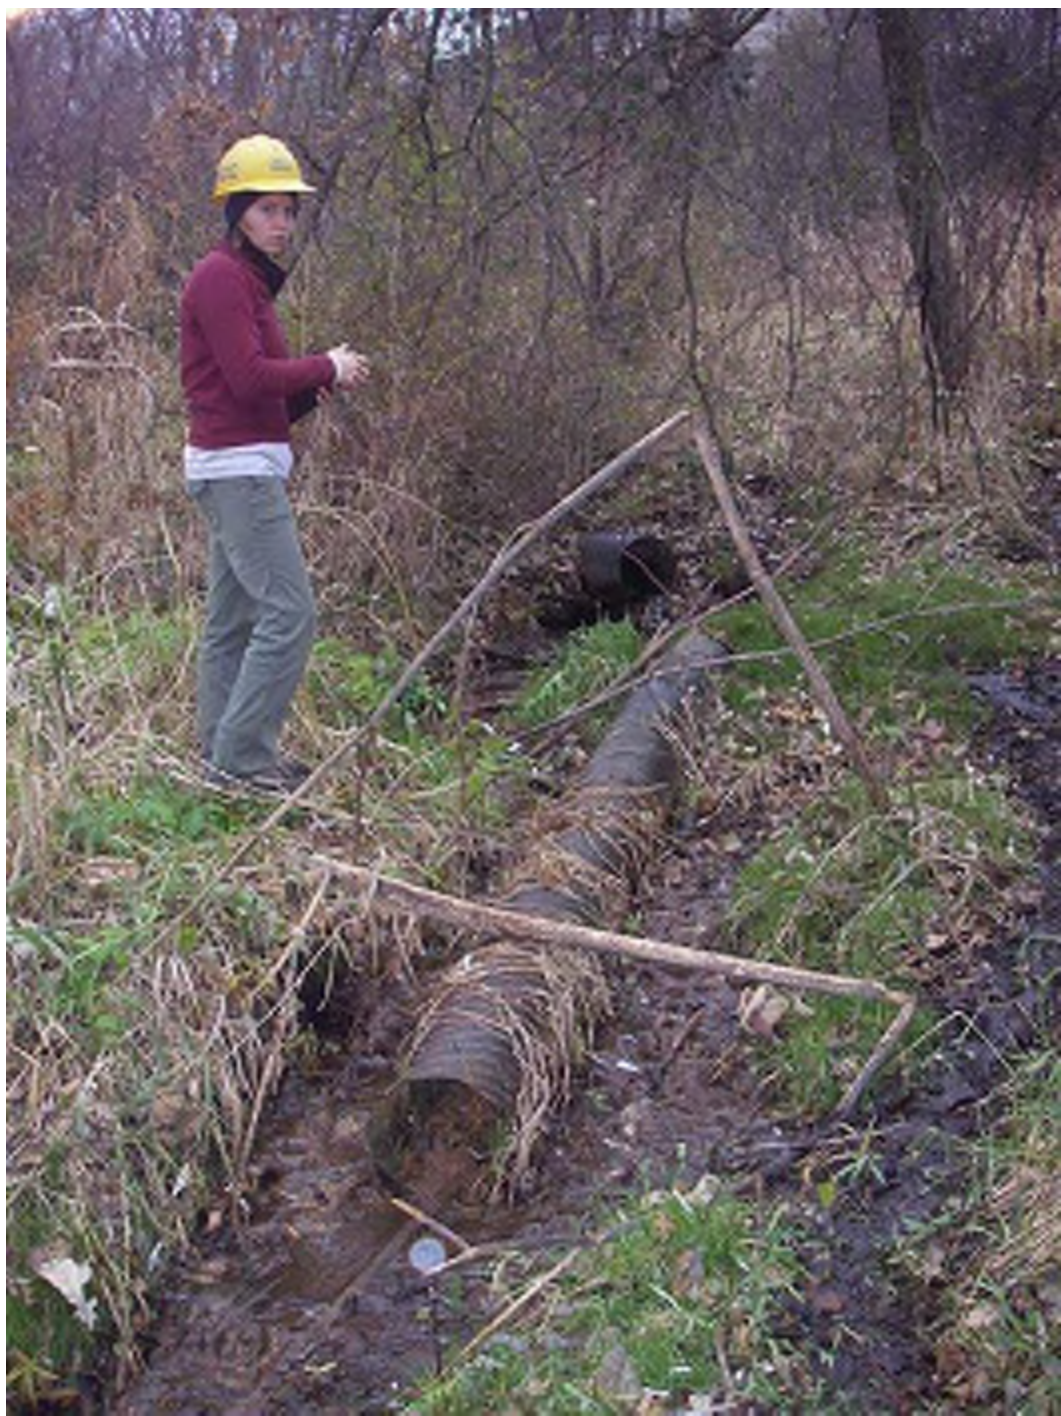
Waypoint 34

Drain pipe outlet

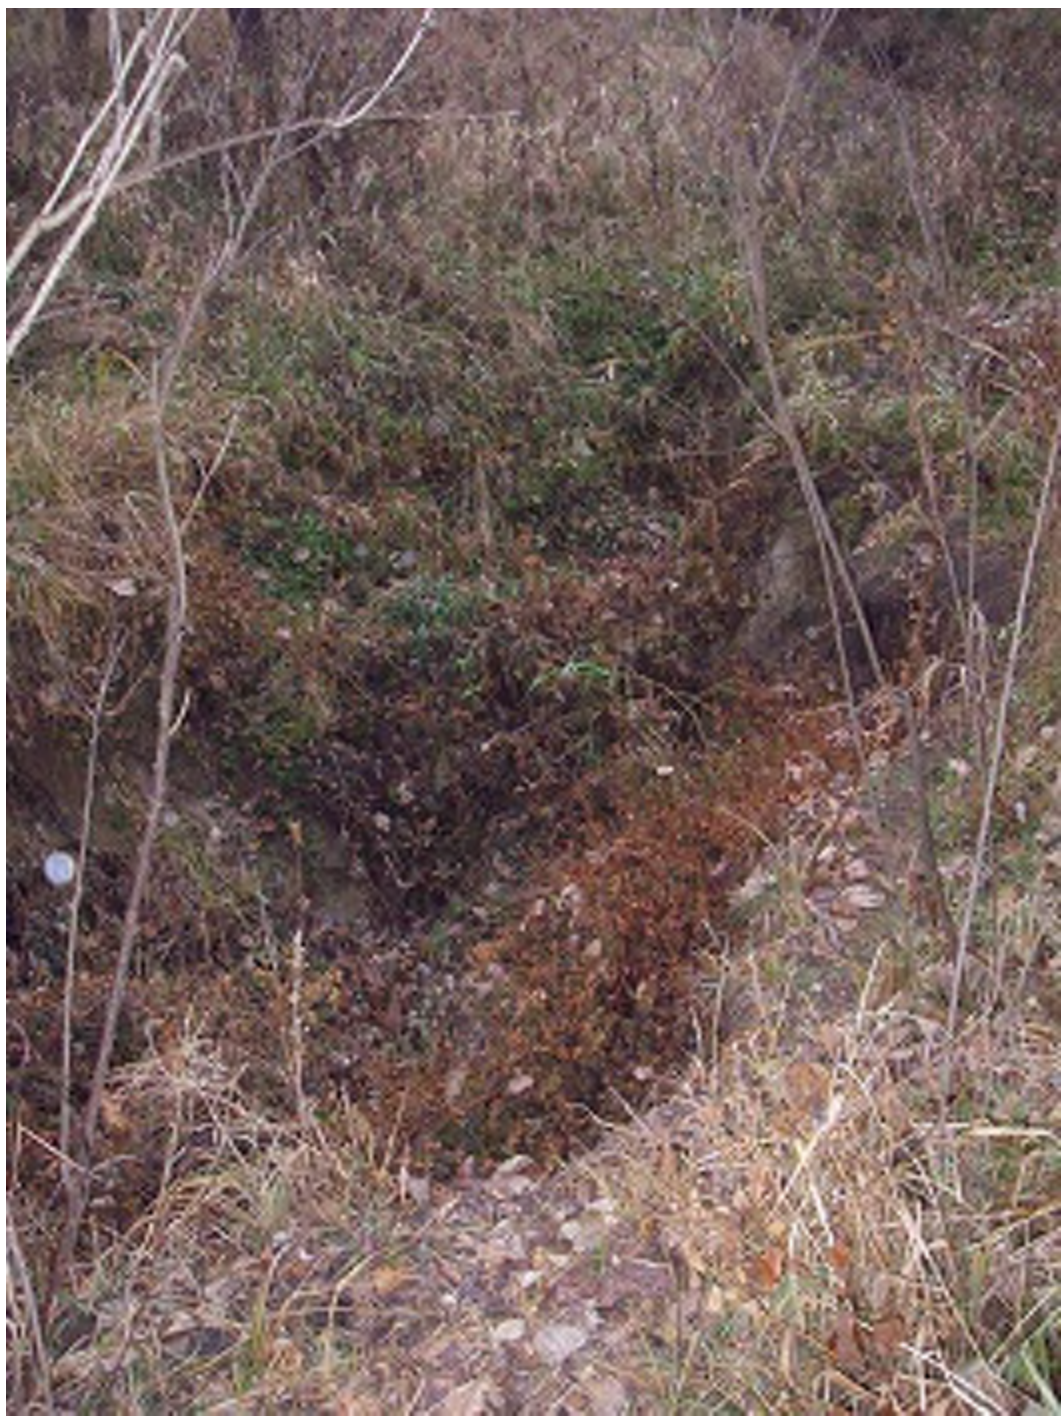
Waypoint 35

Storm pipe outlet - deep pit

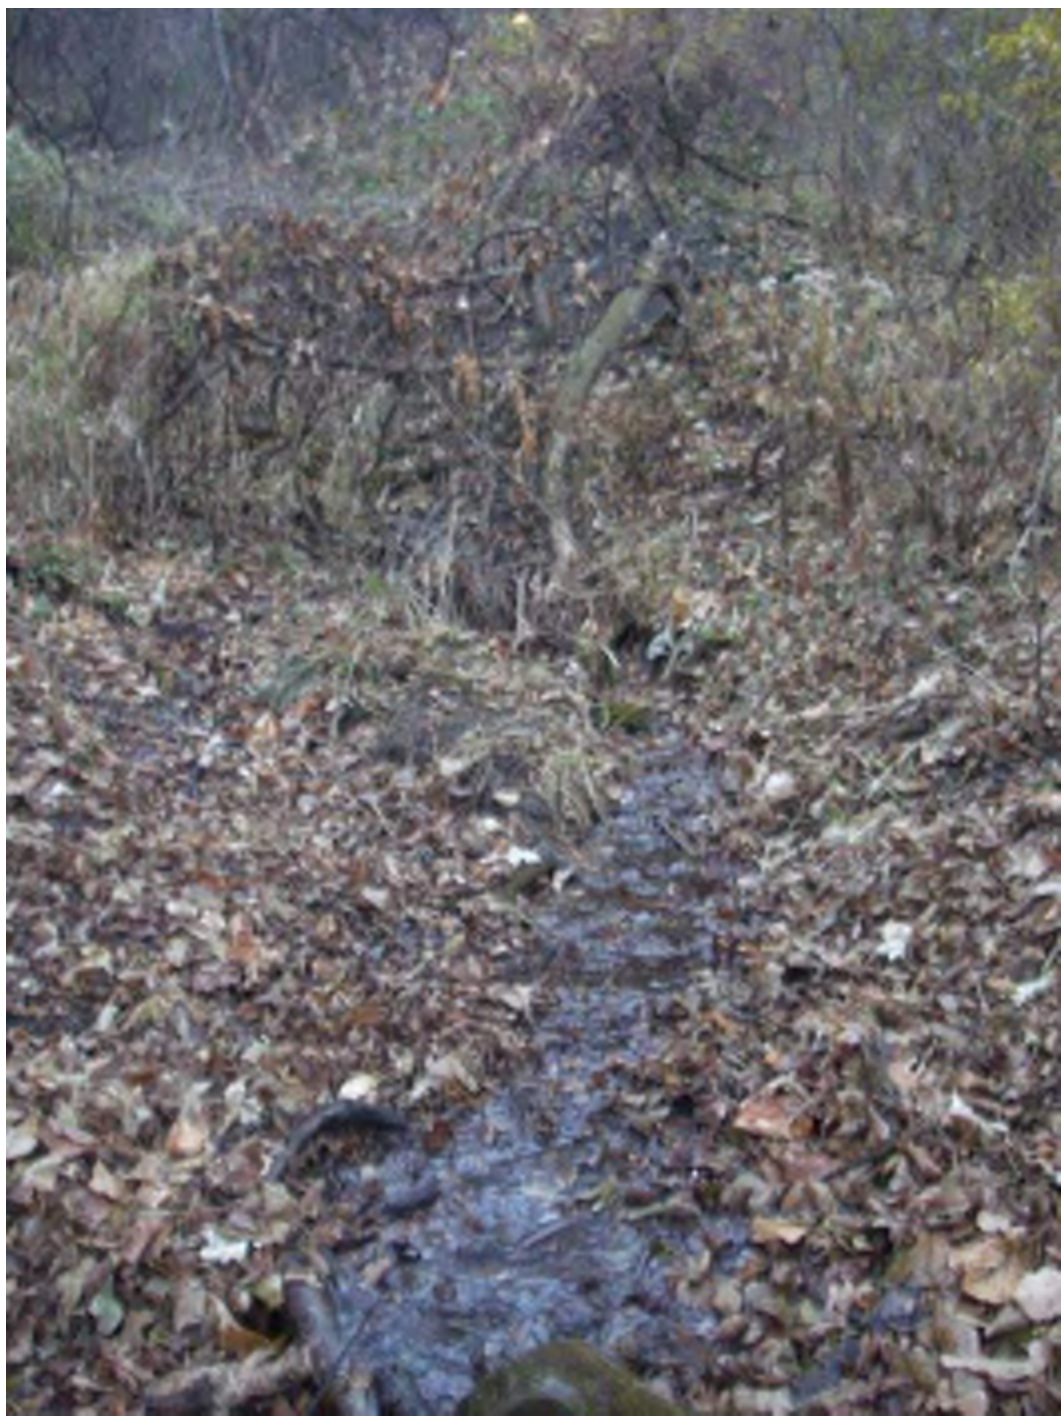
Waypoint 38

Groundwater seepage/spring

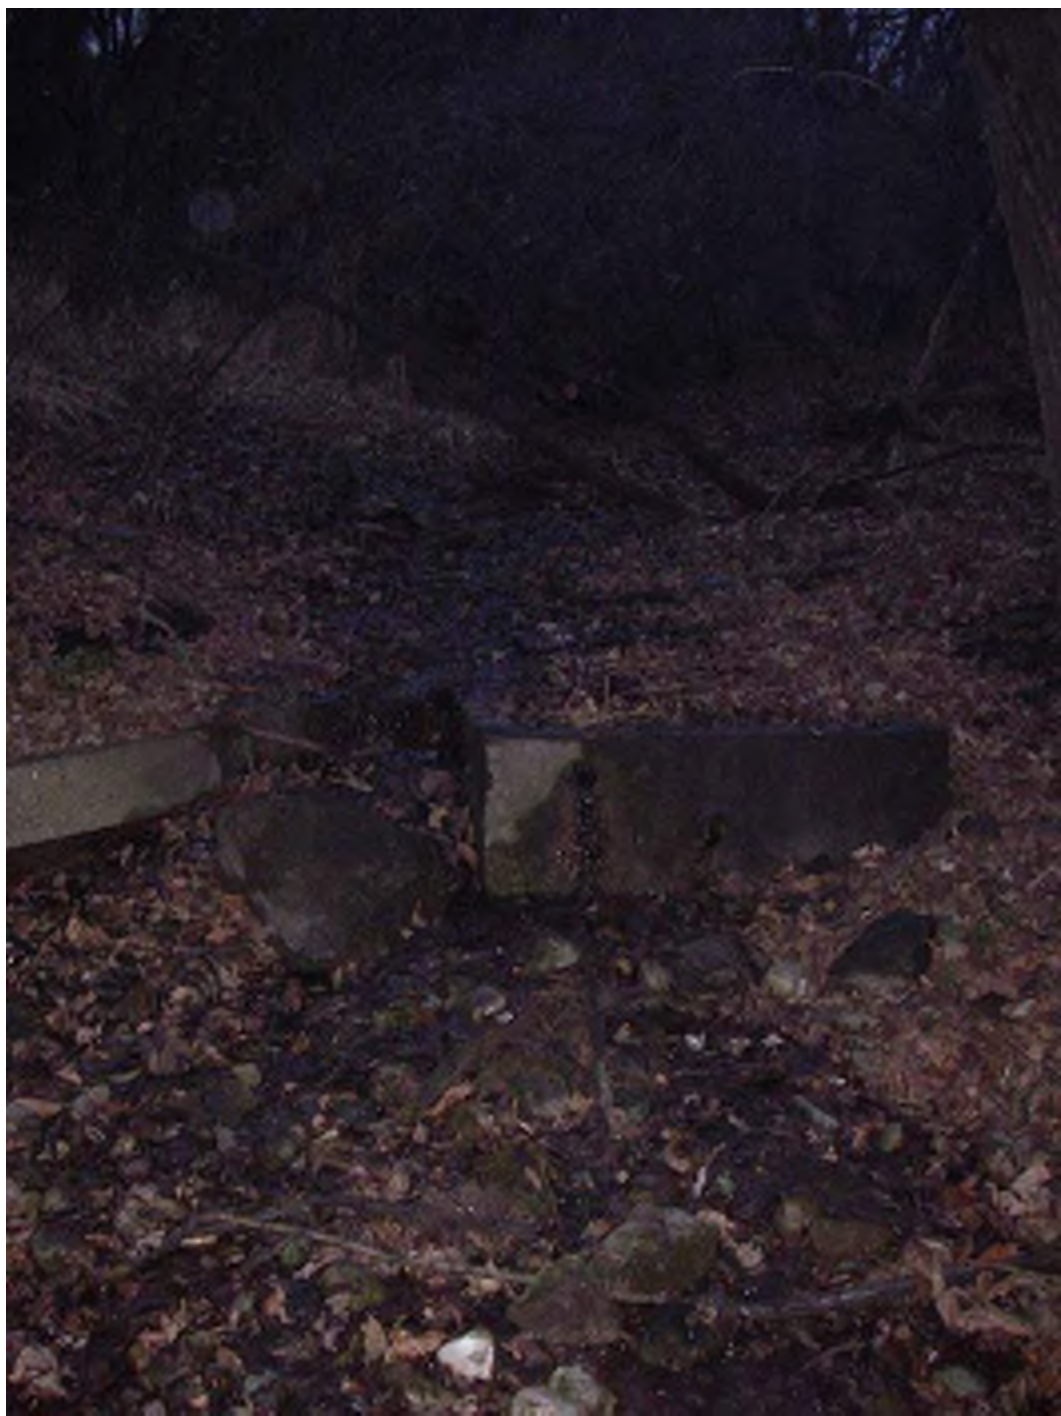
Waypoint 39

Outlet pipe

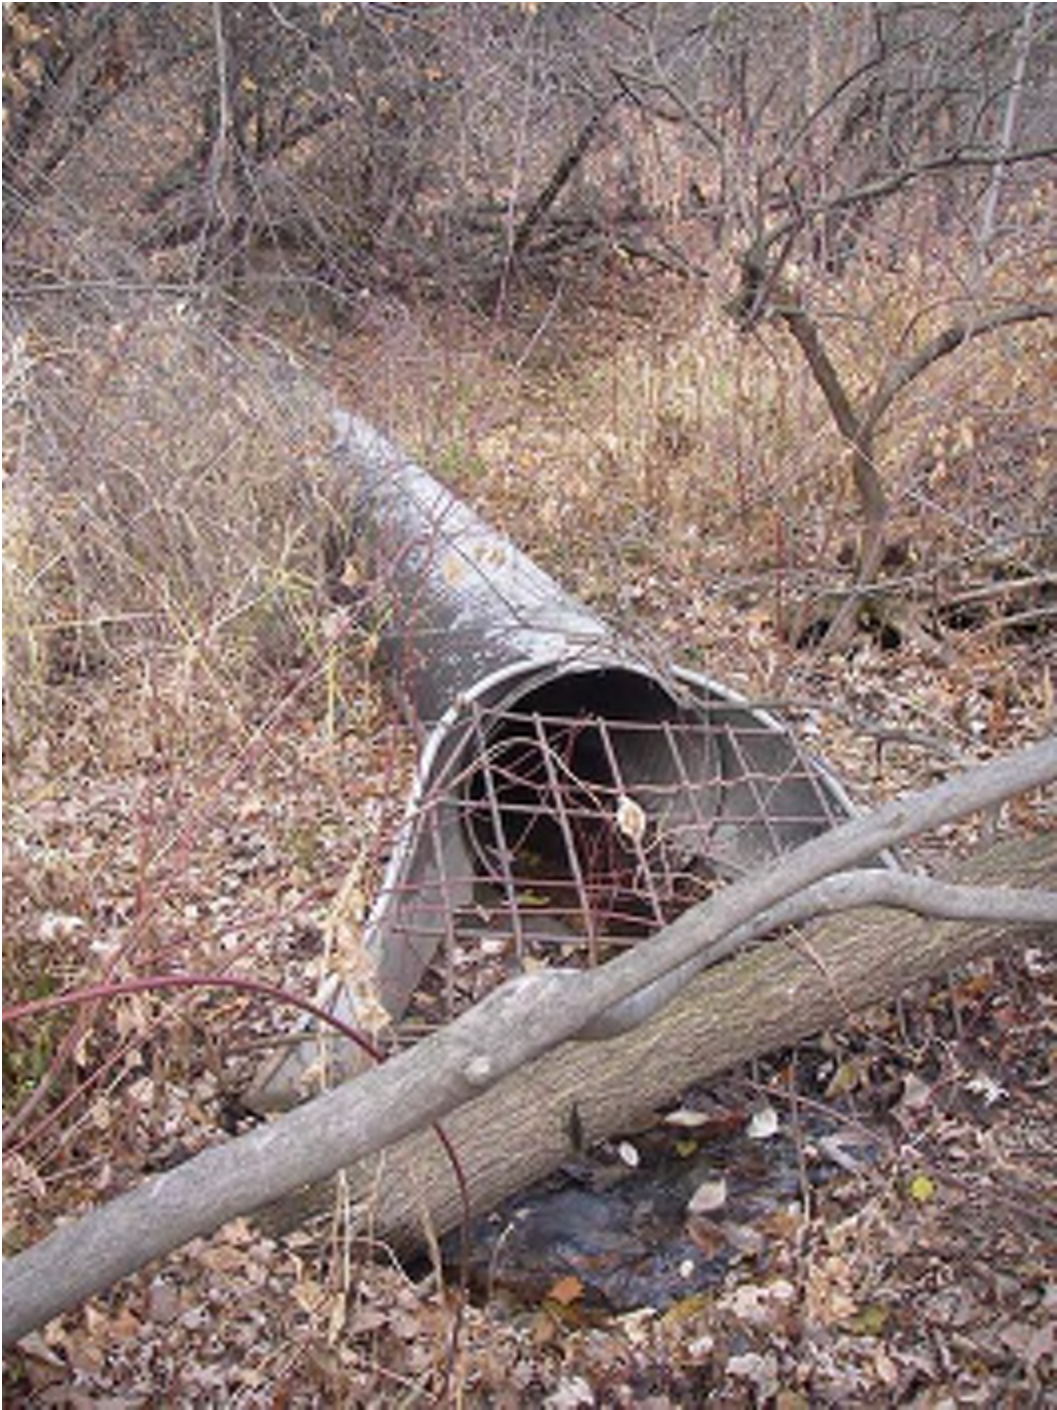
Waypoint 57

Storm drain outlet

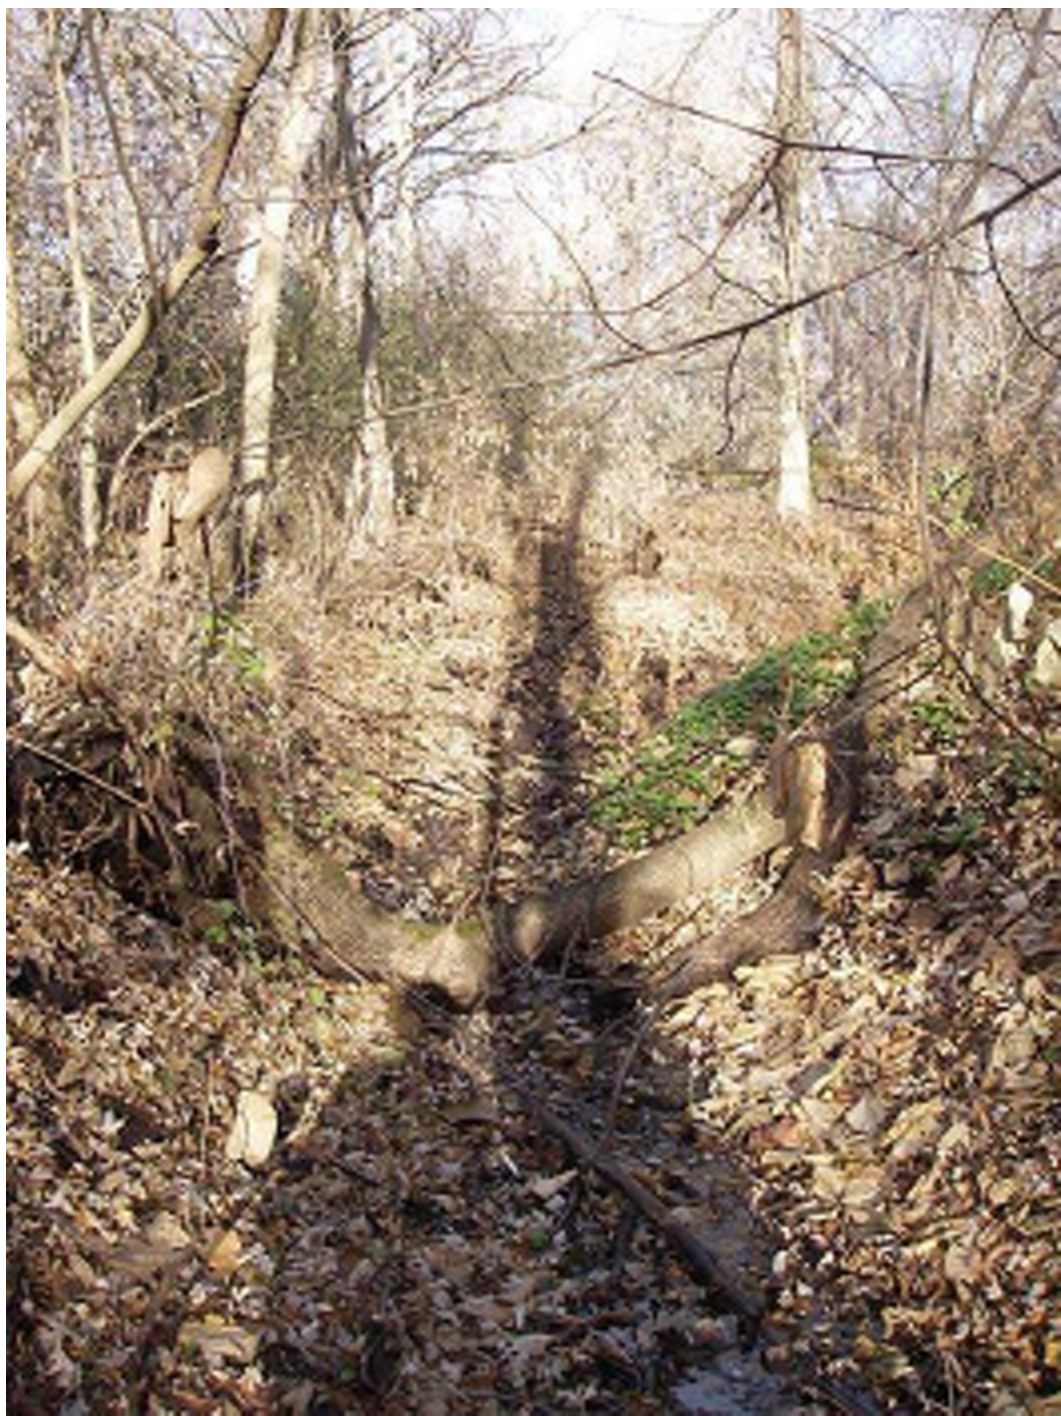
Spring with water table seepage

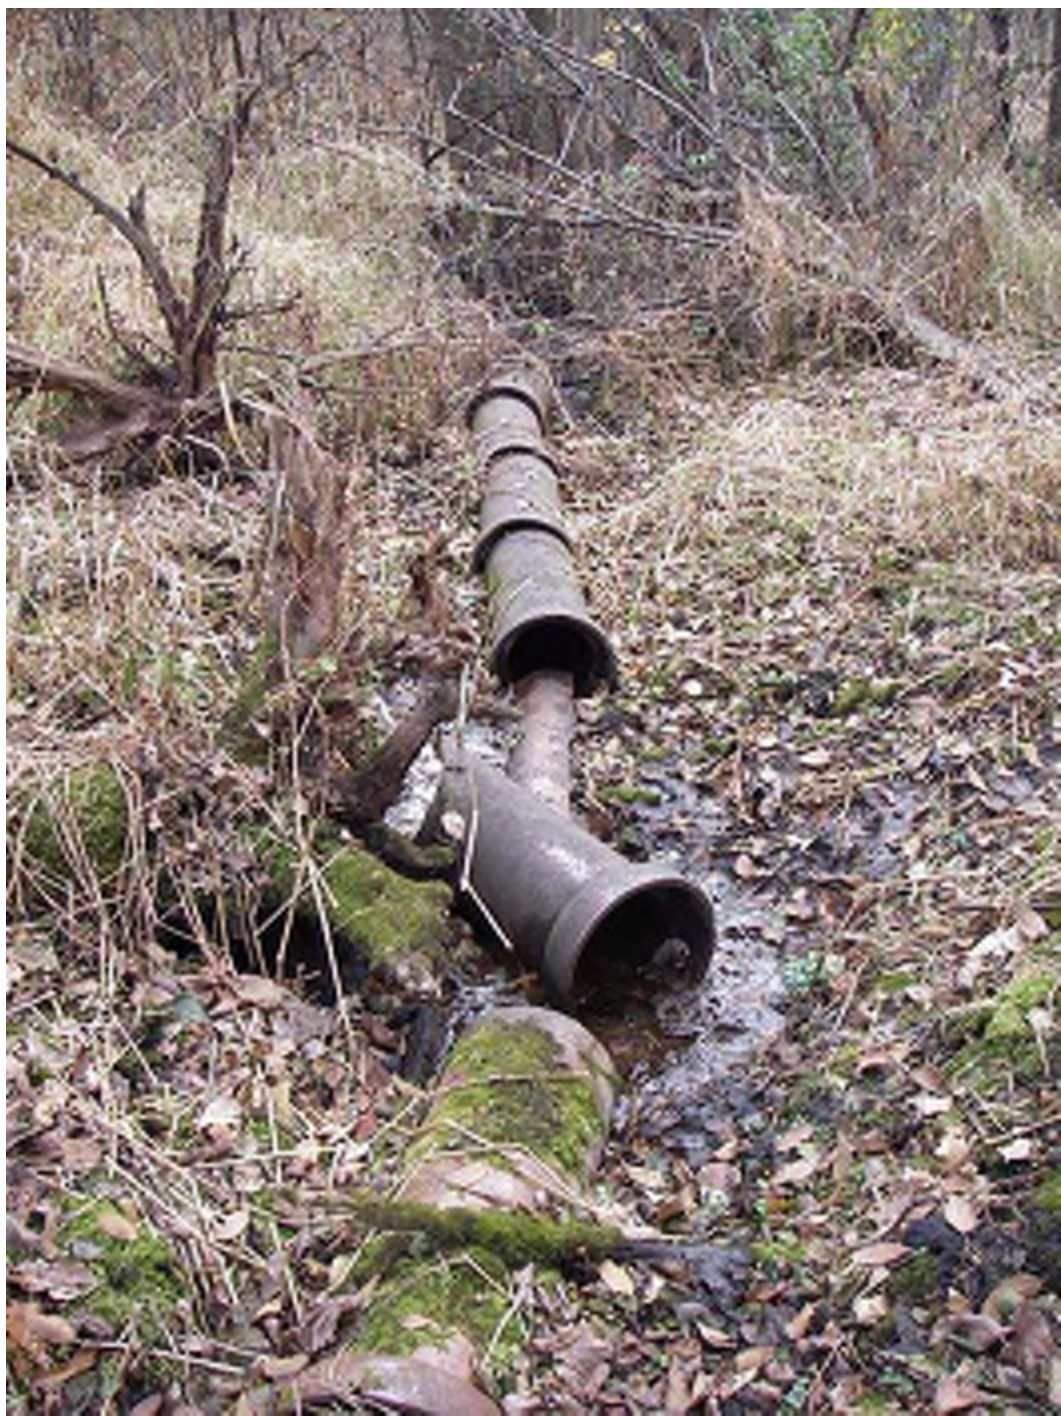
Pipe outfall

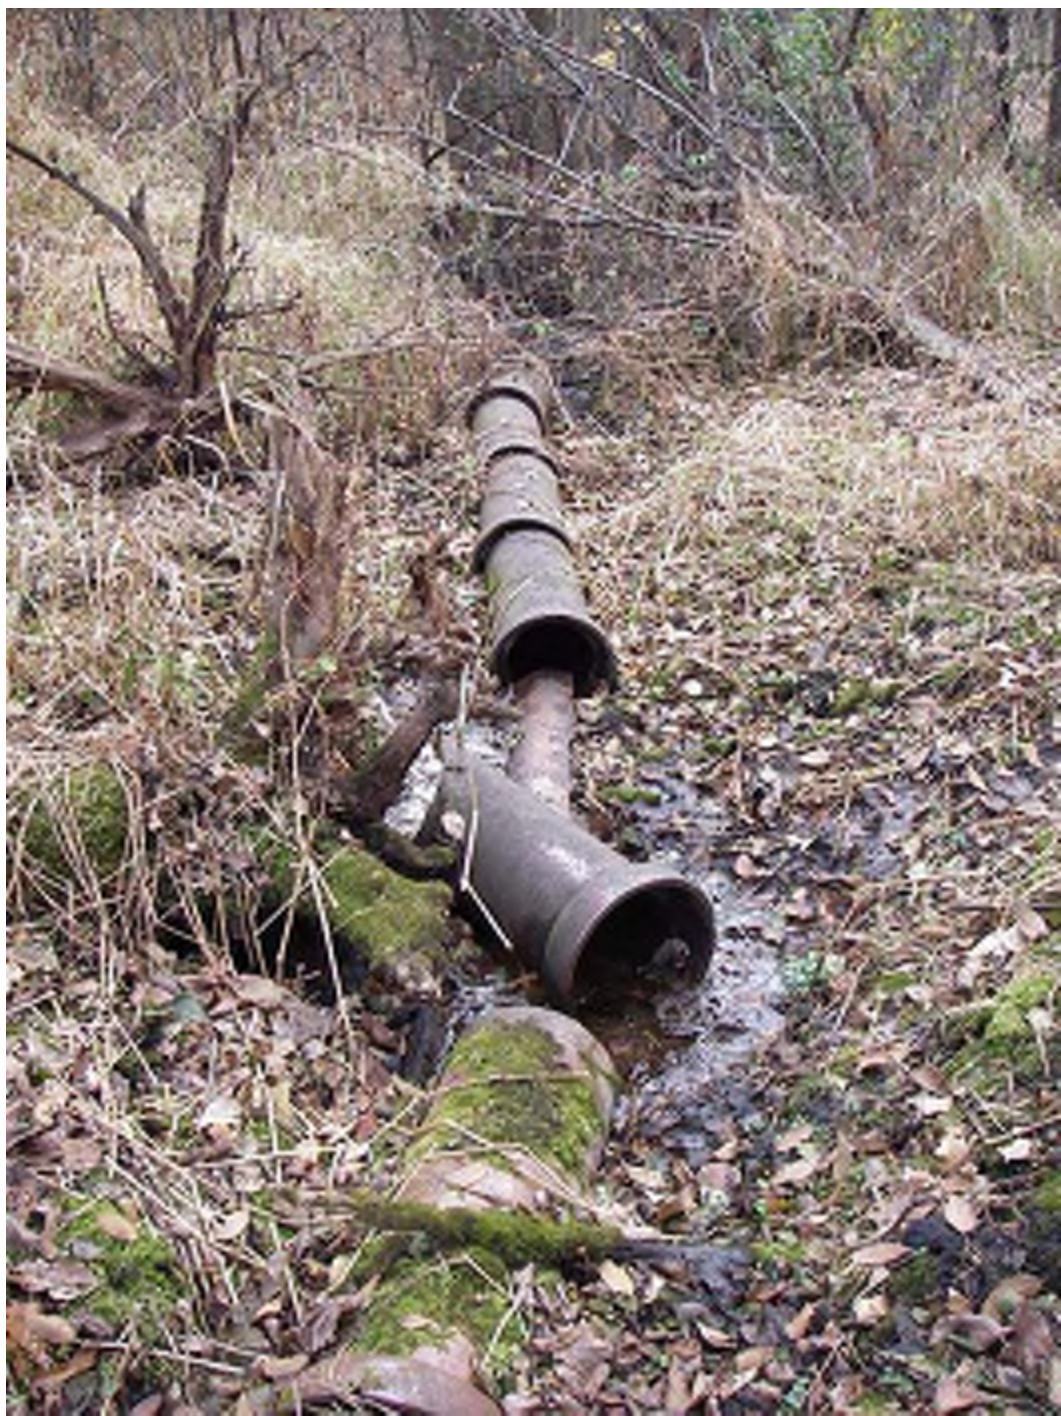
40 ft. of broken clay pipe along a long spring
