Appendix K: Lower Minnesota River Watershed District: Gully Inventory

Gully Inventory Map
 Area #1
 Lower Minnesota River Watershed District
 Watershed Management Plan

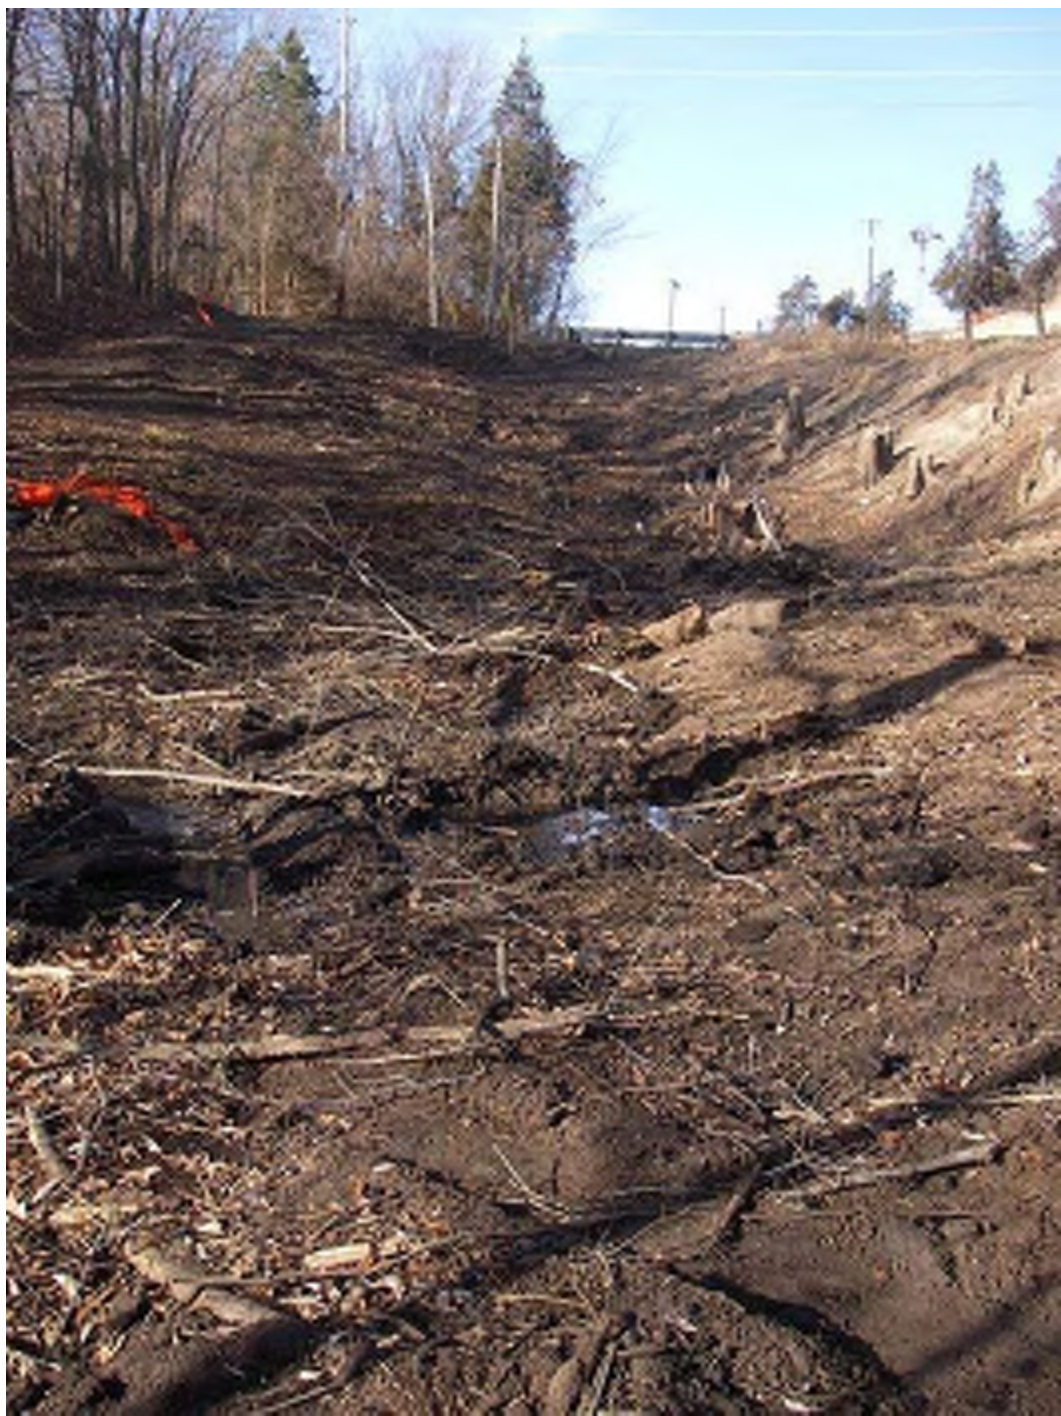
construction/erosion, standing water

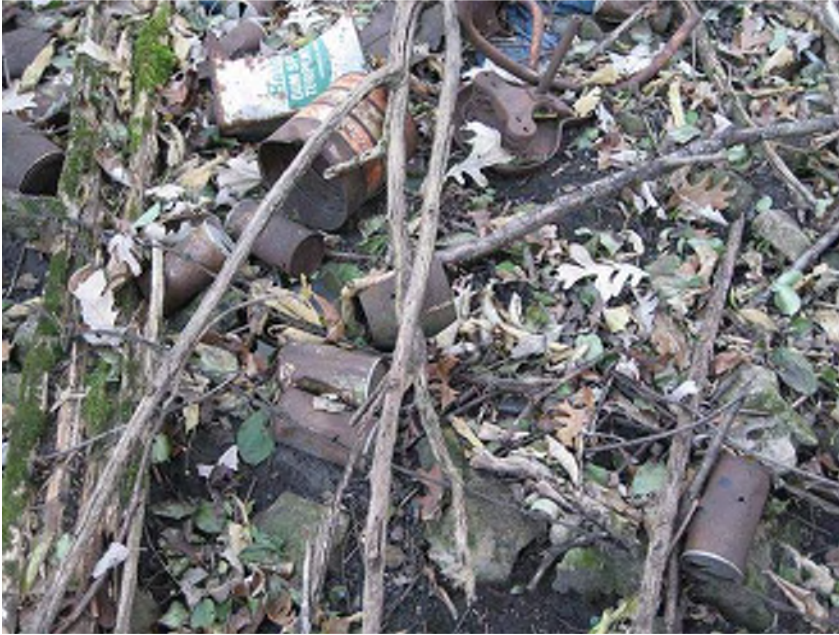
All pictures - Large dump site; lots of bottles, cans, metal containers, misc. metals (rusted); old style of cans indicate they've been here

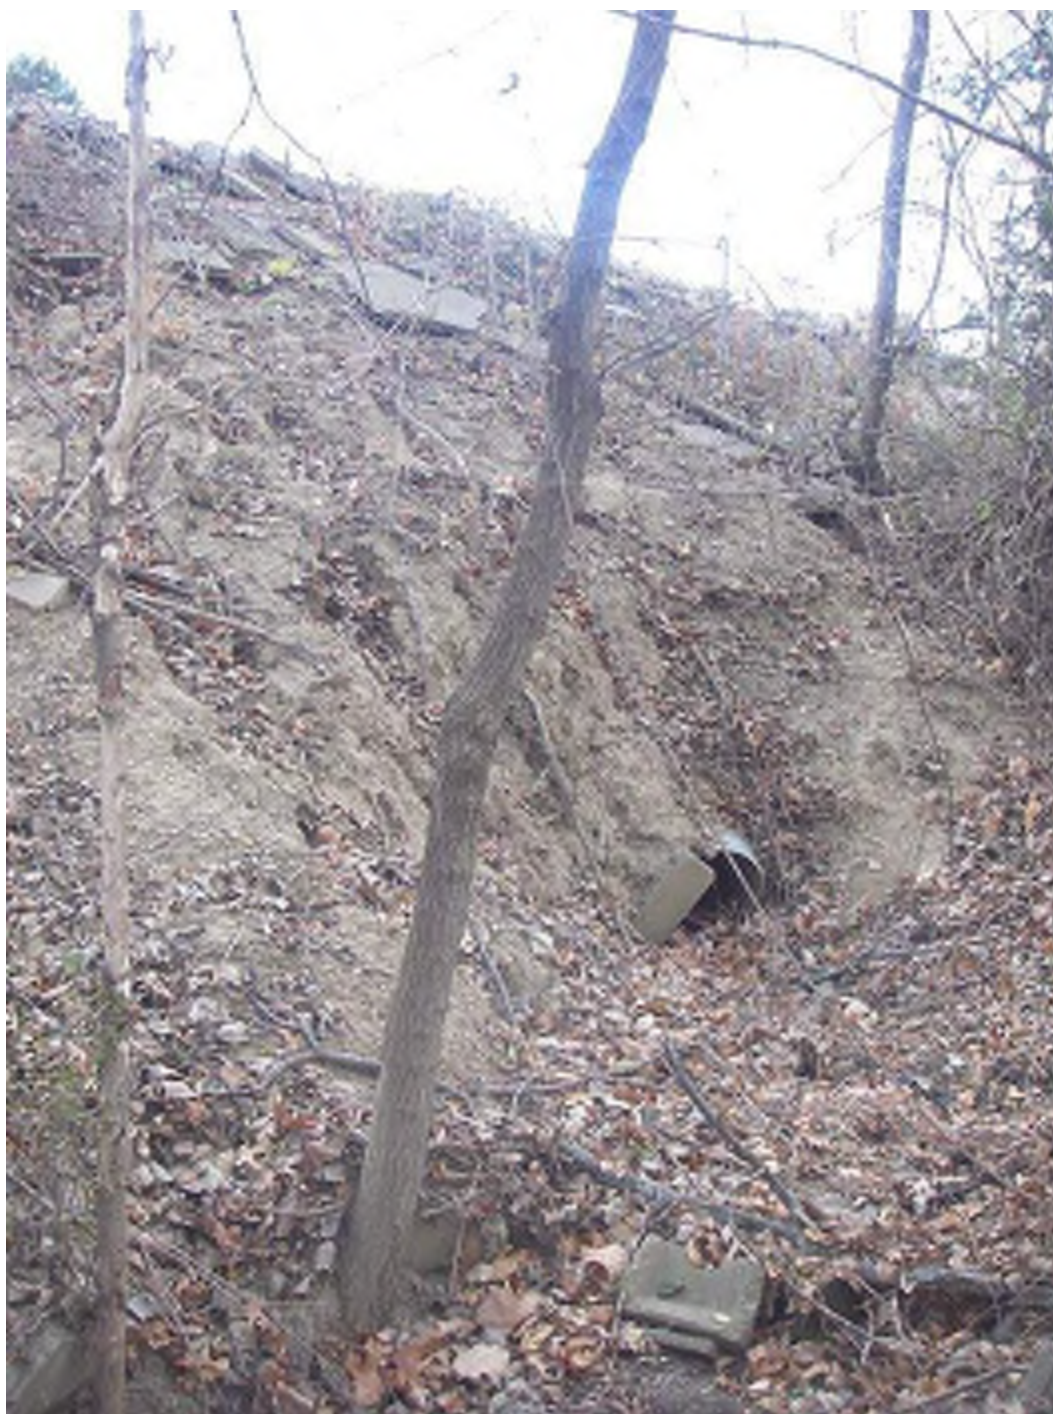
Drain pipe from trailer park & erosion

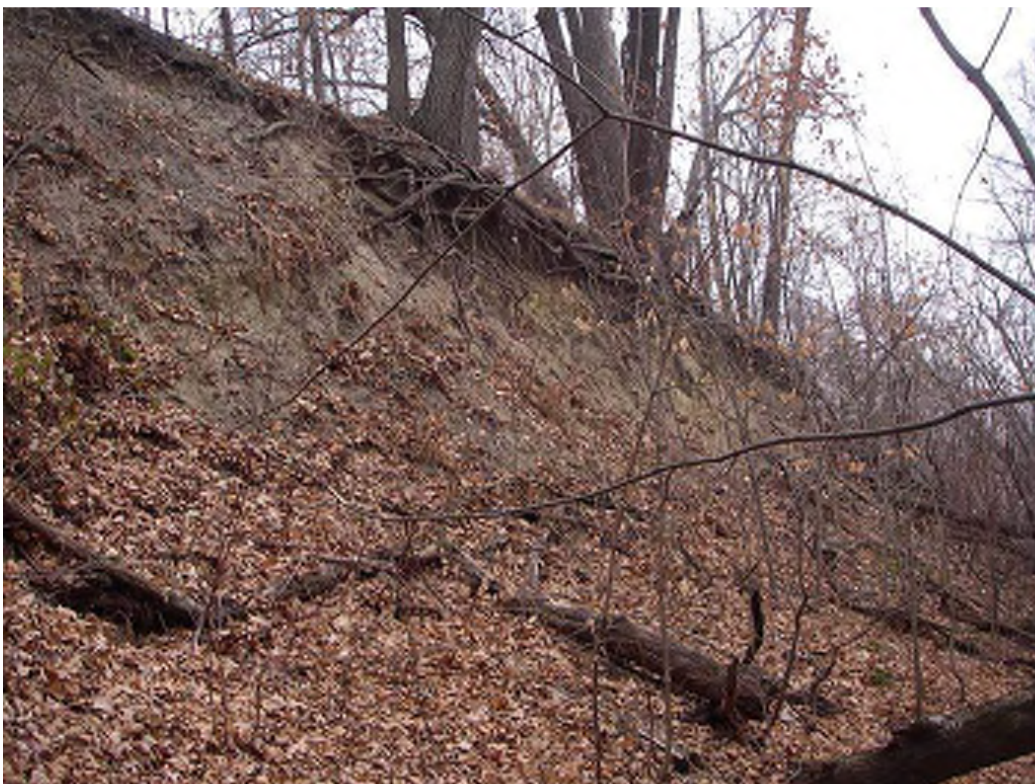
Extreme soil erosion

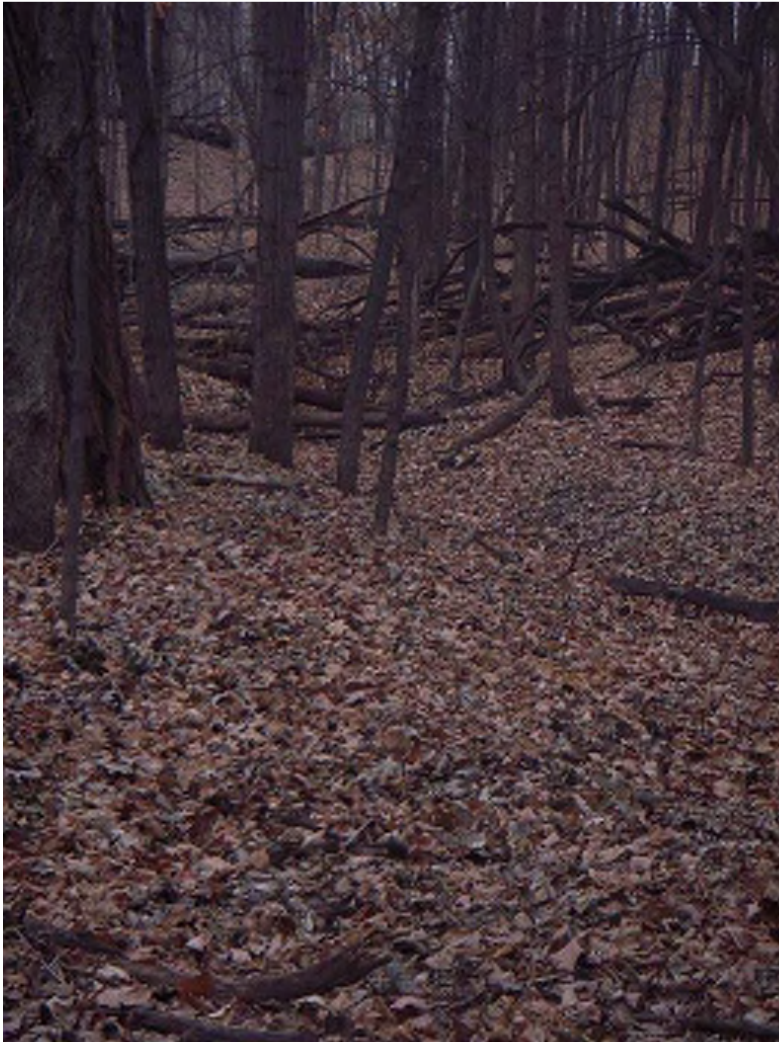
End of gully; severe erosion throughout gully/near newer housing development; is erosion caused by construction?

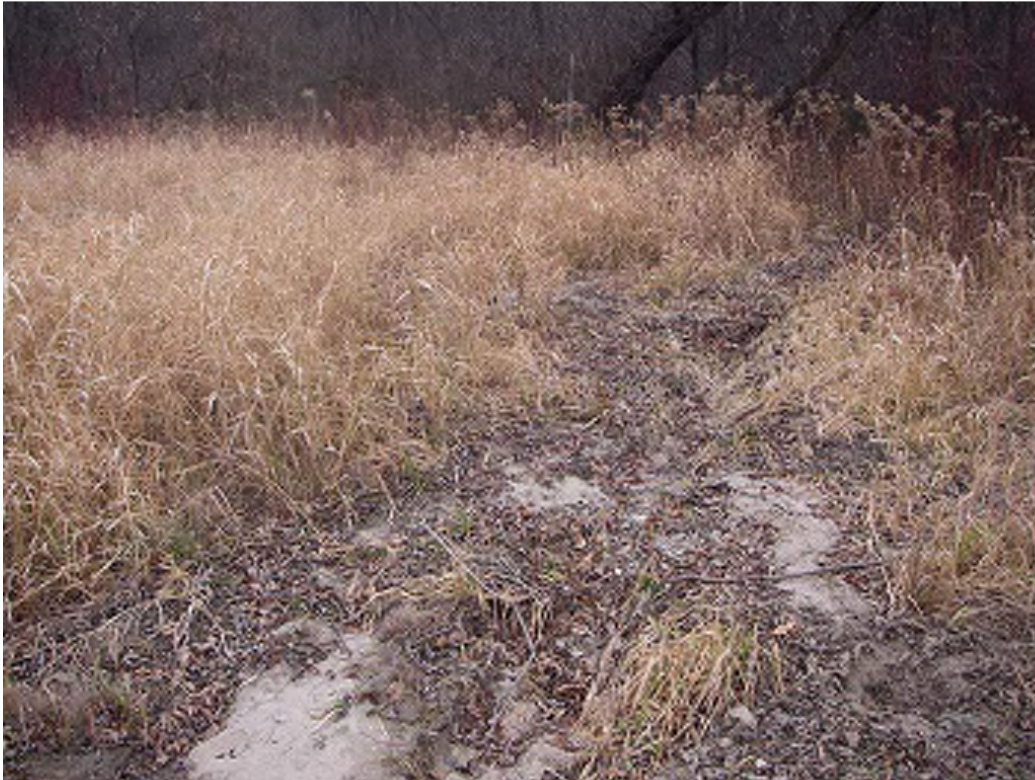
End of gully; severe erosion throughout gully/near newer housing development; is erosion caused by construction?

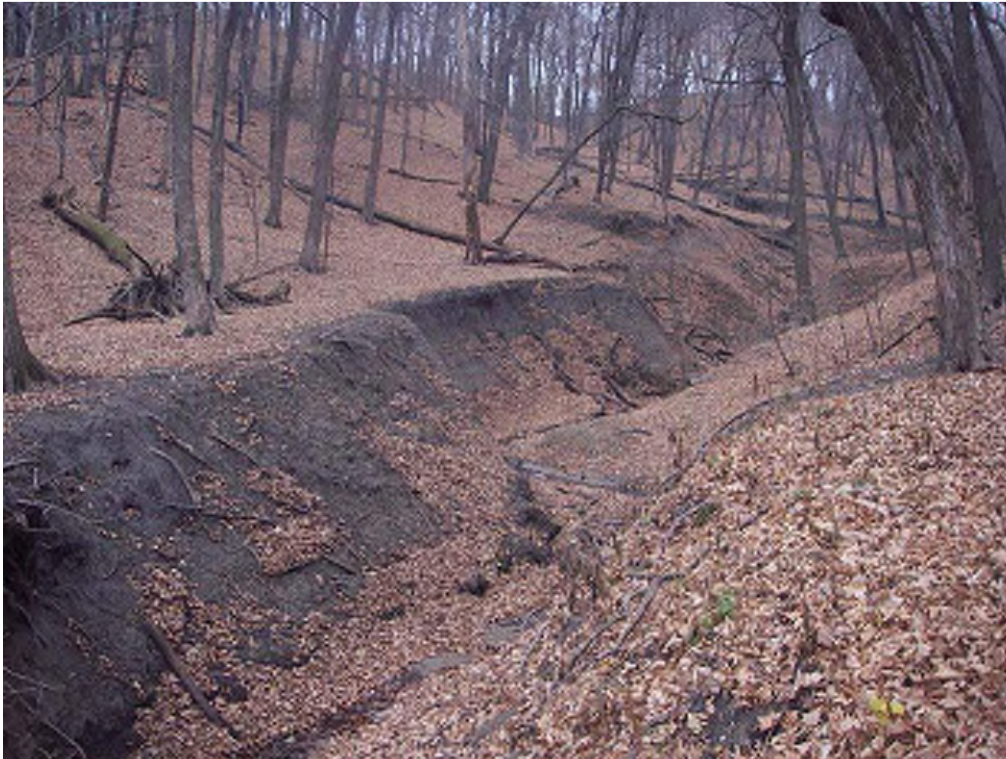
Severe erosion throughout gully/near newer housing development; is erosion caused by construction? Moderate erosion

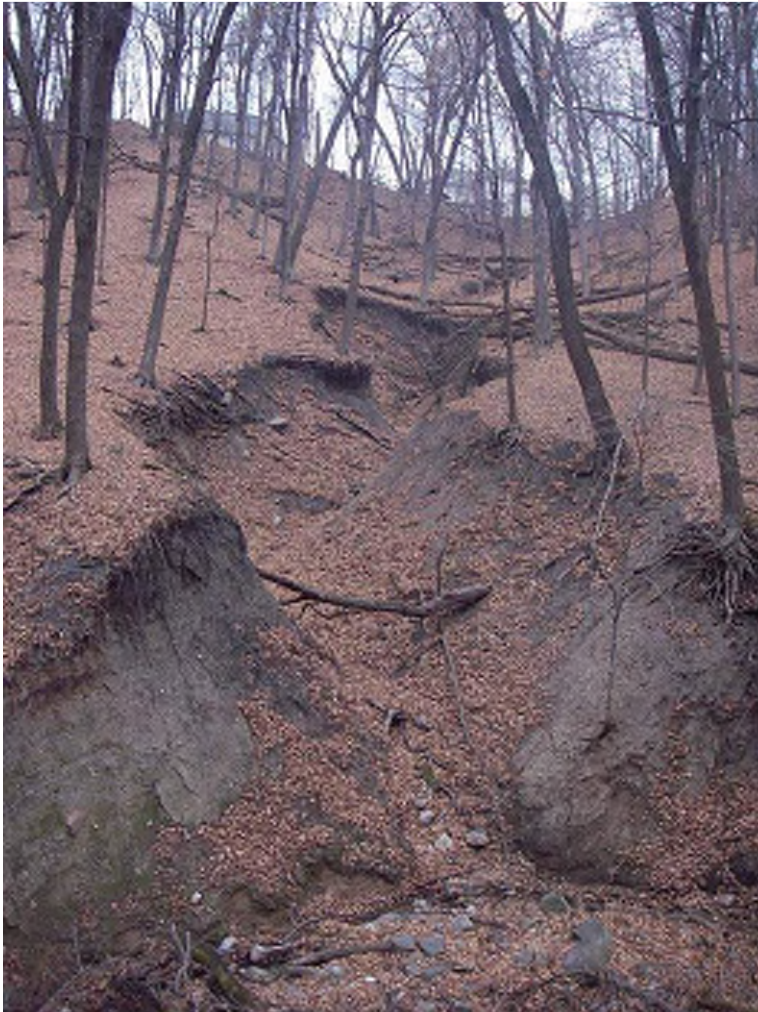
Branch of gully; severe erosion throughout gully/near newer housing development; is erosion caused by construction?

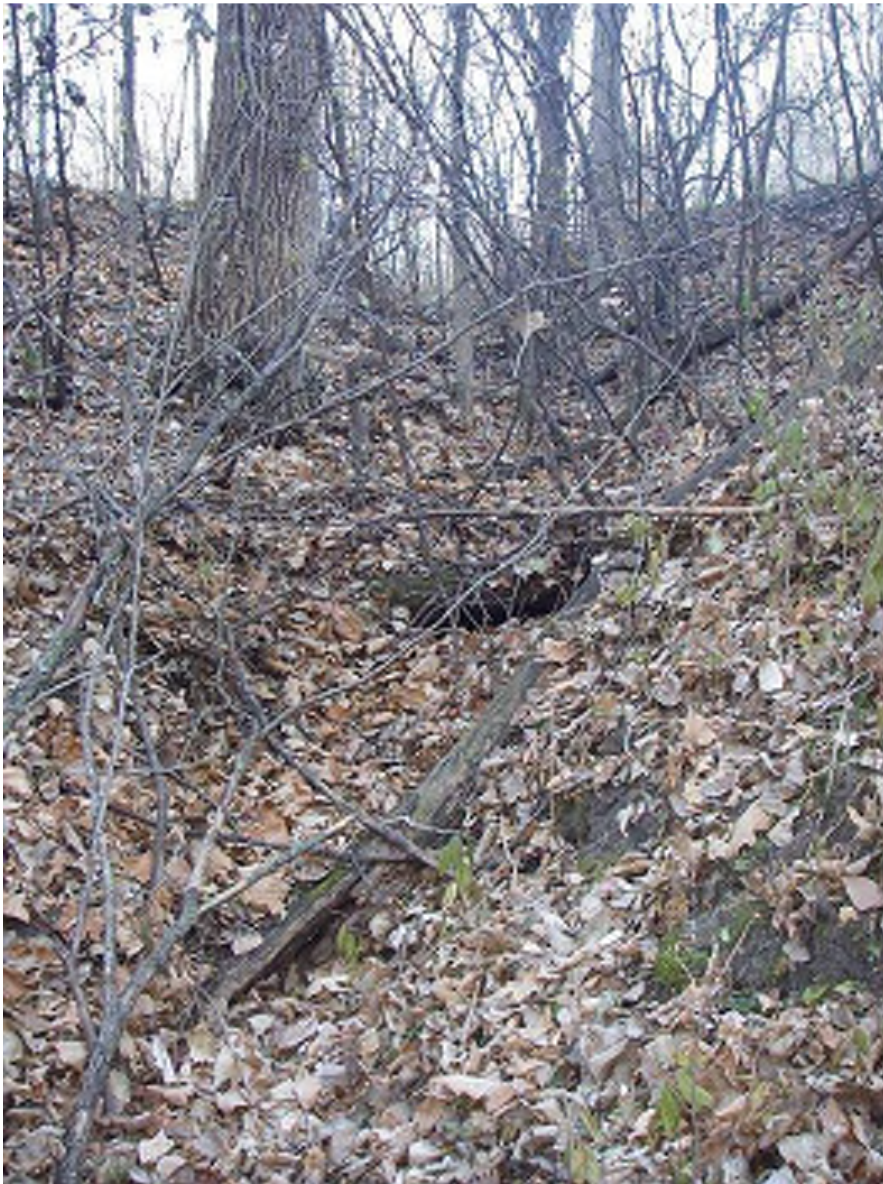
Severe erosion throughout gully/near newer housing development; is erosion caused by construction?

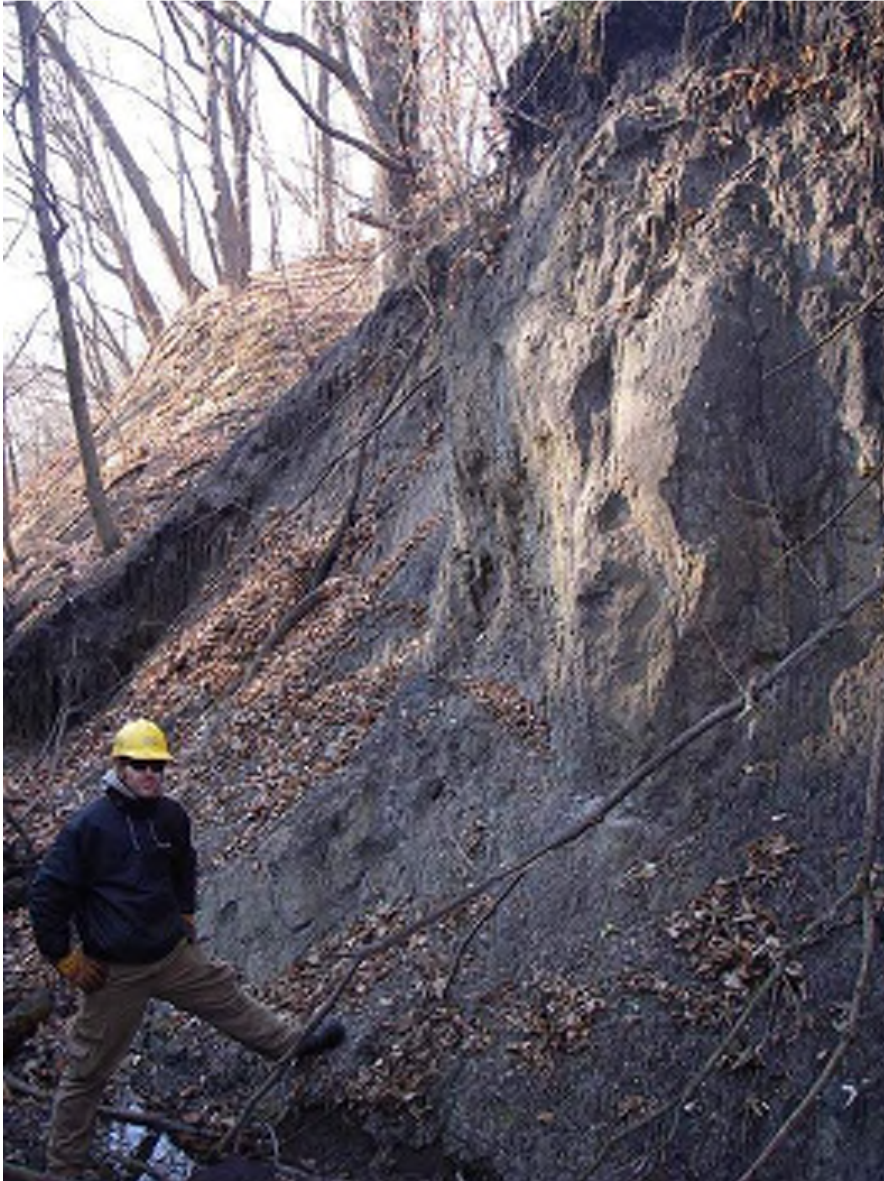
Severe erosion throughout gully/near newer housing development; is erosion caused by construction?

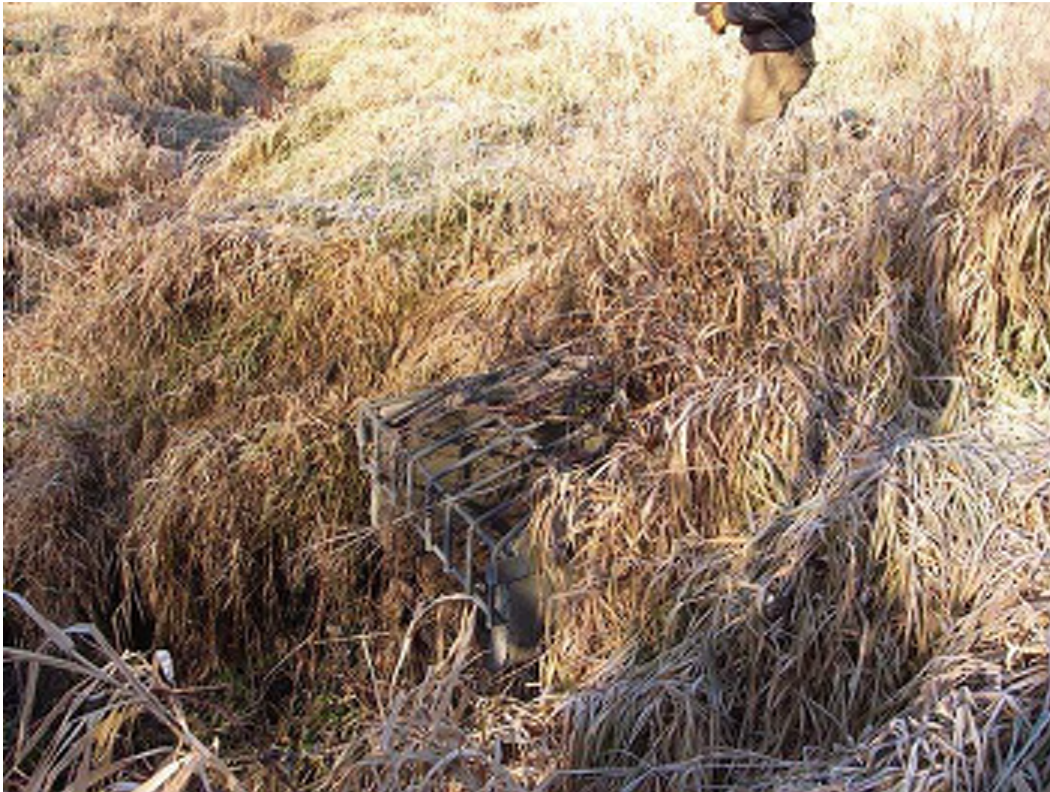
Drain pipe; severe erosion throughout gully/near newer housing development; is erosion caused by construction?

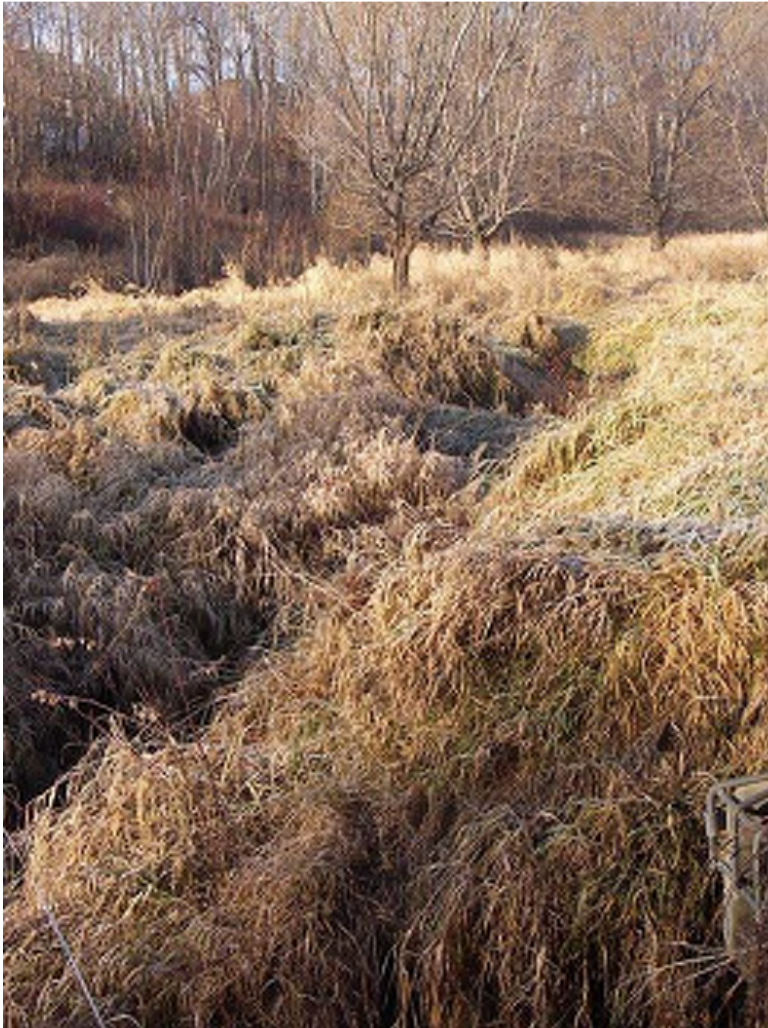
Start of gully; severe erosion throughout gully/near newer housing development; is erosion caused by construction?

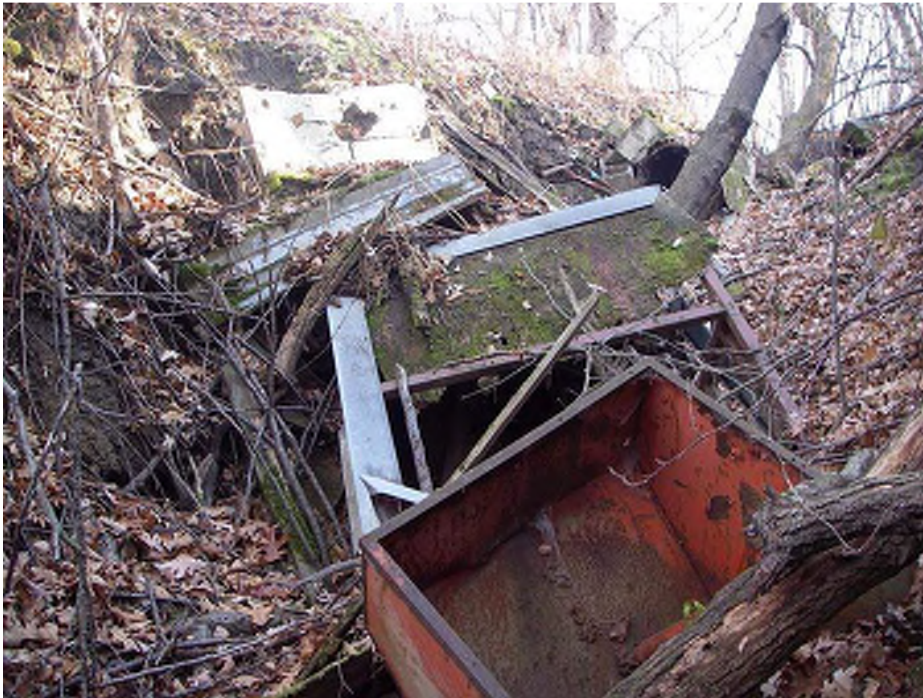
Garbage in branch at start; severe erosion throughout gully/near newer housing development; is erosion caused by construction?

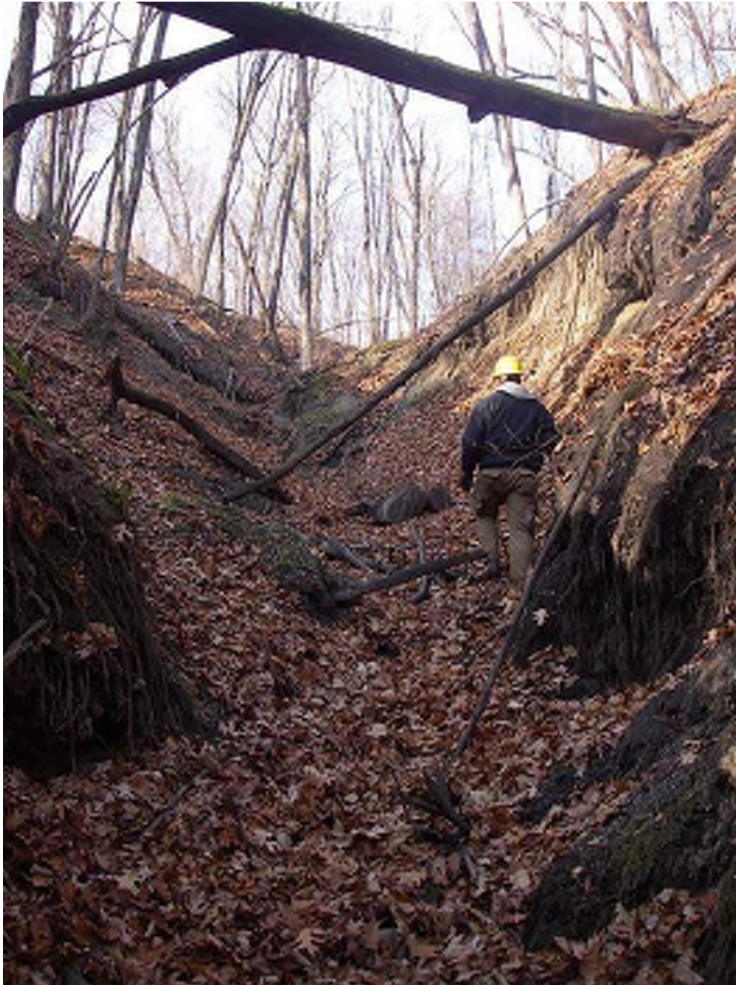
Branch w/moderate to severe erosion throughout gully/near newer housing development; is erosion caused by construction?

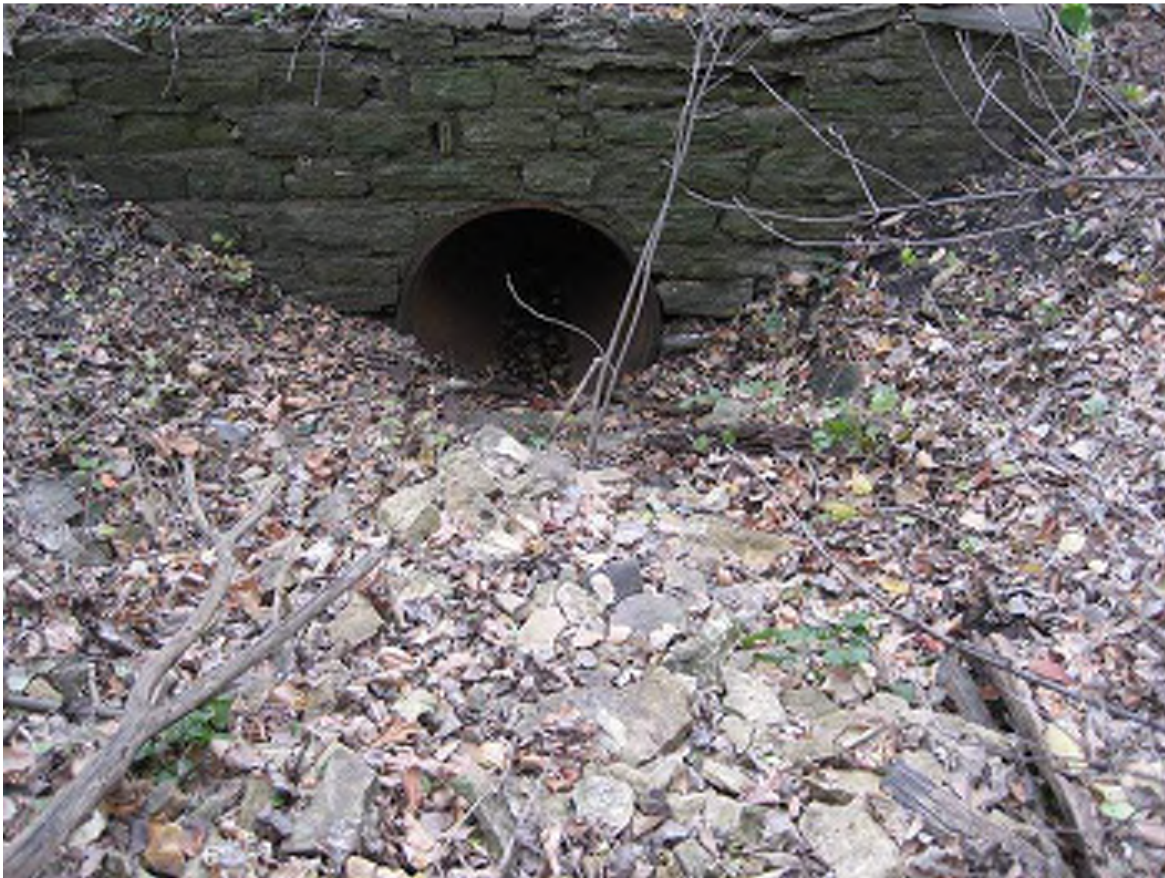
Culvert coming down from trail above; lots of loose rock; looking down at culvert; moderate erosion.

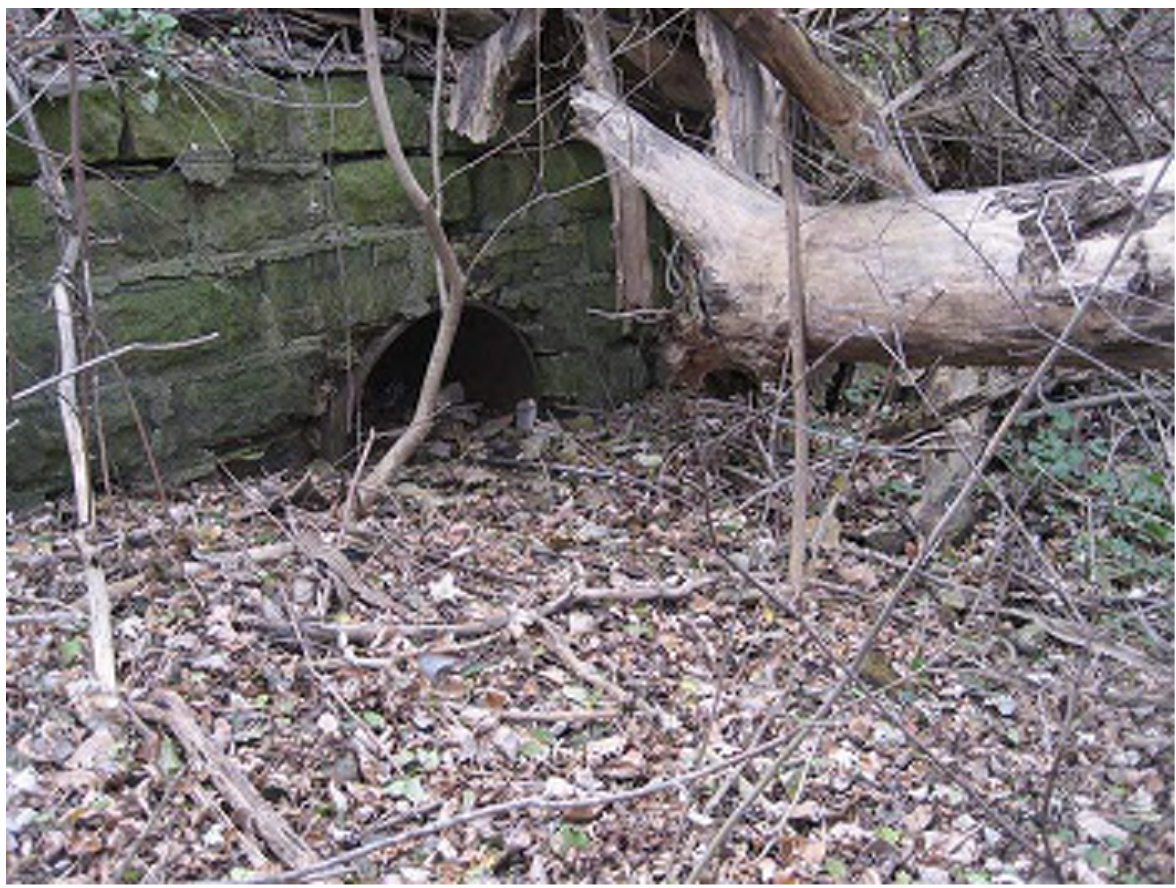
Culvert on lower side; half full with loose rock; minimal erosion.

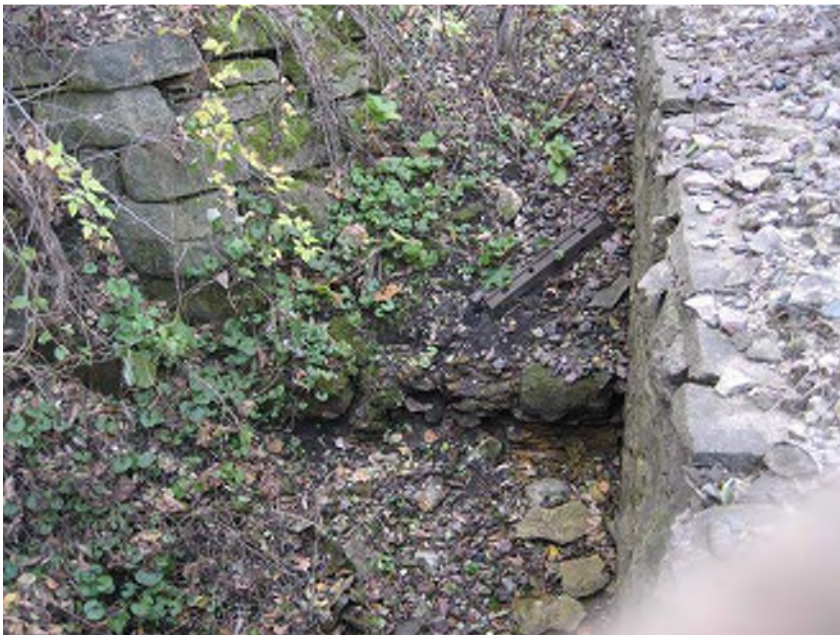
Sides next to culvert are beginning to erode; minimal erosion.

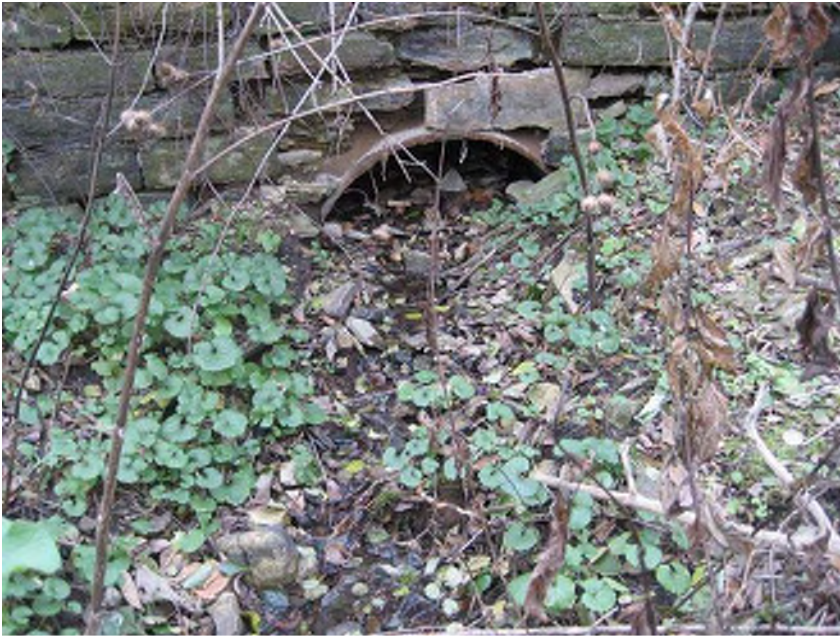
River side of culvert has cut away the stream bank along the river; culvert has lots of loose rock in culvert; moderate to major erosion.

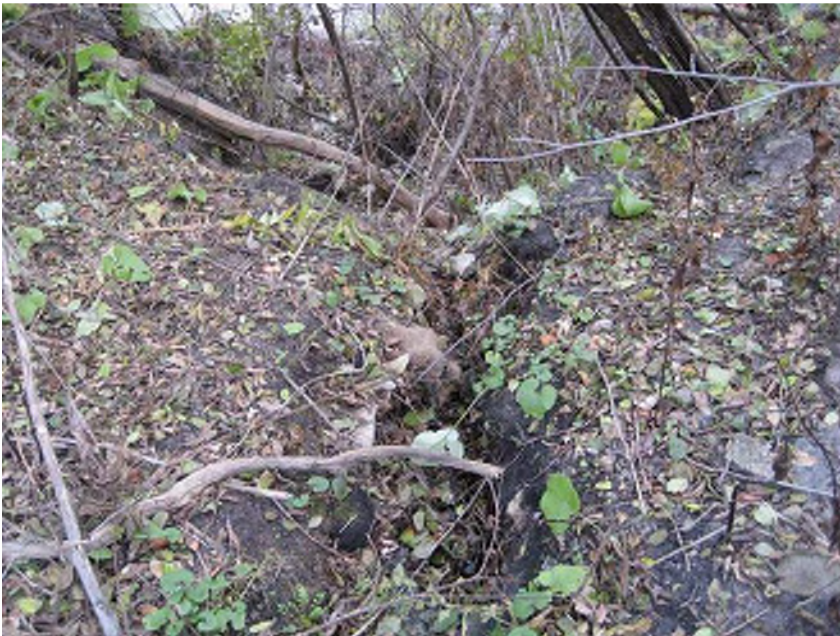
River side of culvert has cut away the stream bank along the river; culvert has lots of loose rock in culvert; moderate to major erosion.

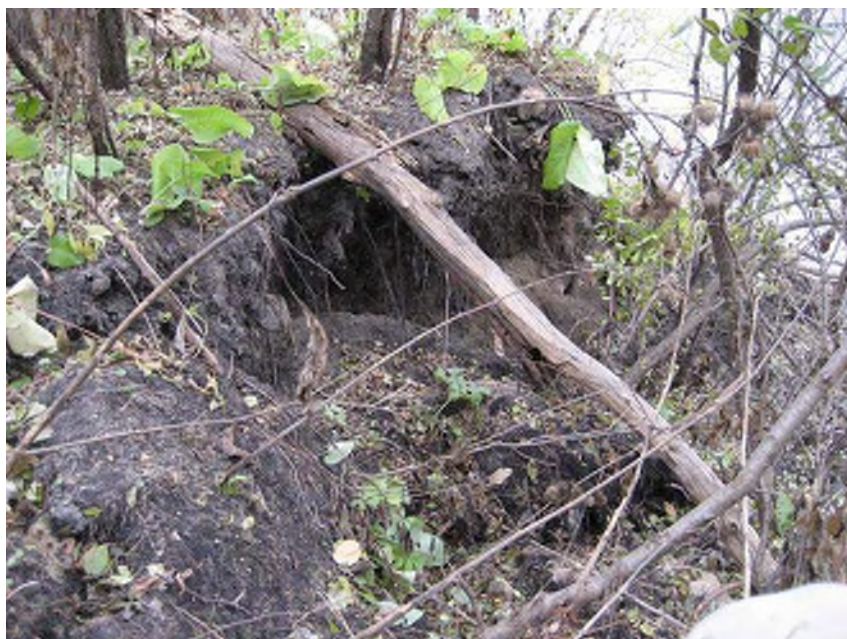
River side of culvert has cut away the stream bank along the river; culvert has lots of loose rock in culvert; moderate to major erosion.

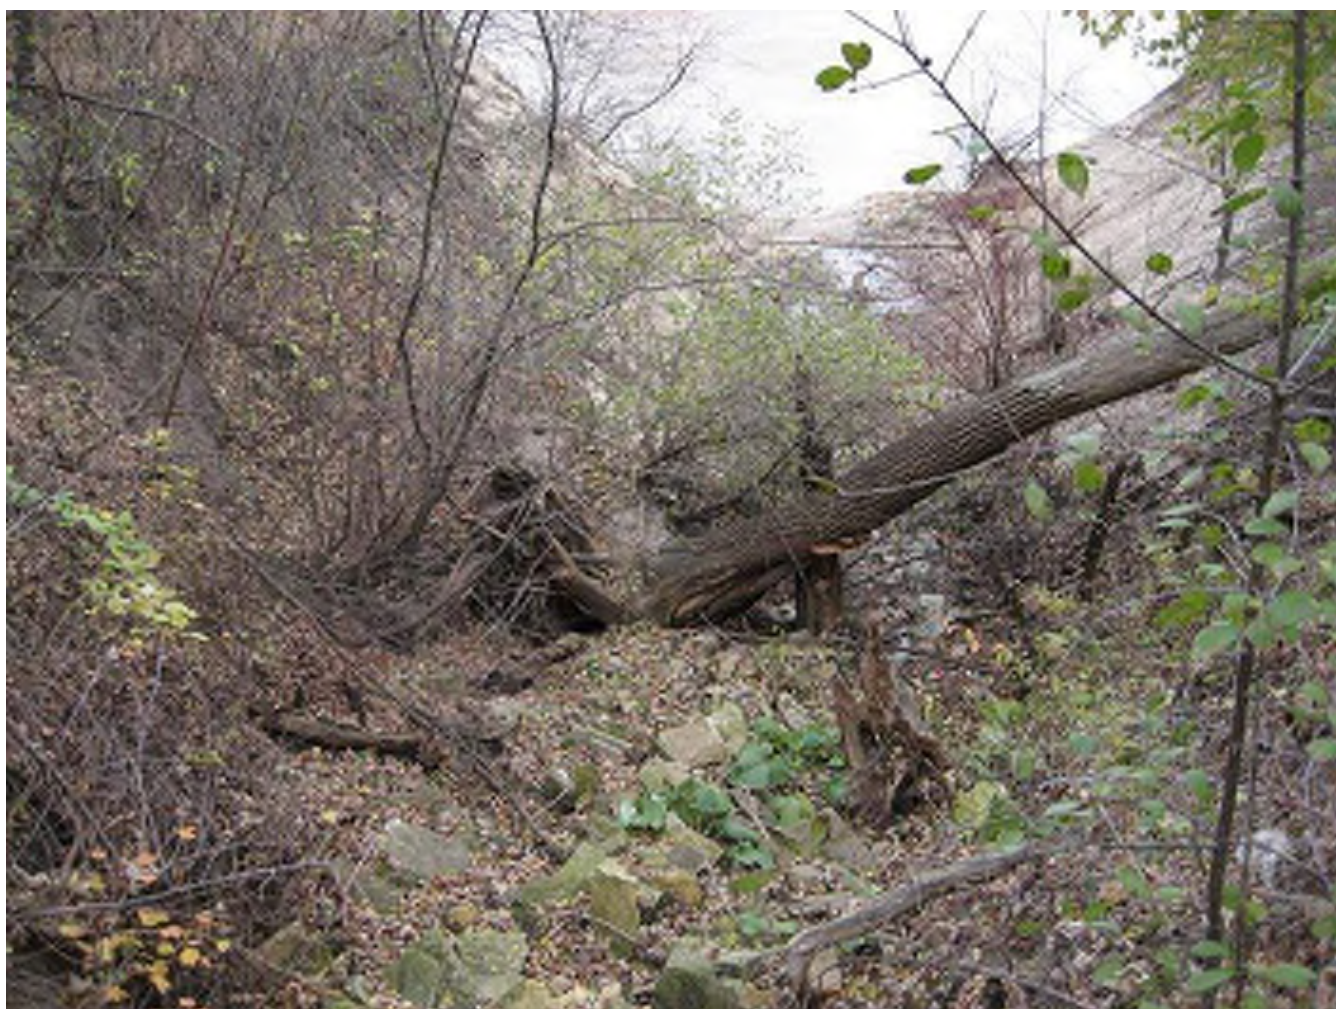
Major erosion; sides cut out all the way to the river; loose rock and exposed soil.

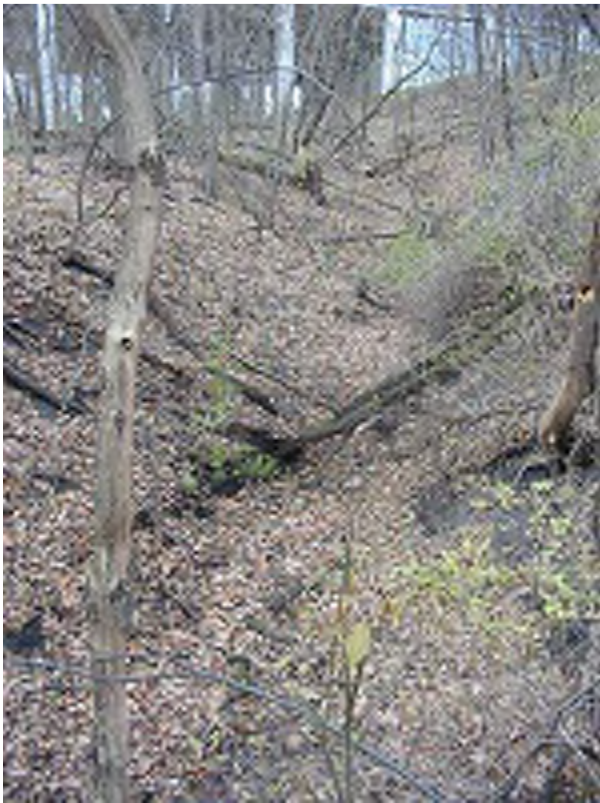
Gully/spring, cut fairly deep w/steep banks along west side/loose soil

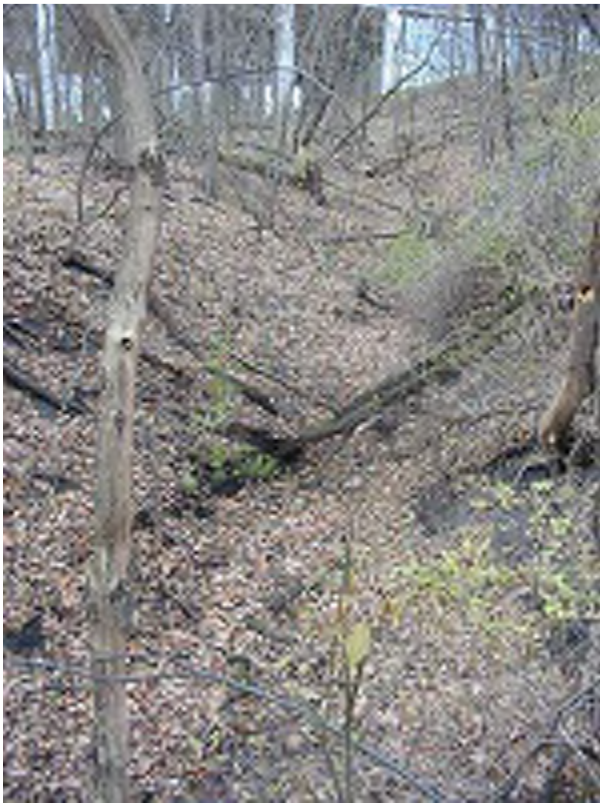
Gully/spring, cut fairly deep w/steep banks along west side/loose soil

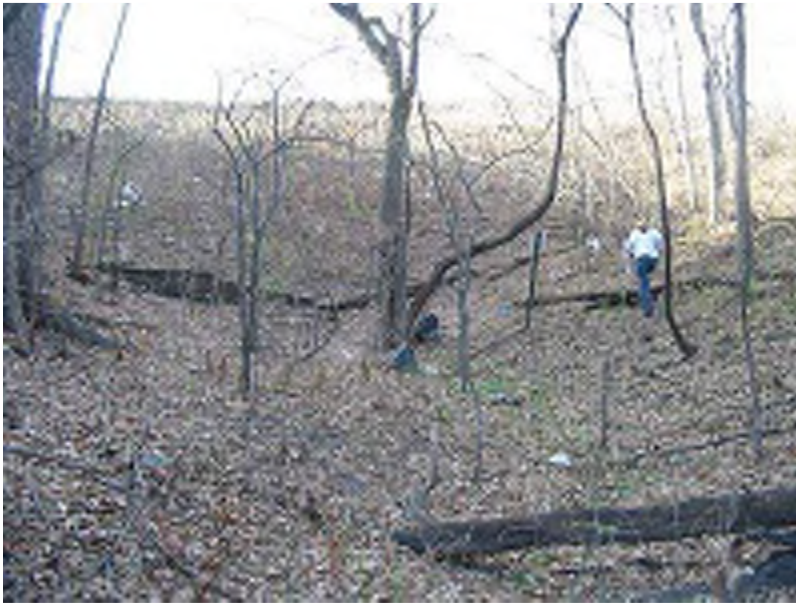
Top of gully-small broken retaining wall, top of gully looks fine, garbage, TV

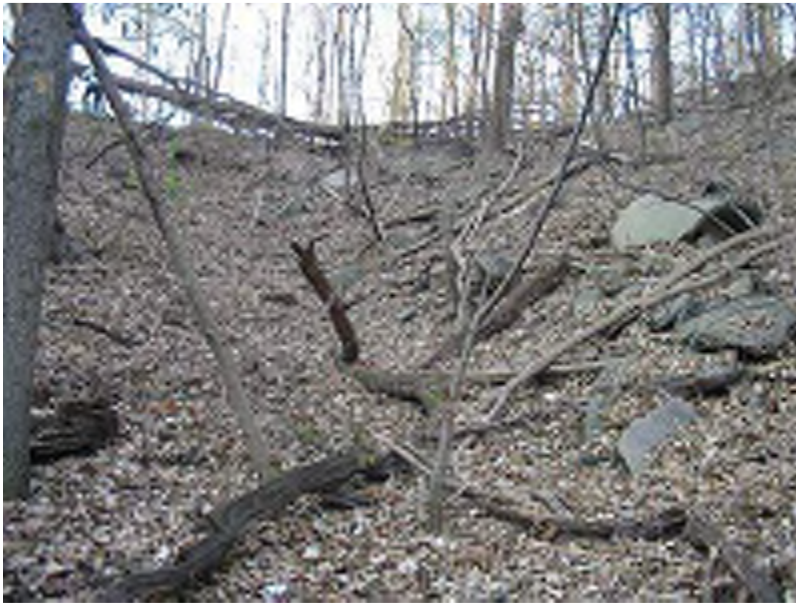
Top of gully, lots of broken concrete/4587 erosion cut

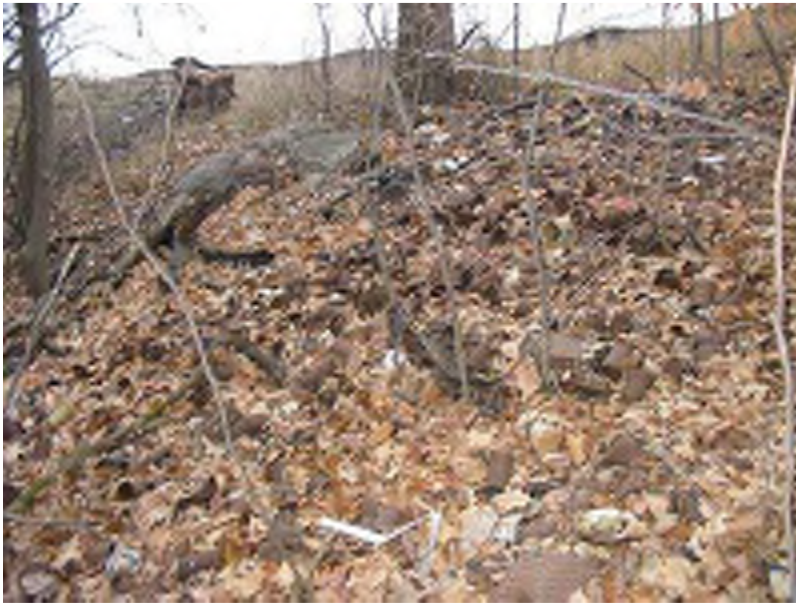
Pile of rusty cans

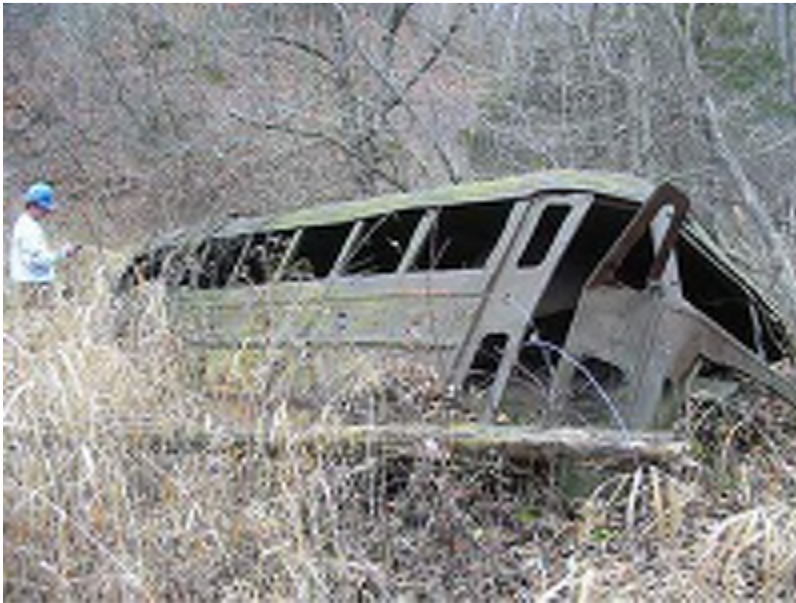
Rusty bus
