LOWER MINNESOTA RIVER WATERSHED DISTRICT

Technical Memorandum

Re: Lower Minnesota River Watershed District Dredge Site Update

Re: Lower Minnesota River Watershed District Dredge Site Visit Summary

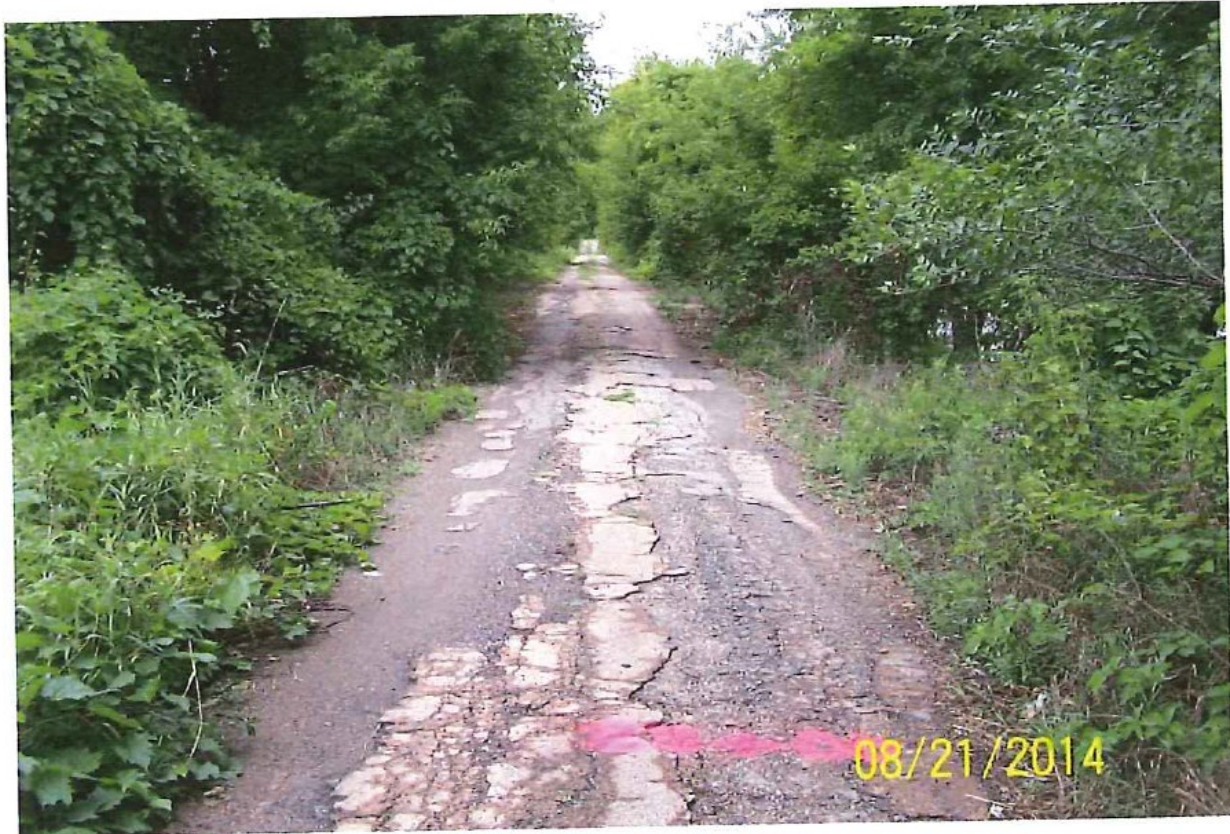
Figure 3. 2015 Vernon Avenue pavement condition (AET, 2015)

AET completed a pavement condition analysis of Vernon Avenue in June 2015 to determine if the roadway was adequate for haul trucks to remove the existing USACE dredged material stockpile on the Site. Four soil borings were collected along Vernon Avenue between Trunk Highway 13 and the Twin Cities & Western Railroad (TCWR). These borings established the roadway surface ranged from zero to 2.5 inches of deteriorated bituminous asphalt pavement. AET concluded the roadway was “in very poor condition,” the road was approaching its end of service life, and the pavement strength was not adequate for heavy truck loading (Figure 3).

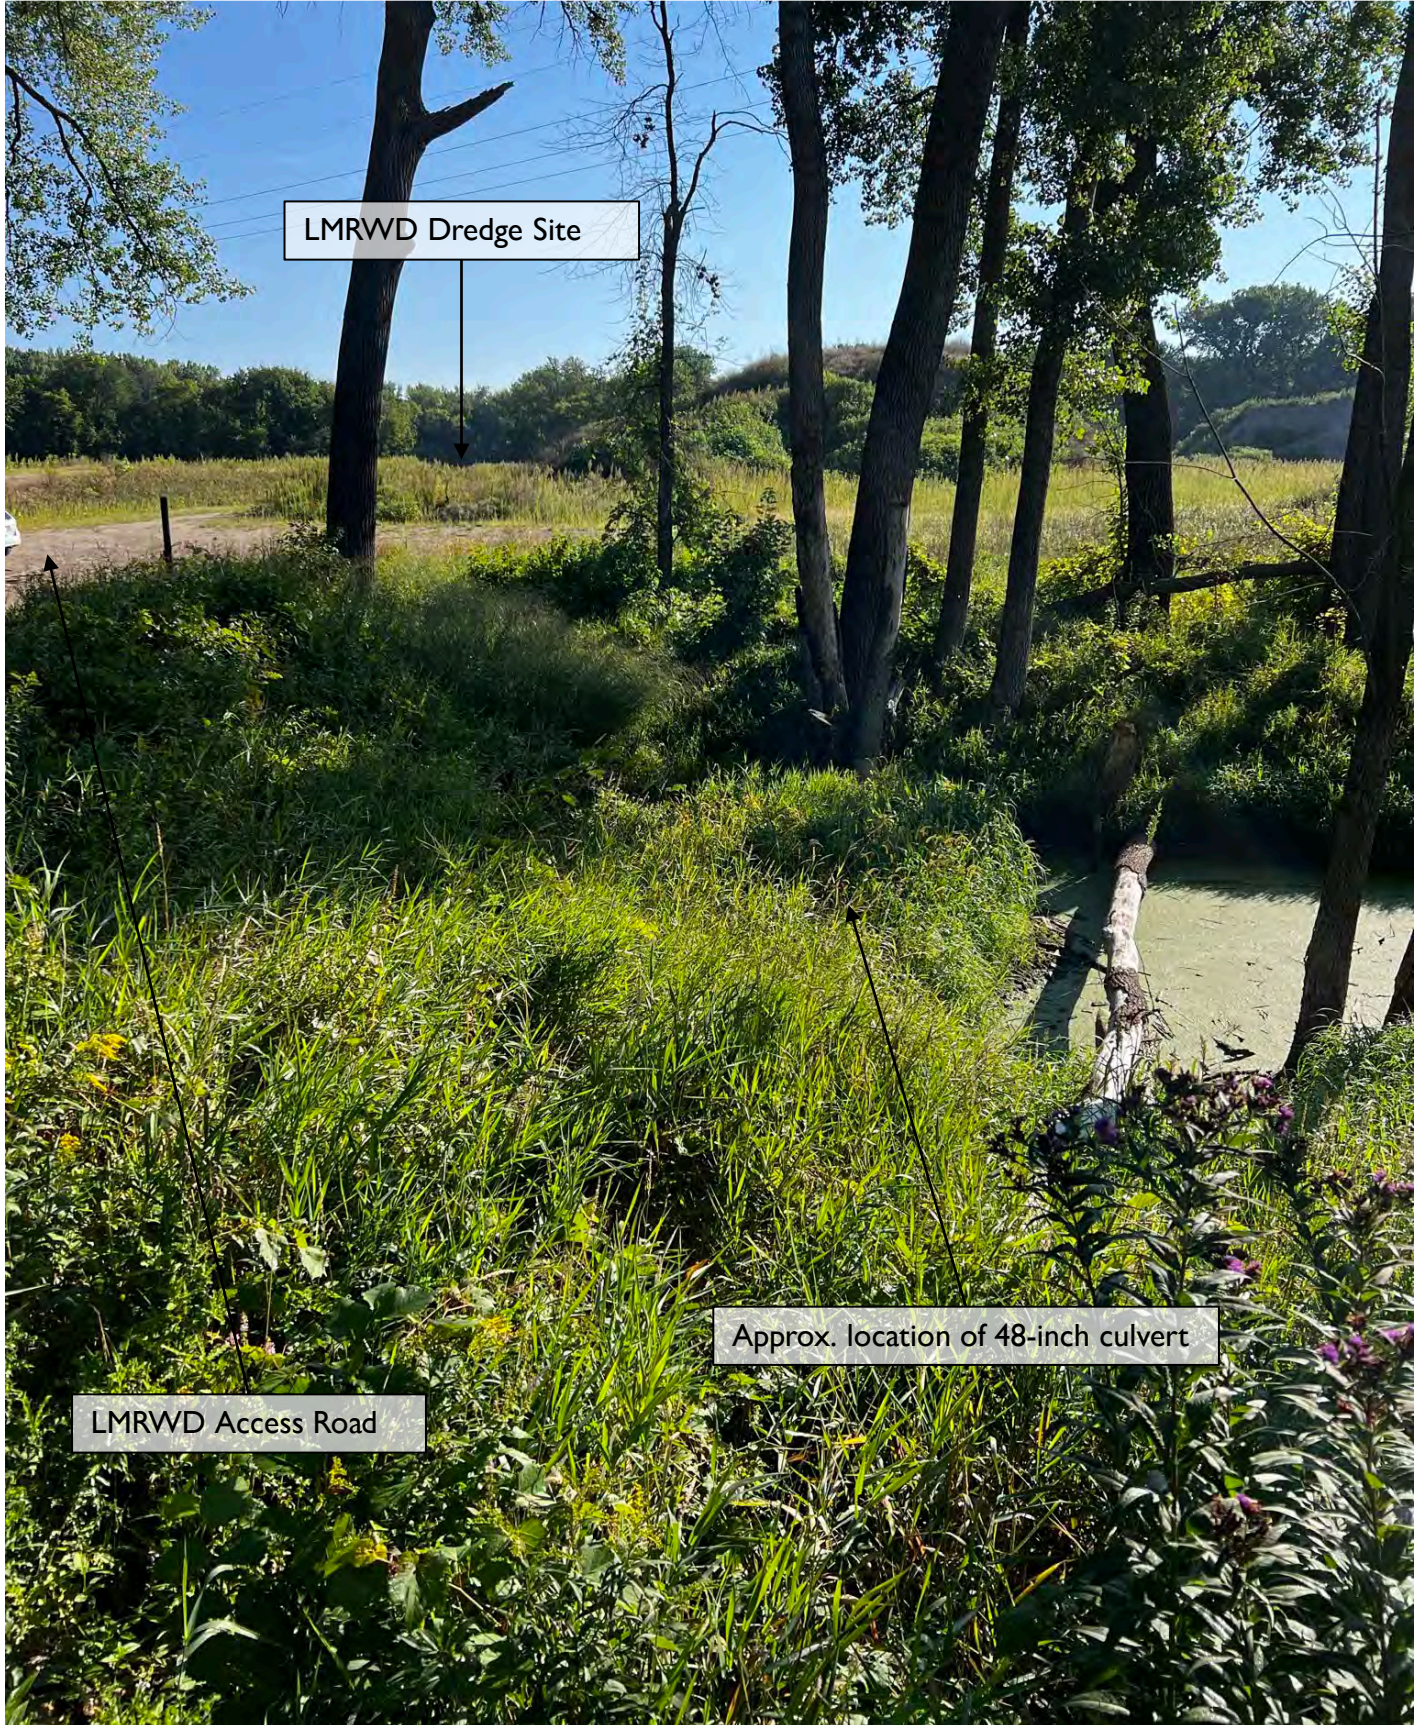
On August 22, 2022, staff from Young Environmental visited the LMRWD Site and reviewed the current conditions (Attachment 1). Unfortunately, heavy vegetation entirely obscured the access road culvert and most of the roadway embankment along Vernon Avenue (Photo 1A, Attachment 1).

Photo 1A. LMRWD Dredge Site access road culvert (upstream, not visible due to dense vegetation)

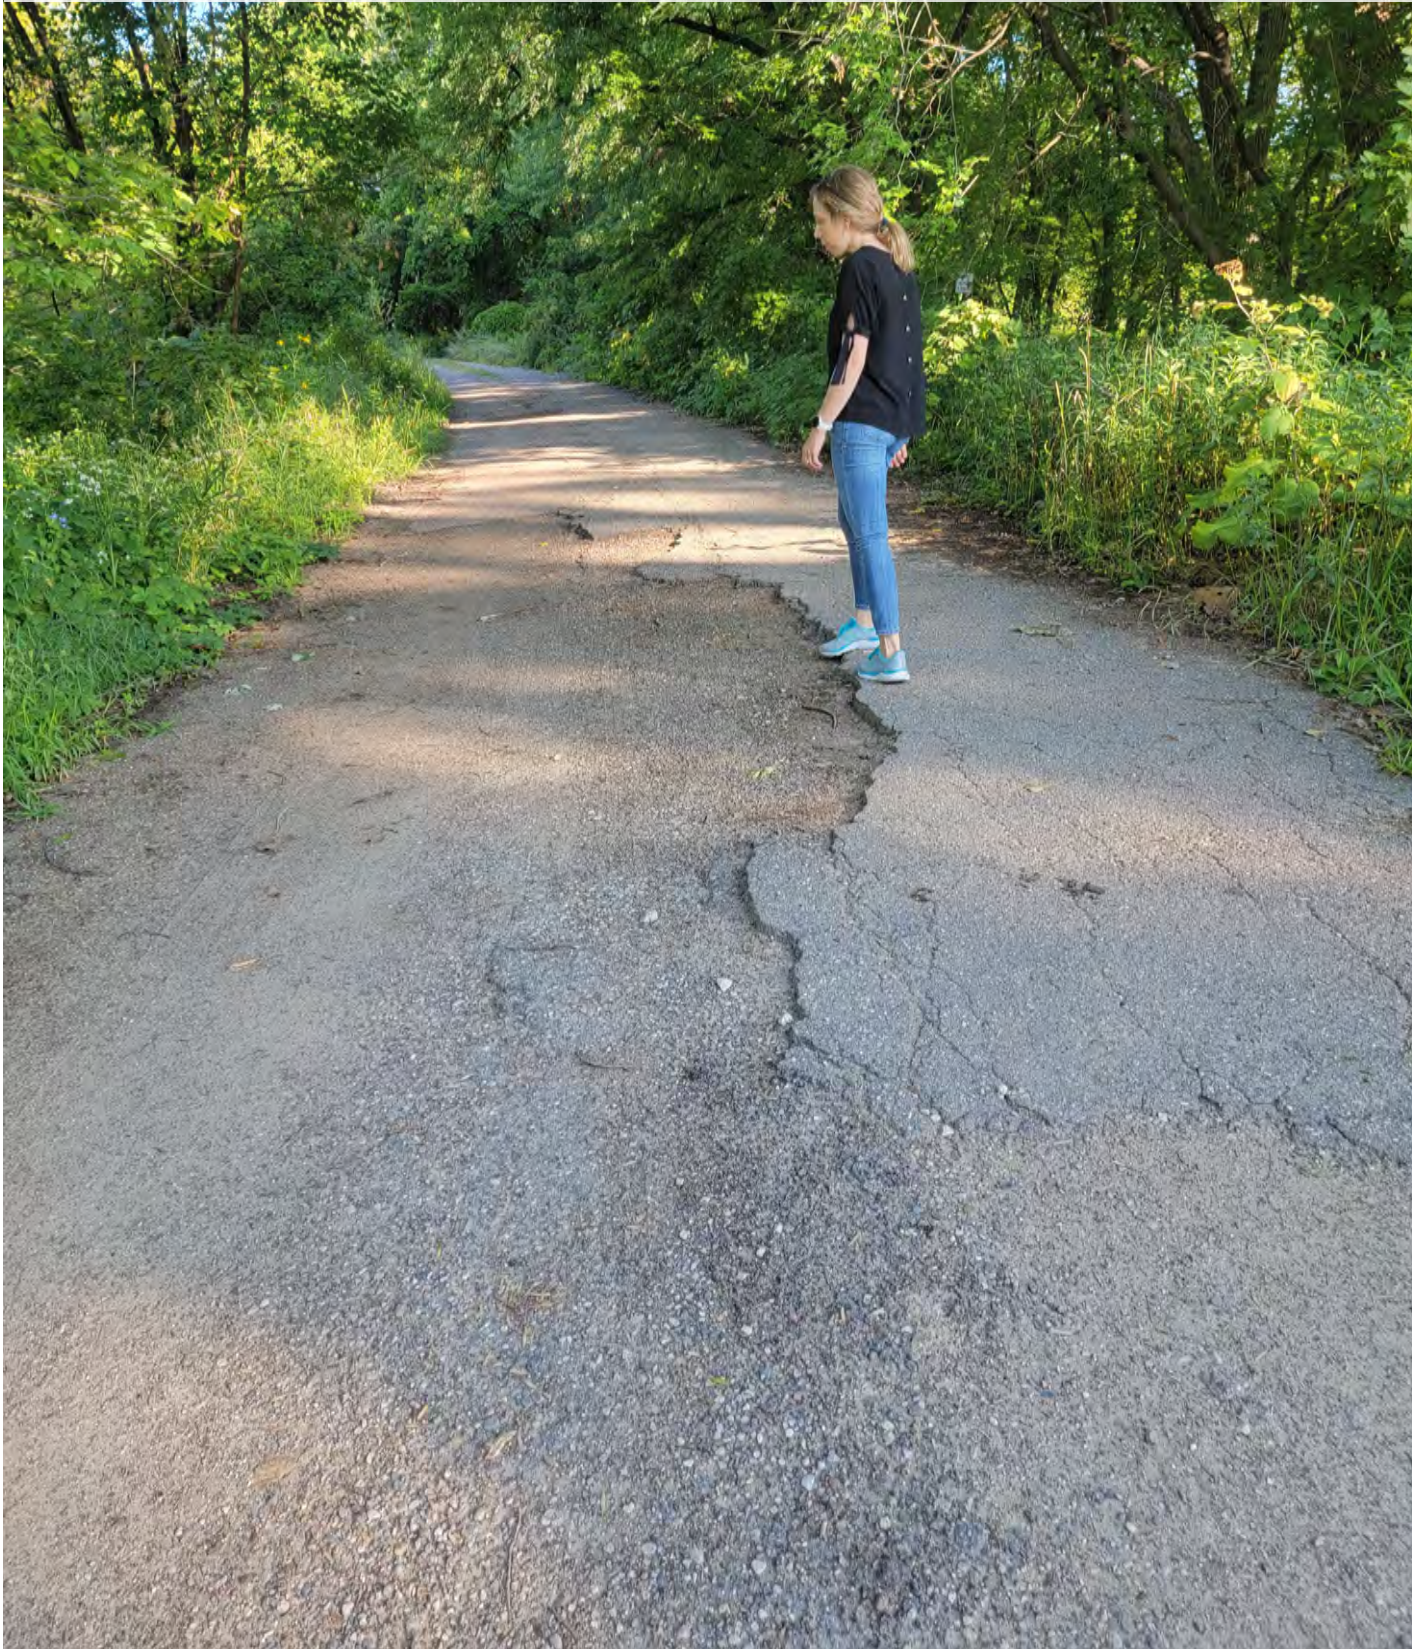
Photo 1B. Vernon Avenue looking north, from LMRWD Dredge Site access road. This portion of Vernon Avenue provides access to the Twin Cities and Western Railroad bridge and did not appear to be heavily trafficked. In 2015, the AET soil boring B-4 indicated the bituminous pavement was 1.5-inches thick but deteriorated.

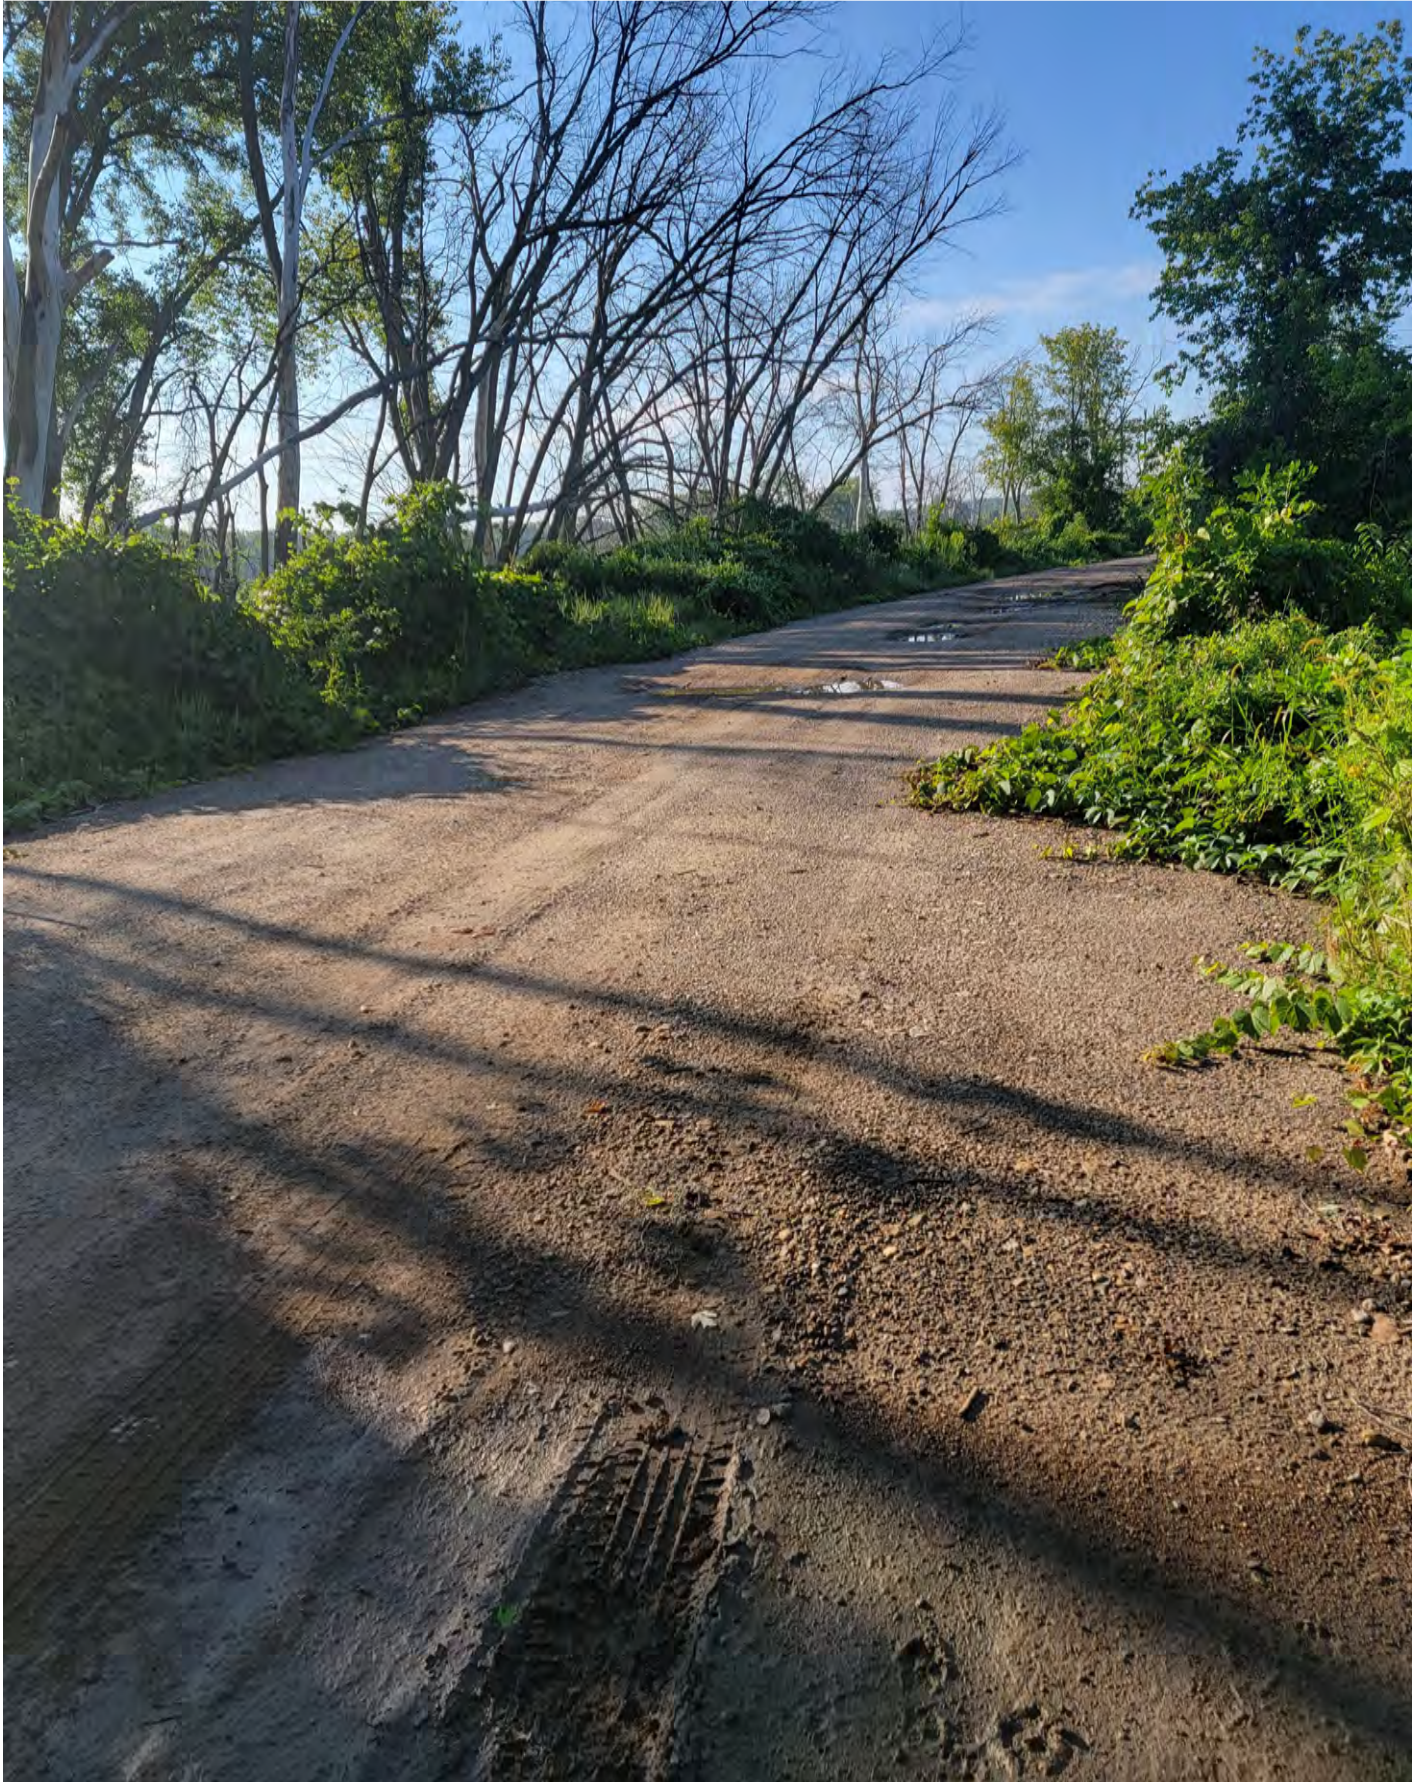
Photo 1C. Vernon Avenue looking south from dredge site access road

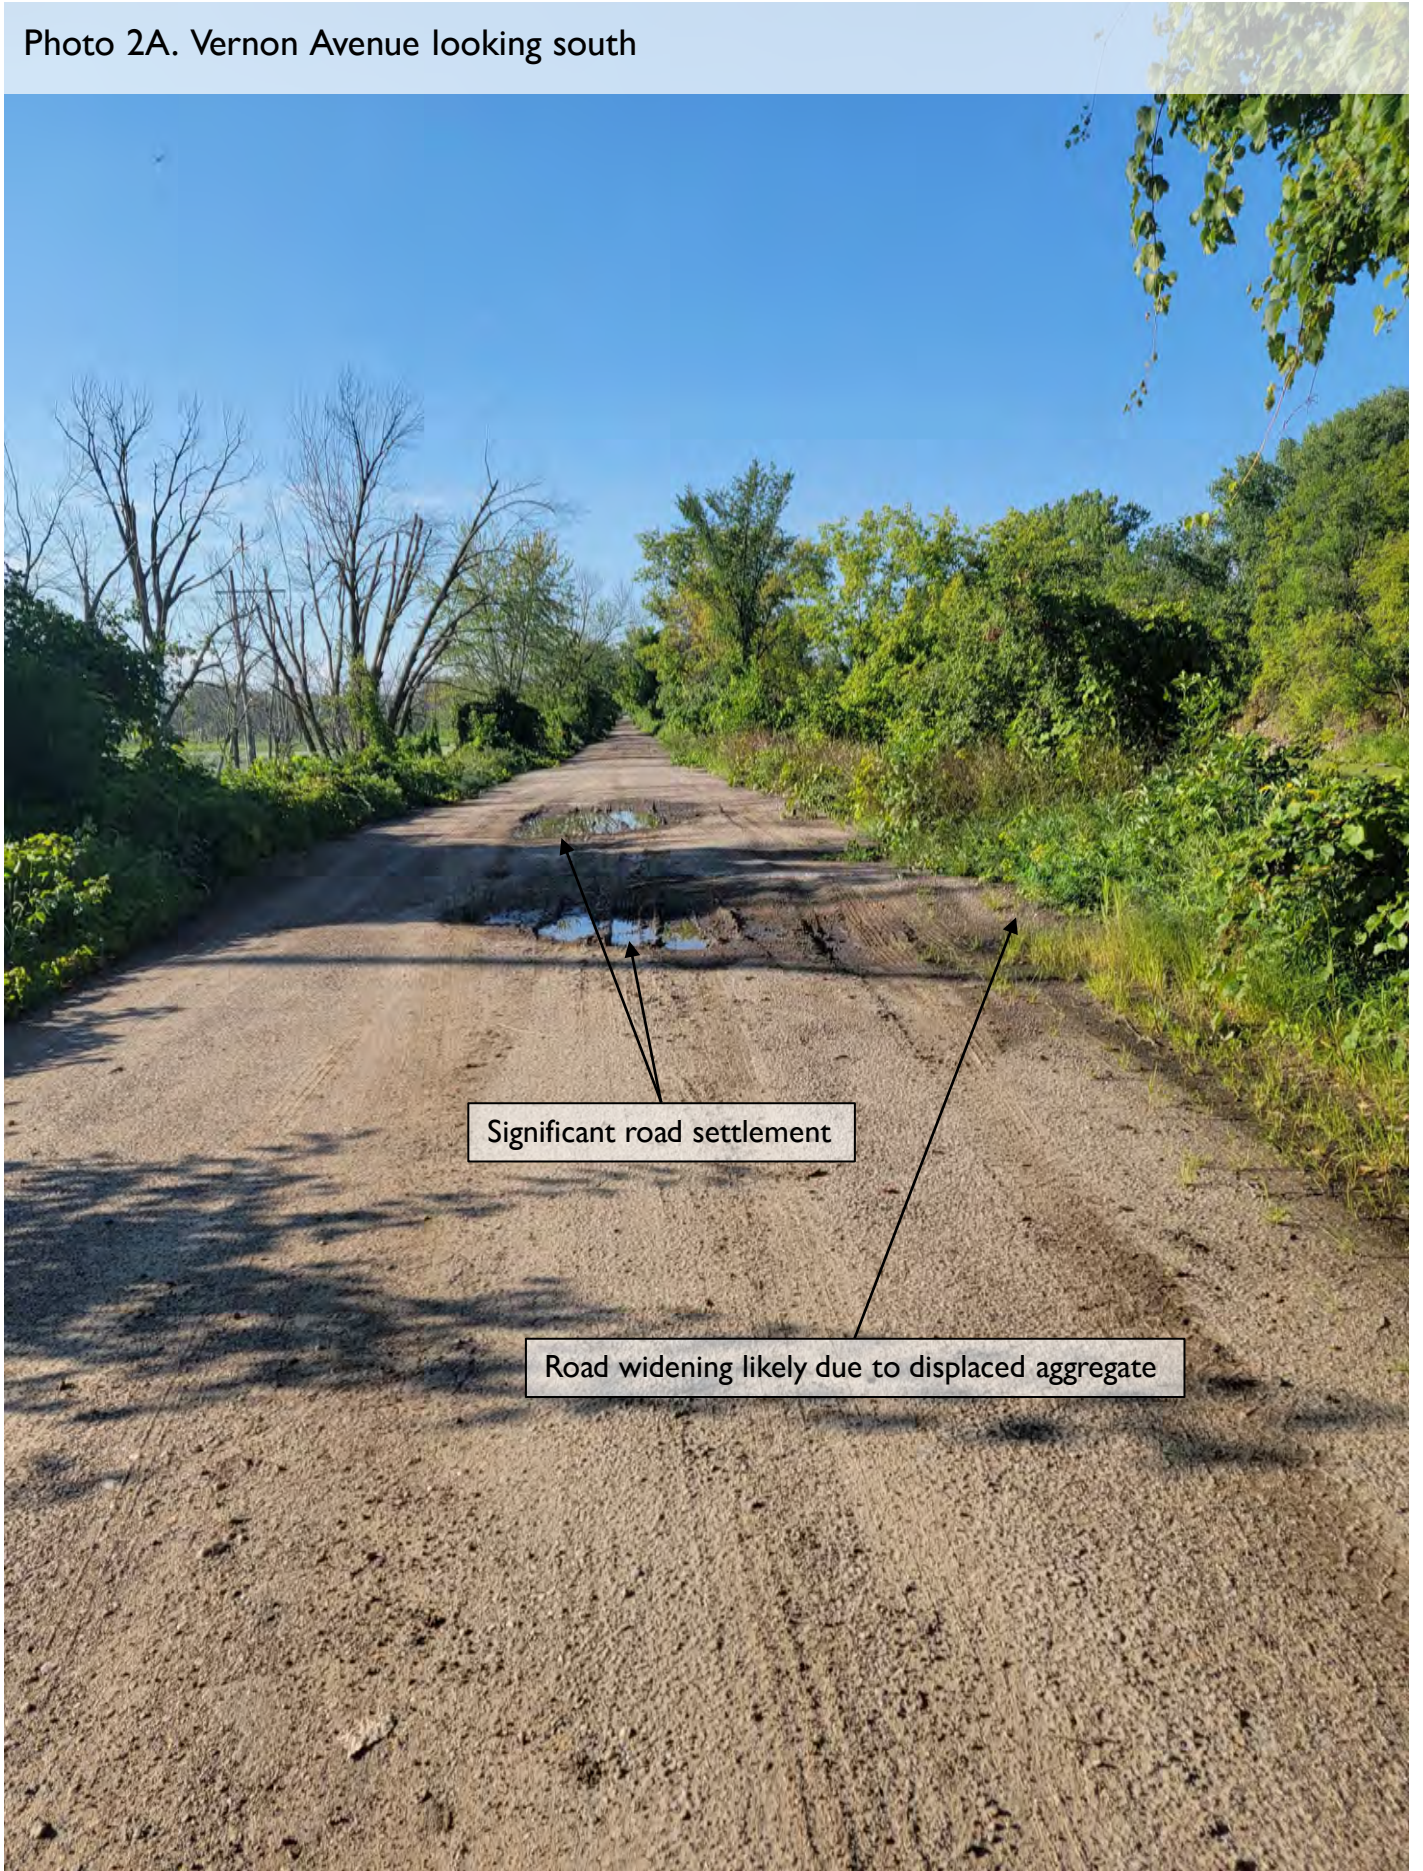
Photo 2A. Vernon Avenue looking south

Significant road settlement

Road widening likely due to displaced aggregate

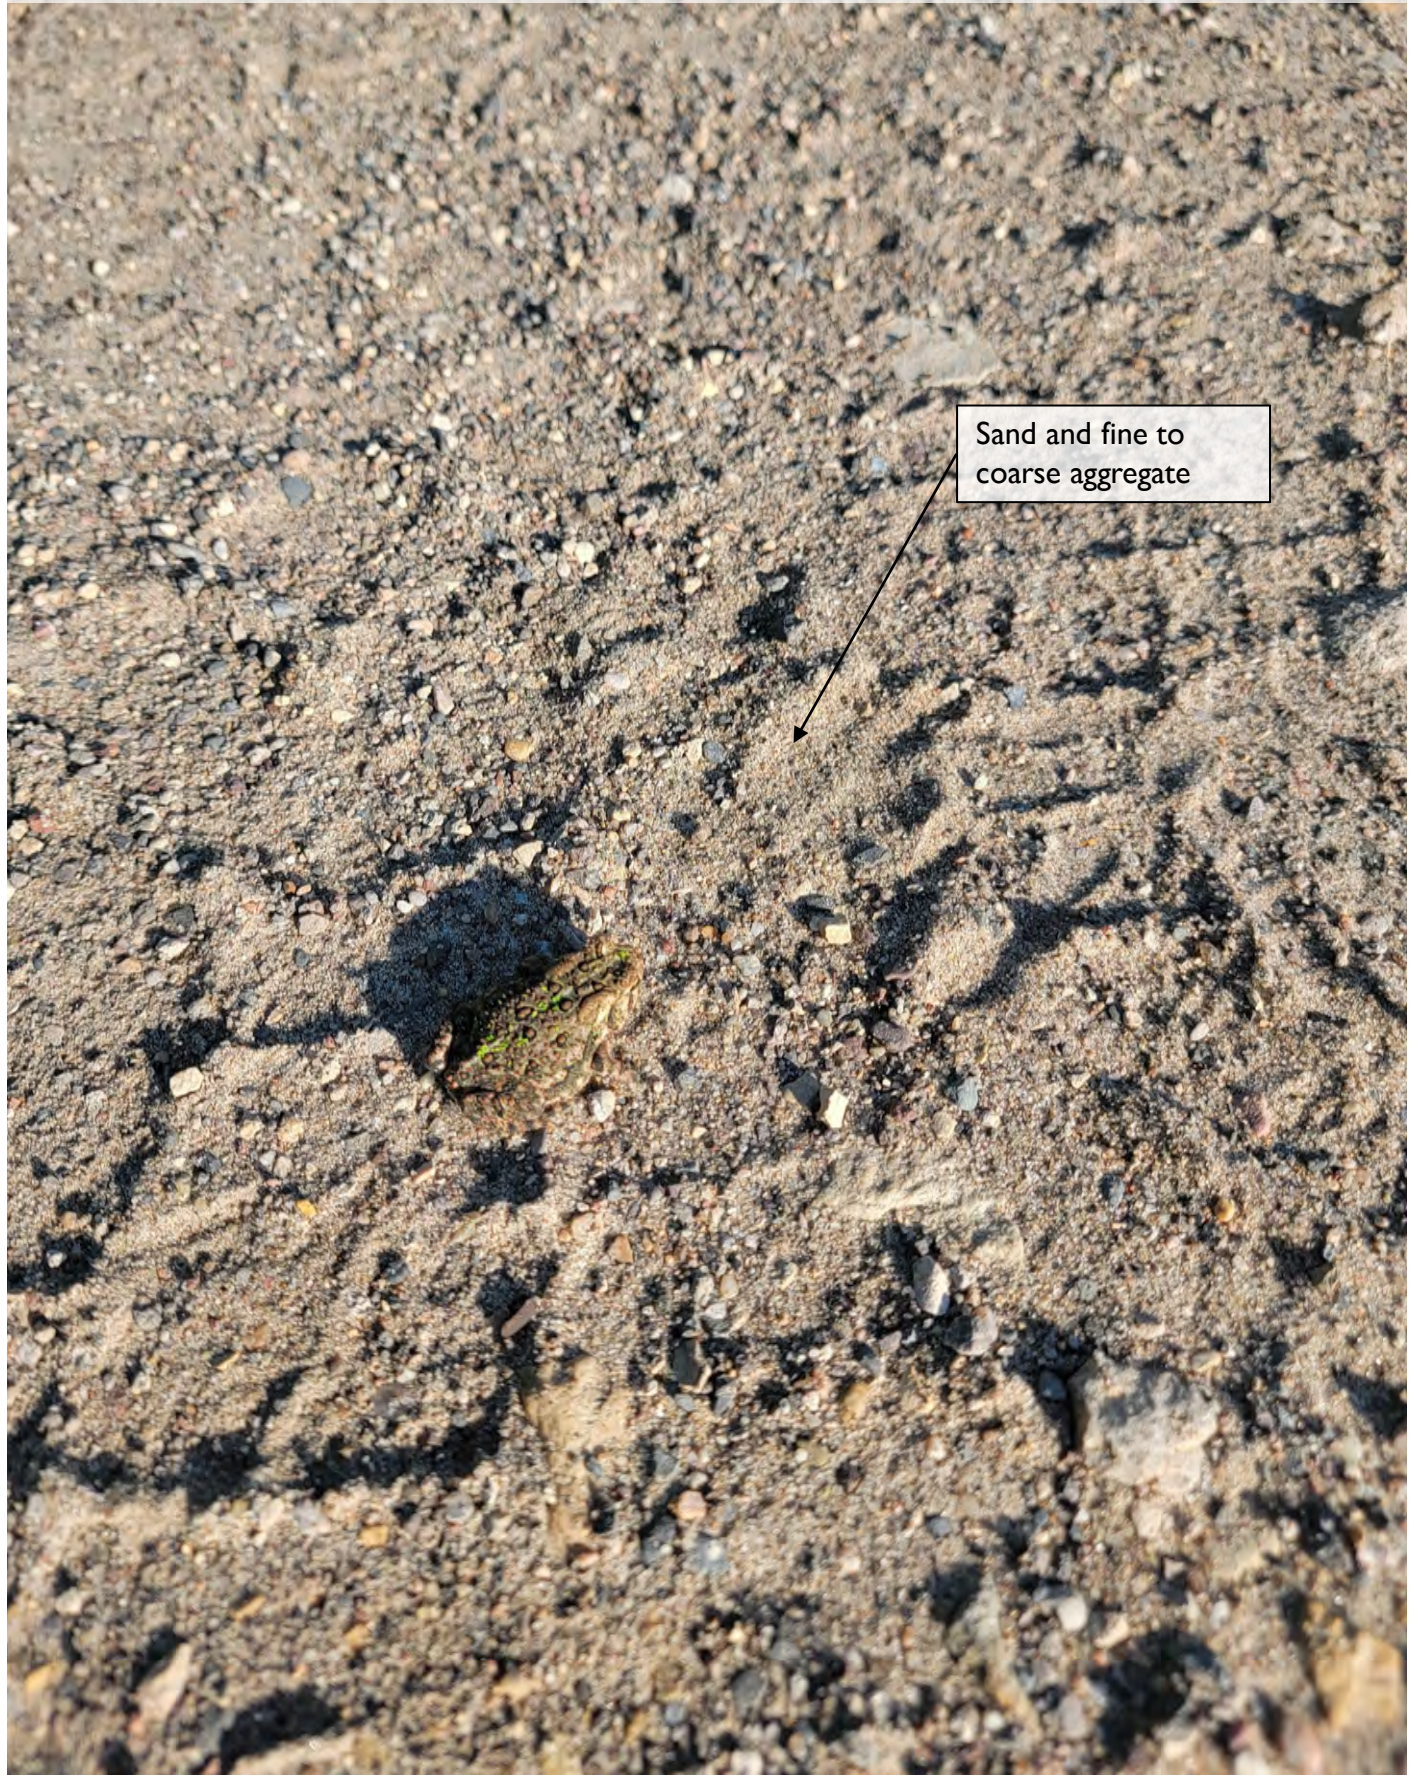
Photo 2B. Frog and typical Vernon Avenue road surface near Photo 2 location

Sand and fine to coarse aggregate

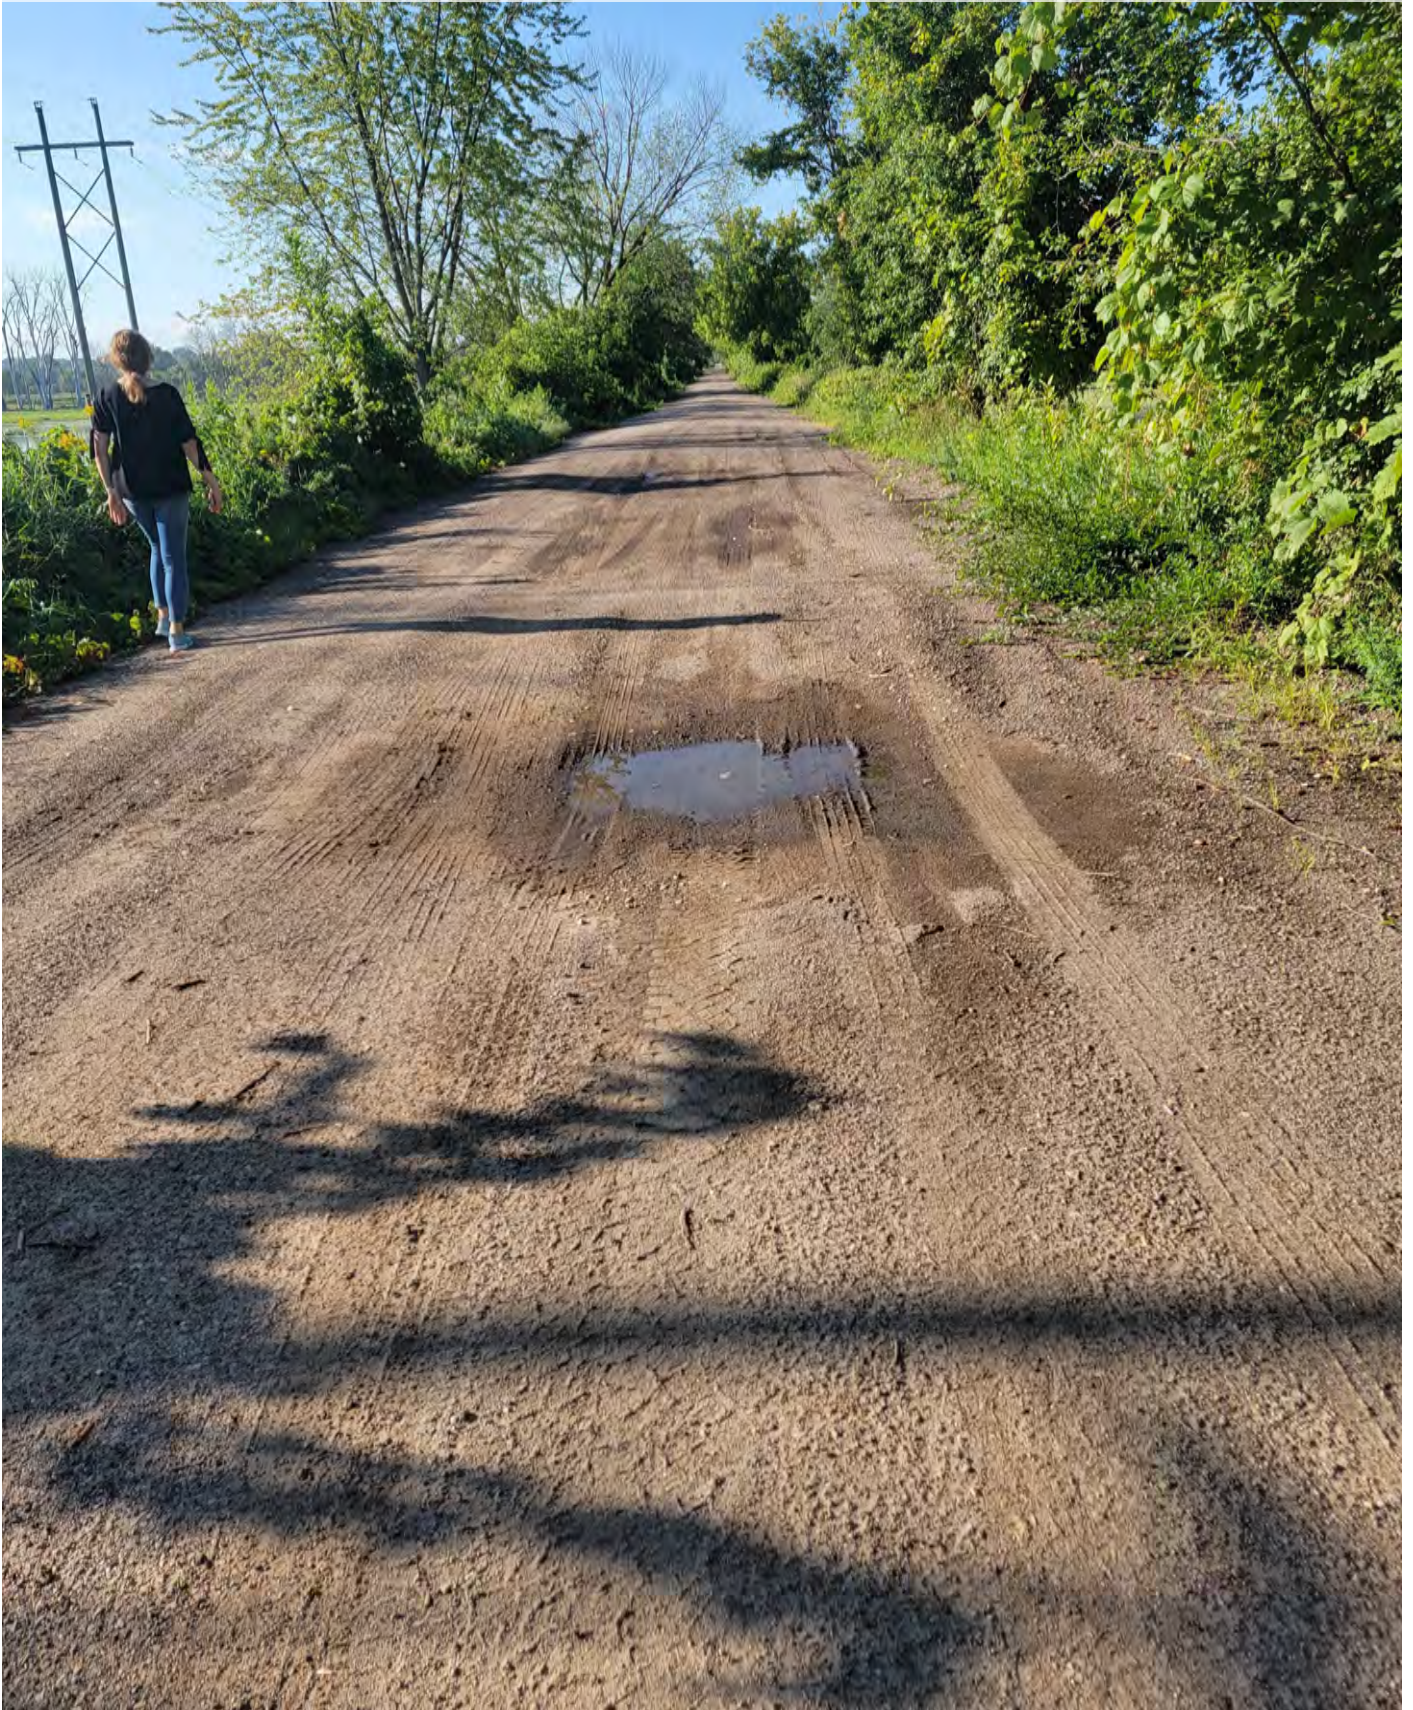
Photo 3A. Vernon Avenue looking south. In 2015, the AET soil boring B-3 indicated the roadway was reduced to 0.25-inch chip seal layer atop 11.5-inches of sandy fill.

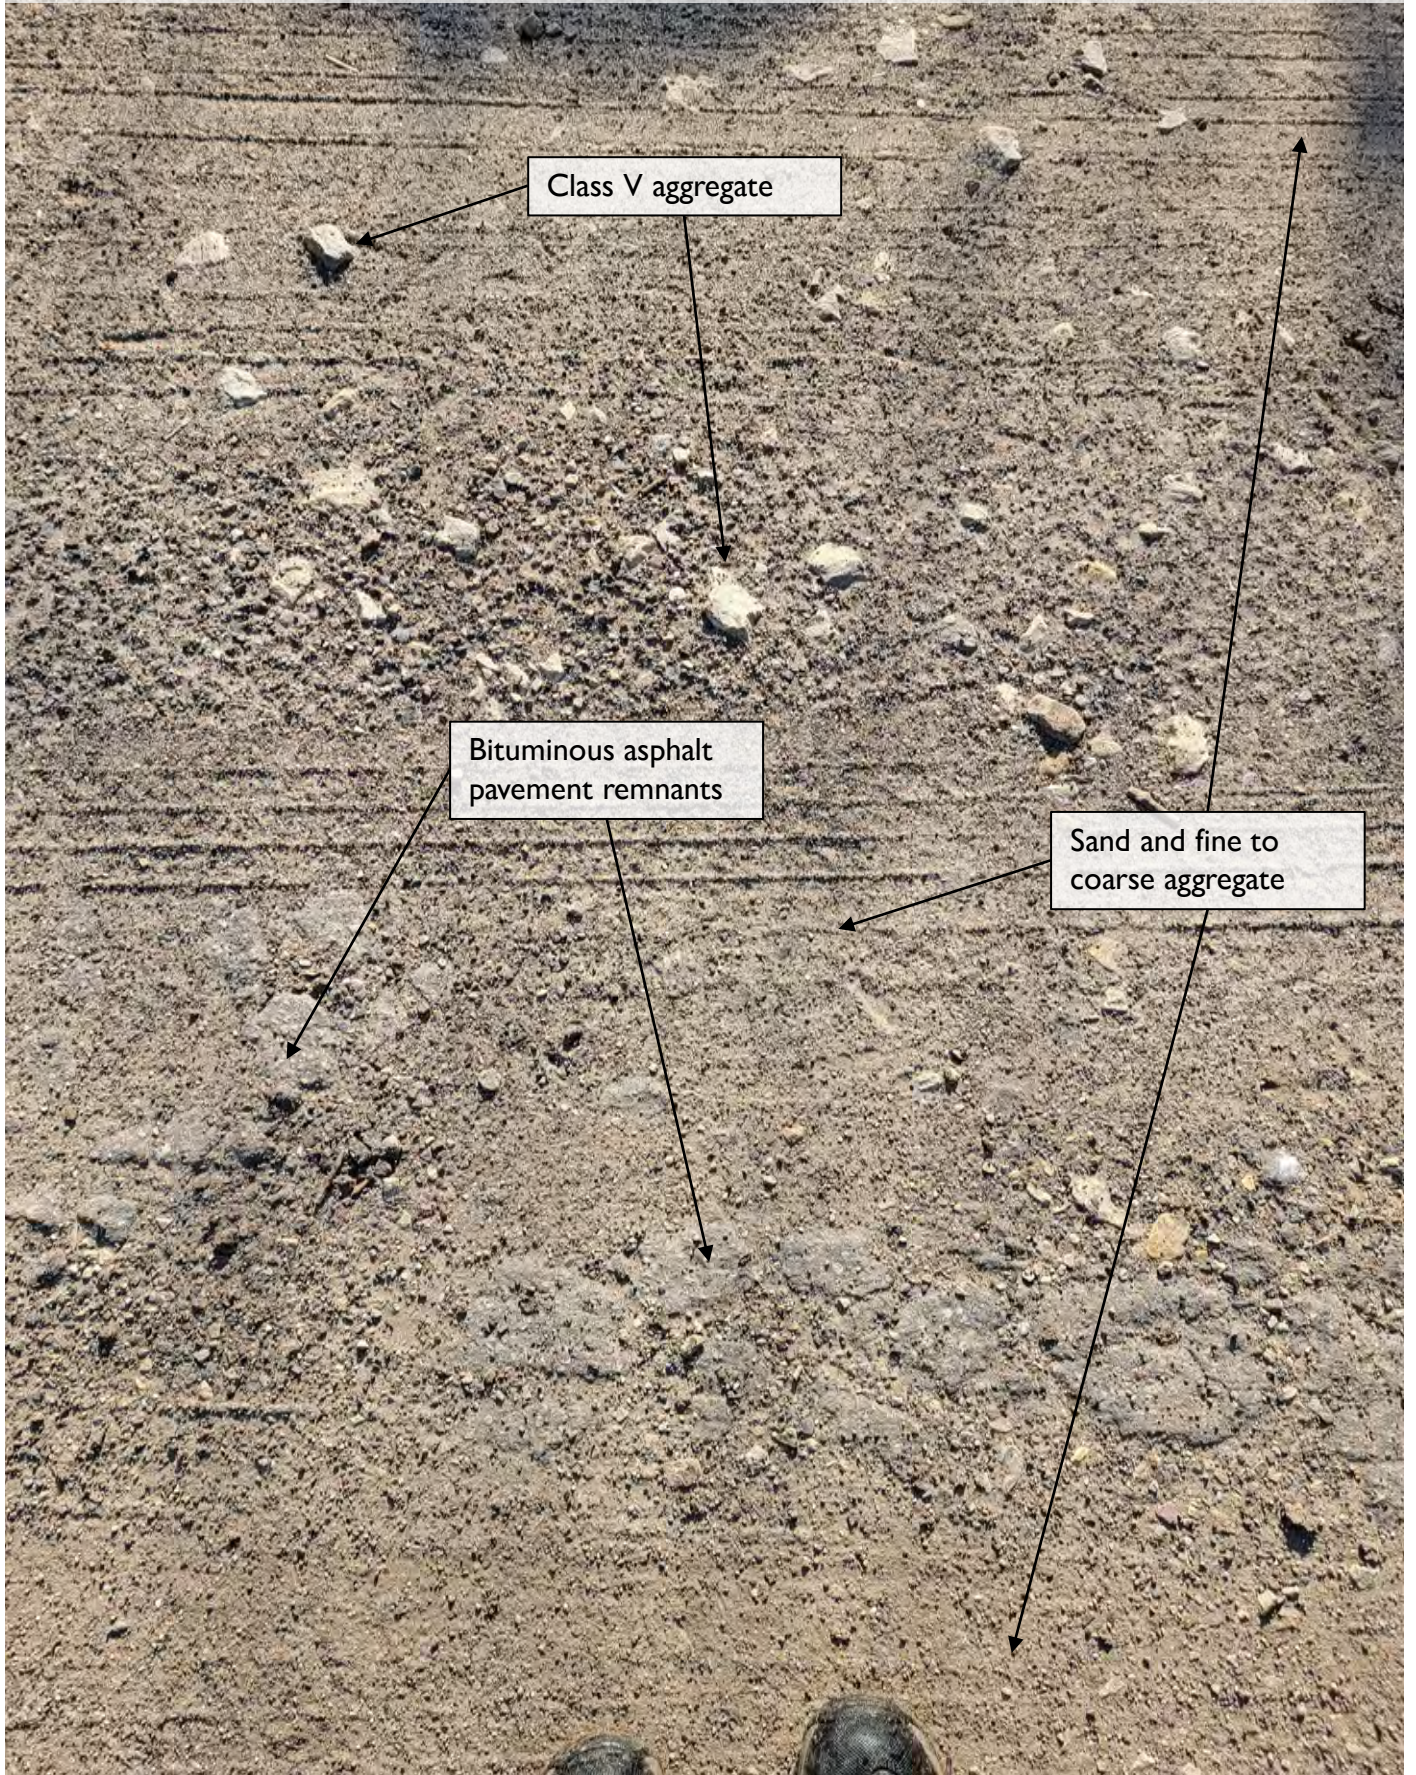
Photo 3B. Typical Vernon Avenue road surface near Photo 3 location

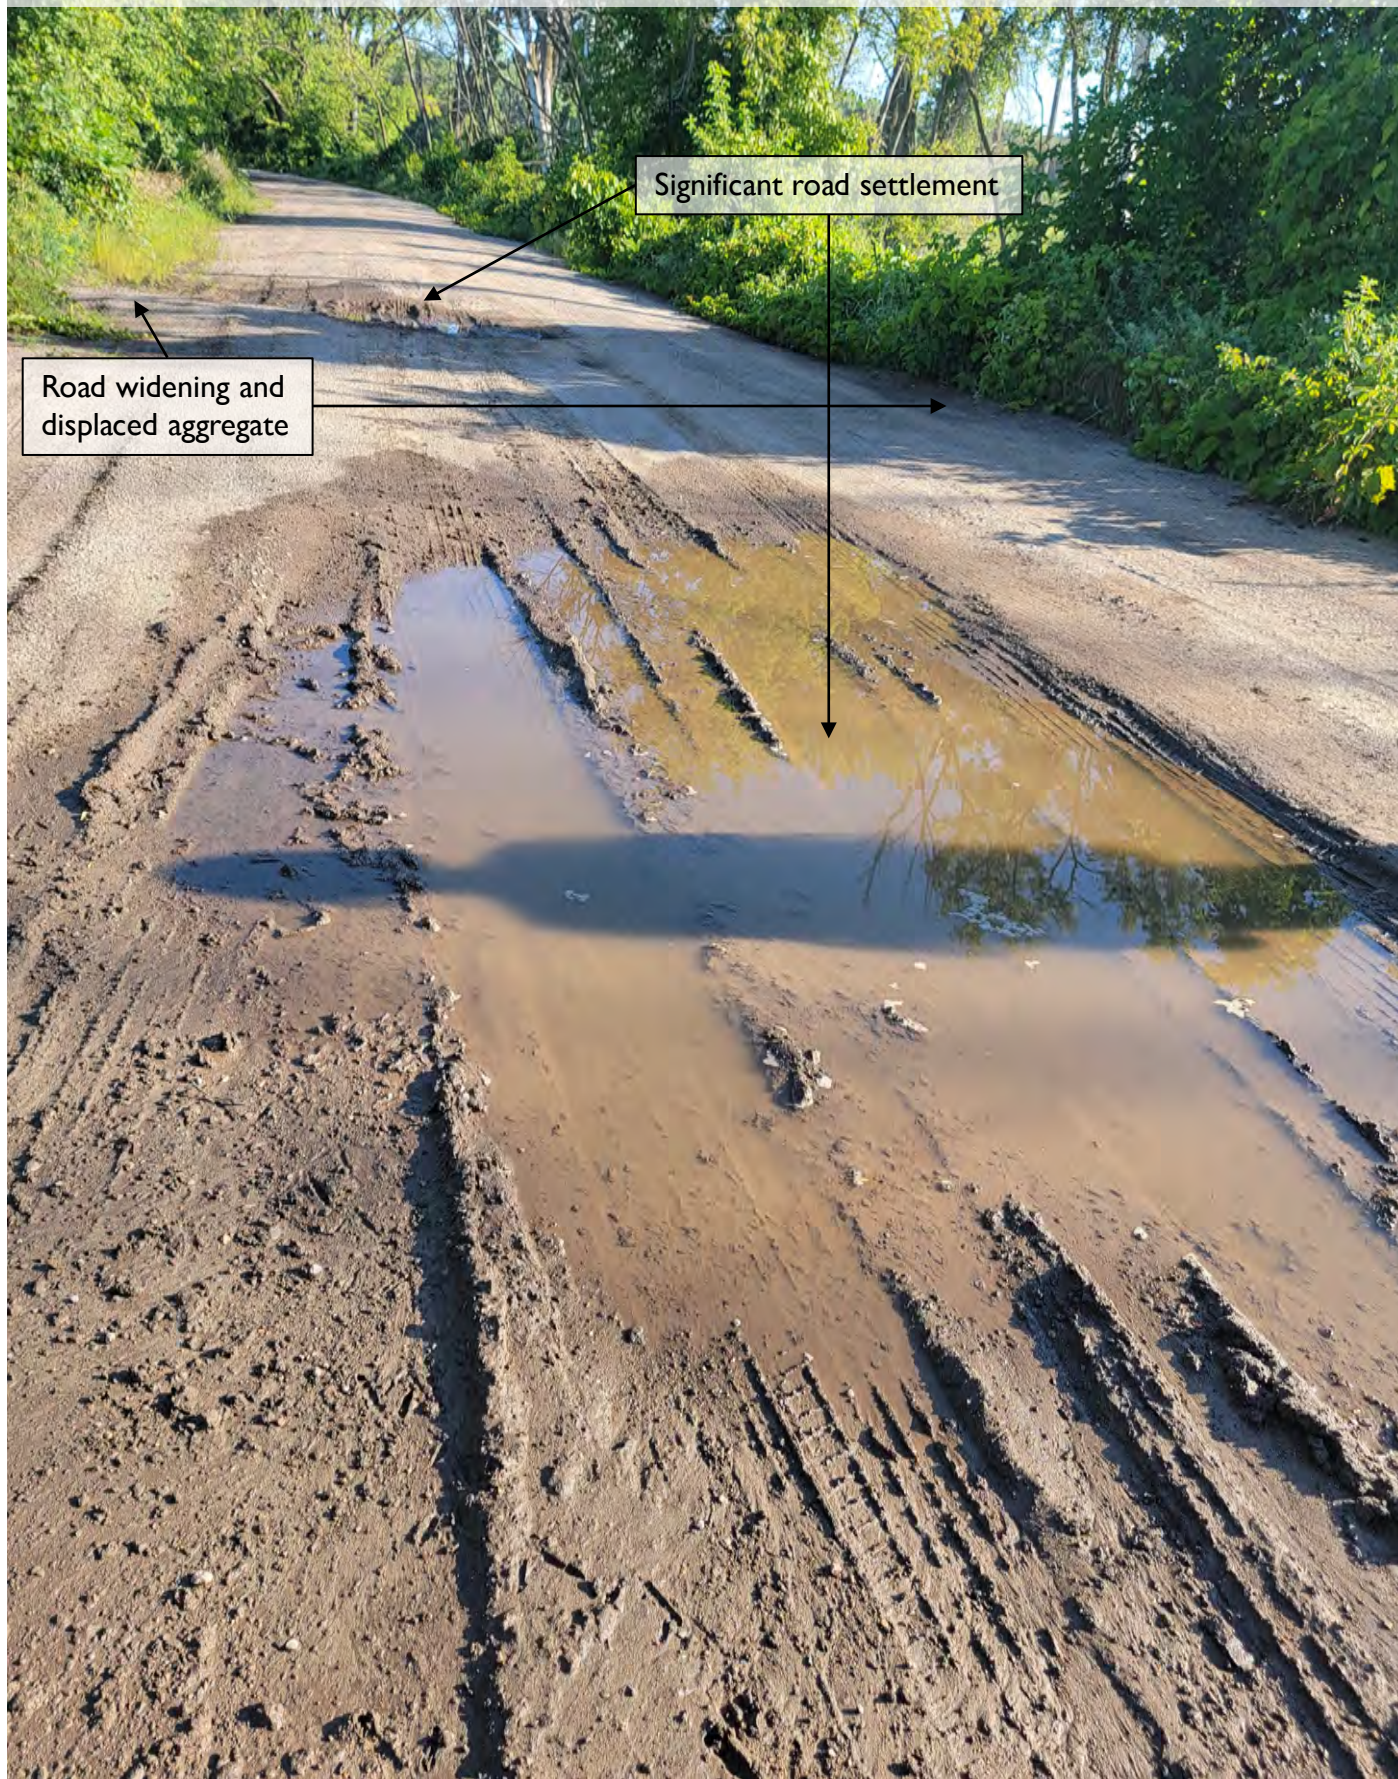
Consistent with the background information reviewed, Vernon Avenue was in poor condition, with many deep ruts and a deteriorating road surface (Photo 4A, Attachment 1). Much of the roadway appeared to be sandy material overlaying a decomposed bituminous pavement (Photos 1B, 2B, 3B, and 4B, Attachment 1), but large sections of the roadway appeared to be entirely sand (Photo 3, Attachment 1). Due to the road's location within the Minnesota River floodplain, it is possible that the sandy material observed is may also be sediment deposition from past flood events, which may need further soil borings or review to confirm. When compared to Figure 3 and the 2015 AET report, the 2022 field conditions appear to indicate that Vernon Avenue has continued to deterioration.

Photo 4A. Vernon Avenue settlement and rutting, looking north
