LOWER MINNESOTA RIVER WATERSHED DISTRICT

Technical Memorandum

Re: Lower Minnesota River Watershed District Dredge Site Update

Re: Lower Minnesota River Watershed District Dredge Site Visit Summary

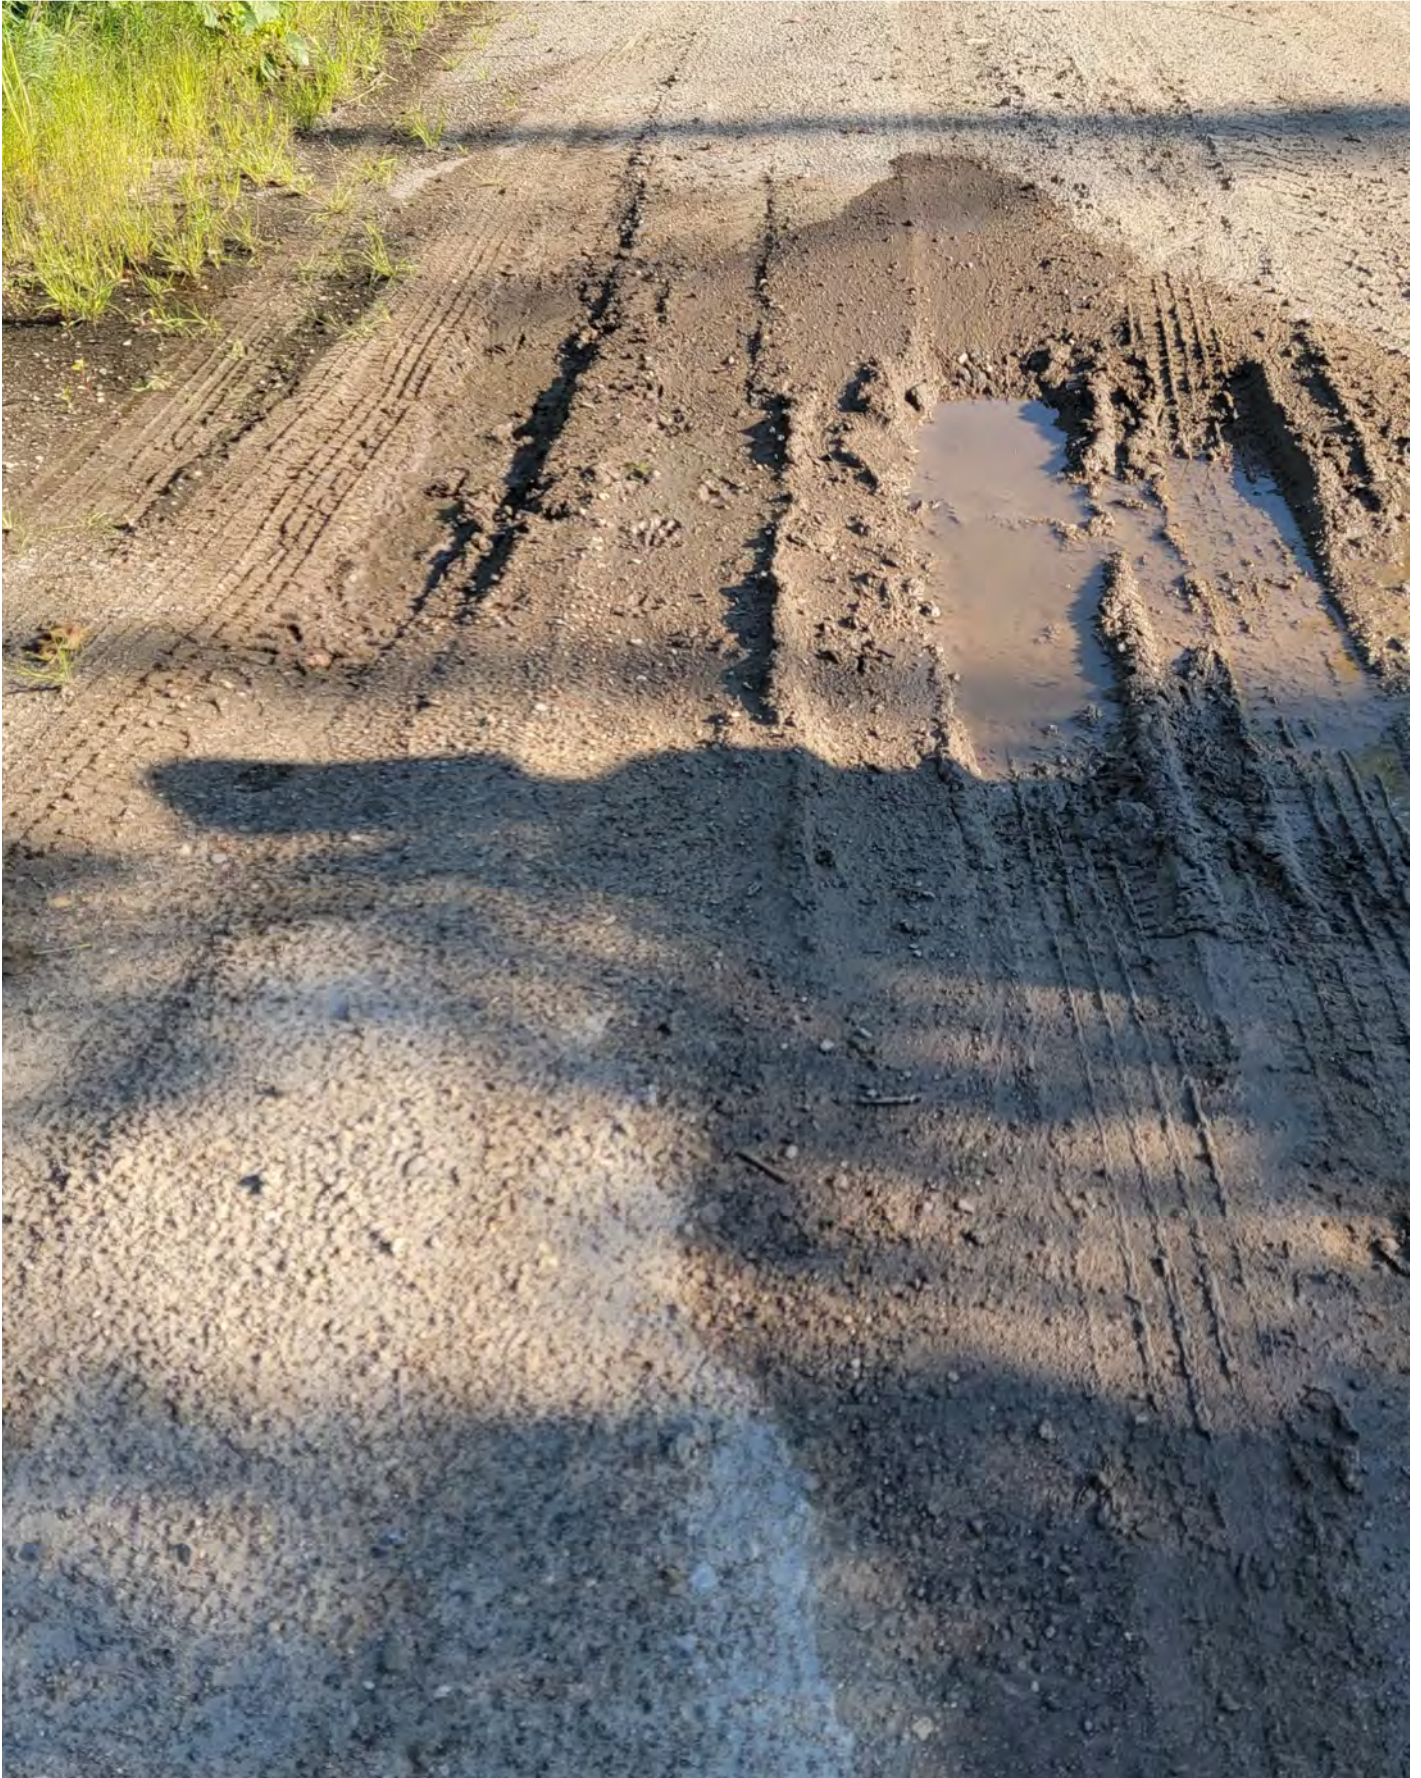
Photo 4B. Close up of rutting and pavement condition, looking north

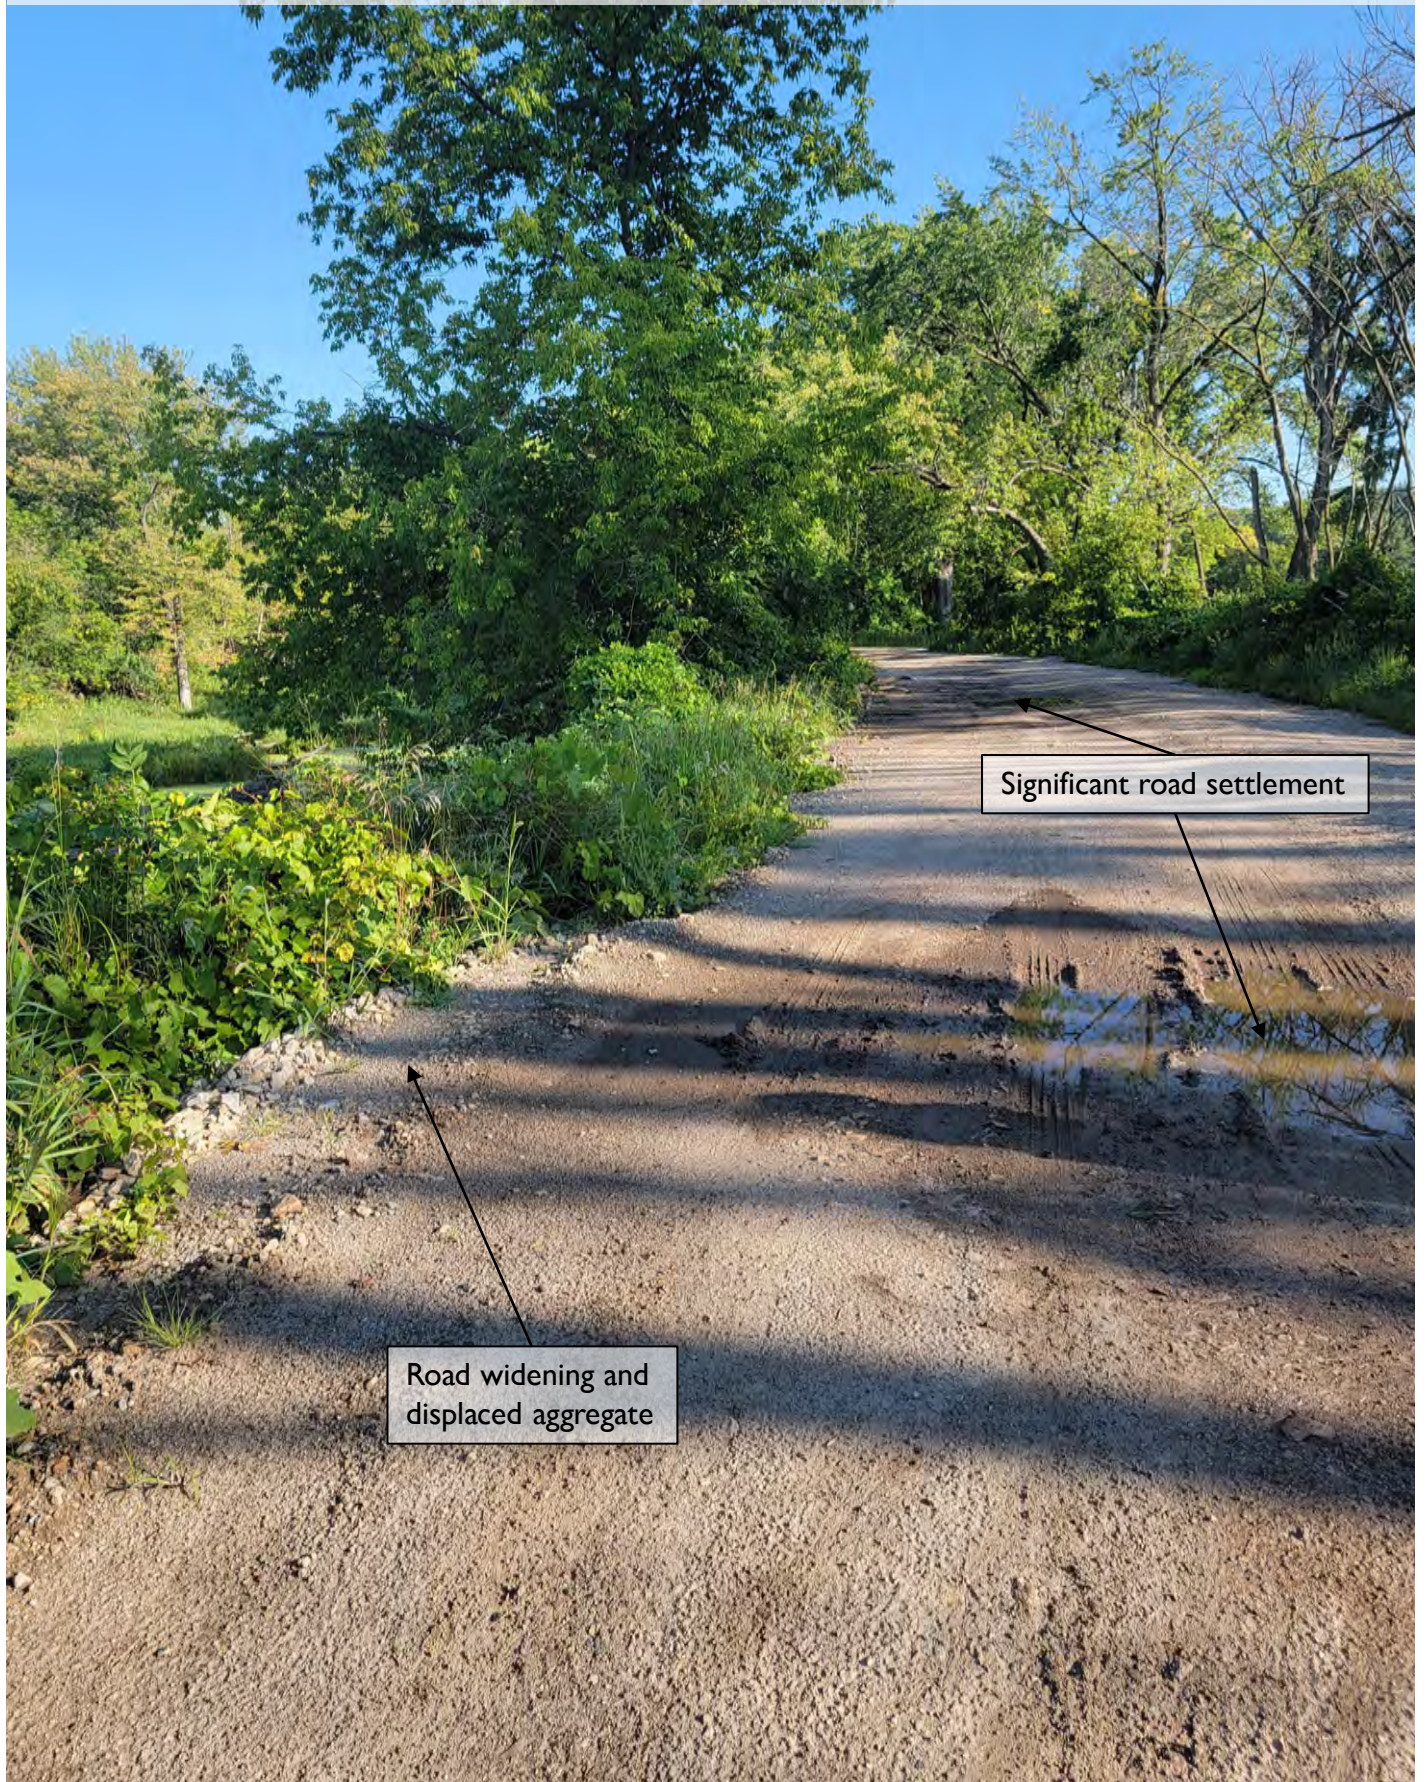
Also consistent with LS Marine's maintenance concerns, there was evidence of road widening due to displaced aggregate (Photos 1C, 2A, 4A, and 5, Attachment 1). The road widening may be intentional turnouts from the 2015–2016 stockpile removal, which would have allowed the trucks hauling sediment offsite to bypass each other on the narrow road. It is also possible that because the road surface is in such poor condition, the aggregate placed by LS Marine is not properly secured in place and gets displaced from heavy truck traffic and rainfall. If this is the case, continuing to place aggregate to fill the ruts and depressions in the roadway does not appear to be a sustainable solution and could adversely affect the neighboring wetlands over time. LS Marine should be consulted to determine if the road widening was intentional or the result of further roadway degradation.

Photo 5. Vernon Avenue road widening and settlement, looking north

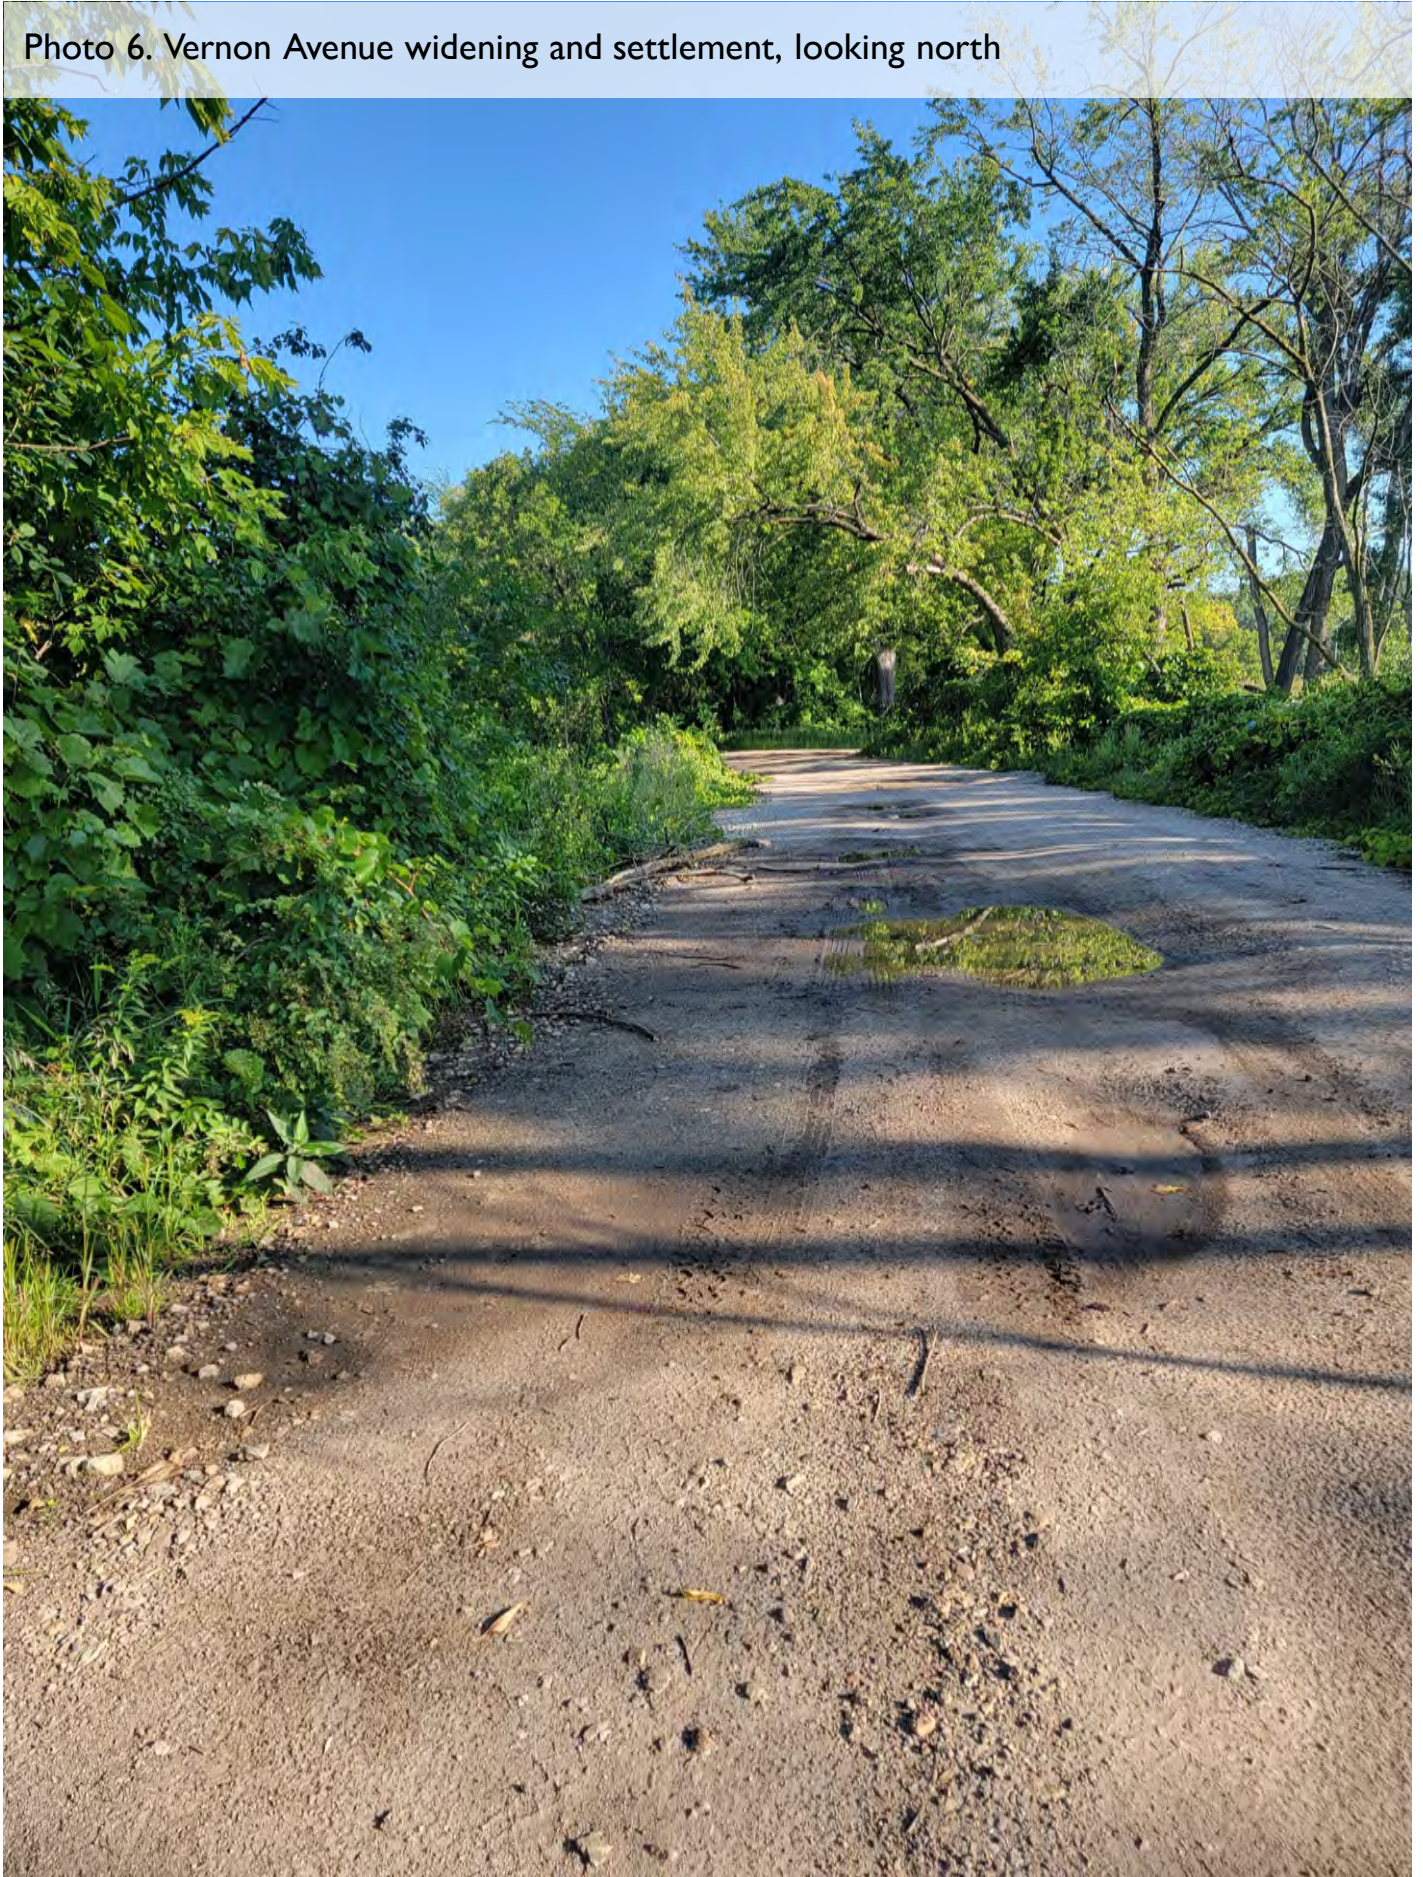
Road widening and displaced aggregate

Significant road settlement

Photo 6. Vernon Avenue widening and settlement, looking north

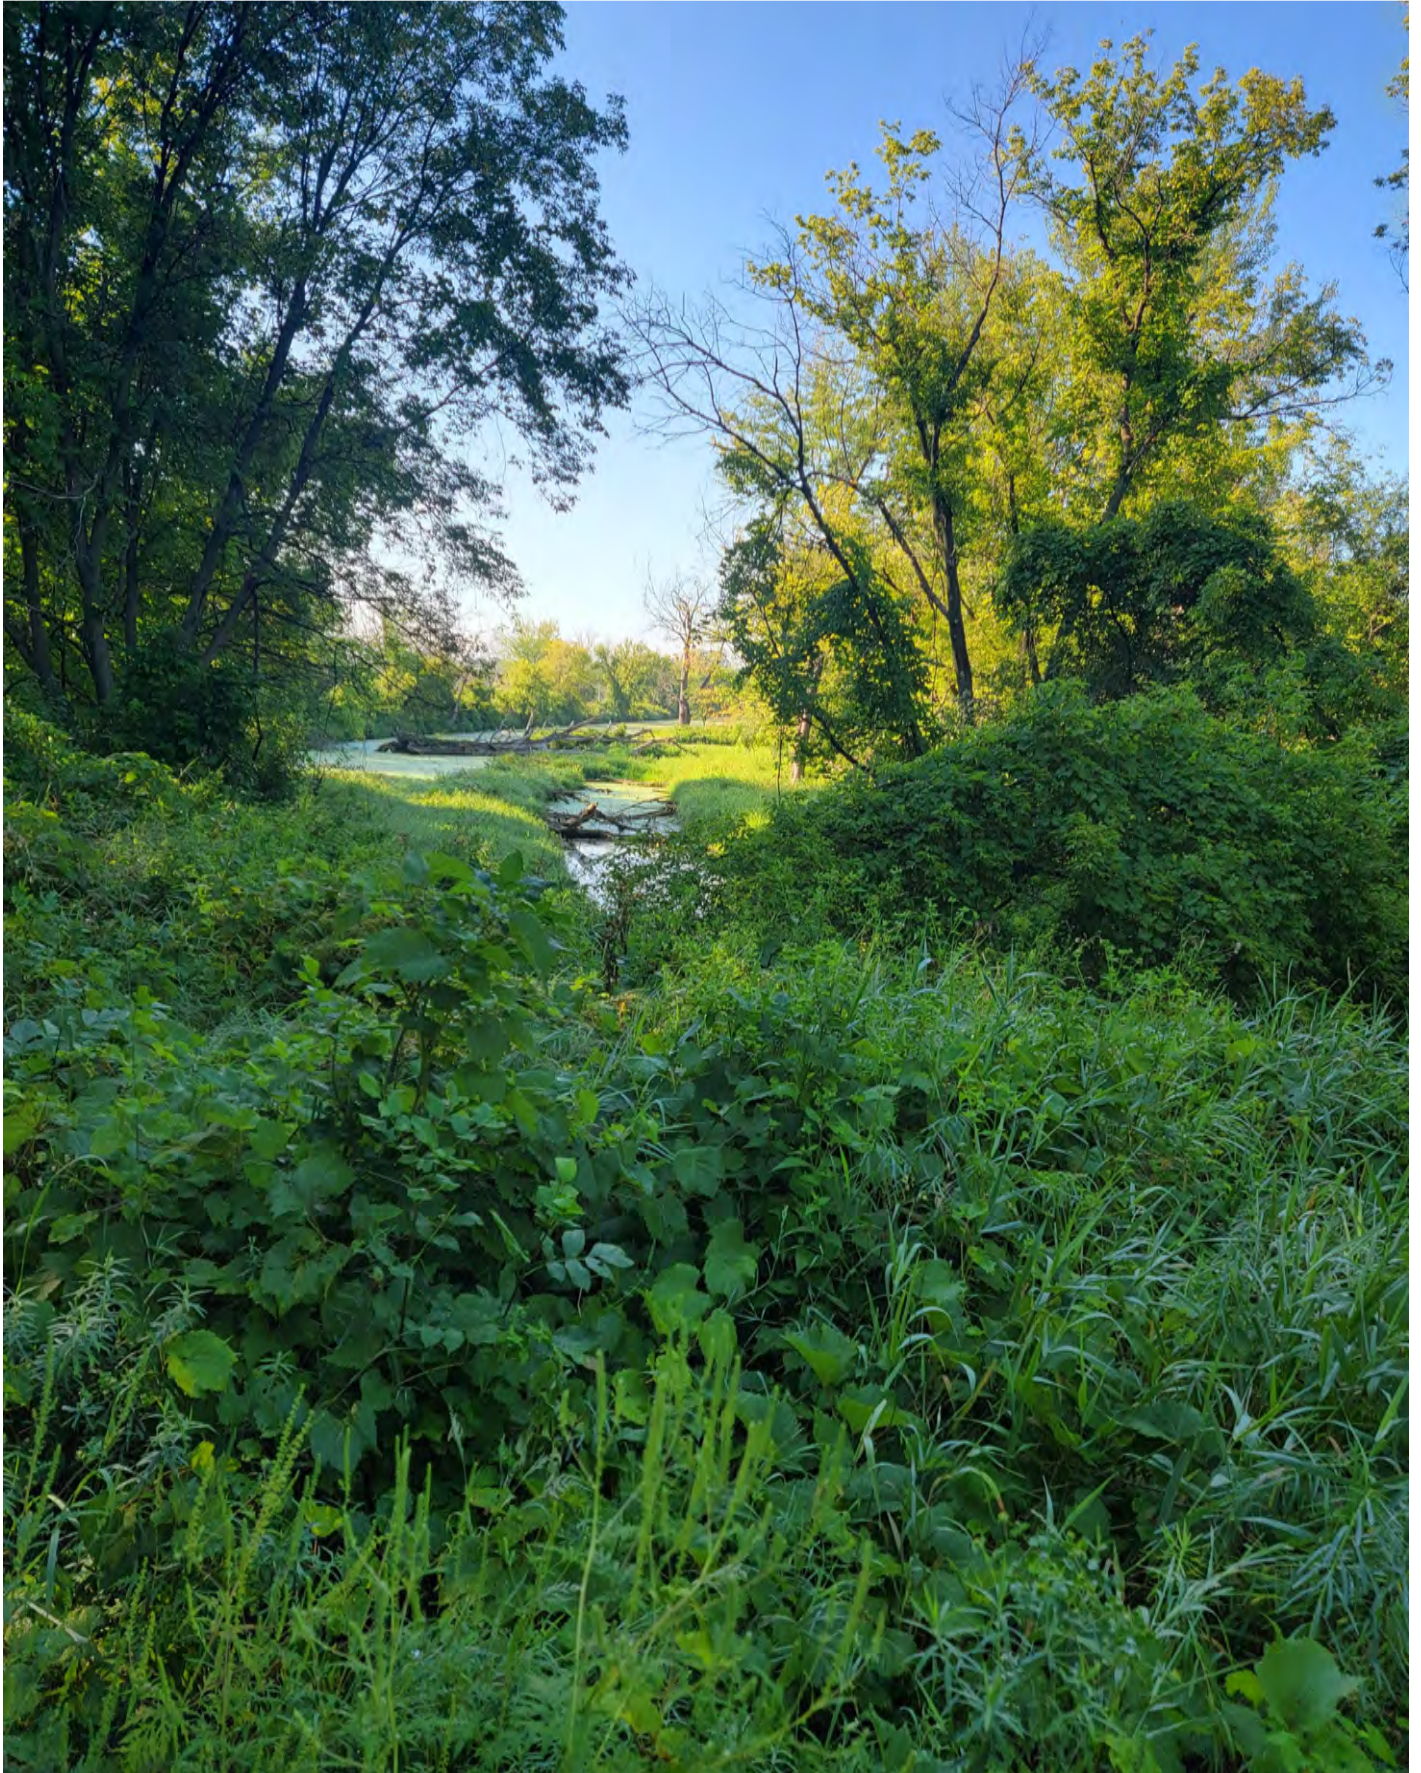
Photo 7. Vernon Avenue looking south at west wetland and heavy vegetation

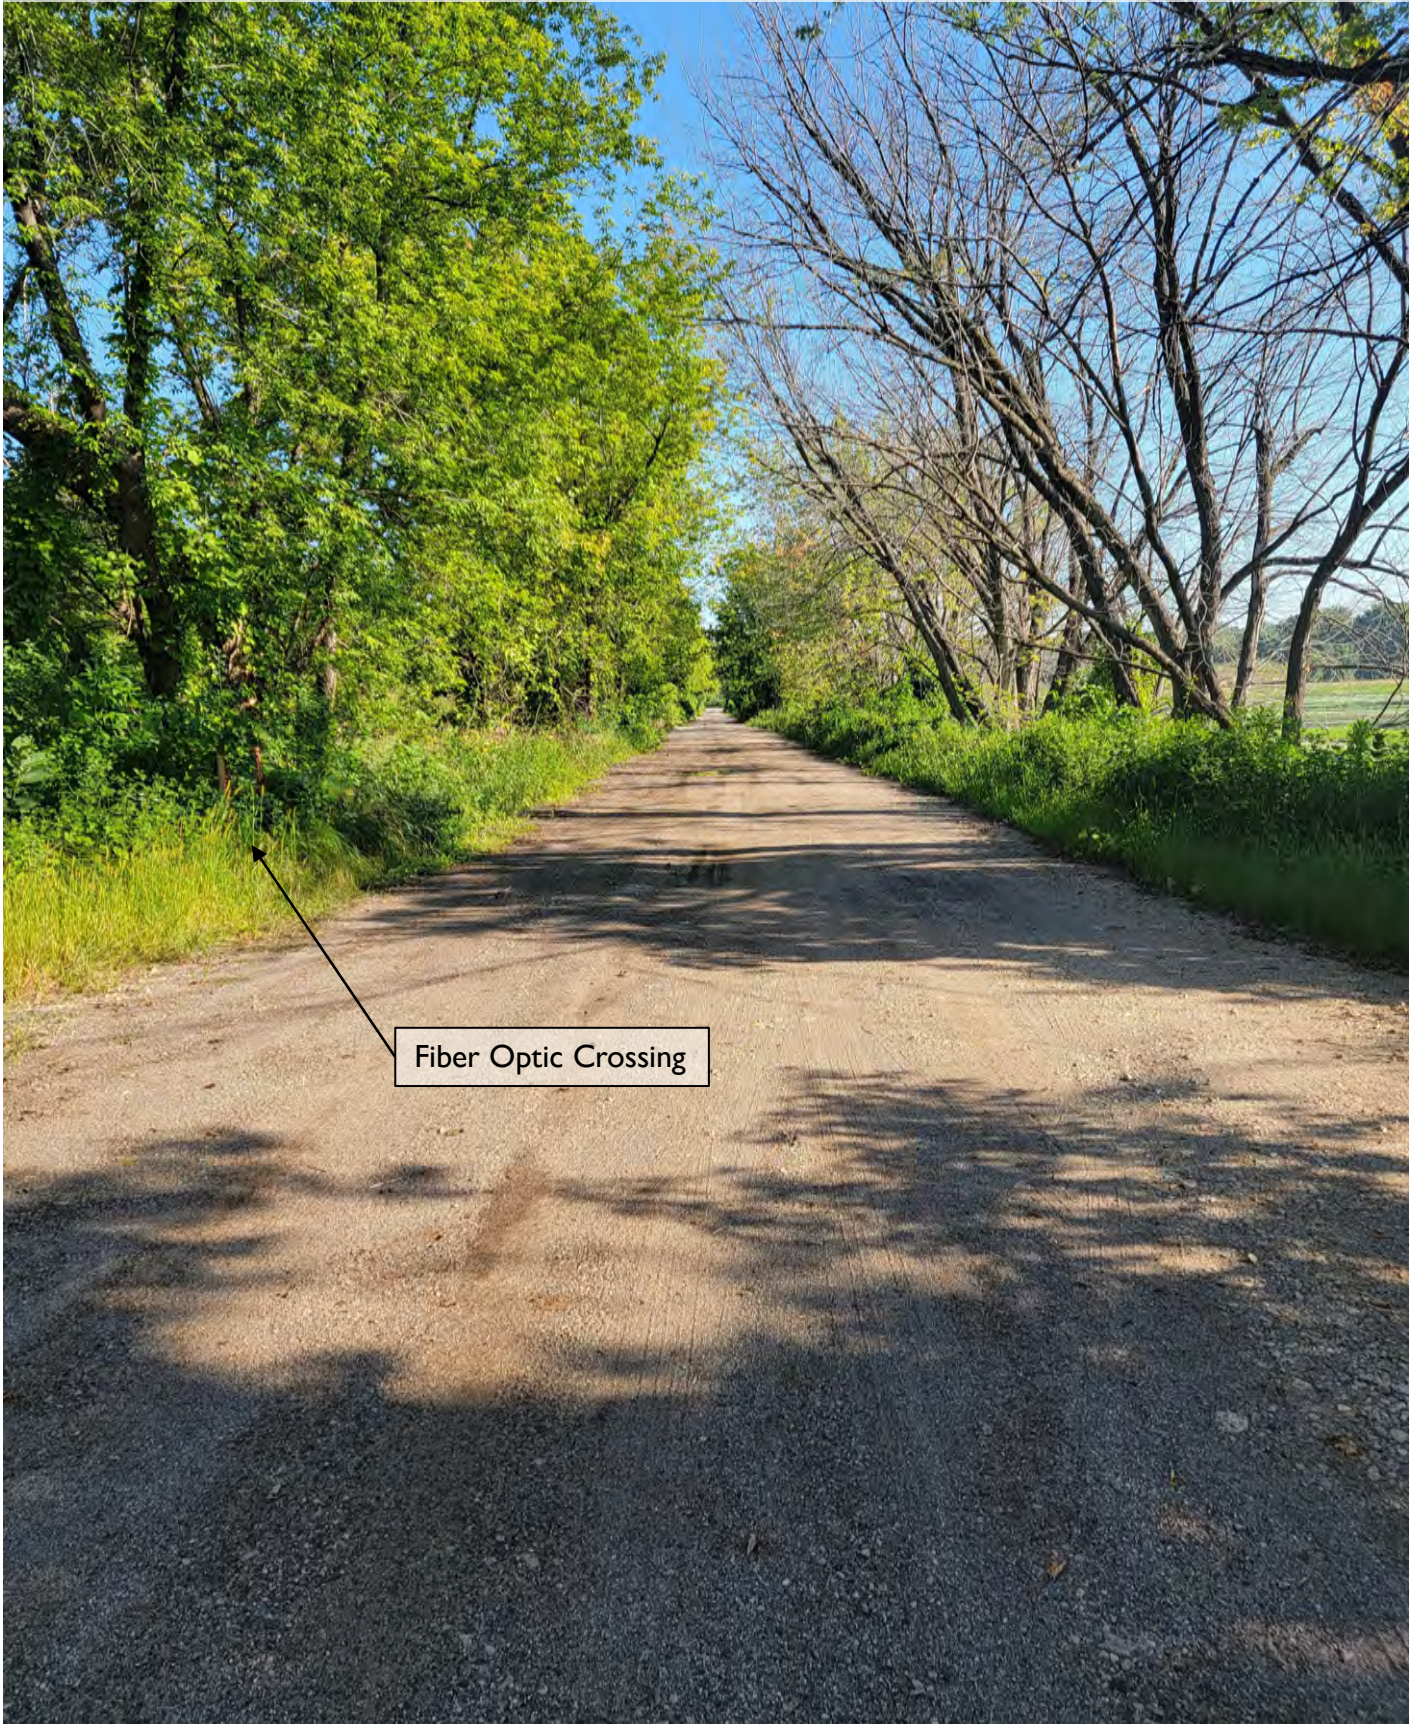
Photo 8. Vernon Avenue looking north from railroad crossing. In 2015, AET soil boring B-2 indicated the roadway had a 2.5-inch deteriorated bituminous pavement surface.

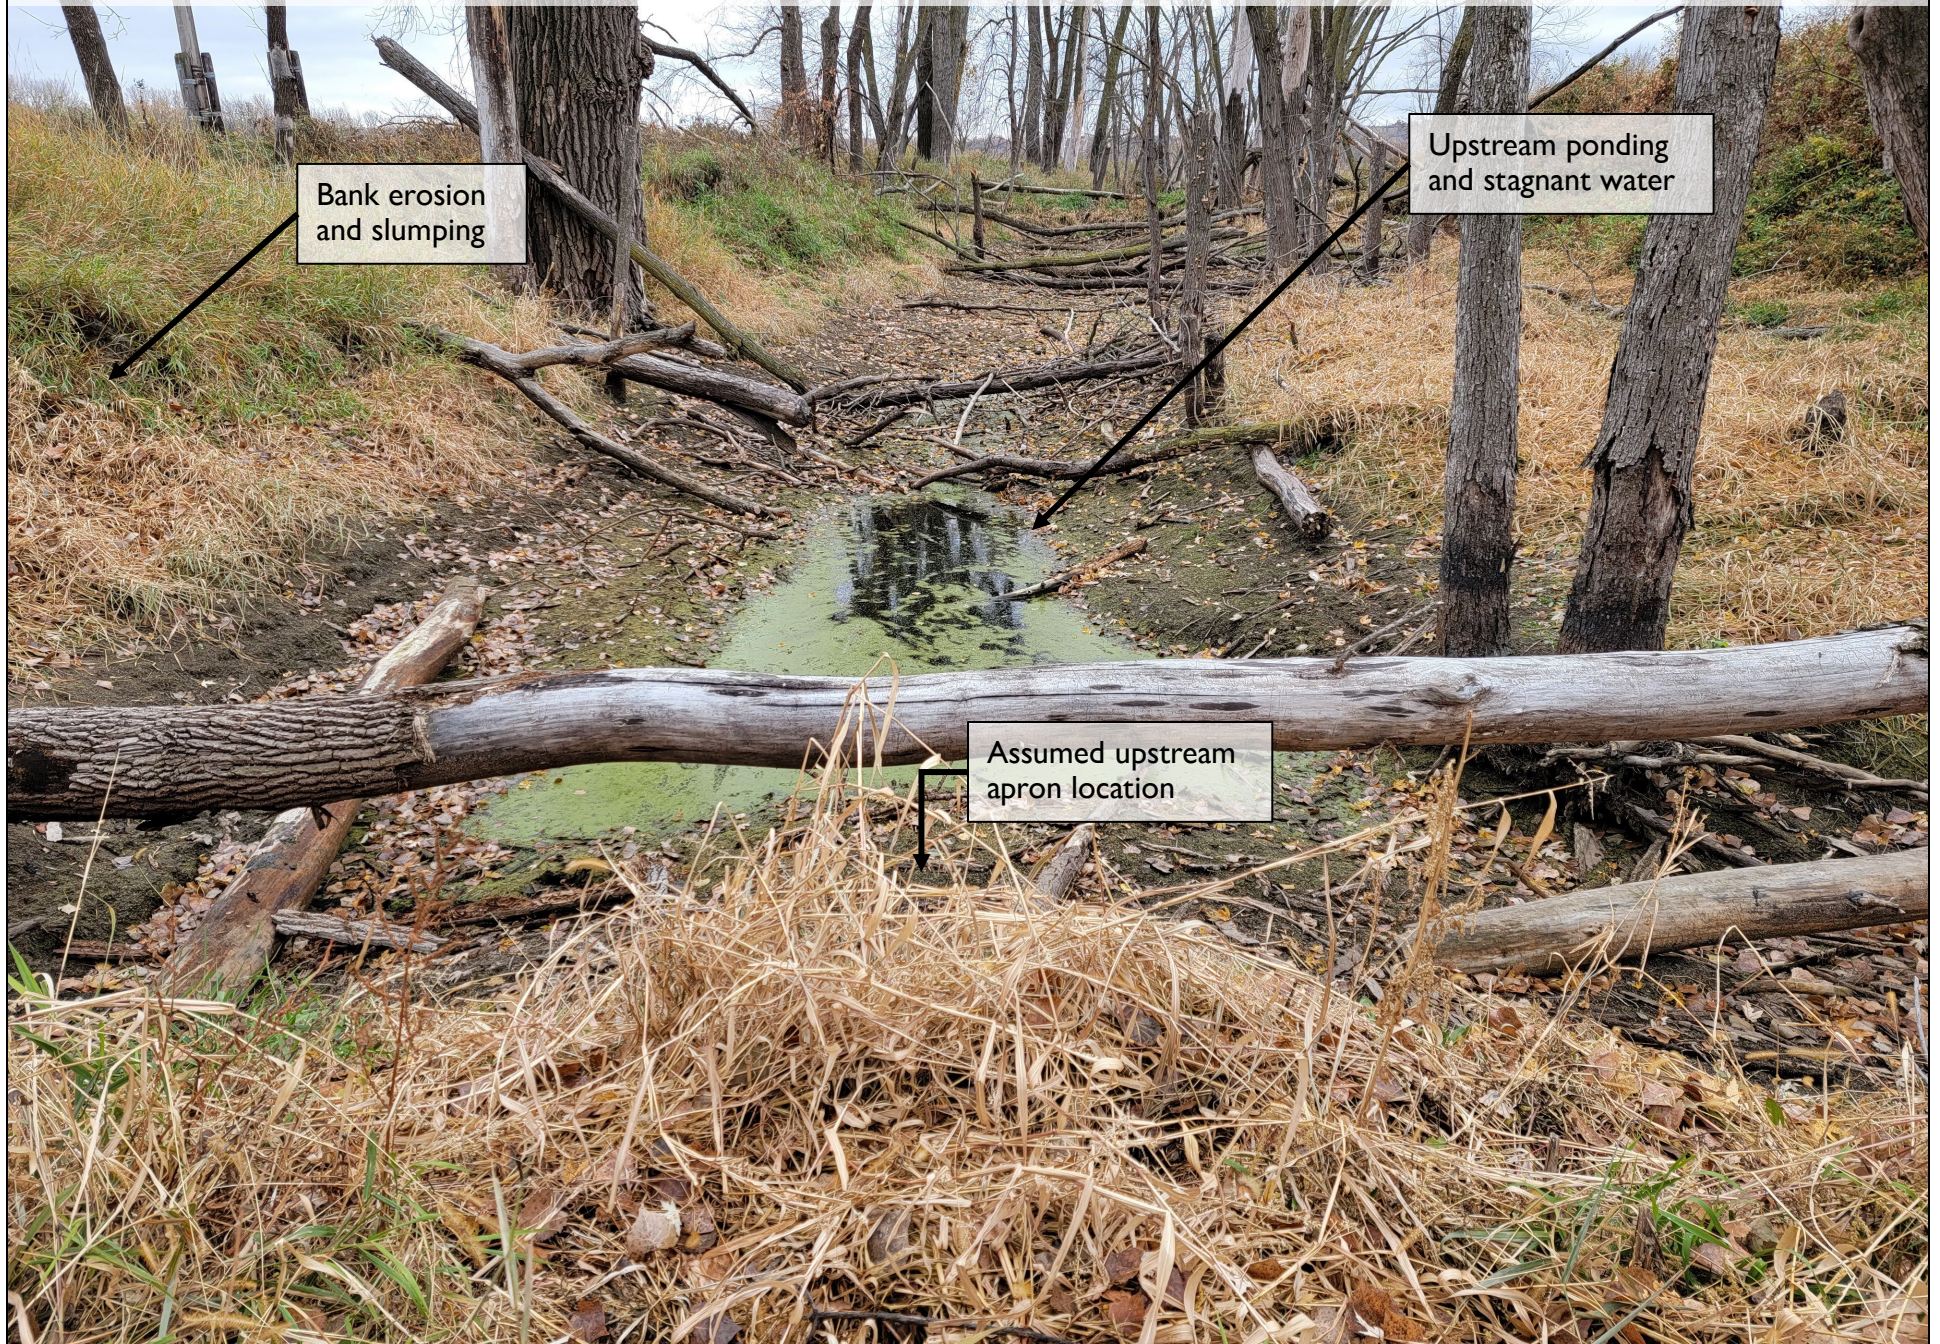
The access road culvert is a 48-inch reinforced concrete pipe with flared aprons and trash guards. The upstream end of the culvert on the south side of the access road was completely blocked by sediment and tree debris, as shown in Attachment 2. The culvert location was not immediately discernable due to the large debris buildup, and like the previous site visit, Young Environmental staff were unable to find the culvert apron under the accumulated sediment (Photo 1, Attachment 2). The accumulated sediment has also created a stagnant pond immediately upstream of the culvert, which following rain events, likely increases in elevation as the water slowly percolates through the sediment and into the culvert downstream. This bounce in water surface elevations appears to be contributing to the erosion of the roadway embankment and the development of in-slope cavities forming above the pipe apron (Photo 2, Attachment 2).

1. Looking south at upstream ponding area above the presumed culvert apron alignment.

Bank erosion
and slumping

Upstream ponding
and stagnant water

Assumed upstream
apron location

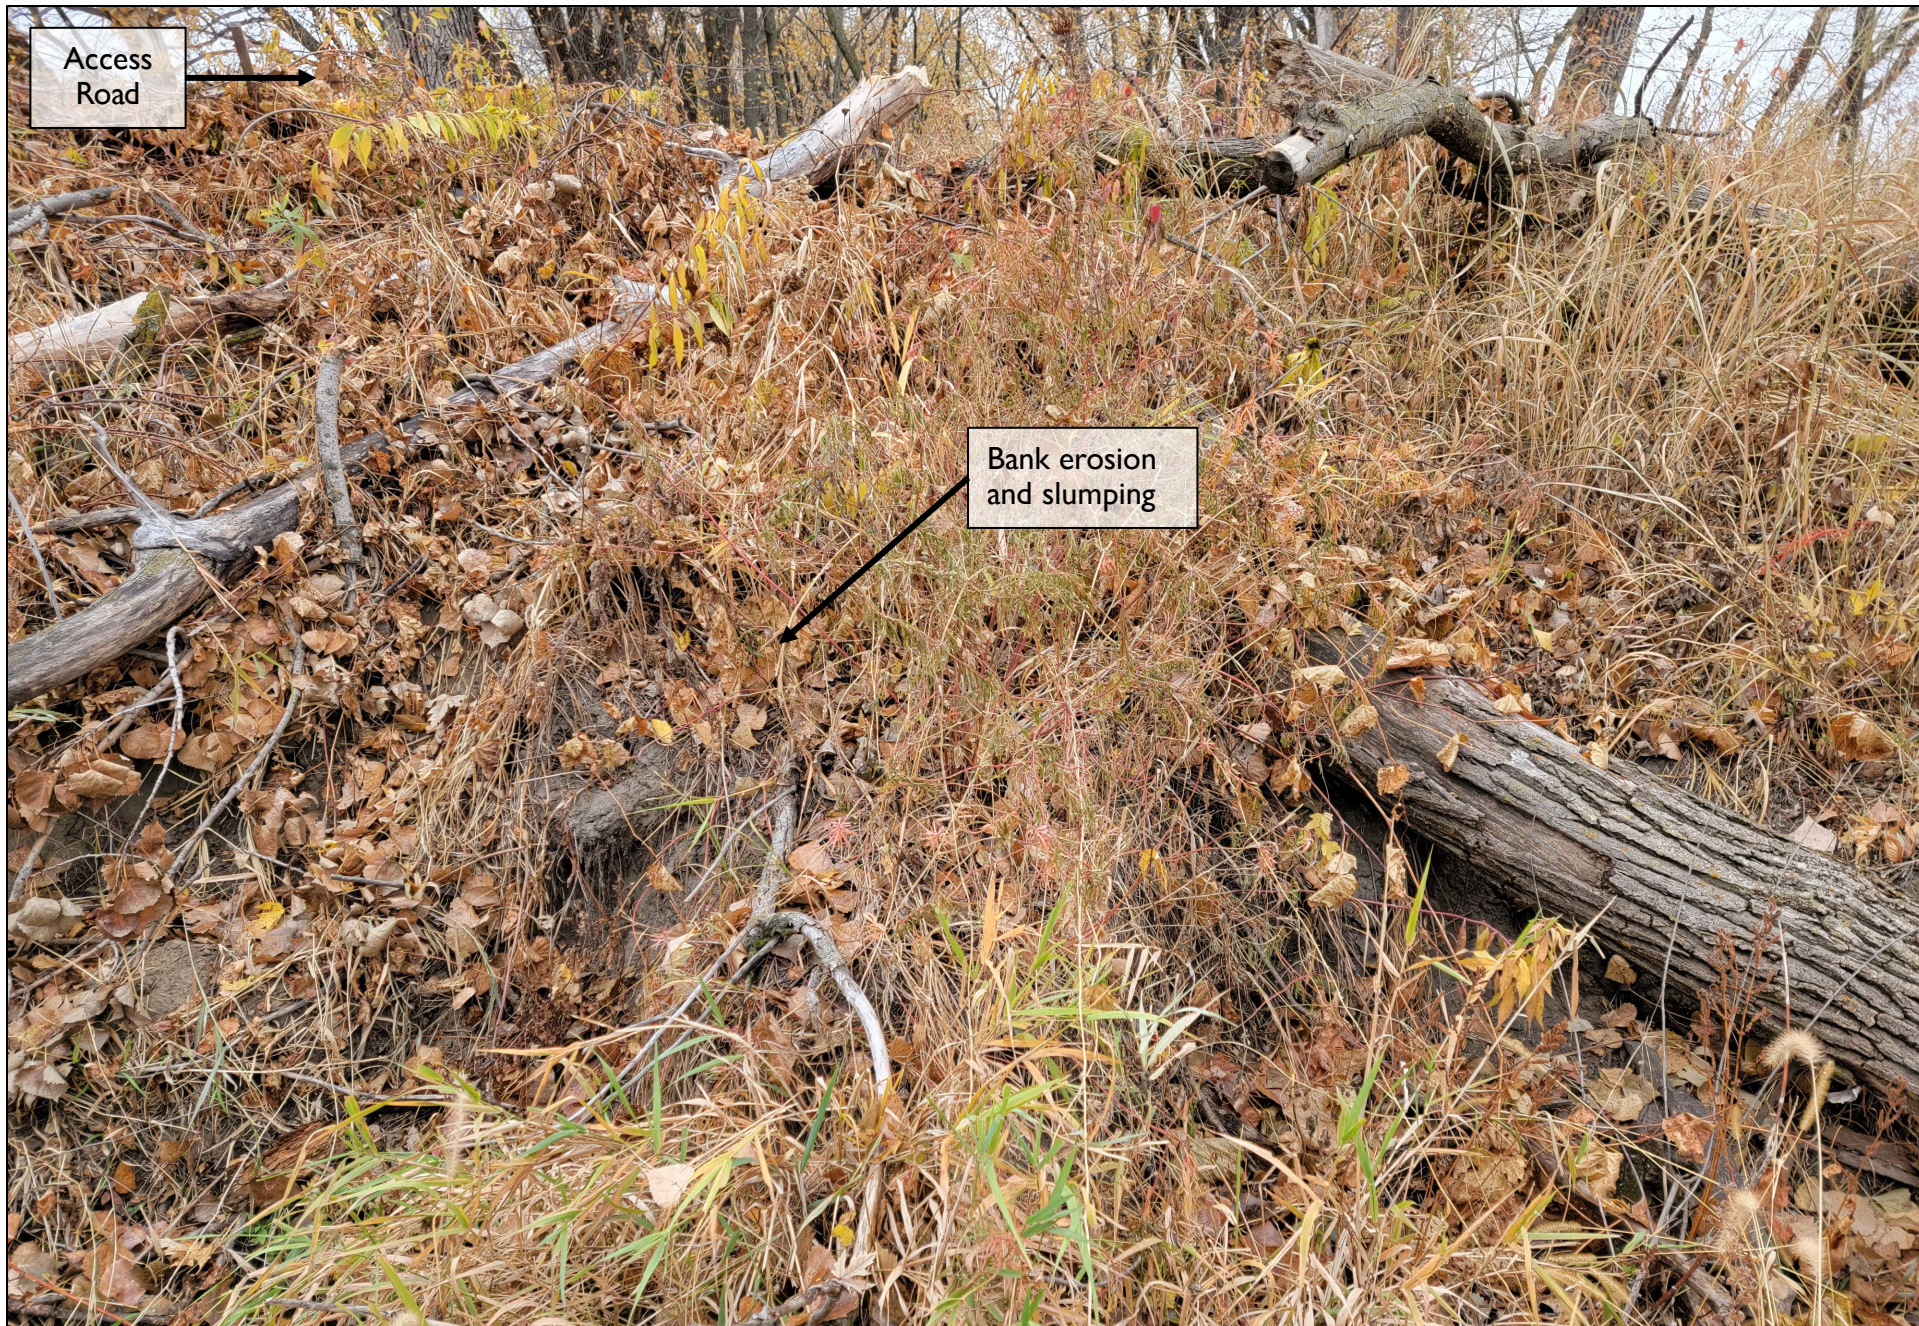
2. Looking north at upstream embankment from above the presumed culvert alignment at debris and inslope erosion.

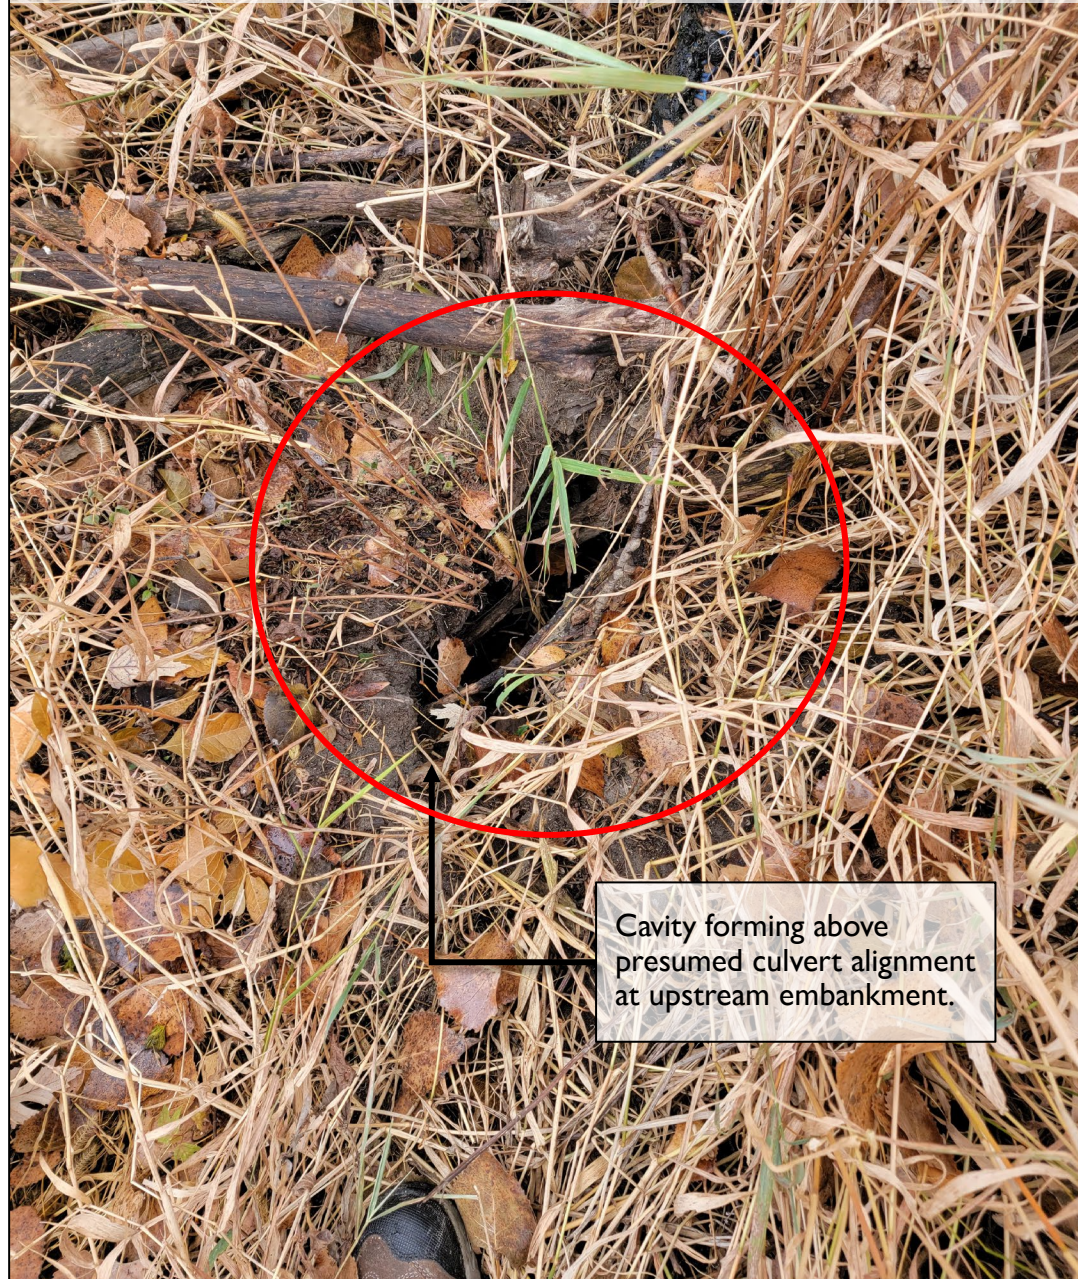
The accumulated sediment at the upstream entrance was covered in vegetation but not solidly packed, and depressions and holes appeared to be forming above the presumed location of the culvert (Photo 3, Attachment 2). Depressions and vertical holes in the embankment fill above a culvert can often indicate that the culvert pipe sections have separated and are allowing the embankment fill to infiltrate the culvert.

3. Looking down at the presumed upstream culvert apron alignment and cavity forming in embankment.

Cavity forming above
presumed culvert alignment
at upstream embankment.

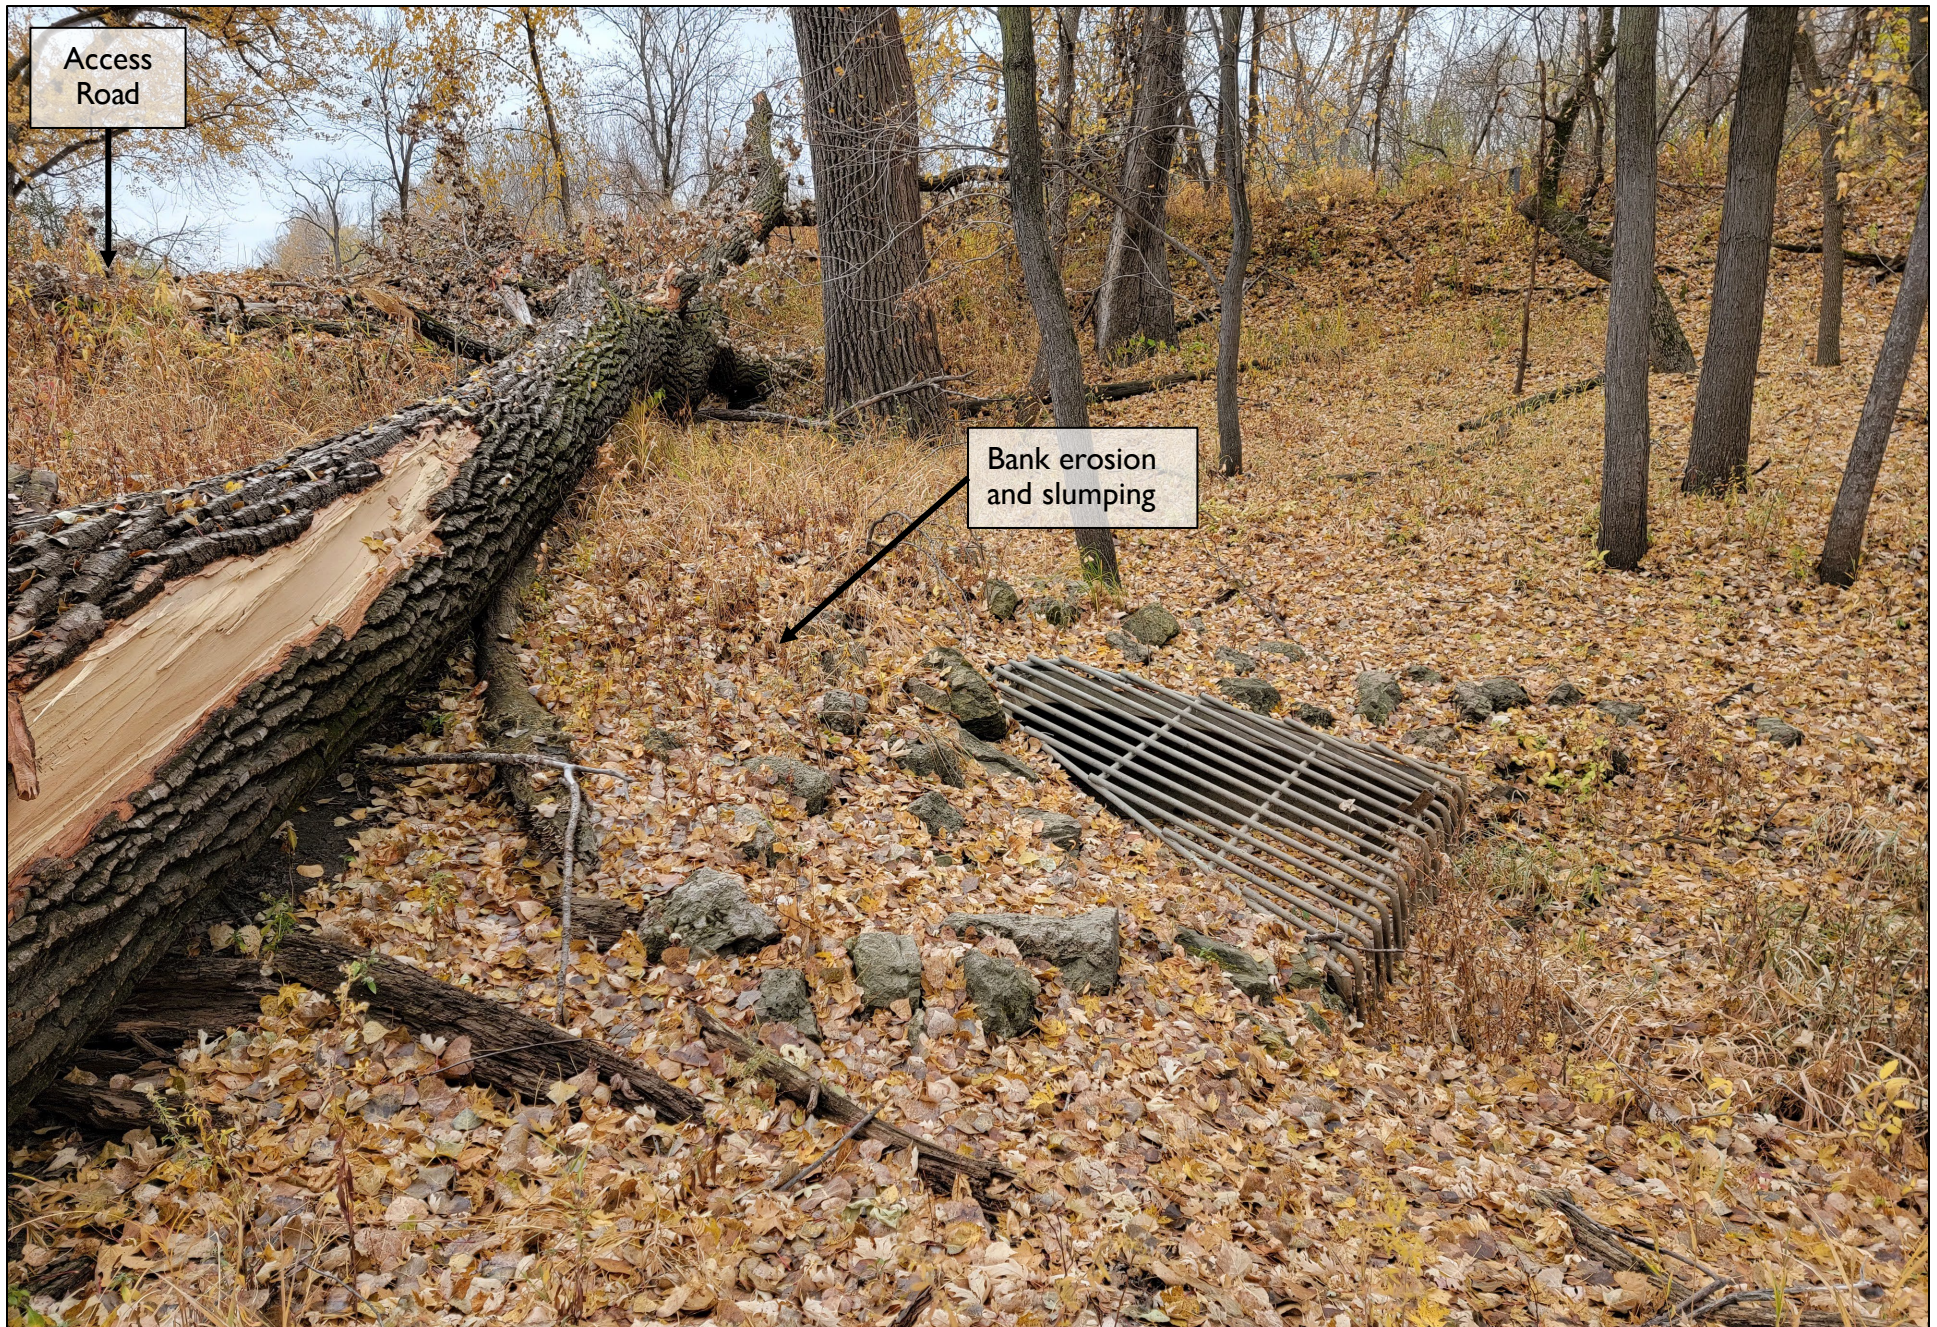
Downstream, on the north side of the access road, the culvert, apron, trash guard, and riprap were all visible and appeared to be in good condition (Photo 4, Attachment 2). There were no visible cracks or joint separation and only minor blemishes on the culvert itself; however, the pipe appeared to be approximately 30 percent filled with sediment (Photo 5, Attachment 2). The culvert and downstream channel showed no signs of flowing water, likely due to the blocked culvert entrance, but they showed some minor deposition and sediment accumulation at the downstream culvert outfall (Photo 6, Attachment 2).

4. Looking west at downstream embankment, culvert outfall apron and trash guard, and left bank.
