LOWER MINNESOTA RIVER WATERSHED DISTRICT

Technical Memorandum

Re: Lower Minnesota River Watershed District Dredge Site Update

Re: Lower Minnesota River Watershed District Dredge Site Visit Summary

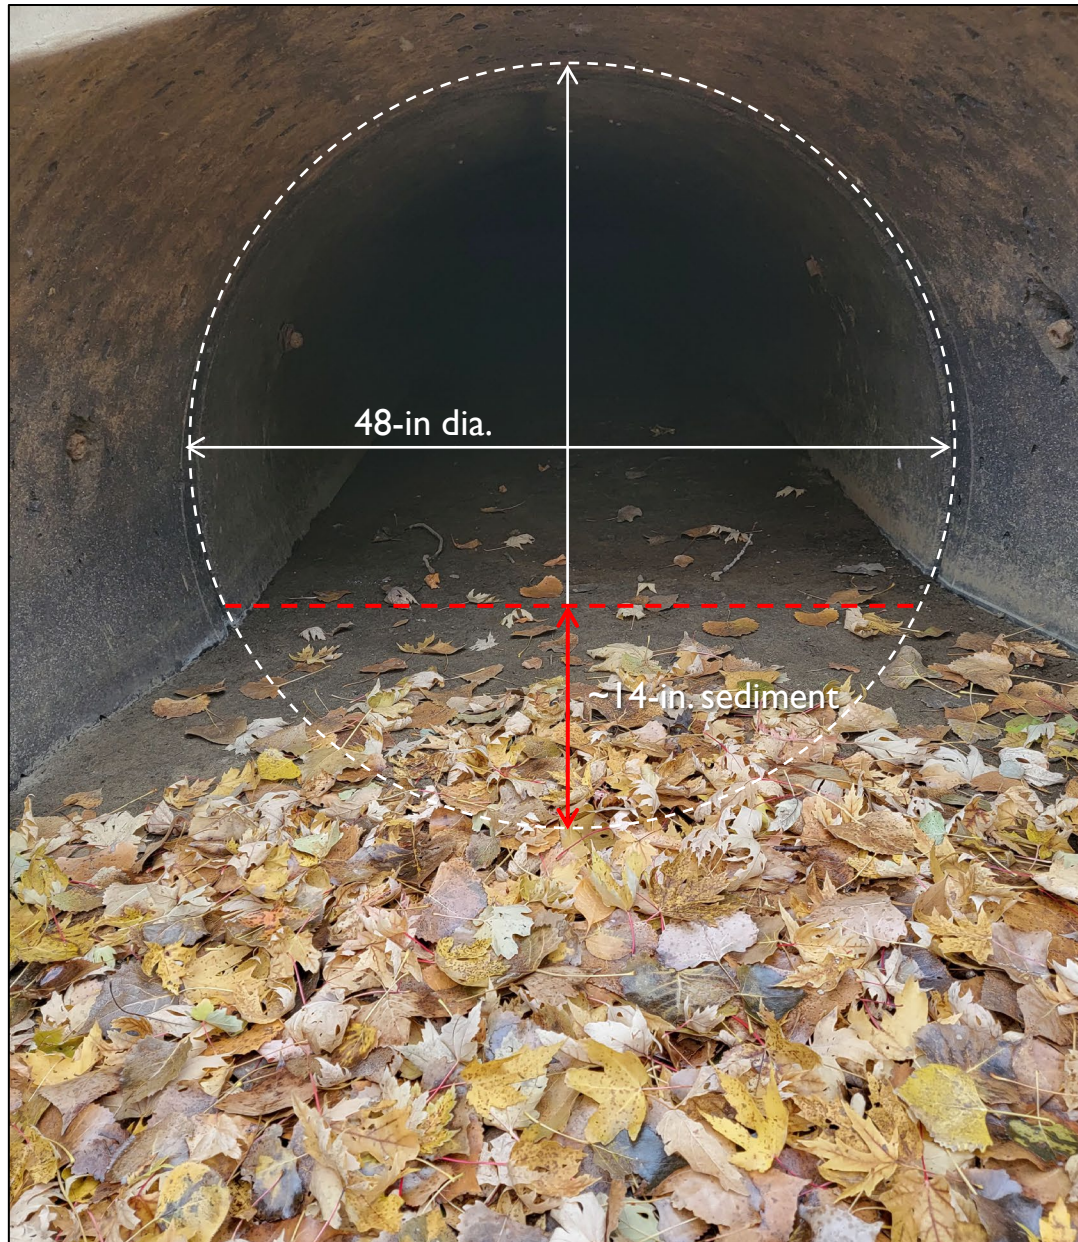
Downstream, on the north side of the access road, the culvert, apron, trash guard, and riprap were all visible and appeared to be in good condition (Photo 4, Attachment 2). There were no visible cracks or joint separation and only minor blemishes on the culvert itself; however, the pipe appeared to be approximately 30 percent filled with sediment (Photo 5, Attachment 2). The culvert and downstream channel showed no signs of flowing water, likely due to the blocked culvert entrance, but they showed some minor deposition and sediment accumulation at the downstream culvert outfall (Photo 6, Attachment 2).

5. Looking upstream from the downstream culvert apron at pipe sedimentation (approximate culvert diameter shown with white dashed lines, approximate sedimentation shown in red).

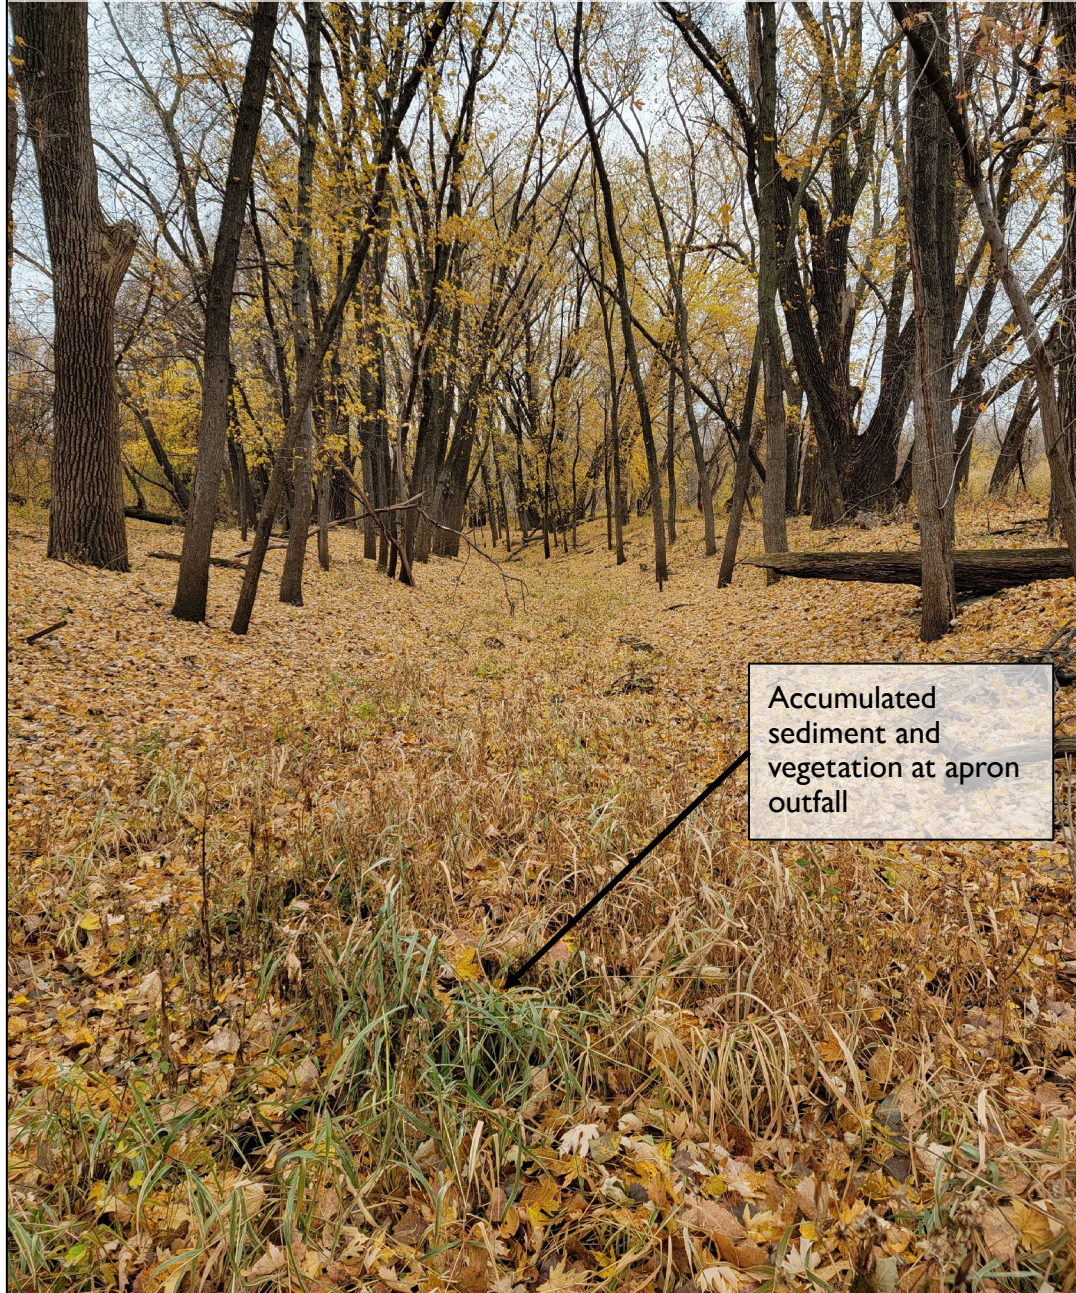
6. Looking north at downstream channel from the downstream culvert apron.

Accumulated sediment and vegetation at apron outfall
