LOWER MINNESOTA RIVER WATERSHED DISTRICT

Item 7. E. – 2025 Gully Inventory – Post Field Assessment Summary

Re: 2025 Gully Inventory – Post-Field Assessment Summary

2023 Gully Inventory and Condition Assessment Project

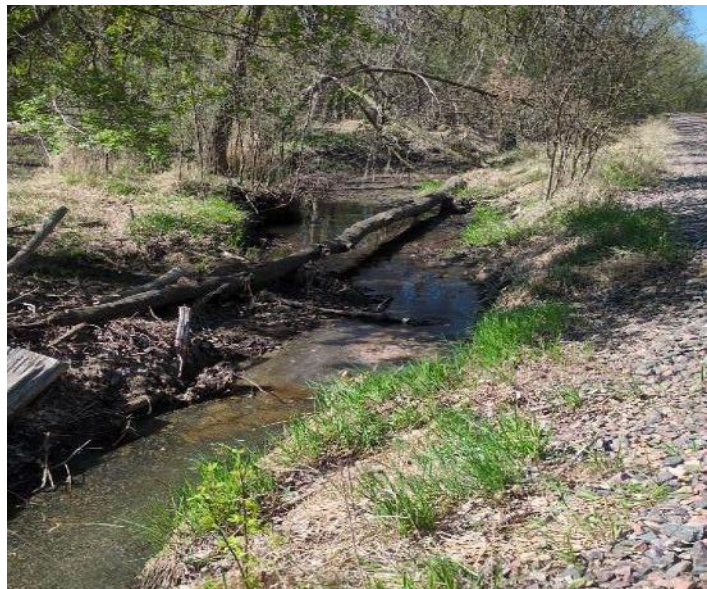
Photo 5. BVL52 Gully Condition

BVL52 and 8 are located adjacent to railroad tracks. The gullies were accessed by walking along the City right-of-way (Hayes Drive), exiting Hayes Drive to the north, following a constructed drainage channel, and through undeveloped, US Fish and Wildlife Service land. The gullies were close in proximity (within 50 feet of one another). BVL52 is a long drainage ditch that runs along the south side of the elevated rail line. BVL8 is a small gully that has developed where a natural drainage network empties into the larger drainage ditch (BVL52).

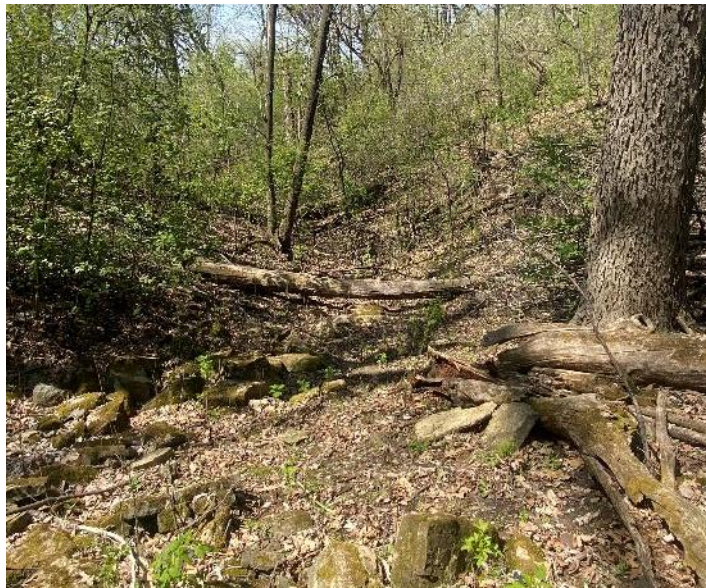
Photo 8. MDH14 Gully Condition

MDH11 and 14 are located near Sibley Memorial Highway along the railroad tracks. Both gullies were accessed by parking at the Big Rivers Regional Trail parking lot and walking along the trail. MDH14 is a short distance from the parking lot, and there appears to be rip rap installed previously to prevent erosion. MDH11, shown on page 9, is further north along the trail, has a wide base, and dense vegetation growing in it.

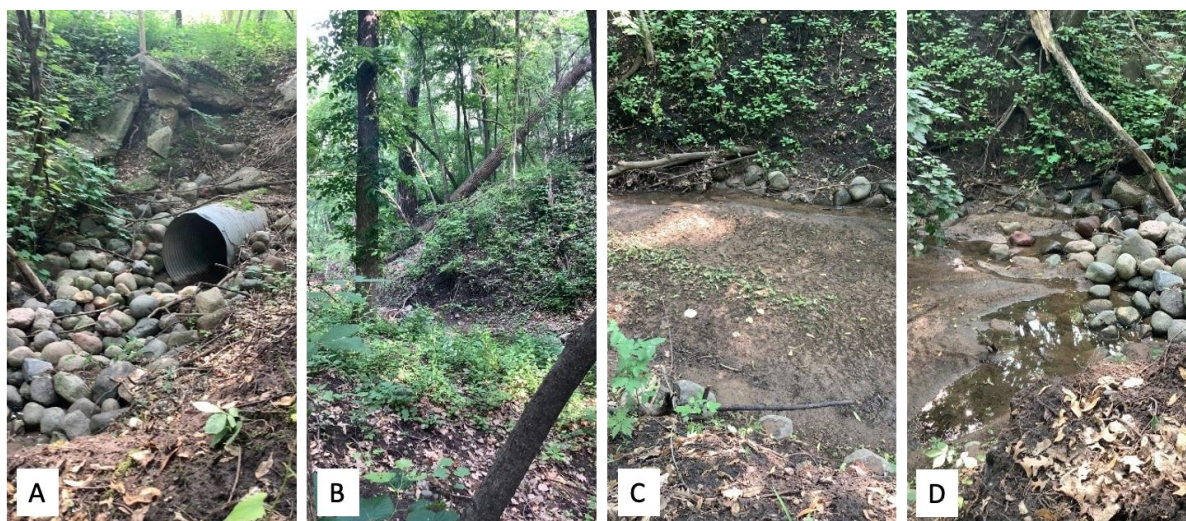
- **Ranking Score Breakdown:** This gully has a total erosion score of **47**, which is greater than the 2021 assessment's score of **32**. This is due to the gully being longer, deeper, and less vegetated than in the last visit. BVL62 is in impact Tier A, meaning it is near high value resource areas in the LMRWD, adding **10** points to the final ranking score. BVL62 specifically impacts Black Dog Fen. It also has 18 sites of active investigation or cleanup within a 1-mile radius, adding **4.5** points to the final ranking score. Gully BVL62 received a total of **61.5** points (Table 6), which is the highest-ranking score given out of all the gullies surveyed.

Figure 8. Photos of gully BVL62. A) Headcut with large pipe outfall and surrounding rip rap. B) Facing North at bank from the side of the headcut. C) Gully bottom condition. D) Image of water pooling at bottom of rip rap

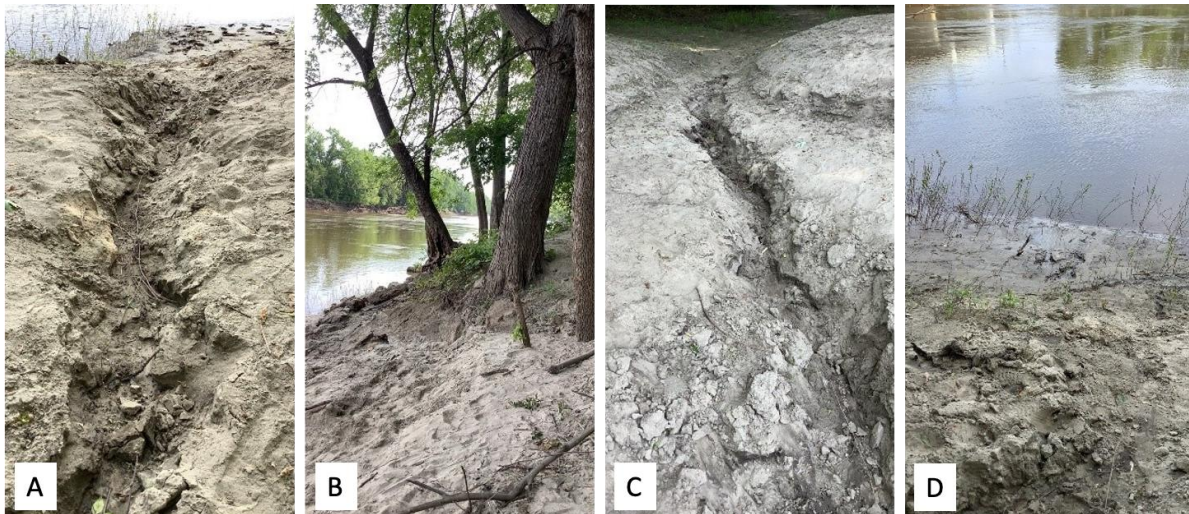
- **Ranking Score Breakdown:** The calculated erosion score was **42**, which is greater than the previous year's score of **35**. SHK1 is in impact Tier B because it directly discharges sediment to the Minnesota River, which is defined as an impaired water body, adding **7** points to the final ranking score. This gully has 32 active investigation or cleanup sites within a mile radius, adding **8** points and giving it a final score of **57** (Table 7).

Figure 9. Photos of gully SHK1. A) Facing north looking down at gully. B) Facing south looking up at gully. C) Leaning tree along bank adjacent to the gully. D) Water at gully edge in the Minnesota River.

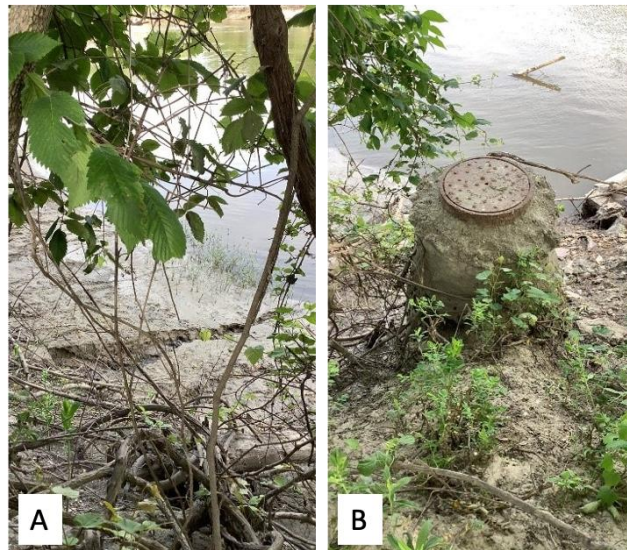
- **Ranking Score Breakdown:** The erosion potential score is **42**, which is higher than the previous erosion score of **34**. SHK10 falls into impact Tier B because of its proximity to the Minnesota River, which is an impaired waterbody, contributing **7** points to the final score. This gully was found to have 32 active investigation or cleanup sites found within a mile radius adding another **8** points, giving it a final score of **57** (Table 8).

Figure 10. Photos of gully SHK10. A) Facing northwest looking down at gully. B) Image of structure that is surrounded by evident erosion.

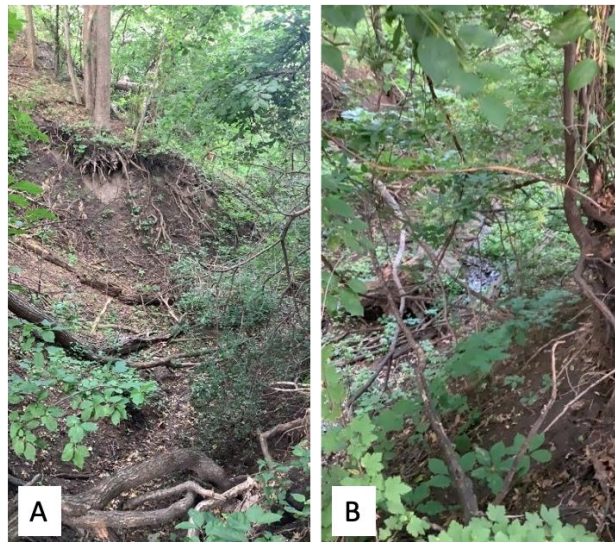
- **Ranking Score Breakdown:** The gully ultimately has an erosion score of **44**, which is higher than the previous erosion potential score of **39**, due to the gully being longer and less vegetated. BVL3 is in impact Tier A contributing **10** points, as this site is near the location of the high value resource, Black Dog Fen. There are also 30 active investigation or cleanup sites within a 1-mile radius of this gully, which contributed **7.5** points. Gully BVL3 received a total of **61.5** points (Table 9), which is the highest score given from these assessments.

Figure 11. Photos of gully BVL3. A) Facing west by the headcut, viewing overhanging bank B) Seepage at gully bottom

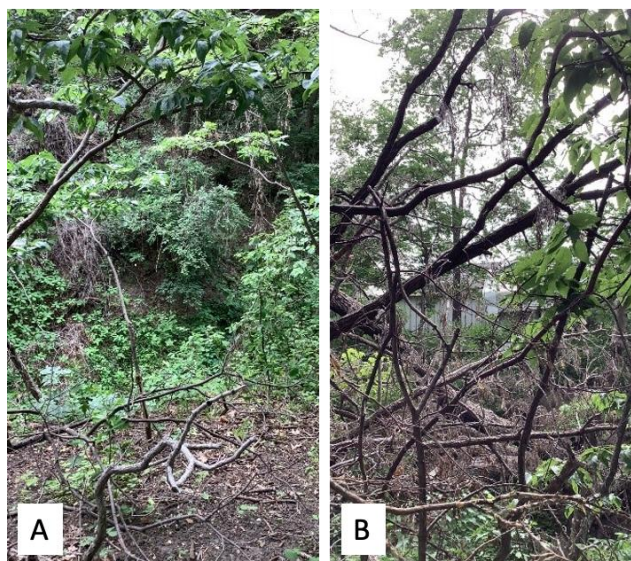
- **Ranking Score Breakdown:** The final erosion potential score was calculated to be **44**. This gully fell into impact Tier A, due to its proximity to the high value resource Black Dog Fen, contributing **10** points to the final ranking score. Lastly, there were 21 active investigation or cleanup sites within a mile of the gully contributing another **5.25** points. The final score for this gully is **59.25** (Table 10).

Figure 12. Photos of gully BLM68. A) Facing southeast on bank, looking down at the gully. B) Image of large shed near the gully

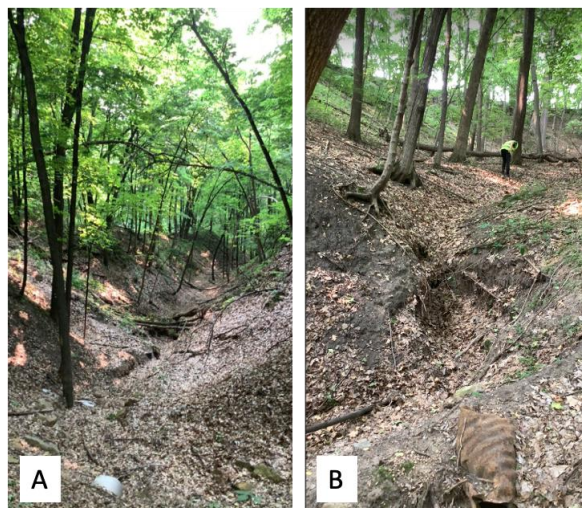
- **Ranking Score Breakdown:** CVR81 received a final erosion score of **50**, which is tied for the highest erosion potential score of all the gullies surveyed. Previously, CVR81 received an erosion potential score of **43**; however, the gully has become more V-shaped, developed overhanging banks, and had more sediment aggradation, increasing its erosion potential score during the 2023 Project assessment. CVR81 is within impact Tier B, as it affects the impaired waterbody of Spring Creek, accounting for **7** points toward its final score. CVR81 has 6 active investigation and cleanup sites within a mile radius, giving it an additional **1.5** points toward the final score. The final ranked score for this gully is **58.5** (Table 11).

Figure 13. Photos of Gully CVR81. A) Northeast looking down from headcut with view of outlet. B) East looking at new headcut development

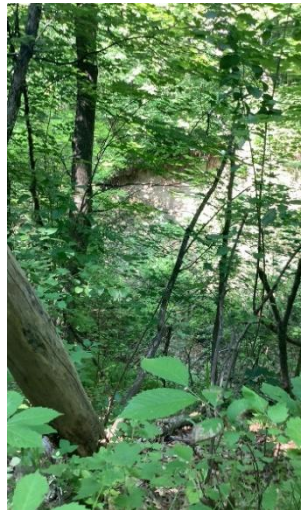
- **Ranking Score Breakdown:** CVR55 received a previous erosion score of **32** and had a large increase in erosion since the last assessment. Due to its easily erodible material and large size, CVR55 received an initial erosion score of **45**. Seven points were added because the gully is in impact Tier B contributing **7** points, affecting the impaired waterbody Spring Creek, which is of some concern to LMRWD. There were also 3 active investigation or cleanup sites near the gully, adding **0.75 points** to the score. The total score for this gully was **52.75** (Table 12)

Figure 14. Photo of CVR55. Facing west looking downstream of the gully.

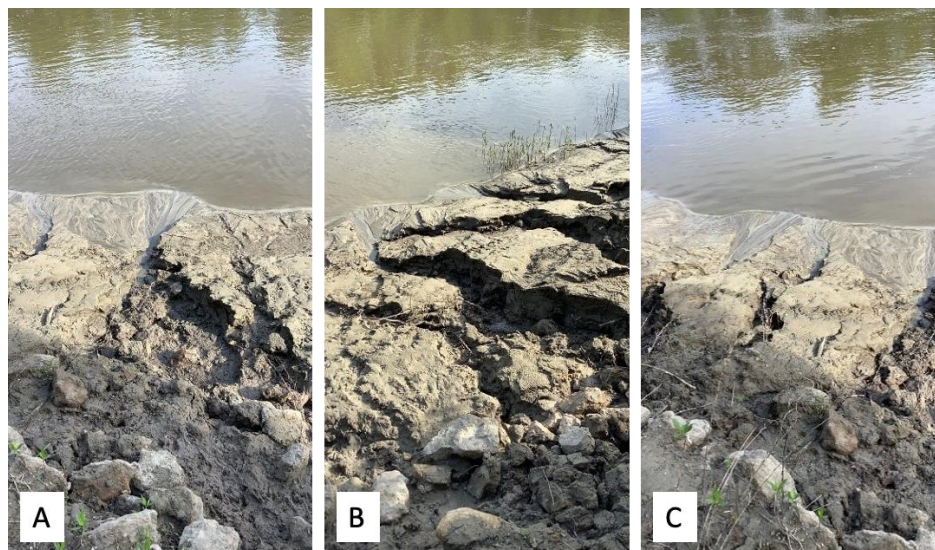
- **Ranking Score Breakdown:** Due to these conditions, this gully received an erosion potential score of **37**. This gully was found to be within impact Tier B and **7** points were awarded to the gully ranking score. Lastly, 14 MPCA active investigation or cleanup sites were found within a 1-mile radius resulting in **8** points added. In total, SHK3 received a ranking score of **52** (Table 13) and was the second highest ranked gully on public property without a safety concern.

Figure 15. Photos of gully SHK3. A) Facing north looking downstream from the headcut. B) Facing northeast looking at the side of the gullies. C) Another view of the gully from the headcut.

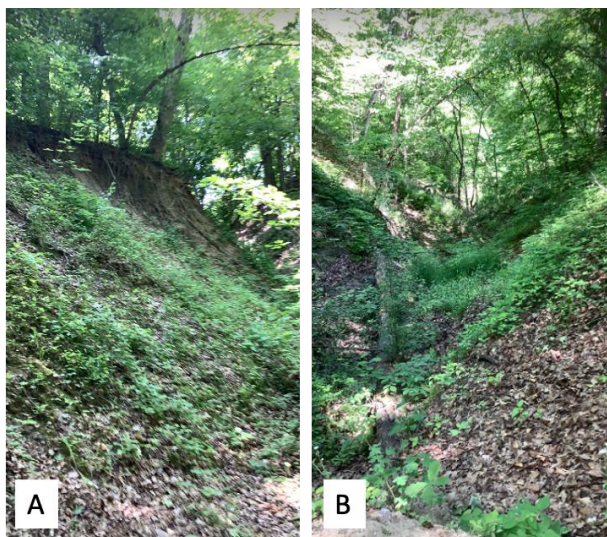
- **Ranking Score Breakdown:** The erosion score of the gully was **43**. The previous erosion score for CVR56 was **41**, suggesting that the gully has not changed drastically but has continued to actively erode. The gully is in impact Tier B affecting the impaired waterbody Spring Creek and contributing **7** points towards the ranking score. Lastly, 4 active investigation and cleanup sites were found within a 1-mile radius, contributing 1 point towards the final score of **51** (Table 14).

Figure 16. Photos of gully CVR56. A) Facing west looking towards left bank from inside. B) Facing north looking up gully.

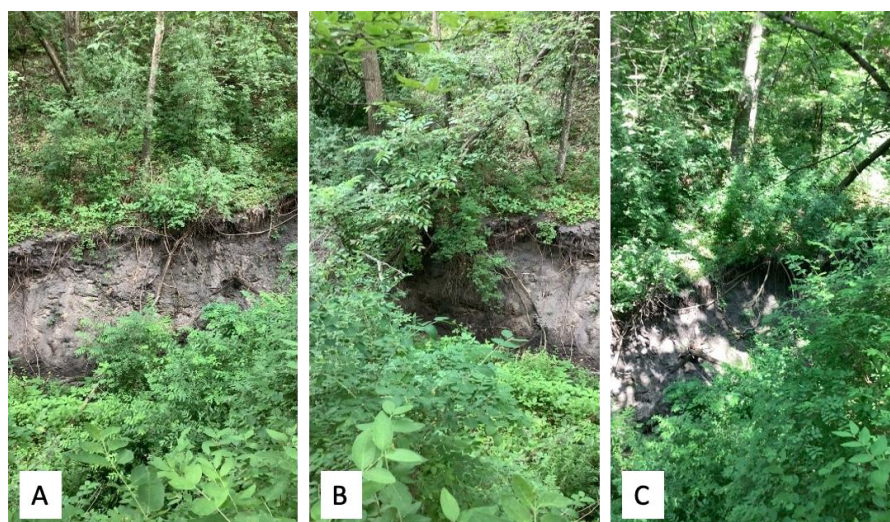
- **Ranking Score Breakdown:** This gully received a potential erosion score of **50**, which is higher than its previous erosion score of **45**. This change in erosion score is due to the change in gully depth and lack of vegetation during the 2023 Project assessment. This gully is located in impact Tier B contributing **7** points, due to its proximity to an impaired waterbody or tributary to a high value resource. BLM78 contained only 1 active investigation or cleanup site within a 1-mile radius, contributing **0.25** points to the ranking score. BLM78 resulted in a final score of **57.25** (Table 15).

Figure 17. Photos of gully BLM78. A) Facing south looking across the gully at bare bank. B) Facing southeast at bare bank. C) Facing southwest at bare bank with leaning trees.

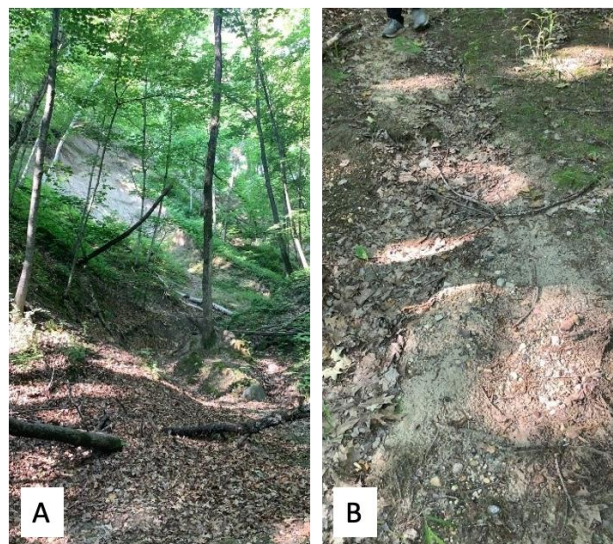
- **Ranking Score Breakdown:** The current erosion score of this gully is **47**. CVR38 had a previous erosion score of **40** and previously had more vegetation on its banks. This increased erosion score indicates that CVR38 is unstable and should be considered for a restoration project. This gully fell within impact Tier B contributing **7** points, which is of some concern to the LMRWD as it is near an impaired waterbody, Spring Creek. There are 6 active investigation or cleanup sites within a 1-mile radius, bringing the total score for CVR38 to **55.5** (Table 16).

Figure 18. Photos of gully CVR38. A) Facing south looking up at headcut. B) Gully bottom material and aggradation.

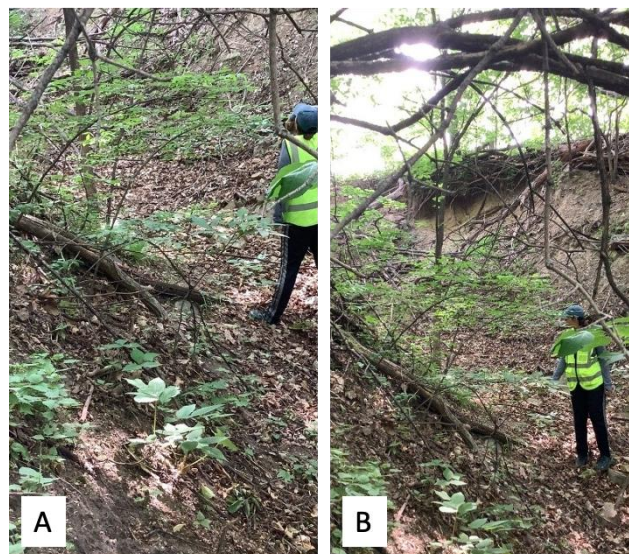
- **Ranking Score Breakdown:** The overall erosion potential score was **43**. In previous assessments, this gully received a score of **39**, but as the gully became deeper, narrower, and less vegetated, the erosion potential score increased. Additionally, the gully material is no longer sand and has eroded away to a fine-grained cohesive material. It was also noted from 2020 that the nearby homeowner had expressed concerns about the gully worsening. CVR76 is in impact Tier B contributing **7** points, due to its proximity to Spring Creek. There are 4 active investigation or cleanup sites within a 1-mile radius of CVR76, which contributed **1** point. This resulted in gully CVR76 receiving a final ranking score of **51** (Table 17).

Figure 19. Photos of gully CVR76. A) Facing east looking up at the gully. B) Facing east looking at headcut.

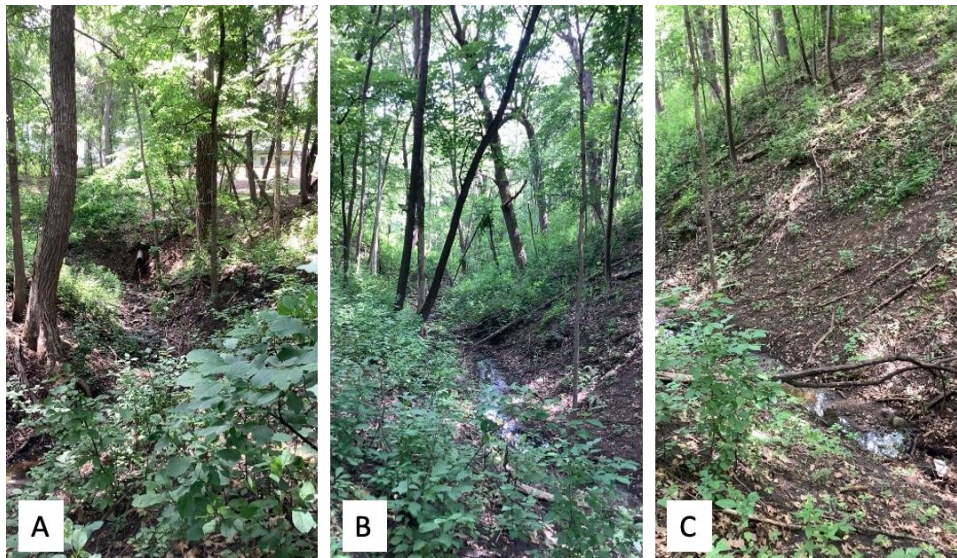
- **Ranking Score Breakdown:** BVL15 received an erosion score of **39**. Previously, this gully had an erosion score of **37**, but has become more V-shaped and less vegetated. This gully is in impact Tier A, contributing **10** points for Black Dog Fen and has 15 active investigation or cleanup sites within a 1-mile radius for a total score of **52.75** (Table 18). Since the outfall is likely the cause of this erosion and it is near a residential home, BVL15 is a gully of concern.

Figure 20. Photos of gully BVL15. A) Facing south viewing the drainage feature in the headcut. B) Facing north looking down at the gully from bank. C) Bare bank of gully with water flowing in channel.

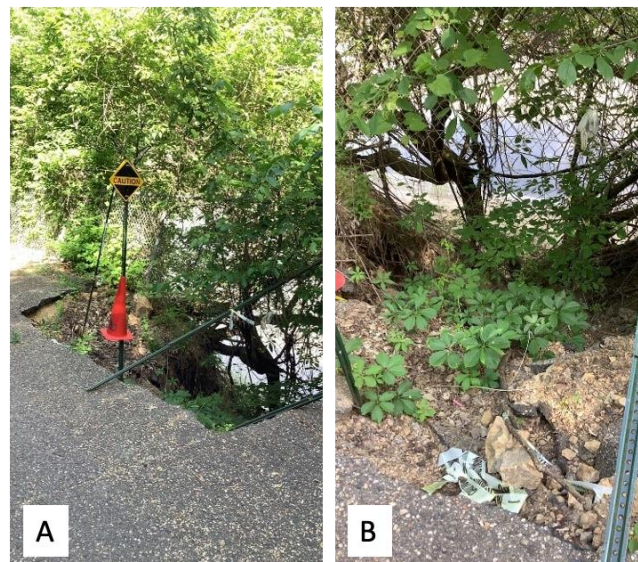
- **Ranking Score Breakdown:** SHK16 was given an erosion potential score of **32**. Previously, this gully had a similar erosion score of **31**. It is within impact Tier B, contributing **7** points, due to its proximity to the Minnesota River and has 14 active investigation or cleanup sites within a 1-mile radius, contributing **3.5** points to the final ranking score. Although the overall score for SHK16 is only **42.5** (Table 19) and it is located on private land, the gully is causing significant damage to infrastructure and poses a safety threat. Thus, SHK16 should be considered for a restoration project.

Figure 21. Photos of SHK16. A) Gully marked with sign as it encroaches on paved trail. B) Looking down at the gully from the headcut.

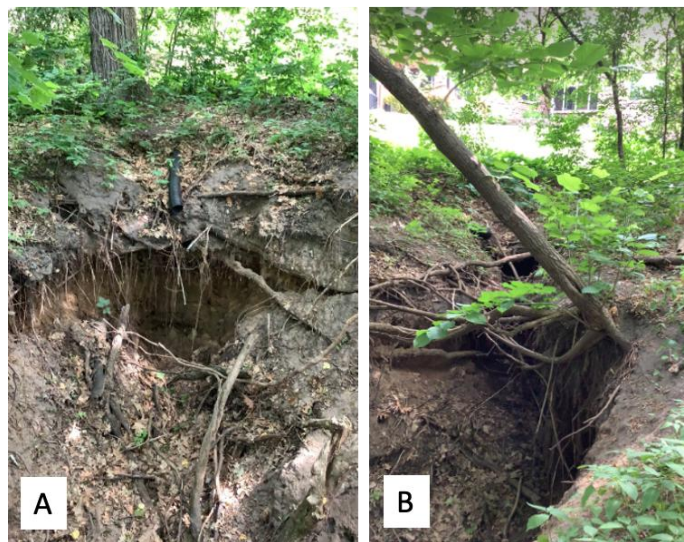
- **Erosion Score Breakdown:** The erosion potential score for this gully is **48**. While the gully is not currently extremely long, it will continue to rapidly grow if no intervention takes place. Many other drainage pipes were observed around the area that could lead to similar issues.

Figure 22. Photos of BLM173. A) Facing north looking at one headcut of the gully. B) Facing northeast looking at another headcut
