SITE LOCATION: CSAH 61-Flying Cloud Drive

PURPOSE: Construction Stormwater Site Visit on behalf of the Lower Minnesota River Watershed District (LMRWD)

DATE & TIME: 19 November 2018, 0830-1100

INSPECTOR: Sarah Duke Middleton, Water Resources Scientist
Young Environmental Consulting Group, LLC

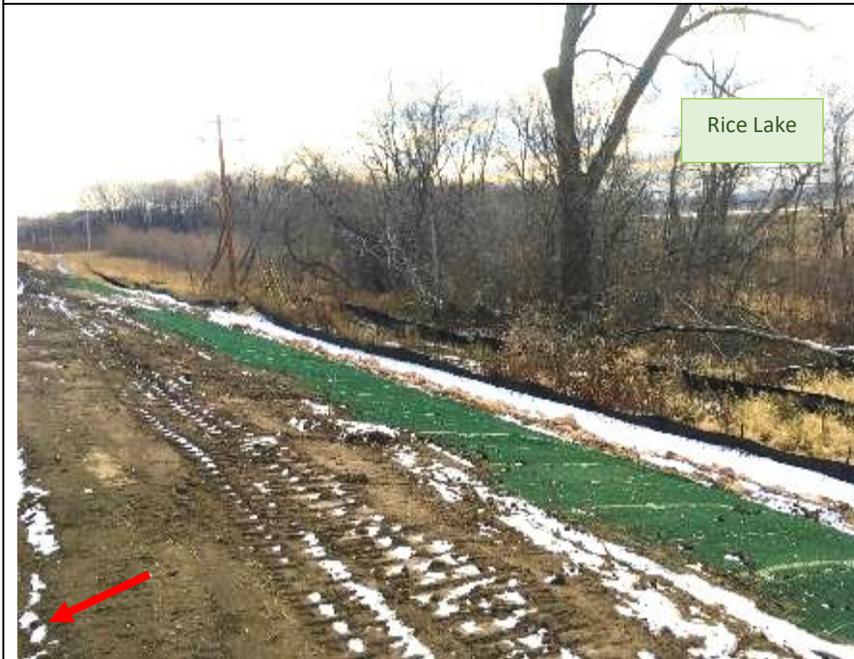
Photo No.: 1

BMPs Present: Two rows of silt fence; geotextile blanket.

Description: Right-of-way (ROW) conditions.

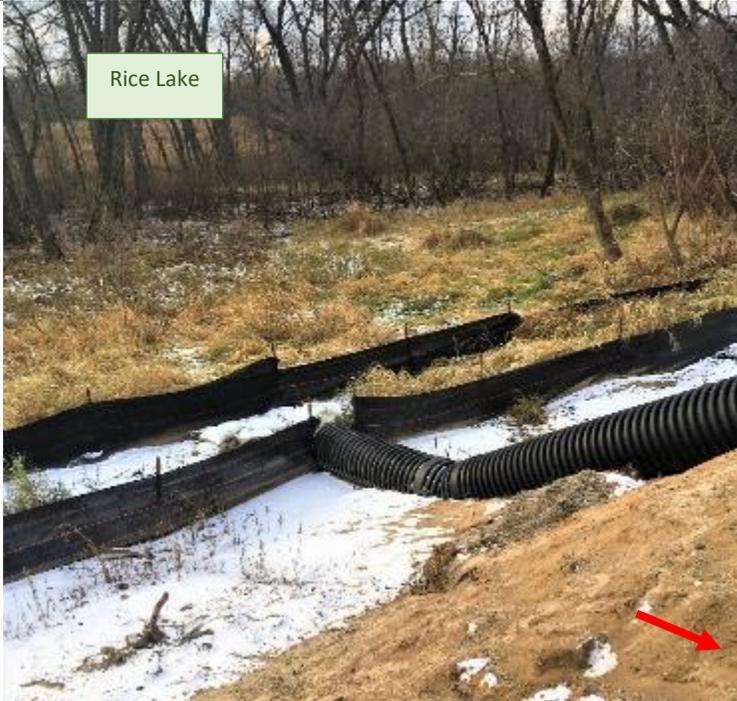
Photo No.: 2

BMPs Present: Two rows of silt fence; sandbags at base of culvert

Description: Downslope side of culvert; removing stormwater discharge from the site (see photo 3 for upslope view).

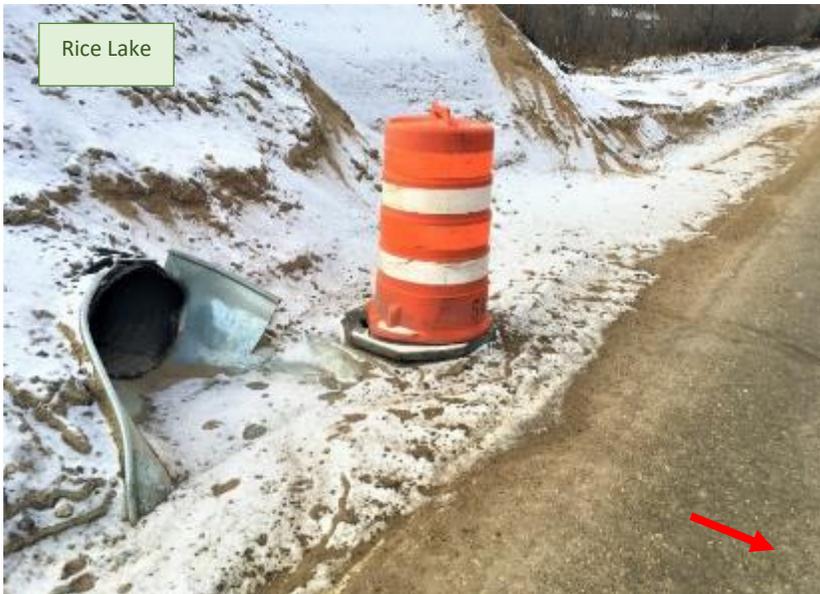
Photo No.: 3

BMPs Present: None visible.

Description: Upslope view of stormwater culvert (see photo 2 for downslope).

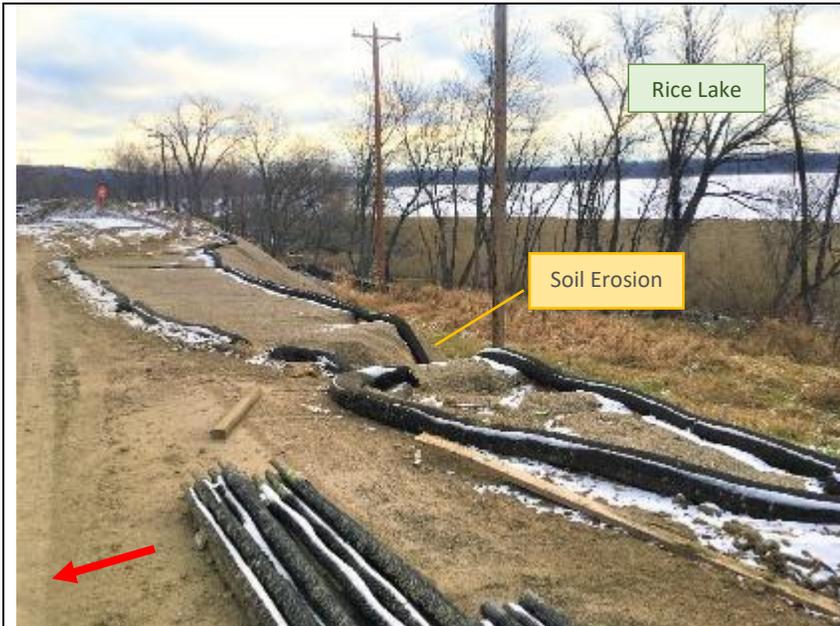
Photo No.: 4

BMPs Present: Two rows of silt fencing (not visible in photo), biologs, Erosion and Sediment Control (ESC) blanket.

Description: BMPs present but failing. Large gaps in ESC blanket are areas of slop erosion.

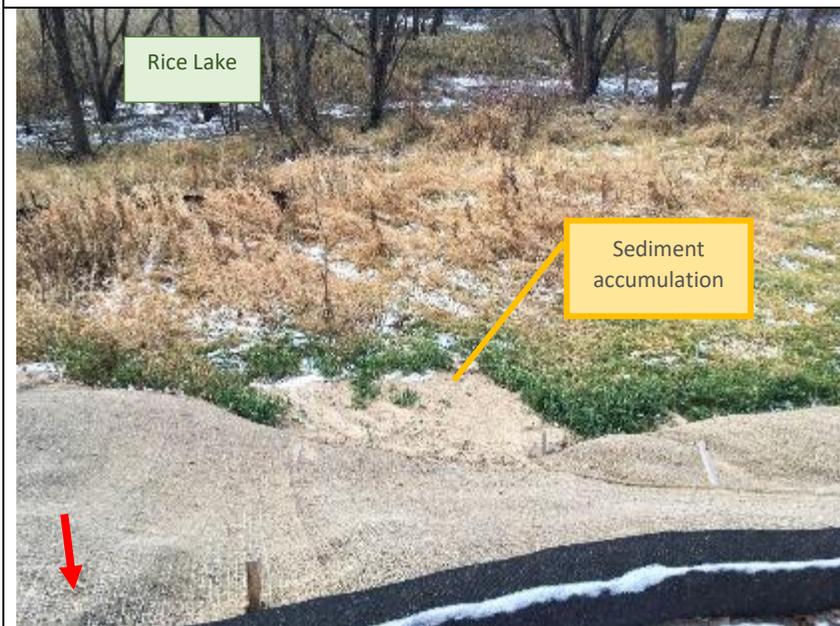
Photo No.: 5

BMPs Present: ESC blanket, biologs, two rows of silt fencing (not visible in photo).

Description: ESC blanket has failed to secure slopes. Most of the ESC blanket no longer makes consistent contact with the soil. At the base of the slope sediments are accumulating.

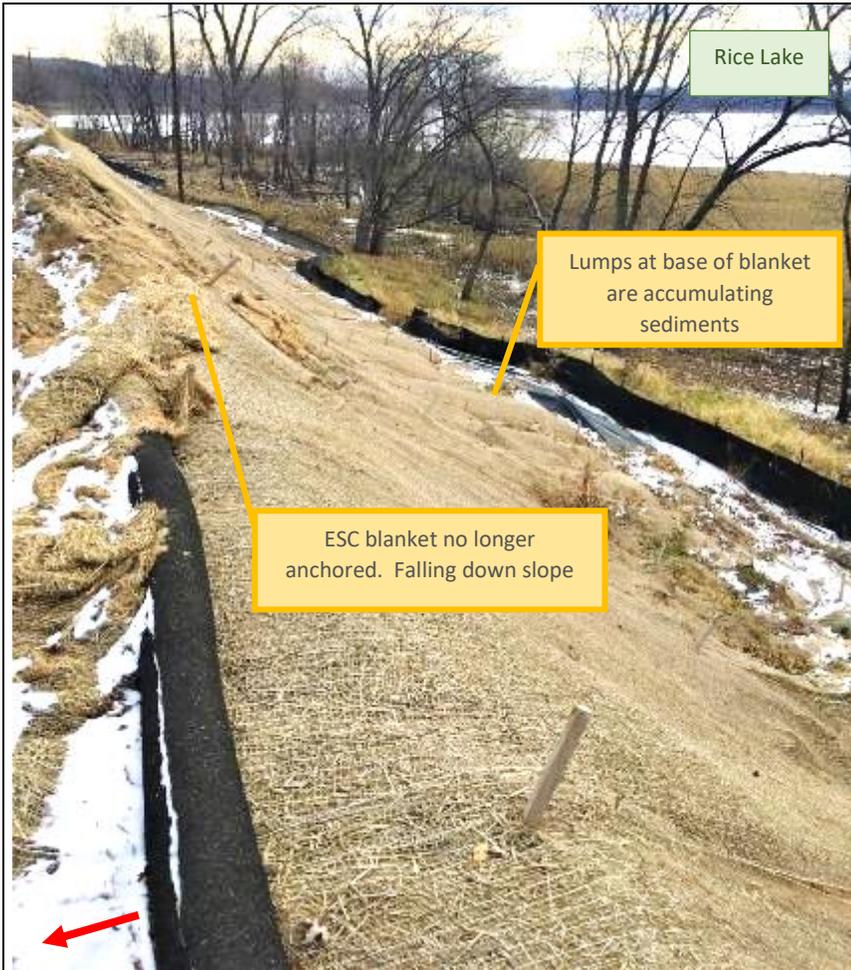
Photo No.: 6

BMPs Present: Two rows of silt fence, ESC blanket, biologs

Description: Failing ESC blanket

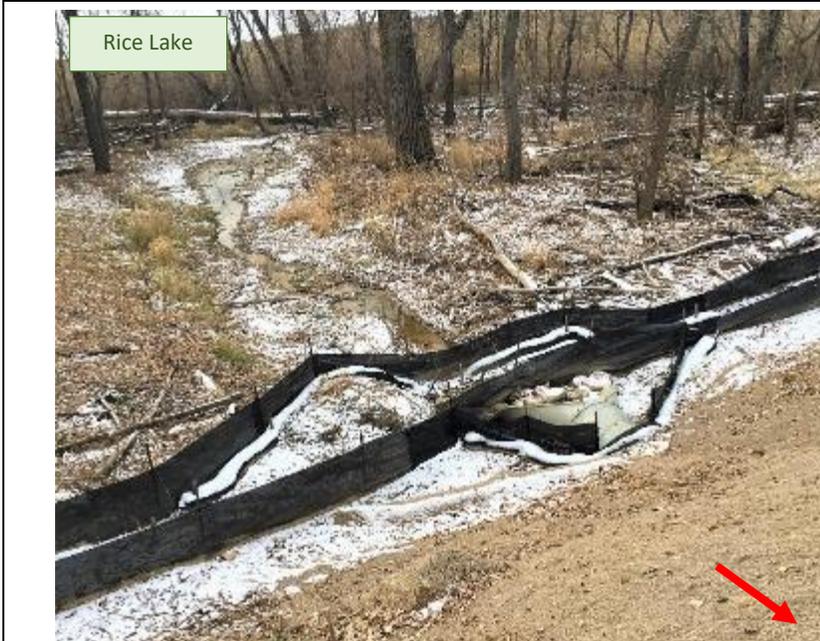
Photo No.: 7

BMPs Present: ESC blanket, two rows of silt fencing, biologs, sandbags at base of culvert

Description: Culvert stabilized with BMPs.

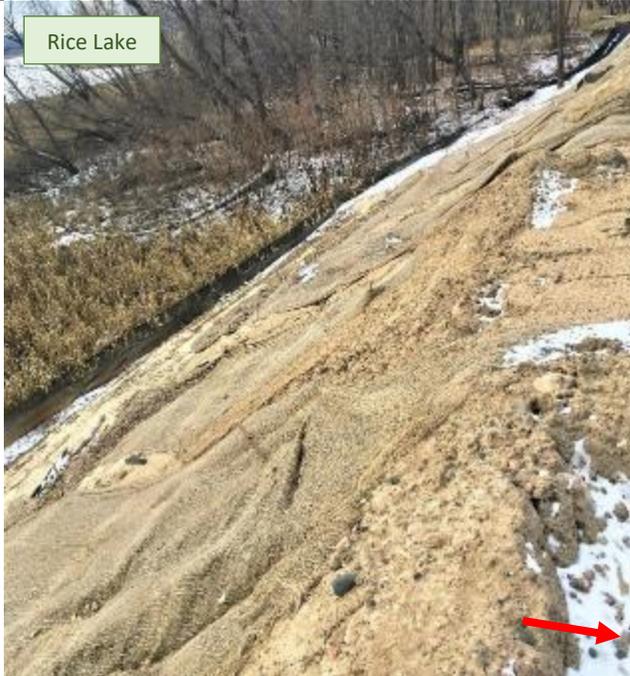
Photo No.: 8

BMPs Present: Two rows of silt fencing, ESC blanket

Description: The ESC blanket is no longer anchored to the soil and is falling down the slope. Sediments are accumulating at the base of the slope.

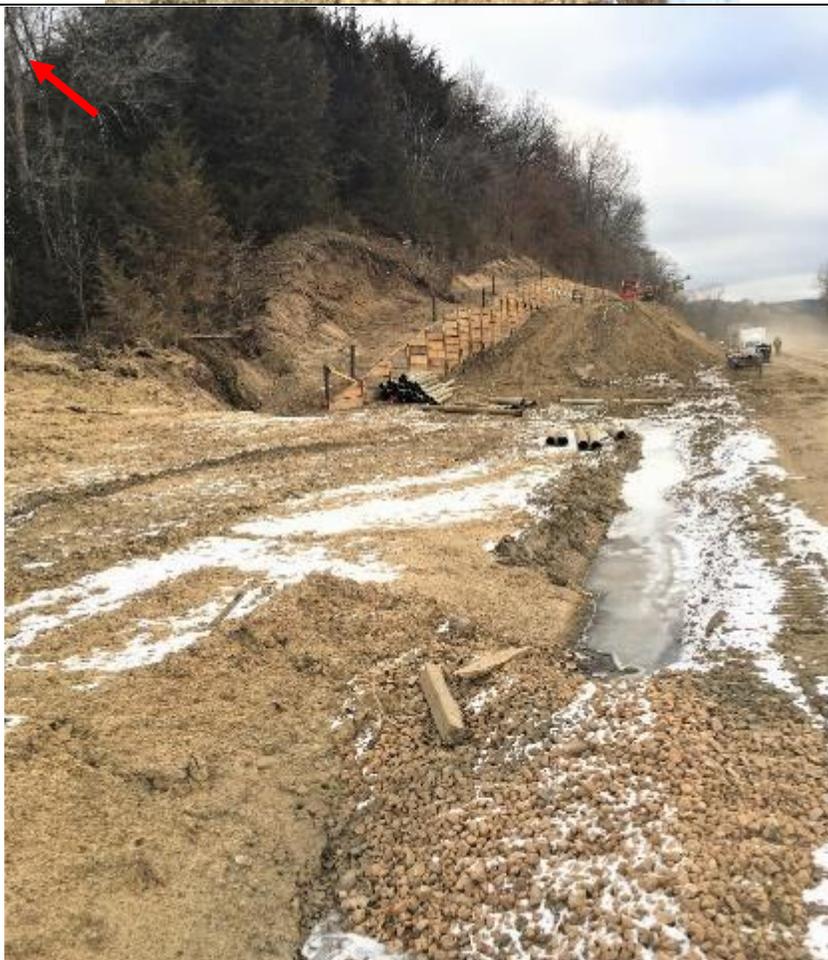
Photo No.: 9

BMPs Present: Rock check

Description: Construction on north side of ROW. Stormwater is channeled along the ditch and meets a rock check.

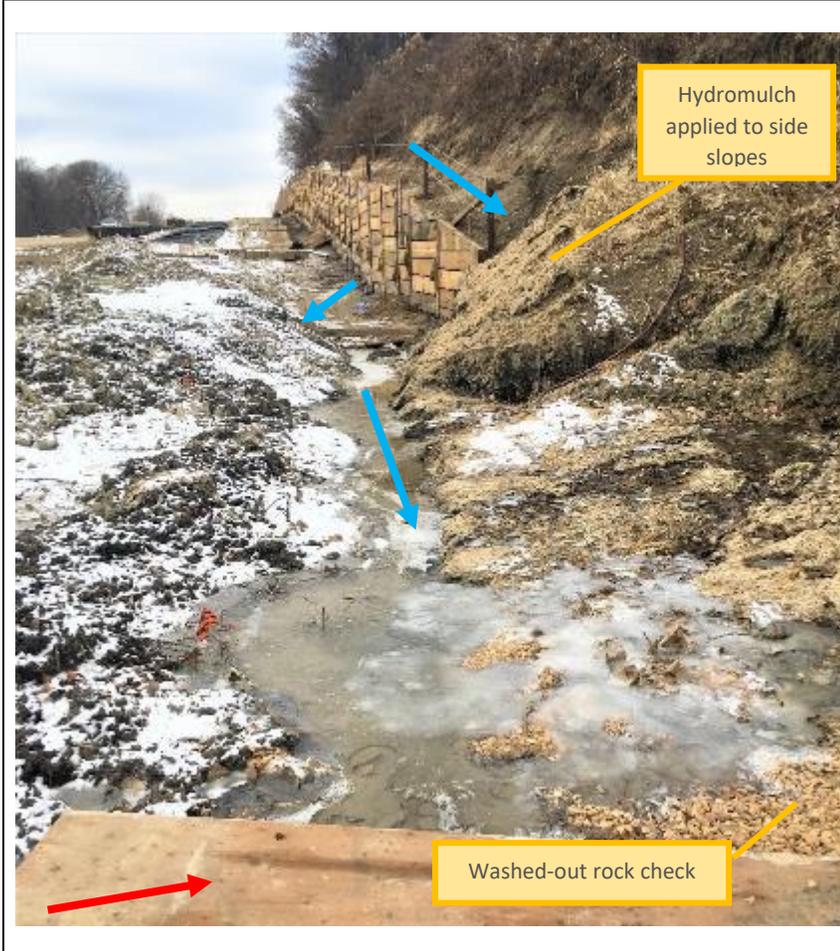
Photo No.: 10

BMPs Present: Hydromulch, rock check

Description: Drainage of stormwater on the northern side of the ROW. Water drains from the base (beneath wooden planks), top and side slopes of the retaining wall and routes into the channel. Clean gravel is present suggesting at one time a defined rock check was present; it appears to no longer be effective. It is unclear if the plywood is construction debris or an energy dissipation method to supplement the washed-out rock check.

The blue arrows indicate the general path of stormwater flow. See photo 11 for a downslope view of the rock check/plywood.

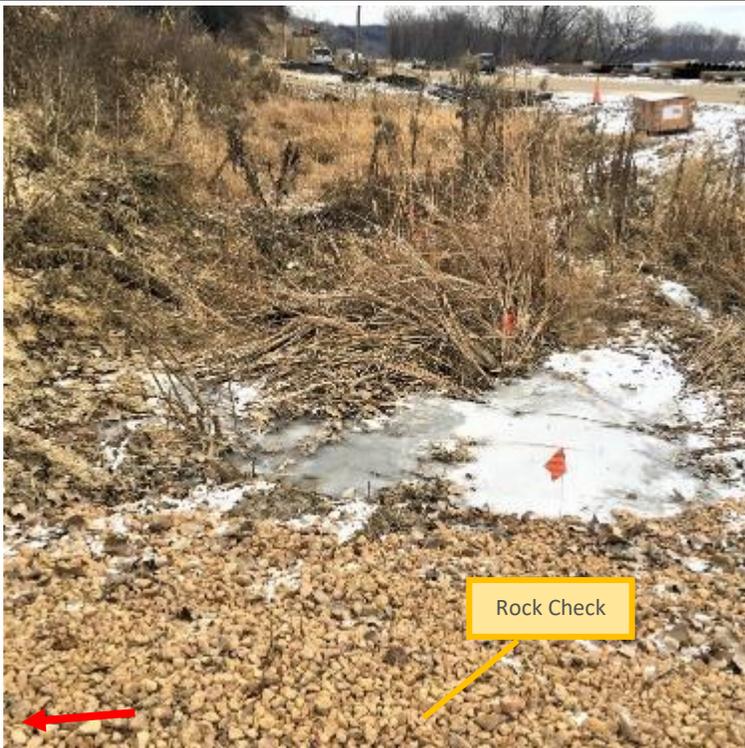
Photo No.: 11

BMPs Present: Rock check

Description: This is the downslope image of photo 10. All stormwater drains to the tall grass after traveling through a second rock check. A culvert was not visible in or around the tall grass.

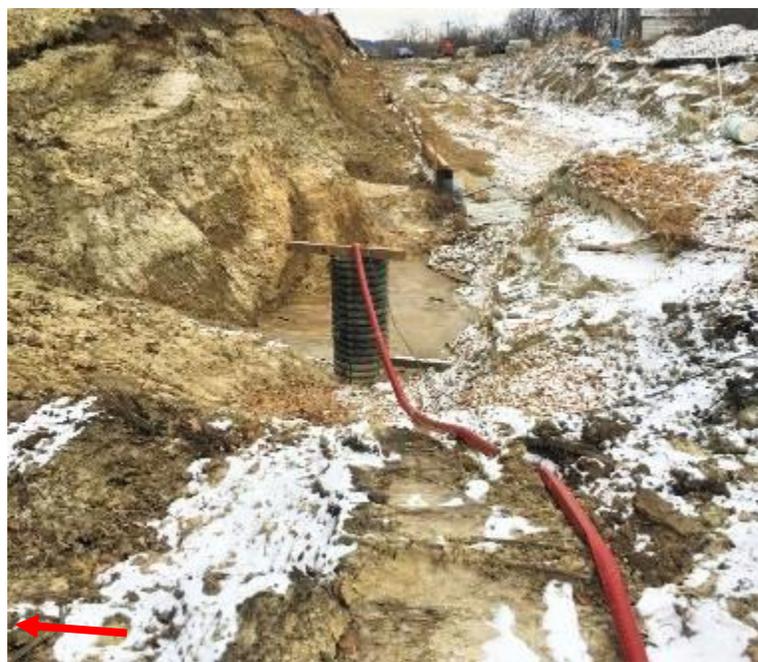
Photo No.: 12

On the project's western end, on the north side of the road (near the construction trailers), dewatering is taking place. This activity was noted during the November 6 site visit. The dewatering setup has changed since that time; specifically, the hose used is no longer attached to the filter bag. On November 19, the hose was positioned on top of the filter bag, with a slow but steady stream of brown fluid coming out. The dewatering area is in what appears to be a wetland. A brown plume, originating from the hose, is present in the water and

extends for several feet. For a visual of this area, see photos 12 through 15, as well as the segment 1 aerial photo. The presence of brown fluid beneath the accumulated snow on the filter bag suggests the hose has been in this position for more than a few hours. The last documented snowfall in the area was 1 to 2 days ago.

BMPs Present: None visible

Description: Dewatering set up. Water appears to be drawn from this area and run through the hose for dewatering farther west on the ROW.

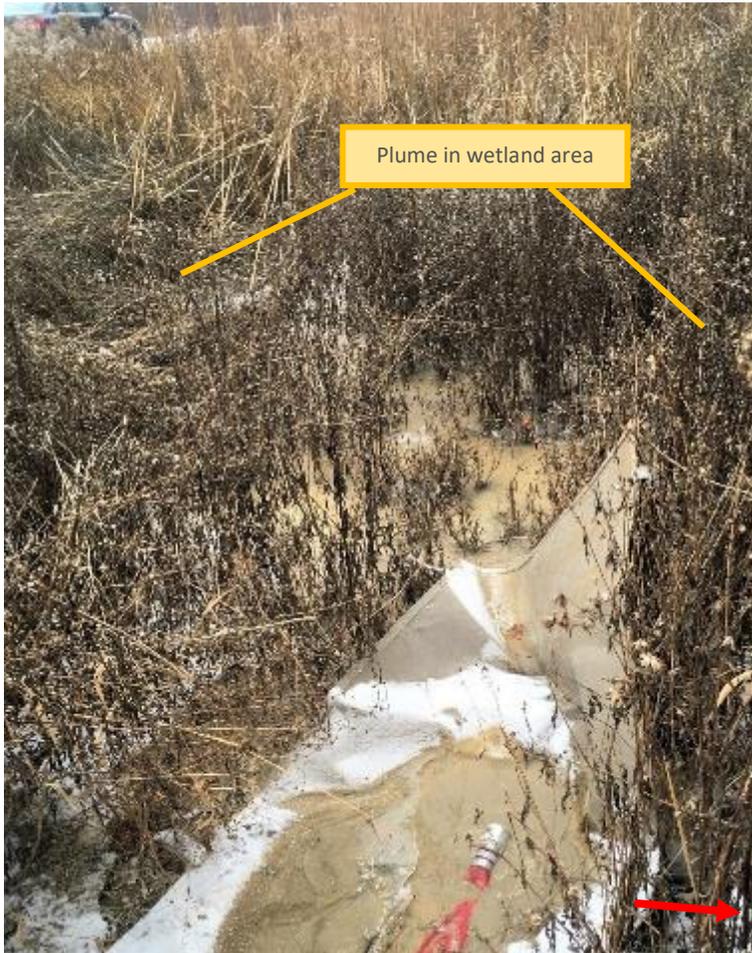
Photo No.: 13

BMPs Present: Unused filter bag

Description: This is the end-of-hose side of the dewatering operation. The hose is not attached to the filter bag; rather it is on top of it. Water is flowing slowly, but steadily out of the hose. The brown liquid is apparent for several feet into the wetland area.

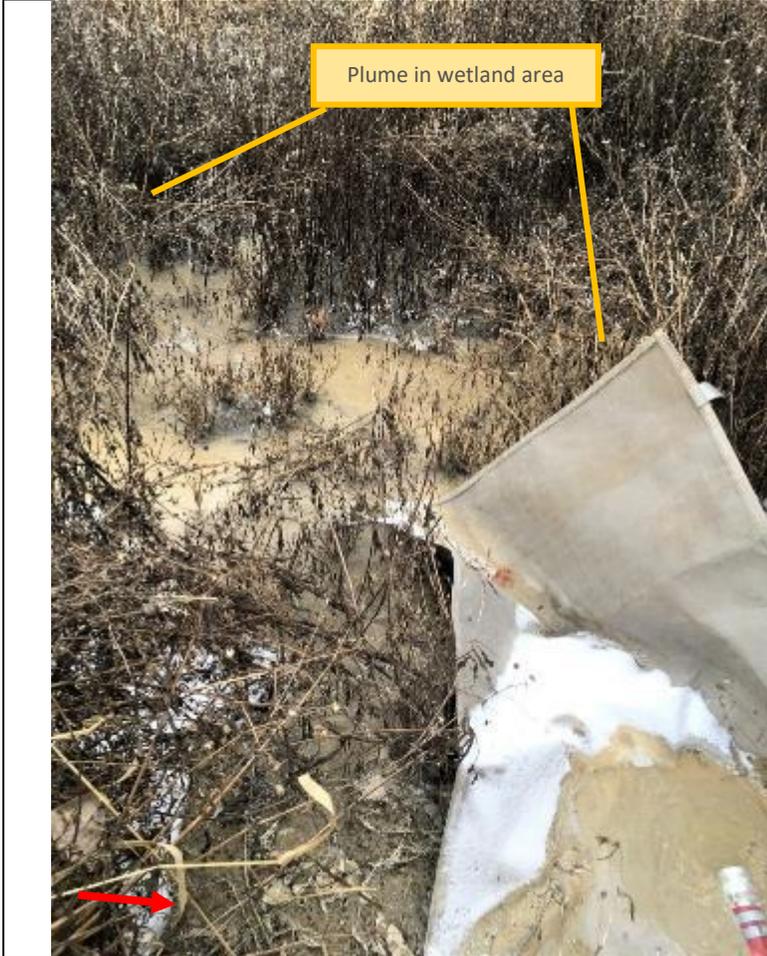
Photo No.: 14

BMPs Present: Unused filter bag

Description: Another view of the dewatering end-of-hose.

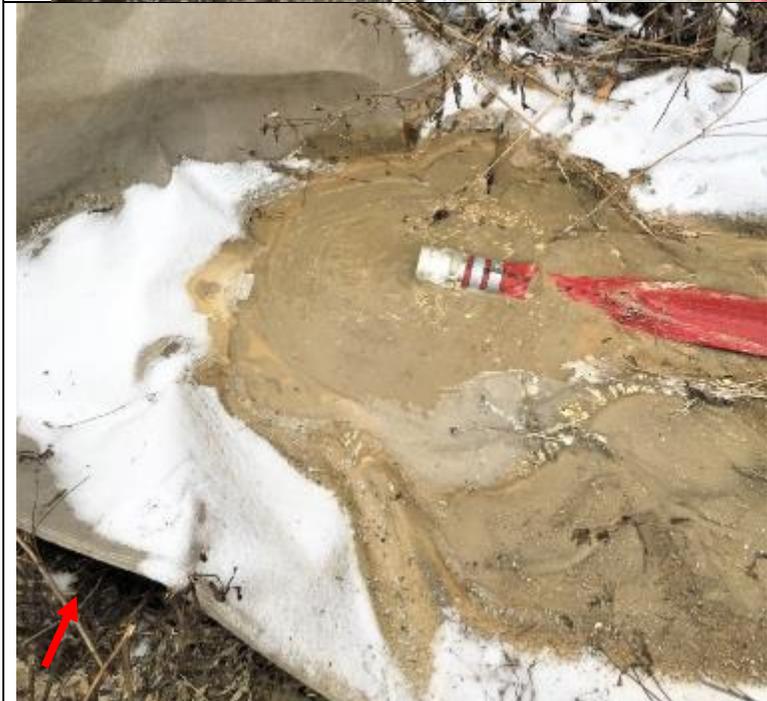
Photo No.: 15

BMPs Present: Unused filter bag

Description: Close up photo of the hose. Ripples around hose are from the steady stream of brown liquid flowing out of it.

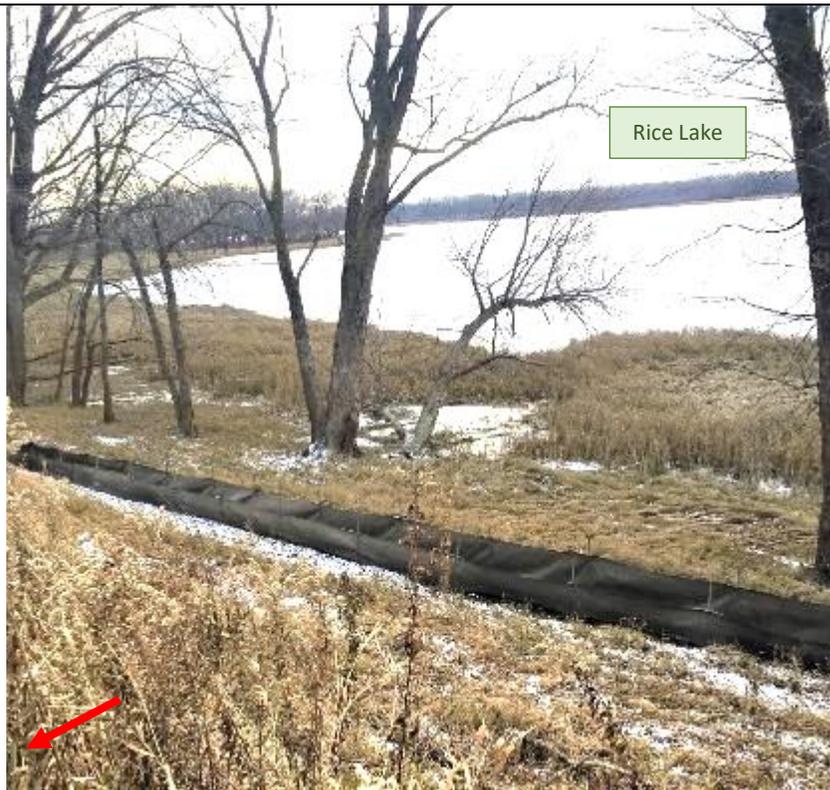
Photo No.: 16

BMPs Present: Two rows of silt fence; vegetative buffer

Description: Section of ROW along Rice Lake. Soils are stable.

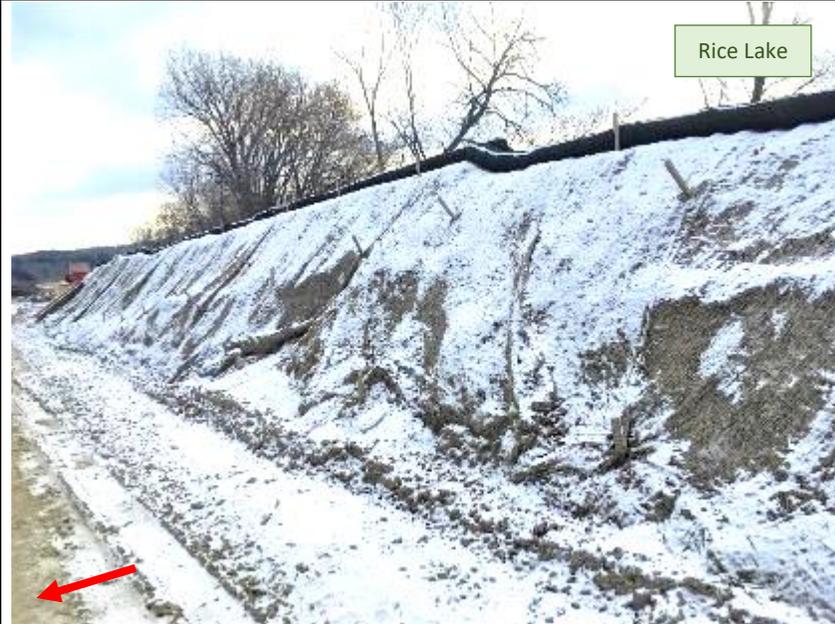
Photo No.: 17

BMPs Present: Biologs, ESC blanket

Description: BMPs are used to stabilize large soil piles on the south side of the ROW.

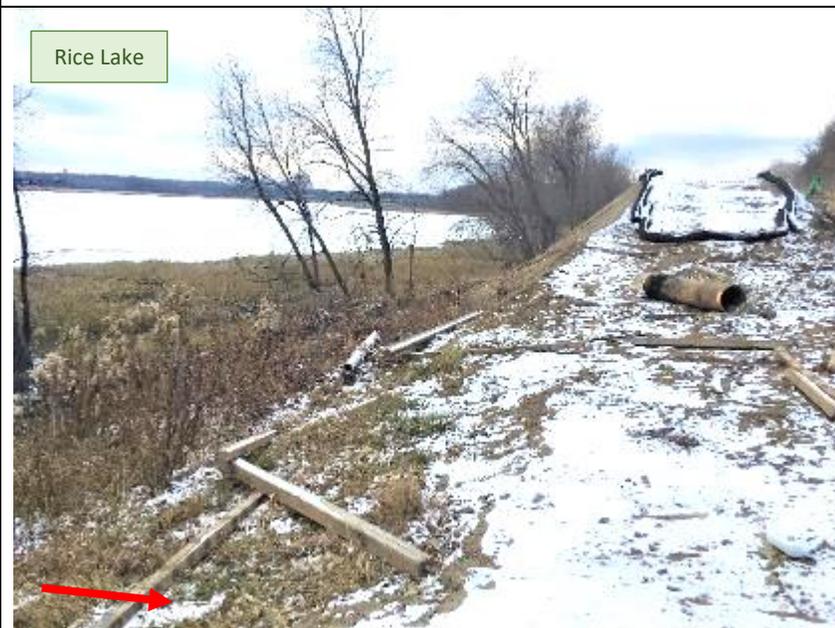
Photo No.: 18

BMPs Present: Biologs and ESC blanket. Not visible in photo – two rows of silt fencing at the base of the slope.

Description: Side view of large soil pile depicted in photo 17. Miscellaneous construction debris is also present in this area.

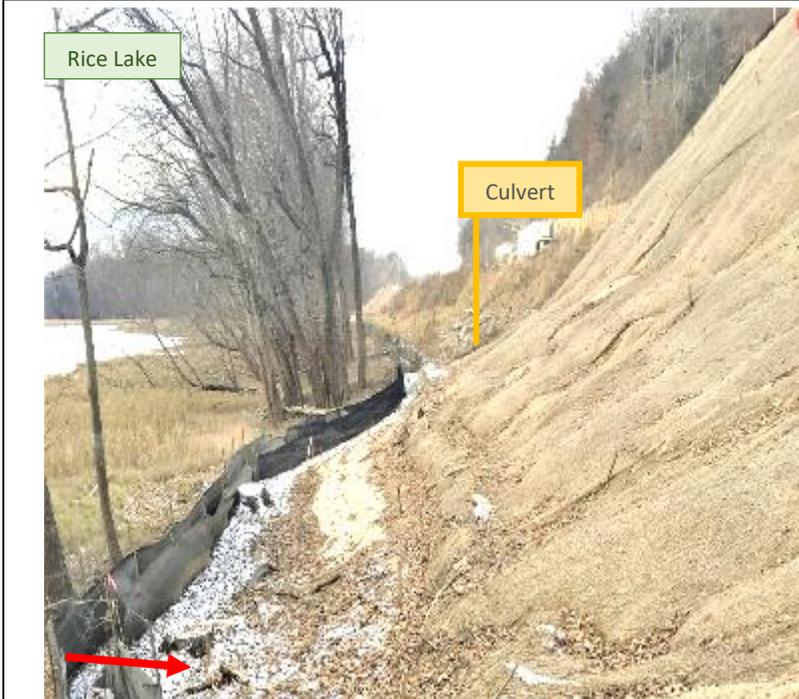
Photo No.: 19

BMPs Present: Two rows of silt fence; ESC blanket

Description: Base of slope (see photos 17 & 18 for top of slope). Waves in ESC blanket indicate erosion beneath BMP with sediment pooling just before the silt fence. See photos 20 –22 for additional images of the culvert

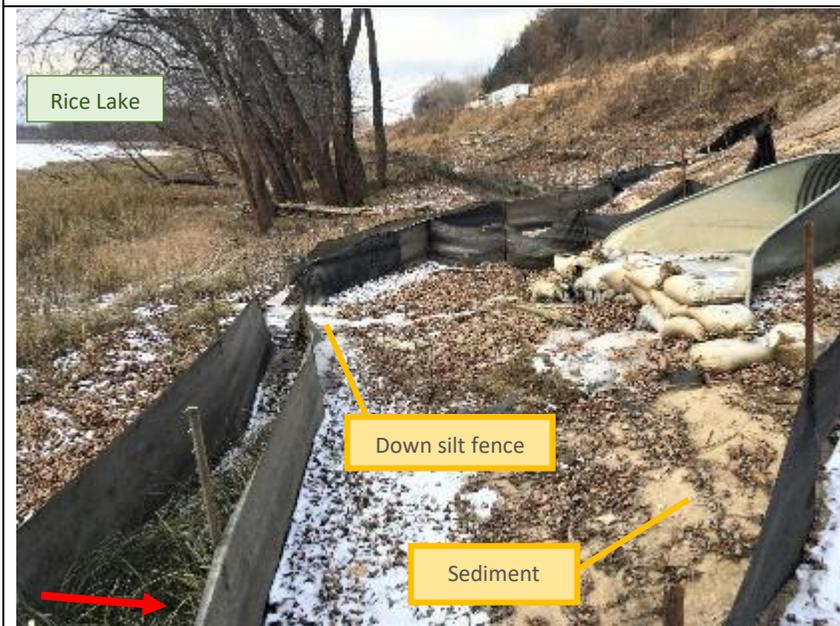
Photo No.: 20

BMPs Present: Several rows of silt fencing; sand bags; ESC blanket

Description: Large culvert outlet near Rice Lake. BMP conditions suggest large volumes of water were discharged at one point. See photos 21 – for additional images in relation to the lake.

See photos 39-41 for the upslope inlet (it is assumed, but not confirmed that the two are connected).

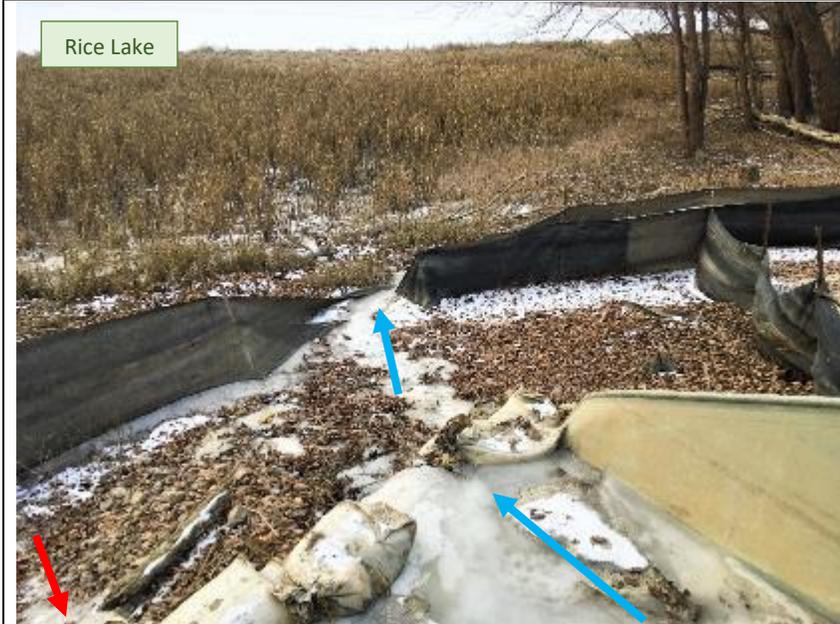
Photo No.: 21

BMPs Present: Several rows of silt fence; sand bags

Description: Flow path of stormwater as it entered Rice Lake. BMPs did not withstand volume of water and failed.

Blue arrows indicate path of water.

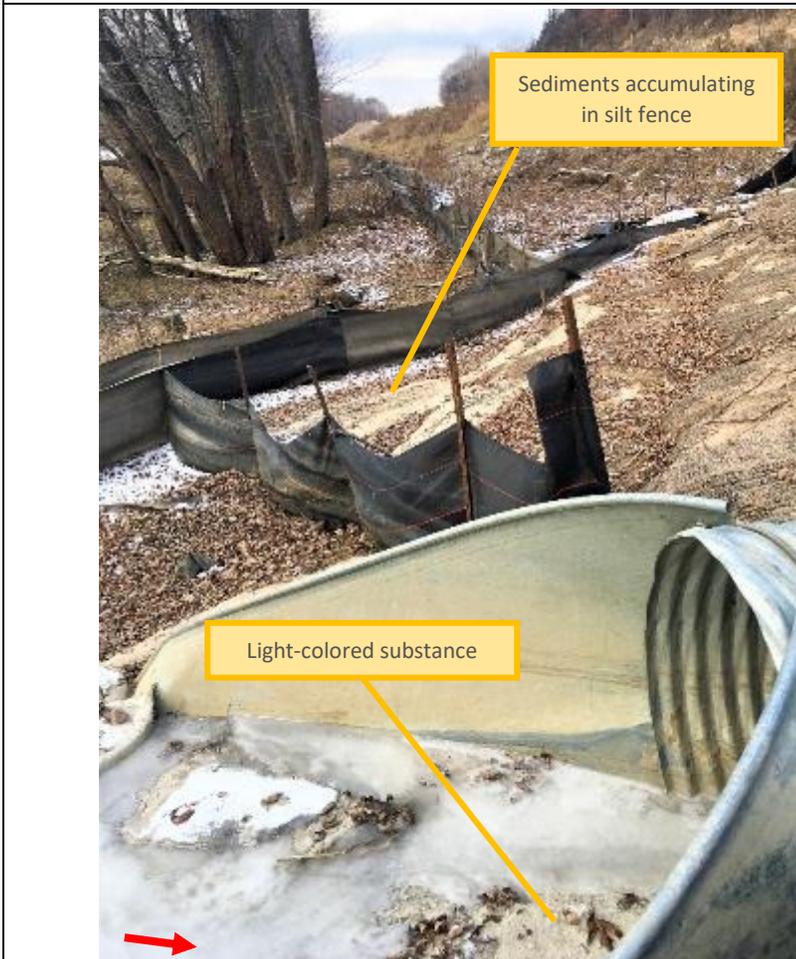
Photo No.: 22

BMPs Present: Several rows of silt fencing; ESC blanket; sand bag berm in culvert

Description: Side view of the outlet with contributing side slopes. ESC blanket was installed upslope of the silt fencing but has been compromised via erosion. Sediment is filling silt fence adjacent to the culvert.

An unknown, light-colored substance has solidified in the bottom of the culvert. It's coloring appears much lighter than surrounding areas where sediment has accumulated (ex: adjacent silt fence). See photos 39-41 for inlet and similar light-colored sediments.

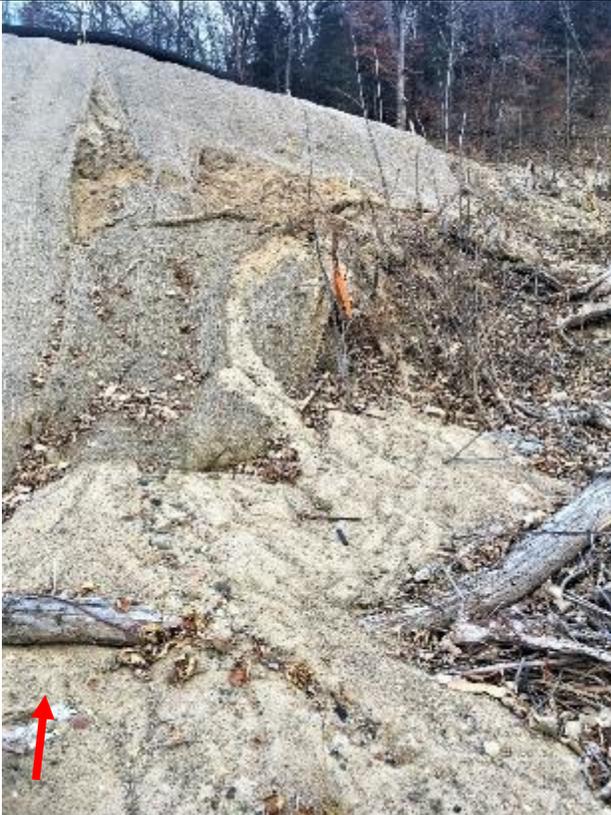
Photo No.: 23

BMPs Present: Biolog; ESC Blanket

Description: Erosion on slope after failure of ESC blanket.

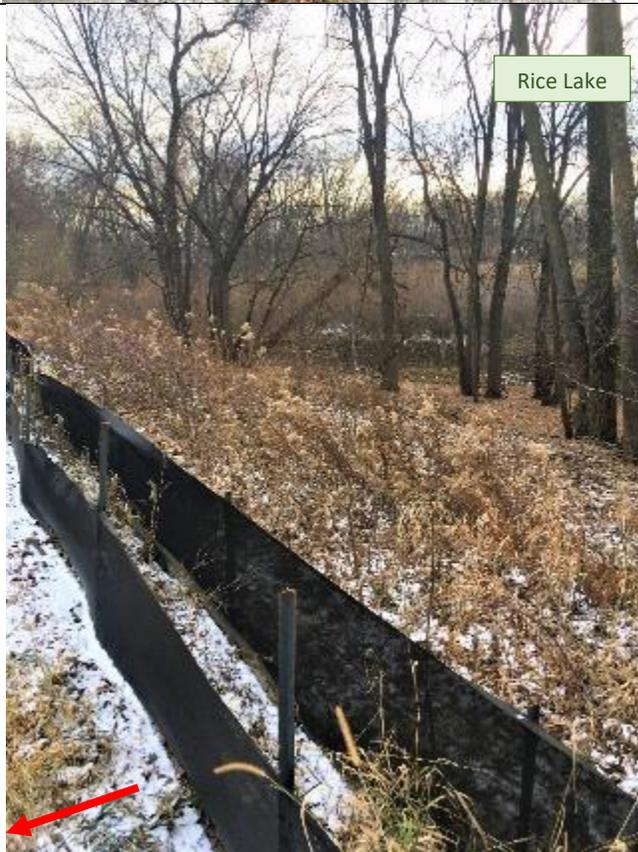
Photo No.: 24

BMPs Present: Two rows of silt fence;
vegetative buffer

Description: Stable soils along Rice Lake.

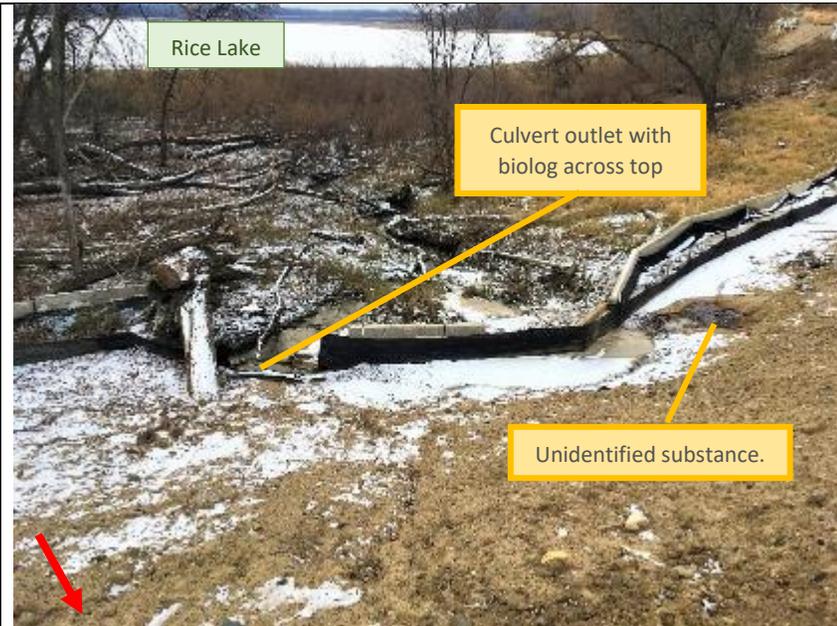
Photo No.: 25

BMPs Present: One row of silt fencing with t-posts; one row of silt fencing with jersey barrier backing; biologs over top of culvert outlet.

Description: Base of slope where culvert outlets into Rice Lake. See photo 28 for another photo of the unidentified substance.

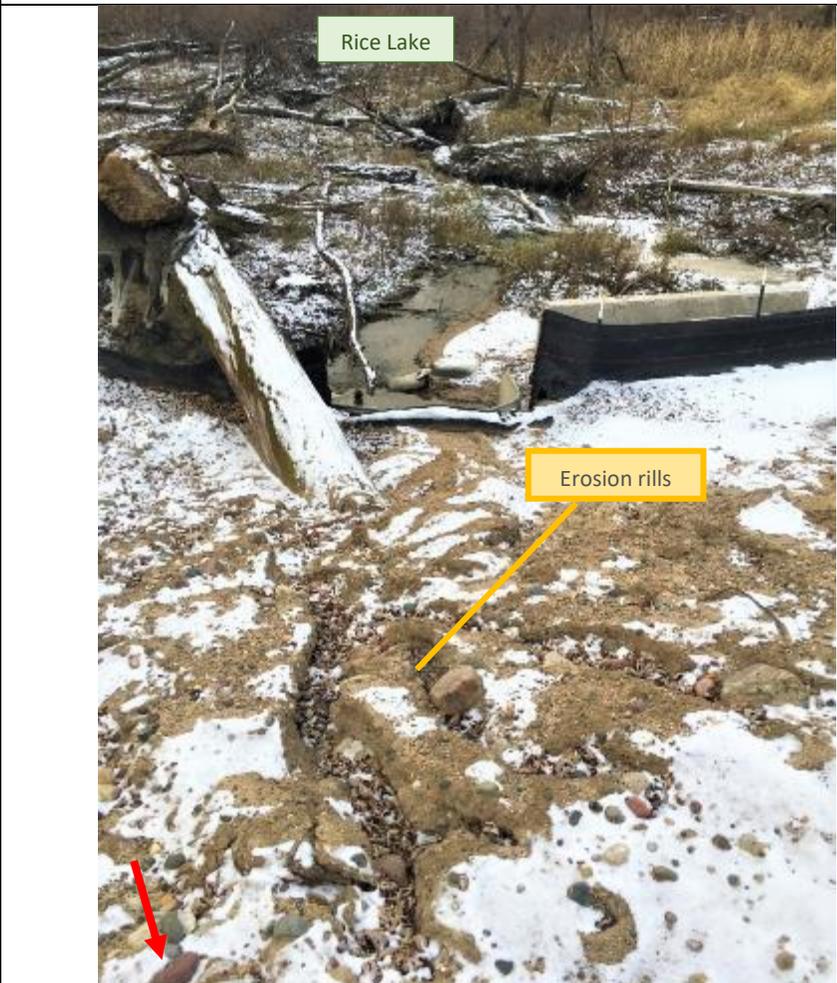
Photo No.: 26

BMPs Present: One row of silt fencing with t-posts; one row of silt fencing with jersey barrier backing; biologs over top of culvert outlet.

Description: Base of slope where culvert outlets into Rice Lake. Some erosion is evident – see rills upslope of culvert.

See photo 36 for upstream inlet on northern side of ROW.

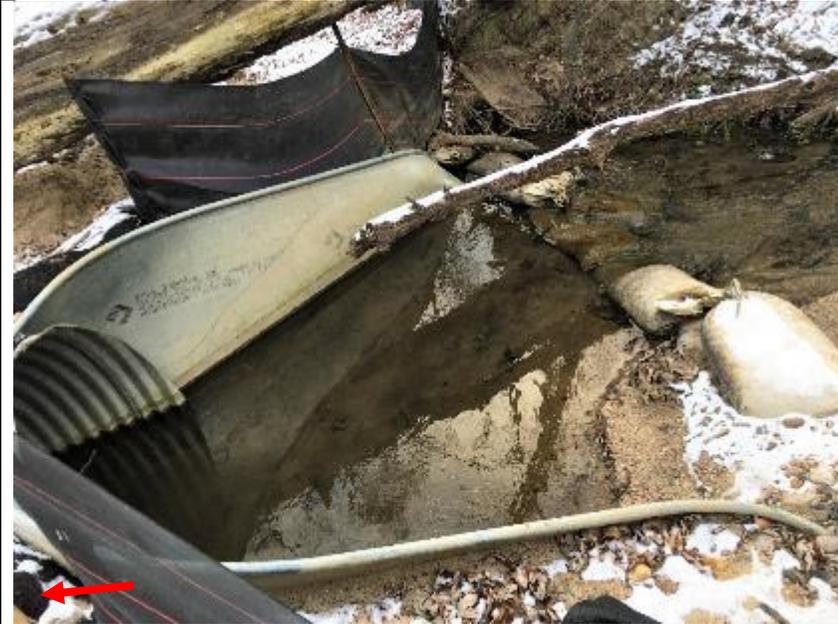
Photo No.:27

BMPs Present: Silt fencing; biolog;
sandbags

Description: Close up of culvert outlet.
Some sediment present at outer lip of
culvert. Sand bags appear to have shifted
since their original installation.

See photo 36 for upstream inlet on
northern side of ROW.

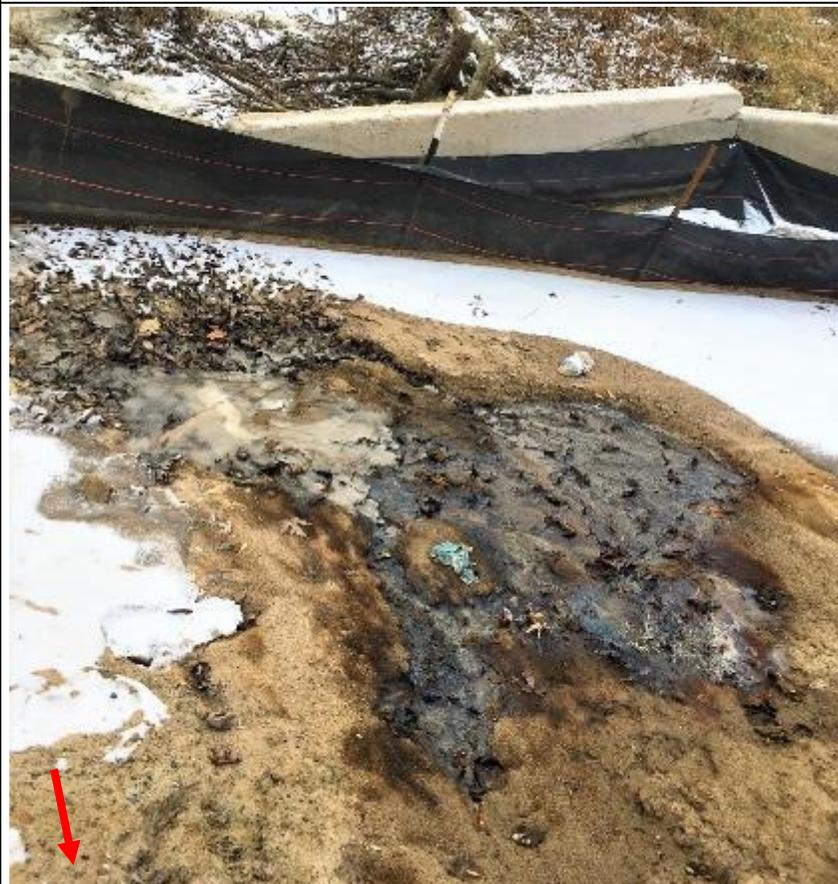
Photo No.: 28

BMPs Present: One row of silt fencing with
t-posts; one row of silt fencing with jersey
barrier backing

Description: Unidentified substance.
No path of origin or runoff from this
point – substance is concentrated in
this area.

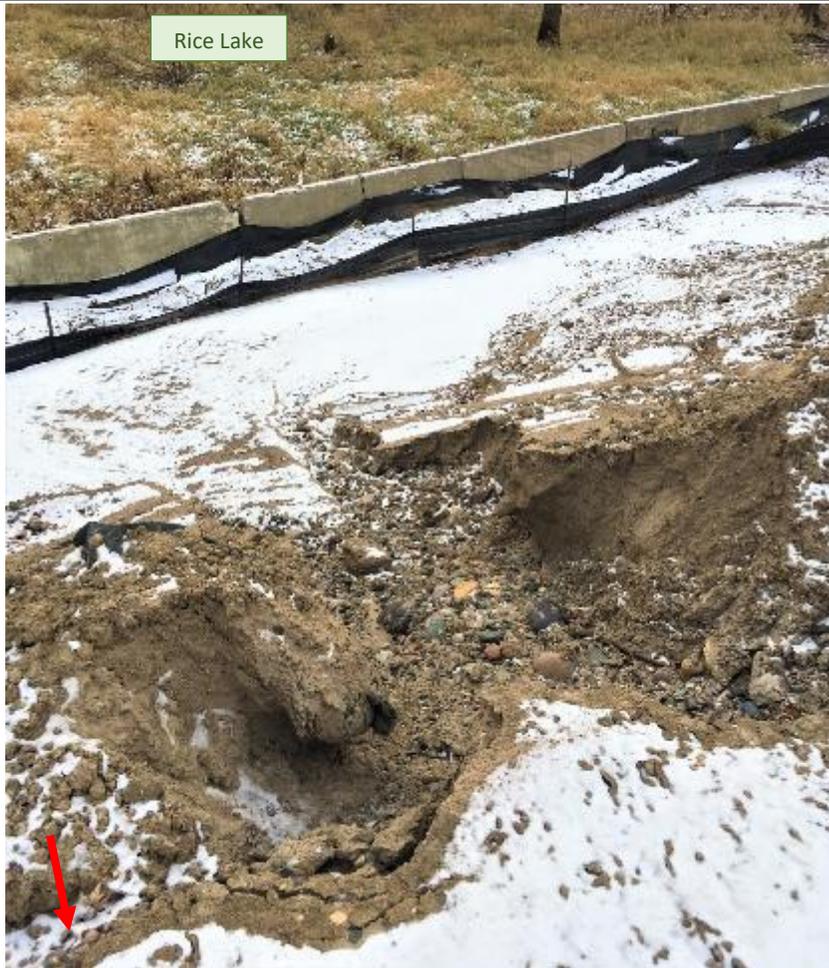
Photo No.: 29

BMPs Present: One row of silt fence with metal t-posts; a second row of silt fencing supported by jersey barriers.

Description: Washout at the top of the slope.

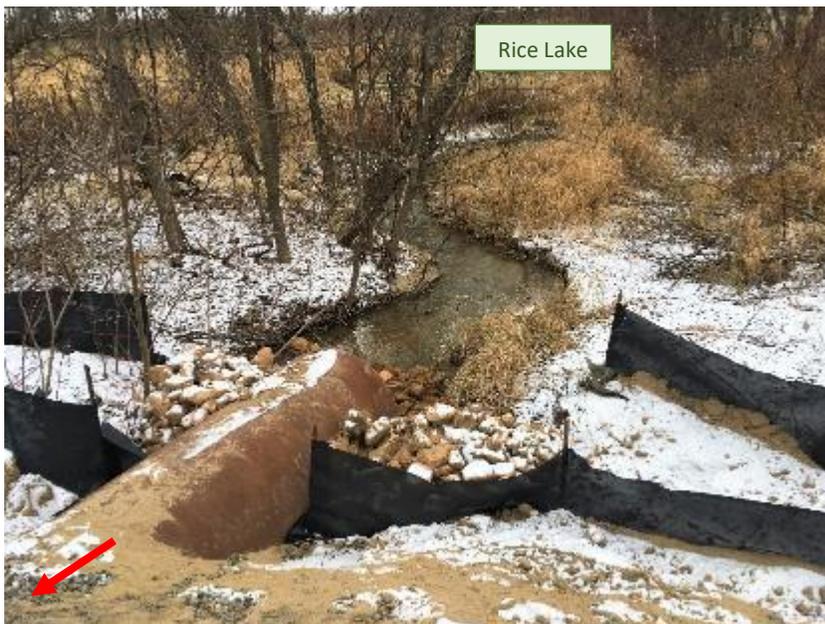
Photo No.: 30

BMPs Present: Two rows of silt fencing; riprap

Description: Downstream southern outlet of unknown creek into Rice Lake.

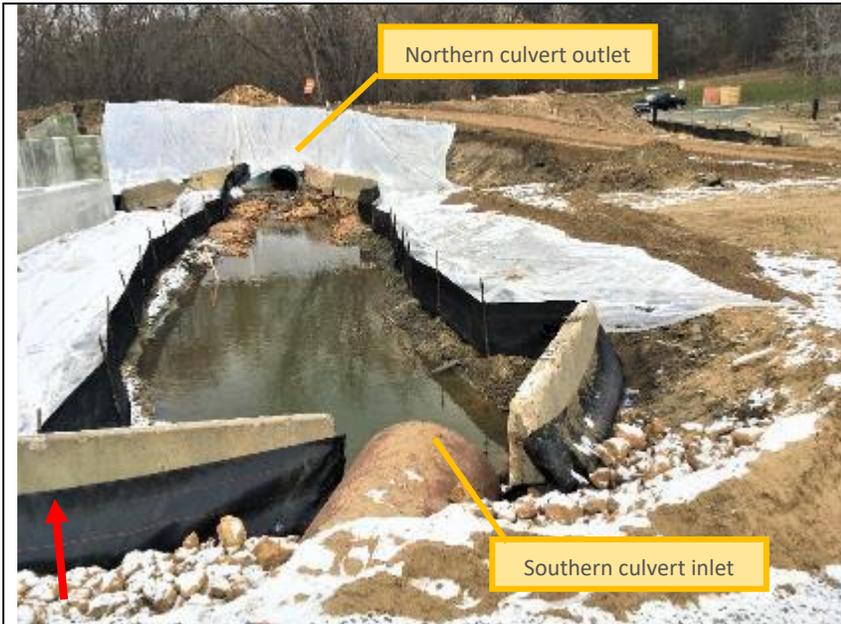
Photo No.: 31

BMPs Present: Silt fence with jersey barrier backing or t-posts; riprap; plastic sheeting covering bare soils.

Description: Inlet of southern culvert (see photo 30 for southern outlet) and outlet of northern culvert. New BMPs installed since last visit to site on 6 November 2018.

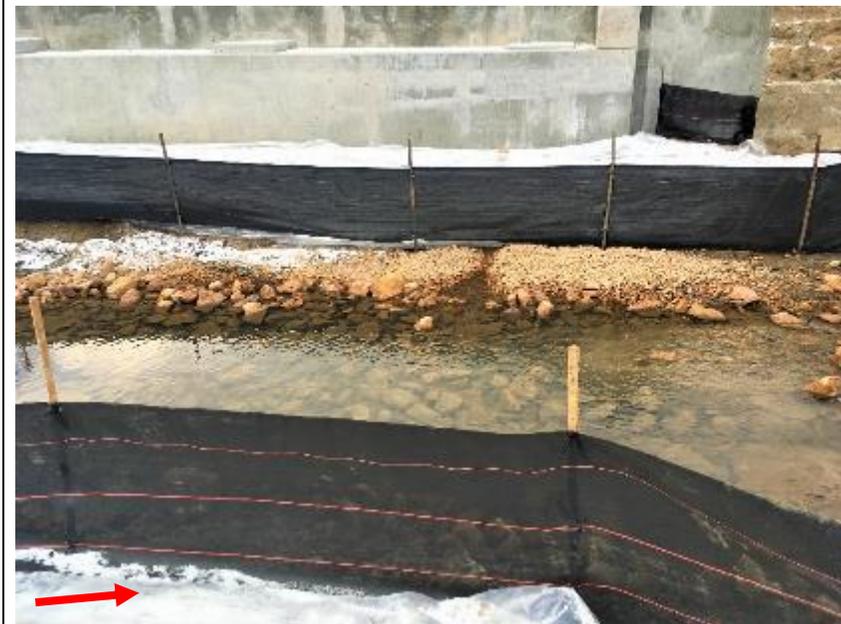
Photo No.: 32

BMPs Present: Silt fence with jersey barrier backing or t-posts; riprap; plastic sheeting covering bare soils.

Description: Unknown creek is stabilized with riprap along bottom. Very little sediment is present. Side slopes are covered in a large plastic sheet.

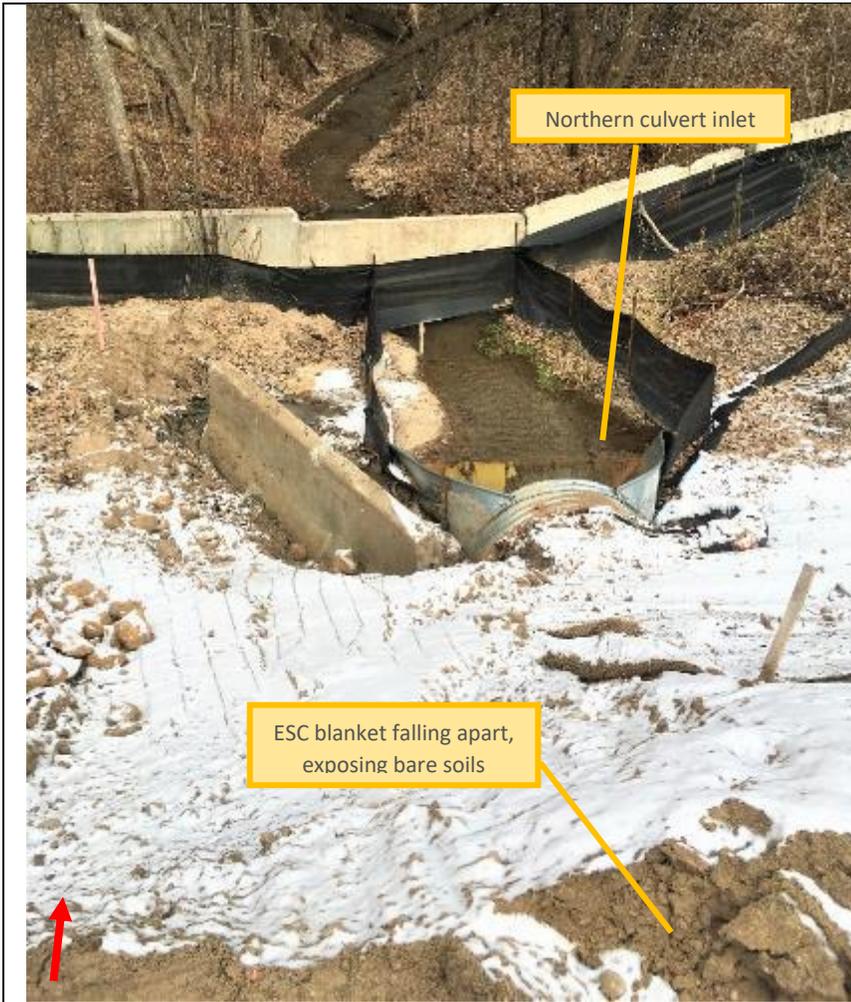
Photo No.: 33

BMPs Present: Silt fence backed with t-posts; silt fencing backed with jersey barriers; ESC blanket; biologs

Description: Northern culvert inlet that channels unknown creek through project area. ESC blanket is in poor condition with many areas of exposed soil.

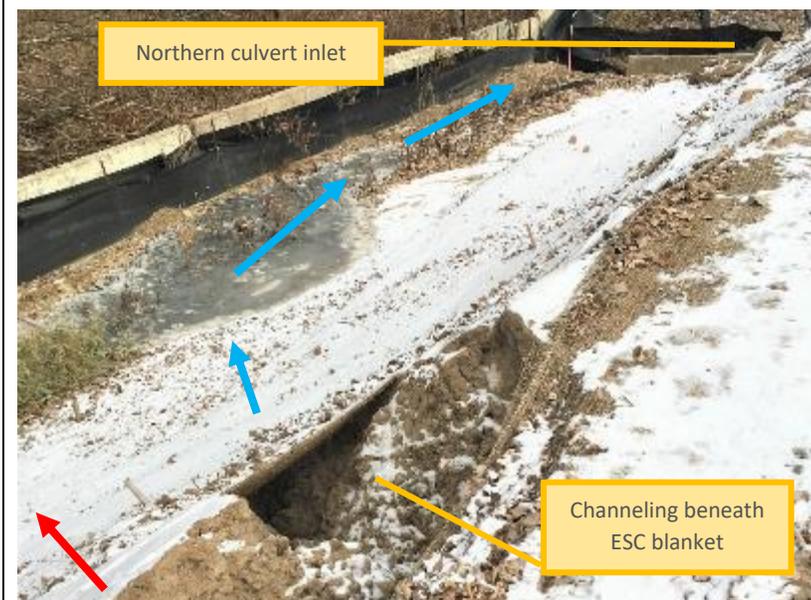
Photo No.: 34

BMPs Present: Silt fence backed with t-posts; silt fencing backed with jersey barriers; ESC blanket

Description: Deep channeling beneath ESC blanket. Water has pooled in channels and leads to the northern culvert inlet (see photo 33). During site visit the pooling water was frozen.

Blue arrows depict flow of water to the northern culvert inlet.
