SITE LOCATION: CSAH 61-Flying Cloud Drive

PURPOSE: Construction Stormwater Site Visit on behalf of the Lower Minnesota River Watershed District (LMRWD)

DATE & TIME: 19 November 2018, 0830-1100

INSPECTOR: Sarah Duke Middleton, Water Resources Scientist
Young Environmental Consulting Group, LLC

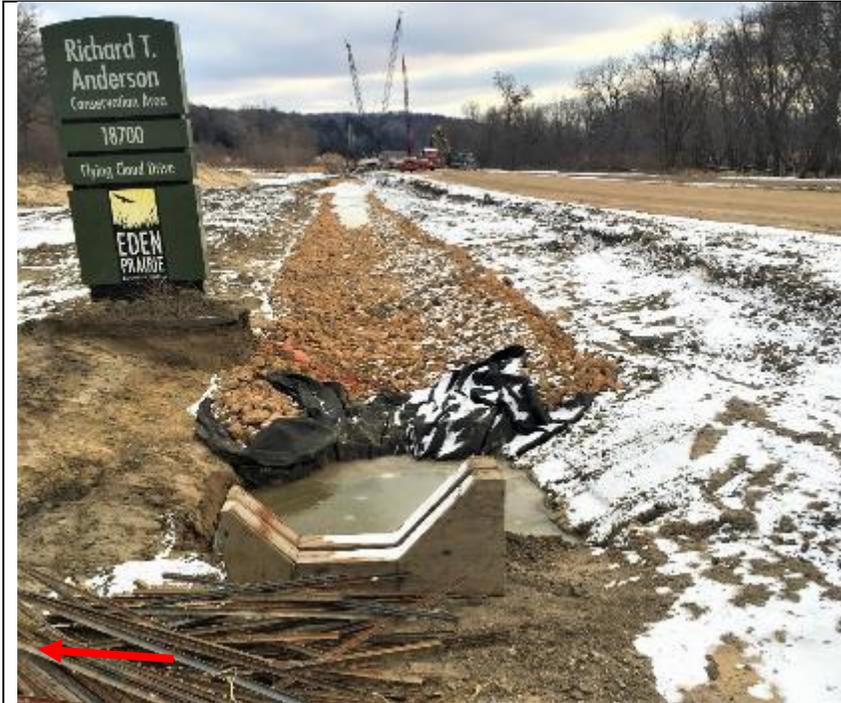
Photo No.: 35

BMPs Present: Riprap; filter fabric; small settling basin

Description: Northern side of ROW with a riprap filter strip, leading to a fabric filter and a small settling basin.

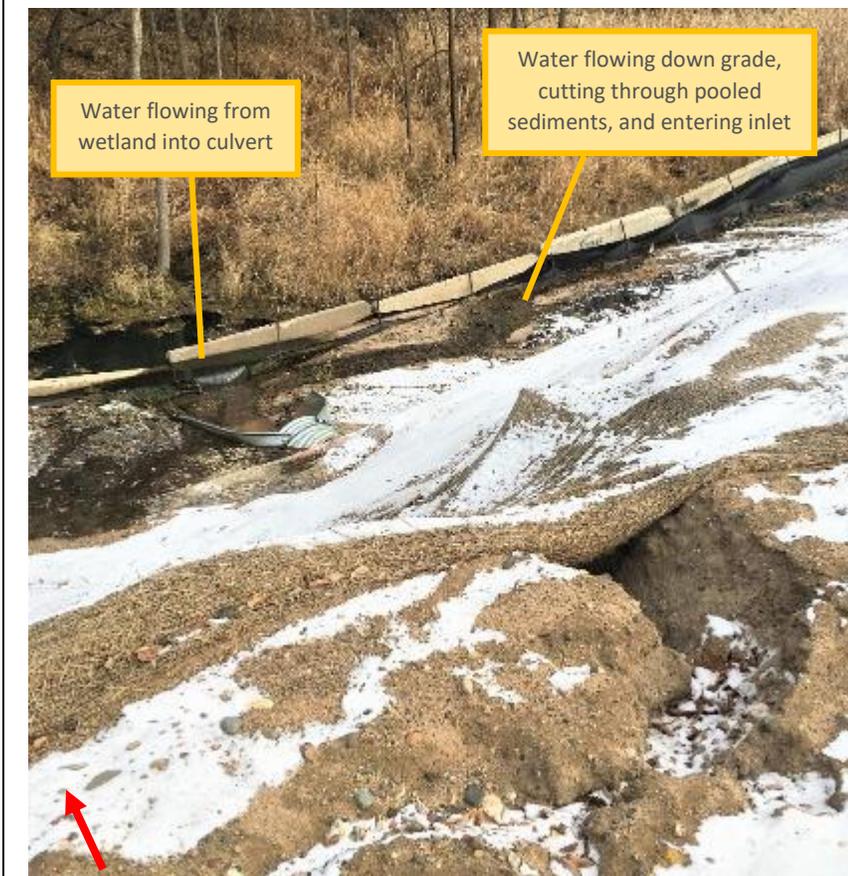
Photo No.: 36

BMPs Present: ESC blanket; silt fencing with jersey barrier

Description: Deep channeling beneath ESC blanket. Sediment has pooled at the base of the slope, in several cases leading to the culvert inlet.

Water from the wetland north of the ROW is flowing over the jersey barriers and into the inlet. See photo 26 and 27 for outlet culvert on southern side of ROW, leading to Rice Lake.

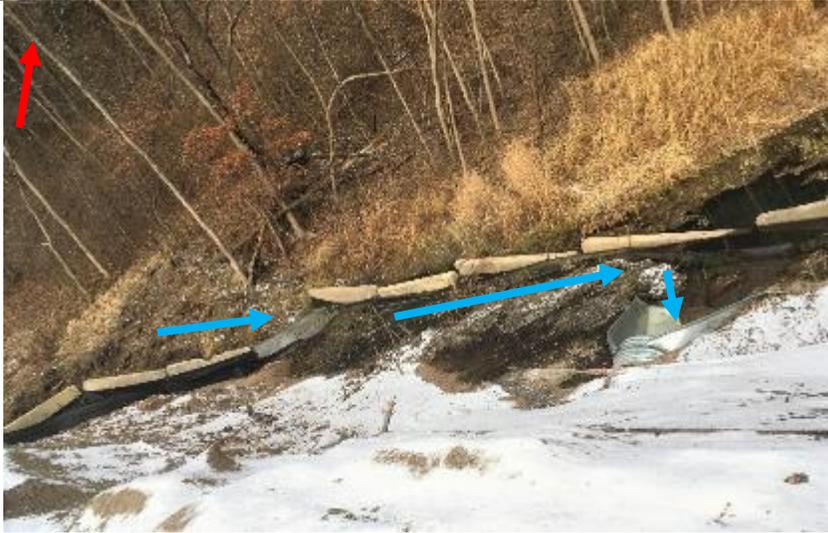
Photo No.: 37

BMPs Present: ESC blanket; silt fencing with jersey barrier

Description: Water flowing from the west, into the culvert (see photo 36 for another view of the area).

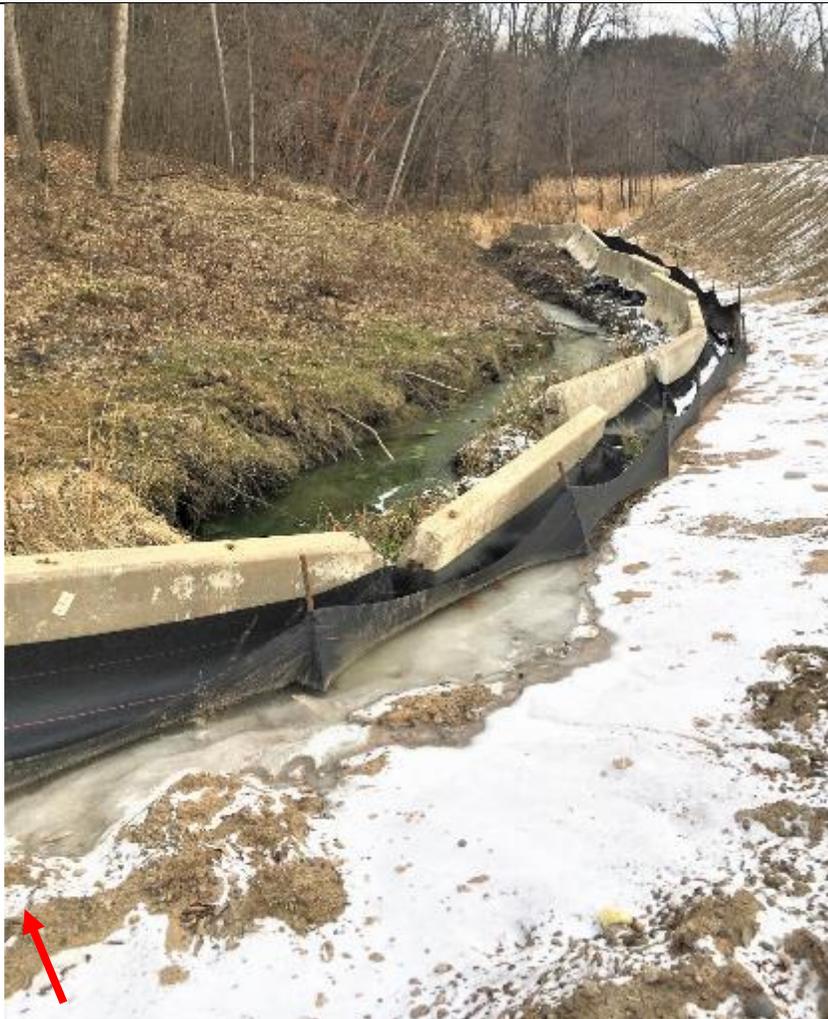
Photo No.: 38

BMPs Present: Silt fence with jersey barrier backing and a second row with metal t-posts.

Description: Water flowing west to east along the northern edge of the ROW. Leads to area/outlet in photos 37 and 36. Water flow has cut into the northern bank; it is unclear if this is a result of the construction activity or a preexisting condition.

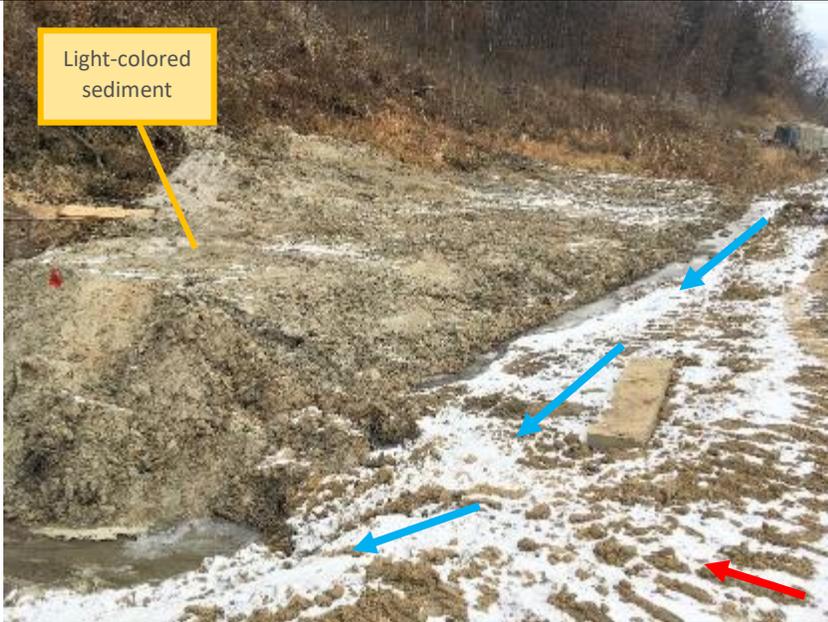
Photo No.: 39

BMPs Present: None visible

Description: Northern side of ROW along ditch line. Stormwater flows along this area, pools (see photo 40), and drains via a buried inlet (see photo 41). The blue arrows illustrate the drainage route.

The lighter-colored sediments in this photo are similar to those accumulating in the large outlet in photo 22. This culvert seems to be directly north of the outlet in photos 20- 22.

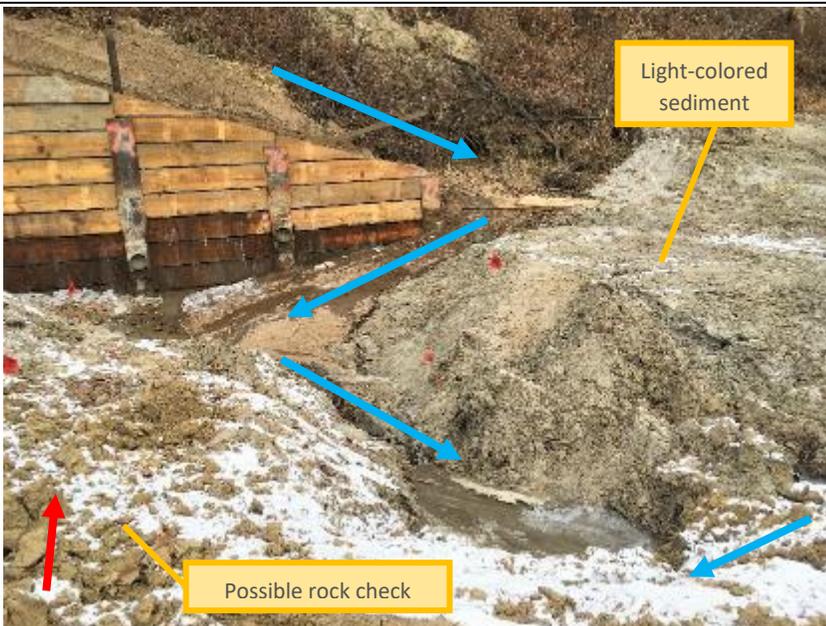
Photo No.: 40

BMPs Present: None clearly visible, but possible rock check that has washed out (?)

Description: Continuation of photo 39, spanning westward. This photo shows the general 'collection' or pooling area for stormwater prior to entering the buried inlet (see photo 41).

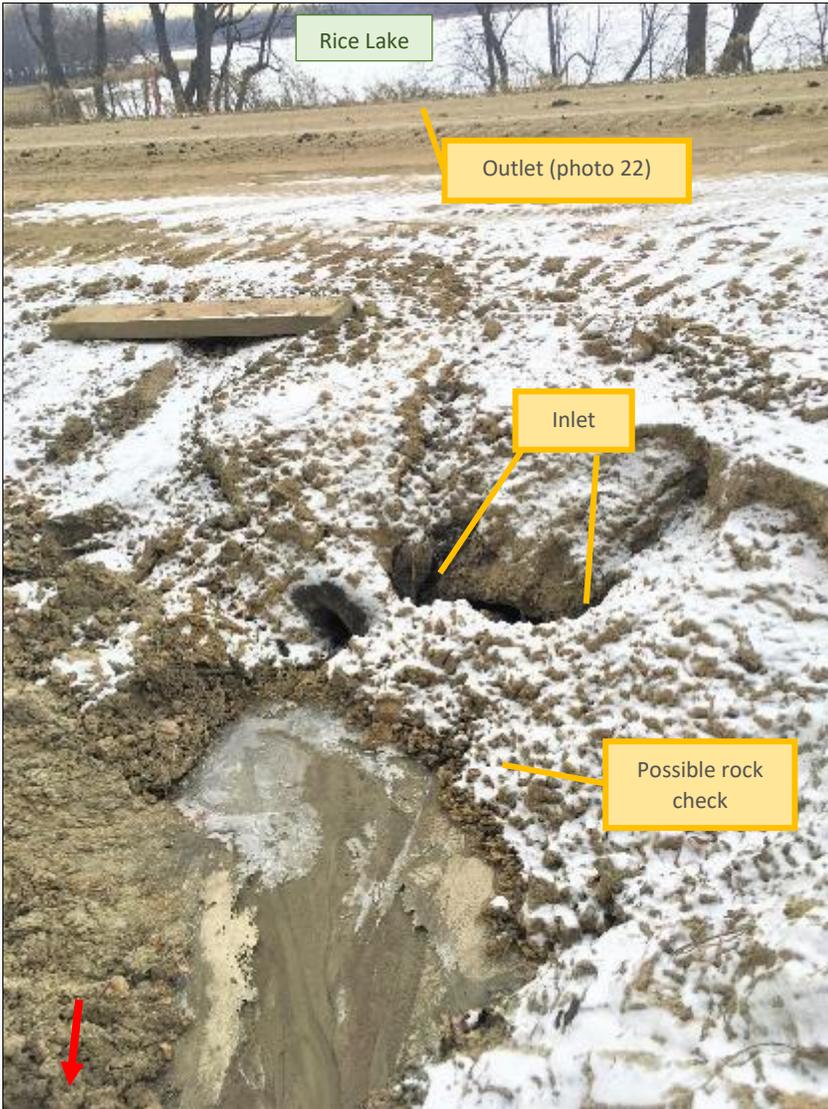
Photo No.: 41

BMPs Present: None visible

Description: Inlet for stormwater from photo 39 and 40. The culvert is nearly invisible due to an accumulation of debris around the opening.

During the 6th November 2018 site visit there were moderate-to-heavy rains. This culvert was draining large volumes of water. Its appearance has not altered since that visit, so it is assumed that the inlet still functions to some extent.

Photos 20- 22 of this log depicts an outlet that lies directly south of this inlet. It is assumed that the two are connected.

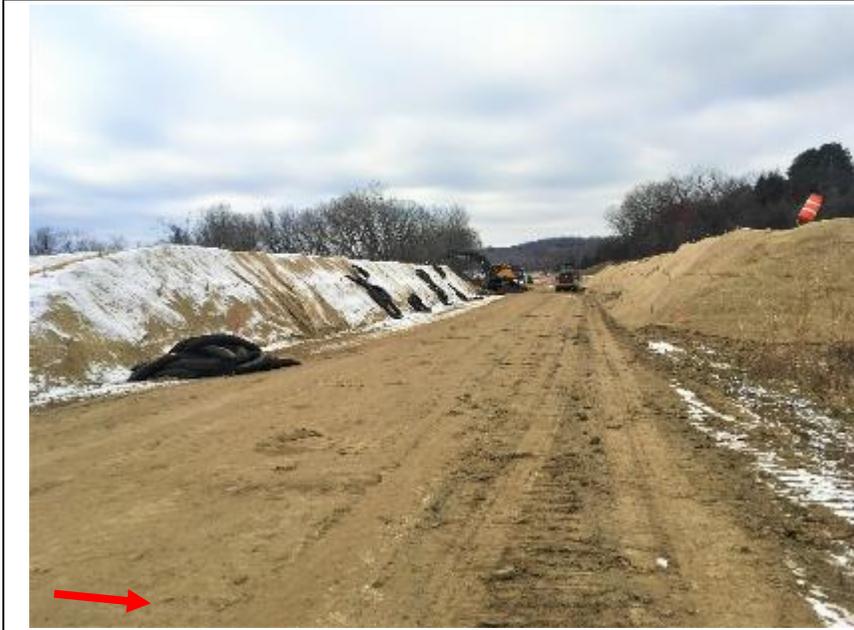
Photo No.: 42

BMPs Present: Biologs; ESC blanket

Description: Roadway, flanked by large soil piles on the northern and southern perimeters. Both sides are covered in ESC blanket. Biologs appear to have been removed recently in anticipation of excavator work on the southern side of the ROW.

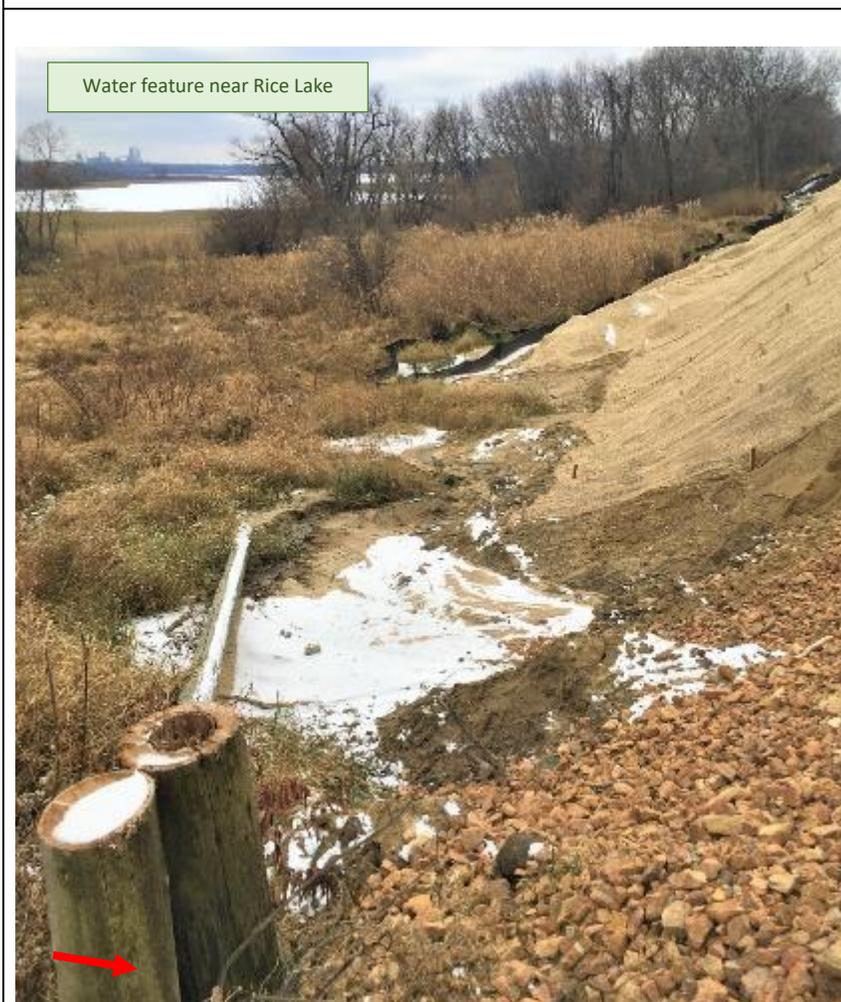
Photo No.: 43

BMPs Present: Two rows of silt fence, rock check, ESC blanket

Description: Downslope of photo 42 roadway construction. Area is largely stabilized, but some sedimentation has occurred.

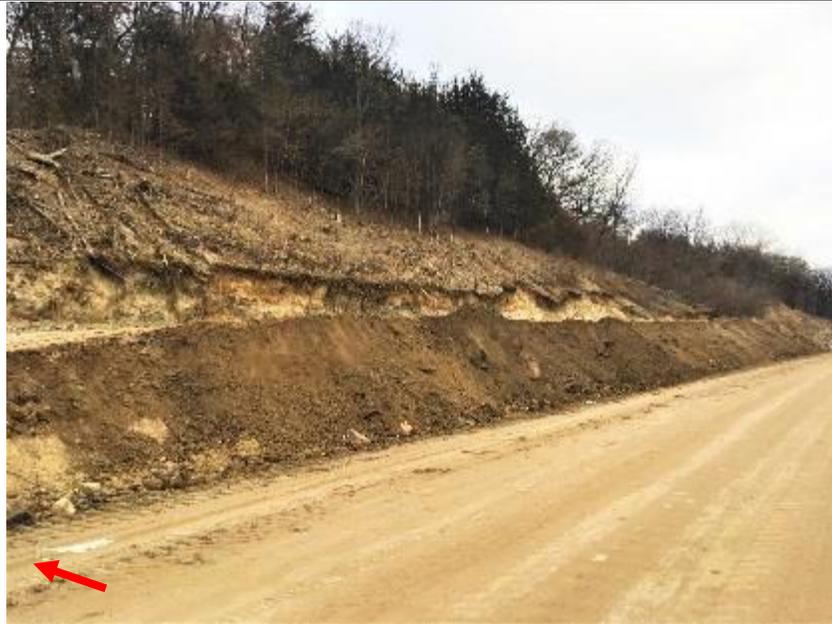
Photo No.: 44

BMPs Present: None visible

Description: Northern side of ROW graded.

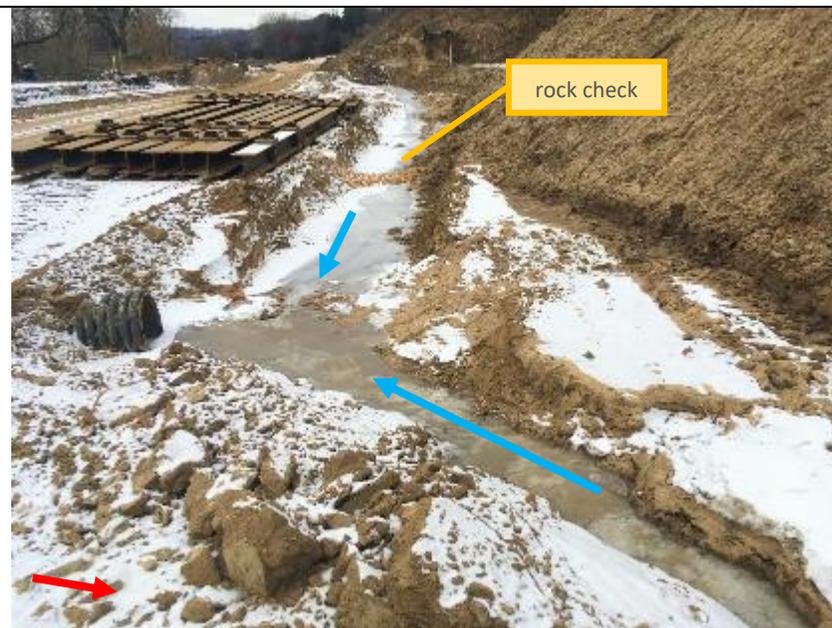
Photo No.: 45

BMPs Present: Rock check

Description: Stormwater inlet on the northern side of the ROW. See photo 46 for the southern ROW outlet.

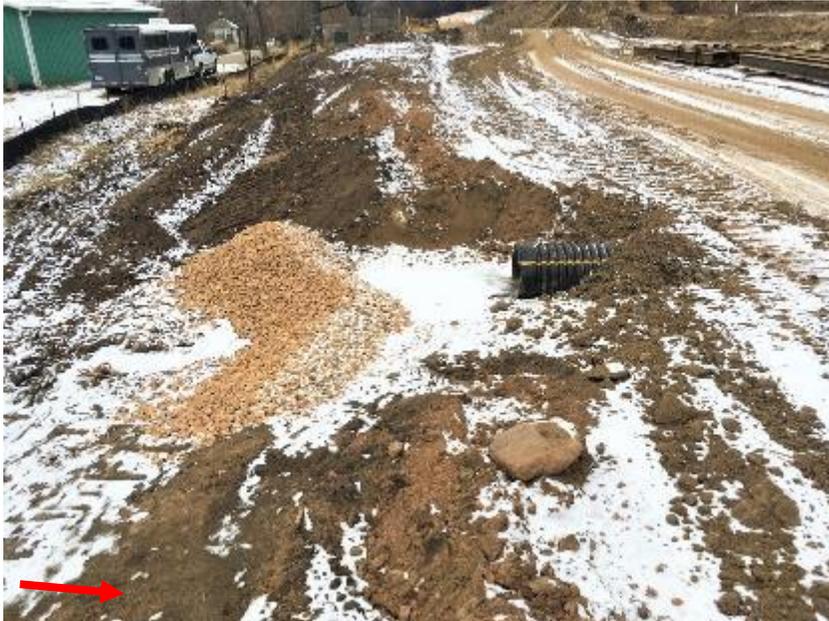
Photo No.: 46

BMPs Present: Rock check; silt fence

Description: Stormwater outlet on the southern side of the ROW. See photo 45 for the northern ROW inlet. It is unclear if the rock present is solely an energy dissipation BMP, or if a settling basin was also intended.

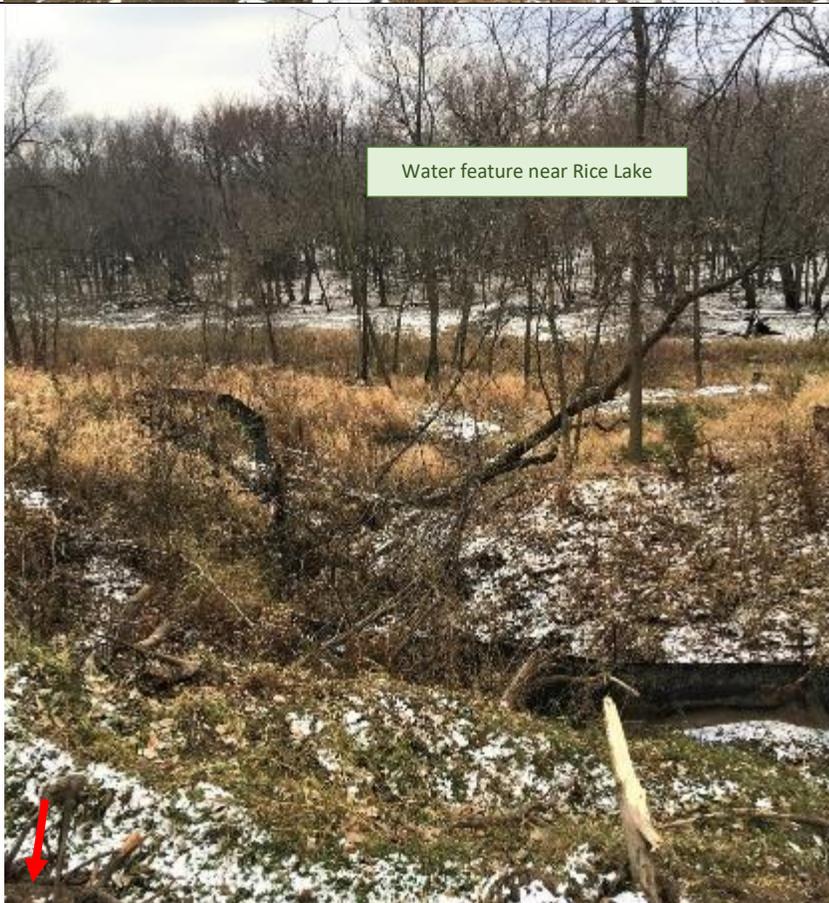
Photo No.: 47

BMPs Present: Silt fence; vegetative buffer

Description: Southern side of ROW. Stable with prevalent vegetation.

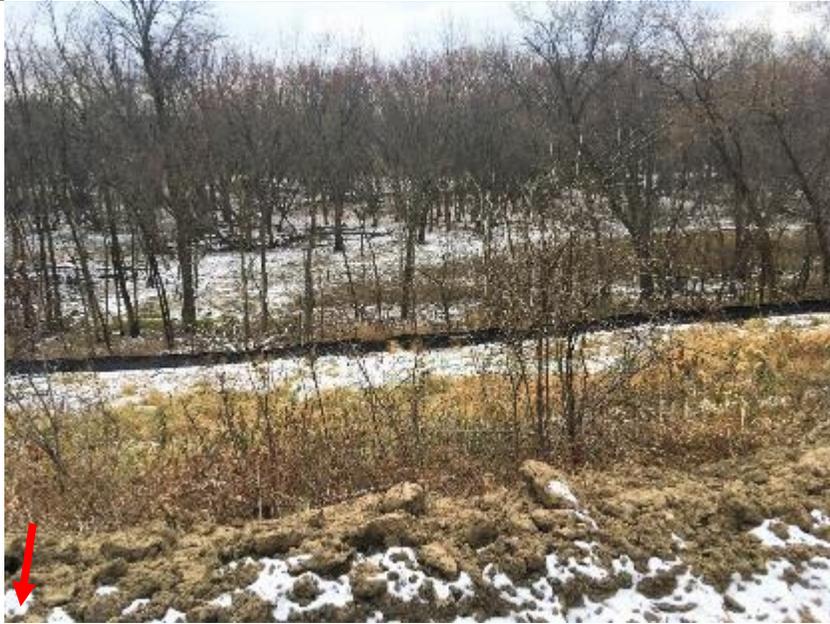
Photo No.: 48

BMPs Present: Vegetative buffer; silt fence

Description: Southern side of ROW stable and covered in vegetation.

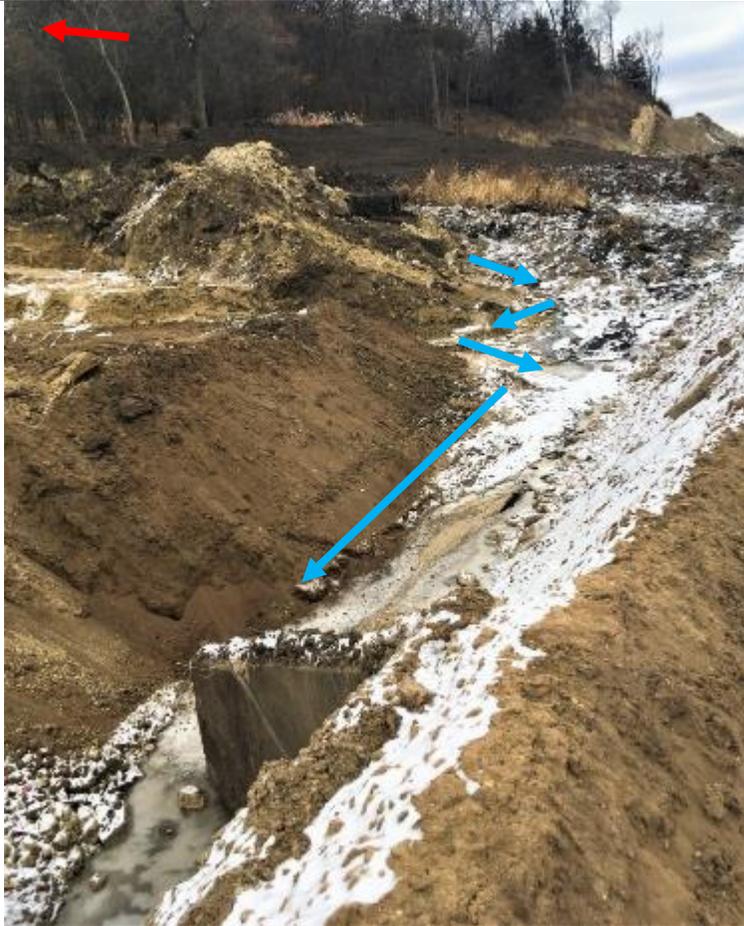
Photo No.: 49

BMPs Present: None visible

Description: Drainage on the north side of the ROW into a large concrete culvert. This photo illustrates the drainage and surround landscape that flow into the culvert. See photo 50 for a view of the inlet.

Black soil at the top of the photo is recently graded.

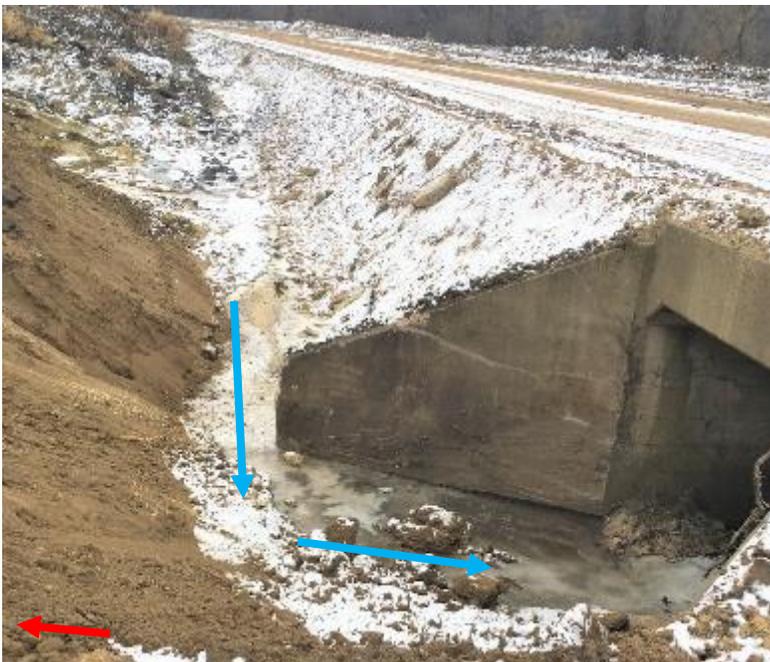
Photo No.:50

BMPs Present: None visible

Description: Large concrete inlet on north side of ROW. See photo 51 for southern outlet.

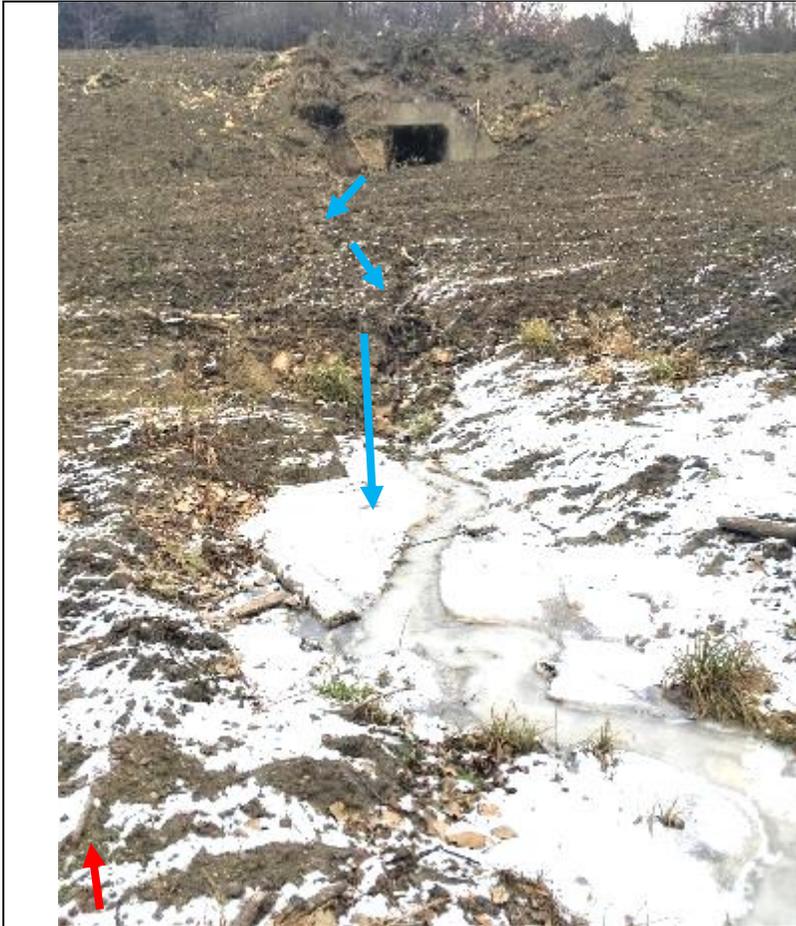
Photo No.: 51

BMPs Present: None visible

Description: Southern outlet (see photo 50 for northern inlet). The area around the culvert was graded recently, but slight channeling has begun to redevelop. Nongraded areas demonstrate a clear flow of water from the outlet.

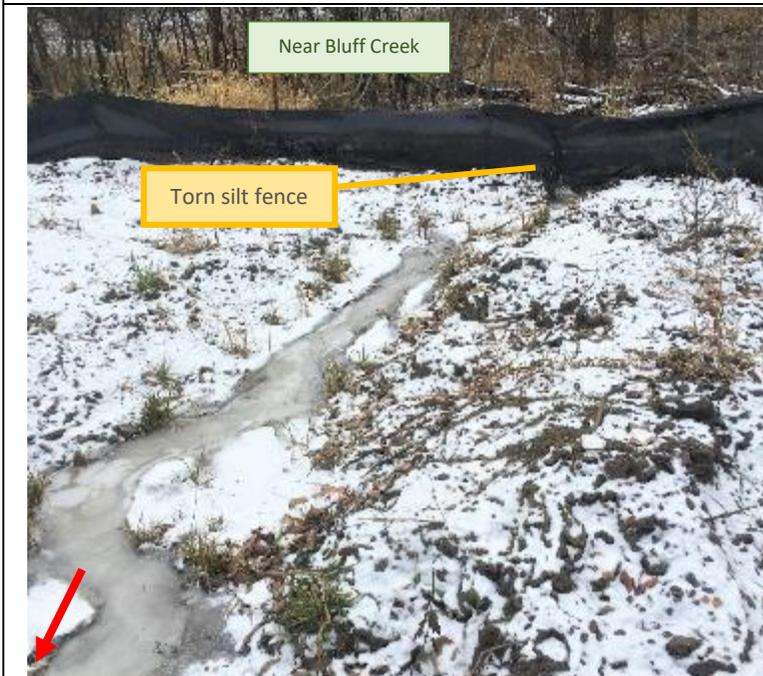
Photo No.: 52

BMPs Present: Silt fence

Description: Flow (now frozen) continues downslope from the culvert outlet (see photo 51) to the silt fence and off the project.

The silt fence is torn where the flow hits the fabric. The span of fabric no longer touches the ground and is held together with several zip ties.

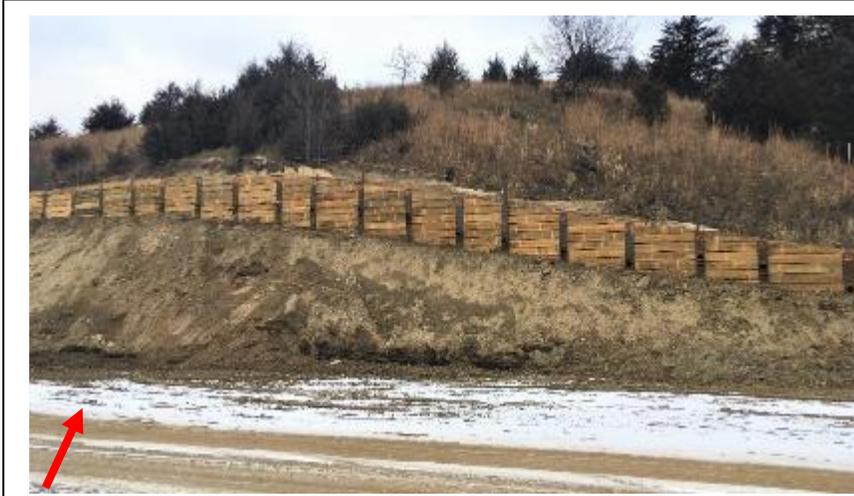
Photo No.: 53

BMPs Present: Hydromulch

Description: Northern side of ROW.

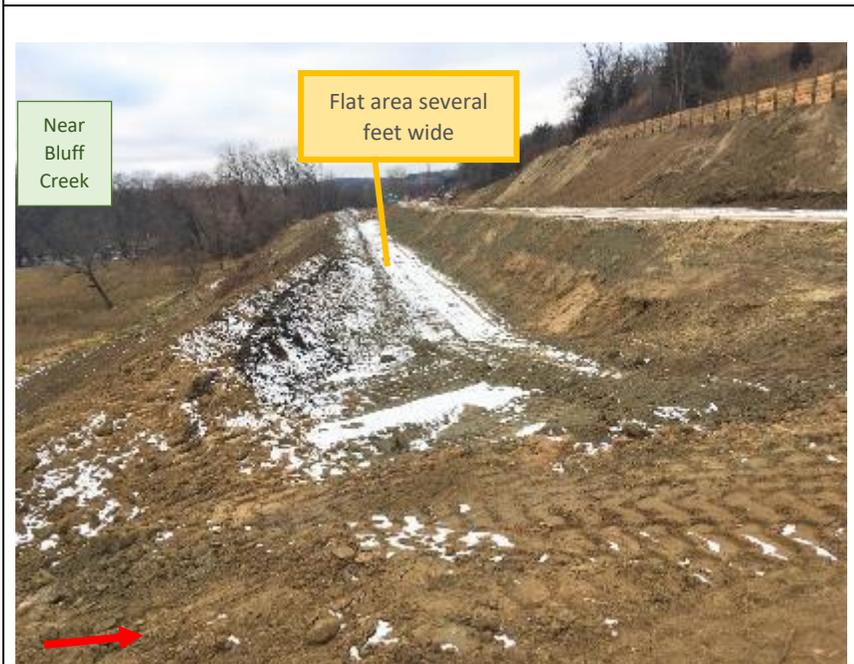
Photo No.: 54

BMPs Present: None visible

Description: North and south sides of Flying Cloud Drive. Area has been graded in a tiered fashion. No areas of erosion were evident.

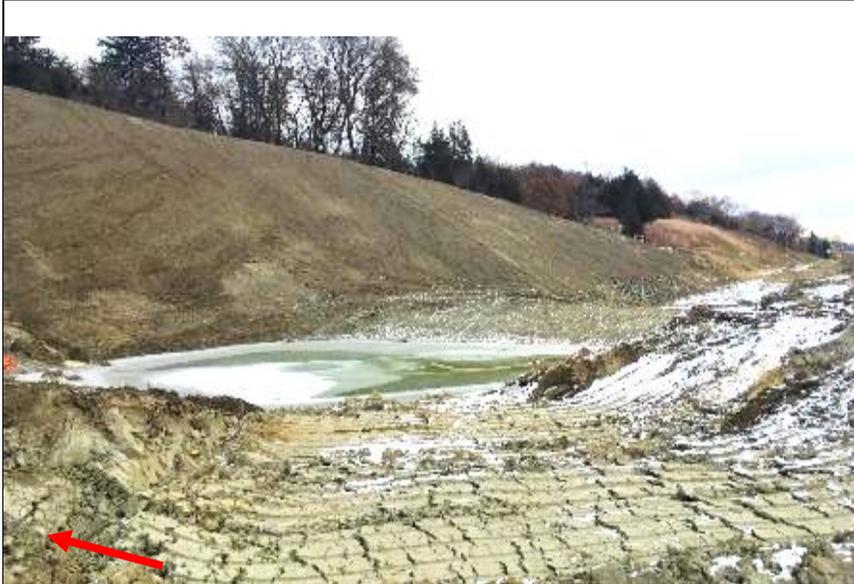
Photo No.: 55

BMPs Present: Possible hydromulch

Description: Retention pond on north side of ROW with a dewatering setup. Possible hydromulch application on graded hillside.

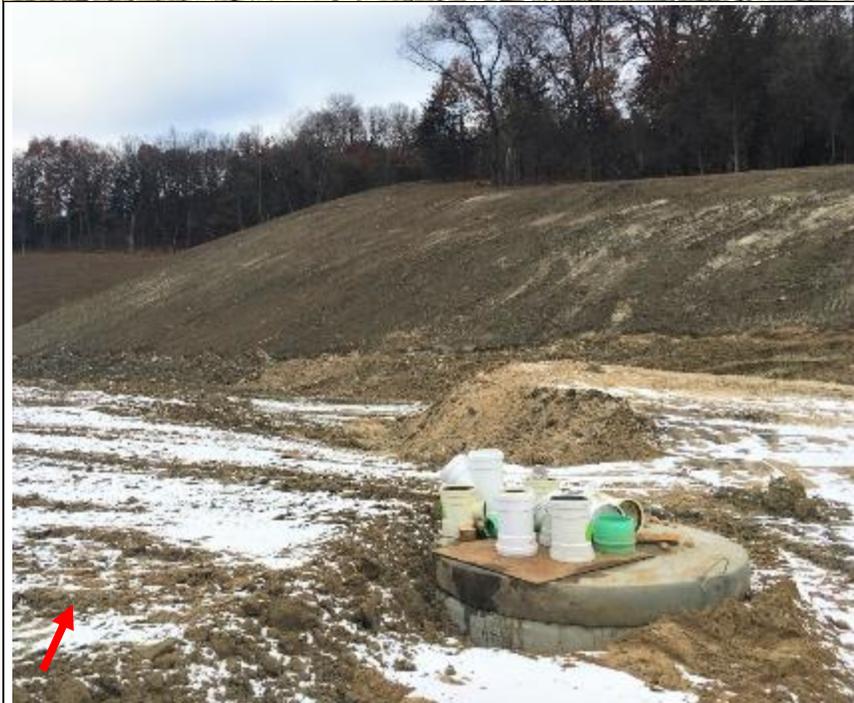
Photo No.: 56

BMPs Present: None visible

Description: Large water conveyance feature on north side of ROW.

See photos 57-59 for downslope outlets. It is assumed, but not confirmed, that the outlets directly south are connected to this conveyance system.

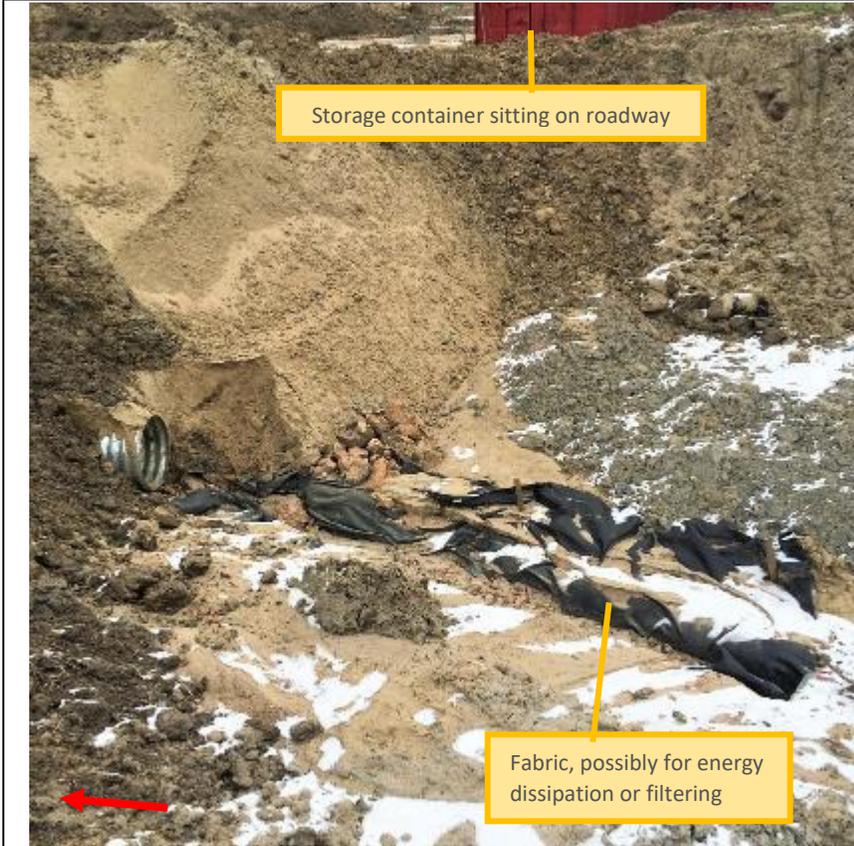
Photo No.: 57

BMPs Present: Possible filter fabric (?), but no longer effective

Description: One of three downslope outlets directly south of the water conveyance system (see photo 56). This culvert is the closest to active construction (see part of red storage container at top of photo), residing on the south side of the ROW, near the top of the slope.

See photo 58 and 59 for the two additional culverts further down the slope.

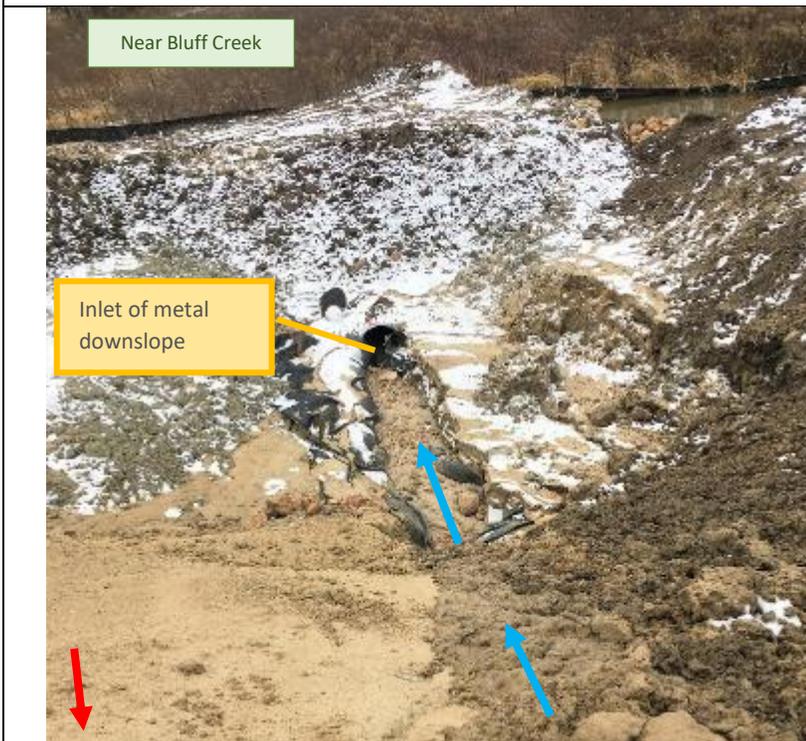
Photo No.: 58

BMPs Present: fabric; silt fence

Description: Culvert from photo 57 drains directly down this slope, into a second culvert. Sediments have accumulated along the flow route. The second culvert is long and metal, and outlets at the silt fence (see photo 59).

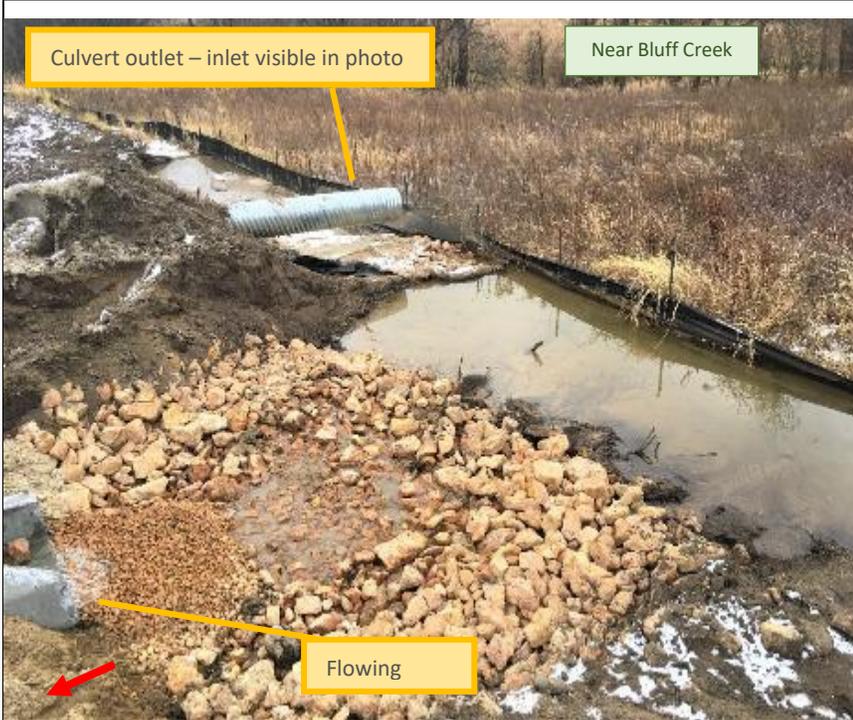
Photo No.: 59

BMPs Present: Riprap; silt fence

Description: Two culverts at the base of the slope. Both outlets have multiple sizes of riprap to dissipate energy. Water is actively flowing out of the concert culvert (the largest of the three outlets).

The silt fence sits low in several places. The depth of the pooling water is unknown, but a minimum of 4-6".

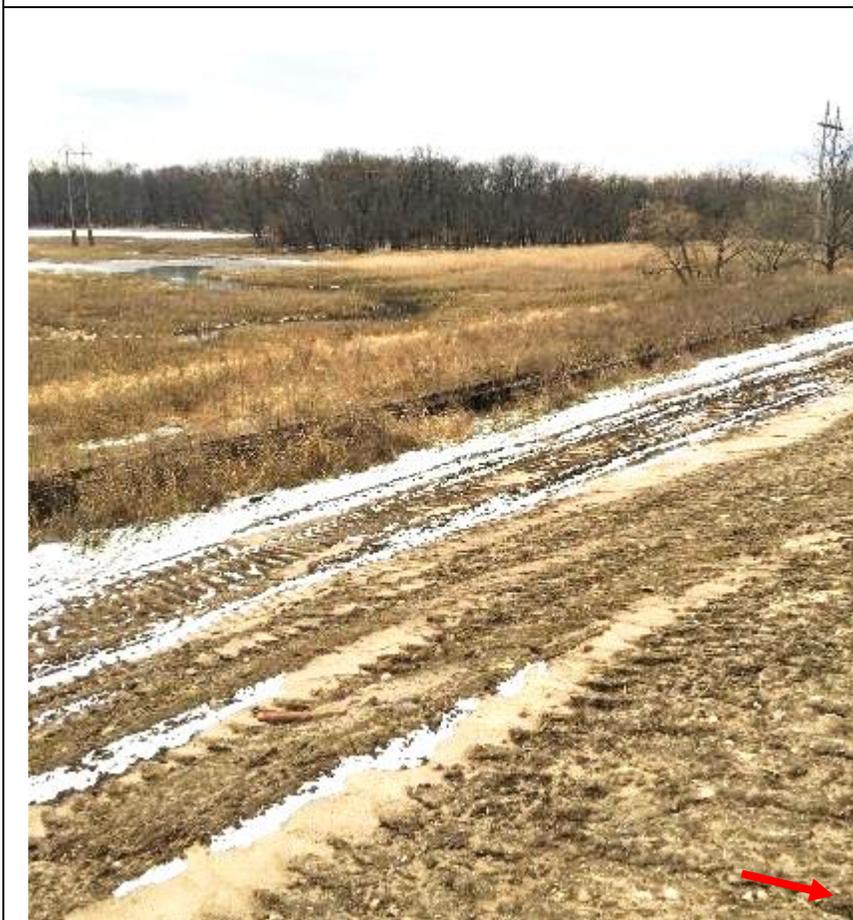
Photo No.: 60

BMPs Present: Two rows of silt fence.

Description: Southern side of the ROW. The slope is graded with sparse vegetation at its base, just before the silt fencing. No erosion is evident.

Unidentified water feature is visible to the south of the silt fencing.

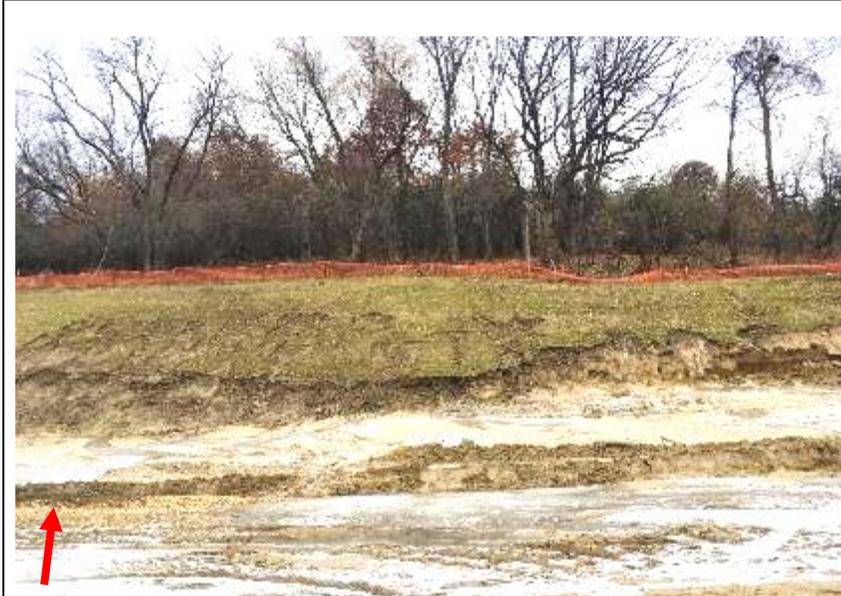
Photo No.: 61

BMPs Present: Hydromulch/vegetation

Description: North side of ROW stabilized with hydromulch that has had some germination and growth. Rills have begun to develop in the seeded area.

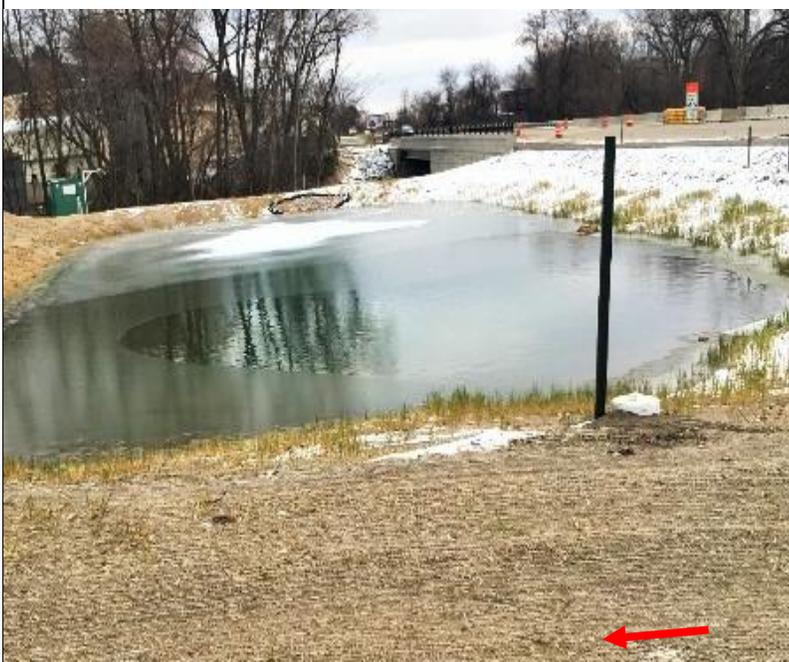
Photo No.: 62

BMPs Present: ESC Blanket; biologs; riprap; vegetation

Description: A stormwater pond stabilized with ESC blanket and seeded. Vegetation became established in the area prior to freezing. The culvert is stabilized with riprap and surrounded by biologs.
