LOWER MINNESOTA RIVER WATERSHED DISTRICT

SITE LOCATION: East Chaska Creek Project Area - Chaska, MN

PURPOSE: Review Current Site Conditions of Project Area and Compare to 2016 Report Conducted by Burns & McDonnell (B&M)

To: Della Schall Young, Principal, Young Environmental Consulting Group, LLC
Linda Loomis, Administrator, Lower Minnesota River Watershed District
From: Jeff Weiss, PE, Senior Water Resources Engineer
Adam Howard, PE, Water Resources Engineer
Subject: East Chaska Creek Assessment
Date: December 10, 2018
Project: 23101028.02

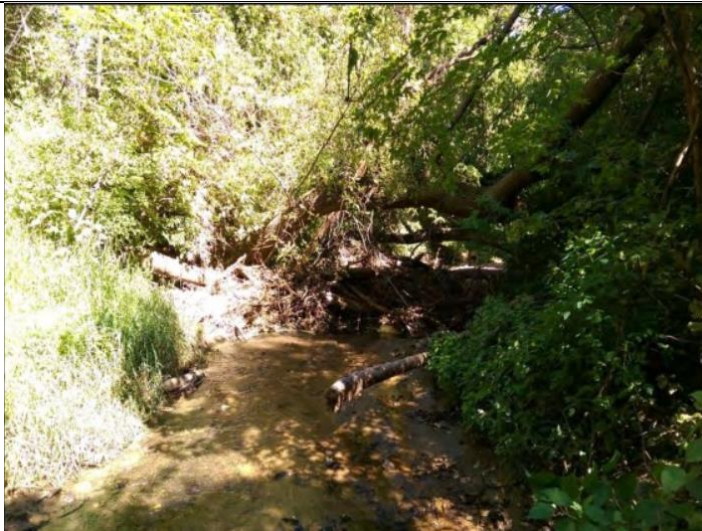
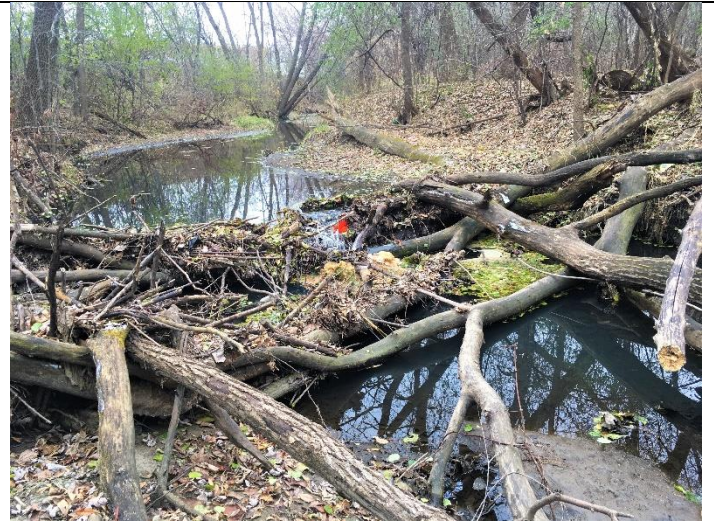
<p>2016 Report: East view of debris, creek levee crossing, and proposed settling basin area.</p>	<p>Nov. 2018 Site Visit: Evidence of site maintenance since 2015 field visits.</p>

<p>2016 Report: Creek levee crossing and debris.</p>	<p>Nov. 2018 Field Visit: Site maintenance evident.</p>

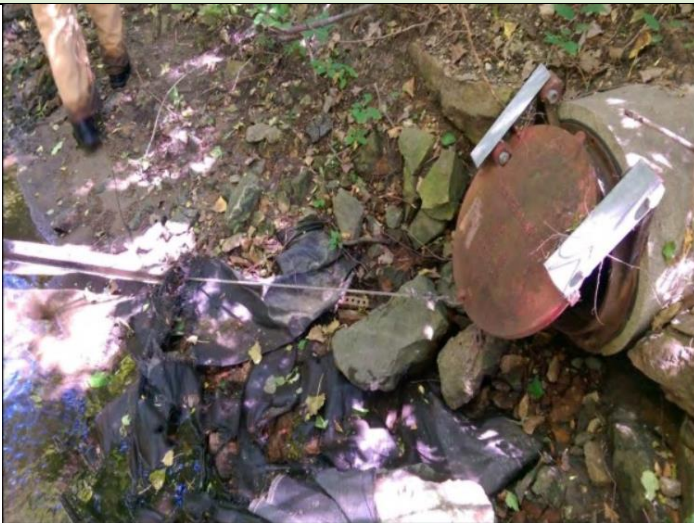
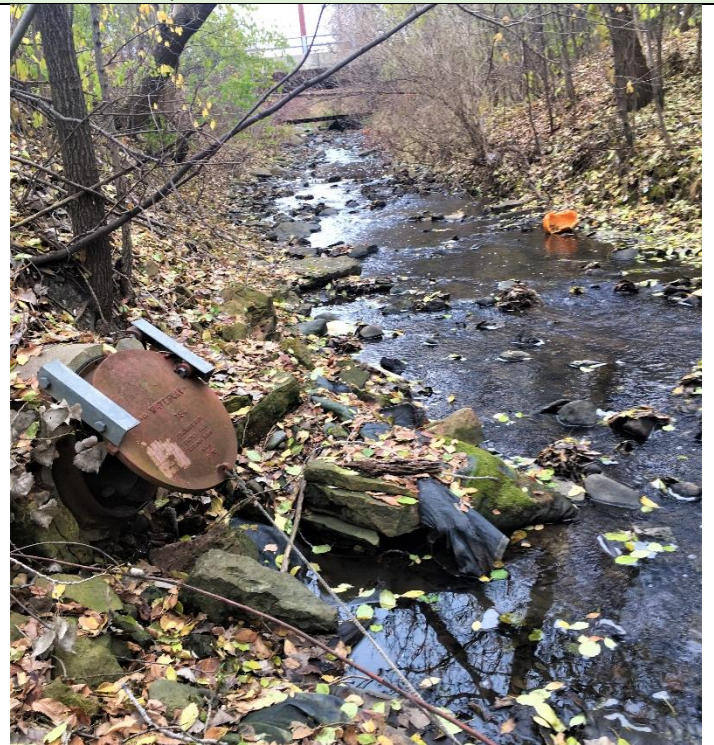
2016 Report: View east of debris.

Nov. 2018 Field Visit: Debris downstream of levee, near Carver County Courthouse.

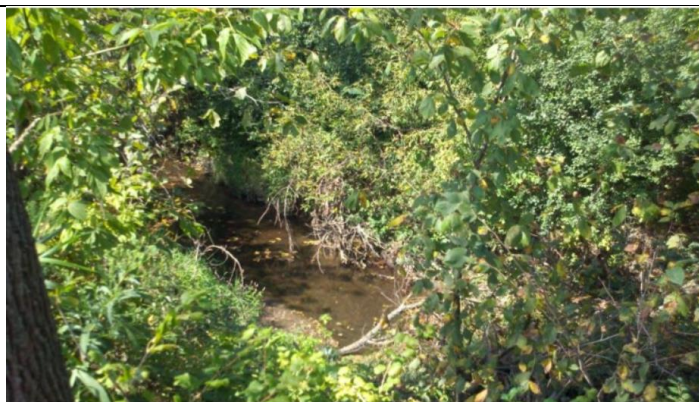
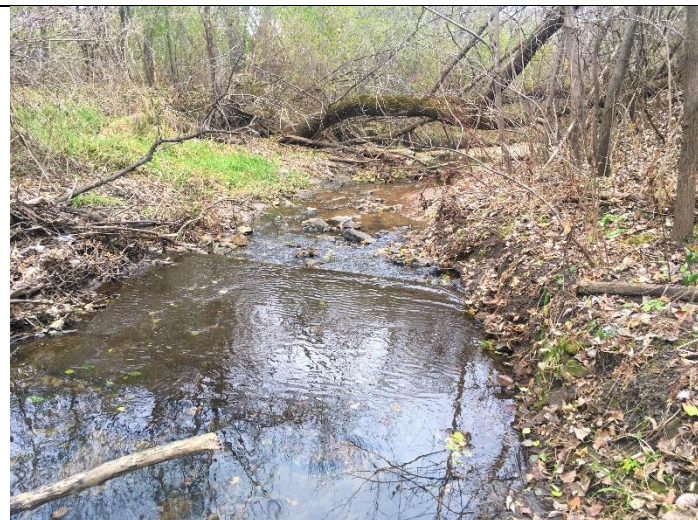
2016 Report: View east of RCP outlet.

Nov. 2018 Field Visit: Upstream (western) view of RCP outlet.

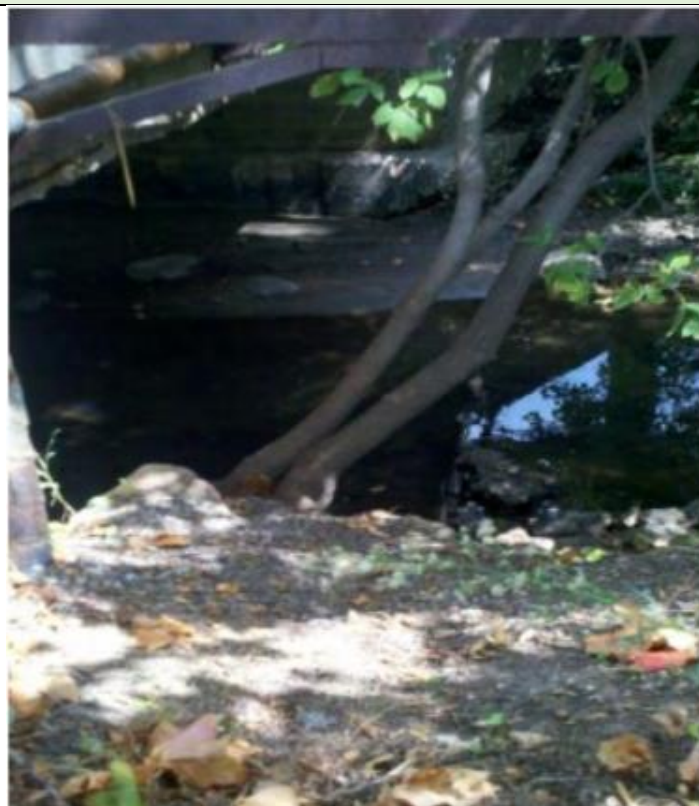
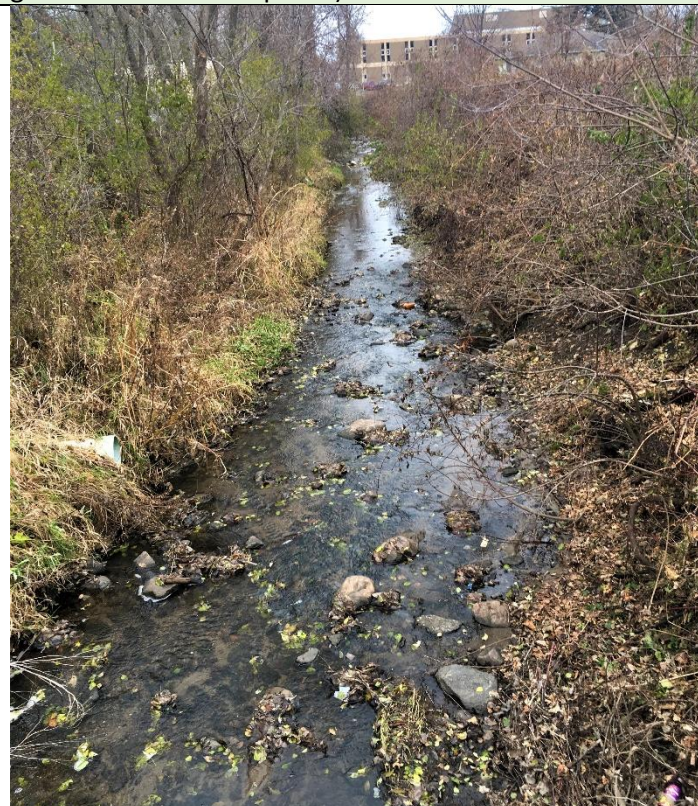
2016 Report: Upstream of Courthouse Lake.

Nov. 2018 Field Visit: Upstream of Courthouse Lake (in general area of 2016 photo).

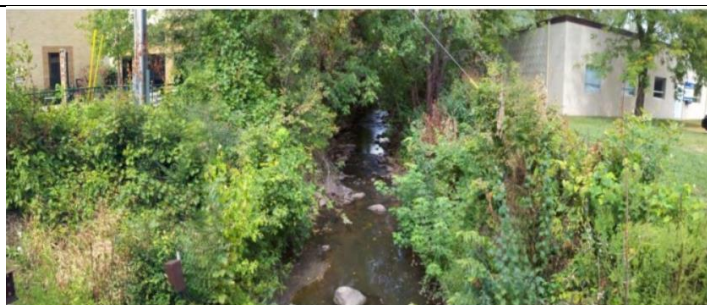
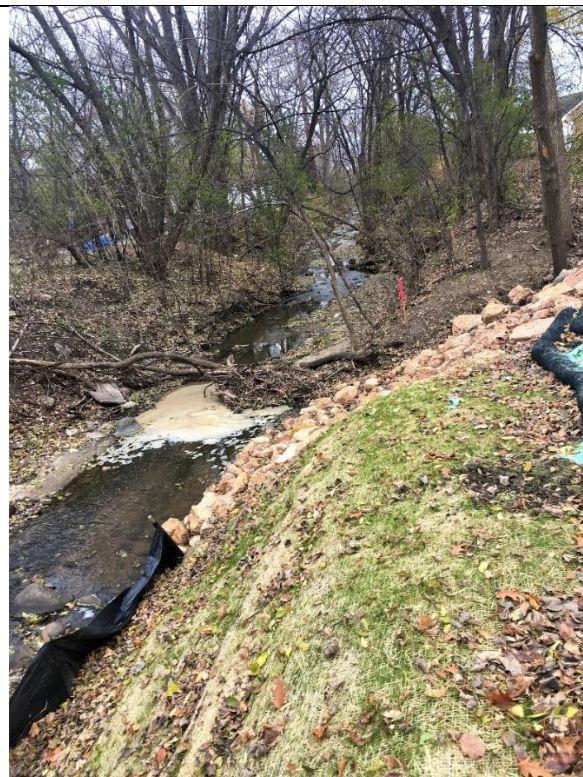
2016 Report: Downstream bridge near intersection of Oak St. and E. Sixth St.

Nov. 2018 Field Visit: Downstream view from pedestrian bridge near Oak St. and E. Sixth St.

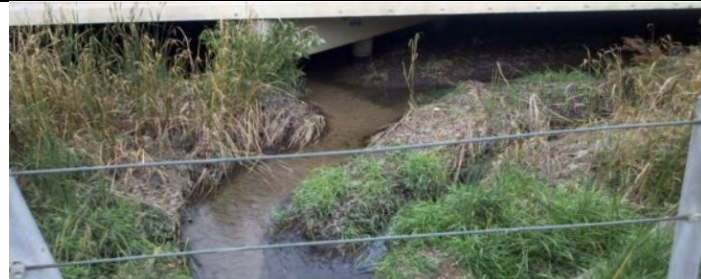
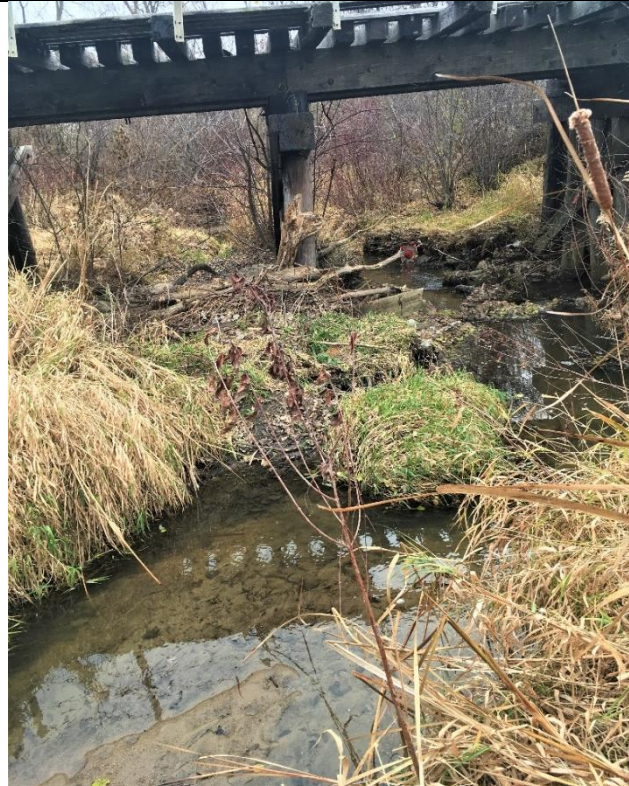
2016 Report: Upstream of bridge near intersection of Oak St. and E. Sixth St.

Nov. 2018 Field Visit: Near Oak St. and E. Sixth St, upstream of pedestrian bridge.

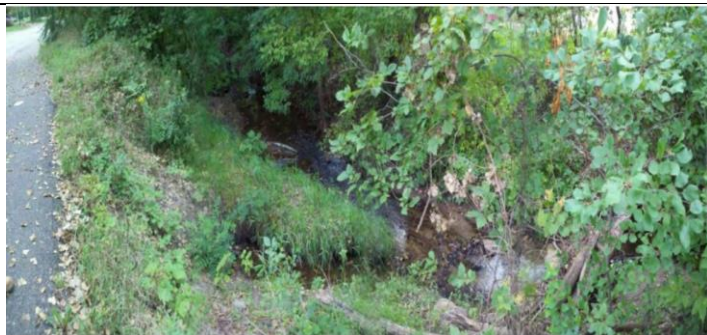
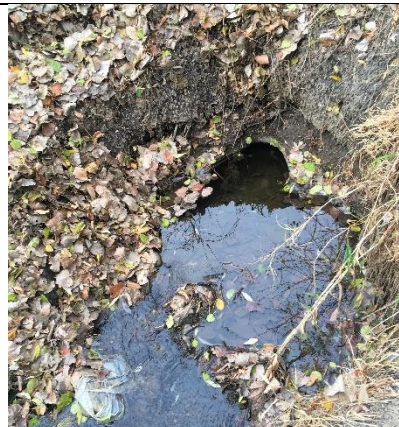
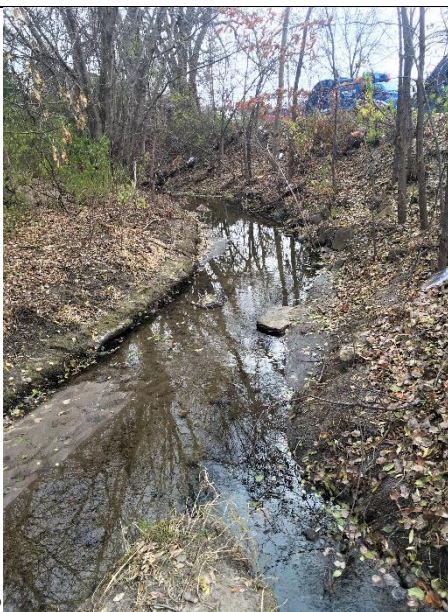
2016 Report: Downstream of County Road 61

Nov. 2018 Field Visit: Downstream of County Road 61, looking at old pedestrian bridge.

Nov. 2018 Field Visit: Photo 1 – outfall. Photo 2 – downstream of outfall. Outfall discharges at lower right corner of photograph.

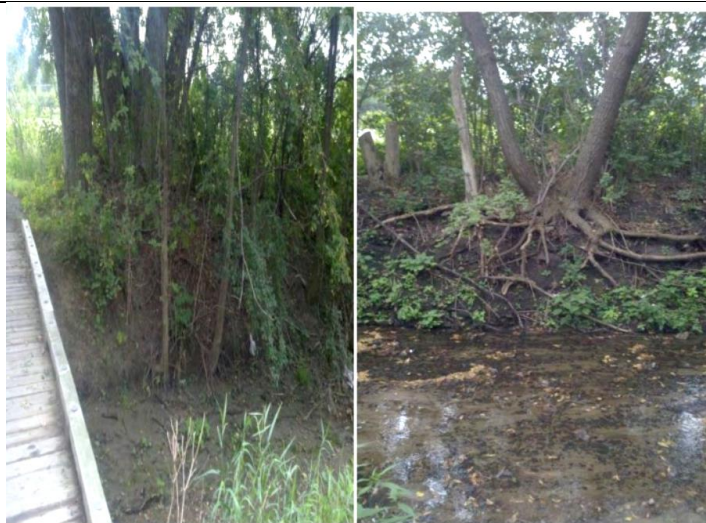
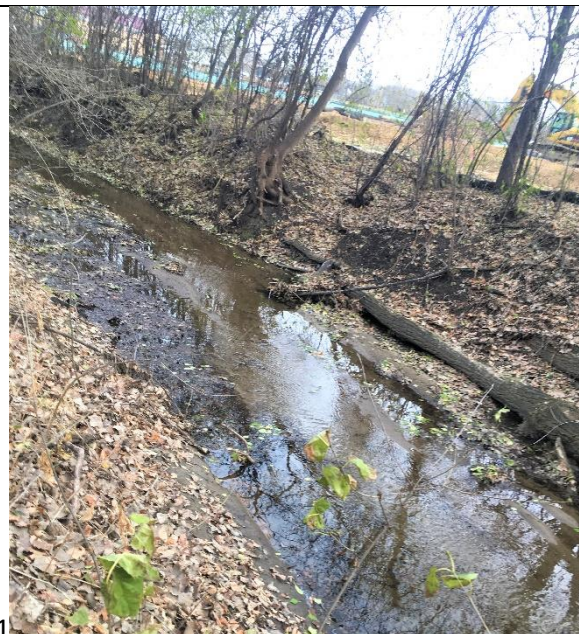
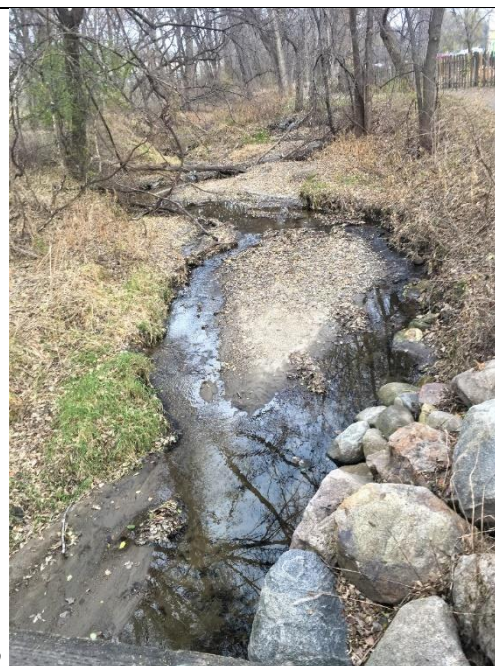
2016 Report: Outfall A – just downstream of Arby’s parking lot.

2016 Report: Pedestrian bridge north of CR 61 and downstream

Nov. 2018 Field Visit: Photo 1- creek bed downstream of pedestrian bridge (looking north/upstream). Photo 2 - view from pedestrian bridge (north of Hwy 61) looking downstream.

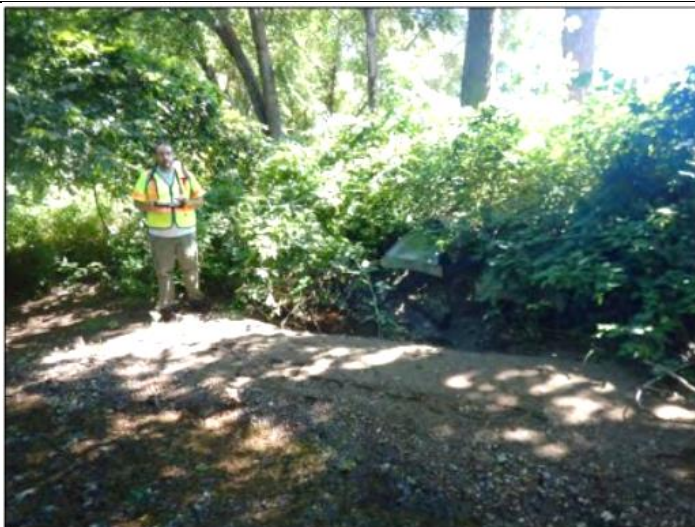
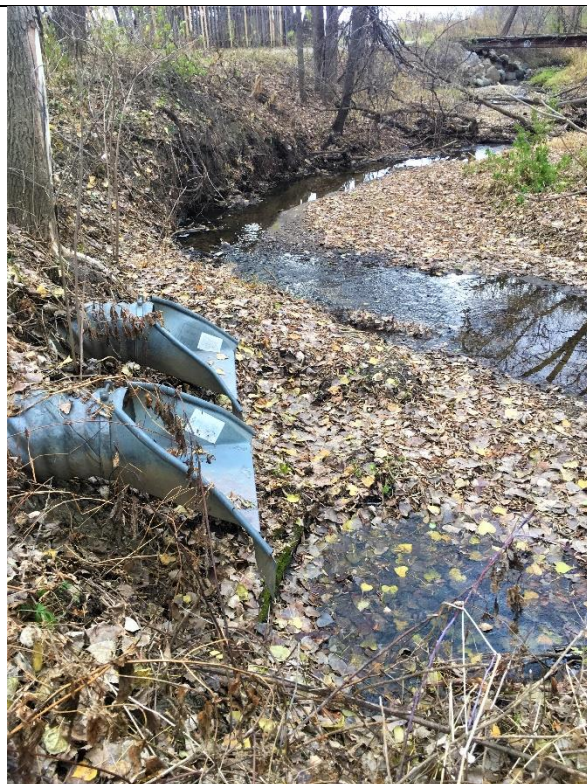
2016 Report: Dual 12" CMP outfalls.

Nov. 2018 Field Visit: Dual outfalls.

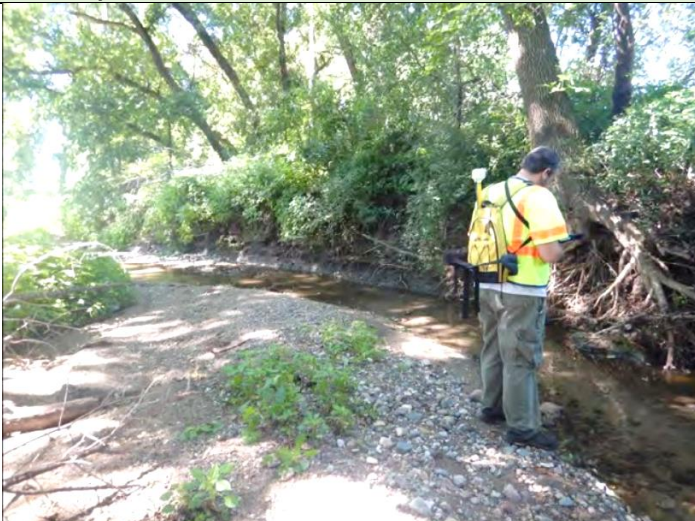
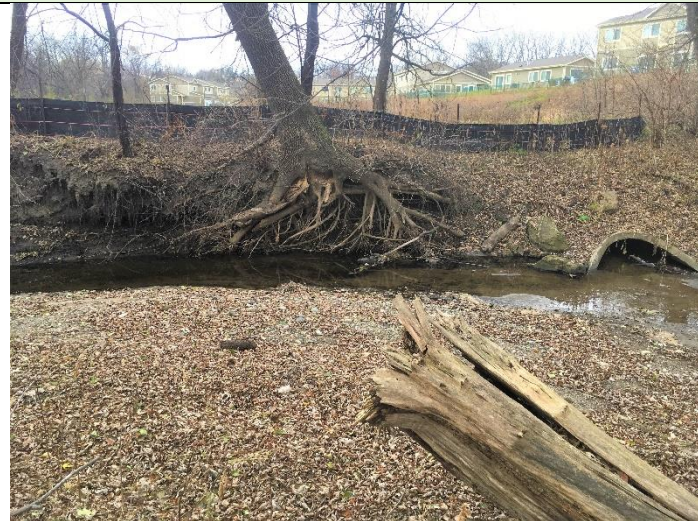
2016 Report: View south of eroded bank.

Nov. 2018 Field Visit: Eroded bank slightly upstream for dual outfalls.

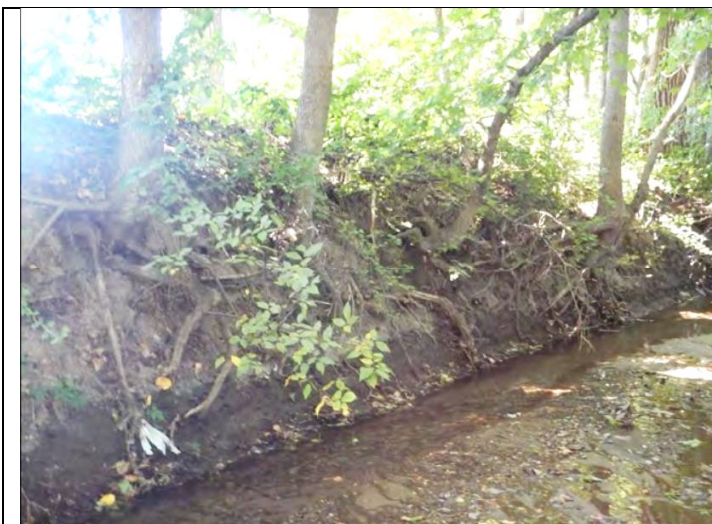
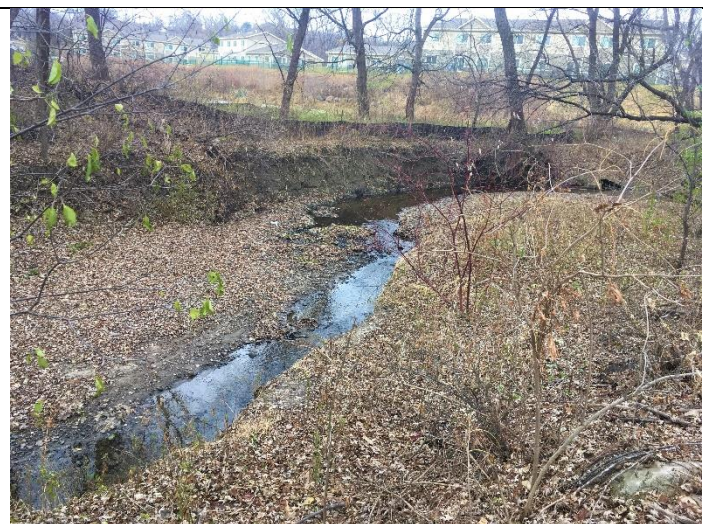
2016 Report: View of eroded bank.

Nov. 2018 Field Visit: View of eroded bank.

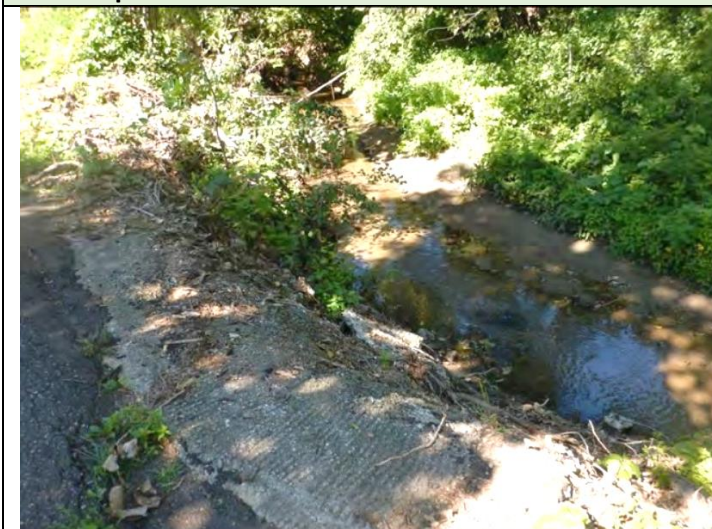
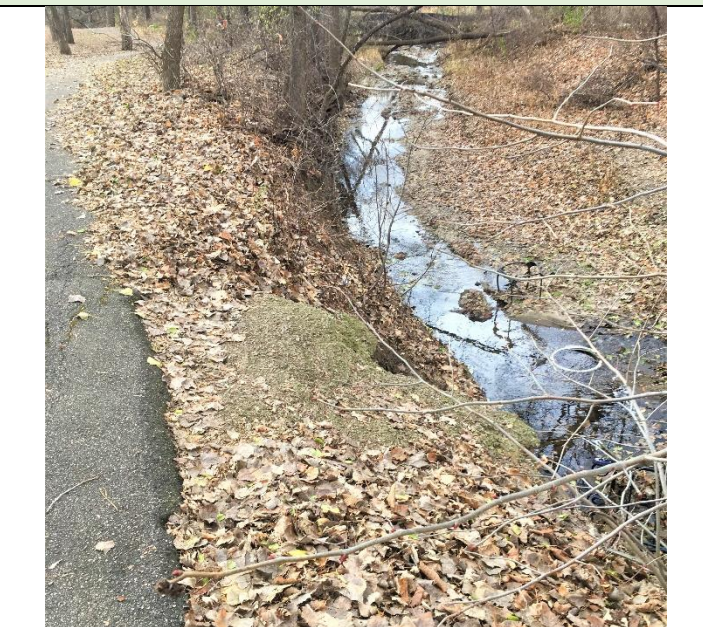
2016 Report: Eastern bank eroded.

Nov. 2018 Field Visit: Eroded eastern bank – in both images (2016 and 2018) the light gray coloring is concrete installed to mitigate loss of bank.

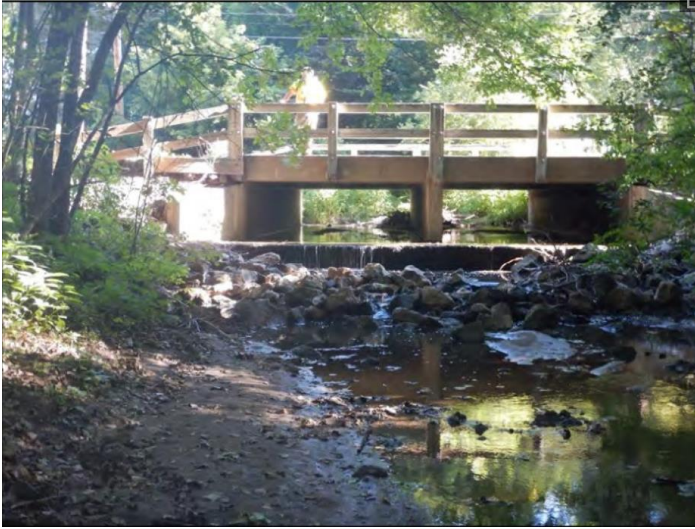
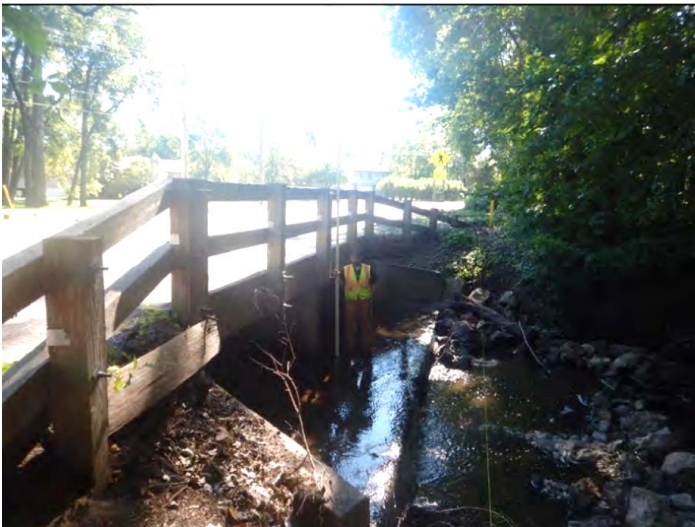
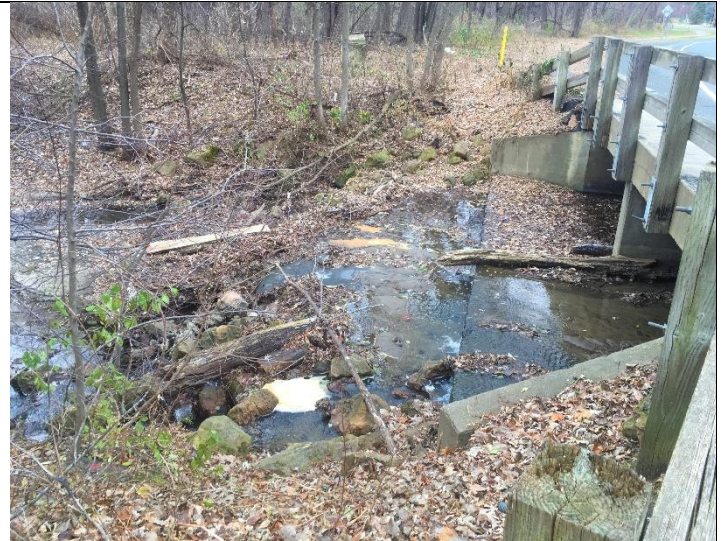
2016 Report: Photo 1 – east view of bridge crossing. Photo 2 – western view of bridge and scour hole.

Nov. 2018 Field Visit: Eastern view of bridge crossing

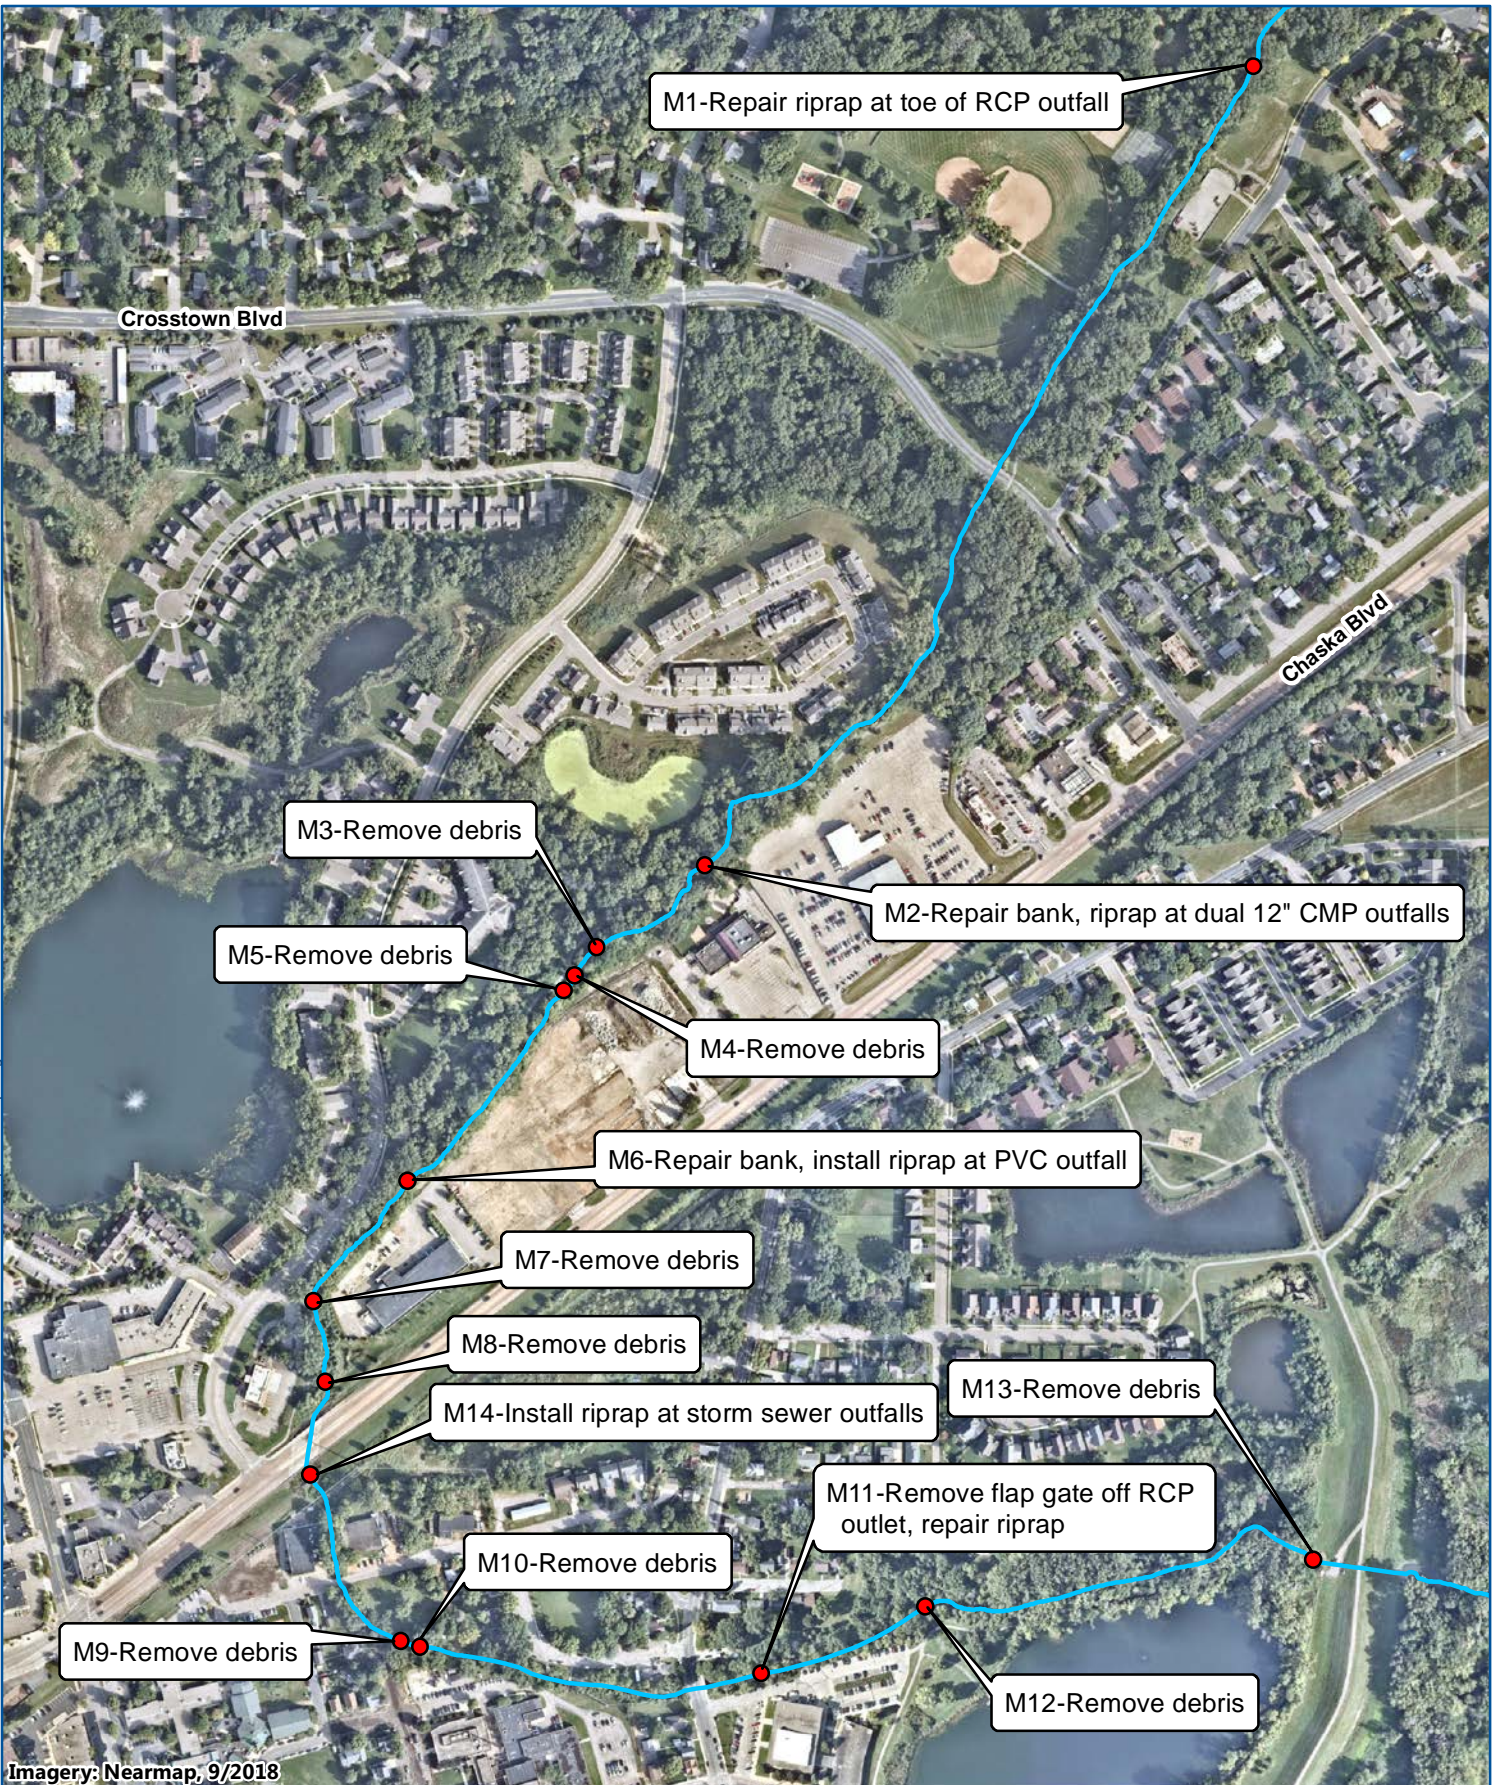
**RECOMMENDED
 MAINTENANCE
 ACTIVITIES**
 East Chaska Creek Project
 Chaska, MN
FIGURE 1

Maintenance No.	Description	Completed Status	Recommendation
M1	Riprap toe at RCP Outfall	No	Complete as planned
M2	Repair bank, riprap at dual 12" diameter CMP outfalls	No	Complete as planned
M3	Remove debris	No	Complete as planned
M4	Remove debris	No	Complete as planned
M5	Remove debris	No	Complete as planned
M6	Repair bank, install riprap at PVC outfall	No	Complete as planned
M7	Remove debris	No	Not necessary
M8	Remove debris	No	Not necessary
M9	Remove debris	No	Not necessary
M10	Remove debris	No	Not necessary

M11	Remove flap gate off RCP outlet, repair riprap	No	Complete as planned
M12	Remove debris	No	Complete as planned
M13	Remove debris and remove material pile on left bank, seed	Yes	N/A
M14	Install riprap at end of storm sewer outfalls	No	Added in 2018

It appeared that one maintenance item (M13) has been completed. Most other previously recommended maintenance tasks (M1, M2, M3, M4, M5, M6, M11, and M12) should still be completed. Of those it should be noted that M12 includes failing riprap with erosion at the site. Also, the debris at M12 is significant enough that it is staging water upstream. Site M14 was added to the list with this assessment as staff observed erosion at the storm sewer outfalls on the downstream side of Chaska Boulevard.

After evaluating photos and field notes, Barr concluded that the maintenance items at M7, M8, M9, and M10 are the lowest priorities, or could be excluded from maintenance activities. Debris is still located at each site and should be removed if it can be done without creating a significant additional disturbance; however, they are minor issues that are not causing significant adverse impacts.

- 1) Add Site M16 to the recommendation maintenance items
- 2) Add Site S4 to the recommended stabilization projects
- 3) Coordinate with the city of Chaska to save money by completing maintenance and stabilization projects at the same time.

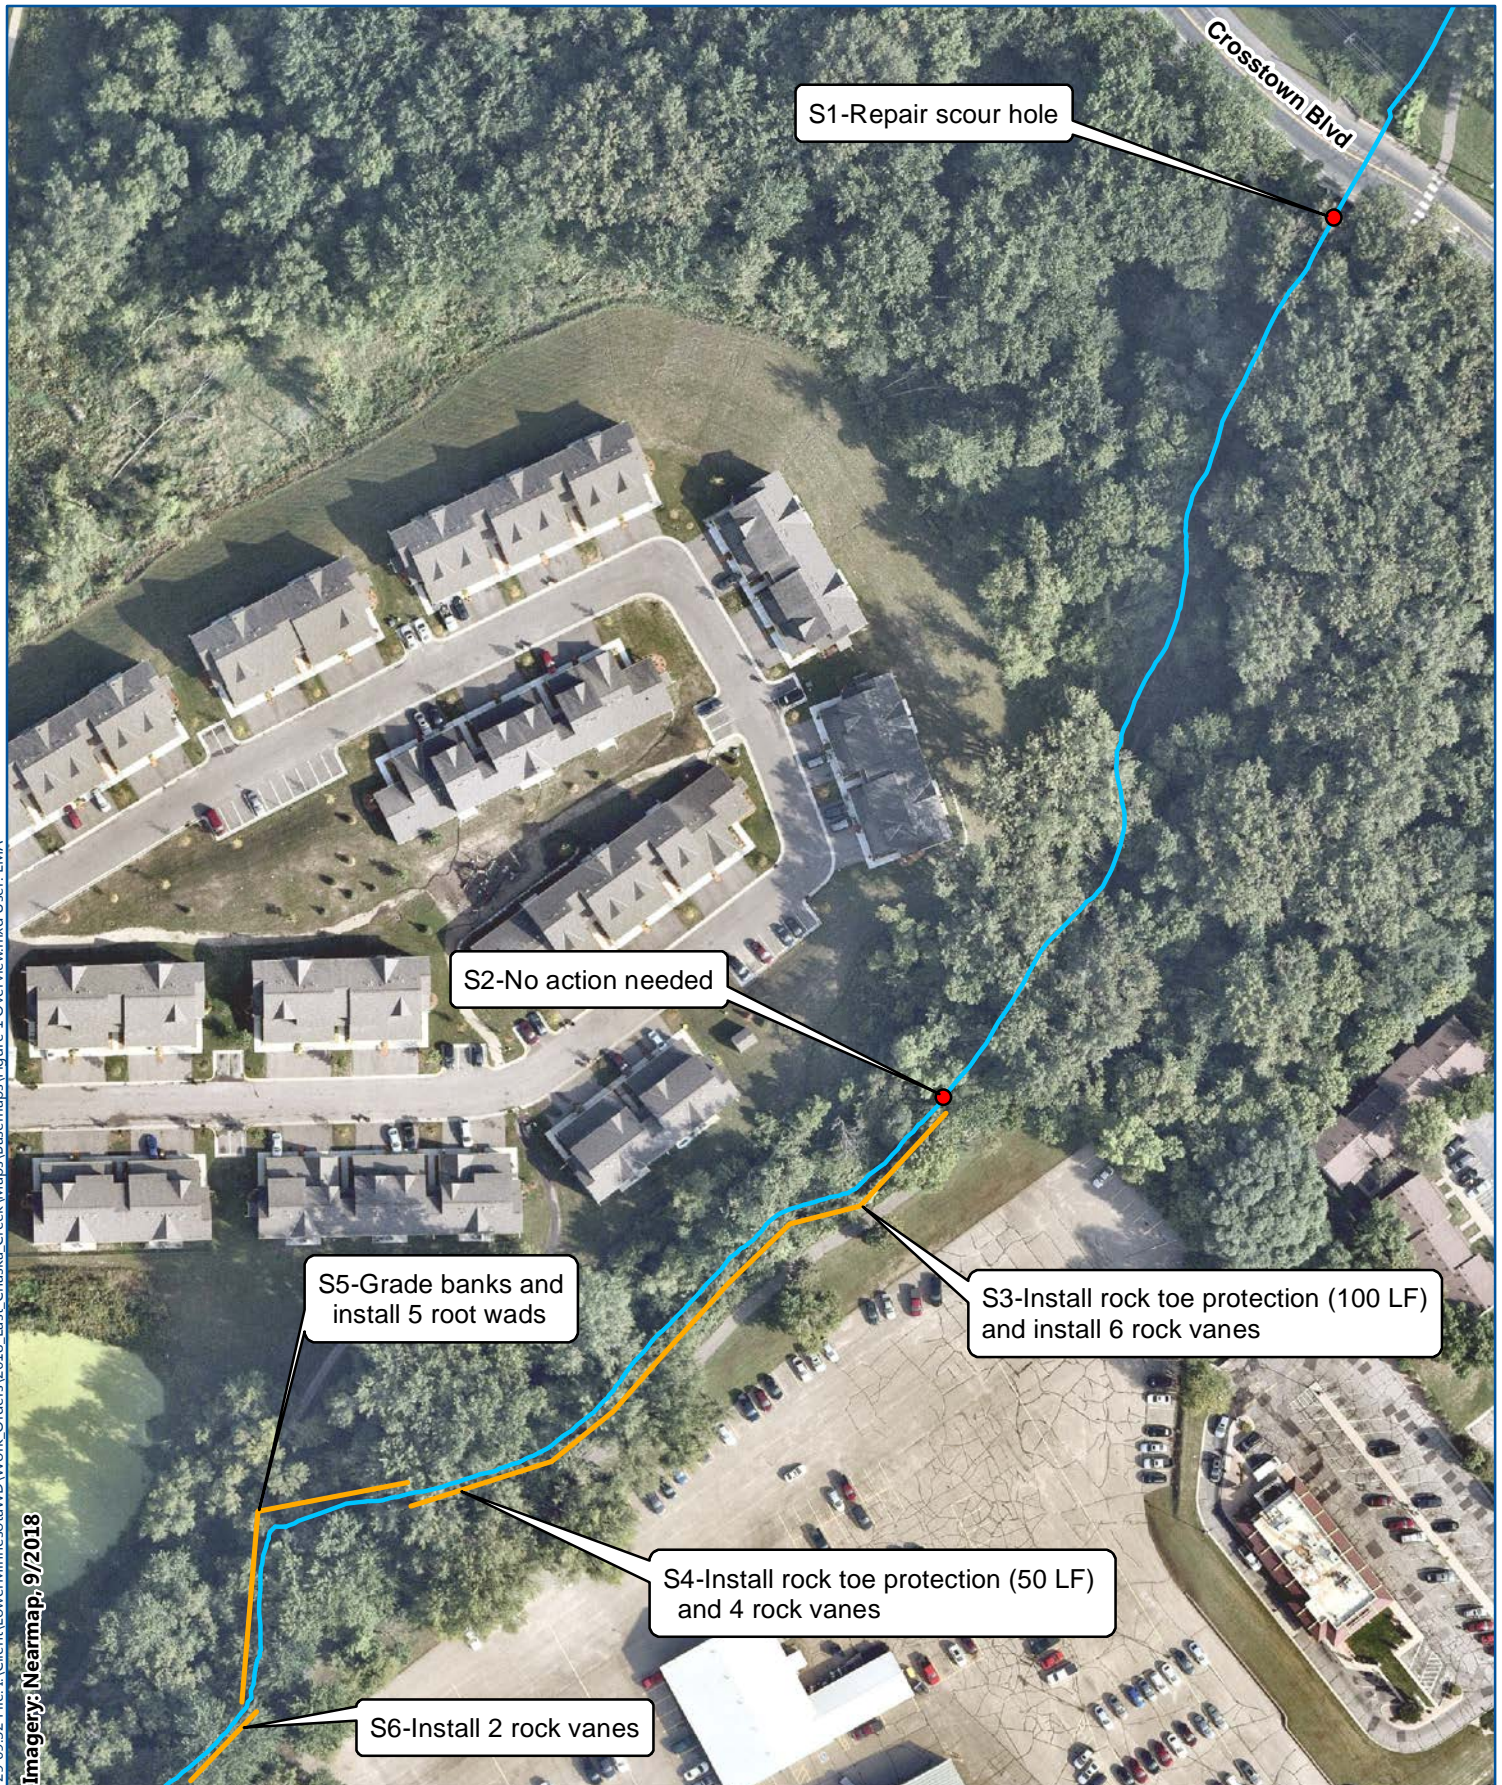
RECOMMENDED CHANNEL STABILIZATION PROJECTS
 East Chaska Creek Project
 Chaska, MN
FIGURE 2

The channel under the Crosstown Boulevard Bridge is lined with concrete so it is wide and flat (Site S1 in Figure 2). The downstream end of the concrete lining is also above the existing channel bed, resulting in a drop of approximately one to two feet. It is possible that the channel downstream developed a headcut that created the drop at this location; however, the banks downstream of the bridge do not have a similar evidence of a headcut moving through the section of stream. In general, the banks are gradually sloping and appear to be at a reasonable height compared to the stream. If a headcut came through this section, the impacts of the headcut appear to have self-mitigated downstream of the bridge. Alternatively, it is also possible that the bridge was originally installed with an elevation drop at the downstream end.

Regardless of the cause, the current situation has a handful of issues that should be mitigated. The main issue present is primarily caused by the fact that the wide, flat concrete lining disperses flow along the entire width of the channel bottom at a nearly even depth, and it spills over the end of the lining like a weir. This results in bank erosion and an over-widened channel for approximately 20-30 feet downstream of the bridge. Furthermore, the combination of the elevation drop and the flat, sheet flow through the bridge also create a barrier for aquatic organism passage.

There are multiple eroding banks within this reach (Sites S2 – S6, Figure 2) that threaten the City's paved trail located between the channel and the Lenzen Chevrolet parking lot. The creek appears to be developing point bars and a meandering pattern through this reach that is otherwise relatively straight. Given the man-made origins of the channel, the original channel may have been created too large for the flows it currently experiences in this location, so a smaller, meandering pattern appears to be developing within the larger channel.

The 2016 report recommended salvaging the existing riprap, regrading, reinstalling riprap, and adding some additional riprap. Barr concurs that this approach is likely the most cost effective option with the following considerations:

- 1) The design of the riprap at the end of the bridge should try to eliminate the weir flow at the end of the bridge and direct flow into a channel width that mimics the channel width downstream of the bridge. Eliminating the weir flow will reduce erosive pressure on the banks immediately downstream of the bridge. There are multiple ways of achieving this that will depend on other design parameters related to the bridge hydraulics.

- 2) Given the elevation drop from the end of the bridge to the existing channel, the design should plan to incorporate a scour hole at the end of riprap. Scour holes naturally occur downstream of elevation drops in streams, so a scour hole is likely to develop anyway. Incorporating it into the design will reduce the risk of adverse impacts.

- 3) If possible, riprap at the end of the bridge should extend above the bottom of the bridge to create additional flow depth to provide for aquatic organism passage. Bridge flow capacity and hydraulics will determine if this is possible.

After reviewing the site, Barr concurs that all of the erosion sites should be stabilized, and we concur with the recommendation to remove temporary asphalt repairs. The armoring and toe protection previously recommended would be effective. The previously recommended grade control structure (S2, Figure 2) can be eliminated because headcutting does not appear to be an issue within this reach.

Alternatively, other stabilization measures could be used to achieve the same goals. Toe protection with riprap is still the most effective option in some places; however, rock vanes and root wads would be used in many locations to provide bank protection at a lower cost. The following table provides a comparison of the 2016 recommendations and alternatives considered in this analysis.

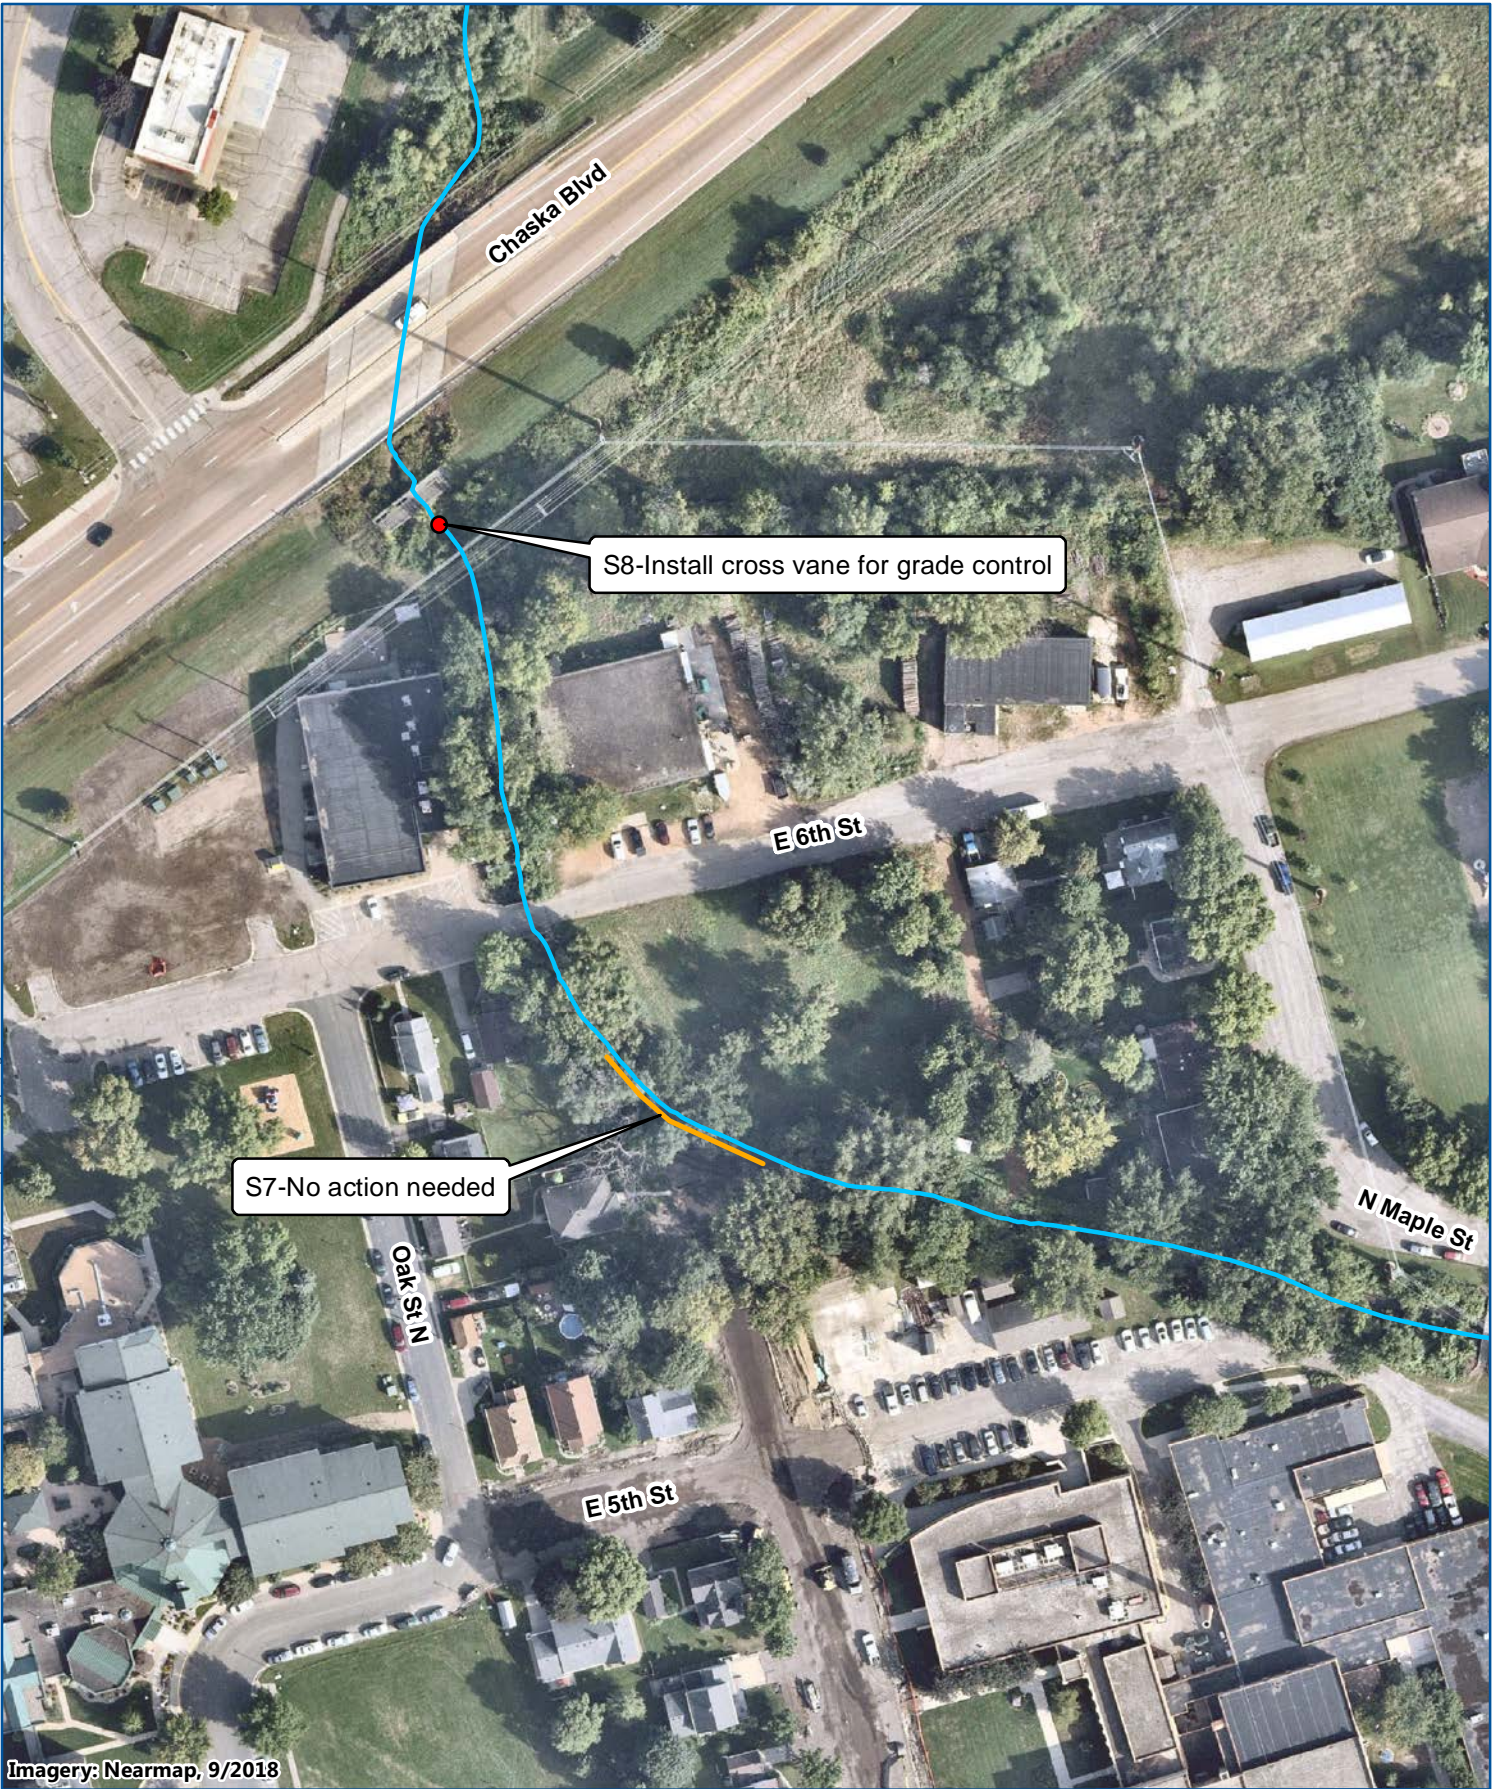
**RECOMMENDED
 CHANNEL STABILIZATION
 PROJECTS**
 East Chaska Creek Project
 Chaska, MN
FIGURE 3

The original recommendation included installing toe protection for approximately 120 feet of the right bank (Figure 3). The 2018 assessment found that the City had recently completed some stabilization work

on this site, including grading and revegetating the bank. As a result, Barr recommends not completing additional stabilization work in this area.

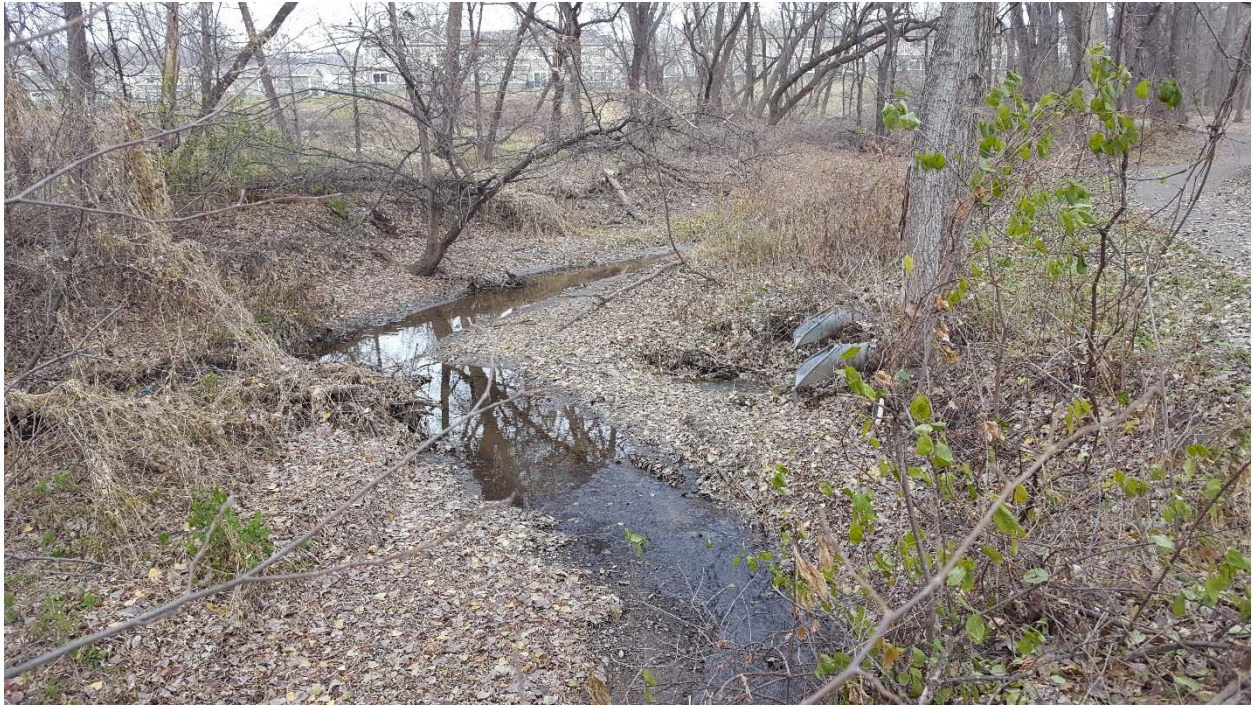
Photo 1: Site M2 –erosion around culvert outfalls.
