LOWER MINNESOTA RIVER WATERSHED DISTRICT

SITE LOCATION: East Chaska Creek Project Area - Chaska, MN

PURPOSE: Review Current Site Conditions of Project Area and Compare to 2016 Report Conducted by Burns & McDonnell (B&M)

To: Della Schall Young, Principal, Young Environmental Consulting Group, LLC
Linda Loomis, Administrator, Lower Minnesota River Watershed District
From: Jeff Weiss, PE, Senior Water Resources Engineer
Adam Howard, PE, Water Resources Engineer
Subject: East Chaska Creek Assessment
Date: December 10, 2018
Project: 23101028.02

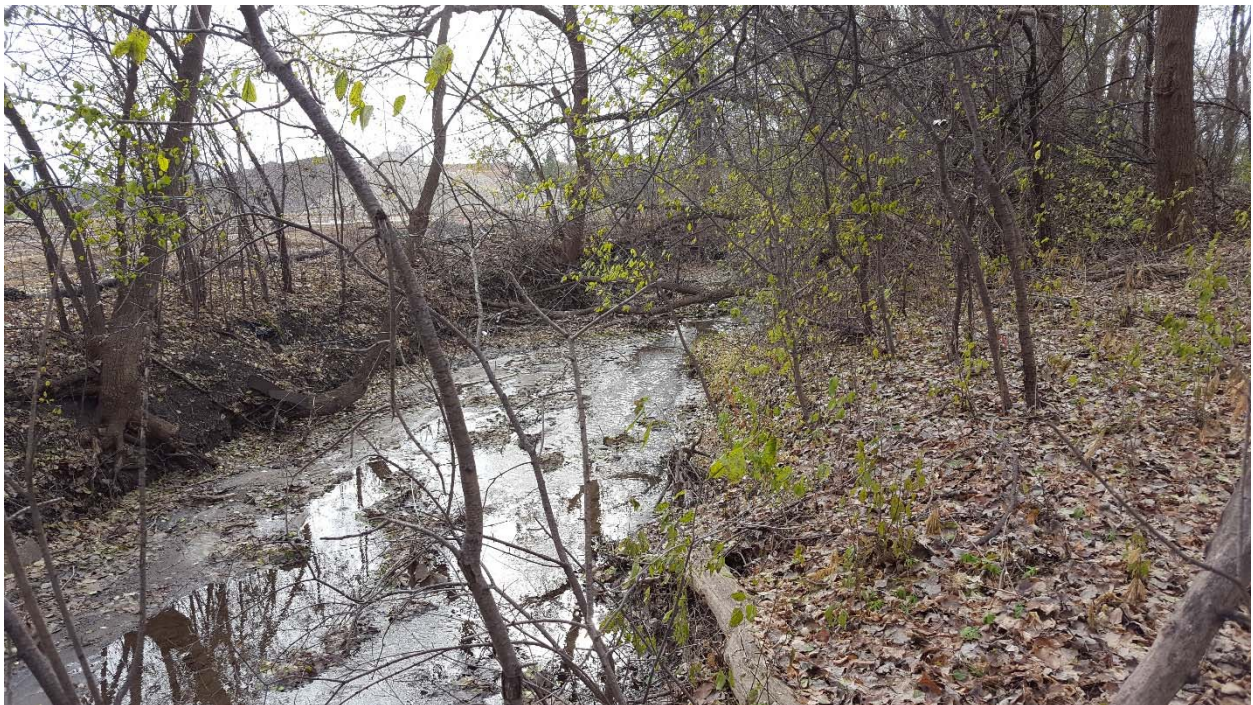
Photo 2: Site M3 – debris in channel creating blockage and minor erosion

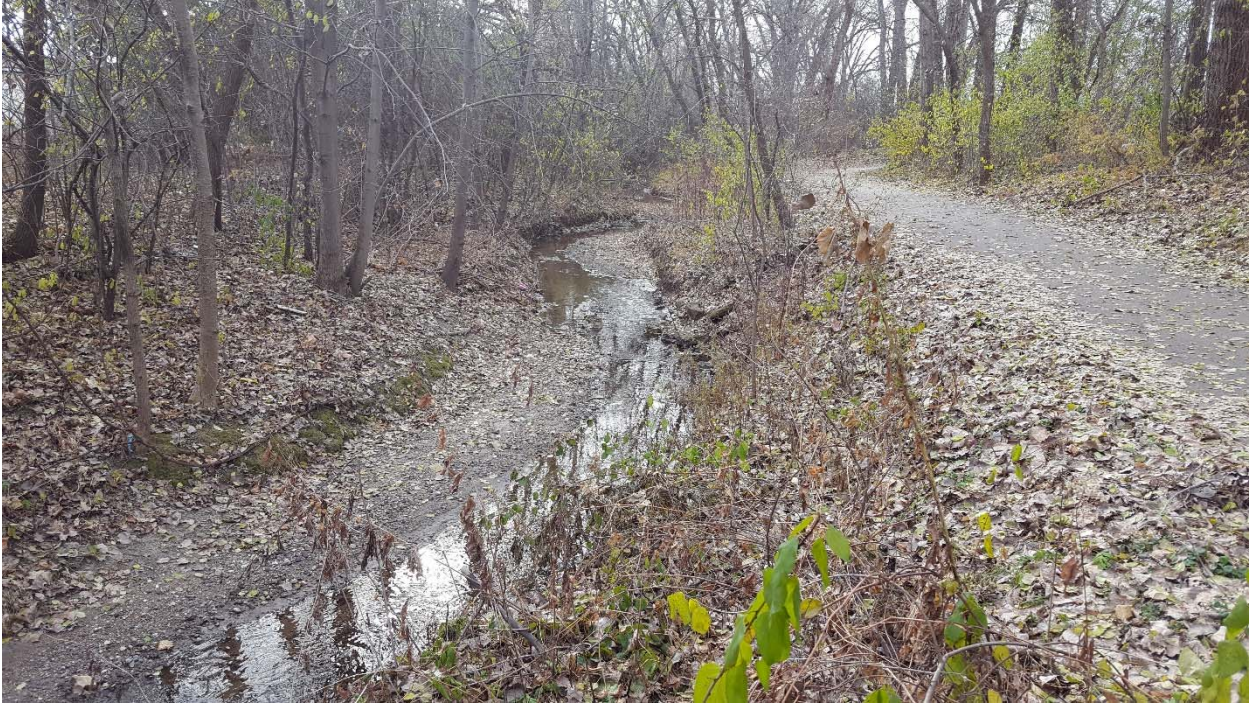
Photo 3: Site M6 – bank erosion adjacent to a PVC outfall

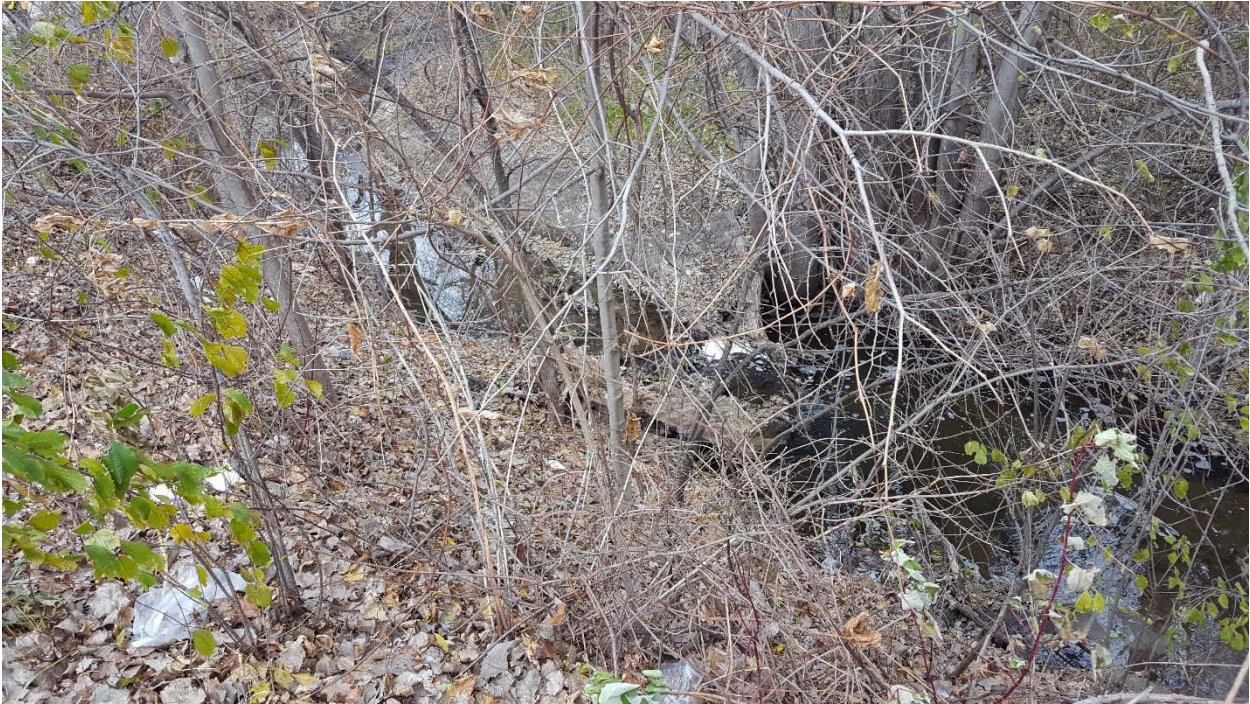
Photo 4: Site M7 – debris in channel causing blockage

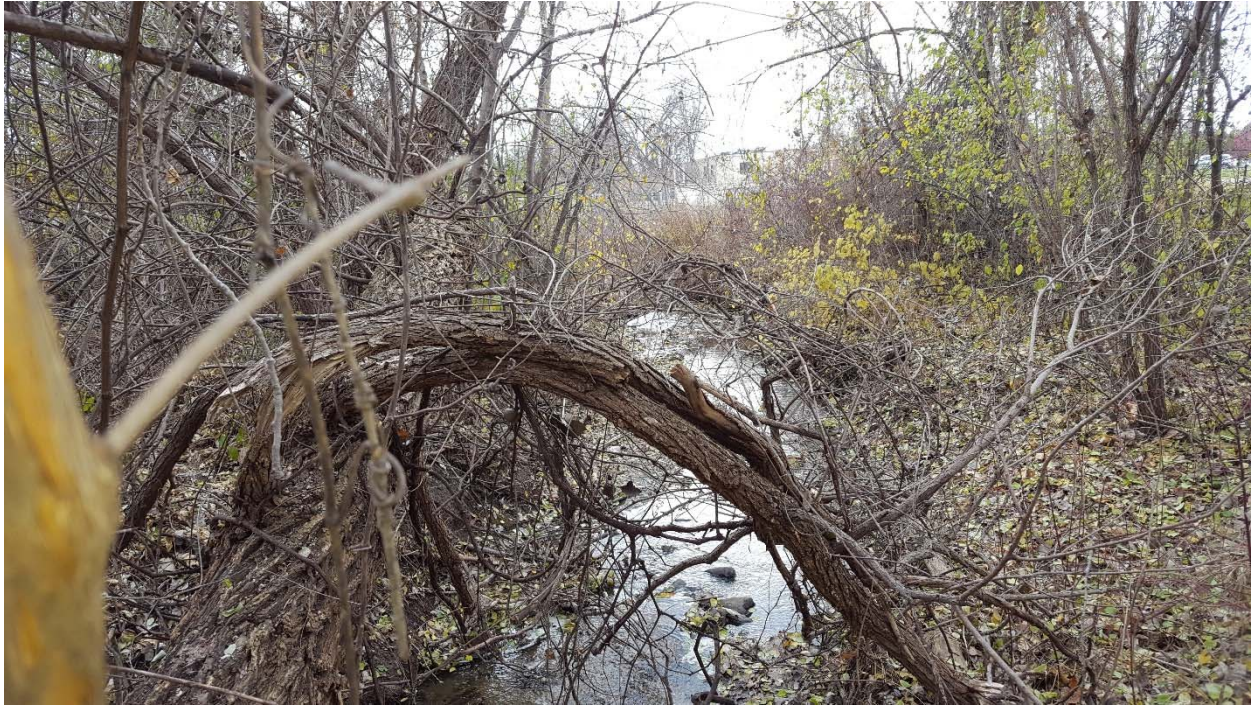
Photo 5: Site M8 – debris in channel

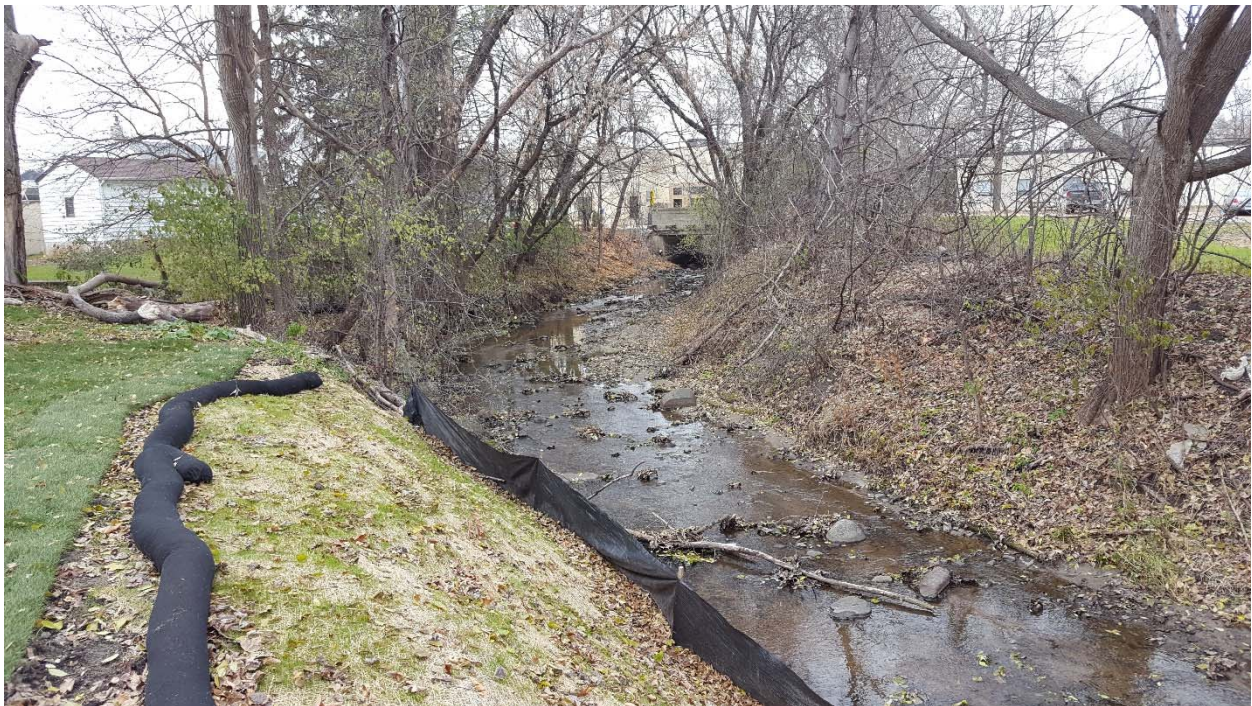
Photo 6: Site M9 – debris in channel upstream of site repaired by city of Chaska

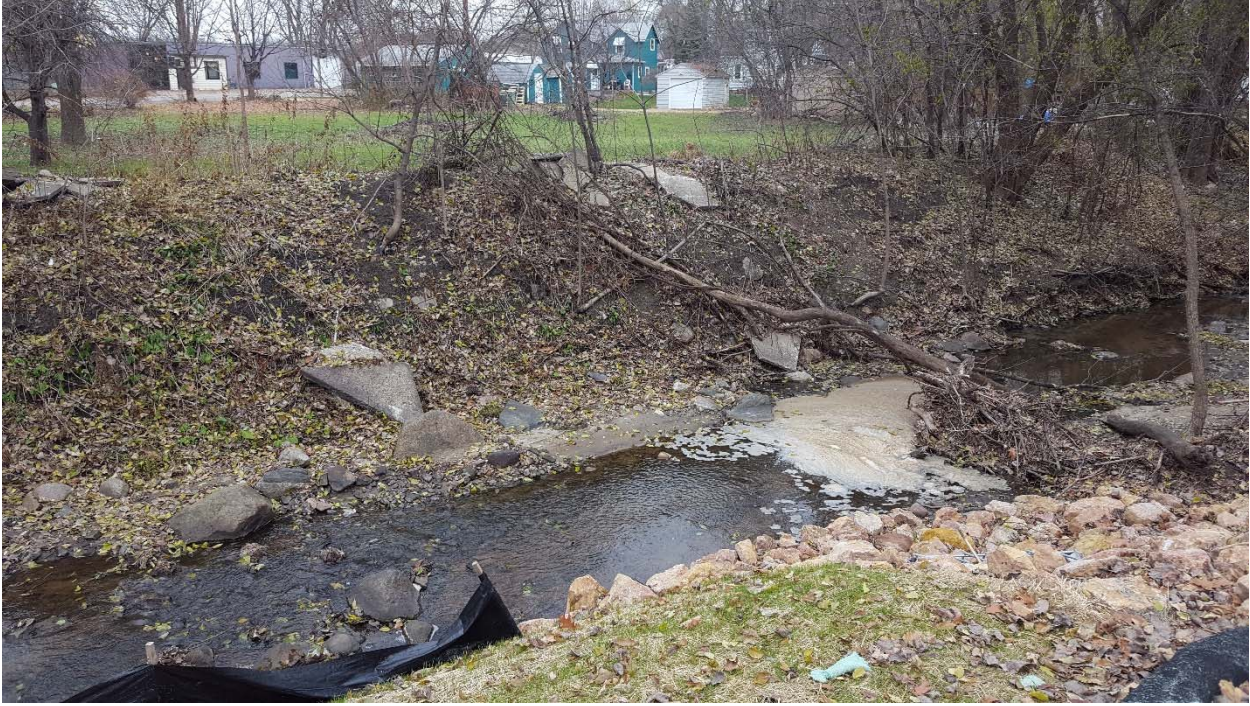
Photo 7: Site M10 – debris in channel downstream of site repaired by city of Chaska

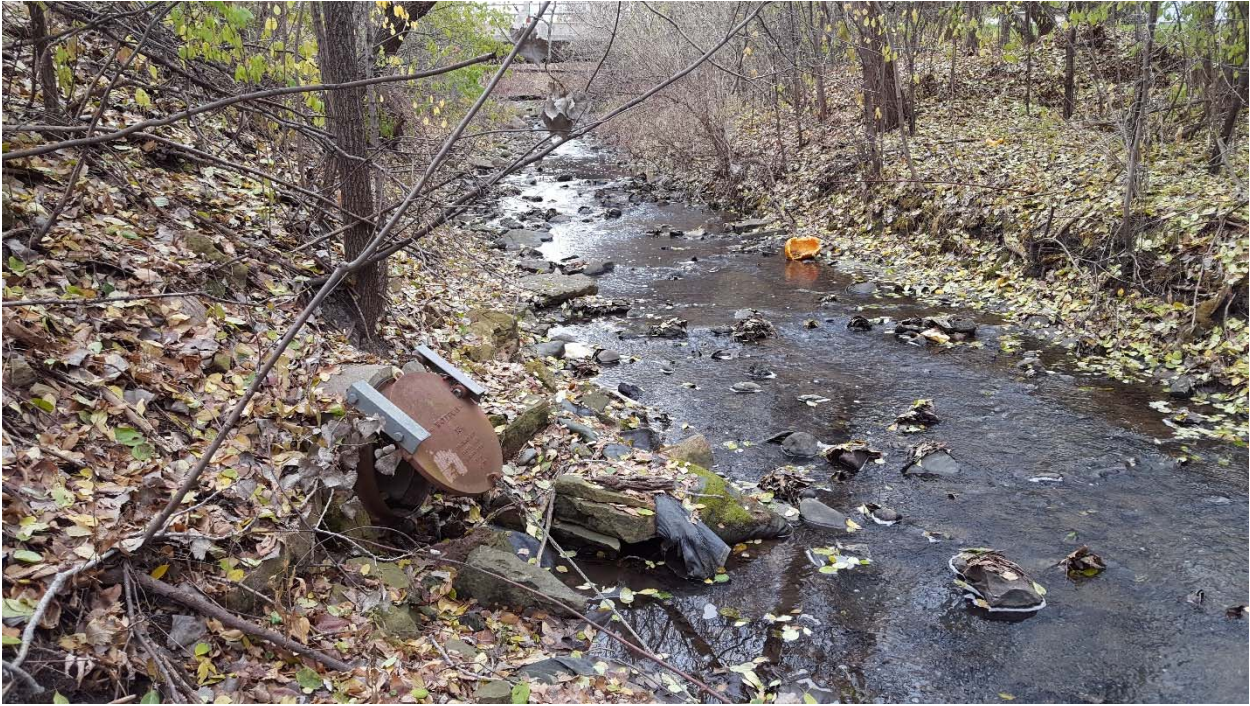
Photo 8: Site M11 – flap on RCP outlet and minor bank erosion

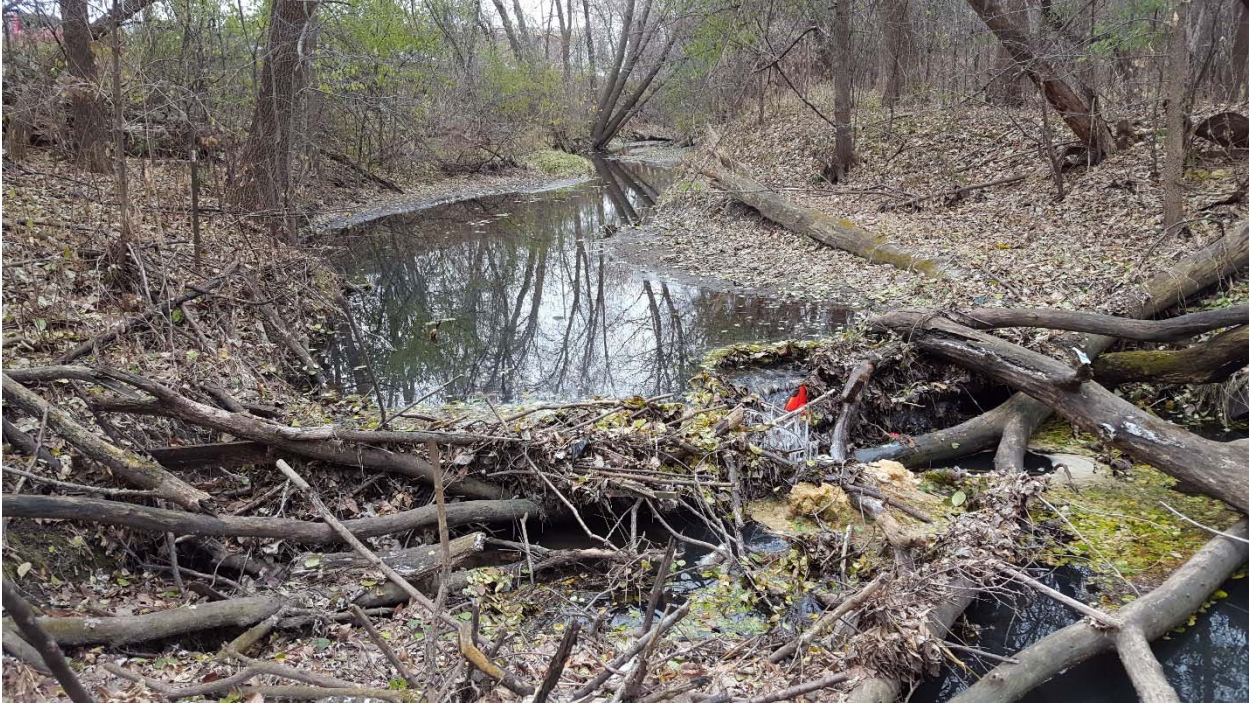
Photo 9: Site M12 – debris jam causing blockage and backwater

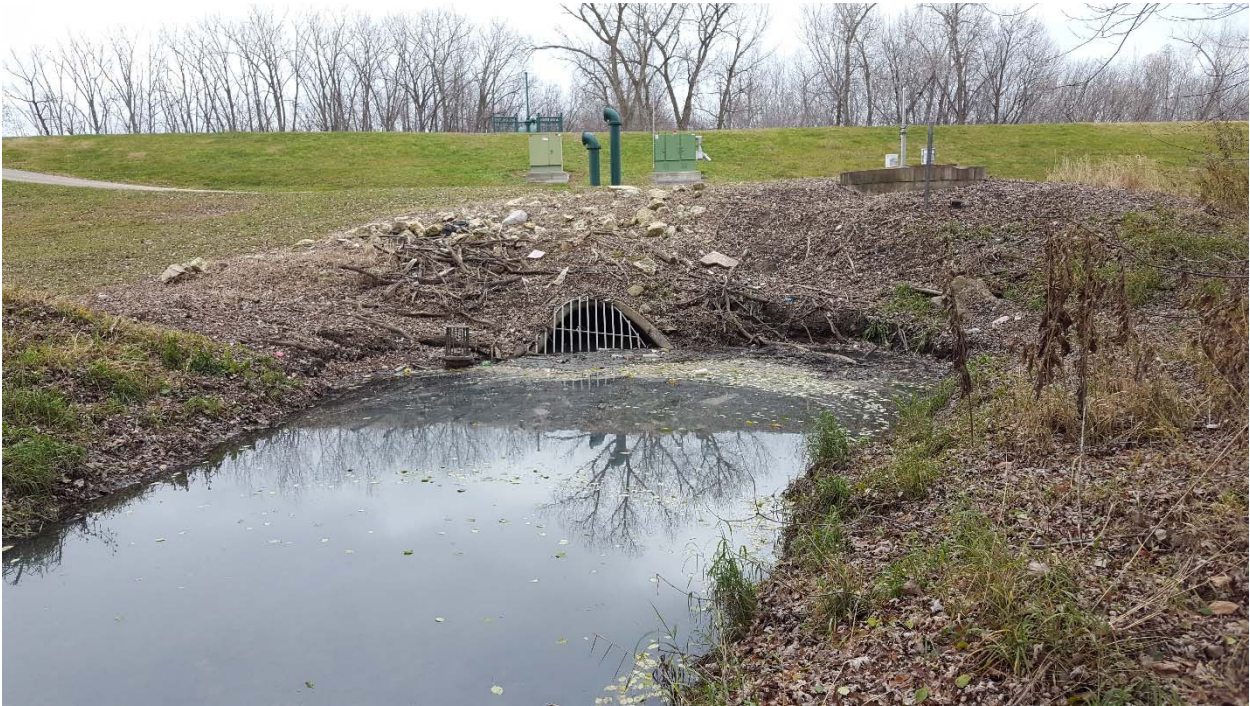
Photo 10: Site M13 – culvert outlet through the levee.

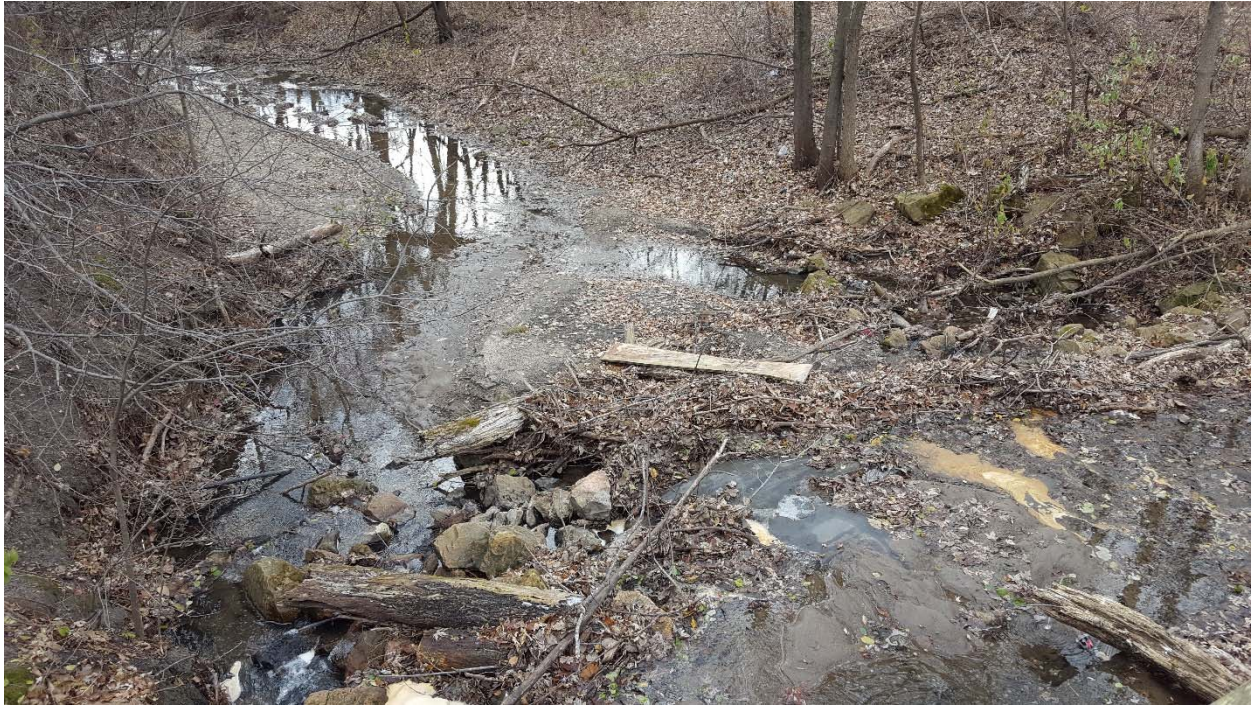
The channel under the Crosstown Boulevard Bridge is lined with concrete so it is wide and flat (Site S1 in Figure 2). The downstream end of the concrete lining is also above the existing channel bed, resulting in a drop of approximately one to two feet. It is possible that the channel downstream developed a headcut that created the drop at this location; however, the banks downstream of the bridge do not have a similar evidence of a headcut moving through the section of stream. In general, the banks are gradually sloping and appear to be at a reasonable height compared to the stream. If a headcut came through this section, the impacts of the headcut appear to have self-mitigated downstream of the bridge. Alternatively, it is also possible that the bridge was originally installed with an elevation drop at the downstream end.

Regardless of the cause, the current situation has a handful of issues that should be mitigated. The main issue present is primarily caused by the fact that the wide, flat concrete lining disperses flow along the entire width of the channel bottom at a nearly even depth, and it spills over the end of the lining like a weir. This results in bank erosion and an over-widened channel for approximately 20-30 feet downstream of the bridge. Furthermore, the combination of the elevation drop and the flat, sheet flow through the bridge also create a barrier for aquatic organism passage.

Photo 11: Site S1 – scour hole and erosion downstream of Crosstown Boulevard

The 2016 report recommended salvaging the existing riprap, regrading, reinstalling riprap, and adding some additional riprap. Barr concurs that this approach is likely the most cost effective option with the following considerations:

- 1) The design of the riprap at the end of the bridge should try to eliminate the weir flow at the end of the bridge and direct flow into a channel width that mimics the channel width downstream of the bridge. Eliminating the weir flow will reduce erosive pressure on the banks immediately downstream of the bridge. There are multiple ways of achieving this that will depend on other design parameters related to the bridge hydraulics.

- 2) Given the elevation drop from the end of the bridge to the existing channel, the design should plan to incorporate a scour hole at the end of riprap. Scour holes naturally occur downstream of elevation drops in streams, so a scour hole is likely to develop anyway. Incorporating it into the design will reduce the risk of adverse impacts.

- 3) If possible, riprap at the end of the bridge should extend above the bottom of the bridge to create additional flow depth to provide for aquatic organism passage. Bridge flow capacity and hydraulics will determine if this is possible.

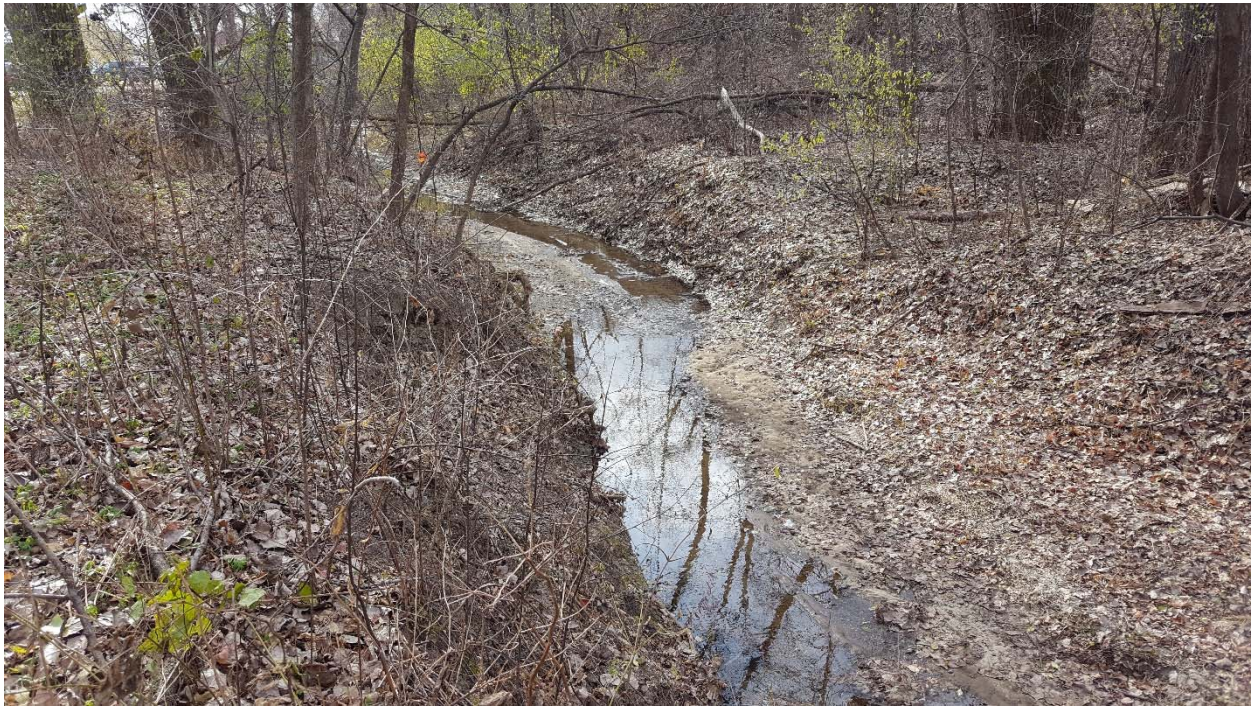
Photo 12: Channel near site S2

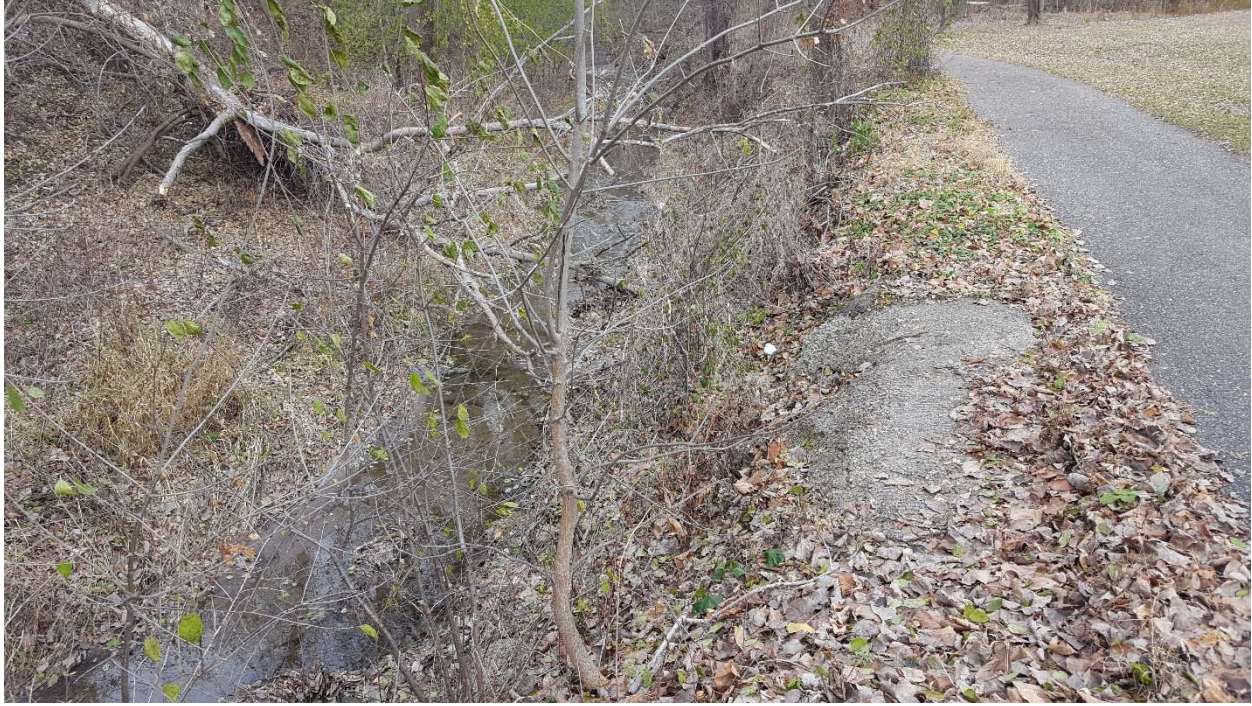
Photo 13: Site S3 – eroding bank between channel and paved trail near Lenzen Chevrolet

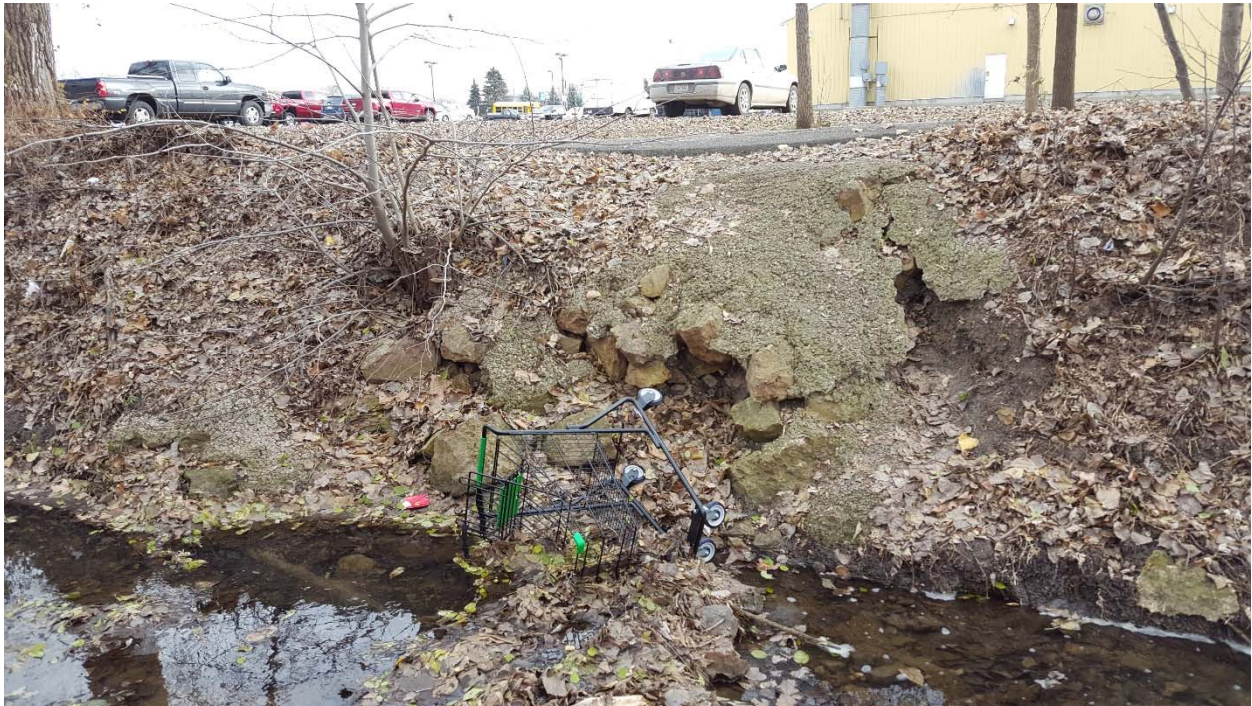
Photo 14: Site S4 – eroding bank and debris in the channel

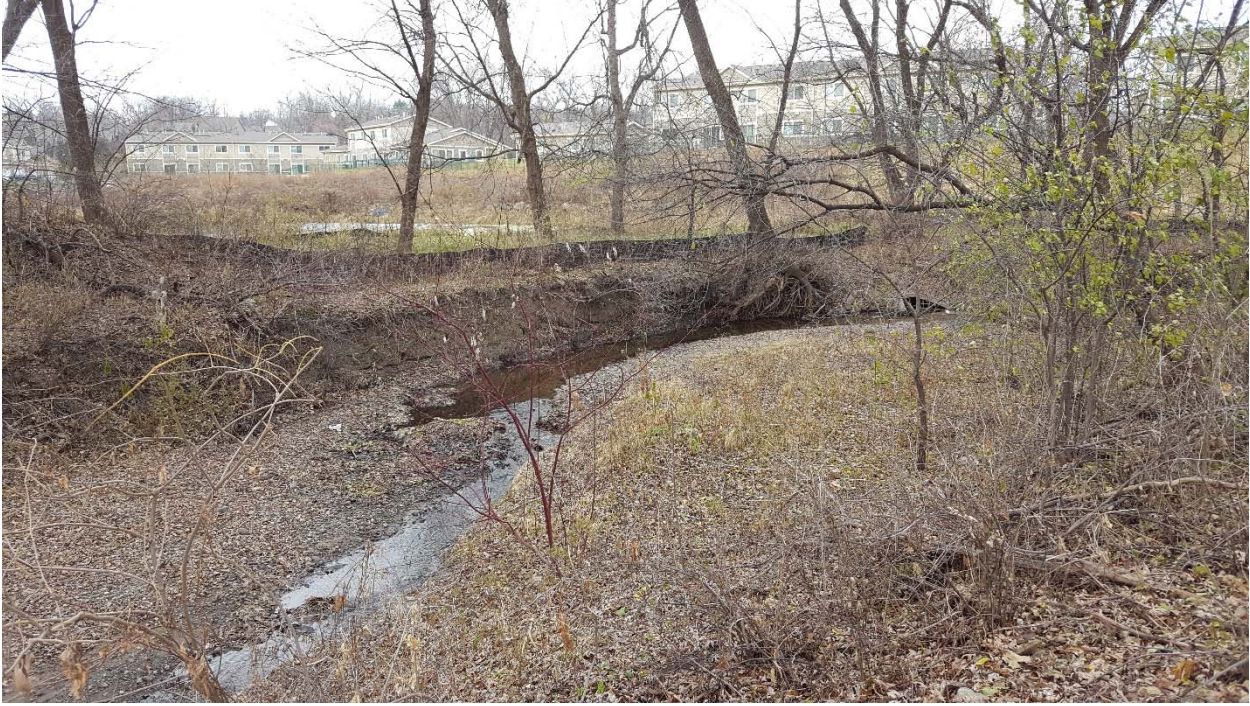
Photo 15: Site S5 – eroding bank and undercut trees

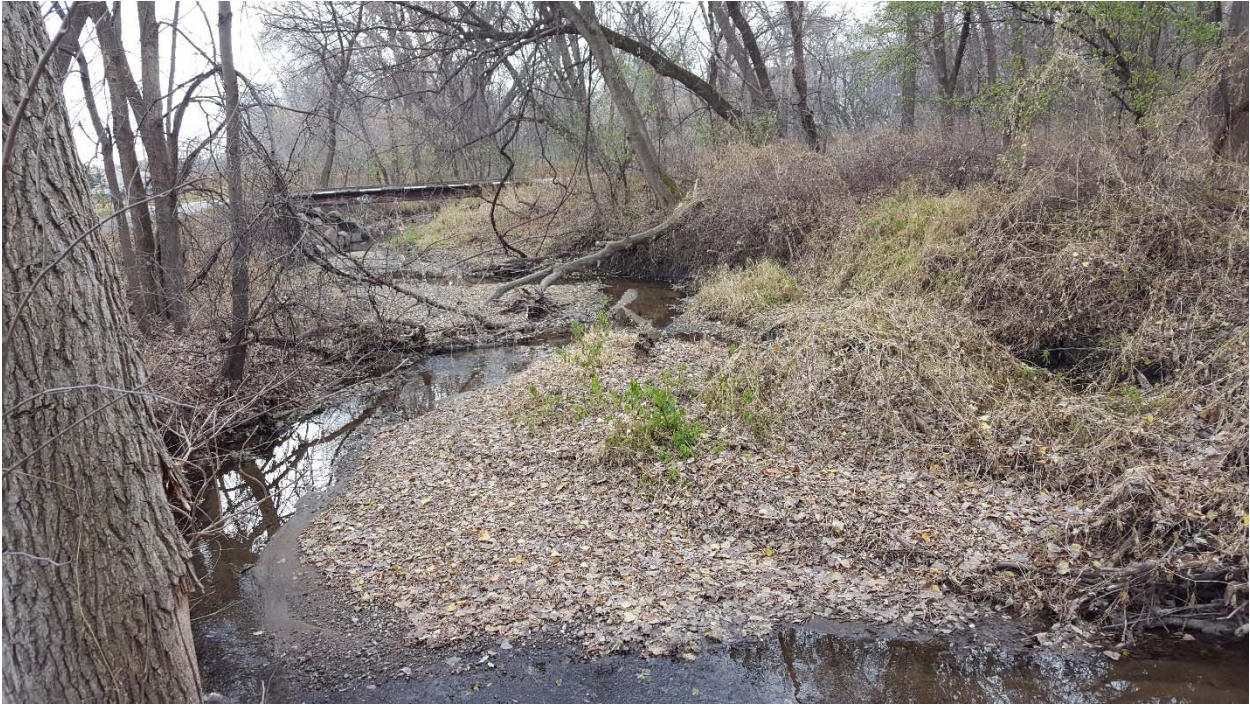
Photo 16: Site S6 – minor bank erosion downstream on Lenzen Chevrolet

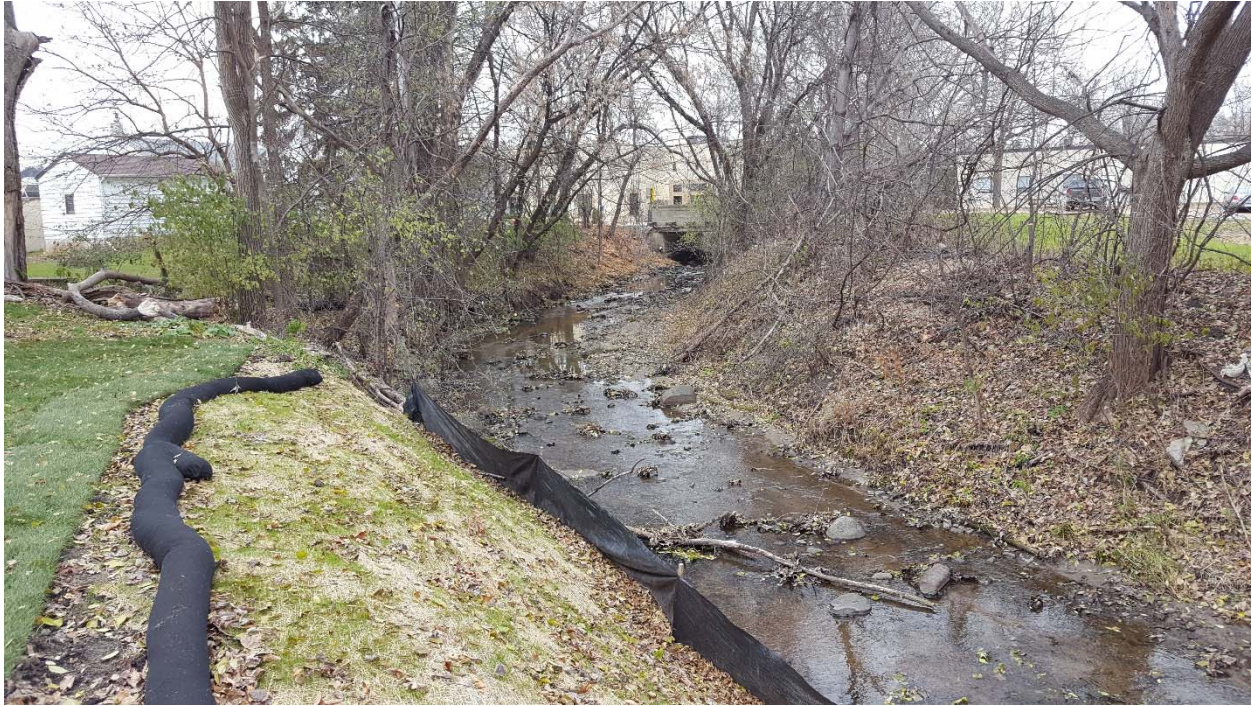
Photo 17: Site S7 – recent repairs made by city of Chaska

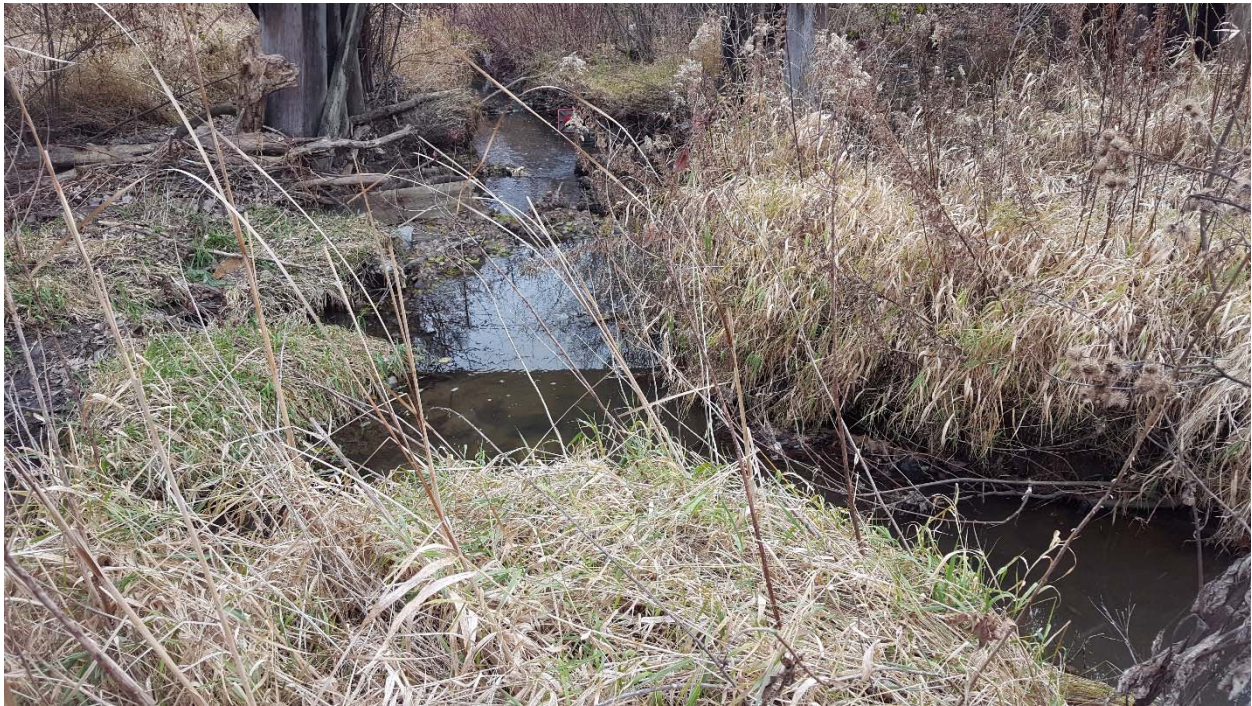
A new recommended stabilization measure is to still a cross vane downstream of the old railroad bridge on the downstream side of Chaska Boulevard. We observed two small headcuts in this area, and a cross vane would provide grade control to reduce the risk of upstream migration. This is also in the vicinity of the new maintenance recommendation, so it may be possible to coordinate the maintenance and stabilization measures.

Photo 18: Site S8 – Two small headcuts in the channel between Chaska Boulevard and the old railroad bridge
