East Chaska Creek Restoration Project

**East Chaska Creek Restoration Project
Project No. 86550**

February 2016

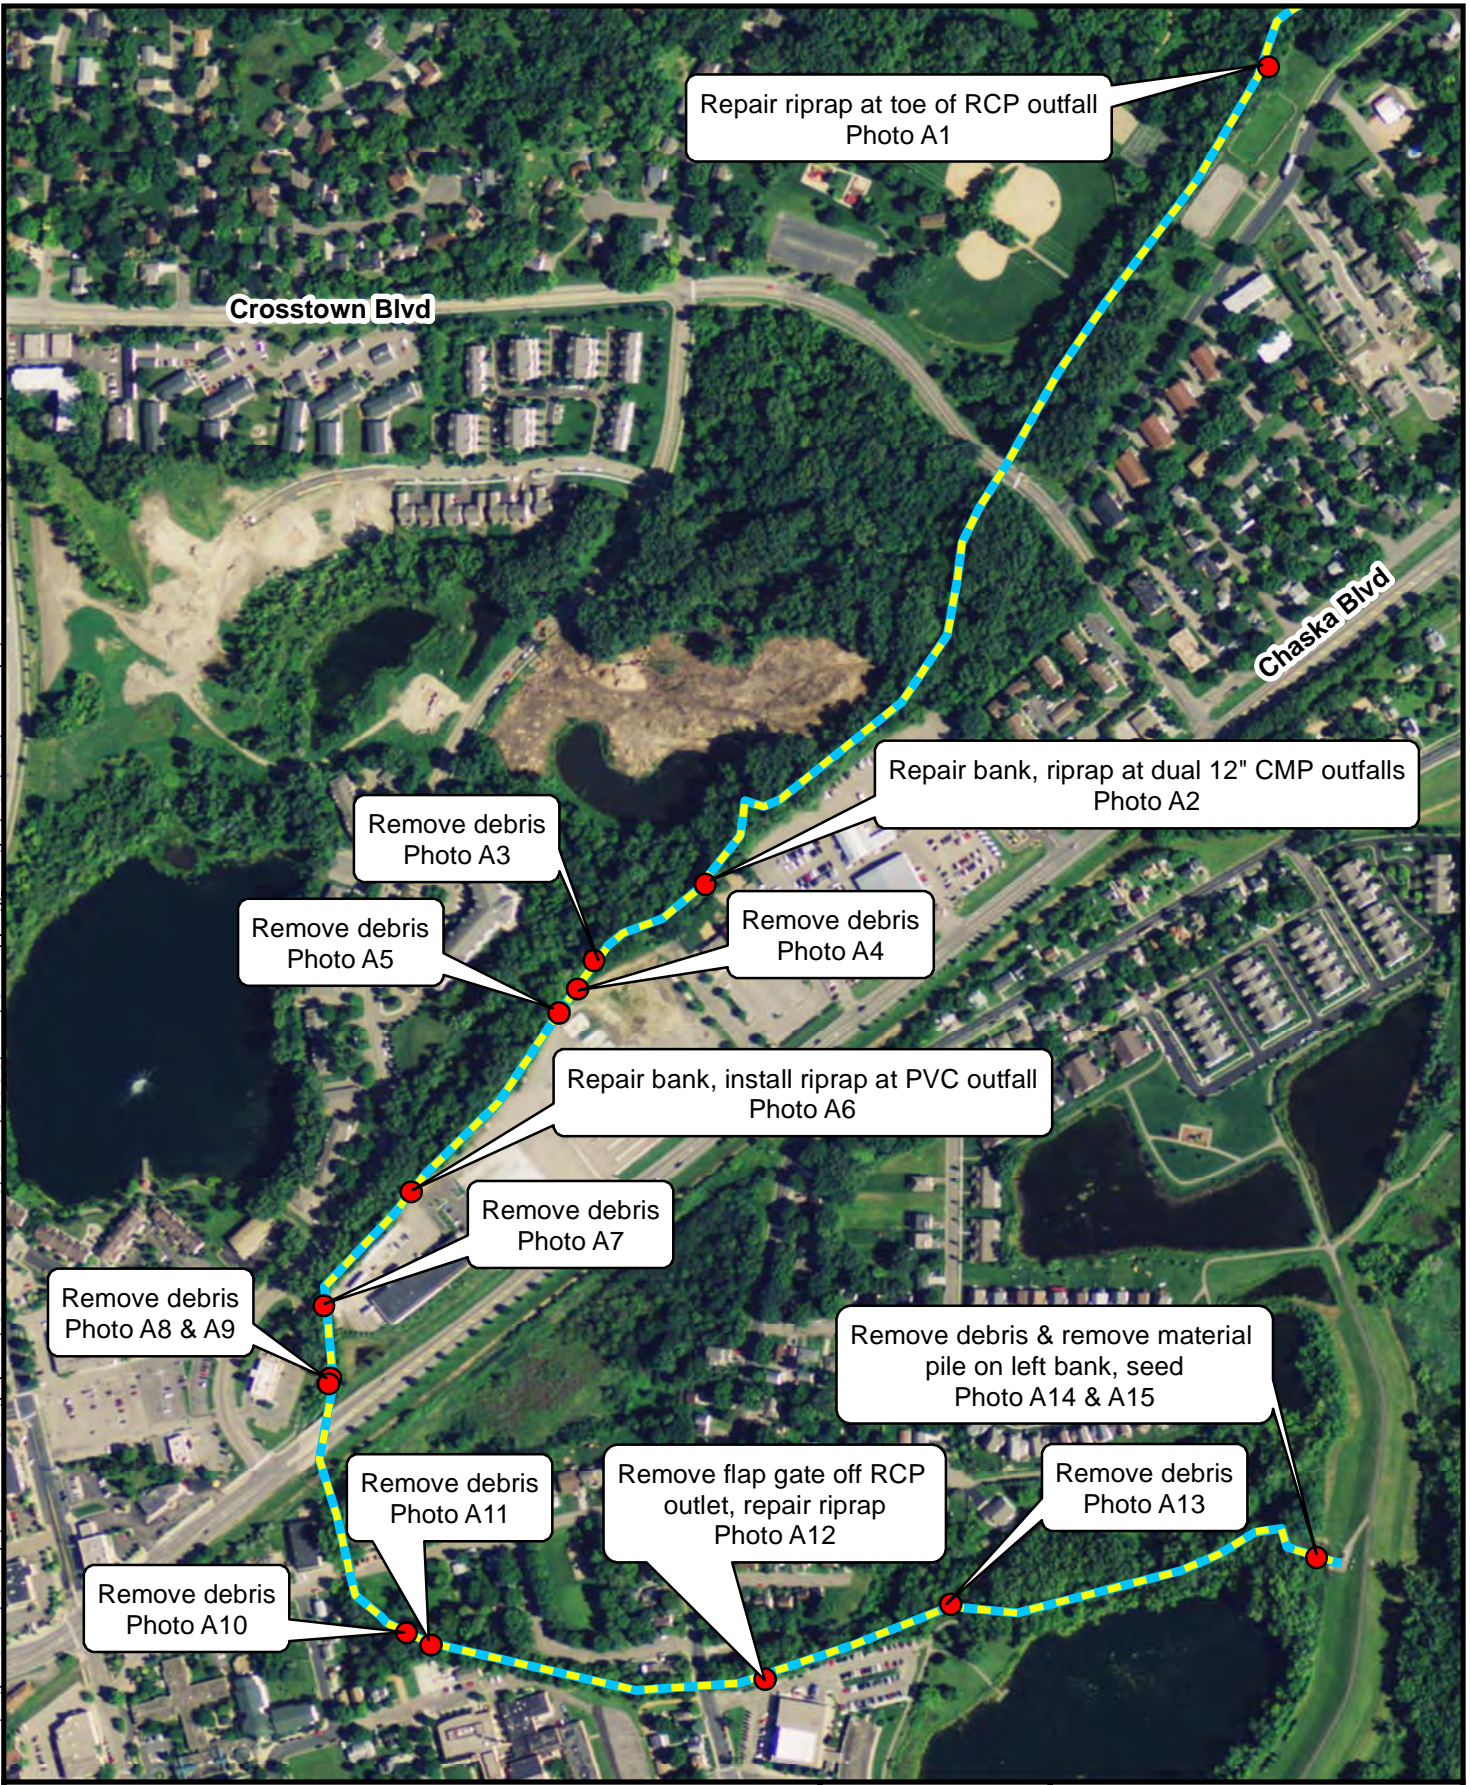
Figure 4
 Recommended Maintenance Activities
 East Chaska Creek Project
 Chaska, Minnesota

The following maintenance activities are recommended for the City to undertake. Since these activities will be undertaken by City staff, no cost estimates were prepared. Figure 4 (Appendix A) shows the locations of these activities, and Appendix C contains photographs of each location (Photographs A1 – A15). In general, these maintenance activities include:

- Removal of debris to maintain the channel capacity and to prevent larger debris jams at road crossings.
- Point repair of stormwater outfalls with riprap to prevent future erosion and to protect outfalls.
- Removal of consolidated sediment at most downstream area near the levee and reseeded of the area to stabilize the lower end of the stream.

These maintenance activities should be done as soon as possible to prevent more costly future improvement caused by lack of maintenance. The lower end of the Creek should be checked routinely for signs of sedimentation upstream of the 84-inch RCP through the levee. Following any flood fighting activities, the sediment and debris removed from the creek should be hauled away from the site and the overbanks reseeded.

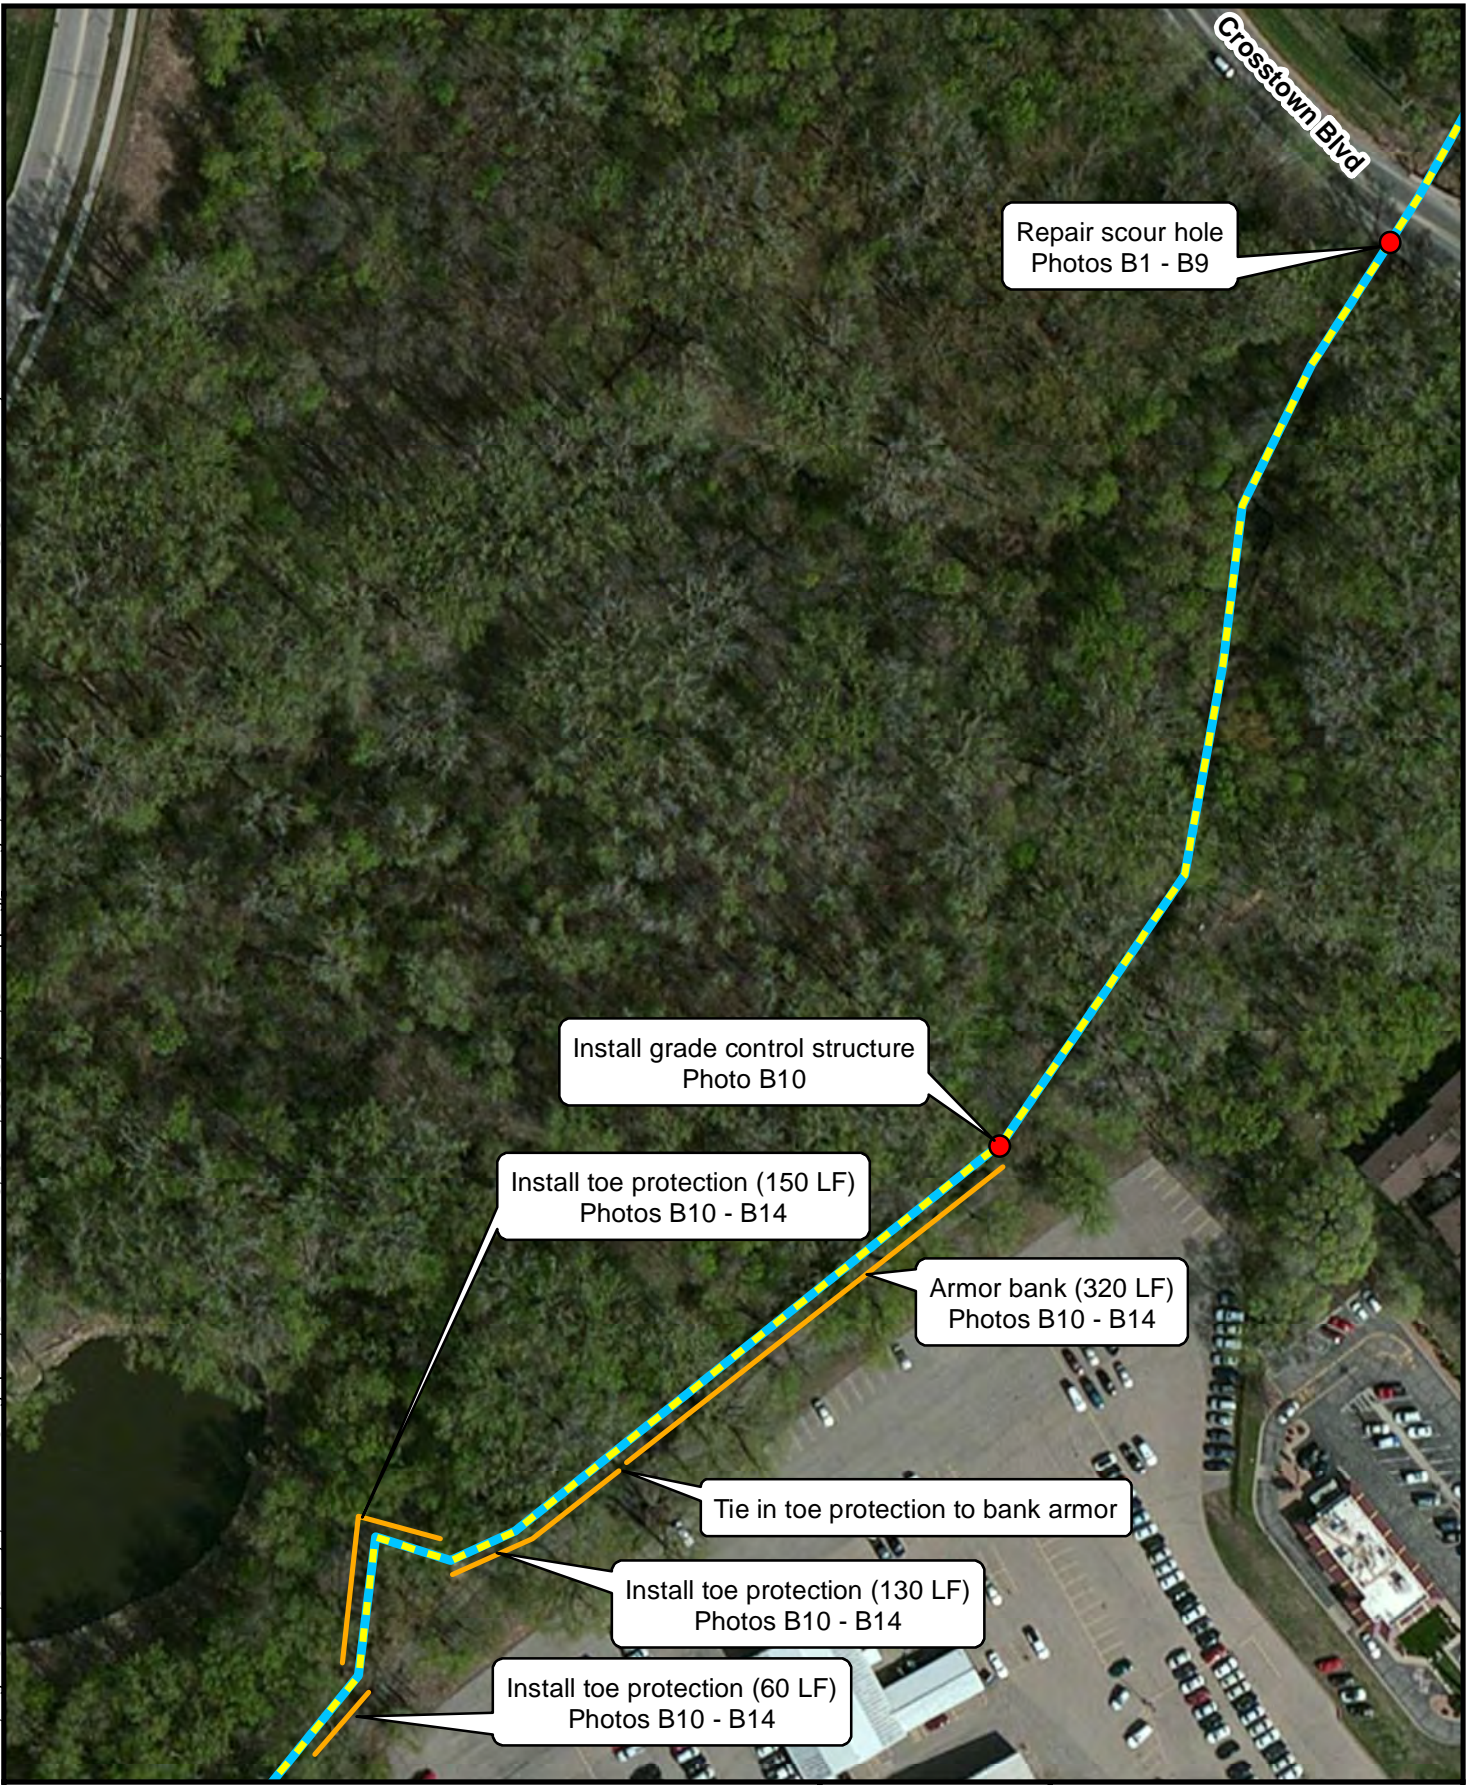
Figure 5
 Recommended Channel Stabilization Projects
 East Chaska Creek Project
 Chaska, Minnesota

This recommended creek improvement consists of repairing the scour hole downstream of Crosstown Boulevard Bridge; the scour hole has been caused by the creek downcutting to this point (Appendix A, Figure 5). The scour hole is approximately 30 feet wide, 10 feet long, and 3 feet deep (Photographs B1 – B9). Repair would consist of salvaging existing riprap, re-grading the channel downstream of the structure apron, and re-installing filter fabric and riprap.

This project consists of repairing bank erosion which threatens the City's paved trail as well as two large cottonwood trees behind Lenzen Chevrolet (Appendix A, Figure 5). The channel through this reach is approximately 6 to 7 feet deep. Two temporary asphalt repairs have been implemented in this location, but the repairs have subsequently failed (Photographs B10 – B14). A grade control structure would also be installed to prevent potential channel downcutting upstream to Crosstown Boulevard. Repairs would consist of removal of temporary asphalt repairs, complete bank hard armoring for approximately 320 linear feet along the left bank, toe protection for approximately 340 linear feet on the left and right banks, and a grade control structure.

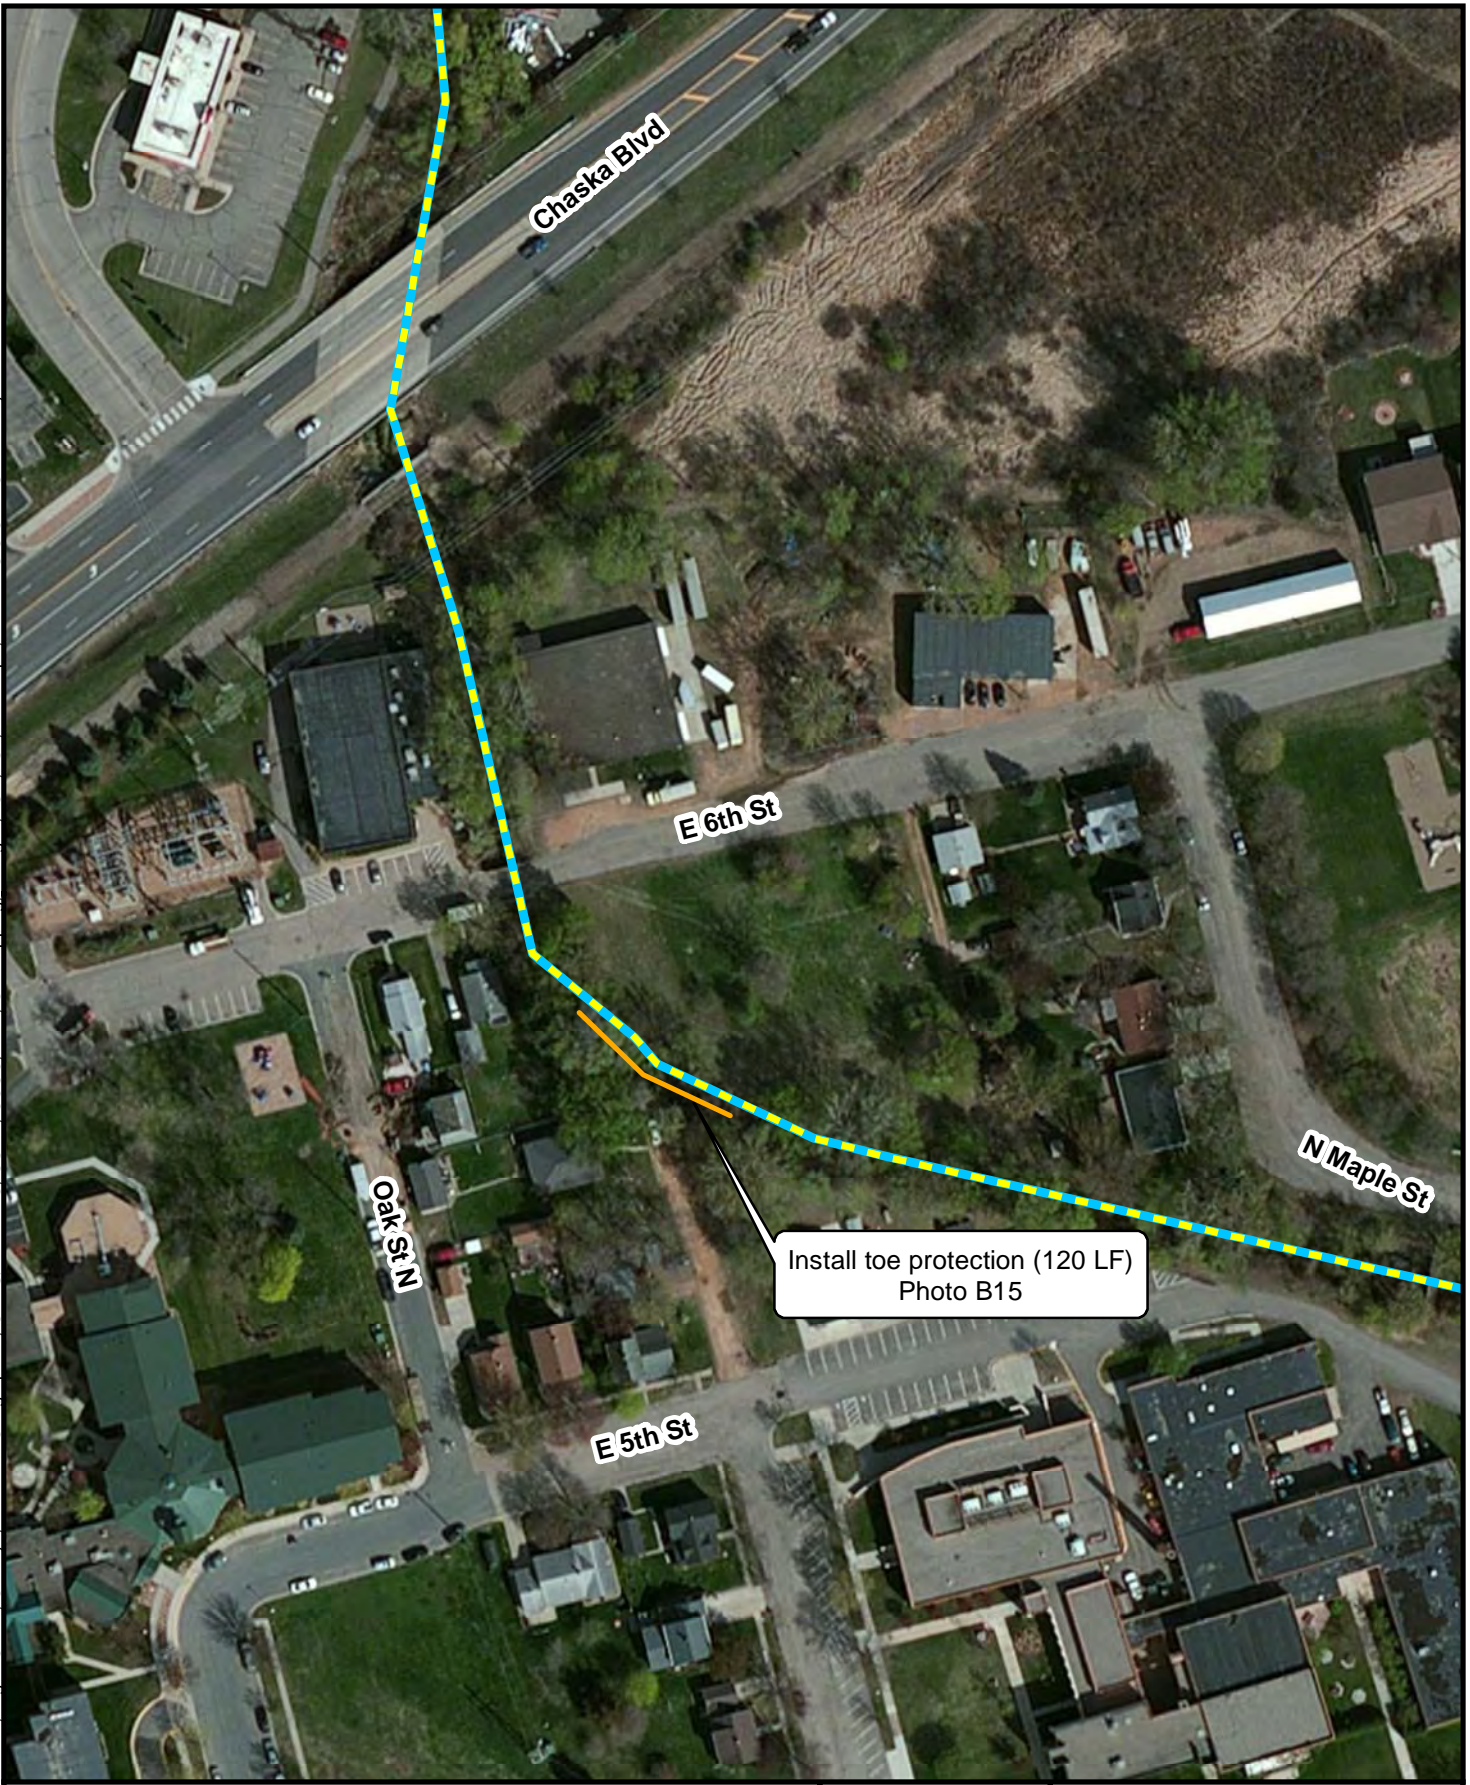
Figure 6
Recommended Channel
Stabilization Projects
East Chaska Creek Project
Chaska, Minnesota

The following channel stabilization projects are recommended primarily to protect City infrastructure and secondarily to reduce future Creek bank and bed erosion. Figures 5 and 6 (Appendix A) show the locations of these activities, and Appendix C contains photographs of each location. Appendix D contains cross section survey information.

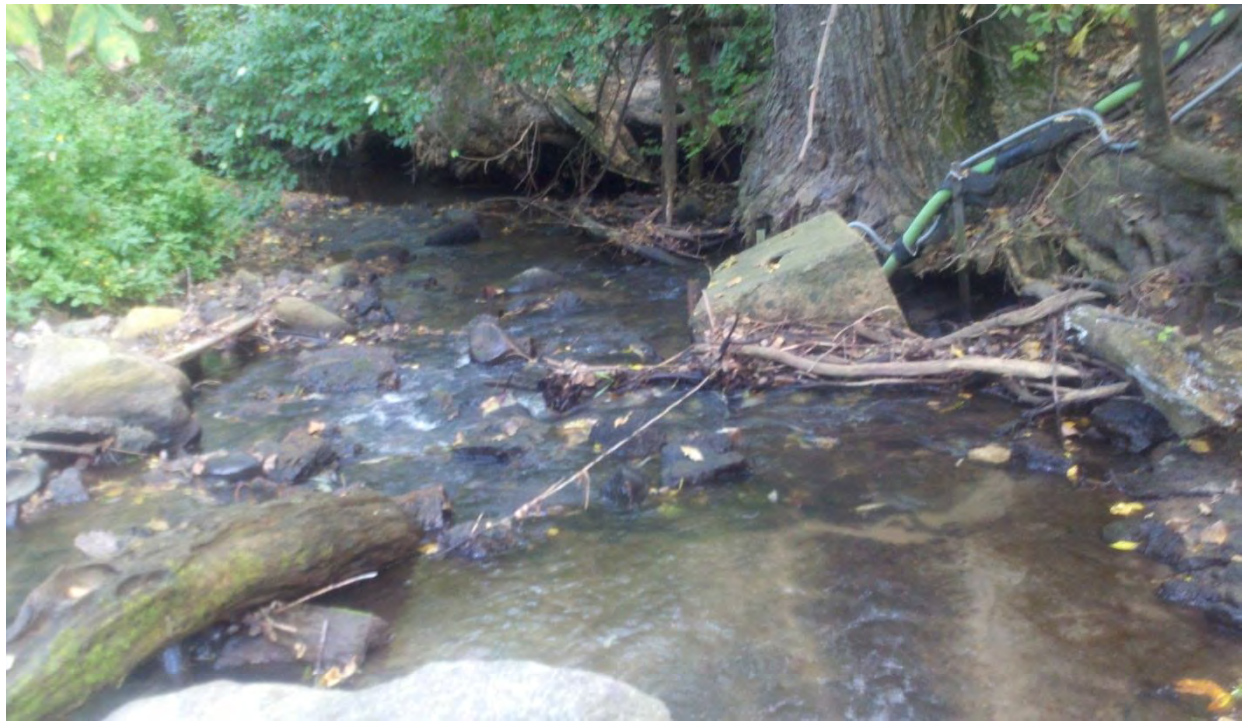
Streambank erosion was observed at the concrete apron near the WOMP station (Photo 2. Riley Creek WOMP station downstream of Flying Cloud Drive (Eden Prairie)

). Erosion was particularly evident at outside bends where undercut banks and exposed tree roots were observed. The right bank wingwall was also noticed to be broken from the apron structure. In sum, excessive active erosion was not observed in Riley Creek near the WOMP station. Suggested actions for Riley Creek include providing energy dissipation structures below County Road 61 and/or redirecting flows away from outside creek meanders to prevent future erosion during runoff events.

Photo 2. Riley Creek WOMP station downstream of Flying Cloud Drive (Eden Prairie)

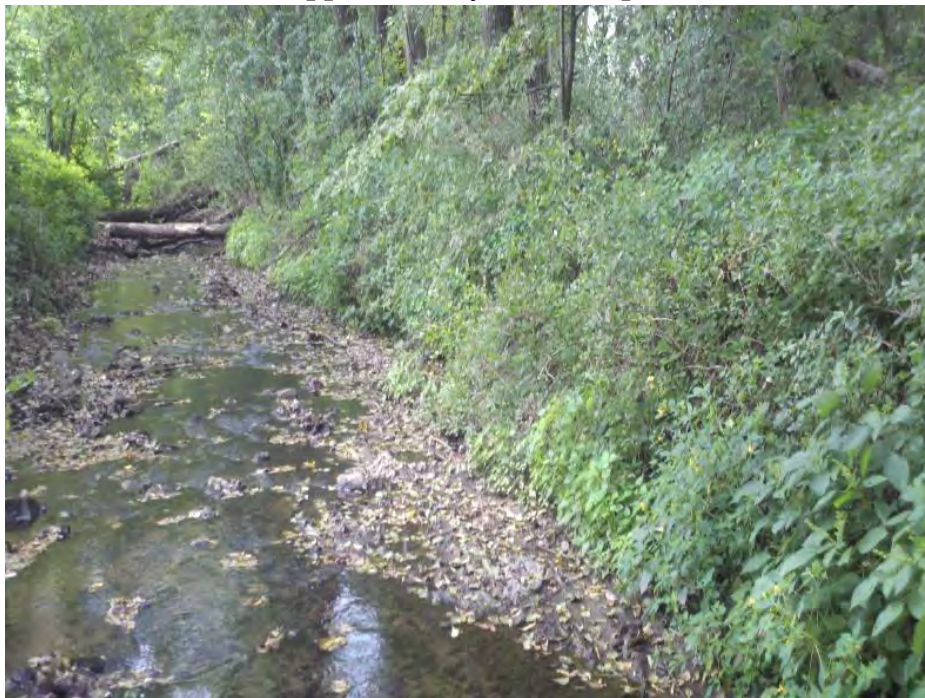
Photo 6. East Chaska Creek log jam northeast of Lions Park

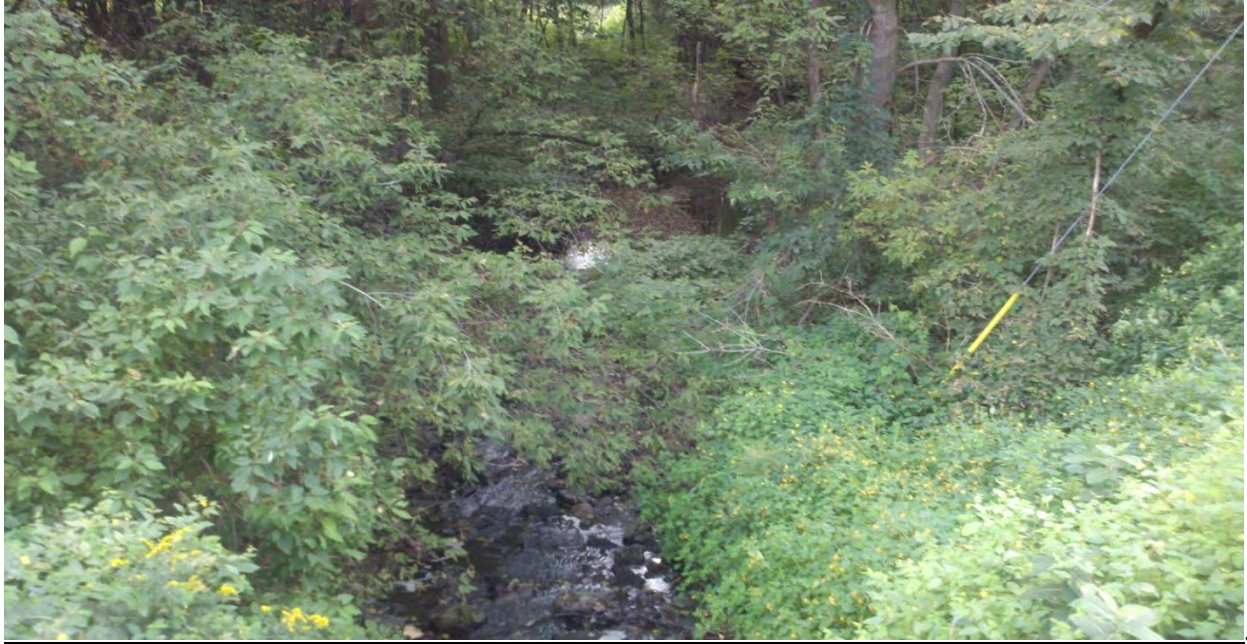
Photo 7. East Chaska Creek riprap effectively dissipating stream velocity (Downstream of Engler Blvd)

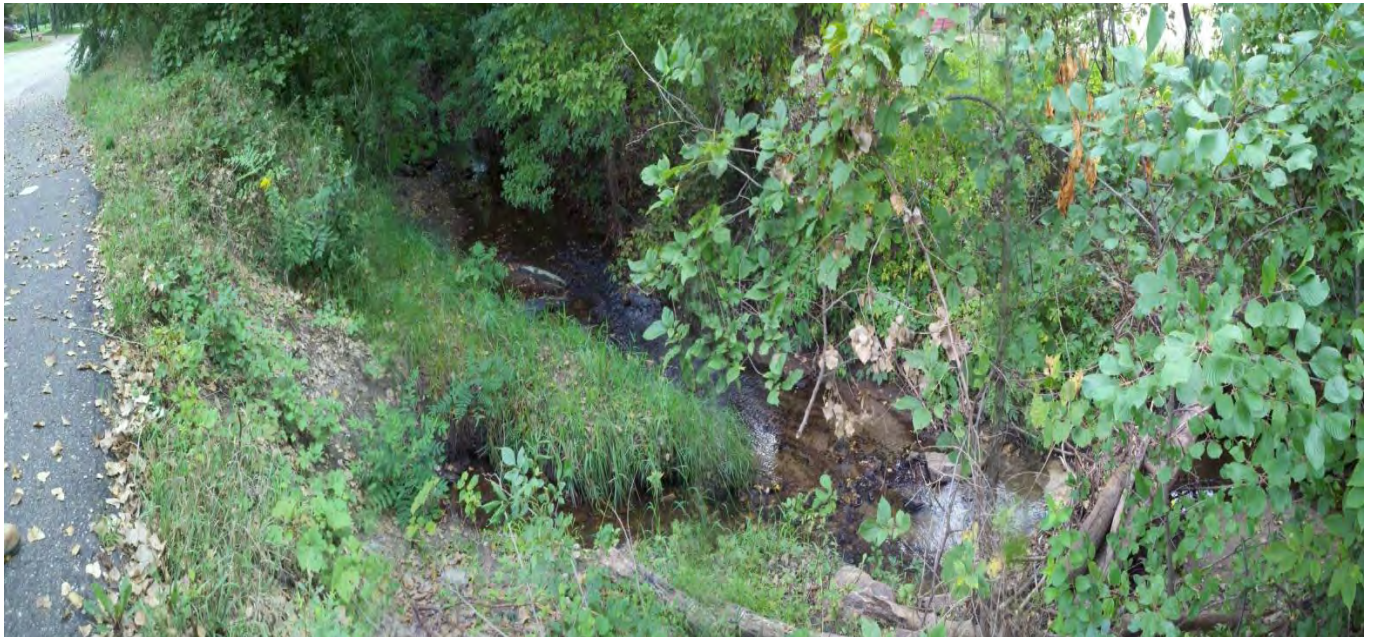
Right bank erosional problems were generally confined to outfall locations (one buried outfall and two hanging outfalls). Outfall A (**Error! Reference source not found.**) consisted of a 24-to-30-inch RCP with apron, and was nearly buried. There was a log jam immediately downstream with eroding stream banks. Sediment was accumulating upstream of the outfall, with the right bank sloughing into channel. Outfall B (**Error! Reference source not found.**) is a 12-inch PVC pipe hanging 2.5 feet above the channel bed. Outfall C (**Error! Reference source not found.**) is a 12-inch CMP hanging six inches above the channel bed.

Photo 8. East Chaska Creek Outfall A (just downstream of Arby's parking lot)

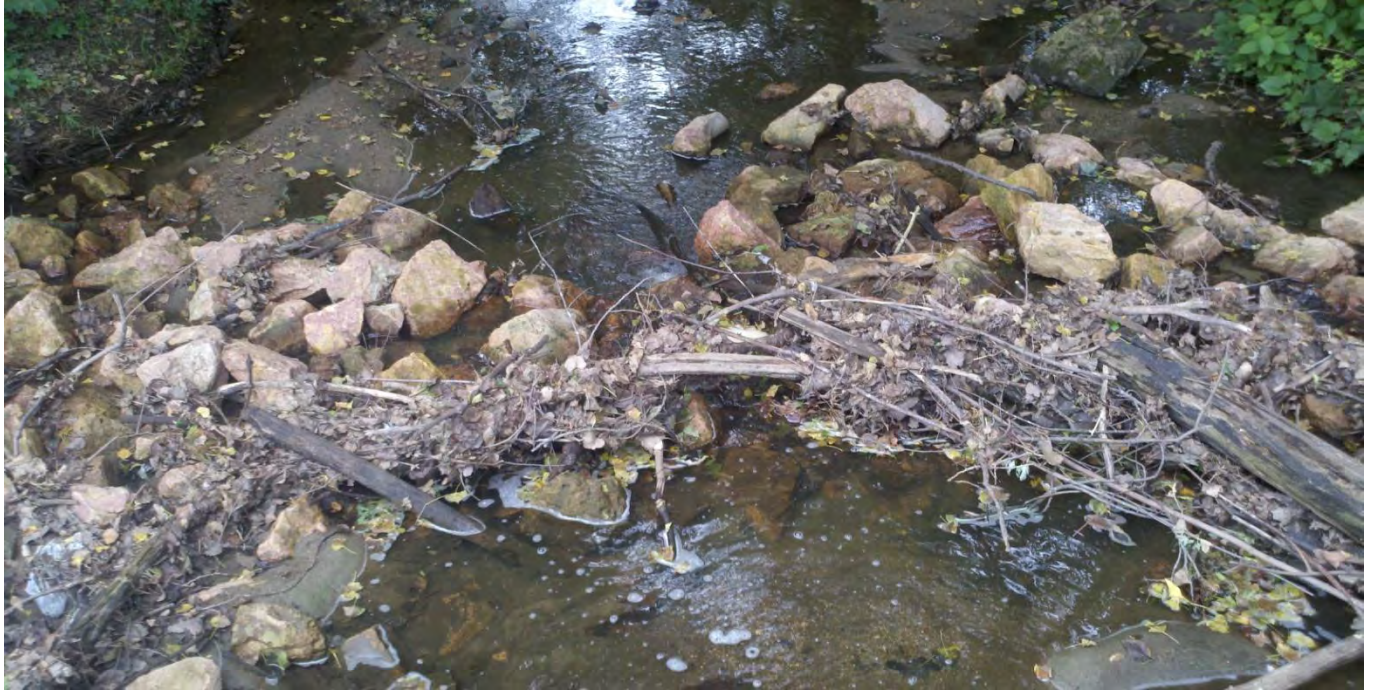
, **Error! Reference source not found.**) the downstream apron channel was downcut approximately two feet. Riprap was present in the channel along with debris jams. The upstream bridge banks and channel were stable.

Photo 12. Downstream of Crosstown Bridge, East Chaska Creek

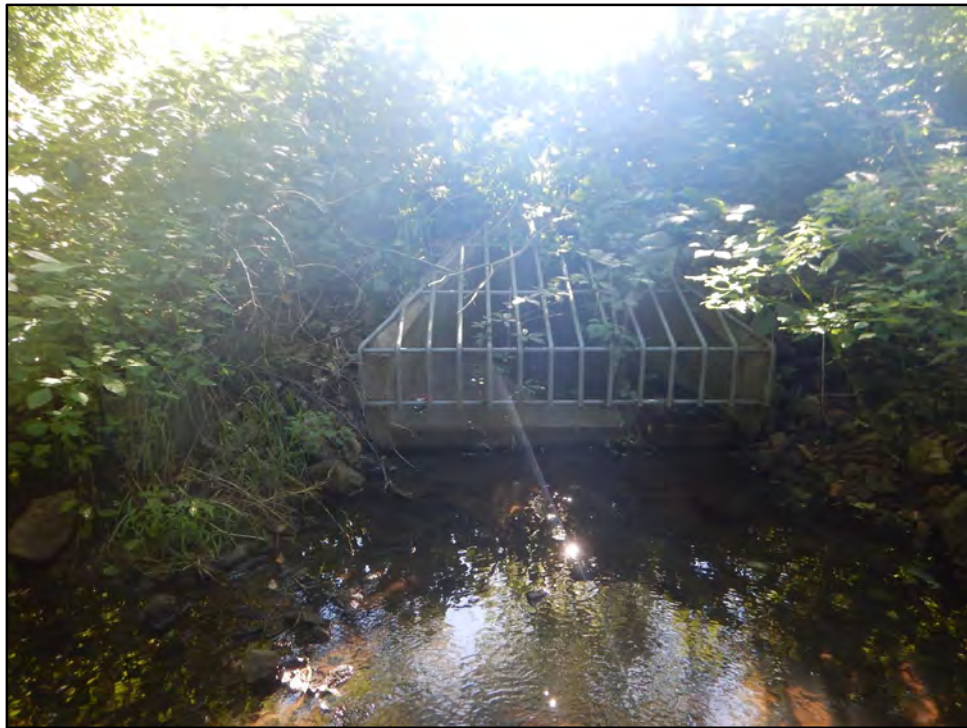
Photograph A-1: View east of RCP outfall.

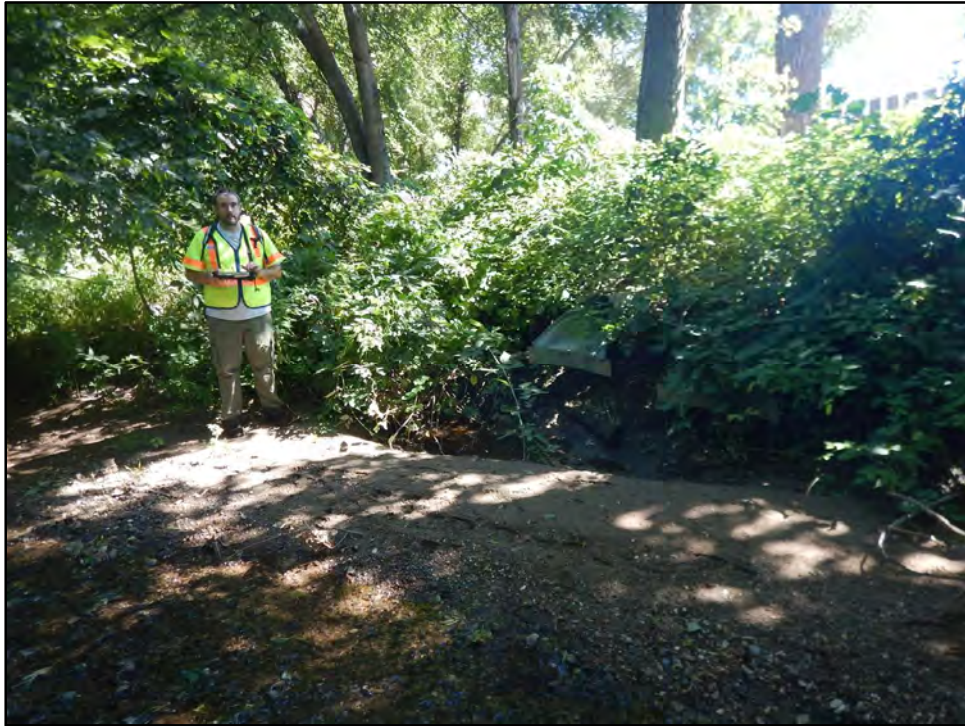
Photograph A-2: View east of dual 12" CMP outfalls.

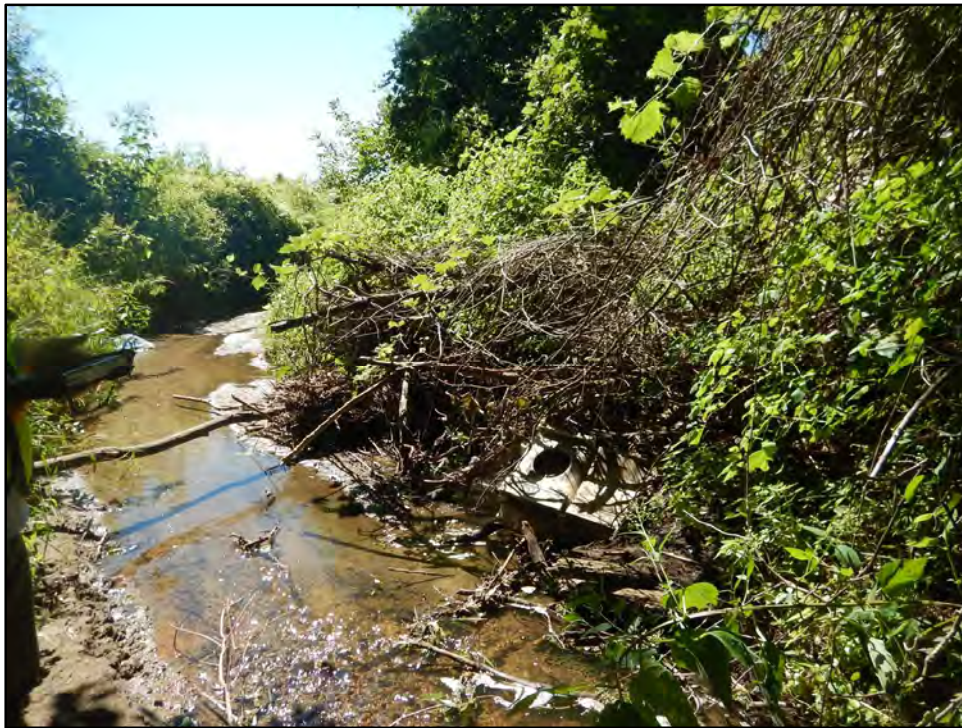
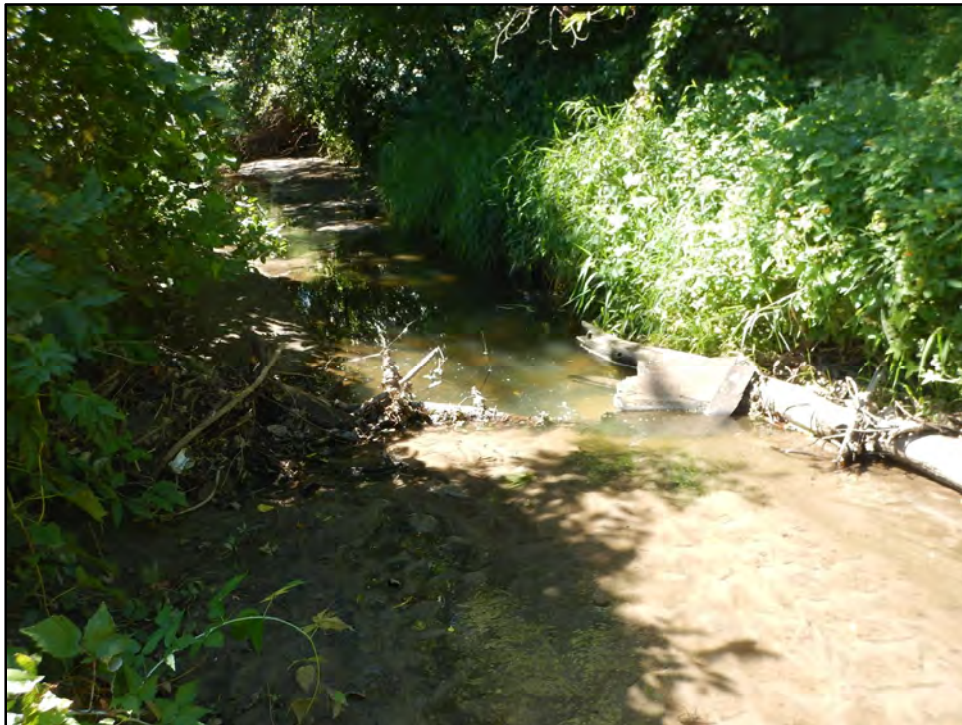
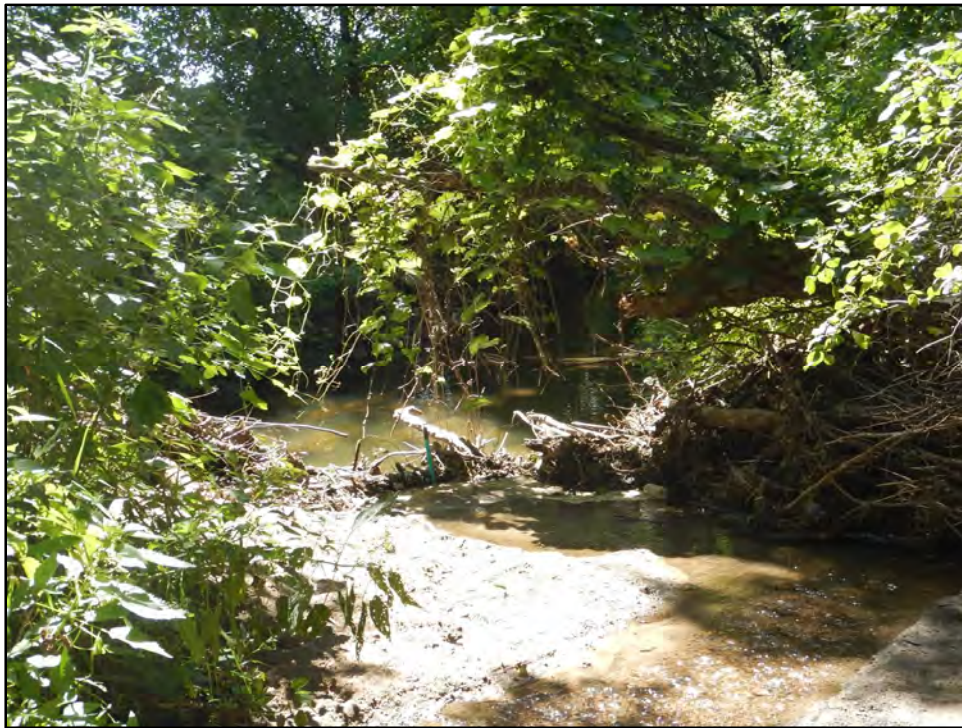
Photograph A-3: View south of debris.

Photograph A-4: View south of debris.

Photograph A-5: View south of debris.

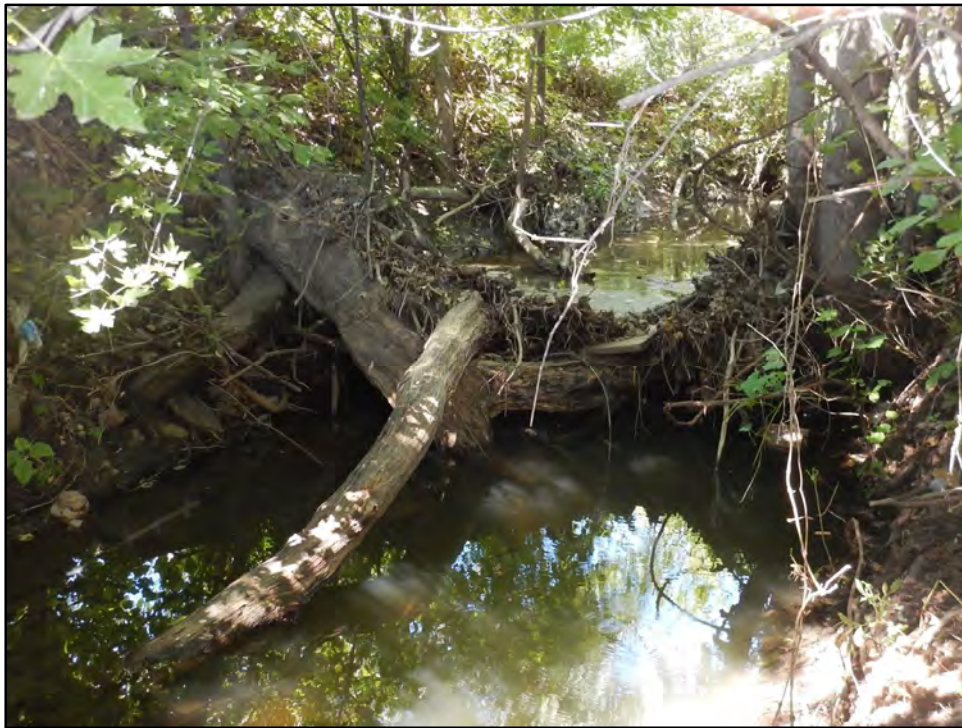
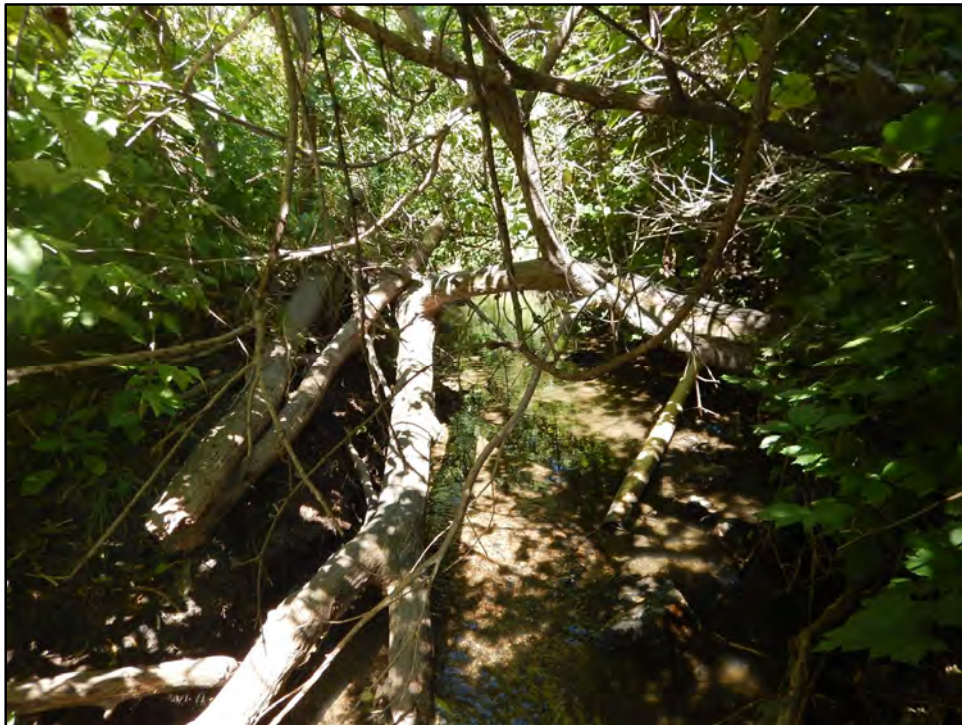
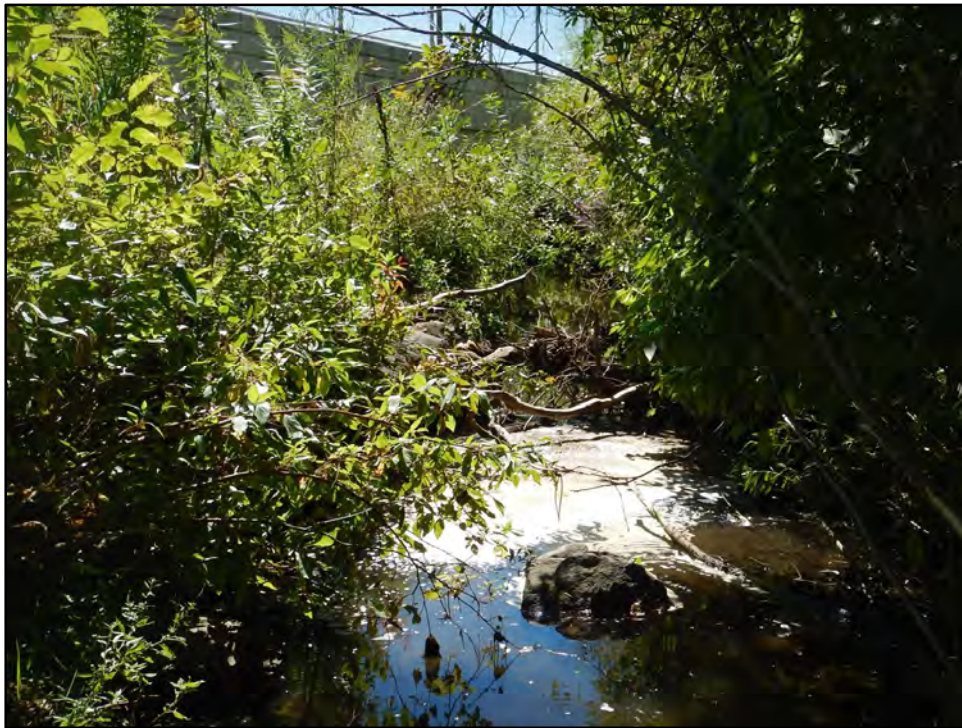
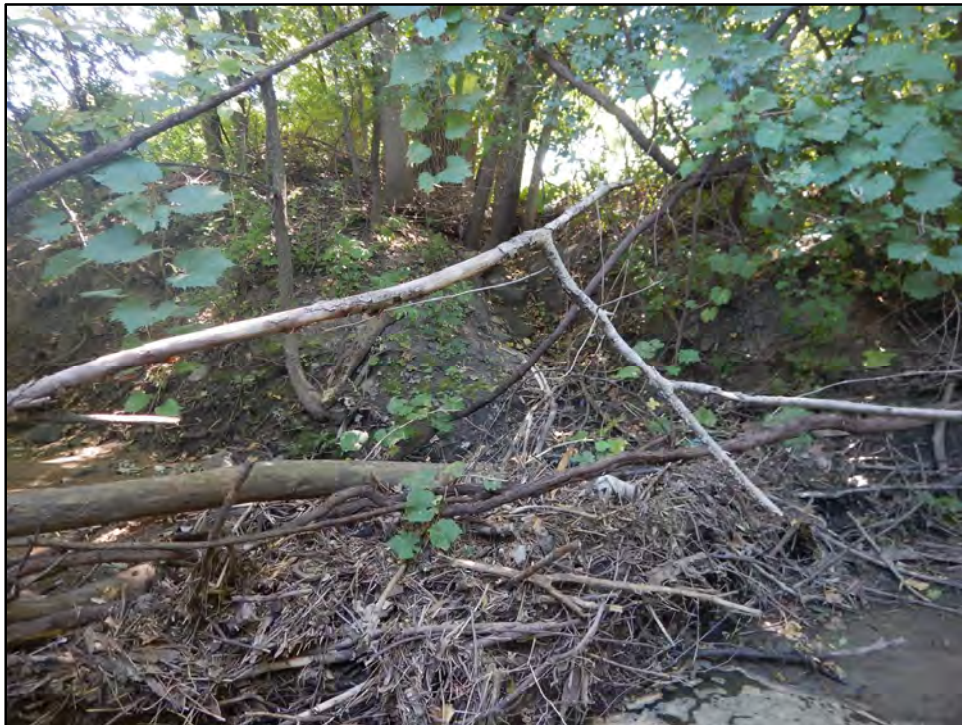
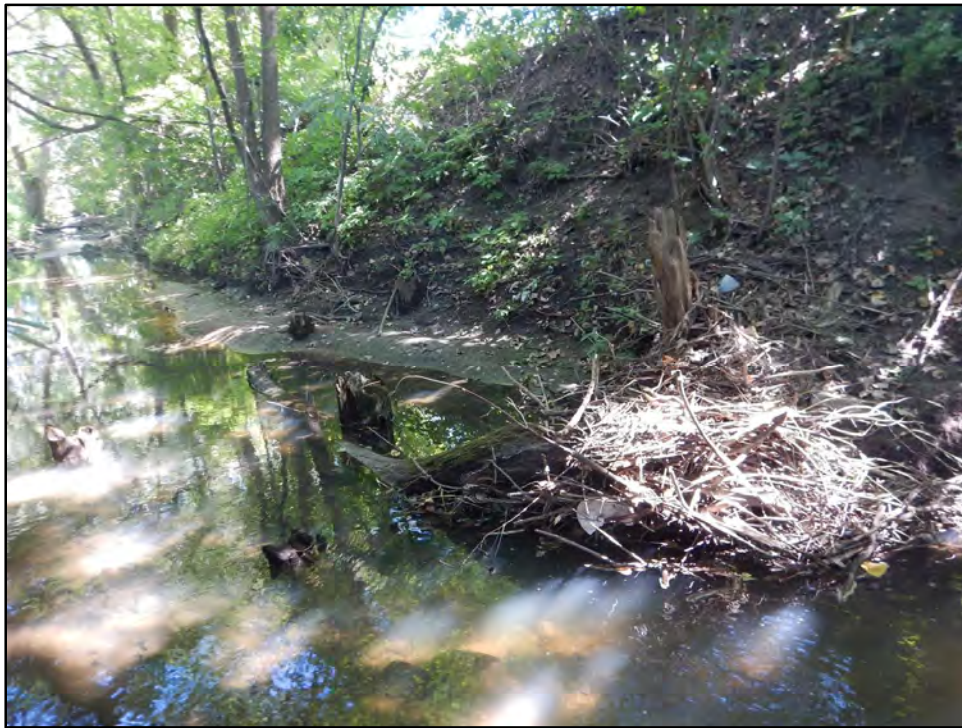
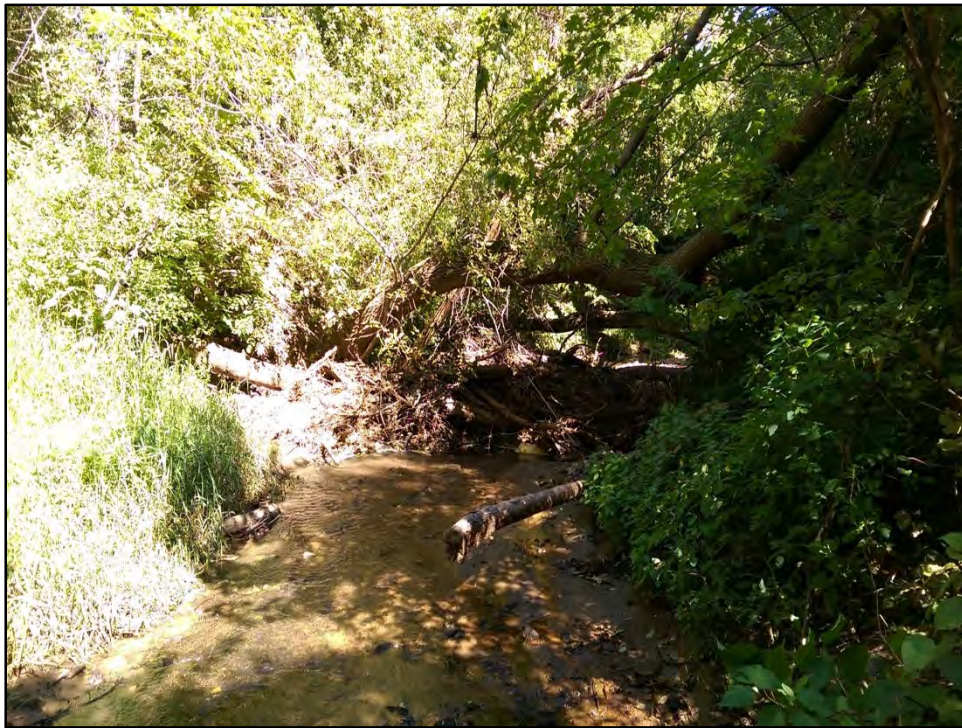
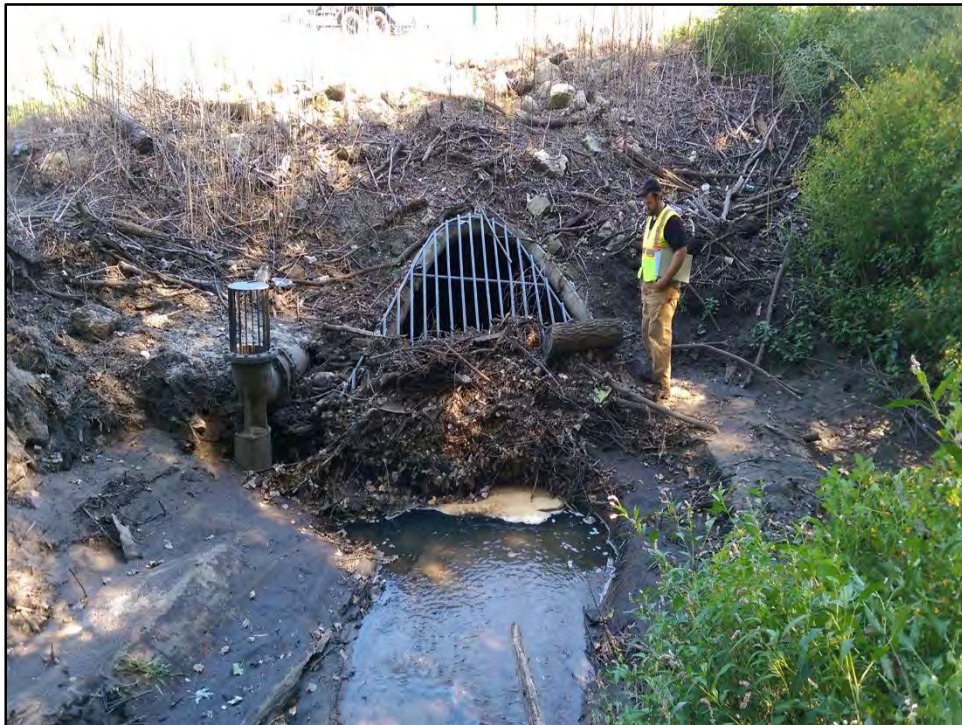
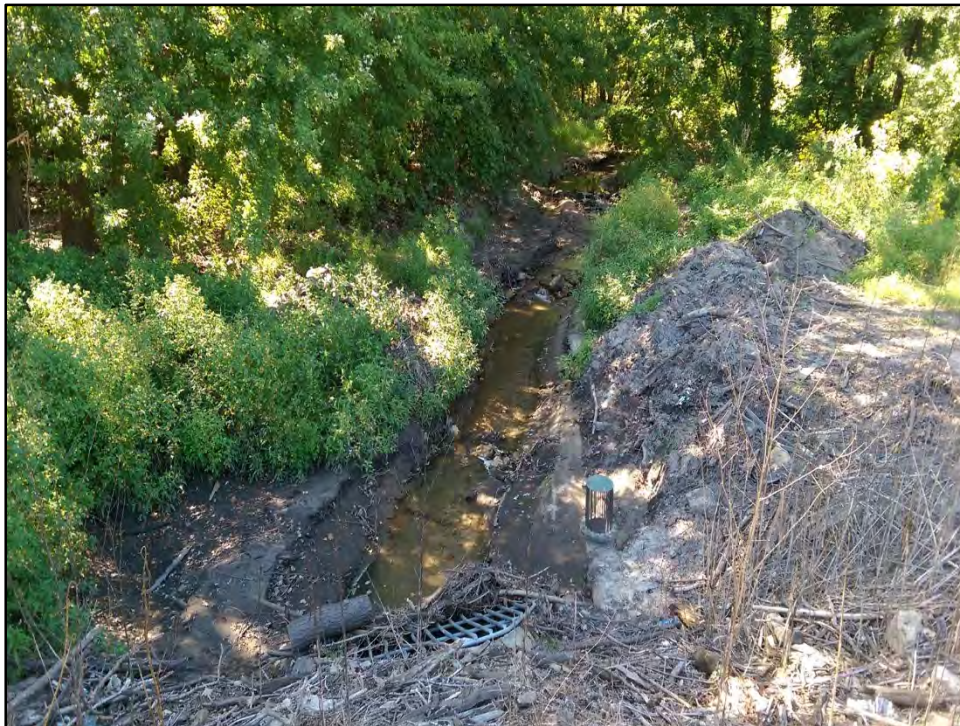
Photograph A-7: View north of debris.

Photograph A-8: View south of debris.

Photograph A-9: View south of debris.

Photograph A-10: View east of debris.

Photograph A-11: View east of debris.

Photograph A-13: View east of debris.

Photograph A-14: View east of debris at RCP.

Photograph A-15: View west of debris and RCP.
