East Chaska Creek Restoration Project

**East Chaska Creek Restoration Project
Project No. 86550**

February 2016

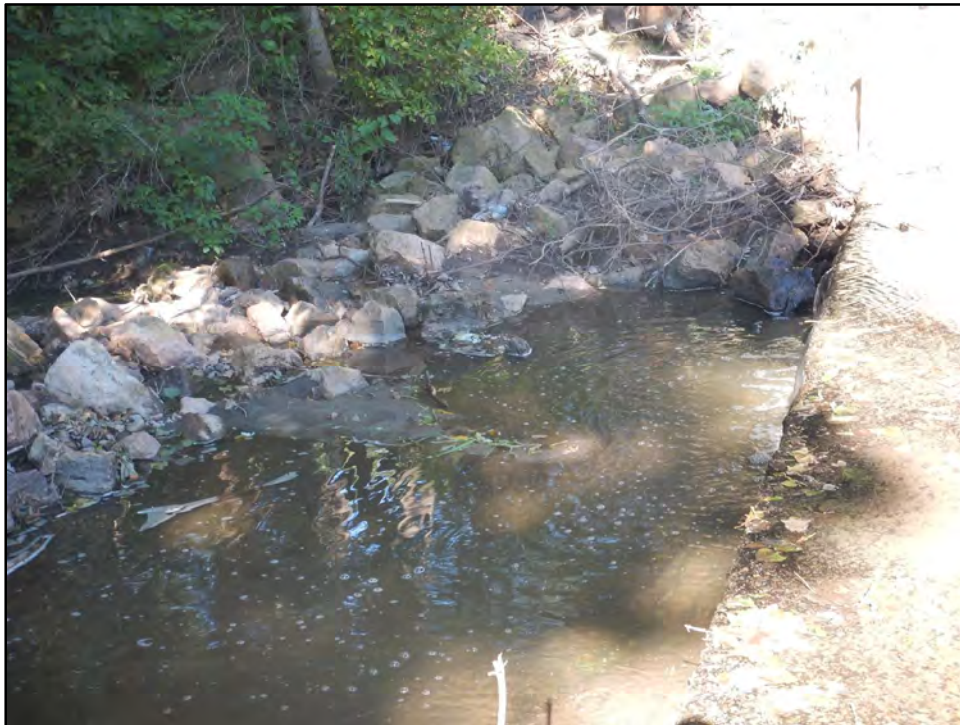
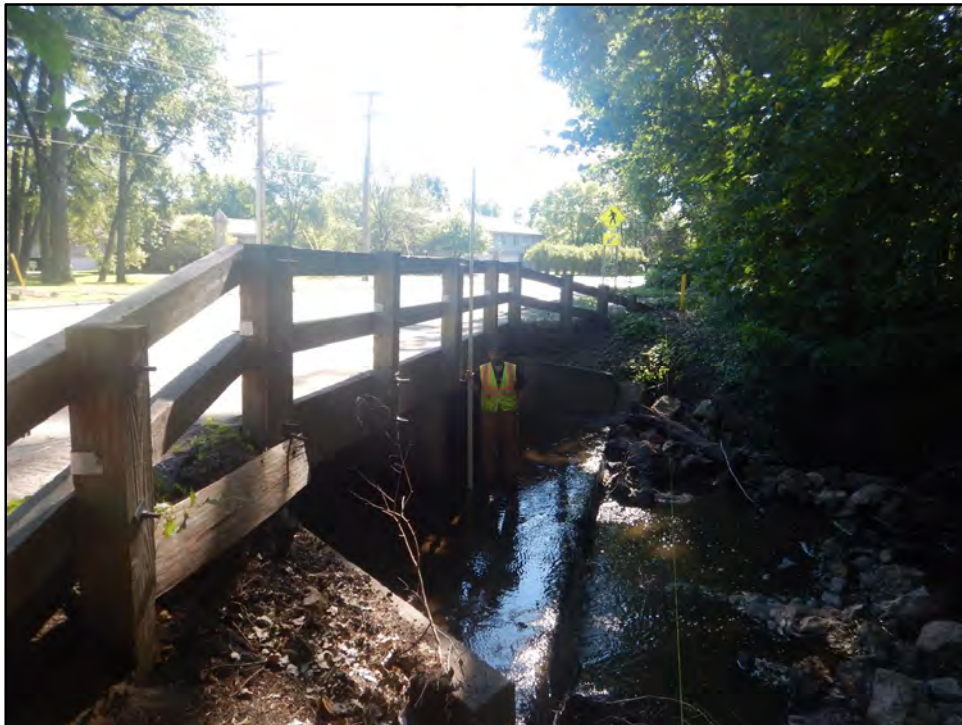
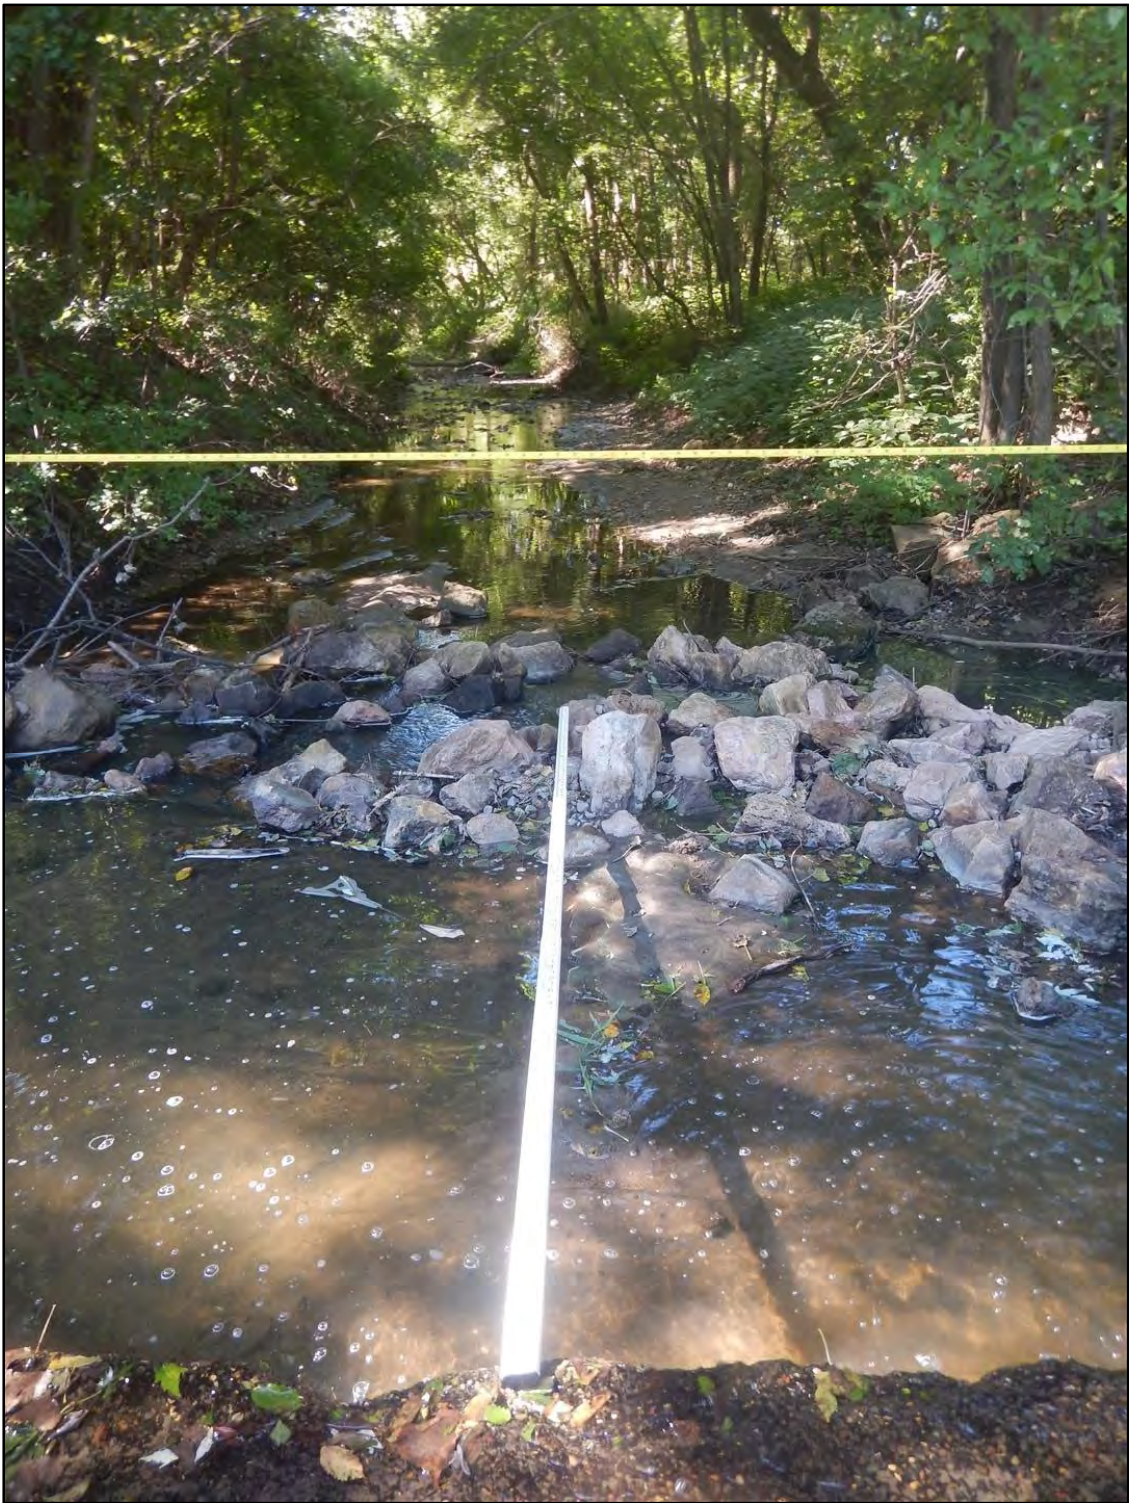
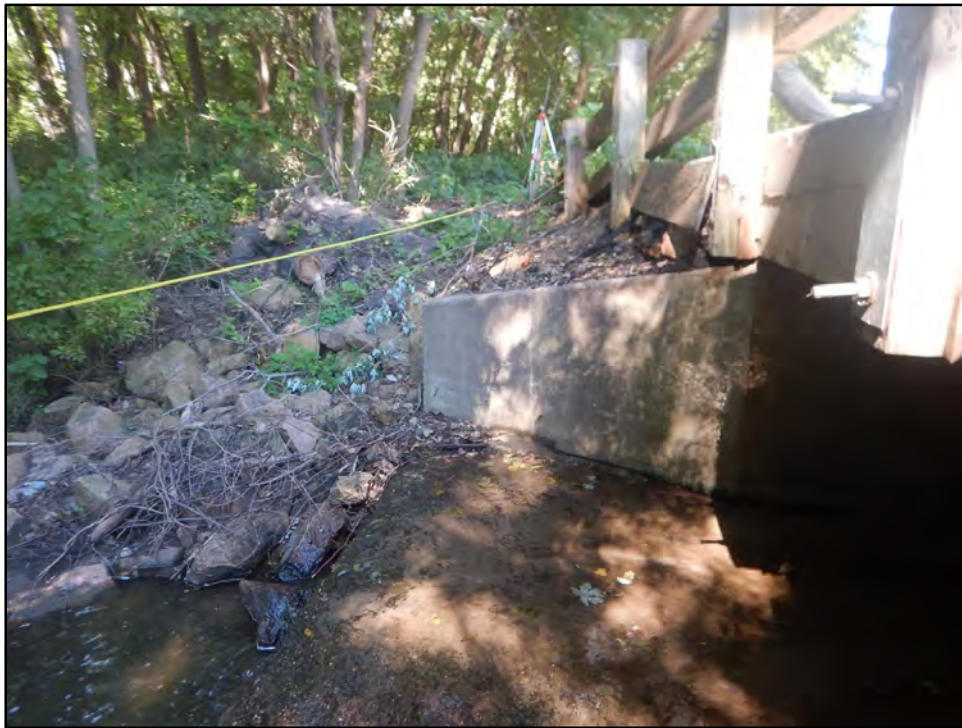
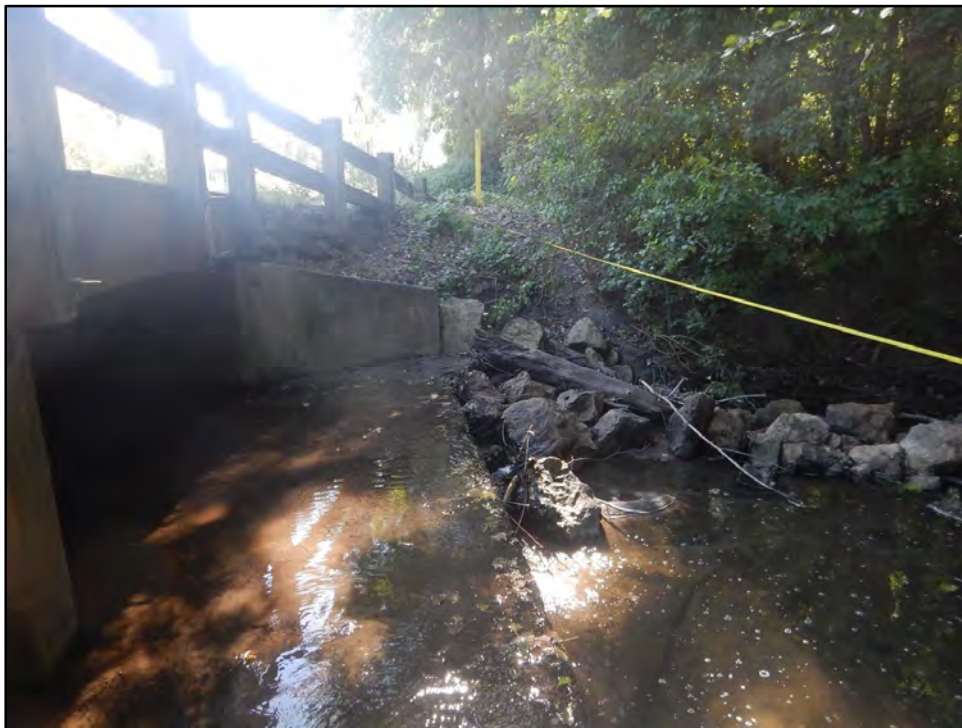
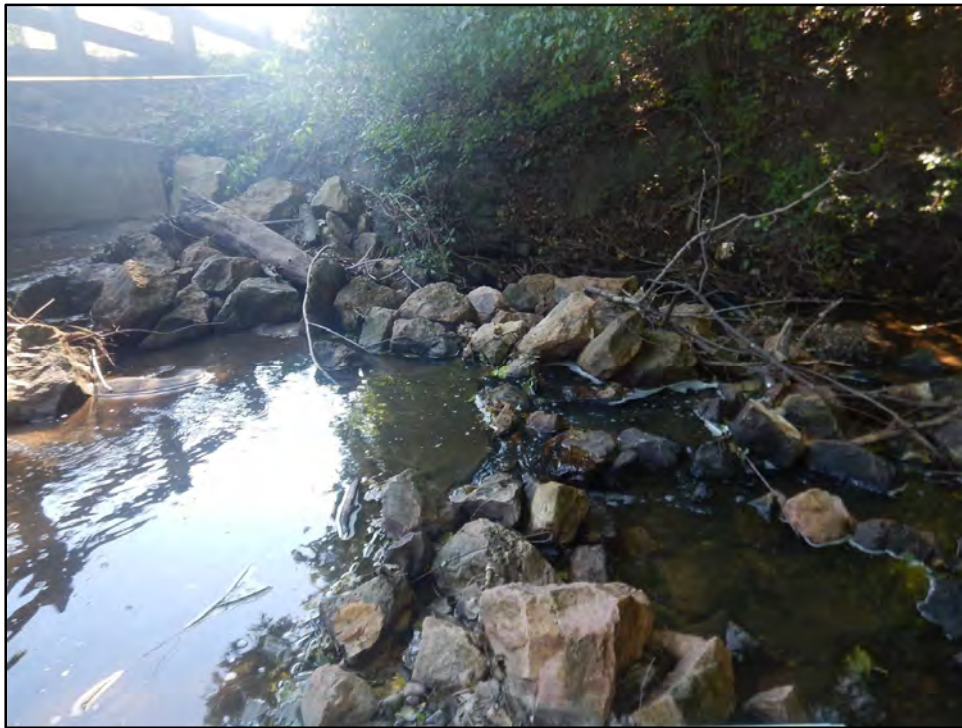
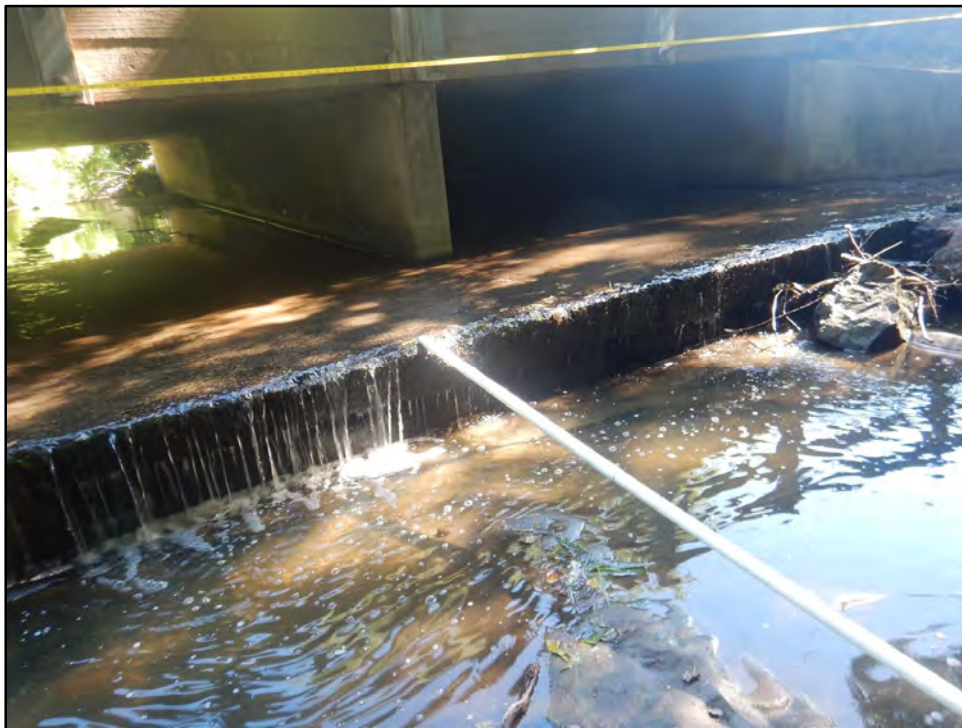
This recommended creek improvement consists of repairing the scour hole downstream of Crosstown Boulevard Bridge; the scour hole has been caused by the creek downcutting to this point (Appendix A, Figure 5). The scour hole is approximately 30 feet wide, 10 feet long, and 3 feet deep (Photographs B1 – B9). Repair would consist of salvaging existing riprap, re-grading the channel downstream of the structure apron, and re-installing filter fabric and riprap.

Photograph B-1: View northwest of scour hole.

Photograph B-3: View southeast of bridge crossing and scour hole.

Photograph B-4: View southwest of scour hole.

Photograph B-5: View northwest of scour hole.

Photograph B-6: View southwest of bridge crossing and scour hole.

Photograph B-7: View southwest of debris and scour hole.

Photograph B-8: View north of bridge crossing and scour hole.

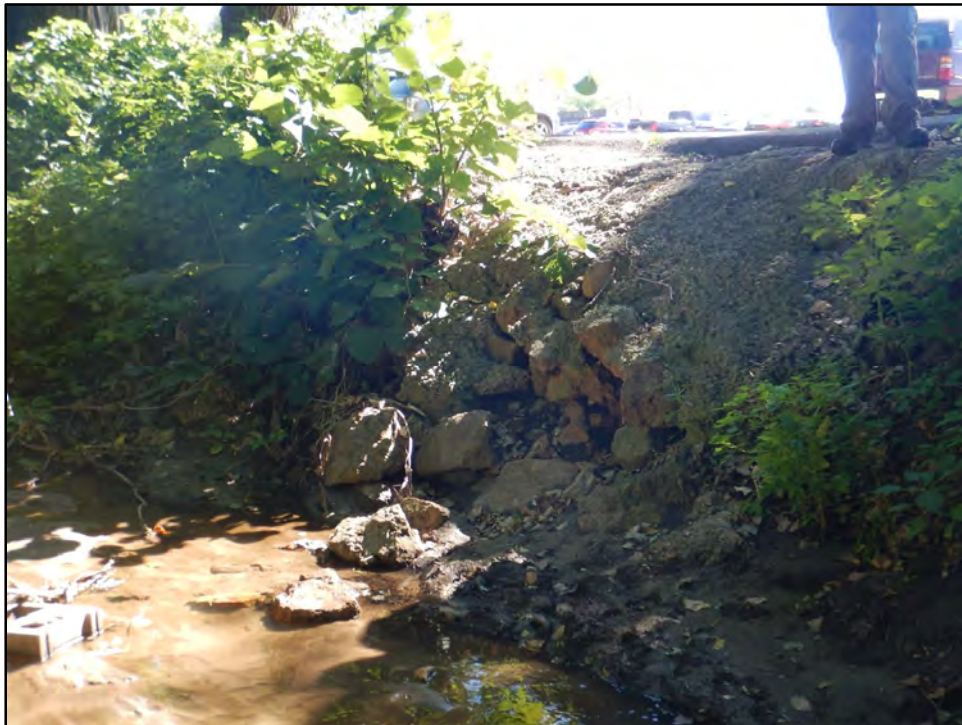
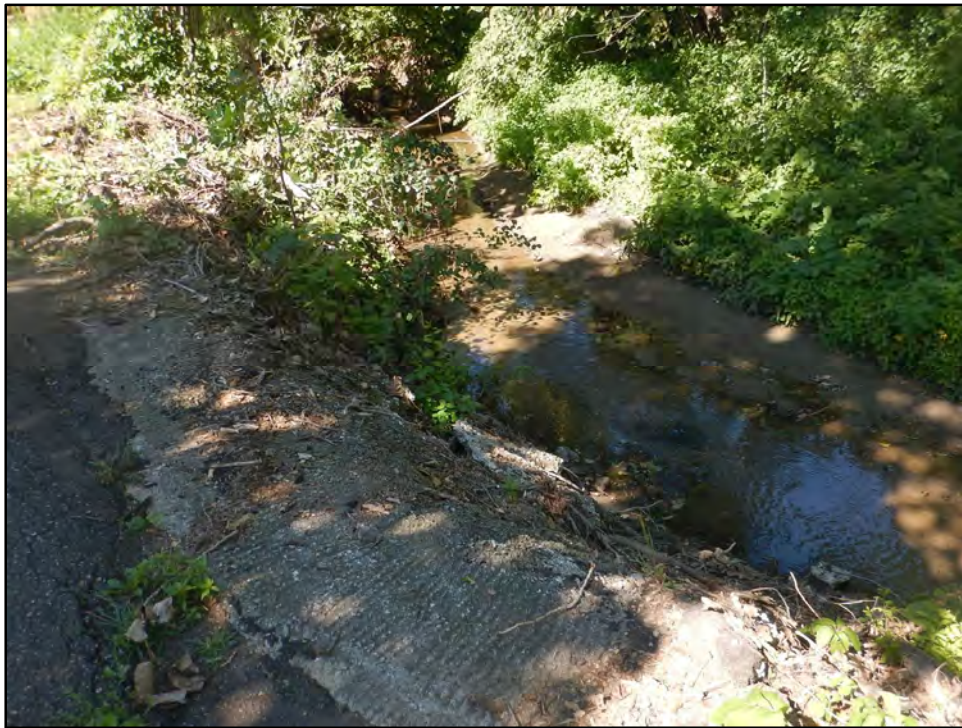
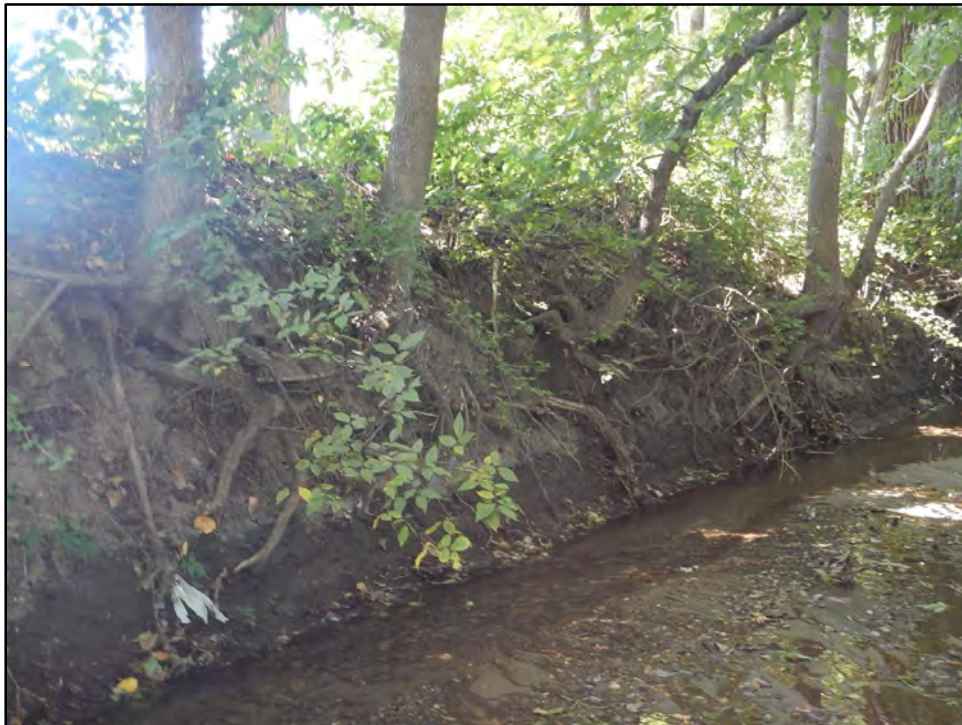
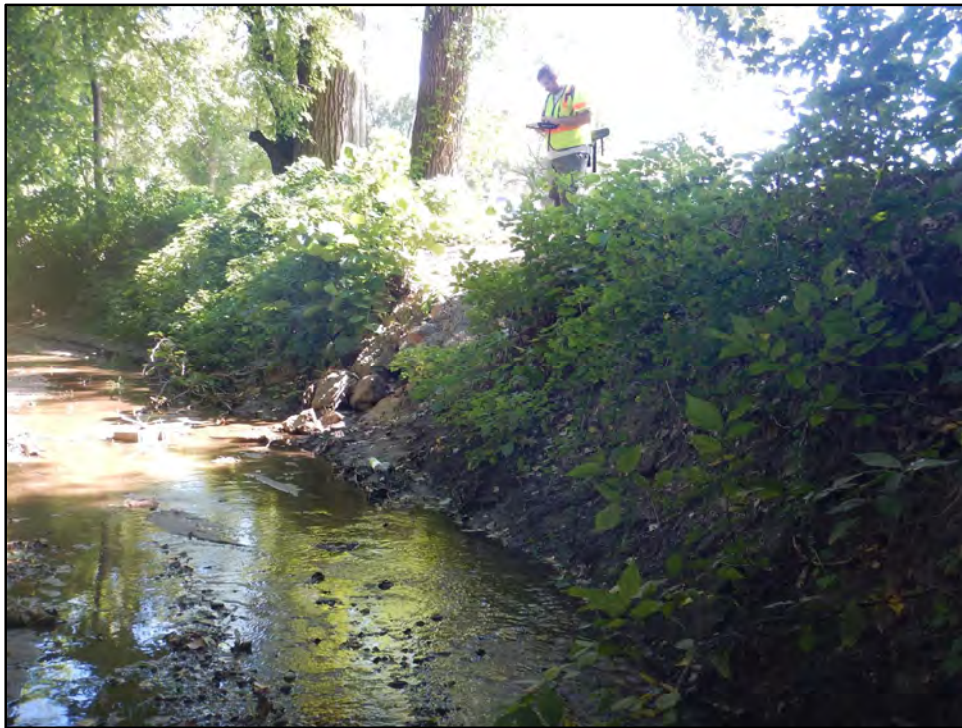
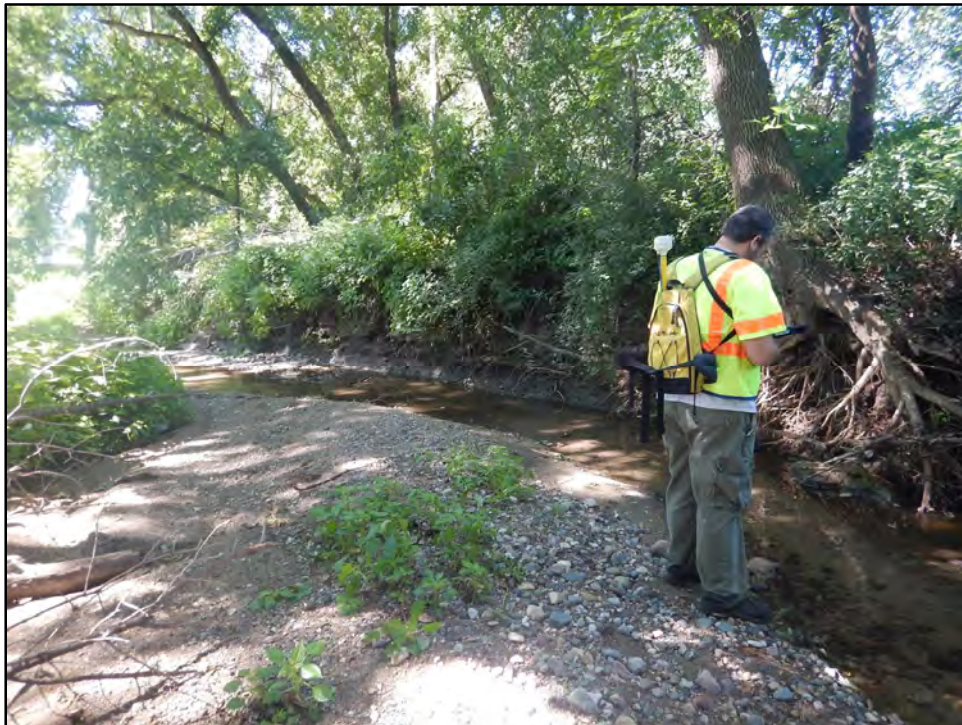
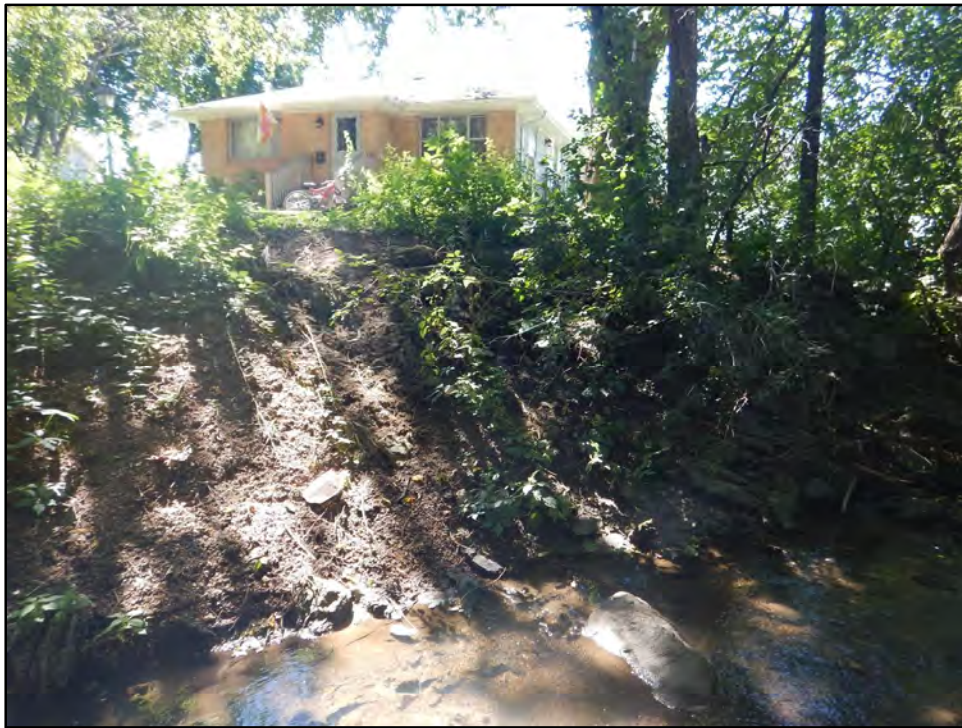
This project consists of repairing bank erosion which threatens the City's paved trail as well as two large cottonwood trees behind Lenzen Chevrolet (Appendix A, Figure 5). The channel through this reach is approximately 6 to 7 feet deep. Two temporary asphalt repairs have been implemented in this location, but the repairs have subsequently failed (Photographs B10 – B14). A grade control structure would also be installed to prevent potential channel downcutting upstream to Crosstown Boulevard. Repairs would consist of removal of temporary asphalt repairs, complete bank hard armoring for approximately 320 linear feet along the left bank, toe protection for approximately 340 linear feet on the left and right banks, and a grade control structure.

Photograph B-10: View east of bank erosion.

Photograph B-11: View south of eroded bank.

Photograph B-12: View south of eroded bank.

Photograph B-13: View north of eroded bank.

Photograph B-14: View south of eroded bank.

Photograph B-15: View south of eroded bank.

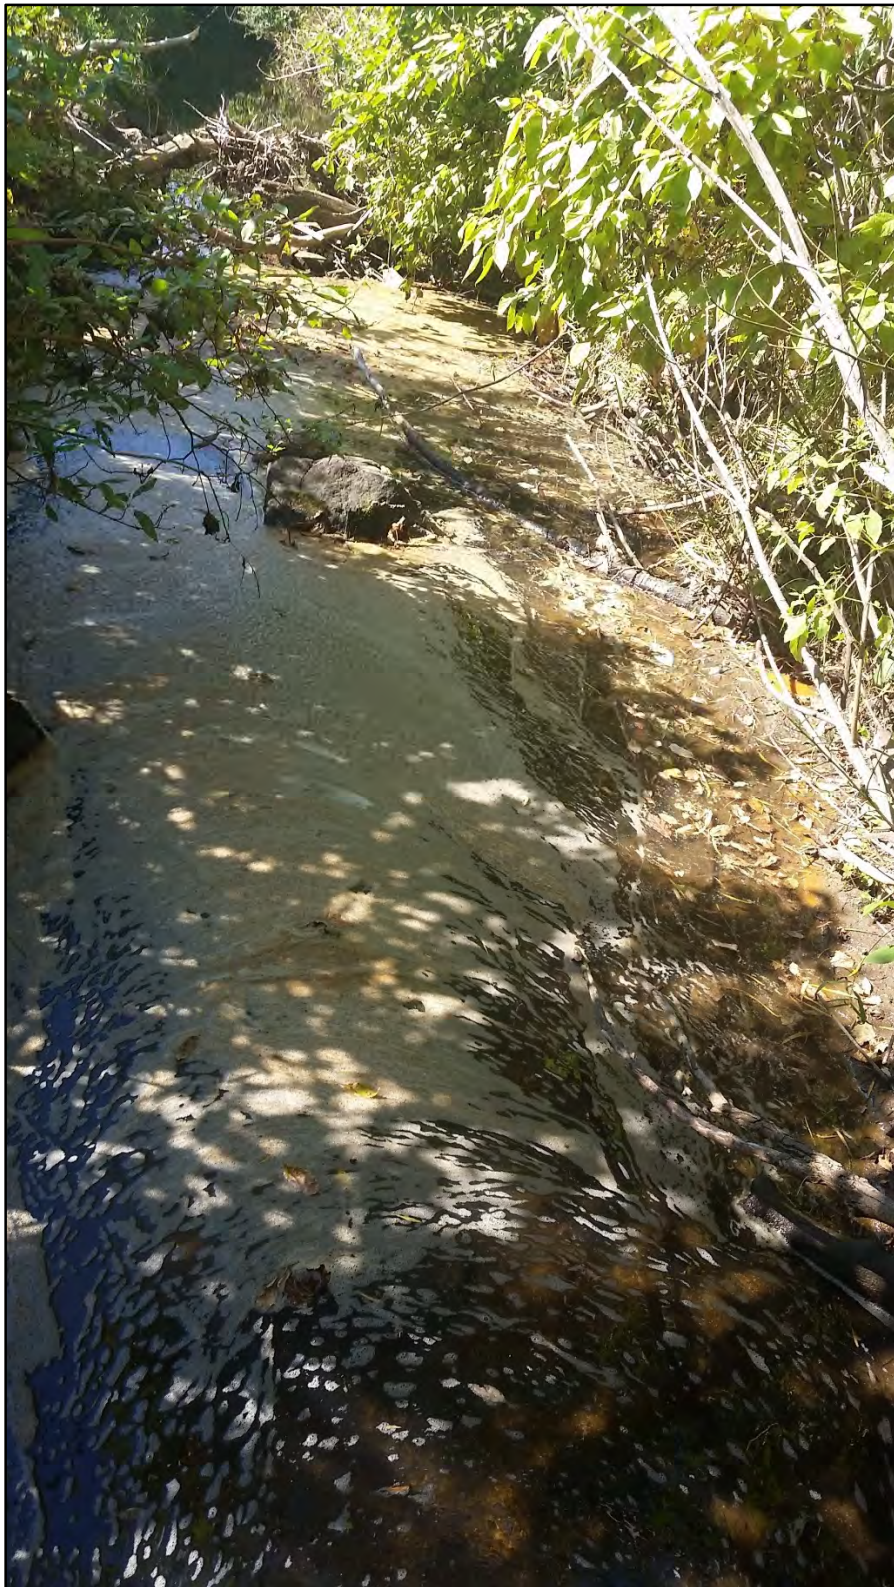
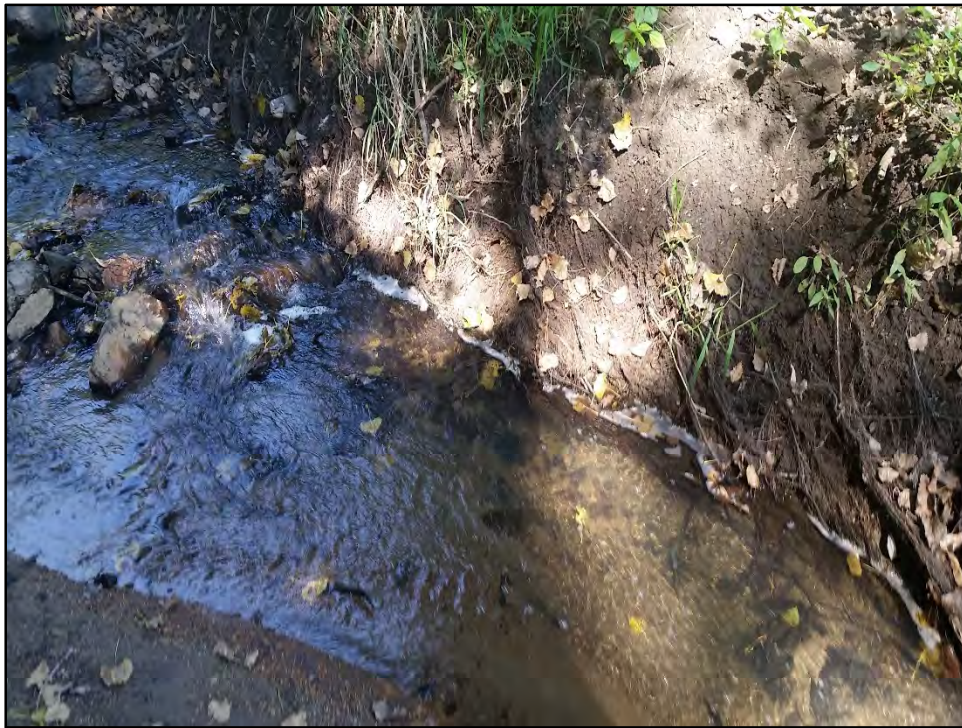
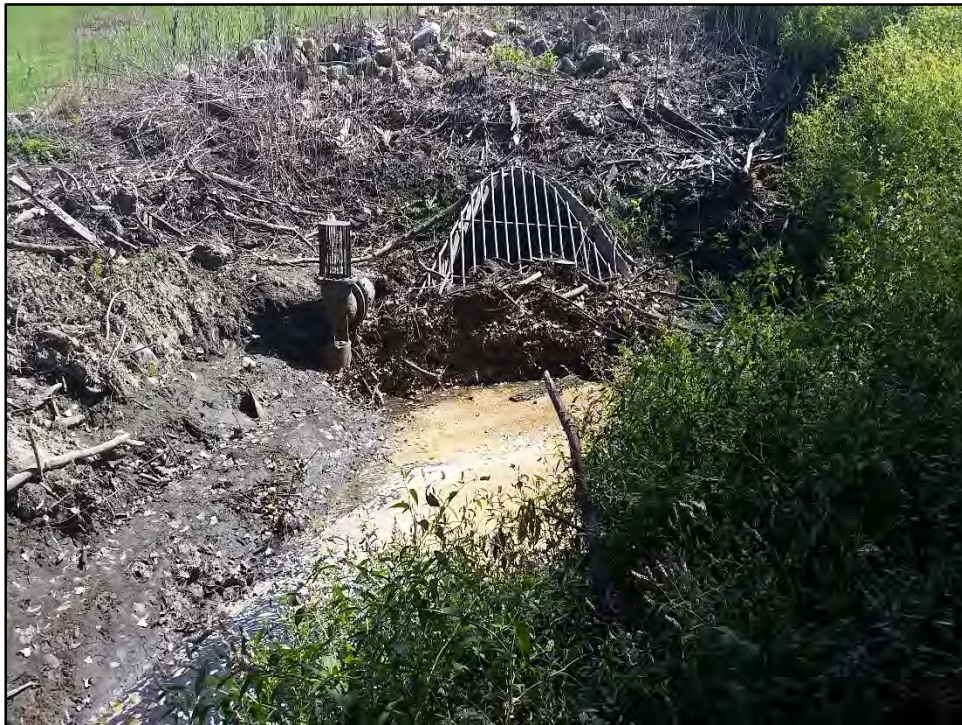
White foam was also observed in a few locations throughout the reach during the field visit on September 14, 2015 (Photographs C7 – C9). These observations coupled with dry weather the preceding 4 days and the MPCA bacteria impairment indicate a potential anthropogenic source (sanitary or septic connection). The District, in cooperation with Carver County and the City of Chaska, could explore the possibility of identifying the flow connection to the Creek from sanitary sources or septic systems that are adversely impairing water quality in the Creek.

Photograph C-7: View south of foam from potential sanitary/septic source.

Photograph C-8: View west of foam from potential sanitary/septic source.

Photograph C-9: View east of foam at levee from potential sanitary/septic source.
