SITE LOCATION: CSAH 61-Flying Cloud Drive

PURPOSE: Construction Stormwater Site Visit on Behalf of the Lower Minnesota River Watershed District (LMRWD)

DATE & TIME: 29 December 2018, 0915-1130

INSPECTOR: Sarah Duke Middleton, Water Resources Scientist
Young Environmental Consulting Group, LLC

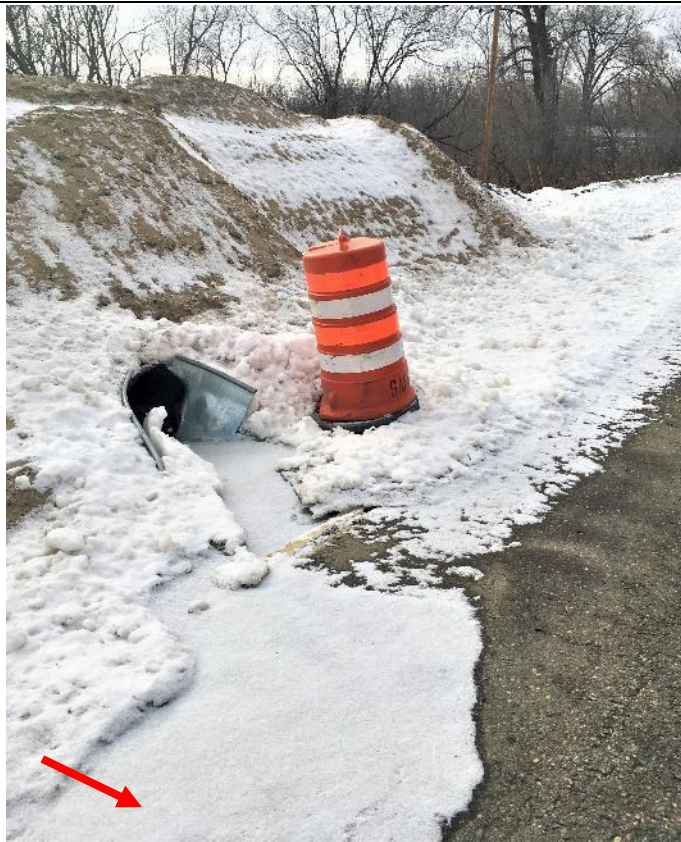
Photo No.: 1

Description: Stormwater inlet on southern side of ROW.

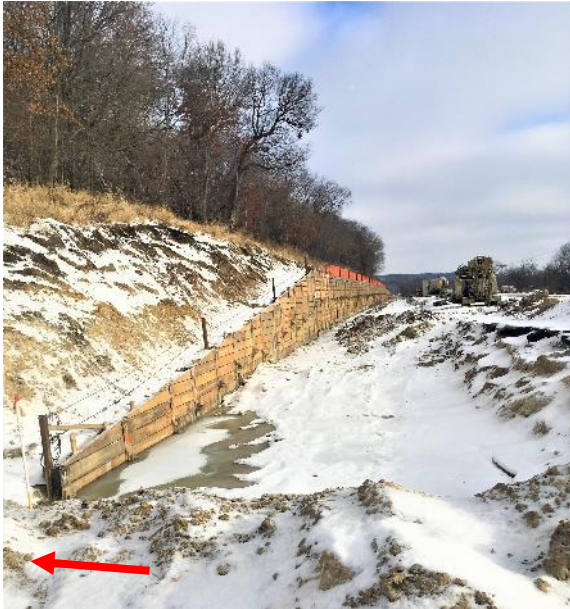
Photo No.: 5

Description: Wall construction on the northern side of the ROW.

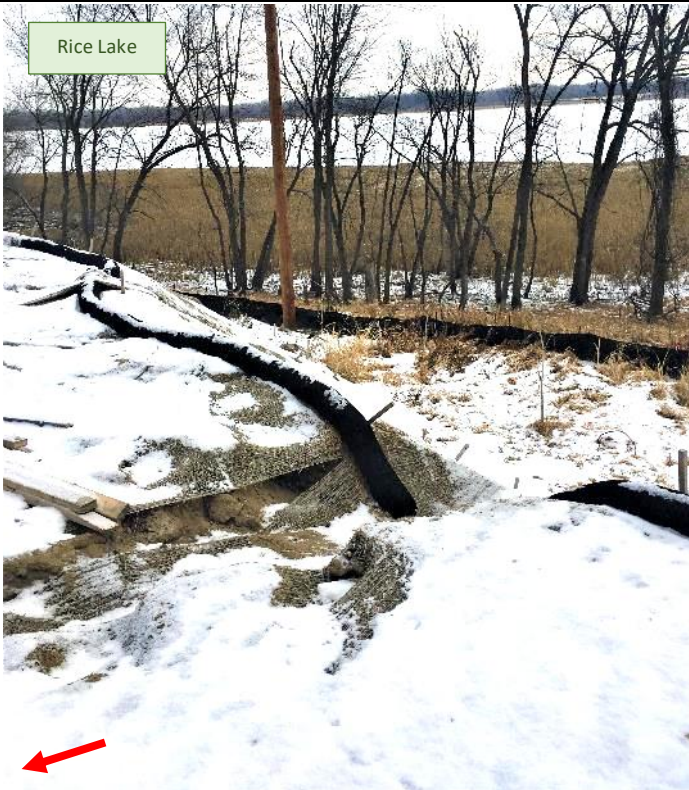
Photo No.: 6

Description: Southern side of the ROW. Washed out areas beneath blanket do not appear to have eroded further (since December 21st site visit).

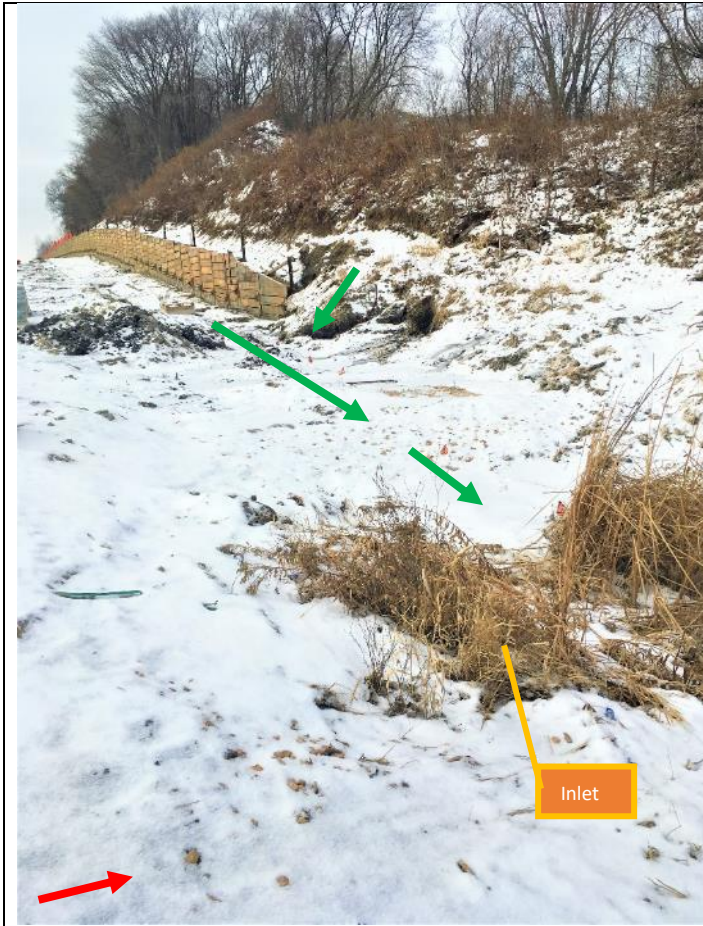
Photo No.: 7

Description: Northern side of ROW conditions. Area appears stable and frozen. Green arrows denote the stormwater drainage route leading to an inlet masked by vegetation.

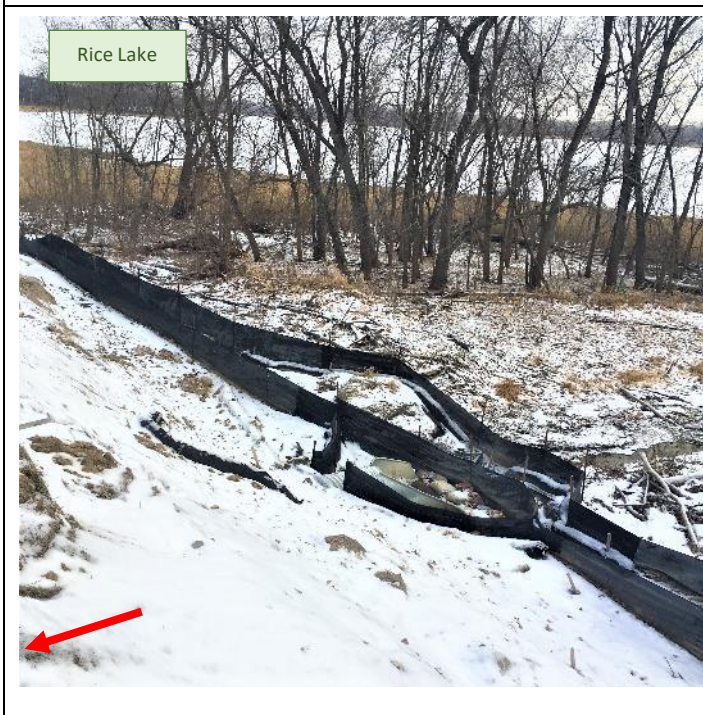
Photo No.: 8

Description: Outlet on southern side of ROW. Area is stable and frozen. During my site visit there was no indication of new erosion or sedimentation post rain event.

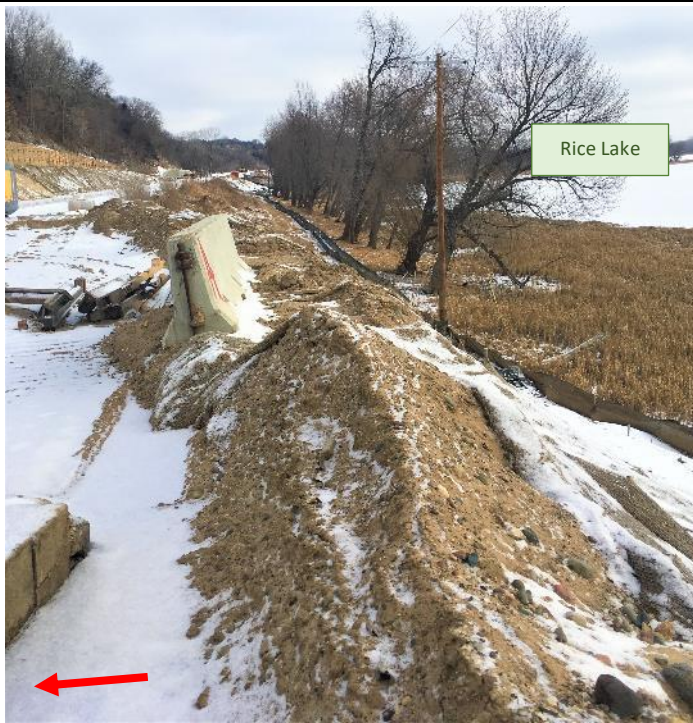
Photo No.: 9

Description: ROW conditions on the southern side of the project. The ground is frozen and silt fencing is intact.

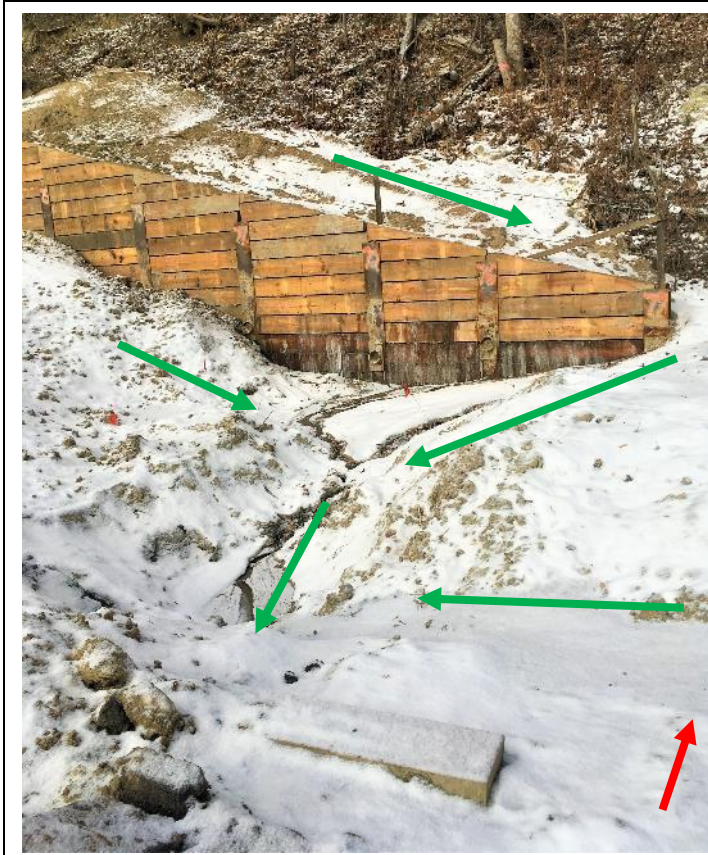
Photo No.: 10

Description: Northern side of ROW. The green arrows indicate stormwater drainage pattern into a partially buried inlet. See photo 11 for inlet and photo 12 for outlet.

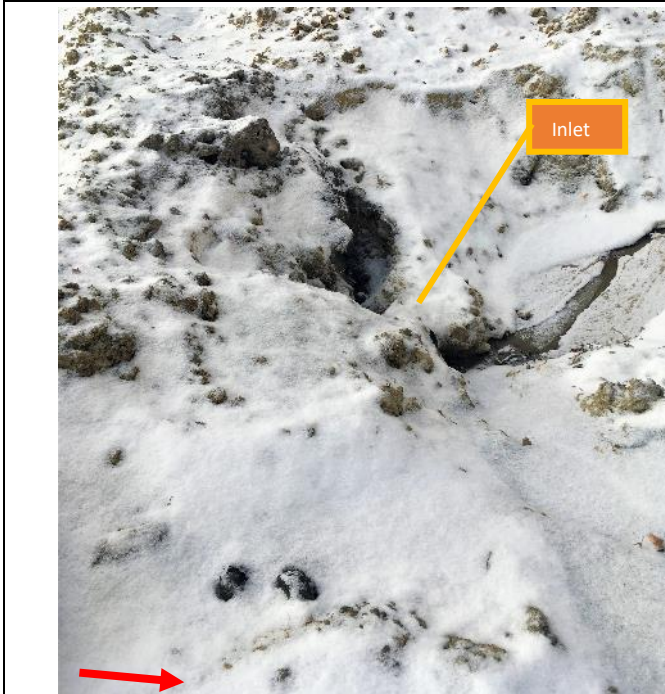
Photo No.: 11

Description: Partially buried stormwater inlet. See photo 10 for drainage leading to this inlet and photo 12 for outlet.

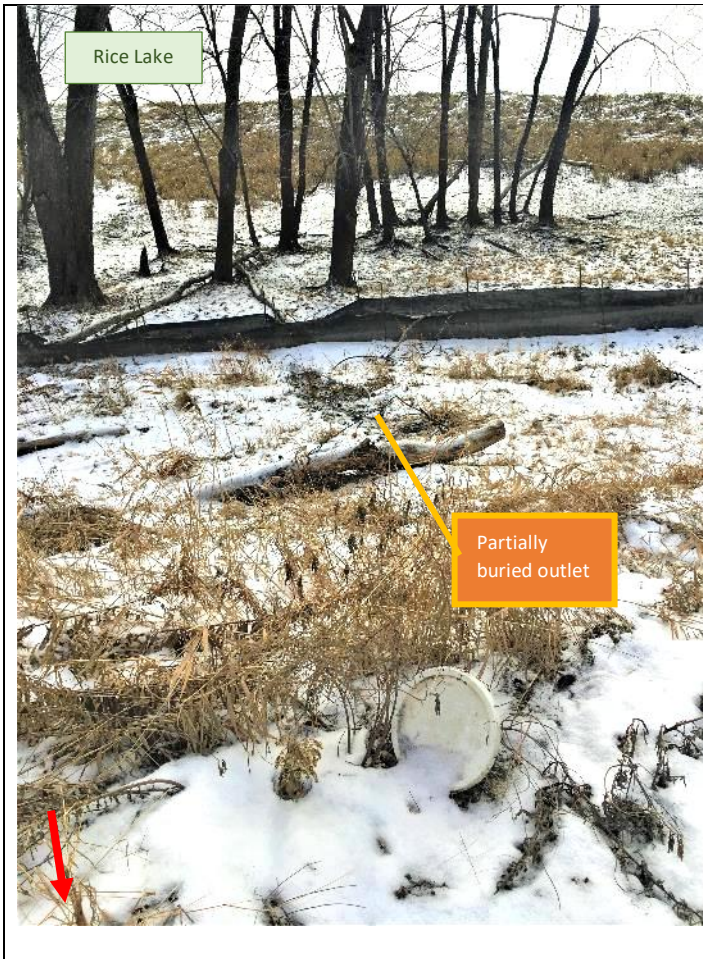
Photo No.: 12

Description: Partially buried outlet (see photos 10 and 11 for inlet and drainage leading to this area). Area is surrounded by vegetation, with no visible erosion or sedimentation. A dark patch of ice leading to the silt fence indicates some water flow occurred recently.

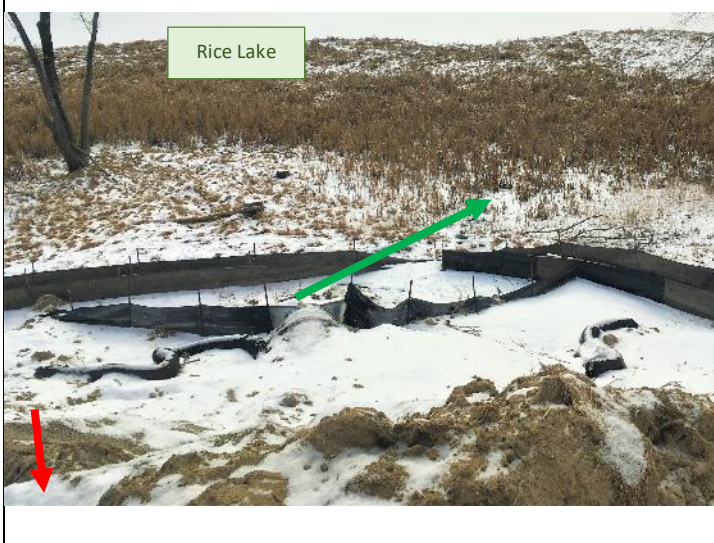
Photo No.: 13

Description: Culvert outlet on the southern side of the ROW. The silt fence fabric is frozen to the ground, allowing stormwater to pass uninterrupted into Rice Lake.

Green arrows indicate route of stormwater through silt fence.

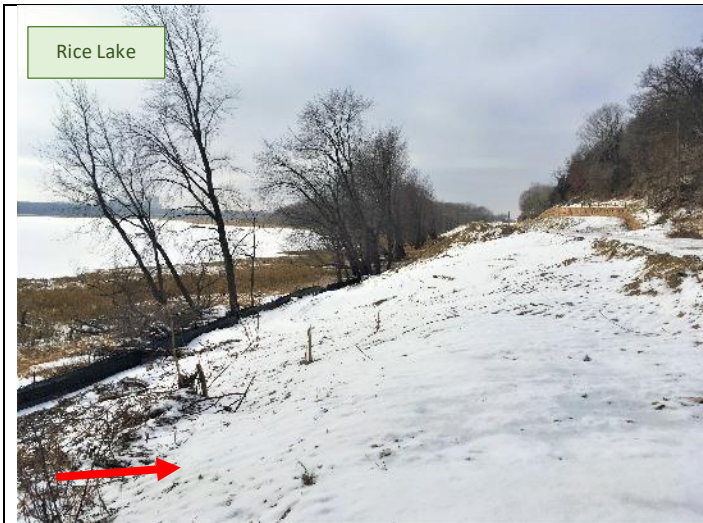
Photo No.: 14

Description: Recently regraded slope approximately 15 yards east of photo 13. Area is stable with no signs of soil movement.

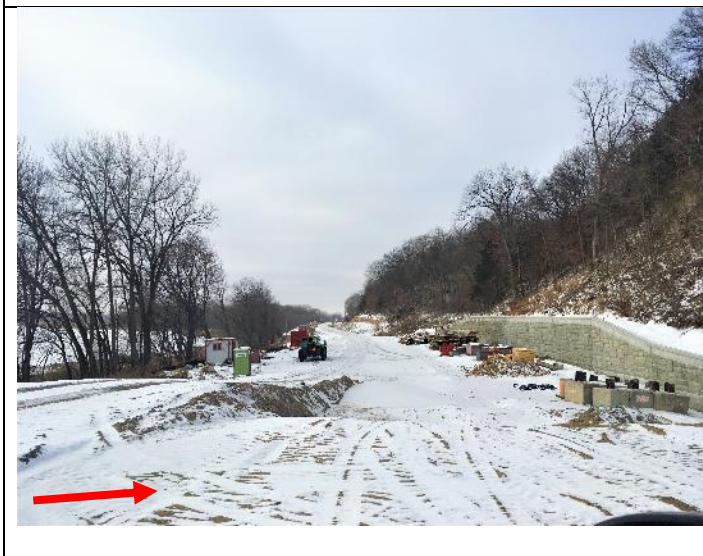
Photo No.: 15

Description: Current ROW conditions. Crews have been regrading this area to raise the roadbed and installing a wall along the northern perimeter.

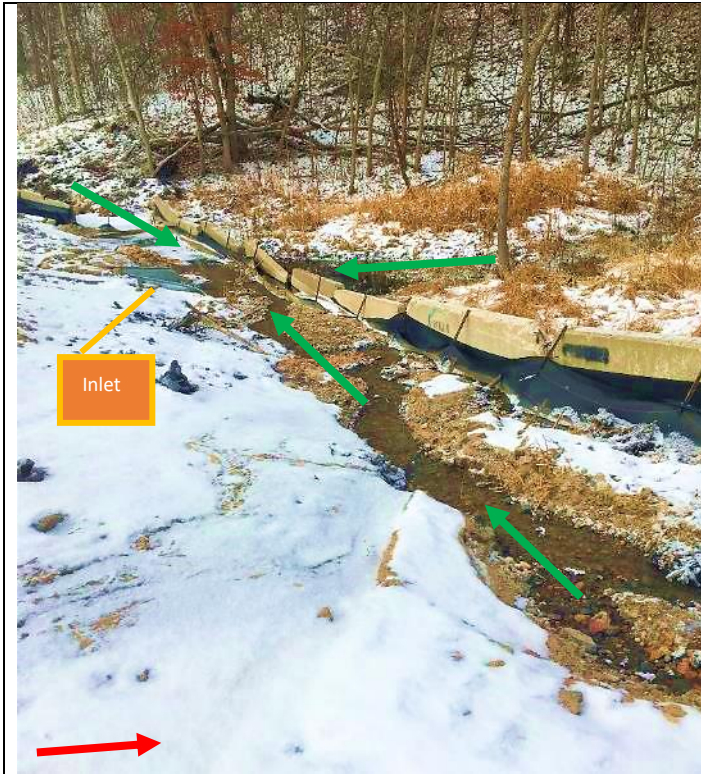
Photo No.: 16

Description: Drainage (green arrows) area leading to a culvert on the northern side of the ROW. Channeling through the rock checks indicates a significant volume of water.

Water drains east, west, and southward into the culvert.

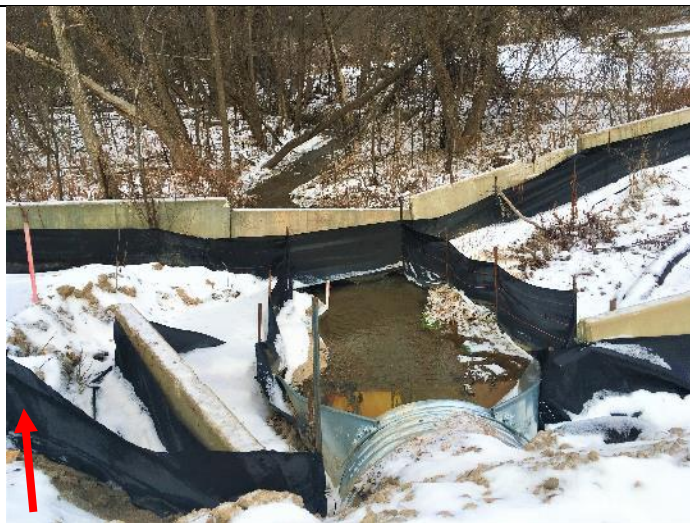
Photo No.: 17

Description: This culvert allows a creek to pass through the center of the project north-to-south. This inlet is on the northern side of the ROW. The area is stable and frozen.

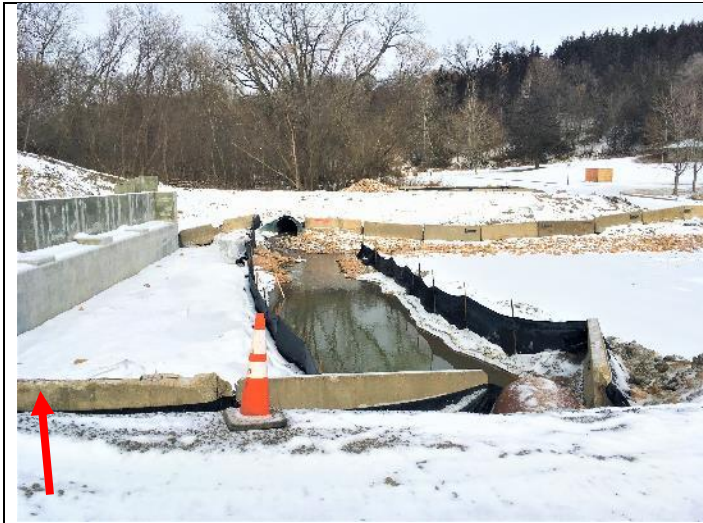
Photo No.: 18

Description: This outlet lies just south of photo 17 and routes the same creek through the center of the road construction. The BMPs are intact and the area is stable.

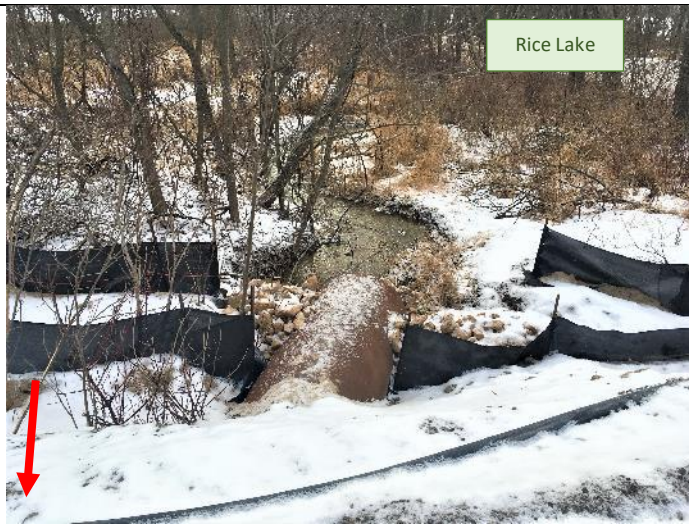
Photo No.: 19

Description: This is the southern outlet for the aforementioned creek (see photos 17 & 18).

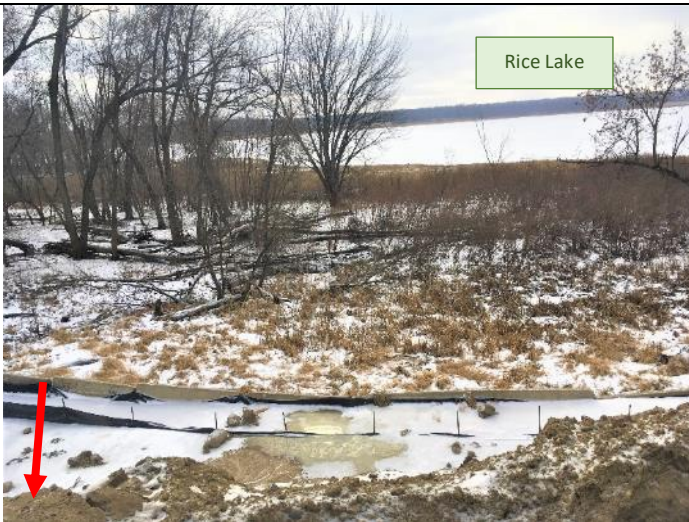
Photo No.: 20

Description: Southern slope on the ROW. Water and some sediments have pooled in both rows of silt fencing and frozen.

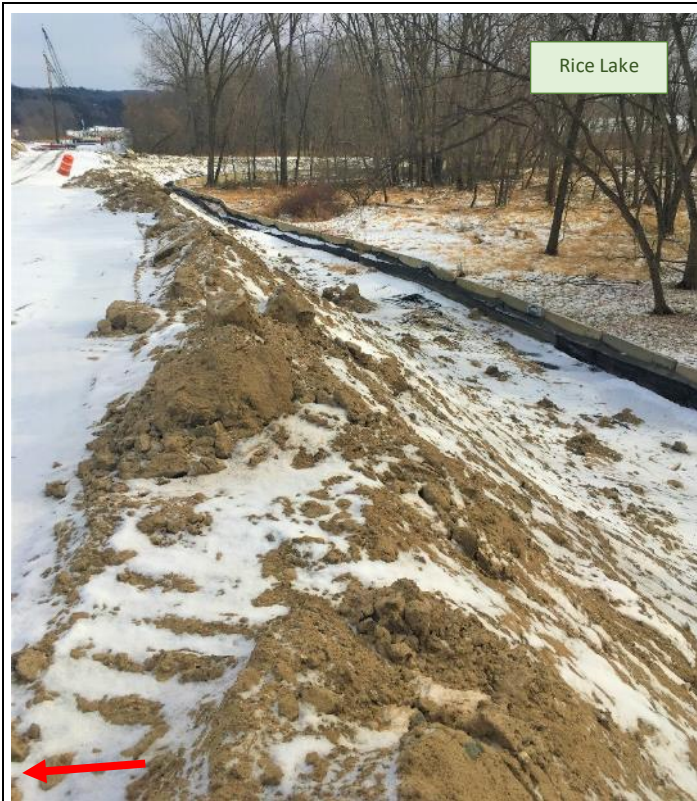
Photo No.: 21

Description: Southern side of ROW conditions. Mid- to late-December this area was regraded. The site is currently frozen and stable, with no evidence of washouts or channeling due to recent weather events.

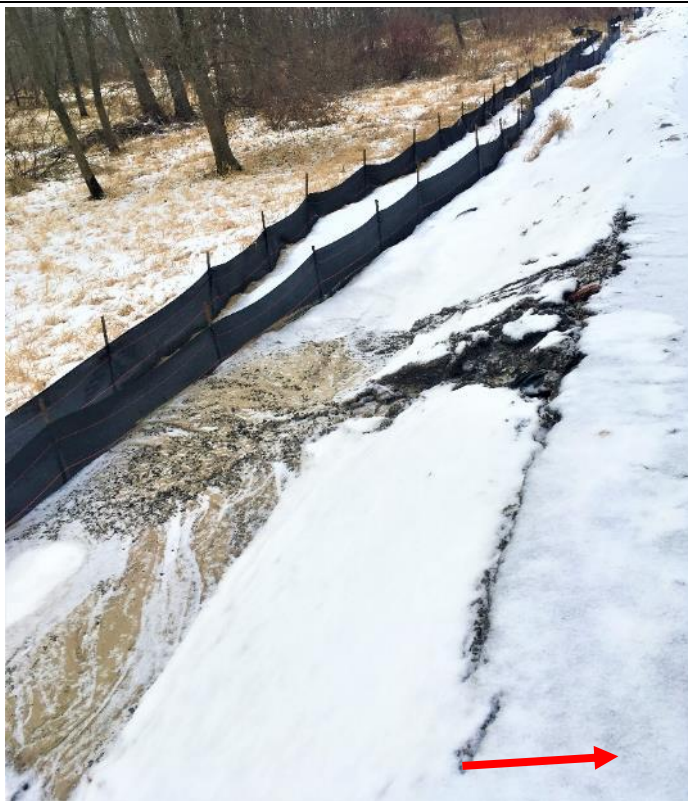
Photo No.: 22

Description: This location was used in mid- to late-December for dewatering. Channeling (present during active dewatering) appears to have been exacerbated by recent precipitation.

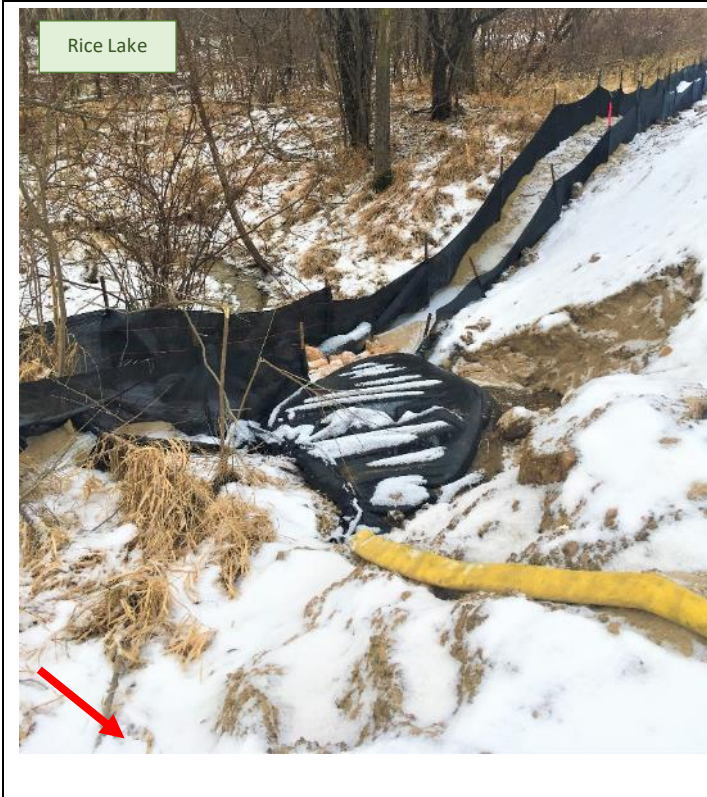
Photo No.: 23

Description: Dewatering setup on southern side of the ROW. An area of brown sediment is visible around the bag.

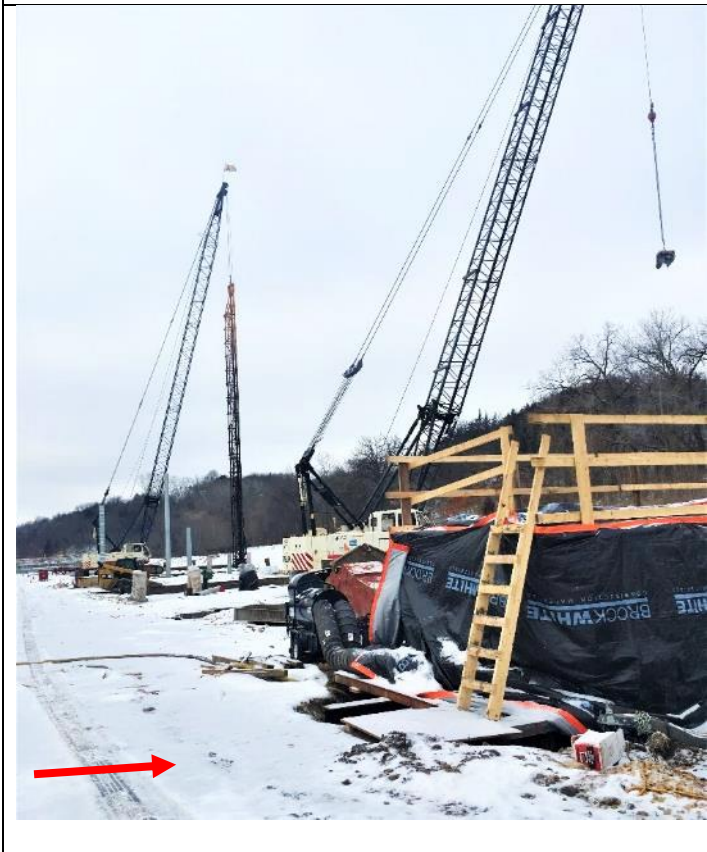
Photo No.: 24

Description: Construction set up for installing pylons.

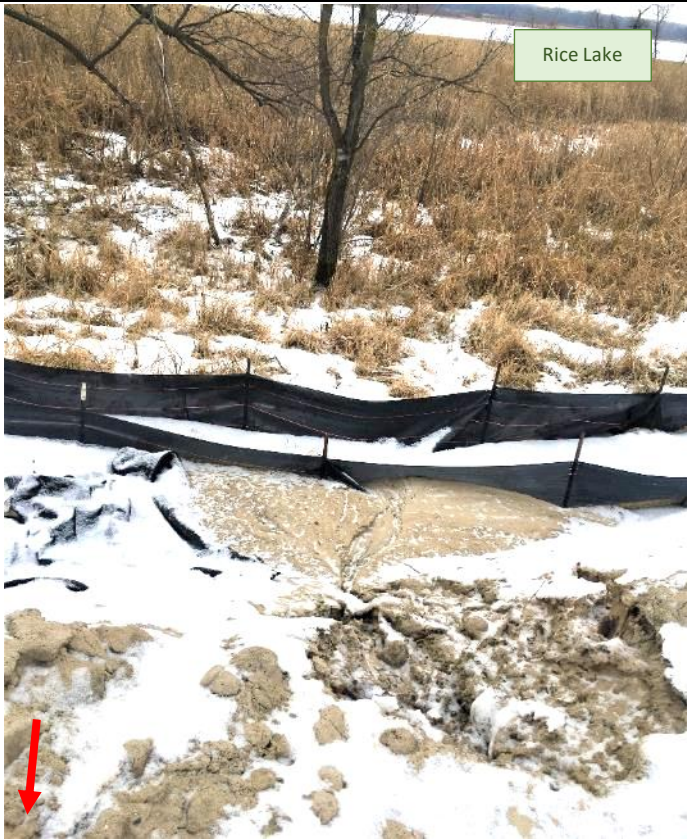
Photo No.: 25

Description: Dewatering setup on the southern side of the ROW. During previous site visits sediment accumulation was noted in this area. The sediment has not breached the silt fence.

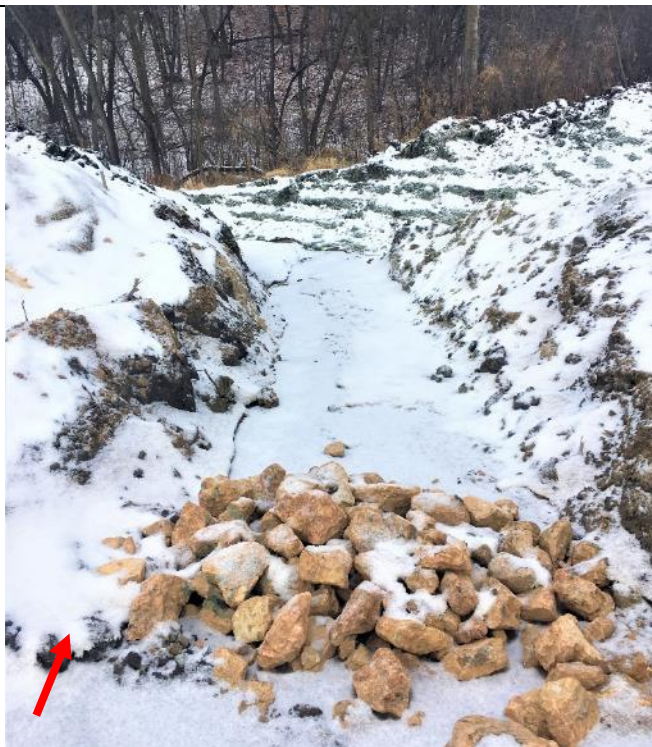
Photo No.: 26

Description: Rock check on the northern side of the ROW. A channel has been created to route stormwater around stock piles.

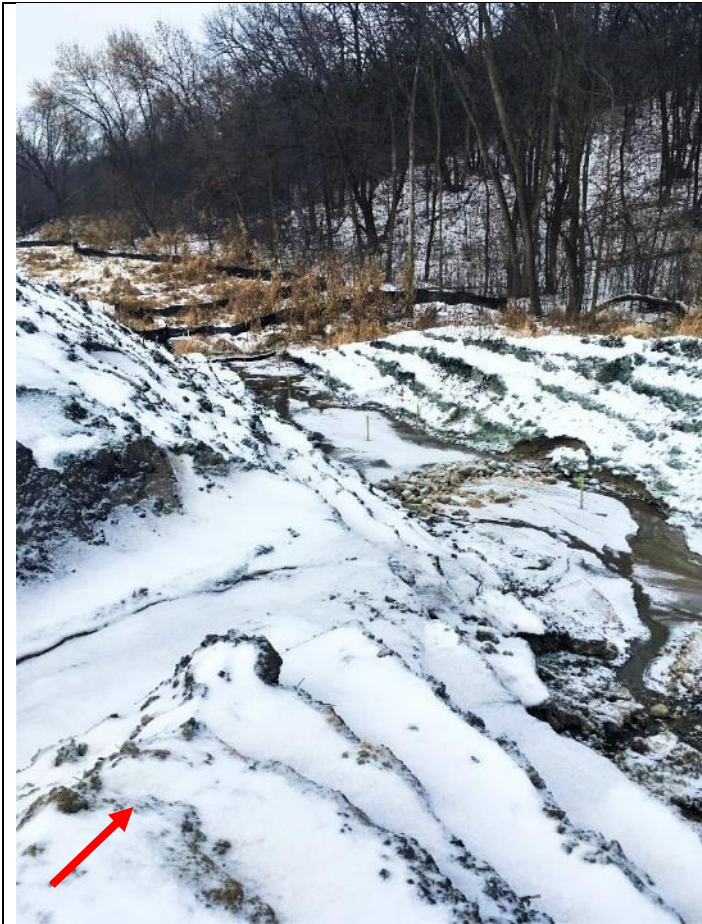
Photo No.: 27

Description: Area along the northern side of the ROW. A stormwater channel has been routed from the main roadway (see photo 26) to the northern perimeter of the project. The channel has several rock checks and the surrounding stock piles are coated in hydromulch. The area was frozen and coated in ice.

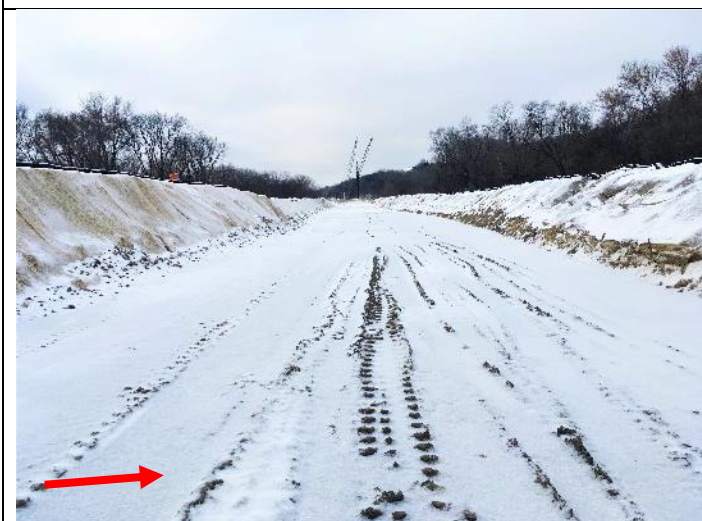
Photo No.: 28

Description: Stabilized stockpiles flanking the southern and northern sides of the ROW. The southern side is stabilized with ESC blanket. The northern side was stabilized with hydromulch during a recent warm weather, once the snowpack had melted.

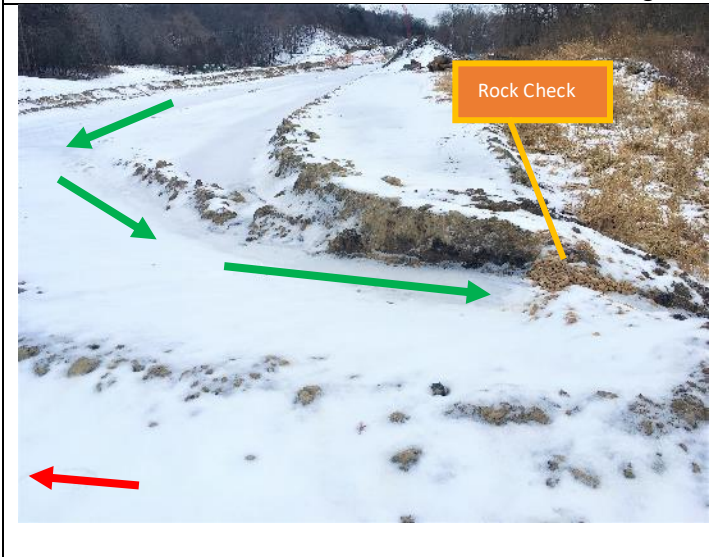
Photo No.: 29
Location: 44°49'10.25"N 93°30'11.95"W
BMPs Present: Rock check
Description: Roadway graded to channel stormwater to the southern side of the ROW. Green arrows indicate channel route. See photo 30 for an additional photo of the drainage area.

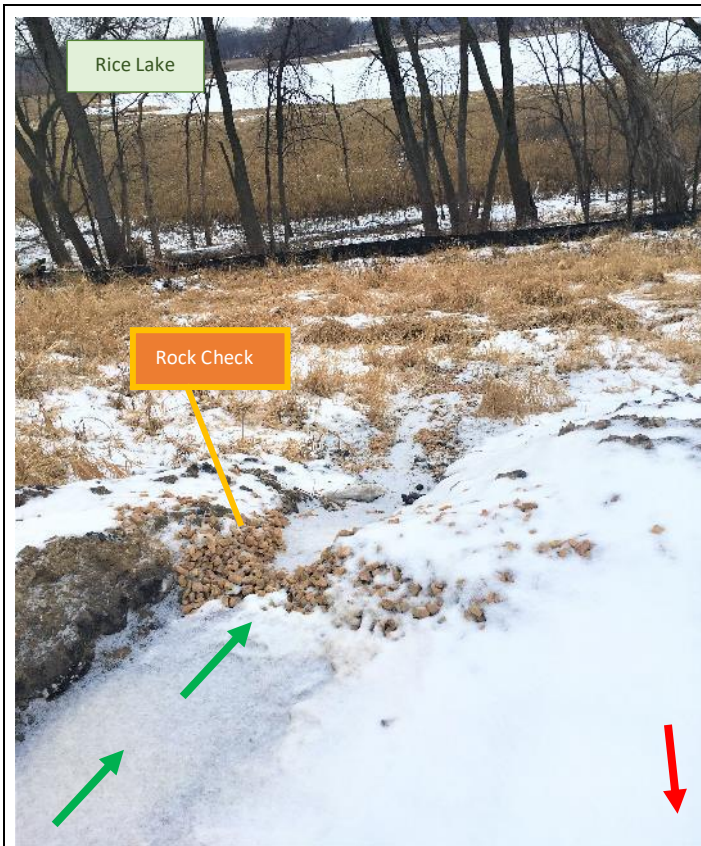
Photo No.: 30

Description: Stormwater channel discharging on the southern side of the ROW. A portion of the rock check has been washed out. See photo 29 for upslope drainage area.

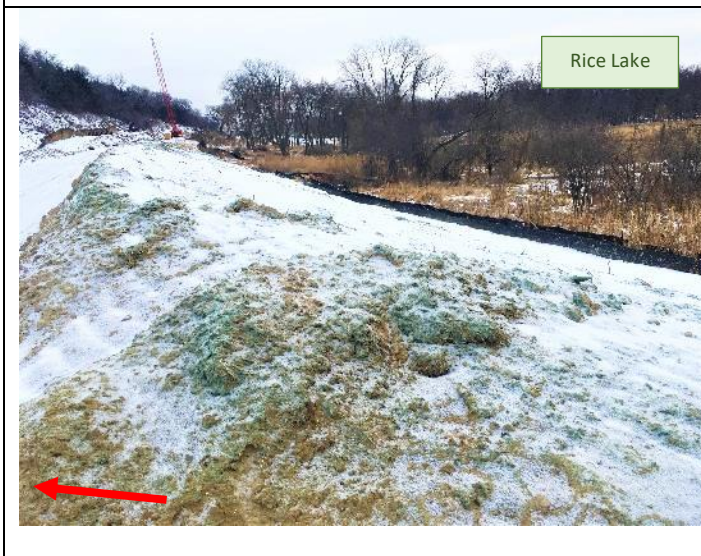
Photo No.: 31

Description: Southern side of the ROW conditions after the rain event. The hydromulch appears unaffected by the recent melting and precipitation events.

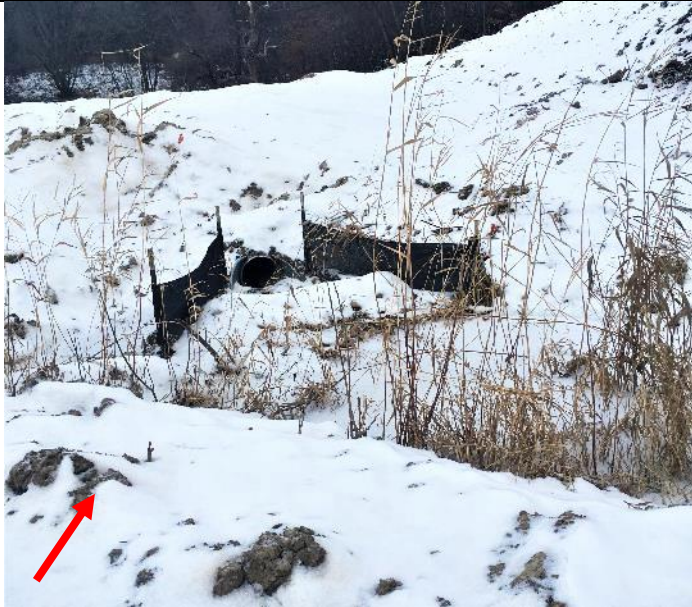
Photo No.: 32

Description: Stormwater outlet on the northern side of the ROW. Silt fence is position on either side of the outlet.

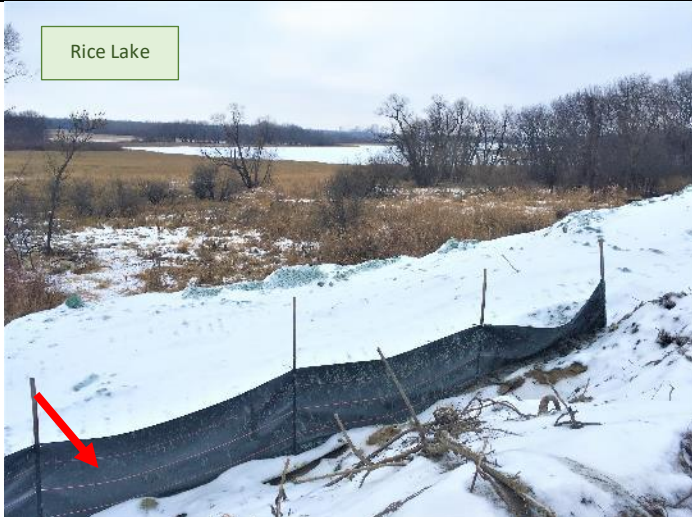
Photo No.: 33

Description: ROW conditions on the southern side of the project. Hydromulch was applied during my list site visit on December 21st. The area is stable and frozen.

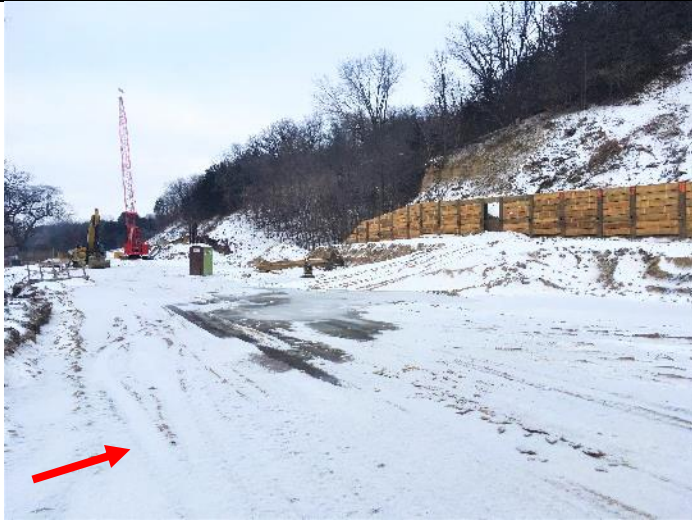
Photo No.: 34

Description: Current ROW conditions. The area is frozen and stable.

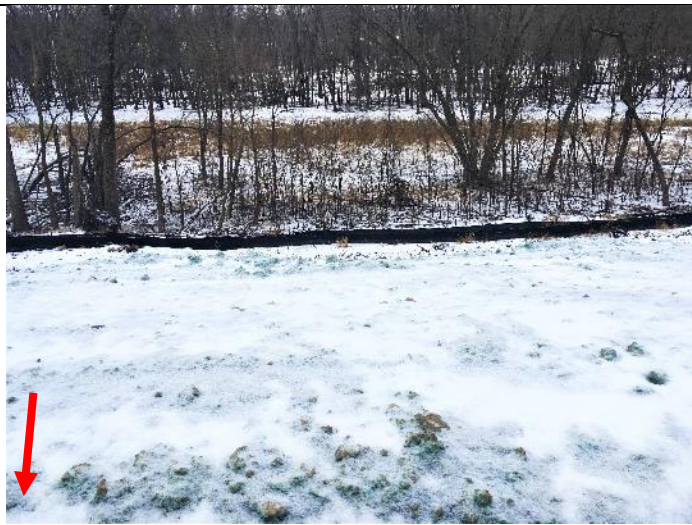
Photo No.: 35

Description: Southern side of the row. Hydromulch was applied to the area during my last site visit on December 21st. The area is stable and frozen.

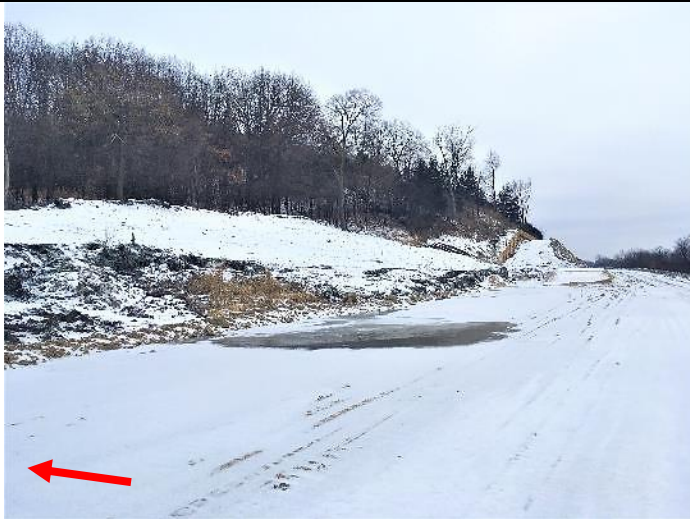
Photo No.: 36

Description: Roadway on the project. Ponding is visible and has begun to freeze. Most of the ROW in this area is coated in at least 1 inch of ice.

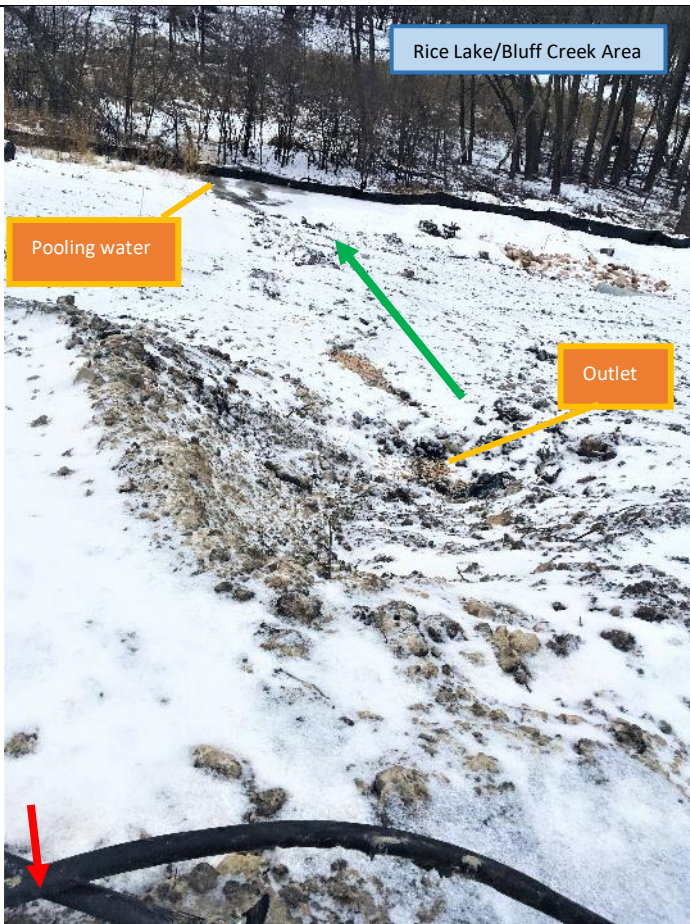
Photo No.: 37

Description: Drainage outlet on the southern side of the ROW. The outlet is small and has formed a slight channel leading to the silt fence. The green arrow indicates route of stormwater. Water has pooled and frozen on the upslope side of the silt fence.

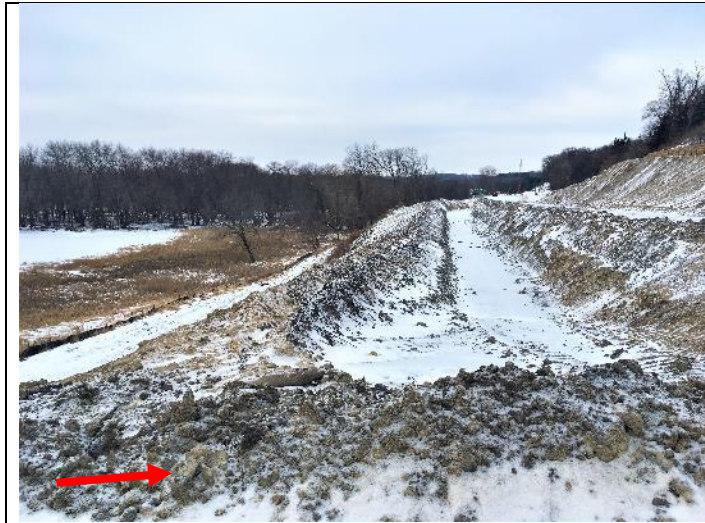
Photo No.: 38

Description: ROW conditions along the southern perimeter of the project. The area is frozen and stable.

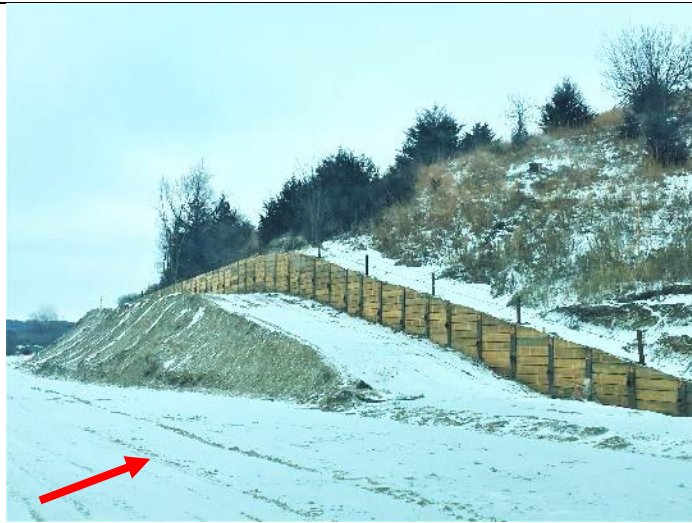
Photo No.: 39

Description: Conditions on the northern side of the ROW. The area is stable and coated in a sheet of ice.

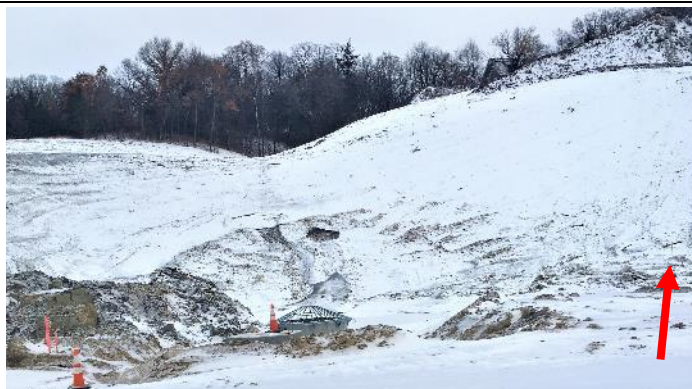
Photo No.: 40

Description: Northern side of the ROW and part of the stormwater conveyance system. See photos 41 and 42 for southern outlets.

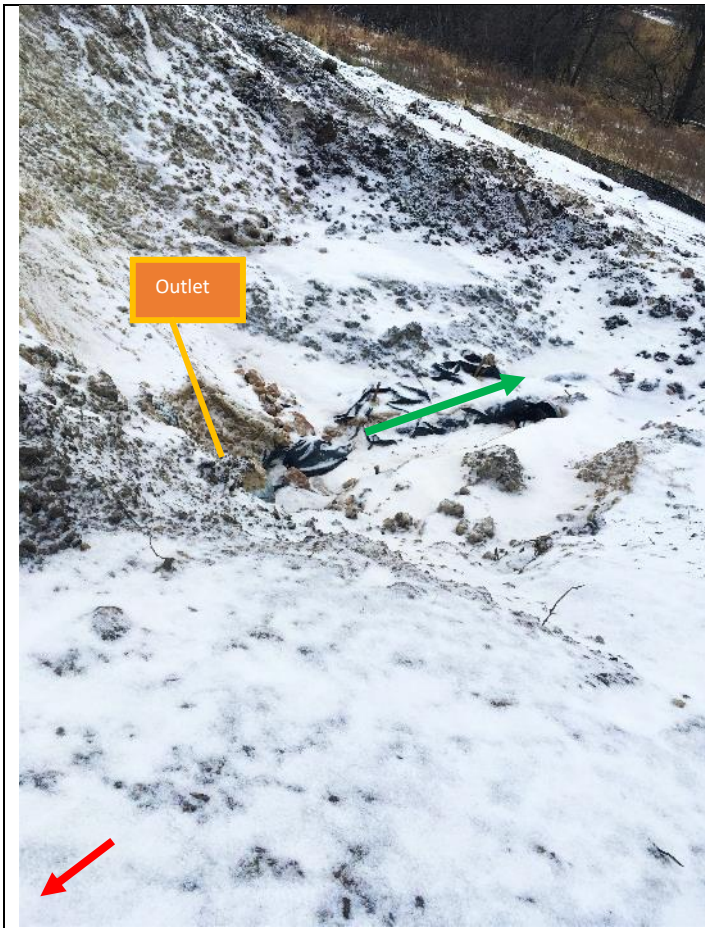
Photo No.: 41

Description: Outlet that lies directly south of the water conveyance structures visible in photo 40. The area is coated with a layer of ice. The green arrows indicate direction of flow.

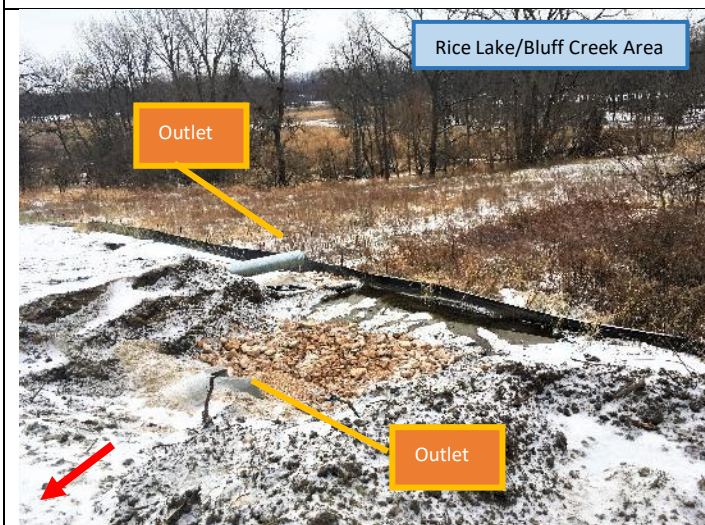
Photo No.: 42

Description: Two outlets on the southern side of the ROW. These outlets lie downslope of the outlet in photo 41. This area is coated in ice and has water pooled at the base of the silt fencing.

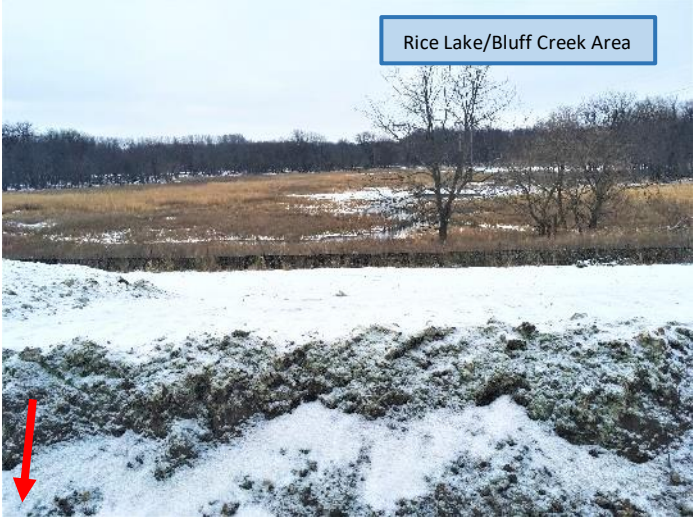
<p>Rice Lake/Bluff Creek Area</p>	<p><u>Photo No.:</u> 43</p> <p><u>Location:</u> 44°49'05.26"N 93°28'57.78"W</p> <p><u>BMPs Present:</u> Two rows of silt fence; hydromulch</p> <p><u>Description:</u> A frozen and stable ROW. Hydromulch was applied in this area in mid-December. The hydromulch remains intact despite recent storm events. During the inspection the area was coated in ice.</p>

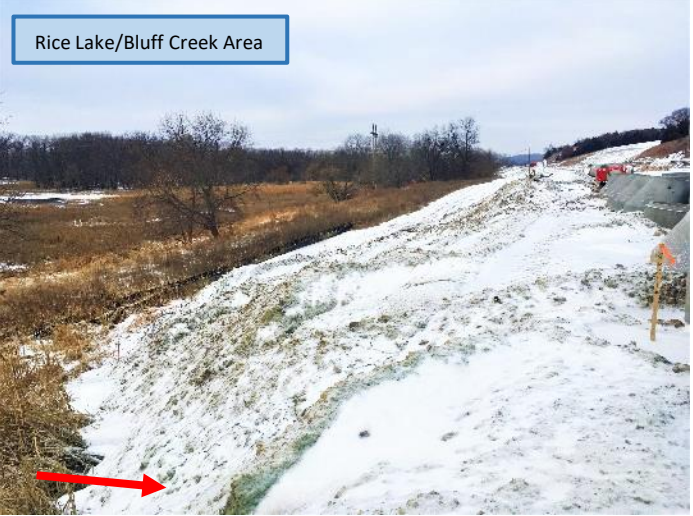
<p>Rice Lake/Bluff Creek Area</p>	<p><u>Photo No.:</u> 44</p> <p><u>Location:</u> 44°49'04.98"N 93°28'58.20"W</p> <p><u>BMPs Present:</u> Two rows of silt fence; hydromulch</p> <p><u>Description:</u> A frozen and stable ROW.</p>
