# LOWER MINNESOTA RIVER WATERSHED DISTRICT

## Executive Summary for Action

**SITE LOCATION:** CSAH 61-Flying Cloud Drive

**PURPOSE:** Construction Stormwater Site Visit on Behalf of the Lower Minnesota River Watershed District (LMRWD)

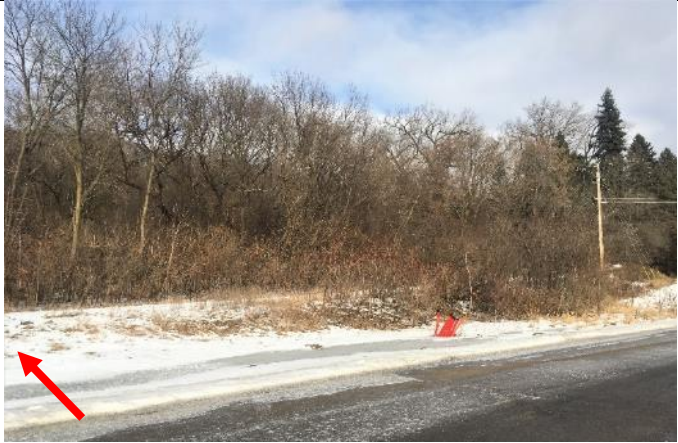
Photo No.: 1  
Location: 44°48'49.89"N 93°31'58.67"W  
BMPs Present: None visible  
Description: Utilities along northern side of ROW.

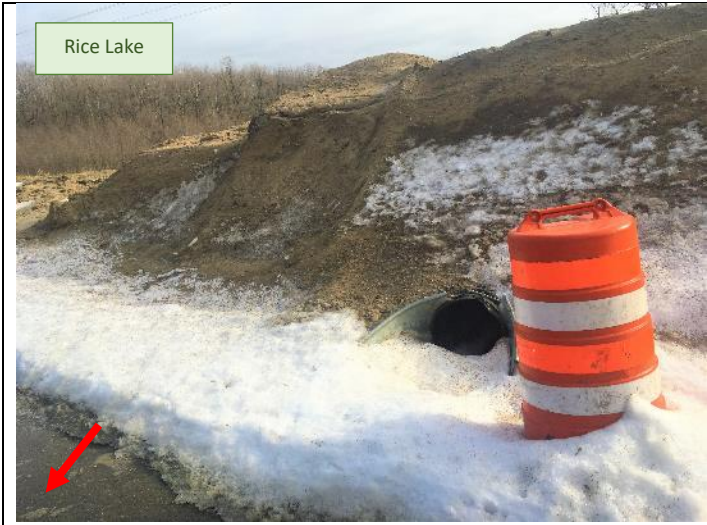
**Photo No.:** 4

**Description:** Stormwater culvert draining from the existing roadbed towards the southern perimeter of the project. See photo 3 for the downslope outlet of this culvert.

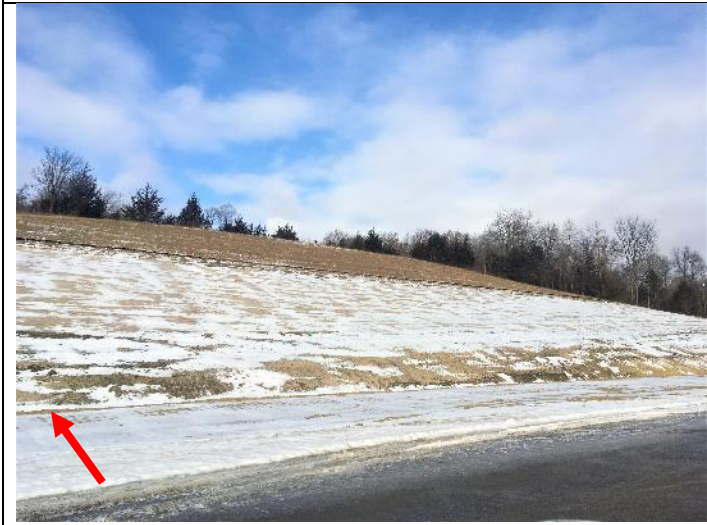
**Photo No.:** 5

**Description:** Slope along northern side of the ROW. Area is stable and frozen.

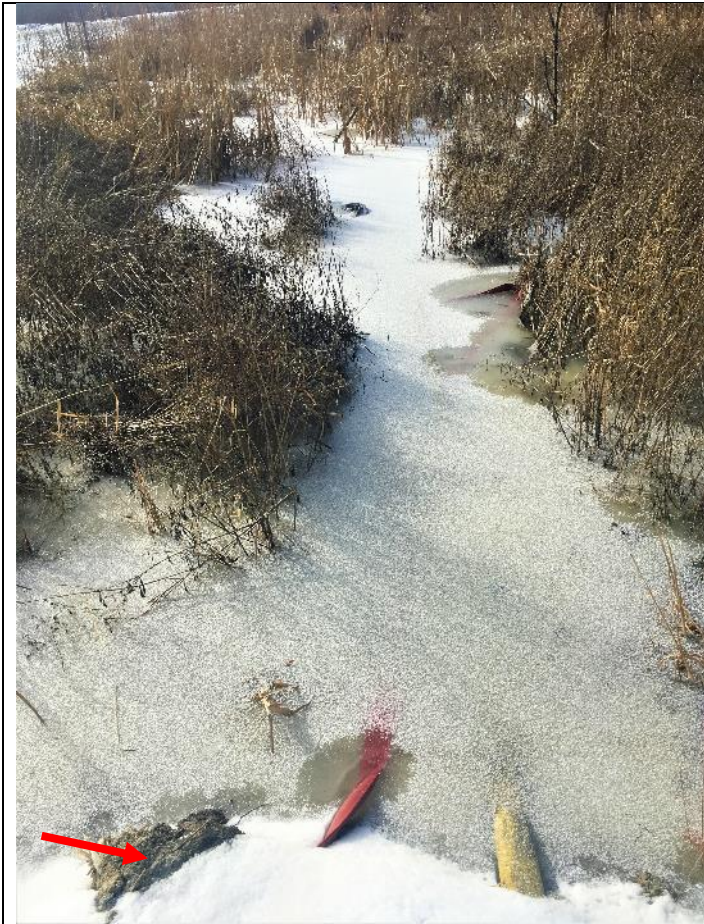
Photo No.: 6

Crews were observed in the center of the project, installing walls along the northern side of the road. Other crews continued to install pylons, which necessitates dewatering in several locations. Several areas had dewatering equipment setups along the southern side of the right of way but there were no active operations. See photos 6 and 25.

Description: This dewatering set up has been in place for several months. There are two hoses leading to this wetland. At least one filter bag is partially frozen into the wetland. It is unclear if the bag is connected to a hose.

During the inspection, this dewatering set up was not in use.

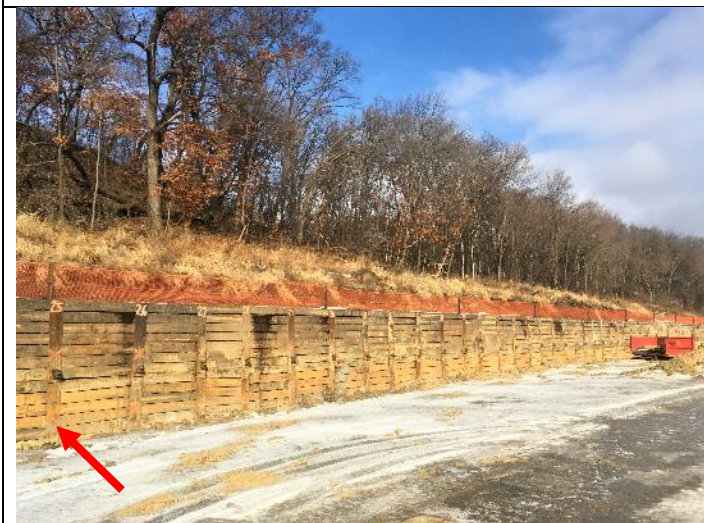
Photo No.: 7

Description: Wall constructed along the northern side of the ROW.

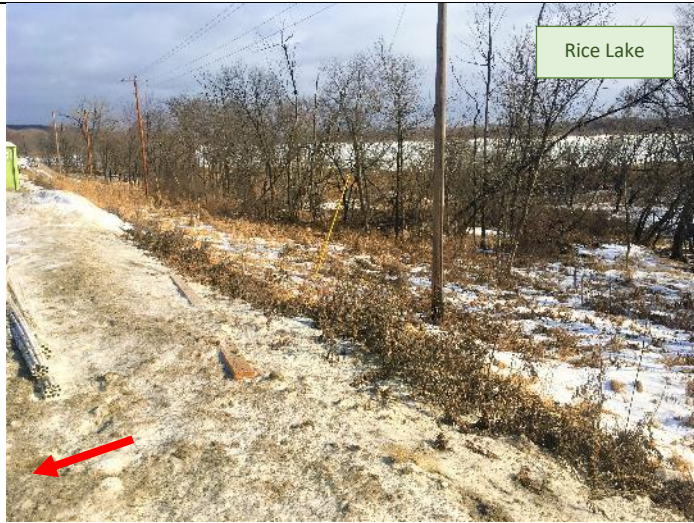
Photo No.: 8

Description: Southern side of ROW.

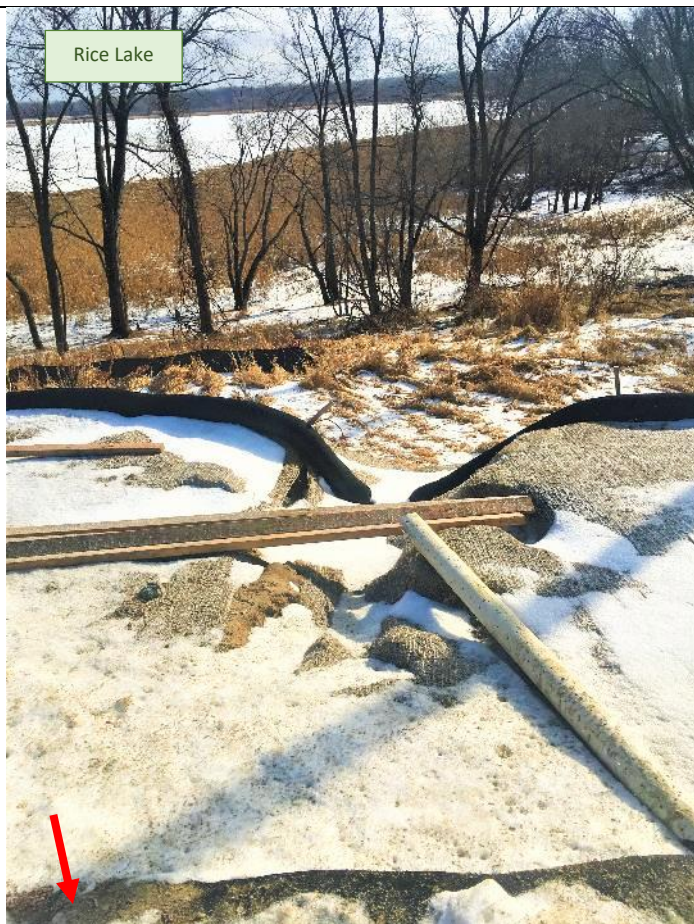
Photo No.: 9

Description: Southern side of the ROW sloping down towards Rice Lake. The dip in the ESC blanket is due to erosion/channeling that took place before frozen site conditions. During this site visit, there was no visible indication of new erosion. BMPs are frozen in place.

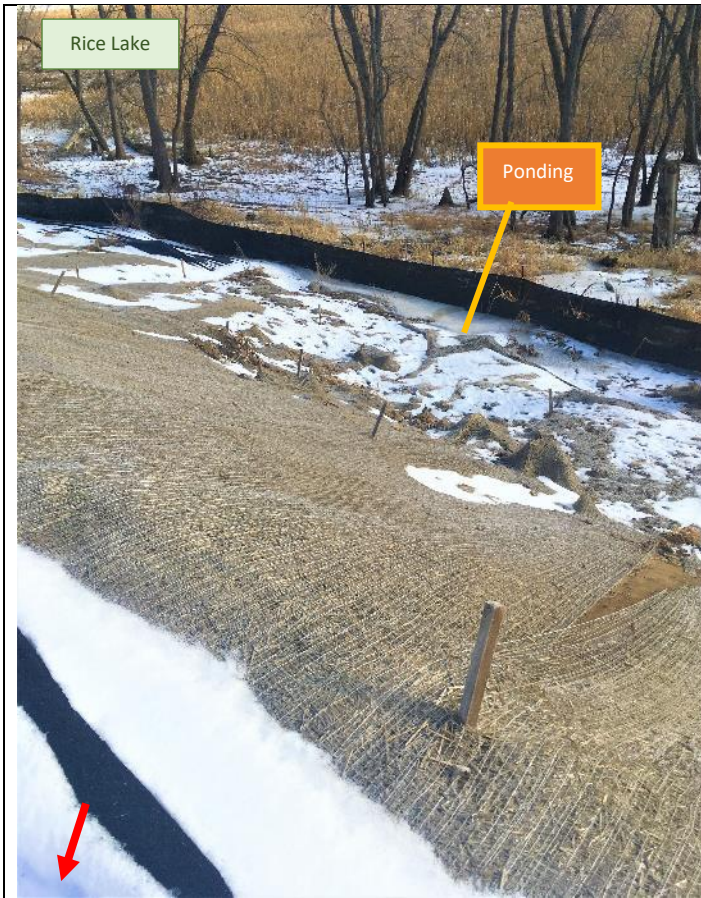
**Photo No.:** 10

**Description:** Slopes leading towards Rice Lake on the southern side of the ROW. Area is stable and frozen. Evidence of some ponding (now frozen) at the silt fence.

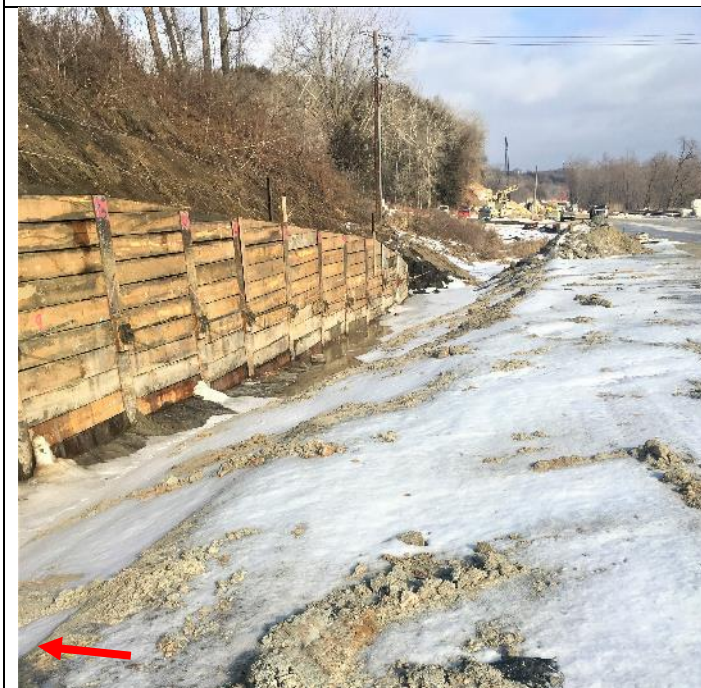
**Photo No.:** 11

**Description:** Wall constructed on the northern side of the ROW.

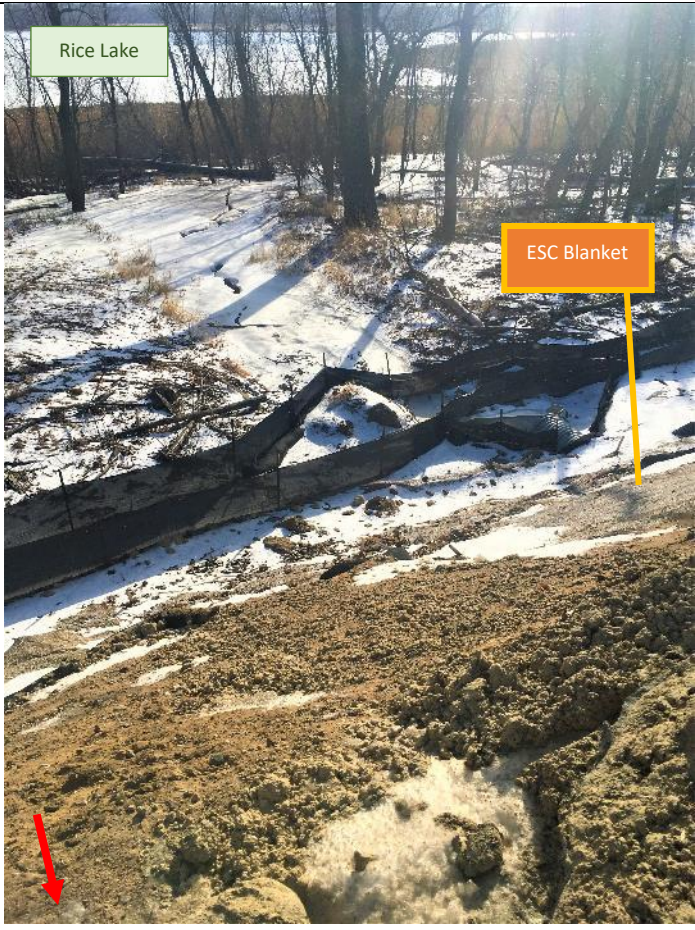
**Photo No.:** 12

**Description:** Culvert outlet leading to Rice Lake. The hillside upslope has had significant snowmelt and is now bare exposed soil. During the inspection the hillside was frozen.

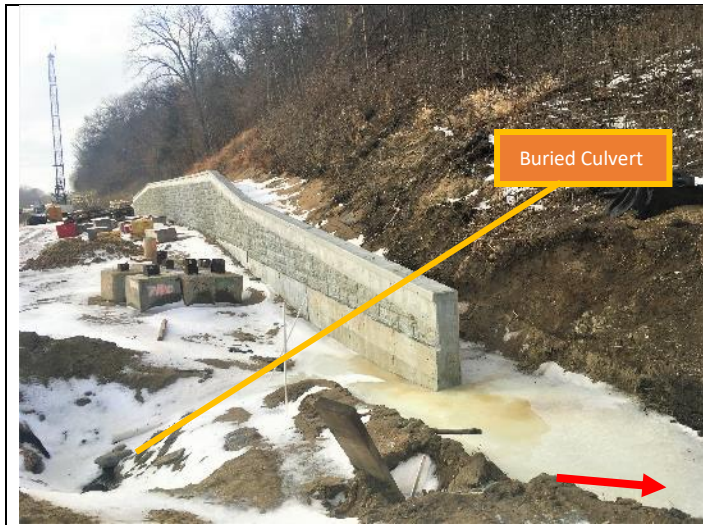
**Photo No.:** 19

**Description:** Active construction area on northern side of the ROW. There is a partially buried culvert near this area (see photo 20), that the stormwater is directed towards.

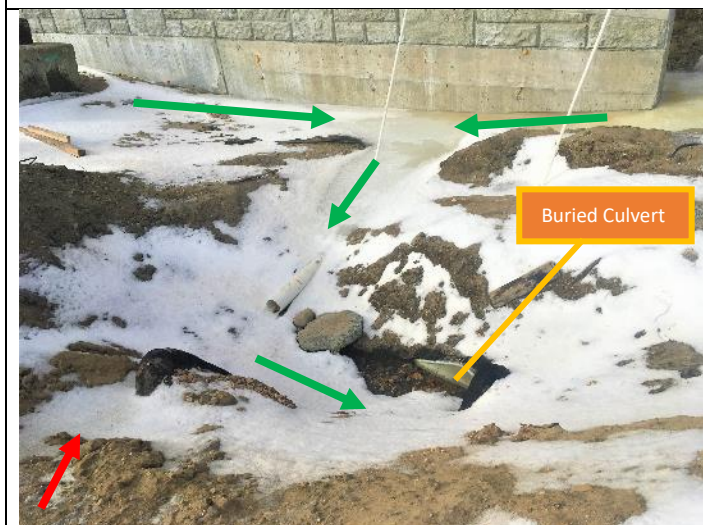
**Photo No.:** 20

**Description:** This photo depicts the stormwater runoff route (green arrows) and the partially buried culvert. See photo 19 for another view of this area.

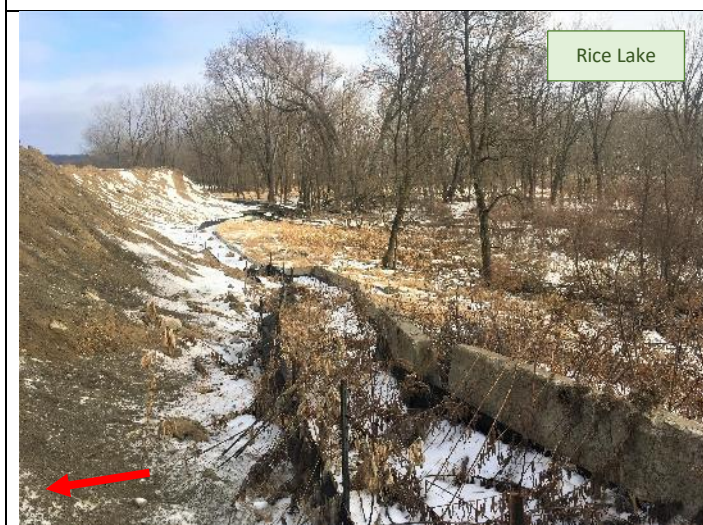
**Photo No.:** 21

**Description:** Southern side of the ROW draining to the Rice Lake area. Most of the snowpack in this area melted within the last 48 hours.

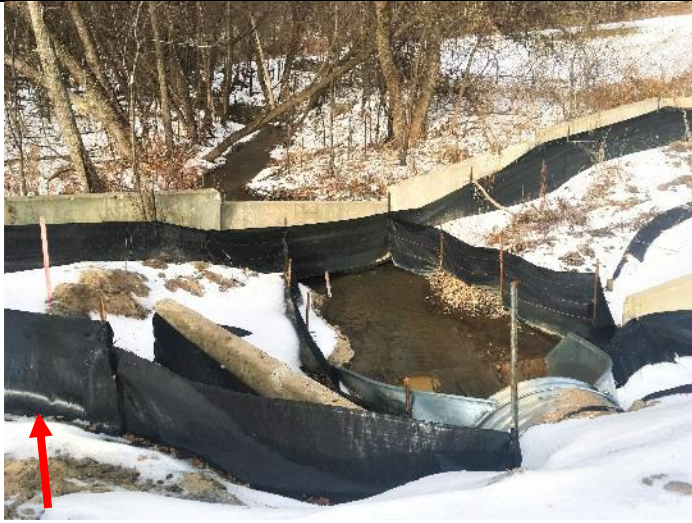
Photo No.: 22

Description: The northern culvert, directing a stream through the project. The BMPs are intact and the area is stable.

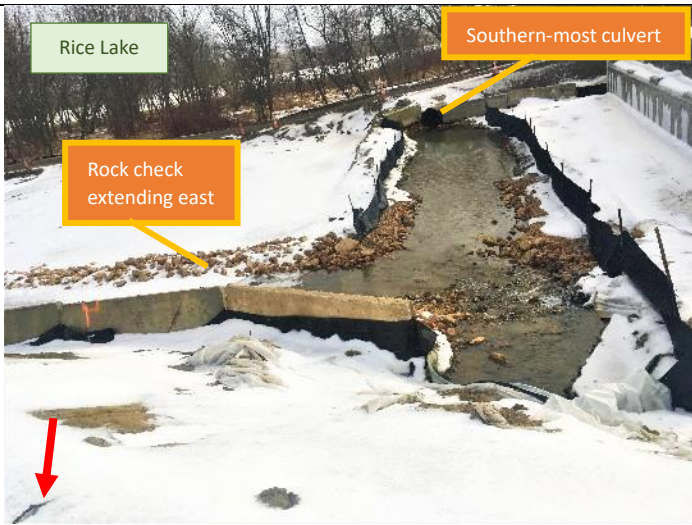
Photo No.: 23

Description: Channeling of stream through the project. See photo 22 for northern culvert. The rock check is filtering and directing flow from the eastern portion of the project, west to the stream.

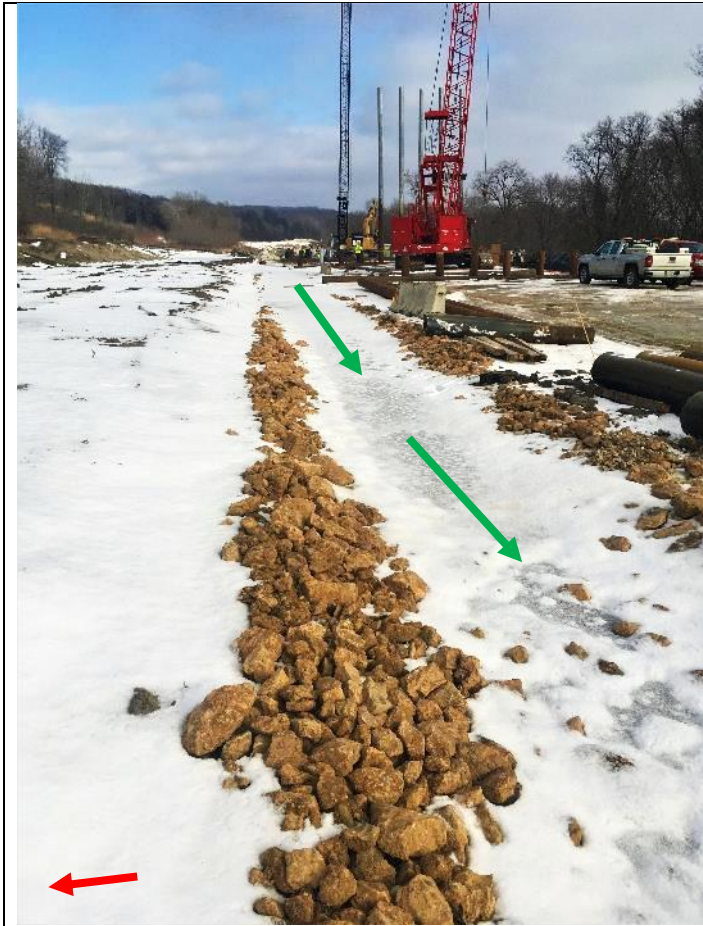
Photo No.: 24

Description: This rock check runs east-west along the northern edge of active construction. It routes water from active work areas, west towards the stream depicted in photo 23.

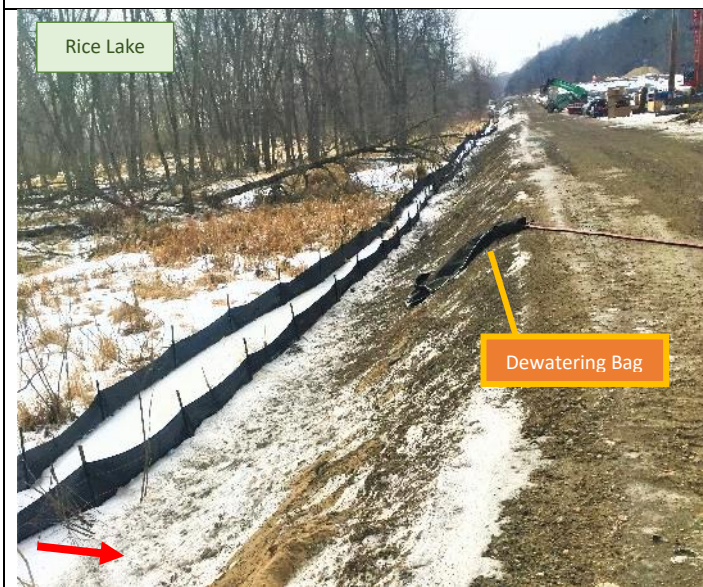
Photo No.: 25

Description: Dewatering setup along the southern perimeter of the project. During the site visit, dewatering was not taking place.

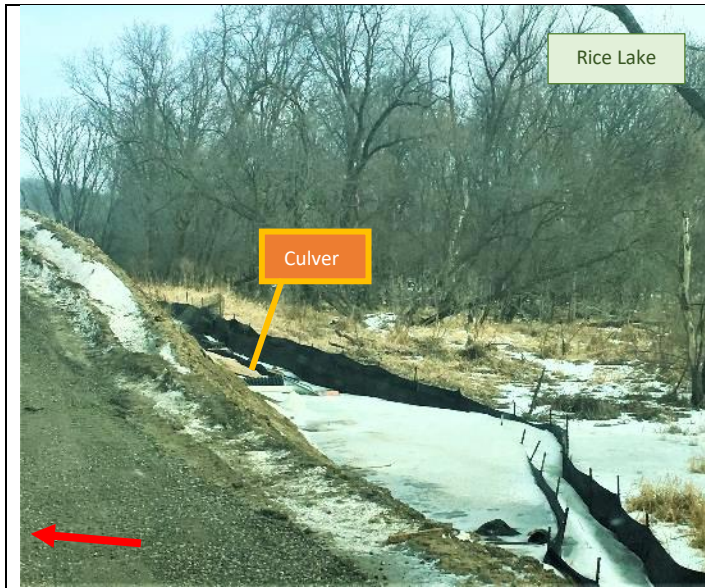
**Photo No.:** 26

In late December, crews hydromulched large sections of the project, predominately slopes on the eastern half of the project. Recent snow melt has not disturbed the hydromulch. Ice dams were visible at the outlets of several culverts and appear to clog the culverts. See photos 16, 17, and 26.

**Description:** Culvert outlet with frozen ice sheets extending out of it.

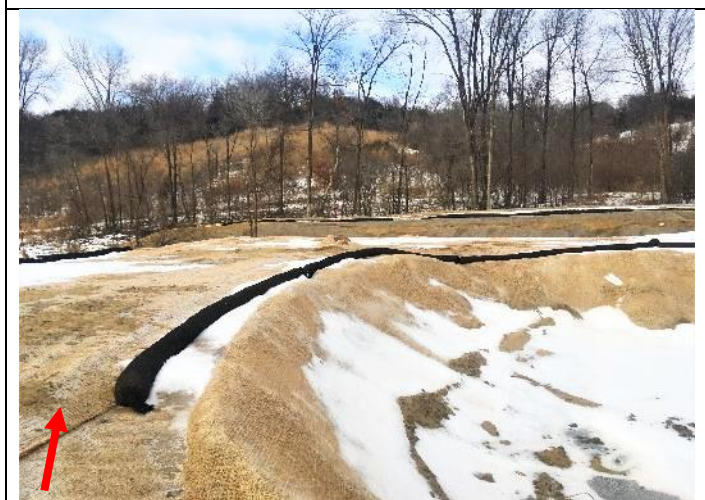
**Photo No.:** 27

**Description:** Stockpiles along the northern side of the ROW, stabilized with ESC blankets and biologs.

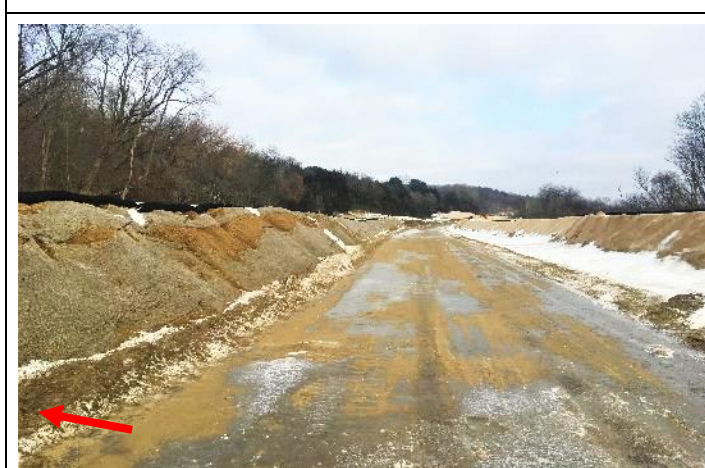
**Photo No.:** 28

**Description:** Stockpiles along the north and southern sides of the ROW. The piles are stabilized with ESC blanket and biologs.

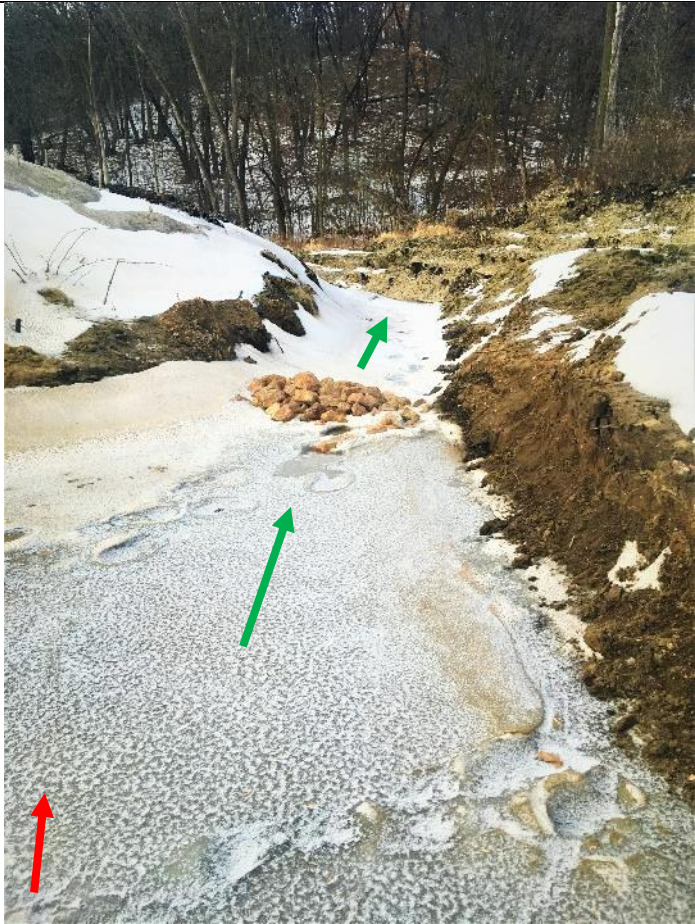
Photo No.: 29

Description: Rock check along the northern side of the ROW. A channel routes stormwater from the roadway, north through the rock check. See photo 30 and 31 for an additional view of the channel farther north.

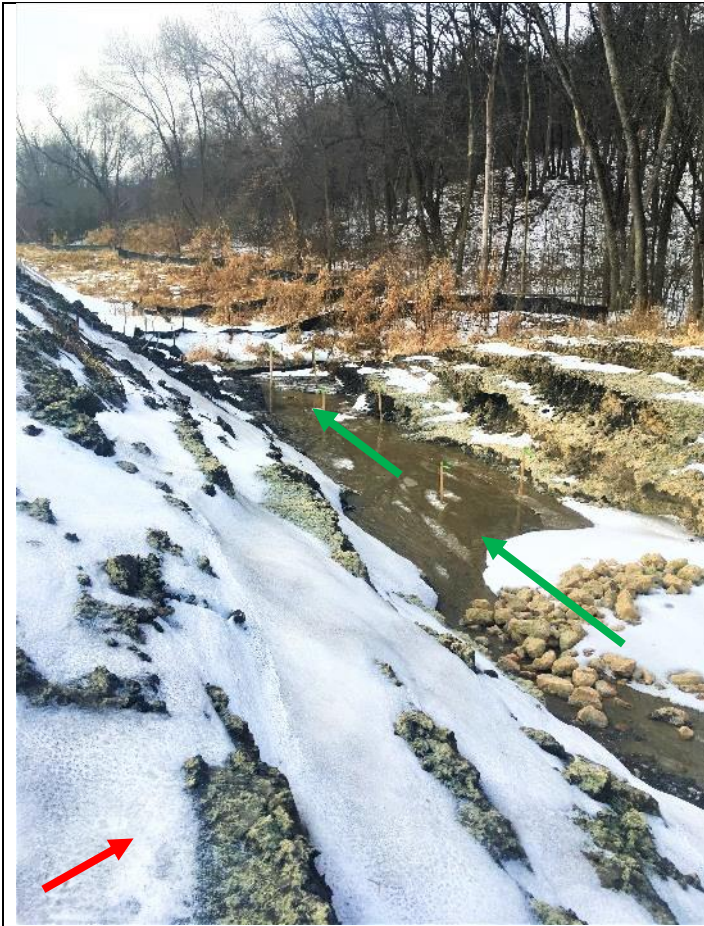
Photo No.: 30

The green arrows indicate water flow. See photo 31 for another view of this channel.

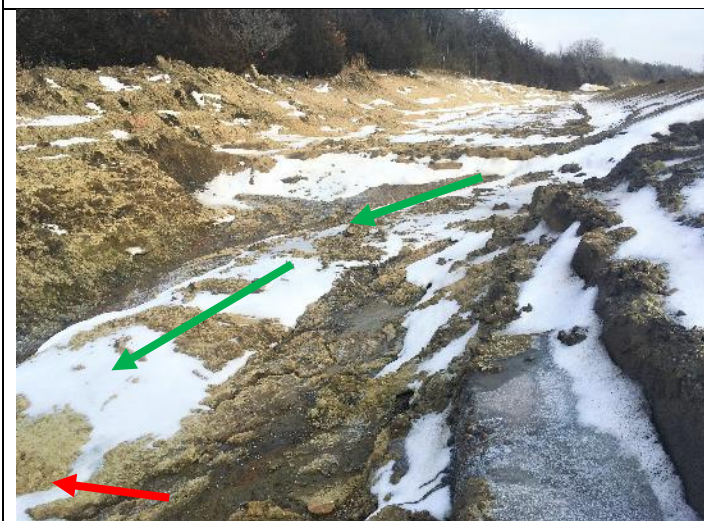
Photo No.: 31

The green arrows indicate water flow. See photo 30 for another view of this channel.

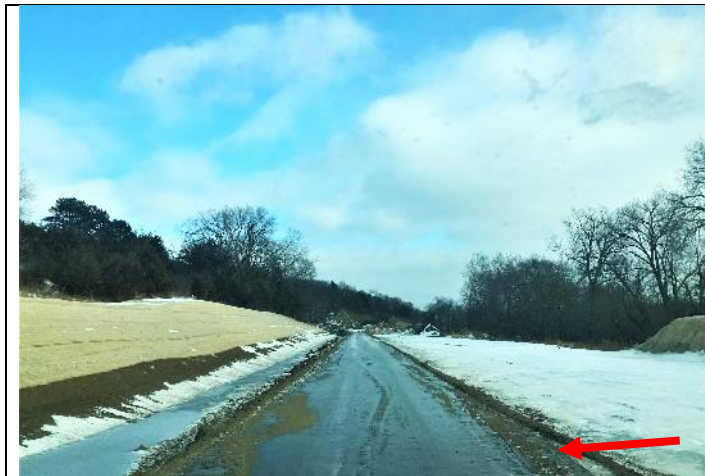
Photo No.: 32

Description: ROW has slopes on the north and south of the roadway stabilized with ESC blanket. There is a channel running along the northern edge of the road. It seems to be intended for routing stormwater off the roadway. This area of the project is coated in ice.

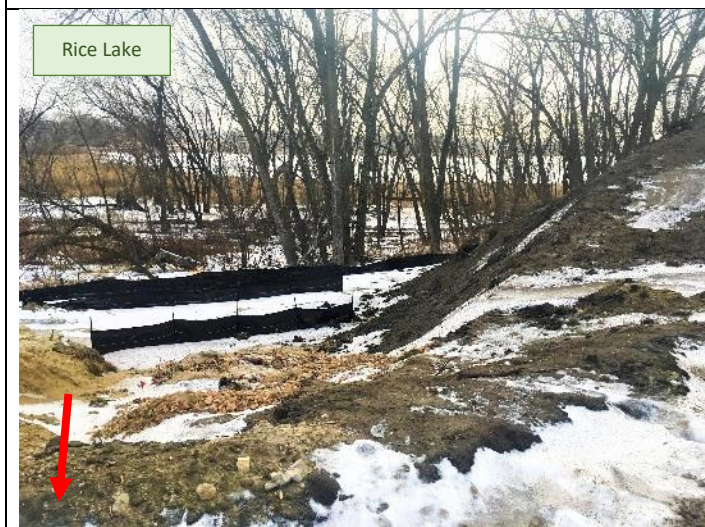
Photo No.: 33

Description: ROW conditions along the southern side of the project. The area is frozen and coated in a thin layer of ice.

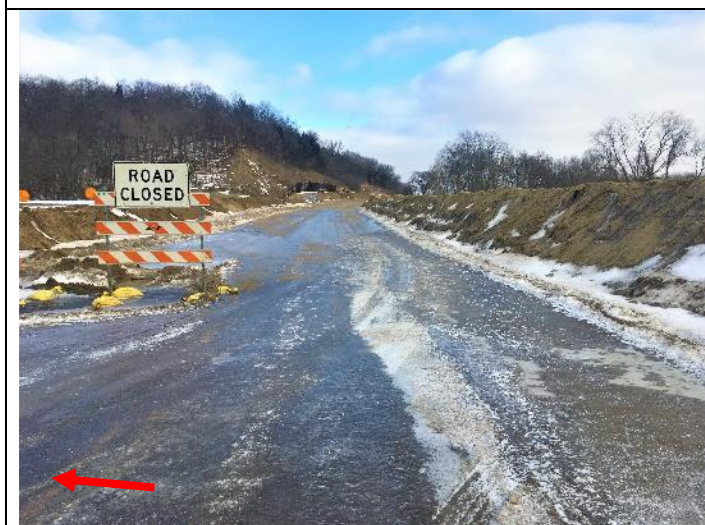
Photo No.: 34

Description: Current ROW conditions. The roadway is coated in a thick layer of ice. Stockpiles on both sides of the roadway have lost most of their snowpack. Bare soils are frozen and coated in a thin layer of ice.

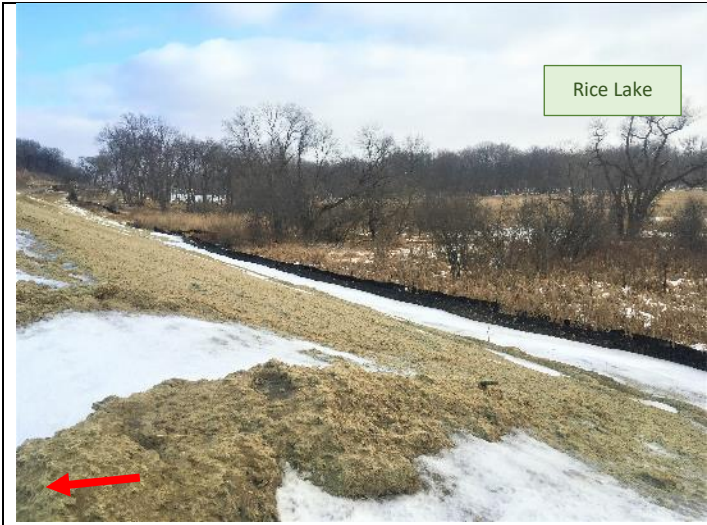
**Photo No.:** 35

**Description:** Southern slopes leading to the Rice Lake area. The slopes are stabilized with hydromulch and a thin coating of ice.

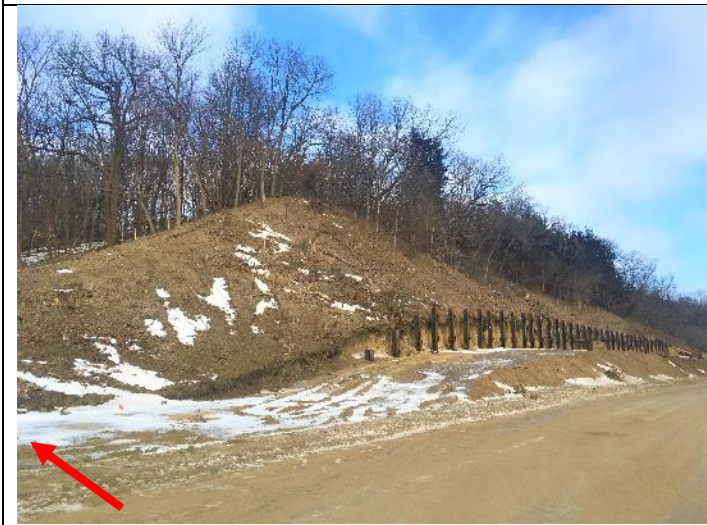
**Photo No.:** 36

**Description:** Wall construction along the northern side of the ROW.

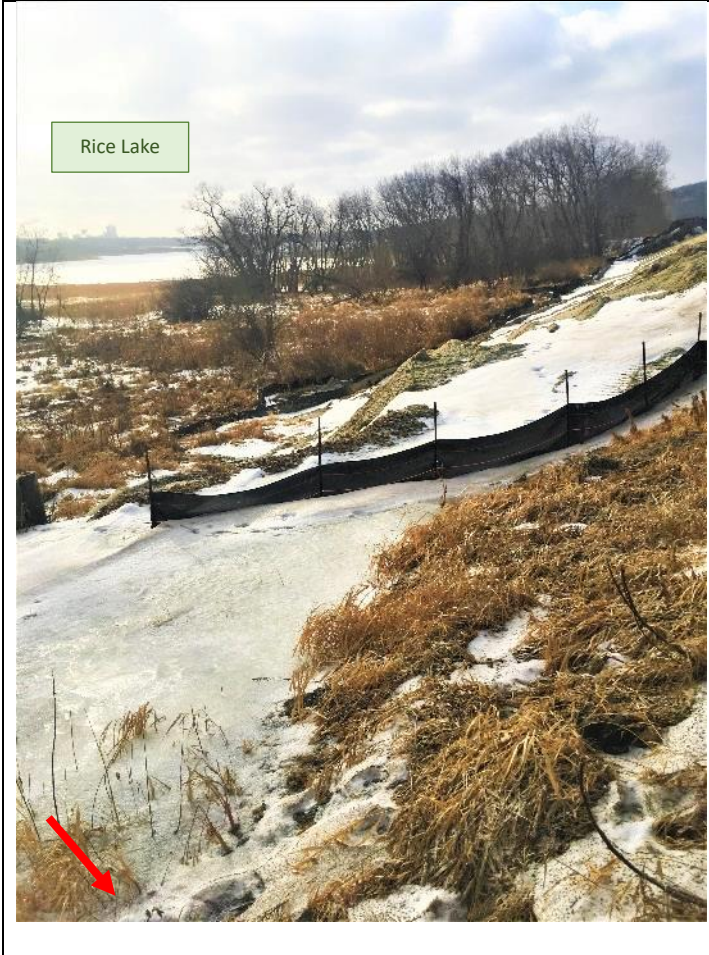
**Photo No.:** 37

**Description:** Slopes leading to the Rice Lake area. BMPs appear intact but are inundated with sheets of ice. No erosion was visible during the site visit.

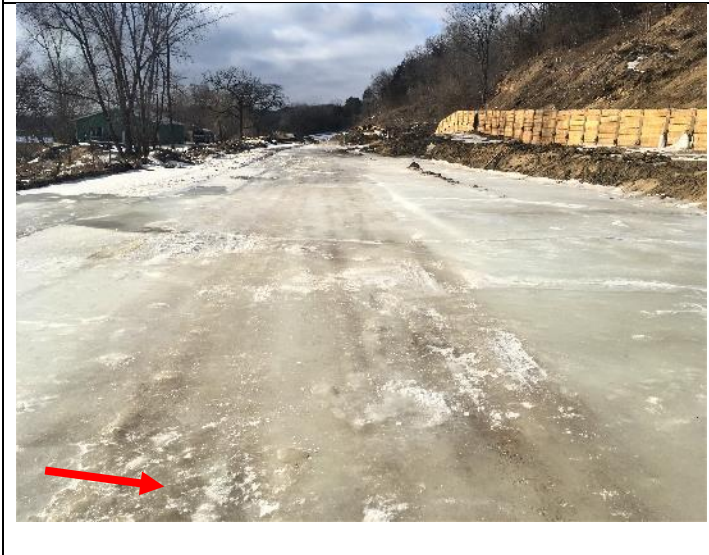
**Photo No.:** 38

**Description:** Roadway is coated in a thick layer of ice. Sheeting of ice suggests that the snowmelt collected in the roadway and froze.

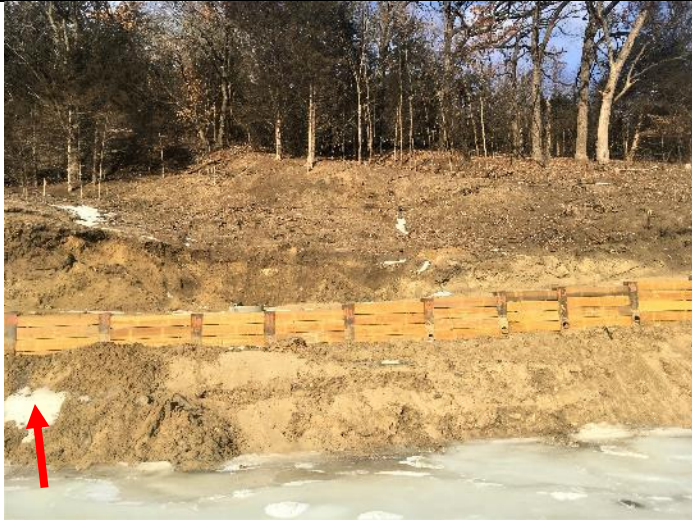
Photo No.: 39

Description: Wall recently constructed along the northern side of the roadway.

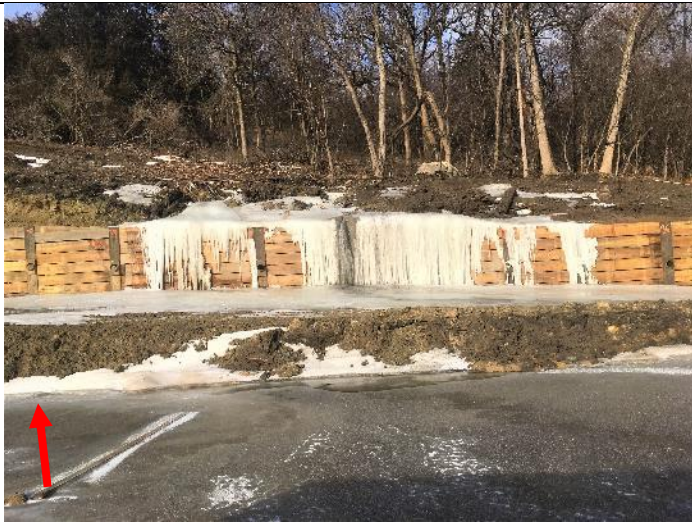
Photo No.: 40

Description: Snowmelt froze as it flows over a newly constructed wall.

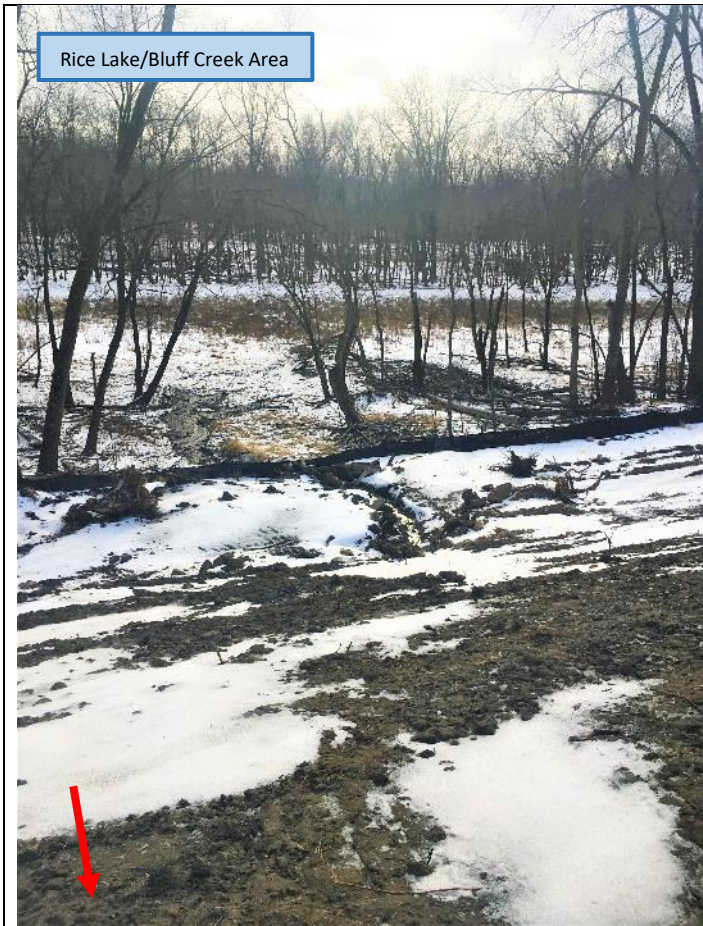
Photo No.: 41

Description: Southern side of the ROW. Snow has melted on most of the slopes.

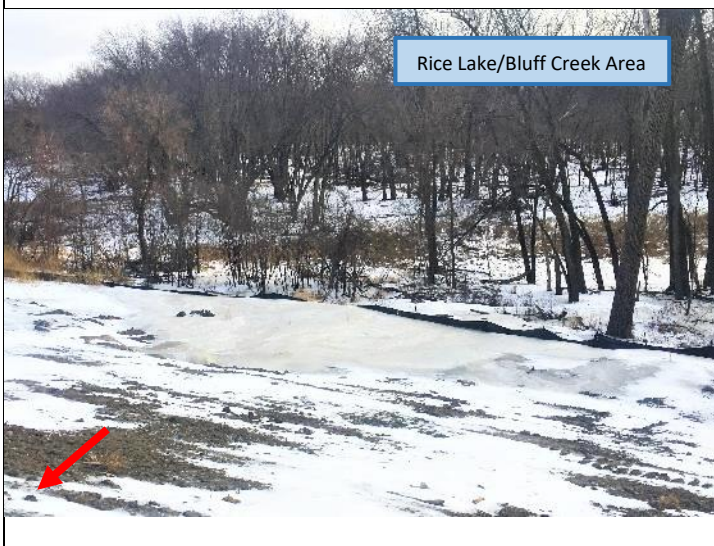
Photo No.: 42

Description: Slopes along the southern side of the ROW. Snowmelt has pooled at the silt fence and froze. BMPs appear to be intact.

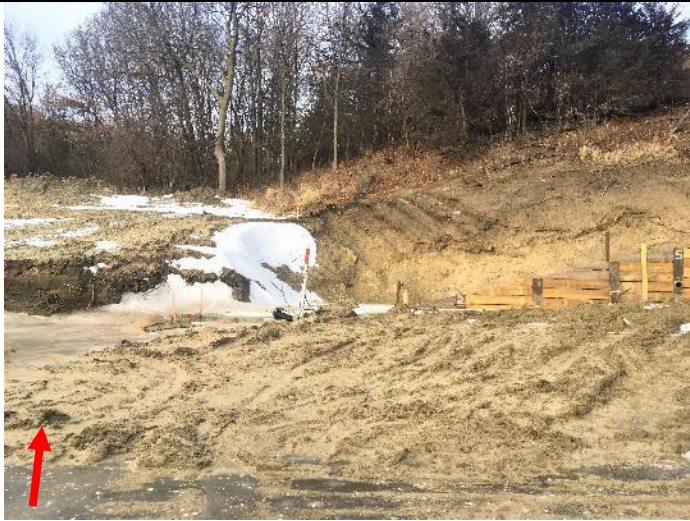
Photo No.: 43

Description: Active construction on the northern side of the ROW. Crews are building walls.

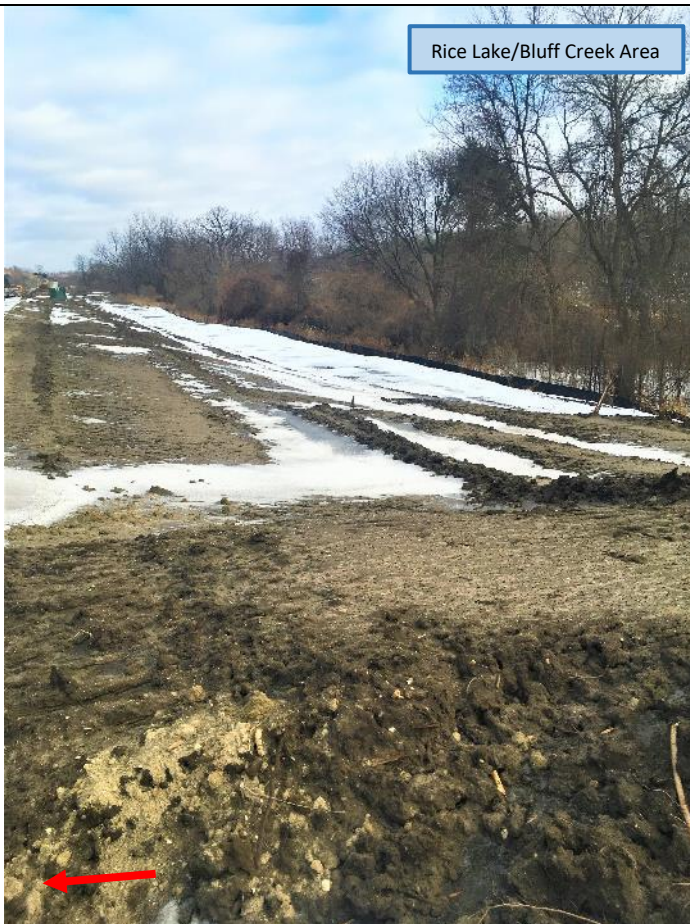
Photo No.: 44

Description: Southern side of the ROW. Most of the snowpack has melted; the area is coated in a thin layer of ice.

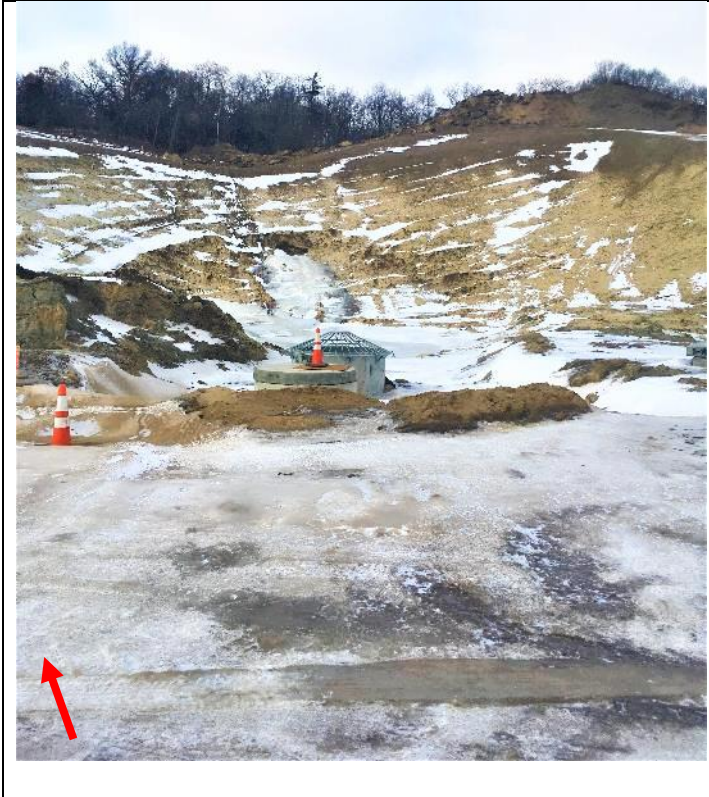
**Photo No.:** 45

**Description:** Stormwater conveyance system on northern side of the ROW.

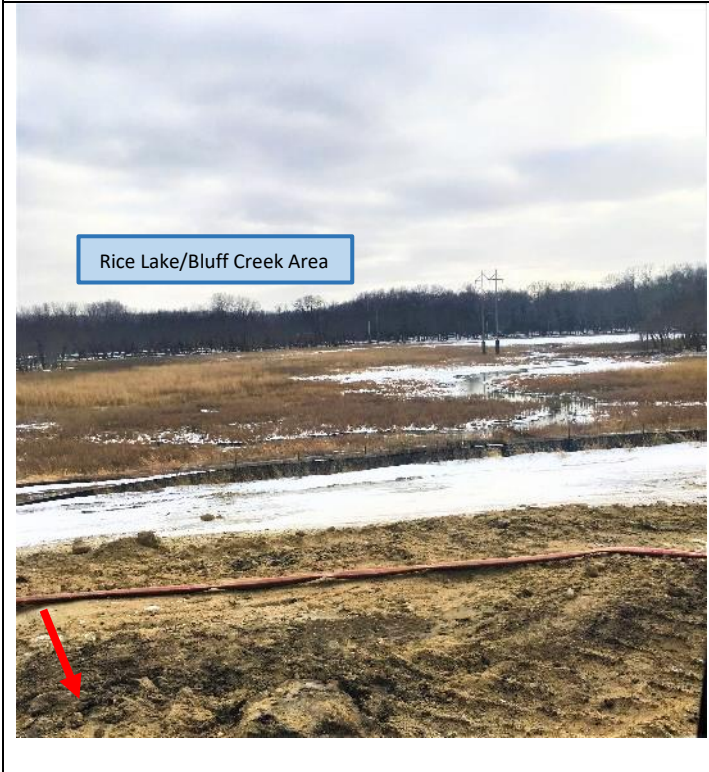
**Photo No.:** 46

**Description:** Stable ROW conditions on the southern edge of the project.
