LOWER MINNESOTA RIVER WATERSHED DISTRICT

Wednesday February 15, 2023

Lower Minnesota River Watershed District (LMRWD) Vernon Avenue Improvements and Access Road Culvert Replacement Project—Engineering Consulting Pool Request for Information (RFI)

Vernon Avenue Improvements and Access Road Culvert Replacement Project

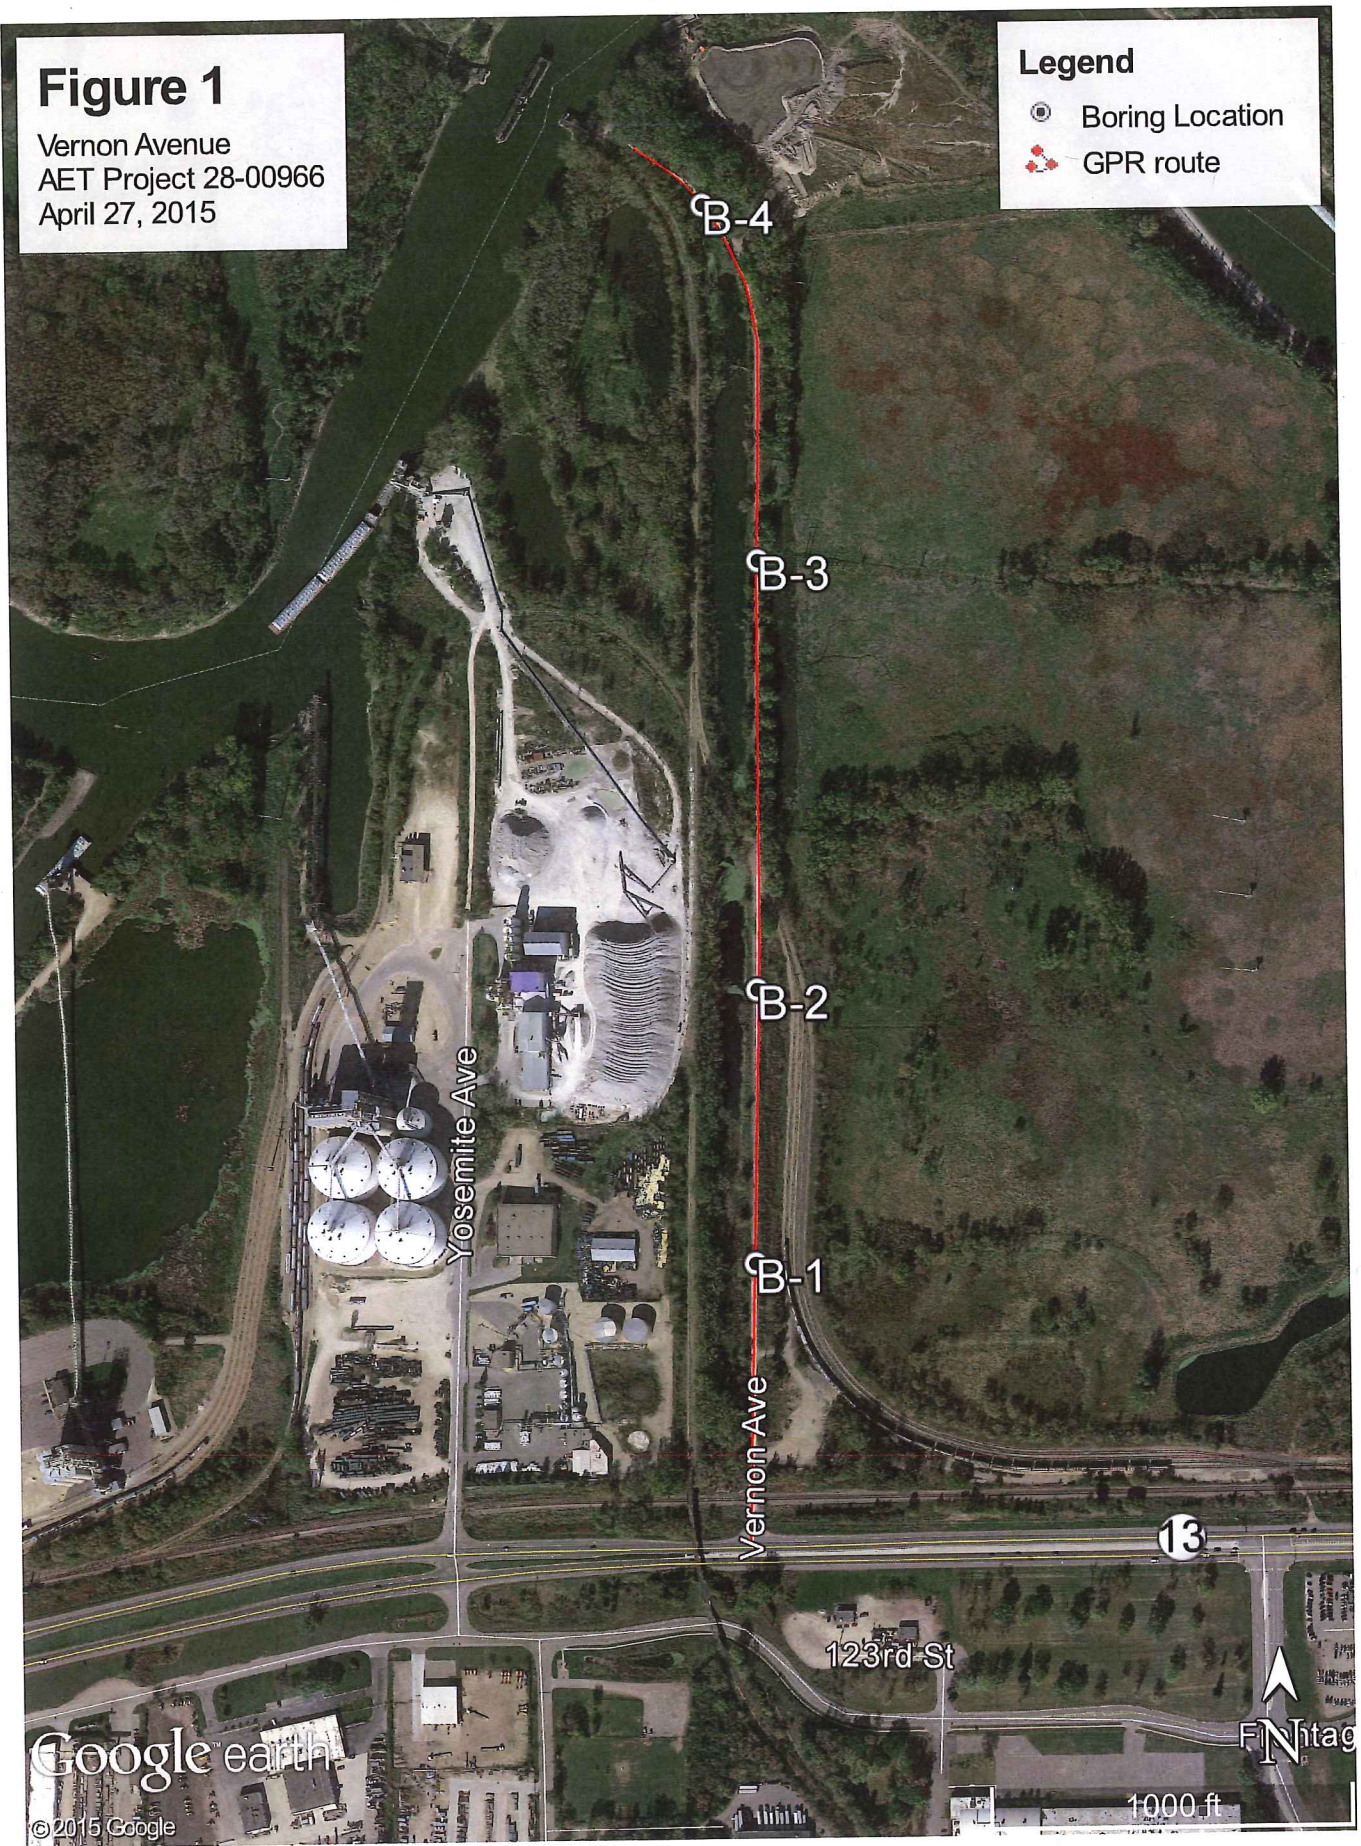
GPR route

The US Corp of Engineers has been performing dredging on the Minnesota River, stockpiling the dredge sands near the terminus of Vernon Avenue. The District will be performing hauling of the sands on Vernon Avenue between Highway 13 on the south and the Minnesota River on the north in Savage, Minnesota. The roadway has not been much used recently as it is overgrown with vegetation. The roadway was constructed on a causeway through the low-lying area near the Minnesota River. The roadway to be assessed is shown in Figure 1.

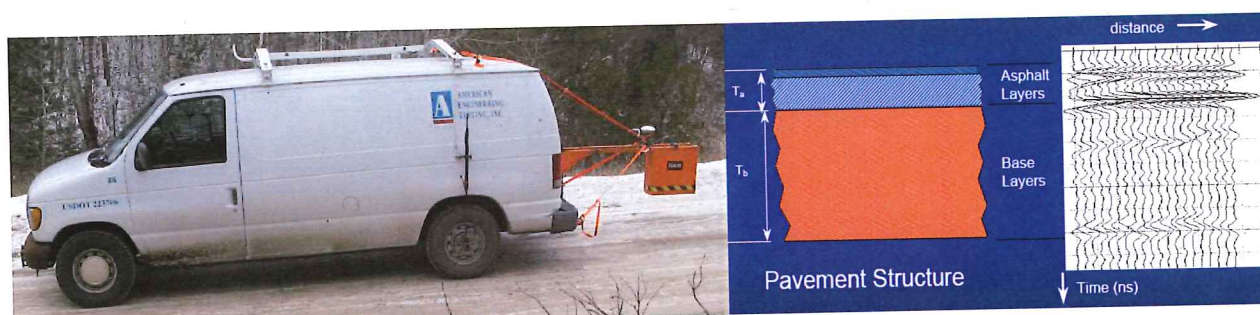
Figure A.1 GSSI 2 GHz air-coupled GPR Test System

The GPR test system owned by AET is a GSSI Roadscan System that consists of a bumper-mounted, 2 GHz air-coupled antenna and a SIR-20 control and data acquisition processor, featuring dual channels. The GPR processor, including a SIR-20 data acquisition system, wheel-mounted DMI (Distance Measuring Instrument), and a tough book with the SIR-20 Field Program constitutes the newest, most sophisticated GSSI Test System, which fulfills or exceeds all requirements to meet ASTM-4748, ASTM D-6087 Standards. Figure C1 provides a view of this equipment.

The GPR antenna emits a high frequency electromagnetic wave into the material under investigation. The reflected energy caused by changes in the electromagnetic properties within the material is detected by a receiver antenna and recorded for subsequent analysis. The 2 GHz air-coupled GPR is capable of collecting radar waveforms at more than 100 signals per second, allows for data to be collected at driving speeds along the longitudinal dimension of the pavements or bridge decks with the antennas fixed at the rear or in front of the vehicle.

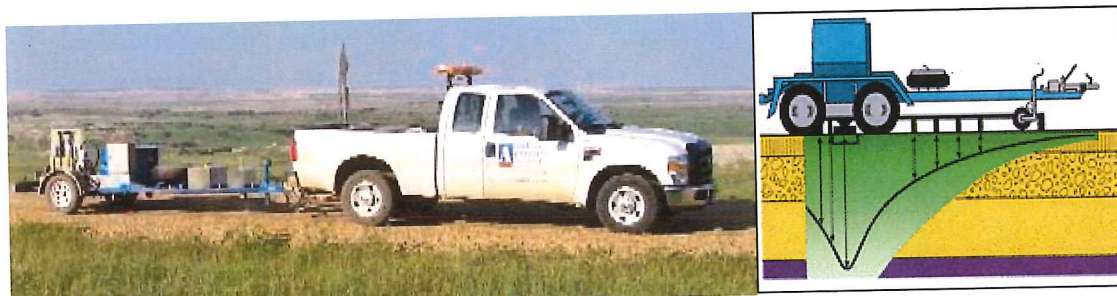
Figure 1 Dynatest 8002 FWD Test System

The FWD owned by AET is a Dynatest 8000 FWD Test System that consists of a Dynatest 8002 trailer and a third generation control and data acquisition unit developed in 2003, called the Dynatest Compact15, featuring fifteen (15) deflection channels. The new generation FWD, including a Compact15 System and a standard PC with the FwdWin field Program constitutes the newest, most sophisticated Dynatest FWD Test System, which fulfills or exceeds all requirements to meet ASTM-4694 Standards. Figure A1 provides a view of this equipment.

The FWD imposes a dynamic impulse load onto the pavement surface through a load plate. Total pulse is an approximately half sine shape with a total duration typically between 25 to 30 ms. The FWD is capable of applying a variety of loads to the pavement ranging from 1,500 lbf (7 kN) to 27,000 lbf (120 kN) by dropping a variable weight mass from different heights to a standard, 11.8-inch (300-mm) diameter rigid plate.

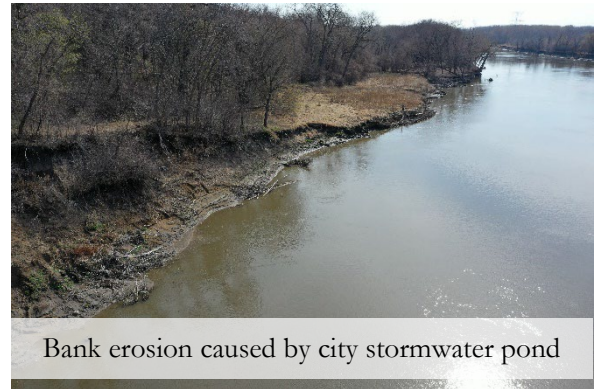
- The underlying soils and groundwater seeps, combined with bluff development and erosive flows from the Minnesota River, have destabilized the slope and resulted in continual erosion since at least 2008.
- Using inclinometers, the Lower Minnesota River Watershed District (LMRWD) has monitored slope movements since 2010. However, geotechnical engineers have warned the LMRWD that due to the nature of the soils in Area 3, the slope is more likely to catastrophically fail without advanced warning.
- The City of Eden Prairie has a stormwater pond just downstream of Area 3 that is exacerbating the natural erosion processes of the river on the slope, causing further instability.
- This is a larger, more complex problem than either the LMRWD or the City can tackle alone.

Bank erosion caused by city stormwater pond

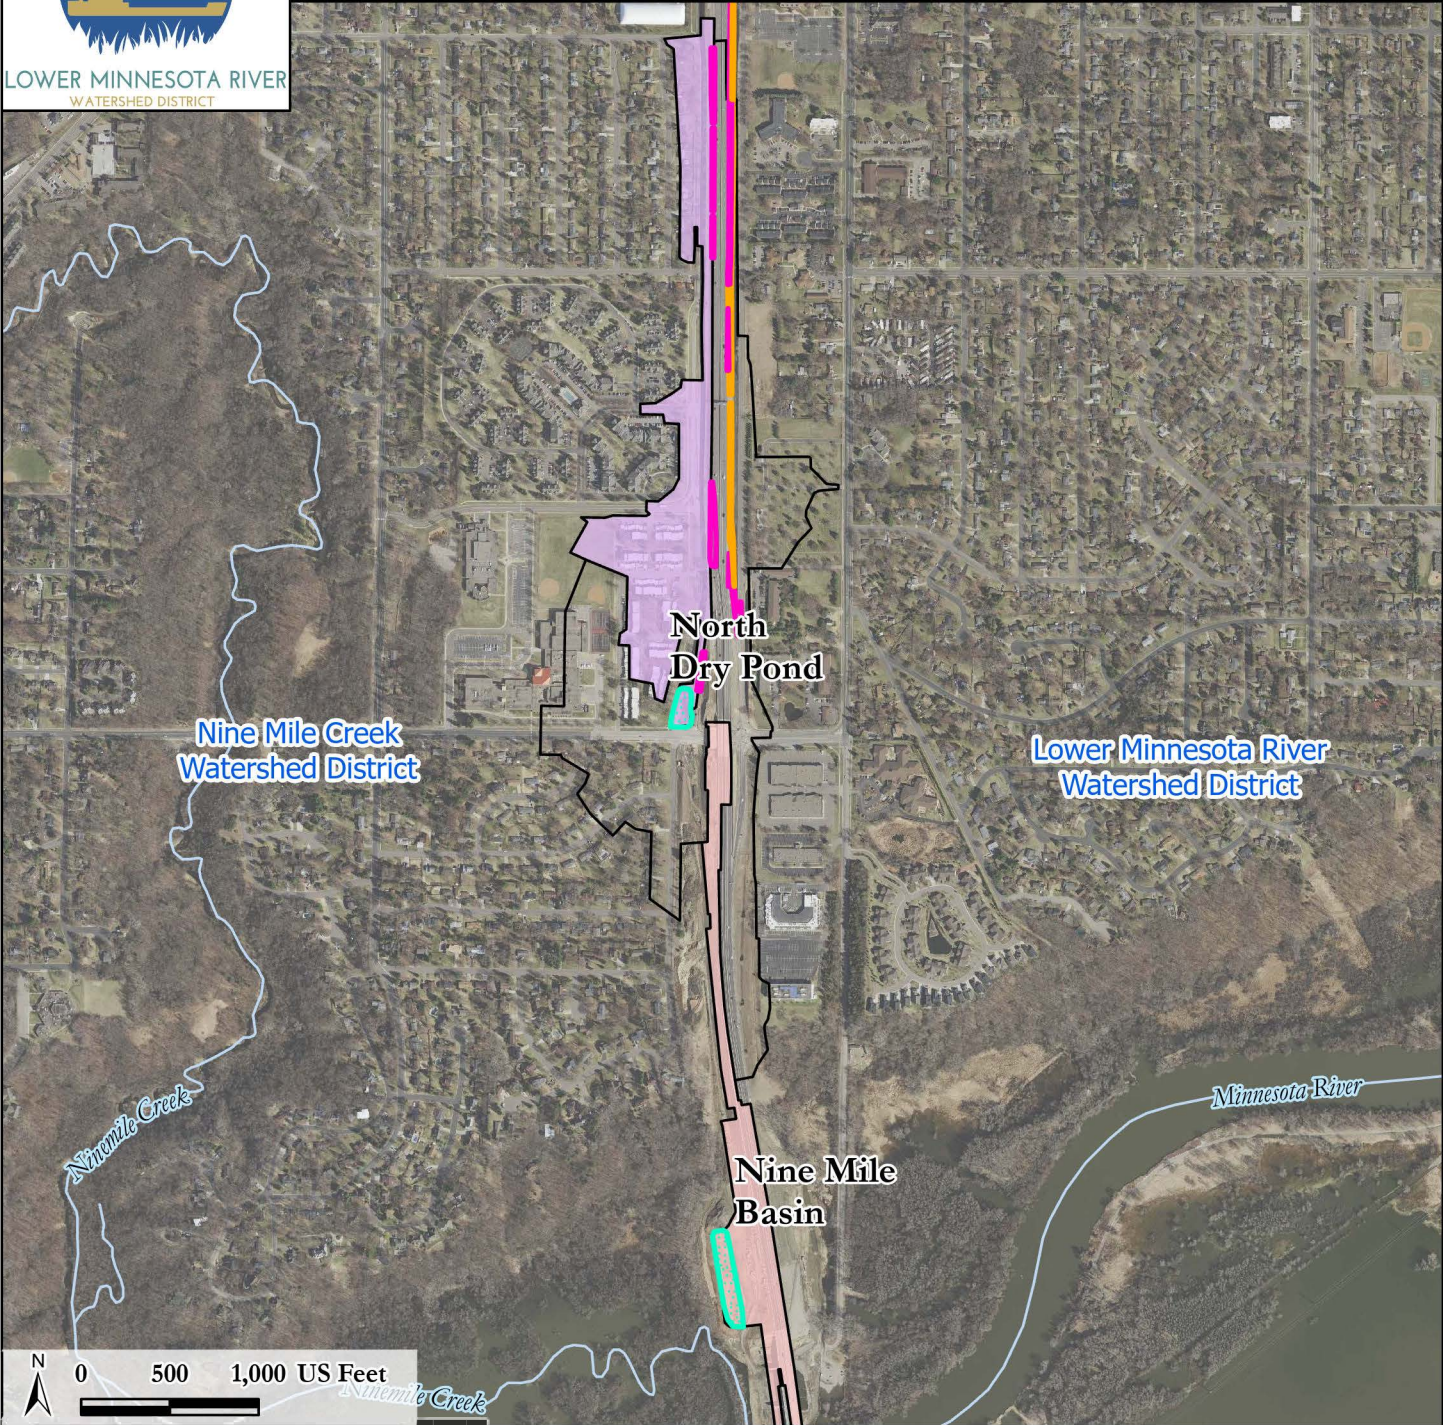
Figure 3: SP 2782-352 (I-35W) Stormwater BMPs
LMRWD No. 2022-041

- Public Waters
- Stormwater BMP
- New Impervious
- Reconstructed Impervious
