LOWER MINNESOTA RIVER WATERSHED DISTRICT

Executive Summary for Action

Item 4. D. - Eden Prairie Area #3 Inclinometer Readings

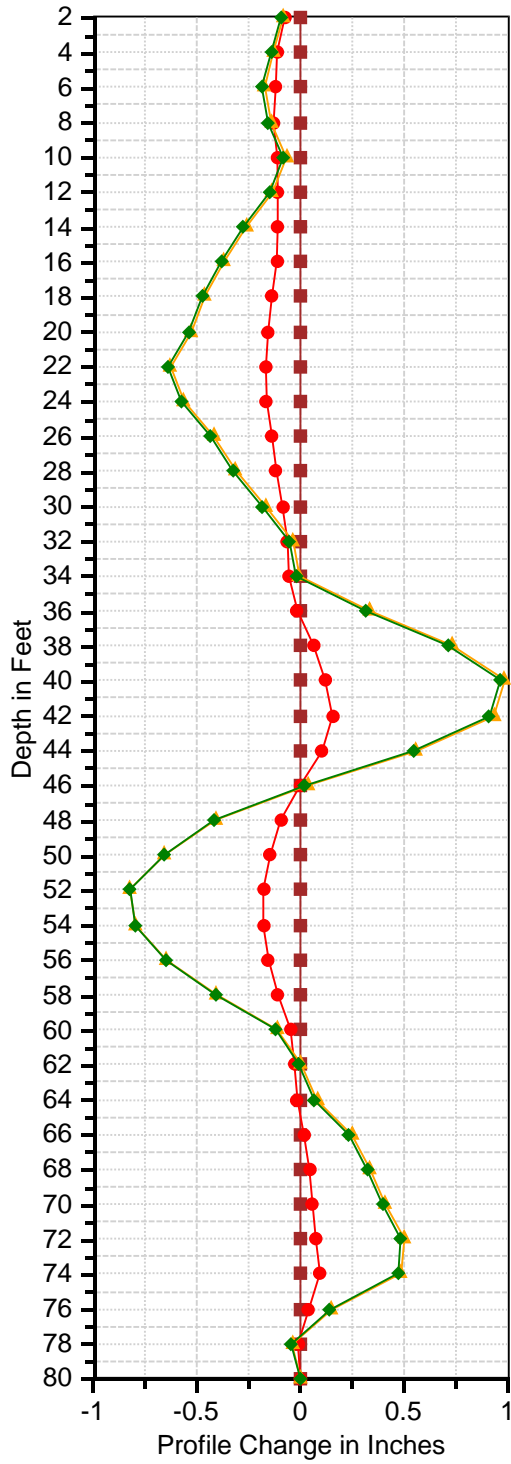
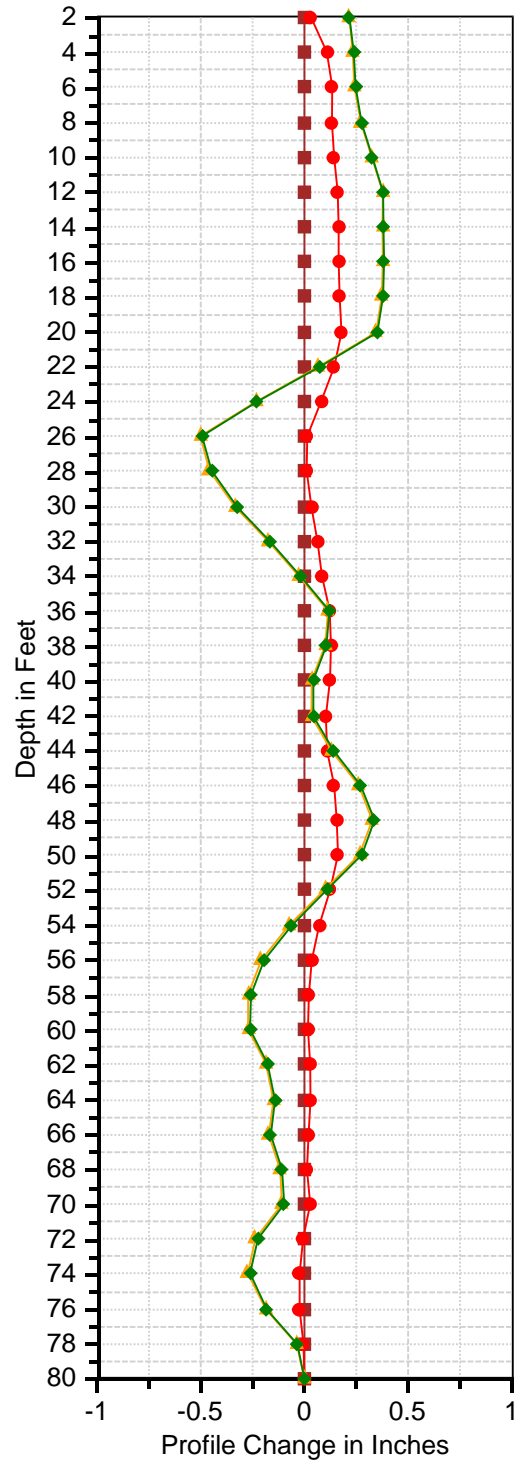
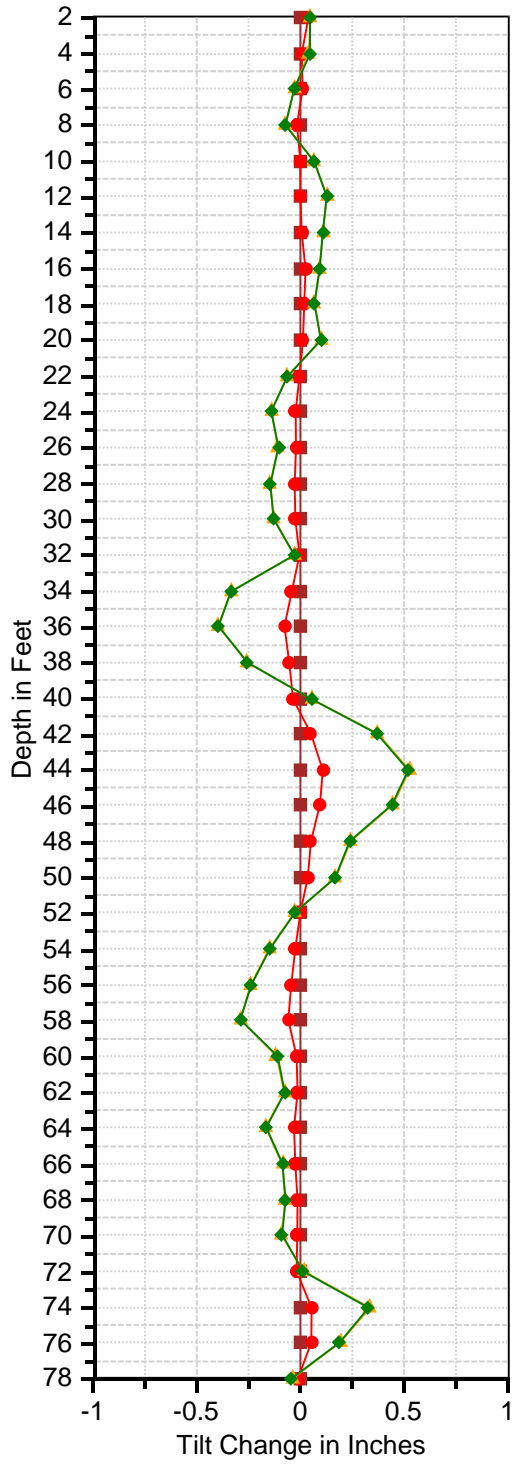
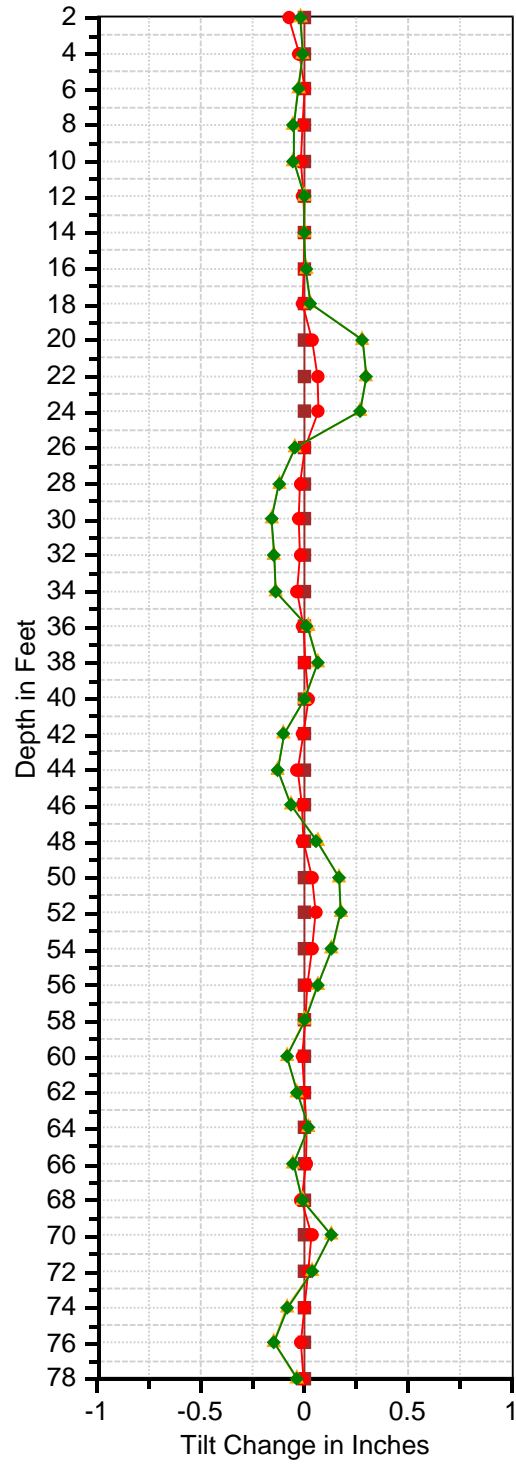
MNRIV ST_3 A

Attached are the most recent plots. We are starting to see more movement in both inclinometers. As I wrote to you earlier there was ice in ST-4 inclinometer for the reading on February 14. However, as you can see, the readings for ST-3 on February 14 and April 22 are essentially identical. I recommend that we take another set of readings soon, say within the next couple of weeks to see if the movement has calmed down.
