## LOWER MINNESOTA RIVER WATERSHED DISTRICT

September 2019 Administrator report

**SUBJECT:** Spring Creek Visit Summary  
June 21, 2019, 3:00–4:05 p.m.  
Spring Creek

## Technical Memorandum

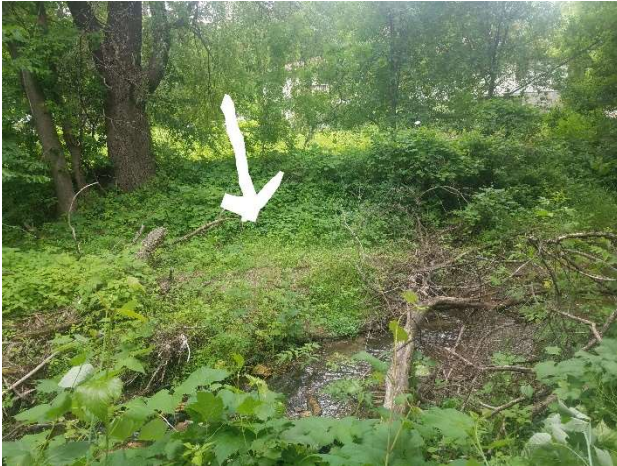
Photo #1

- **112 5th Street West, Carver, MN**
  - Met with the Deb Hartley at 112 5th Street West and discussed some of the issues they have with the Creek. They noted that the Creek has moved almost 30 feet northeast, encroaching into their backyard.
  - Photo 1 indicates with an arrow where the old streambed was located in the mid-1990s, according to the landowners, and the new location.
  - The landowners are concerned that the creek will continue to encroach into their backyard and eventually undercut their garage.
  - Photos 2–4 are of the existing streambed.
- **404 Broadway Street, Carver, MN**
  - The landowner at this location was not present.

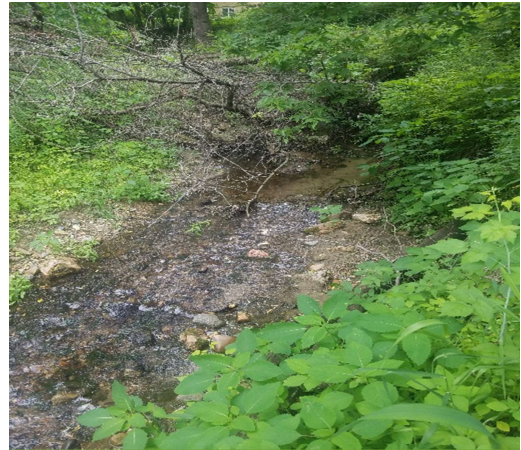
Photo #3

**Photo 3: Downstream section of creek (new growth is on the right, eroded bank is on the left, and the stream path is relatively new). Barr staff in photo.**

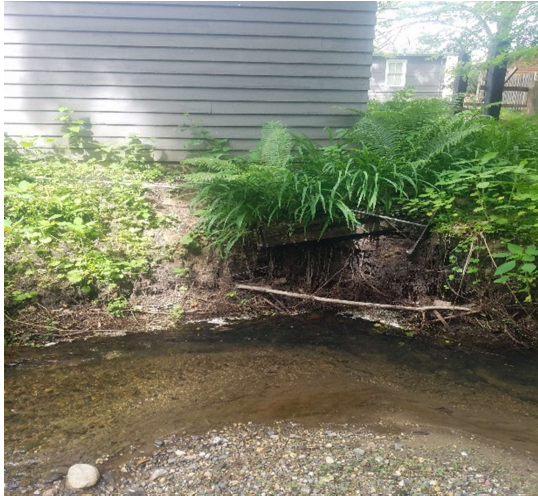
Photo #5

- There are erosion issues on the left bank that are close to undercutting the garage in the backyard, indicated in photos 5 and 6.
- There are concrete slabs in the creek, indicated in photos 7–9, that appear to be left over from a retaining wall.

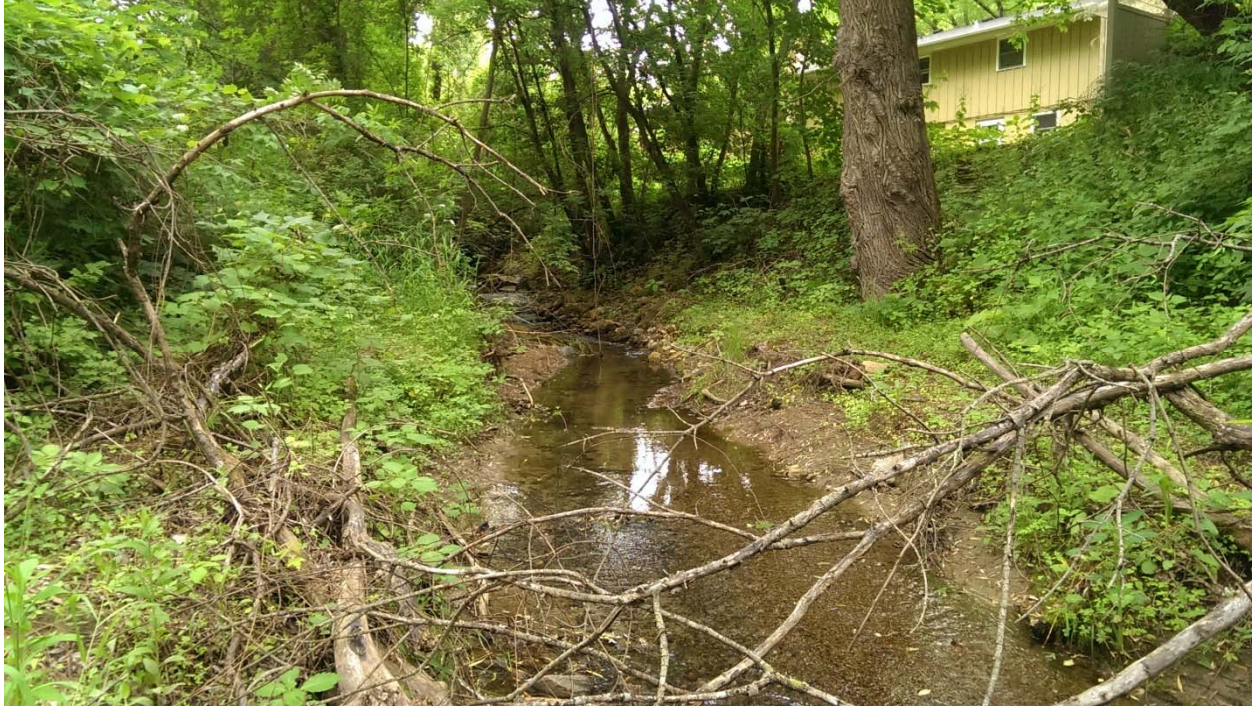
**Photo 1: Upstream section unaffected by significant stream bank instability. Structure is approximately 50-feet from the channel.**

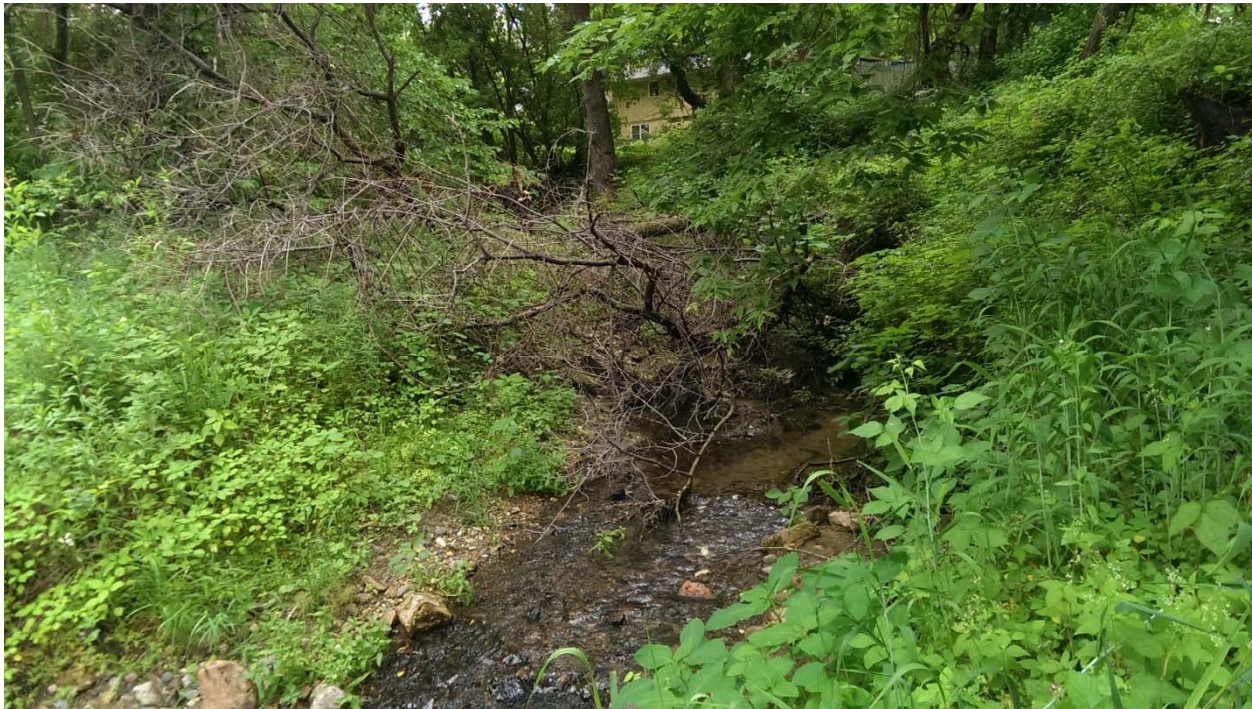
**Photo 2: Stream section facing upstream directly behind garage (sudden drop-off on the right caused by recent erosion, new plant growth on the left, and a previously fallen tree caused by stream bank instability)**

The active bank erosion area is approximately 50-60 feet long, with bank heights between 3-4 feet. The stream gradient in this area is rather steep; however, a survey was not completed to quantify the gradient. The homeowners have stated that flows have increased to the site in recent years, and attribute the increase to development within the watershed. Additional future development within the watershed has been proposed, so they are concerned that the flows will continue to increase.

Evidence observed in the field supports the residents' claim that the stream has moved and become lower. As noted above, an old channel is located nearby, and the channel within the erosion area has tall banks and lacks a sufficient connection to the floodplain. This is evidence that that stream has downcut. Barr and Young Environmental Consulting Group staff did not observe a "smoking gun" of a headcut in the area, but there were several small drops in the stream both within the area in question and in the steep channel upstream of the site.

The erosion observed is likely to continue if stabilization measures are not installed. The erosion does not appear to pose an immediate threat to any structures; however, given the changes the residents have reported in recent years, the system has been changing relatively quickly. Given the recent changes to the system, this site has a moderate level of urgency, meaning that the site should be examined at least once per year and, if possible, visit the site shortly after significant rainfall events to develop a better understanding of the magnitude of flows and velocities at this location. Additional stabilization measures should be installed within five years to minimize the risk of additional erosion; however, installing stabilization measures sooner than five years would be preferable.

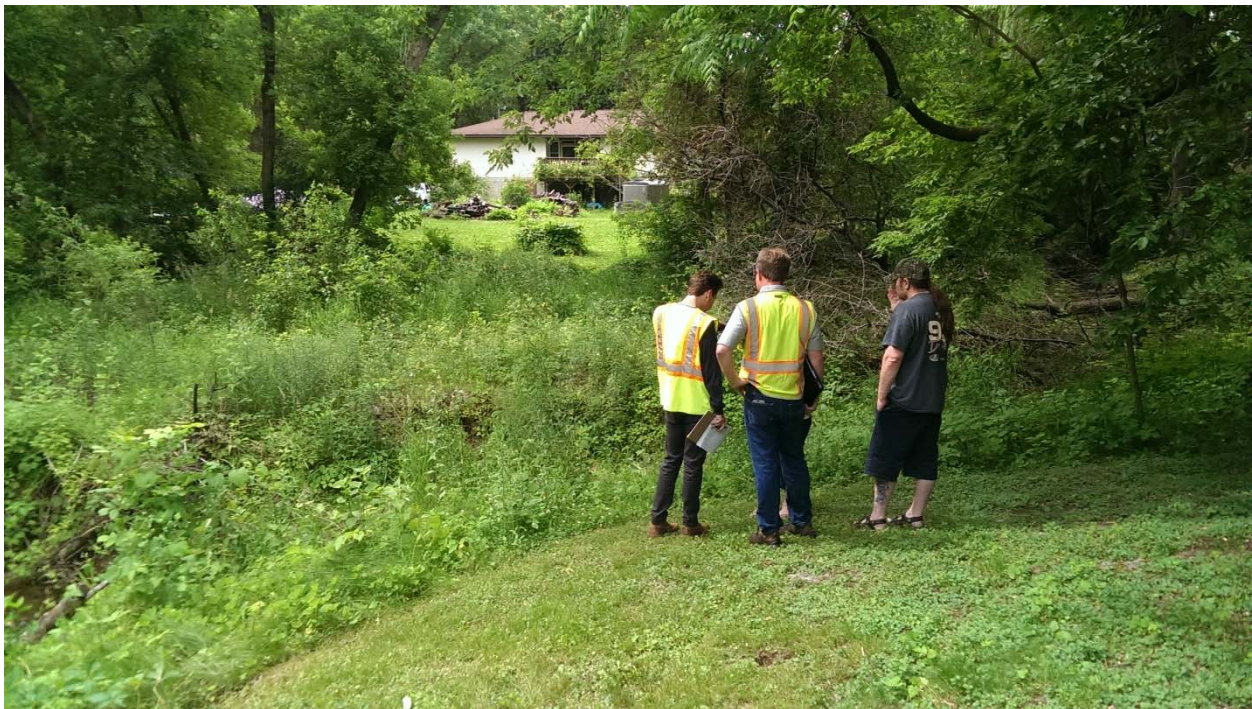
**Photo 4: Area of stream path changes (from the left flows the incoming fork, to the right is the main stem of the creek, and in the center is the new growth and old stream path). Young Environmental Consulting Group staff, Barr staff, and residents in photo.**

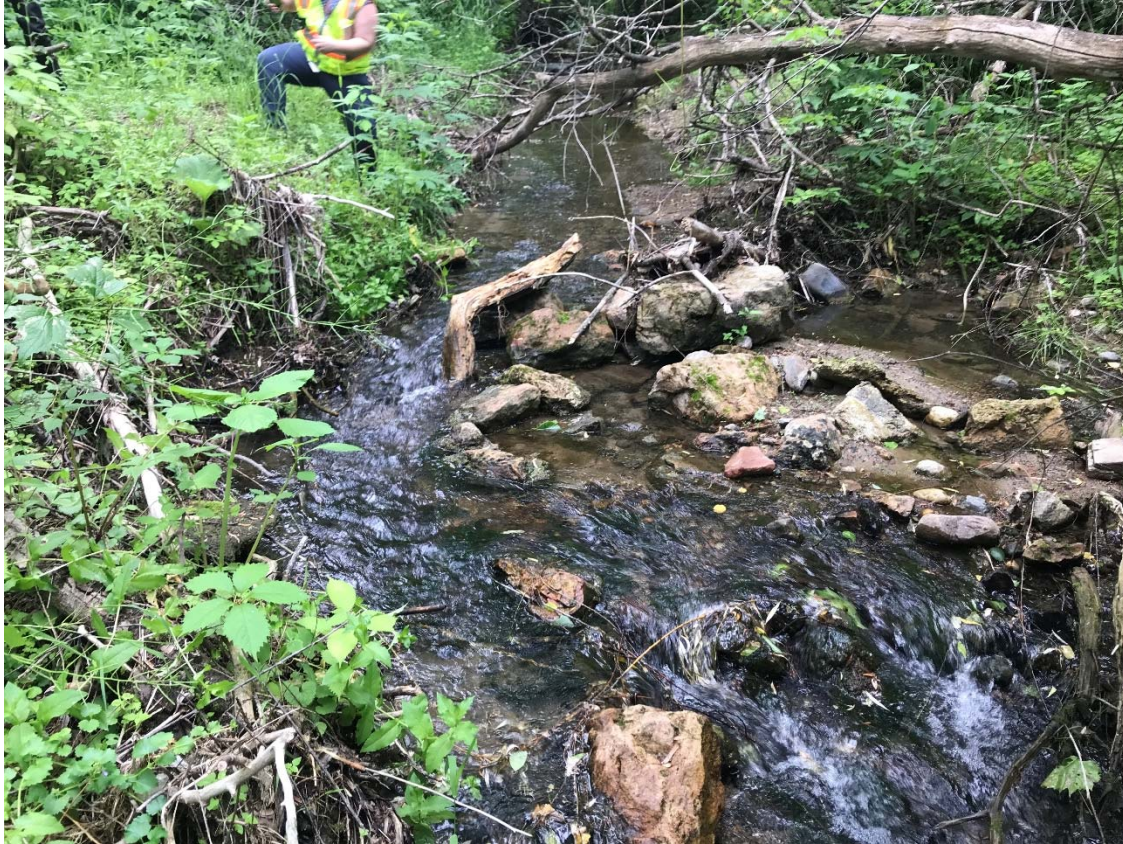
**Photo 5: Small headcuts causing the stream to become incised.**

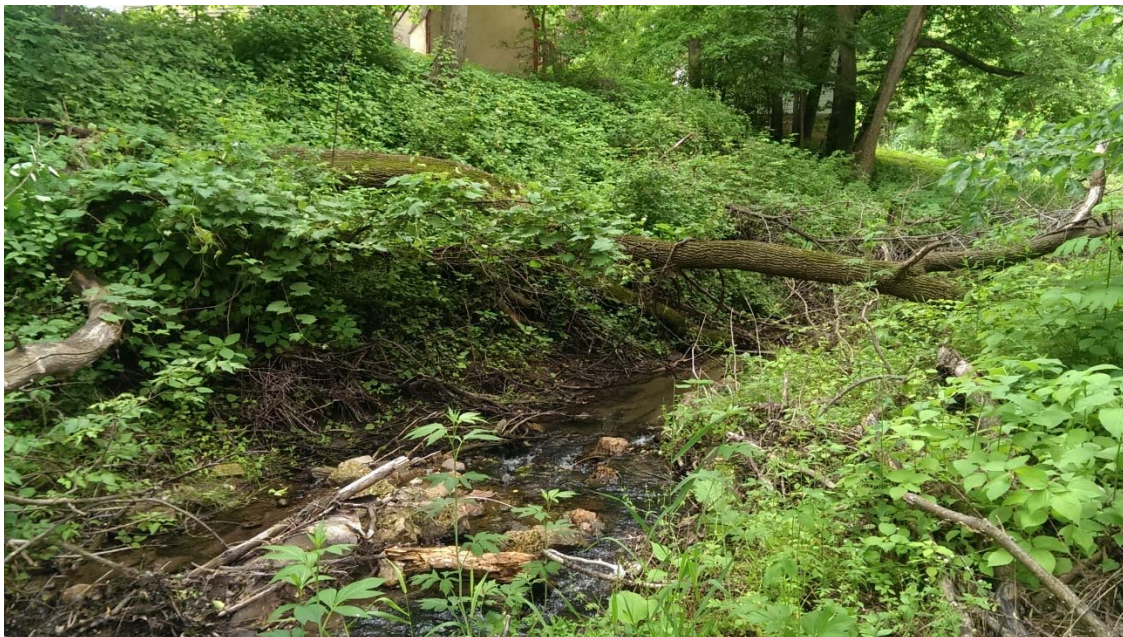
**Photo 6: Bank erosion looking towards the residence at 112 5<sup>th</sup> Street West. Bank is approximately 40 feet from the structure.**

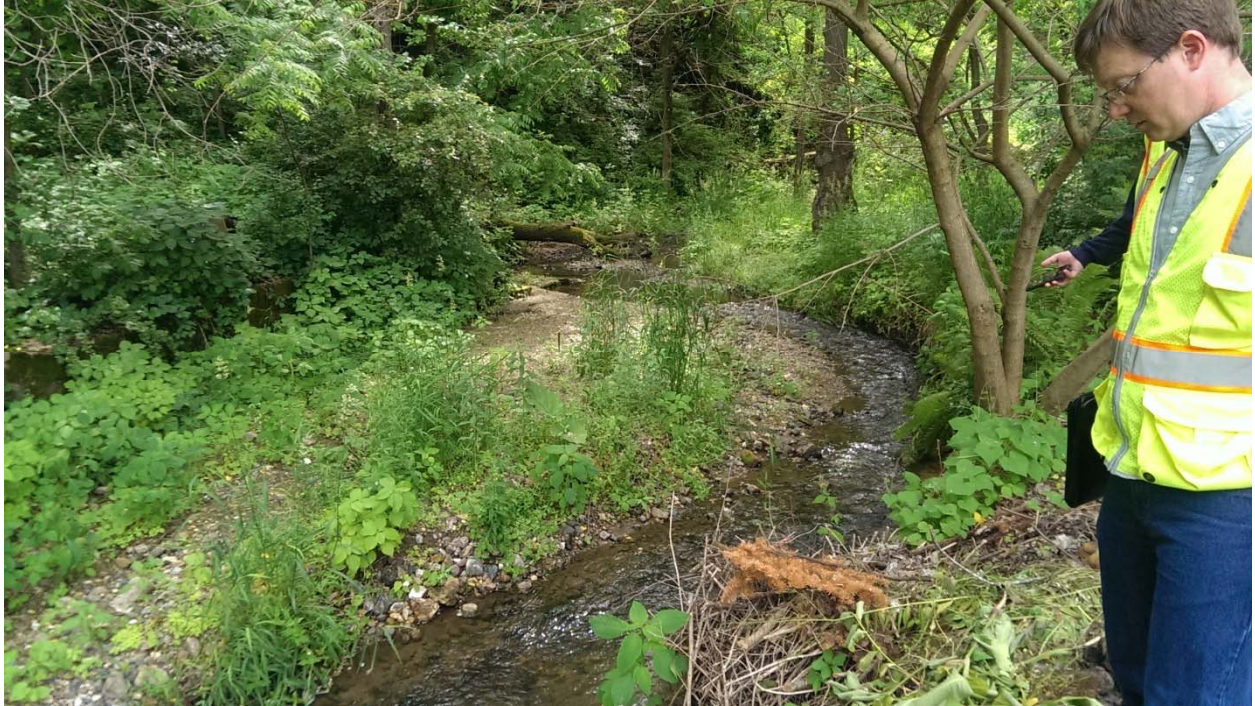
**Photo 7: Upstream section with noticeable change in stream path**

have been straightened at some point in the past, likely when the retaining wall was installed. Some of the cause of erosion may be attributed to the stream attempting to recreate a meander pattern. Fresh sand bars were also observed in this area, which could be eroded material from upstream. The stream gradient is noticeably less steep in this area, so it would be a location for sediment to deposit. The sediment deposition may be exacerbating the channel movement.

- At 404 Broadway, restore the channel to the previous alignment, which will provide additional space between the garage and the creek.
- Restore the previous channel alignment at 112 5<sup>th</sup> Street, with consideration of the modified hydrology draining to this location.

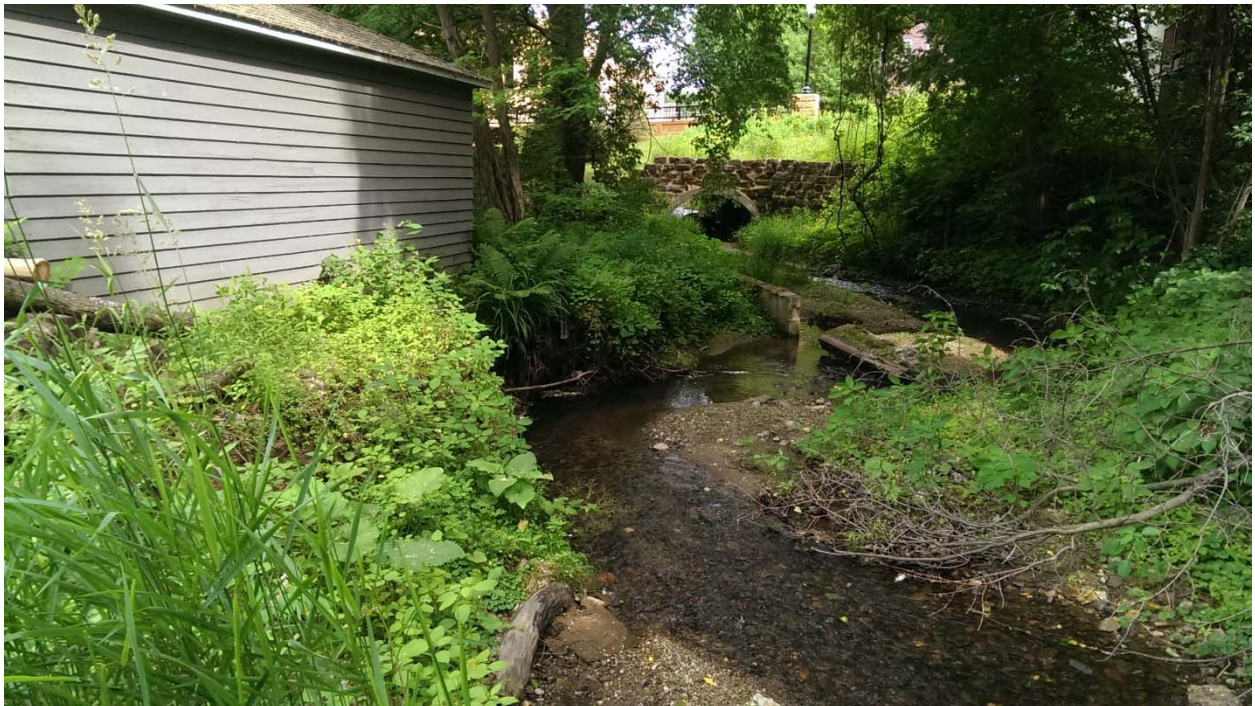
**Photo 8: Downstream section of stream with significant erosion encroaching on the garage and damaged retaining wall**

The erosion has already encroached to within a few feet of the garage, so the garage is under an immediate threat of damage if erosion continues. Stabilization work at this site should be implemented as soon as possible.

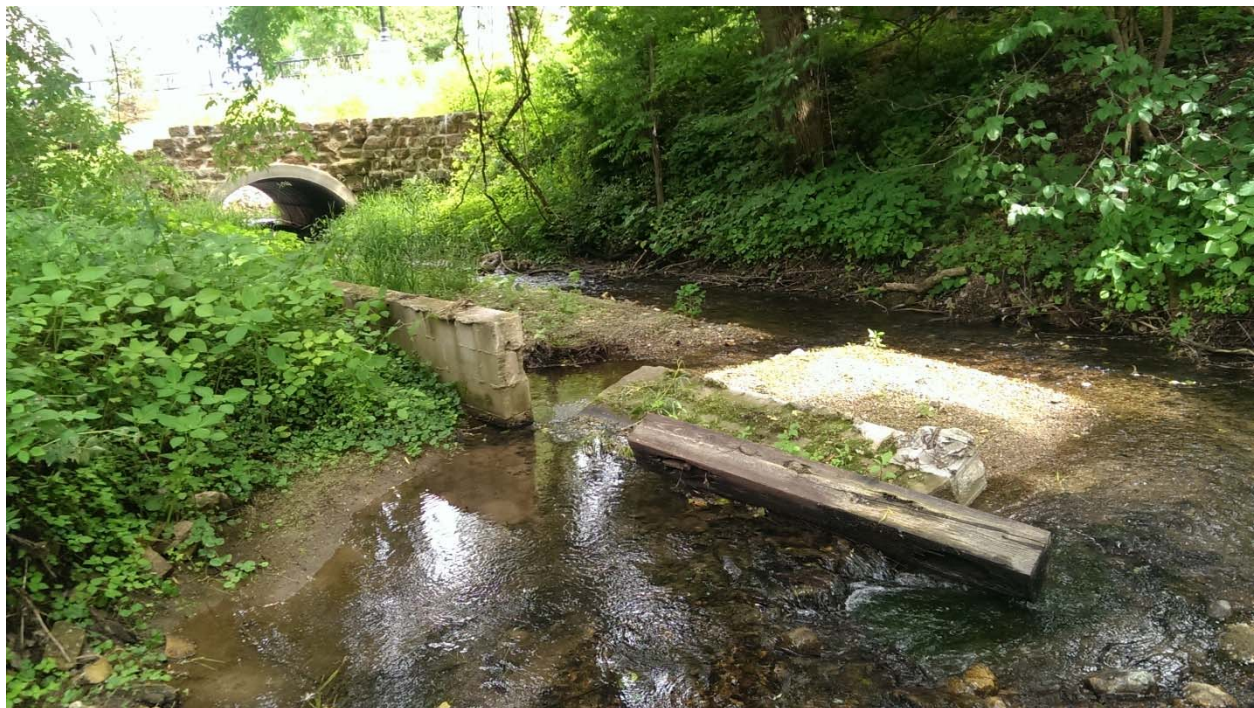
**Photo 10: Close-up of damaged retaining wall most likely caused by stream path change**

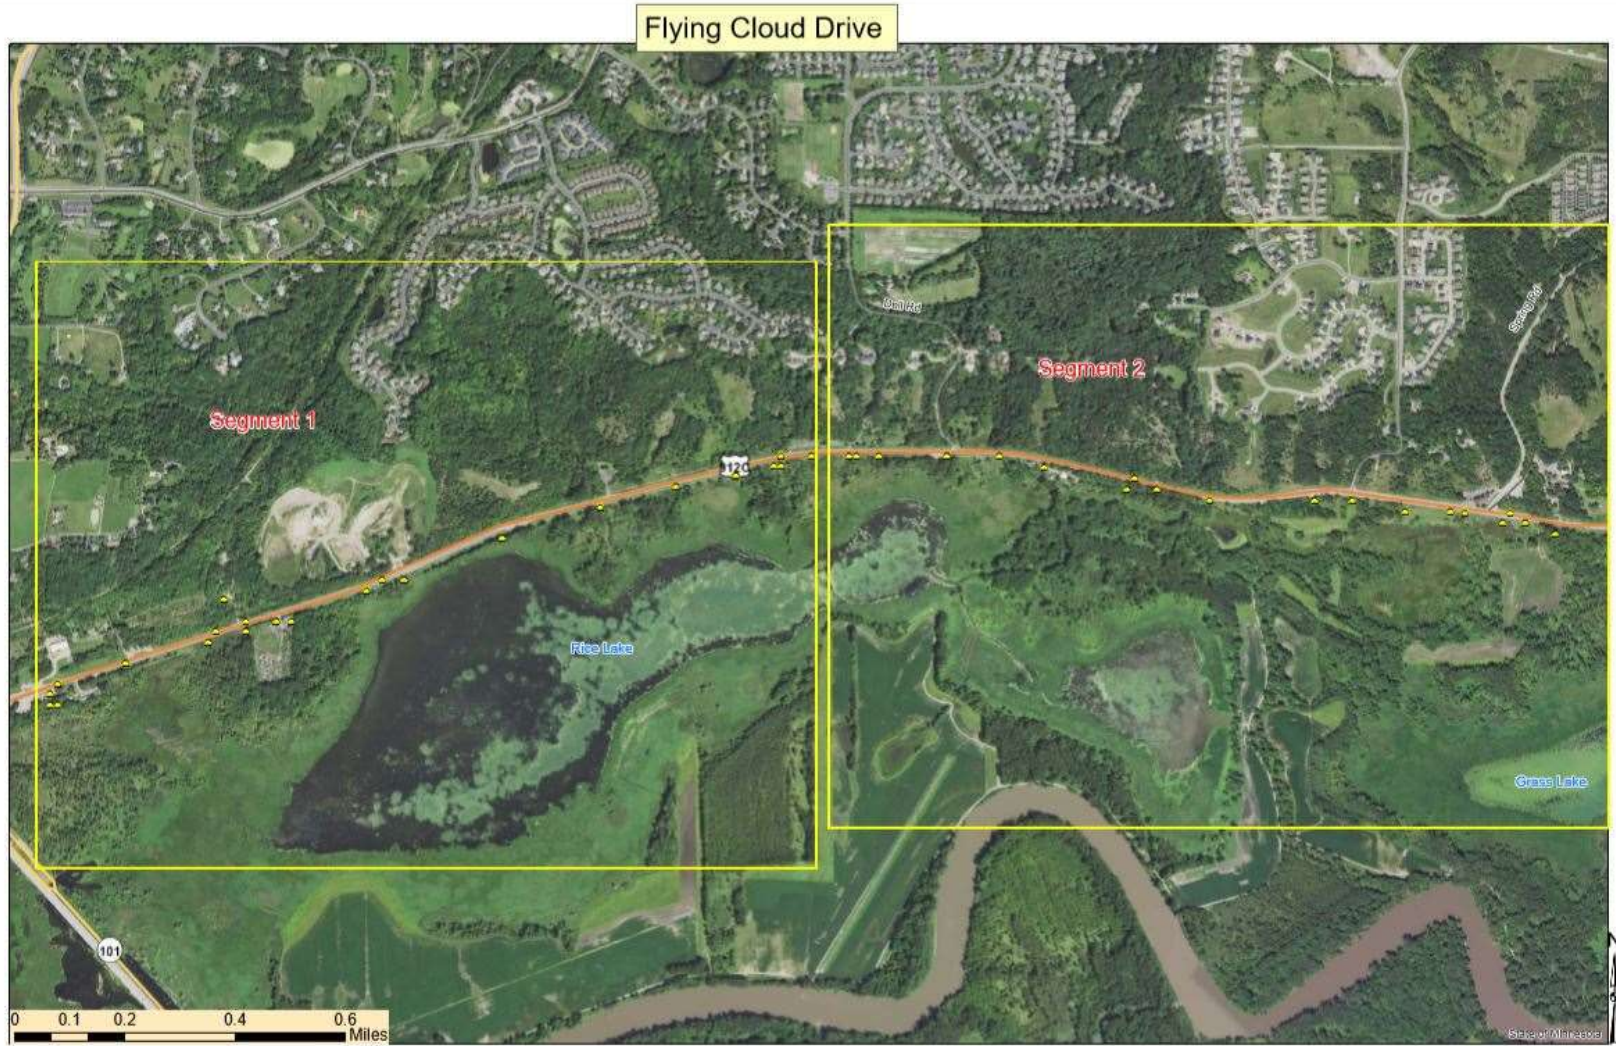
Below is a map indicating where photos were taken. Photos include coordinates and a white arrow indicating north.

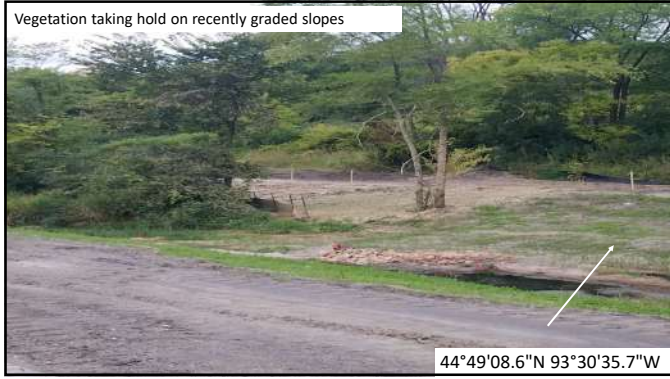
54

Vegetation taking hold on recently graded slopes
