Technical Memorandum

Re: Trout Streams Gaps Analysis and Long-Term Management Plan Site Visit

October 13, 2020, Field Visit

October 13, 2020 Field Visit Photos

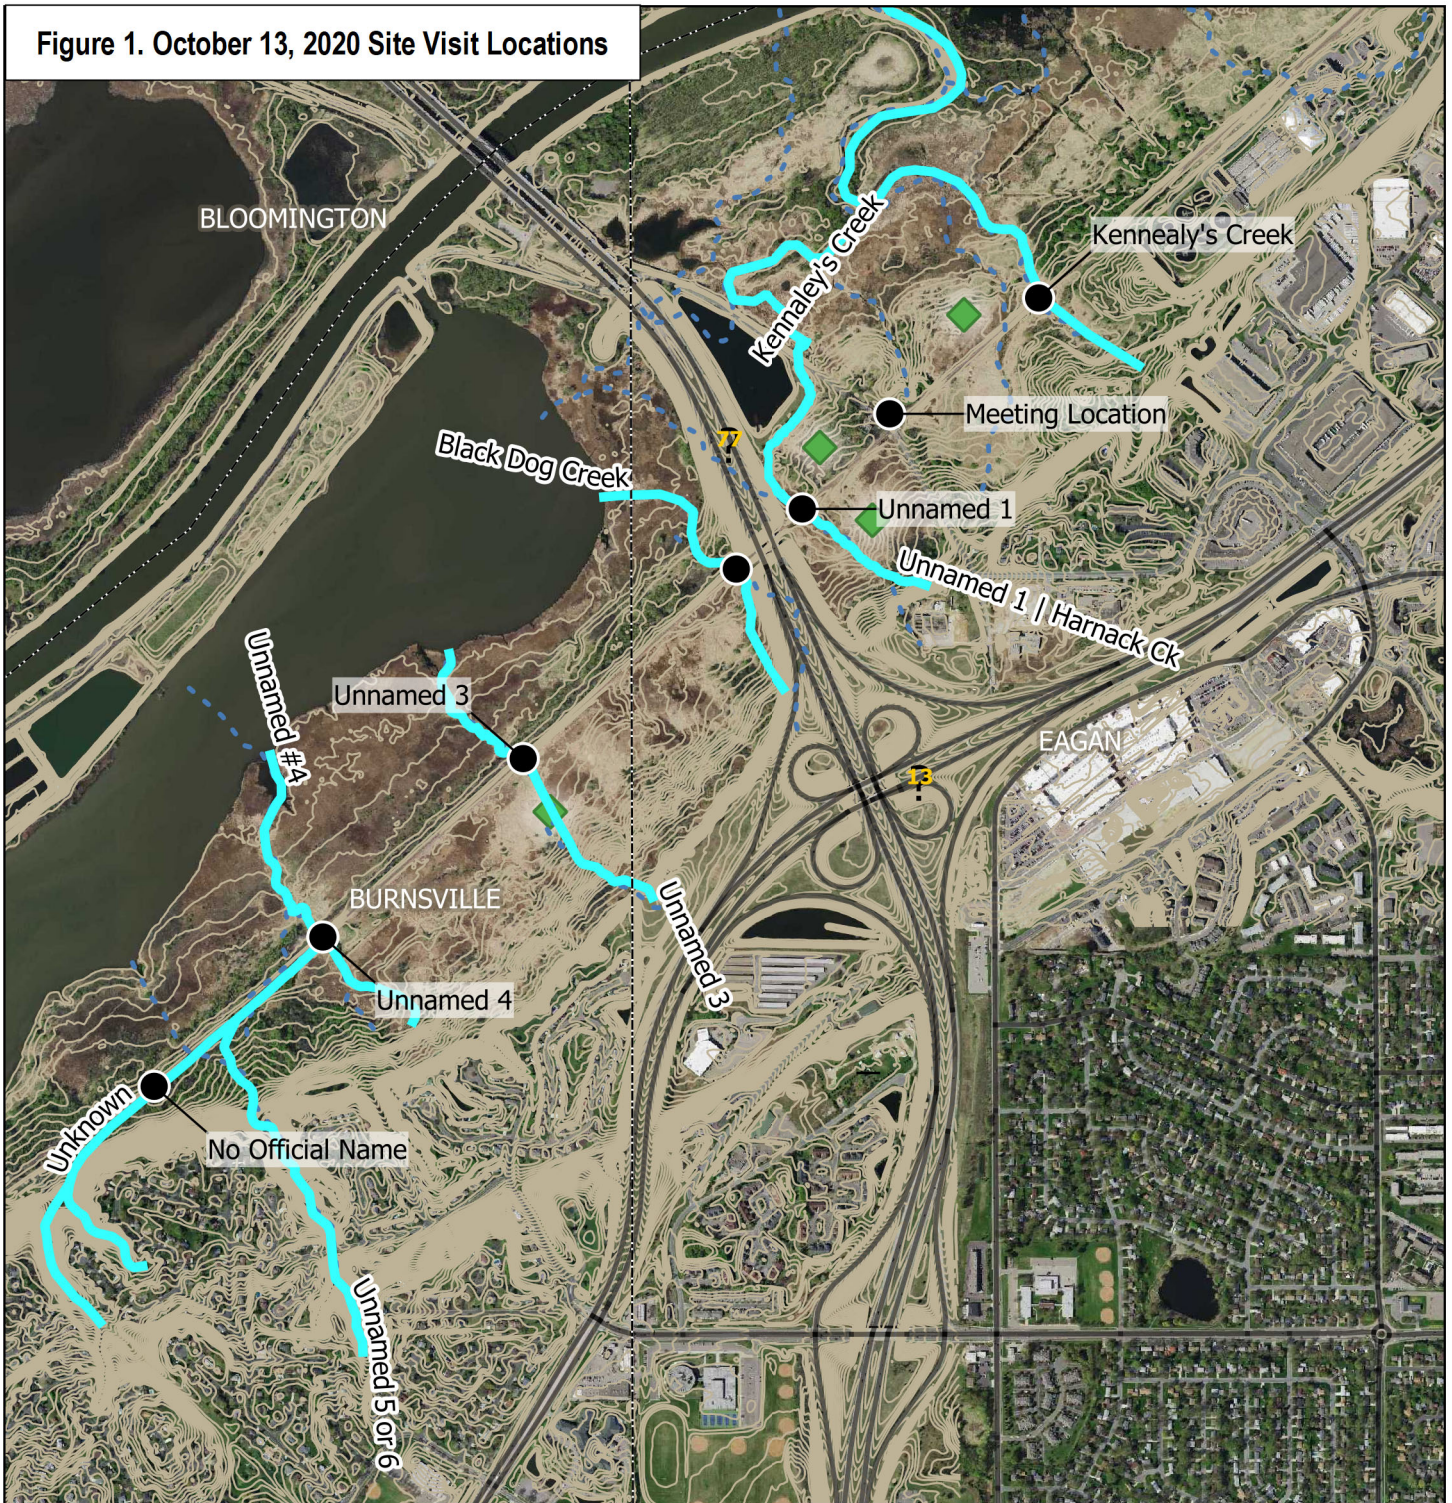
Figure 1. October 13, 2020 Site Visit Locations

On October 13, 2020, the District administrator, staff from Young Environmental, and Mark Nemeth (MnDNR) met at 3725 Nicols Road to review Unnamed 1/Harnack Creek, Unnamed 3, Unnamed 4, Black Dog Creek, and Kennealy's Creek in the field. Mark provided the history of the area and individual sites based on his analysis of historical aerial photography.

The team walked west from the meeting site to Unnamed 1 through 4, then reconvened at the meeting site before walking east to Kennealy's Creek. Mark mentioned that when Cedar Avenue was constructed about 40 years ago, the excavation material was placed on the adjacent hill, which has damaged the native plant community and has eroded down the hill into the trout stream area. Attempts have been made to prevent the material from moving down the hill, including installing containment boxes, but many of those have failed, which affected the springs and surrounding natural area. The group then walked to Kennealy's Creek before concluding the site visit. The following is a high-level summary of the findings in the field.

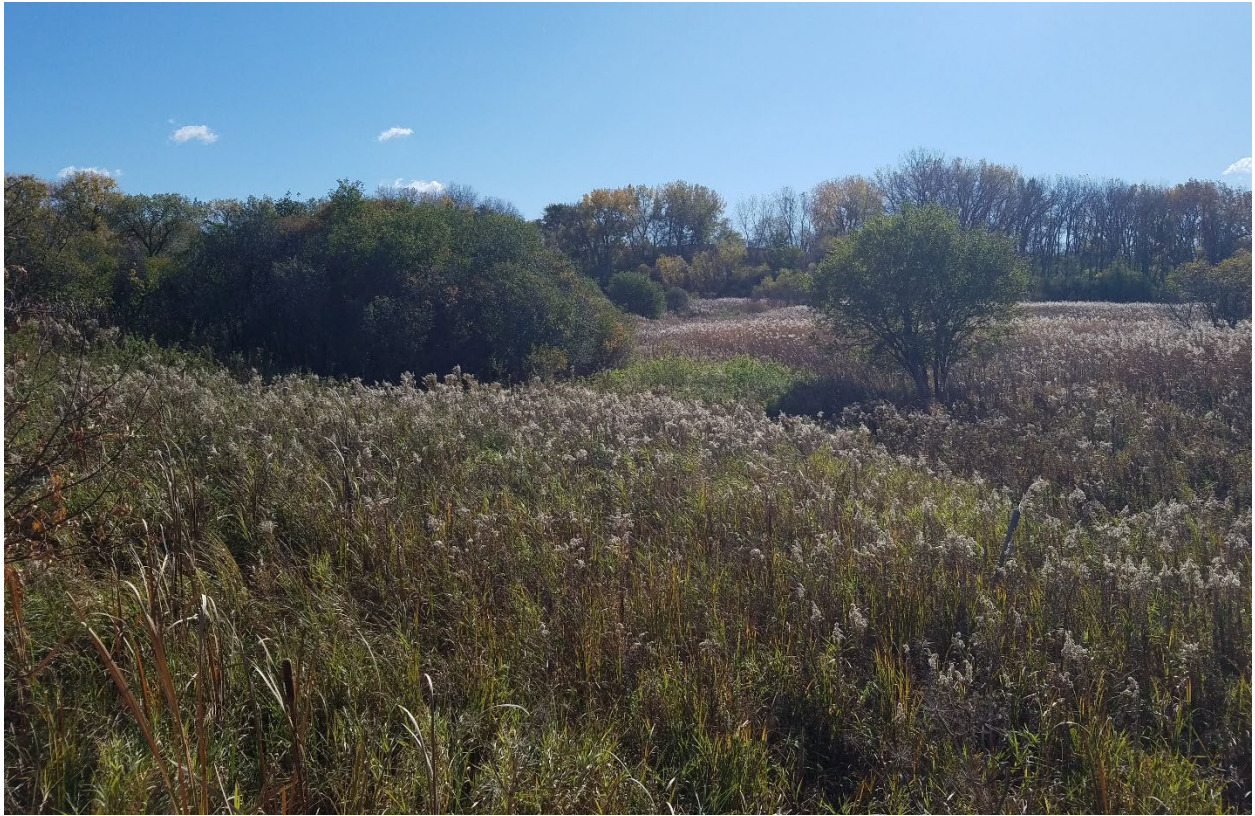
Figure 1. Upstream view of Unnamed 1

- The creek flows under the railroad through an approximately 42-inch-diameter concrete culvert.
- In 2015, the flow was measured and seems to be consistently 1 cfs year-round. Flow at time of visit is estimated to be between 1 and 3 cfs.
- On the south side of the railroad tracks, there is rarely beaver activity. The soil is dark loam, sand, and peat on the south side.
- The north side has more substrate as well as sand.
- The area is experiencing more frequent flooding.

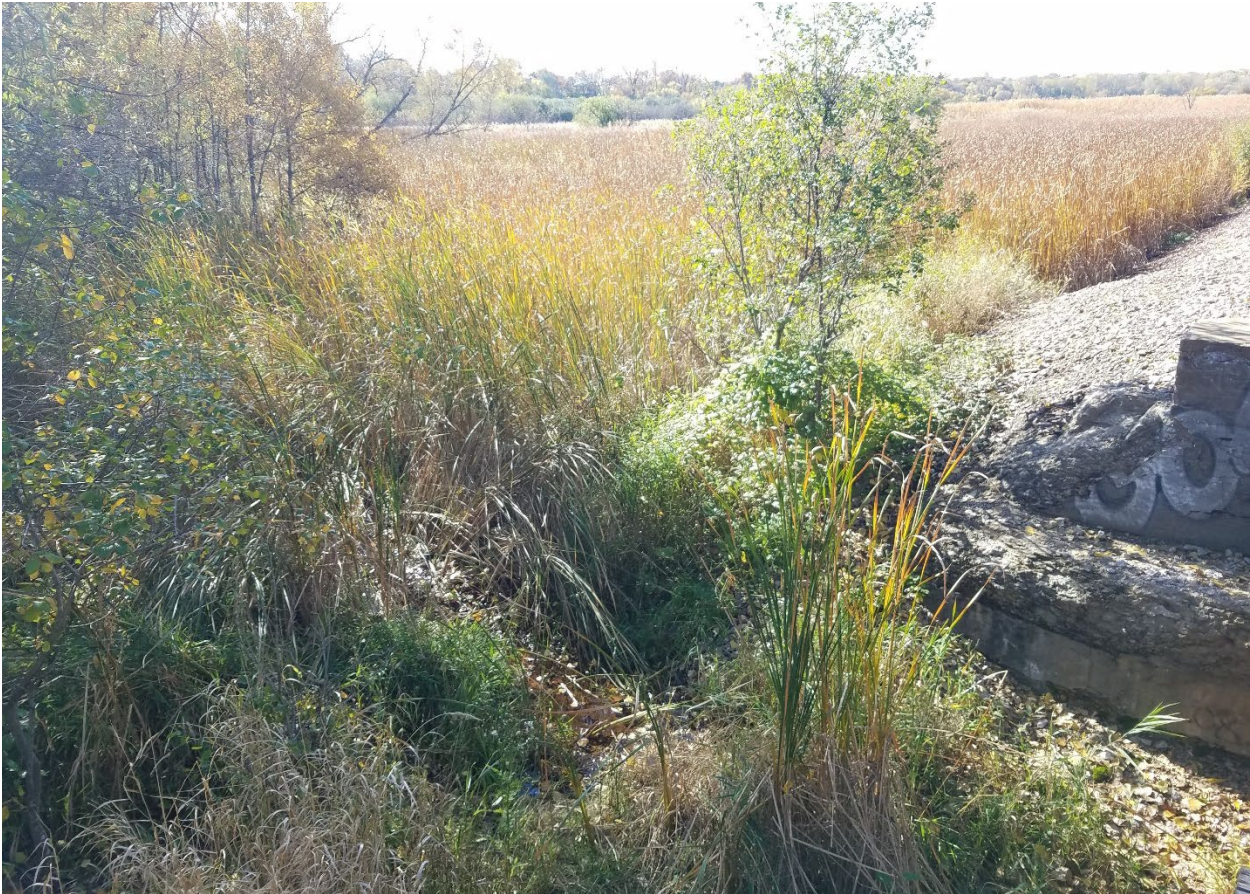
Figure 3. Upstream view of Black Dog Creek

commercial operations for sand harvesting and fishing. Black Dog Creek once flowed west of Cedar Avenue and then east to Black Dog Lake/Minnesota River, but now with the construction of Cedar Avenue, it is separated from its historical headwaters.

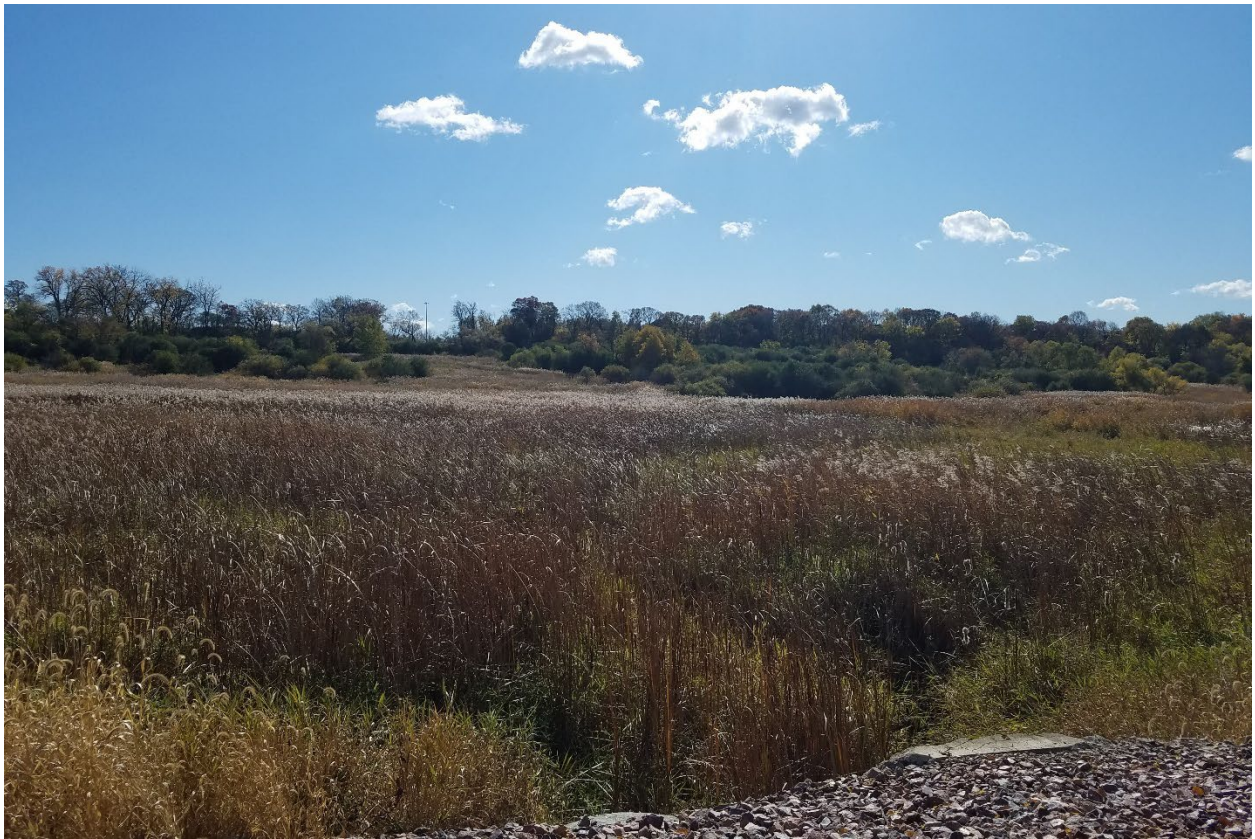
Figure 5. Upstream view of Unnamed 3

- Unnamed 3 flows under the railroad culvert bridge to Black Dog Lake.
- This site was visited in April 2020, and the temperature was taken. It was warm by the lake, but the temperature drops when the sun goes away.
- The culvert bridge is falling apart and degraded.

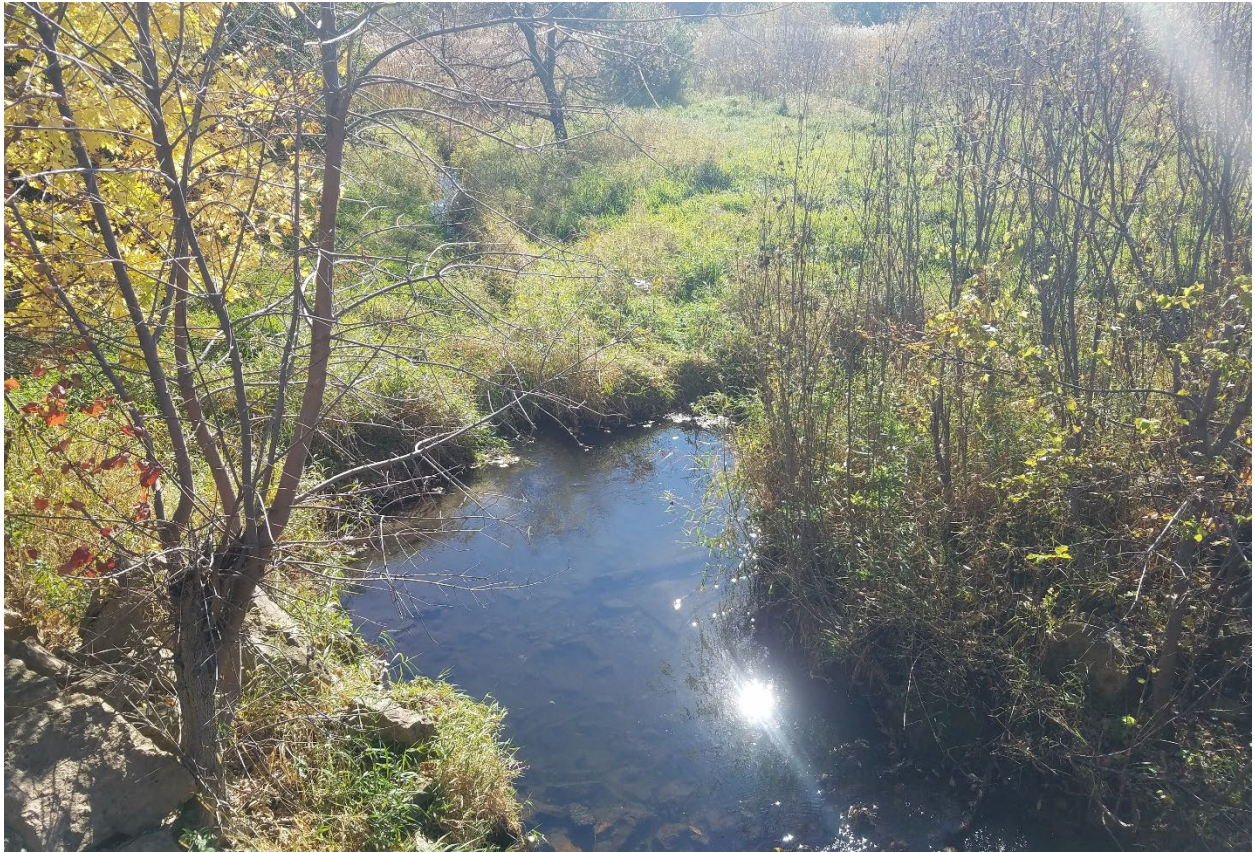
Figure 7. Upstream view of Unnamed 4

- Unnamed 3 flows under the railroad bridge to Black Dog Lake.
- There was high flow, good substrate, and good habitat. The confounding factor is the water source. The railroad company placed new rocks.
- The stream backs up into the pond.
- There are bluffs and gullies by Unnamed 4 on the south side.
- There were unused pieces of pipes on the north side, sitting in the grass.

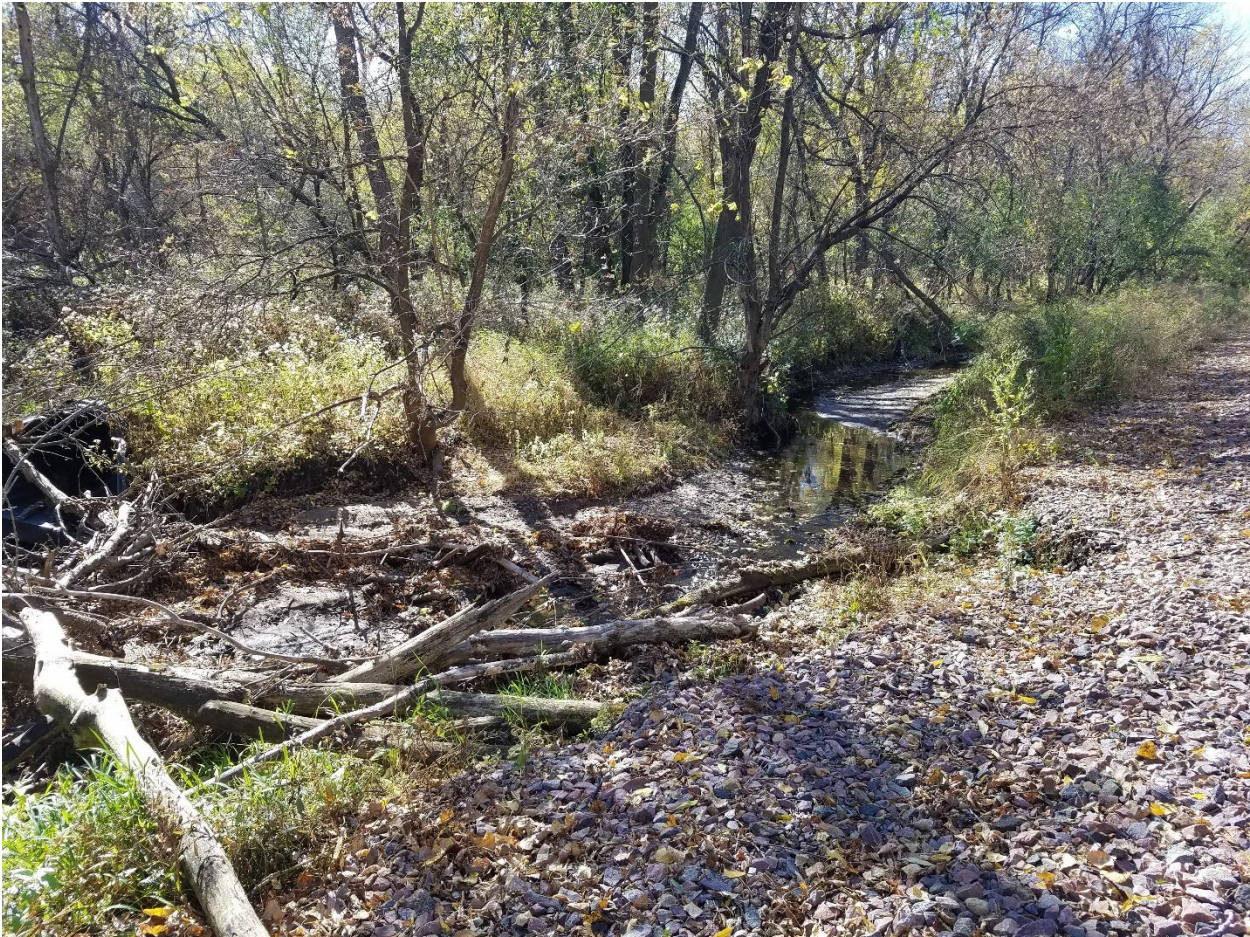
Figure 9. Unnamed 4 tributary, looking upstream

The creek referred to as "No Official Name" below is a tributary of Unnamed 4. It is a gully that once flowed directly to Nicols Marsh through a culvert under the railroad. It is suspected that the city or Union Pacific railroad plugged the culvert and realigned the tributary to flow east to Unnamed 4 to protect the track from overtopping when the city began discharging stormwater flows into the gully area.

- The black culvert goes underground; parts of it are suspected to be disconnected, and it might not be functional.
- At the time of observation, water was discharging from the culvert into the tributary.

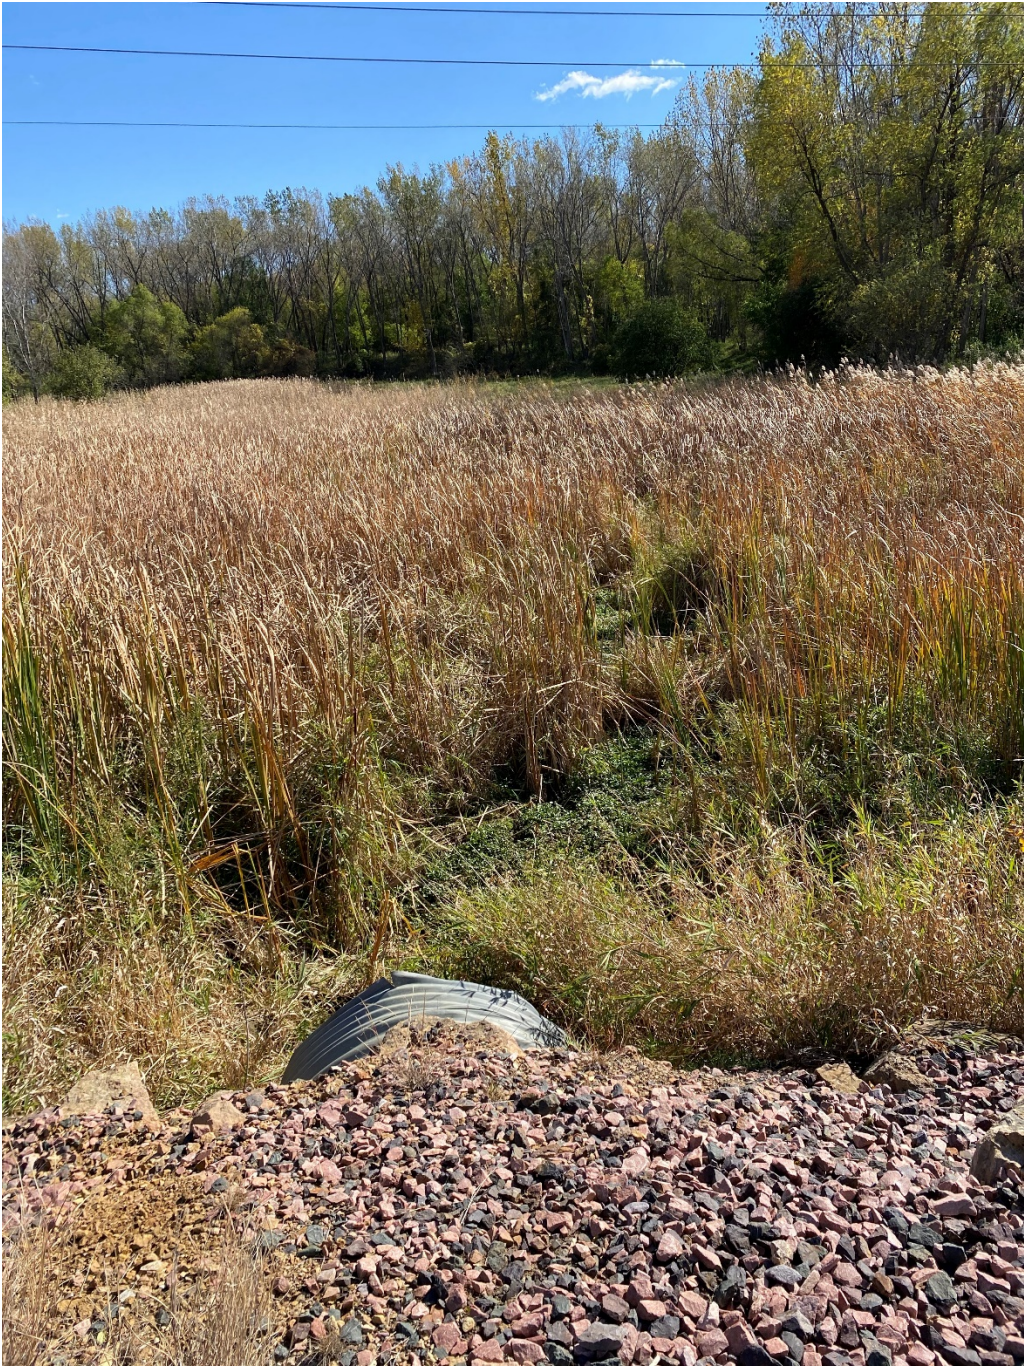
Figure 10. Upstream view of Kennealy's Creek

- Kennealy's Creek had high flow at the time, but Mark said it is about half of what was observed in the winter.
- Watercress was abundant, along with healthy ferns.
