# LOWER MINNESOTA RIVER WATERSHED DISTRICT

# Technical Memorandum

**Re:** Area 3 Minnesota Riverbank Stabilization Project Update

# Area 3 Photo Comparison

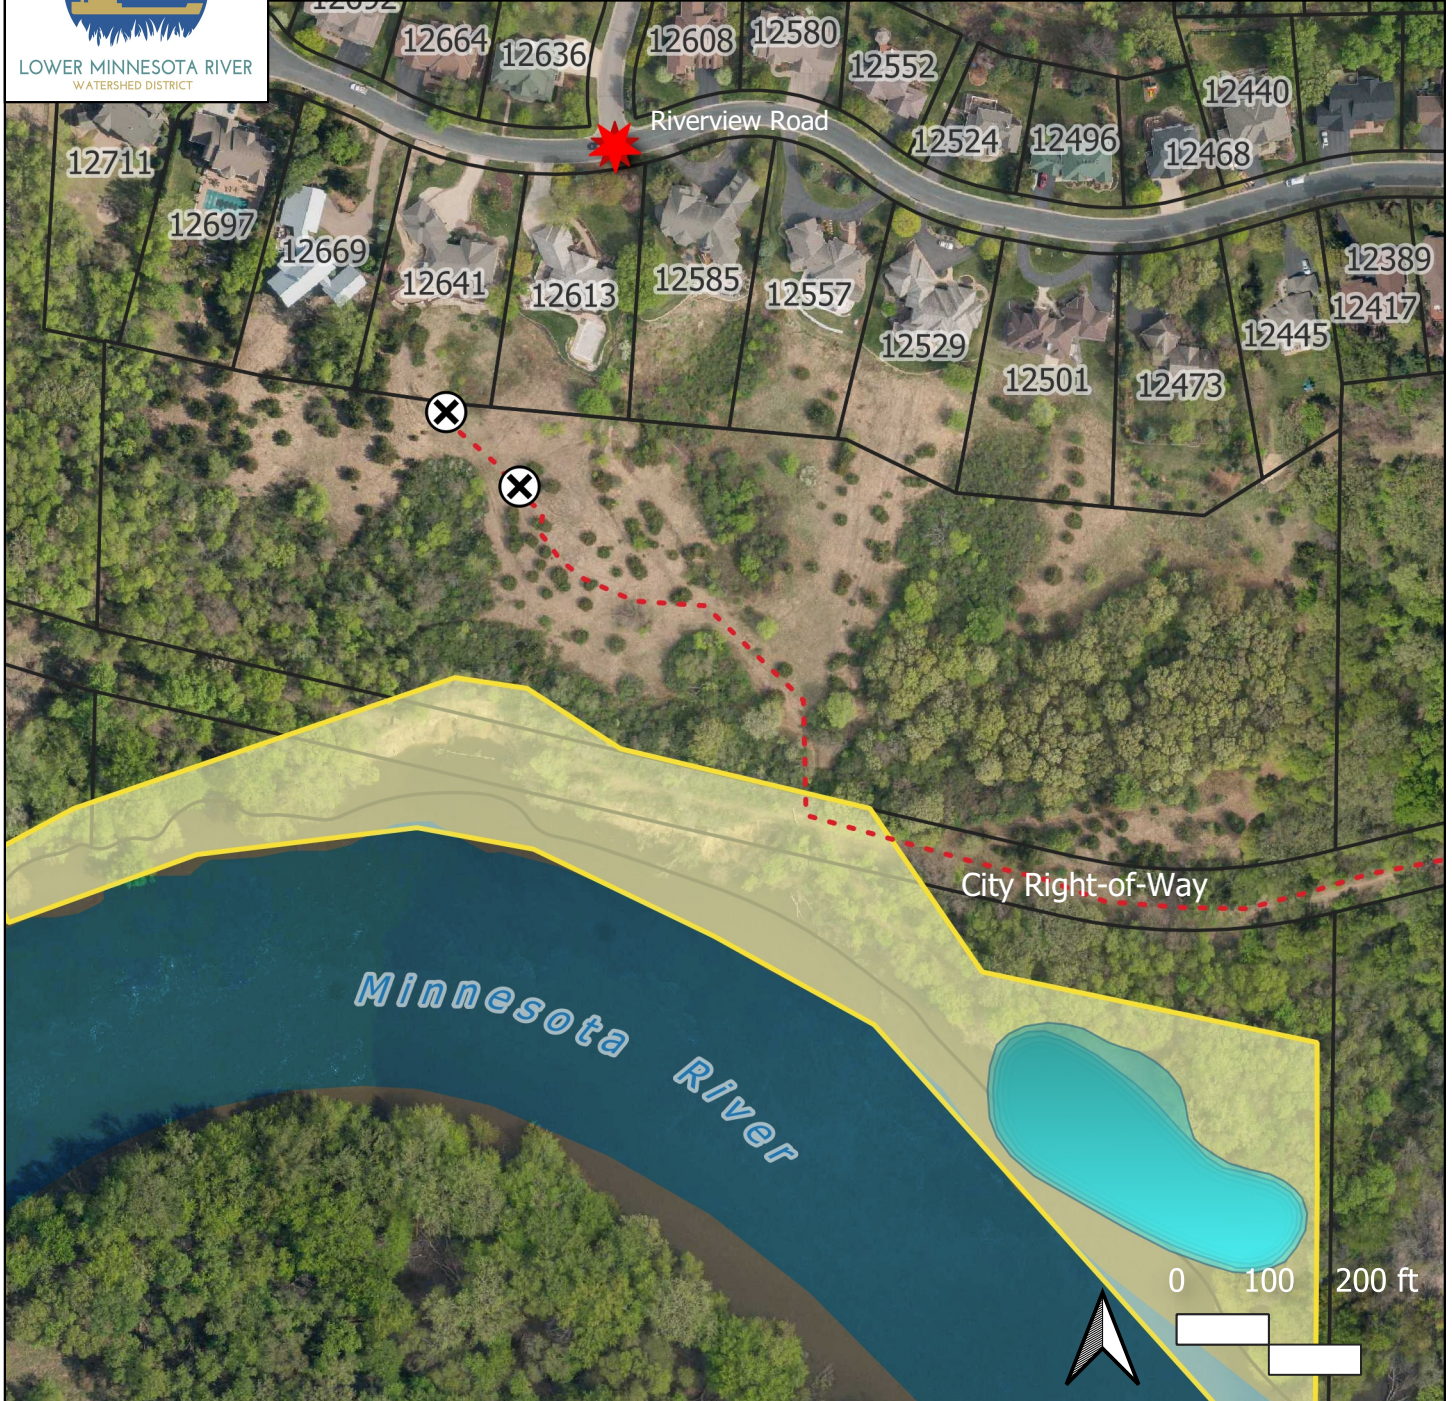
# Minnesota River Area 3 Proposed Soil Borings and Access Routes

Approximate Locations of Proposed Borings
-

Minnesota River Area 3 Project Extents

City of Eden Prairie Stormwater Pond

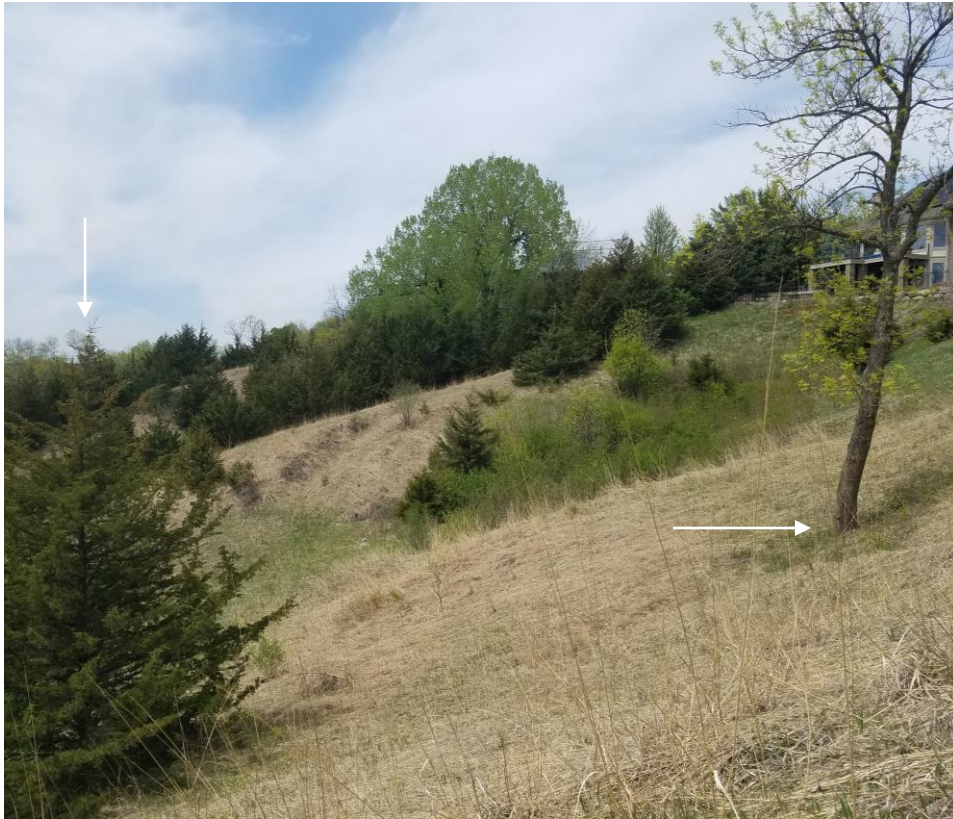
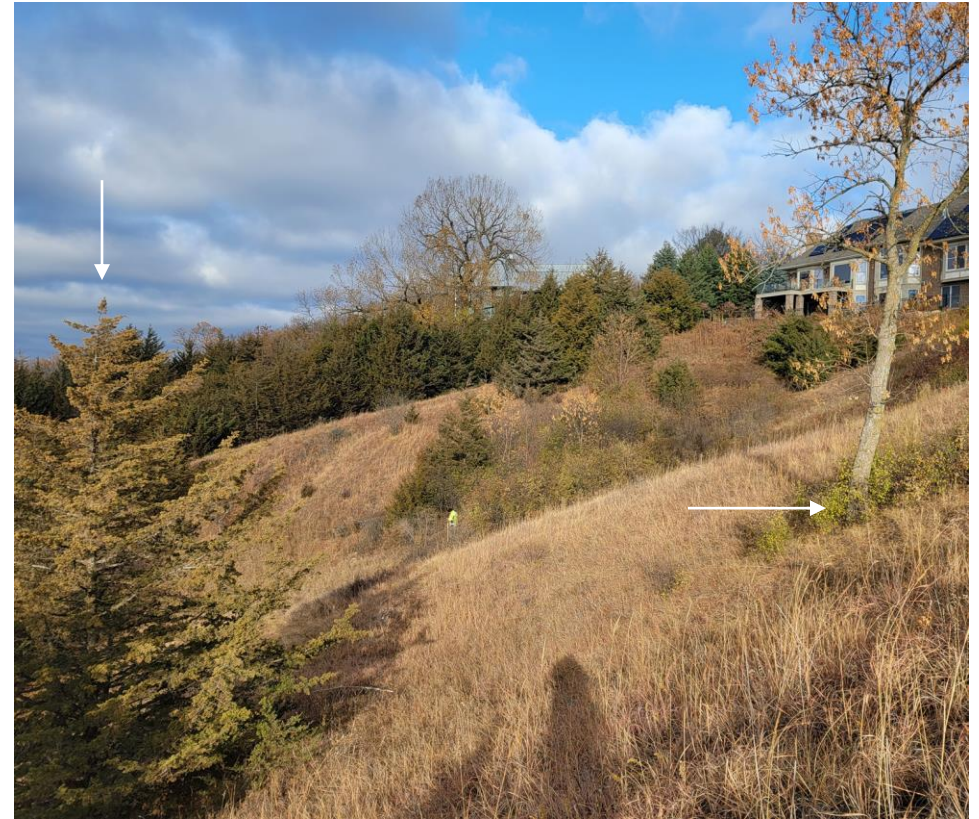
1. Looking east at 12641 Riverview Rd (white arrows are reference points)

May 5, 2020

October 25, 2022

The 1985 feasibility report for the Bluffs West Vicinity, provided by the City, indicates that Pond 35-23-A was intended to hold water “for sedimentation and weed control purposes with an additional four feet to the top of the bank for temporary holding capacity” up to a 10-year flood event. The 1986 record plans indicate that the pond should have been 5.8 feet deep, from pond bottom (elev. 702) to the top of the pond berm (elev. 707.8), with a final normal water elevation of 705. The outlet control structure consisted of a weir leading to a 21-inch concrete pipe that discharges to the Minnesota River. However, during the site visit, it appeared that the outlet control structure was either been completely buried by sediment, or washed out due to frequent inundation by the Minnesota River. Photo comparisons from the 2020 Gully Inventory and Condition Assessment and the site visit are provided in Attachment 6.

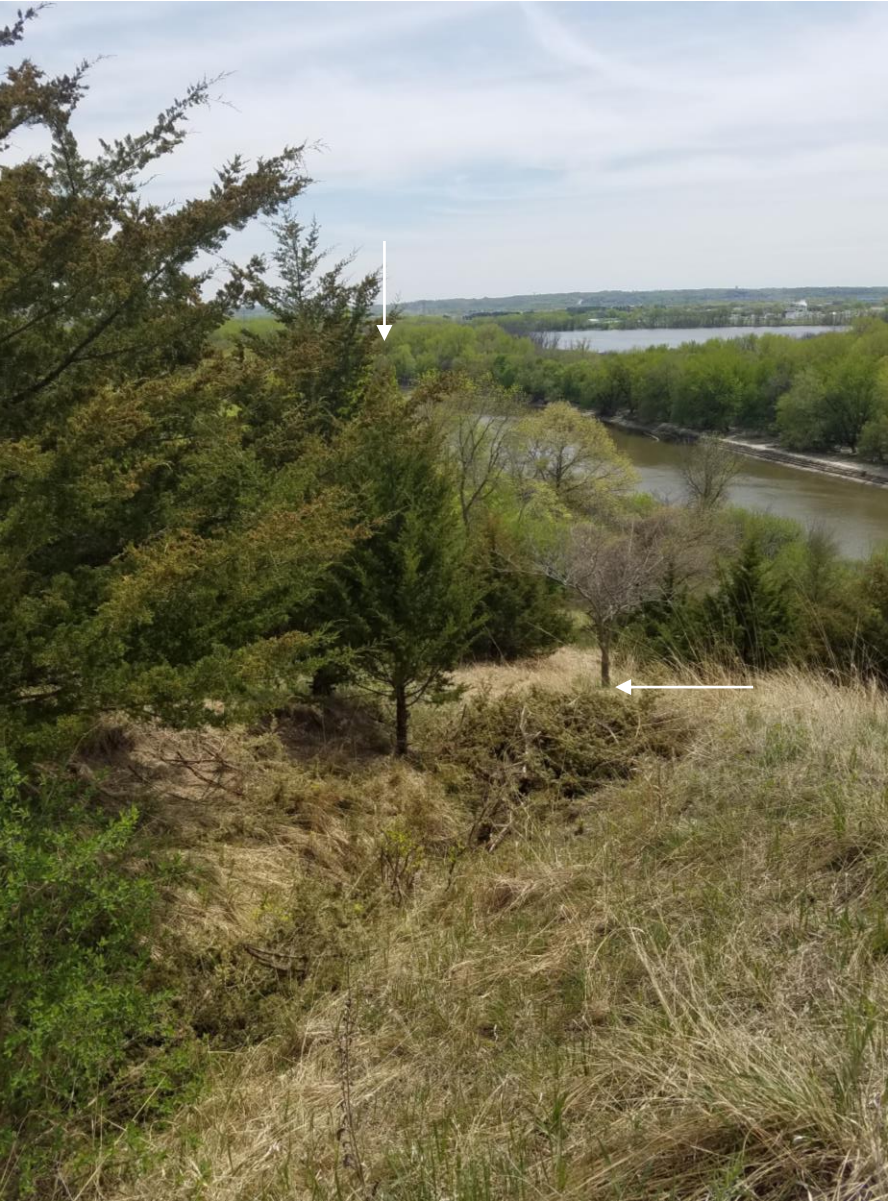
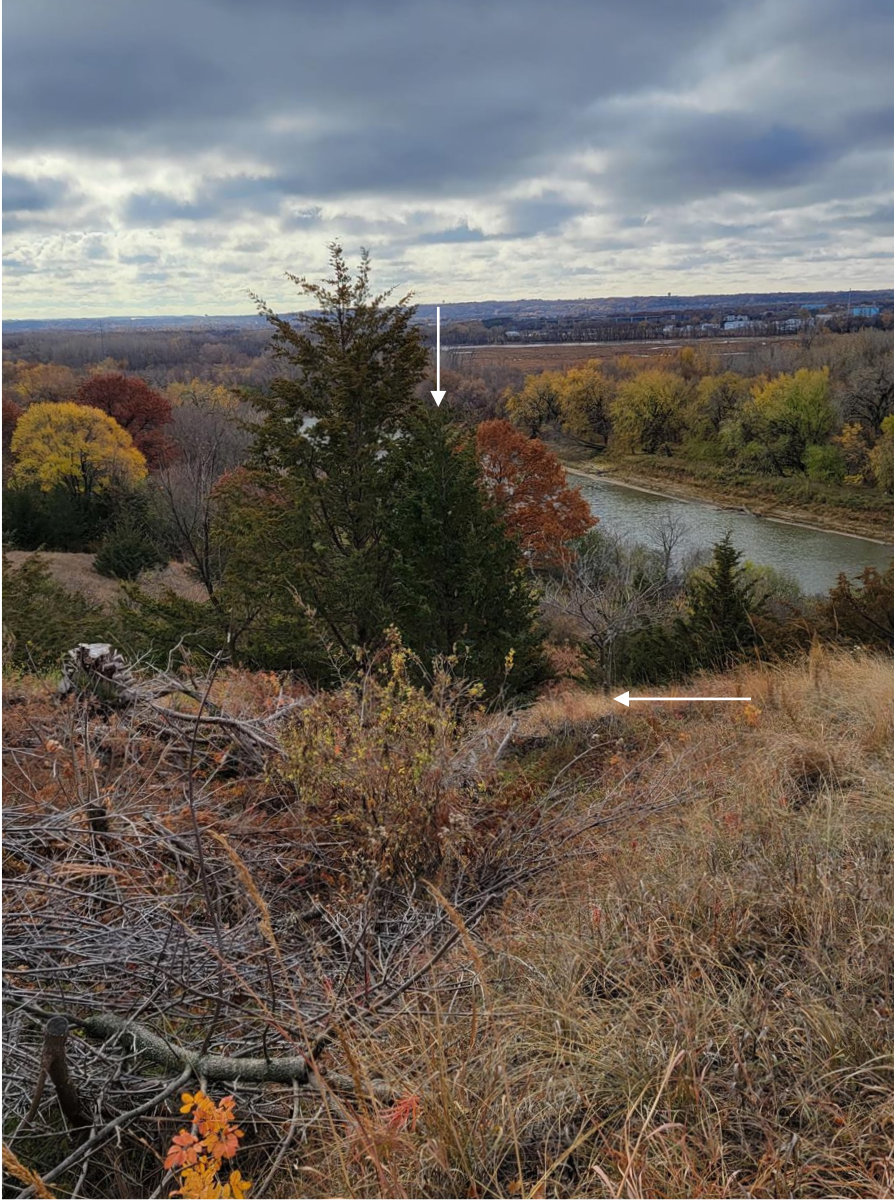
2. Looking south at gully from 12613 Riverview Rd (white arrows are reference points)

May 5, 2020

October 25, 2022

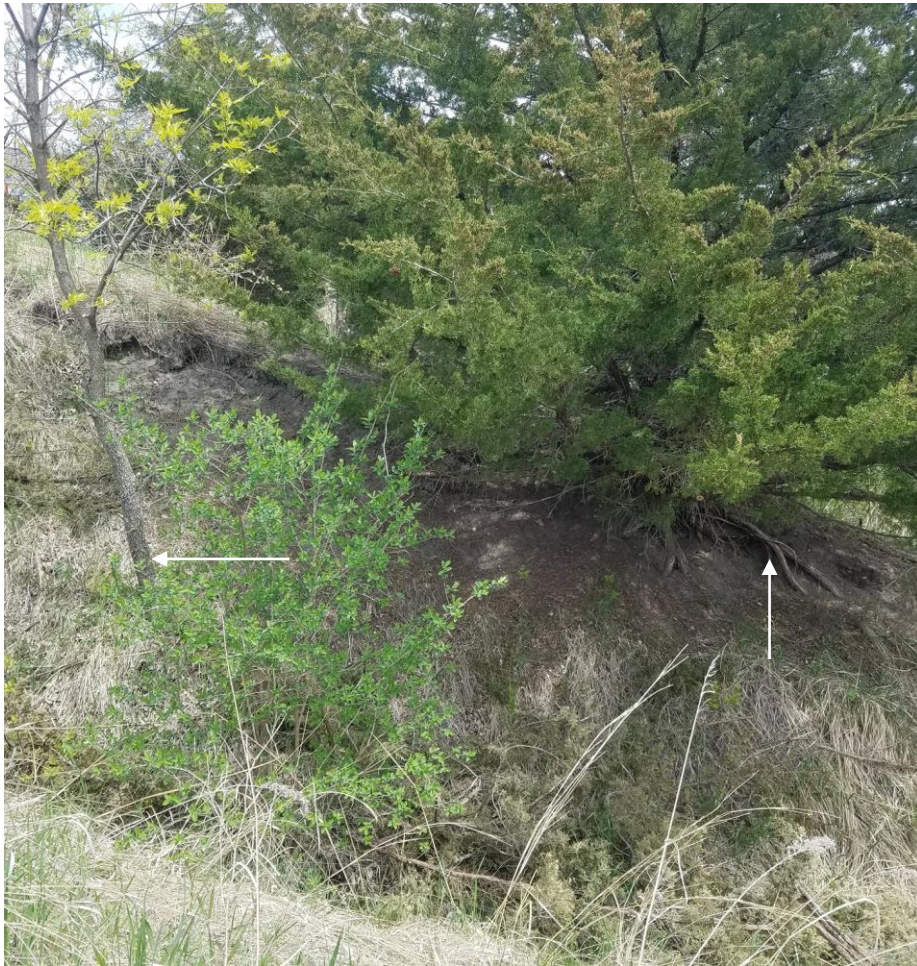
3. Looking east at gully from 12613 Riverview Rd (white arrows are reference points)

May 5, 2020

October 25, 2022

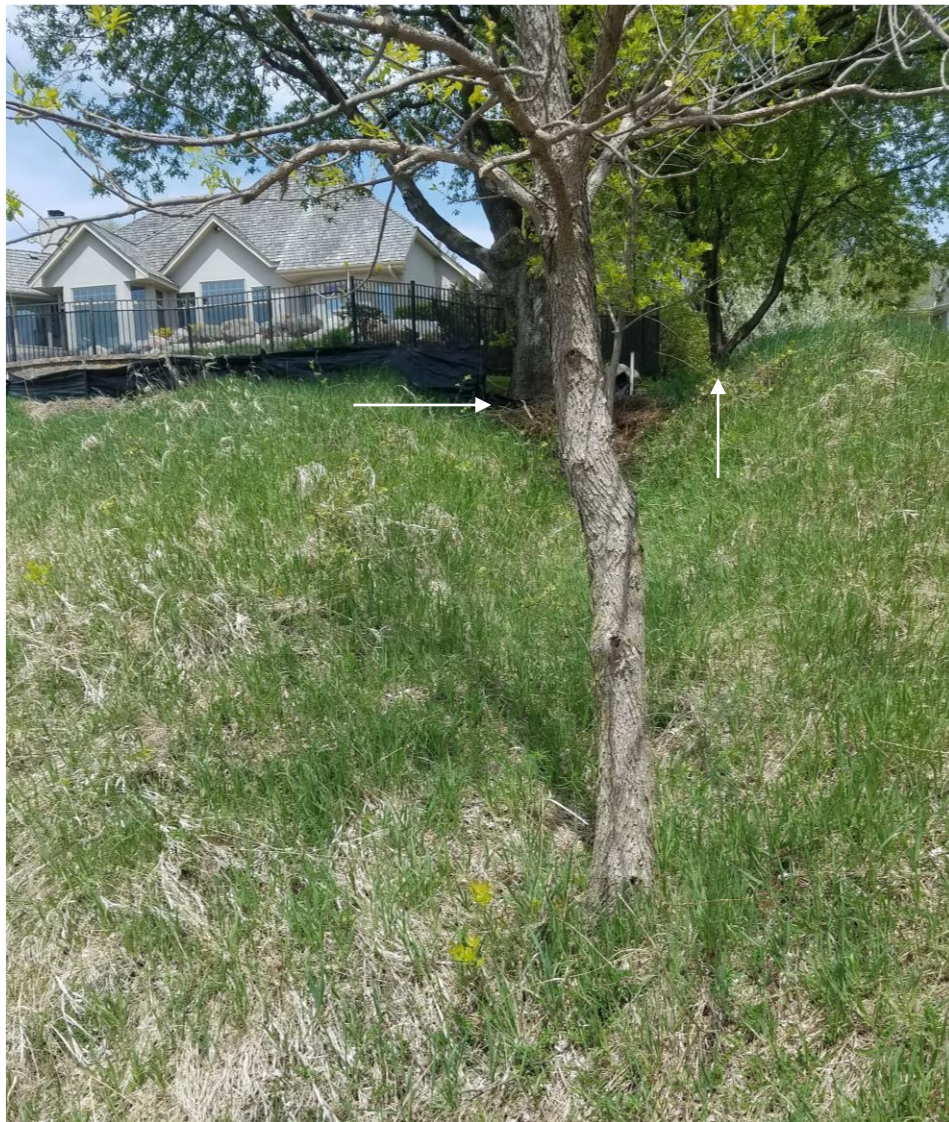
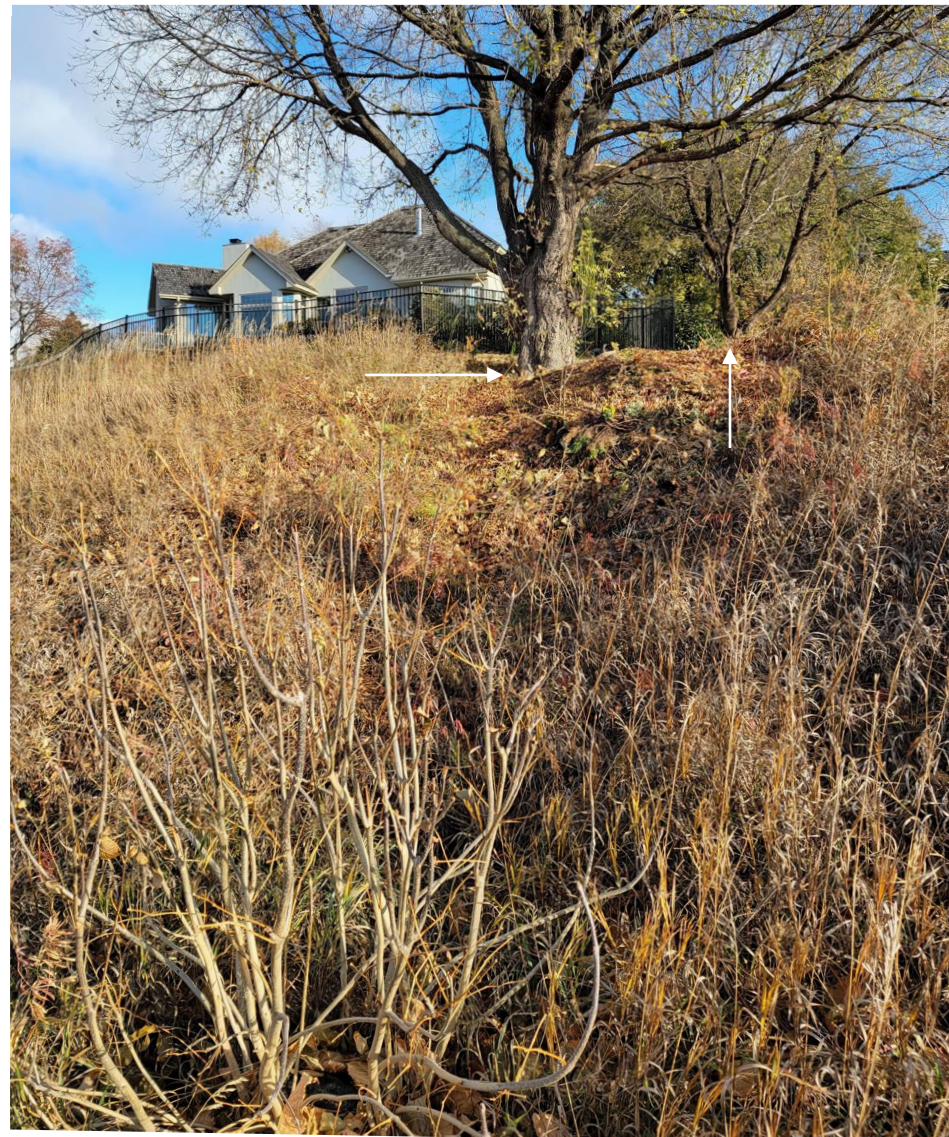
4. Looking north at 12613 Riverview Rd (white arrows are reference points)

- Mabel said that her neighbor at 12613 Riverview Road (Patricia Korte, who was unable to attend because she had already moved to Florida for the winter) has been losing several inches of ground to erosion and is concerned that her pool is moving.

May 5, 2020

October 25, 2022

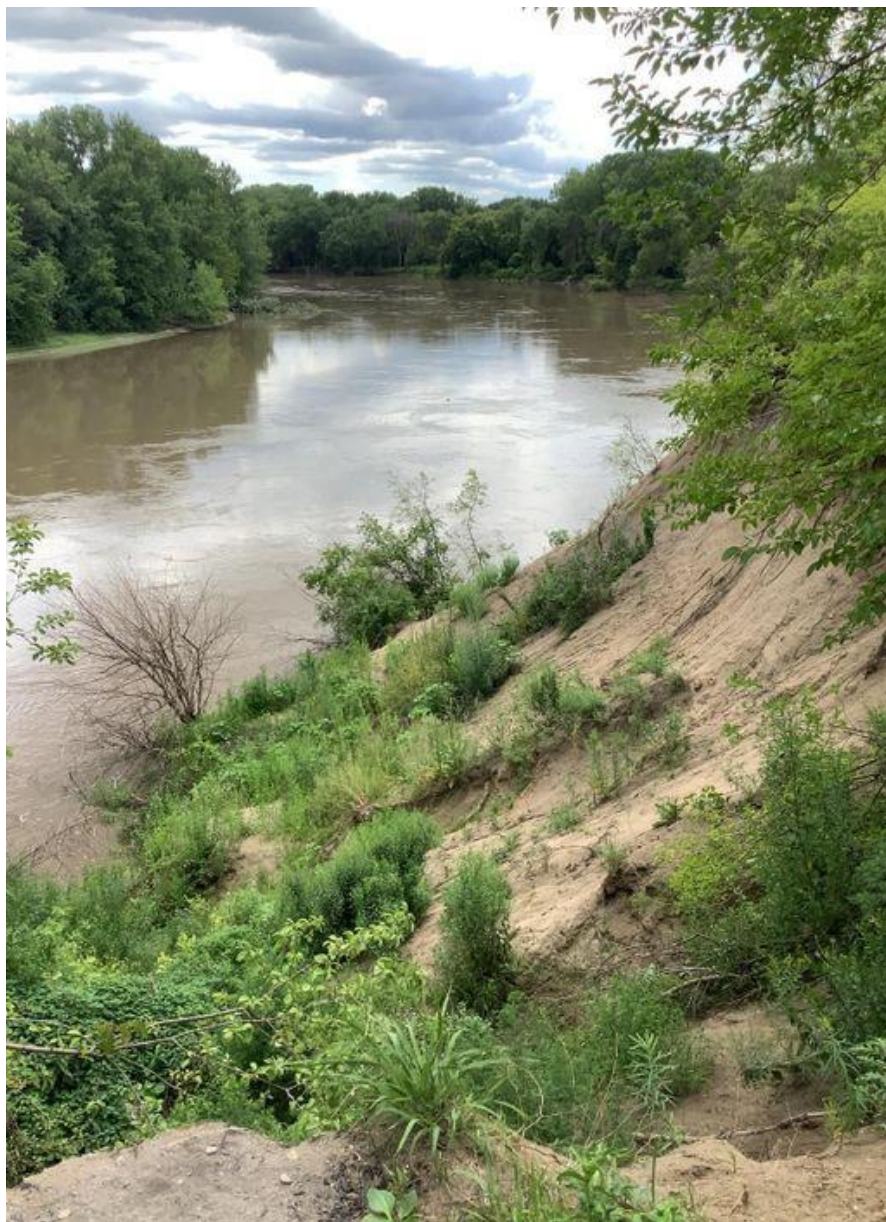
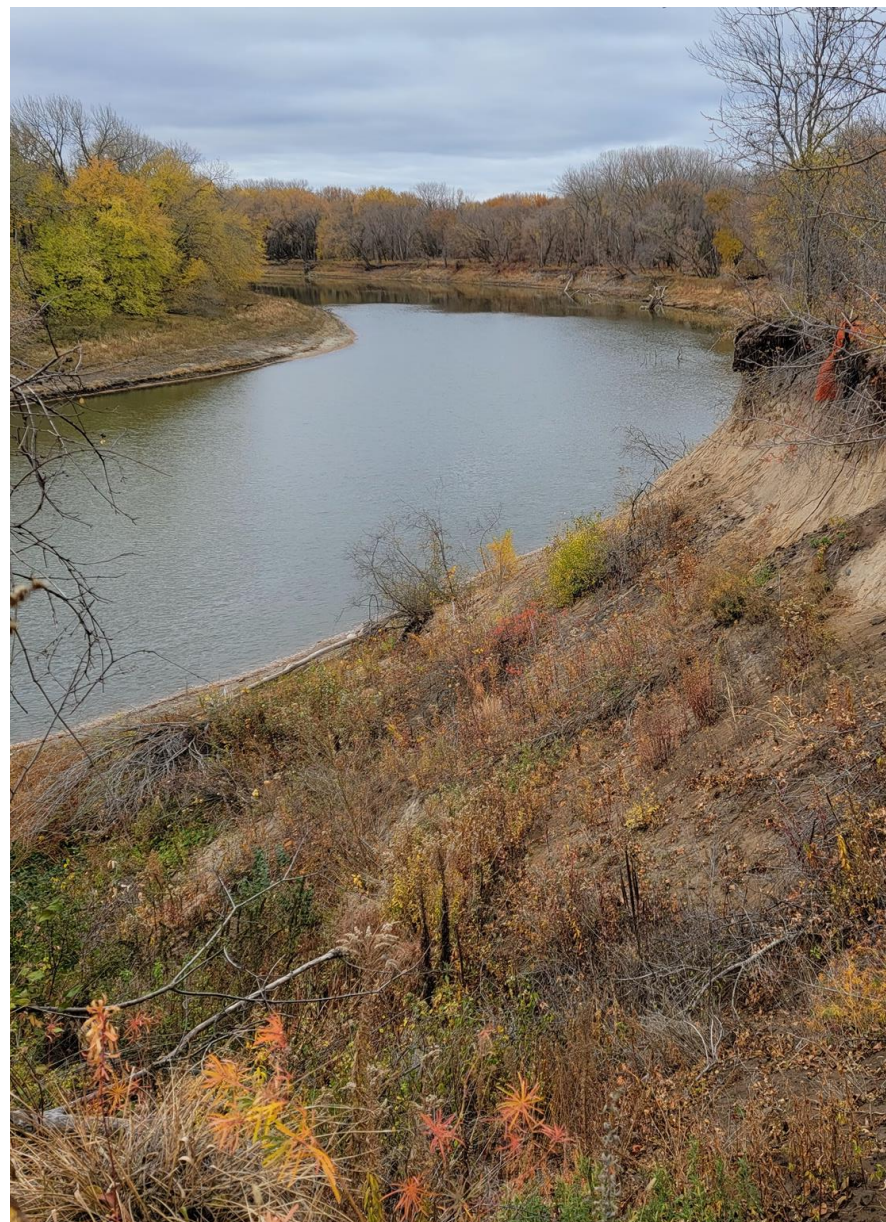
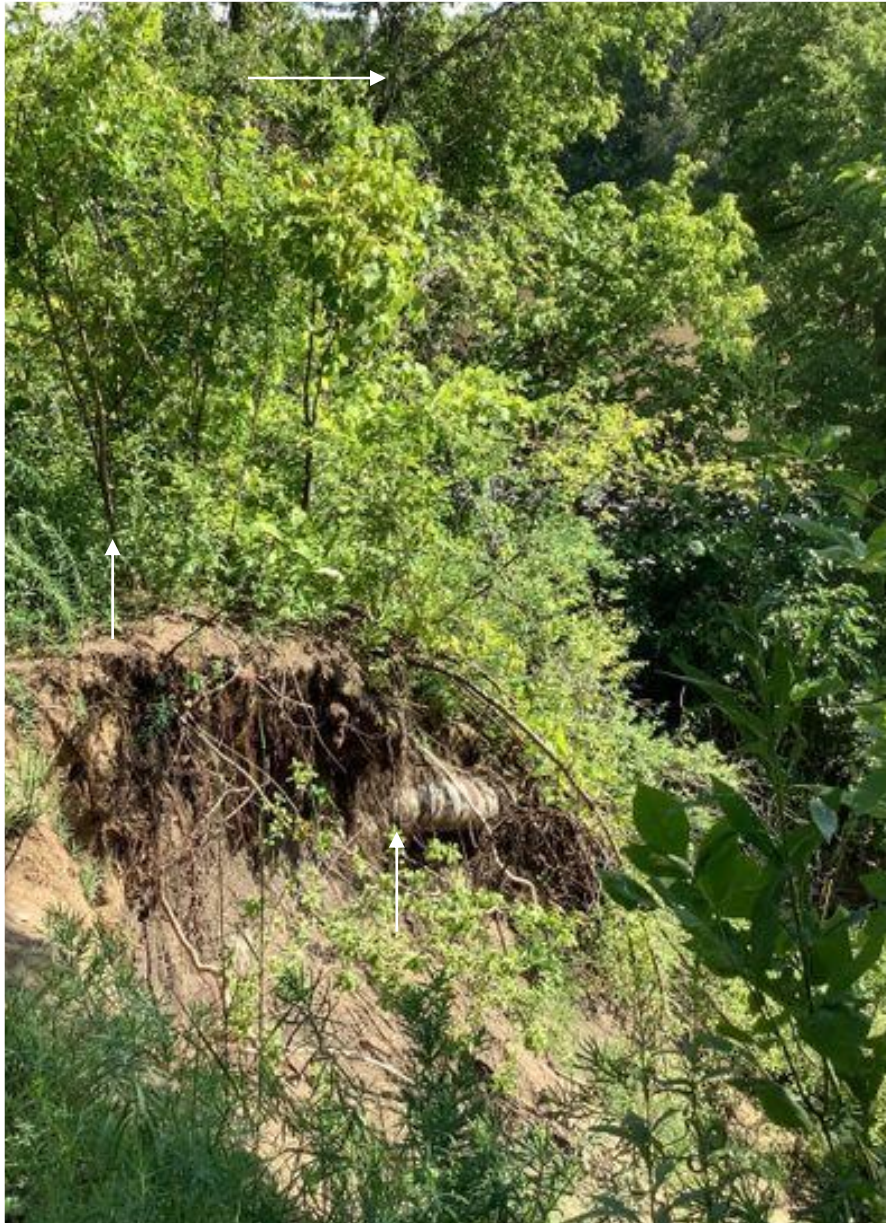
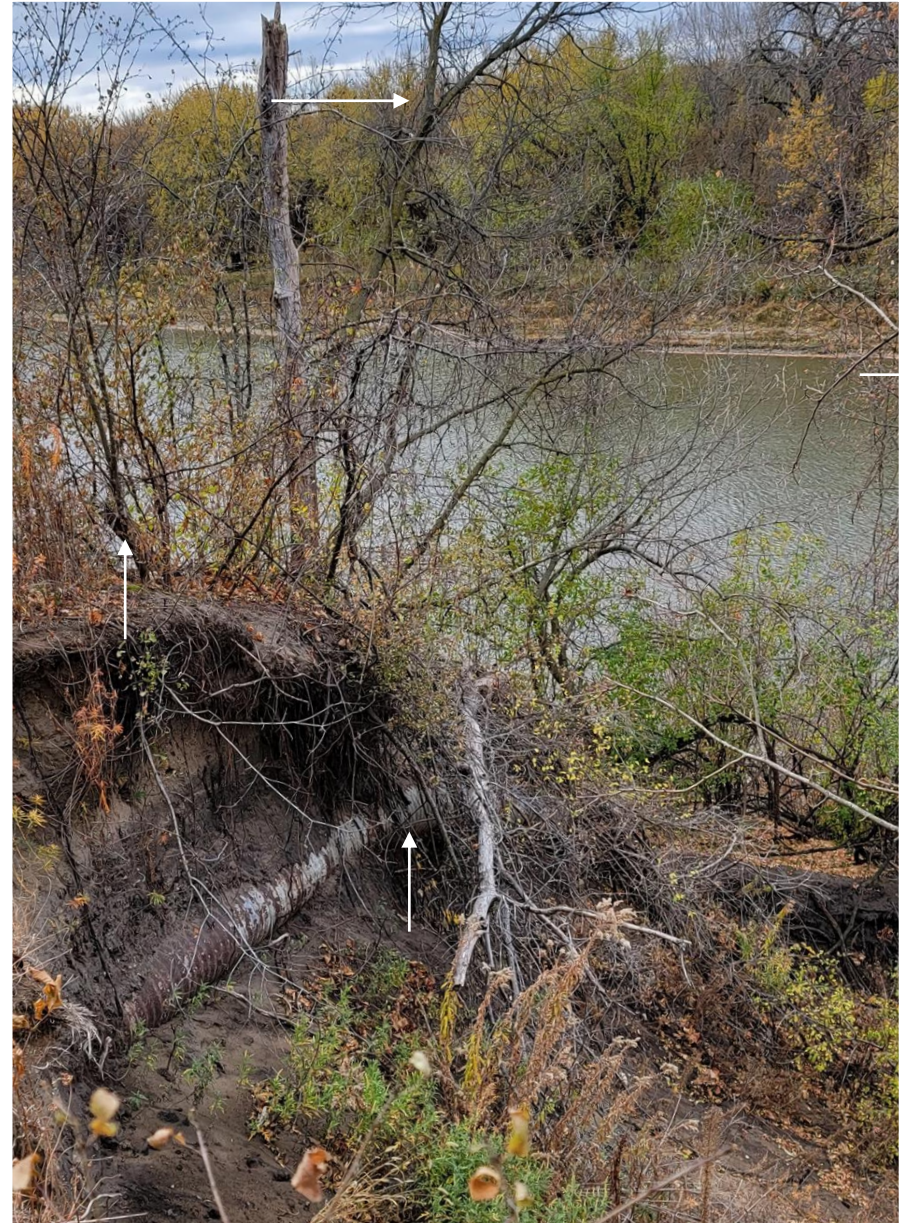
## 5. Looking upstream at Area 3 erosion

July 28, 2020

October 25, 2022
