LOWER MINNESOTA RIVER WATERSHED DISTRICT

Lower Minnesota River Watershed District Board of Managers Meeting
Monday, November 19, 2018

Item 7. F. - Project Reviews

CSAH 61/Flying Cloud Drive inspection report

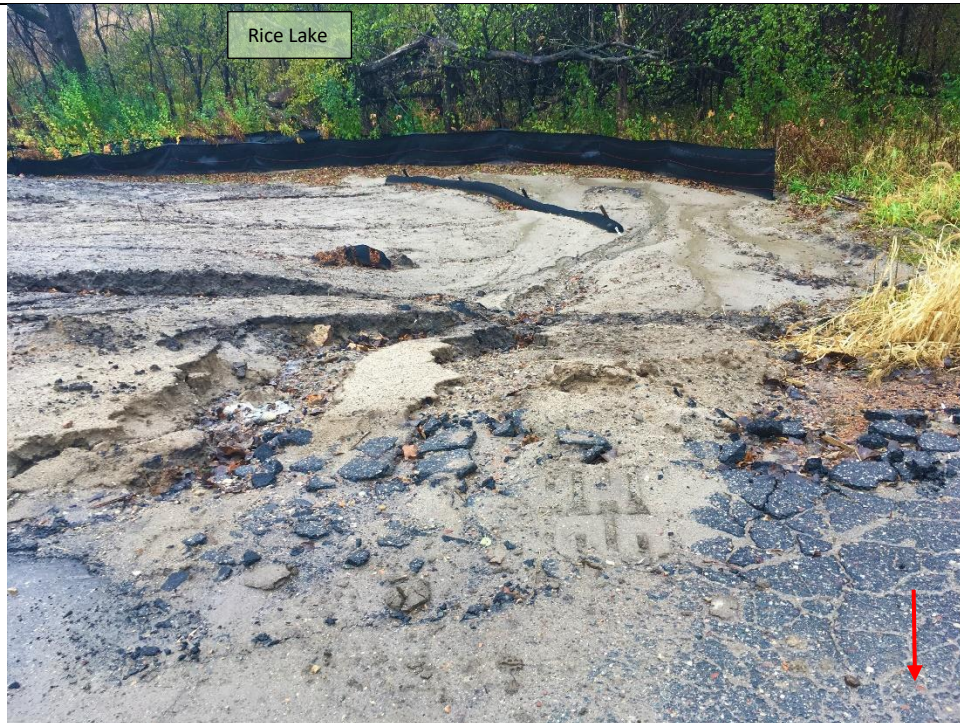
Photo No.: 1

Location: South side of Flying Cloud Drive, west of construction trailer. Facing south towards Rice Lake.

BMPs Present: Two rows of silt fence, biologs.

Description: BMPs overwhelmed with sediment from road.

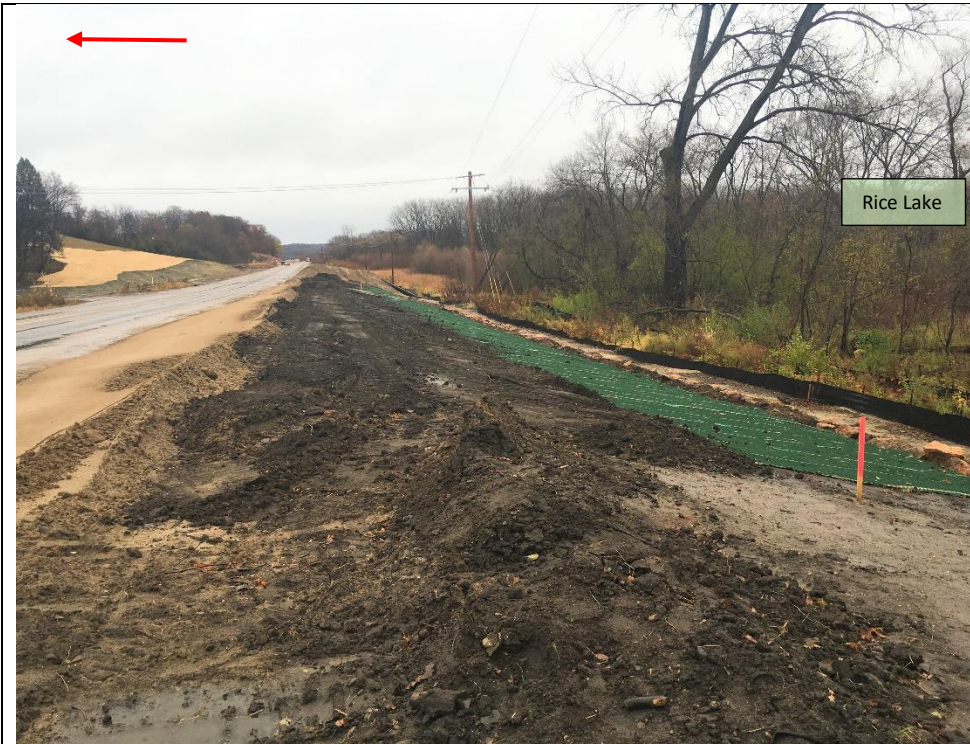
Photo No.: 2

Location: South side of Flying Cloud Drive, 5–10 yards west of Photo 1. Facing east.

BMPs Present: South side of road—Two rows of silt fence, geotextile blanket, rock check downslope of blanket. North side of road—fabric ESC blanket, hydromulch.

Description: BMPs installed along north and southern project perimeters.

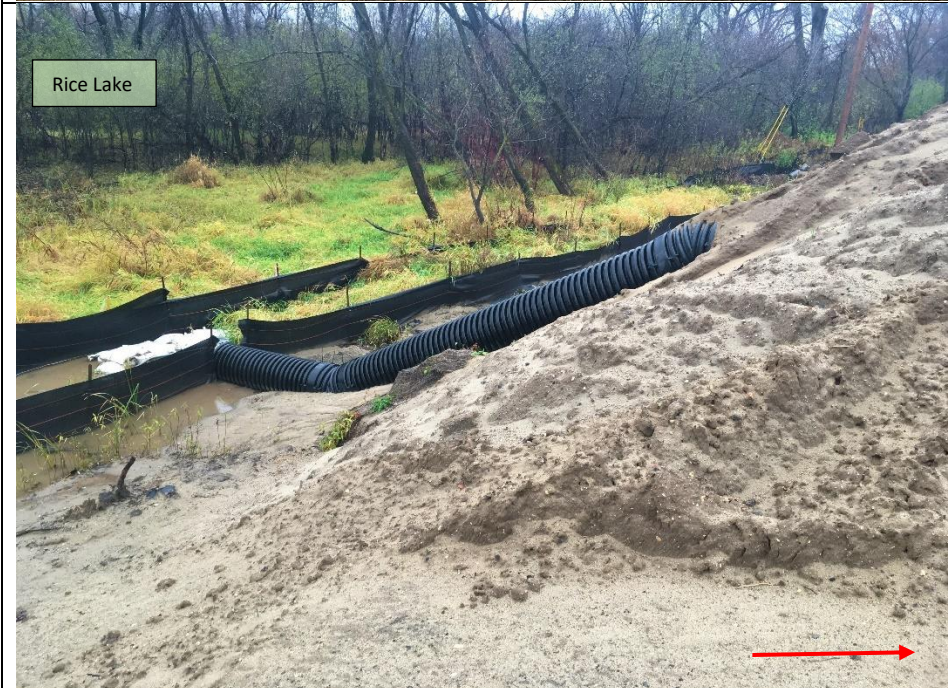
Photo No.: 3

Location: South side of Flying Cloud Drive

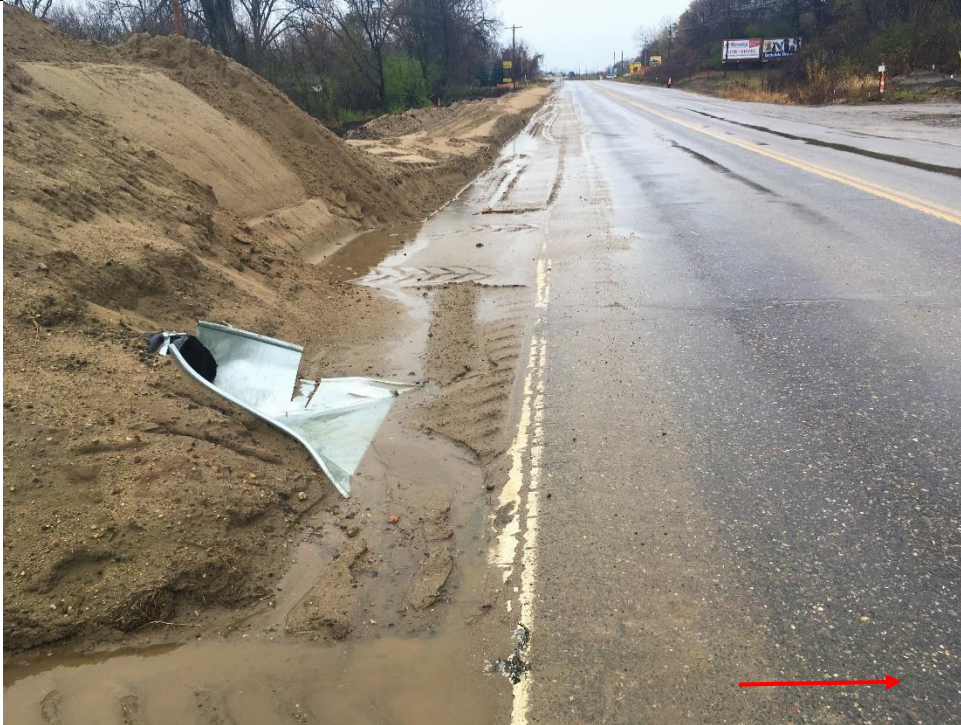
Photo No.: 5

Location: South side of Flying Cloud Drive, facing west.

BMPs Present: Two rows of silt fence, hydromulch.

Description: Site BMPs. The hydromulch appears to have been applied in the last 7–10 days with no germination present at the time of inspection.

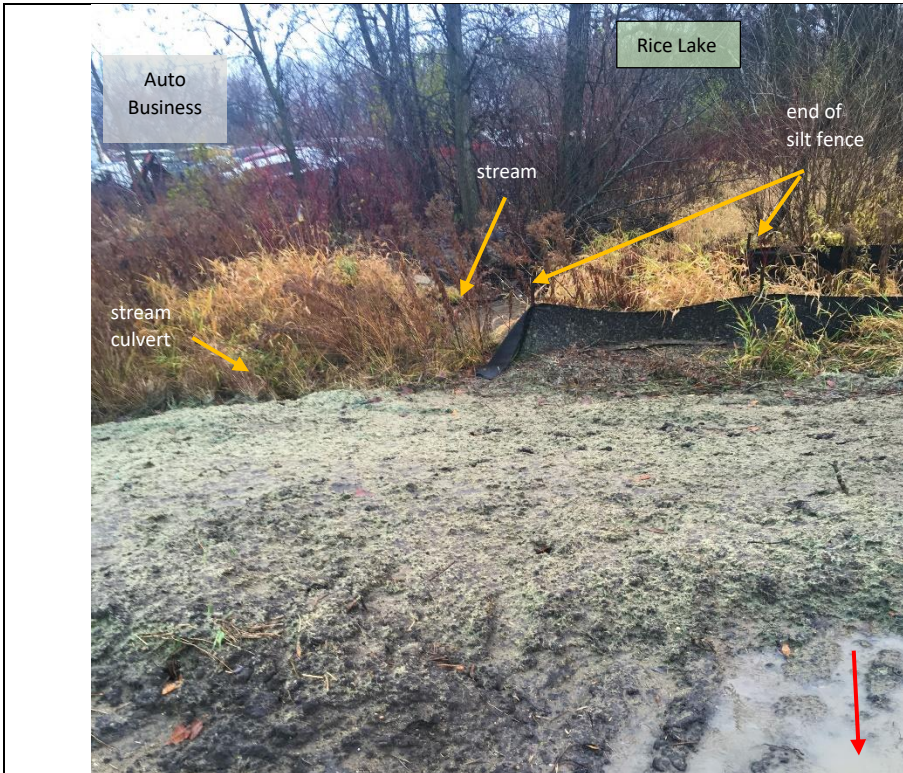
Photo No.: 6

Location: South side of Flying Cloud Drive, adjacent to the auto business, 10–20 yards east of Photo 5. Facing south.

BMPs Present: Hydromulch, two rows of silt fence, some vegetation.

Description: Silt fencing ends just before stream bank. It is unclear what BMPs might be present around the stream culvert (not accessible).

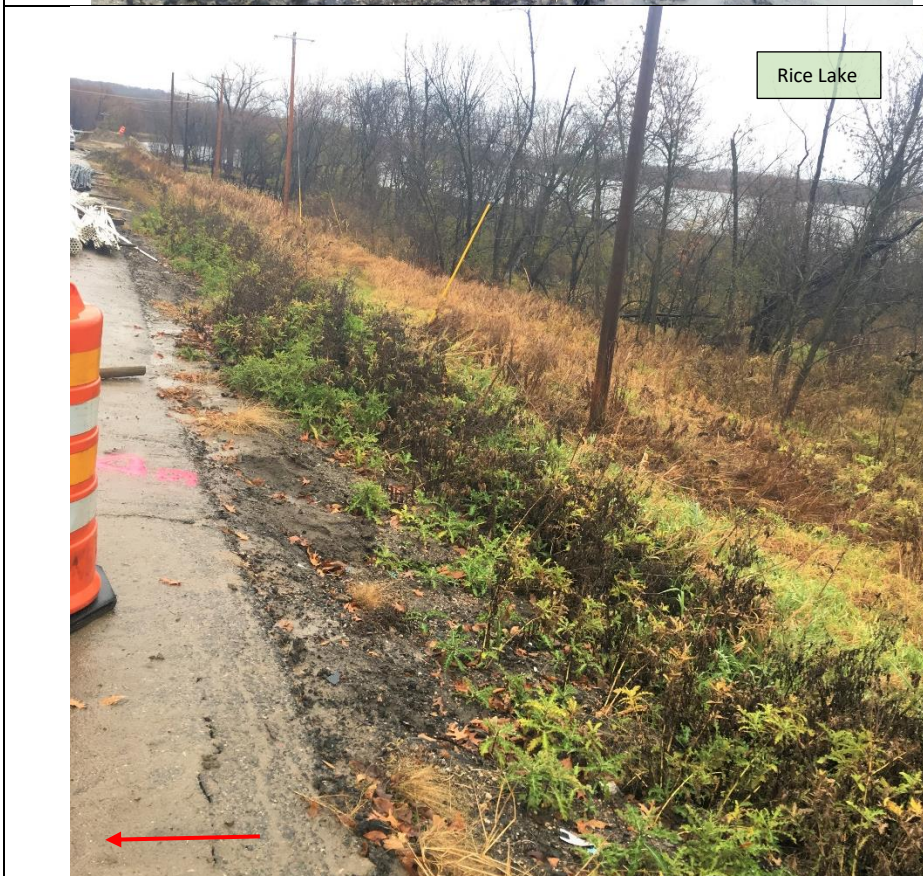
Photo No.: 7

Location: South side of Flying Cloud Drive.

BMPs Present: Vegetative buffer.

Description: In this section, the old road has not been removed and existing vegetation has been left intact up to the roadway.

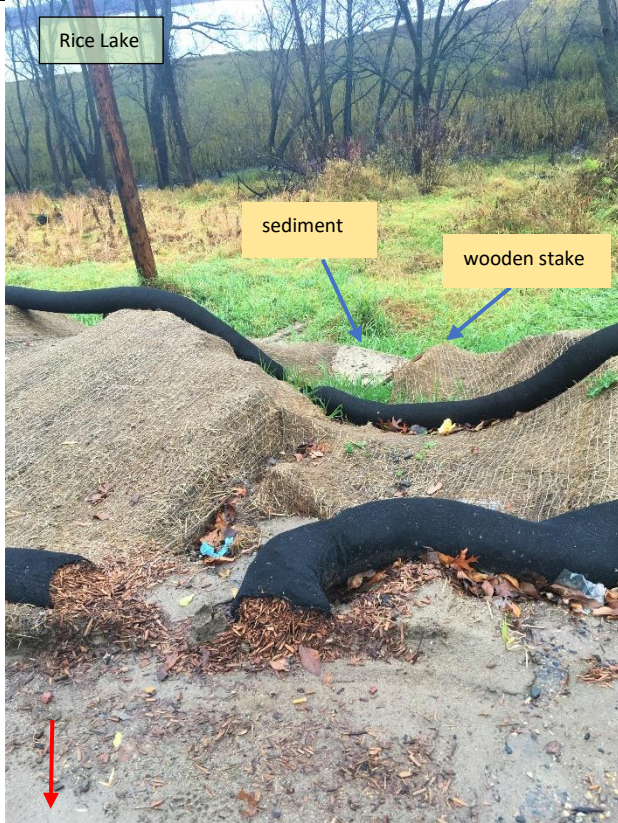
Photo No.: 8

Location: South side of Flying Cloud Drive. *Photos 8–15 in same general area of project.

BMPs Present: Biologs, ESC blanket.

Description: BMPs have failed. Extensive erosion beneath the fabric has resulted in a pool of sediment at base of slope. Soil-to-BMP contact has been lost, yielding all BMPs ineffective. Wooden stakes used to anchor fabric are completely dislodged and sideways.

- Work with USFWS to address sedimentation drainage into Rice Lake immediately.
- Many BMPs have failed on site; review site conditions (slope, drainage, etc.) and ensure that appropriate BMPs are installed for site conditions and anticipated seasonal precipitation.

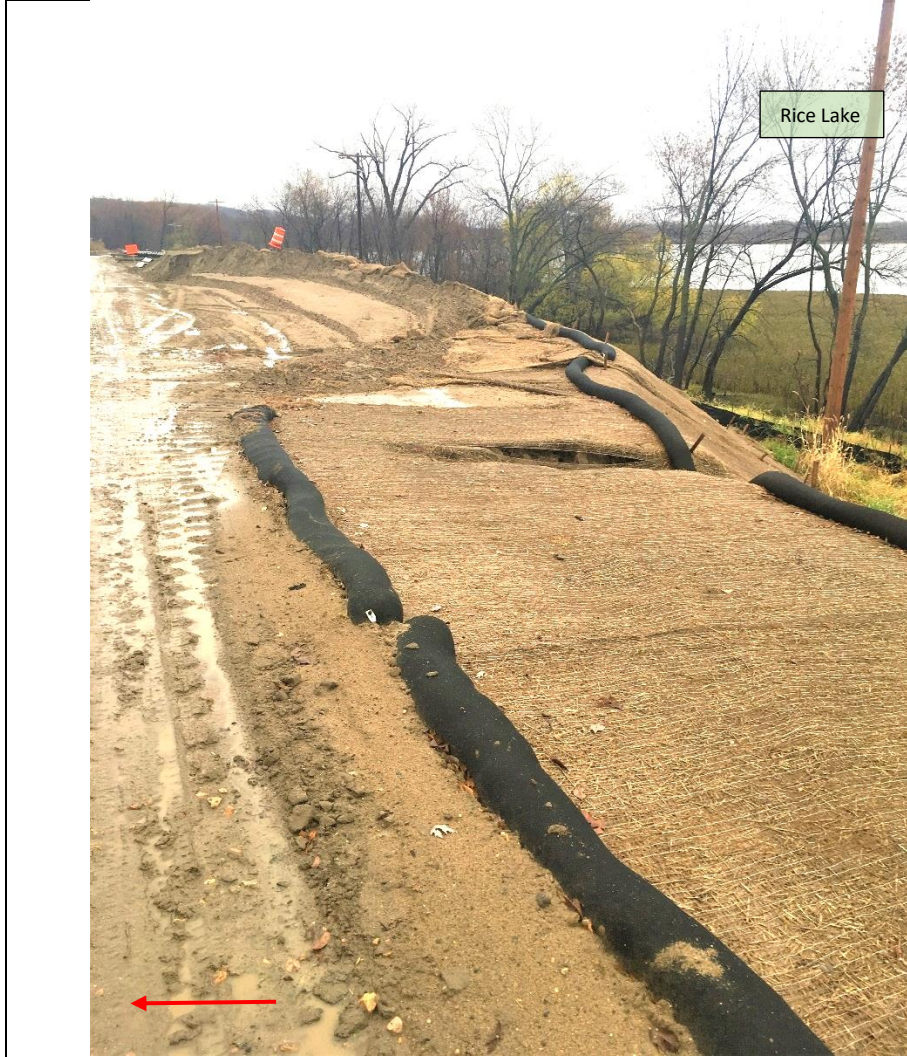
Photo No.: 9

Location: South side of Flying Cloud Drive. *Photos 8–15 in same general area of project.

BMPs Present: Biologs, two rows of silt fence, ESC blanket.

Description: Erosion of slope after BMPs failed to anchor soil. The gap between the blanket and soil is 0.5–1ft+ in multiple areas. Both the biologs and ESC blanket are falling down the slope.

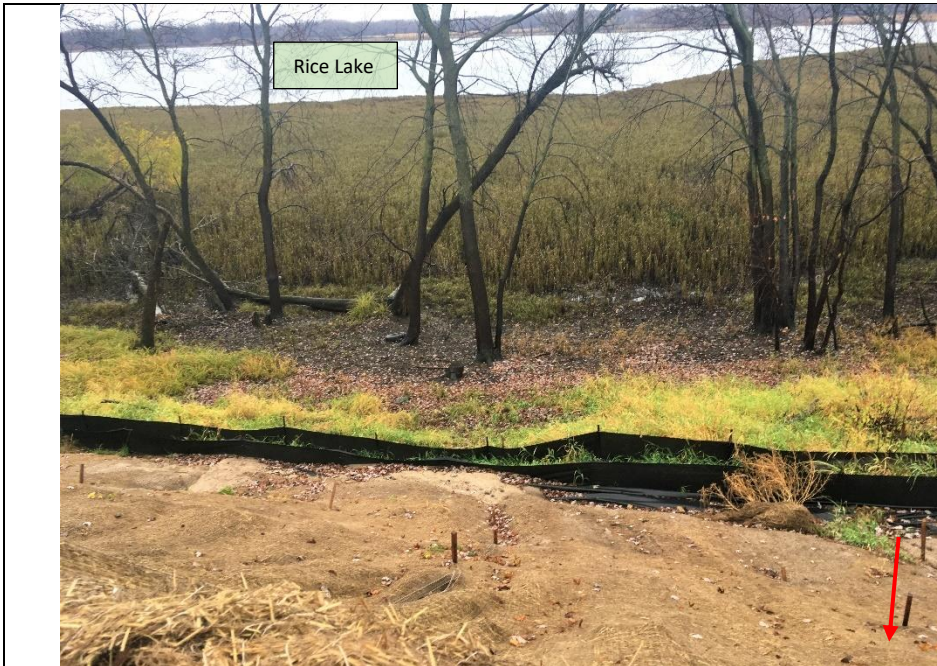
Photo No.: 10

Location: South side of Flying Cloud Drive. *Photos 8–15 in same general area of project.

BMPs Present: ESC blanket, two rows of silt fence, occasional biolog.

Description: Failure of upslope BMPs have resulted in a large accumulation of sediment in silt fence at base of slope. Silt fence was not accessible due to site conditions; it is unclear whether sediments have already gone into Rice Lake.

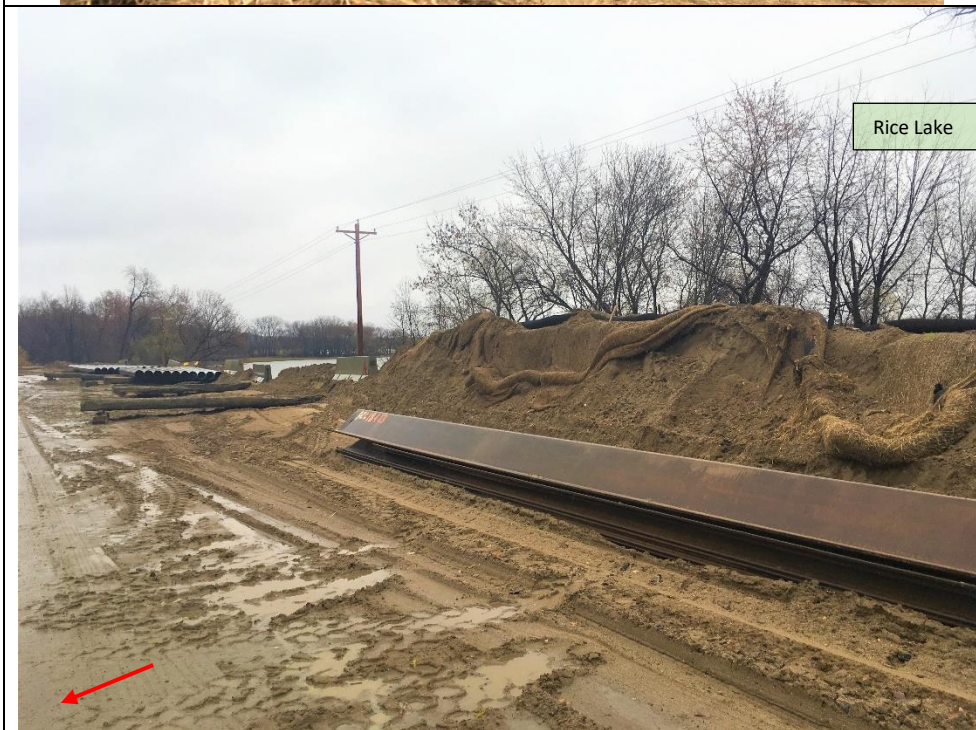
Photo No.: 11

Location: South side of Flying Cloud Drive. *Photos 8–15 in same general area of project.

BMPs Present: ESC blanket, biologs. Jersey barriers seem to be present for safety. not as a stormwater BMP.

Description: Upslope side of large sand pile. Poor BMP installation evident. See Photos 12 and 13 for downslope visual.

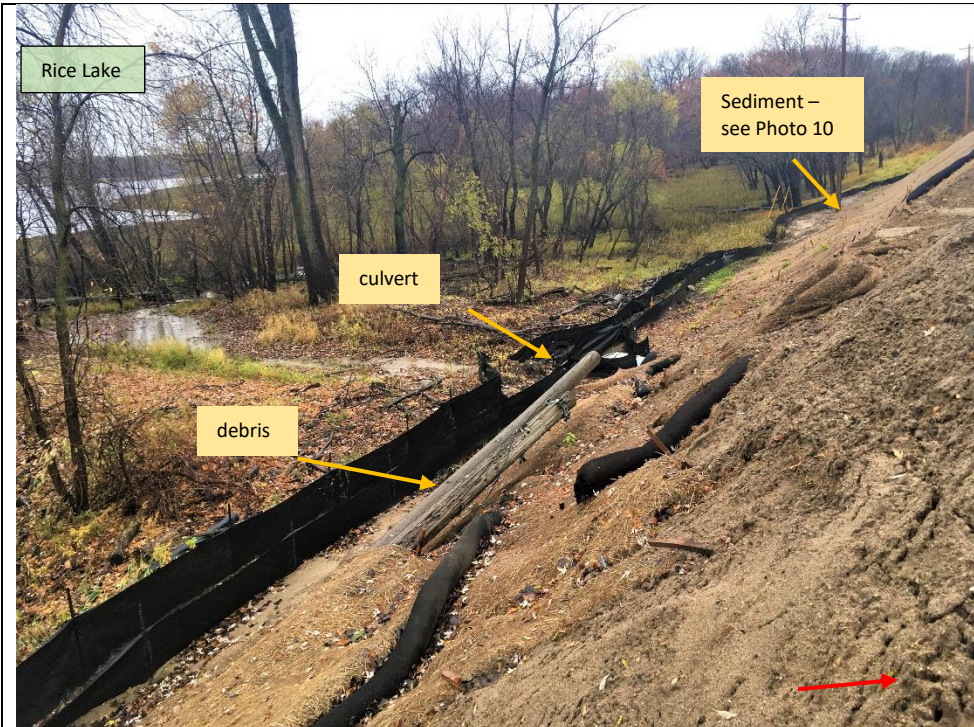
Photo No.: 12

Location: South side of Flying Cloud Drive. *Photos 8–15 in same general area of project.

BMPs Present: ESC blanket, biologs, two rows of silt fence.

Description: Downslope side to Photo 11. Also see Photo 13. Failure of upslope BMPs with misc. debris on slope. Unconfirmed, but probable, sediment in culvert.

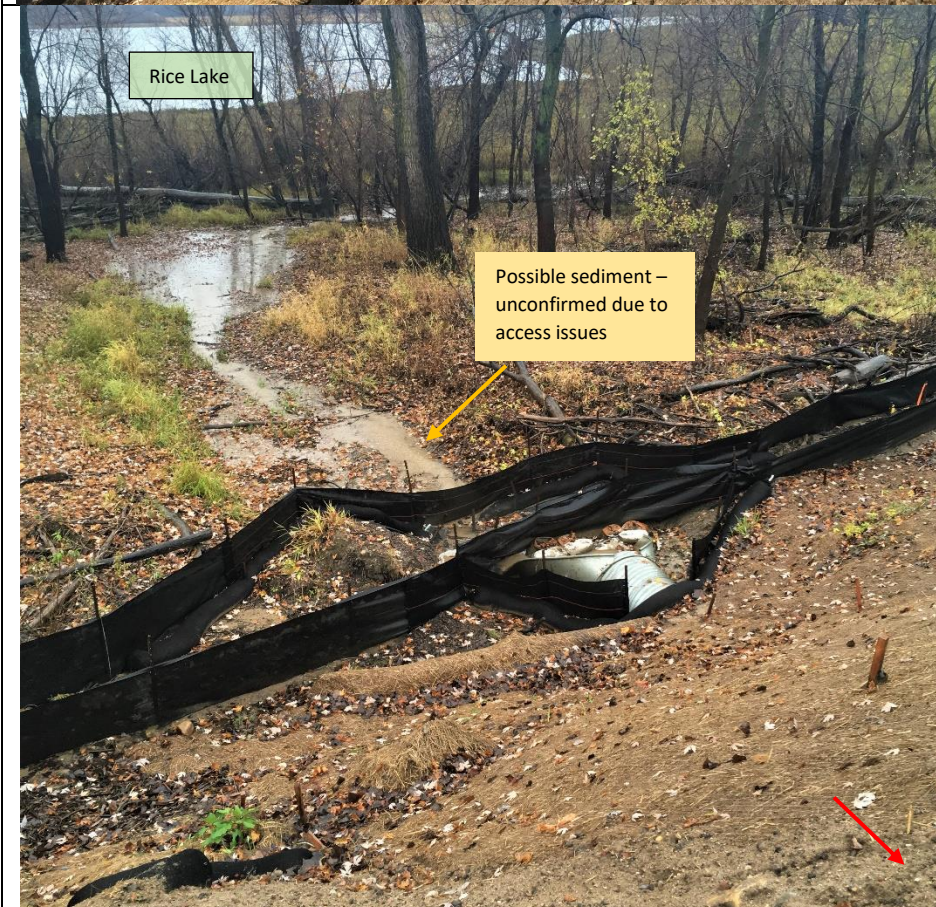
Photo No.: 13

Location: South side of Flying Cloud Drive. *Photos 8–15 in same general area of project.

Description: Downslope side to Photo 11. Also see Photo 12. Unconfirmed, but probable, sediment in culvert.

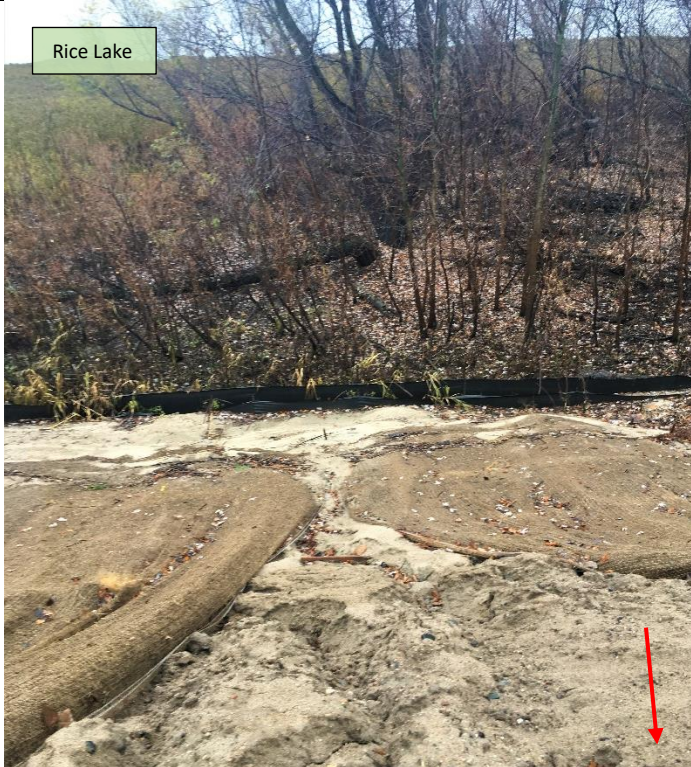
Photo No.: 14

Location: South side of Flying Cloud Drive. *Photos 8–15 in same general area of project.

BMPs Present: ESC fabric, two rows of silt fence.

Description: Major BMP fail with large sediment deposition overwhelming silt fence.

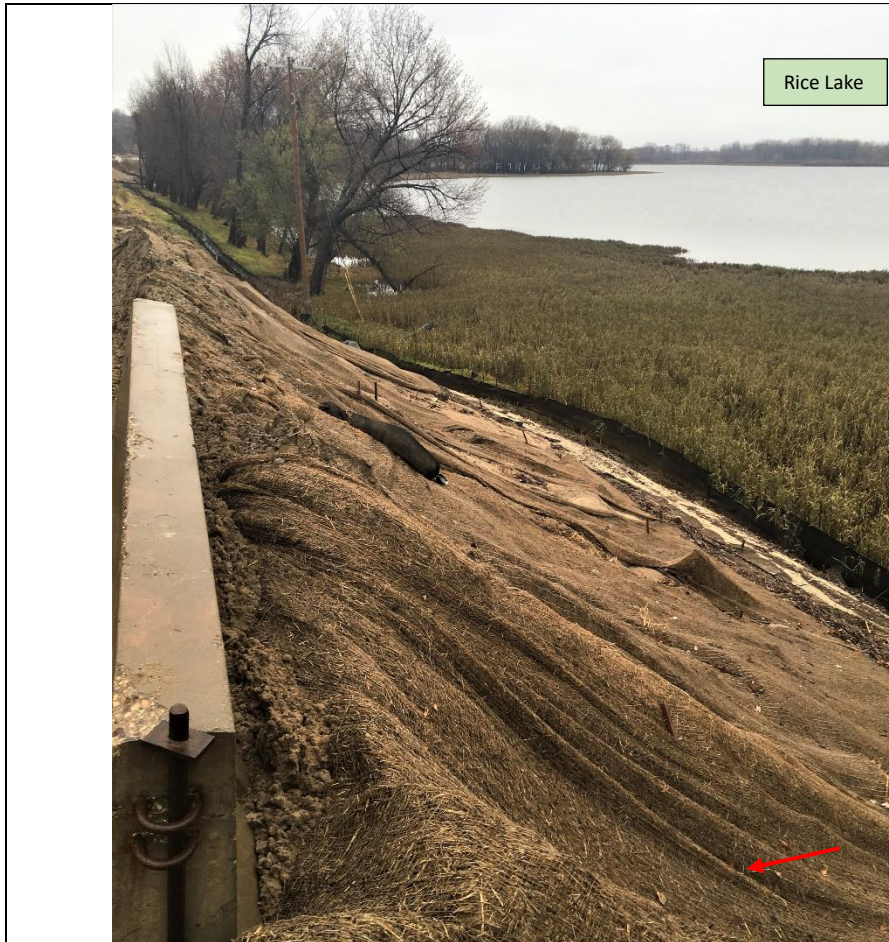
Photo No.: 15

Location: South side of Flying Cloud Drive. *Photos 8–15 in same general area of project.

BMPs Present: Jersey barriers, ESC blanket, biologs, two rows of silt fence.

Description: Major BMP fail with large sediment deposition at base of slope.

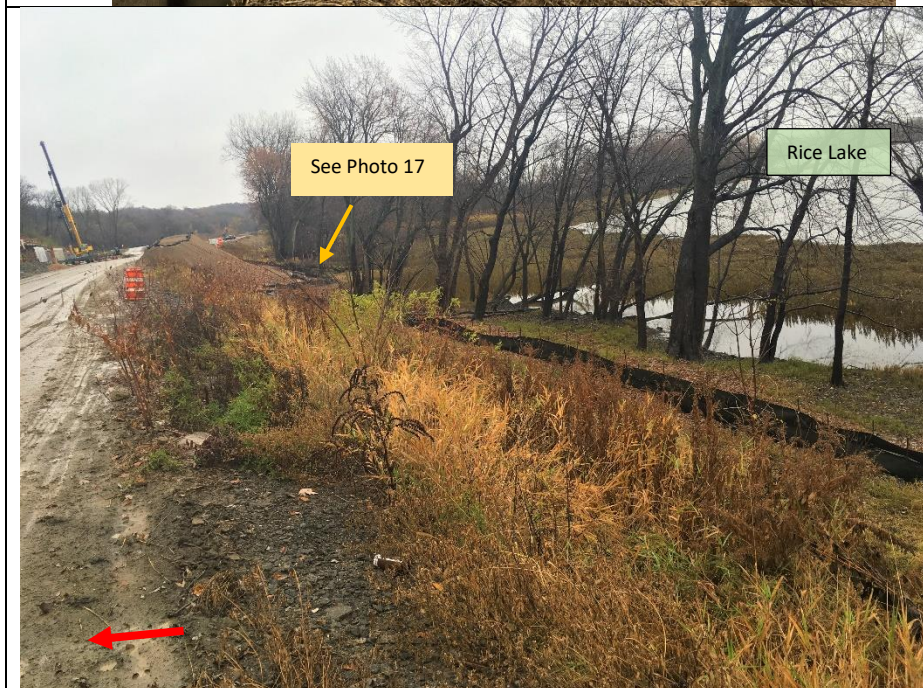
Photo No.: 16

Location: South side of Flying Cloud Drive.

BMPs Present: Two rows of silt fencing, vegetative buffer.

Description: BMPs along Rice Lake.

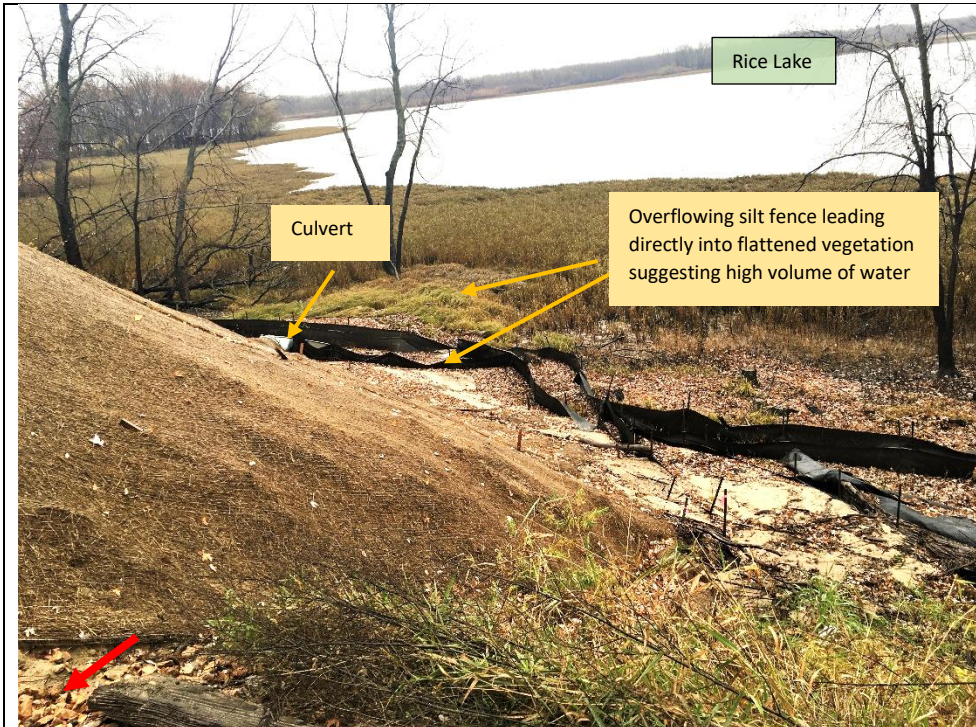
Photo No.: 17

Location: South side of Flying Cloud Drive.

BMPs Present: ESC blanket, two rows of silt fence.

Description: Failure of upslope BMPs contributed to large amounts of sediment deposition at base of slope. Possible sediment in Rice Lake. Not yet confirmed (access issues), but flattened vegetation and full silt fences suggest this is highly probable.

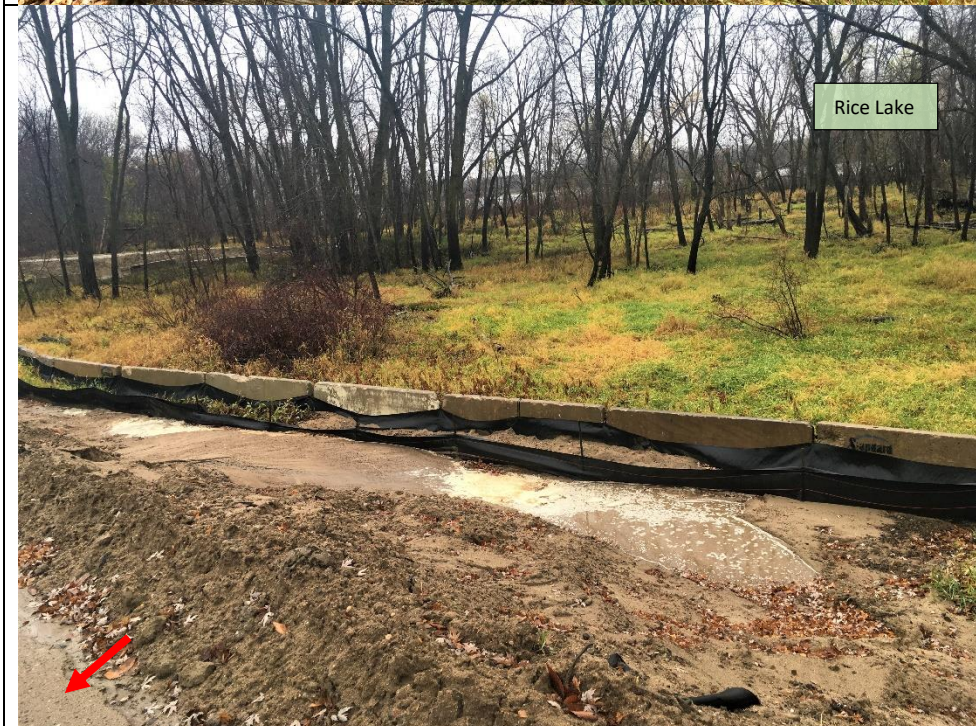
Photo No.: 18

Location: South side of Flying Cloud Drive.

BMPs Present: Two rows of silt fencing; one is supported with jersey barriers.

Description: BMP maintenance required to prevent off-site deposition.

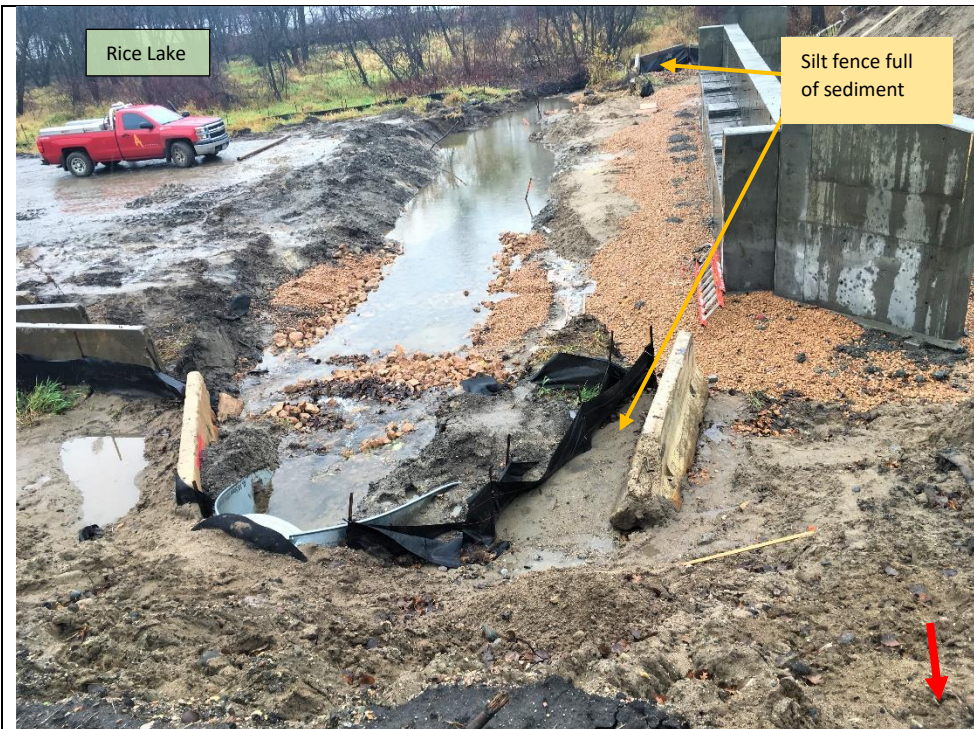
Photo No.: 19

Location: South side of Flying Cloud Drive, near bridge construction.

BMPs Present: Silt fencing with jersey barriers in some locations.

Description: It is unclear if this is a diversion of an existing channel. Installed BMPs are filled with sediment. See Photo 20 for upslope side of culvert.

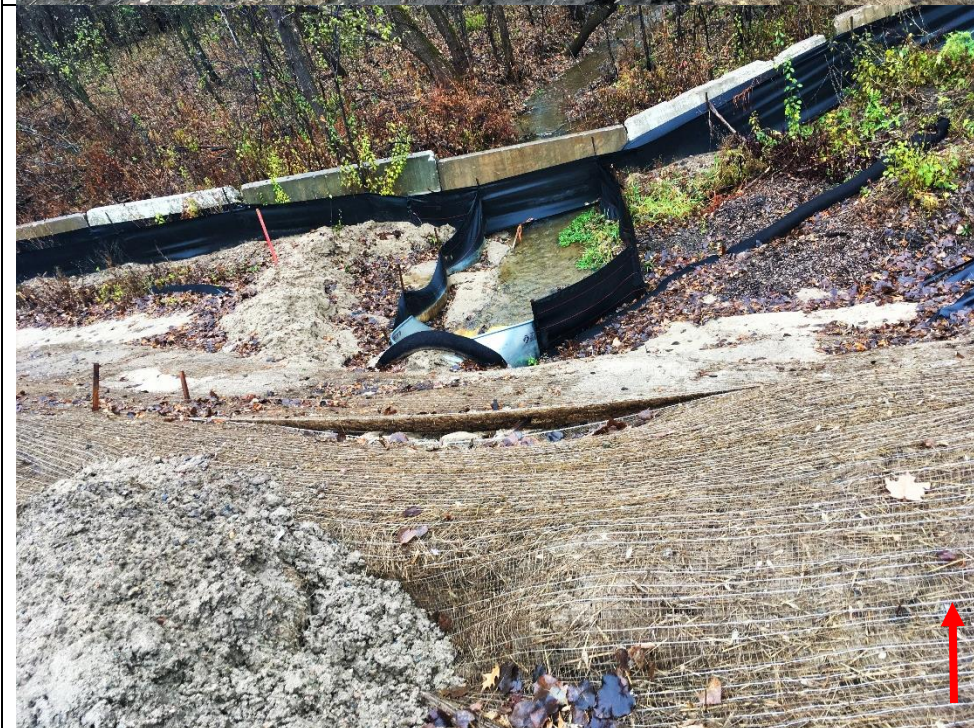
Photo No.: 20

Location: North side of Flying Cloud Drive, near bridge construction.

Description: Upstream (northern) side of culvert. See Photo 19 for downstream photo. ESC blanket is failing, with 0.5–1ft+ gaps between fabric and soil.

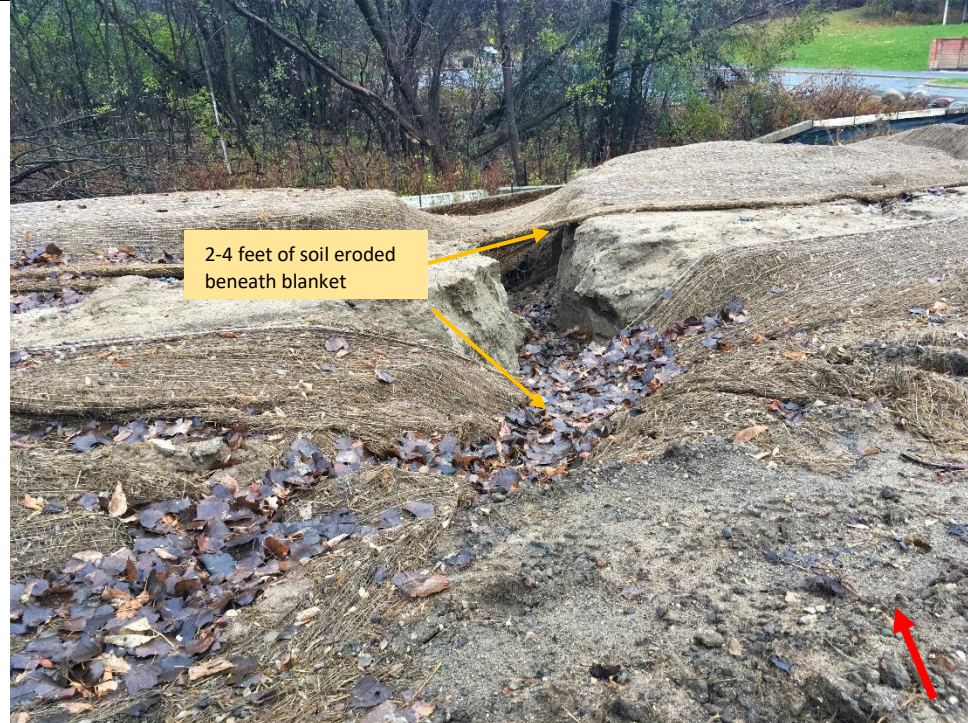
Photo No.: 22

Location: North side of Flying Cloud Drive.

BMPs Present: Silt fence with jersey barrier reinforcement and second row with metal rods, ESC blanket.

Description: BMP failures have permitted sediment to enter culvert. This culvert (north side of project), outlets on southern side of road into Rice Lake.

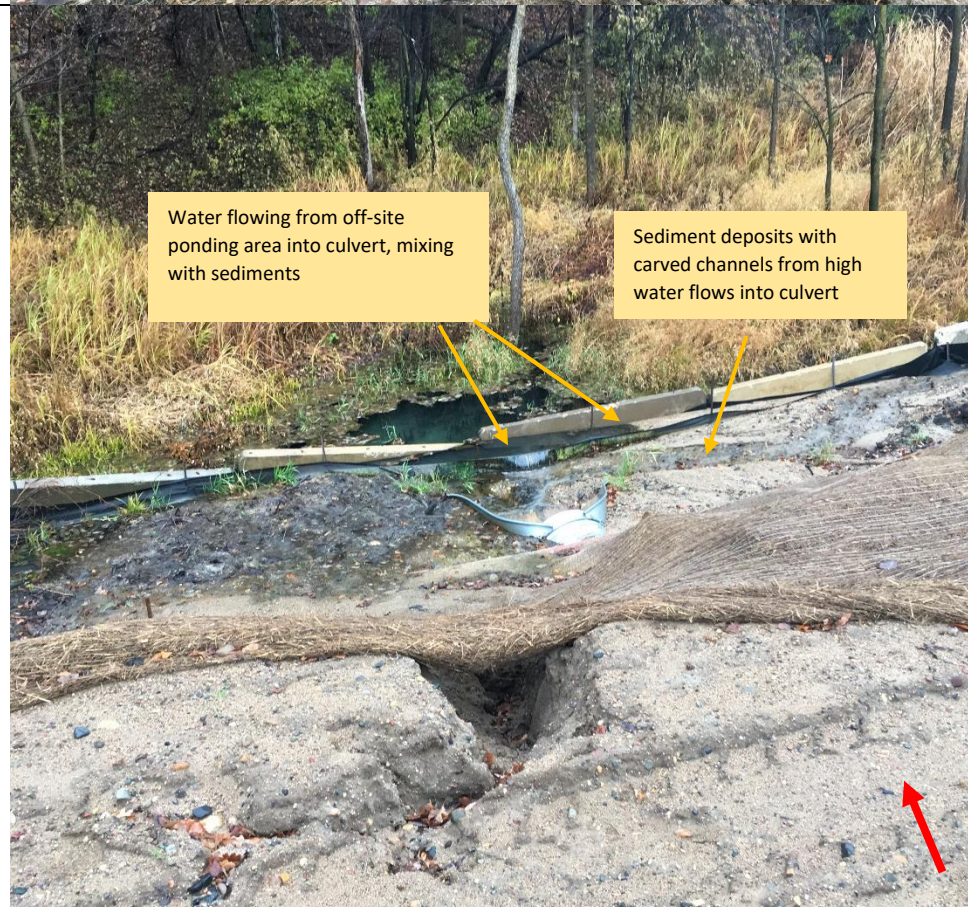
Photo No.: 23

Location: North side of Flying Cloud Drive.

BMPs Present: Silt fence with jersey barrier reinforcement and second row with metal rods, ESC blanket.

Description: Another angle of Photo 22 area.

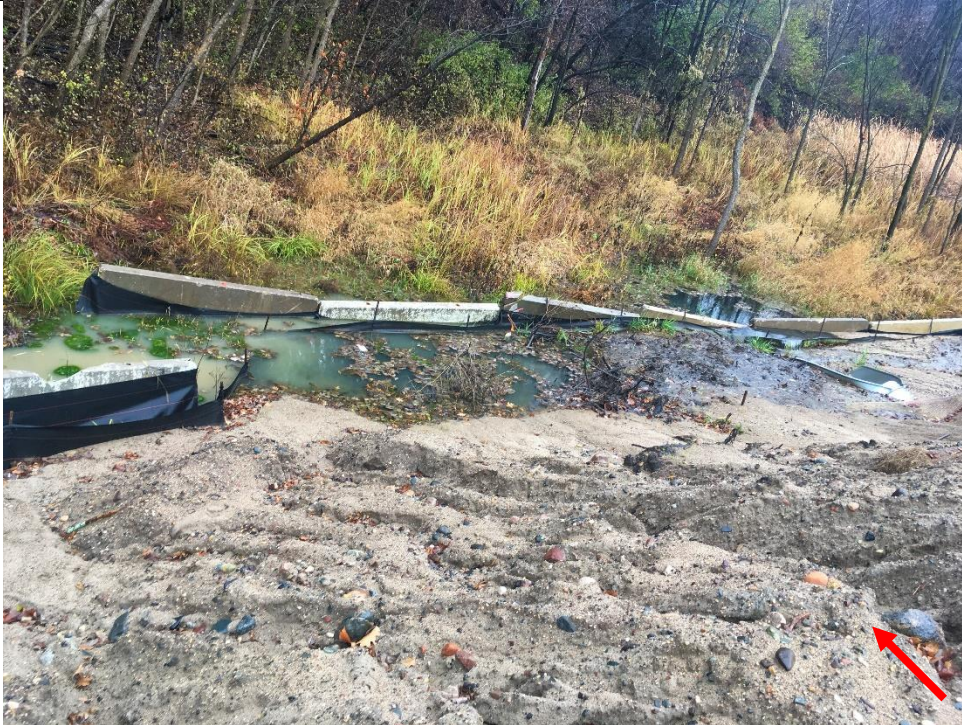
Photo No.: 24

Location: North side of Flying Cloud Drive.

BMPs Present: None evident.

Description: Retaining wall in progress. Note exposed soils above retaining wall and probable drainage pattern. See Photo 25.

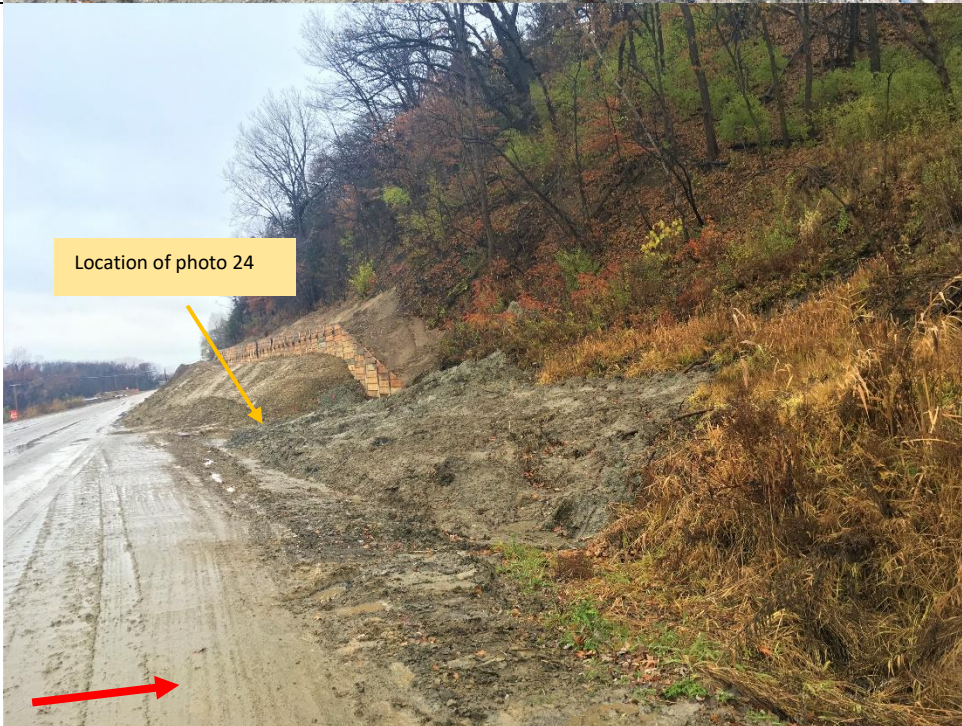
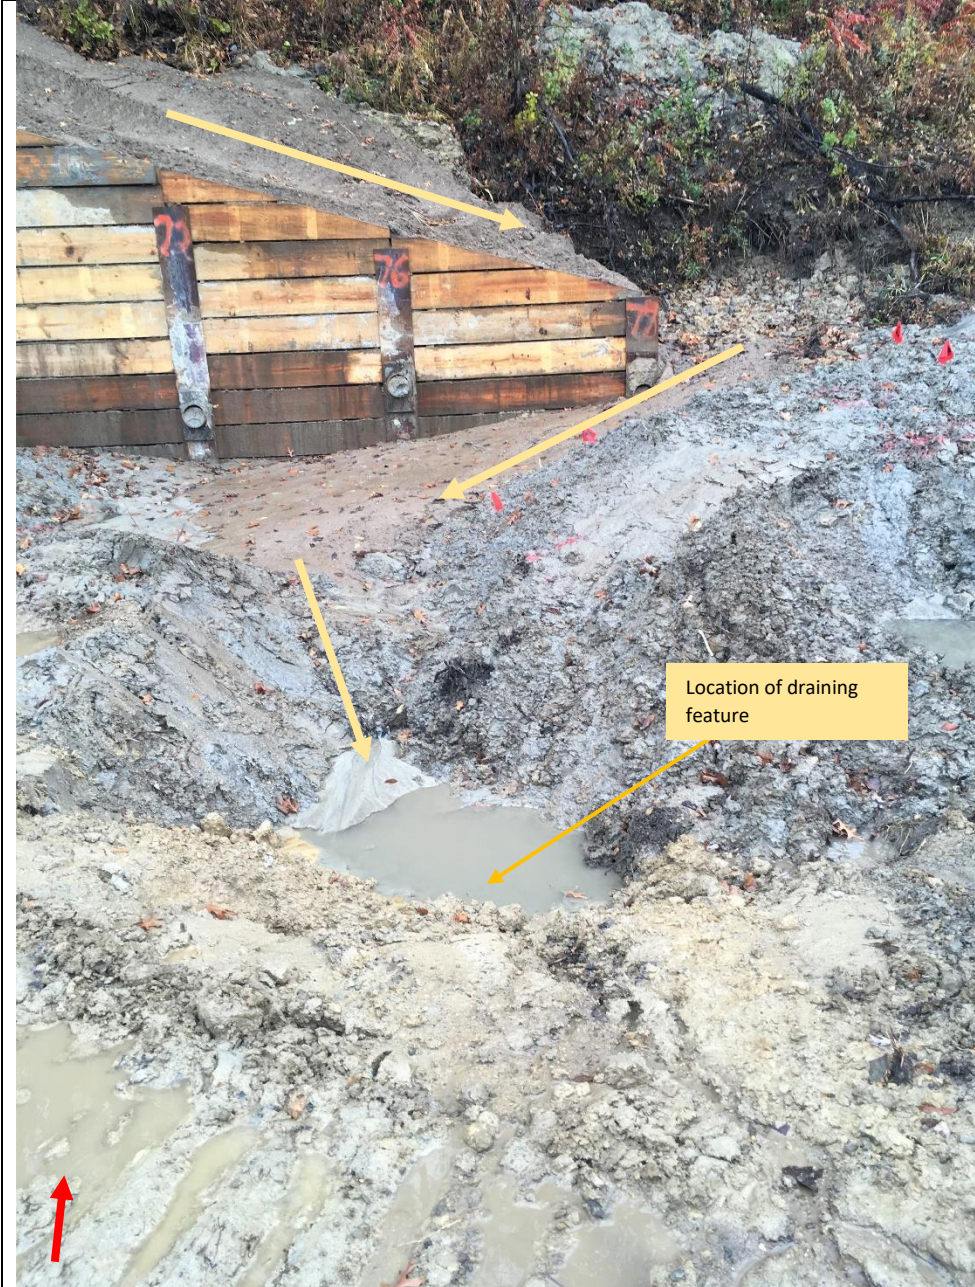
Photo No.: 25

Location: North side of Flying Cloud Drive.

BMPs Present: None.

Description: Sediments flow off retaining wall and into a pooling area (see pale yellow arrows). There is a drainage feature (culvert? pipe?) in this spot, but it is covered by water and sediment. There is no clear outlet.

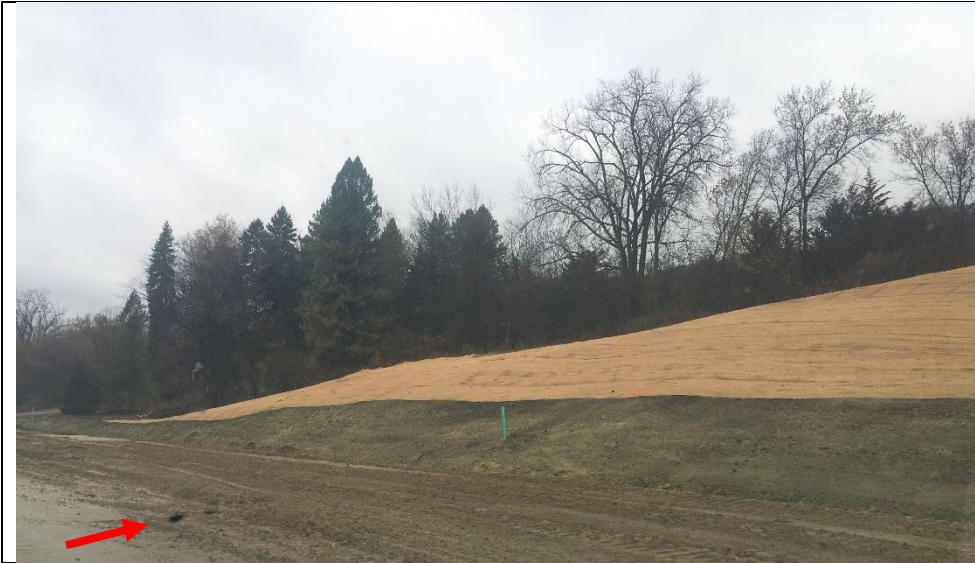
Photo No.: 26

Location: North side of Flying Cloud Drive, not too far from project construction trailer.

BMPs Present: Hydromulch and ESC blanket.

Description: BMPs installed. No indication of germination.

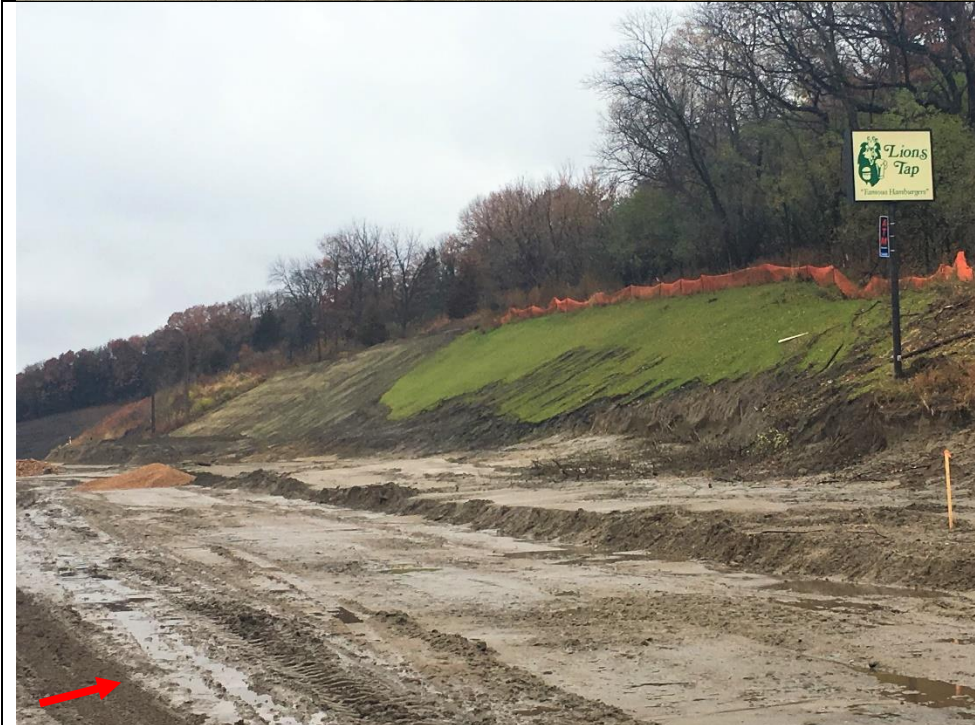
Photo No.: 27

Location: North side of Flying Cloud Drive, western end of project near Lion's Tap restaurant.

BMPs Present: Hydromulch and some vegetation.

Description: BMPs installed on upslope/northern edge of project.

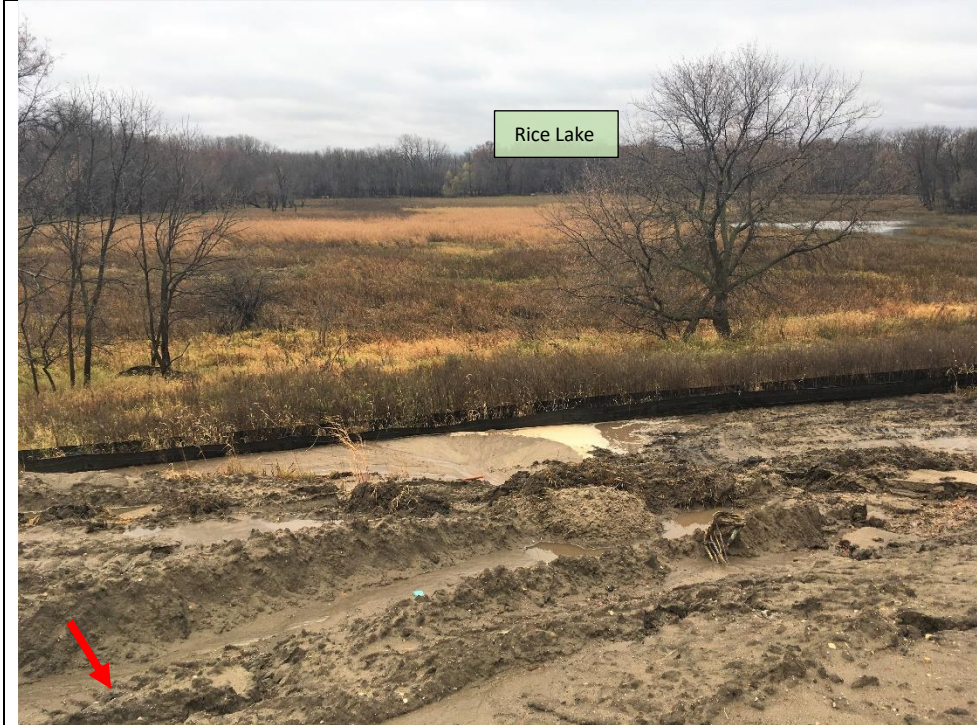
Photo No.: 28

Location: South side of Flying Cloud Drive, western end of project near Lion's Tap restaurant.
