**US Army Corps
of Engineers®**
St. Paul District

Wetland Mitigation Proposal Prospectus

PROJECT NAME Peterson Wetland Bank	Project Type <input checked="" type="checkbox"/> Wetland Bank <input type="checkbox"/> In Lieu Fee Site <input type="checkbox"/> Project Specific (PRM)
---	---

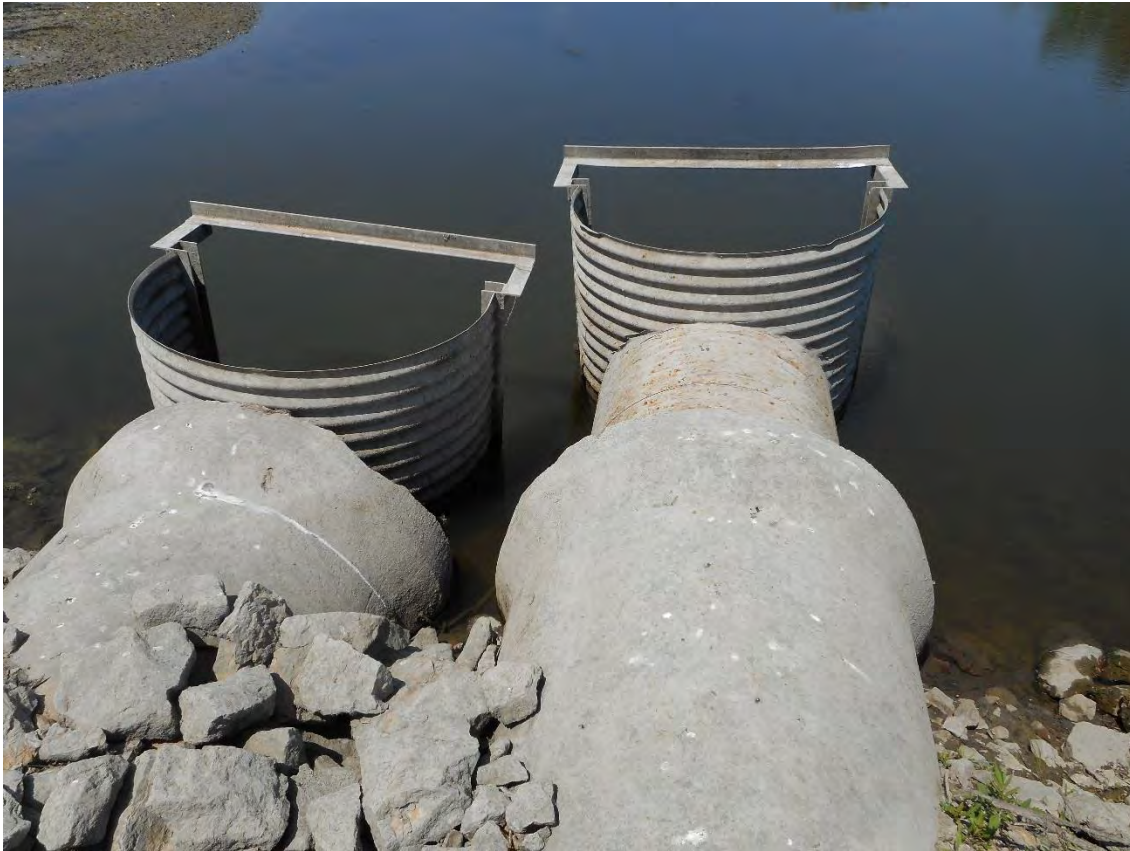
There are two 36" concrete pipes with stoplog weirs at the east end of Rice Lake which are the main control structures for that wetland complex (see photo below and Figure 11). The south pipe (left in the photo) has an invert elevation of 694.599' and the north pipe (right in the photo) has an invert elevation of 695.006'. Under an agreement with the U.S. Fish and Wildlife Service, the Petersons raise and lower the outlet elevation to manage the area for waterfowl and for farming. We suggest that the option to manipulate this outlet remain in place at least through the monitoring period of the wetland bank. This control could be extremely useful when the site is planted to have a better chance for optimal conditions for germination of tree seed and to have more control over potentially catastrophic flooding which could wipe out or set back seed or seedlings as they begin to emerge and are still vulnerable to flooding.

36-inch Concrete Outlet Pipes with Stoplog Weirs at East End of Rice Lake Looking Northwest (photo taken 7/17/17)

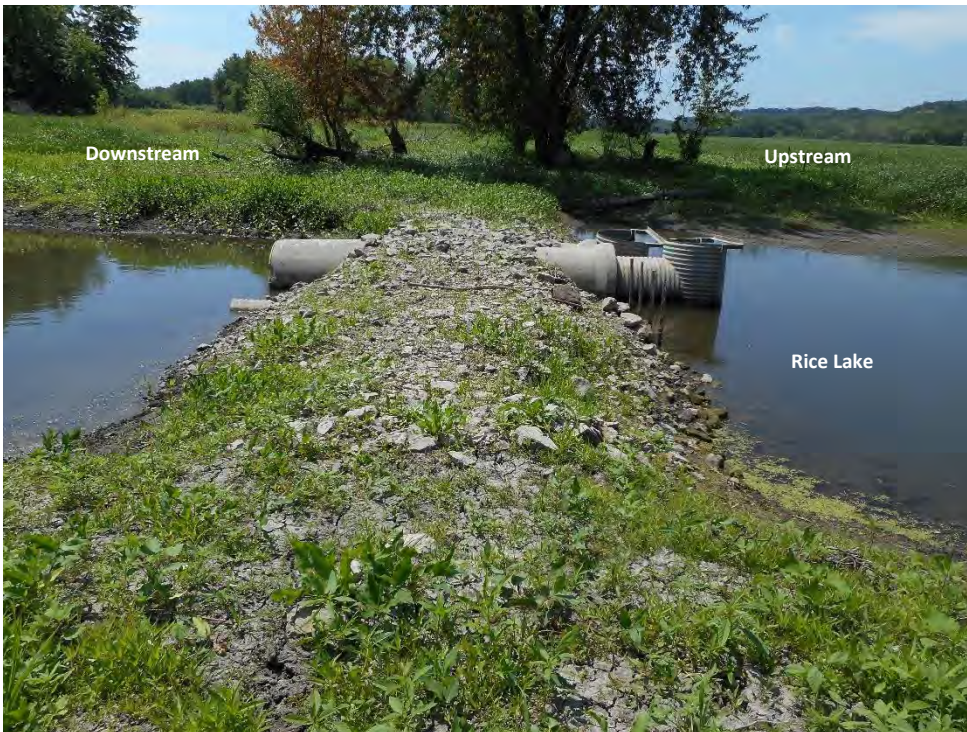
If all the stoplogs are in place and the 15" CMP flap is shut, the outlet of Rice Lake is controlled by the field road over the structures. The top of this road has been surveyed at 698.411'. Below is a photo of the field road that crosses over the pipes.

Field Road Over Outlet Pipes at Rice Lake Outlet Looking South (photo taken 7/17/17)

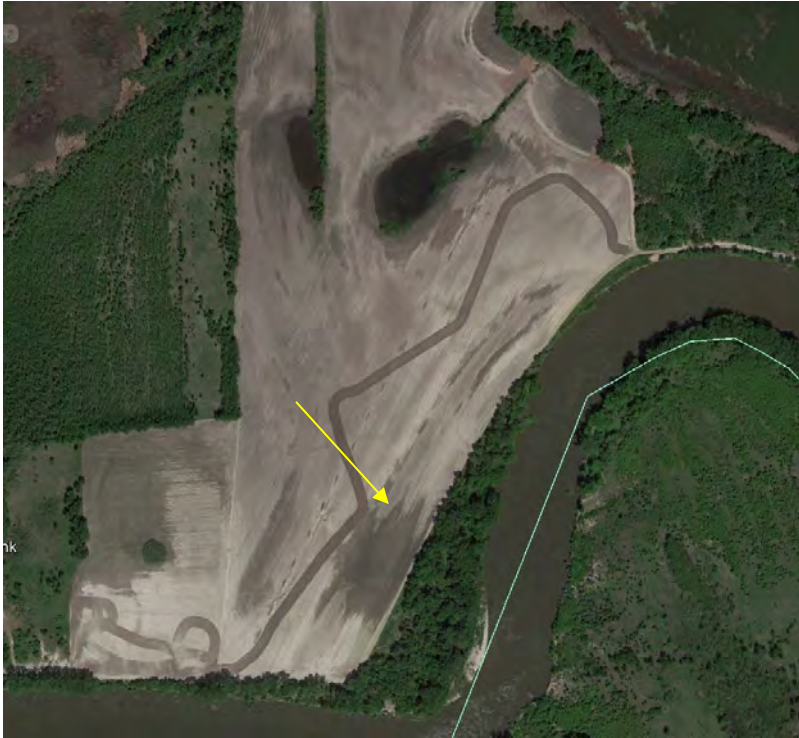
Example of Low Area on the Site Being Mimicked Through the Restoration Plan

This area is currently farmed and is proposed as part of the mosaic zone. On several of the historic aerial photographs in Appendix B, low areas that may have been the old river channel can be seen in a parallel orientation with the river (see 1951, 2006, 2010, 2017) in this area. Similar depressional areas exist in wooded areas of the floodplain in this vicinity; however, they are difficult to detect in aerial photography due to tree cover.

The project is a wetland restoration in two different ways. As mentioned earlier, the wetland boundary has yet to be determined but it is apparent that some portion of the northern part of the site that is commonly farmed is wetland. These areas would be fully restored through the hydrologic restoration techniques described earlier (disabling of ditches). The other way in which wetland would be restored involves the portions of the site that are being farmed between the 704' and 706' contours that would be deepened to create a mosaic of wetland and upland. The wetland areas in this zone are considered a restoration of what was likely to have been present on the site before agricultural practices eliminated them. The best evidence for such areas is on the site in the southeastern part of the wetland bank that is close to the river (see below).

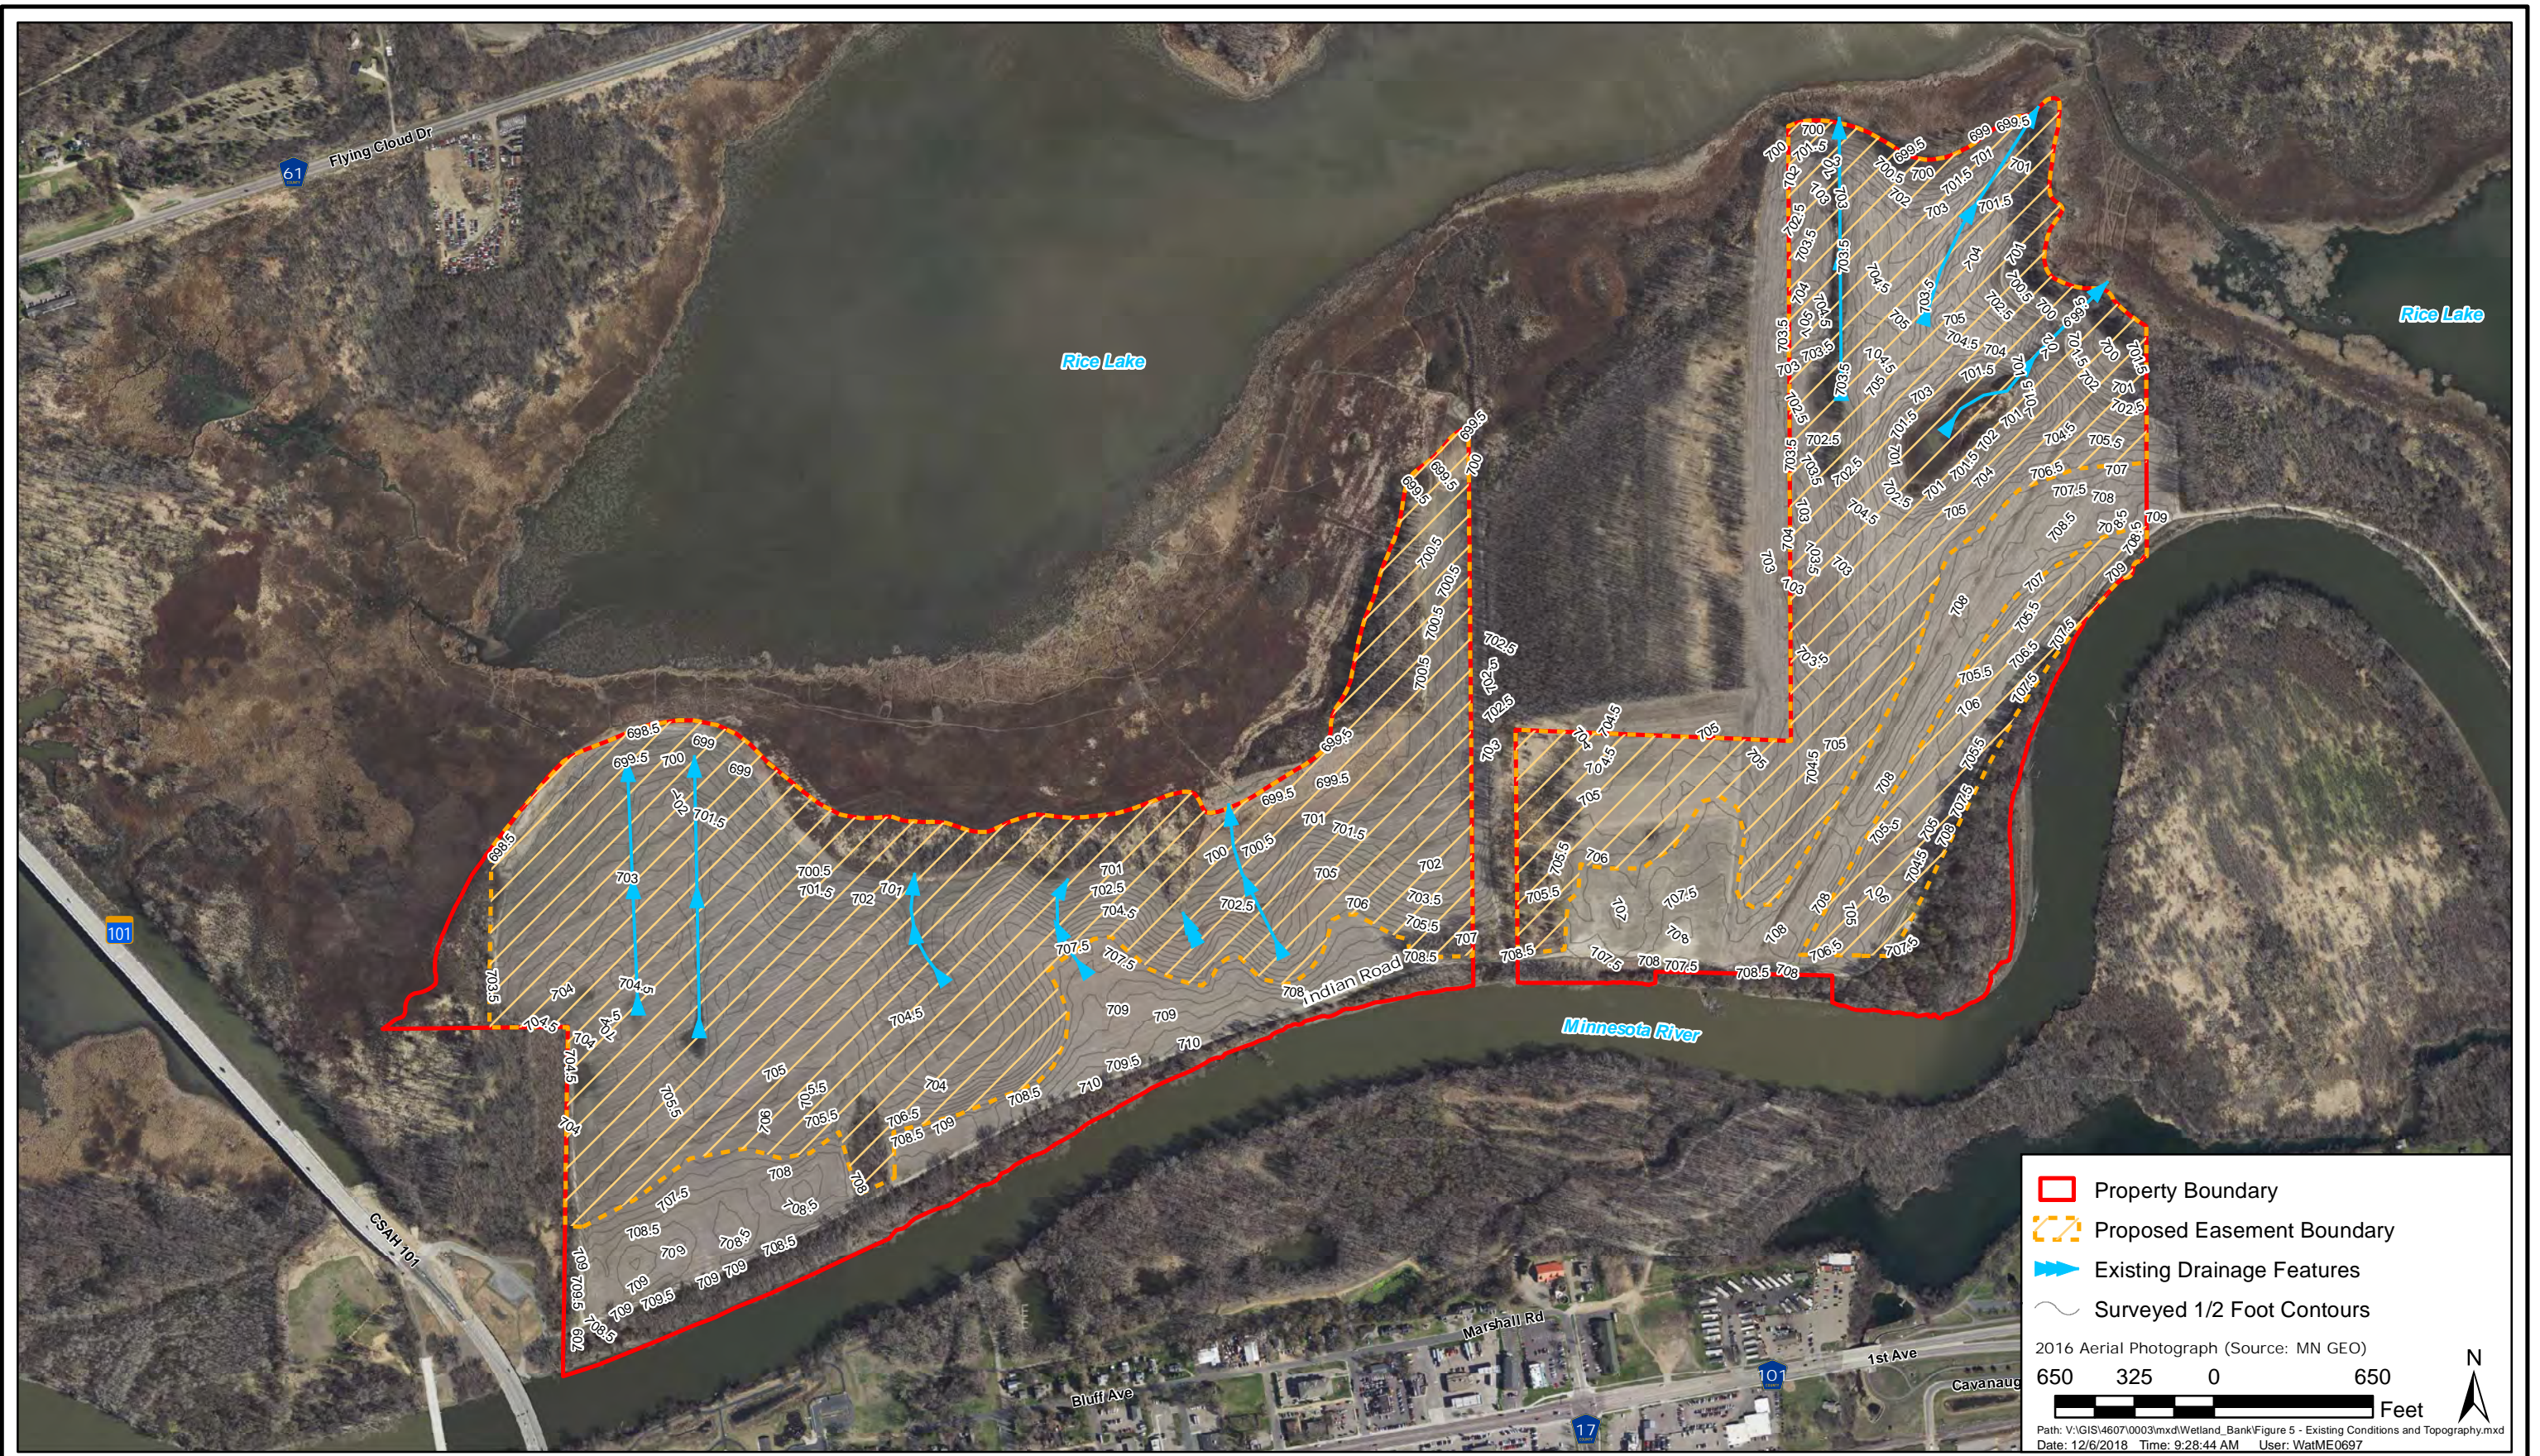
Figure 4

Property Boundary
 Proposed Easement Boundary
▶ Existing Drainage Features
~ Surveyed 1/2 Foot Contours

Existing Conditions and Site Topography

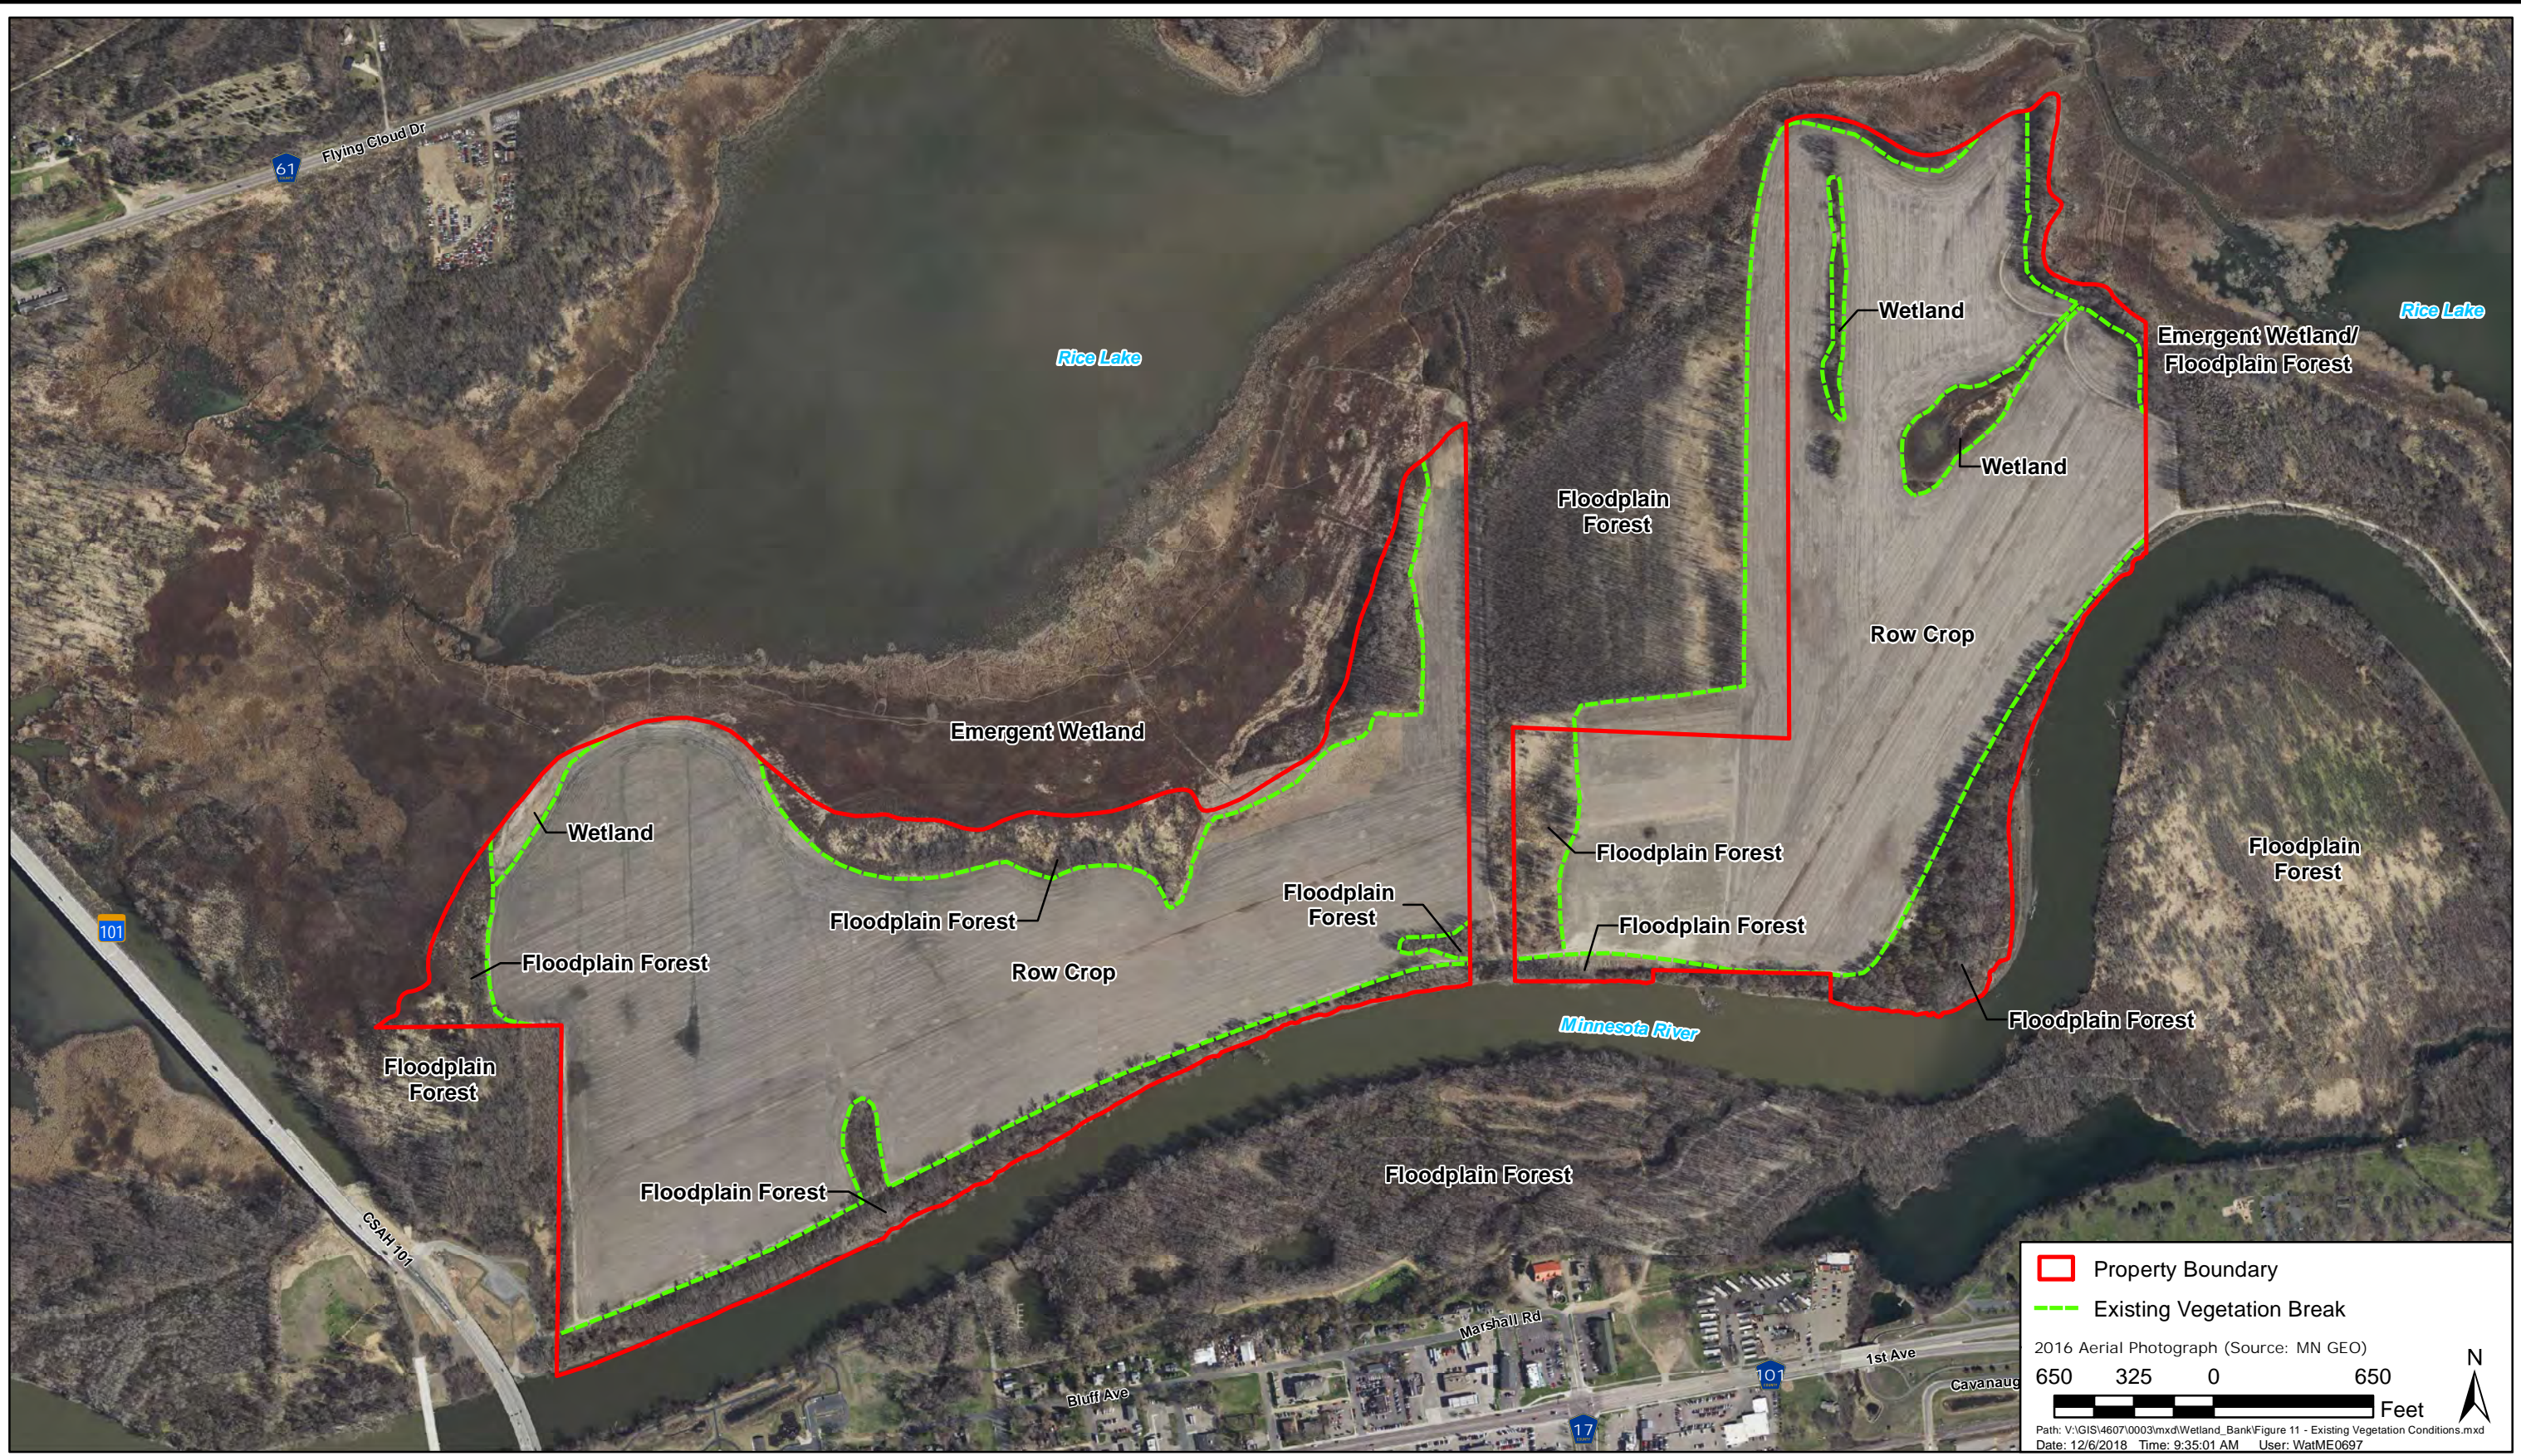
DEC 2018
Figure 5

SEVER PETERSON
Existing Vegetation Conditions

Most of the proposed site is currently row-cropped as it has been for several decades. Indian Road is a two-track field road that runs along the southern boundary of the site, immediately north of the Minnesota River. Public land is present to the west and east of the site (USFWS). The Rice Lake wetland complex is immediately north of the site and the Minnesota River is to the south. Existing conditions and site topography (1/2-ft. contours as surveyed by Wenck) are shown in Figure 4 and existing vegetative conditions are depicted in Figure 5. Existing Property Ownership is depicted in Figure 6.

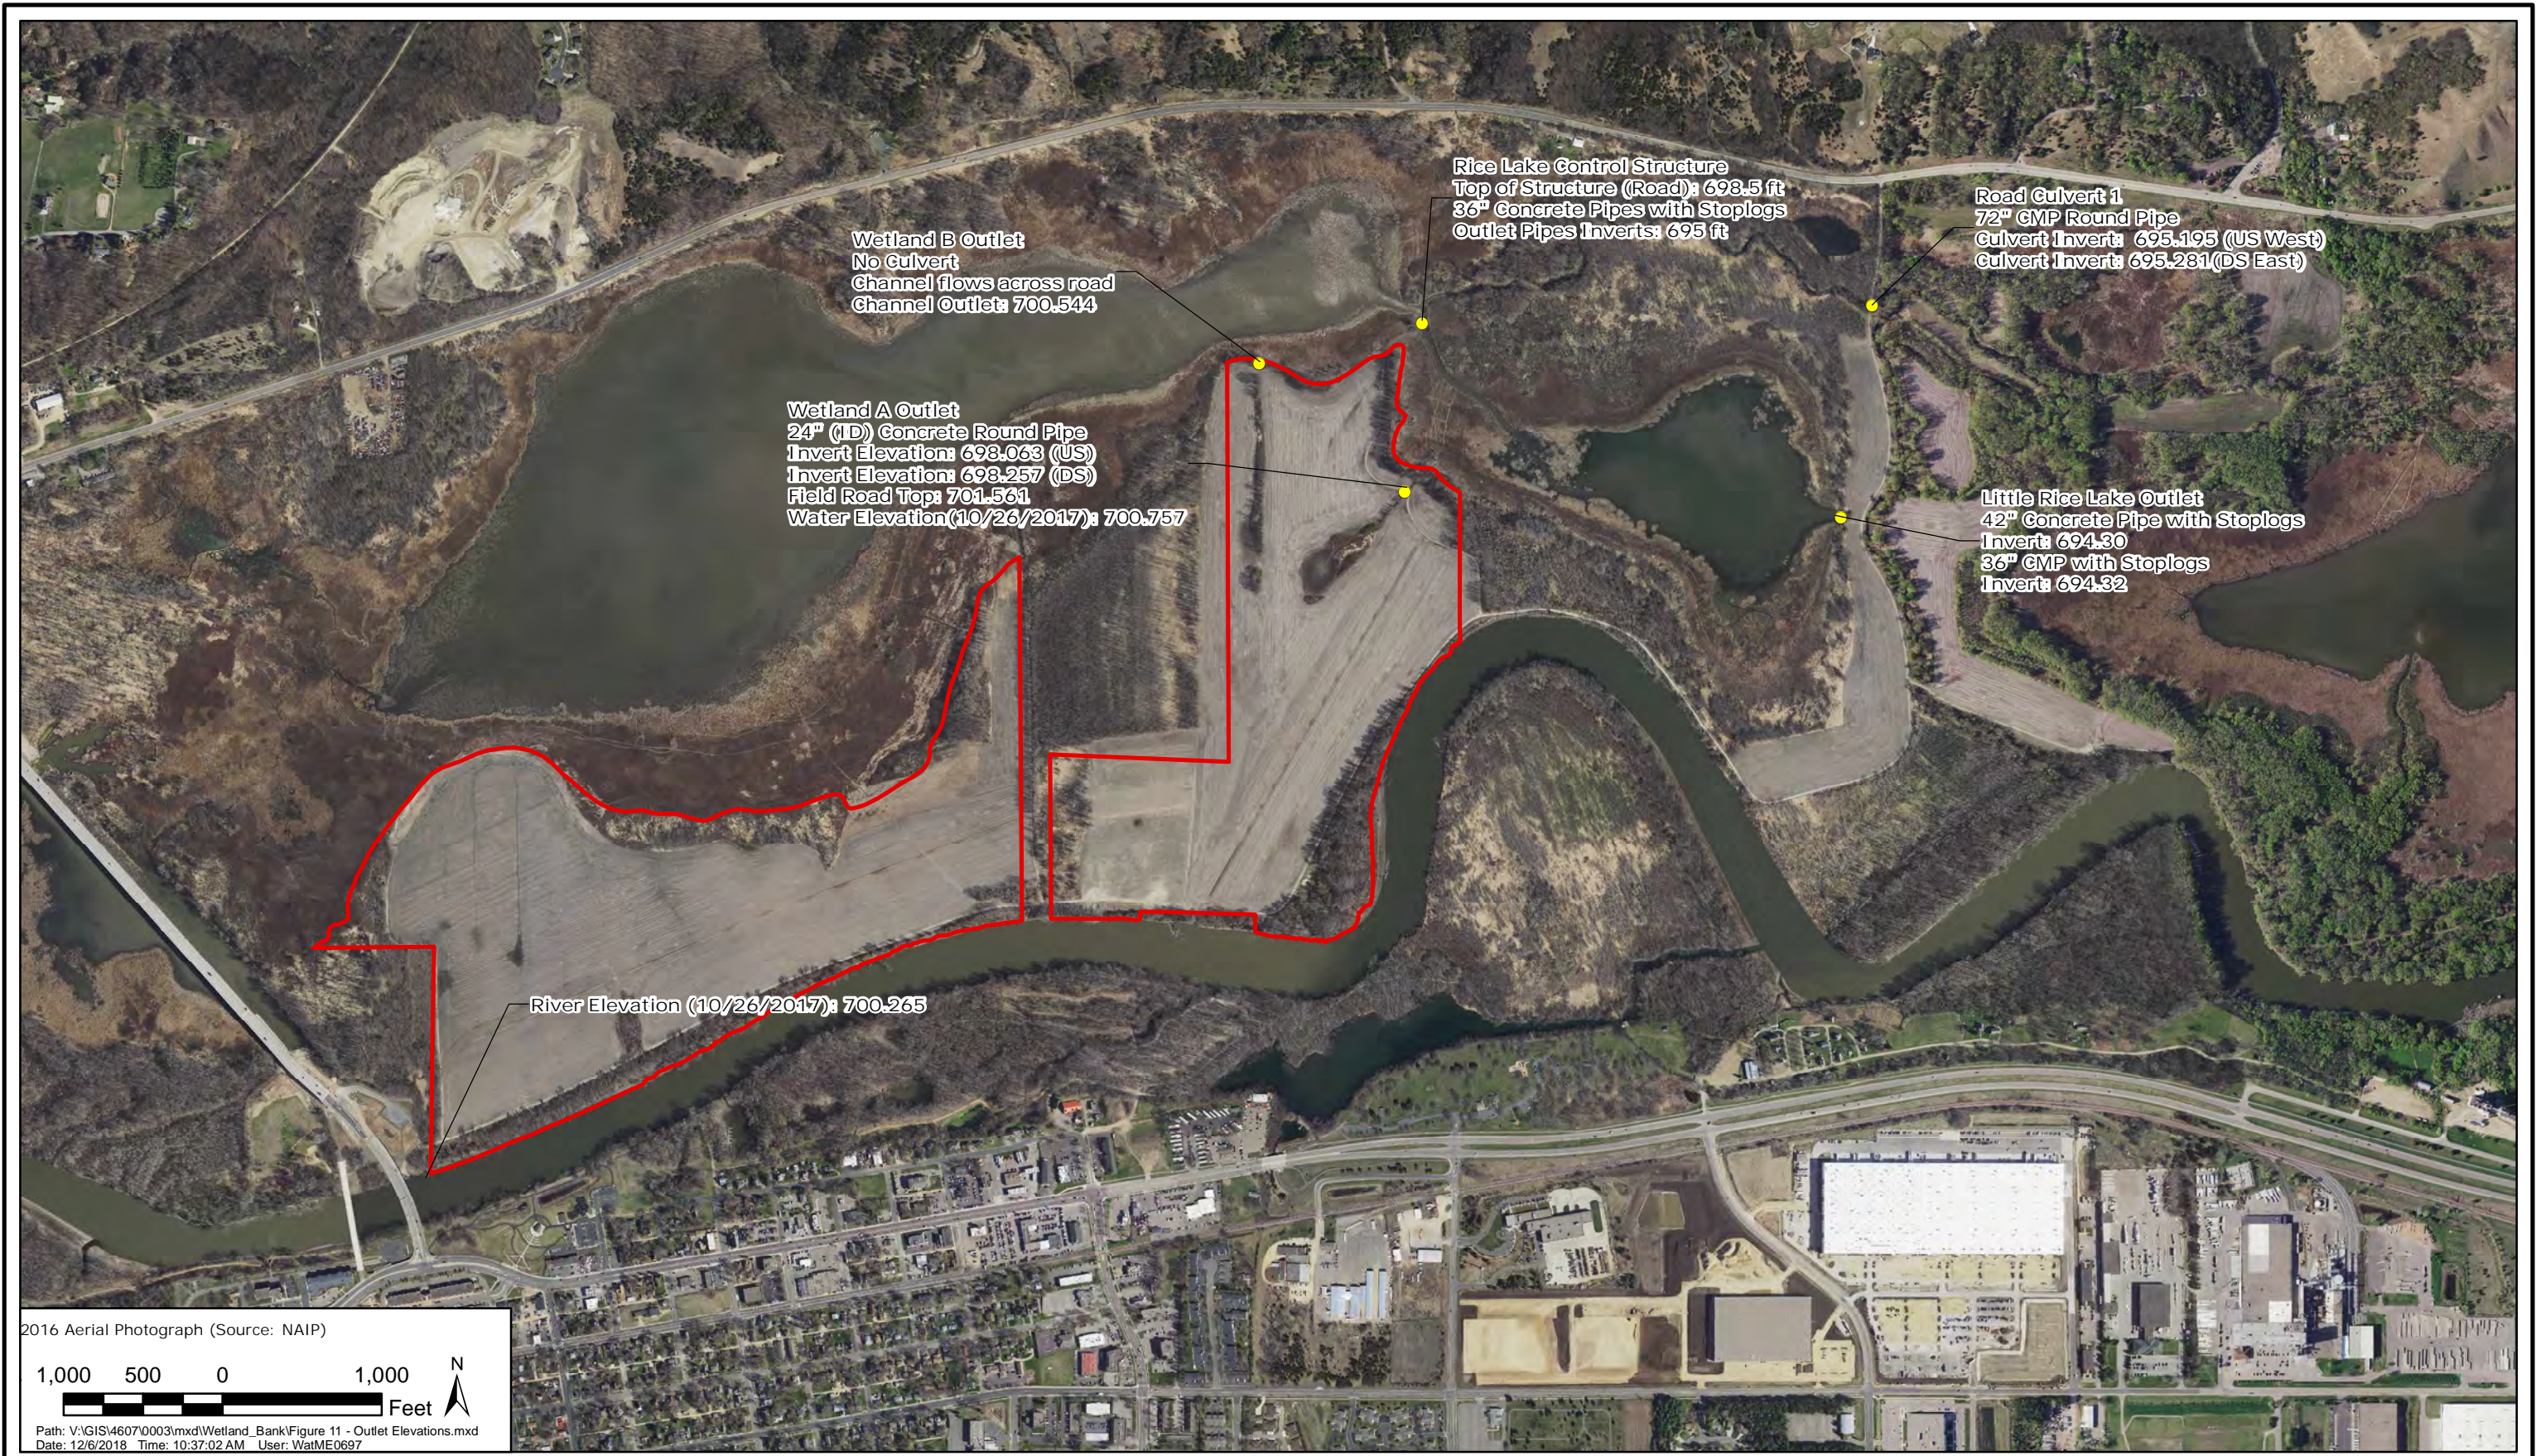
Figure 11

Outlet Survey Information (October 26 & November 20, 2017)

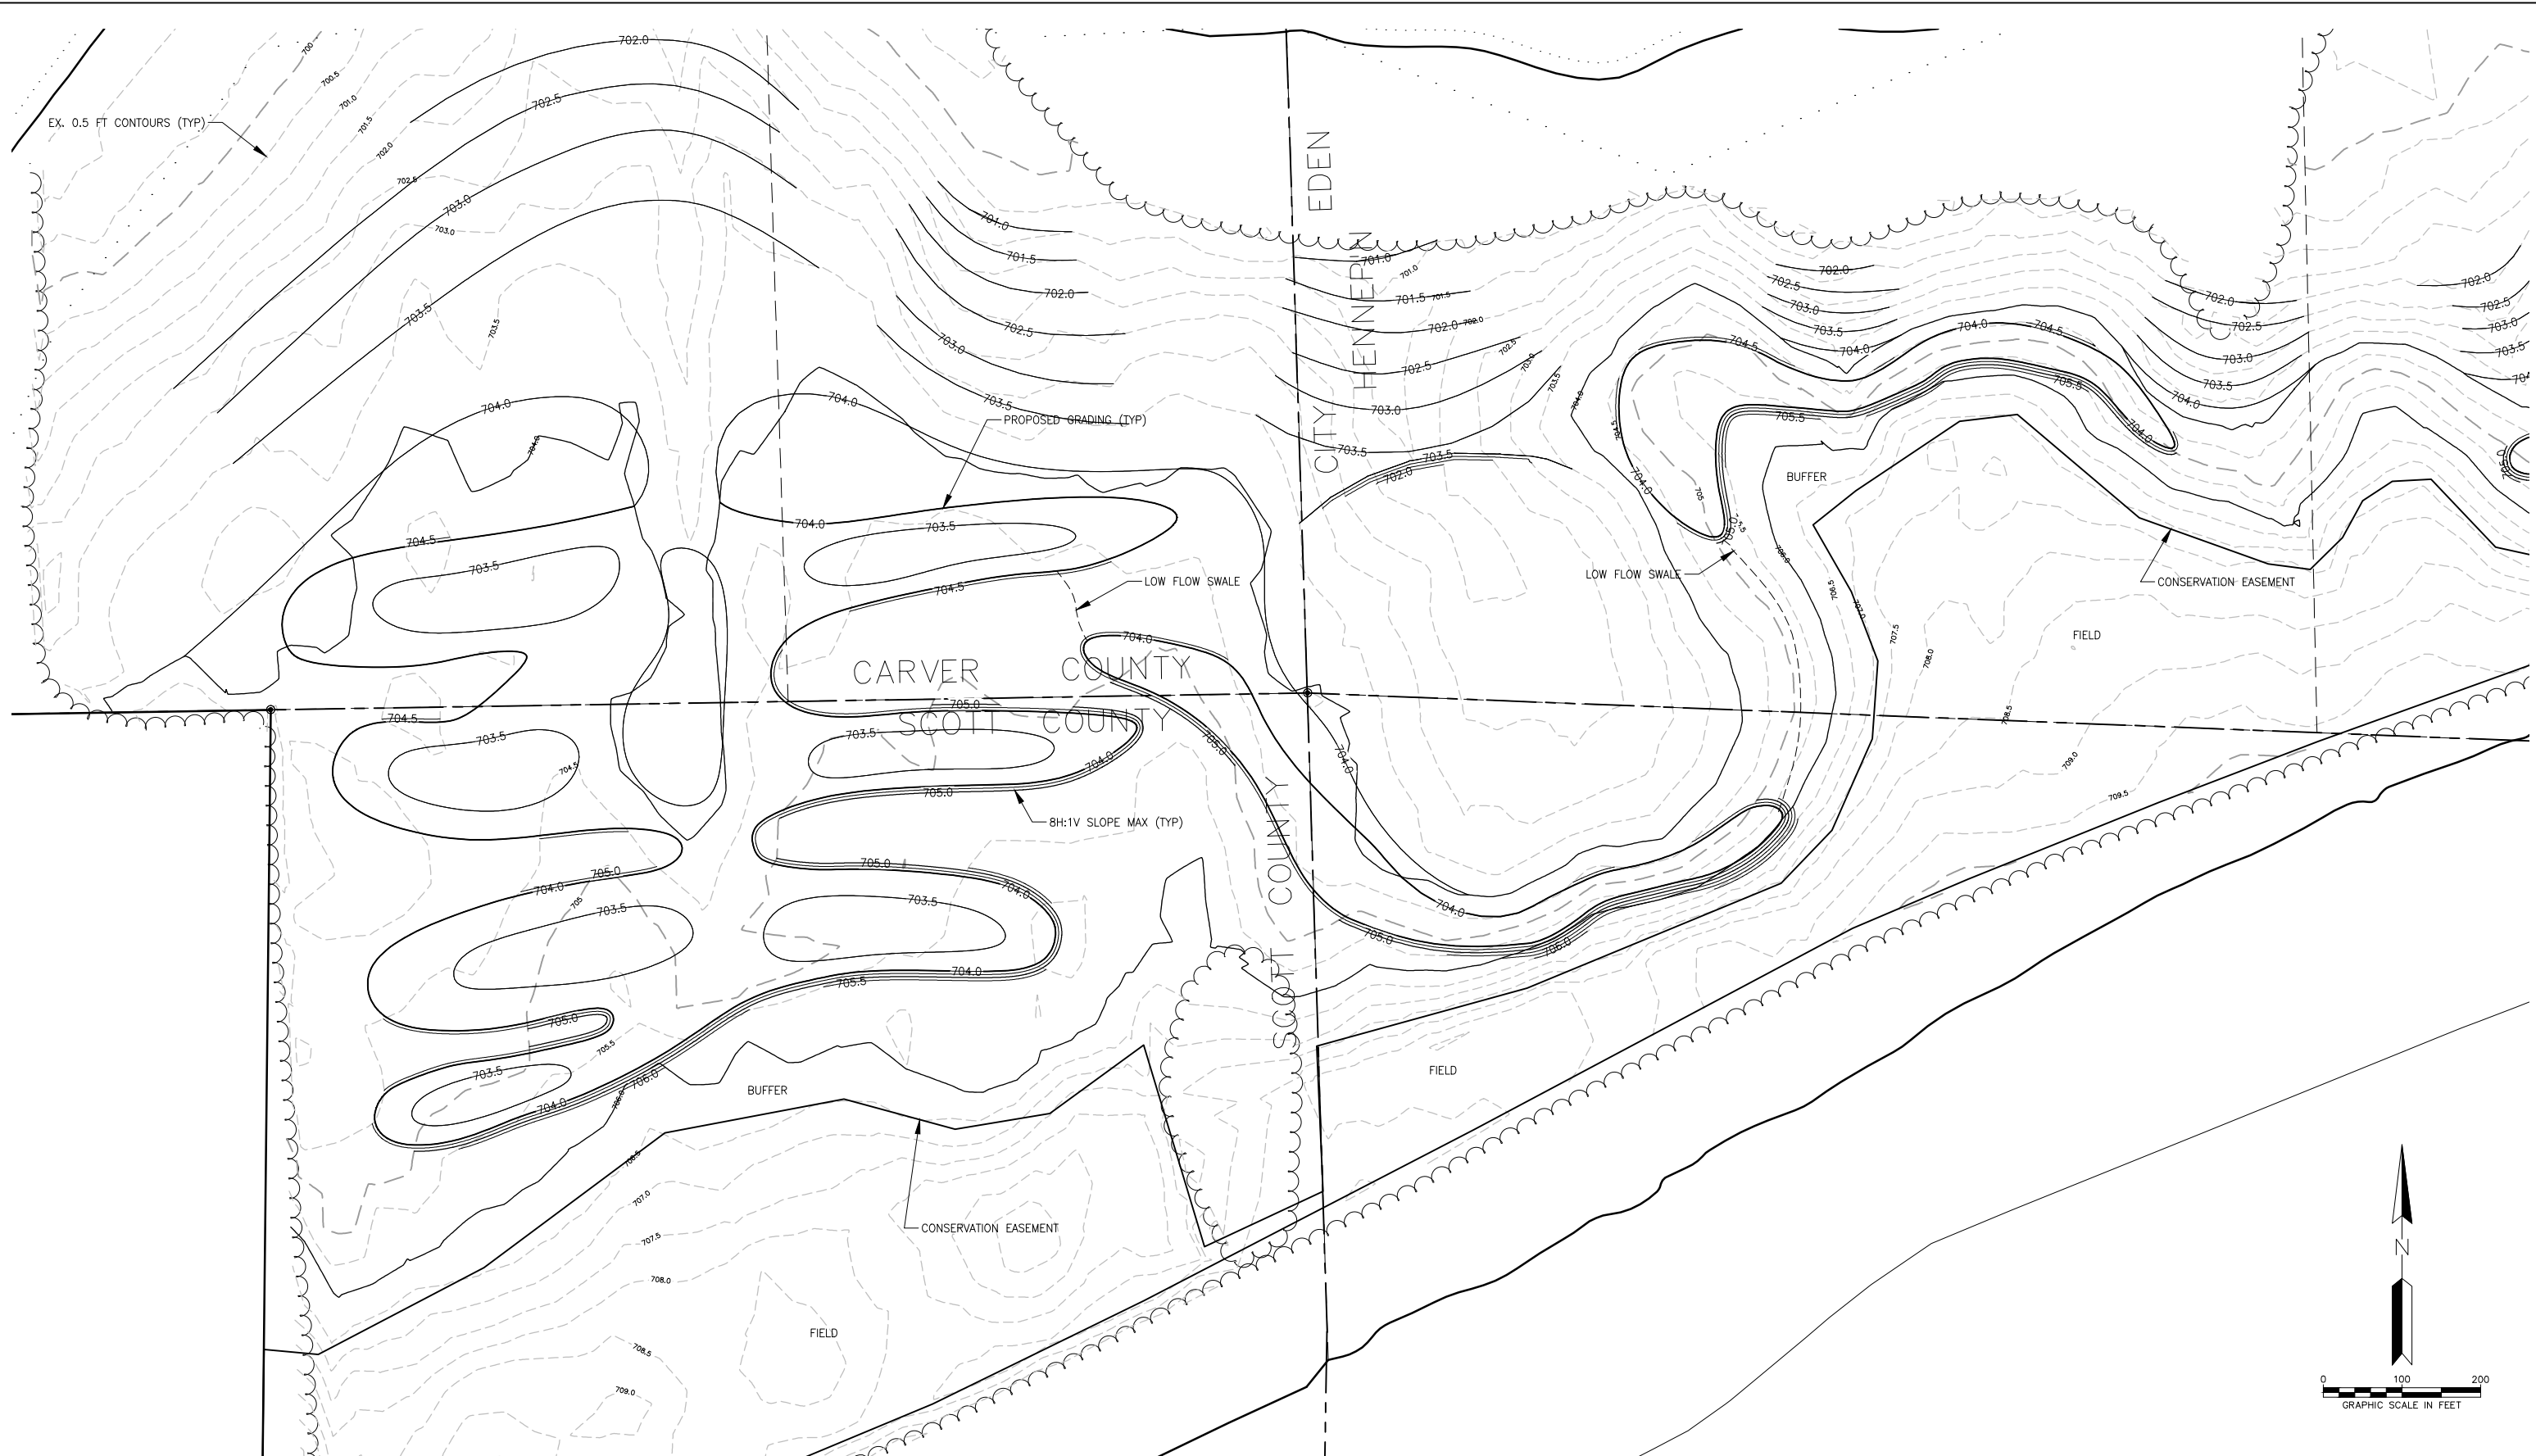
SHEET TITLE ENLARGED GRADING AND DRAINAGE PLAN				
DWN BY XXX	CHK'D XXX	APP'D XXX	DWG DATE NOV 2018	SCALE AS SHOWN
PROJECT NO. 4607-0003	SHEET NO. C-302	REV NO. 0

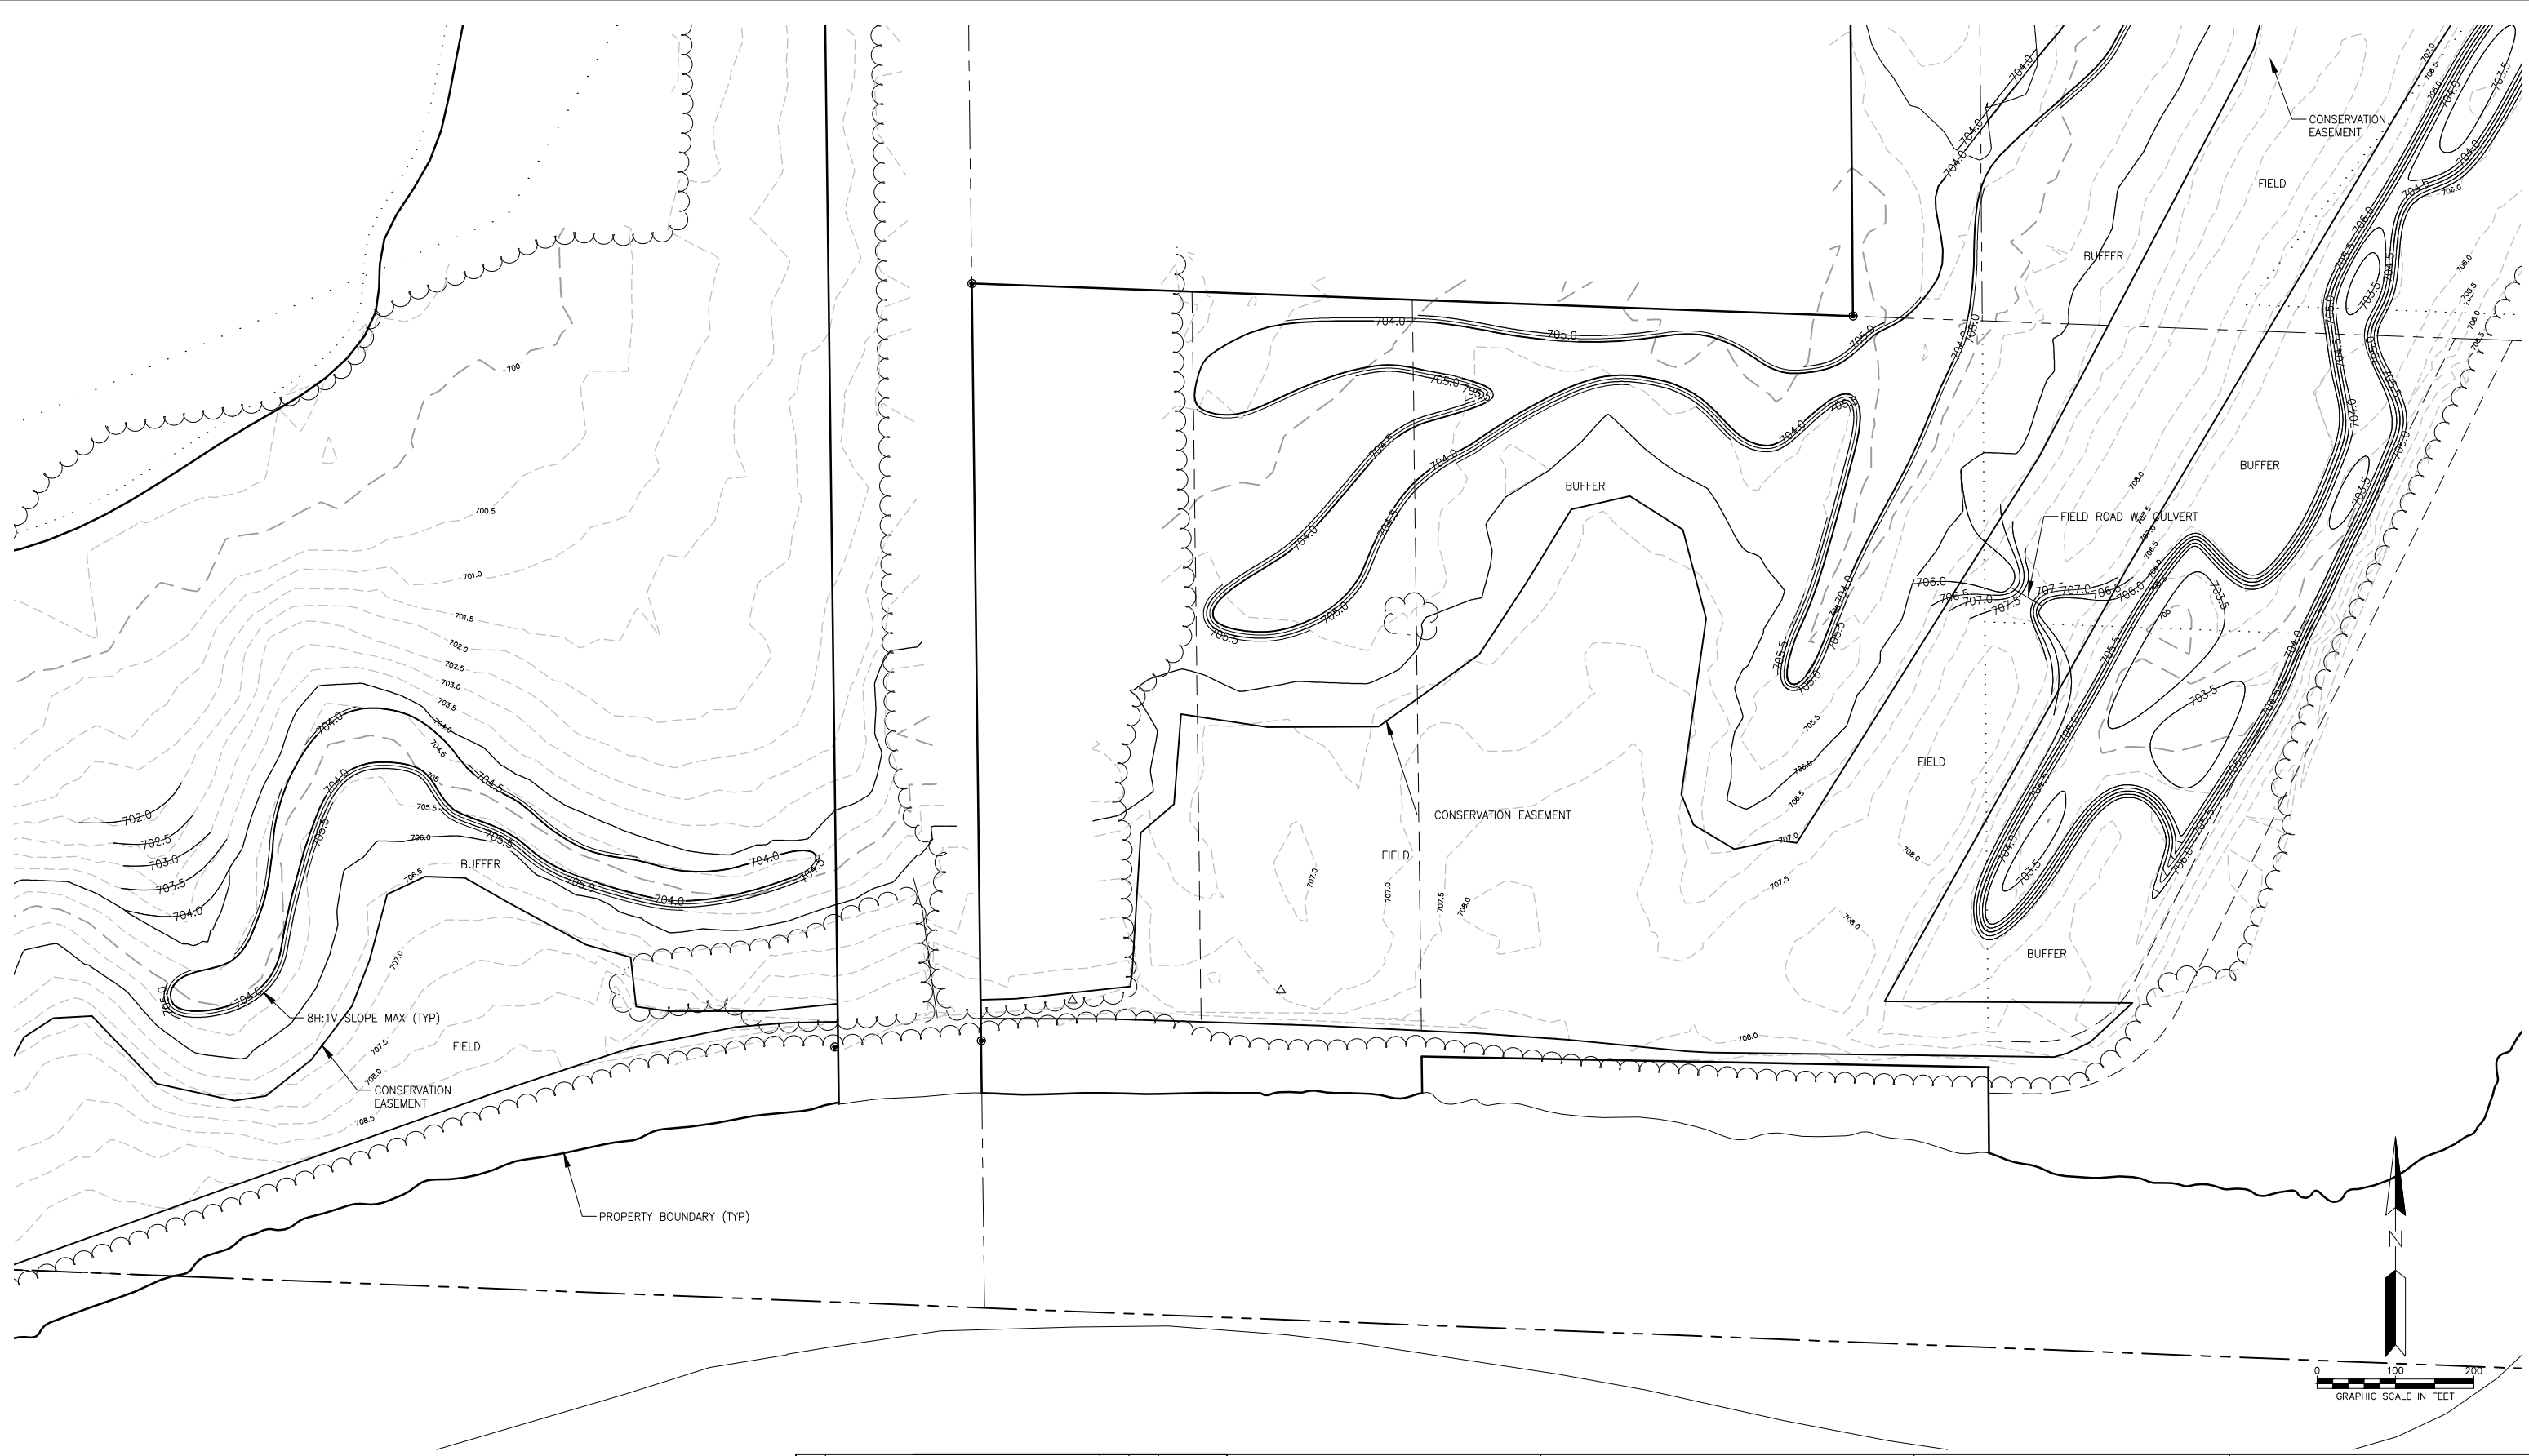
SHEET TITLE ENLARGED GRADING AND DRAINAGE PLAN			
DWN BY XXX	CHK'D XXX	APP'D XXX	DWG DATE NOV 2018
PROJECT NO. 4607-0003	SHEET NO. C-303	SCALE AS SHOWN	REV NO. 0
