**US Army Corps
of Engineers®**
St. Paul District

Wetland Mitigation Proposal Prospectus

PROJECT NAME Peterson Wetland Bank	Project Type <input checked="" type="checkbox"/> Wetland Bank <input type="checkbox"/> In Lieu Fee Site <input type="checkbox"/> Project Specific (PRM)
---	---

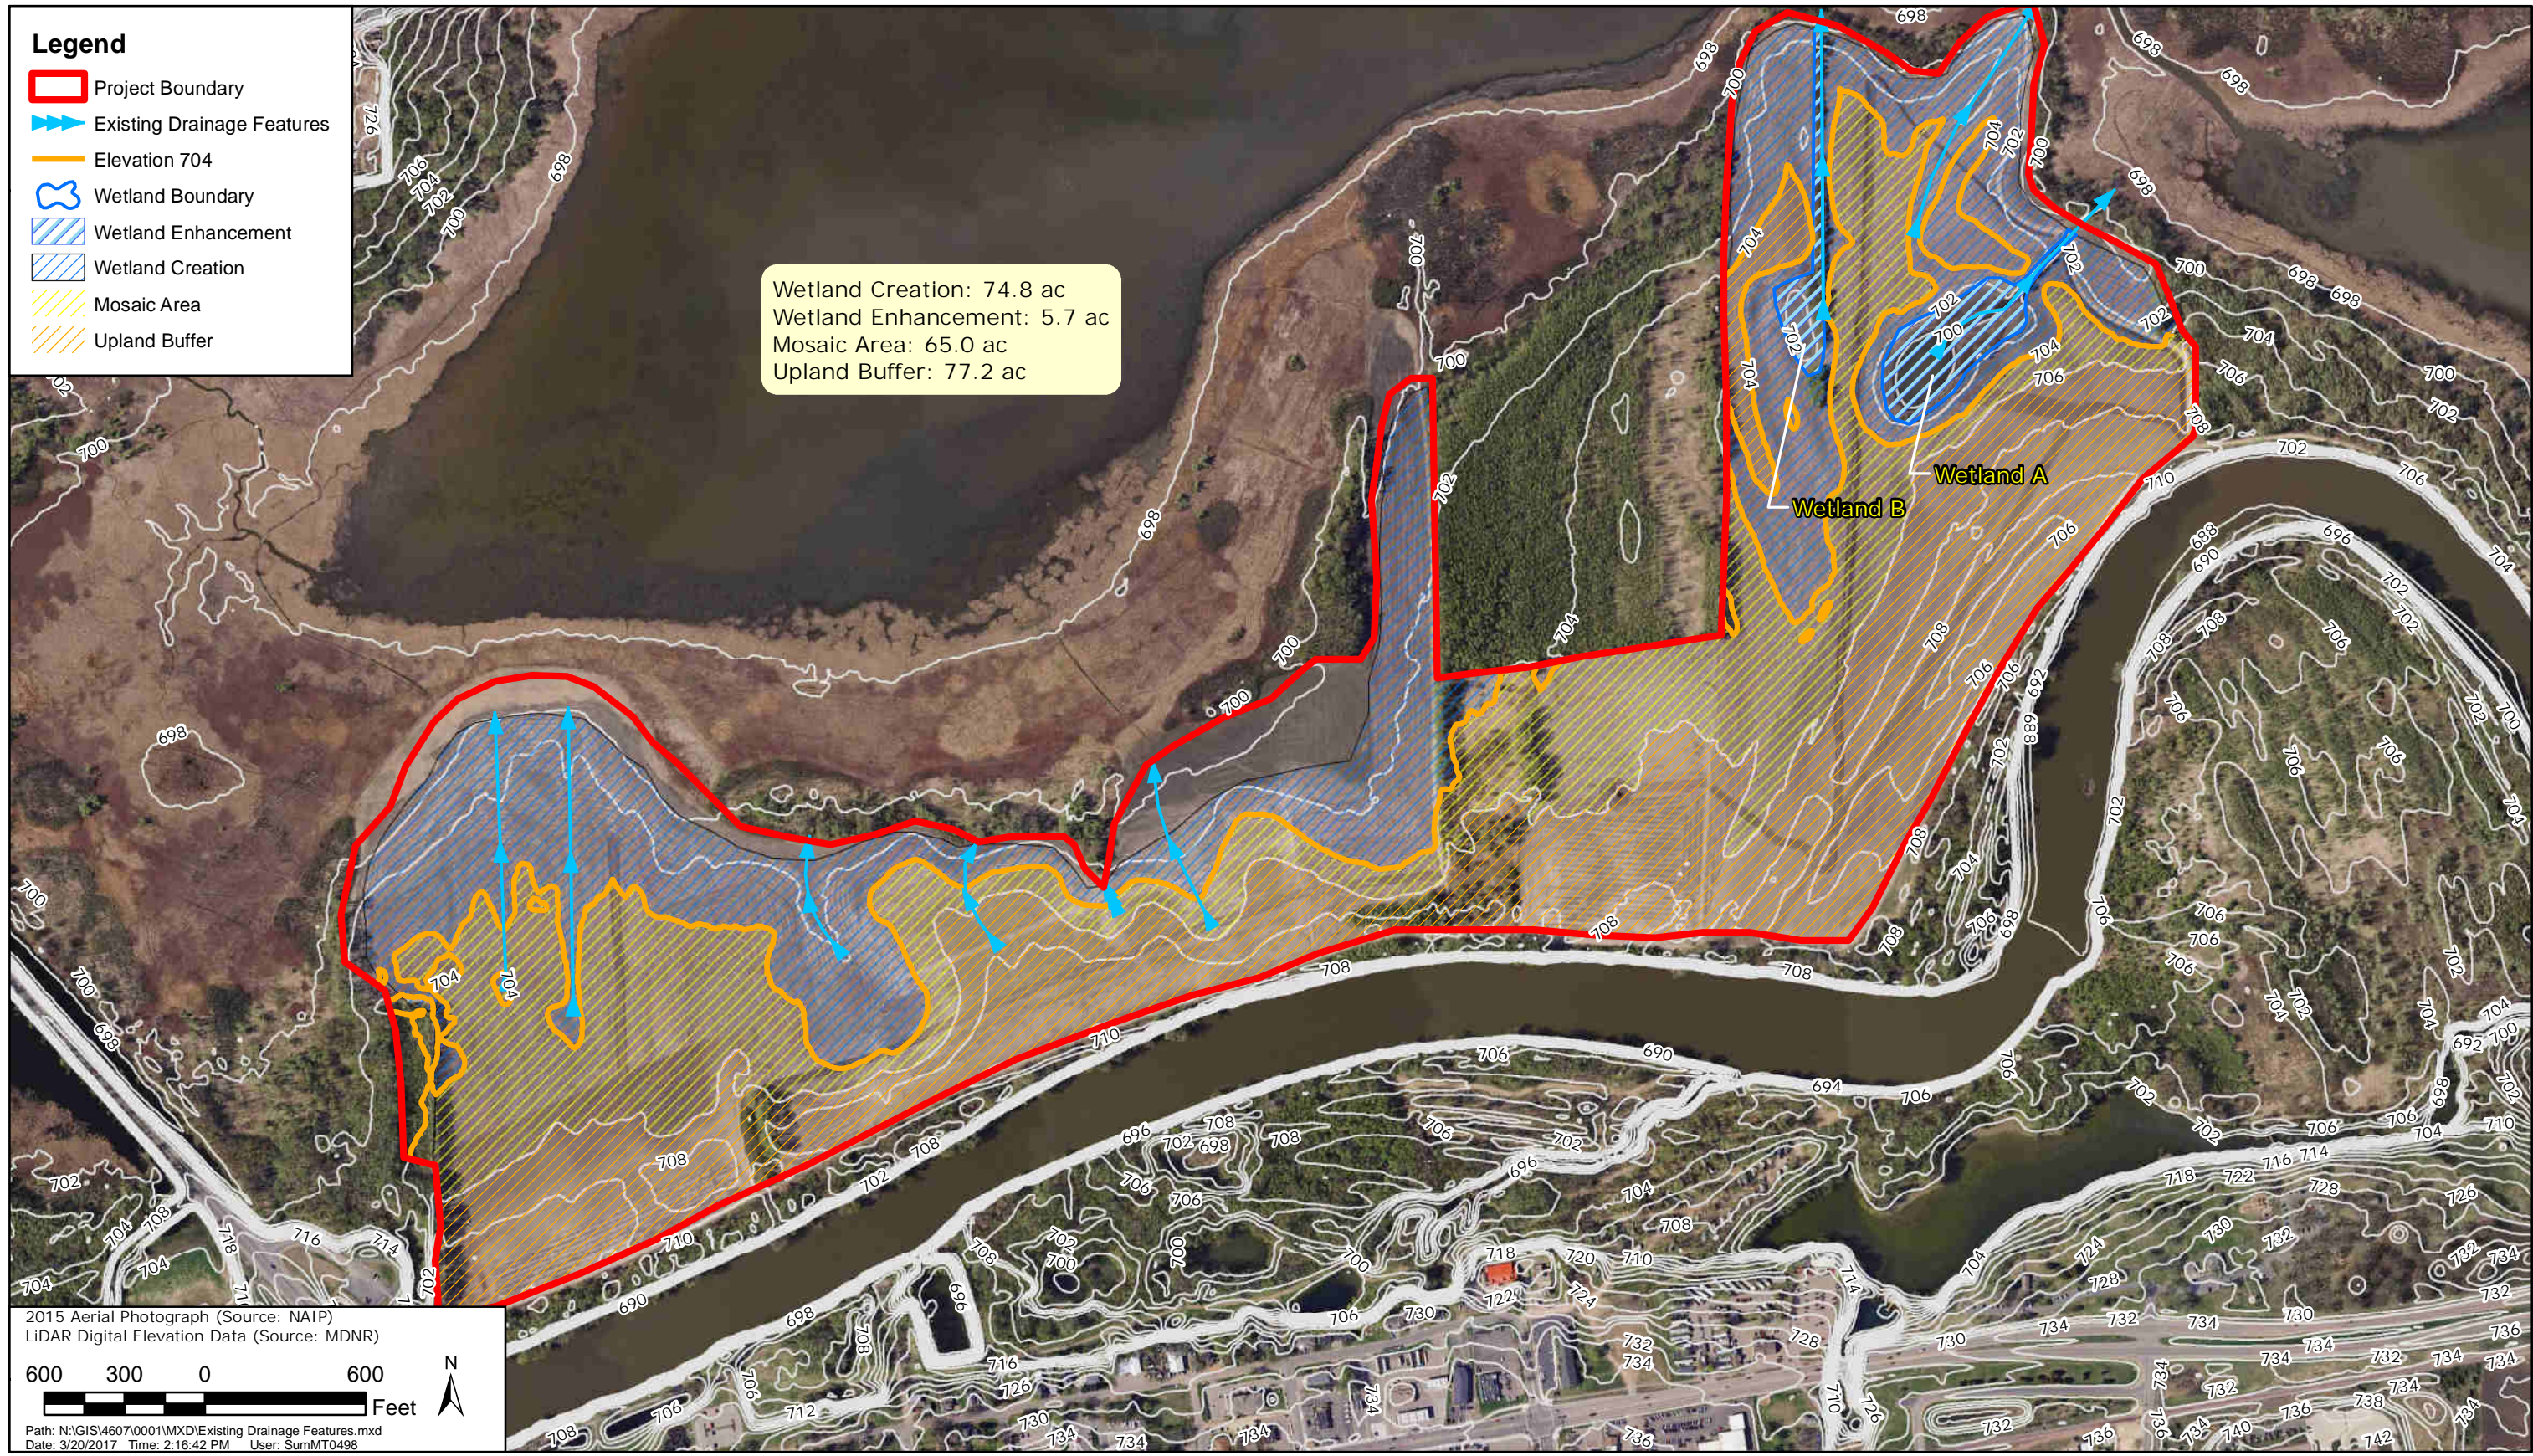
Wetland Creation: 74.8 ac
 Wetland Enhancement: 5.7 ac
 Mosaic Area: 65.0 ac
 Upland Buffer: 77.2 ac

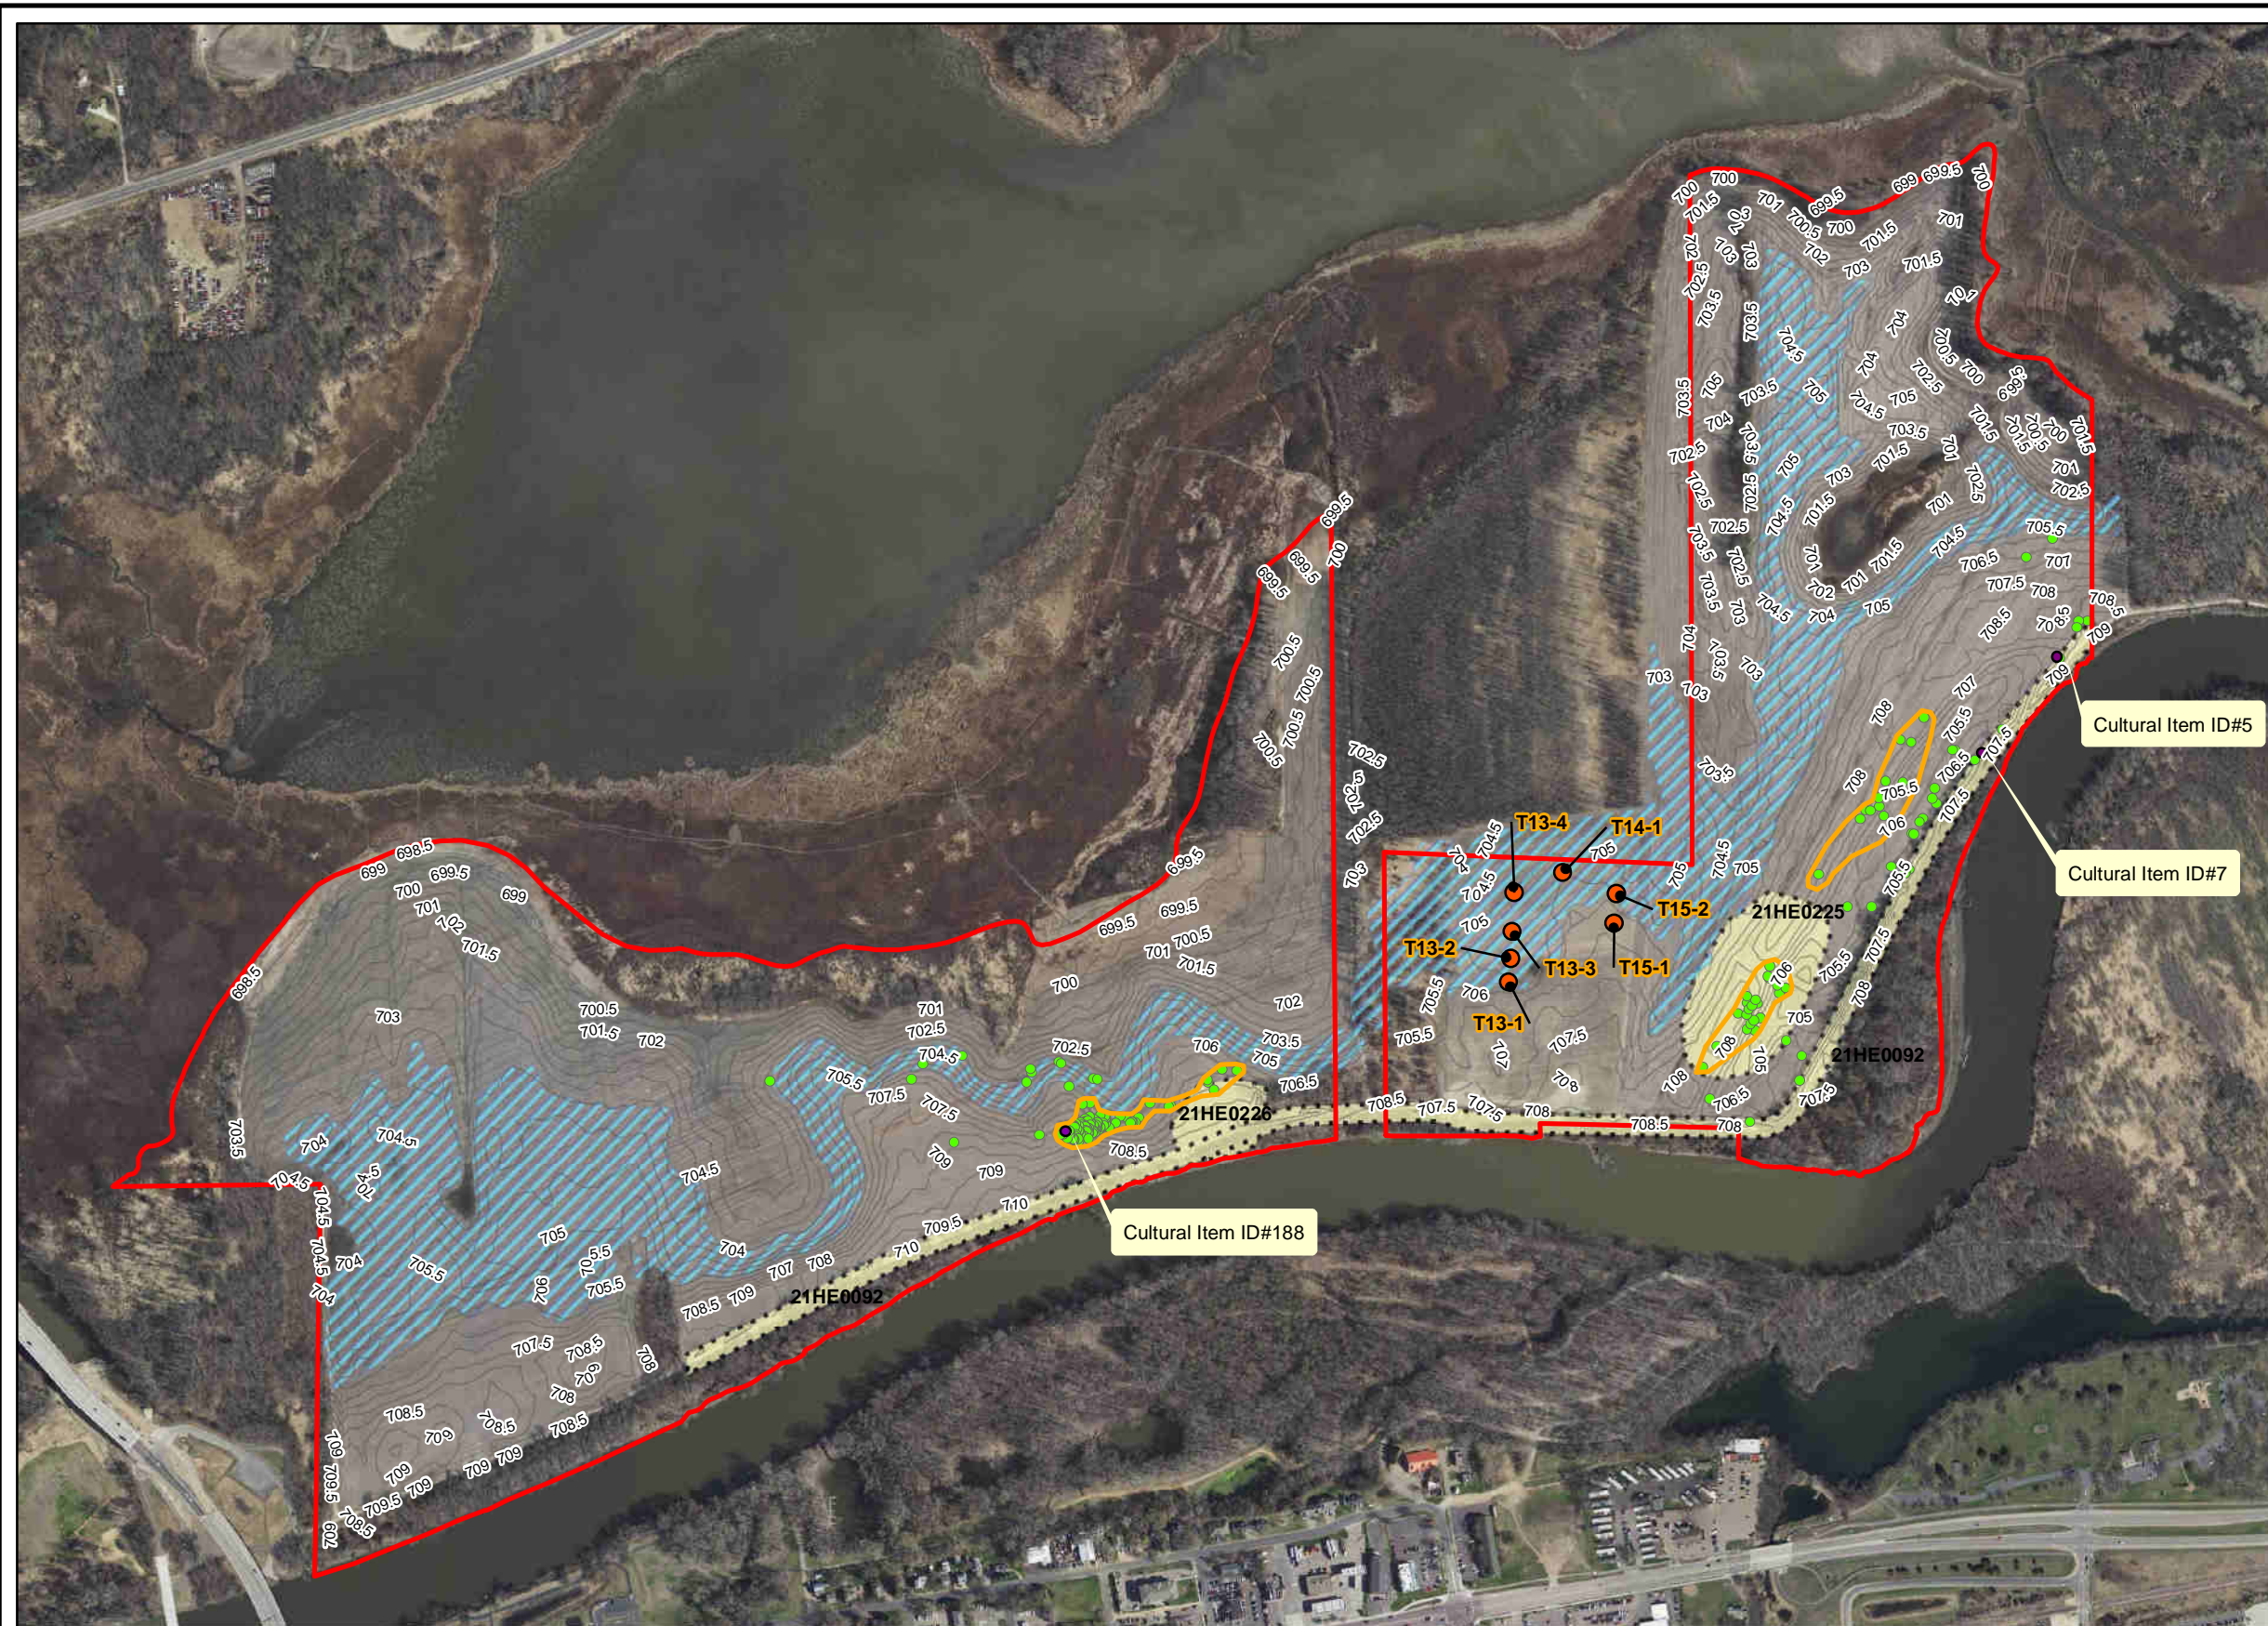
JULY 2017
 Figure 9

- ### Legend
- Project Boundary
 - Ground Recon Findings
 - Shovel Test Locations
 - Surveyed 1/2 Foot Contours
 - Between 704 and 706 (APE)
 - Previously Recorded Archeological Site Boundaries
 - ALO Archeological Site Boundaries

As shown in **Figure 9**, six of Wenck’s soil pits yielded Ab horizons (T13-1 through T13-4, T15-1, and T15-2) and one additional location yielded a possible Ab horizon (T14-1). ALO excavated one archaeological shovel test (ST) at each of these seven locations. Maximum depths of shovel tests reached 70-102 cmbs, and a bucket auger was used in two of the shovel tests (STs 14-1 and 15-2) to sample through the Ab horizons, attaining maximum depths of 122 cm and 120 cm, respectively, where water was encountered.

A total of 65 locations were mapped at archaeological surface finds at 21HE0225 as a result of the surface reconnaissance survey in the soybean fields comprising the APE (**Figure 9**). **Plate 6** illustrates the field conditions at this site. A total of 67 archaeological artifacts were inventoried during the field survey; 26 of them were collected for analysis in ALO's laboratory (**Table 3**).

A total of 208 locations were mapped at 21HE0226 as a result of the surface reconnaissance survey in the soybean fields comprising the APE (**Figure 9**). **Plate 20 and Plate 21** illustrate the field conditions at

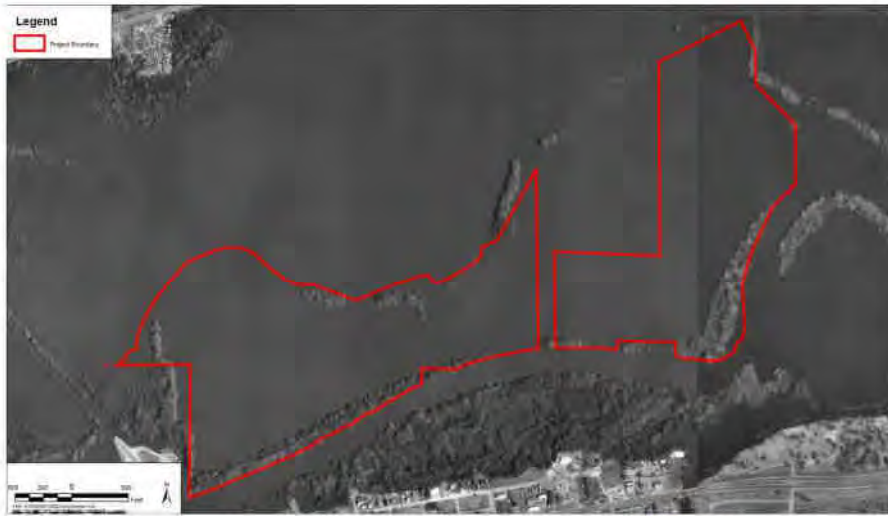
PETERSON WETLAND BANK
1997

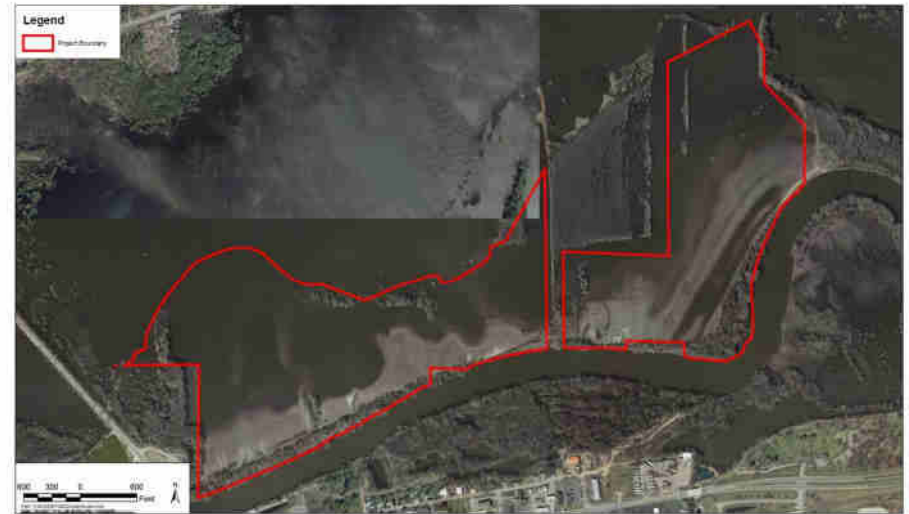
PETERSON WETLAND BANK
2010

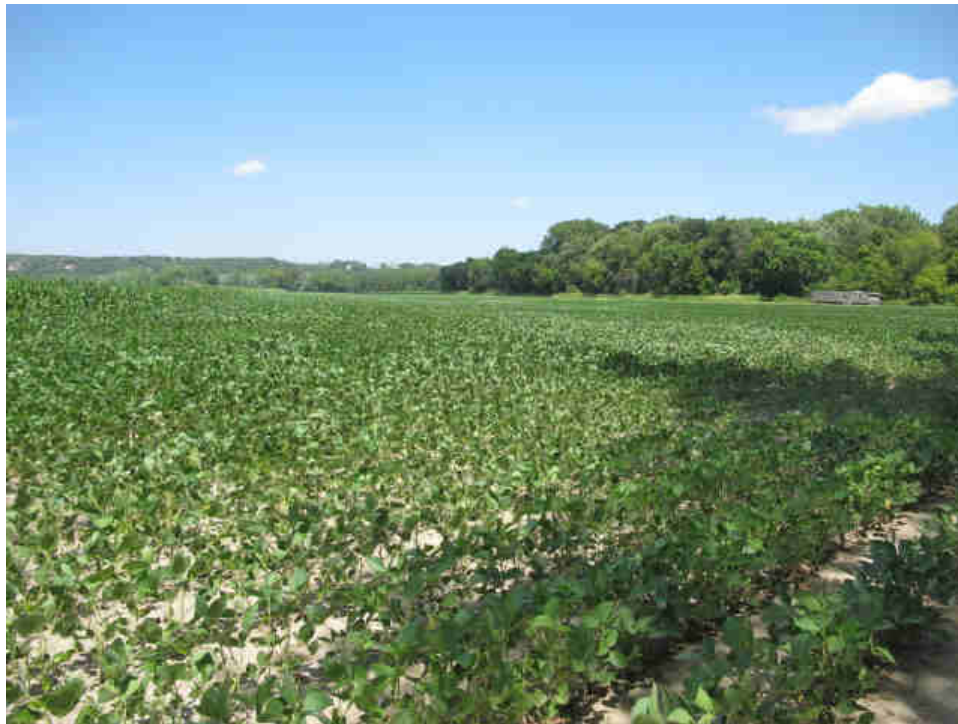
Plate 6. View from Indian Road Looking at South End of 21HE0225 and Northeastward Across Site
Note: Hunting trailer parked permanently along Indian Road to the east.

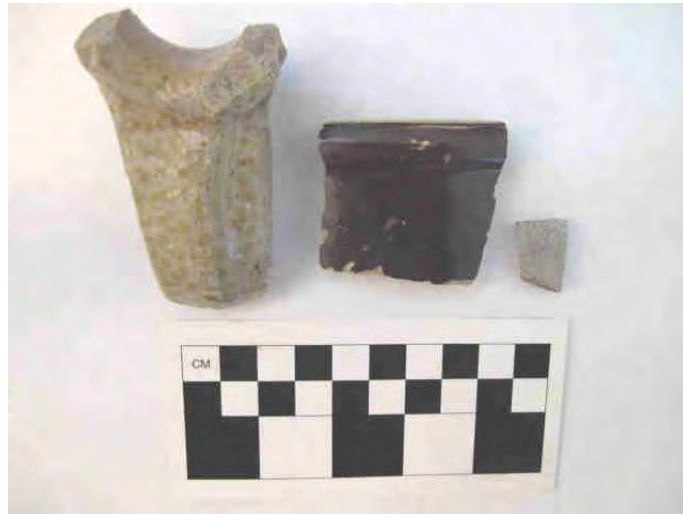
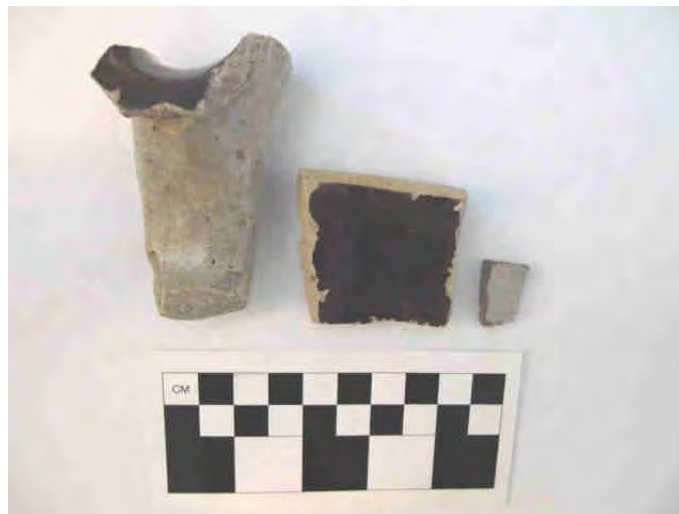
Plate 7. Stoneware Collected from 21HE0225

a. handle, rim & body, exterior.

b. obverse.

The total artifact assemblage, as recorded in the field, is comprised of 25 ceramic fragments, 16 glass fragments, 12 bone fragments, eight shell fragments, four lithic objects, and two metal fragments. The ceramic assemblage includes five stoneware (three collected, **Plate 7a & b**), 14 whiteware (one collected, **Plate 8a & b**), two earthenware (both collected, **Plate 9a & b**), three porcelain (two collected, **Plate 10a & b**), and one rim with blue-white transfer printing (one collected, **Plate 11a & b**) fragments.

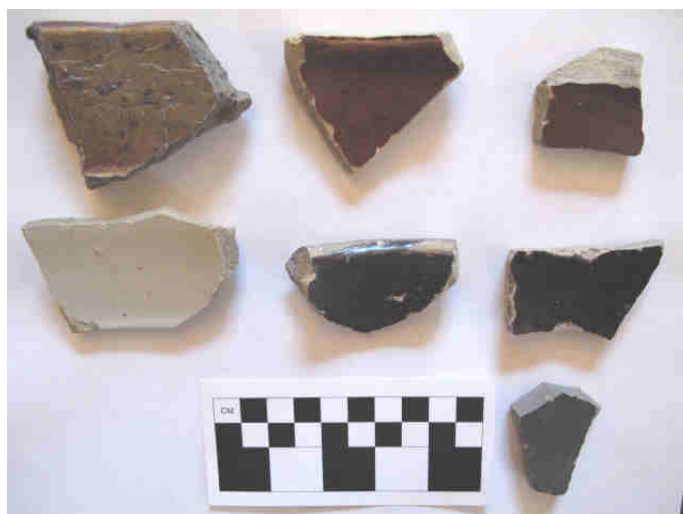
Middle Row left to right: cream-colored glaze; dark brown glaze; black glaze.

Bottom Row: grayish black with matte finish.

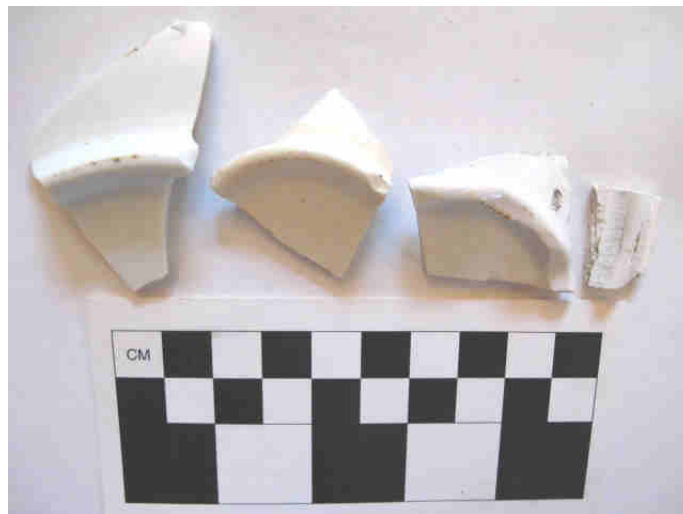
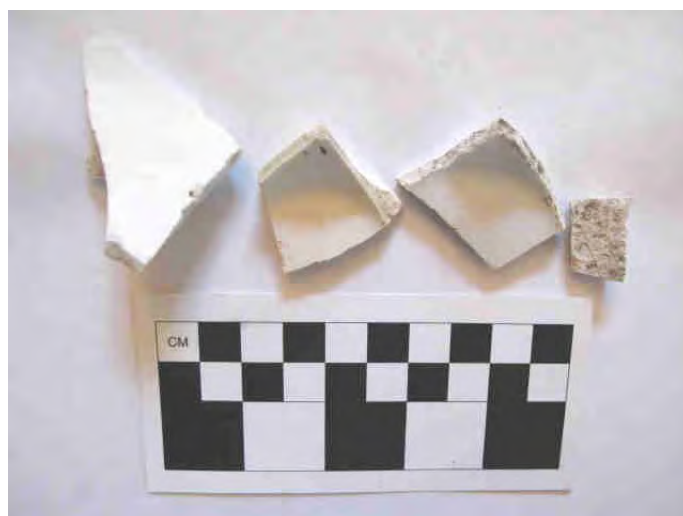
Plate 32. Whiteware Collected from 21HE0226

a. exterior.

b. obverse – interior.

The ceramic assemblage is comprised of stoneware (n=10), whiteware (n=15), other (n=2). Seven of the stoneware sherds were collected. They have a variety of glazes and finishes, including one with dark blue decoration (**Plate 31a & b**). Four whiteware base sherds were collected (**Plate 32a & b**).

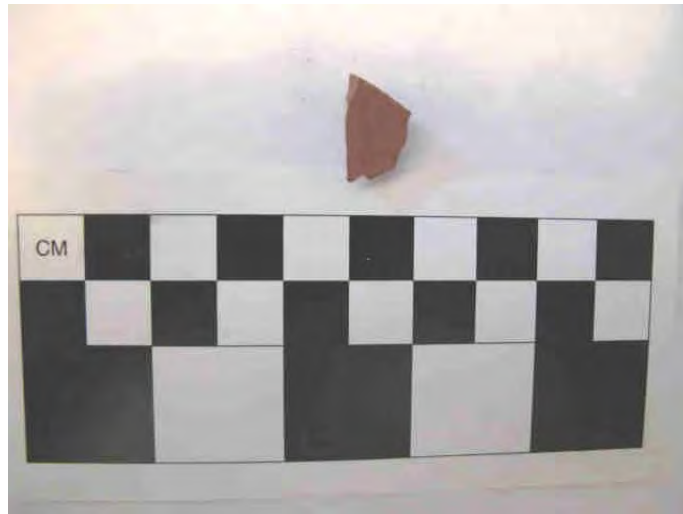
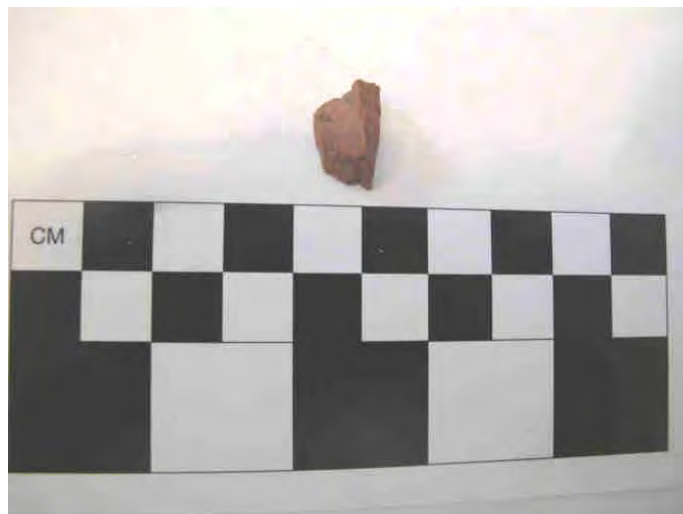
Plate 33. Possible Red Ceramic Fragment Collected from 21HE0226

a. View 1.

b. obverse.

Two other ceramic fragments were collected as well – a possible piece of red ceramic, possibly from a clay pigeon (**Plate 33a & b**) and a clay pipe fragment (Cultural Item ID #188 – see **Figure 10, Table 4, and Plate 34a & b**). The clay pipe fragment is the most unique artifact observed and collected by ALO from 21HE0226. Likely manufactured from kaolin clay, no base or spur appears to be present on this pipe fragment. Clay pipes were considered inexpensive and disposable items that were generally manufactured, used, and thrown away within a very short timeframe. Individual styles often can be traced

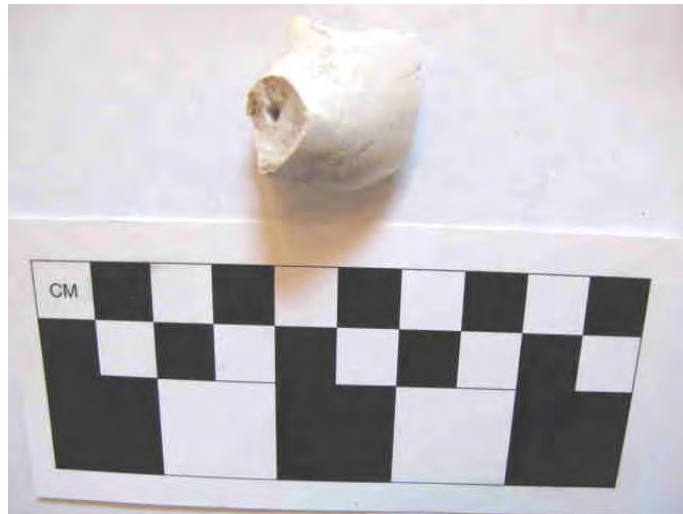
Plate 34. Pipe Bowl Fragment Collected from 21HE0226

a. exterior.

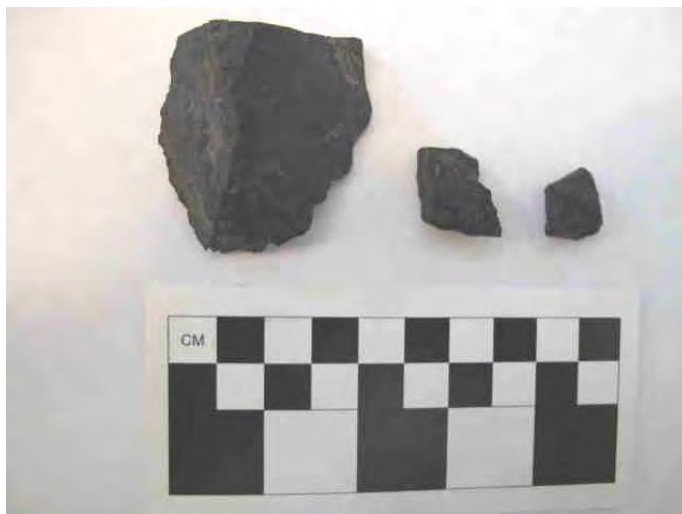
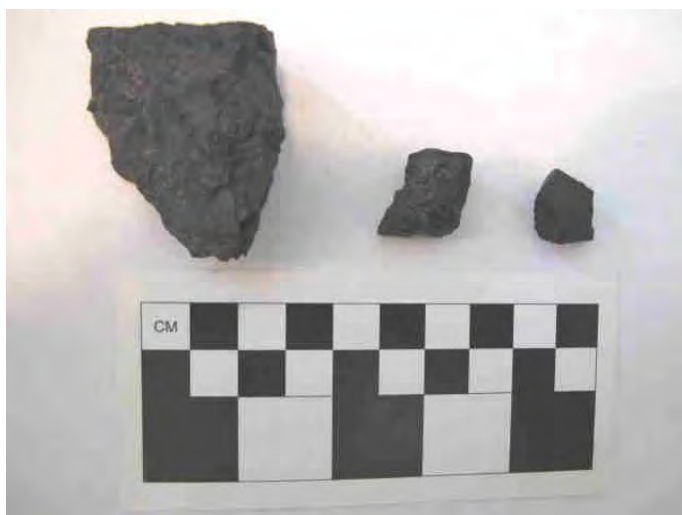
Plate 35. Lithics Collected from 21HE0226

a. Left to right: coal and two unknown black fragments (possibly coal or degraded clay pigeon).

b. obverse.

Twenty-four lithic fragments, mostly coal chunks, were recorded in the field. Only the largest chunk was collected (**Plate 35a & b**).

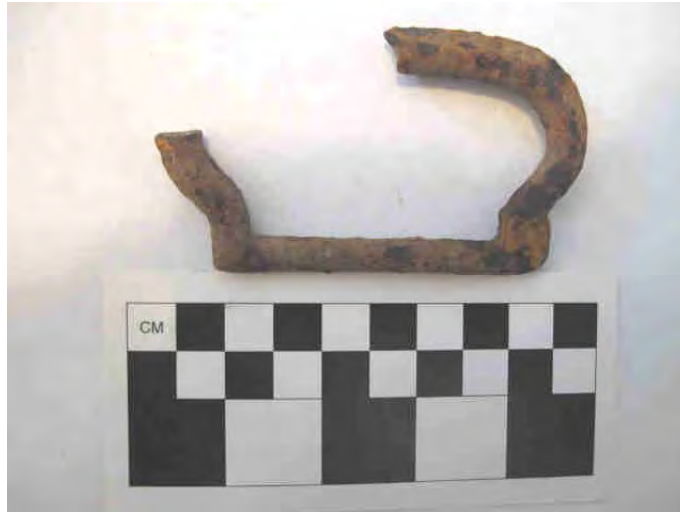
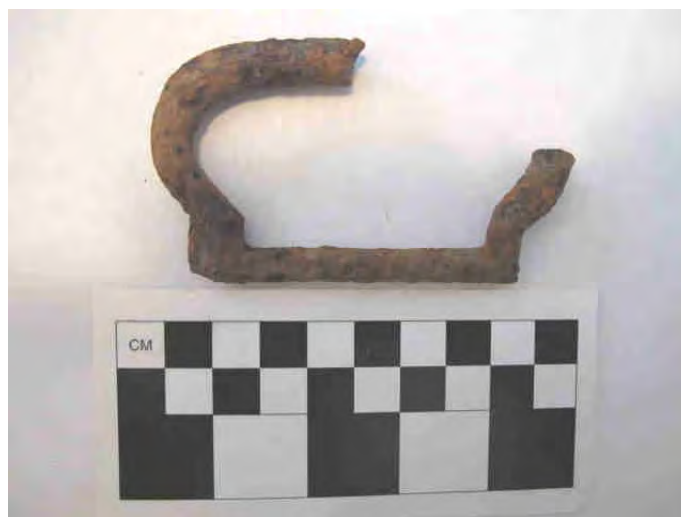
Plate 36. Metal Collected from 21HE0226

a. broken bracket, rusted.

b. obverse.

Six shell fragments were recorded in the field (n=3 mollusc, n=3 gastropod), but none was collected. Four metal fragments were recorded during the survey, but only one was collected (**Plate 36a & b**). Two bone fragments from an unidentified mammal were observed, but neither was collected. Two fragments of terra cotta (e.g., flower pot material) were observed, but neither was collected. Two unknown fragments were encountered and collected (**Plate 35a & b**); they may be pieces of coal or degraded clay pigeon. One charcoal fragment was observed, but not collected (distinct from coal chunks in the Lithics category).
