Technical Memorandum

Re: East Chaska Creek Restoration—Final Walk-Through

Re: East Chaska Creek Restoration—Construction Update

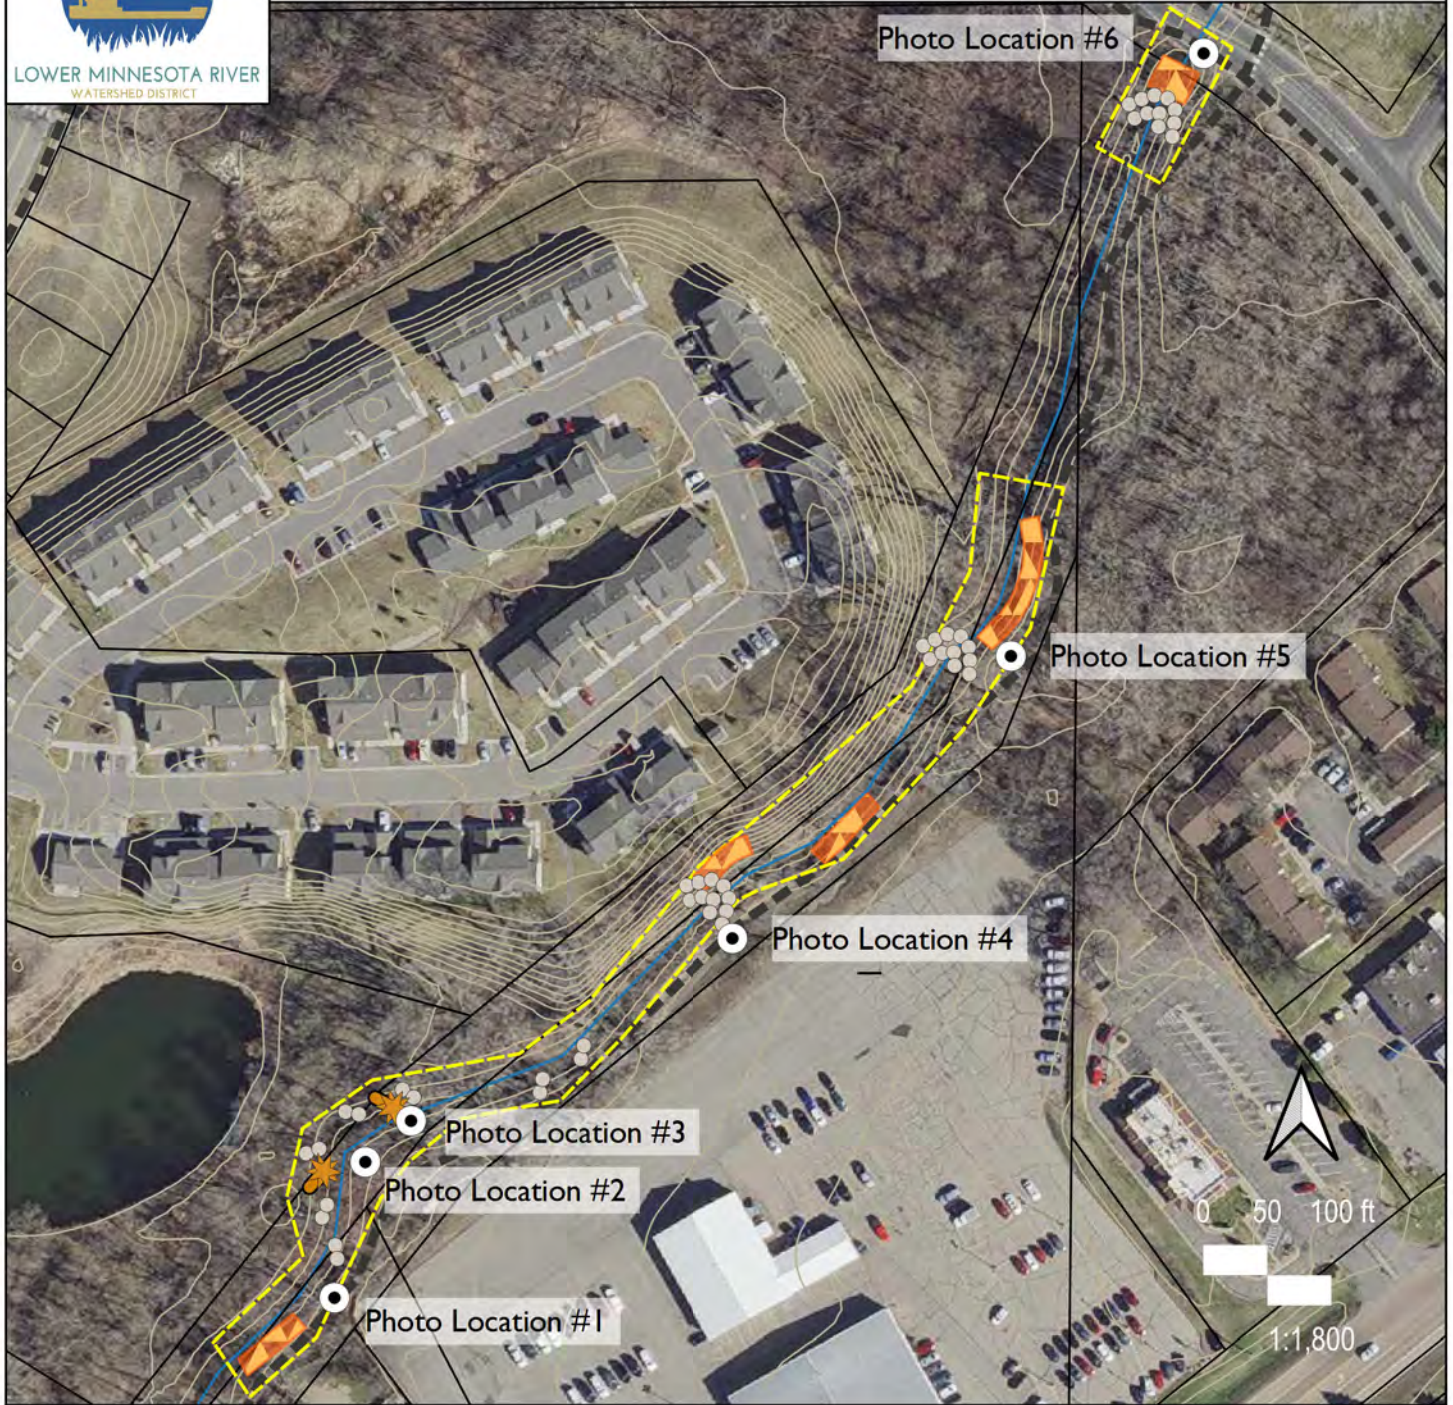
Figure 1: East Creek Restoration May 6, 2021 Photo Locations

- Areas 1 and 3: Dormant seed placed in March to stabilize the disturbed areas had a poor germination rate, and the frozen material placed on the banks produced a bumpy and rather messy appearance (Attachment 1, Areas 1 and 3 photos).

- Areas 4 and 5: The two constructed cross-vane structures appeared to have caused bank erosion as a result of improper elevations of the header rocks.

During the site walk, it was apparent that the dormant seed placed in March to stabilize the disturbed areas had a poor germination rate and that the frozen material placed on the banks gave a bumpy and rather messy appearance (Attachment 1, Photos 1 and 3).

Several of the in-channel rock structures appeared to have caused bank erosion as a result of improper elevations of the header rocks and/or footer logs. These locations were noted by Barr and will be reviewed by the design engineer to determine what actions need to be taken (Attachment 1, Photos 2, 4, and 5).

- *Blackstone has since regraded these areas, provided additional erosion control blankets, and reseeded.*
- Area 2: The right bank was noted to be too steep, especially near the city stormwater outfall and rootwad stream feature.

After discussion with the City and Blackstone, Barr directed Blackstone to return to the site to compact the lumpy areas and reseed if necessary. The City has provided stakes indicating where plants (red twig dogwood and swamp white oak) will be placed. Several banks were noted to be too steep, especially near the City stormwater outfall, and Blackstone said its crew would return and flatten the slope to prevent further erosion.

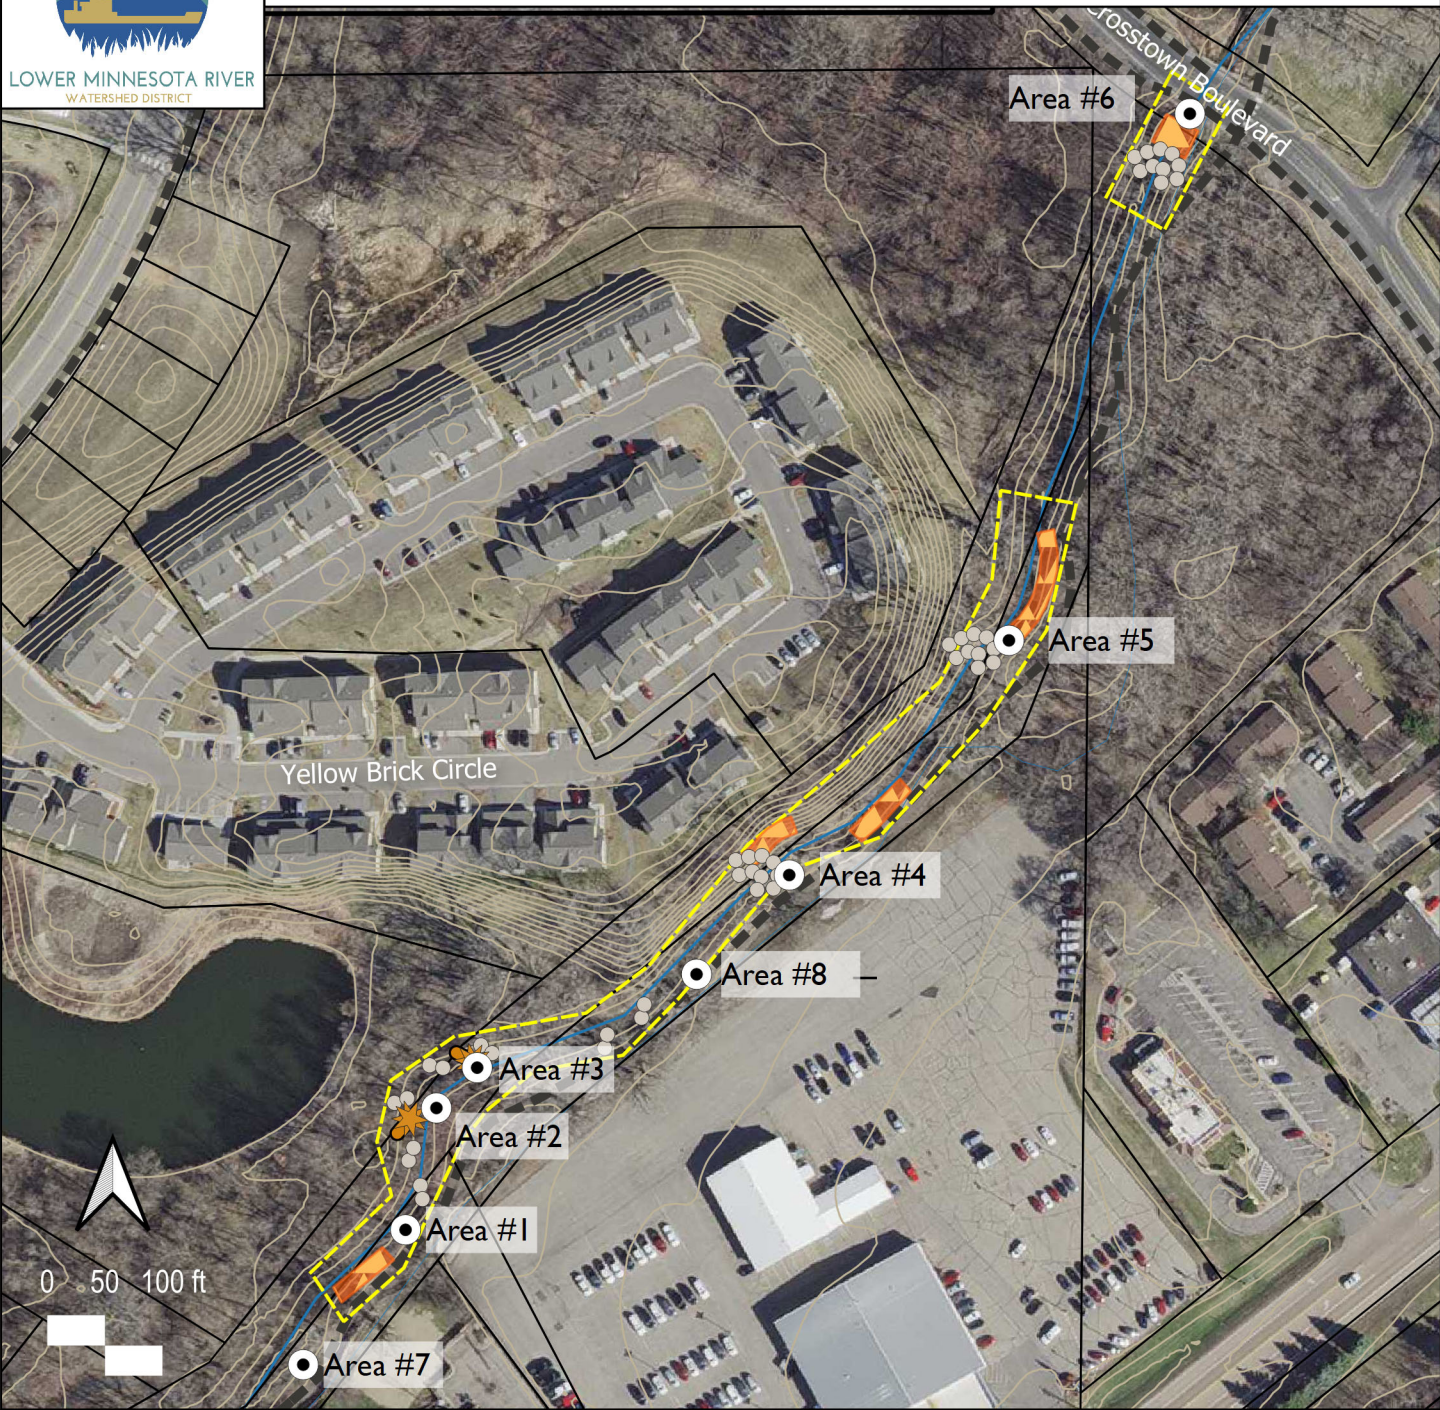
Figure I: East Creek Restoration May 28, 2021 Photo Locations

Additionally, during the May 28, 2021, site walk, it was noted that two additional areas had been corrected (Figure 1, Areas 7 and 8). Both areas are outside the original East Chaska Creek Restoration project and were discussed as being outside the project scope of work during the May 6, 2021, site walk.

- Area 7: Two storm outfalls were found to be hanging during the May 6 site walk. The locations were discussed, and it was noted the area was outside the project limits.
 - *Riprap has been placed under the stormwater outfalls, and additional seeding appears to have been placed.*
- Area 8: Left bank erosion had previously been stabilized by the city with concrete to protect the trail. This was discussed in the field, but it was observed that this area was not part of the East Chaska Creek project; Blackstone noted if additional material was left over, it could be placed in this area.
 - *Riprap has been placed along the left bank, filling in the undercut areas.*
