2021 GULLY INVENTORY AND CONDITION ASSESSMENT, VOLUME 2

July 15, 2022

Lower Minnesota River Watershed District
Gully Inventory and Condition Assessment, Volume 2
Chaska, Minnesota

Revision 0
July 15, 2022

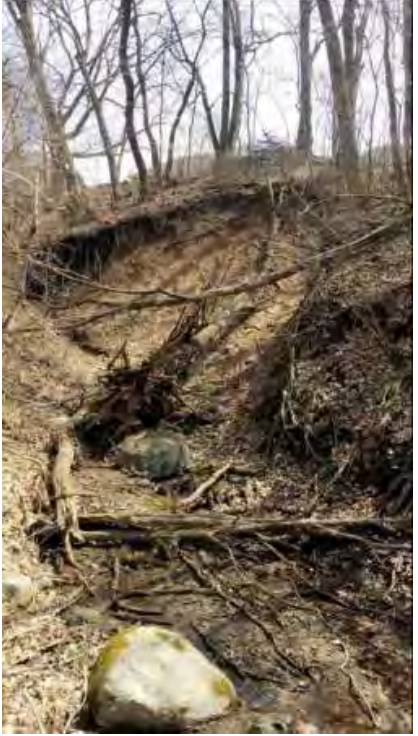
Name and Location	Concerns, Management Category, and Recommendations	
<p>Site 3 (Gully 07:21-11:37)</p> <p>10550 McCool Court</p>	<p>Concerns: Private irrigation and groundwater springs were destabilizing the slope on a private residential property. Spring flows were also observed to be contributing to erosion.</p> <p>Management Category: Management required</p> <p>Recommendations: Stabilize the gully with fill and riprap; encourage the landowner to extend downspouts and drainpipes to the toe of slopes, and provide energy dissipation at these outlets to prevent further erosion (i.e., private irrigation management). Increase vegetation and add boulders around the spring to slow flows. In severe cases the report recommended installing dry wells or a vegetated swale to collect water and increase permeability in the soil.</p>

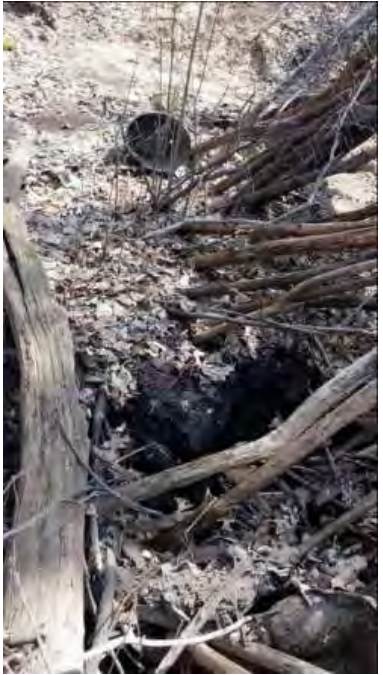
<p>Site 4 (Gully 08:11-10:27)</p> <p>10640 McCool Court</p>	<p>Concerns: Private irrigation was destabilizing the slope on a residential property.</p> <p>Management Category: Management required</p> <p>Recommendations: Stabilize the gully with fill, turf reinforcement mat, and vegetation in addition to private irrigation management.</p>

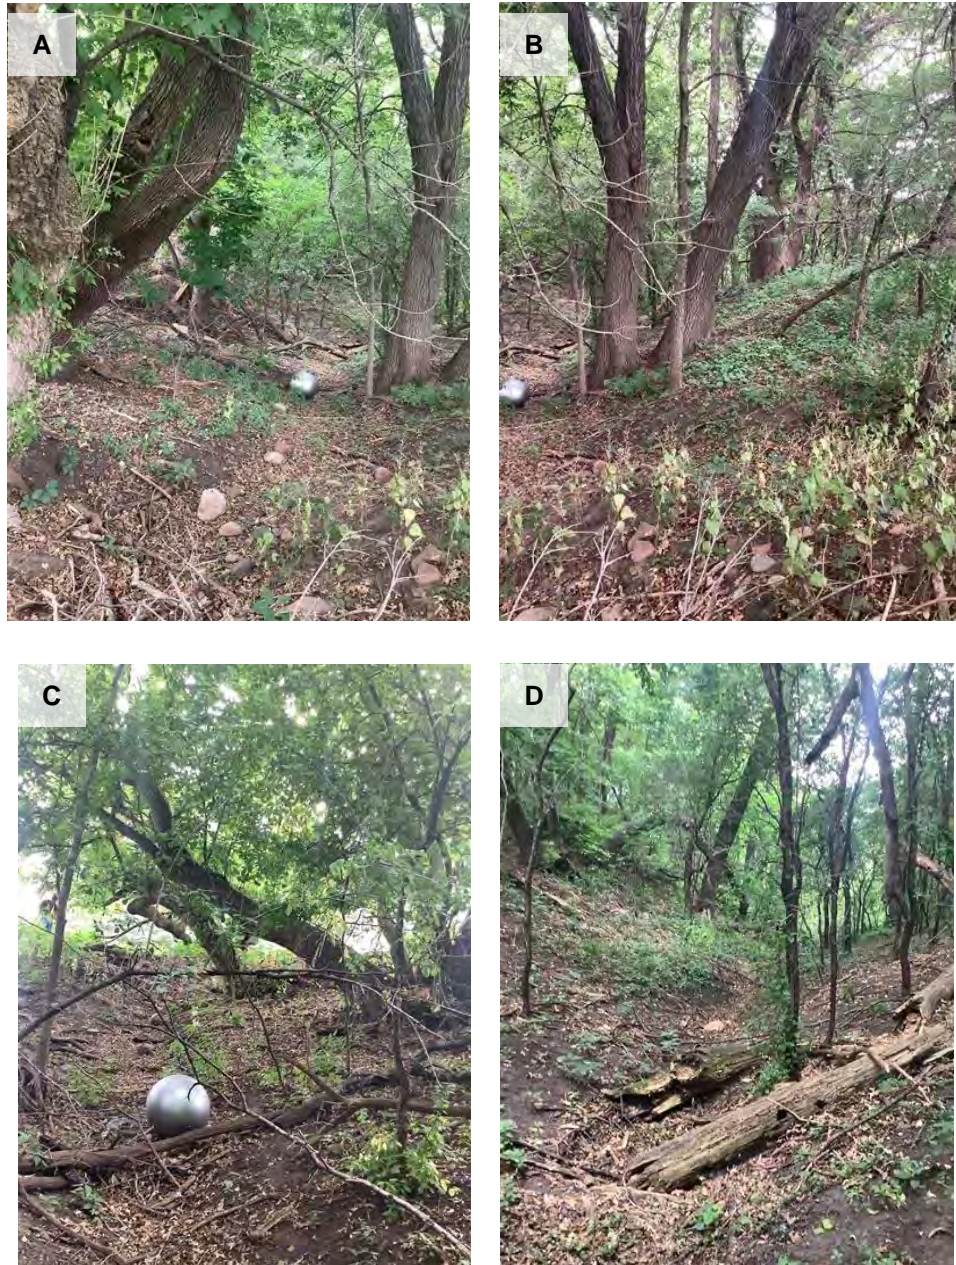
Figure 12: Photos of Gully 07:21-11:37 A) Downstream view of left bank, B) Downstream view of right bank, C) Upstream view of left bank, D) Downstream view of meeting with Site 07:21-11:44

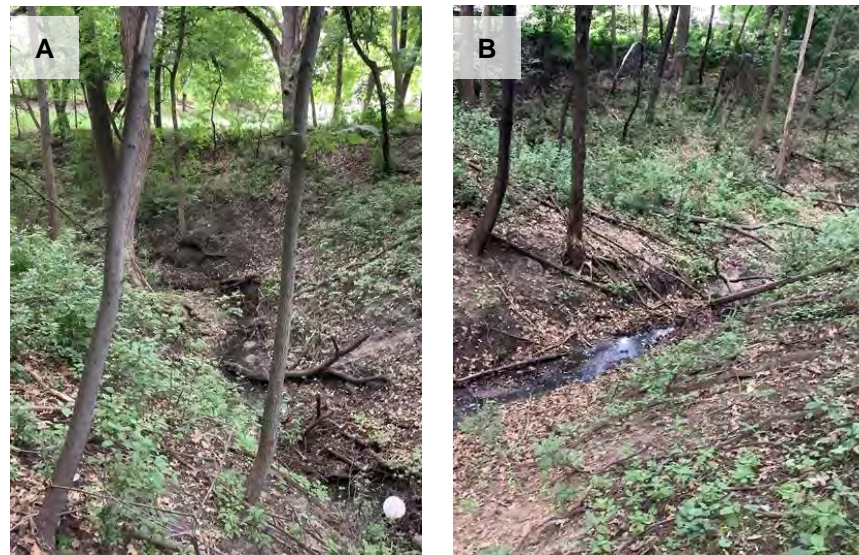
This site was located at the west end of Cedarbridge Park in Burnsville. This was a very large gully with a constant flow of water at the bottom. The bottom of the gully had no vegetation although each bank had a moderate amount (Figure 16). The bank angles were about 45°, and the gully took a general V-shape. There was severe degradation on the banks of the gully along with moderate slumping of the banks. Additionally, there were many pistol-butted trees, indicating a slowly progressing slope failure. This site scored a 37 for erosion potential, placing it in the moderate erosion category; however, when combined with the Tier 1 impact zone, this gully is classified as a high-risk site.

Figure 16: Photos of Gully 06:08-13:18 A) Upstream view of gully, B) Downstream view of gully

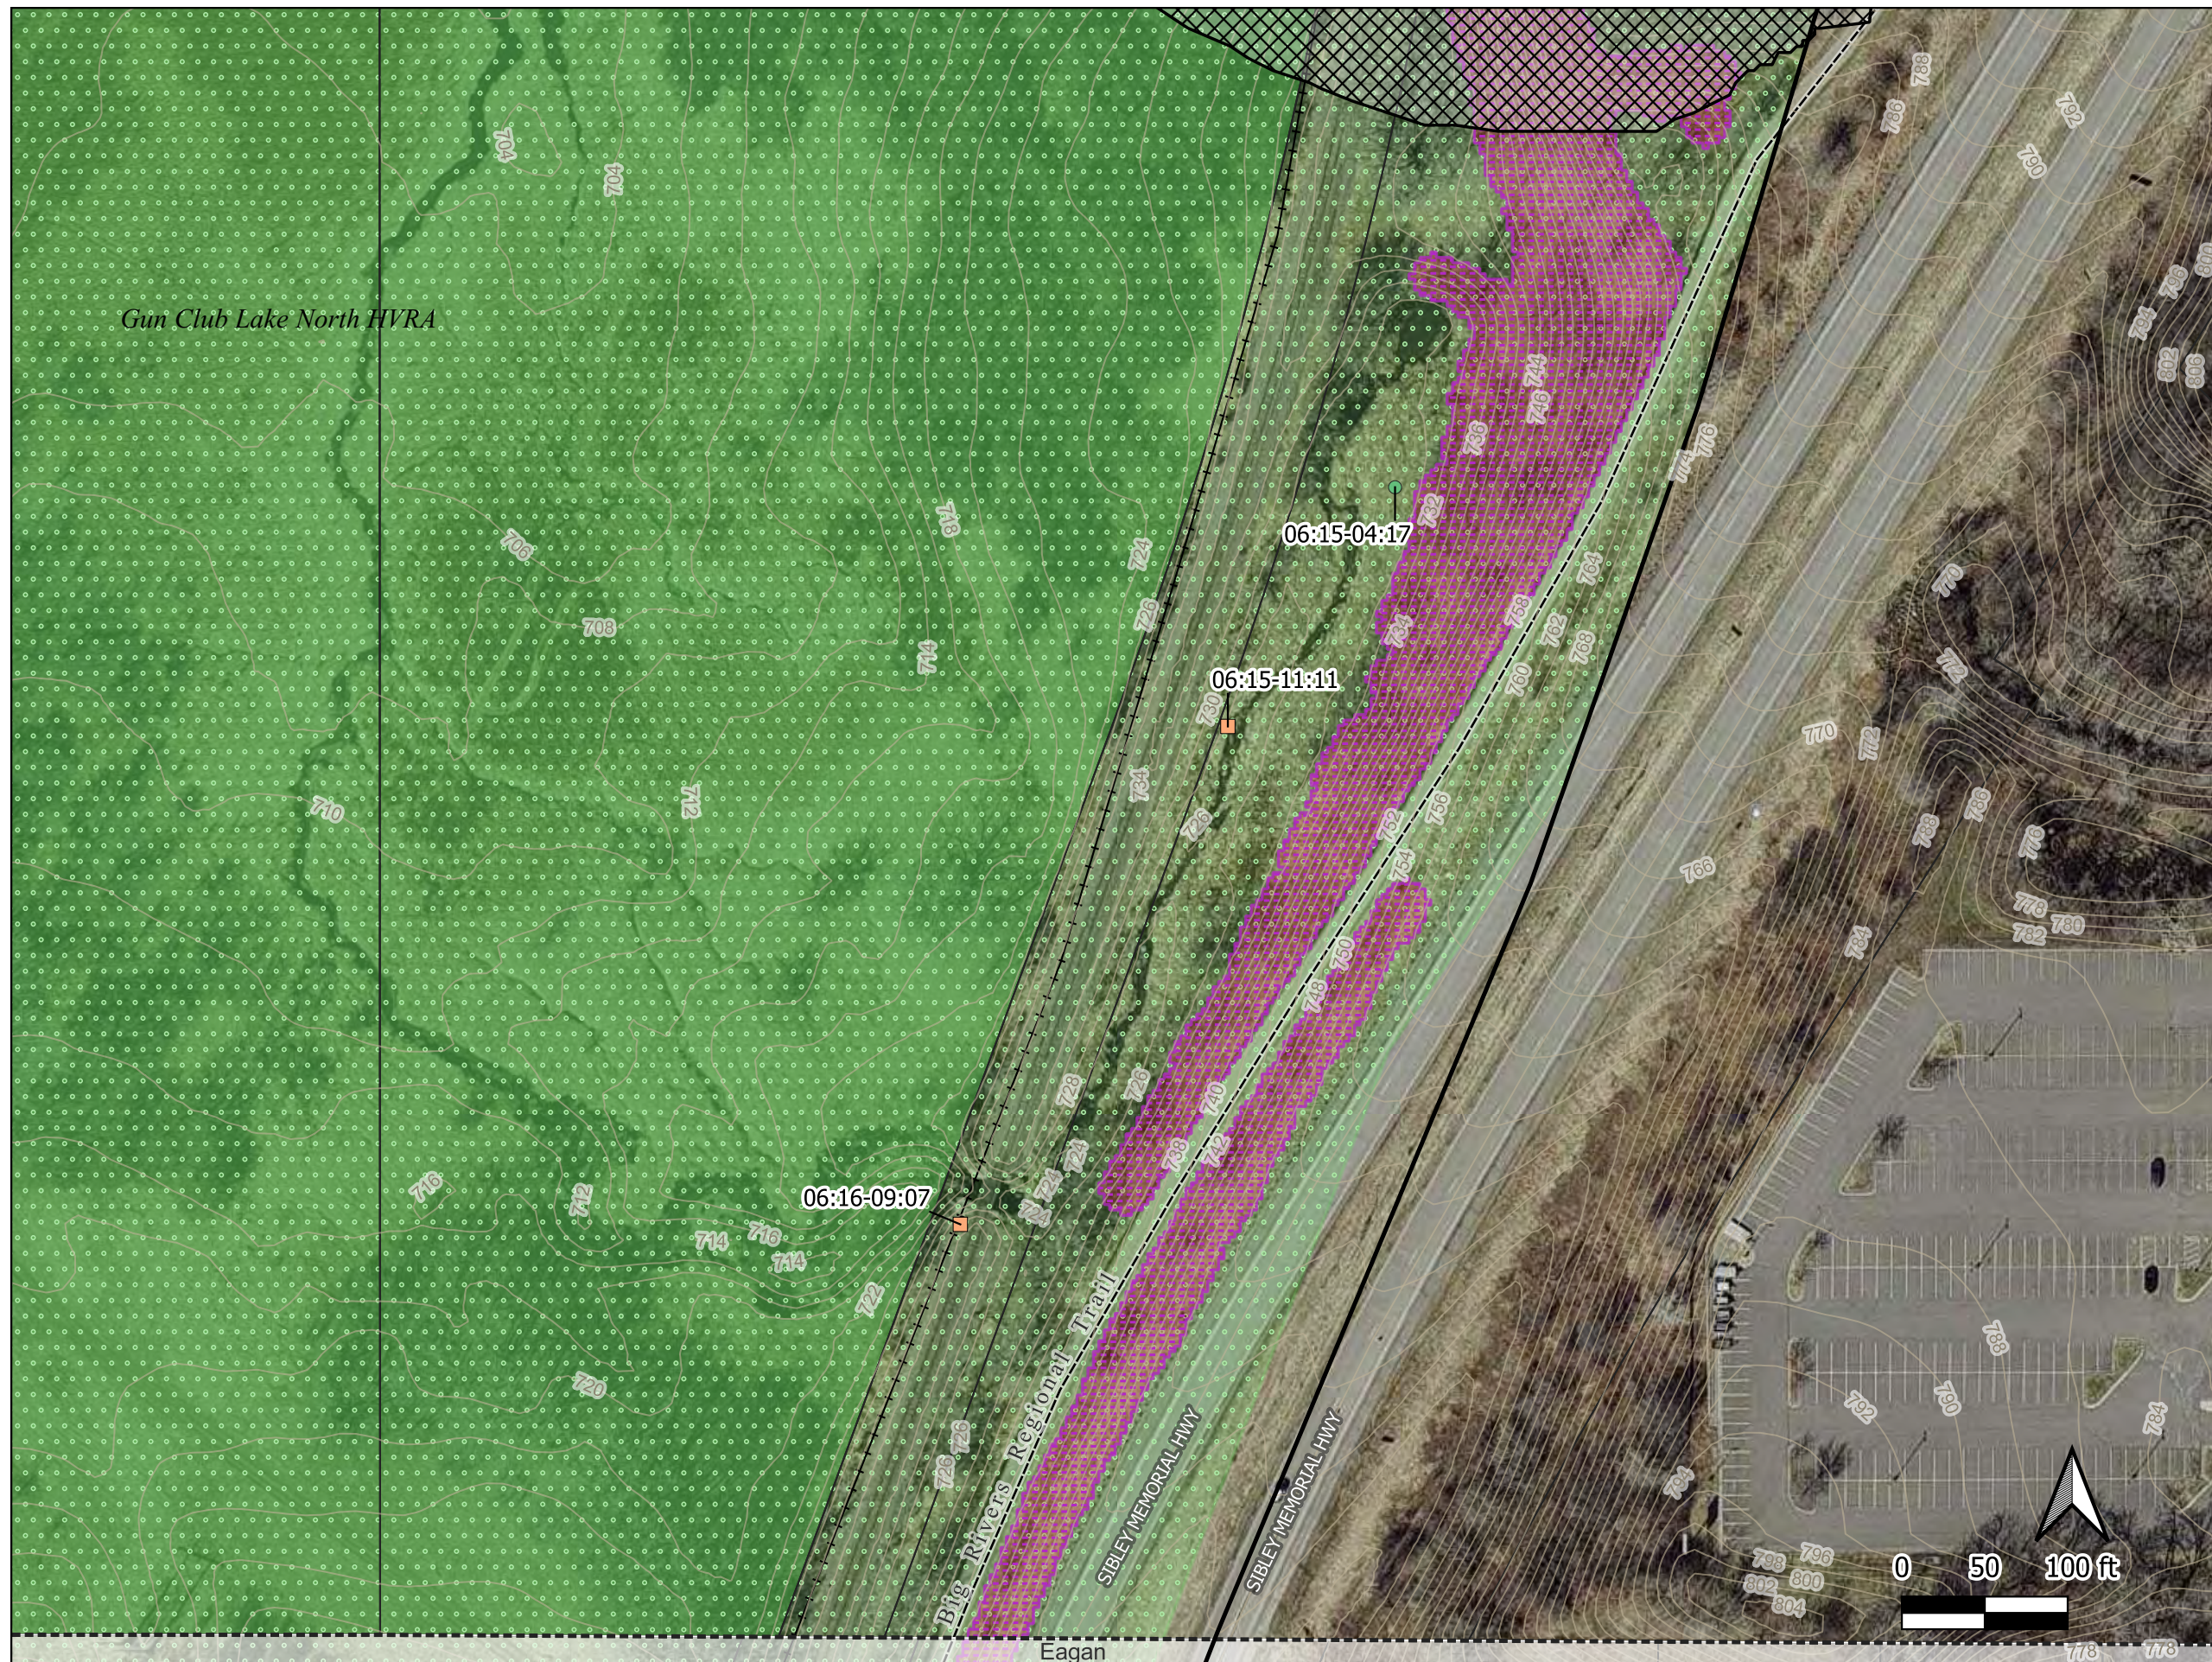
Figure 34: Gun Club Lake North Gullies

Of those locations identified as high-risk, only the sites near Gun Club Lake North warrant further attention at this time because of the potential effects on the calcareous fen (Figure 34).

This area is already under review as part of a stormwater intrusion study for the Gun Club Lake North fen complex. This area has been degraded because of the influx of warmer and more polluted stormwater runoff, which has created a scar on the fen. As part of the 2021 Gully Project, this area was surveyed to establish the current conditions in this gully.

The Gun Club Lake North gullies show evidence of extreme slumping, and the information has been incorporated into the stormwater intrusion study. It is recommended that the Big Rivers Regional Trail area be assessed once construction is complete to confirm whether the gullies identified by desktop analysis exist and to confirm the impact construction may have had on the existing Gun Club Lake North gullies and the gullies that were surveyed in 2020. It is possible that some of these sites may have been fixed during Big River Regional Trail construction; but because of the trail's proximity to Gun Club Lake and waters that connect the Minnesota River, it is crucial that this area be surveyed.

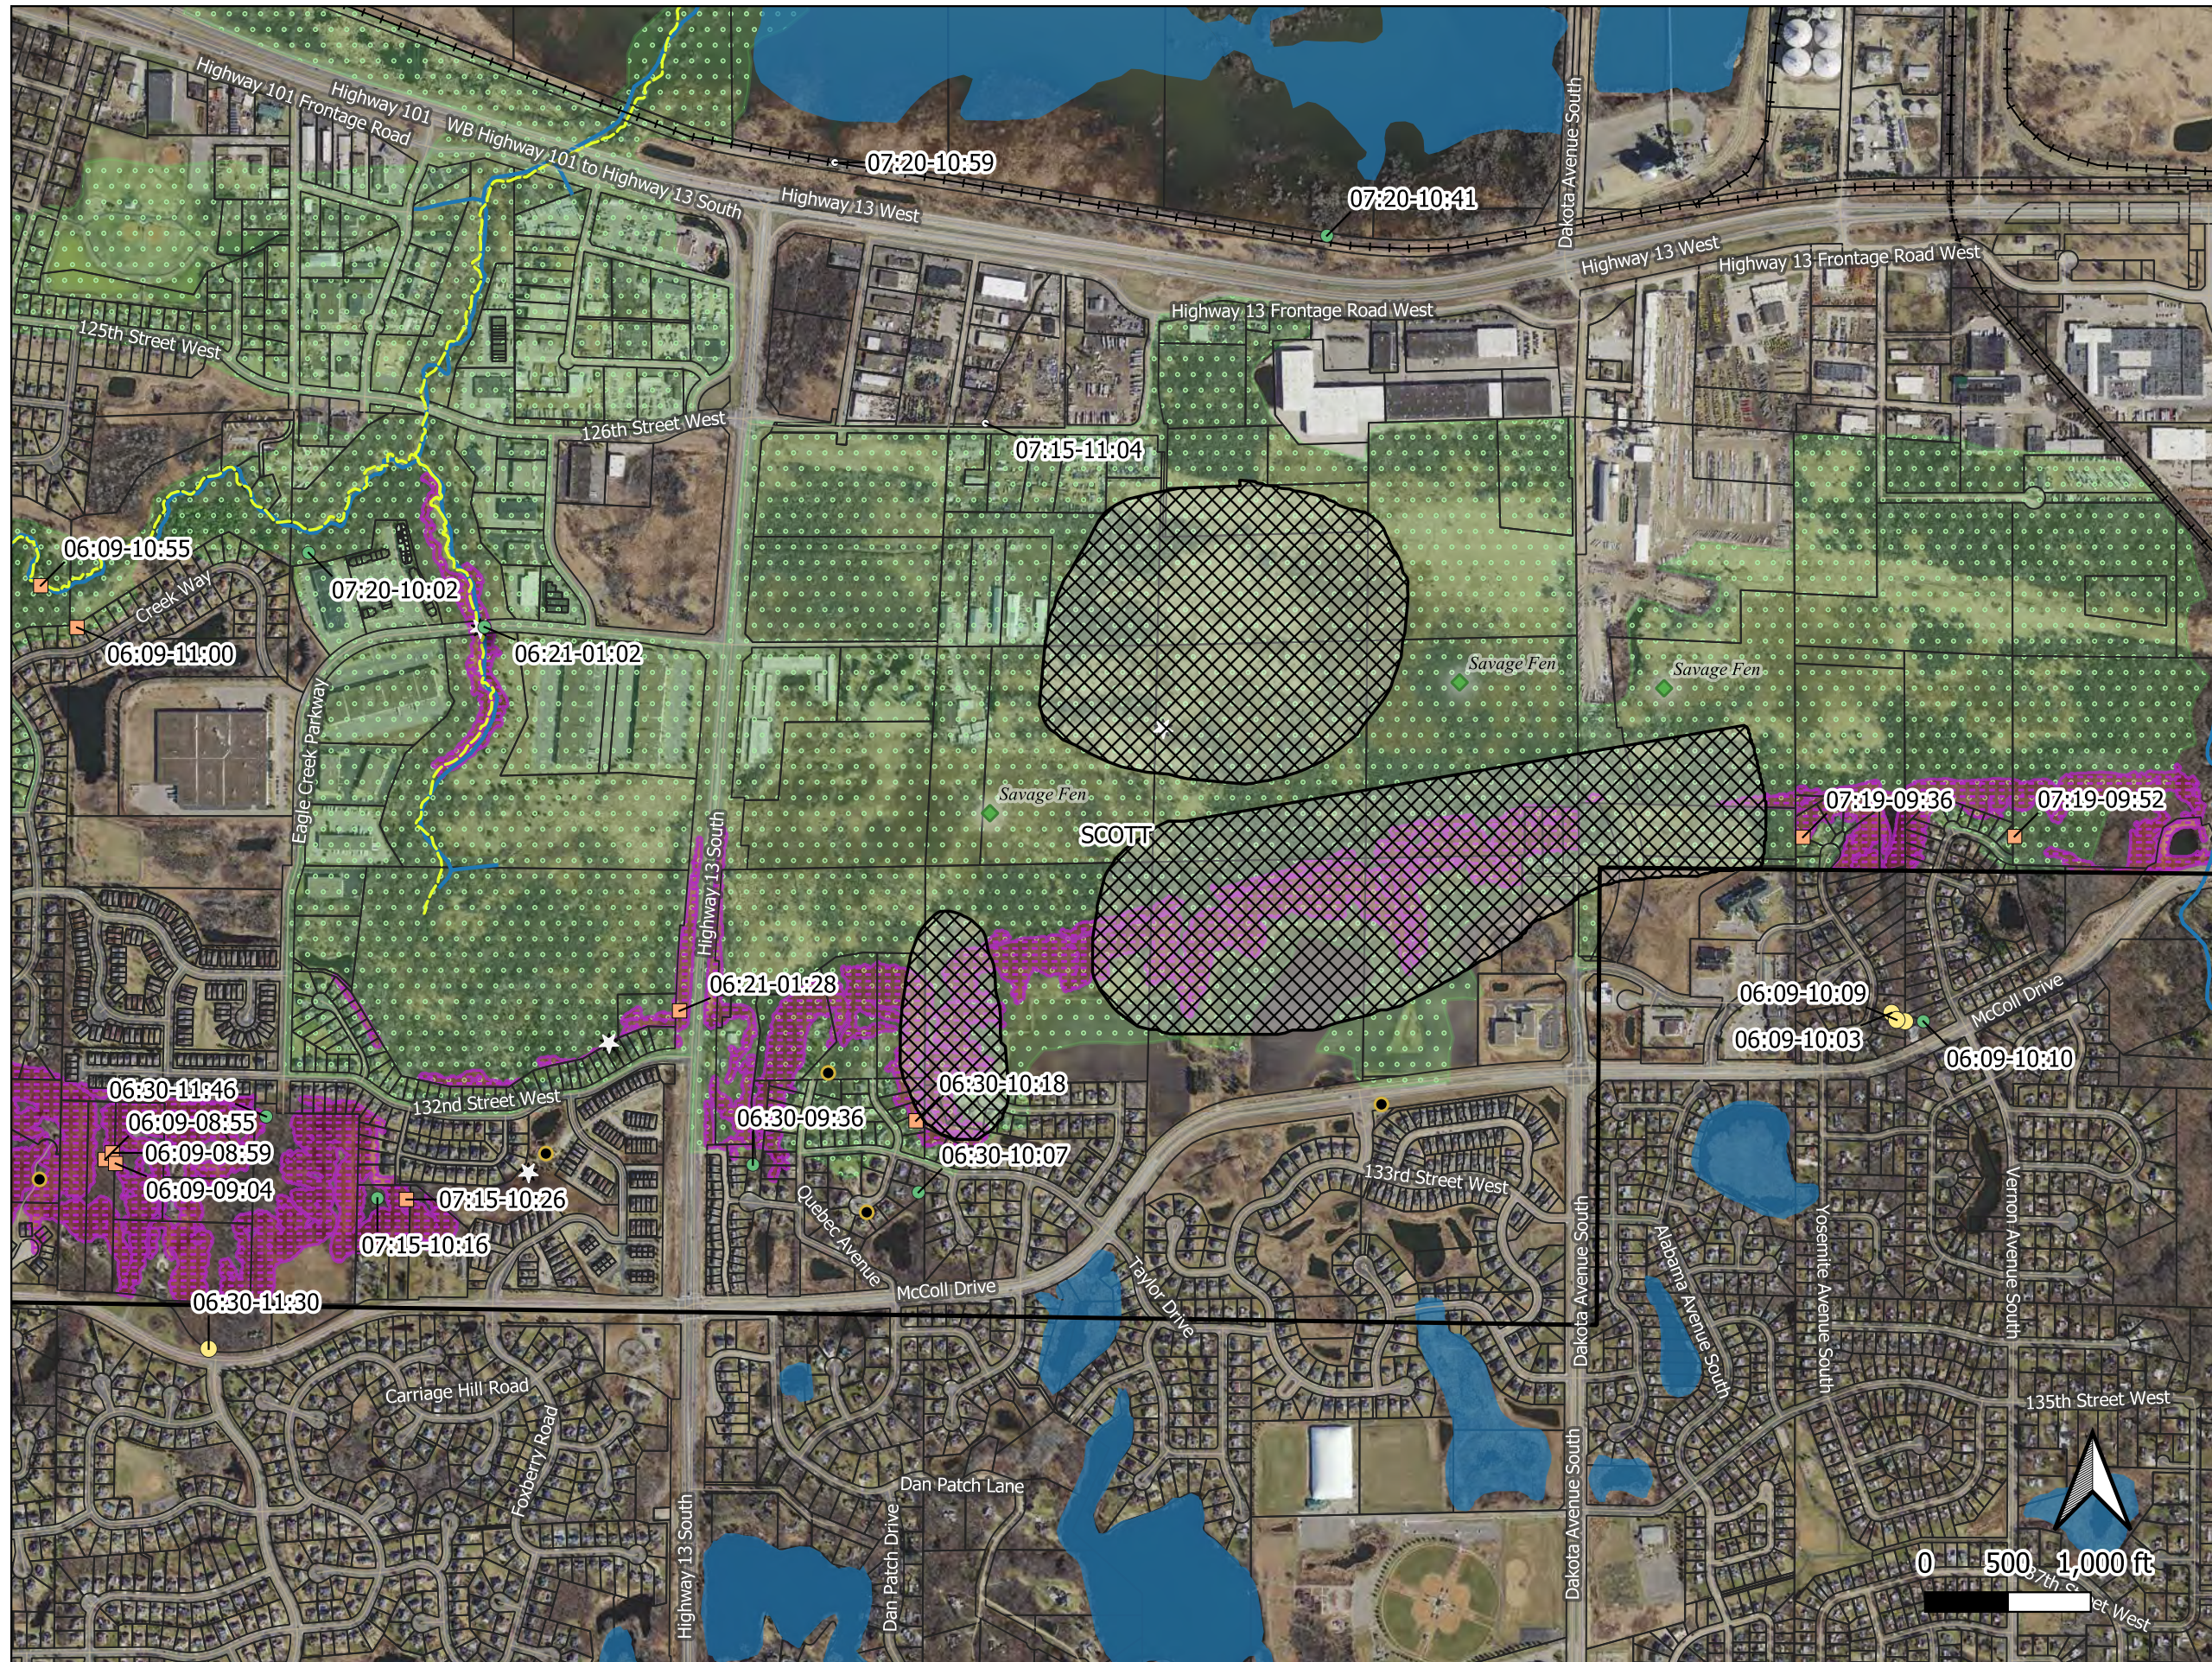
Figure 39: Savage Bluffs HPR

The Savage Bluff area includes the southern border of the LMRWD within Savage and the bluffs that drop down into the Savage Fen Natural Science Area (Figure 39). Many high-risk gullies were identified in this area; however, none were classified as VHR. An example of one of these high-risk gullies appears below and in Figure 40.

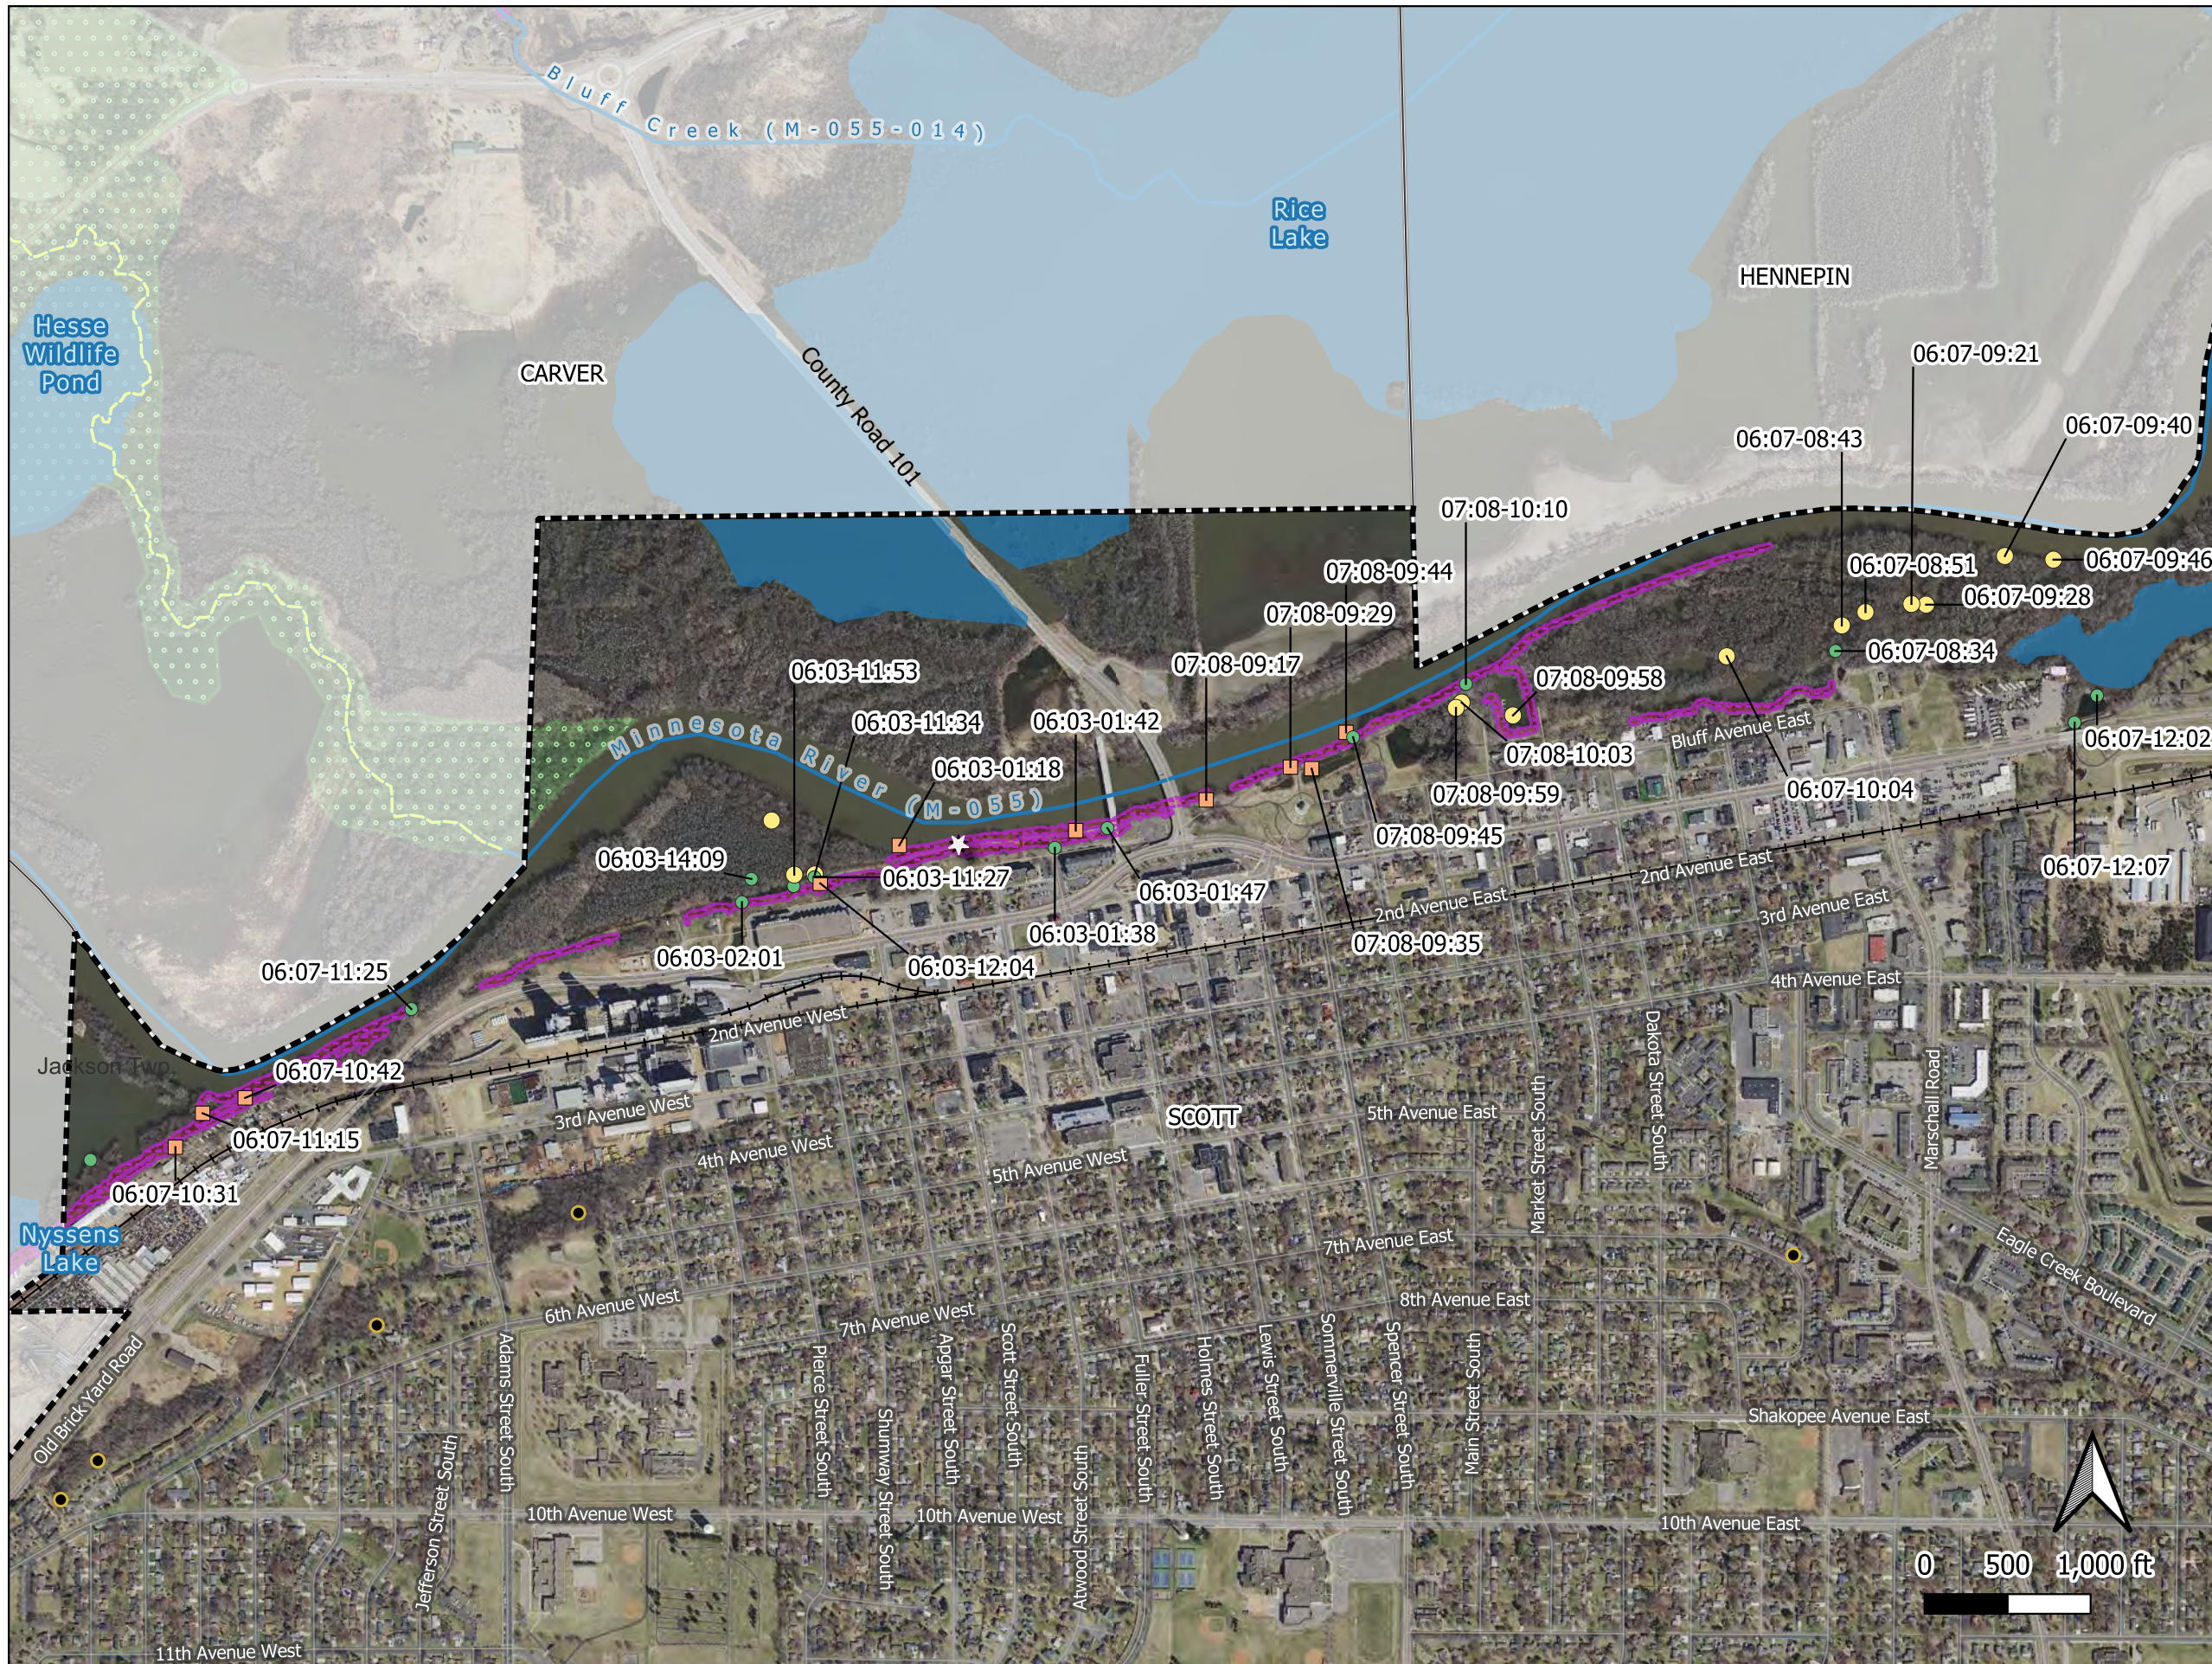
Figure 42: Shakopee Bluffs HPR

These gullies represent areas within Shakopee that are adjacent to the Minnesota River and subject to periodic flooding from it (Figure 42). At the time of observation, the Minnesota River was at historically low levels; future evaluation of the gullies near the Minnesota River should occur during higher river levels to determine whether these sites are true gullies and not backwater channels to the Minnesota River.

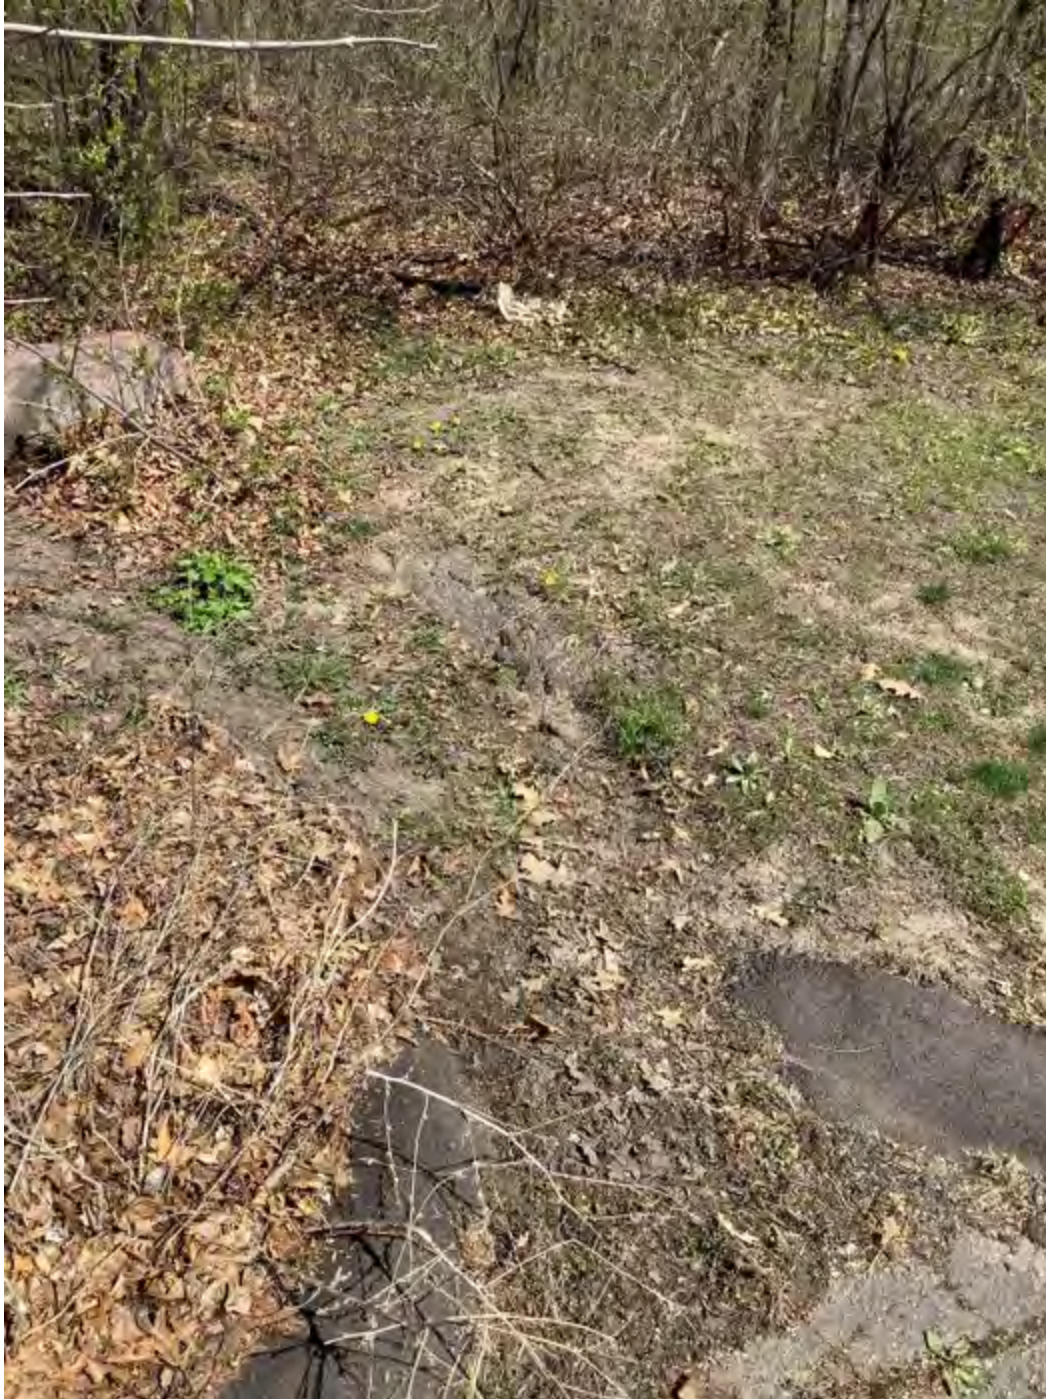
GULLY ID: ESPM Site 6

PREVIOUS WAYPOINT ID: Site 6	
SURVEY DATE: April 22, 2021 12:04 PM	
LOCATION:	
TYPE OF SITE: Gully	
SITE SUMMARY: Sunny Rain in previous 24 hours: Yes: Low Intensity, No Along a Road Long: >100' gully. The problem indicators were: Degradation, Aggradation, Flattened and/or slumping banks (widening), undercut or overhanging banks (lateral scouring), pistol-butted or leaning trees	Gully Head UTM Estimation: 30 ft, Observation Point correction, if applicable: 15T4674994956382 Connections to other points, if applicable:
GULLY INFORMATION	
EROSION POTENTIAL:	High
GULLY DEPTH:	Shallow: <3'
BOTTOM WIDTH:	Narrow/V Ditch, Medium: 1'-5'
TOP WIDTH:	Medium: 5'-10', Narrow: 1'-5'
BANK CONDITION:	Some Vegetation
BOTTOM CONDITION:	Some Vegetation
CHANNEL SLOPE:	Steep
GULLY SHAPE:	U-shaped
GULLY MATERIAL:	Gravel/cobble/ boulders , Sand, Fine-grained cohesive
WATER LEVELS	None, N/A
SEEP	No
APPARENT CAUSES:	Slope, Unstable drainage feature entering system

ADDITIONAL NOTES: Near site 6 Invasive Species? None Type: Burdock, None Debris? Little trash Existing Stabilization? Rip rap or burlap under rocks at top of gully Success: No

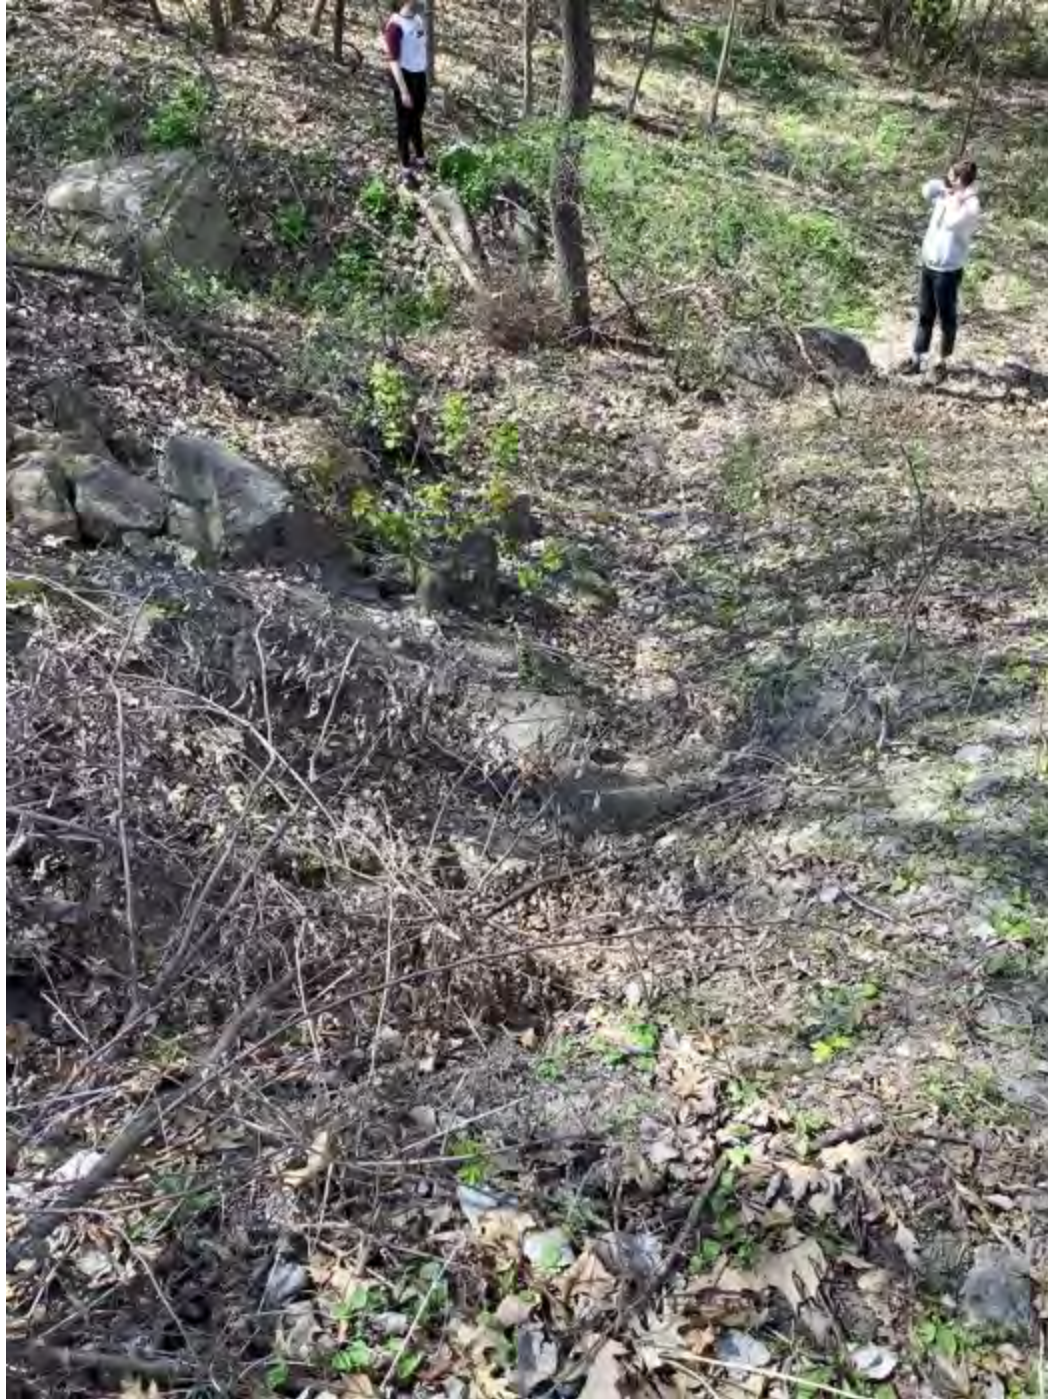
GULLY ID: ESPM Site 11	  <p style="text-align: center;">Gully Head UTM Estimation: 20 feet,</p> <p style="text-align: center;">Observation Point correction, if applicable:</p> <p style="text-align: center;">Connections to other points, if applicable:</p>
PREVIOUS WAYPOINT ID: Site 11	
SURVEY DATE: April 22, 2021 1:29 PM	
LOCATION: Savage	
TYPE OF SITE: Gully	
SITE SUMMARY: Sunny Rain in previous 24 hours: No Along a Road Medium: 50'-100' gully. The problem indicators were: Degradation, Aggradation, Loss of Bank Vegetation, Vertical and/or bare banks (incision), Flattened and/or slumping banks (widening)	
GULLY INFORMATION	
EROSION POTENTIAL:	High
GULLY DEPTH:	Shallow: <3'
BOTTOM WIDTH:	Medium: 1'-5'
TOP WIDTH:	Narrow: 1'-5'
BANK CONDITION:	Some Vegetation
BOTTOM CONDITION:	Bare Soil
CHANNEL SLOPE:	Steep
GULLY SHAPE:	V-shaped
GULLY MATERIAL:	Sand, Fine-grained cohesive
WATER LEVELS	None, N/A
SEEP	No
APPARENT CAUSES:	Slope, Unstable drainage feature entering system , Channel Incision

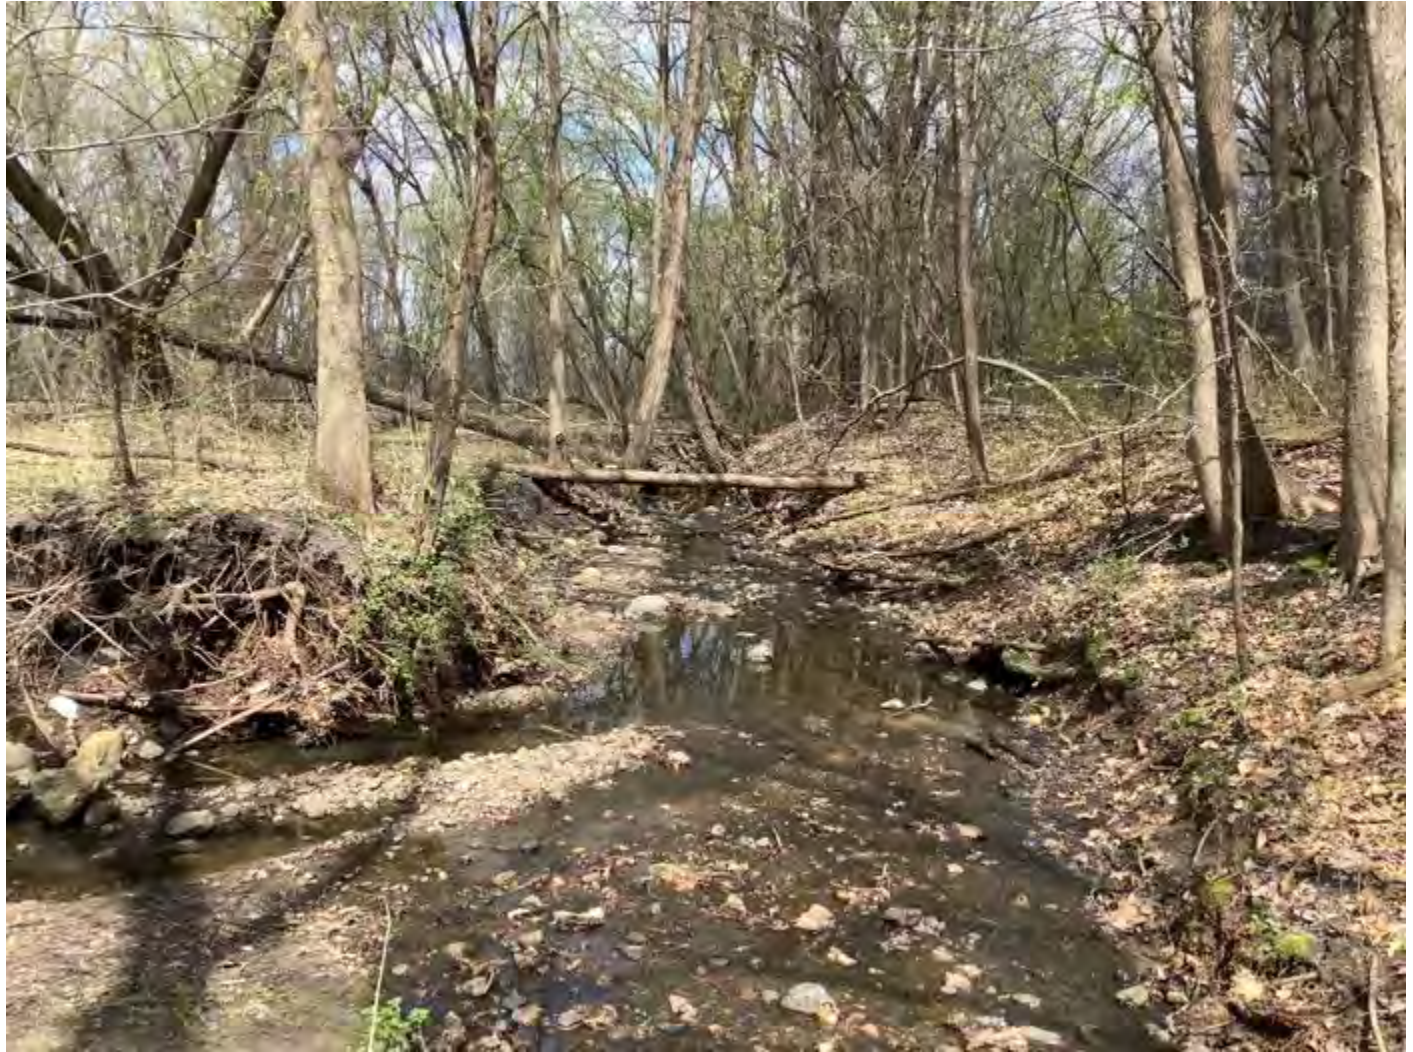
GULLY ID: ESPM Site 22

PREVIOUS WAYPOINT ID:	
SURVEY DATE: April 17, 2021 2:26 PM	
LOCATION:	
TYPE OF SITE: Gully	
SITE SUMMARY: Sunny Rain in previous 24 hours: No Heavily Forested Long: >100' gully. The problem indicators were: Loss of Bank Vegetation, undercut or overhanging banks (lateral scouring)	Gully Head UTM Estimation: 20, Observation Point correction, if applicable: Connections to other points, if applicable:
GULLY INFORMATION	
EROSION POTENTIAL:	Low
GULLY DEPTH:	Shallow: <3'
BOTTOM WIDTH:	Wide: >5'
TOP WIDTH:	Wide: >10'
BANK CONDITION:	Some Vegetation
BOTTOM CONDITION:	Armored
CHANNEL SLOPE:	Steep
GULLY SHAPE:	U-shaped
GULLY MATERIAL:	Gravel/cobble/ boulders
WATER LEVELS	Low, Slow
SEEP	No
APPARENT CAUSES:	None/Unknown
ADDITIONAL NOTES: 8ft storm drain outlet creates stream Invasive Species? Medium Type: Common Buckthorn Debris? Some Existing Stabilization? N/a Success: N/A

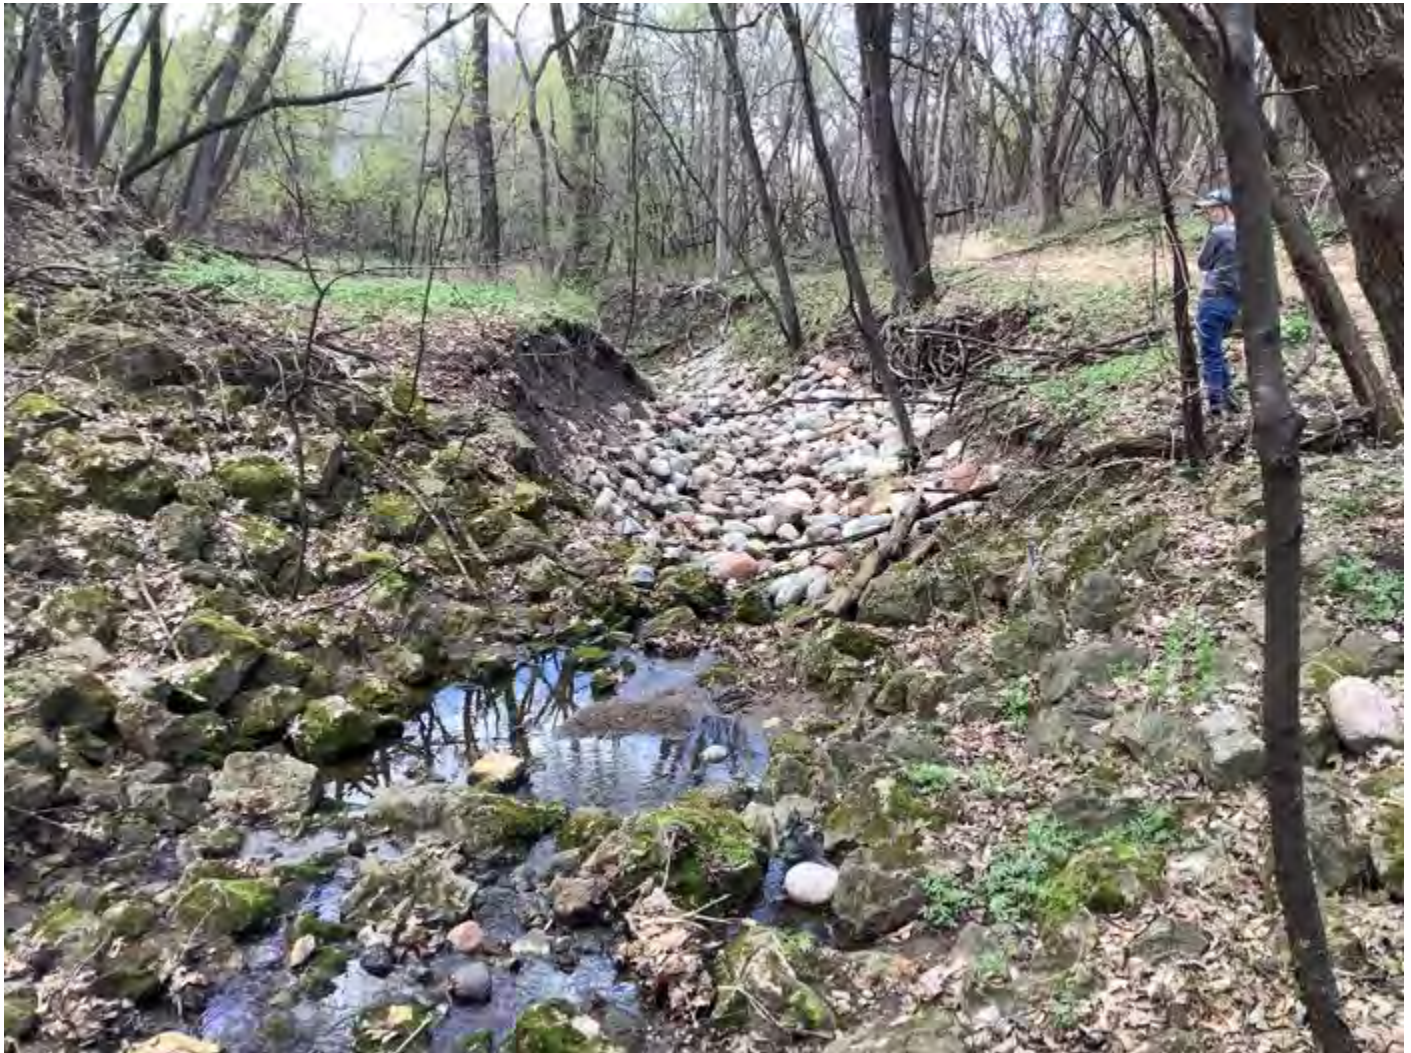
Right off road access

PREVIOUS WAYPOINT ID:	
SURVEY DATE: April 17, 2021 2:12 PM	
LOCATION:	
TYPE OF SITE: Gully	
SITE SUMMARY: Sunny Rain in previous 24 hours: No Off of Walking Trail Long: >100' gully. The problem indicators were: Degradation, Loss of Bank Vegetation, Vertical and/or bare banks (incision), pistol-butted or leaning trees	Gully Head UTM Estimation: 100ft, Observation Point correction, if applicable: Connections to other points, if applicable:
GULLY INFORMATION	
EROSION POTENTIAL:	High
GULLY DEPTH:	Shallow: <3'
BOTTOM WIDTH:	Wide: >5'
TOP WIDTH:	Wide: >10'
BANK CONDITION:	Bare Soil
BOTTOM CONDITION:	Some Vegetation
CHANNEL SLOPE:	Flat
GULLY SHAPE:	U-shaped
GULLY MATERIAL:	Gravel/cobble/ boulders
WATER LEVELS	Low, Slow
SEEP	Yes
APPARENT CAUSES:	Slope, Scour from debris jam or other channel obstruction, Channel Incision, Dense Canopy
ADDITIONAL NOTES: In wildlife refuge and disappears after entering hidden pipe, couldn't find outlet Invasive Species? Medium Type: Common Buckthorn Debris? No Existing Stabilization? Boulders on slopes (pictured) Success: Yes
