2021 GULLY INVENTORY AND CONDITION ASSESSMENT, VOLUME 2

July 15, 2022

Lower Minnesota River Watershed District
Gully Inventory and Condition Assessment, Volume 2
Chaska, Minnesota

Revision 0
July 15, 2022

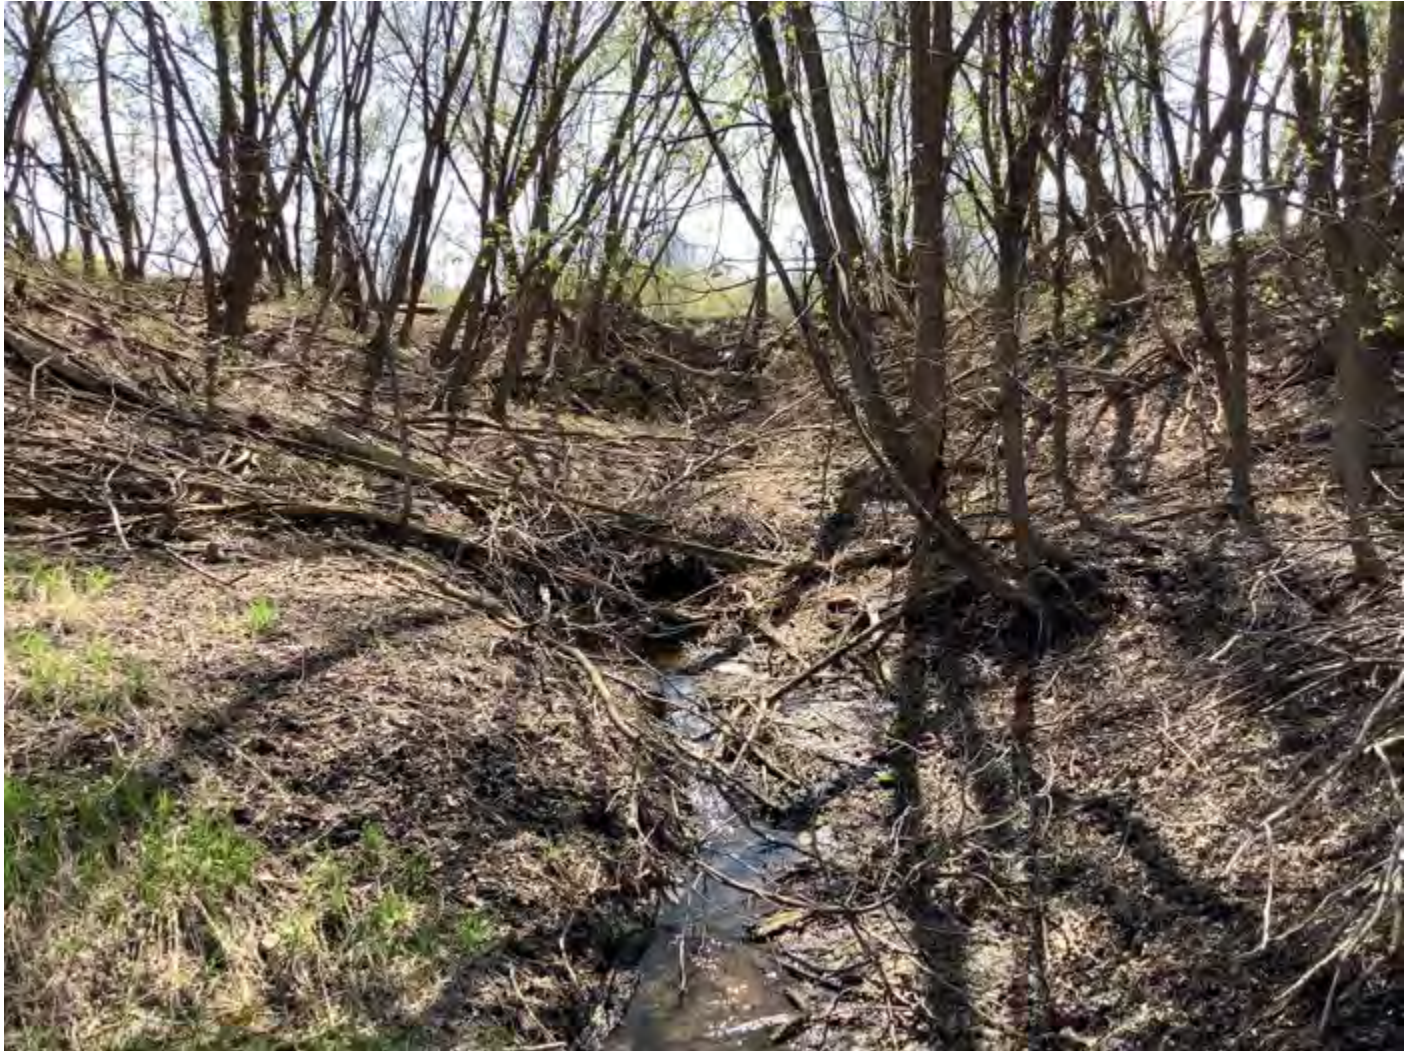
Top

PREVIOUS WAYPOINT ID:	
SURVEY DATE: April 17, 2021 12:47 PM	
LOCATION:	
TYPE OF SITE: Gully	
SITE SUMMARY: Sunny Rain in previous 24 hours: No Along a Road Long: >100' gully. The problem indicators were: None	<p>Gully Head UTM Estimation: 100ftish,</p> <p>Observation Point correction, if applicable:</p> <p>Connections to other points, if applicable: No</p>
GULLY INFORMATION	
EROSION POTENTIAL:	Low
GULLY DEPTH:	Shallow: <3'
BOTTOM WIDTH:	Medium: 1'-5'
TOP WIDTH:	Narrow: 1'-5'
BANK CONDITION:	Heavy Vegetation
BOTTOM CONDITION:	Bare Soil, Heavy Vegetation
CHANNEL SLOPE:	Flat
GULLY SHAPE:	U-shaped
GULLY MATERIAL:	Sand
WATER LEVELS	Low, Slow
SEEP	No
APPARENT CAUSES:	None/Unknown
ADDITIONAL NOTES:	
Invasive Species? None Type: None	
Debris? No	
Existing Stabilization? NONE Success: N/A

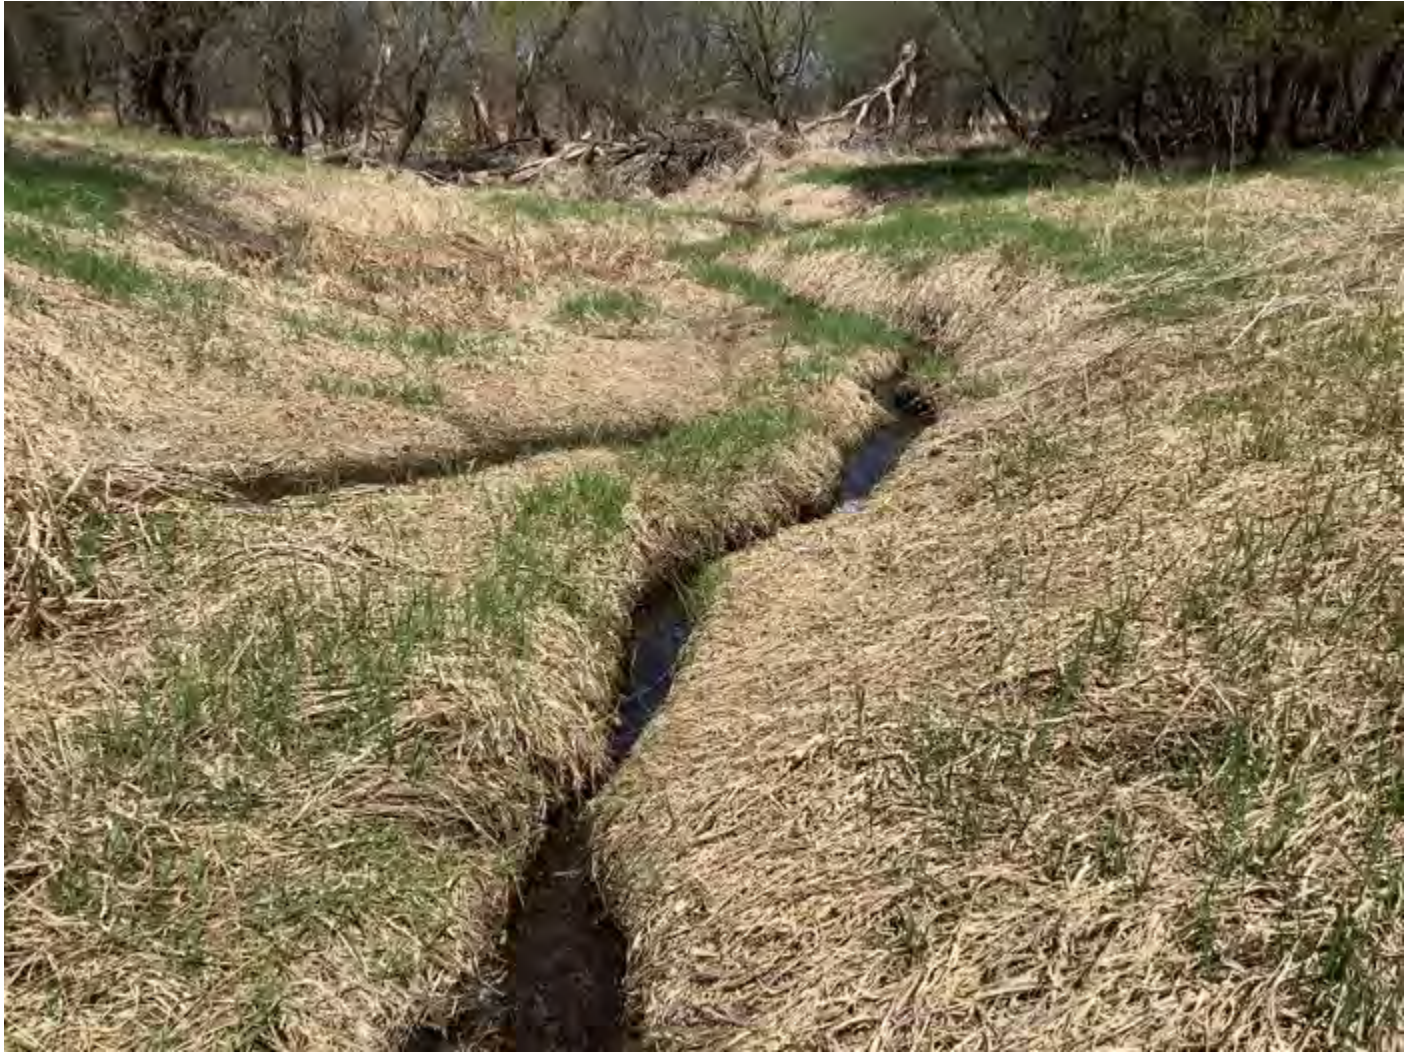
What rest of stream looks like

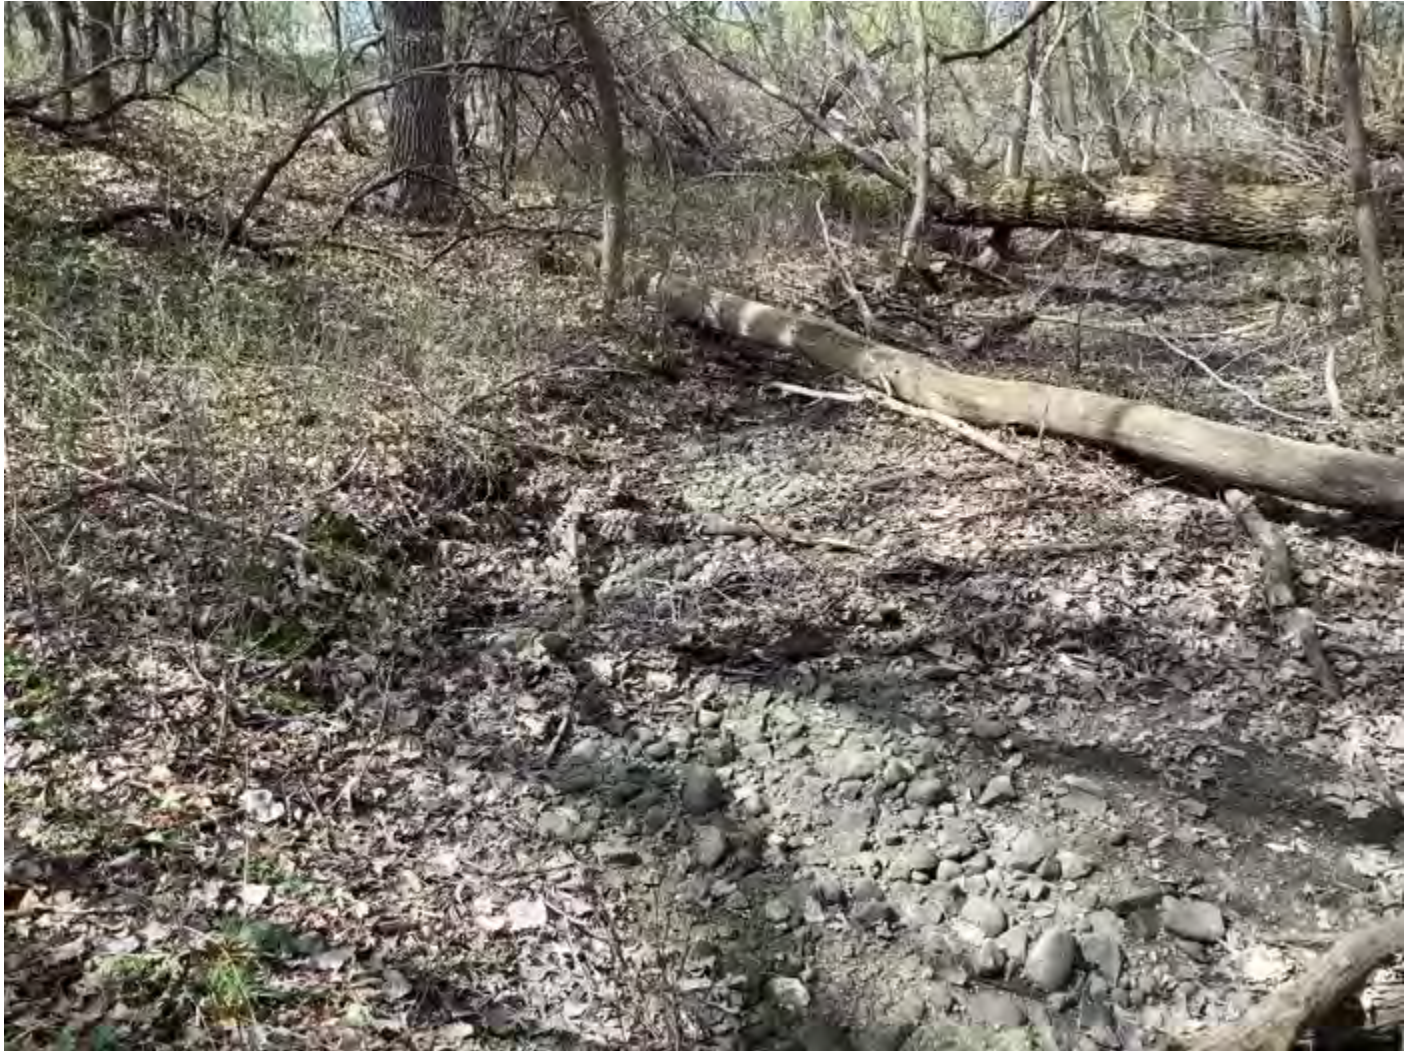
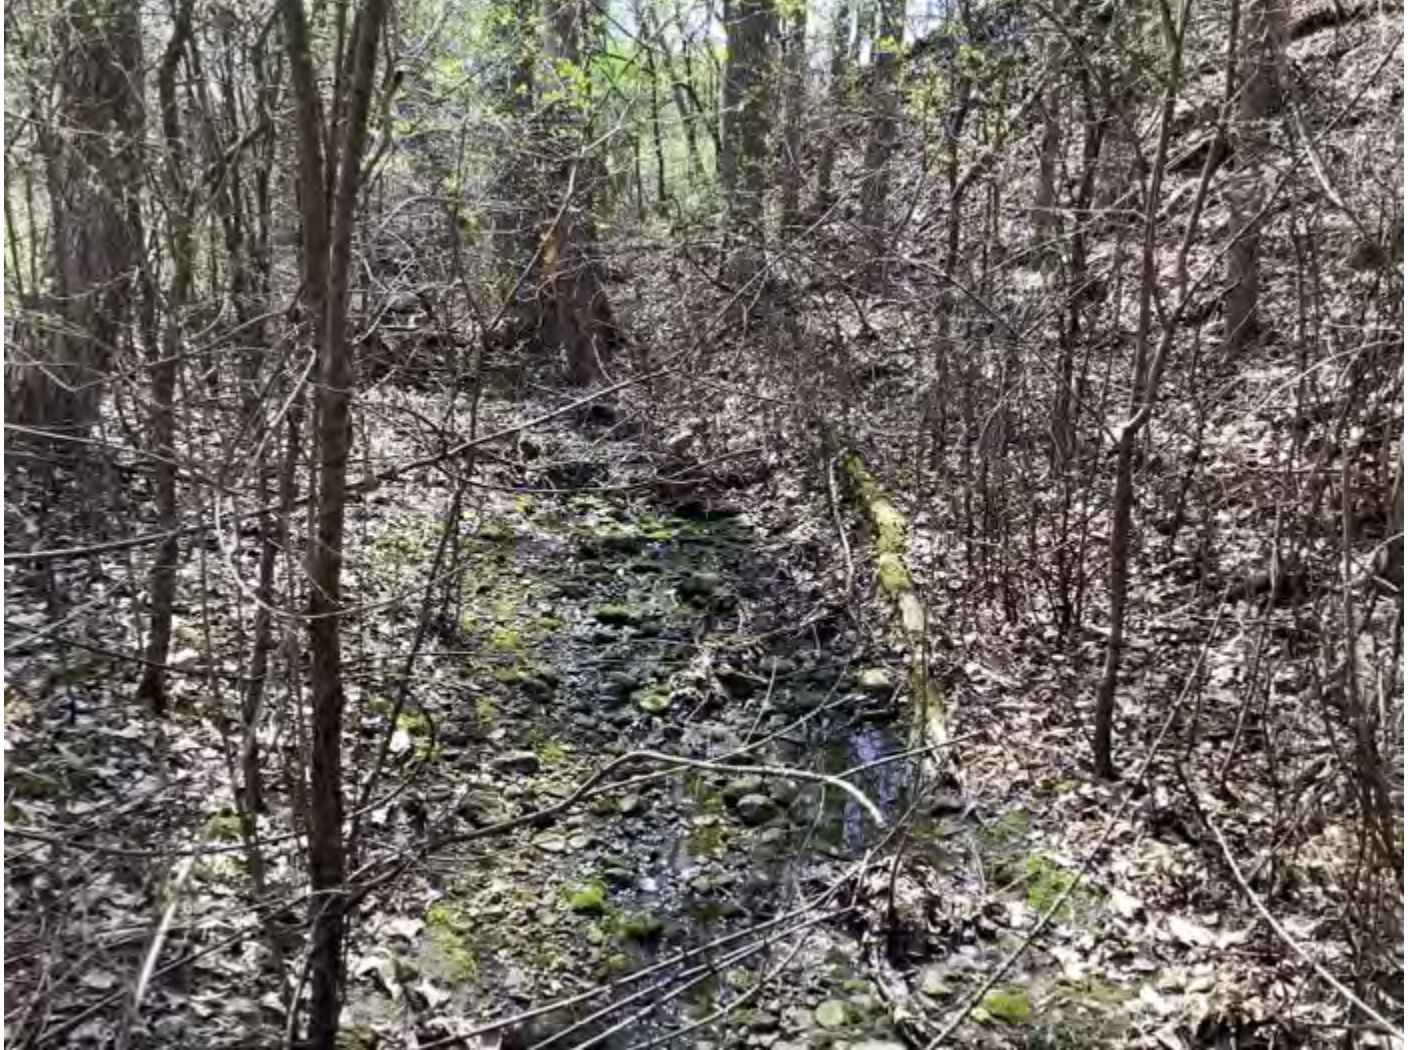
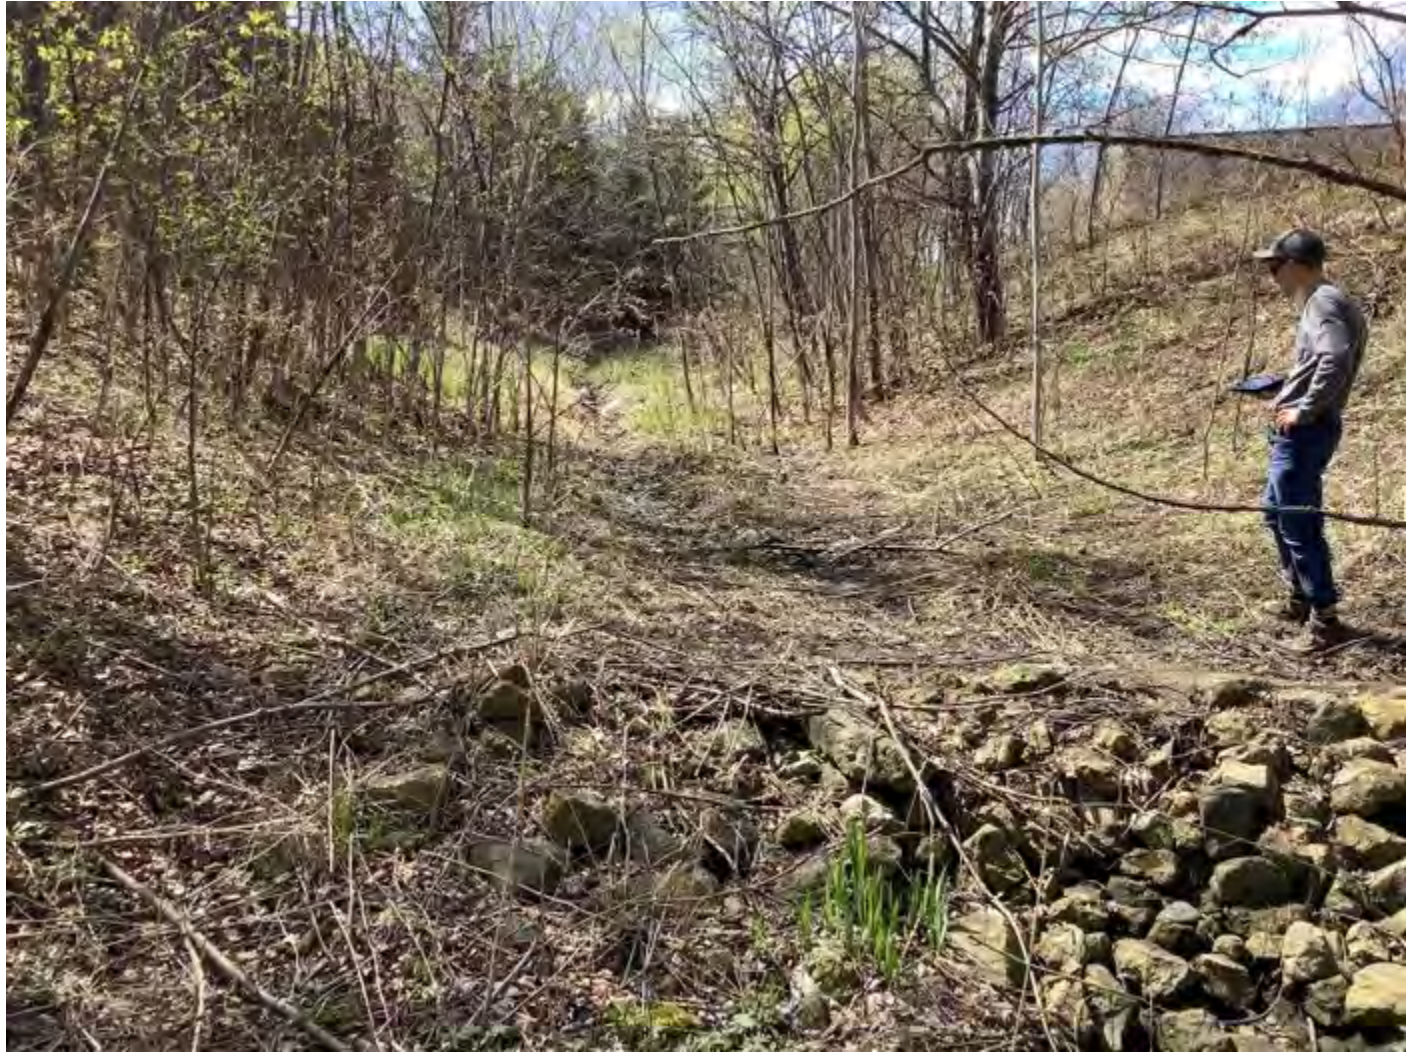
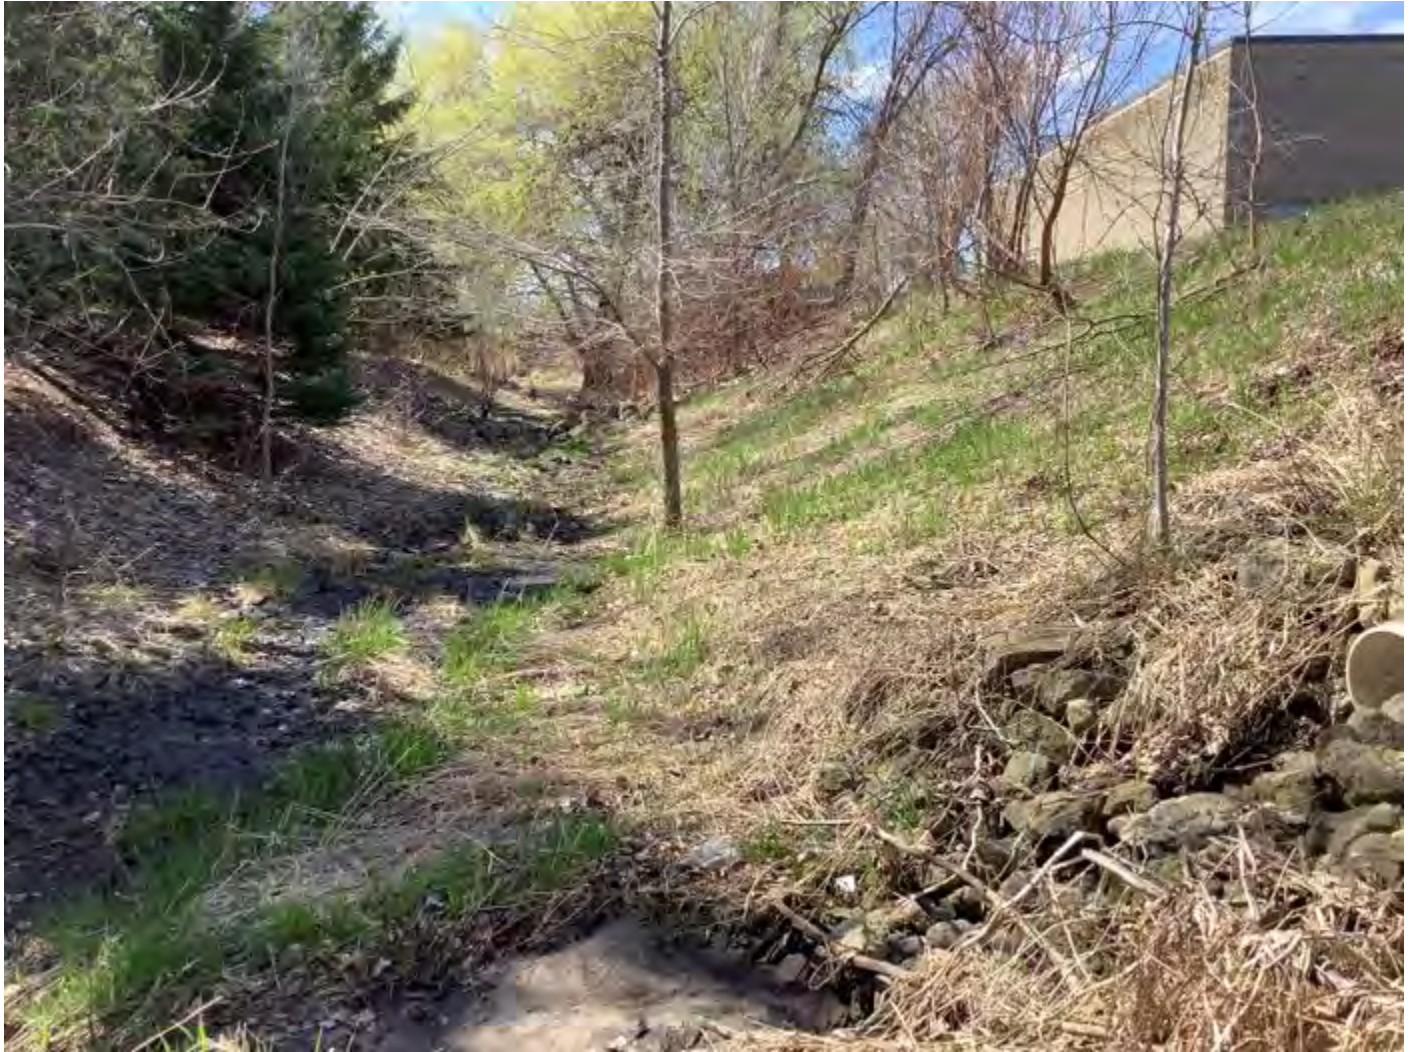
GULLY ID: ESPM Site 28

PREVIOUS WAYPOINT ID:	
SURVEY DATE: April 17, 2021 12:18 PM	
LOCATION:	
TYPE OF SITE: Gully	
SITE SUMMARY: Sunny Rain in previous 24 hours: No Along a Road Long: >100' gully. The problem indicators were: None	<p>Gully Head UTM Estimation: 100ft,</p> <p>Observation Point correction, if applicable:</p> <p>Connections to other points, if applicable: We had two locations which are the same gully</p>
GULLY INFORMATION	
EROSION POTENTIAL:	Low
GULLY DEPTH:	Shallow: <3'
BOTTOM WIDTH:	Medium: 1'-5'
TOP WIDTH:	Wide: >10'
BANK CONDITION:	Heavy Vegetation
BOTTOM CONDITION:	Armored
CHANNEL SLOPE:	Flat
GULLY SHAPE:	U-shaped
GULLY MATERIAL:	Gravel/cobble/ boulders
WATER LEVELS	None, N/A
SEEP	No
APPARENT CAUSES:	None/Unknown
ADDITIONAL NOTES:	
<p>Part of the stormwater drainage system, looks like it receives heavy flow during storm events but it's in great shape. Gully empties into wetland where it joins wastewater treatment outflow.</p> <p>Invasive Species? Low</p> <p>Type: Common Buckthorn</p> <p>Debris? Not much trash, some</p> <p>Existing Stabilization? Rip rap with energy dissipation Boulder piles (pictured) also one erosion control log</p> <p>Success: Yes</p>
