LOWER MINNESOTA RIVER WATERSHED DISTRICT

Item 7. E. – 2025 Gully Inventory – Post Field Assessment Summary

Re: 2025 Gully Inventory – Post-Field Assessment Summary

2023 Gully Inventory and Condition Assessment Project

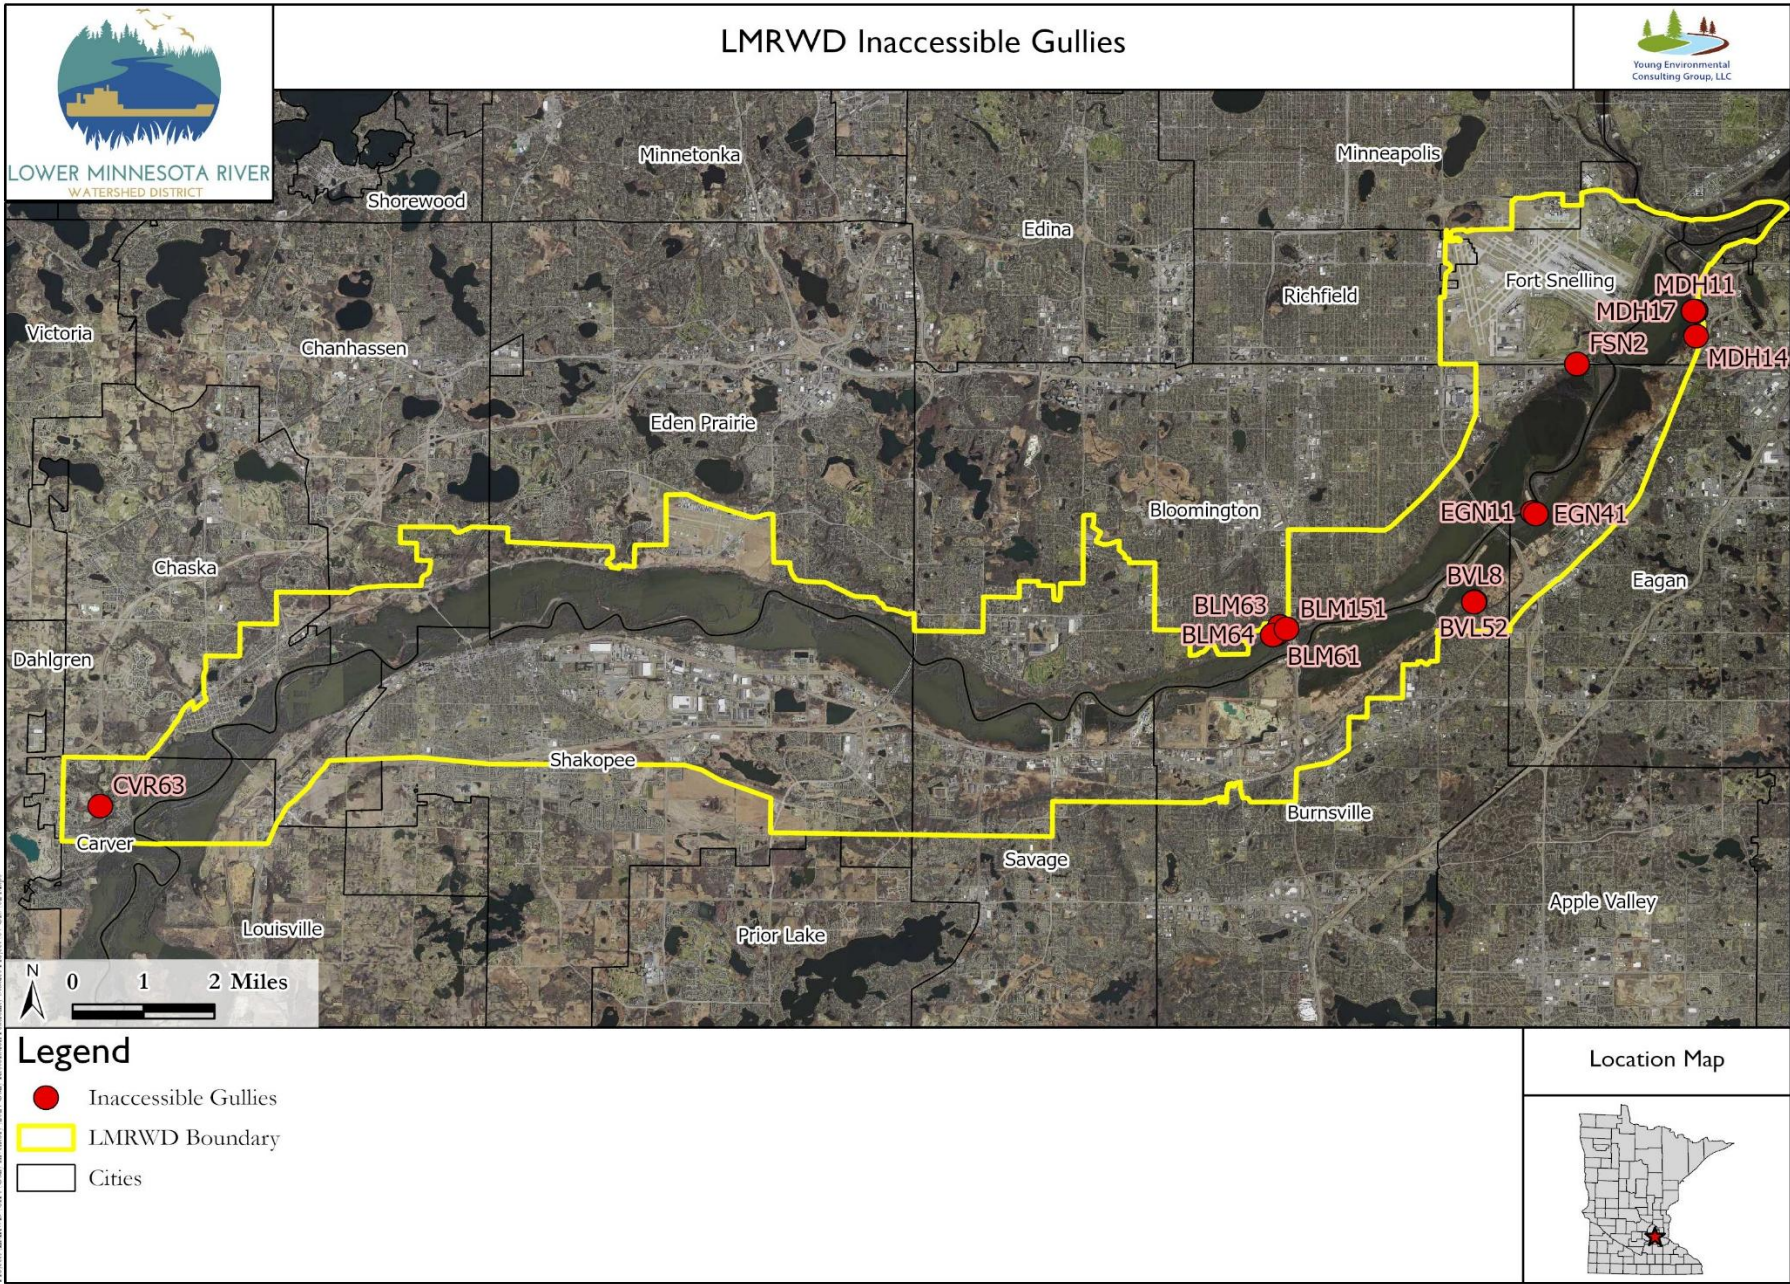
Figure 1. Previously Inaccessible Gullies Surveyed in 2025

EGN11 and 49 were the only gullies field staff were not able to access. GPS pinpoints the location of these gullies within the Minnesota River, suggesting that the coordinates are inaccurate

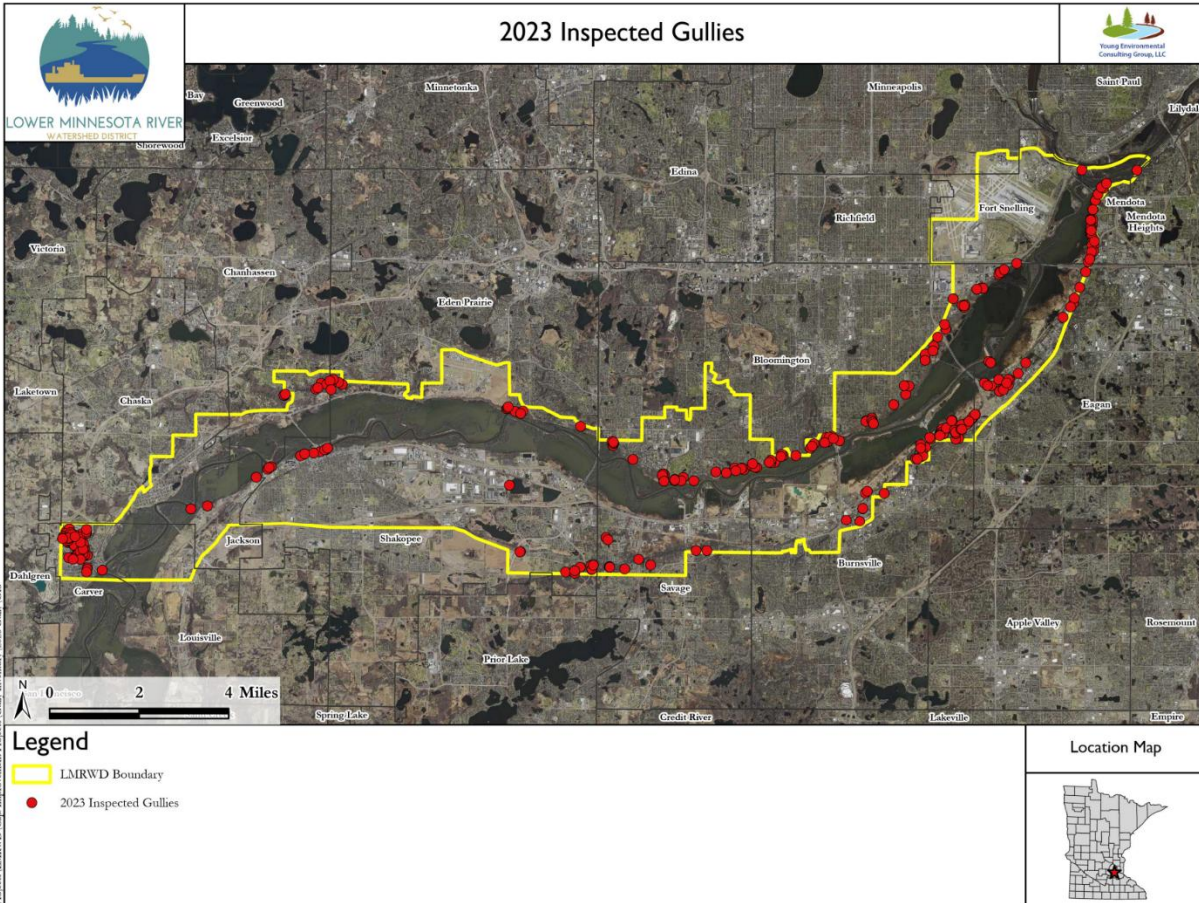
Figure 1. Map of all gully sites assessed during the 2023 Gully Inventory within the LMRWD boundary

The project team planned to visit a total of 315 gully sites over the course of 5 weeks (Figure 1) and compiled a fieldwork plan spreadsheet that included site information, site access points, and planned visit dates to ensure all sites would be evaluated within the project timeline. The project team decided to include six additional questions in Survey123 to help evaluate the overall condition of the surveyed gullies and better support the 2023 ranking process (Table 2).

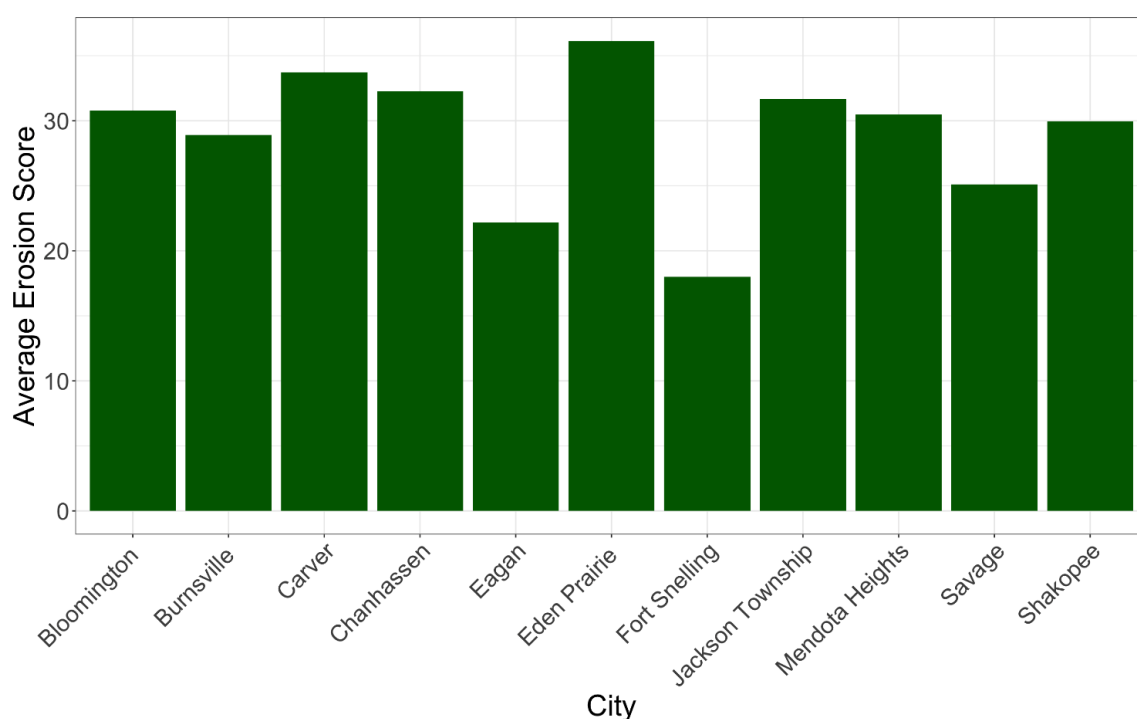
Figure 3. Bar plot of average erosion scores organized by city.

The average erosion potential score, calculated with the Survey123 field assessment, for all gullies surveyed, was 30.5, and the highest and lowest scores were 50 and 8, respectively. The low score of 8 is due to riprap being added and effectively stabilizing the gully. The average erosion potential score per city is shown in Figure 3, where Eden Prairie was shown to have the highest average erosion potential score. This is most likely due to the smaller number of gullies surveyed in Eden Prairie (14) and the location of several within the Richard T. Anderson Conservation Area, where the potential for erosion is very high.

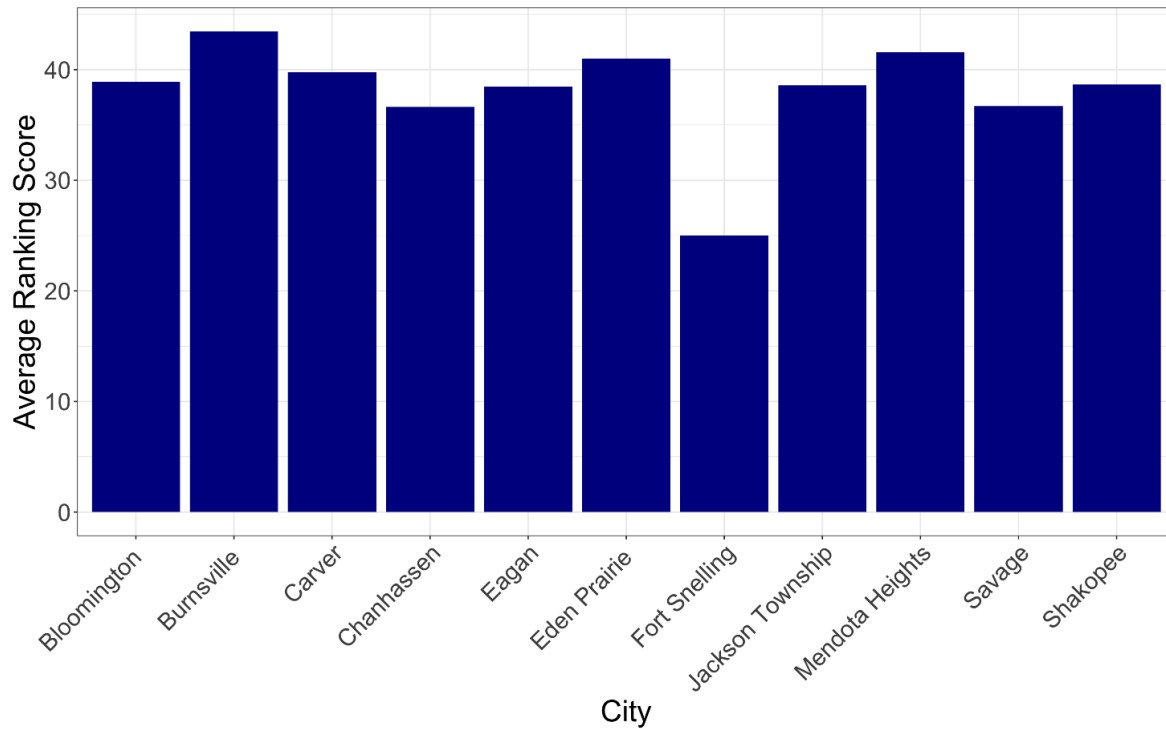
Figure 4. Average Ranking Score by City

The average gully ranking score (which includes the erosion potential score, proximity to LMRWD resources, and quantity of MPCA sites) across all gullies surveyed was 39.8, where the highest and lowest score was 61.5 and 17, respectively. Average ranking score sorted by city is shown in Figure 4, where Burnsville had the highest average ranking score.

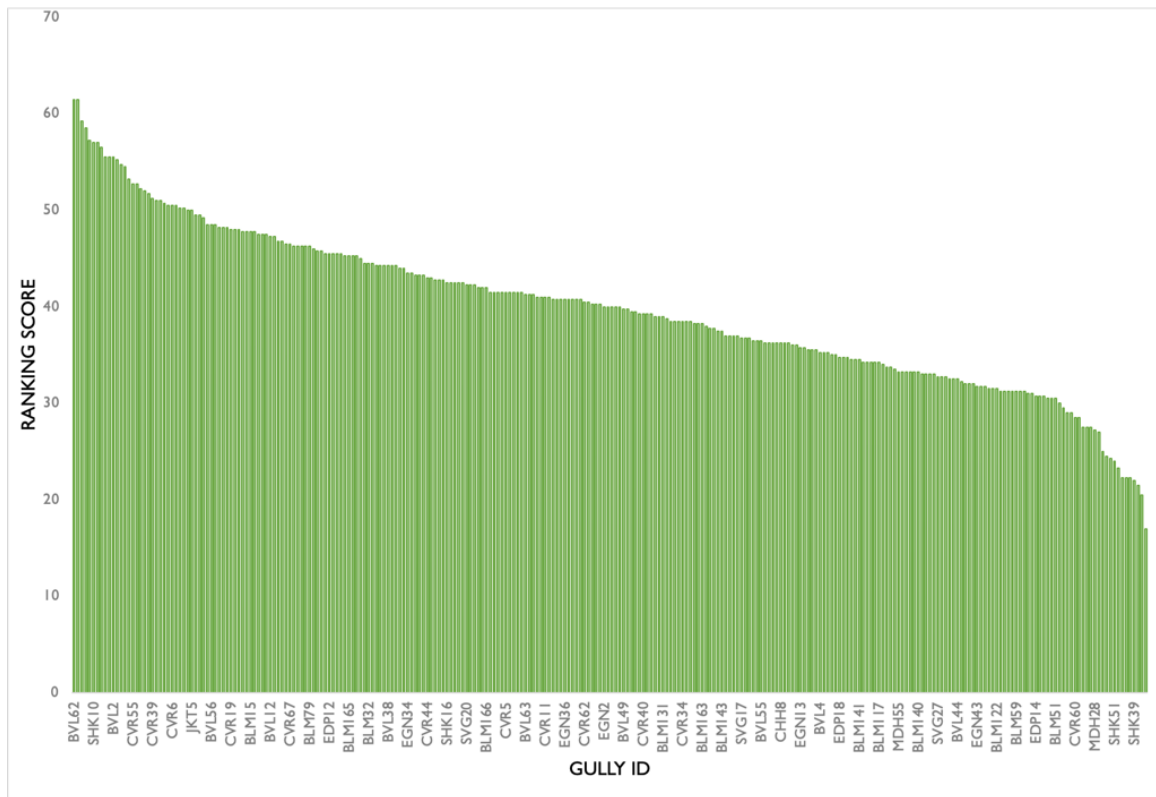
Figure 5. Overall Gully Ranking Scores

The overall ranking scores for each individual gully are plotted in Figure 5 and summarized in the Overall Ranking Score column in Table 3.

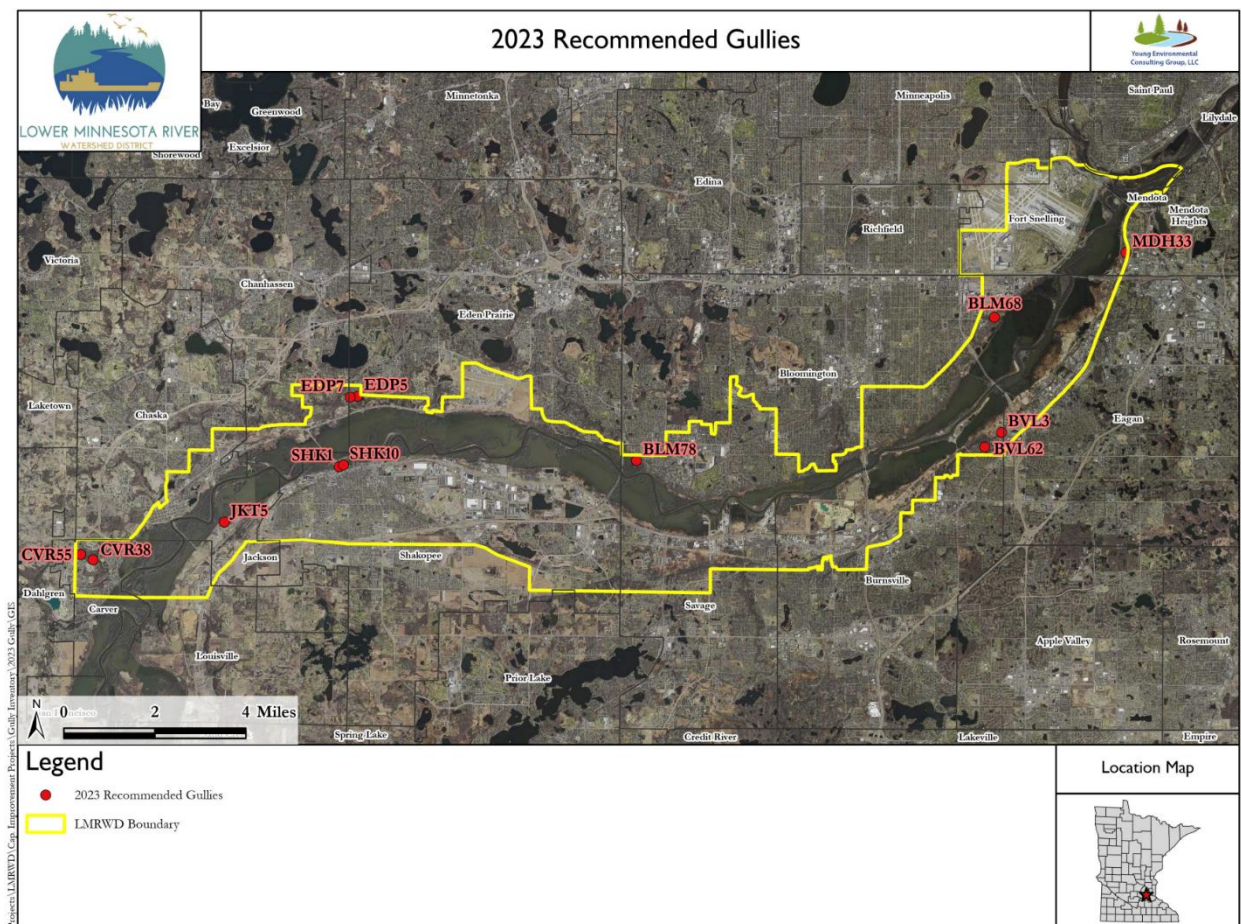
Figure 7. Map of recommended gully sites within the LMRWD boundaries

All gullies that were deemed accessible (details on determining accessibility are included in Appendix B) were categorized into one of four groups including, 1) private property with no safety concerns, 2) private property with safety concerns, 3) public property with no safety concerns, and 4) public property with safety concerns. The gullies were then ranked within their given category (Appendix C). The top three gullies in each category are described in Sections 5.5.1 through 5.5.4. Locations of each gully within the watershed district are shown in Figure 7.
