# LOWER MINNESOTA RIVER WATERSHED DISTRICT

## Executive Summary for Action

**SITE LOCATION:** CSAH 61-Flying Cloud Drive

**PURPOSE:** Construction Stormwater Site Visit on Behalf of the Lower Minnesota River Watershed District (LMRWD)

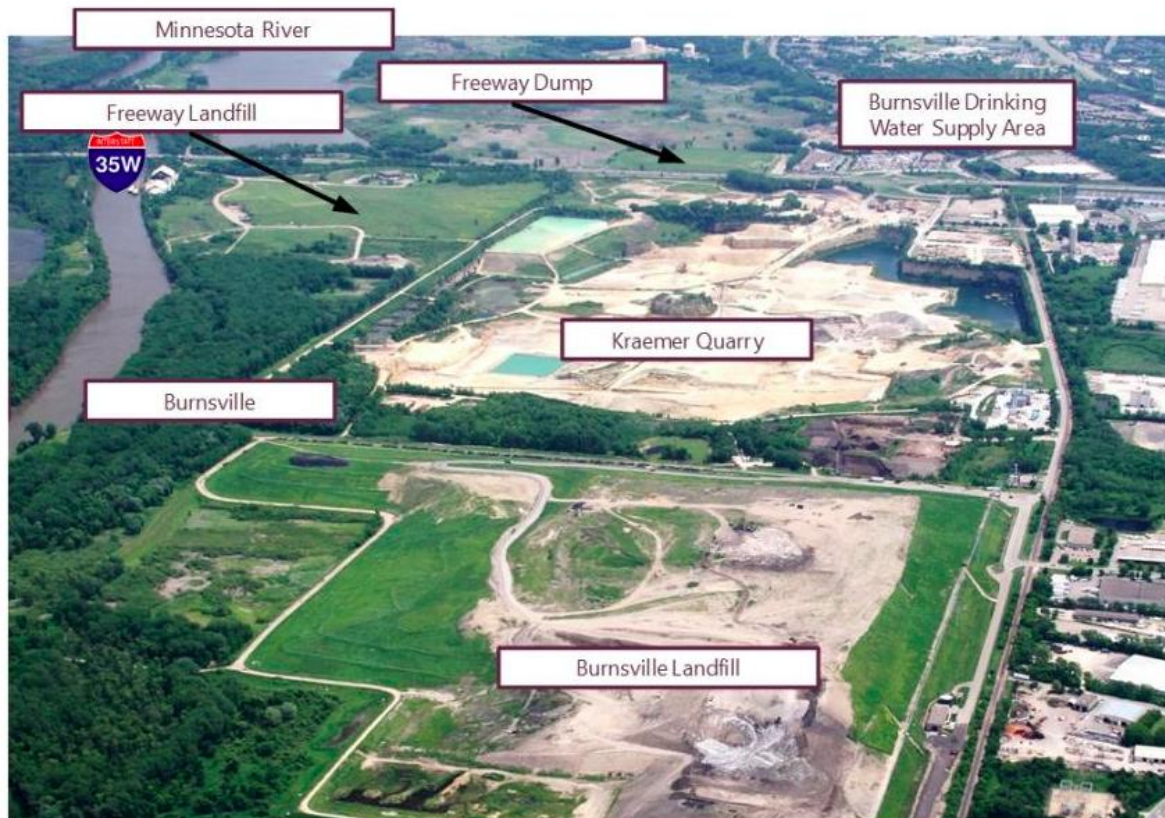
The Freeway Landfill accepted trash from 1969 to 1990. By today's standards, it would not be allowed to operate on a wetland. [Courtesy of Minnesota Pollution Control Agency.](#)

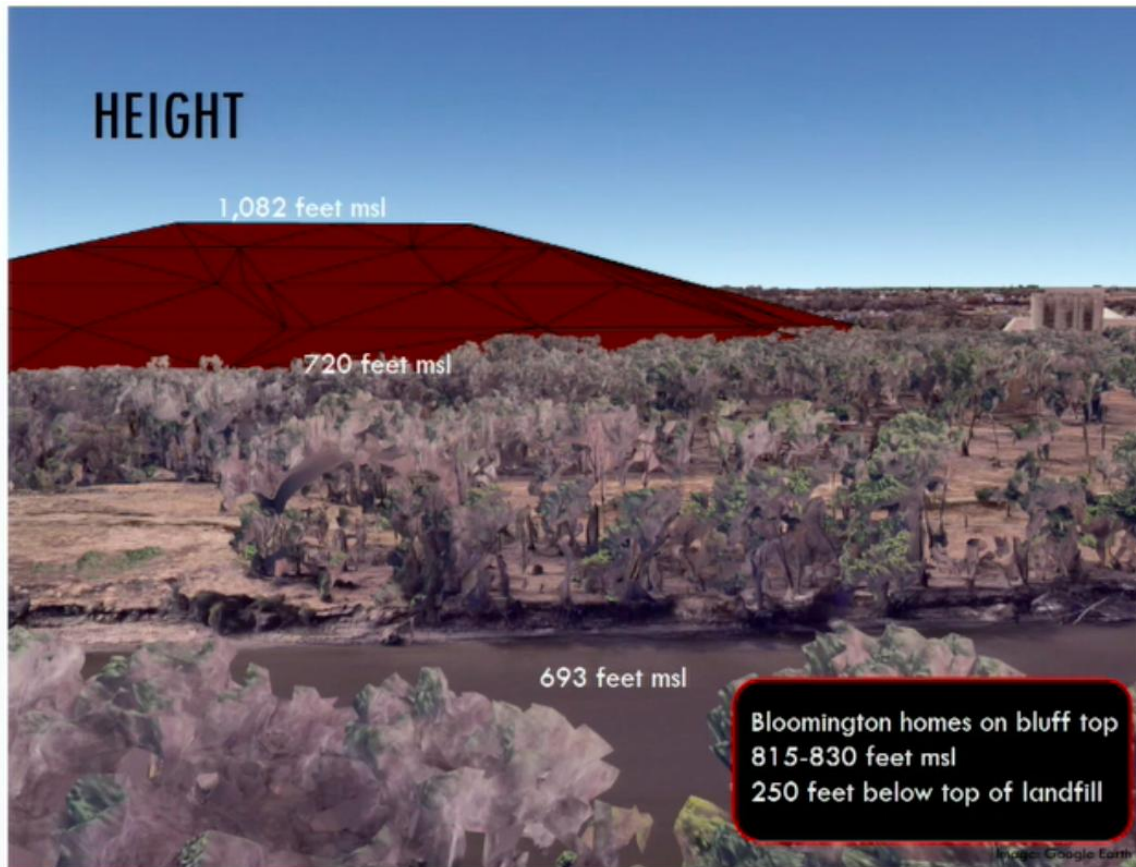
A rendering created by the City of Bloomington using Google Earth illustrates concerns that the landfill mound would become the dominant visual feature of the Minnesota River Valley.
