Gully Inventory Map	Legend		\mathbf{T}
Area #1	LMRWD Boundary (not official)	FEMA Floodway	\mathbb{N}
Lower Minnesota River Watershed District	City/Township Boundary	100-Year FEMA Floodplain	T
Watershed Management Plan	Gully Inventory Locations	500-Year FEMA Floodplain	Not to Scale

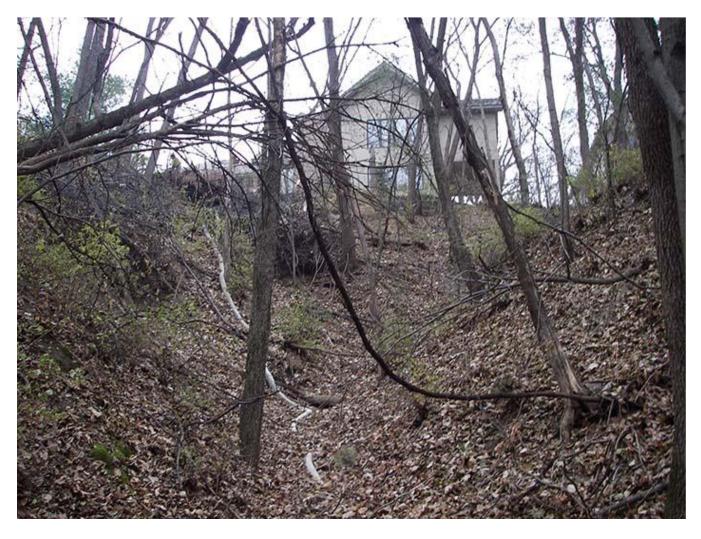
Tree debris; exposed soil.

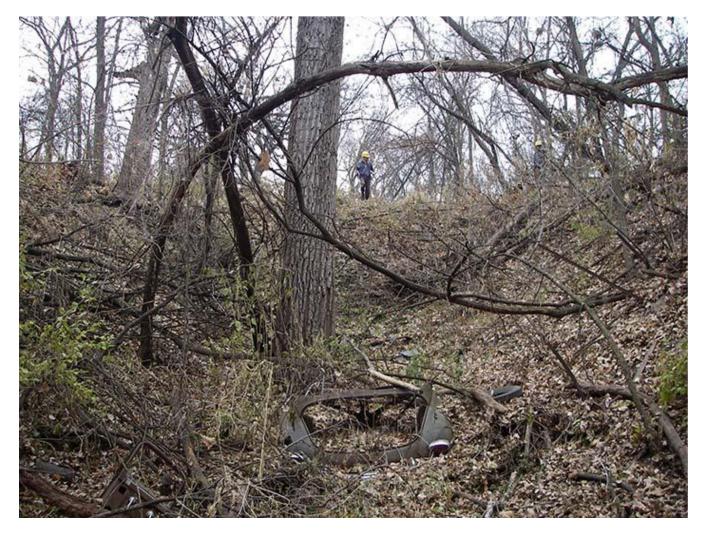
Trash, car, glass, cans

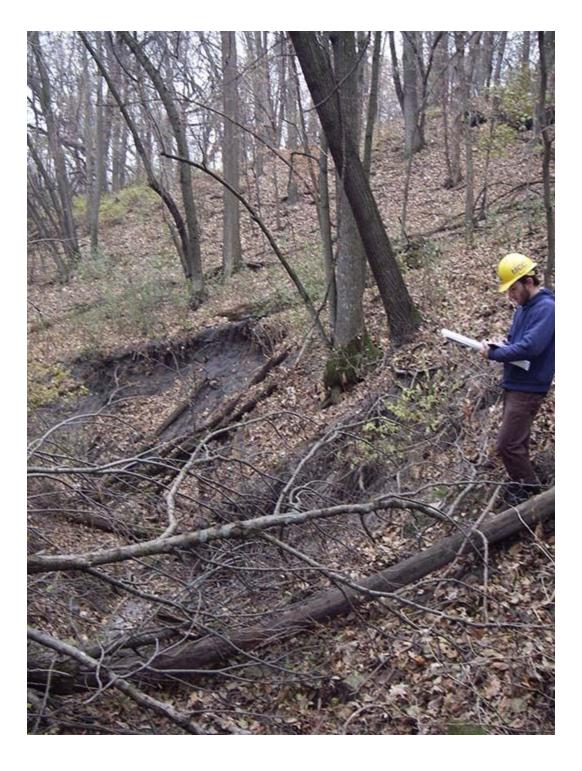
Eroded banks

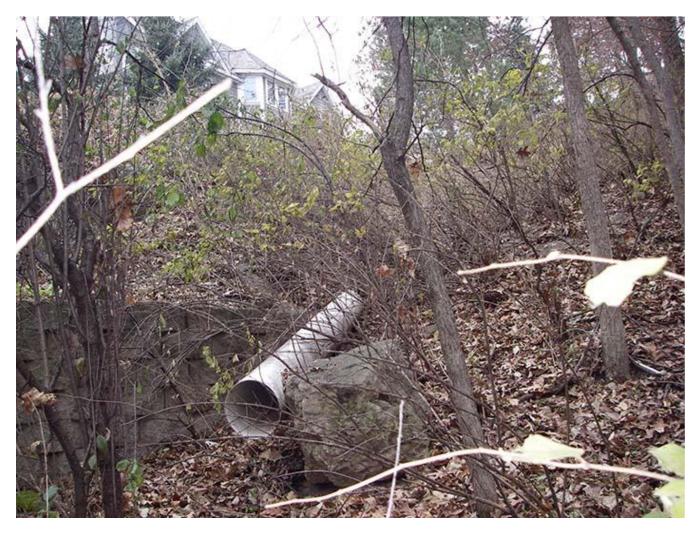
Drain pipe

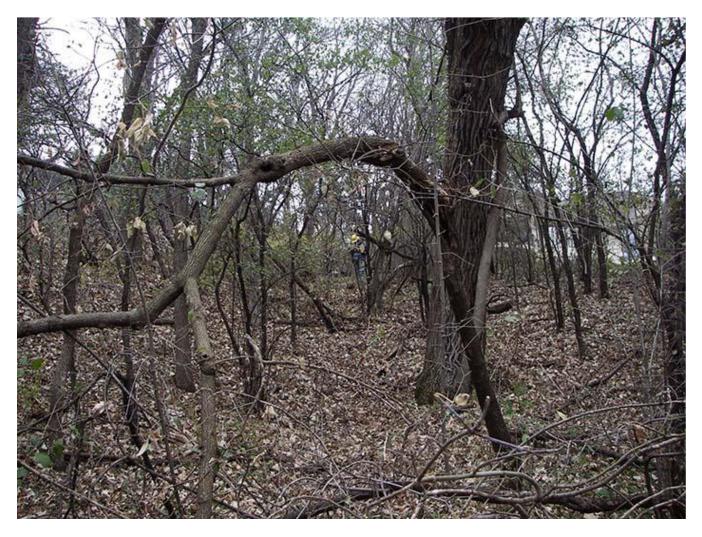
Minimal erosion; minor tree litter.

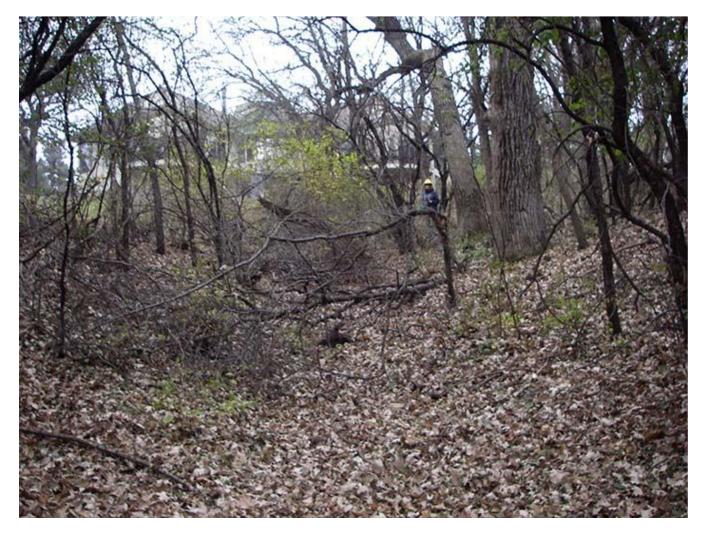
Minimal erosion.

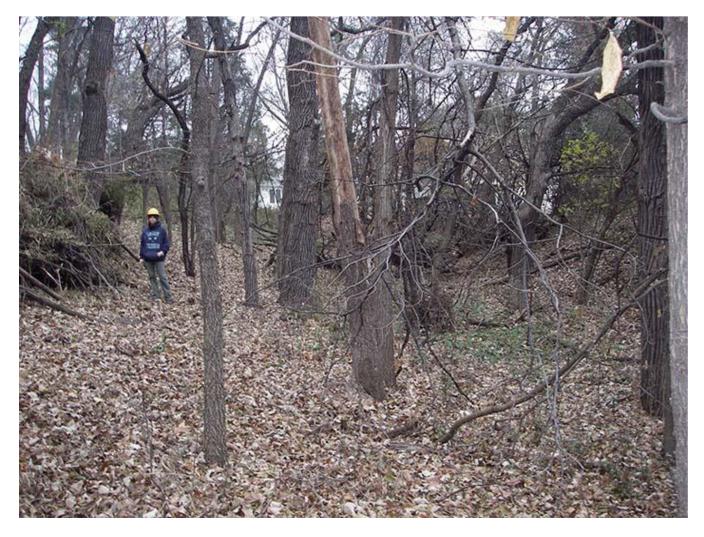
Minimal erosion.

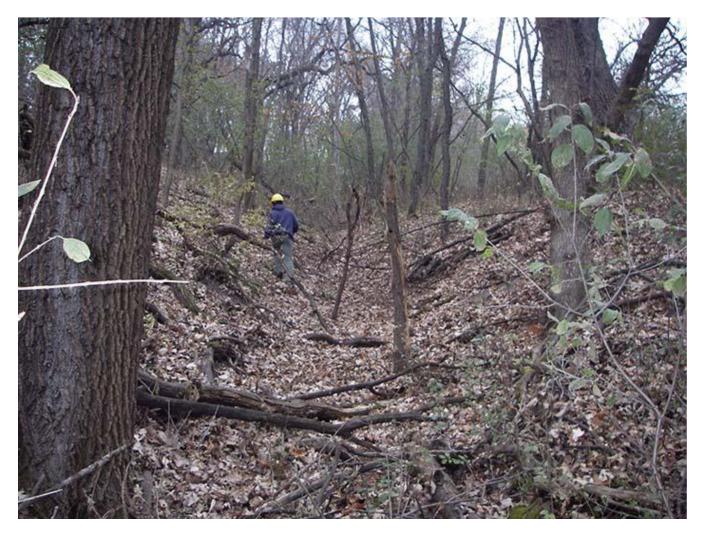
Minimal erosion.

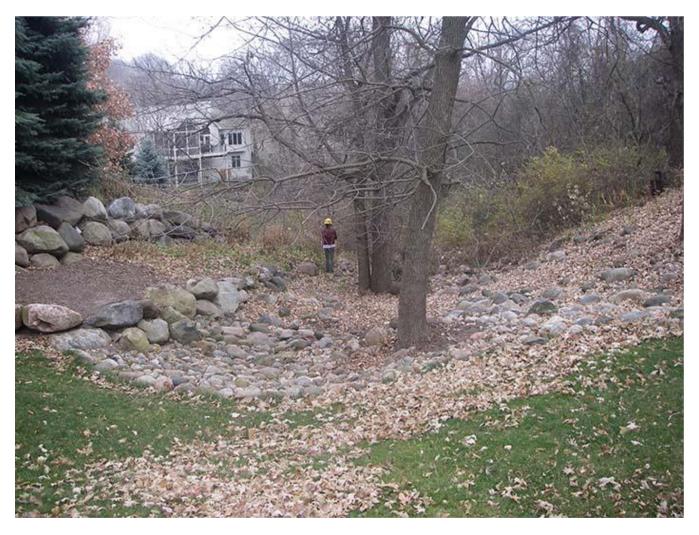
Erosion control; matting, stone drain field.

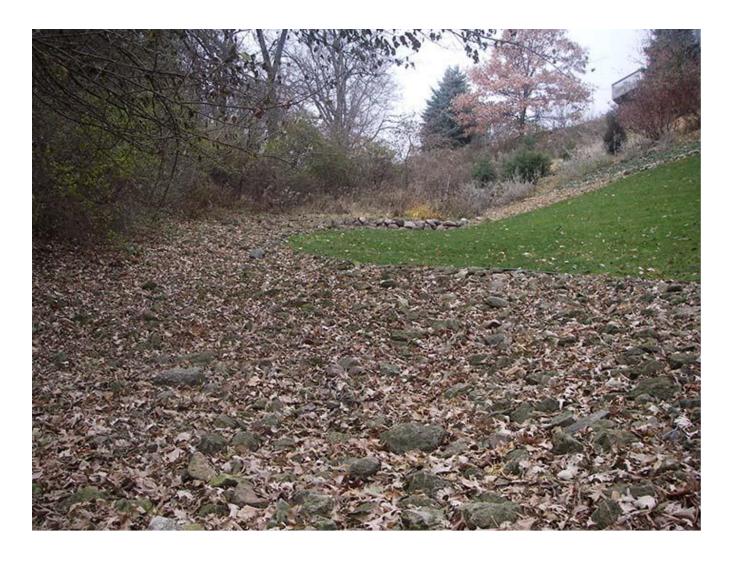
Erosion control; matting, stone drain field.

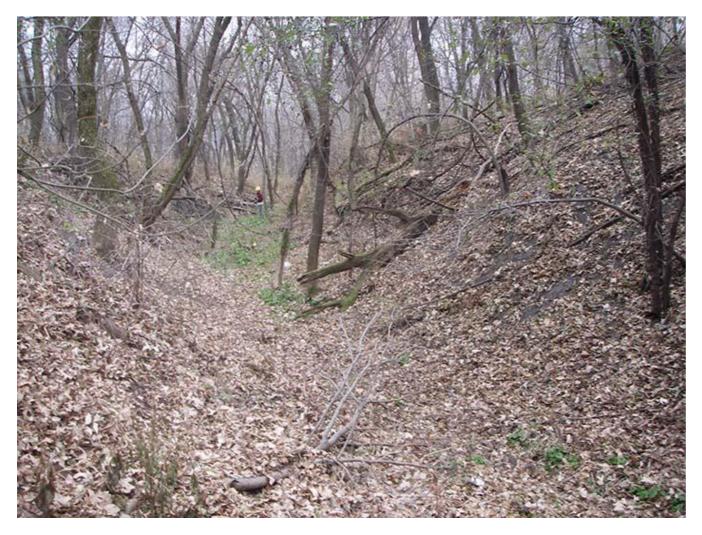
continuation of WP018 gully; med.erosion; tree litter.

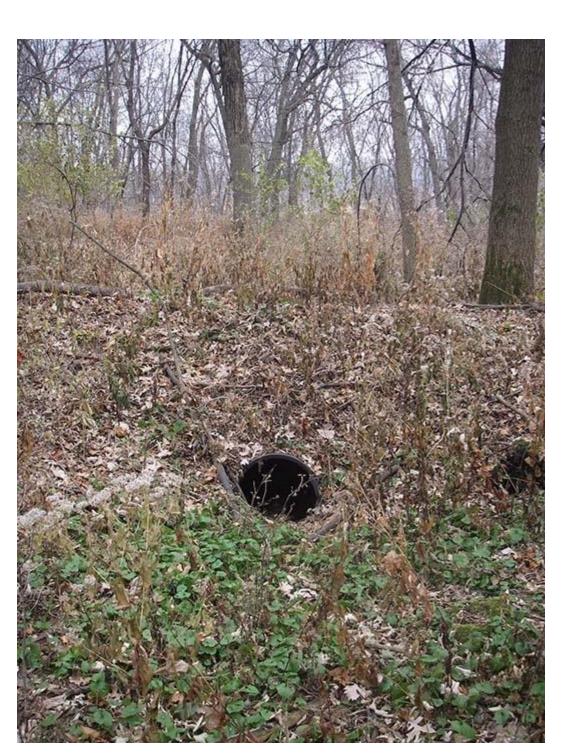
Drain pipe entrance for 018 WP

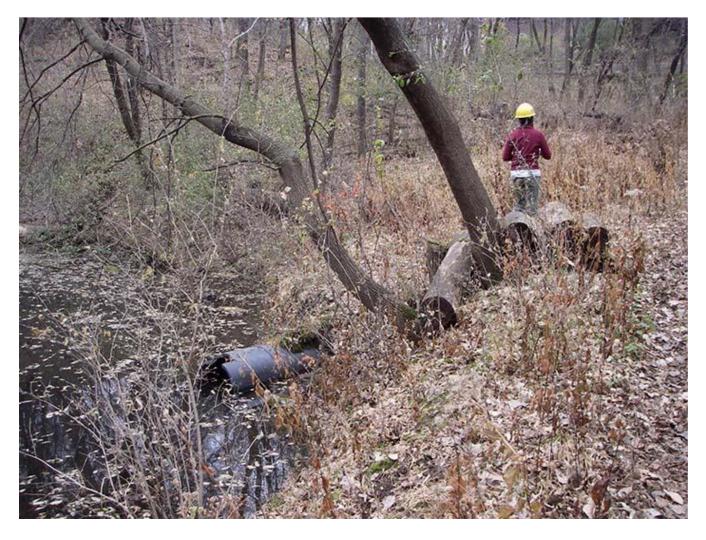
Drain pipe exit into pond

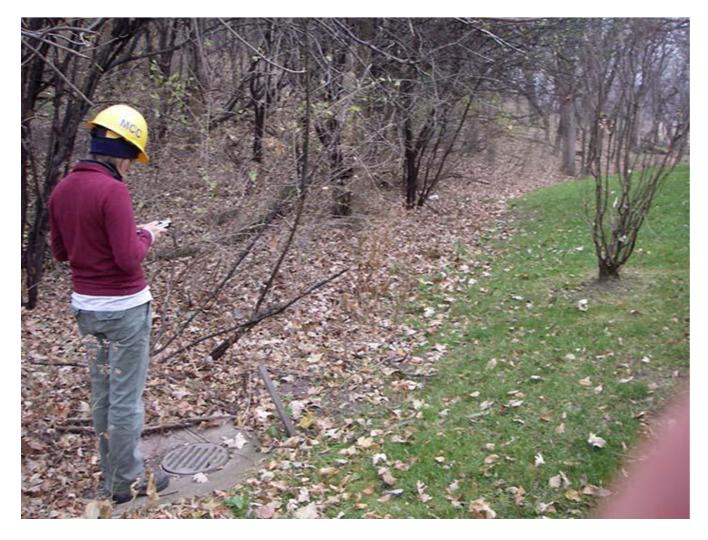
Storm drain

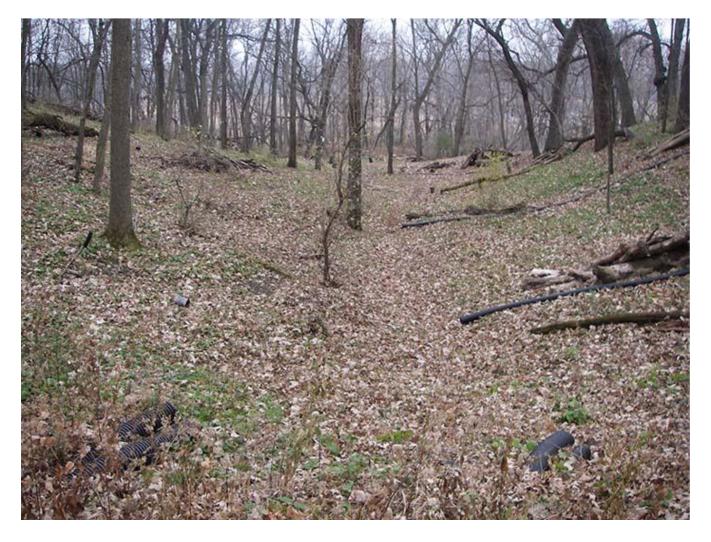
Minimal erosion, house gutter drain pipes

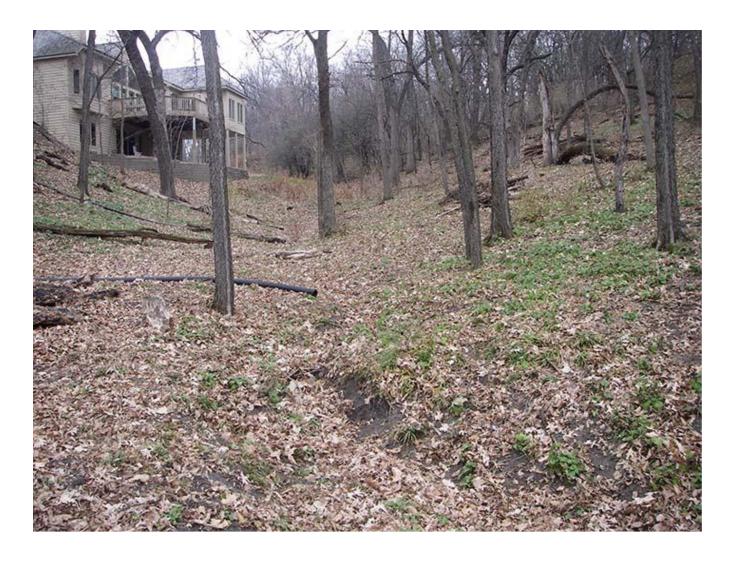
Gully uphill view

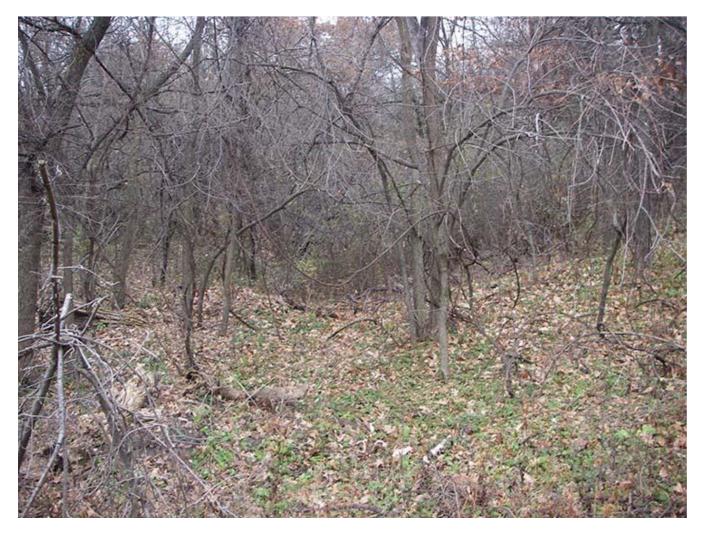
Minimal erosion.

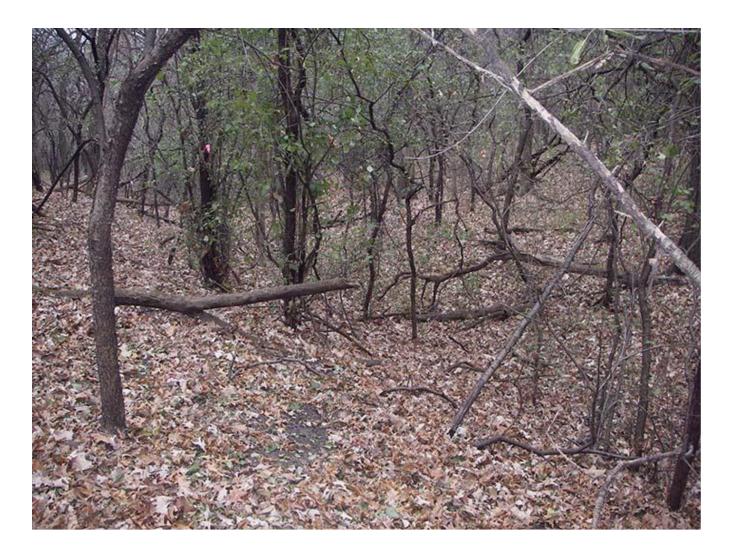
Spring

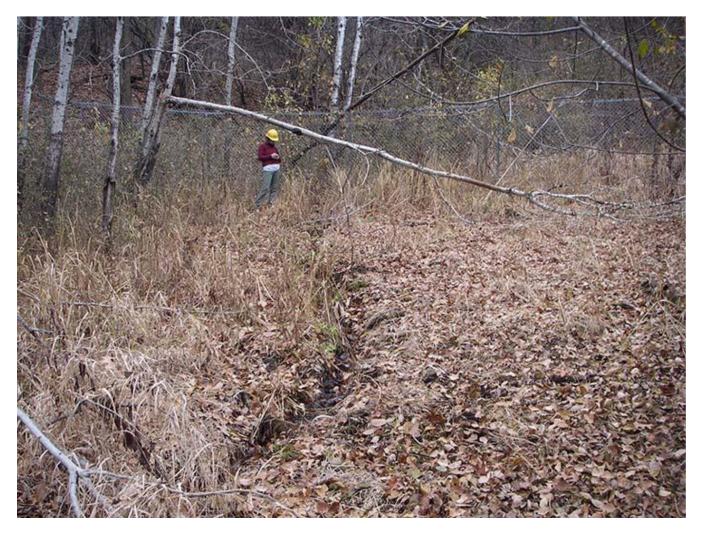
Spring & small channel leading to wetland

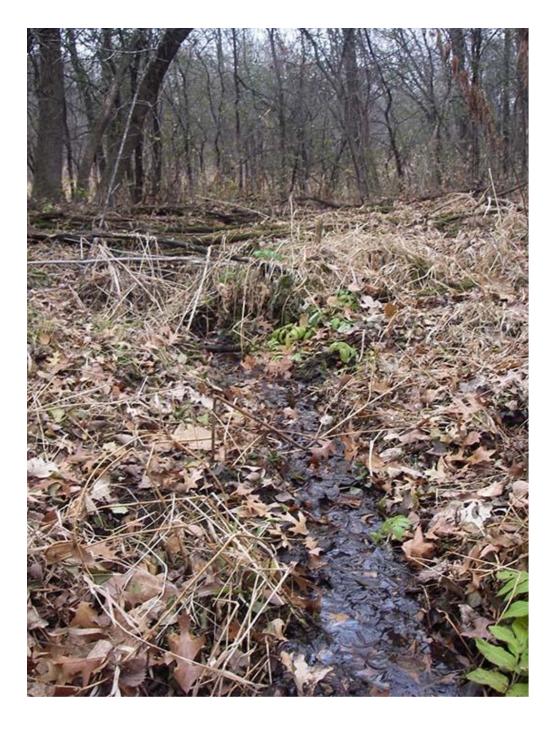
Spring & small channel leading to wetland

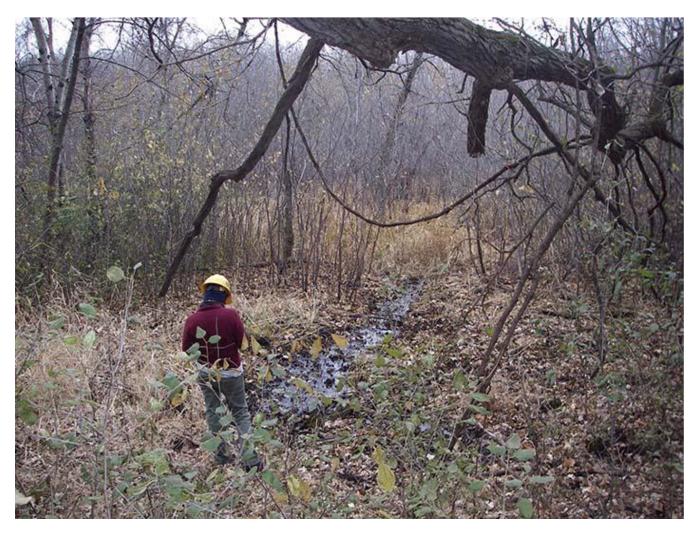
Location: Masonic Lodge - Compass Drive

Spring & small channel 20 ft. long leading to wetland

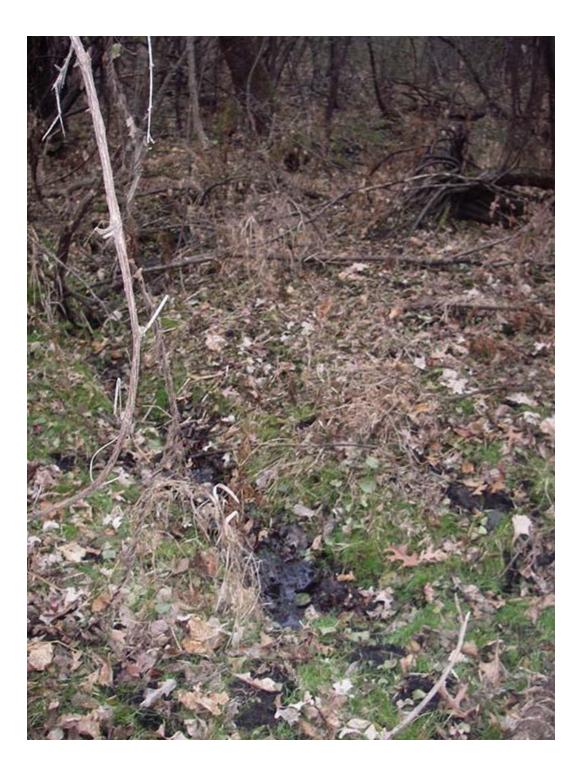
Location: Masonic Lodge - Compass Drive

Spring & small channel leading to wetland

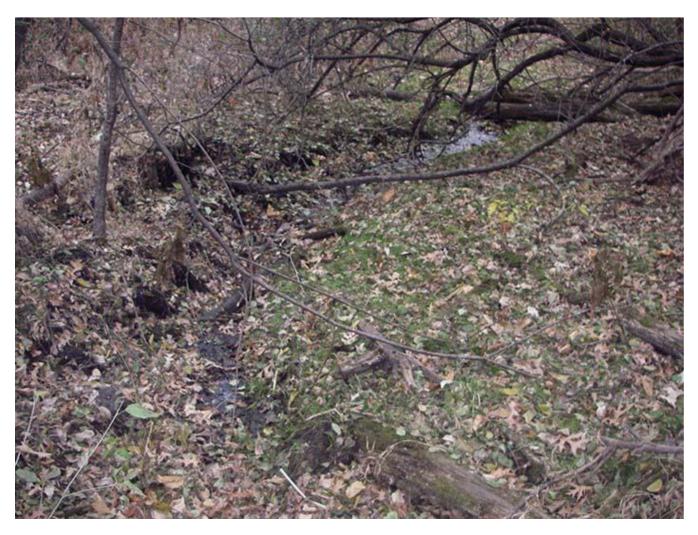
Location: Masonic Lodge - Compass Drive

Spring & small channel leading to wetland

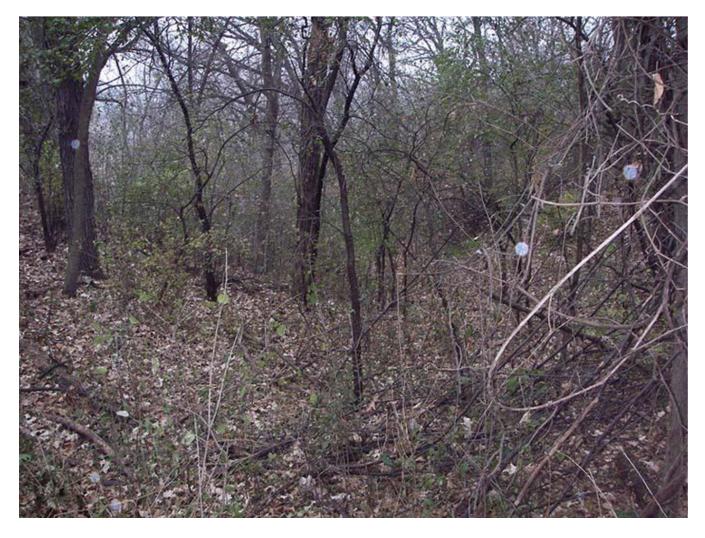
Location: 11531 Palmer Circle

Minimal erosion

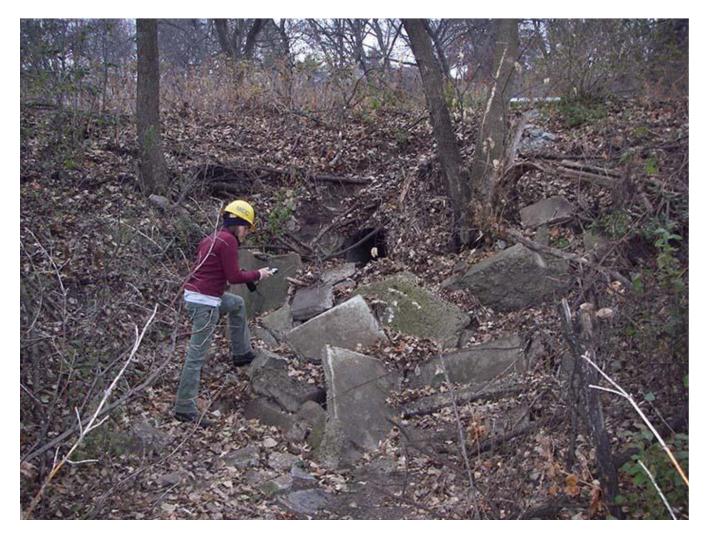
Location: 11641 Palmer Drive

Storm sewer drain pipe outlet

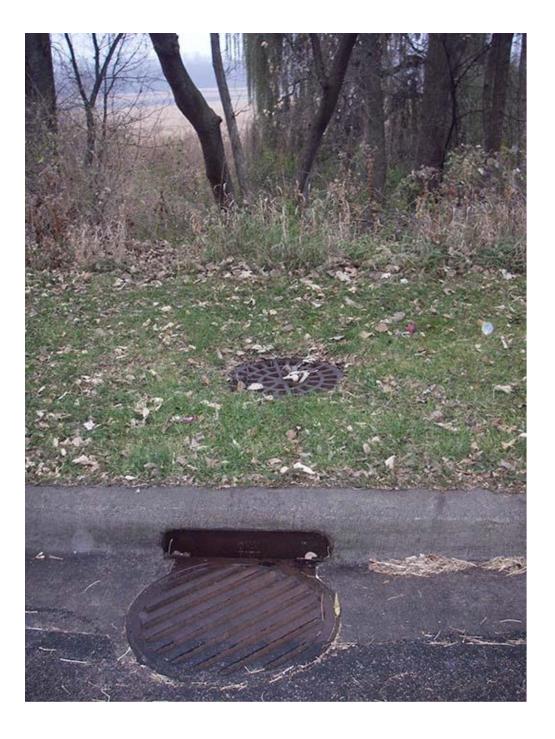
Storm sewer drain pipe outlet from street above

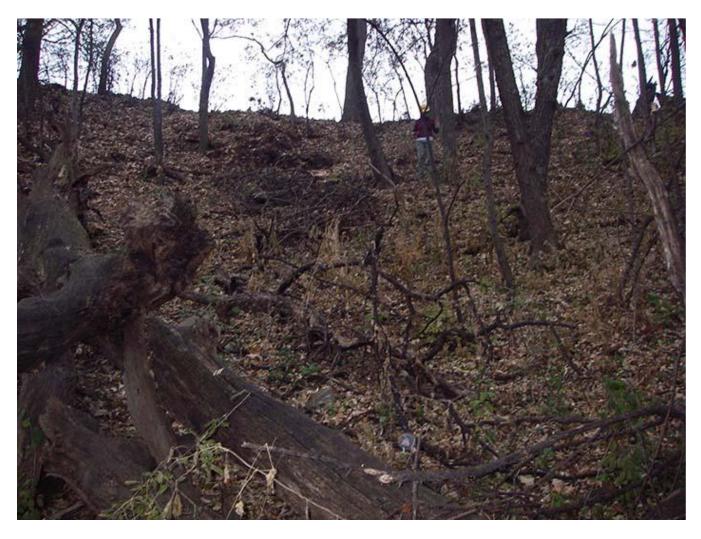
Location: 4617-4525 Overlook Drive

Steep bank, minimal erosion visible

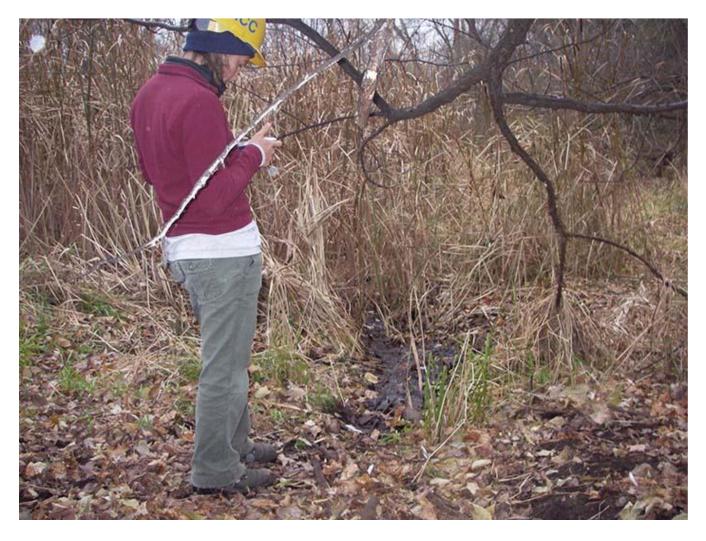
Location: 4617-4525 Overlook Drive

Water table, spring seepage

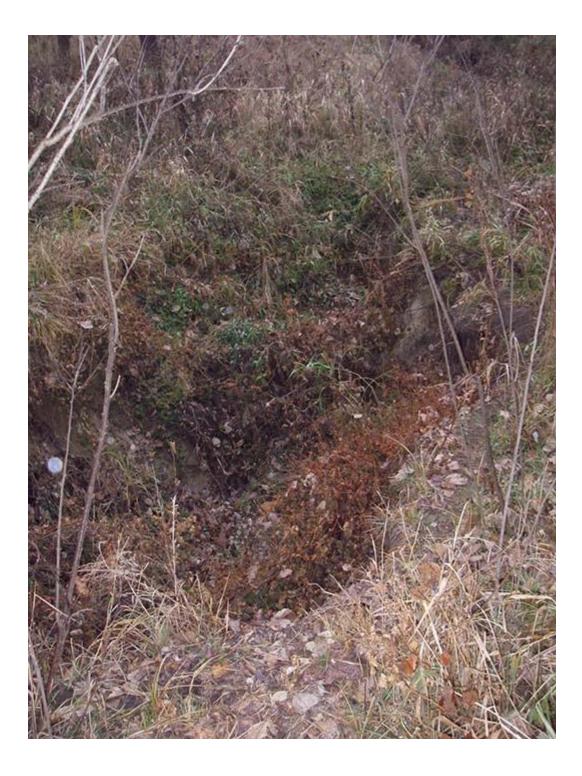
Location: 4617-4525 Overlook Drive

Storm pipe outlet - deep pit

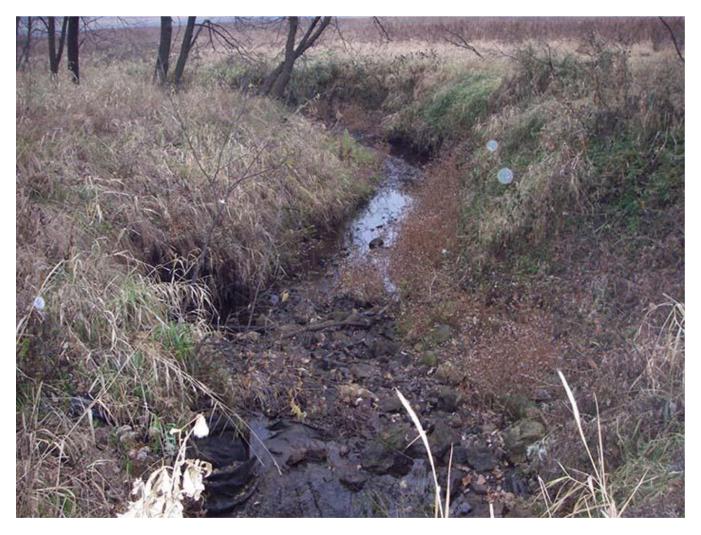
Location: 4617-4525 Overlook Drive

Storm pipe outlet from above

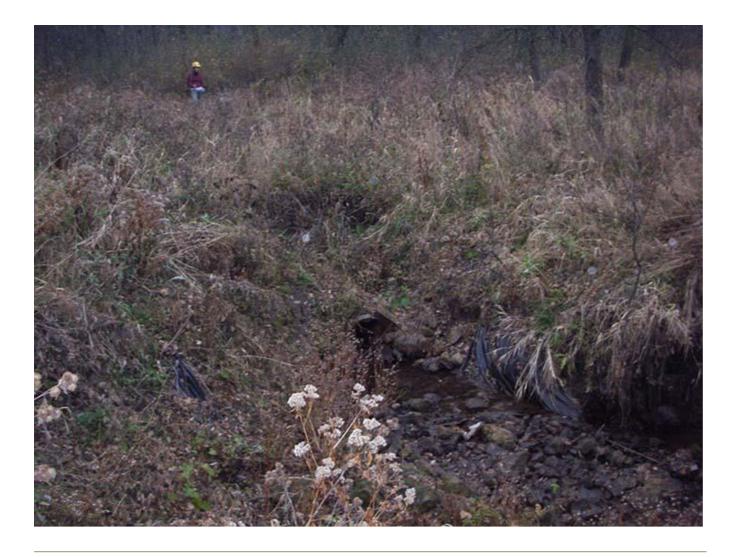
Storm pipe outlet from below

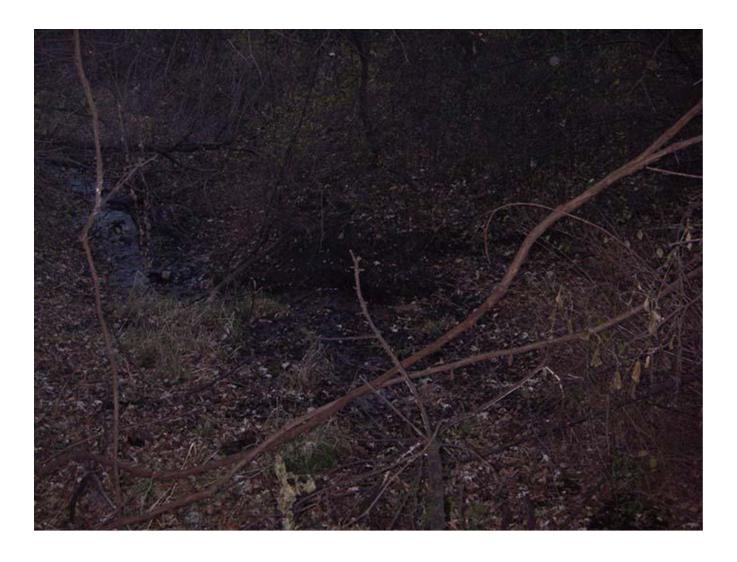
East branch of gully

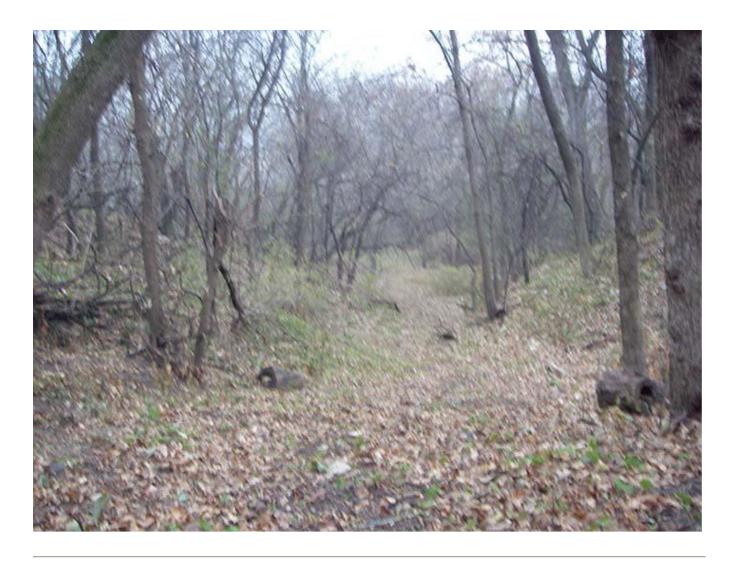
Downhill view of gully

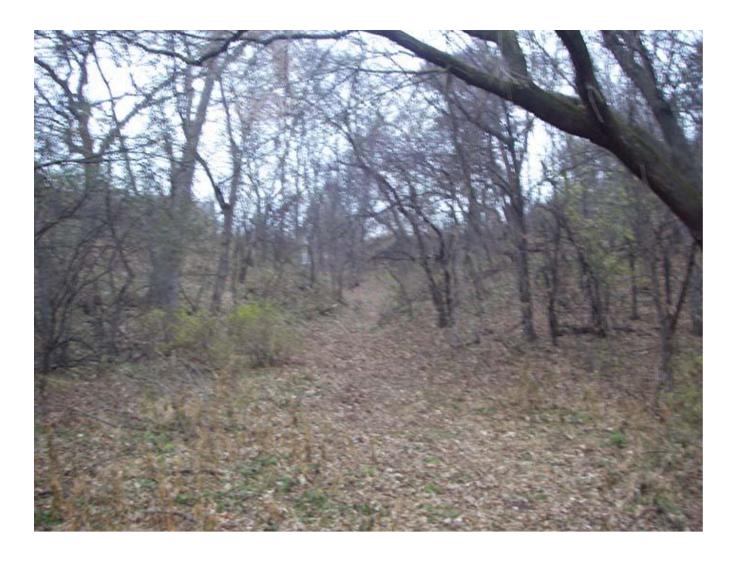
Uphill view of gully

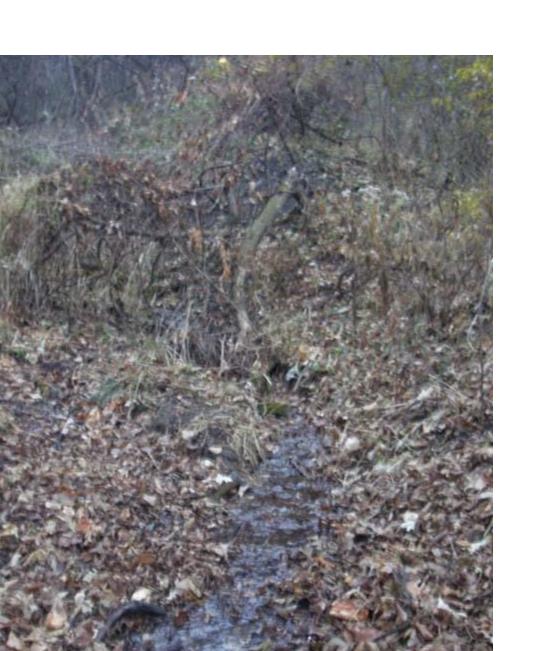
Location: 4617-4525 Overlook Drive

Groundwater seepage/spring

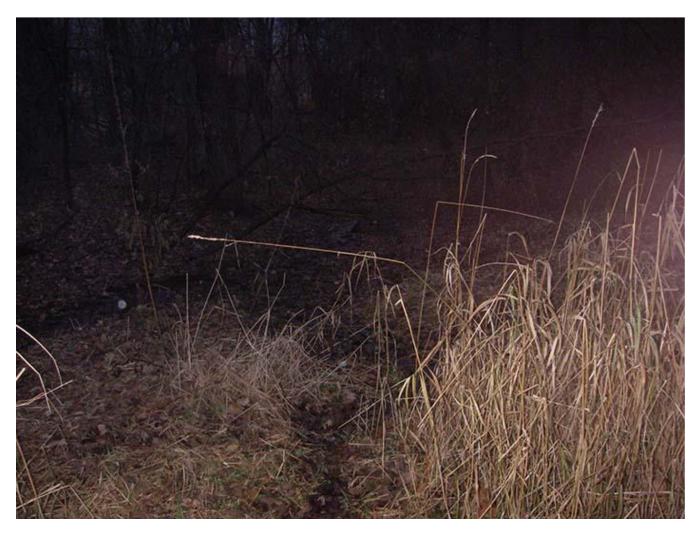
Location: 4617-4525 Overlook Drive

Groundwater seepage/spring with watercress around

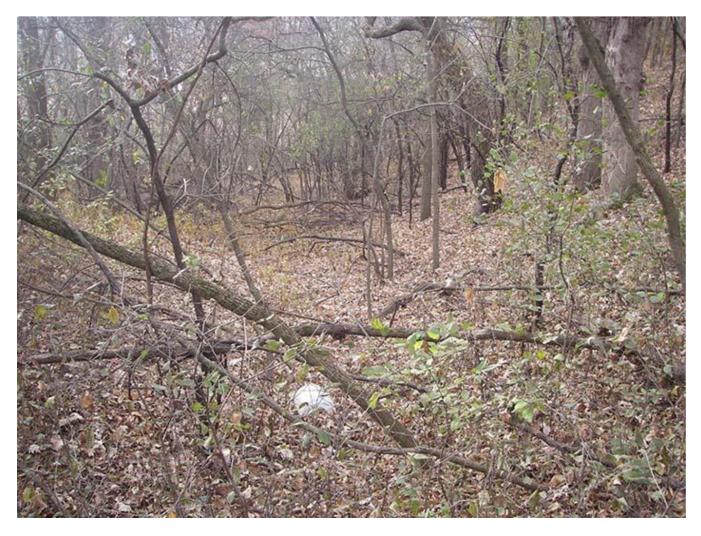
Location: 4617-4525 Overlook Drive

Minimal erosion, some tree debris

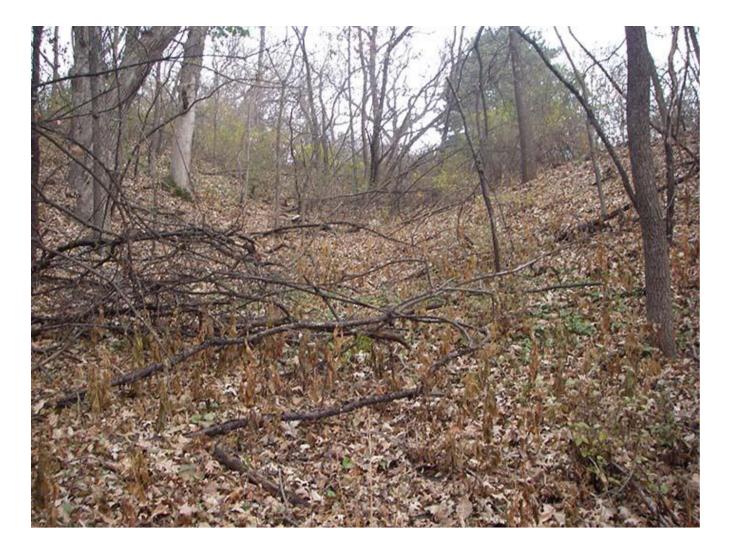
Uphill view

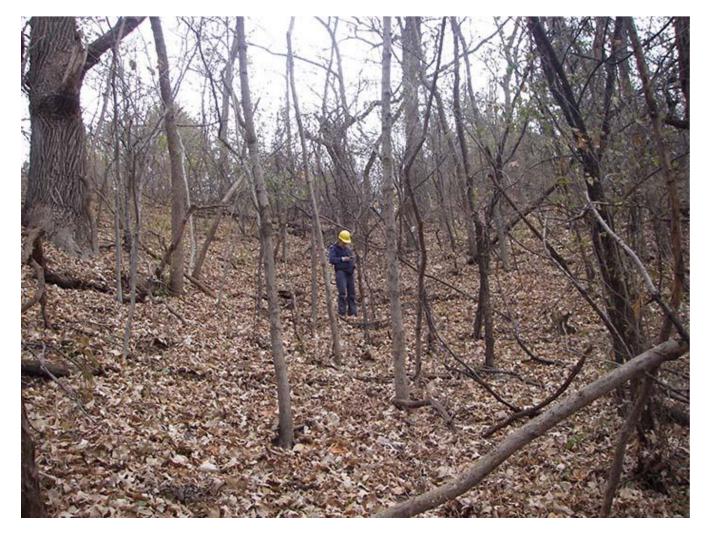
Location: 4215-4125 Overlook Drive

Minimal erosion

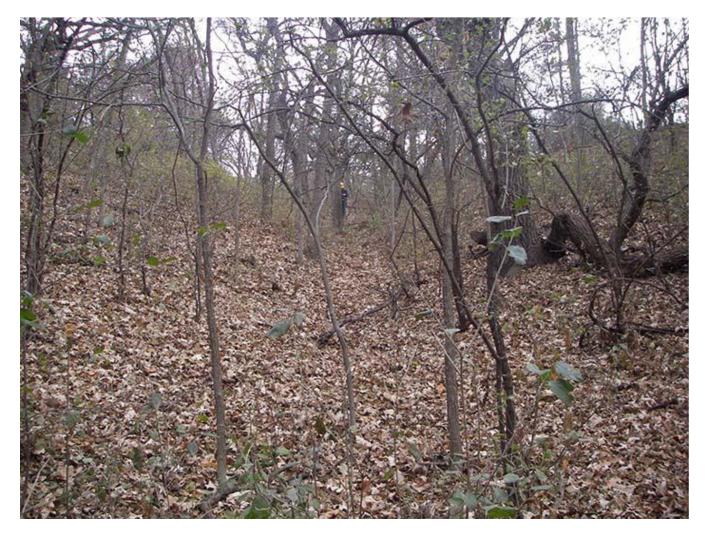
Location: 4215-4125 Overlook Drive

Minimal erosion

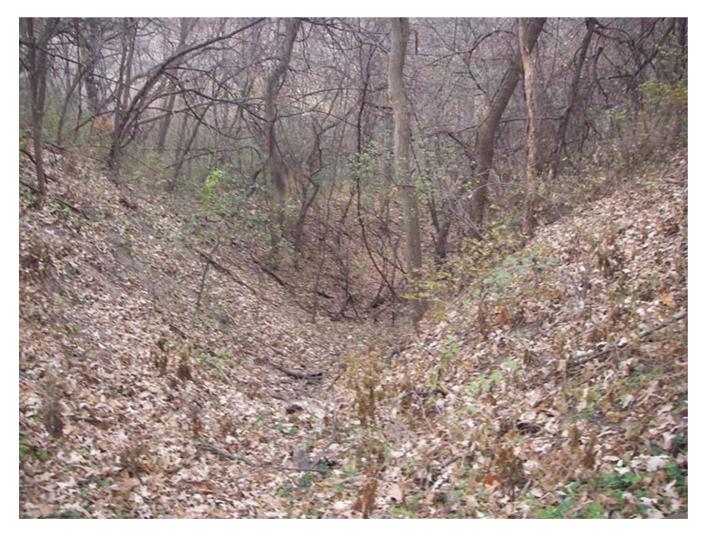
Location: 4215-4125 Overlook Drive

Pronounced gully

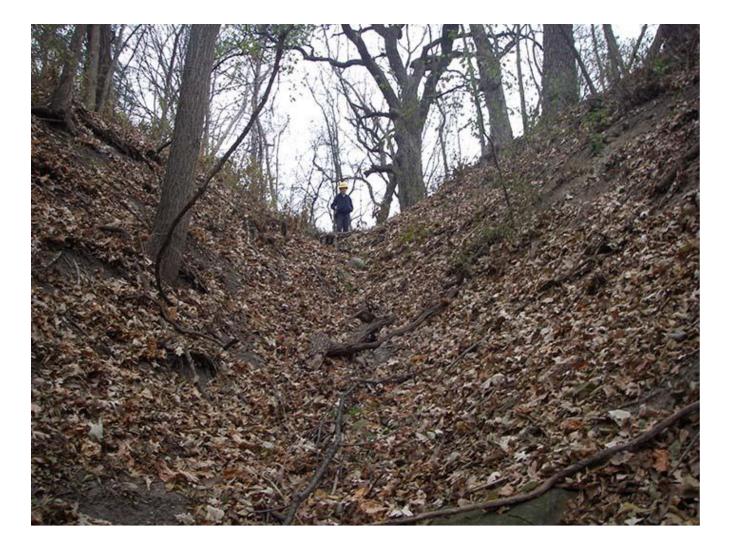
Significant erosion

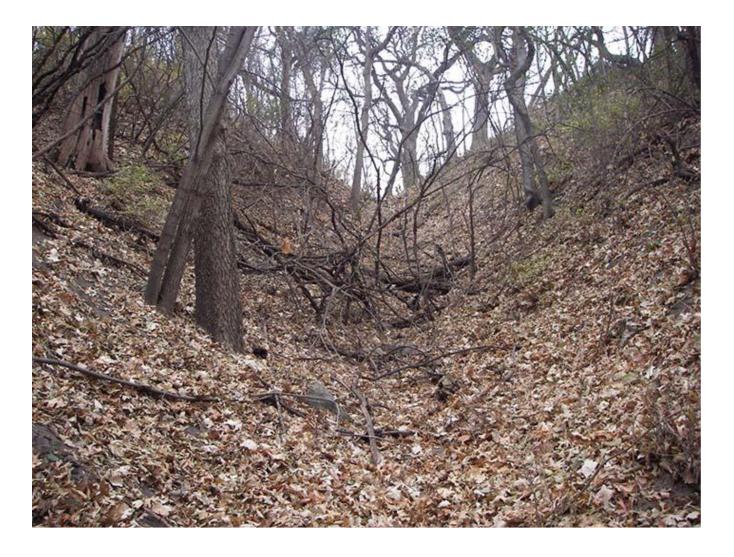
Significant erosion uphill view further down the gully

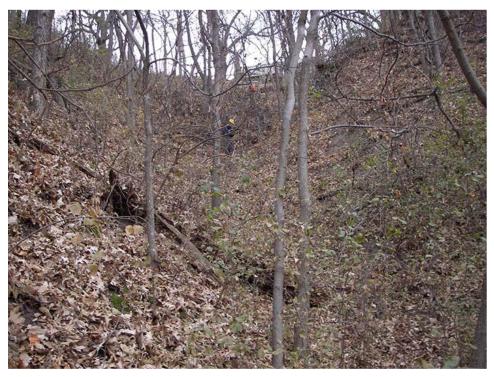
Location: 4107 Overlook Circle

bowl-shaped gully, quite steep, large amount of tree debris from homeowner, exposed soil on slopes w/ significant erosion

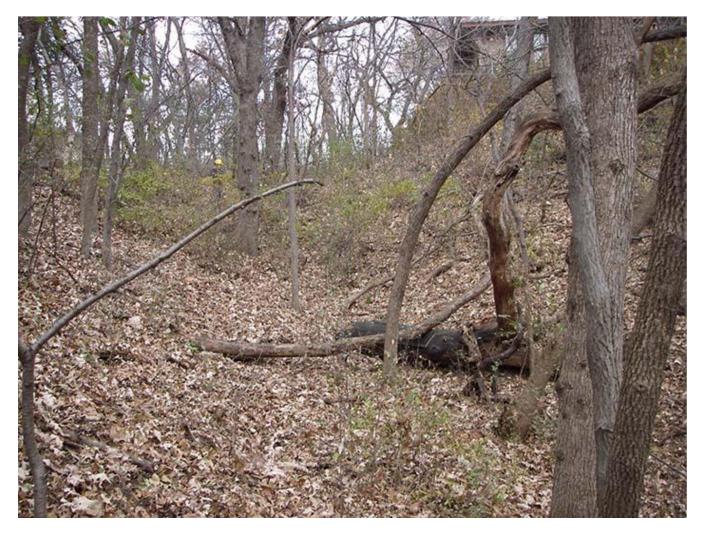
Location: 3917 Overlook Drive

Minimal erosion, some tree debris

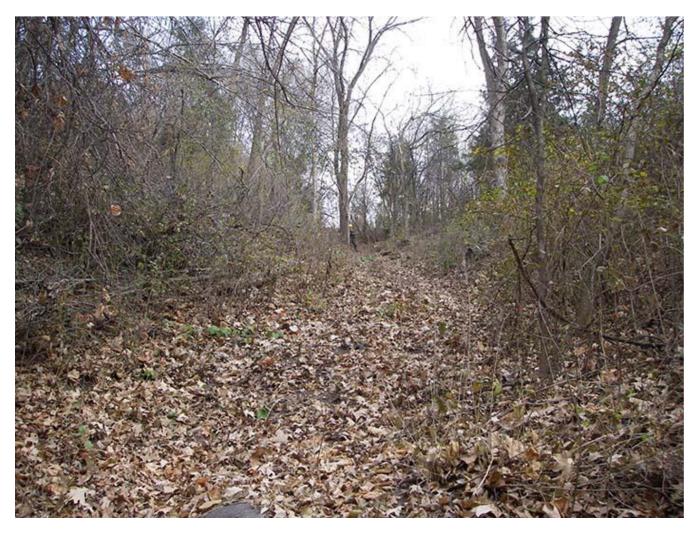
Location: 3821 Overlook Drive

Path cleared down the gully, flagging down gully, minimal erosion

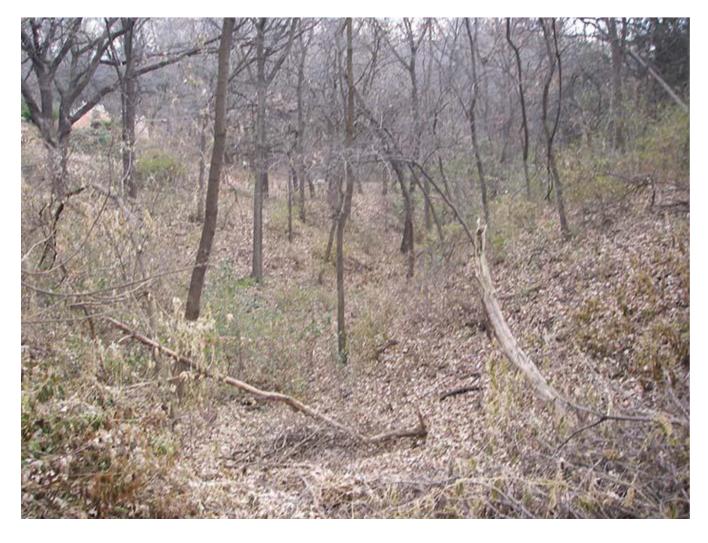
Location: 3811-3801 Overlook Drive

Deep gully, some erosion

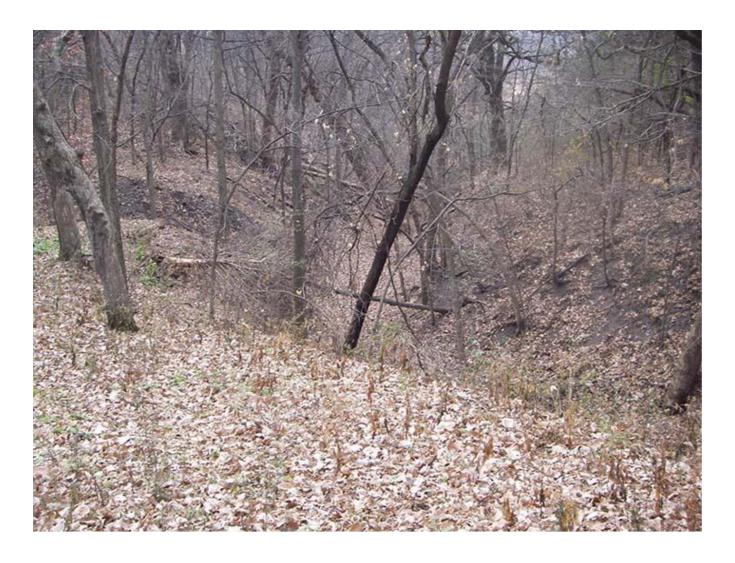
Eroded bank downhill, some large tree debris

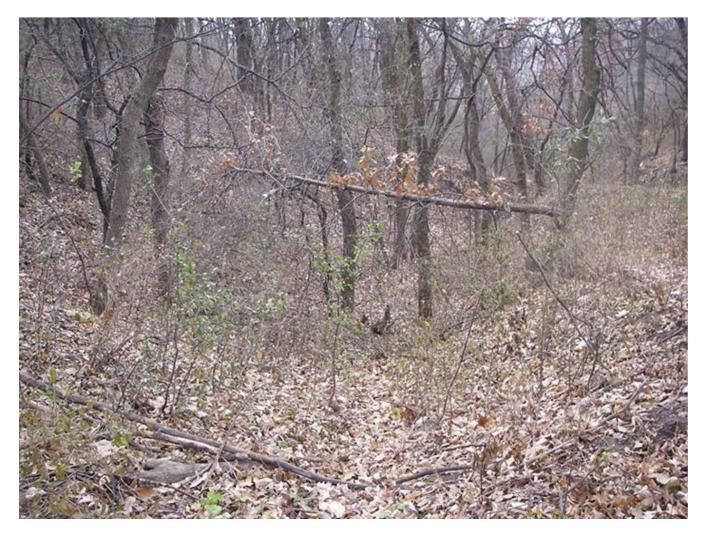
Location: 3811-3801 Overlook Drive

East branch of gully

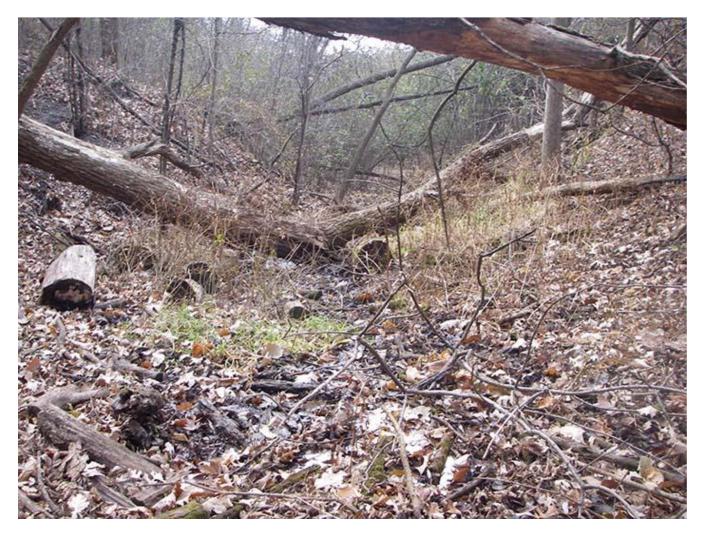
Location: 3811-3801 Overlook Drive

Spring/groundwater seepage and channel feeding to marsh

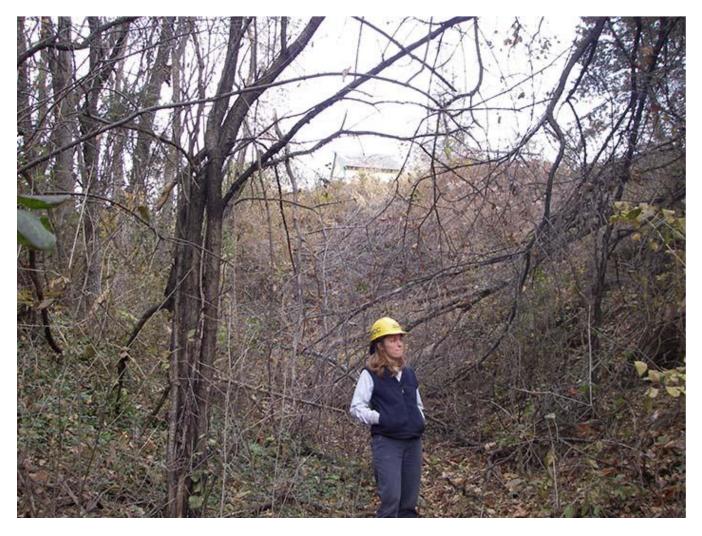
Location: 3701 Overlook Drive

Deep gully w/some erosion & some tree debris

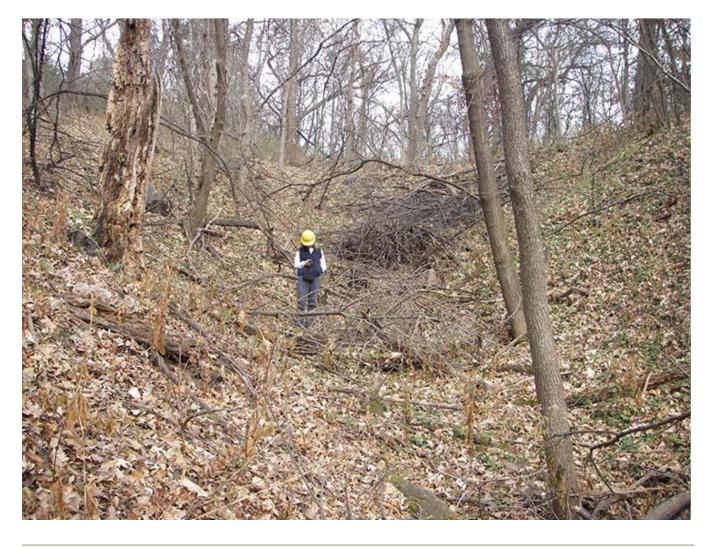
Location: 3501 Overlook Drive

Gully w/lots of tree debris

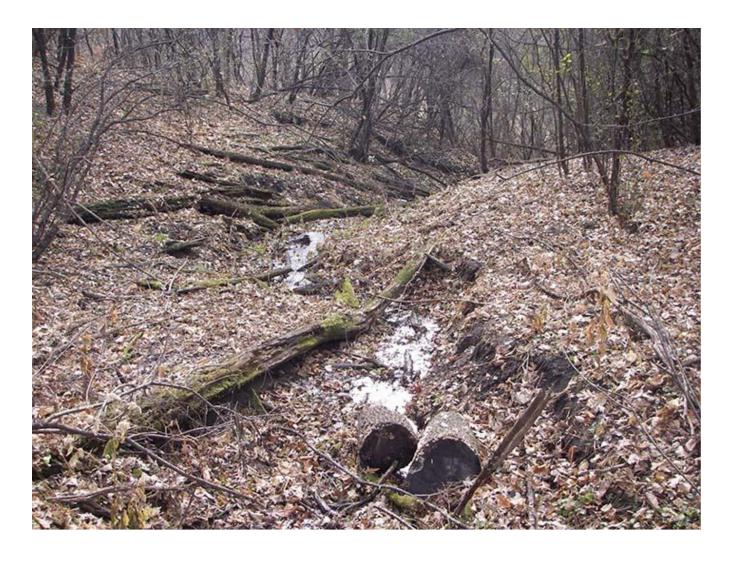
Good spring 10 ft. from WP053 GPS point forming deep channel & stream, some metal trash

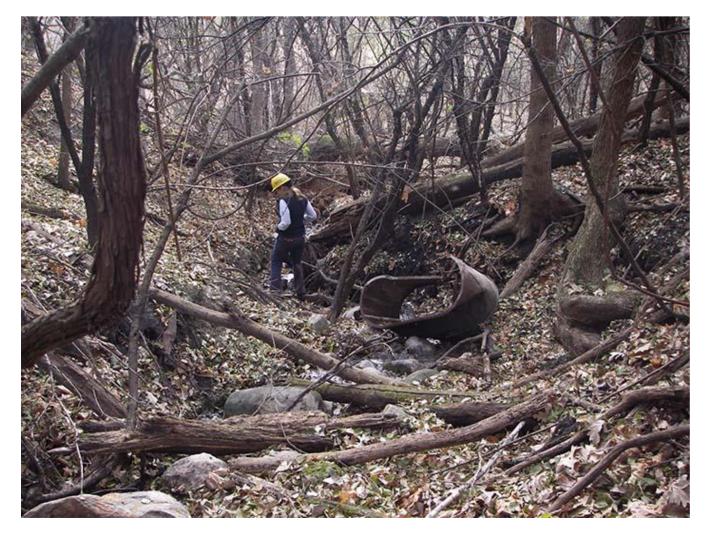
Pronounced erosion

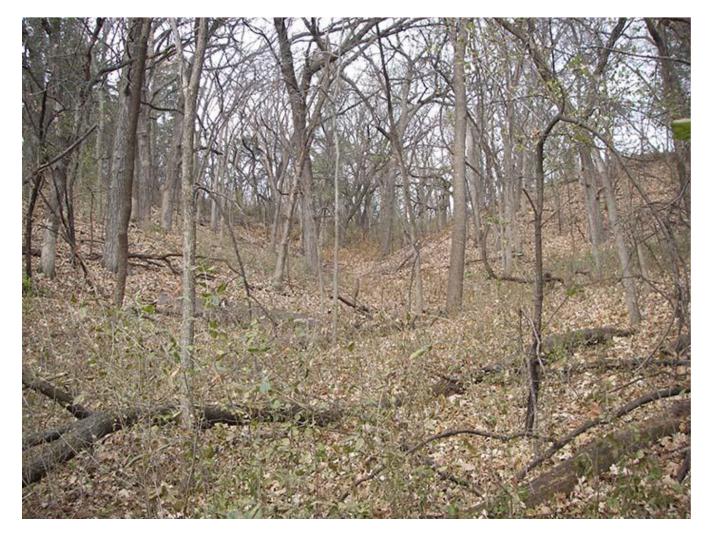
Location: 3401 Overlook Drive

Minimal erosion

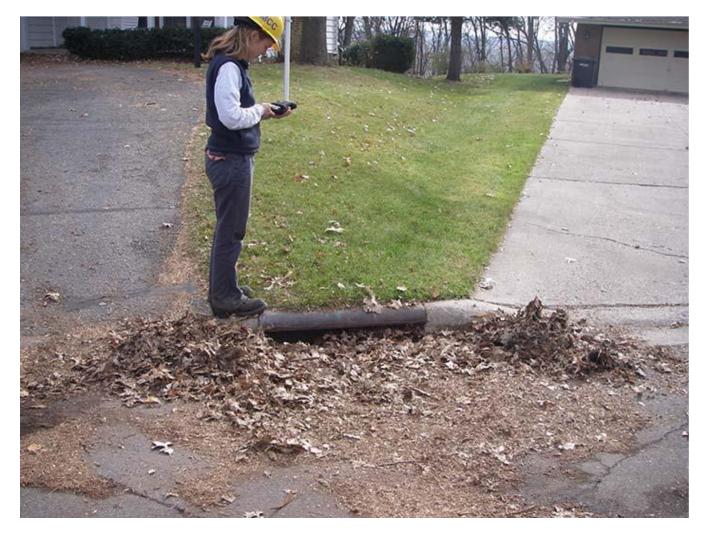
Location: 10325 10th Avenue Circle South

Storm drain

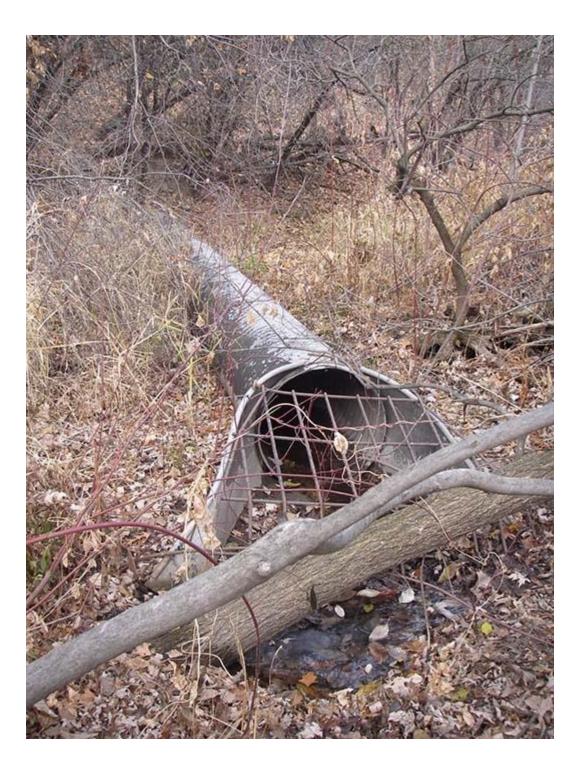
Location: 10325 10th Avenue Circle South

Storm drain outlet
