Gully Inventory Map	Legend		\mathbf{T}
Area #1	LMRWD Boundary (not official)	FEMA Floodway	\mathbb{N}
Lower Minnesota River Watershed District	City/Township Boundary	100-Year FEMA Floodplain	T
Watershed Management Plan	Gully Inventory Locations	500-Year FEMA Floodplain	Not to Scale

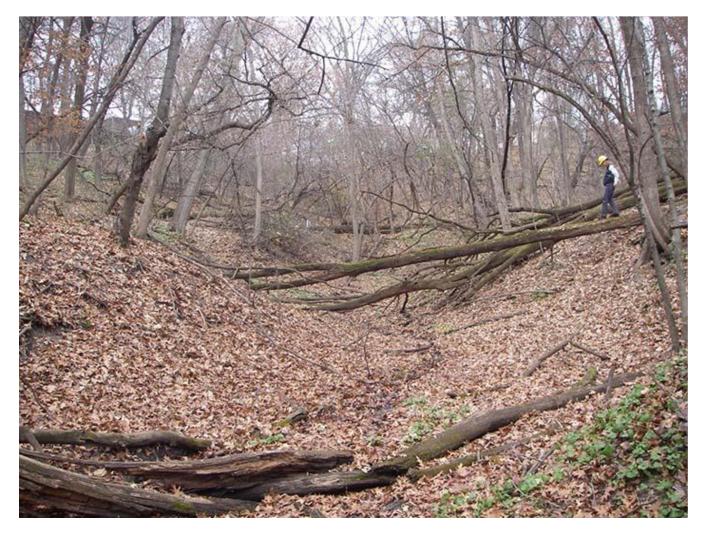
Uphill shot of point 058

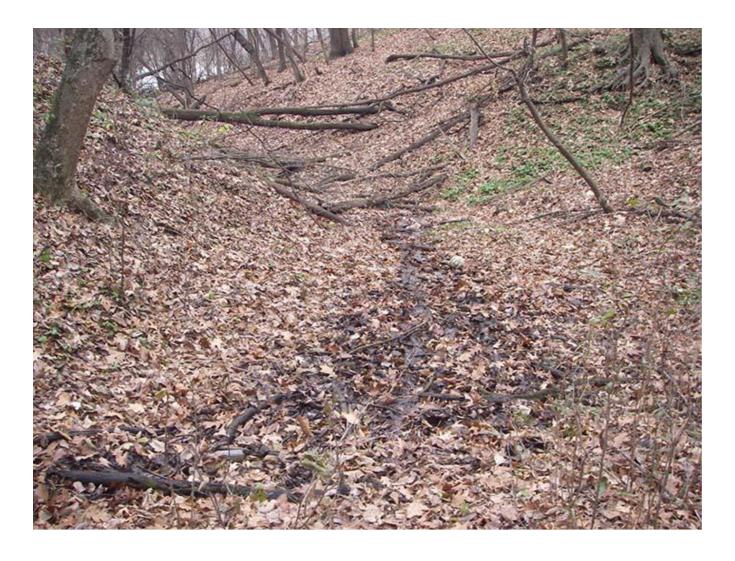
Water table/spring from point 058

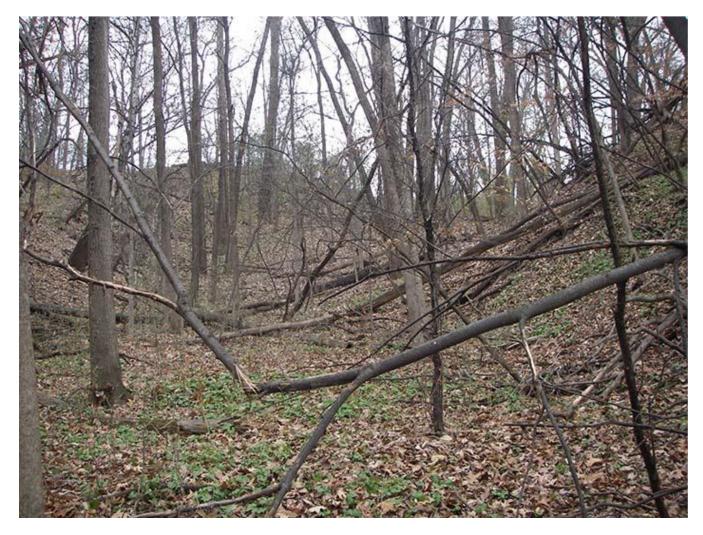
Location: 10233-10217 10th Avenue Circle

E. branch uphill shot from point 058, min. erosion

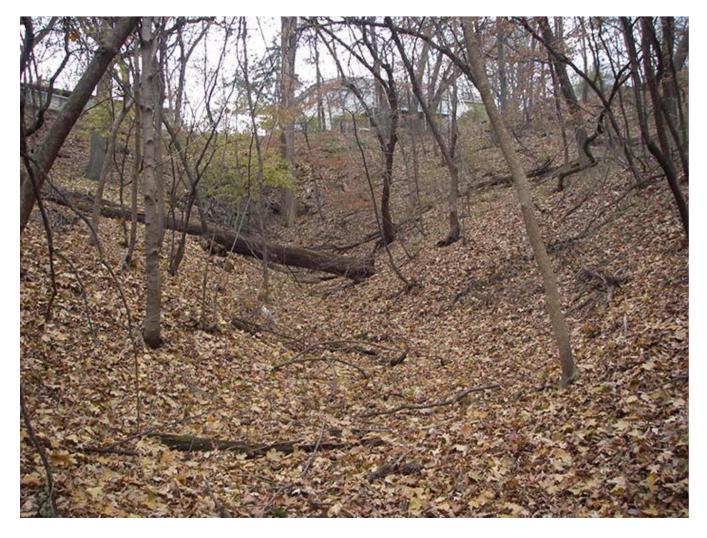
Location: 10233-10217 10th Avenue Circle

W. branch: uphill, some tree debris in gully

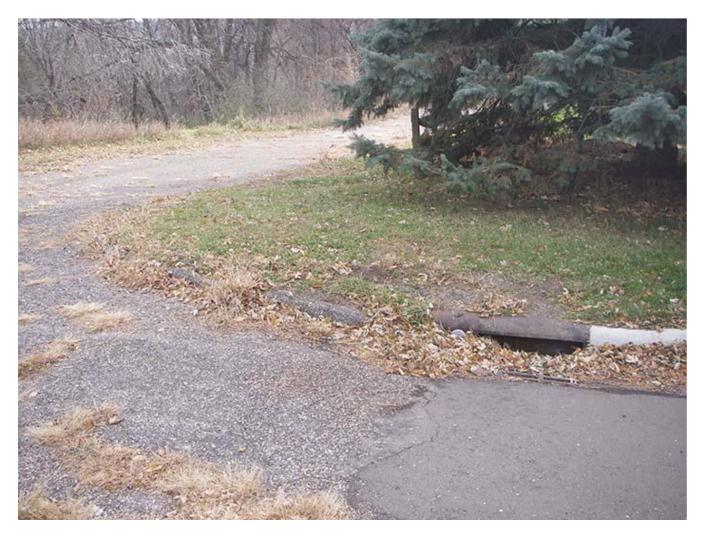
Location: 10201 10th Avenue Circle & East 102nd

Storm sewer*

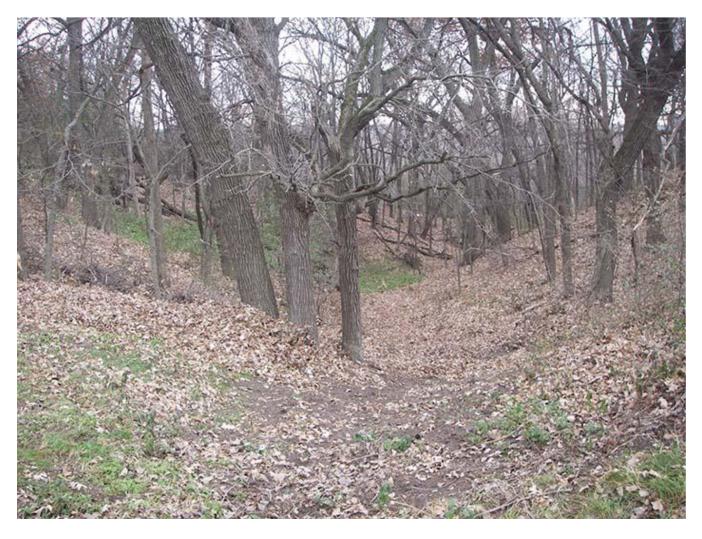
Location: 10201 10th Avenue Circle & East 102nd

Minimal erosion

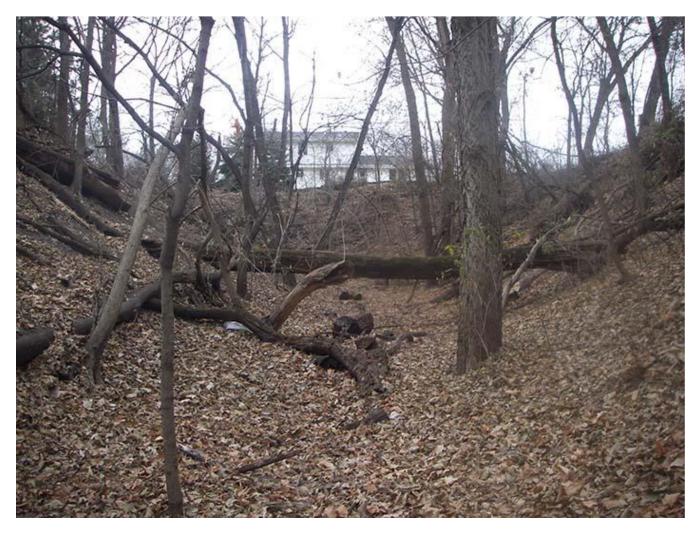
Location: 10001 10Th Avenue South - 1012 Mound

Drainage pit, erosion very evident, bare soil on all sides of slopes

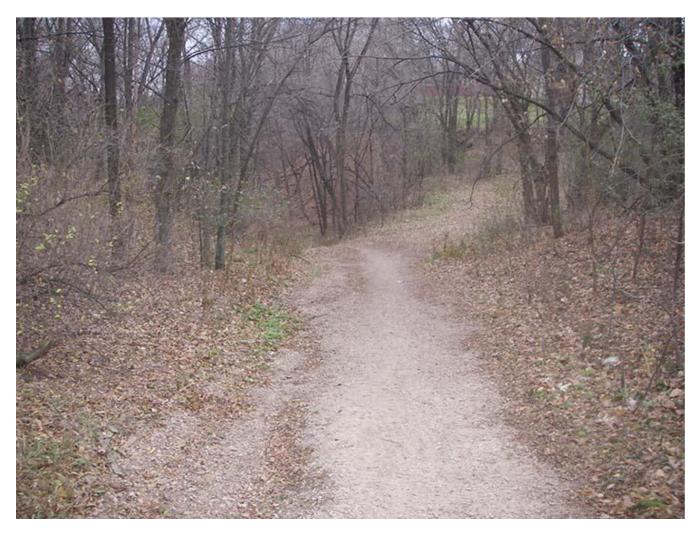
Location: 9801 11th Avenue South (severe soil

Path - some erosion down center of trail

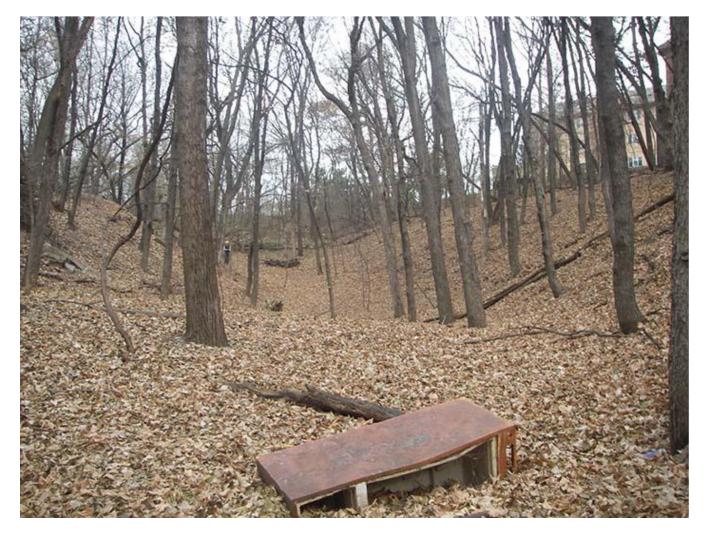
Location: 9801 11th Avenue South (severe soil

NE branch of gully, some erosion apparent

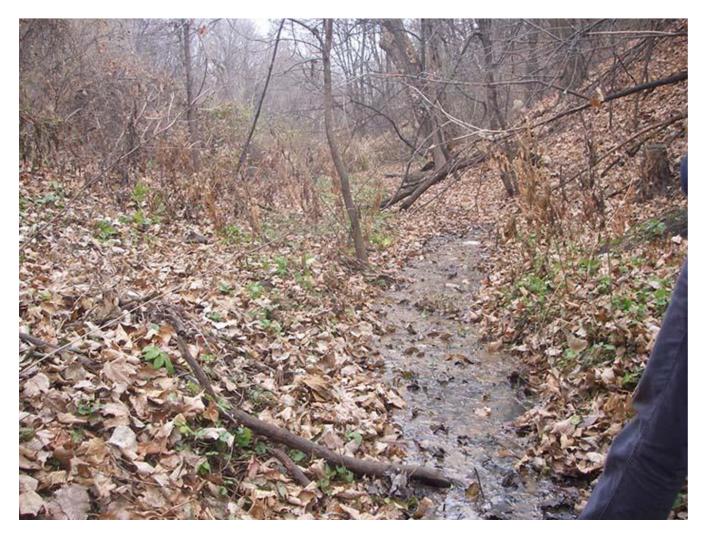
Location: 9801 11th Avenue South (severe soil

Spring on west edge of path

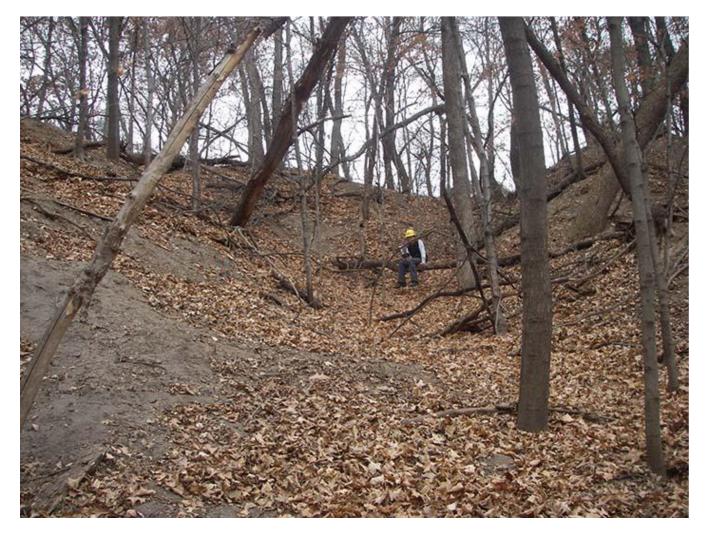
Location: 9801 11th Avenue South (severe soil

Branch off main gully

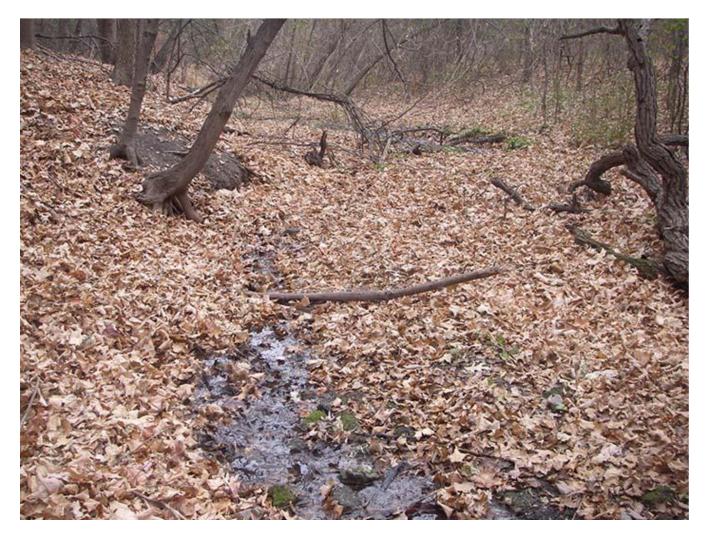
Location: 9801 11th Avenue South (severe soil

Spring on east edge of path

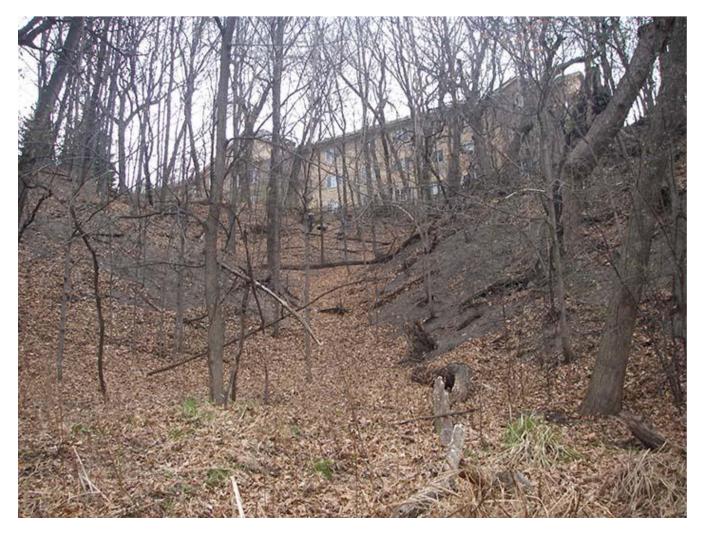
Location: 9801 11th Avenue South (severe soil

Branch and outlet pipe off main gully, severe erosion

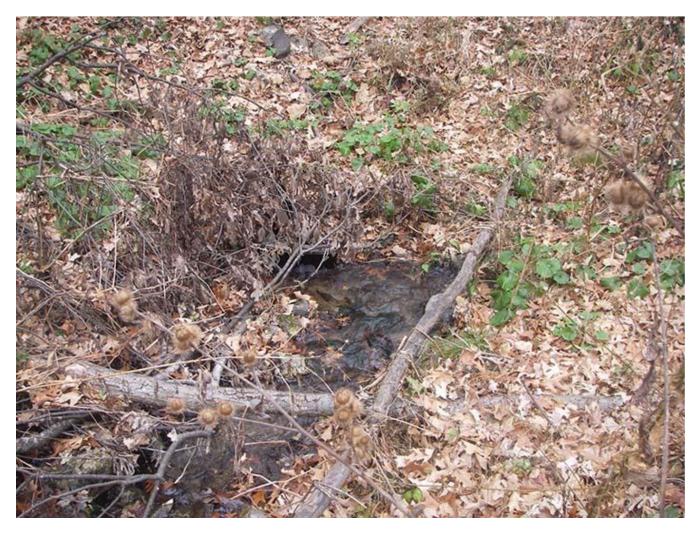
Location: 9801 11th Avenue South (severe soil

Pipe outfall

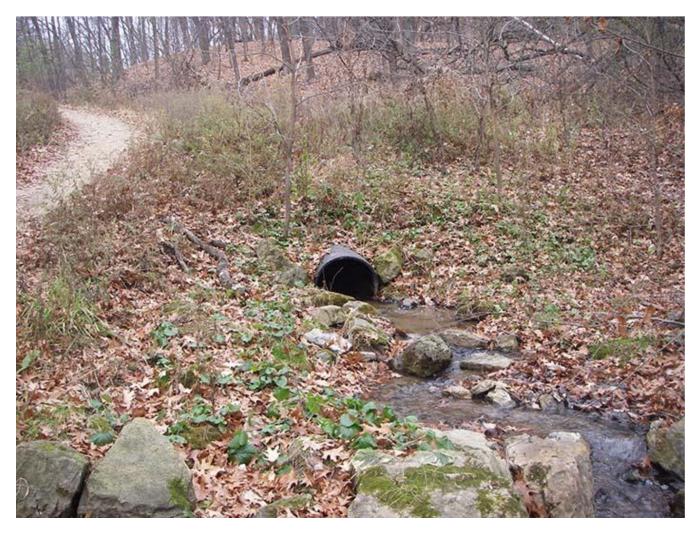
Location: 9801 11th Avenue South (severe soil

Outlet of pipe

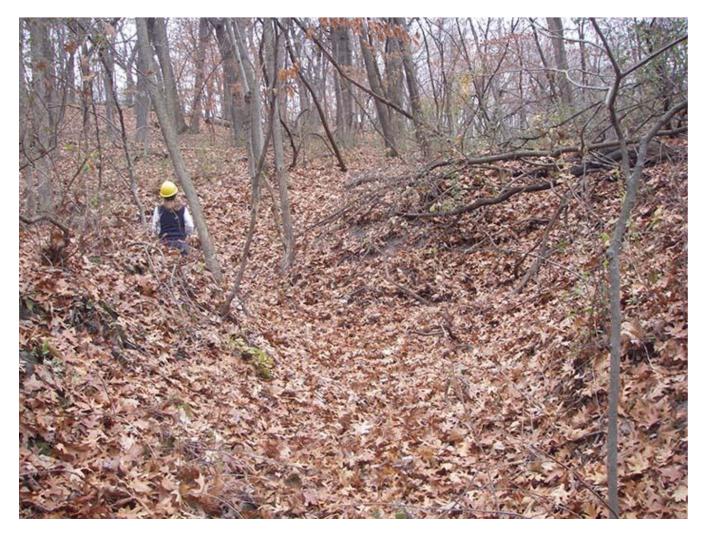
Location: 9801 11th Avenue South (severe soil

Minimal erosion and some tree debris

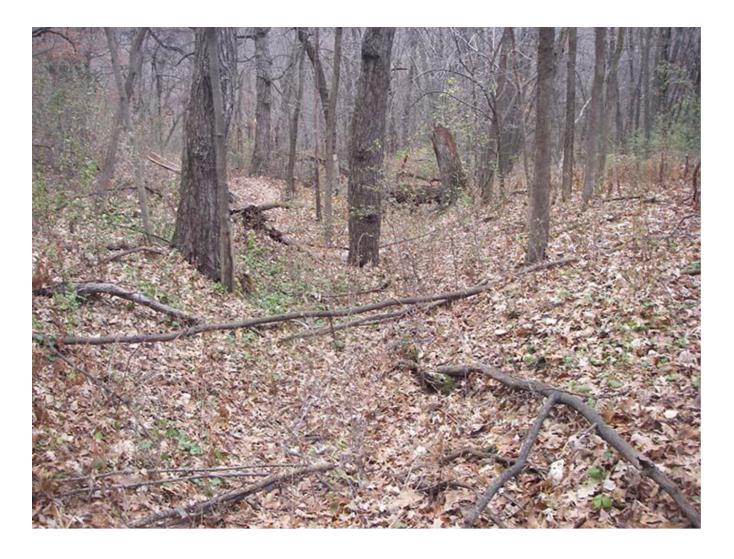
Minimal erosion and some tree debris

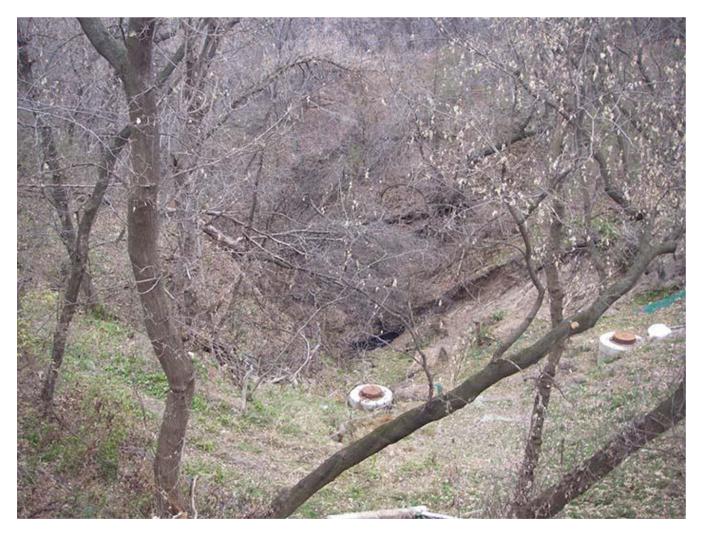
Location: 1401 East 100th Street

Deep gully with severe erosion

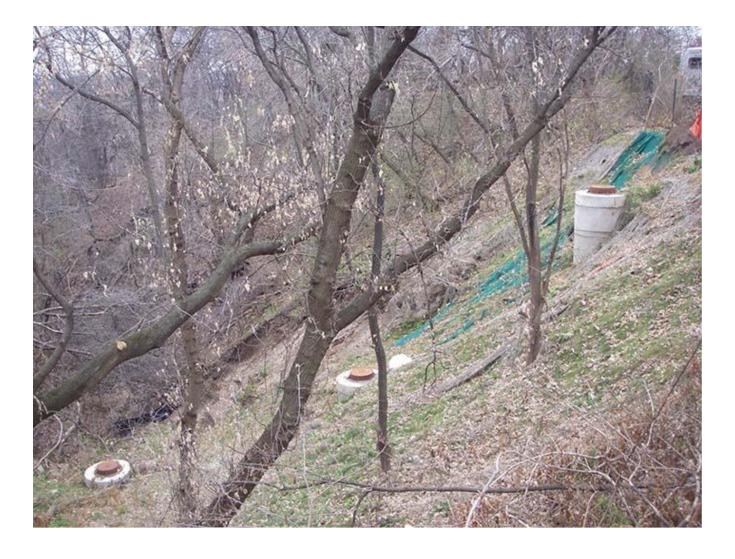
Some erosion control in place

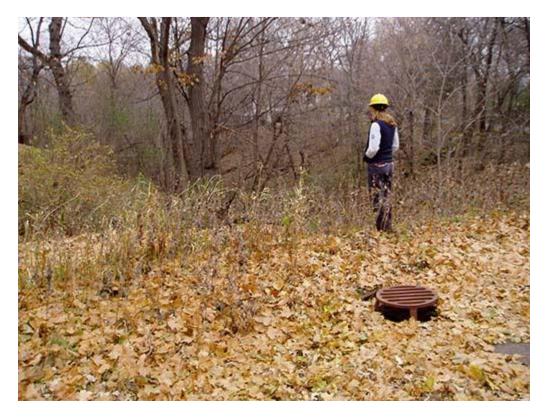
Location: 1800 Orchard Springs-1636 Orchard Spr

Storm drain

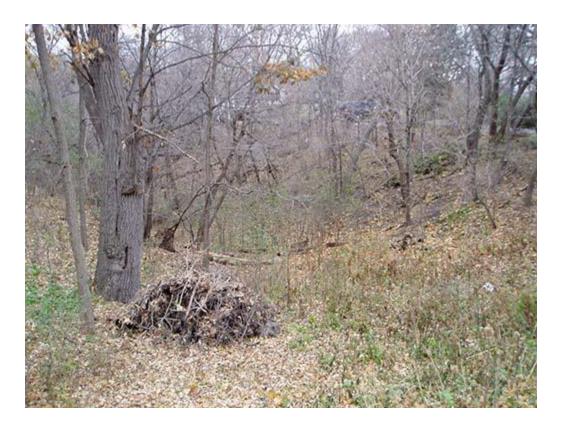
Beginning of gully erosion

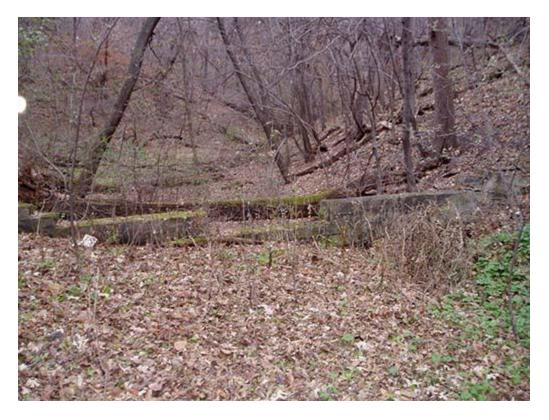
Location: 1800 Orchard Springs-1636 Orchard Springs

Retaining wall in gully, erosion apparent, bare soil

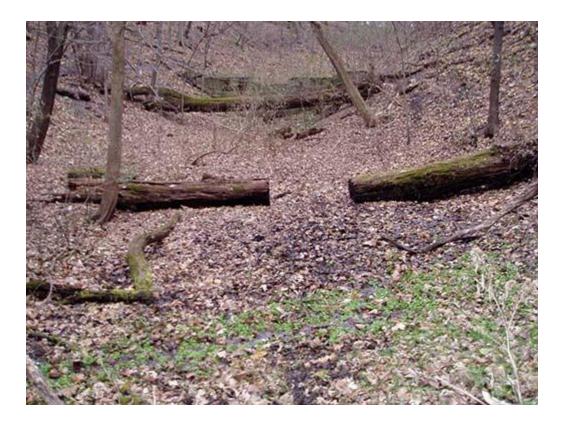
Spring by retaining wall

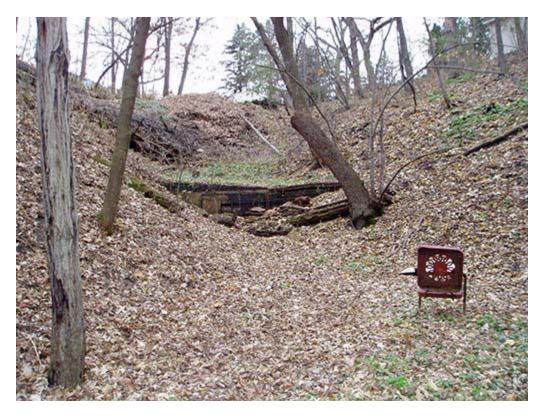
Location: 1800 Orchard Springs-1636 Orchard Springs

Branch and retaining wall, erosion apparent

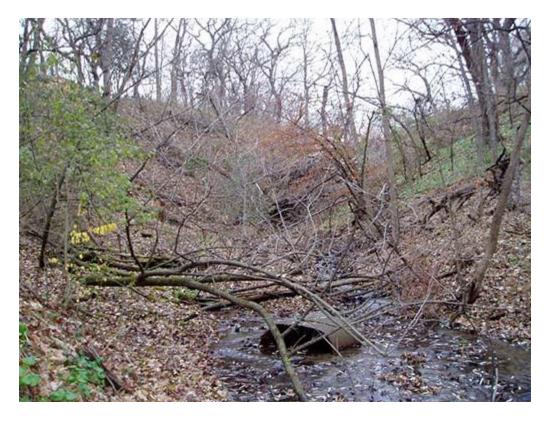
Location: 9524-9530 Riverview Avenue

Gully with a lot of tree debris

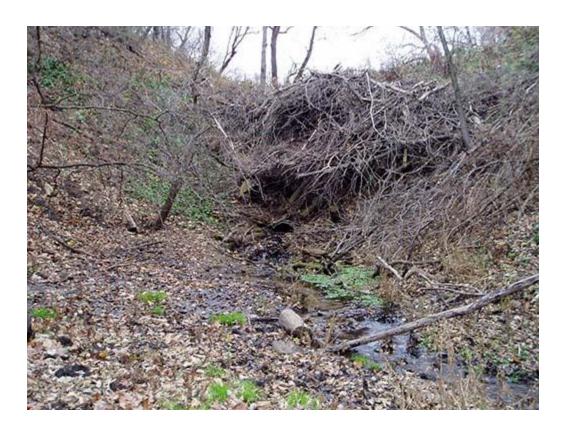
Culvert under dam

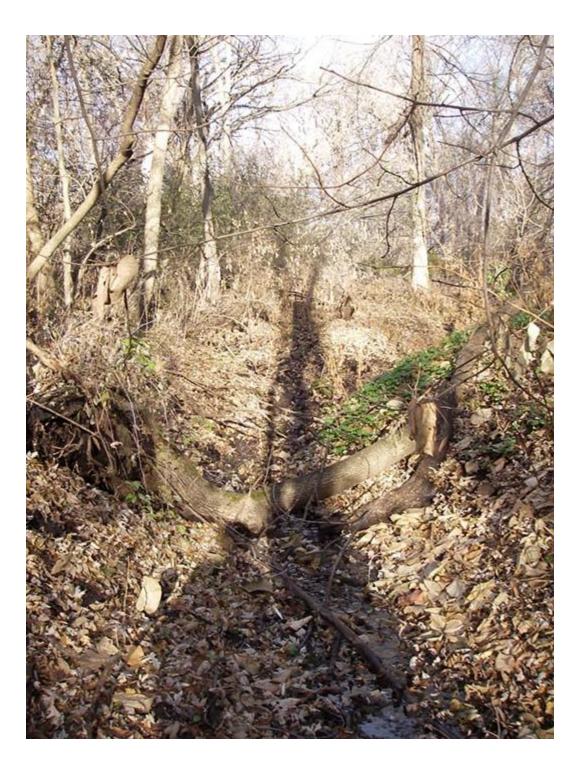
Location: 9300 Old Cedar Avenue South

Spring with water table seepage

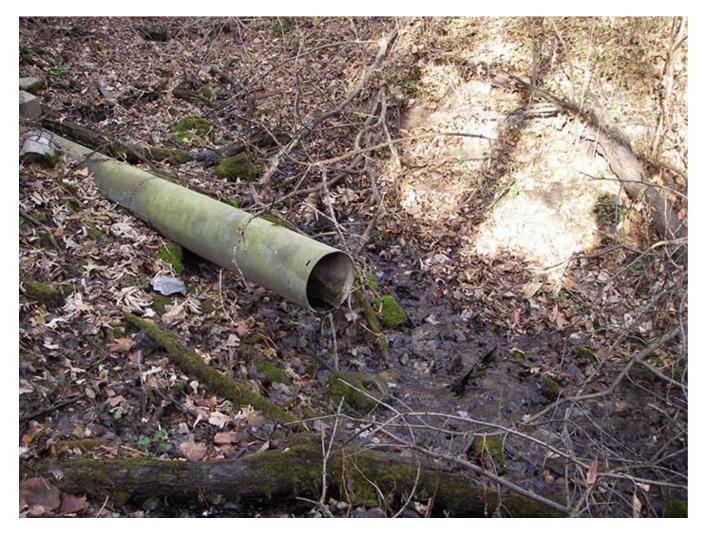
Location: 9300 Old Cedar Avenue South

Pipe outlet and spring

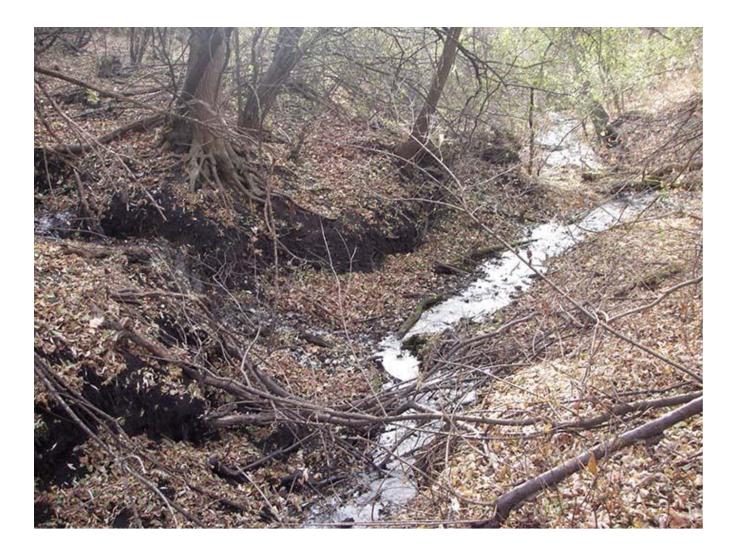
Some severe erosion throughout gully

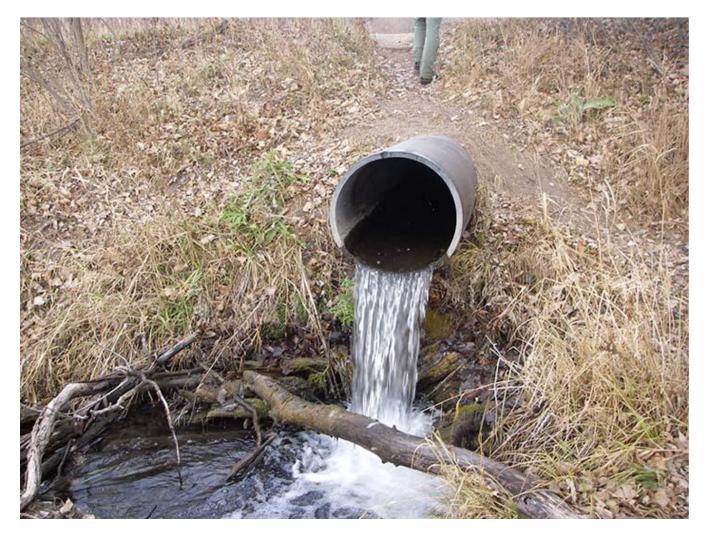
Location: Old Cedar Bridge

Pipe outfall

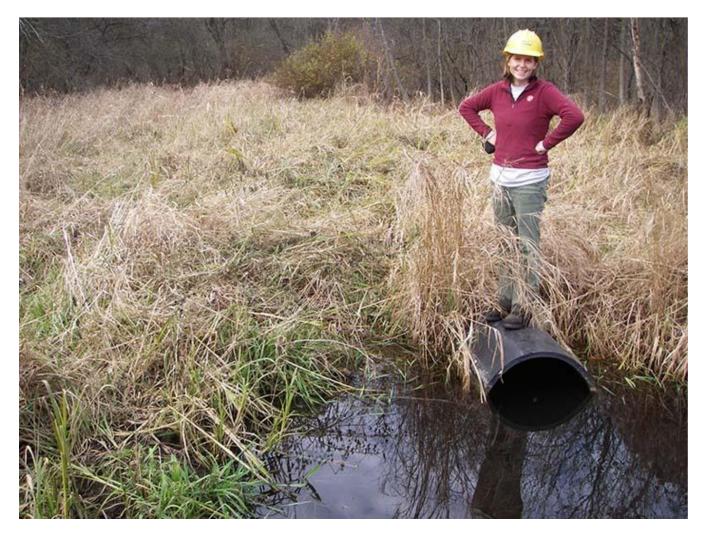
Location: Old Cedar Bridge

40 ft. of broken clay pipe along a long spring

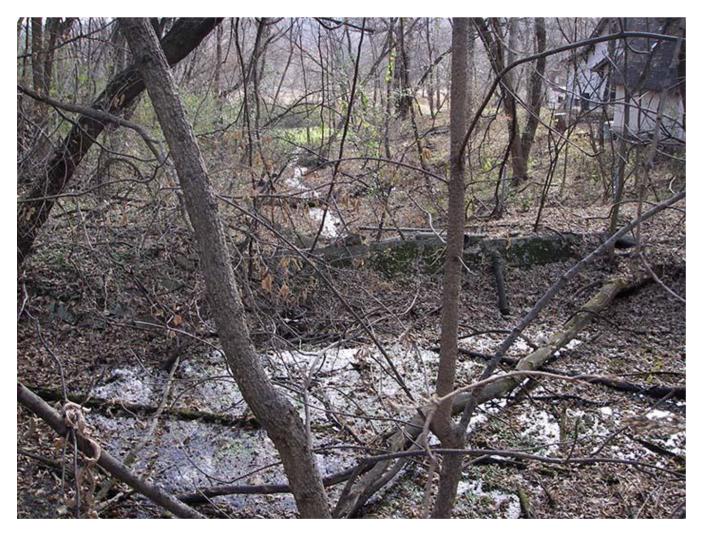
Location: 9347 Cedar Ave. - 9405 Old Cedar Ave.

Spring w/retaining wall and outlet pipe on top of wall, minimal erosion

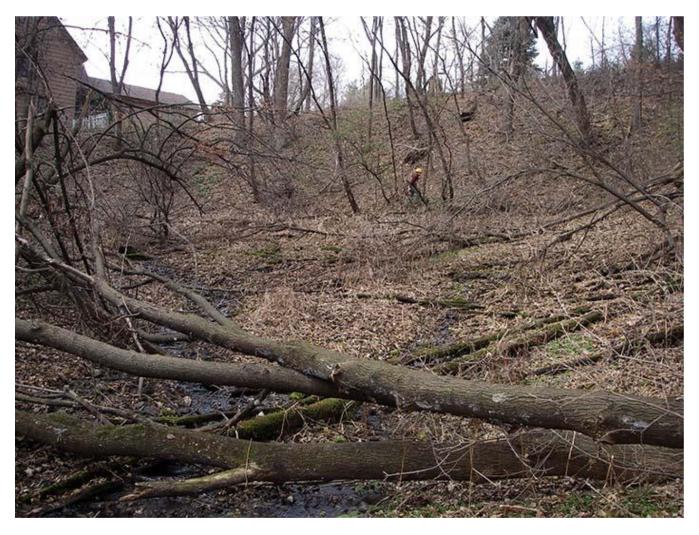
Location: 1865-1875 Meadowview Road

Some erosion present/spring-S. Branch

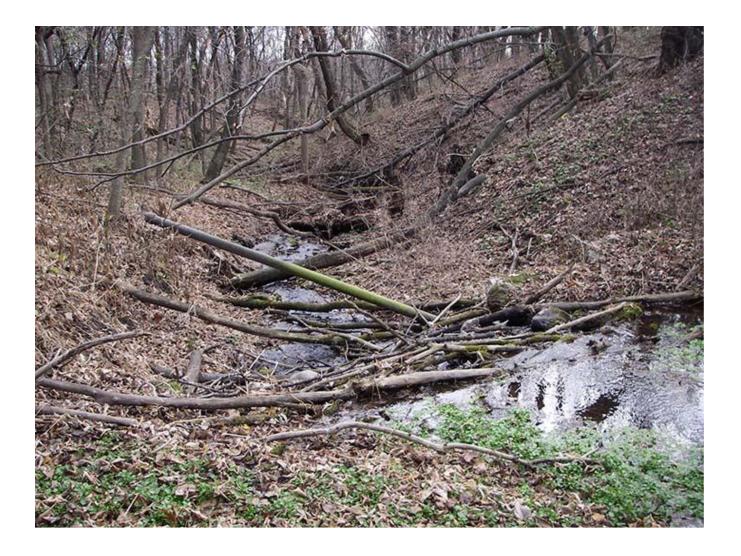
Old retaining wall, some erosion

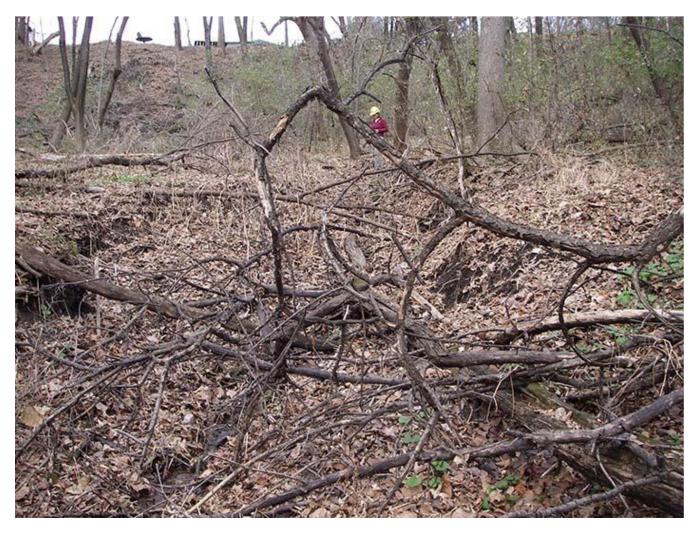
Location: 1865-1875 Meadowview Road

N. branch of spring, tree litter

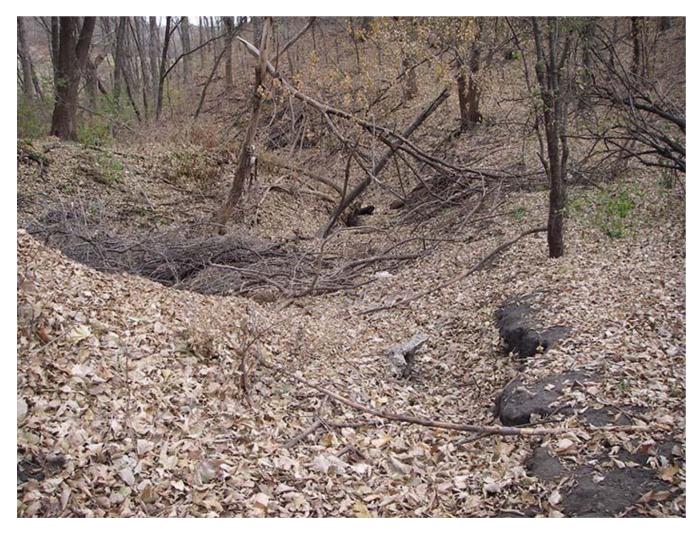
Location: 9145 Meadowview Road - 9109 Springsid

Severe erosion on banks and spring

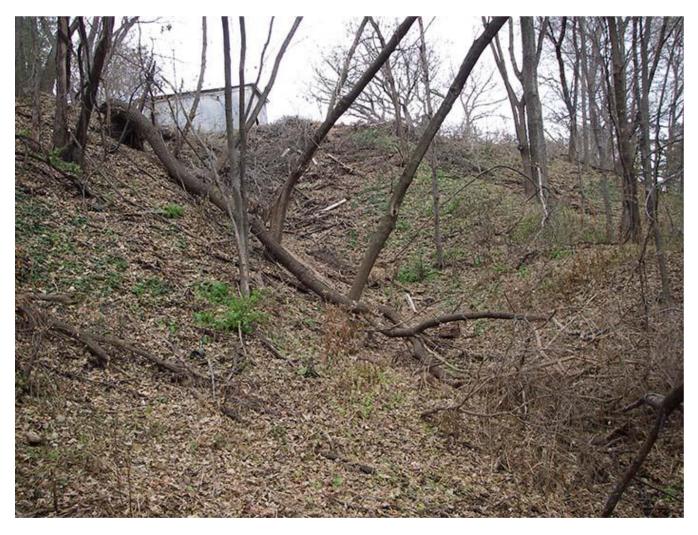
Spring on N. branch, much tree debris

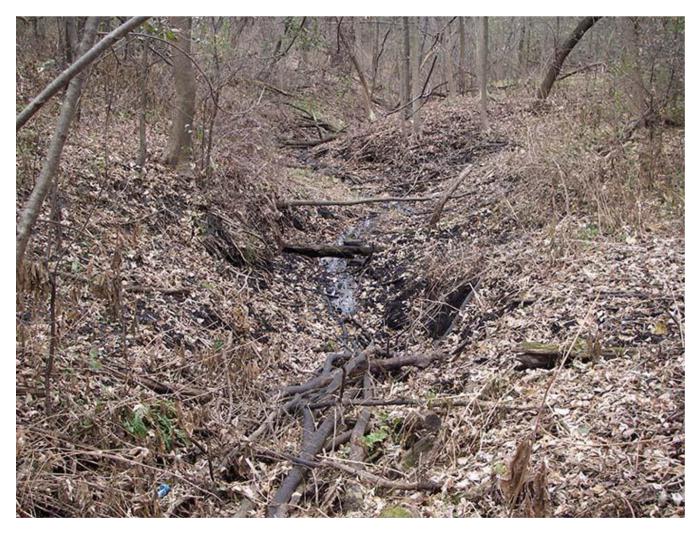
Location: 8905-8920 River Ridge Road

Spring, some severe erosion and tree debris

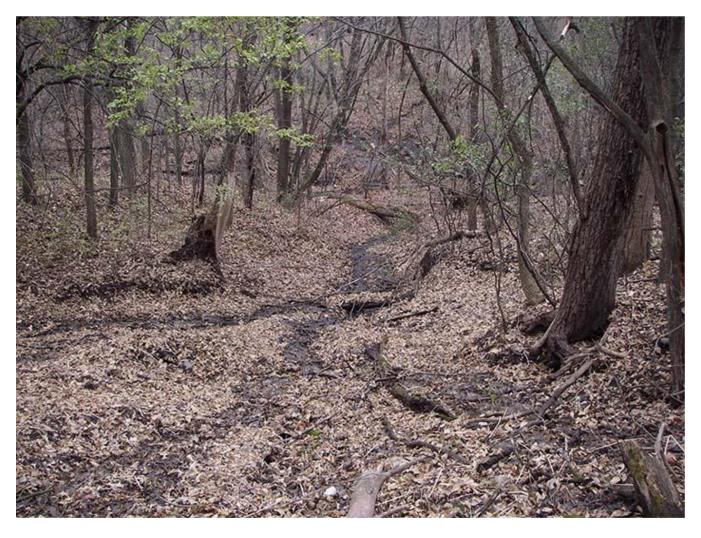
Location: 8905-8920 River Ridge Road

S. branch, spring, moderate erosion

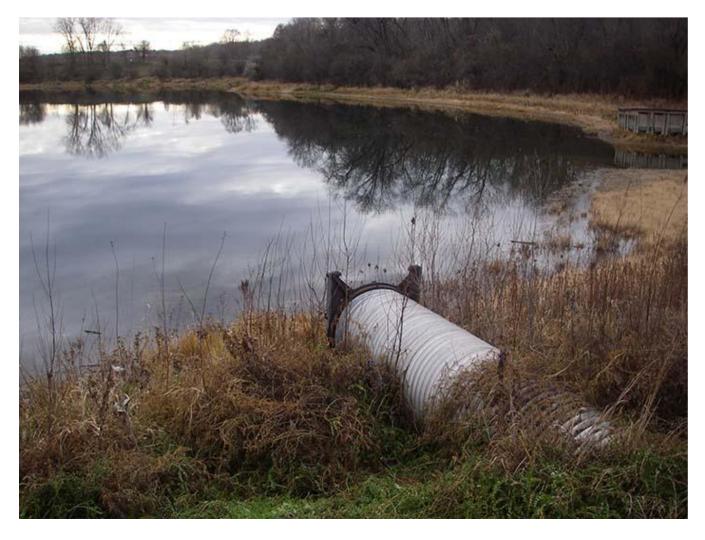
Location: Lower Bass Ponds

No erosion, pipe outlet

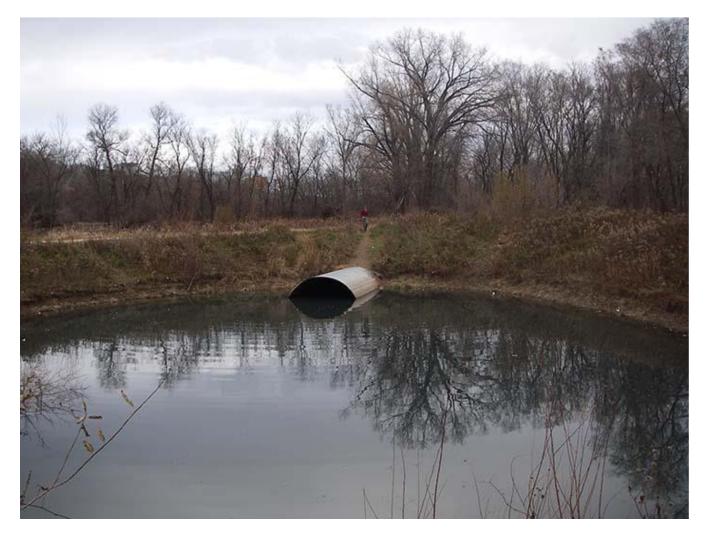
Location: Lower Bass Ponds

Outlet pipe

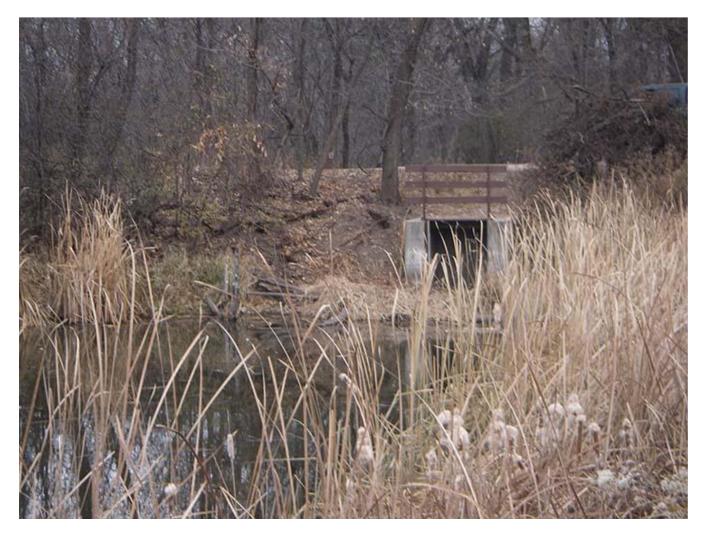
Location: Lower Bass Ponds

Outlet pipe

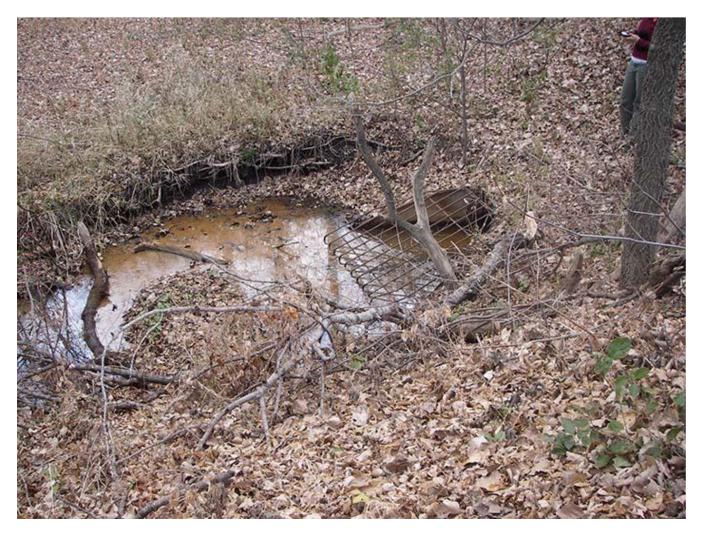
Location: Lower Bass Ponds

Culvert

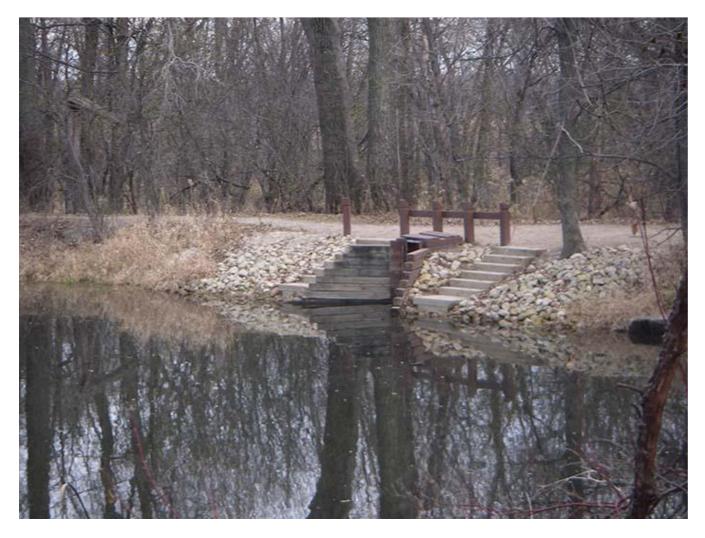
Location: Lower Bass Ponds

Culvert

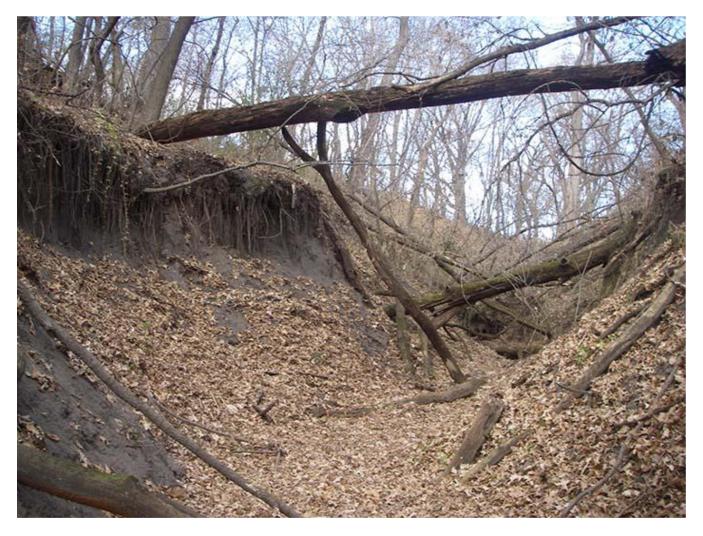
Location: Bass Ponds Stream-furthest East and d

Extreme erosion

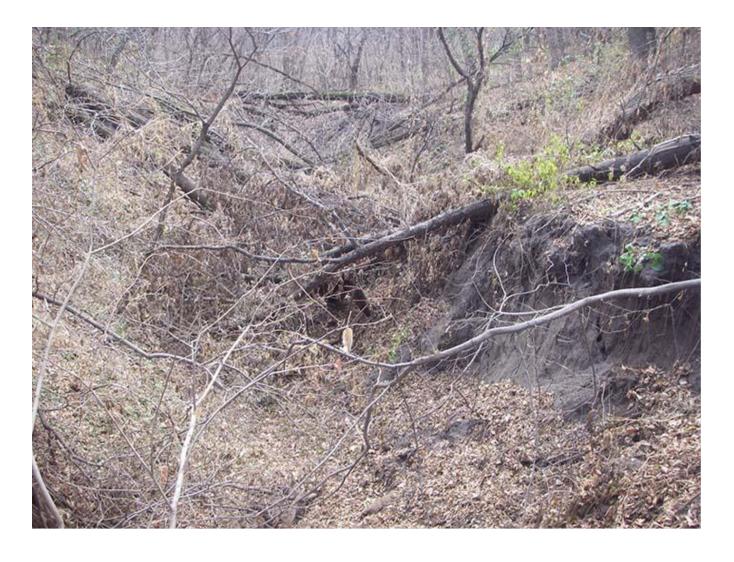
Extreme erosion

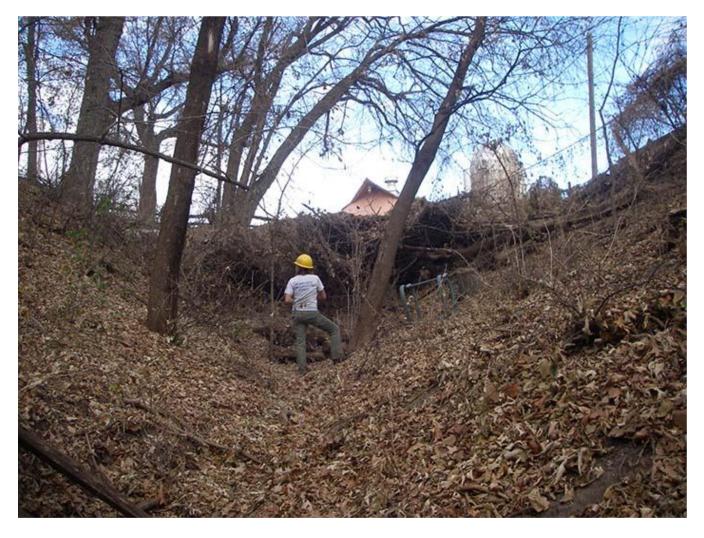
Location: Bass Ponds Stream-furthest East and d

Lots of tree litter

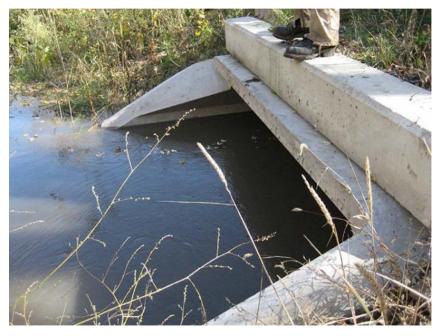
Waypoint 100A

Concrete culvert along paved trail on river side; culvert goes under paved trail; high water; little erosion; couldn't get to river shore cu

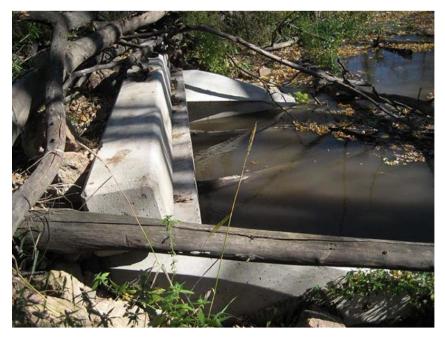
Concrete culvert on other side of paved trail; culvert goes under paved trail; high water; little erosion; couldn't get to river shore cue t

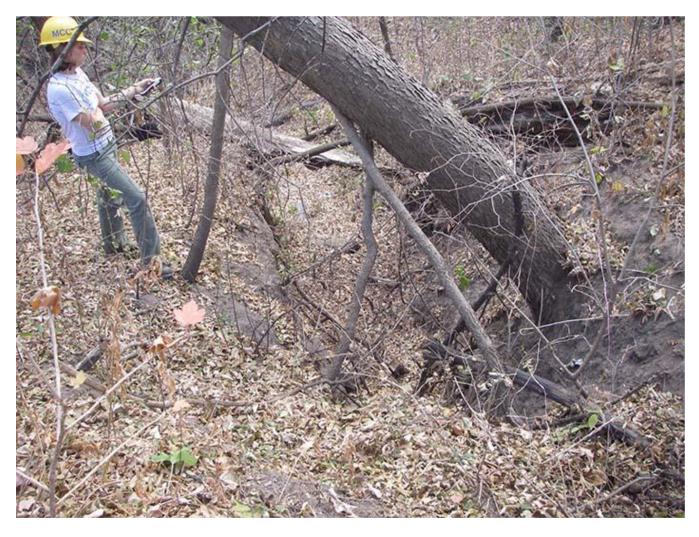
Location: Bass Ponds Stream-furthest East and d

Deeply eroded gully/tributary

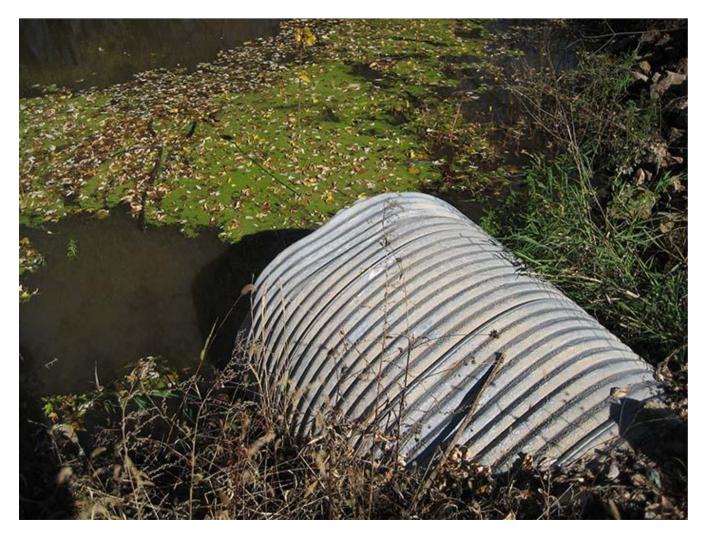
Waypoint 101A

Metal culvert piping going under paved trail - river side.

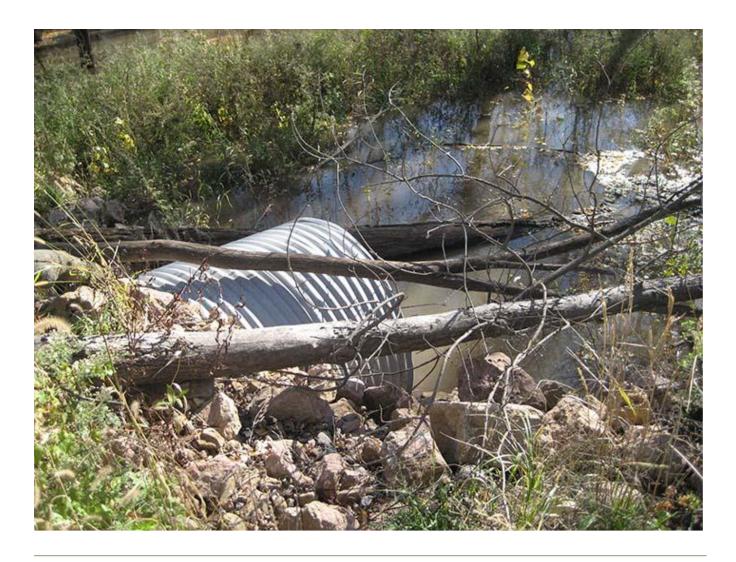
Metal culvert piping going under paved trail - opposite side of trail.

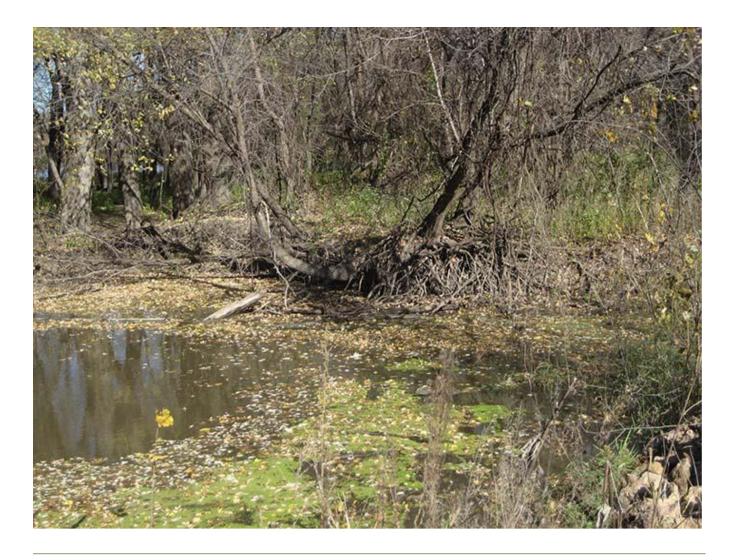
Small amount of erosion on riverside of trail at metal culvert.

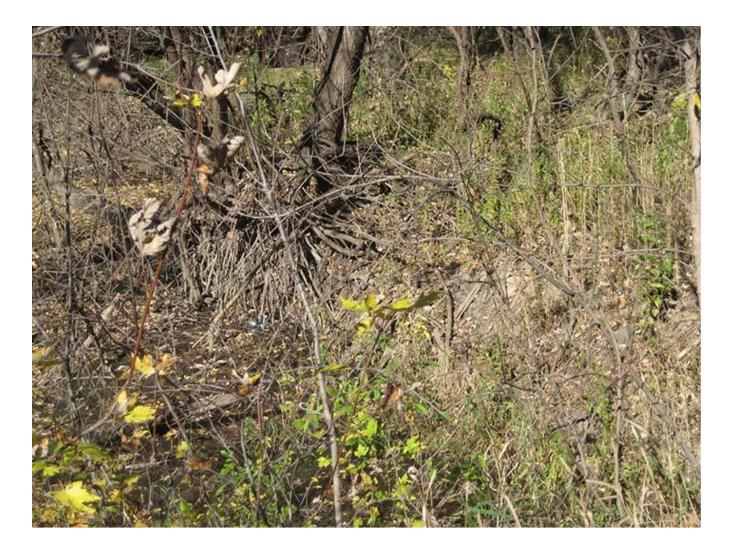
Closer picture of erosion.

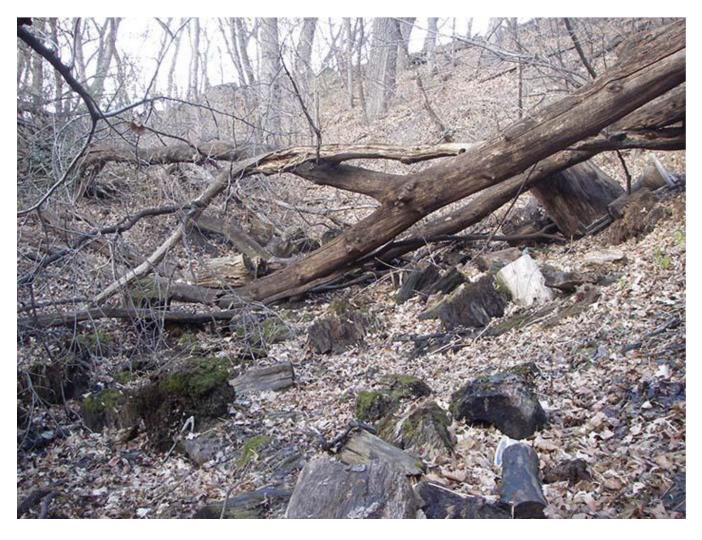
Location: Bass Ponds Stream - first tributary

Some trash and some erosion at spring

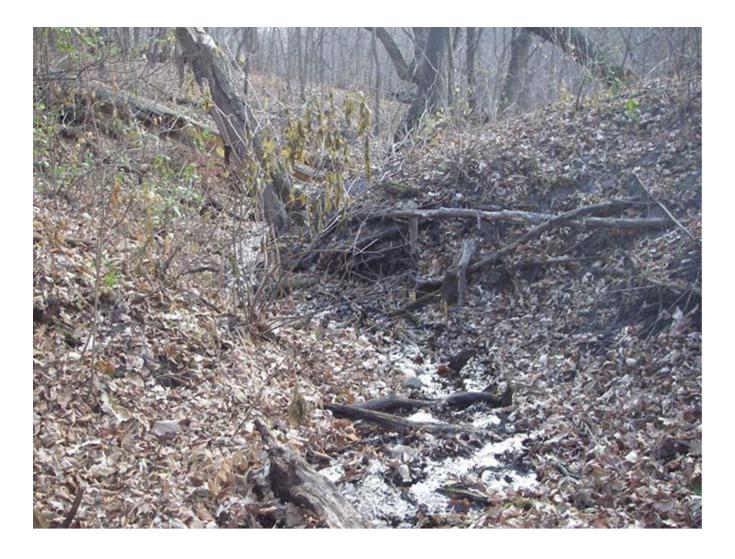
Erosion

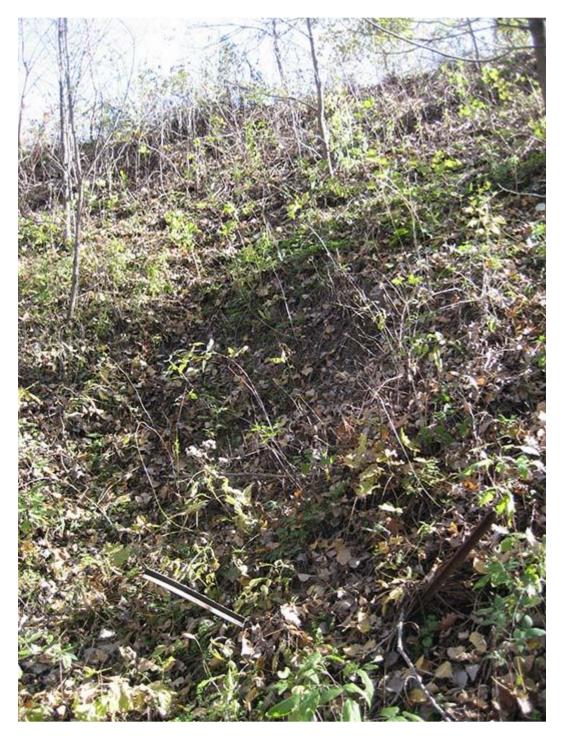
Waypoint 102A

Between trail and quarry; steep hillside slope with slight erosion.

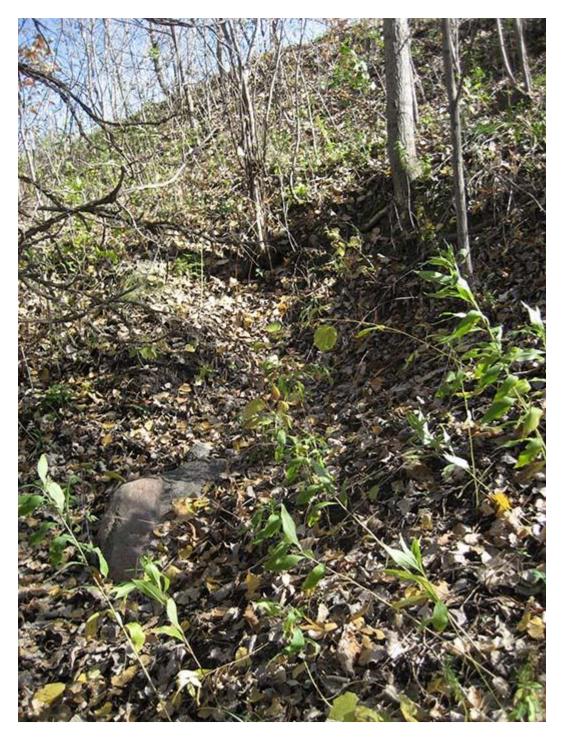
To the left of previous picture; slight erosion.

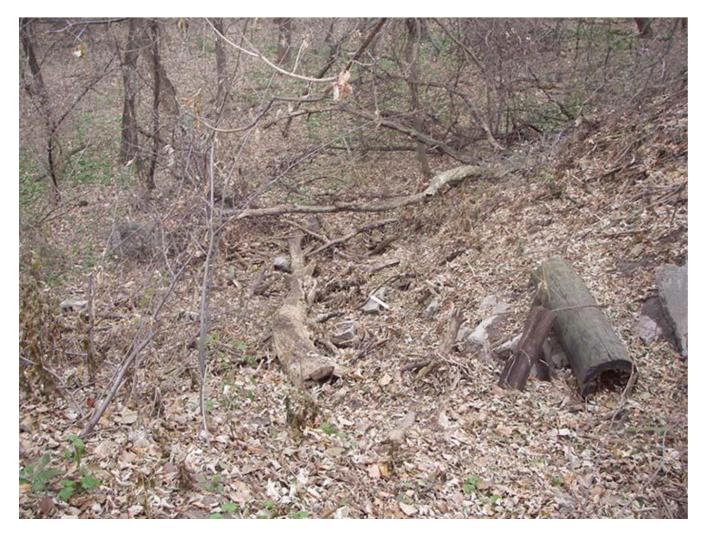
Location: Upper Bass Ponds stream

Erosion and trash heap

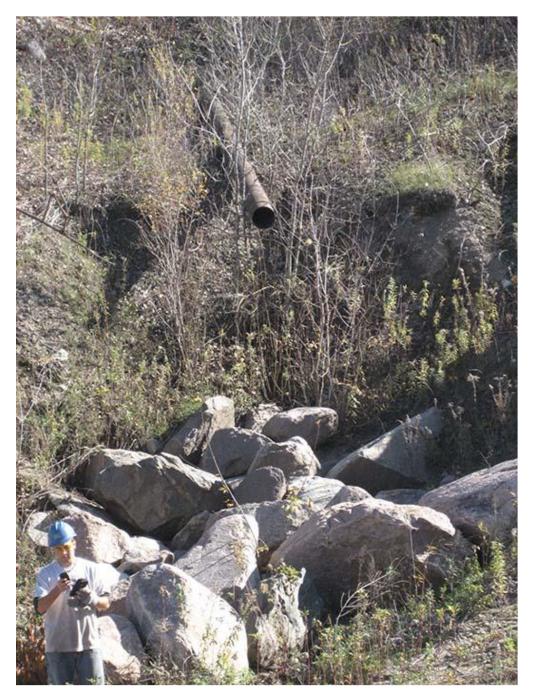
Waypoint 103A

Long metal piping coming down from quarry onto large boulders; major erosion.

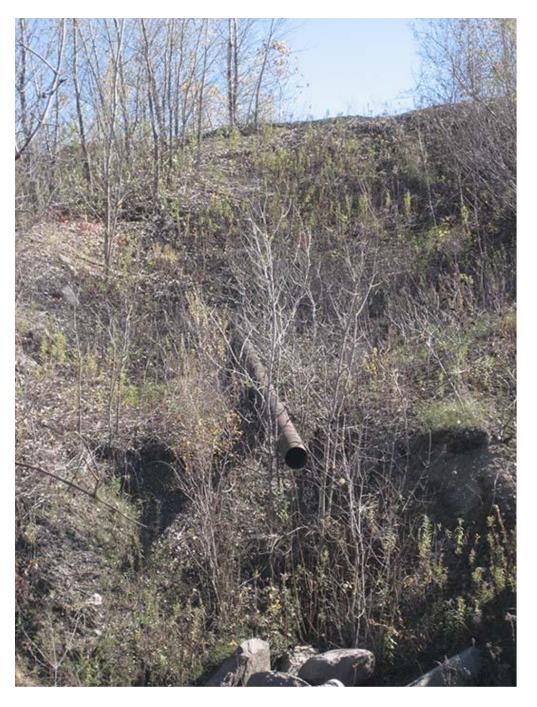
Long metal piping coming down from quarry onto large boulders; major erosion.
