Gully Inventory Map	Legend		\mathbf{T}
Area #1	LMRWD Boundary (not official)	FEMA Floodway	\mathbb{N}
Lower Minnesota River Watershed District	City/Township Boundary	100-Year FEMA Floodplain	T
Watershed Management Plan	Gully Inventory Locations	500-Year FEMA Floodplain	Not to Scale

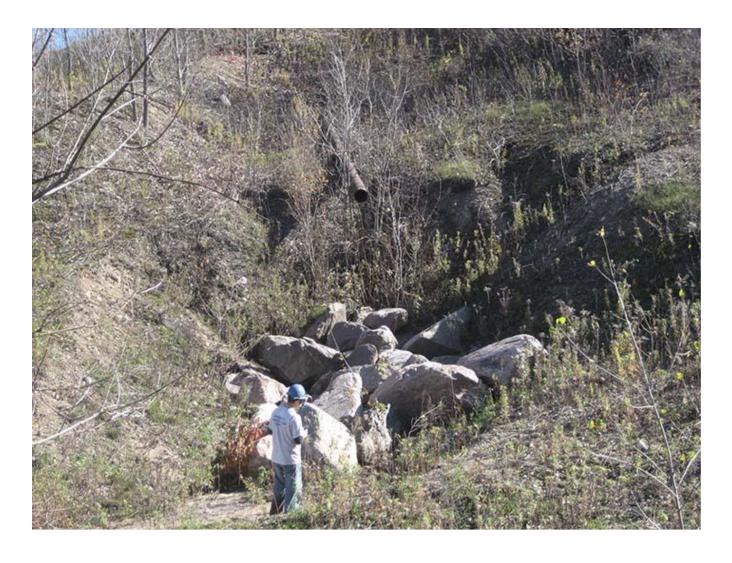
Long metal piping coming down from quarry onto large boulders; major erosion.

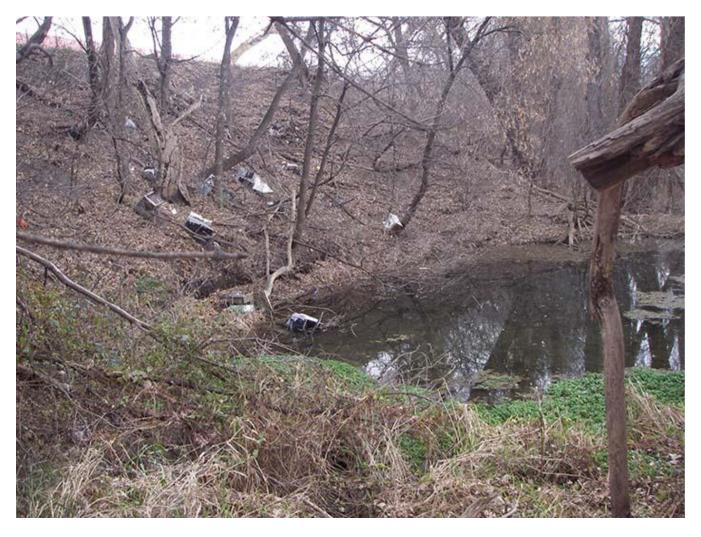
Location: Upper Bass Ponds stream

Bass ponds stream source/spring

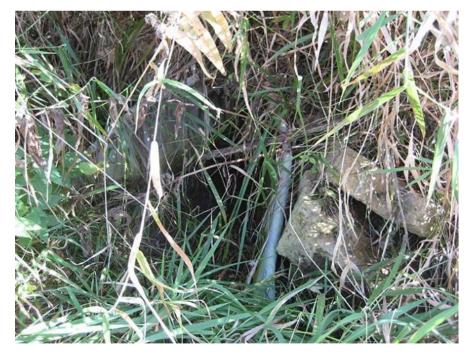
Waypoint 104A

Small culvert going under paved trail; little or no erosion

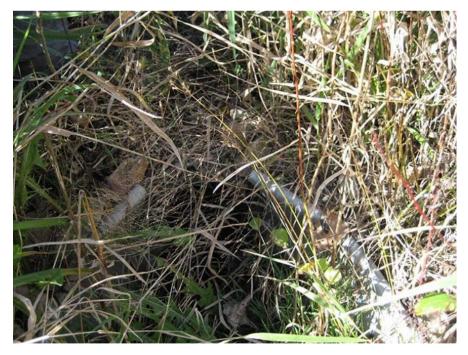
Small culvert going under paved trail; little or no erosion

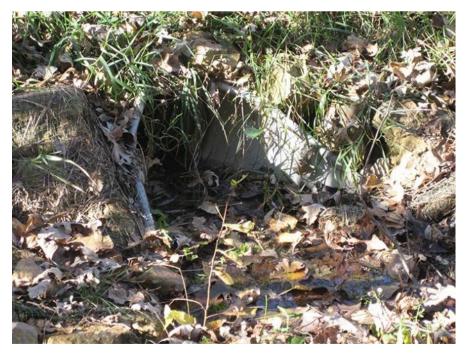
Opposite side of path from river; culvert going under path; erosion matting/rock placed under culvert; pooling water around culvert.

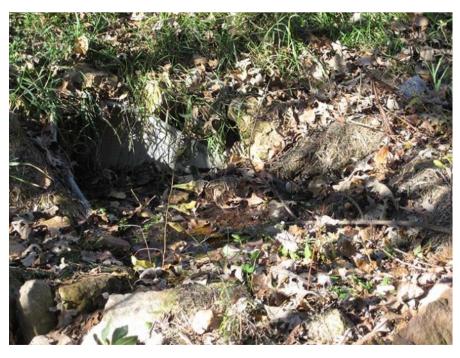
Opposite side of path from river; culvert going under path; erosion matting/rock placed under culvert; pooling water around culvert.

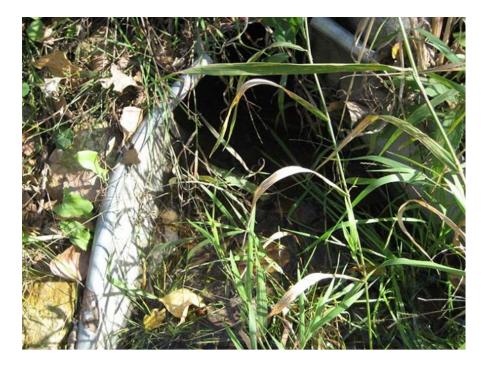
River side of trail; matting/rock layer; pooling water.

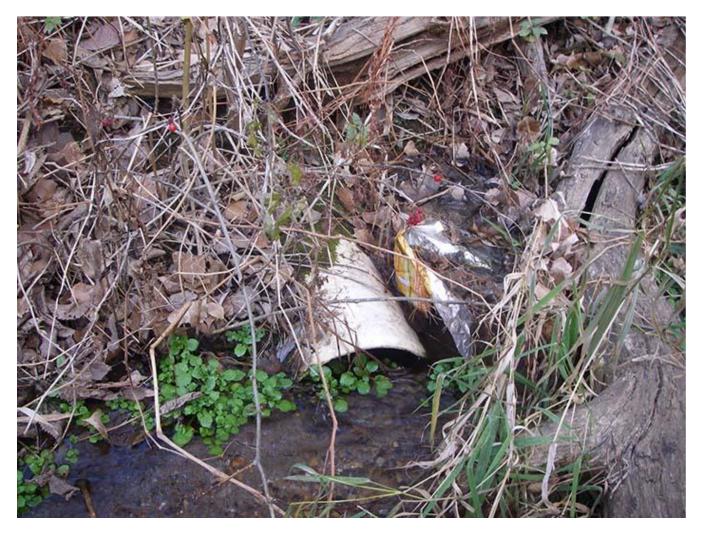
Location: Upper Bass Ponds stream

Pipe outfall at spring/somewhat buried

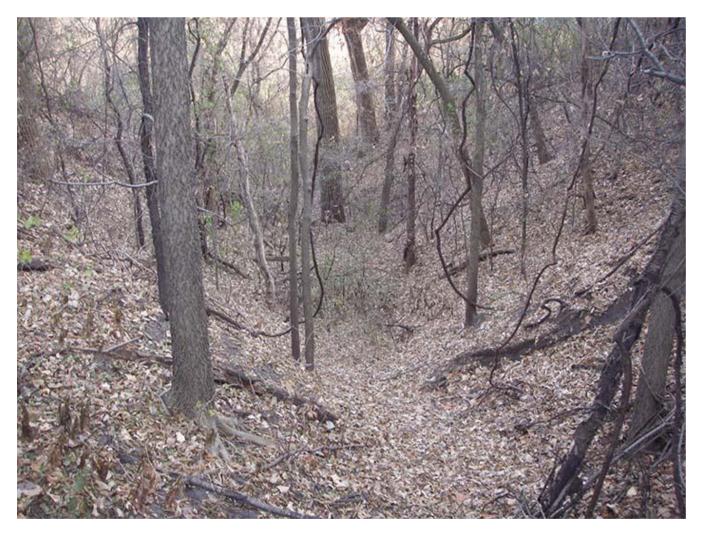
Location: 4301 American Blvd.

Deep erosion

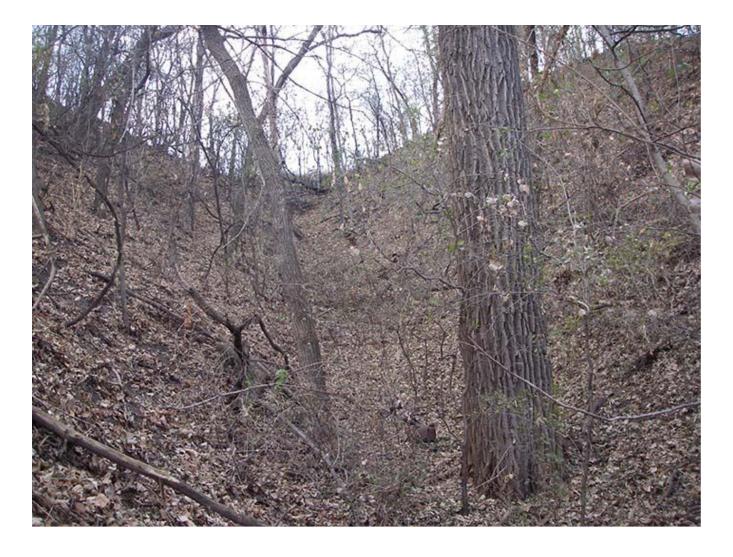
Deep erosion

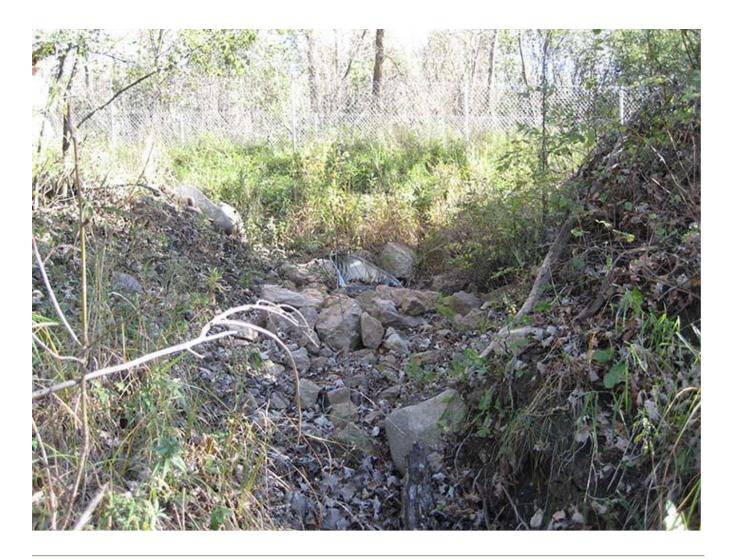
Major erosion

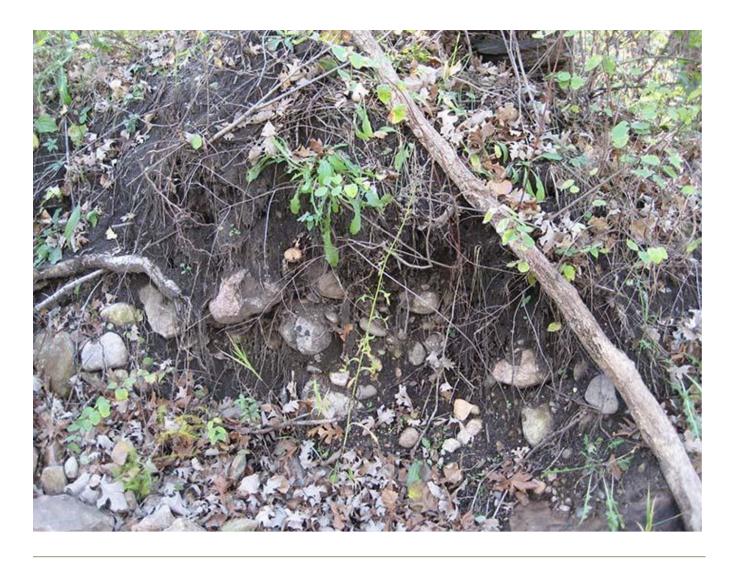
Severe erosion

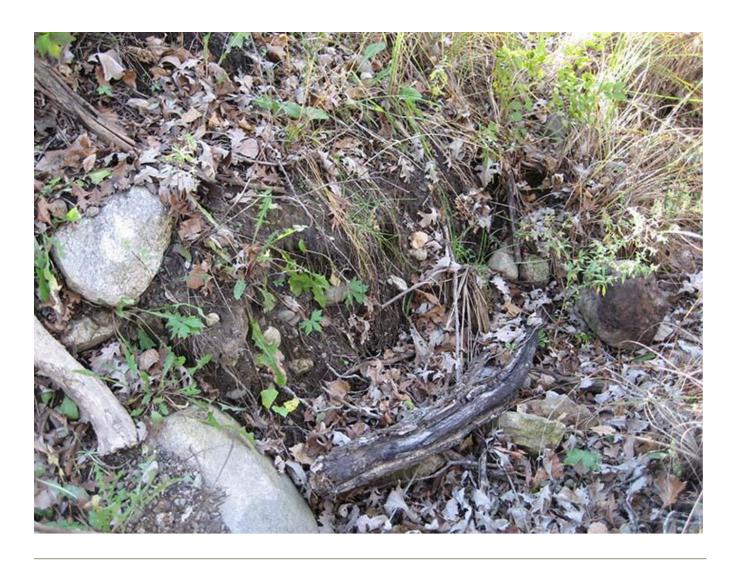
Severe erosion

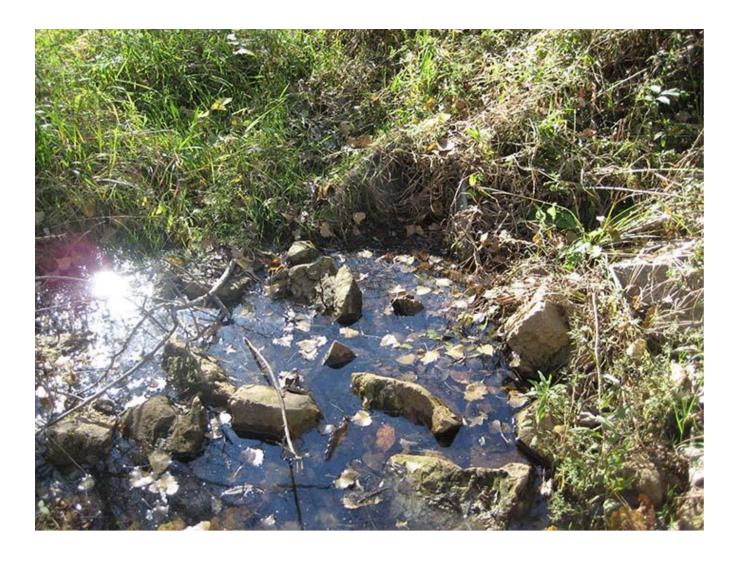
Location: 4301 American Blvd.

Some erosion; Multiple 111

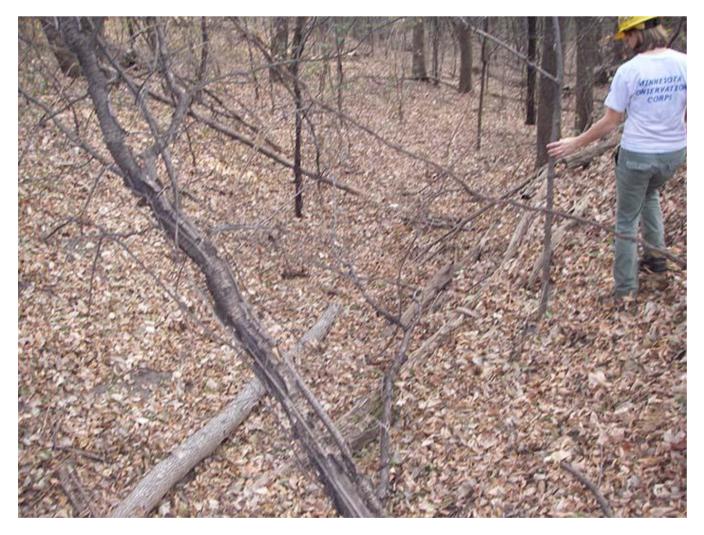
Gully with tree litter;

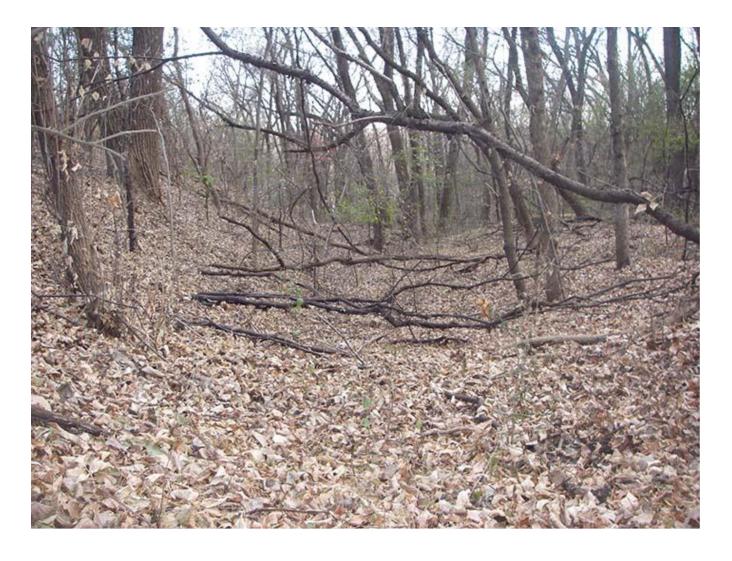
Waypoint 107A

Top of gully; lots of litter, cans, bottles, refrigerator, mattress, rugs, tires, etc.

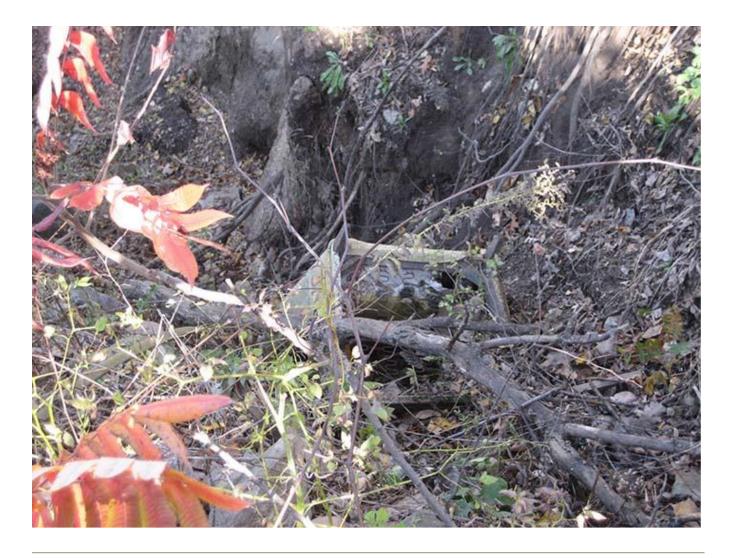
Major erosion.

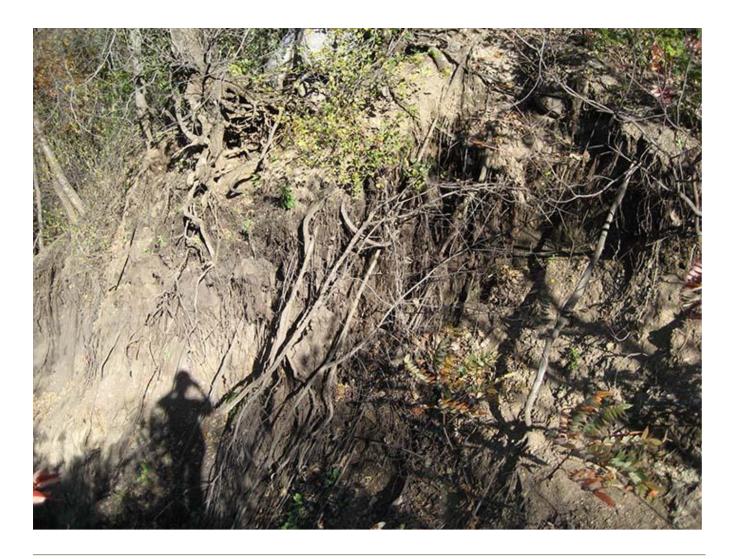
Looking down at gully.

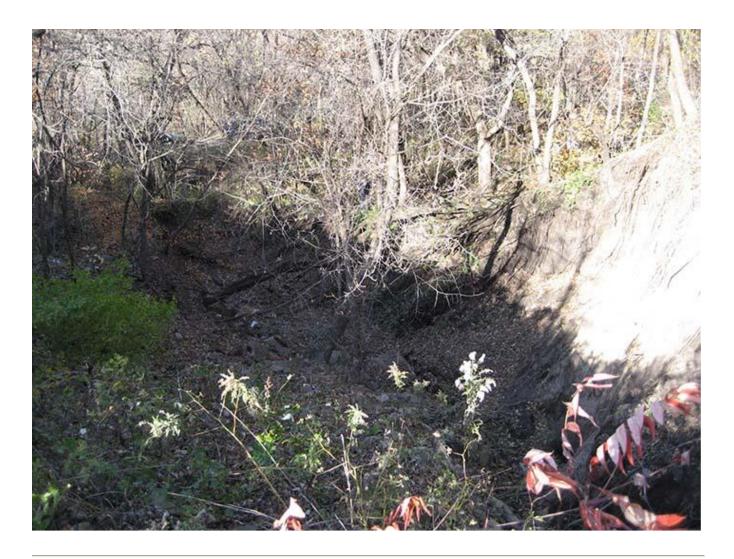
Middle of gully looking up.

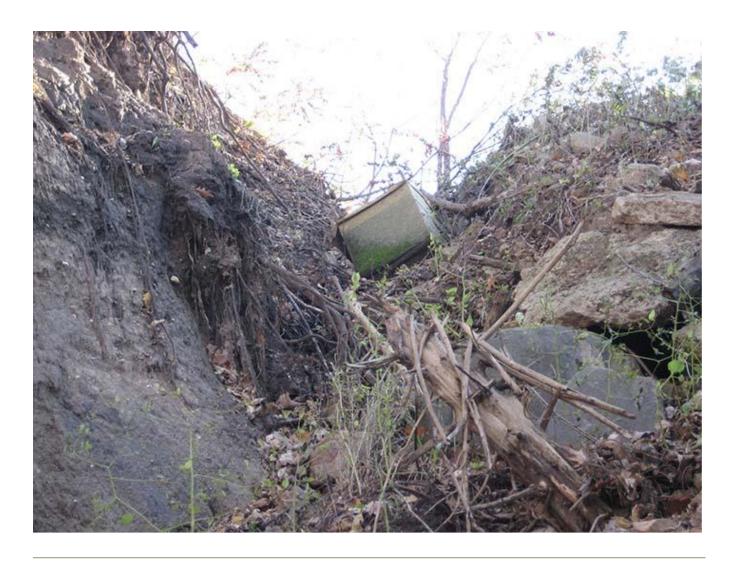
Natural water springs; large boulders.

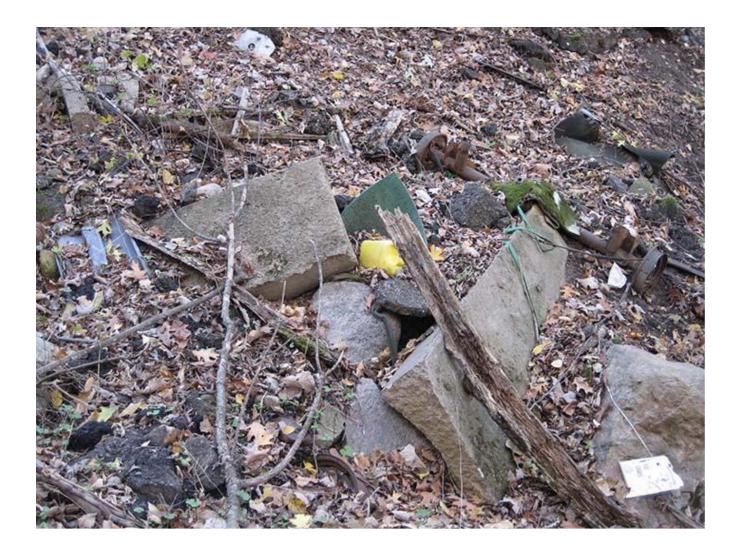
Location: 4301 American Blvd.

Trash, Multiple 112

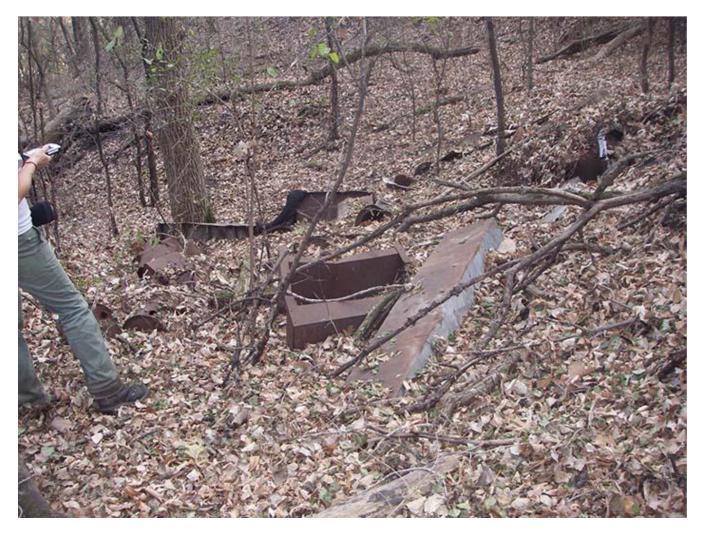
Waypoint 108A

Bottom of gully; culvert going under trail.

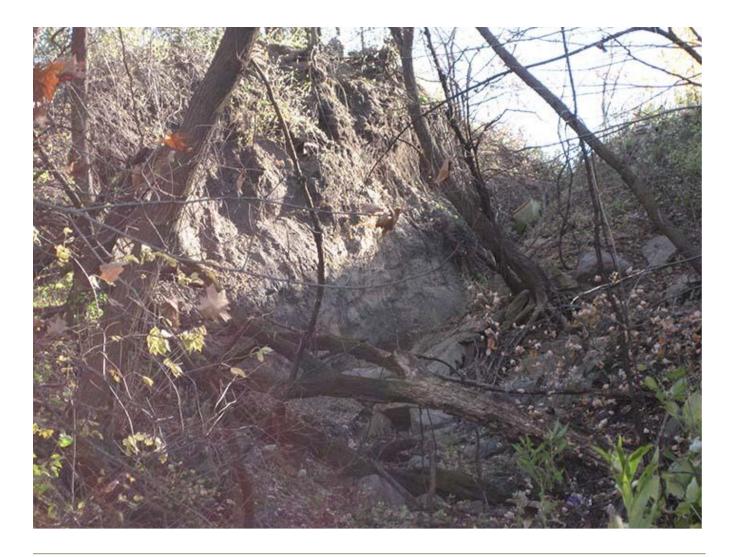
River side of trail; other end of culvert.

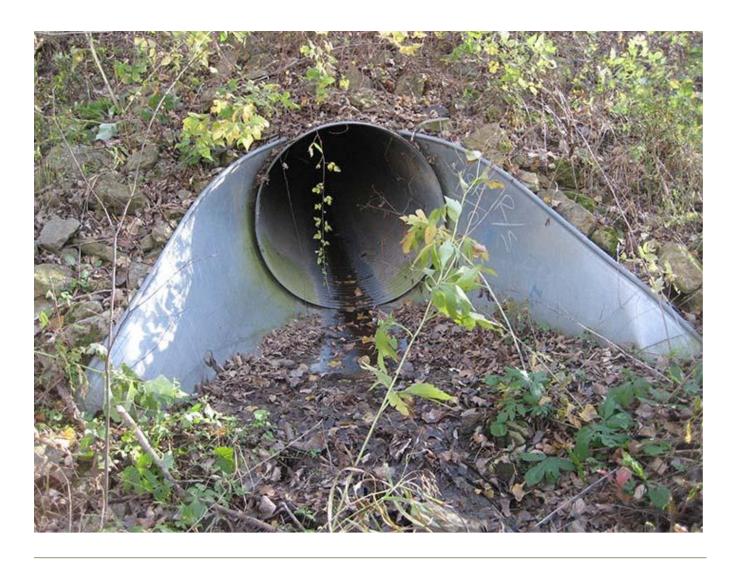
Slight erosion coming out of culvert.

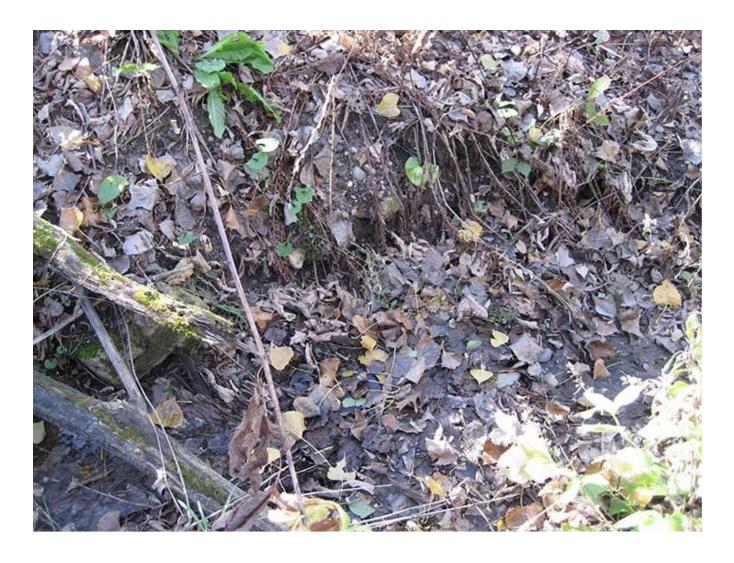
Waypoint 109A

Small culvert on river side of trail; small amount of erosion.

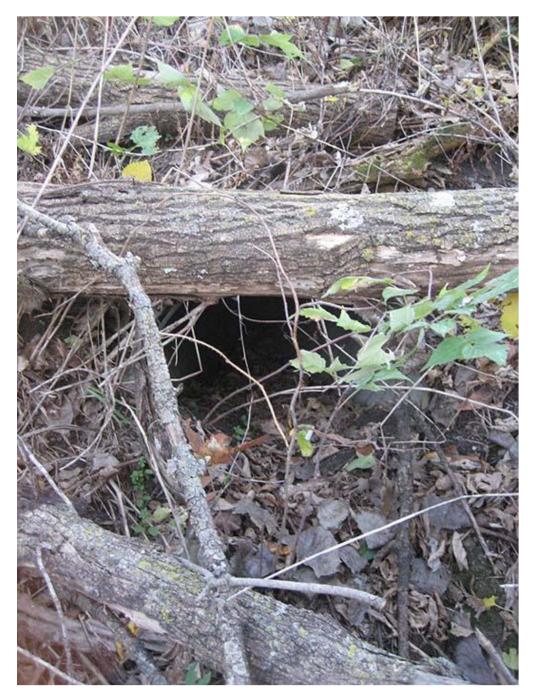
Other end of culvert.

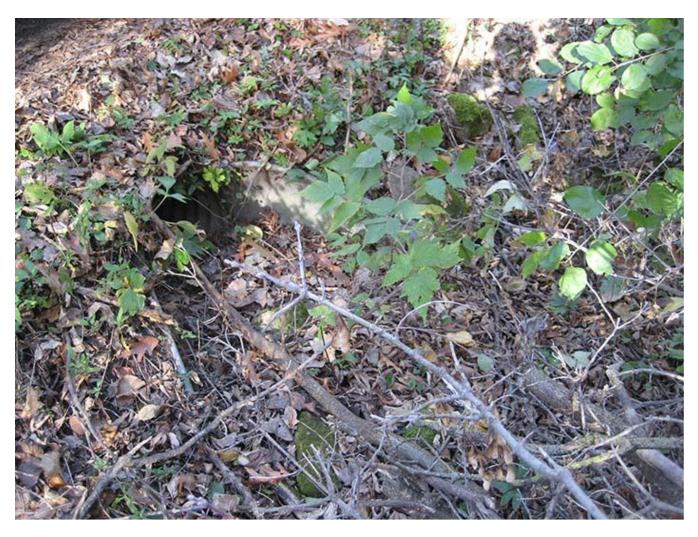
Location: Bade Residence off #213

construction/erosion, standing water

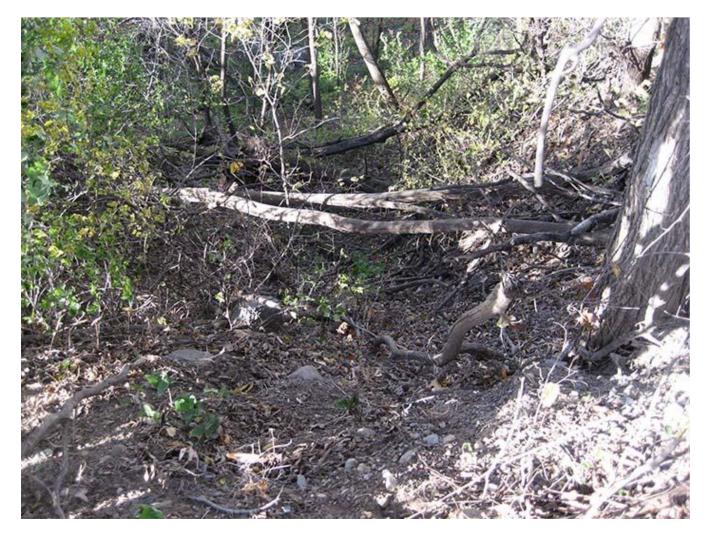
Looking up at gully.

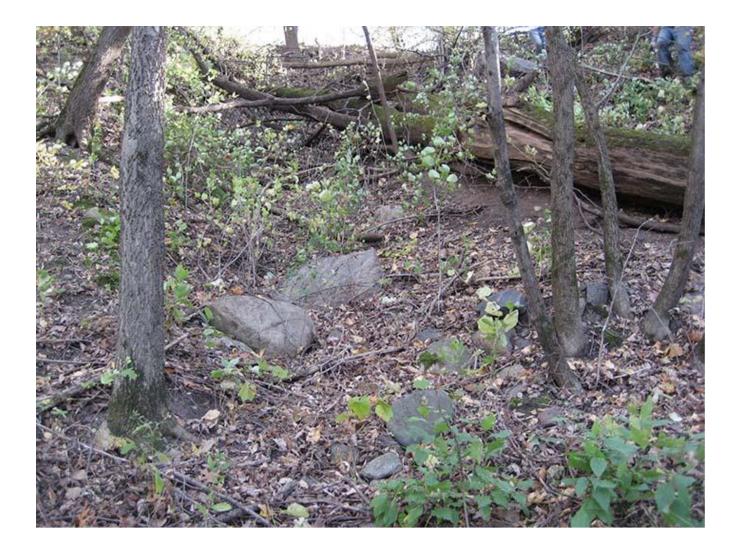
Location: Bade Residence off #214

Delta/end of water flow into lake

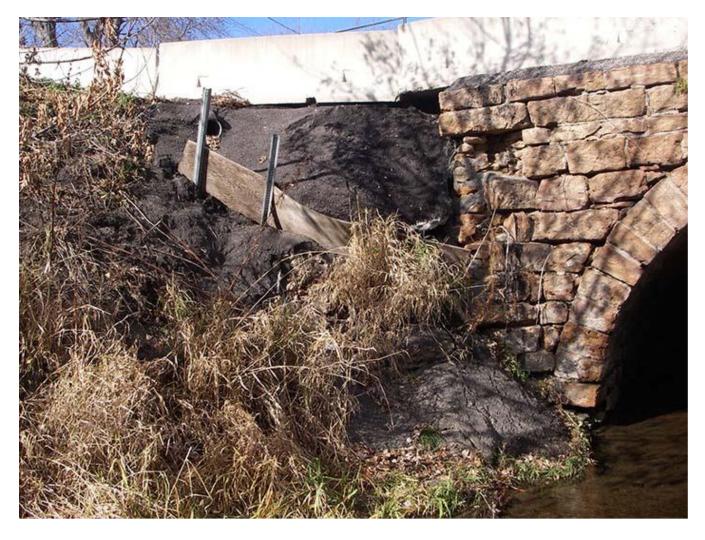
Waypoint 111A

Culvert going under trail opposite of river side; little erosion.

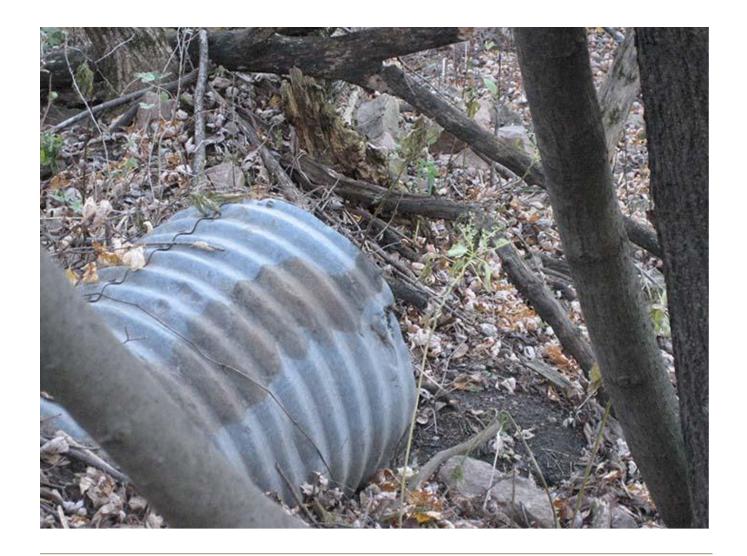
Same culvert as previously

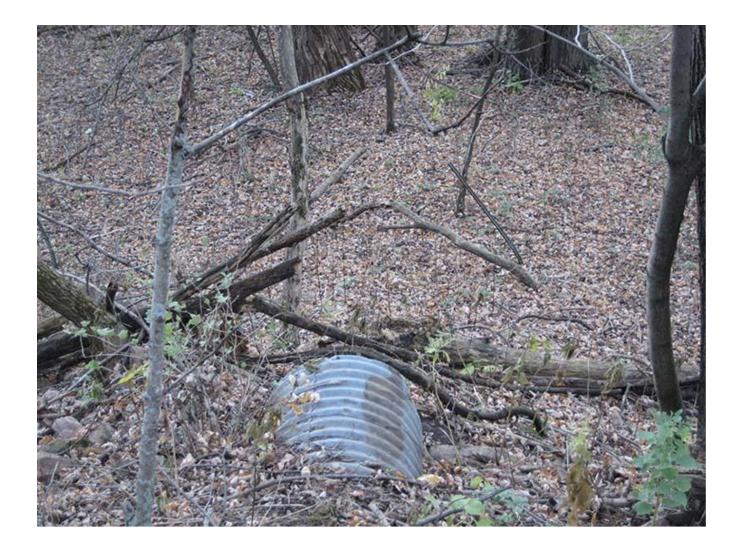
Location: Bade Residence off #212

Heavy erosion middle short & short of finger tip

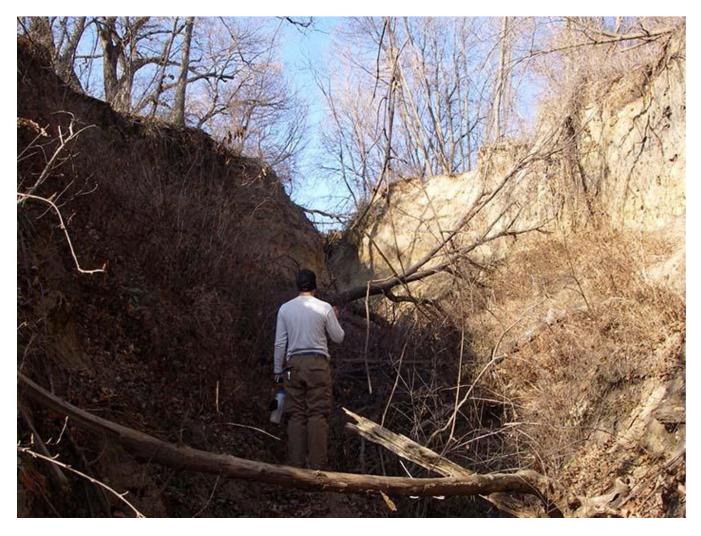
Heavy erosion middle short & short of finger tip

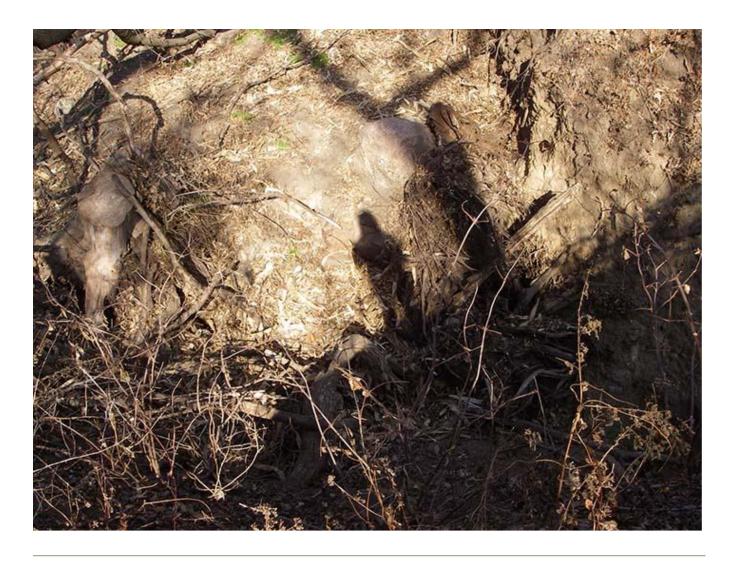
Eroded stream bank

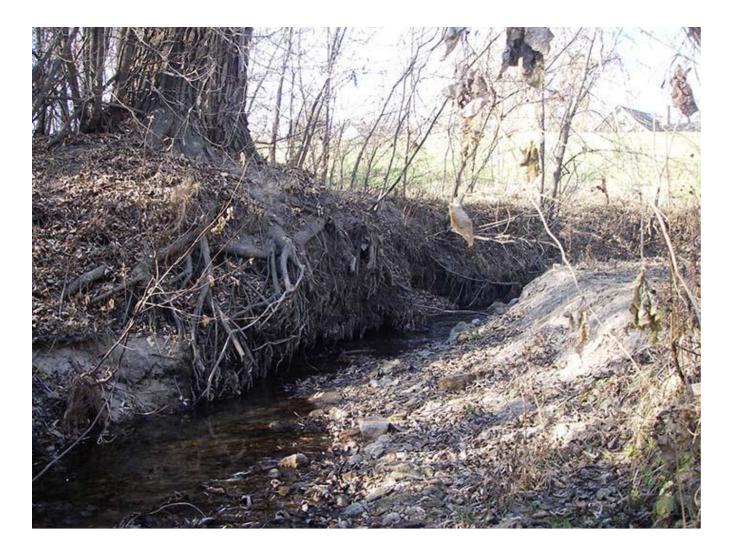
Waypoint 112A

Culvert opposite side of river going under trail; very little erosion.

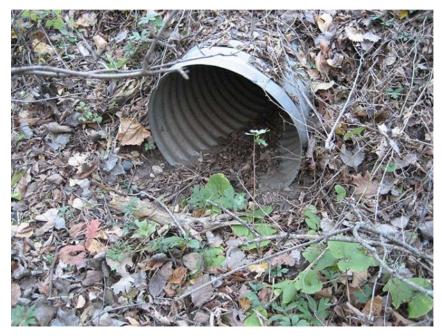
Culvert on river side of trail; large drop-off under culvert; probably some erosion but could not see due to leaves/ground cover; too hard t

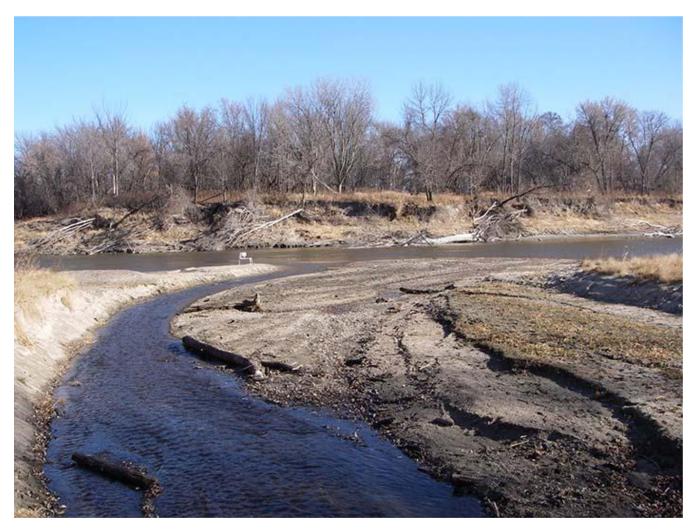
Eroded banks of stream

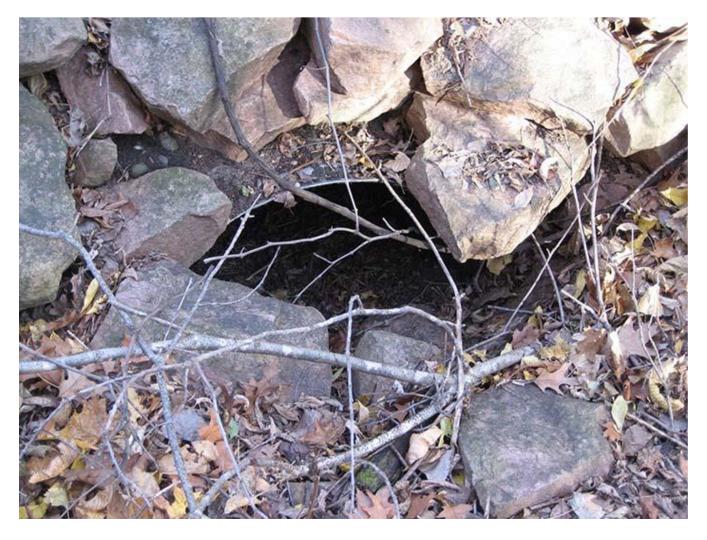
Culvert on river side; large rocks around it; small amount of erosion.

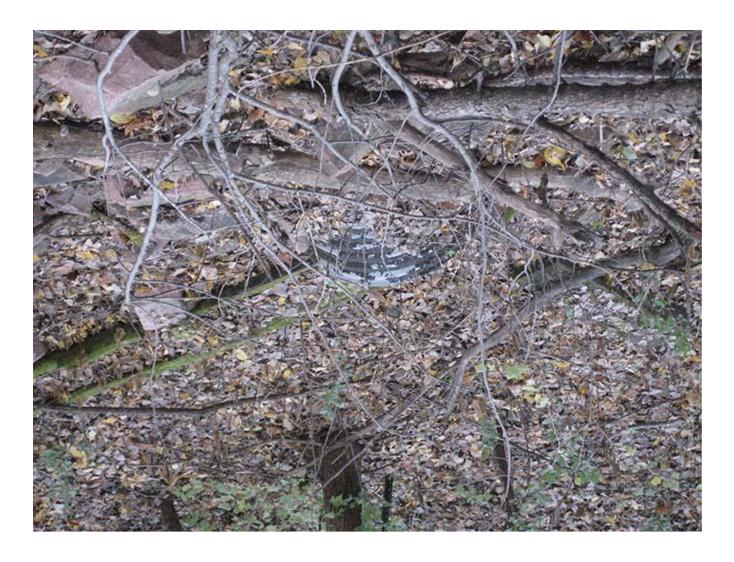
Location: Carver Stream (large amounts of tree

Drain pipe exit

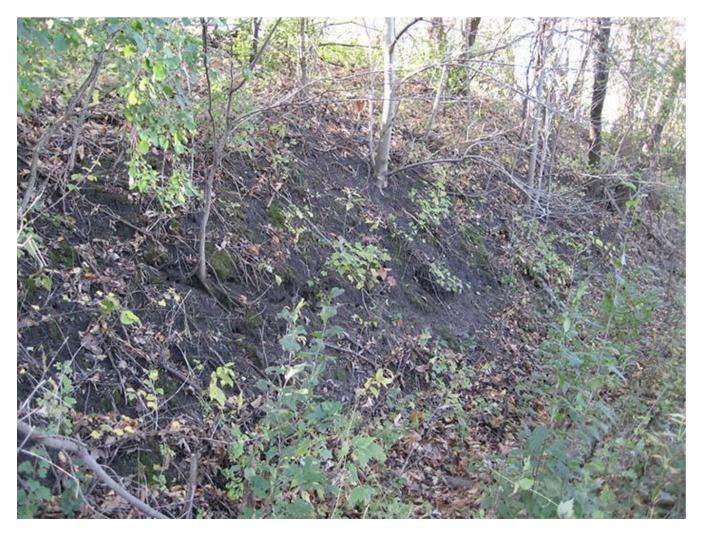
Location: Carver Stream (large amounts of tree

Drain pipe exit

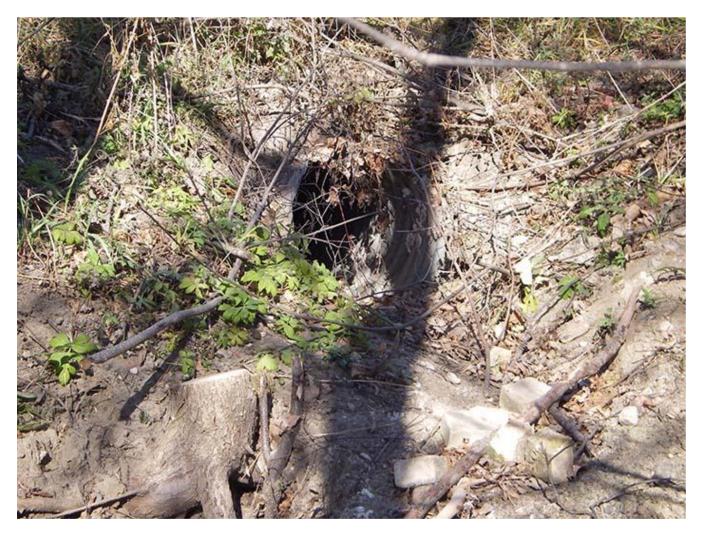
Erosion control matting

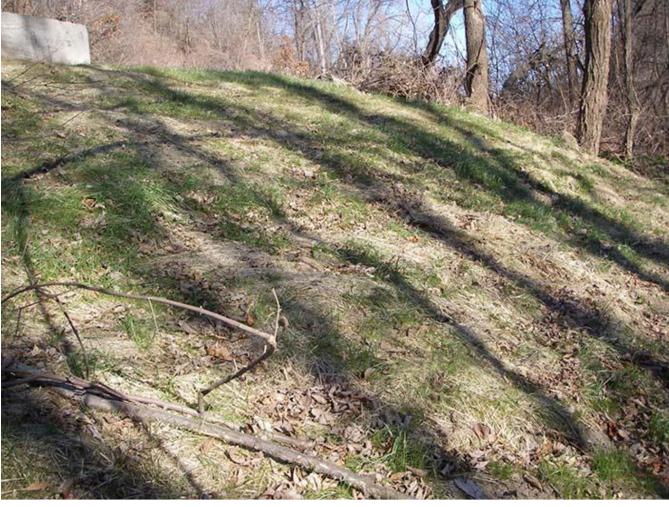
Gully from WP1716 drain pipe

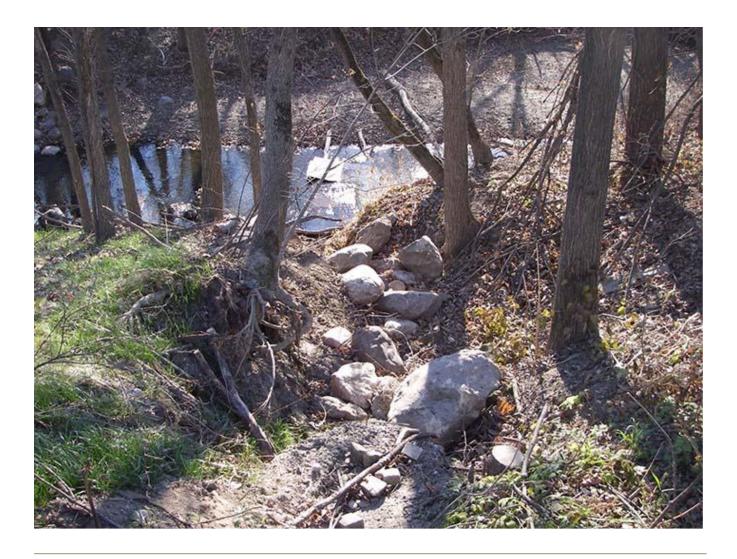
Erosion control along bank of river

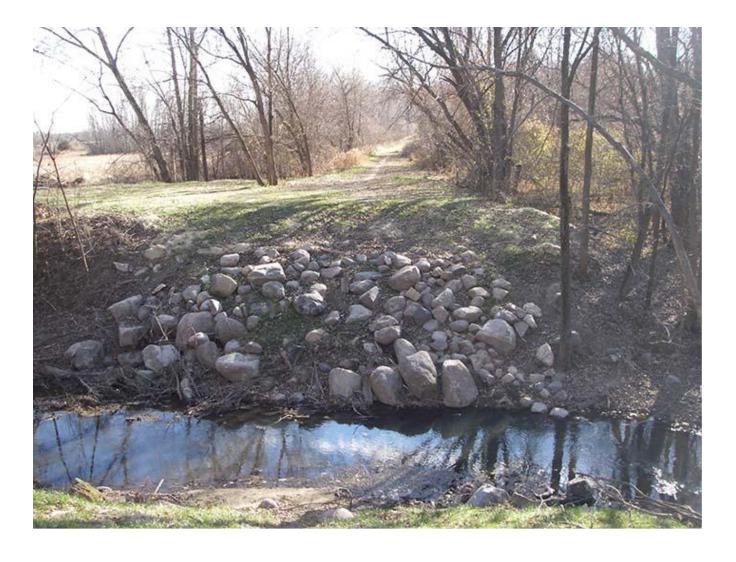
Waypoint 115A

Culvert going under trail opposite river side.

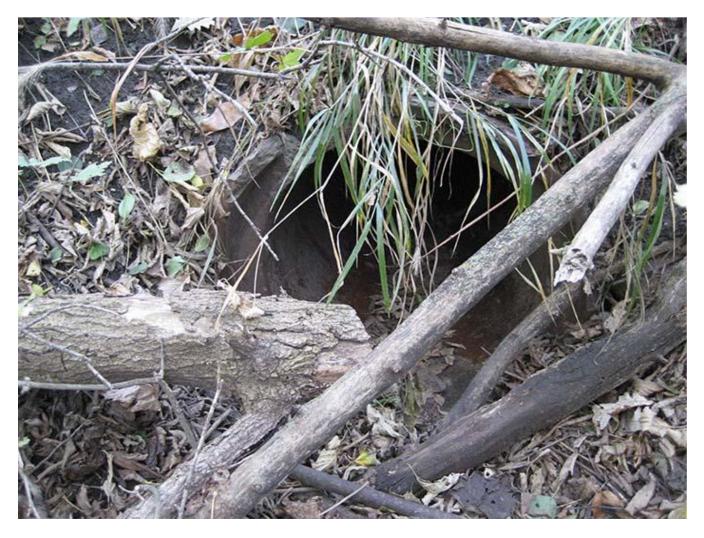
Above culvert; moderate erosion.

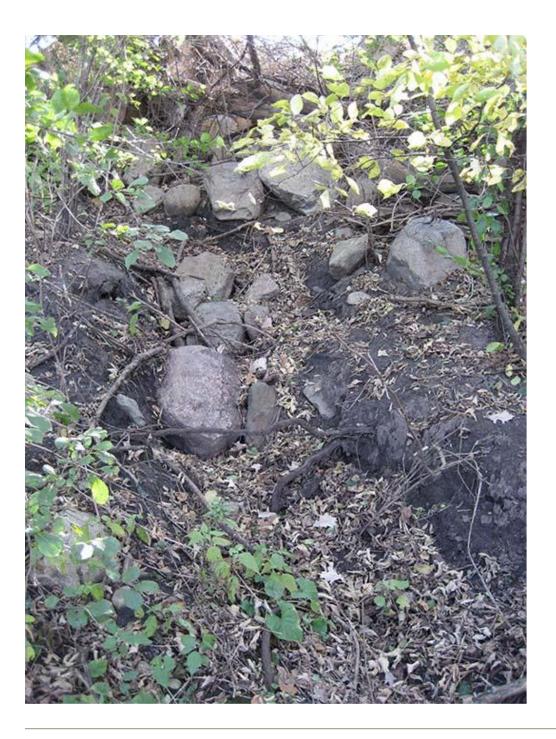
Culvert on river side of trail; cement culvert; minor erosion.

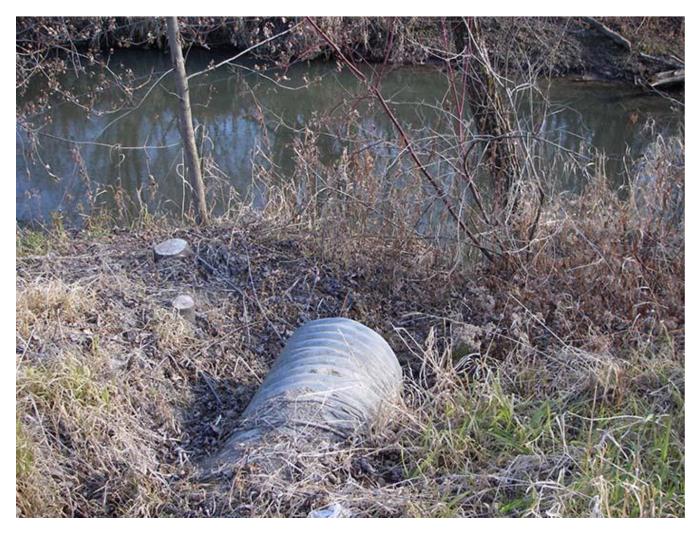
Waypoint 116A

Cement culvert opposite river side of trail; minor erosion.

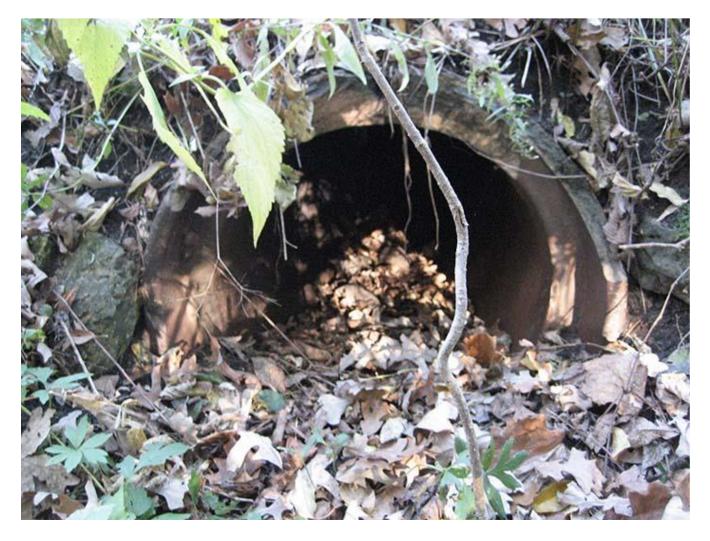
Culvert on river side of trail; minor erosion.

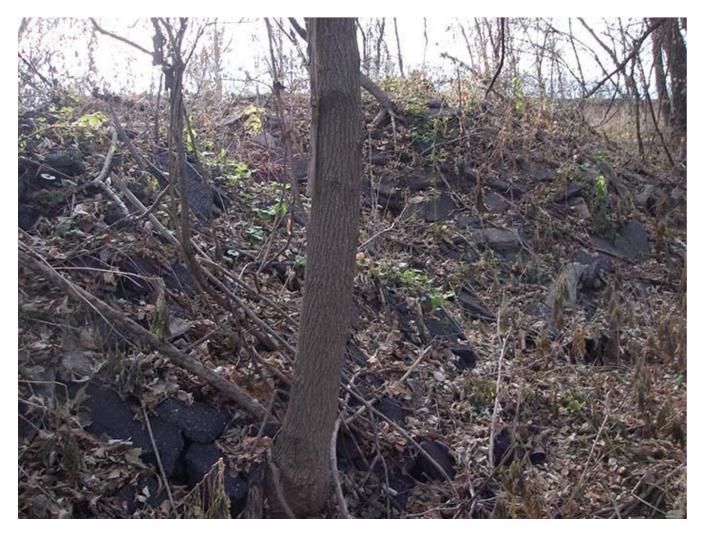
Blacktop/cement rubble piles and trash

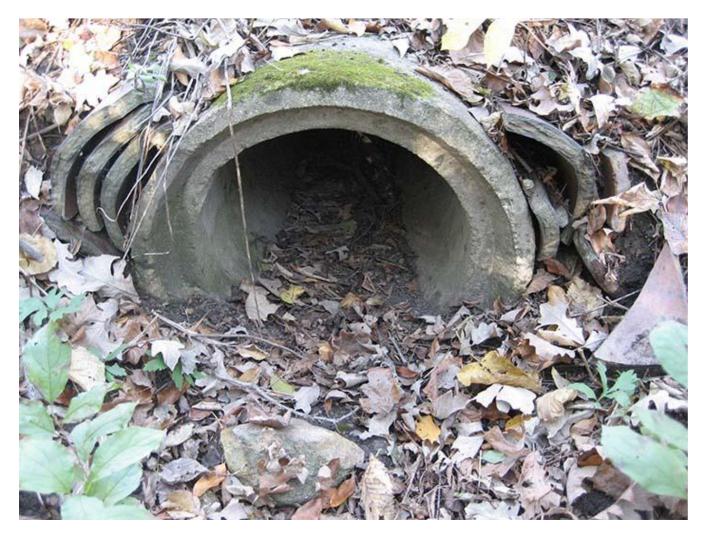
Waypoint 118A

Cement culvert opposite river side; minor erosion.

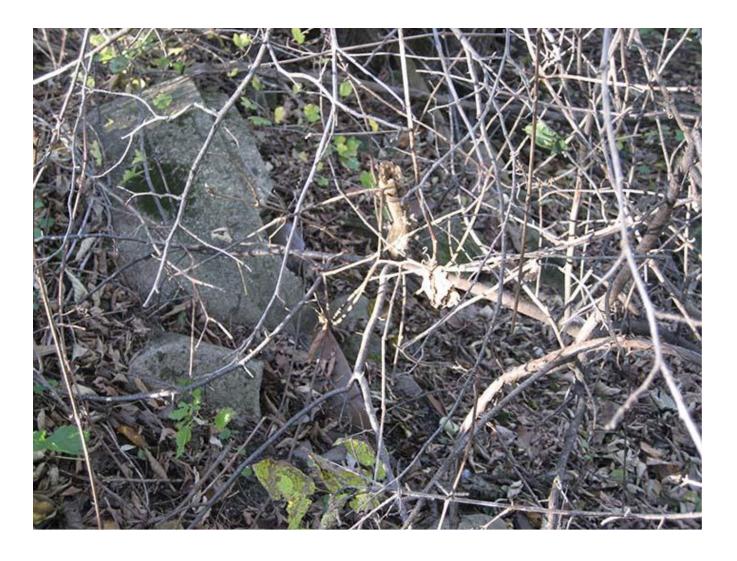
Culvert on river side of trail; minor erosion.

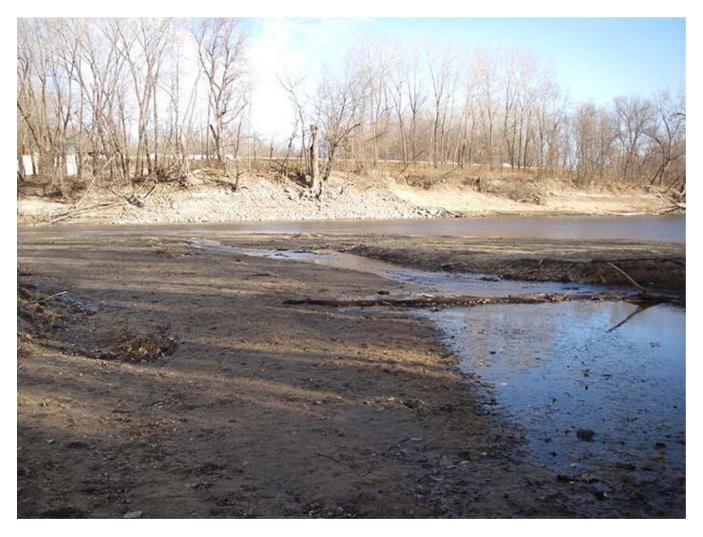
Outlet of stream into river

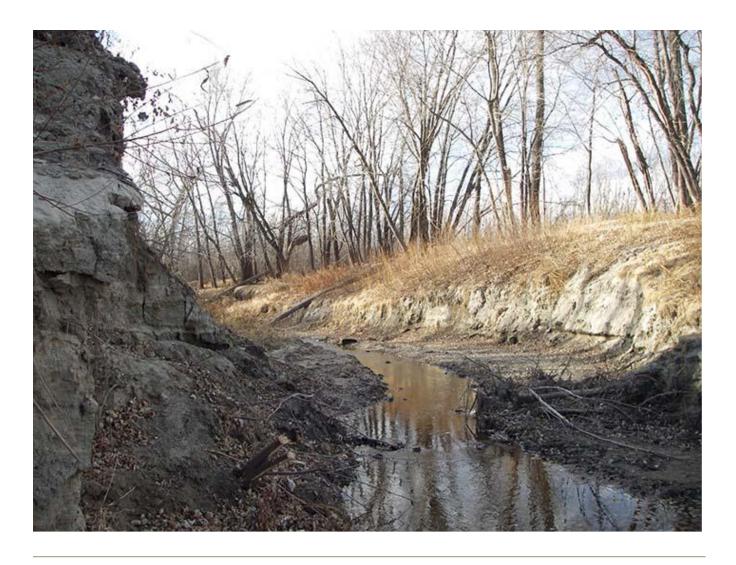
Erosion of banks

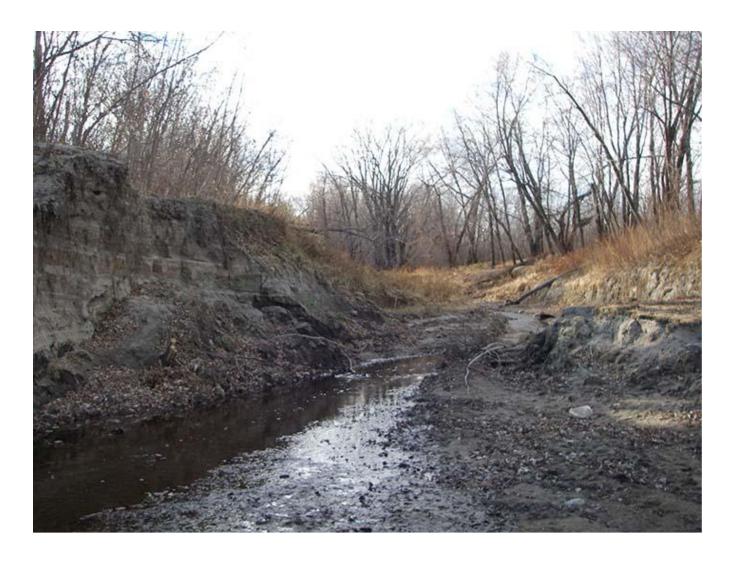
Erosion of banks

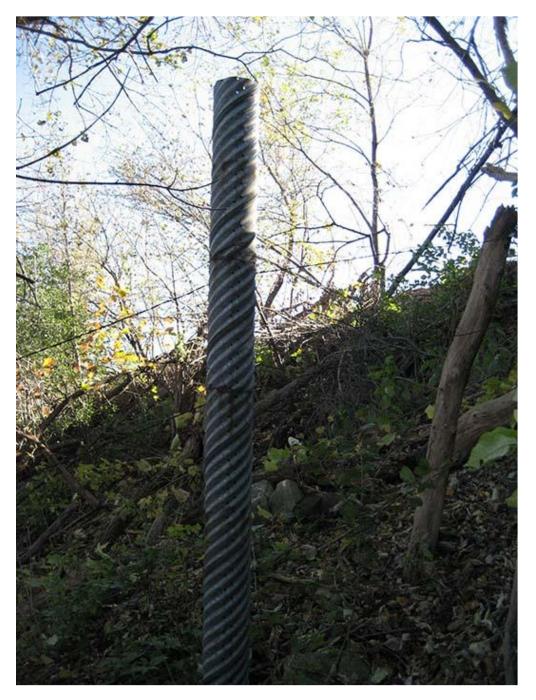
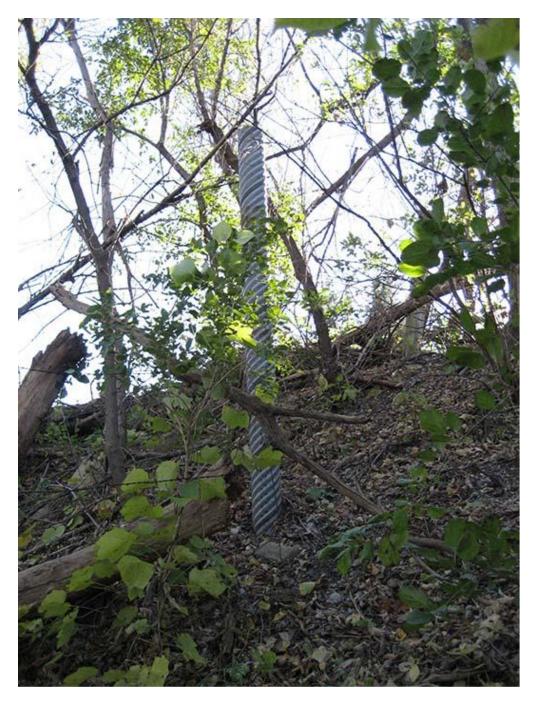
Waypoint 119A

Large pipe coming out of ground; seems to be holding up barbed wire fence.

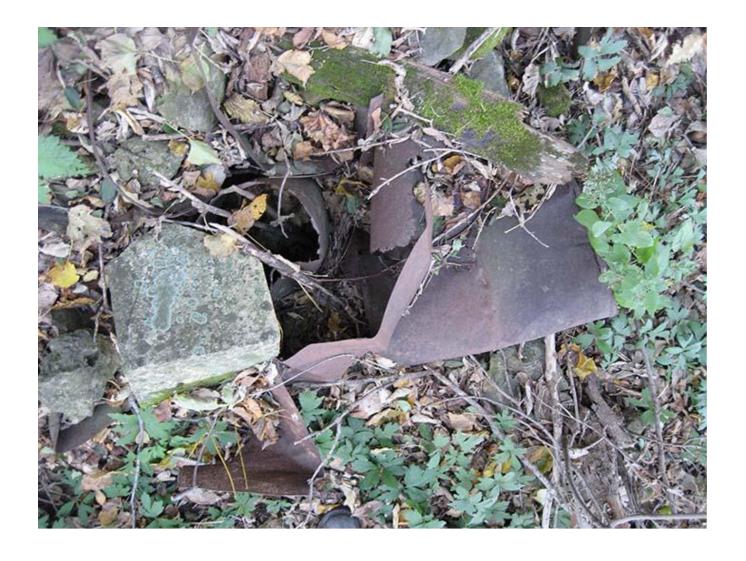
Scrap metal dumping.

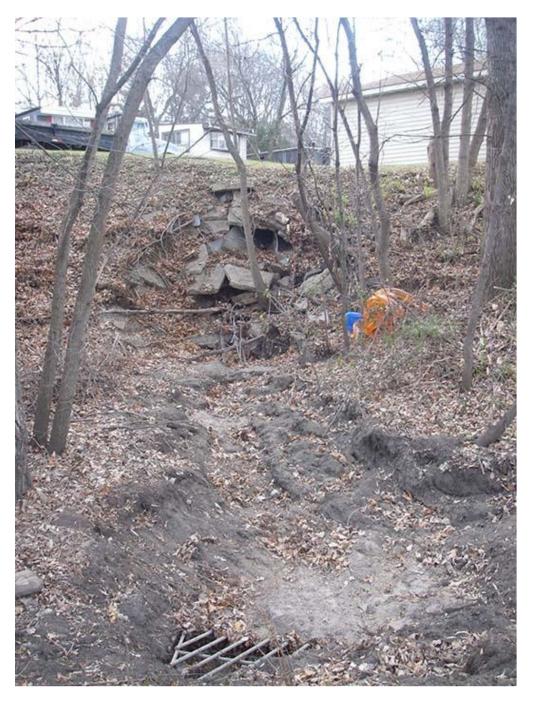
Drain pipe from trailer park & erosion

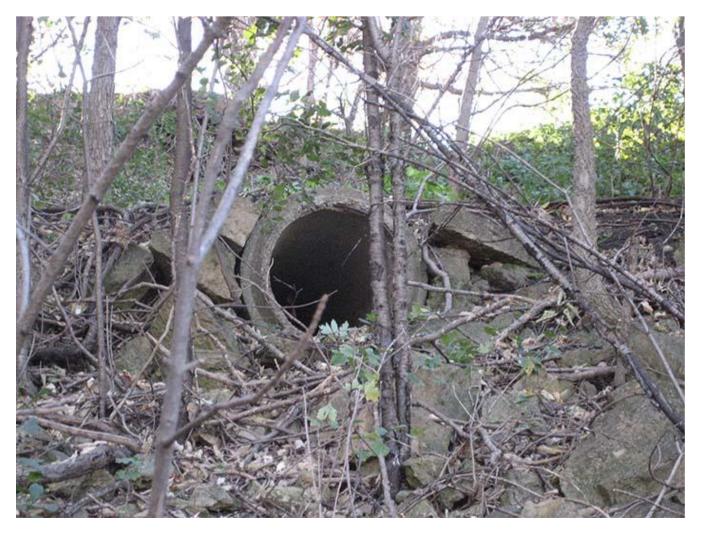
Waypoint 120A

Culvert coming out of side of slope; minor erosion.
