Gully Inventory Map	Legend		\mathbf{T}
Area #1	LMRWD Boundary (not official)	FEMA Floodway	\mathbb{N}
Lower Minnesota River Watershed District	City/Township Boundary	100-Year FEMA Floodplain	T
Watershed Management Plan	Gully Inventory Locations	500-Year FEMA Floodplain	Not to Scale

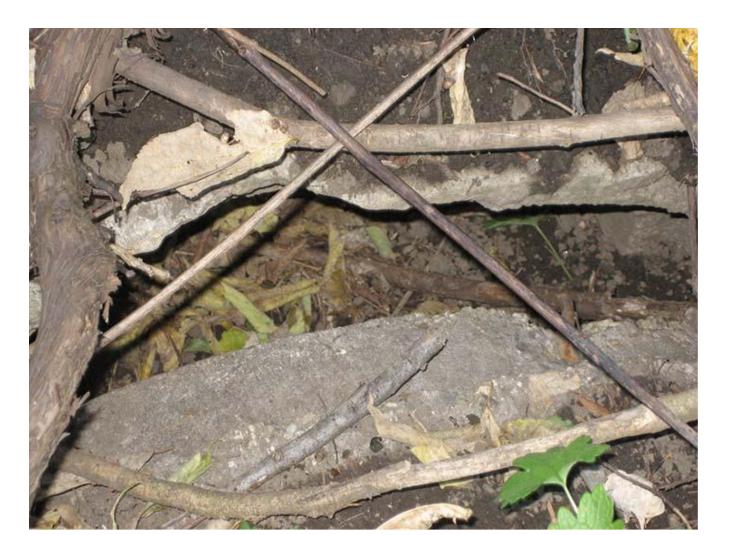
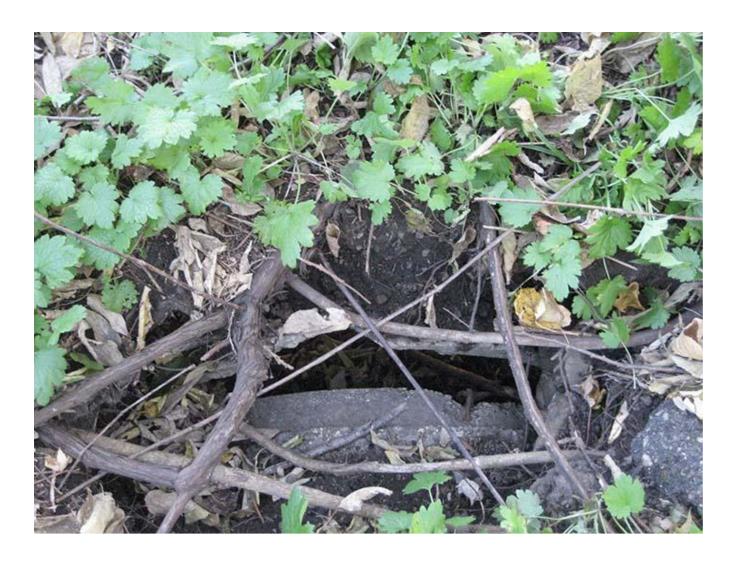
Large gap between two culverts.

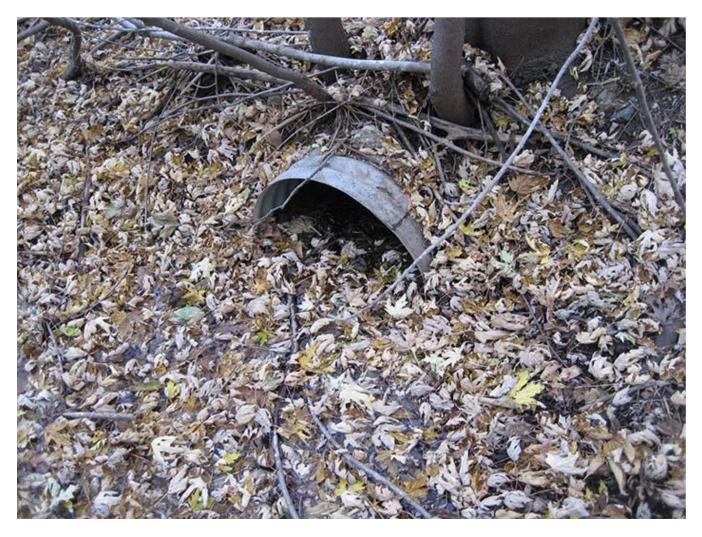
Waypoint 121A

Culvert opposite river side halfway under water; possibly clogged.

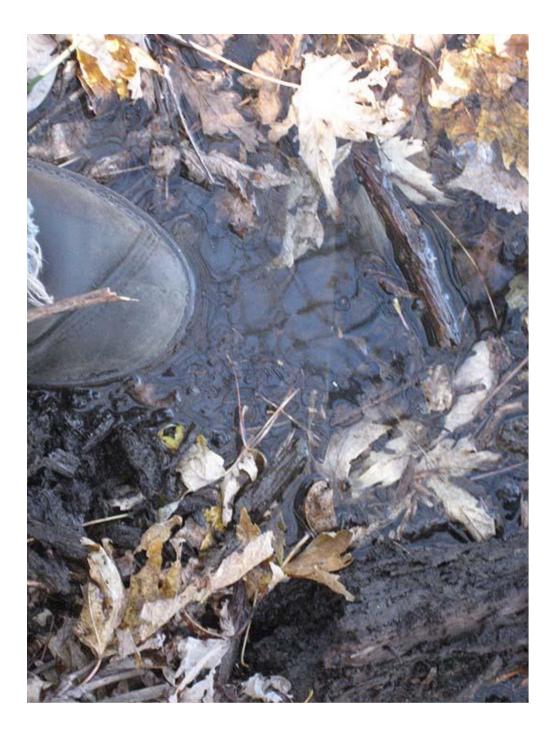
Culvert on river side completely under water

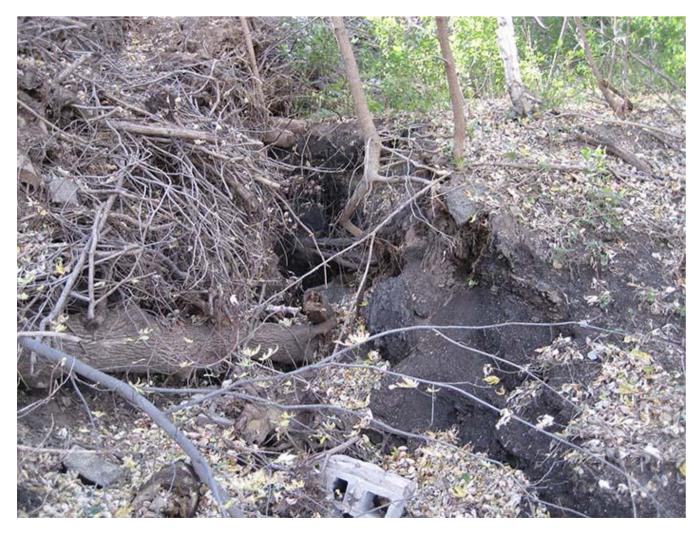
Waypoint 122A

Large amount of erosion cut 3-5 feet into the ground.

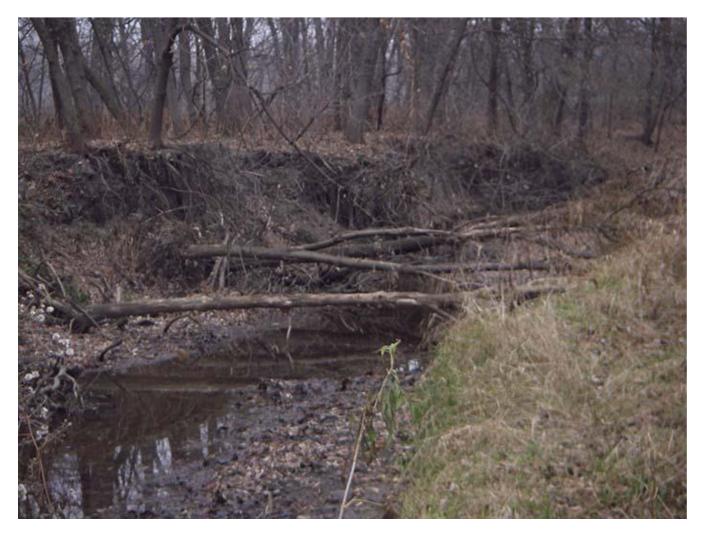
Heavy erosion on stream bank

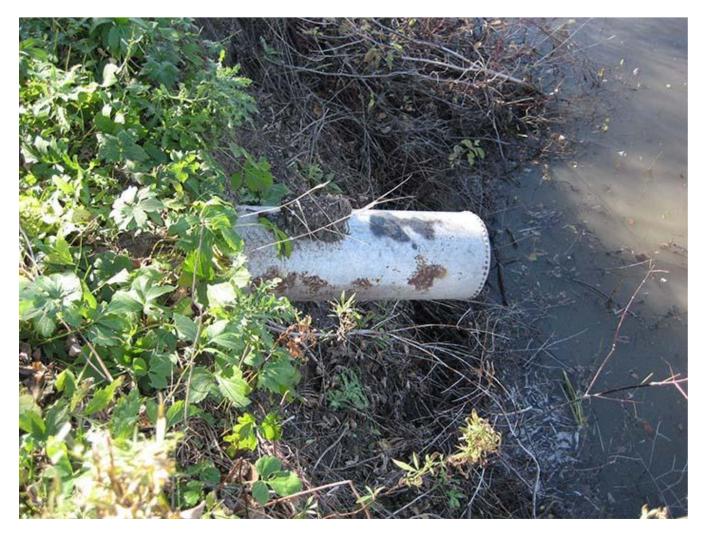
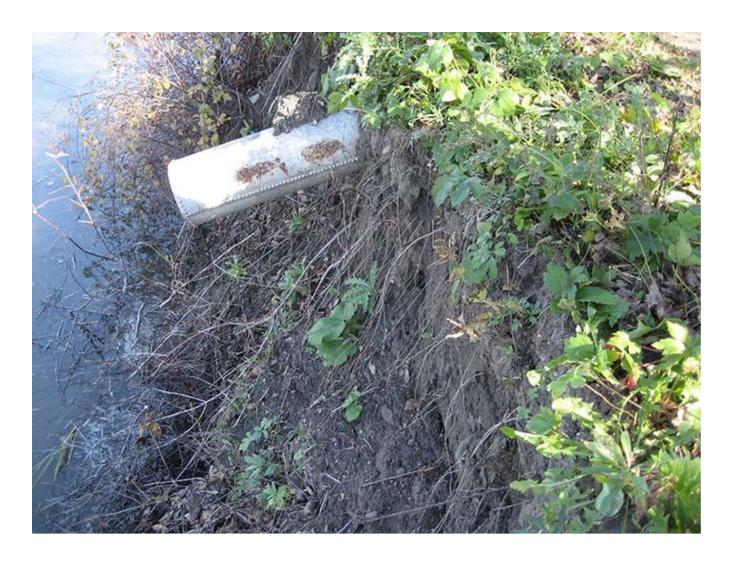
Waypoint 124A

Culvert coming from underneath path to river.

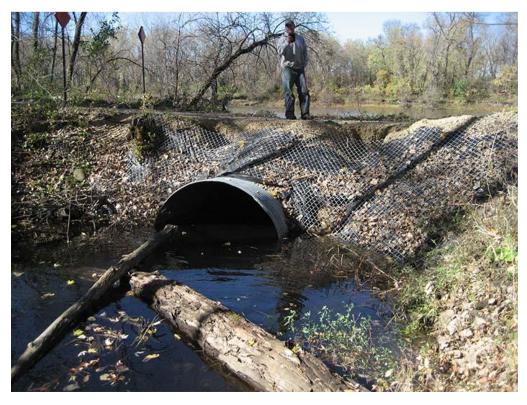
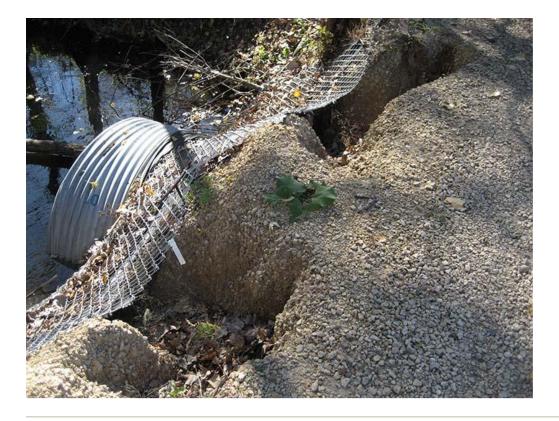
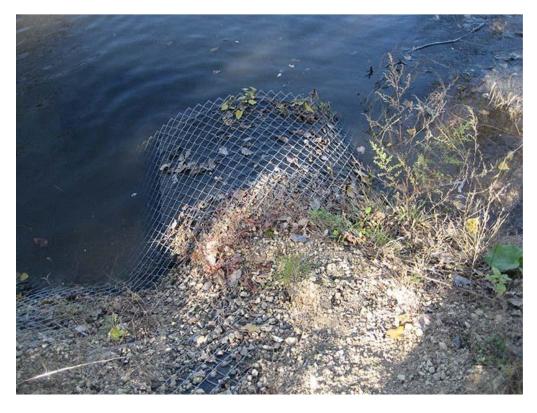
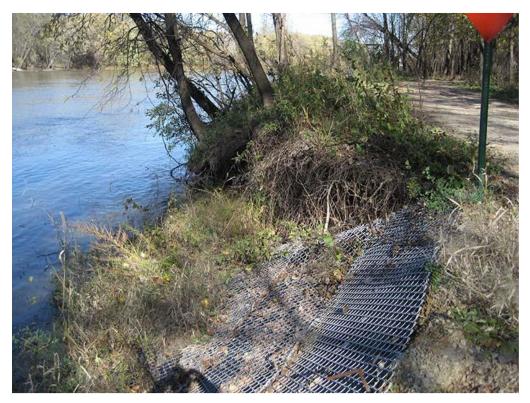
Waypoint 125A

Newly installed metal culvert, matting and fencing laid over slope to control erosion; some major erosion on trail.

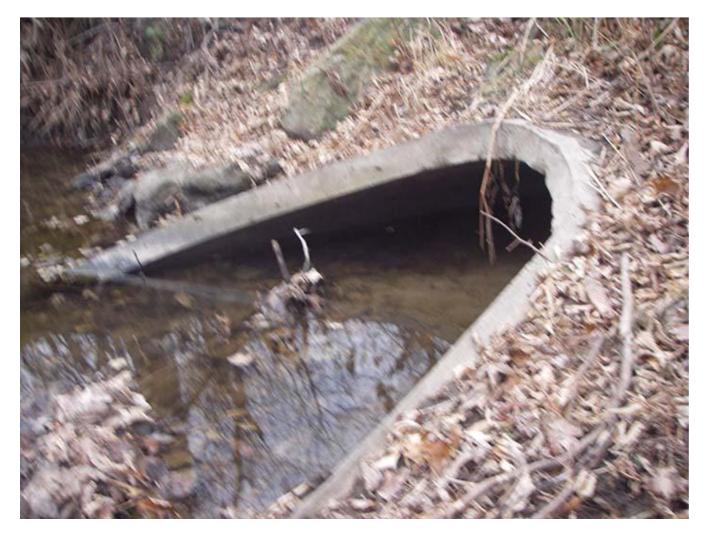
Drain pipe and bank erosion

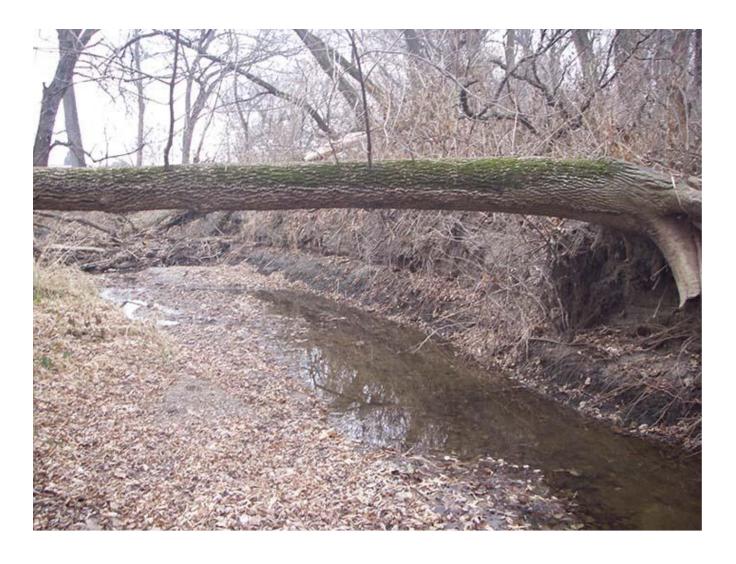
Drain pipe and bank erosion

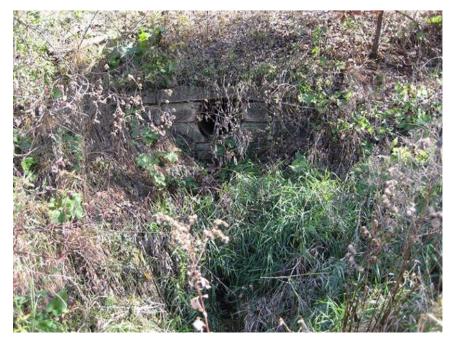
Waypoint 126A

Culvert coming from underneath railroad tracks; little erosion.

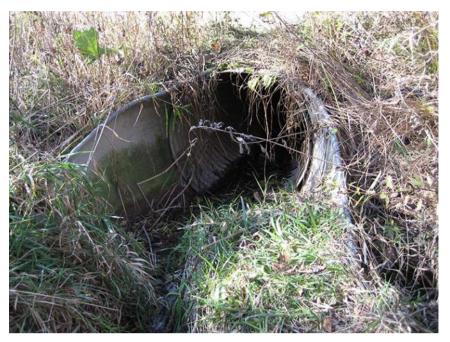
Culvert going under path; minor erosion.

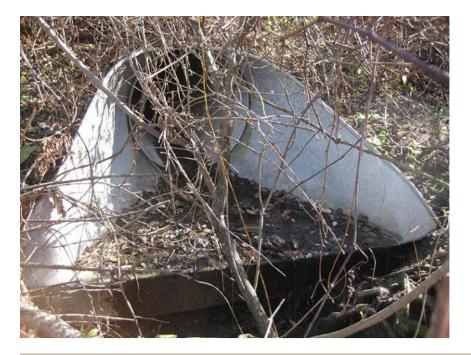
Culvert on river side of trail; cement slab under lip of culvert then approx. 6" drop-off to ground; lots of logs and debris at bottom.

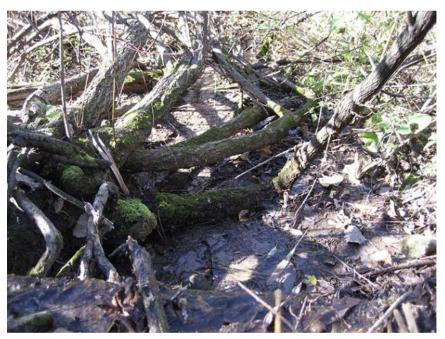
Culvert on river side of trail; cement slab under lip of culvert then approx. 6" drop-off to ground; lots of logs and debris at bottom.

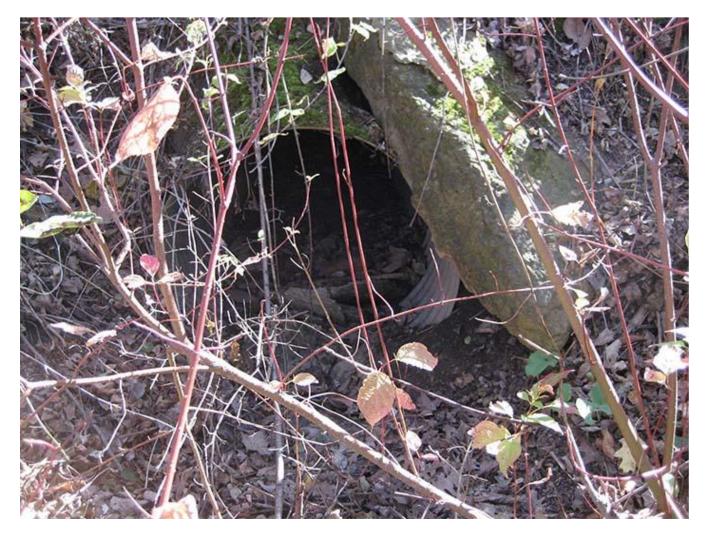
Waypoint 127A

Culvert outlet from under railroad tracks; moderate erosion.

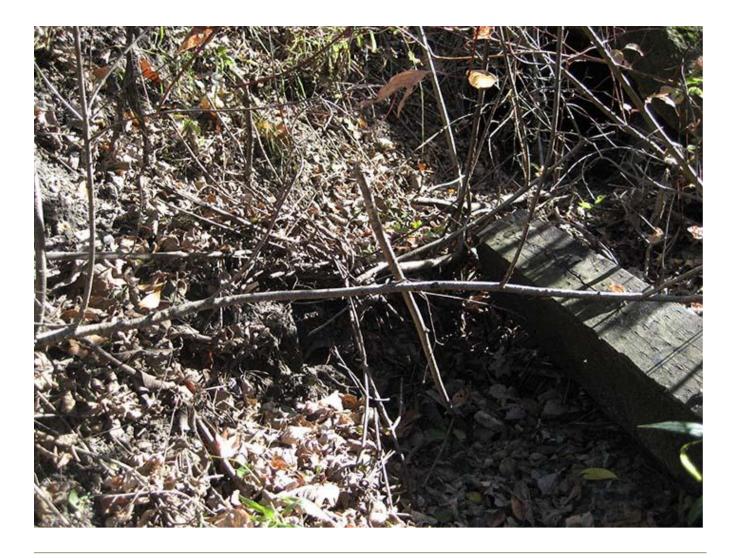
Culvert outlet from under railroad tracks; moderate erosion.

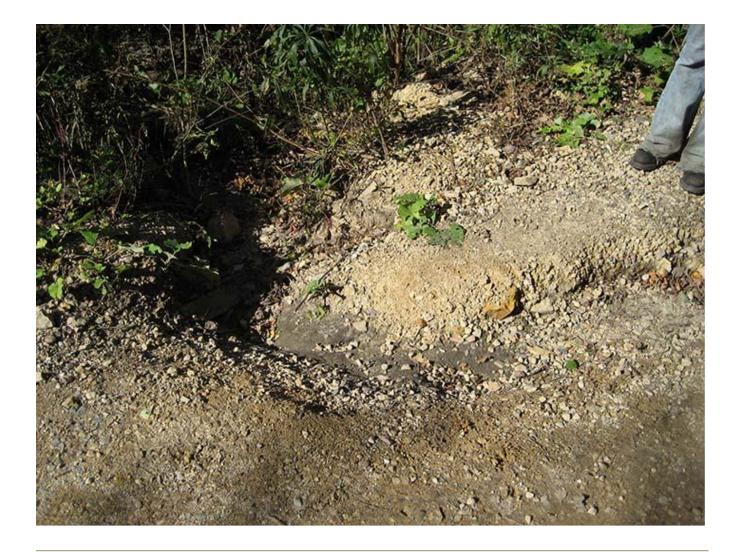
Erosion of trail due to no culvert going under trail; major erosion.

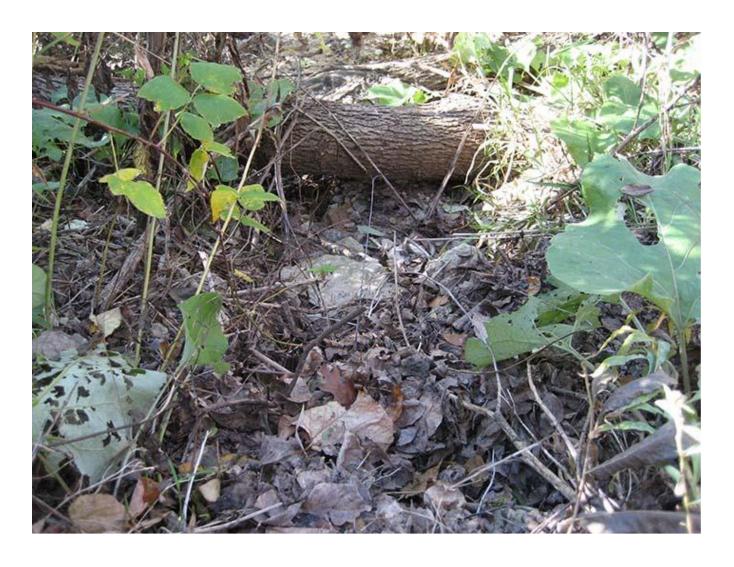
Erosion of trail due to no culvert going under trail; major erosion.

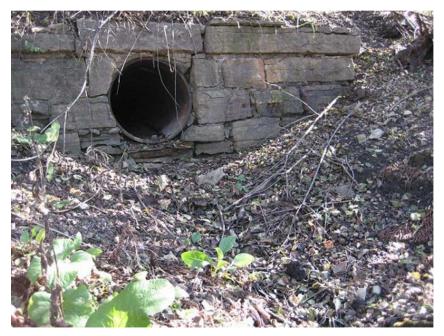
Waypoint 128A

Culvert going under railroad; moderate erosion.

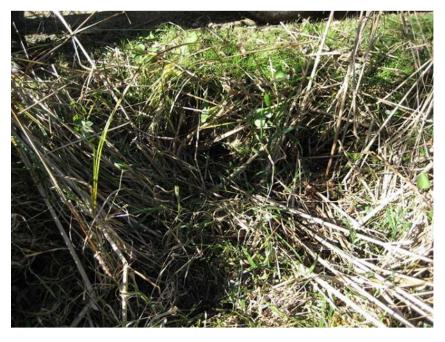
Culvert going under trail below picture #1; culvert is buried and very hard to see; lots of grass and reeds covering both inlet and outlet o

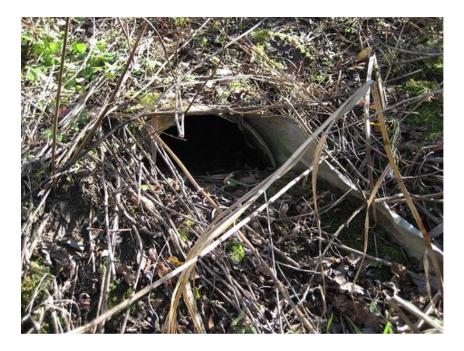
Culvert going under trail below picture #1; culvert is buried and very hard to see; lots of grass and reeds covering both inlet and outlet o

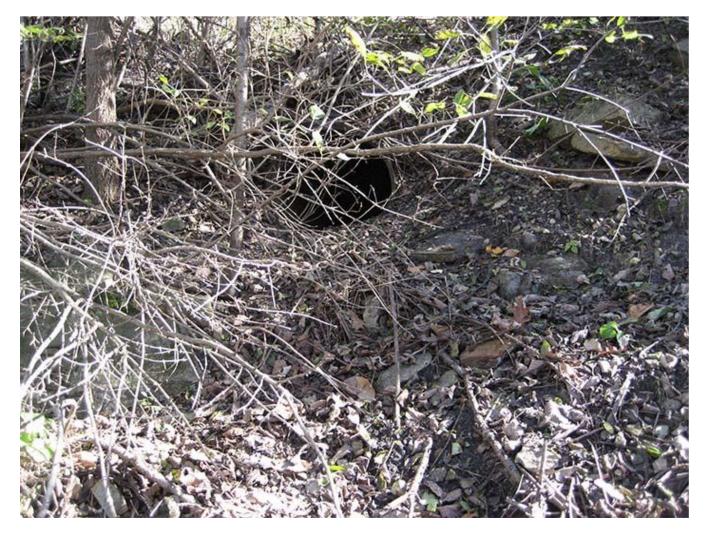
Waypoint 129A

Culvert coming out from railroad.

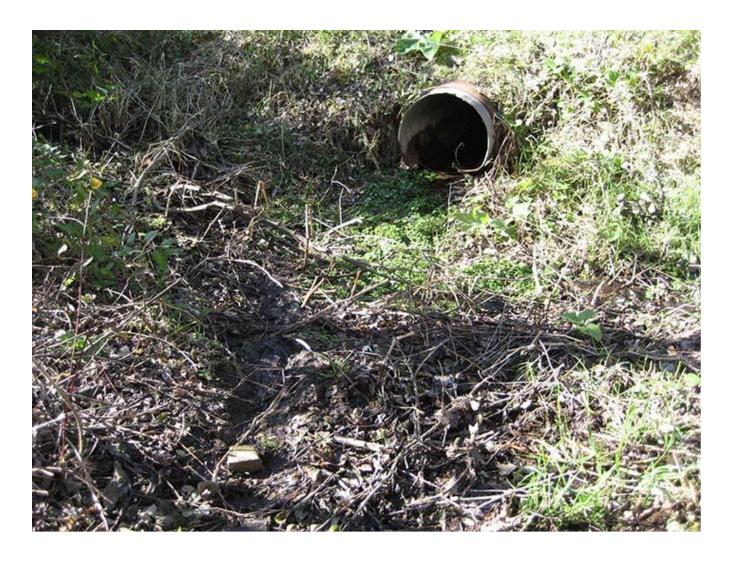
Culvert going under trail below picture #1; moderate erosion on both sides on culvert.

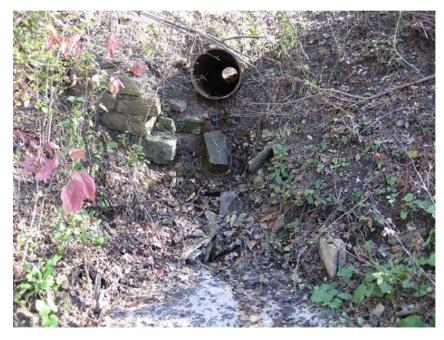
Waypoint 130A

Culvert going under trail below picture #1; culvert is buried and very hard to see; lots of grass and reeds covering both inlet and outlet o

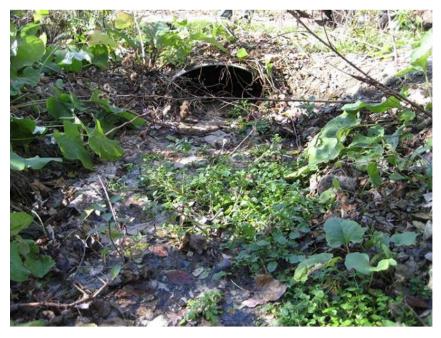
Culvert going under trail; lots of washed out sand and moderate erosion.

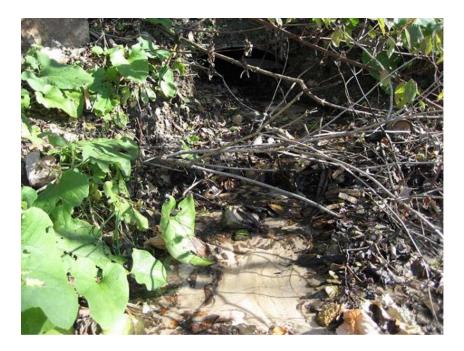
Culvert going under trail; lots of washed out sand and moderate erosion.

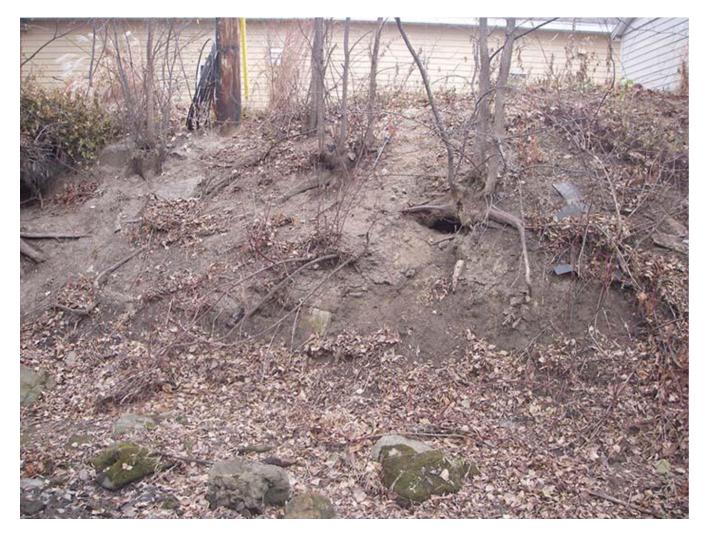
Drain pipe and erosion

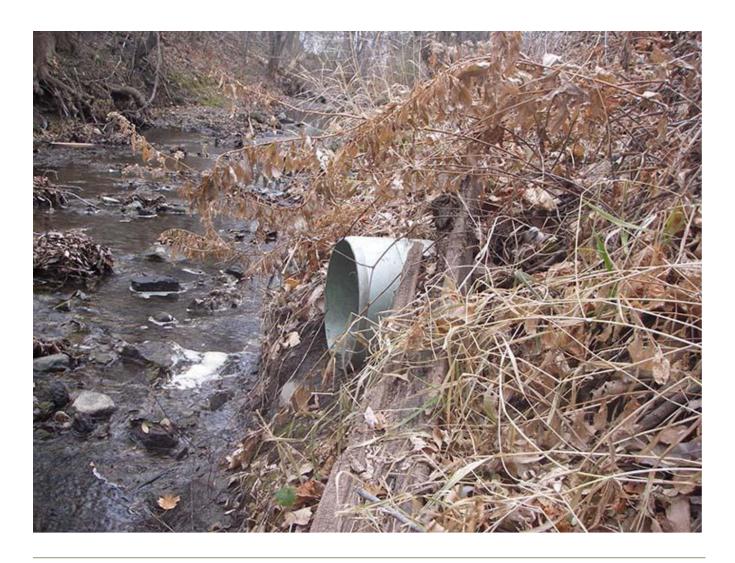
Drain pipe and erosion

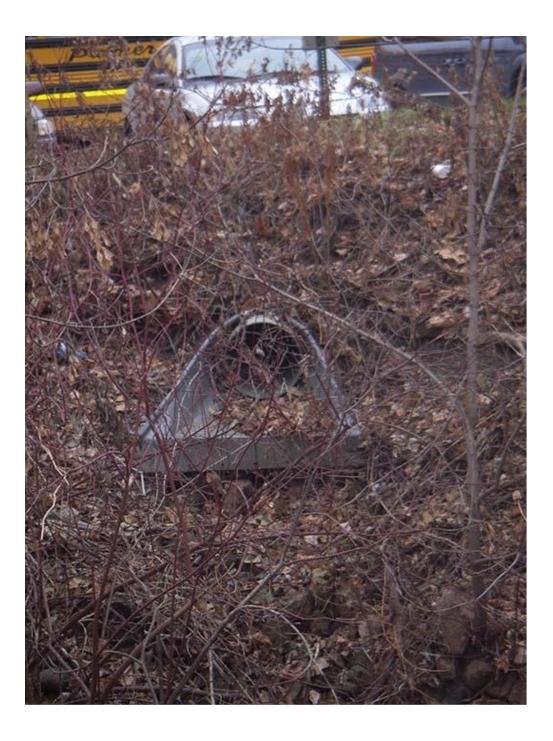
Drain pipe 40 years downstream

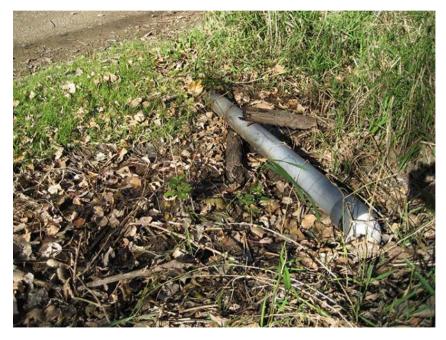
Waypoint 131A

PVC pipe going under trail; not effective due to pipe being too high; water is not able to go through pipe.

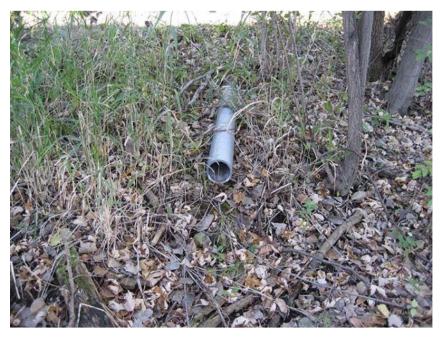
PVC pipe going under trail; not effective due to pipe being too high; water is not able to go through pipe.

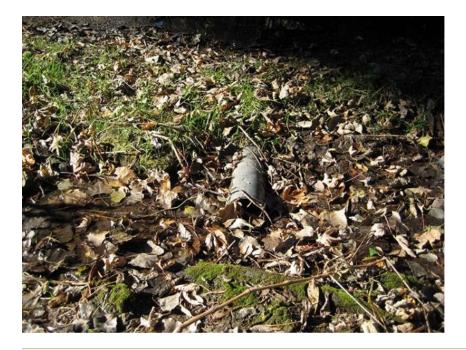
PVC pipe going under trail; pooling water at top part of pipe; possibly clogged; minor erosion; approx. 20-feet between pipe shown in pictu

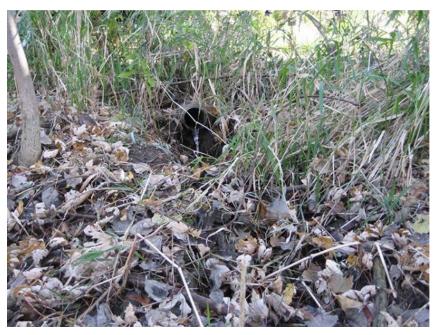
PVC pipe going under trail; pooling water at top part of pipe; possibly clogged; minor erosion; approx. 20-feet between pipe shown in pictu

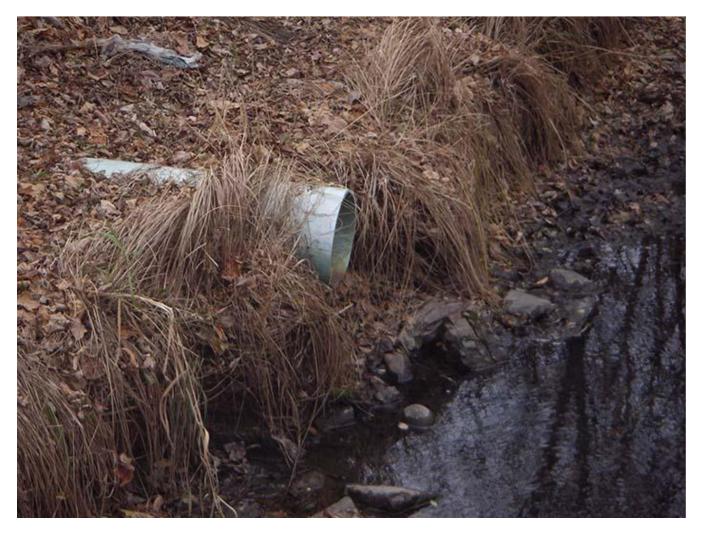
Drain pipe

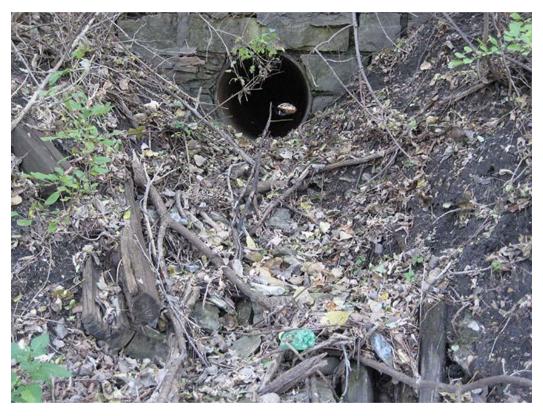
Waypoint 132A

Pipe coming from under railroad tracks; moderate erosion; lots of leaves, rock and branches.

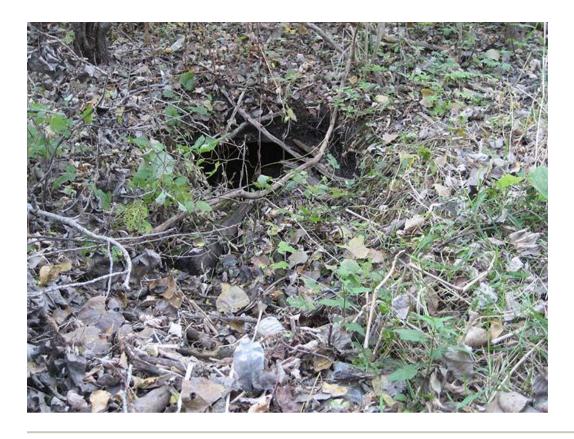
Culvert going under path; minimum erosion; lots of rocks, leaves and branches; area below culvert in picture #1.

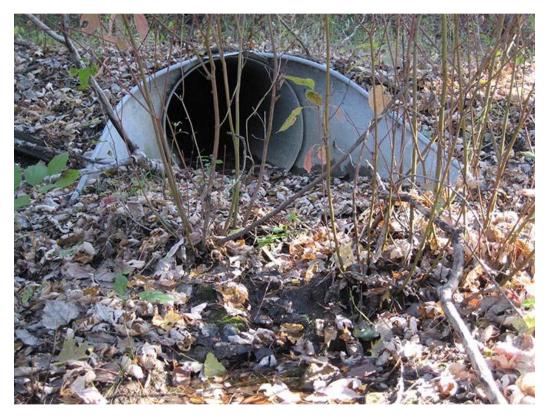
Culvert going under path; minimum erosion; lots of rocks, leaves and branches; area below culvert in picture #1.

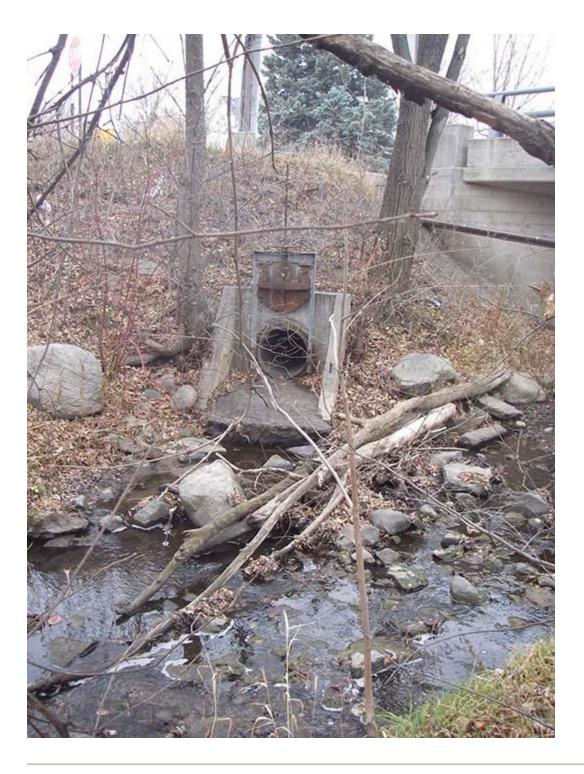
Two drain pipes

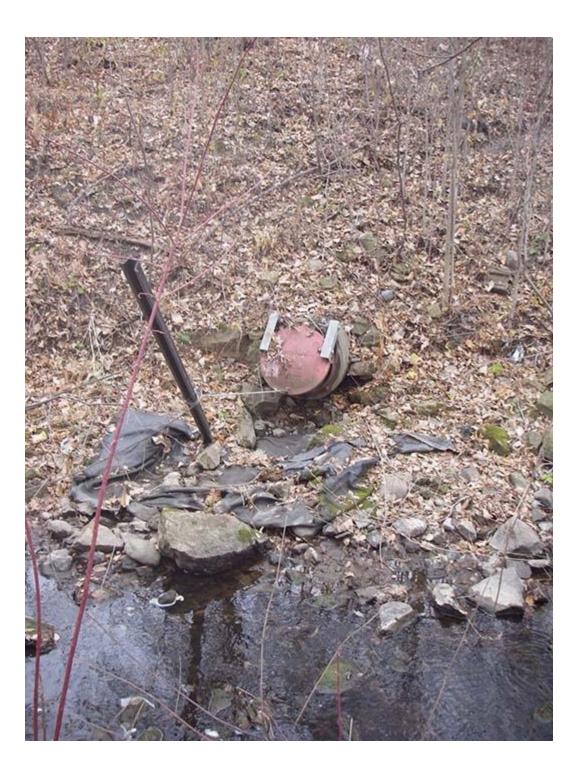
Two drain pipes

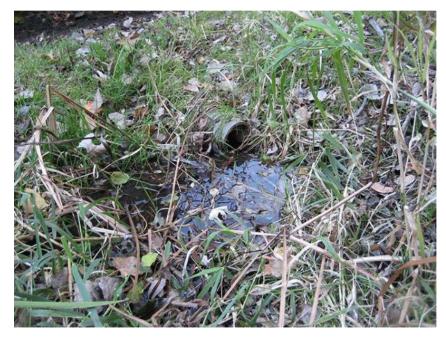
Waypoint 133A

PVC pipe going under trail; very little erosion; pooling water at inlet side; covered by tall grass; 2 sets of pipes approx. 20-feet apart;

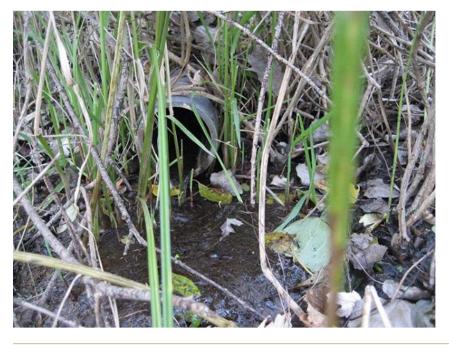
PVC pipe going under trail; very little erosion; pooling water at inlet side; covered by tall grass; 2 sets of pipes approx. 20-feet apart;

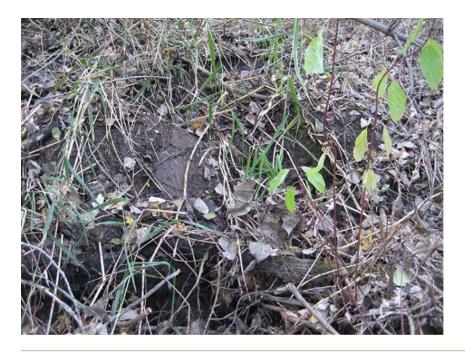
PVC pipe going under trail; very little erosion; pooling water at inlet side; covered by tall grass; 2 sets of pipes approx. 20-feet apart;

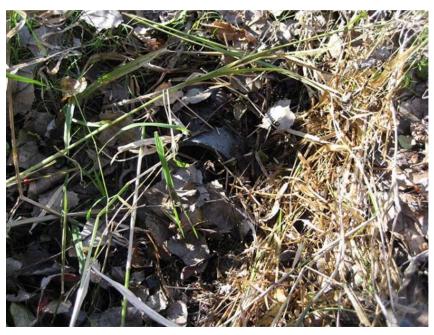
PVC pipe going under trail; very little erosion; pooling water at inlet side; covered by tall grass; 2 sets of pipes approx. 20-feet apart;

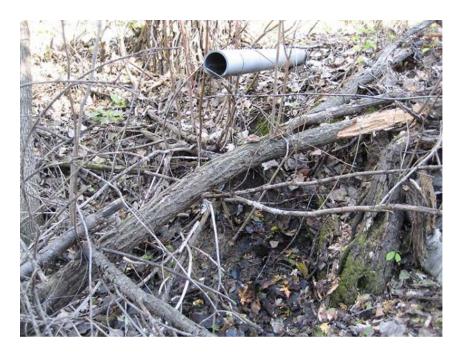
PVC pipe going under trail; very little erosion; pooling water at inlet side; covered by tall grass; 2 sets of pipes approx. 20-feet apart;

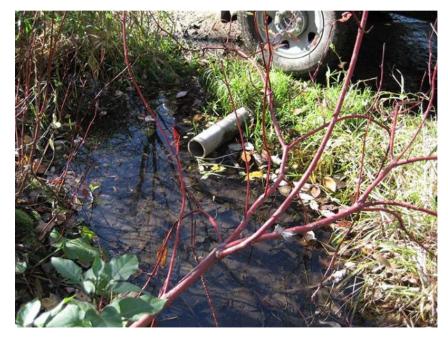
Waypoint 134A

PVC pipe going under trail; pipe is not low enough to ground for water to flow through pipe; instead water flows around the pipe and over th

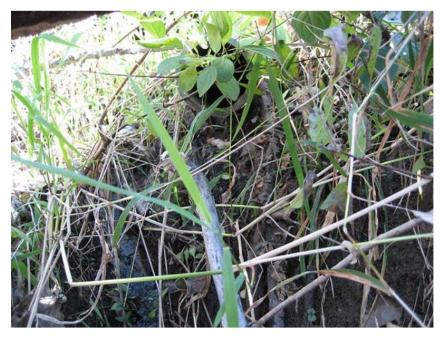
Eroding under pipe due to water going over trail.

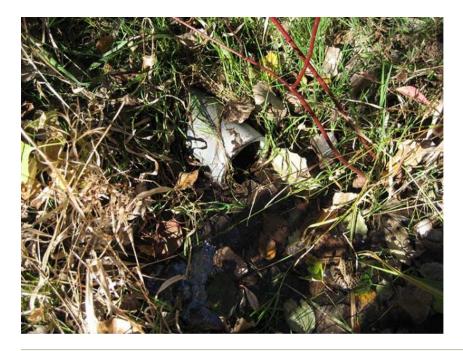
PVC pipe going under trail.

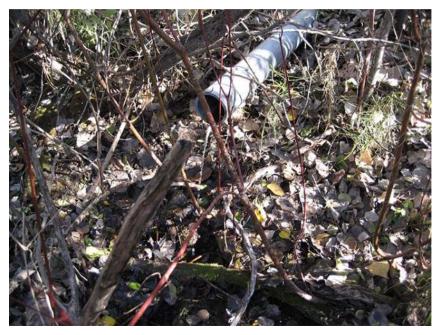
Minimal erosion due to logs under the flow of the piping.

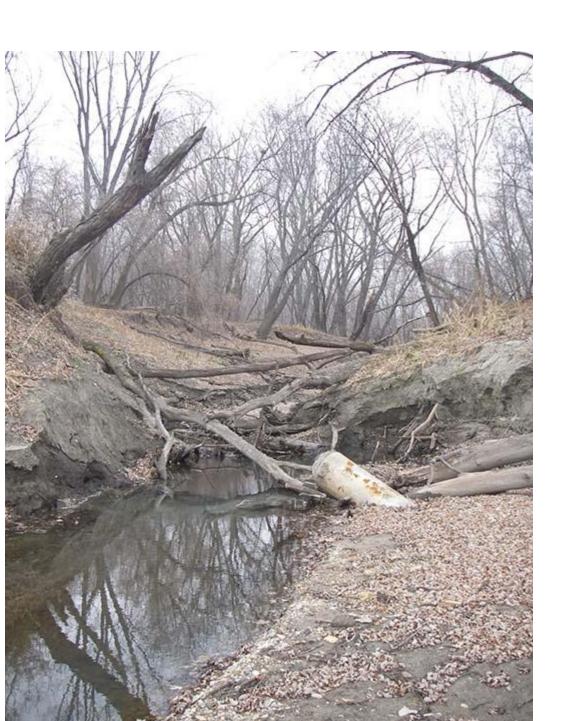
Location: Trailer Park (East Chaska Creek)

Mouth of creek at river, moderate soil erosion

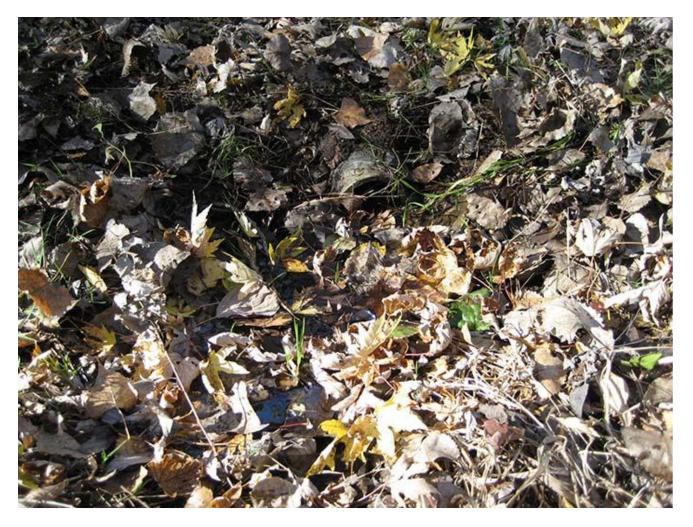
Waypoint 135A

PVC pipe going under trail; pooling water with lots of leaf litter; slow output of water.

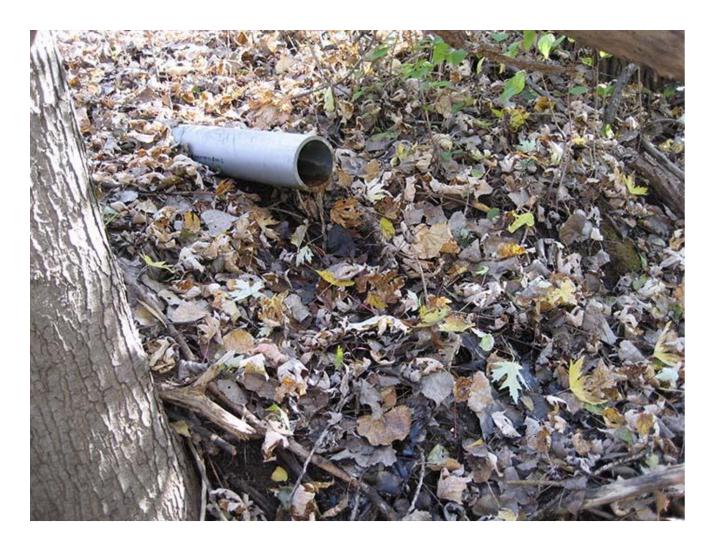
PVC pipe outlet; minimum erosion.

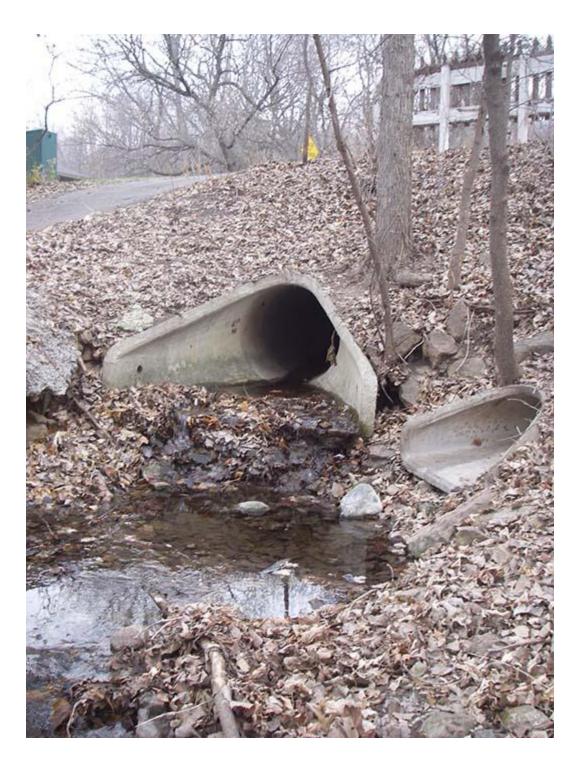
Location: Trailer Park (East Chaska Creek)

Culvert at Engler Blvd.

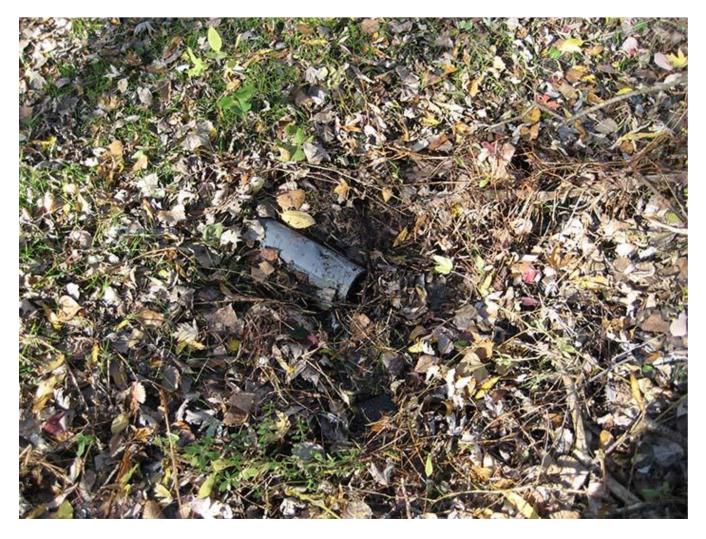
Waypoint 136A

PVC piping going under trail.

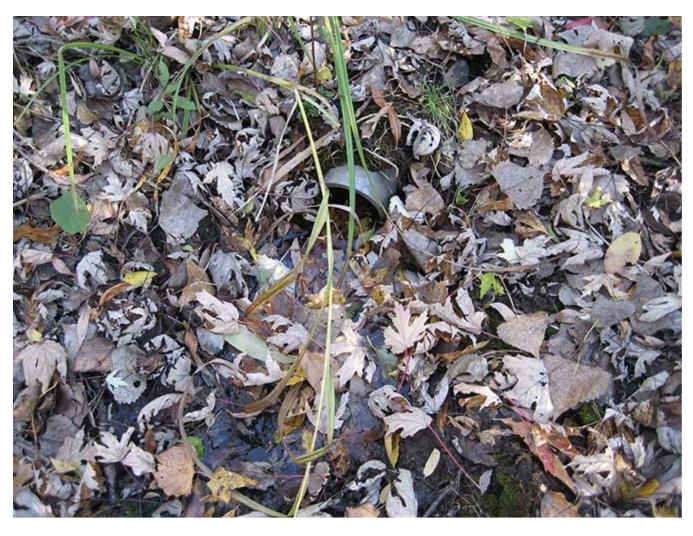
Pooling water at outflow end of pipe; minimum erosion.

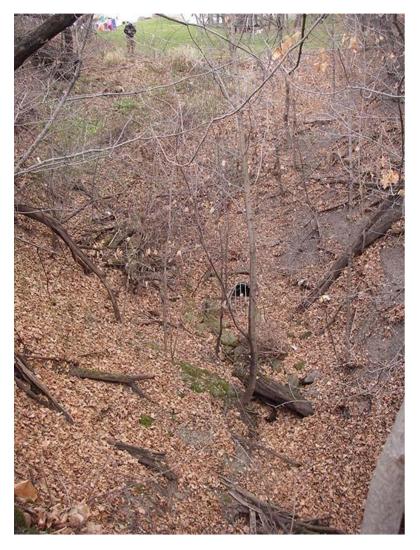
Location: Bluff Ridge No. 1

Start of gully

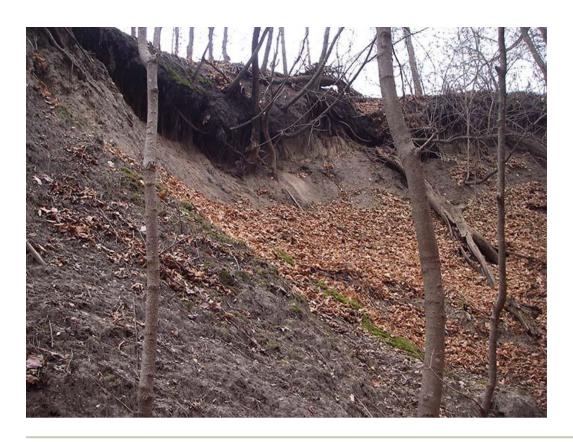
Extreme soil erosion

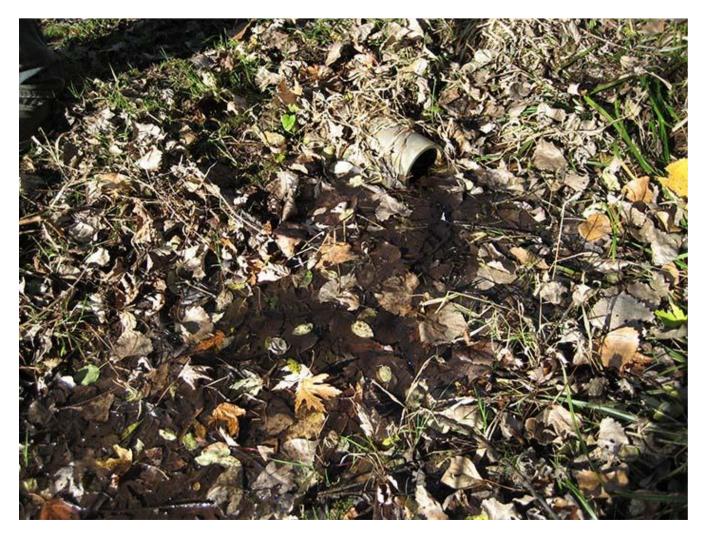
Waypoint 137A

PVC pipe going under trail; pooling water at intake end of pipe.

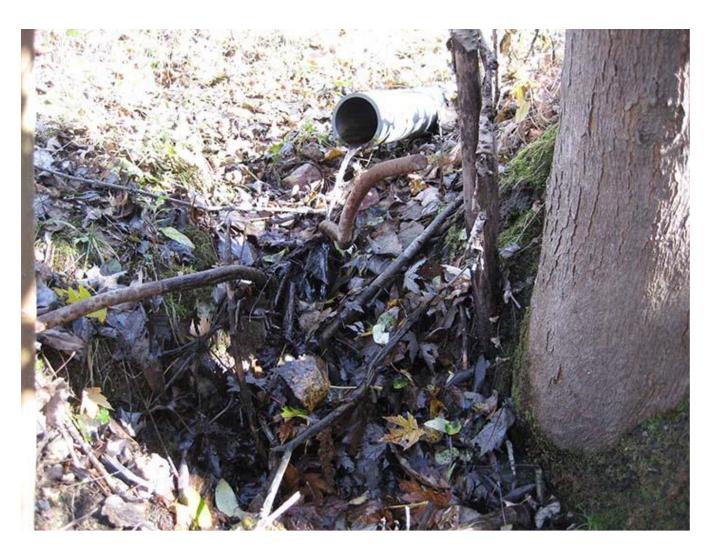
PVC outlet; moderate to major erosion.

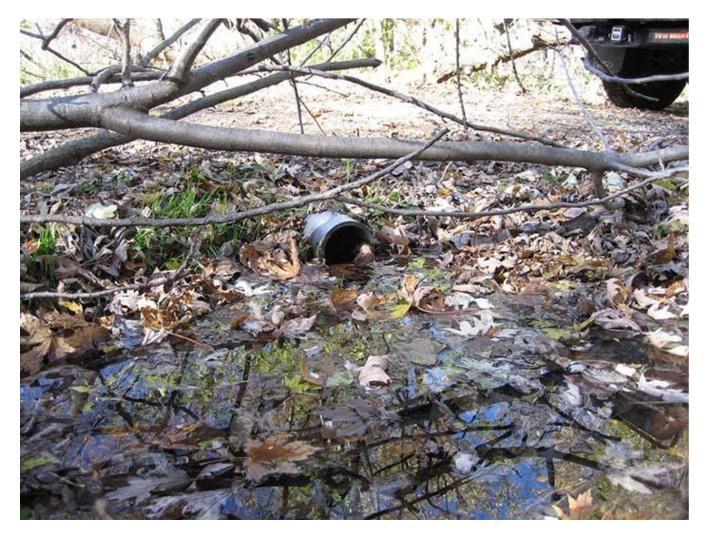
Waypoint 138A

PVC pipe going under trail; pooling water.

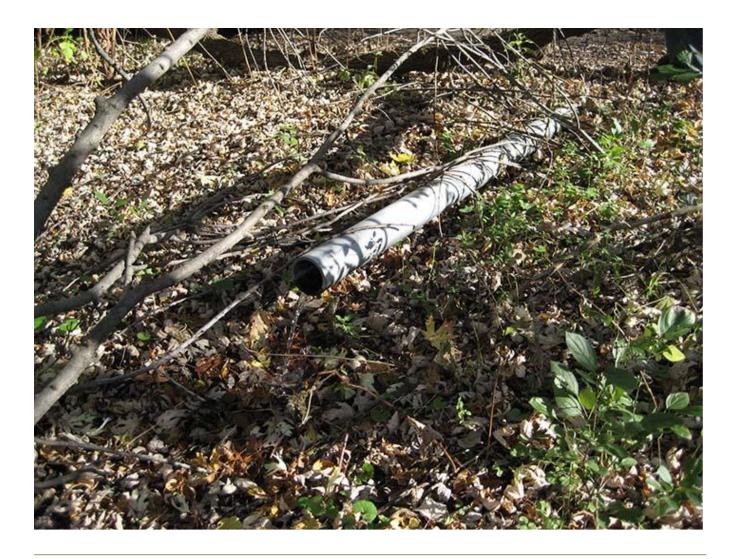
PVC outlet.

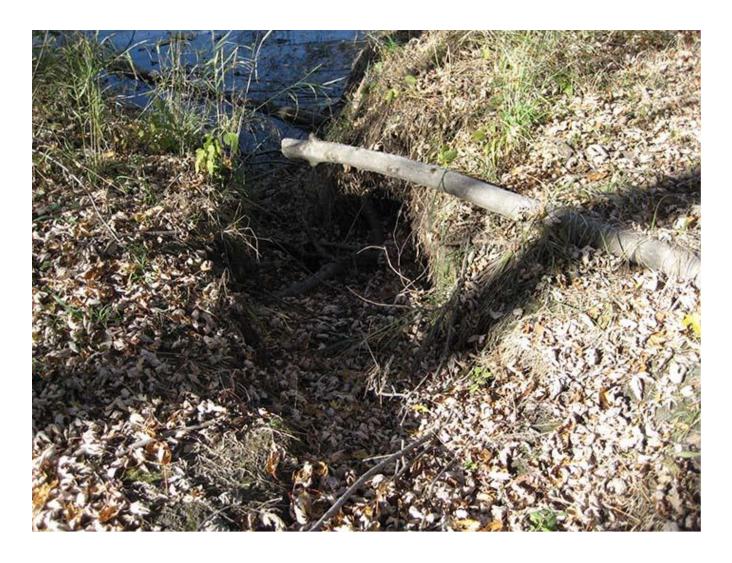
Major erosion due to outlet of PVC pipe.

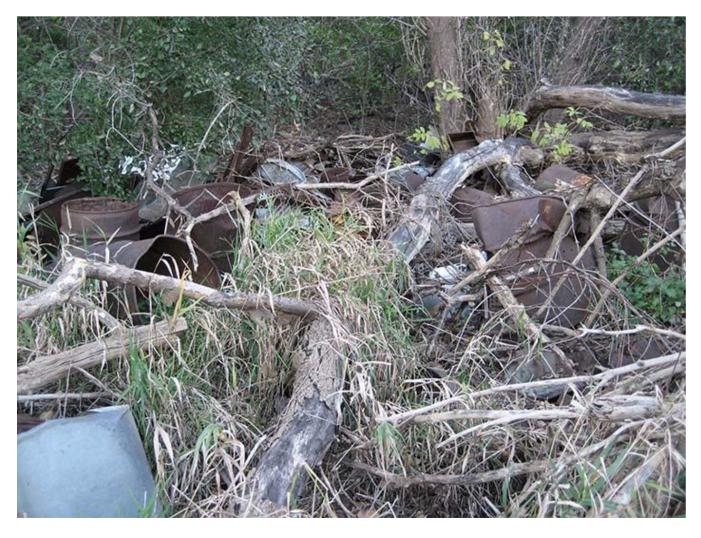
Waypoint 139A

Dump side; lots of old barrels and metal scraps.

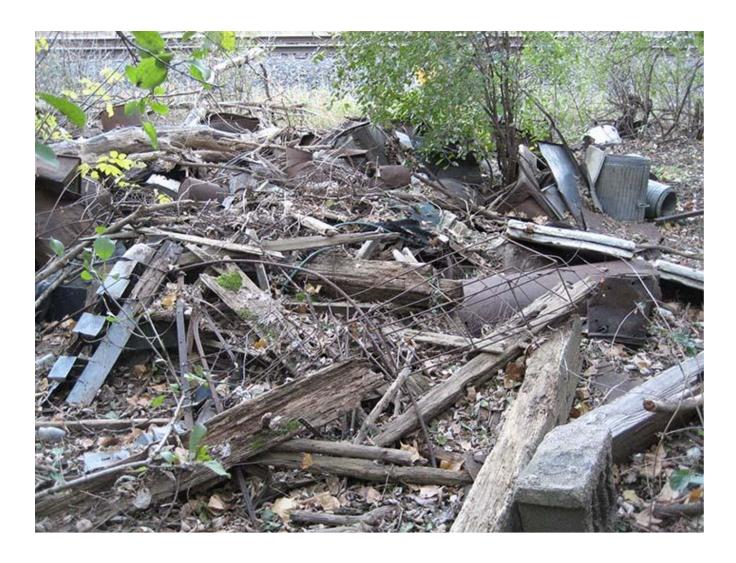
Dump side; lots of old barrels and metal scraps.

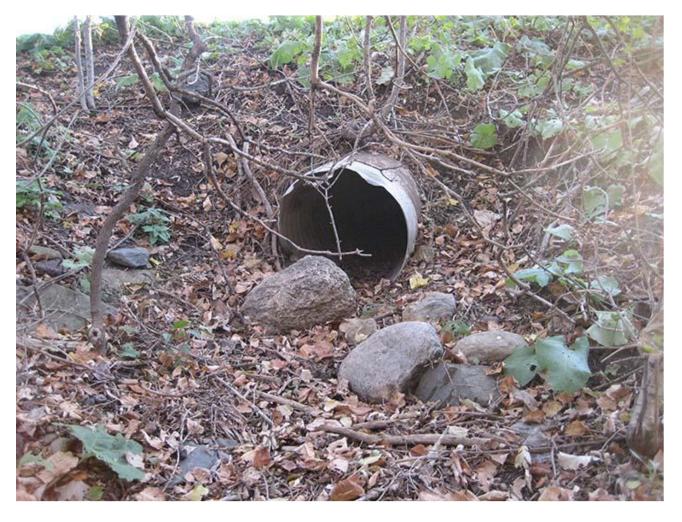
Waypoint 140A

Culvert output coming from under trail; minor erosion.

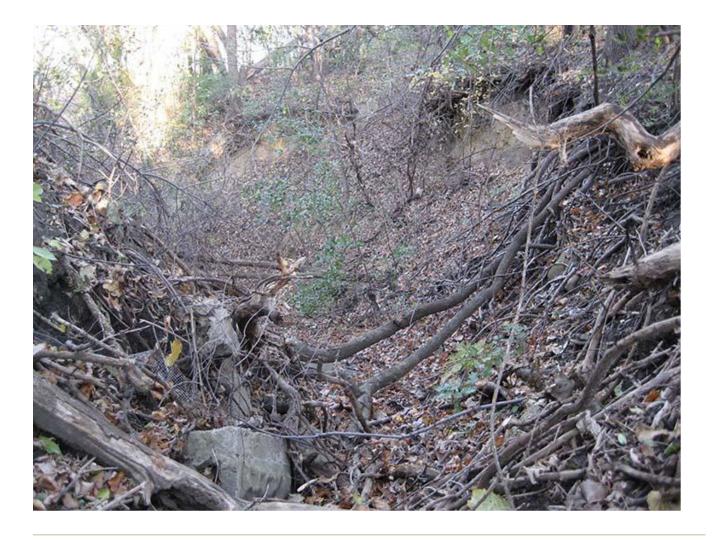
Major erosion; gully further below culvert in picture #1; some litter; looking down gully.

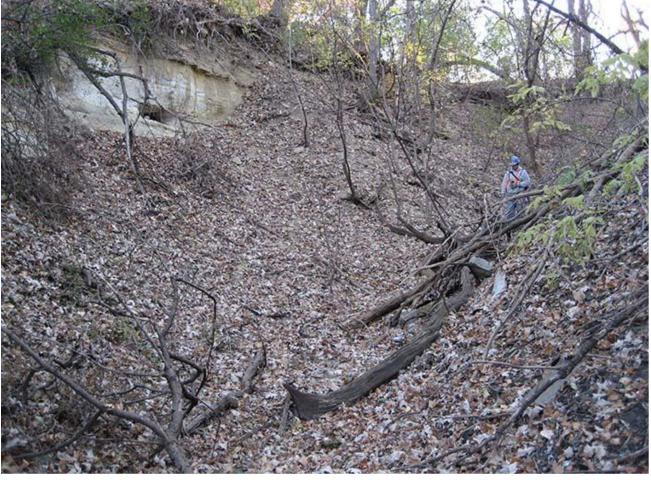
Looking up at gully; major erosion.

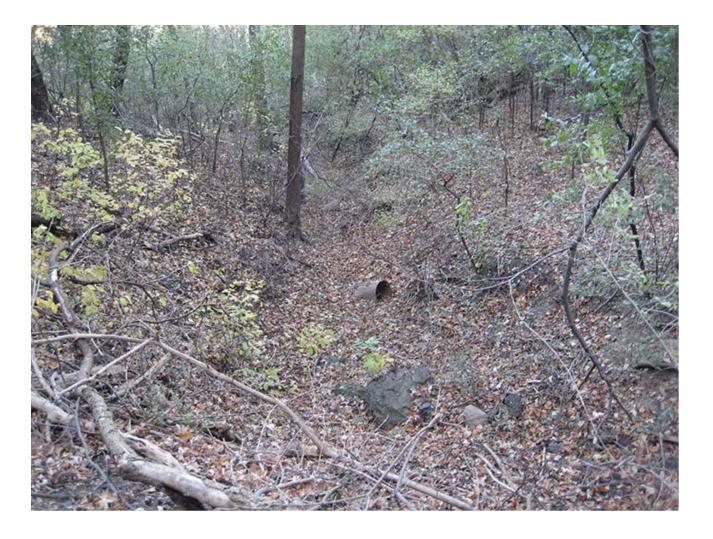
Looking down at gully; major erosion.

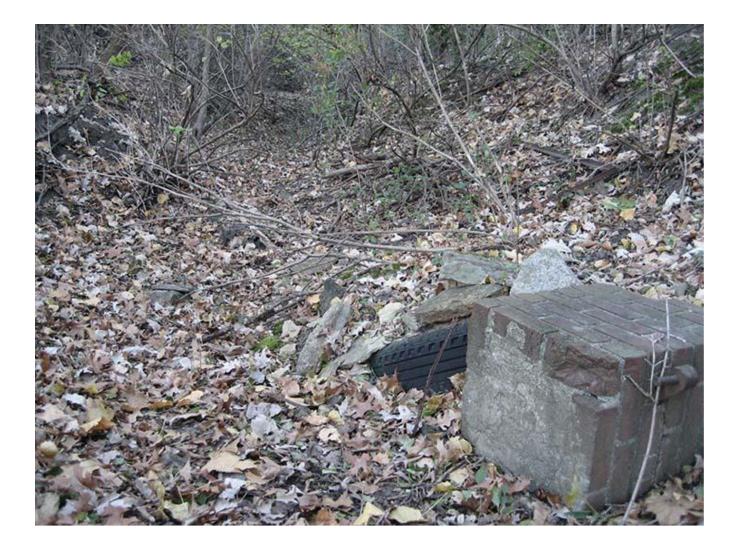
Looking up gully; moderate erosion heading towards major erosion in near future.
