Gully Inventory Map	Legend		\mathbf{T}
Area #1	LMRWD Boundary (not official)	FEMA Floodway	\mathbb{N}
Lower Minnesota River Watershed District	City/Township Boundary	100-Year FEMA Floodplain	T
Watershed Management Plan	Gully Inventory Locations	500-Year FEMA Floodplain	Not to Scale

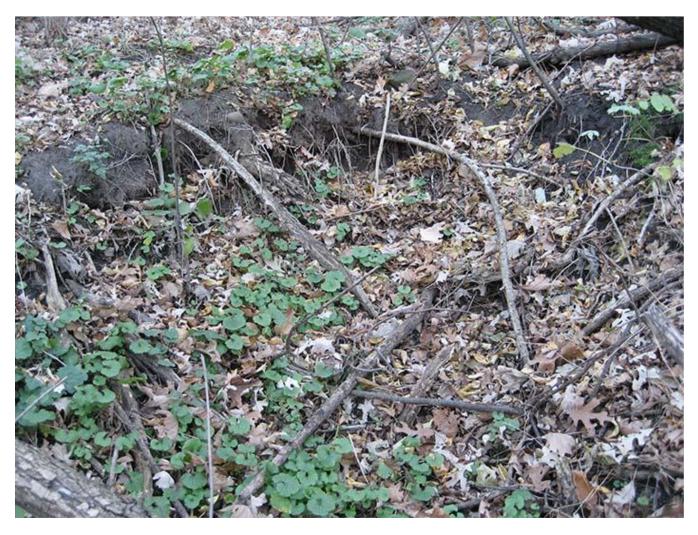
Waypoint 142A

Beginning of erosion; minimal erosion; could potentially turn into a large gully.

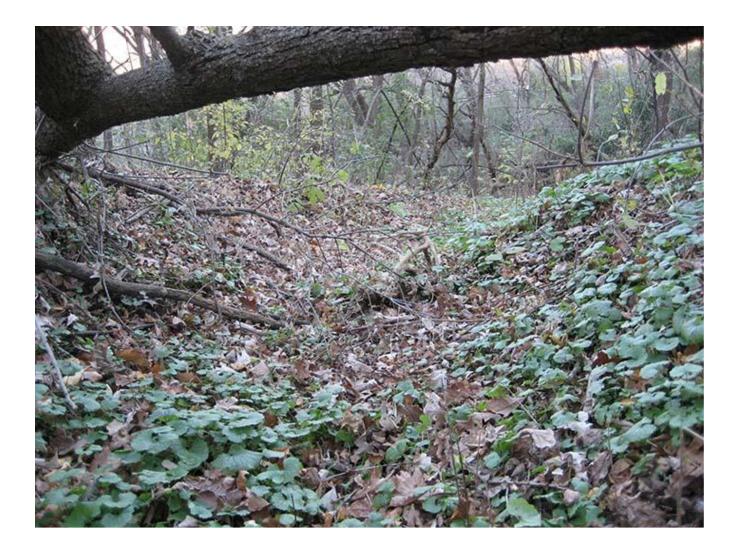
Beginning of erosion; minimal erosion; could potentially turn into a large gully.

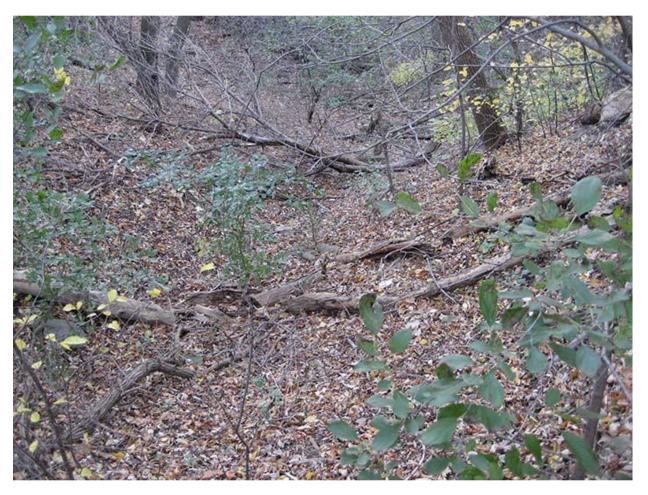
Waypoint 143A

Very large gully off of trail; minor erosion but hard to tell due to leaf litter; no culverts.

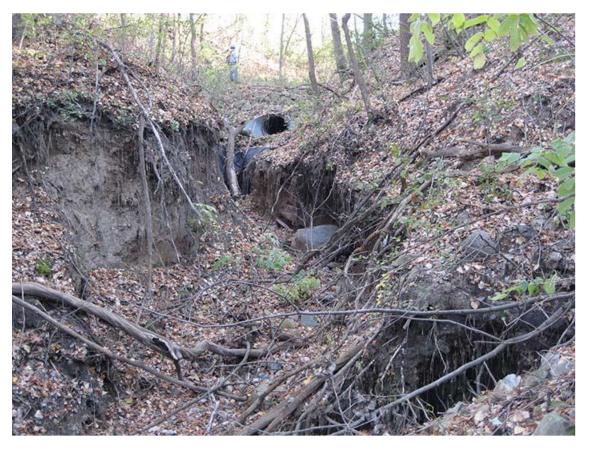
Waypoint 144A

Looking up gully at culvert with black matting underneath; major erosion; large cuts going into ground.

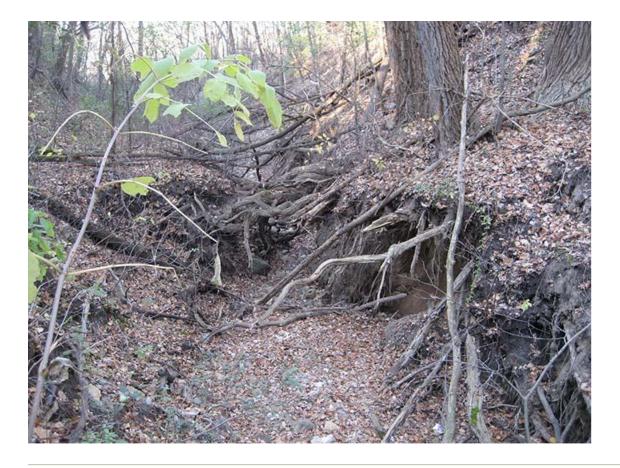
Looking down gully; large boulders at bottom of gully with lots of sand deposits.

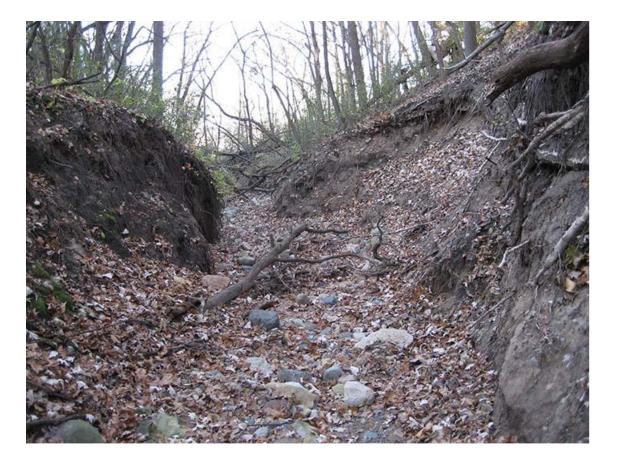
Looking down gully; large boulders at bottom of gully with lots of sand deposits.

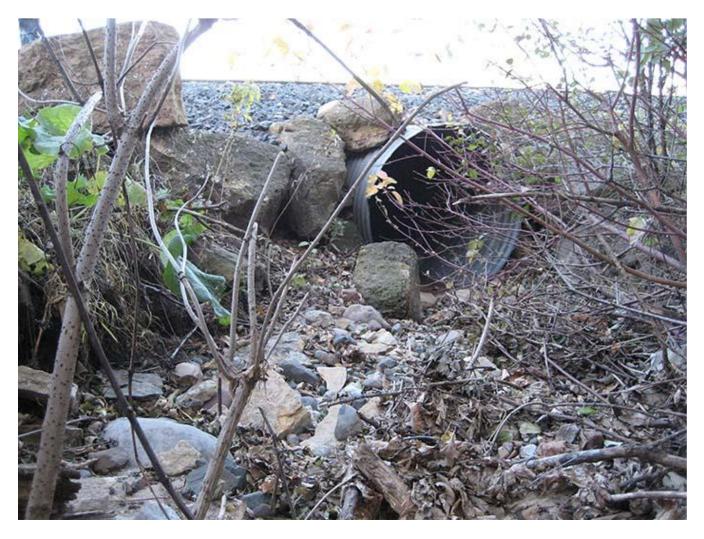
Waypoint 145A

Culvert at bottom of gully; major erosion.

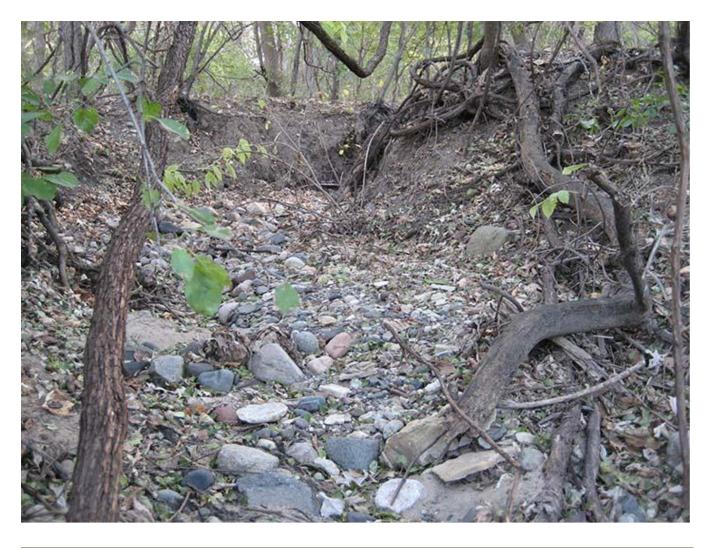
Further up in gully; major erosion.

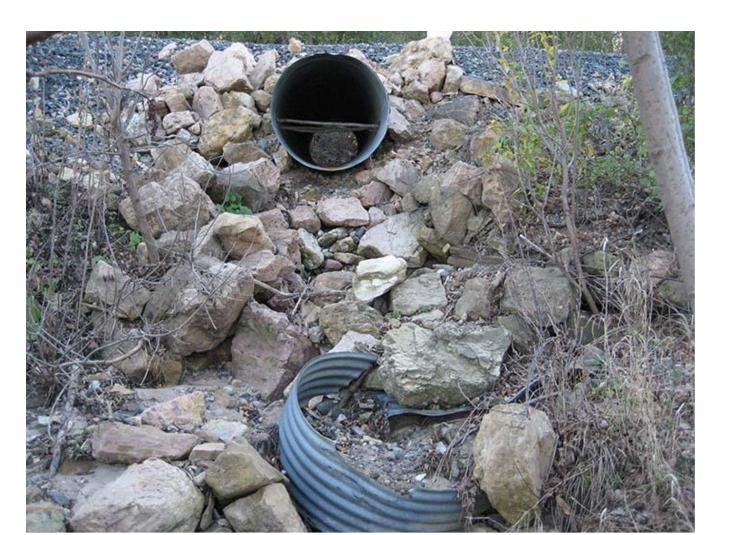
Other side of culvert; minimal erosion.

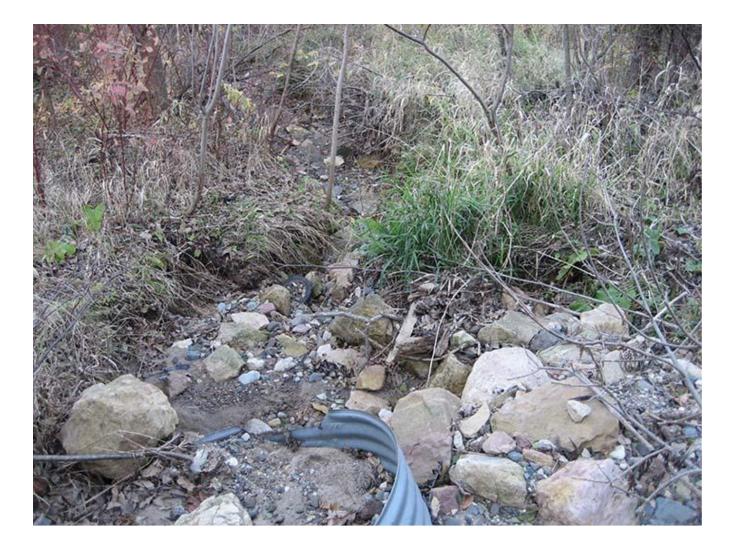
Bottom of culvert; minimal erosion.

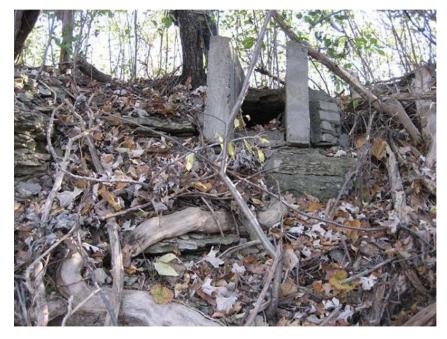
Waypoint 146A

Make-shift culvert made out of concrete; overall looks good.

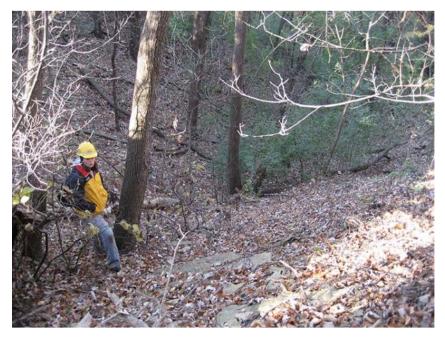
Looking down gully; flat rocks placed below culvert to slow down speed of water; very minor erosion; lots of cans, glass bottles, old metal

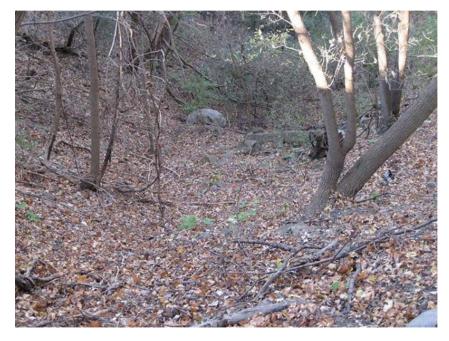
Waypoint 147A

Looking down gully; minimal erosion; some erosion due to uprooted tree; lots of old metal, cans, bottles and old are; at top there is a thic

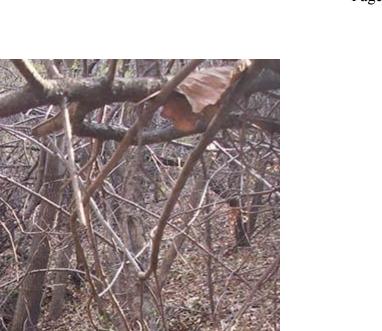
Start of gully

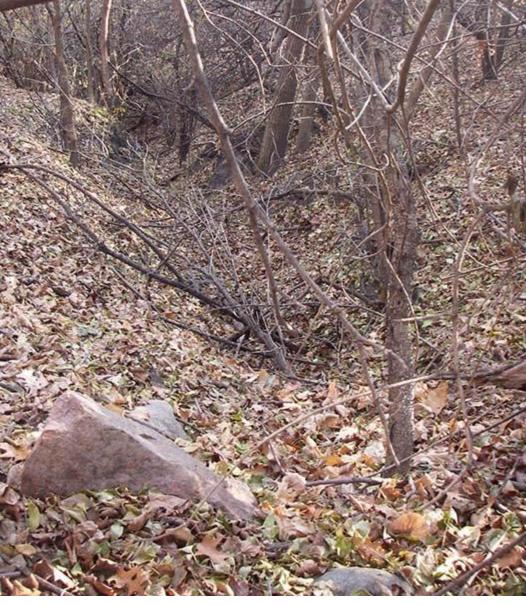
Waypoint 148A

Drop-off about 8-feet; major erosion at top then merges into a gully which has minimal erosion; looking up at beginning of drop-off.

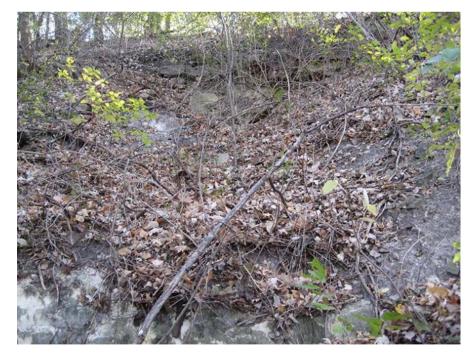
Looking down gully; small drop-off about 3-feet.

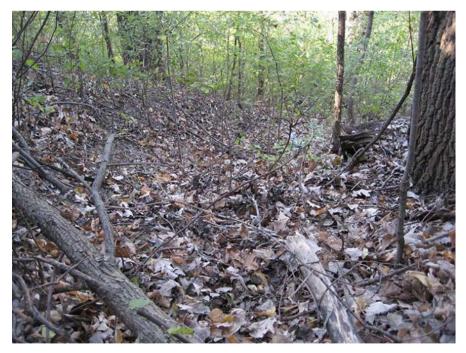
Location: Heidi Lane No. 1

End of gully-mild to moderate erosion

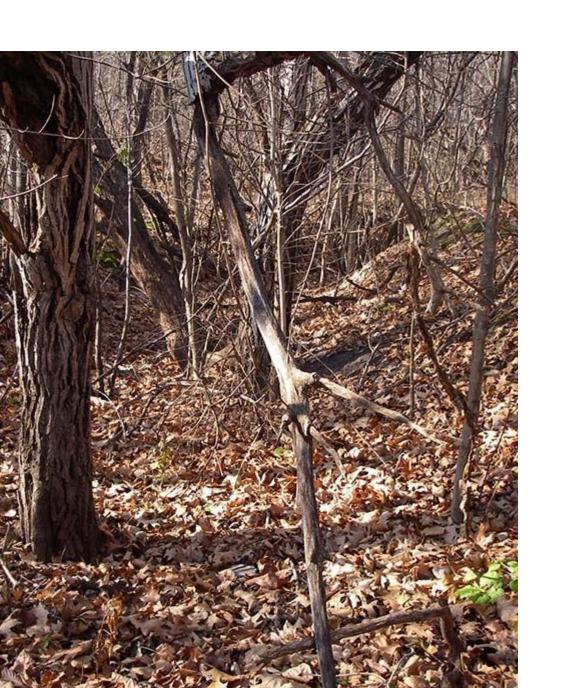
Waypoint 149A

Large gully with moderate to major erosion; hard to see sides of gully due to leaf litter.

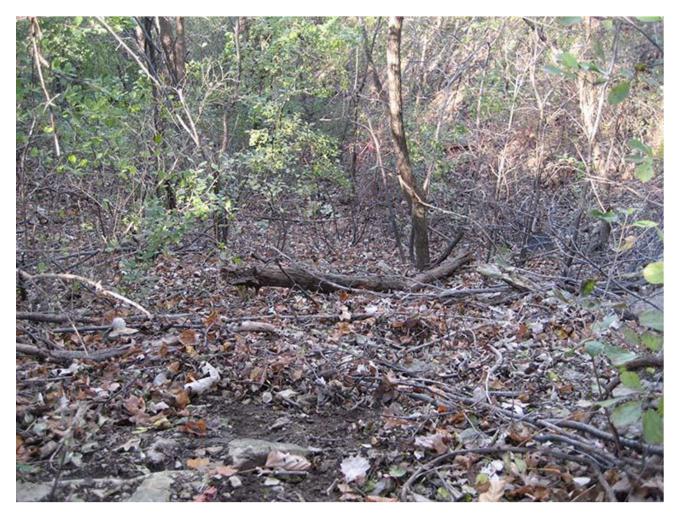
Location: Heidi Lane No. 2

End -no major concerns

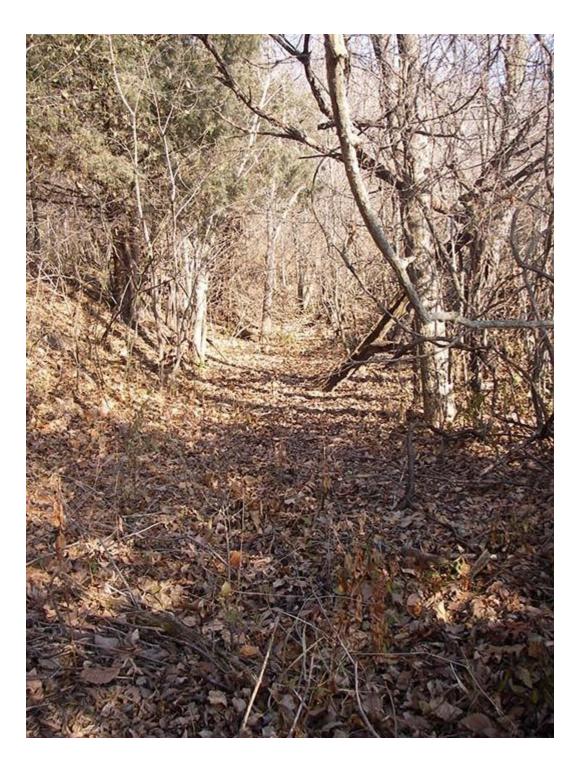
Waypoint 150A

Looking down gully; lots of rock at top of gully; minimal erosion.

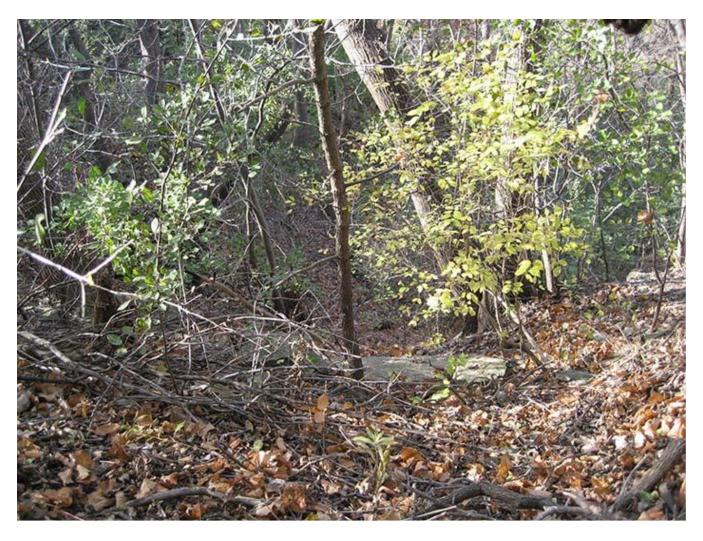
Looking down gully; lots of rock at top of gully; minimal erosion.

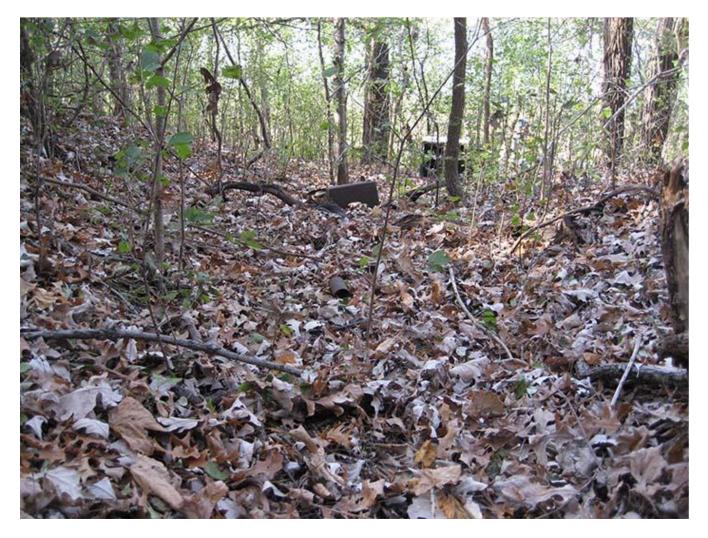
Waypoint 151A

Bottom of gully of waypoint 150A; minimal erosion.

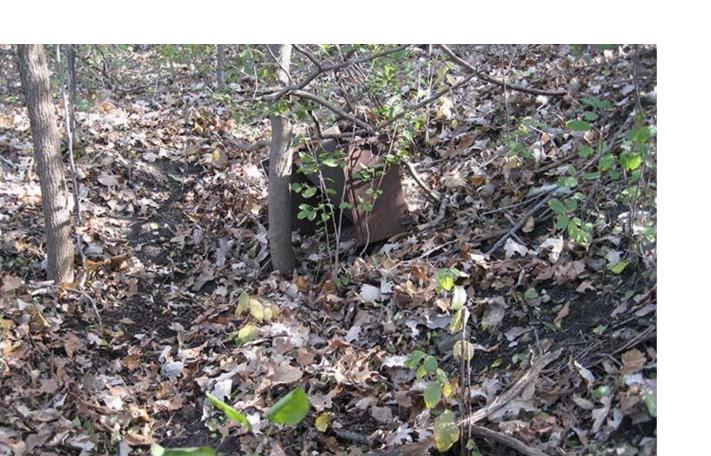
Bottom of gully of waypoint 150A; minimal erosion.

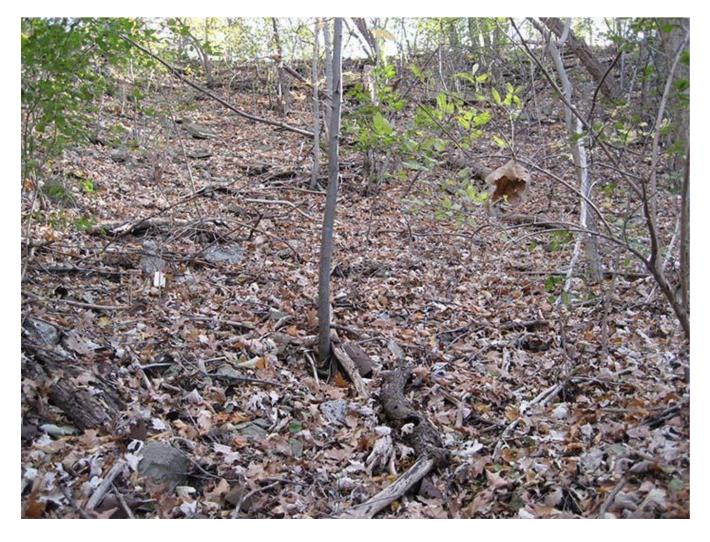
Waypoint 152A

Looking up at gully; minimal erosion.

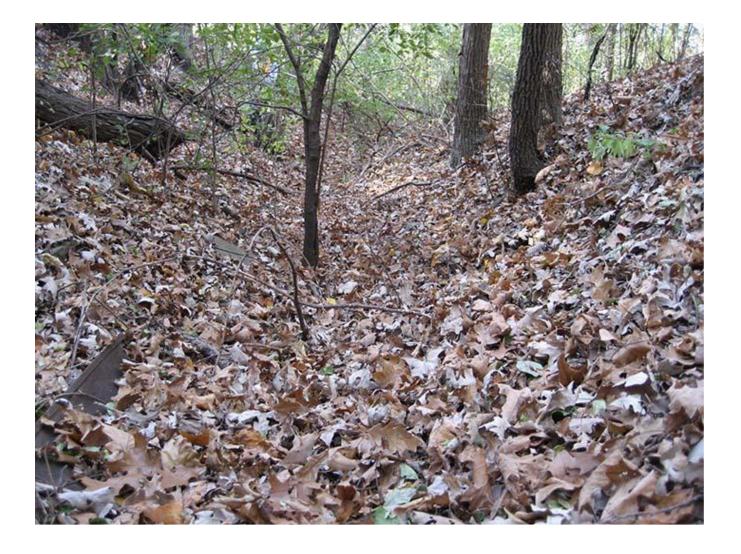
Looking downhill at gully; minimal erosion.

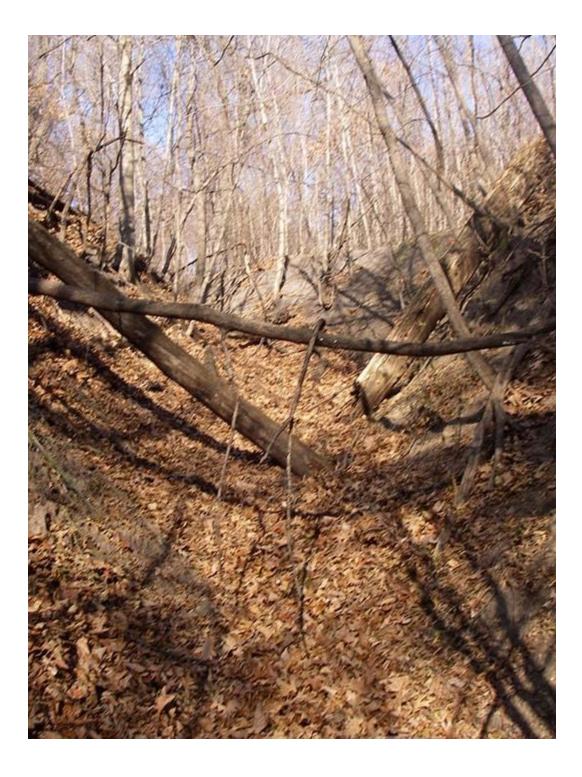
Location: Heidi Lane No. 2

Branch w/moderate to severe erosion

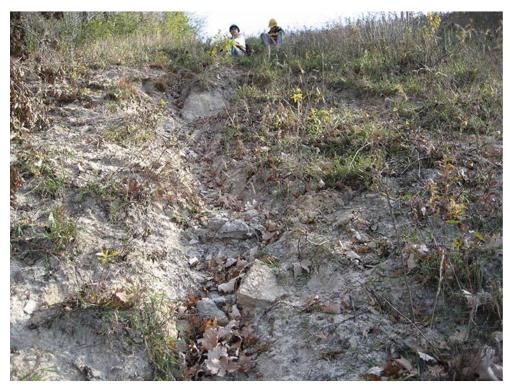
Waypoint 153A

Looking up at some moderate erosion; looks like water coming down a deer trail and starting to erode part of the slope.

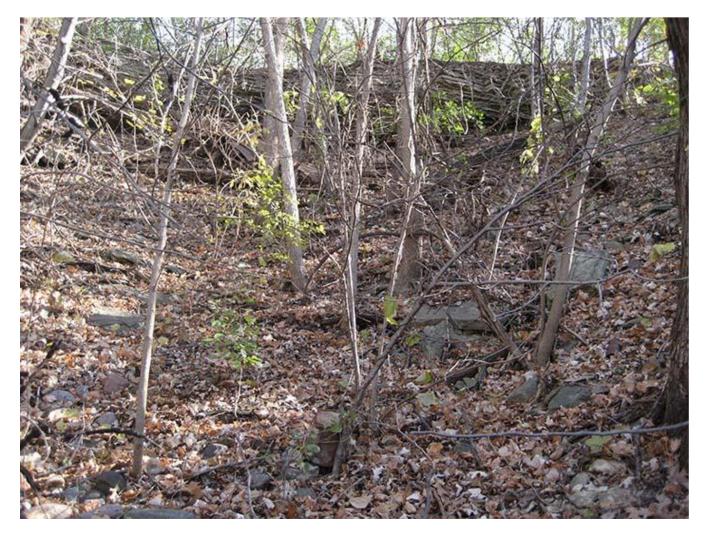
Waypoint 154A

Looking up at gully; top of gully about a 10-foot layer of rock.

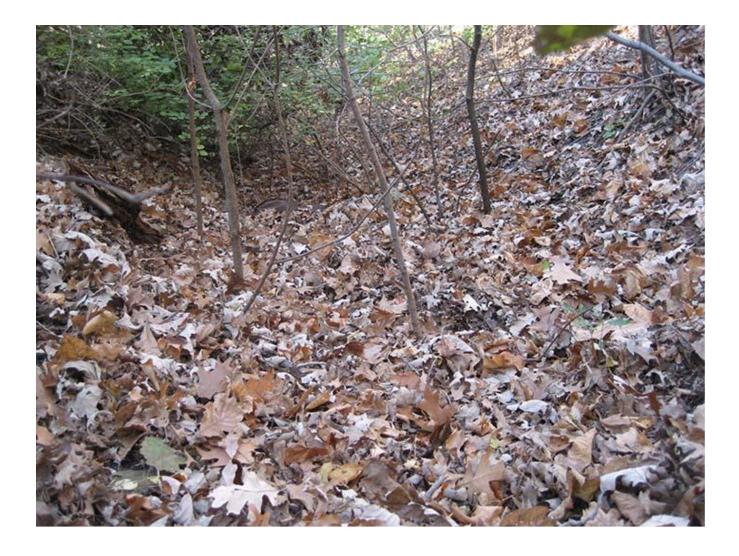
Looking down gully; some sides of gully have moderate erosion.

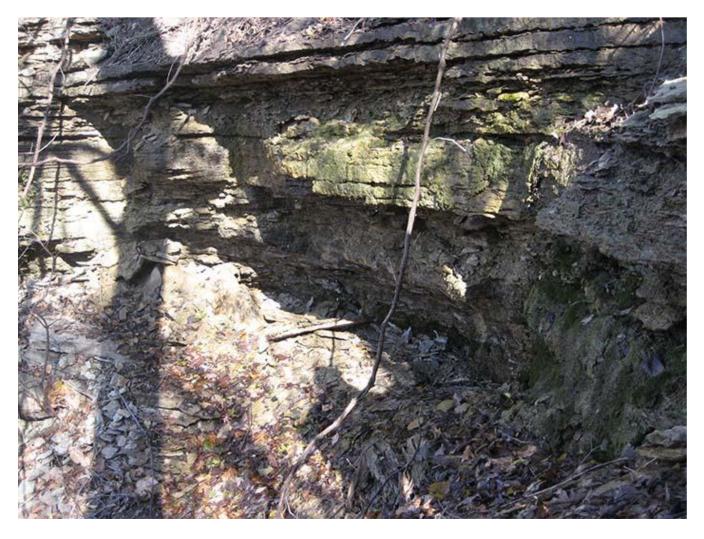
Waypoint 155A

Large rock shelf at top of gully with water coming out of rock layer.

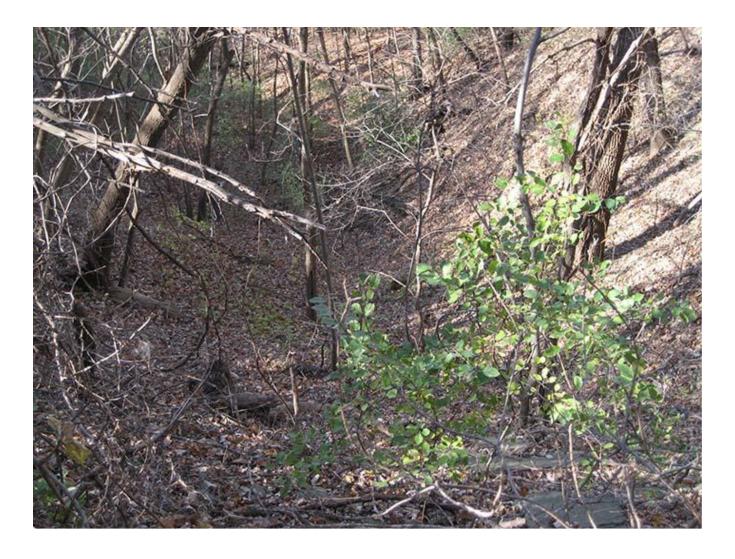
Looking down gully; minor to moderate erosion.

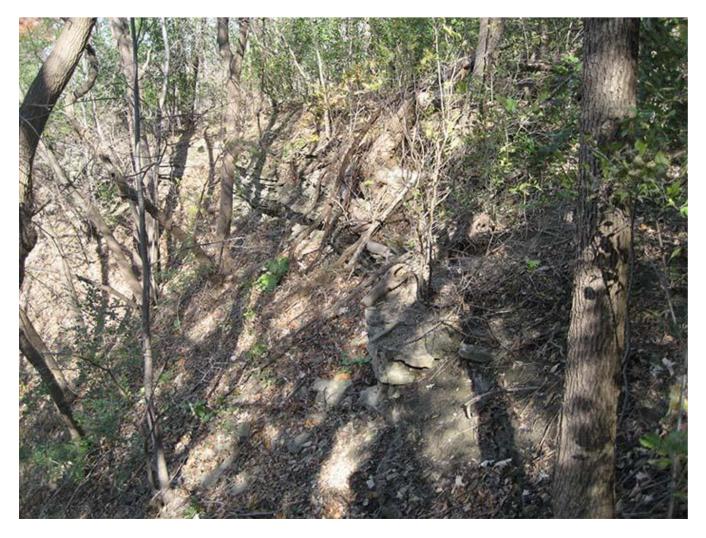
Waypoint 156A

Large rock shelf at top of gully with an approx. 6-foot drop off.

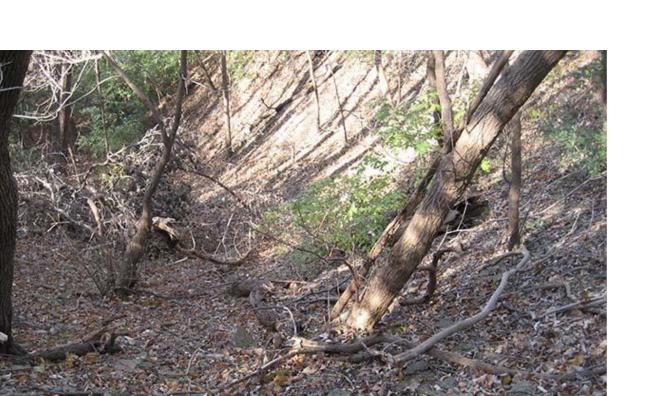
Looking down gully; minimal to moderate erosion.

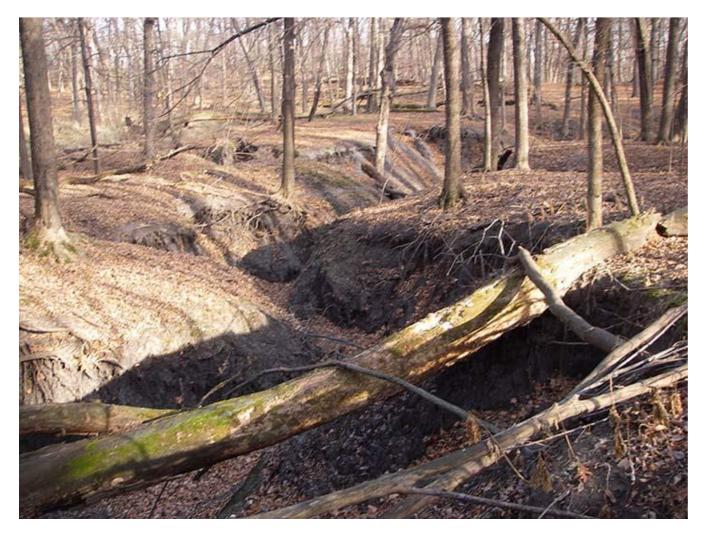
Location: West Farm Road

Garbage and erosion

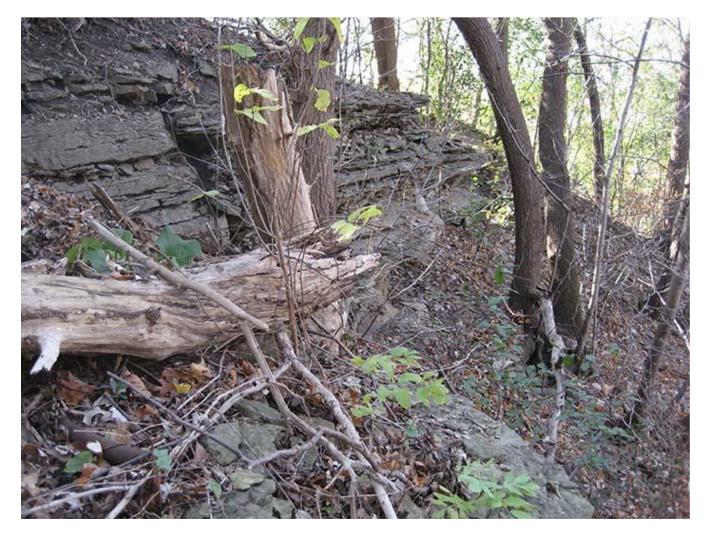
Waypoint 157A

Rock shelf at top of gully approx. 8-feet.

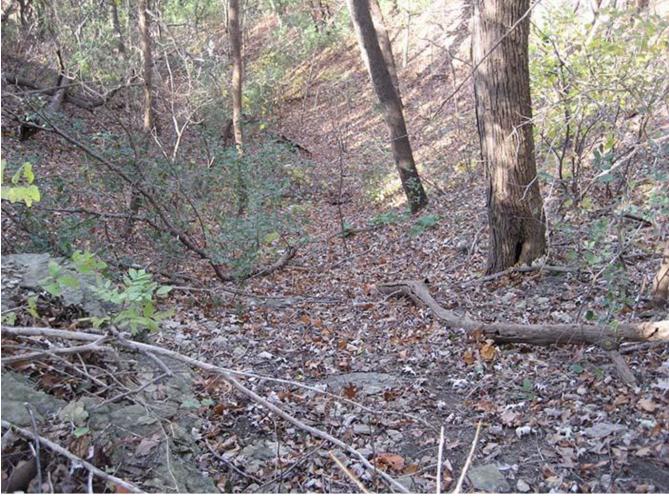
Looking down gully; minimal erosion.

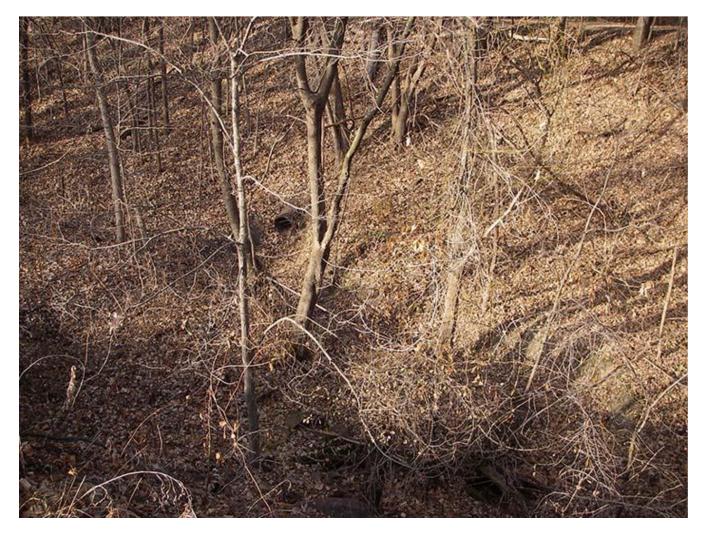
Location: West Farm Road

Severe erosion

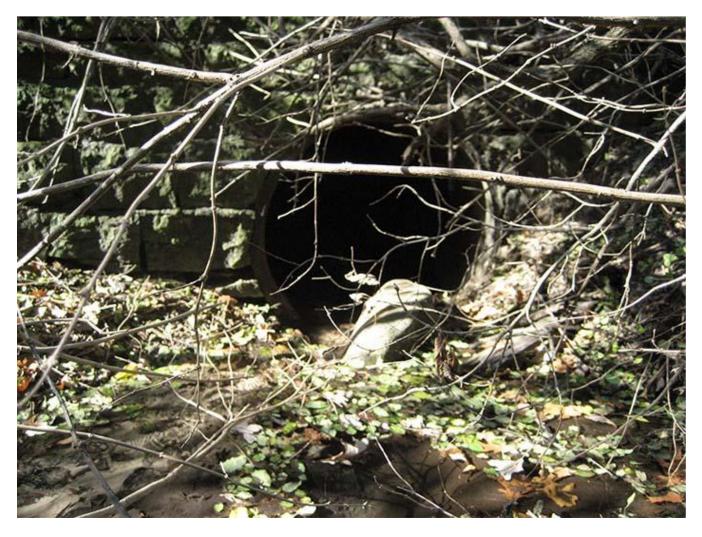
Waypoint 158A

Culvert on slope side going under railroad tracks.

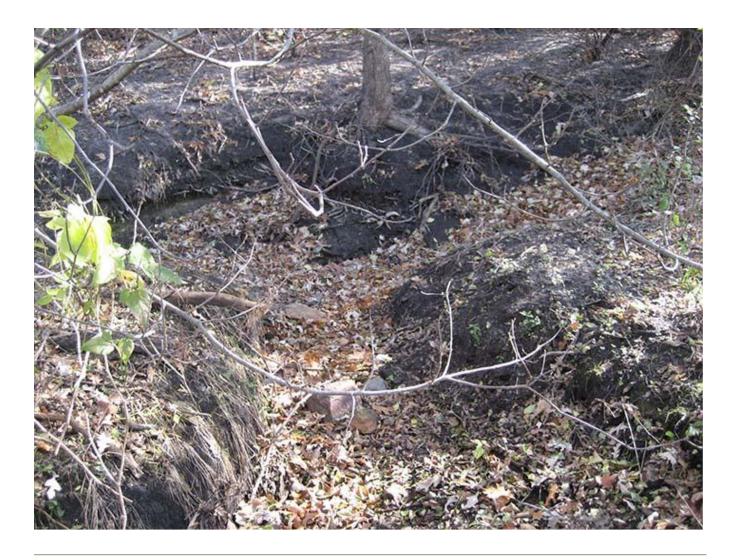
Erosion above culvert in picture #1; major erosion.

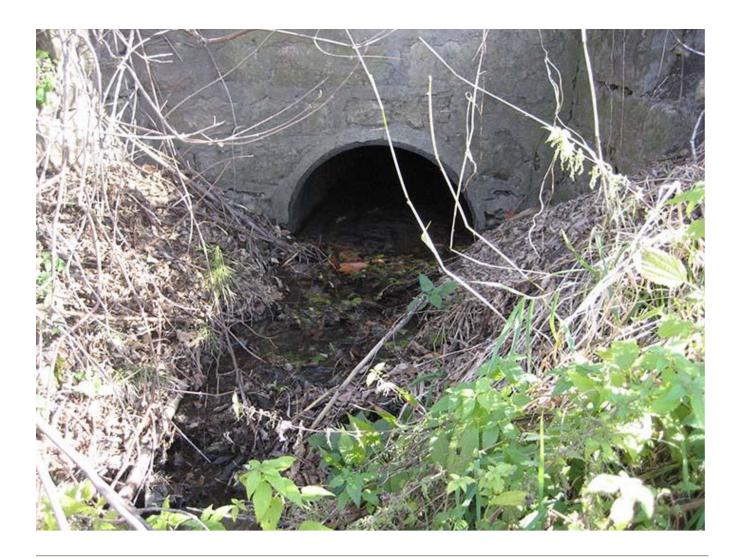
Culvert on lower side of railroad tracks.

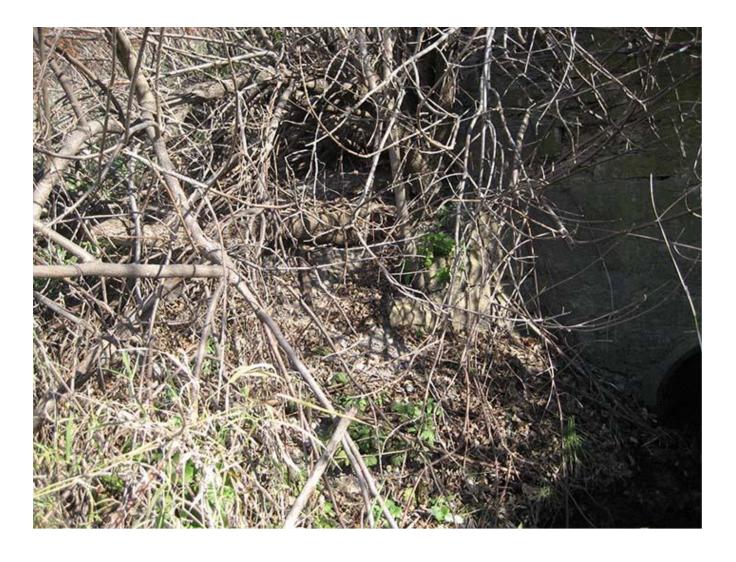
Moderate erosion on sides of culvert.

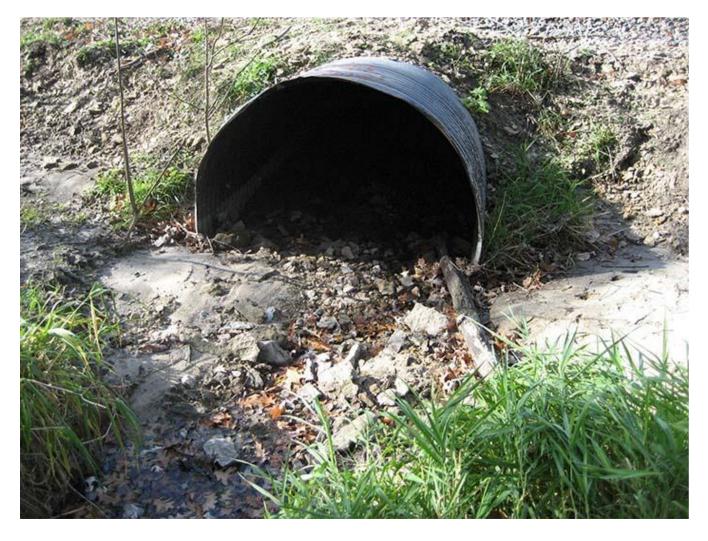
Waypoint 159A

Culvert on slope side.

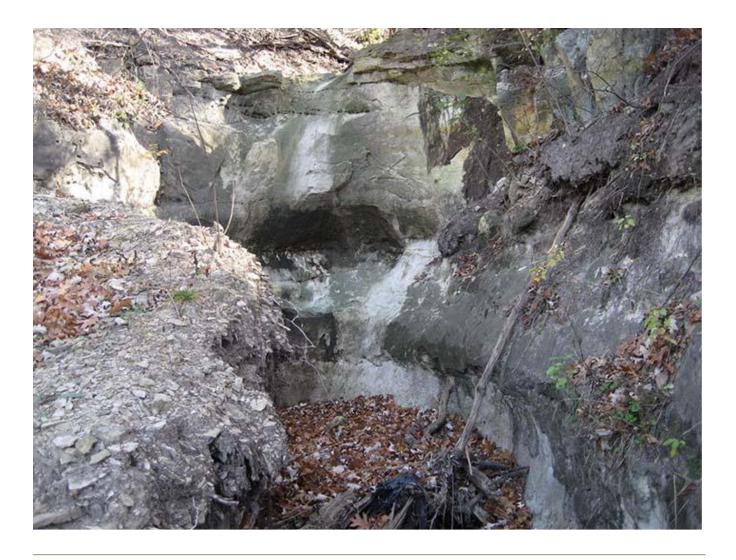
Waterfall? Major erosion above culvert in picture #1.

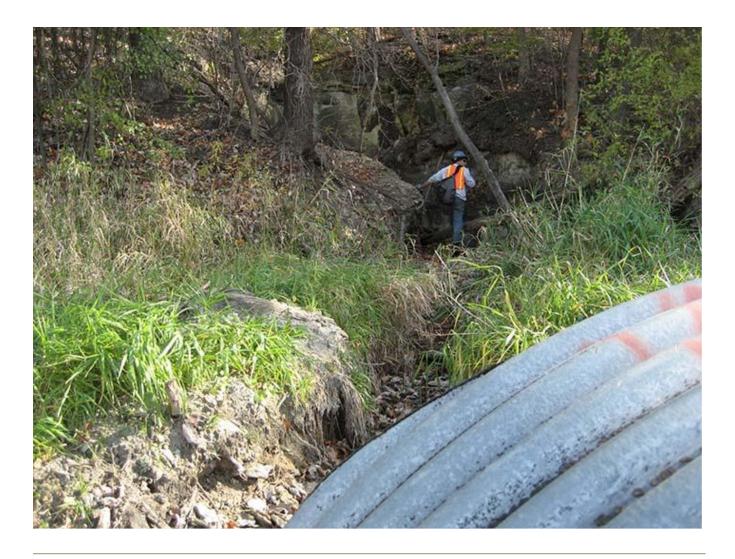
Looking up towards picture #2; major erosion.

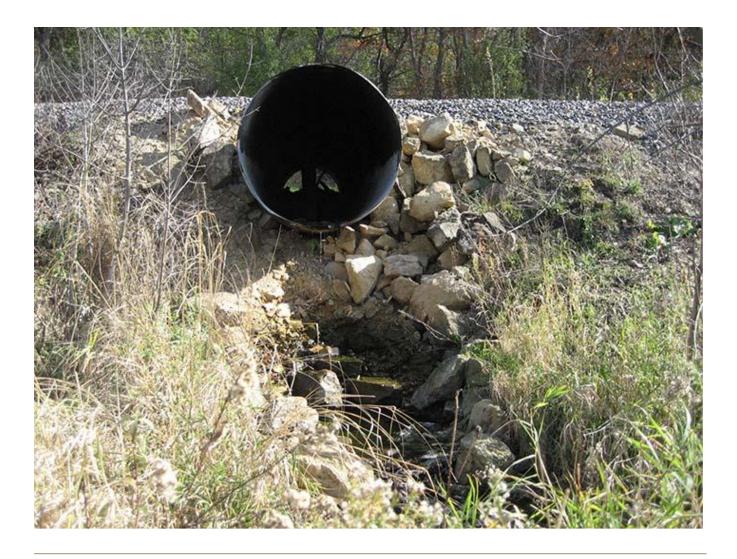
Down slope side of culvert in picture #1; starting to erode.

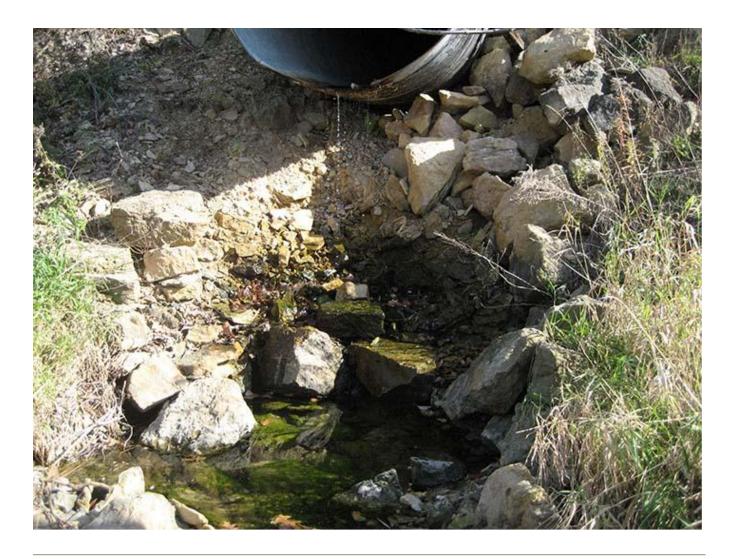
Down slope side of culvert in picture #1; starting to erode.

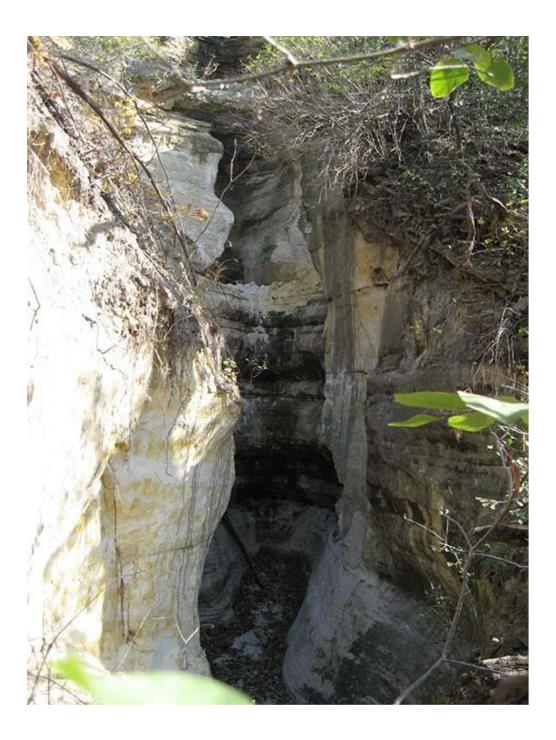
Farther up slope cut into rock; 30-foot drop.

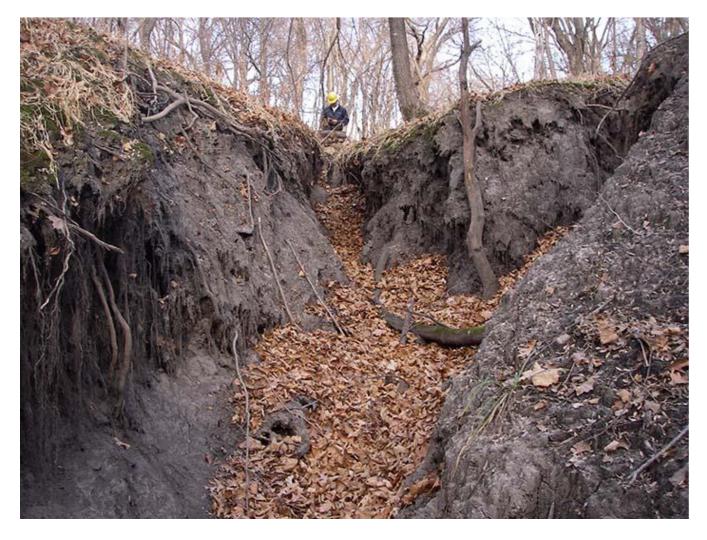
Severe erosion

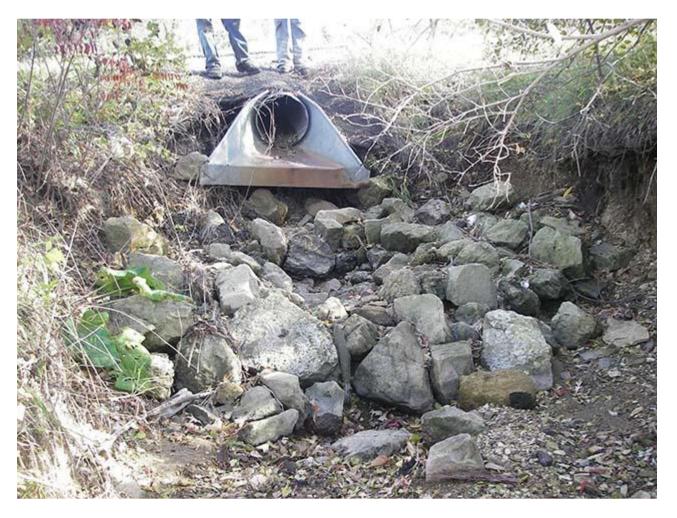
Waypoint 160A

Culvert coming from under road.

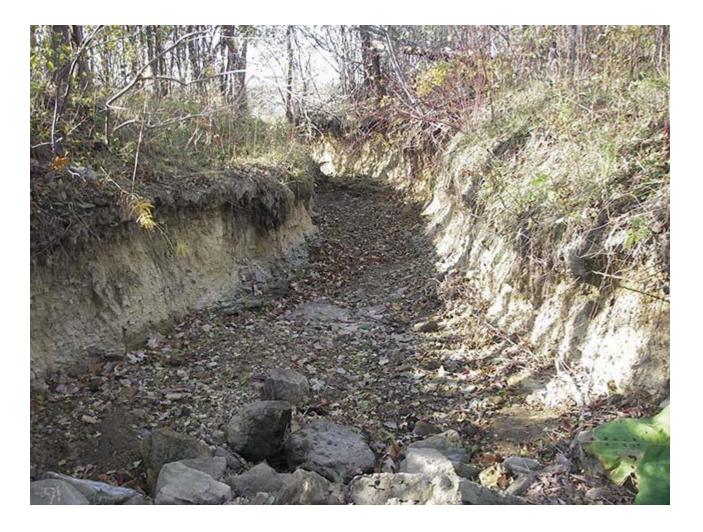
Erosion due to the culvert; 3-4 foot cut.

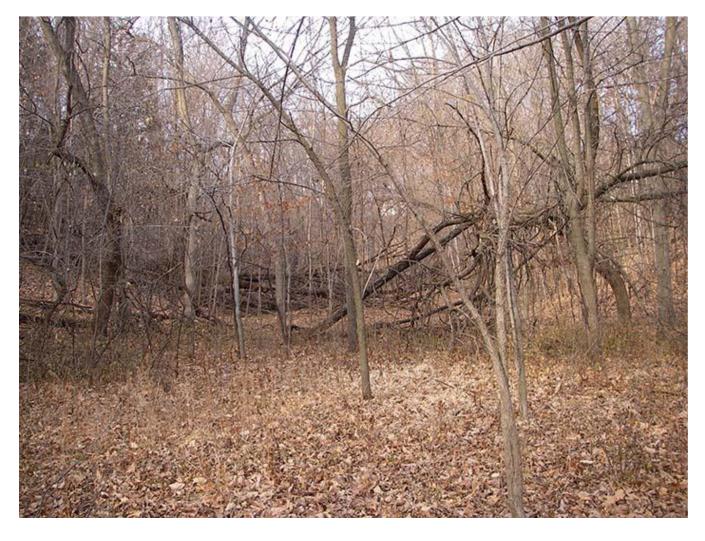
Branch/erosion

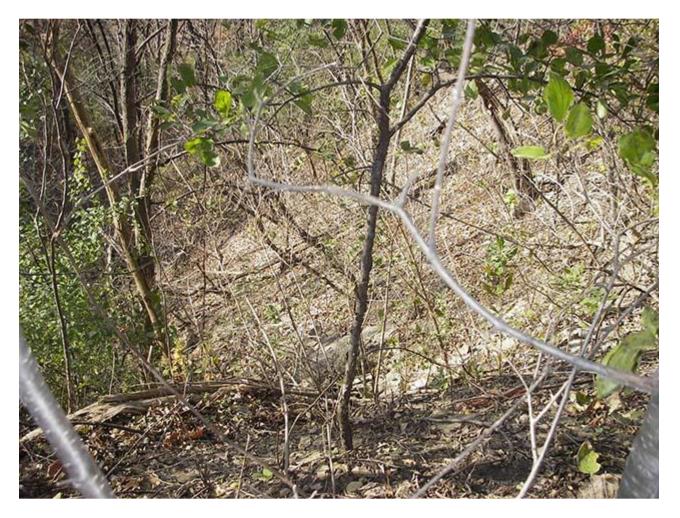
Waypoint 161A

Looking down gully; lots of rock and erosion; hard to access due to rough terrain.

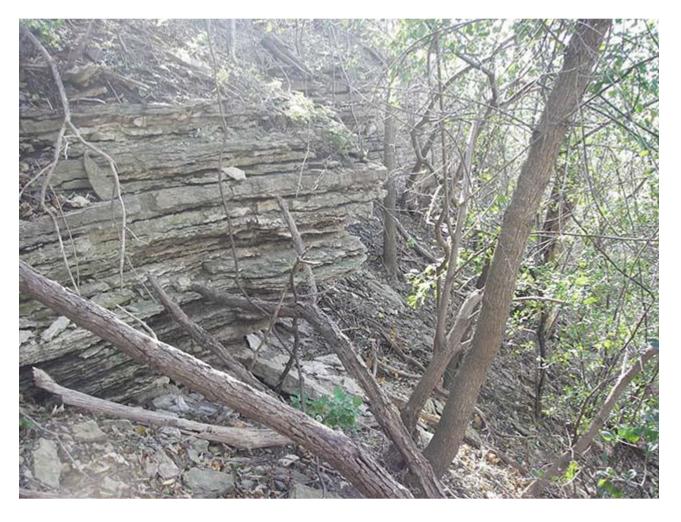
Waypoint 162A

Very large gully with large rock ledge.

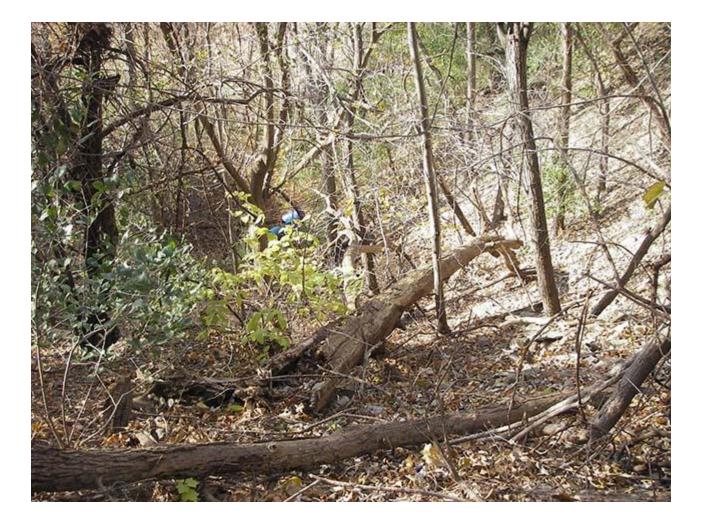
Looking down gully; large blue barrels midway down.

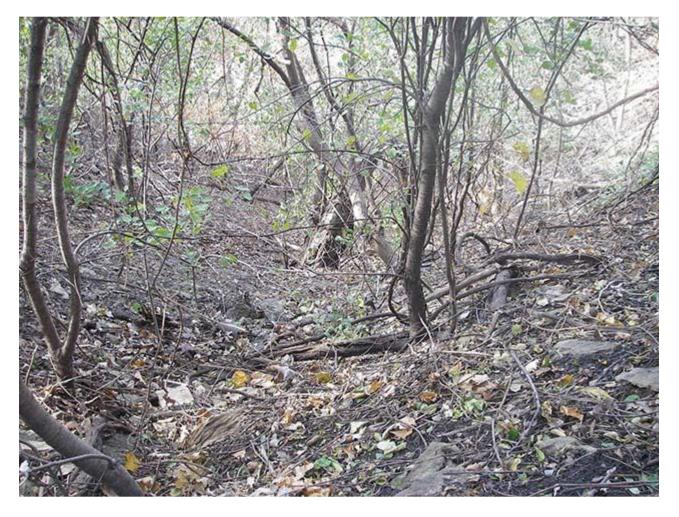
Waypoint 163A

Large gully with moderate erosion.

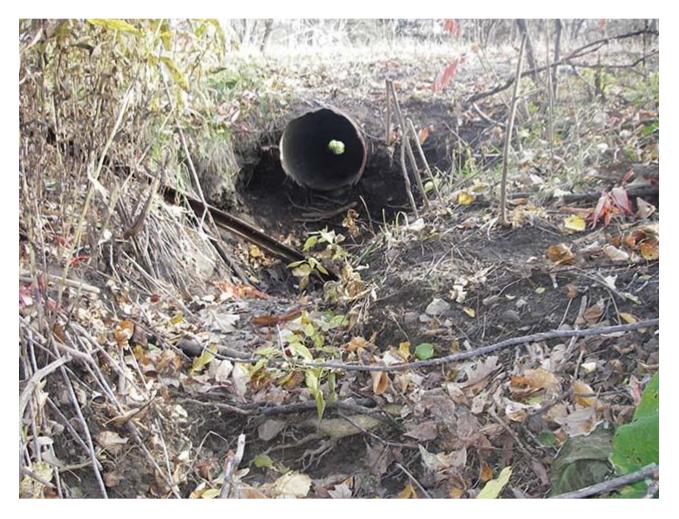
Waypoint 164A

Culvert coming from under road.

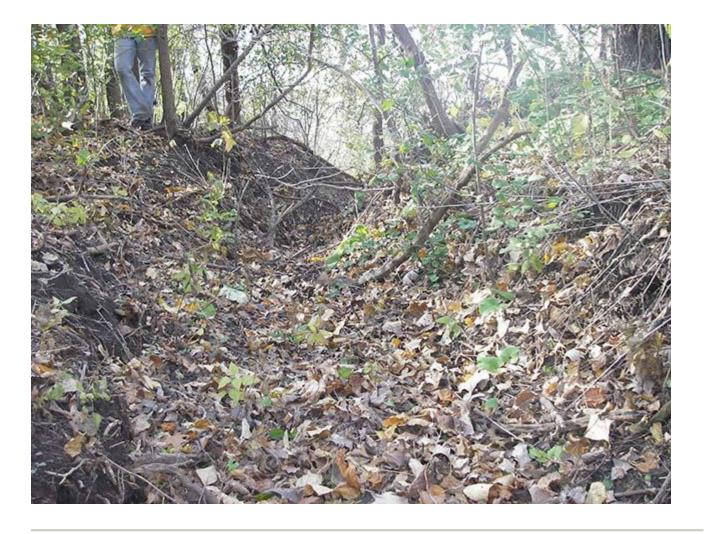
Looking down from culvert; moderate to major erosion.

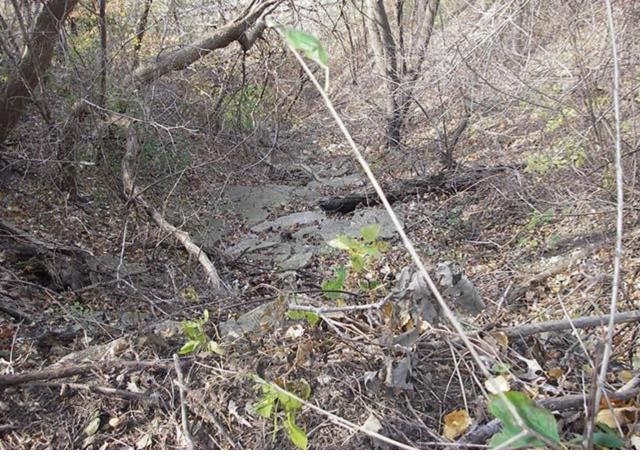
10-foot drop-off into large ravine.

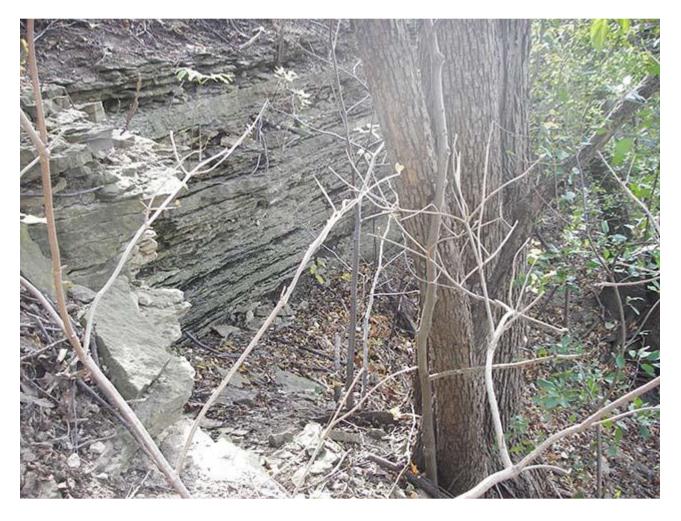
Waypoint 165A

Large rock ledge at top of gully.

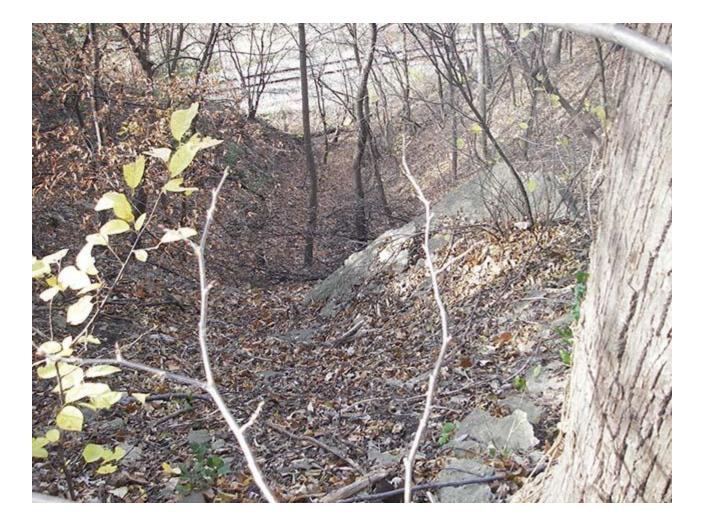
Looking down gully; steep sides with moderate erosion.

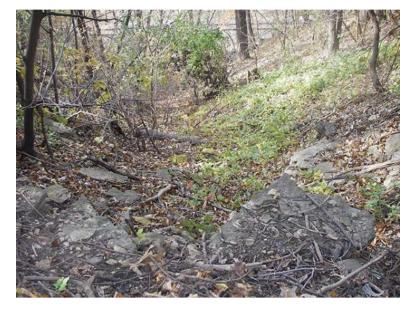
Waypoint 166A

Small rock ledge at top; looking down gully, minimal to moderate erosion; below gully there is a culvert going under the railroad tracks; mo

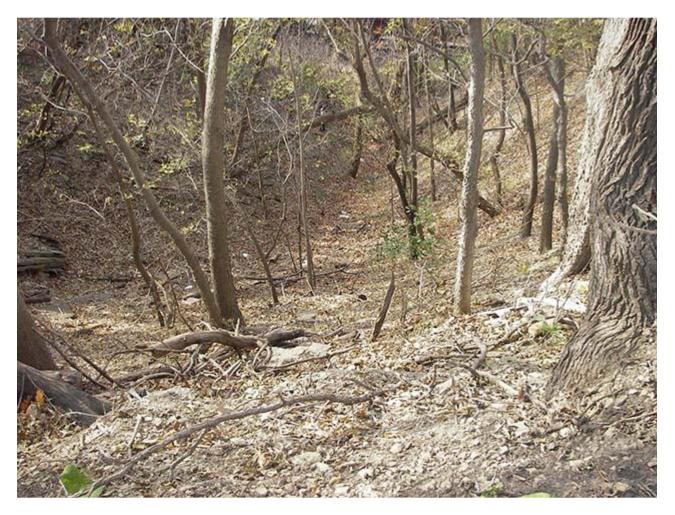
Waypoint 167A

Large gully with moderate erosion; large rock shelf at top of gully.

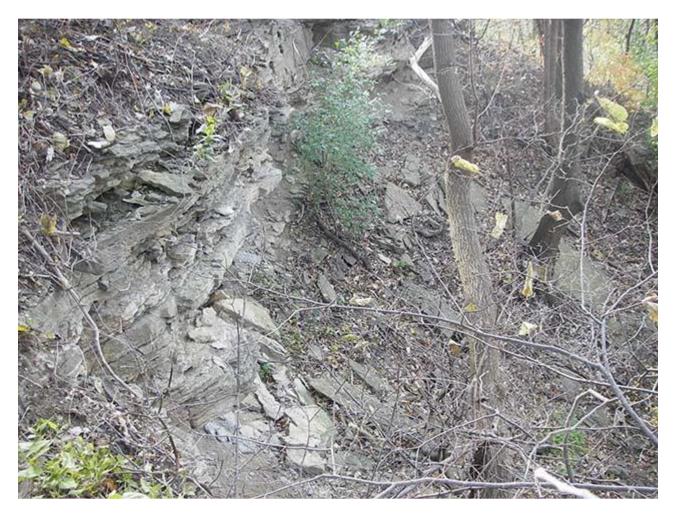
Waypoint 168A

Very large rock shelf at top of large gully; moderate erosion.
