Gully Inventory Map	Legend		\mathbf{T}
Area #1	LMRWD Boundary (not official)	FEMA Floodway	\mathbb{N}
Lower Minnesota River Watershed District	City/Township Boundary	100-Year FEMA Floodplain	T
Watershed Management Plan	Gully Inventory Locations	500-Year FEMA Floodplain	Not to Scale

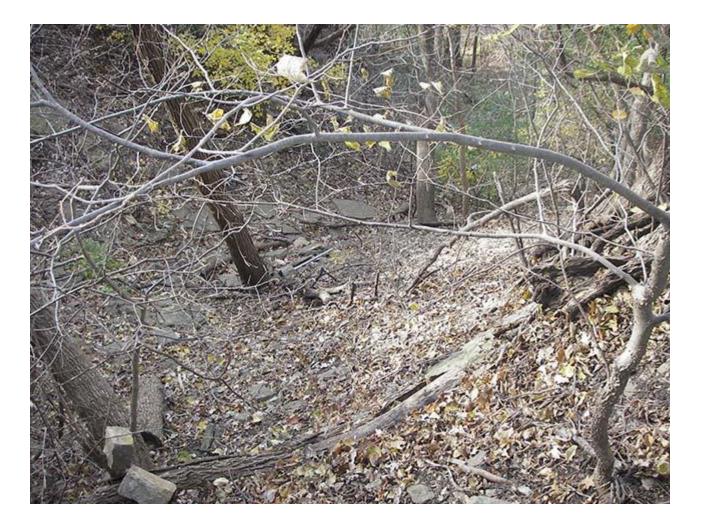
Culvert at bottom of gully going under railroad tracks; minor erosion.

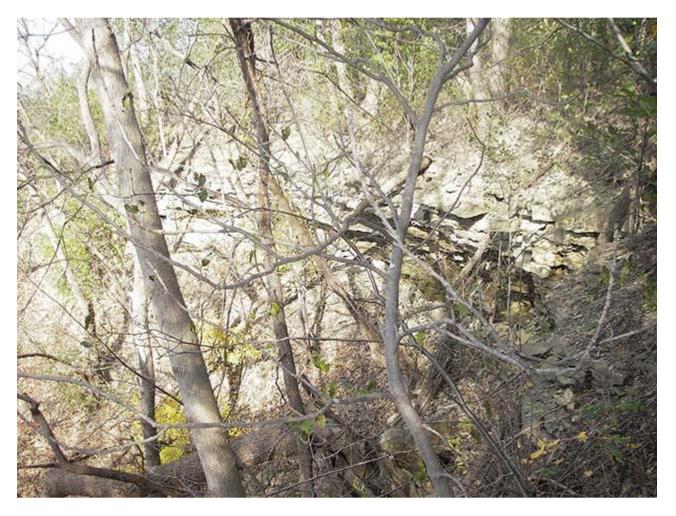
Waypoint 169A

Large gully with large rock shelf at top of gully; moderate erosion.

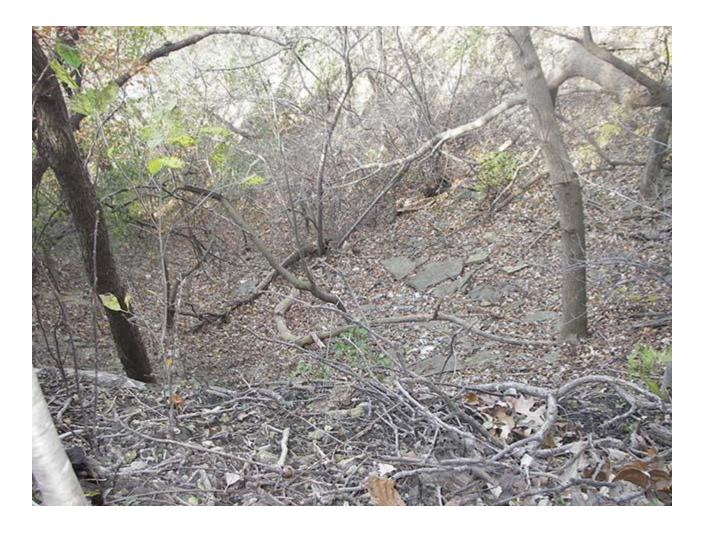
Culvert at bottom of gully going under railroad tracks; minor erosion.

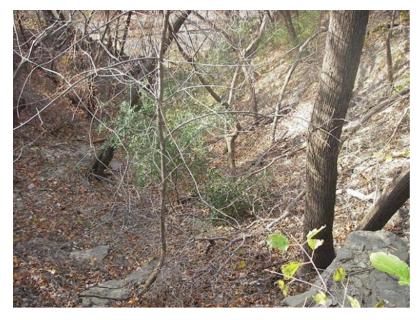
Waypoint 170A

Large gully with large rock shelf at top; moderate erosion; culvert at bottom of gully going under railroad tracks; moderate erosion.

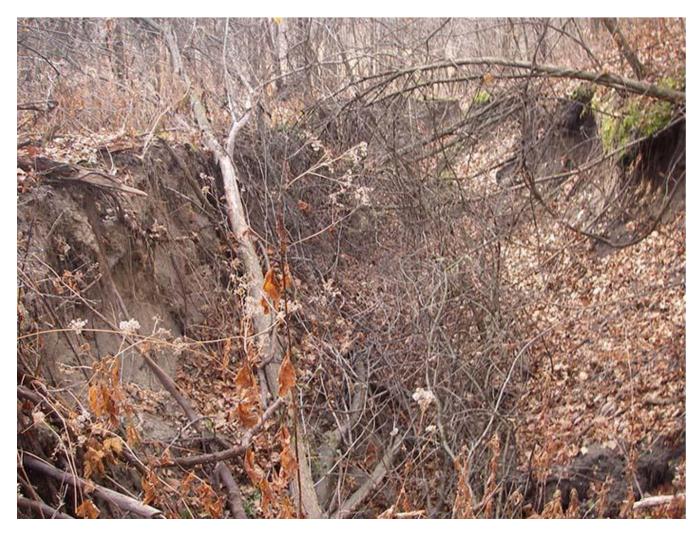
Severe erosion in two parallel gullies

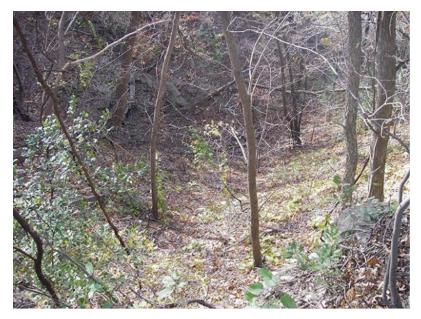
Waypoint 171A

Large gully with large rock shelf at top; moderate erosion; culvert at bottom of gully going under railroad tracks; moderate erosion.

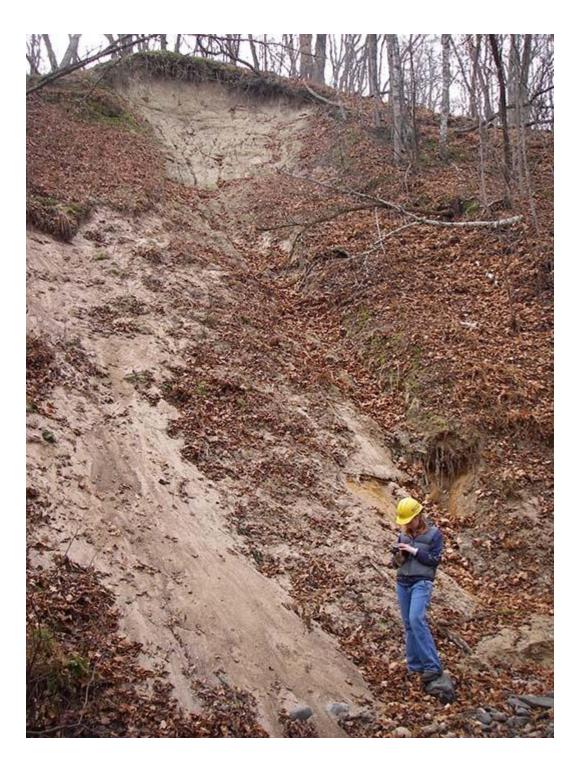
Severe erosion

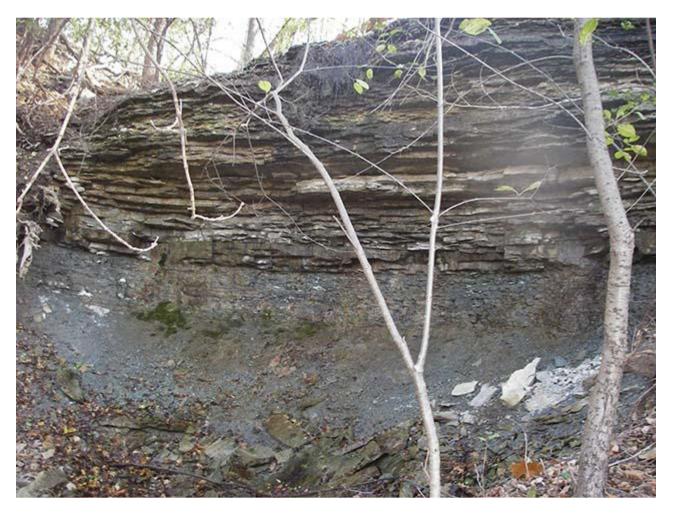
Waypoint 172A

Large gully with large rock ledge at top; major erosion.

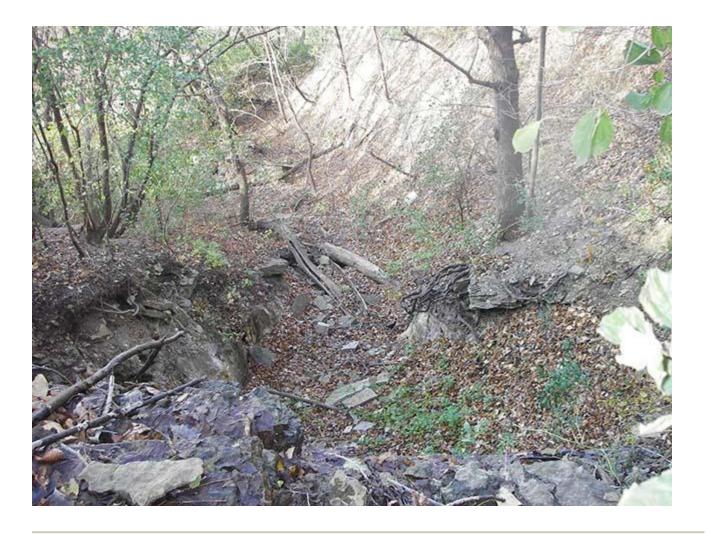
Large gully with large rock ledge at top; major erosion.

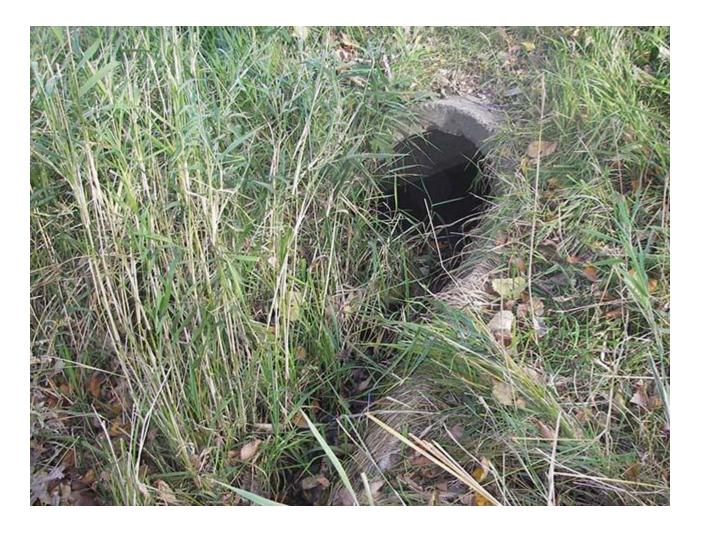
Culvert at top of gully coming from under road.

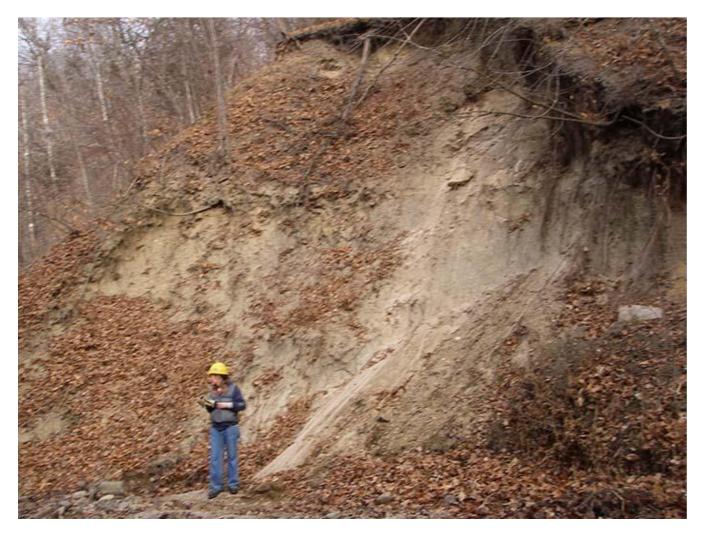
Severe erosion

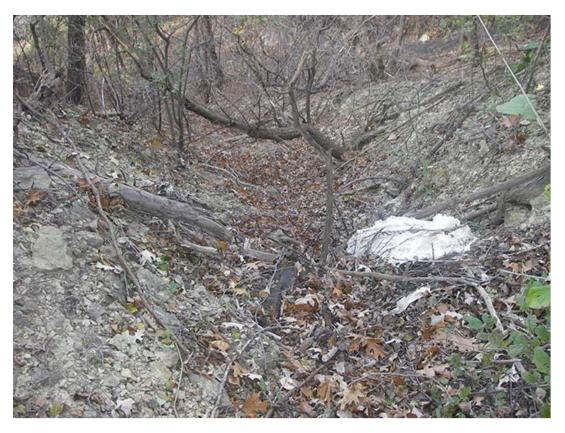
Waypoint 173A

Large gully with two arms going down and connecting midway down gully; arm #1 has moderate erosion.

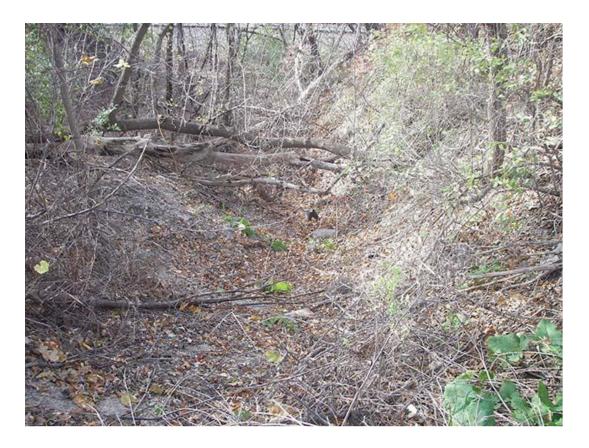
Arm #2 has major erosion.

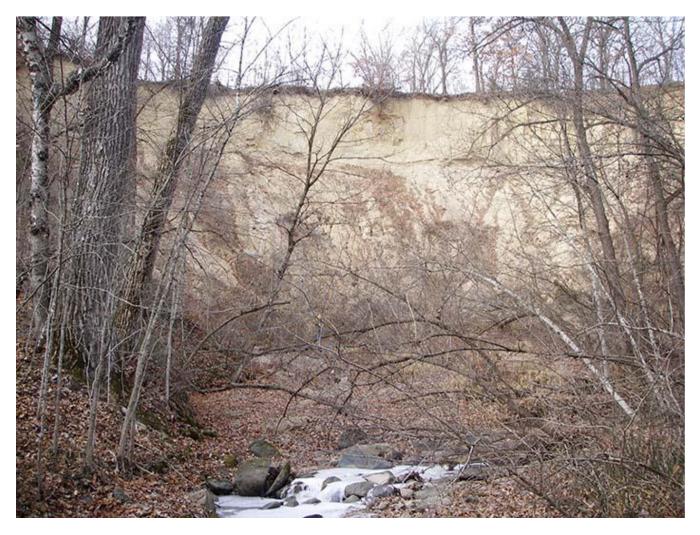
Severe erosion

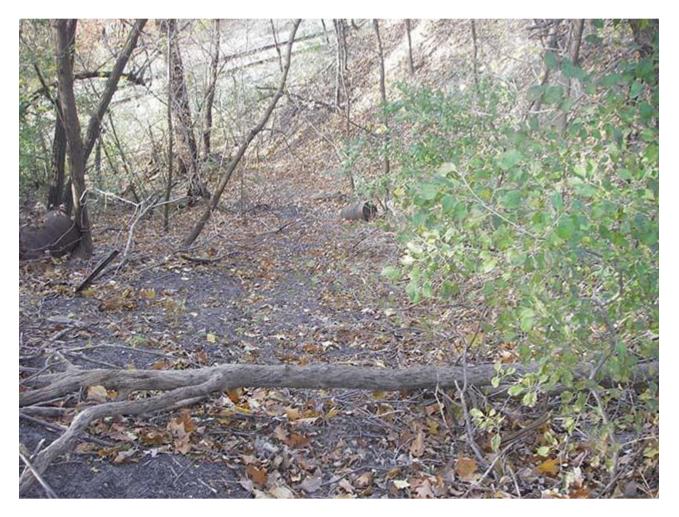
Waypoint 174A

Looking down at large gully; moderate erosion.

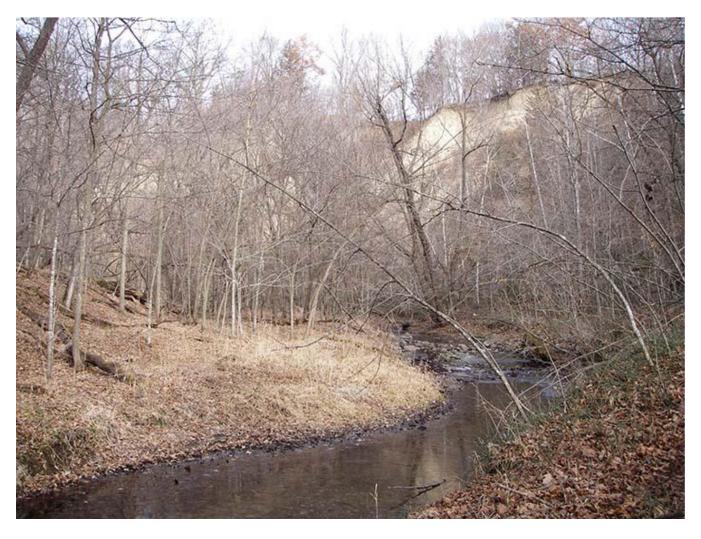
Severe erosion

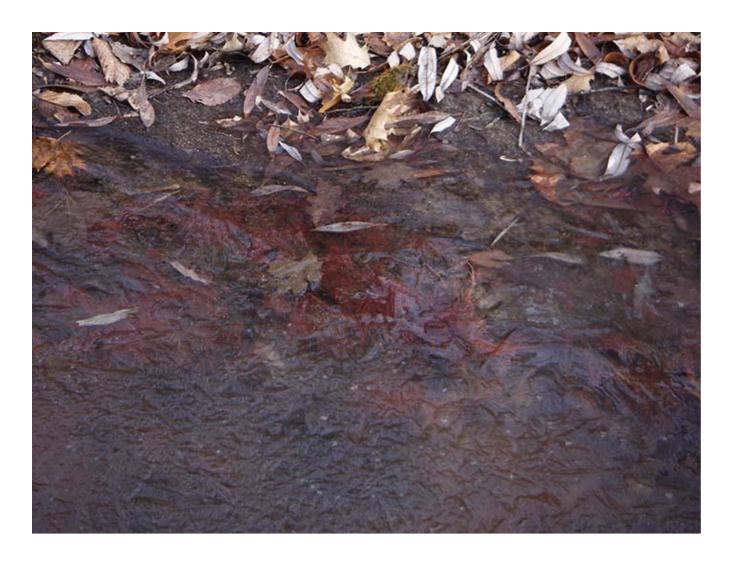
Fresh water sponges

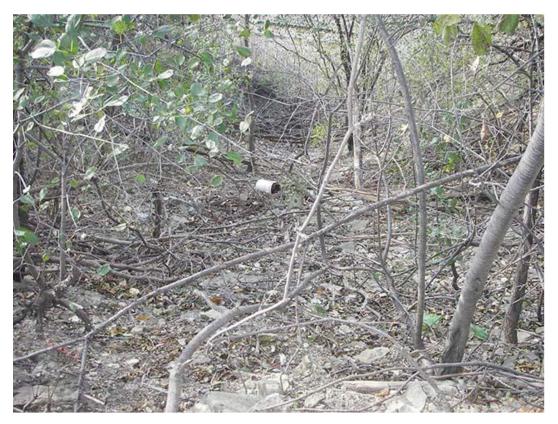
Waypoint 175A

Looking down at gully; moderate to major erosion; looks like large amounts of water flow down gully.

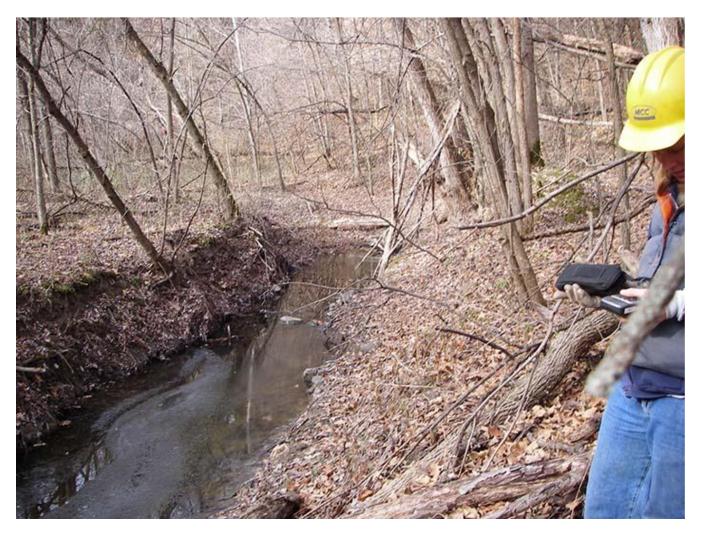
Location: Bluff Creek Park

End

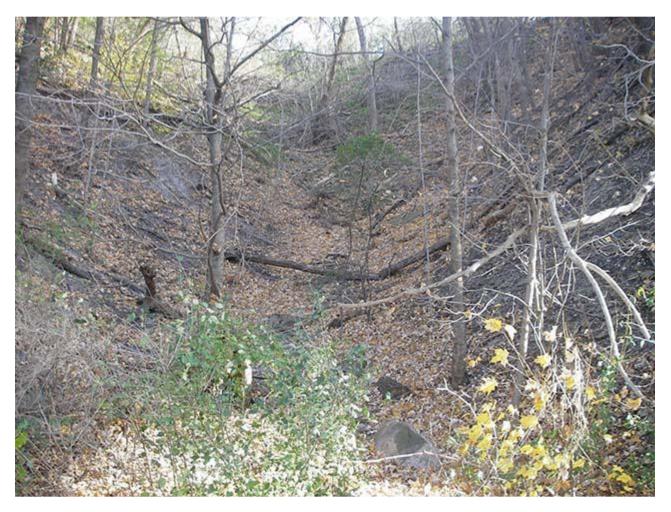
Waypoint 176A

Looking up at gully from railroad tracks; moderate to major erosion.

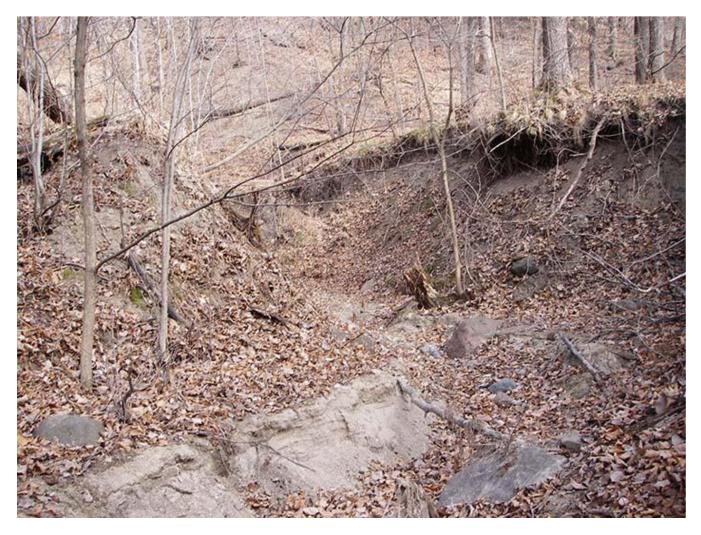
Location: Bluff Creek Park

Branch

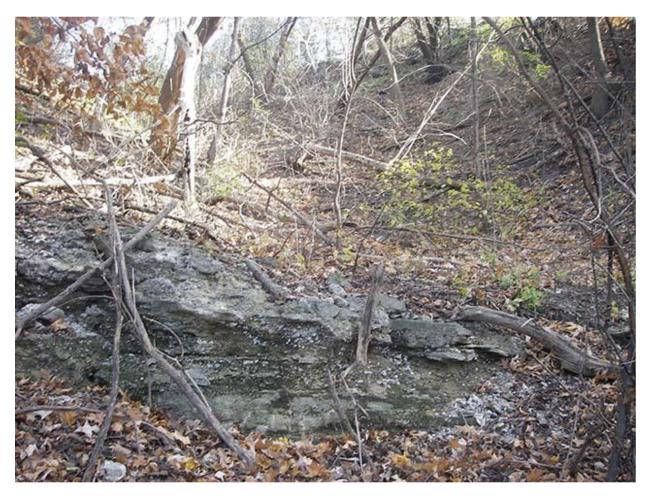
Waypoint 177A

Looking up at large gully from railroad tracks; lots of rock ledges; minimal erosion.

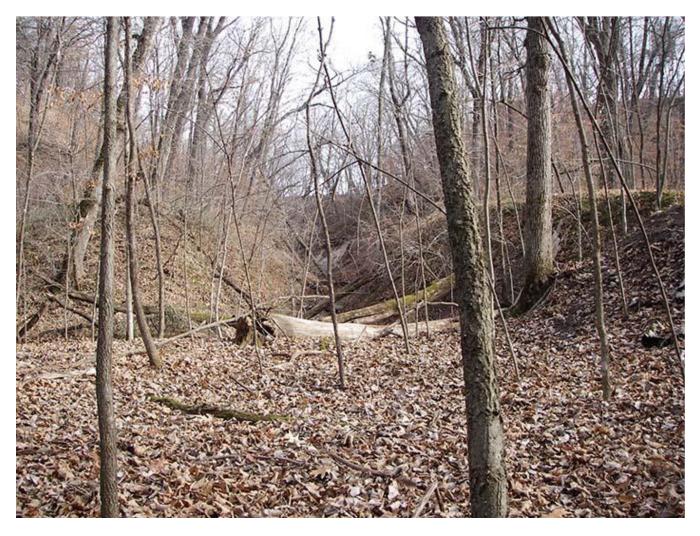
Location: Bluff Creek Park

Branch

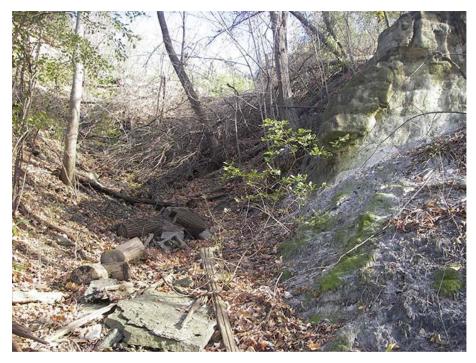
Waypoint 178A

Medium gully with moderate erosion on sides; lots of down trees and brush; looking up at gully from railroad tracks.

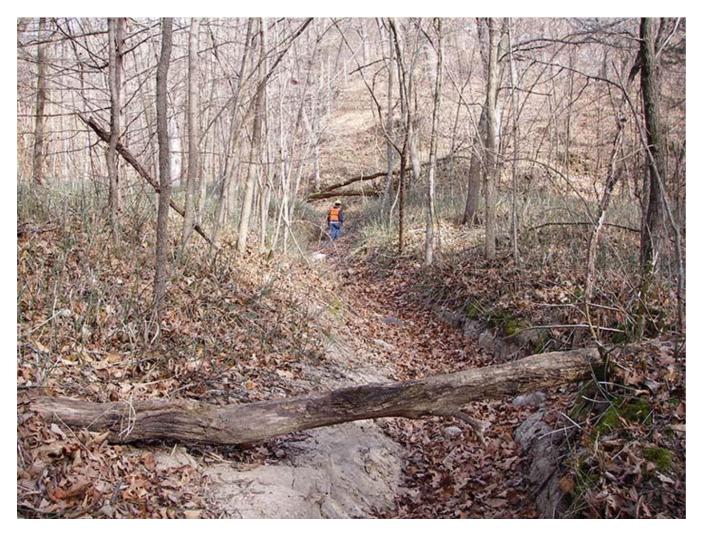
Location: Bluff Creek Park

Branch

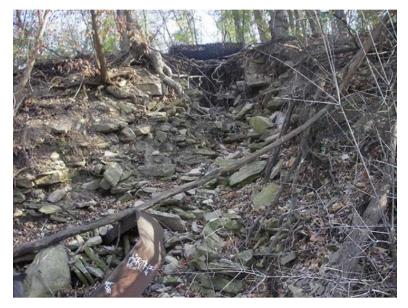
Waypoint 179A

Looking up at small gully from railroad tracks; lots of small rock and some sort of erosion control method at top; looks like a fence laying

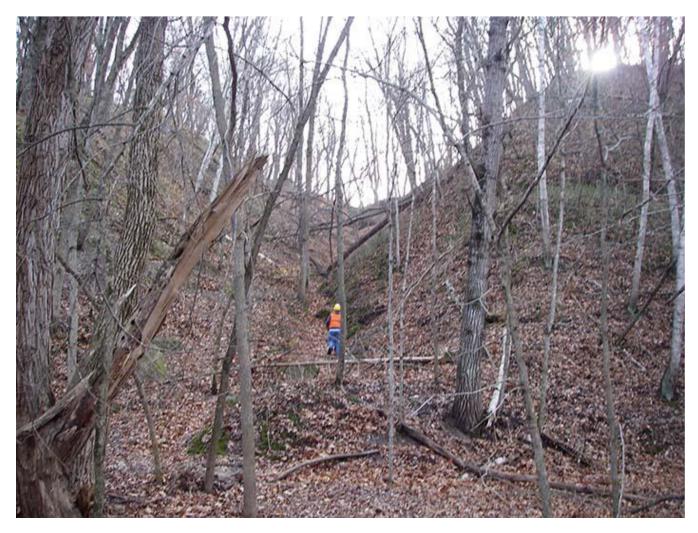
Location: Bluff Creek Park

Branch

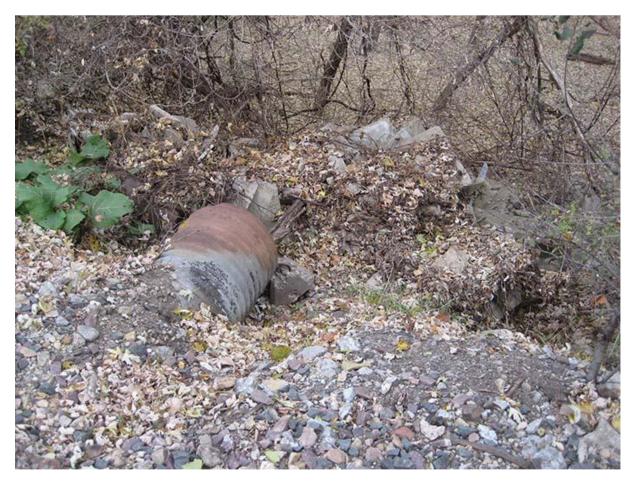
Waypoint 180A

Lower side of railroad tracks; culvert with lots of cement piled below culvert; minimal erosion.

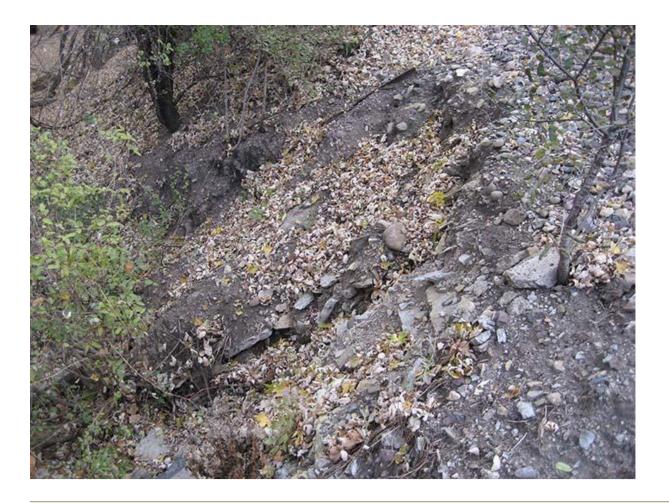
Lower side of railroad tracks; culvert with lots of cement piled below culvert; minimal erosion.

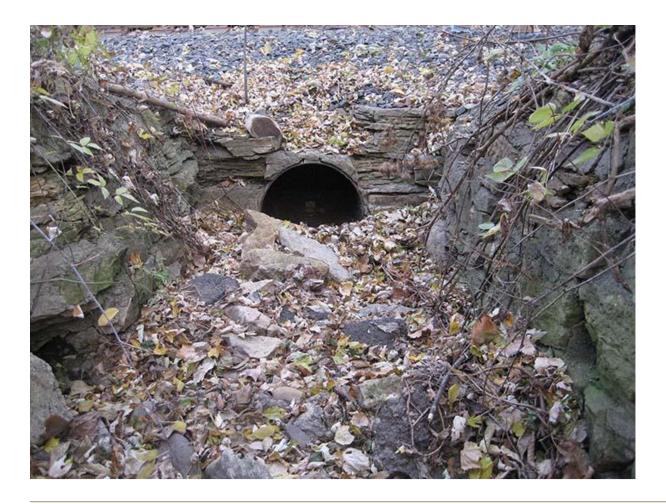
Upper side of culvert; lots of rock and debris.

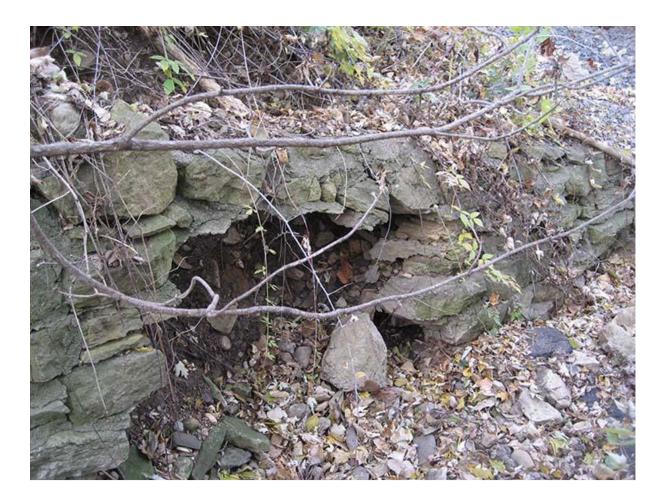
Side where water flows into culvert; rock and soil removed; moderate erosion.

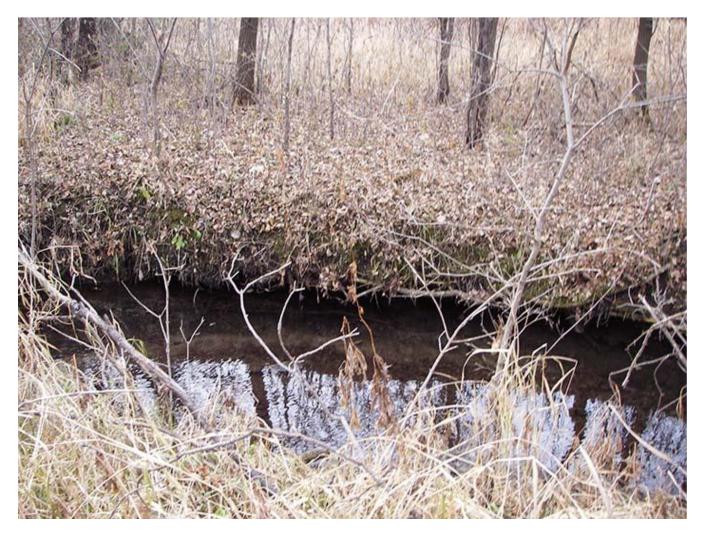
Location: Bluff Creek Park

Branch

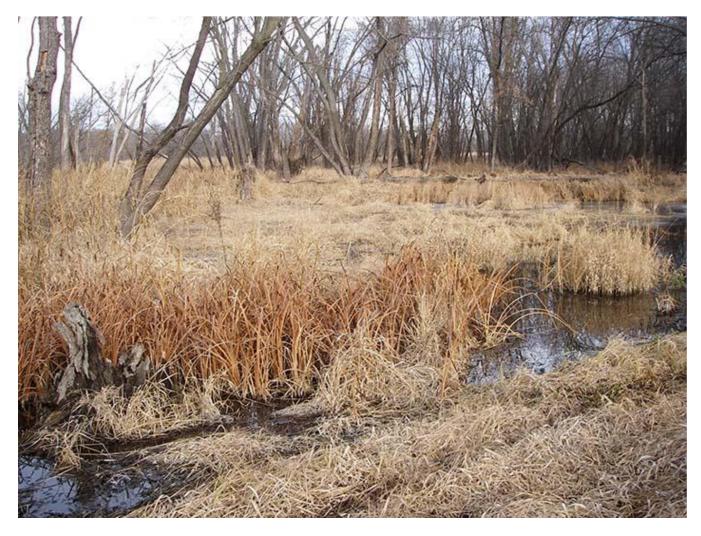
Location: Assumption Creek

Erosion (undercutting)

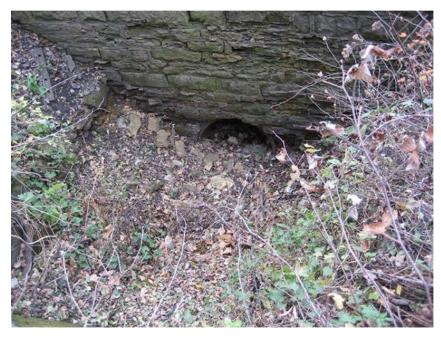
Waypoint 182A

Above railroad tracks, a chute leading water down through the culvert.

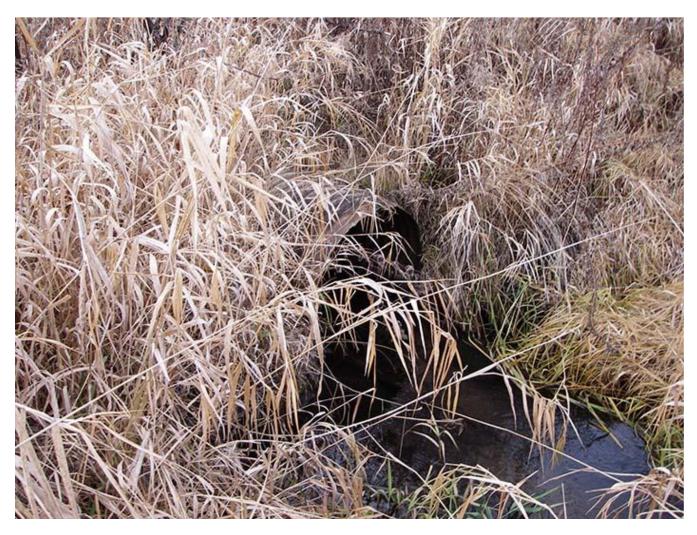
Location: Assumption Creek

End

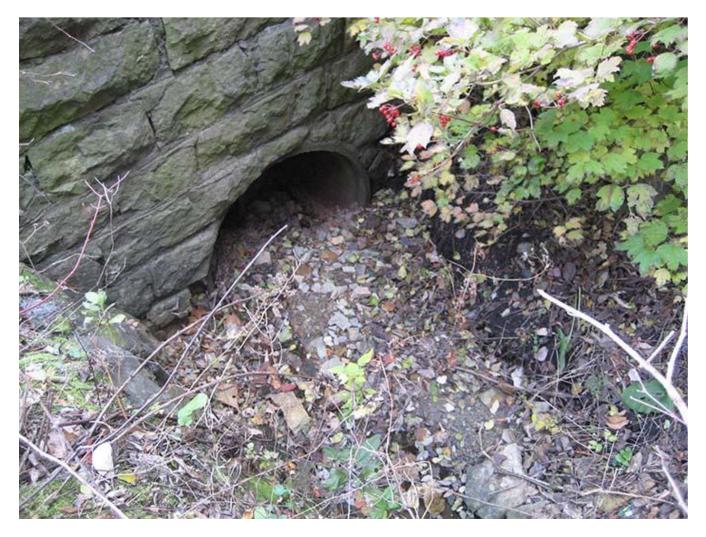
Waypoint 183A

Culvert on upper side of railroad.

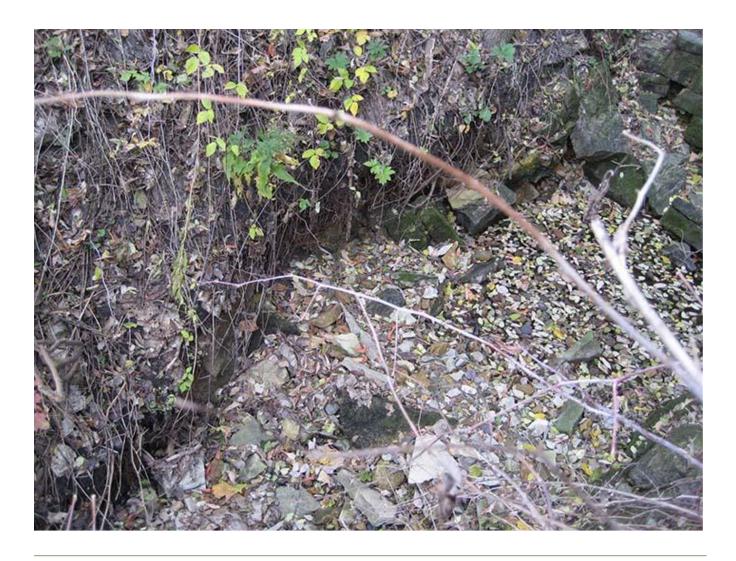
Moderate erosion.

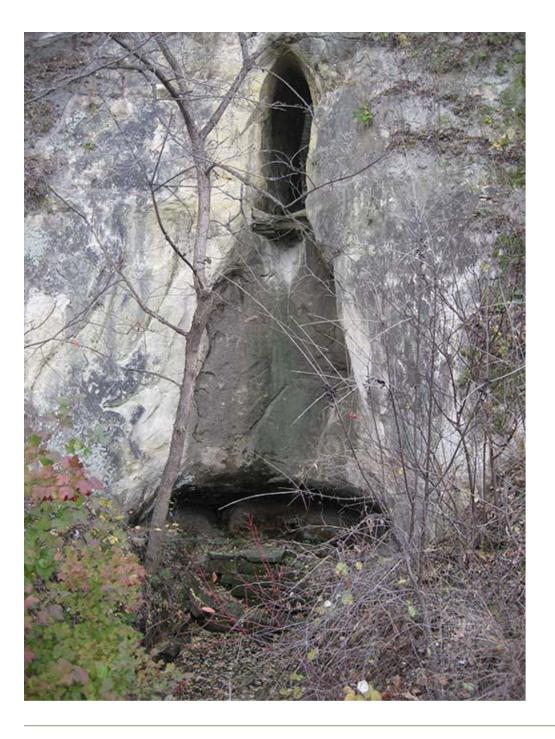
Part of bank beginning to cut under.

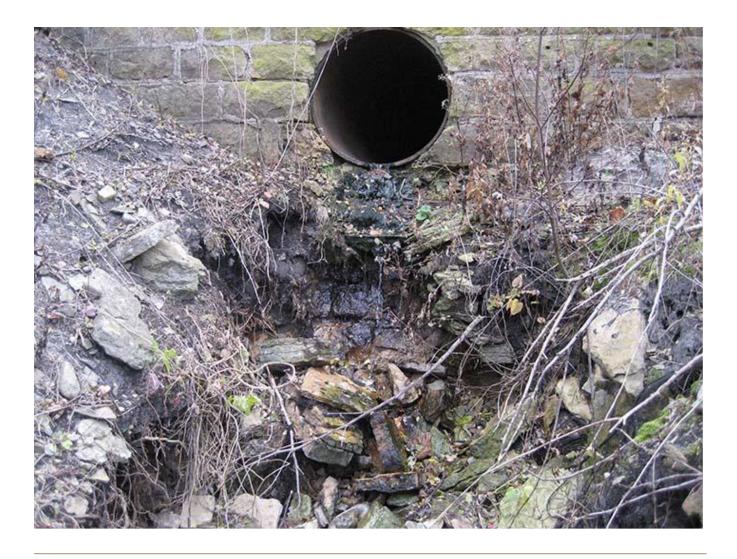
Major erosion on lower side of railroad tracks; undercutting bank.

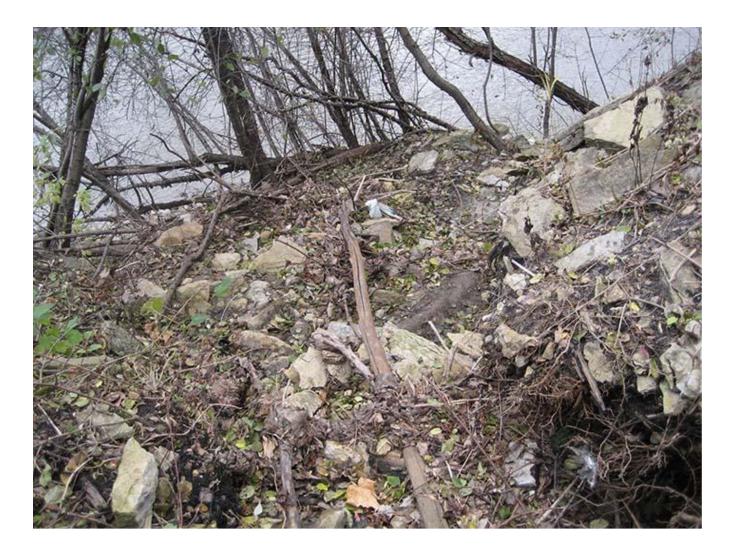
Lots of fallen rock; cutting out river bank.

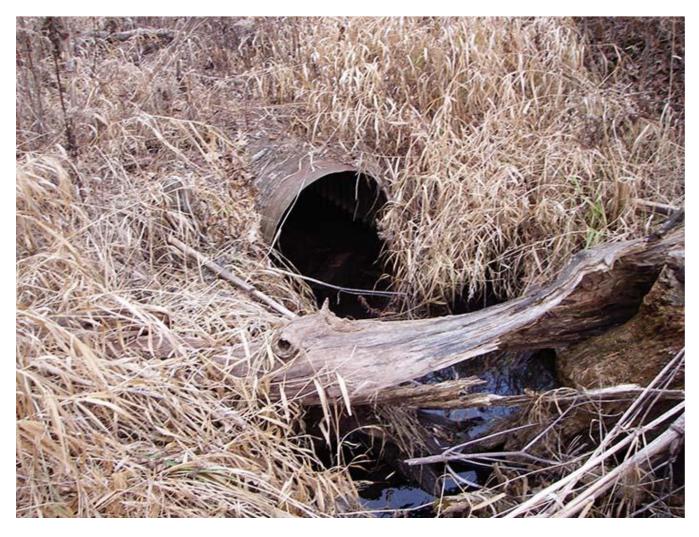
Location: Assumption Creek

Drain pipe

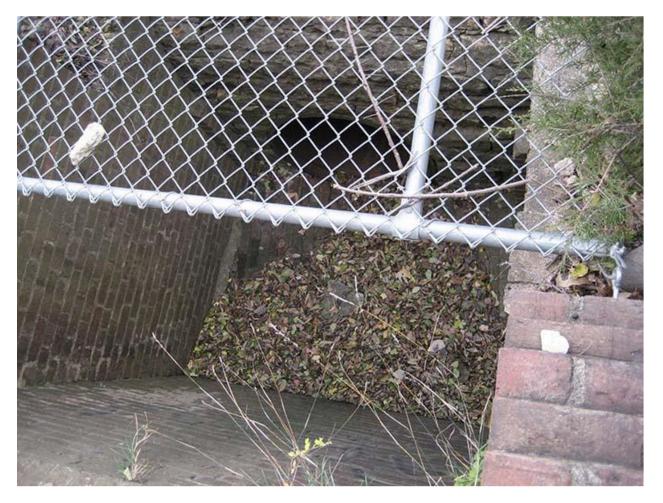
Waypoint 184A

Upper side of railroad tracks; culvert minimal erosion.

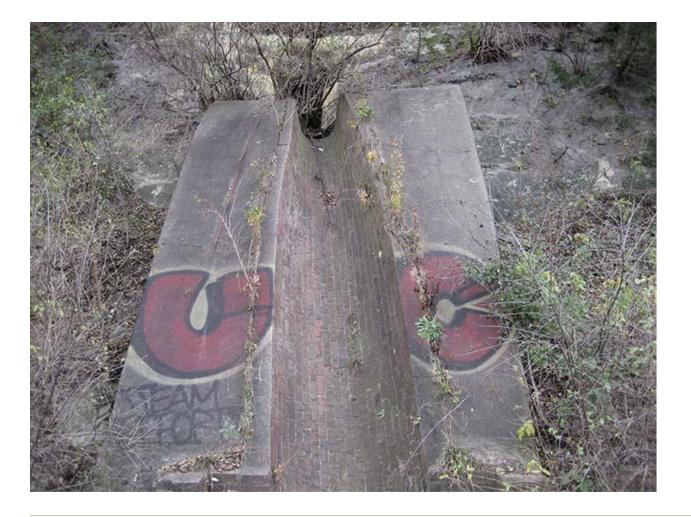
Upper side of railroad tracks; culvert minimal erosion.

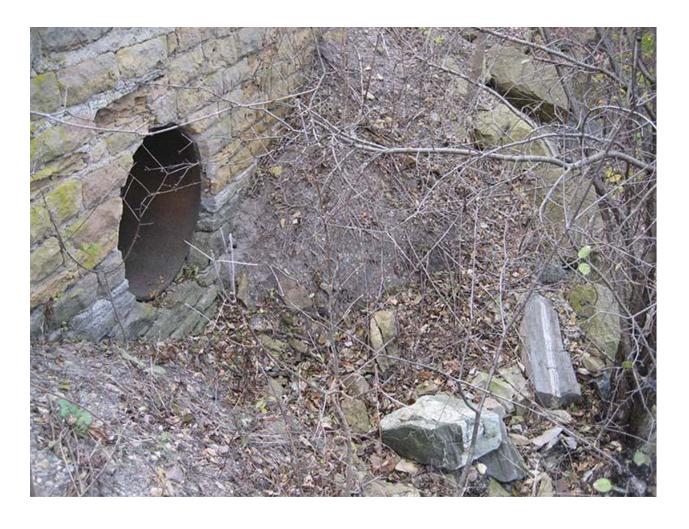
Lower side of culvert; lots of large rock and rip-rap protecting river bank; minimal erosion.

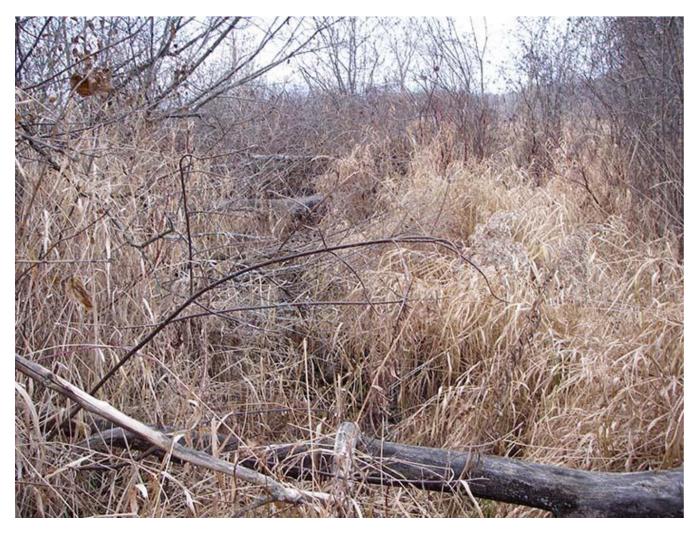
Location: Assumption Creek

Drain pipe

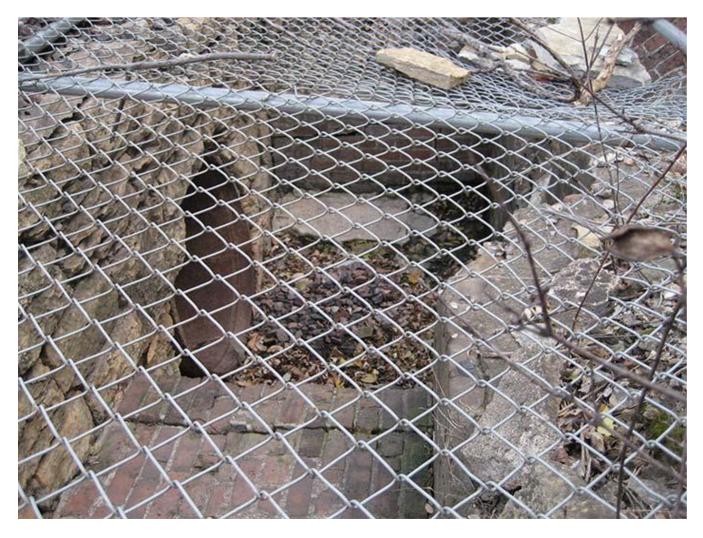
Waypoint 185A

Culvert on upper side of railroad tracks; minimal erosion.

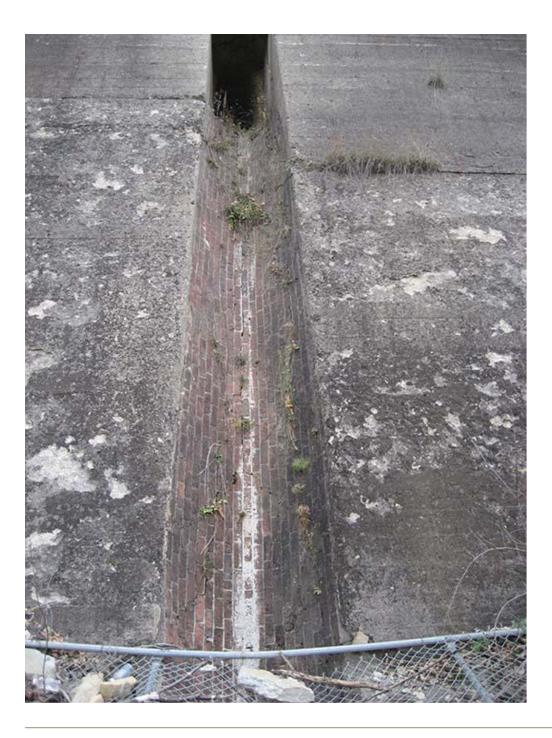
Culvert on upper side of railroad tracks; minimal erosion.

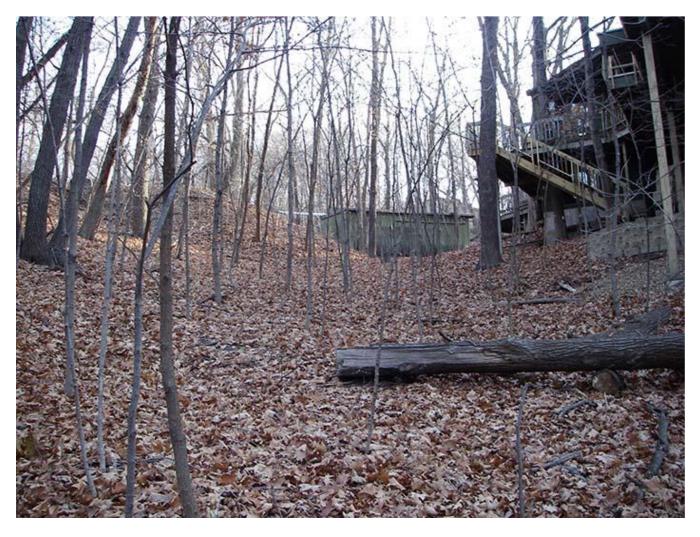
Location: Assumption Creek

Branch

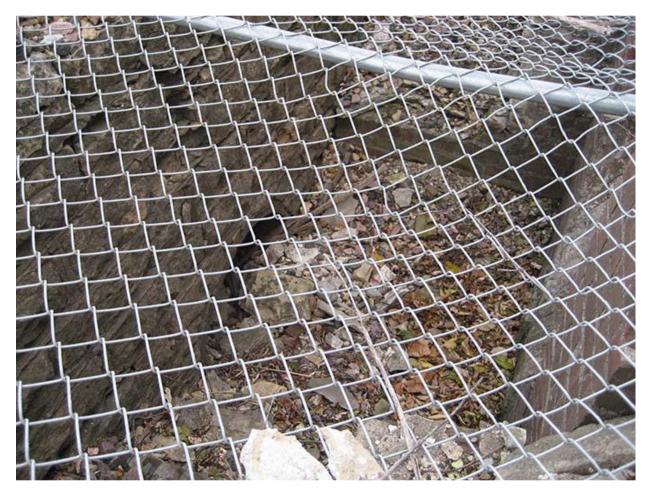
Waypoint 186A

Culvert on upper side of railroad tracks; minimal erosion.

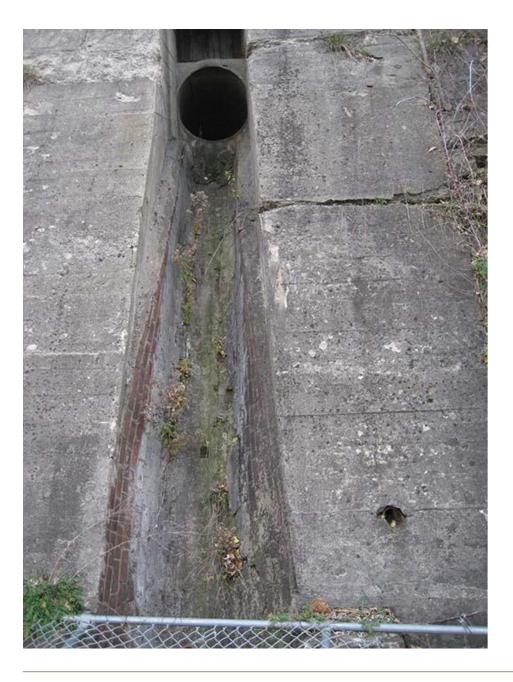
Culvert on upper side of railroad tracks; minimal erosion.

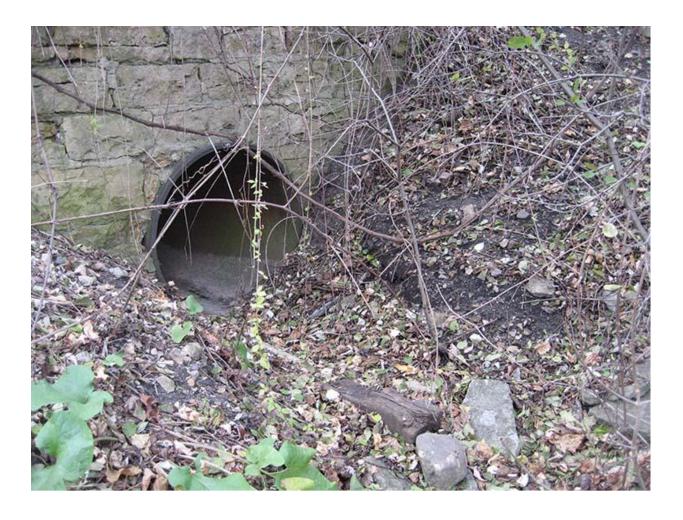
Culvert on lower side of railroad tracks; sides of culvert starting to erode; minimal erosion.

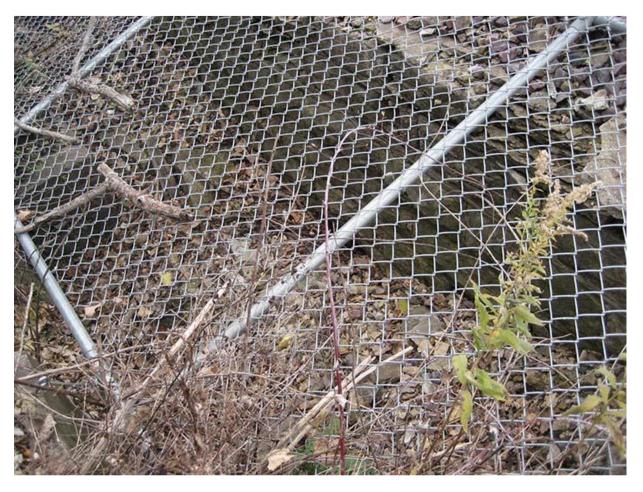
Waypoint 187A

Lots of rocks, sticks and leaves covering culvert; minimal erosion.

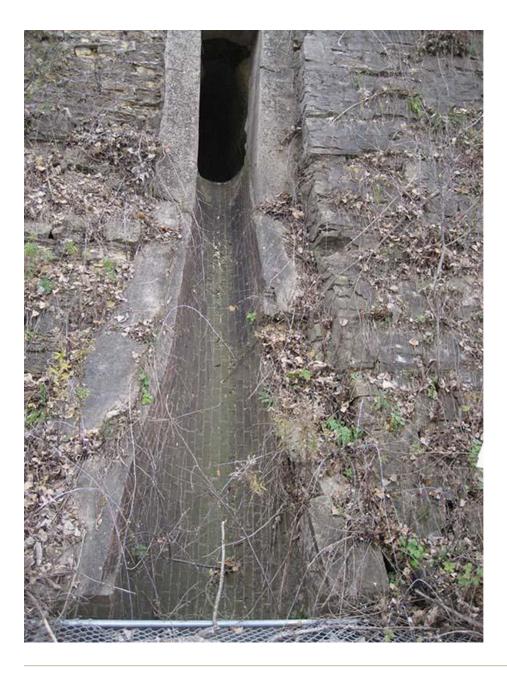
Culvert on upper side of railroad tracks.

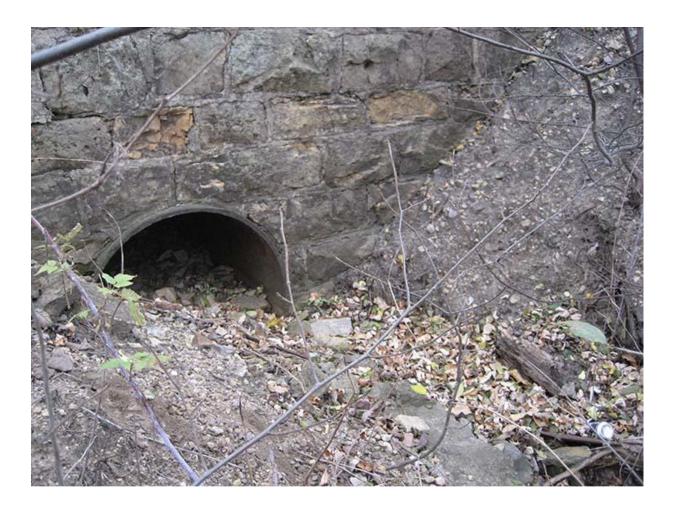
Lower side of railroad tracks; sides of culvert starting to erode; minimal to moderate erosion.

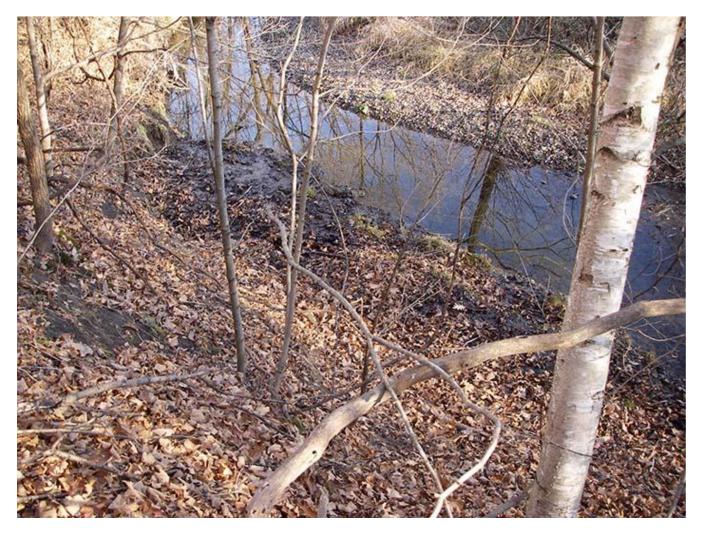
Location: Bluff Creek Park

Erosion on side of creek, laying soil in the creek

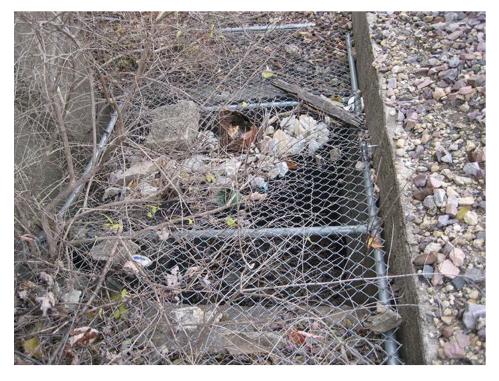
Upper side of railroad tracks; lots of garbage and rock on top of fencing that is laid over top of culvert; minimal erosion.

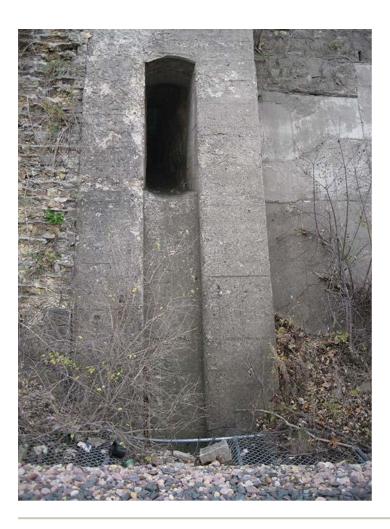
Upper side of railroad tracks; lots of garbage and rock on top of fencing that is laid over top of culvert; minimal erosion.

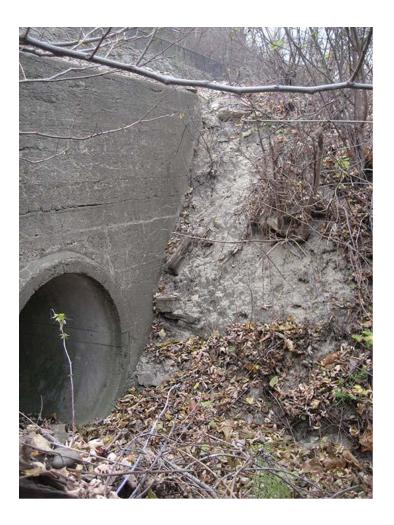
Lower side of railroad tracks; culvert had lots of rip-rap; sides starting to erode; moderate erosion.

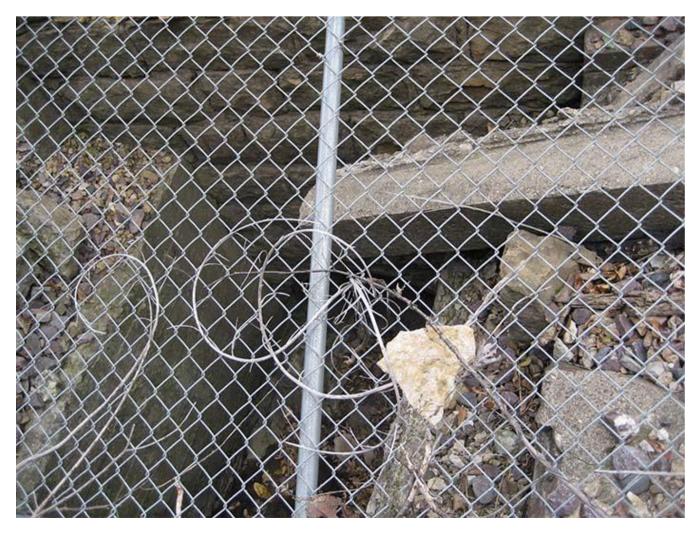
Waypoint 189A

Large cement culvert going under railroad tracks and into river.

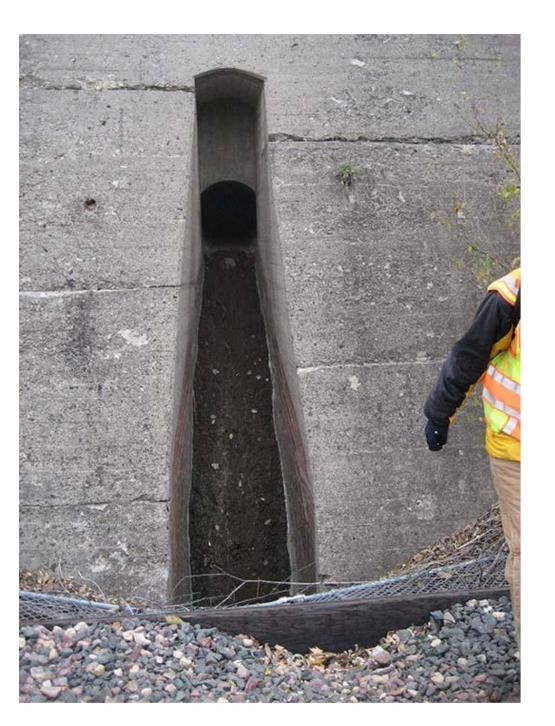
Large cement culvert going under railroad tracks and into river.

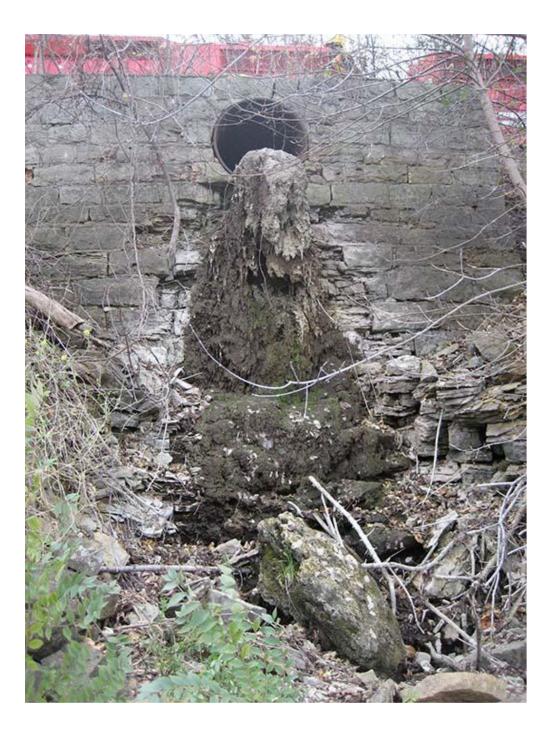
Lower side of culvert; minimal erosion; lots of rock surrounding the culvert.

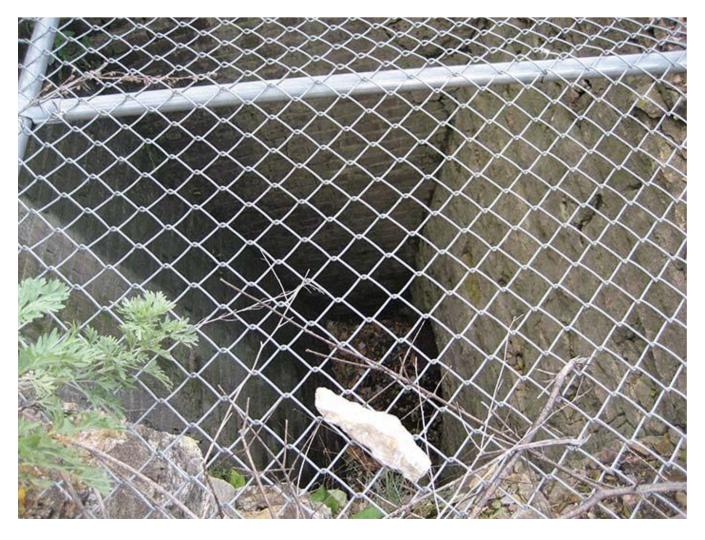
Waypoint 190A

Culvert at upper side of railroad tracks; minimal erosion.

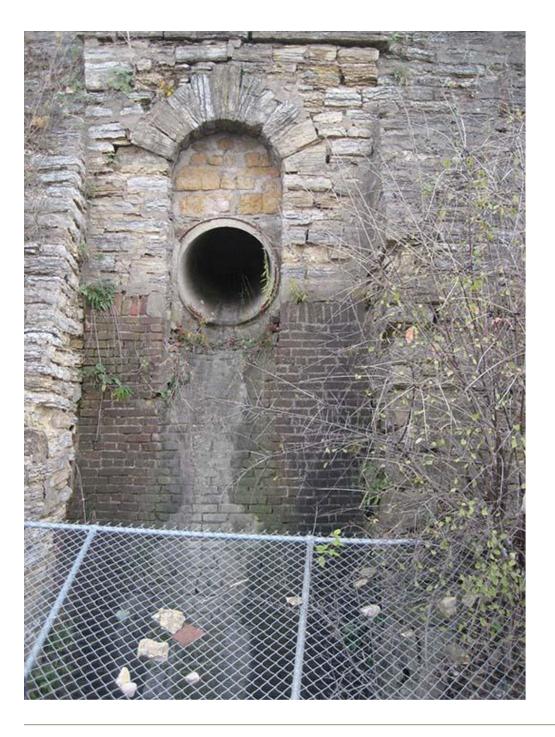
Culvert at upper side of railroad tracks; minimal erosion.

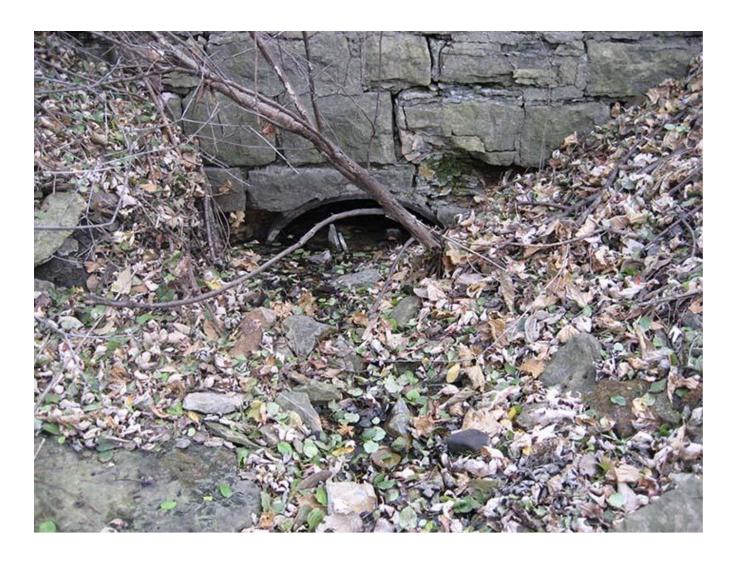
Lower side of culvert; full of rock and sand; water pooling at outlet; minimal erosion.

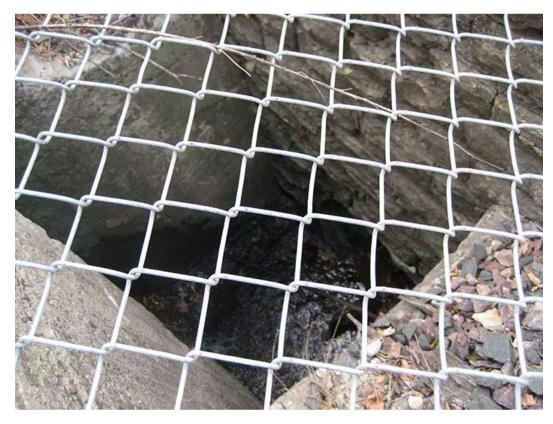
Waypoint 191A

Culvert on upper side of railroad tracks; water coming down through culvert; minimal erosion.
