Gully Inventory Map	Legend		\mathbf{T}
Area #1	LMRWD Boundary (not official)	FEMA Floodway	\mathbb{N}
Lower Minnesota River Watershed District	City/Township Boundary	100-Year FEMA Floodplain	T
Watershed Management Plan	Gully Inventory Locations	500-Year FEMA Floodplain	Not to Scale

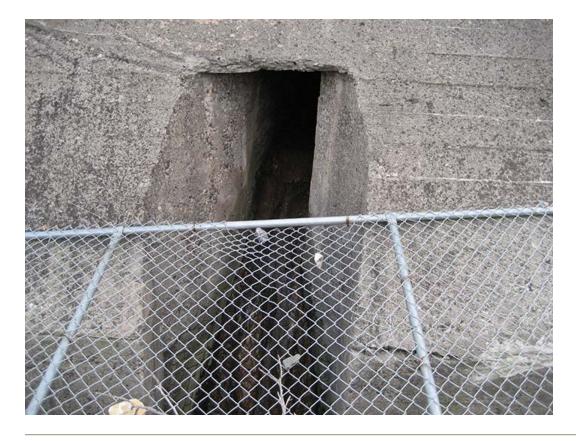
Culvert on upper side of railroad tracks; water coming down through culvert; minimal erosion.

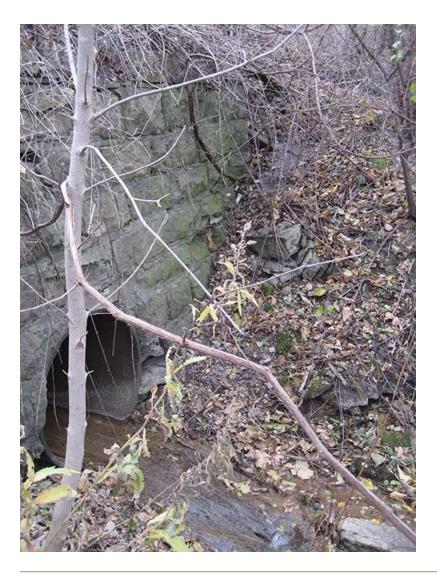
Culvert on lower side of railroad tracks.

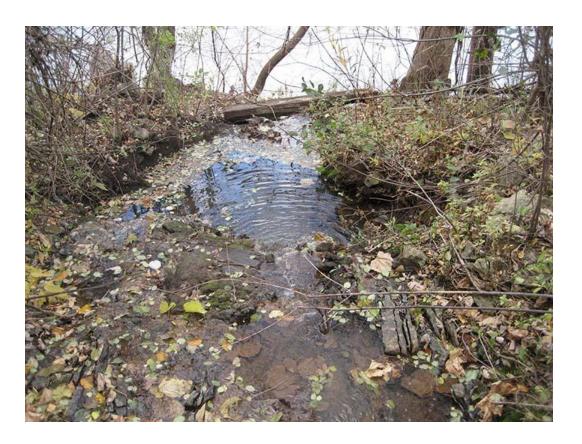
Water coming out of culvert and going through 2 large pools of water before going into river; moderate erosion.

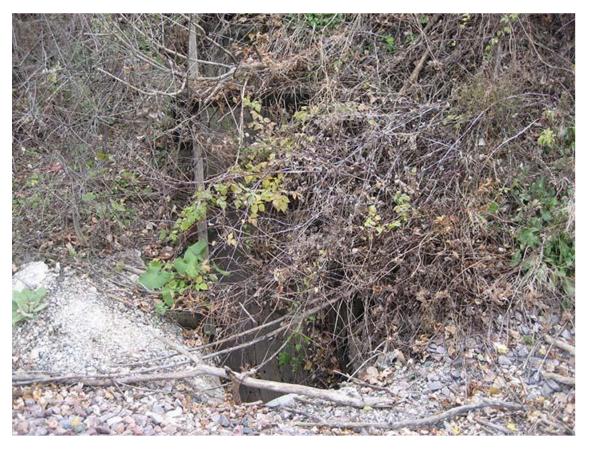
Waypoint 192A

Culvert going under railroad tracks

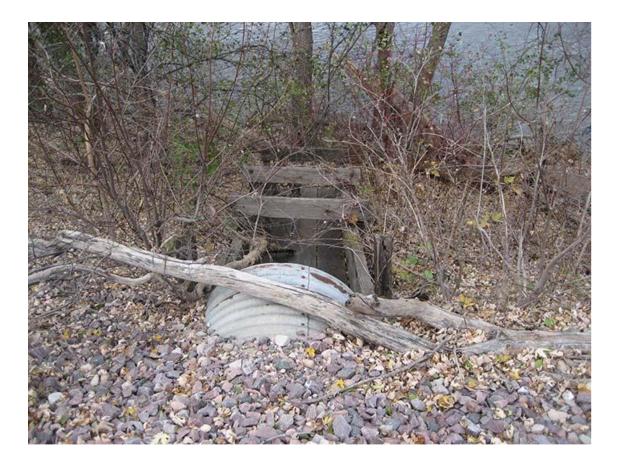
Upper side has wooden track to bring water down through the culvert to the other side and to the river.

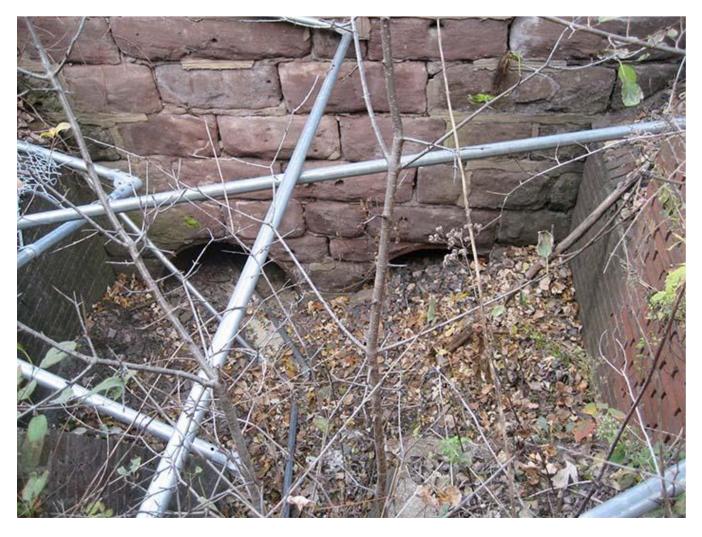
Waypoint 193A

Two culverts on upper side of railroad tracks going under tracks.

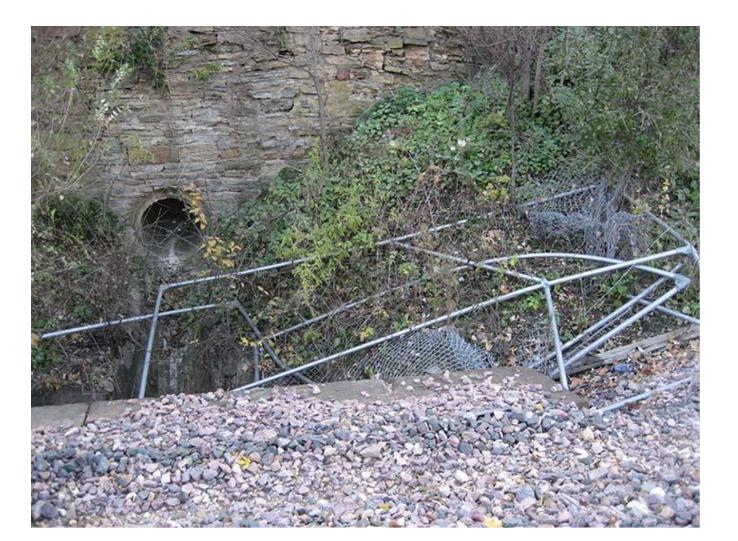
Fencing covering top of culverts is completely smashed and torn apart.

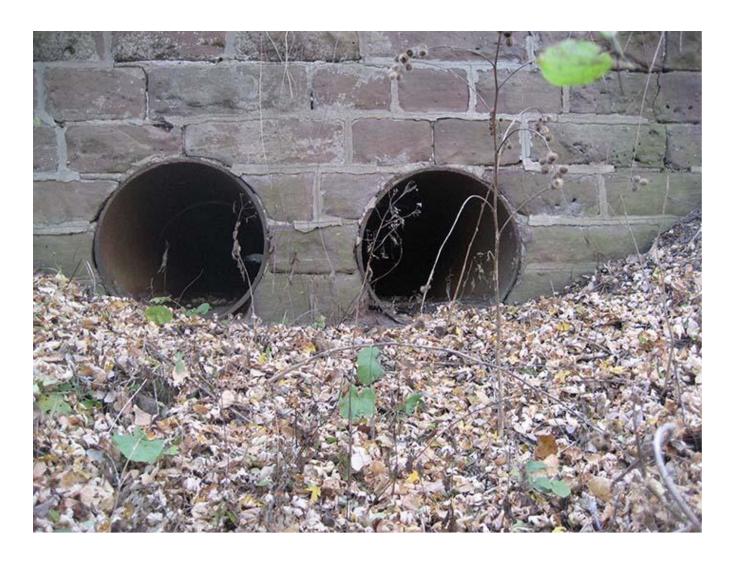
Lower side of culvert; minimal erosion.

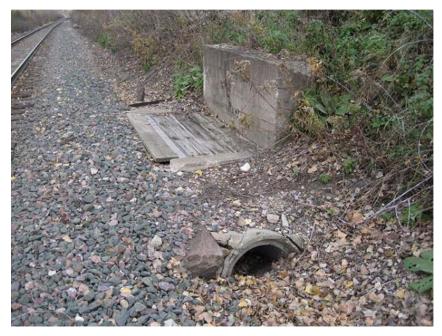
Waypoint 194A

Culvert of upper side of railroad tracks; minimal erosion.

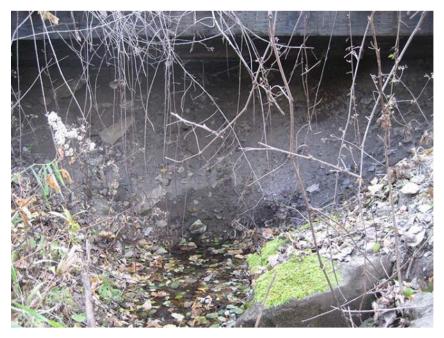
Large chunks of concrete on lower side of culvert; moderate erosion; no actual culvert but it looks like there used to be one and then it ma

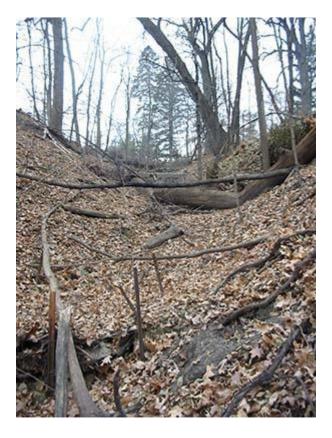
Location: 6601 Auto Club Road

Cement block erosion control, leaf and mulch dumping; overall looks good

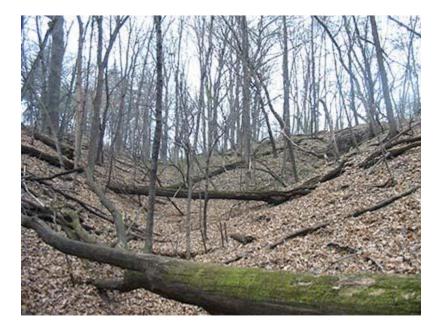
Location: 6601 Auto Club Road

Trash manhole dumping

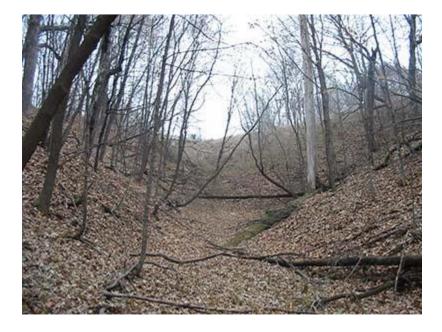
Location: 6601 Auto Club Road

Overall looks good.

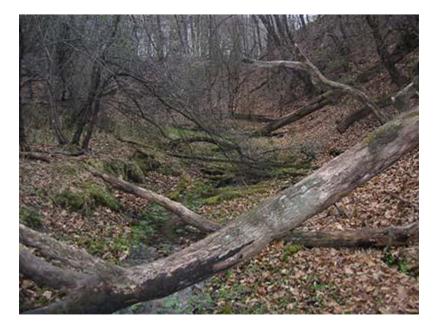
Location: 6601 Auto Club Road

Groundwater discharge; overall looks good

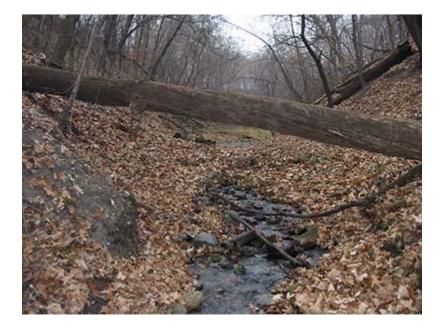
Location: 6601 Auto Club Road

Man made road barrier/bridge

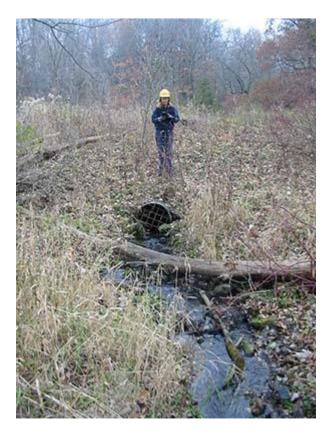
Location: 6601 Auto Club Road

Pond outlet 1; overall looks good

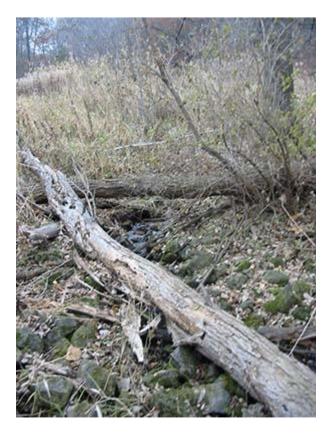
Location: 6607 Auto Club Road

Pond outlet 2; overall looks good

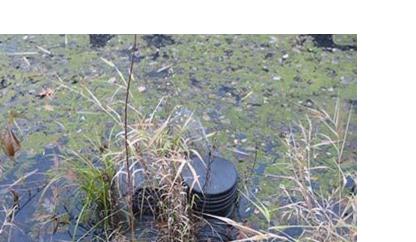
Pond drain 2

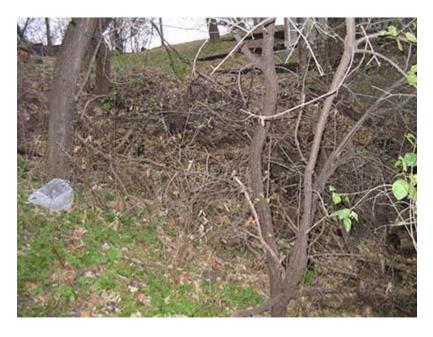
Location: 6301/6251/6501 Auto Club Road

Logs and brush at top of gully; not much erosion, lots of buckthorn/garlic mustard.

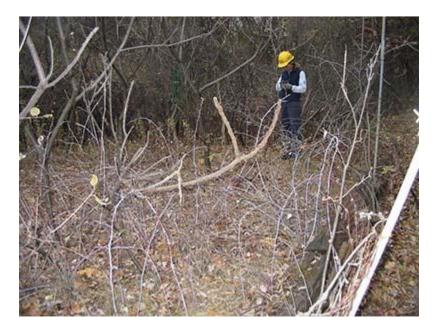
Location: 6301/6251/6501 Auto Club Road

Abandoned garden; not much erosion, lots of buckthorn/garlic mustard.

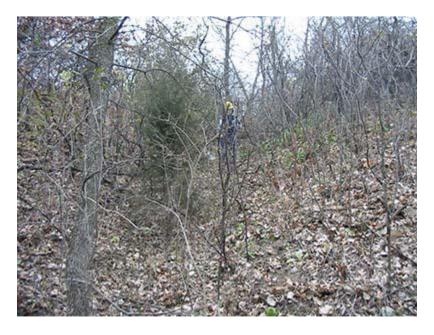
Location: 6301/6251/6501 Auto Club Road

Cut brush along top of gully; not much erosion, lots of buckthorn/garlic mustard

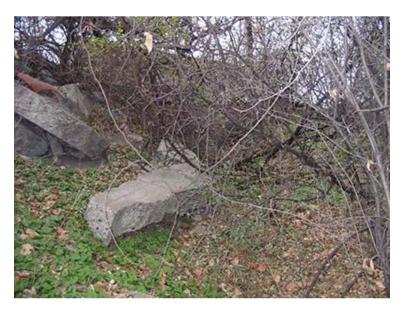
Location: 6301/6251/6501 Auto Club Road

Cement blocks erosion right up to yard; much erosion, lots of buckthorn/garlic mustard.

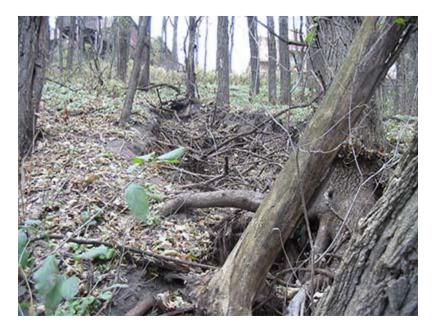
Location: 6121 Auto Club Road

Small gully-just getting started

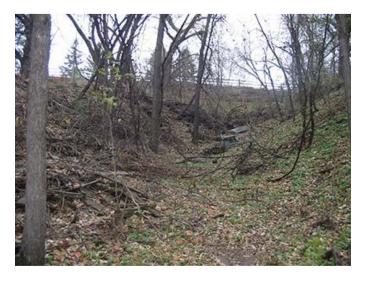
Location: 6001 Auto Club Road

Metal scraps, one tile line/drainage erosion not much of an issue, lots of garlic mustard/buckthorn

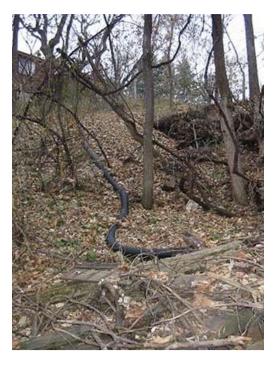
Metal scraps, one tile line/drainage erosion not much of an issue, lots of garlic mustard/buckthorn

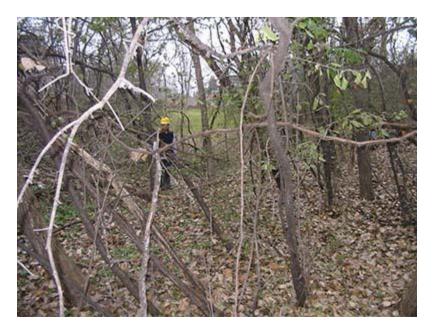
Location: 11710 Normandale - west side of road

Some groundwater seepage at bottom

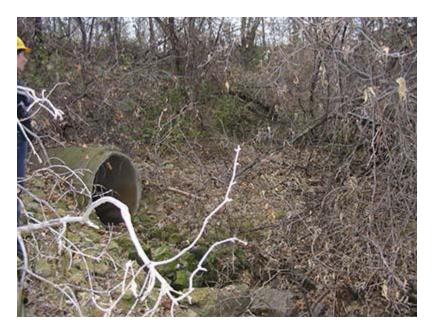
Location: 11710 Normandale - east side of road

Large cement pipe w/riprap

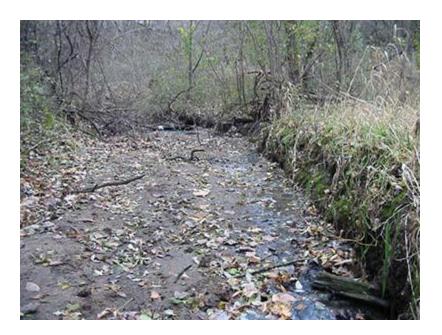
Erosion below riprap

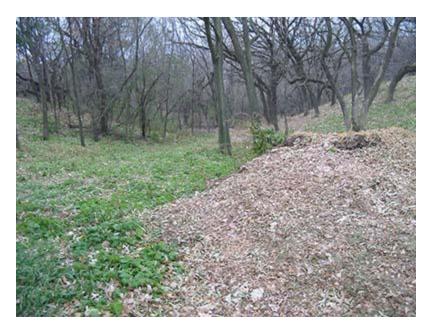
Location: 3325 Overlook

large pile of mulch at top, 4-wheeler tracks down gully

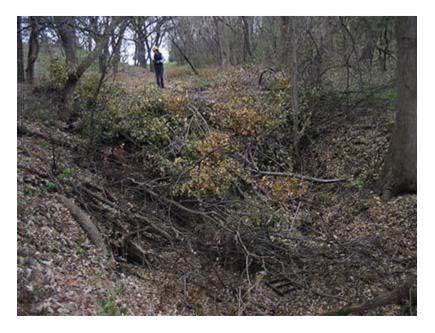
Location: 3325 Overlook

Large amount of brush & dirt when gully gets steeper, some bank erosion

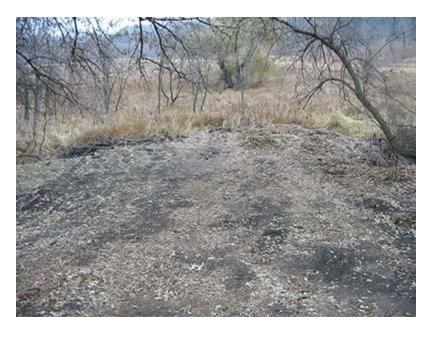
Pushed dirt and brush at bottom of gully

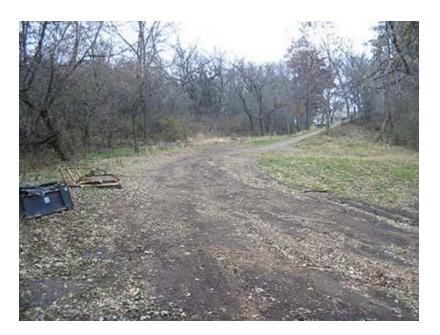
Pushed dirt and brush at bottom of gully

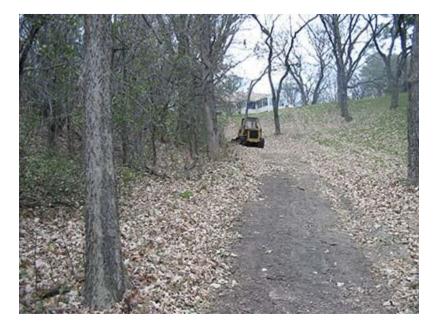
Location: 3301-3315 Overlook

Top of gully

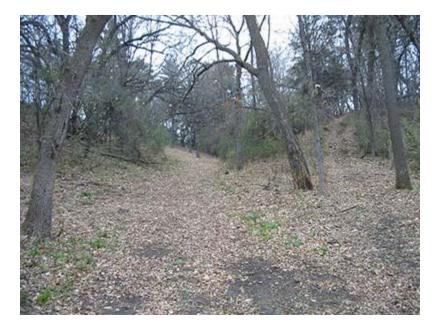
Location: 3301-3215 Overlook

Landscaped road

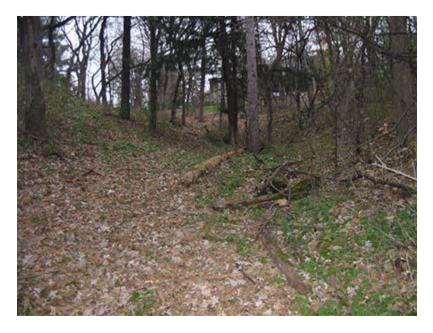
Location: 3301-3215 Overlook

Top of gully

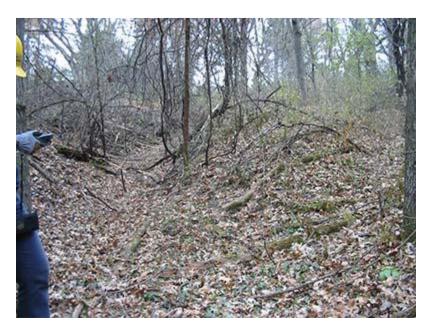
Location: 3131-3125 Overlook

Some cat brush at top, no real concerns

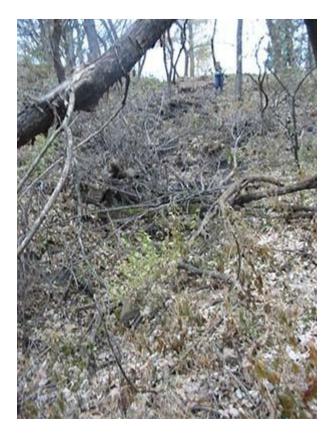
Location: 3115-3119 Overlook

Gully in hillside - drops into 4463

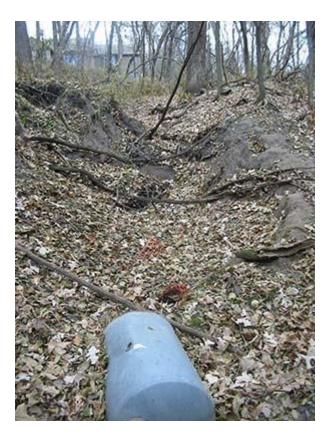
Gully in hillside - drops into 4463

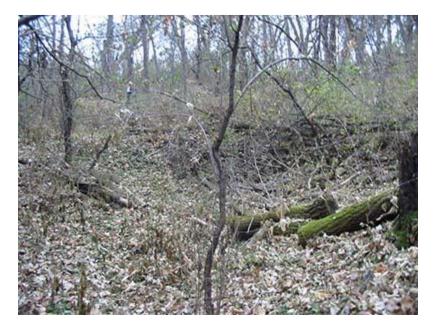
Location: 3115-3119 Overlook

Top of gully

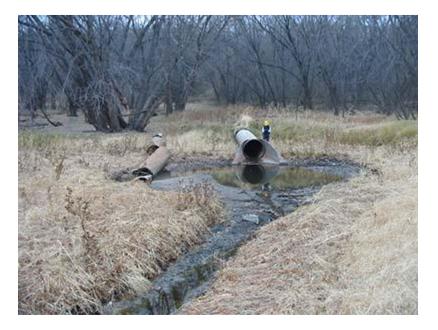
Location: 3115-3119 Overlook

Pipe outlet

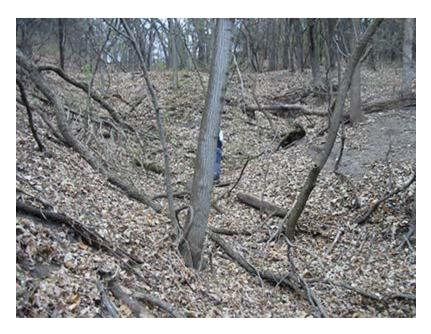
Location: 3001 Overlook

Eroding gully with some old woven wire fence

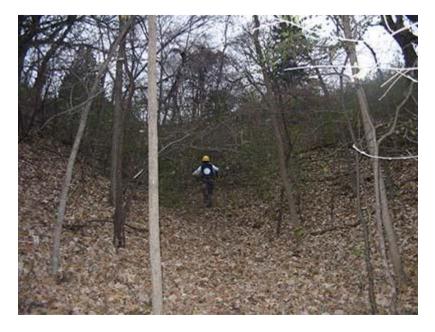
Location: 3001 Overlook

Top of gully

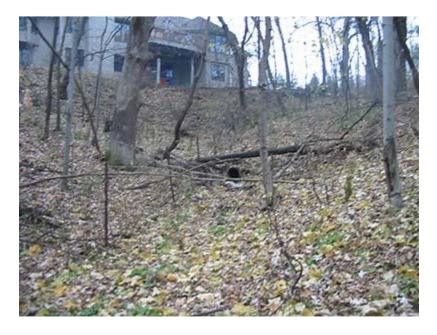
Location: 2815/2621 Overlook

random deeper cut gullies throughout the drain

Gully top drainage pipe; random deeper cut gullies throughout the drain

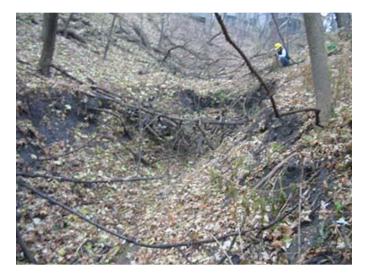
Location: 2815/2621 Overlook

random deeper cut gullies throughout the drain

Deep cut gully below 4469-about 60 yards in length; random deeper cut gullies throughout the drain.

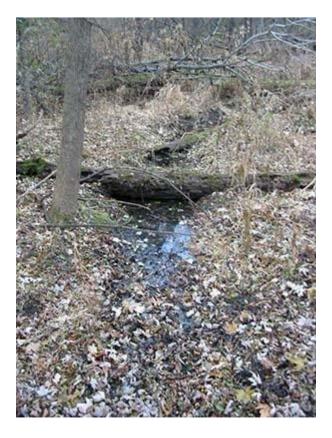
Location: 2815/2621 Overlook

random deeper cut gullies throughout the drain

Springs that disappear; random deeper cut gullies throughout the drain

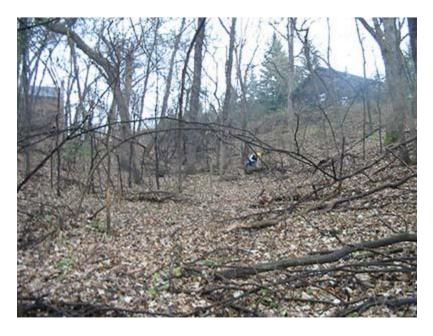
Location: 2815/2621 Overlook

random deeper cut gullies throughout the drain

Top of gully; random deeper cut gullies throughout the drainage.

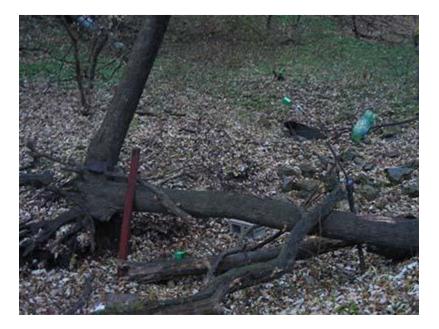
Location: Queen Avenue

Storm water pipe outlet

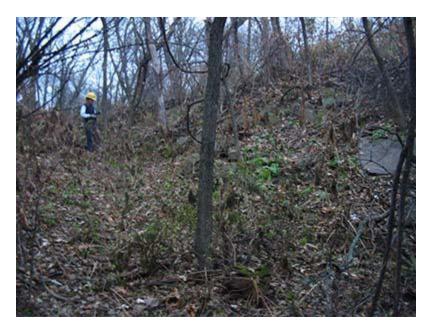
Location: Queen Avenue

Top of gully, lots of cement chunks, no real erosion problems

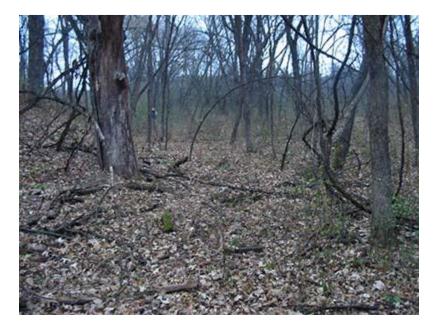
Location: Queen Avenue

Top of gully, no erosion problems

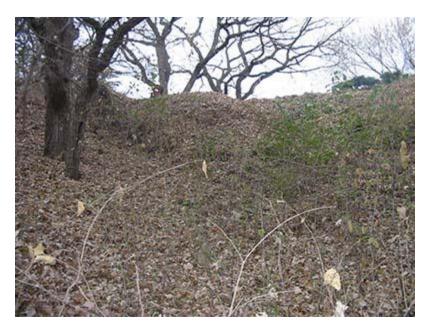
Location: 2273 Overlook (could be 2213)

Leaves and mulch piled at top, looks fine otherwise

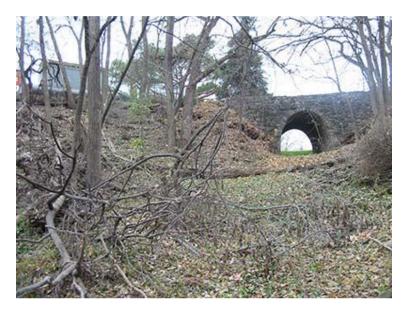
Location: 2949 Overlook-City Property

Top of gully, some bare dirt behind house, dumped mulch, some erosion halfway down gully

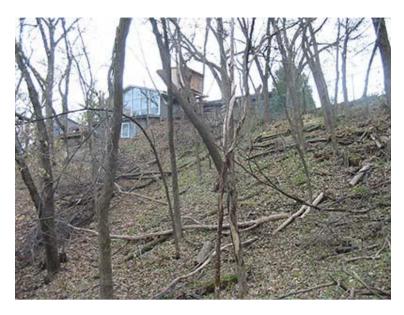
Top of gully, some bare dirt behind house, dumped mulch, some erosion halfway down gully

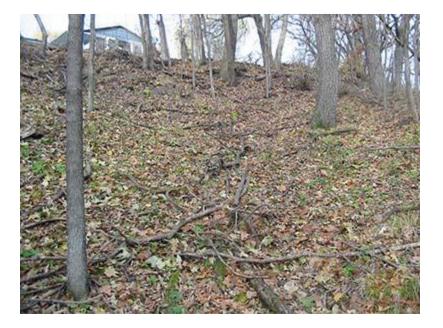
Location: 2951 Overlook-City Property

Looks fine

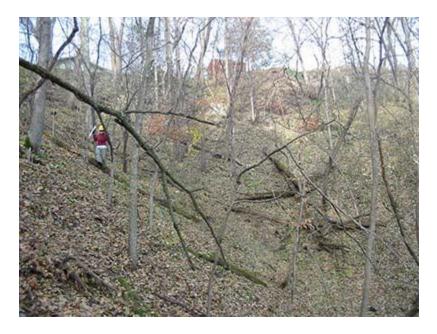
Location: 2952 Overlook-City Property

Some mulch and brush dumping, no erosion problems, but steep

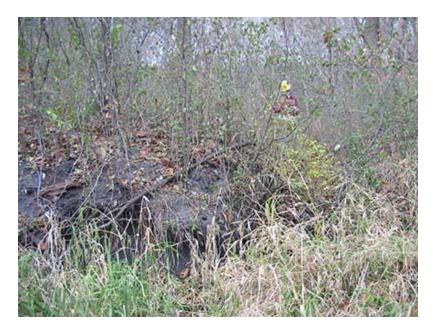
Location: 2954 Overlook-City Property

Spring empties into creek, unvegetated, undercut banks

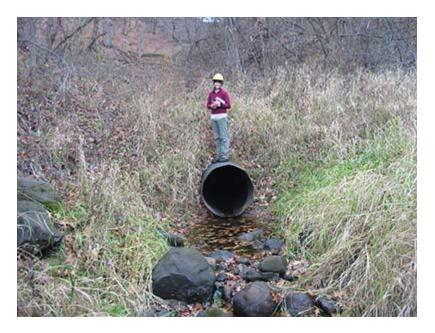
Location: 2955 Overlook-City Property

Storm water pipe

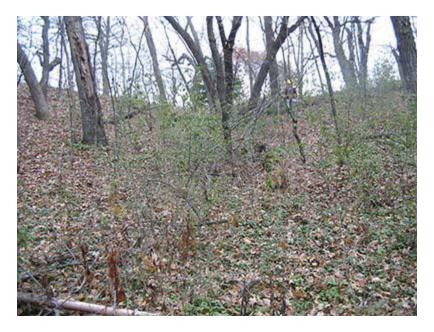
Location: 11020/11018 Glen Wilding

Looks good

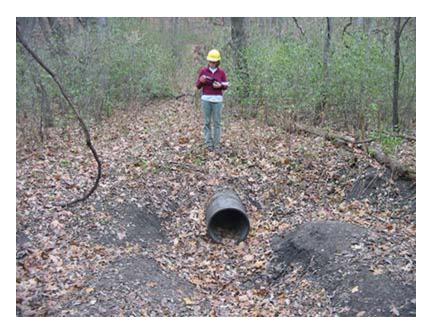
Location: 11020/11018 Glen Wilding

Pipe with depress/erosion hole

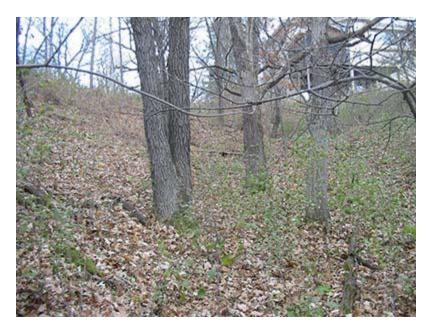
Location: 11020/11018 Glen Wilding

Looks good

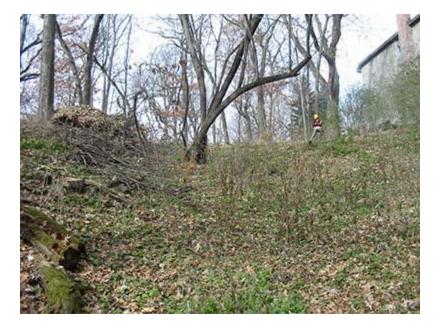
Location: 11036 Glen Wilding

Looks good

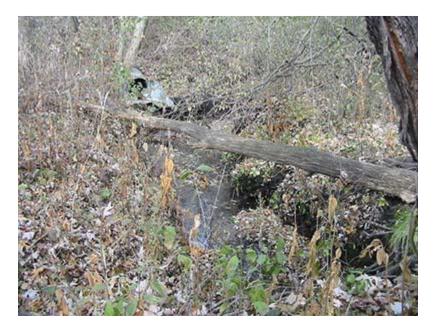
Location: 1209 River Terrace

Stormwater pipe, some water flow, undercut bank

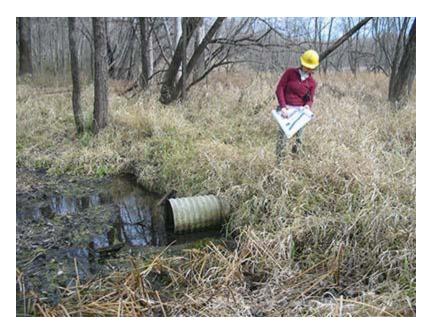
Culvert under land bridge, drains where the pond appears to be located

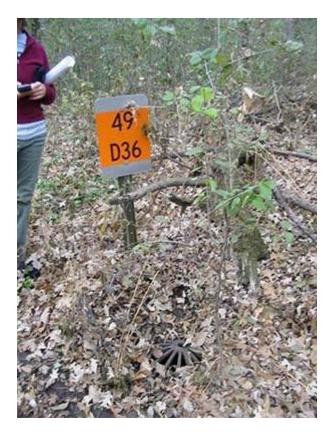
Location: 1209 River Terrace

Storm water grate

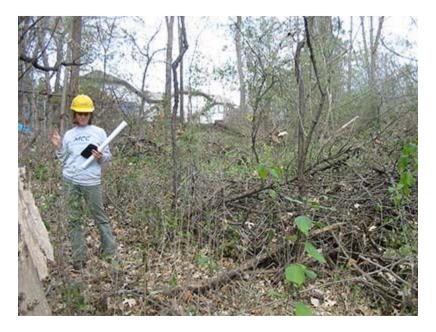
Location: 1025/1101 River Terrace

Top of gully - looks good

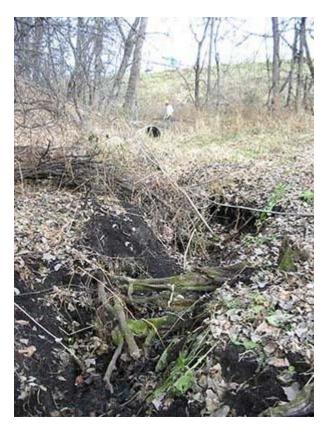
Location: City property next to 35W - west side

Culvert w/ cut gully below

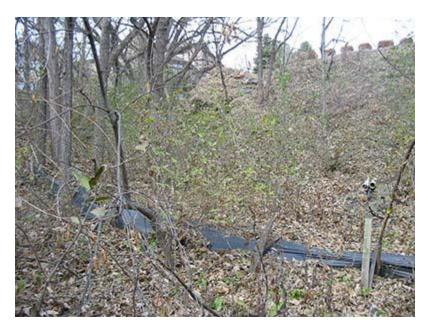
Location: City property next to 35W - west side

Top of gully, 2 small storm water pipes, leaves pushed into gully

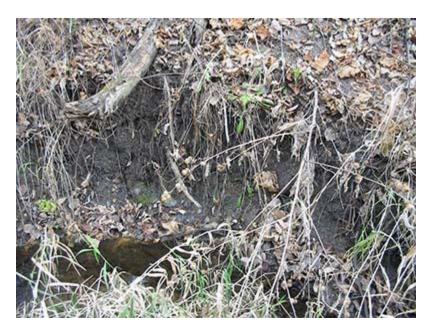
Location: City property between 35W & Lyndale A

Bank erosion on active stream

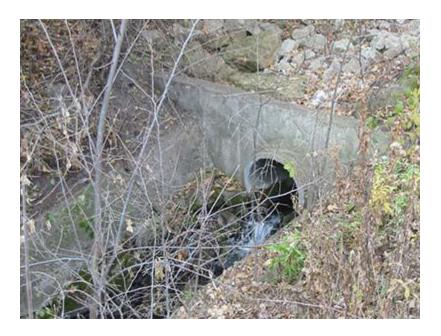
Same culvert close up

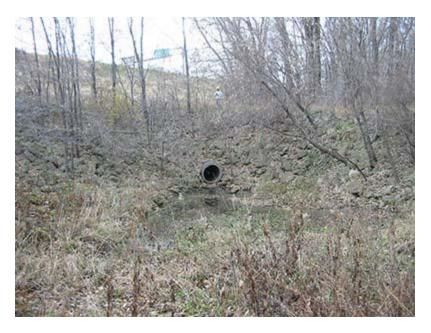
Location: City property between 35W & Lyndale A

Stormier culvert from under 35W

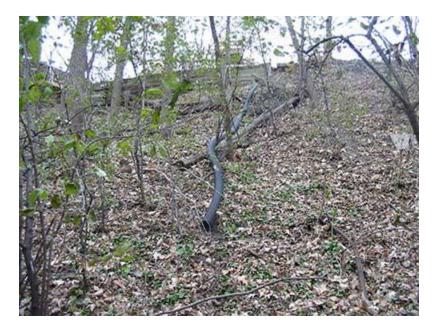
Location: 151 107th Street

House drainage pipe/tube

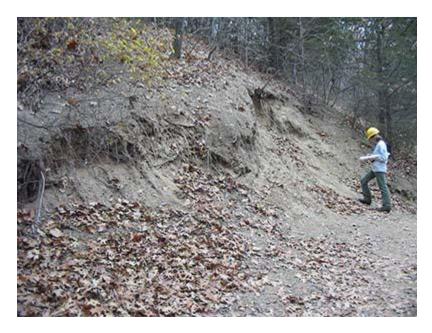
Location: 201 107th Street

Erosion on bike path in between 161 & 201

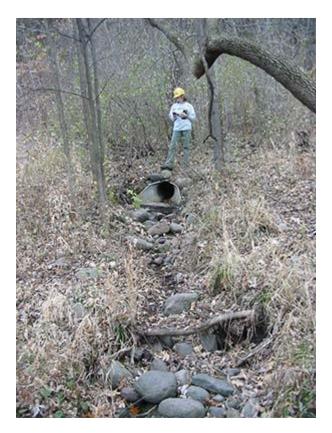
Location: 201 107th Street

Storm water outlet

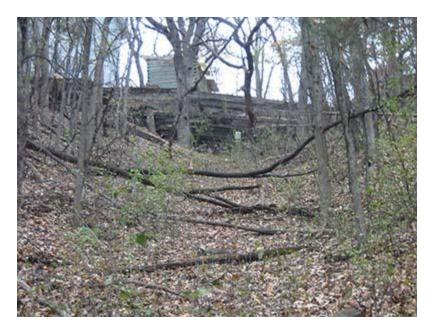
Location: 201 107th Street

Top of gully w/retaining wall & small drainage pipe

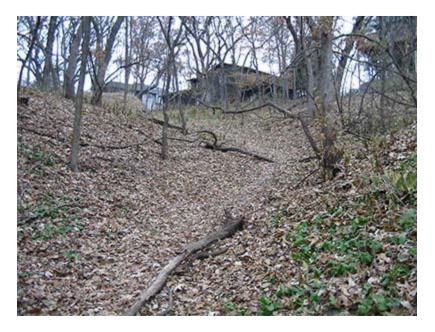
Location: 211 105th Street Circle

Top of gully

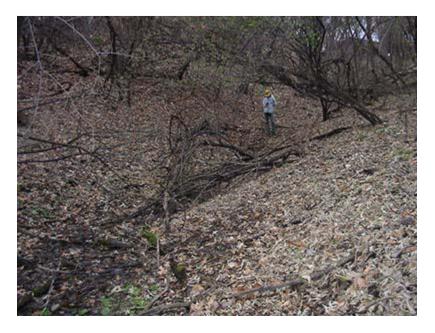
Location: 211 105th Street Circle

Spring - looks healthy-watercress

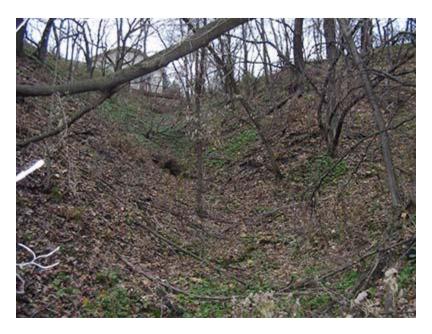
Location: 211 105th Street Circle

Top of gully - lots of garlic mustard

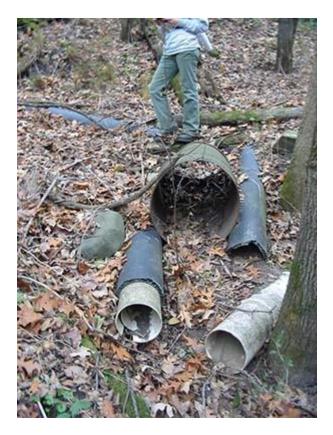
Location: 211 105th Street Circle

Pipes - active drainage?

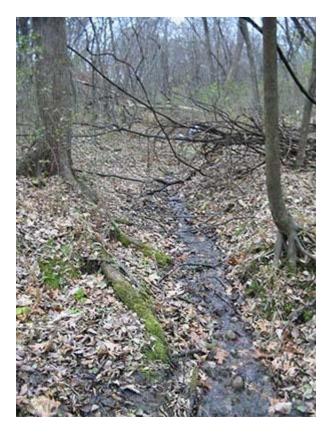
Location: 211 105th Street Circle

Spring - looks healthy-watercress

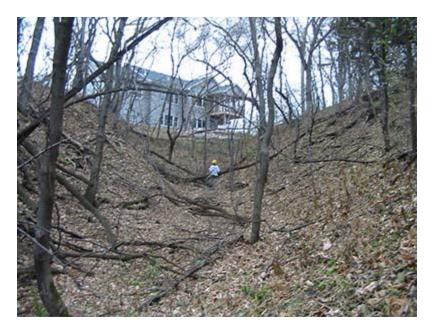
Location: 211 105th Street Circle

Top of gully

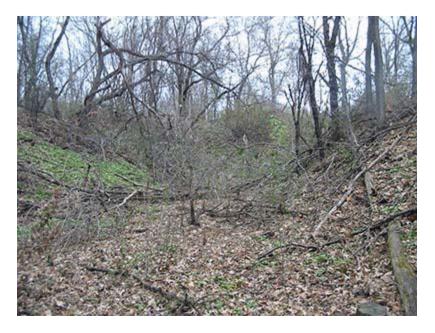
Location: 211 105th Street Circle

Top of gully

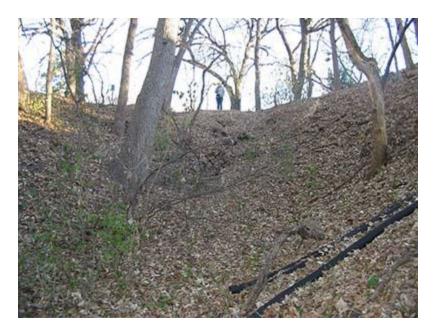
Location: 421,413 East 104th Street - lots of g

Leaves/mulch at top-drainage pipe but not connected

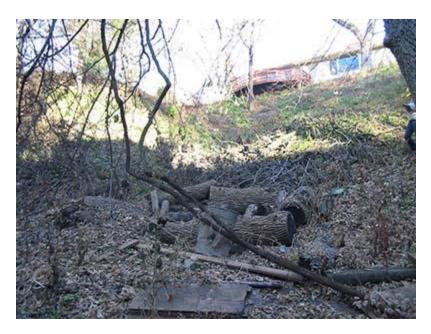
Location: 421,413 East 104th Street - lots of g

Finger of gully-lots of brush and ??? Chunks

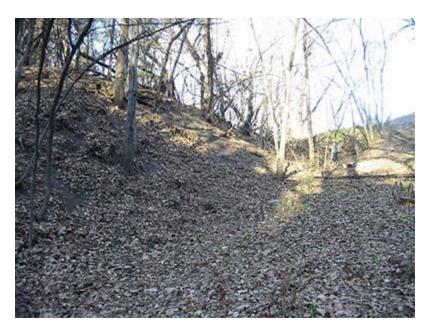
Location: 421,413 East 104th Street - lots of g

Finger of gully-lots of brush and ??? Chunks

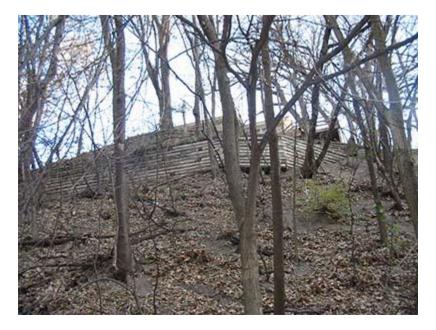
Location: 421,413 East 104th Street - lots of g

Retaining wall above spring/4526 is spring

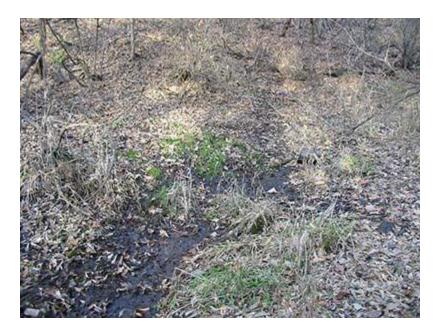
Spring

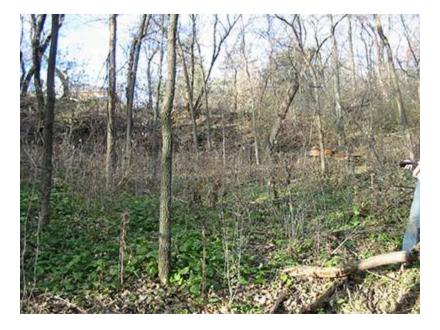
Location: 421,413 East 104th Street - lots of g

Finger - brush at top

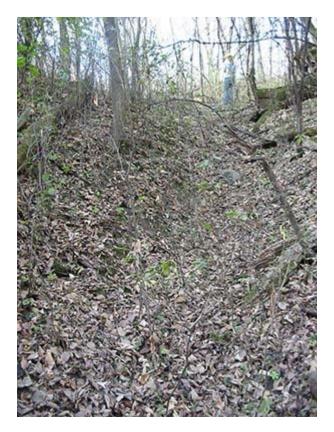
Location: 421,413 East 104th Street - lots of g

Finger - moderate erosion in gully

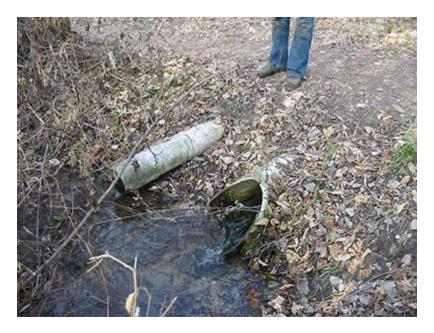
Location: 421,413 East 104th Street - lots of g

Culvert under walking path

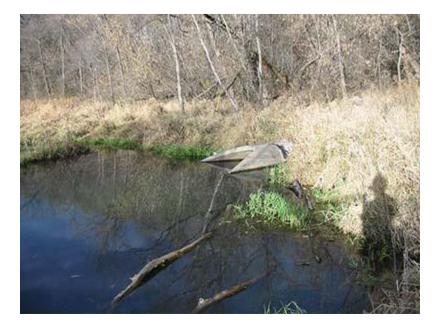
Location: 421,413 East 104th Street - lots of g

Storm water outlet

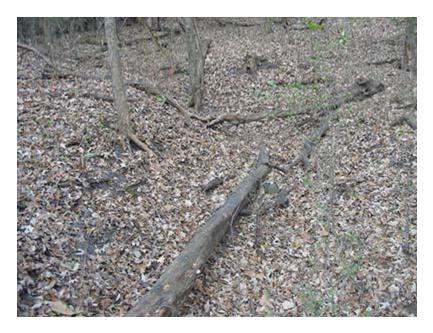
Location: City Property

"V" cut erosion gully - not too bad

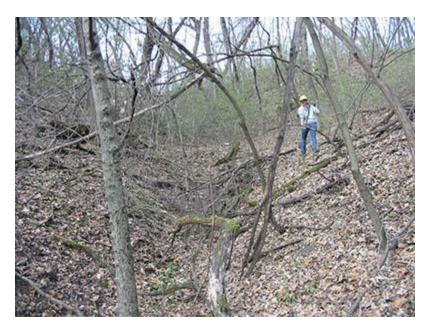
Location: City Property

Top of gully, some bare banks - looks just o.k.

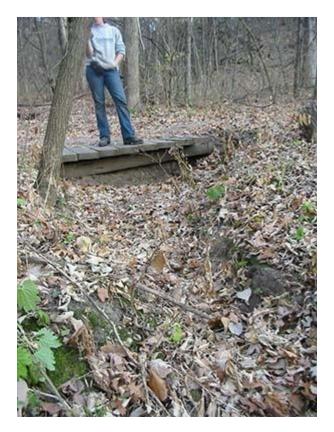
Location: Columbus Road

Walking path bridge erosional storm water stream underneath

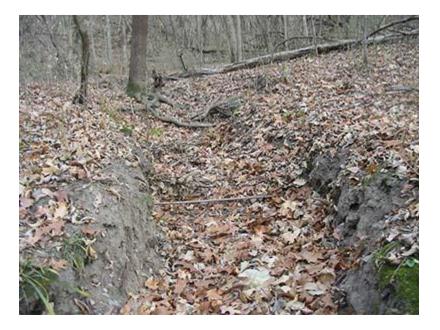
Location: Columbus Road

Down cut stream bed

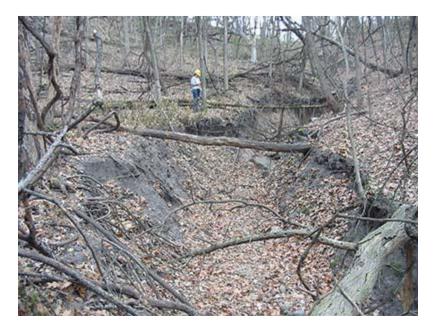
Location: Columbus Road

Deeply cut stream bed-bad bank erosion

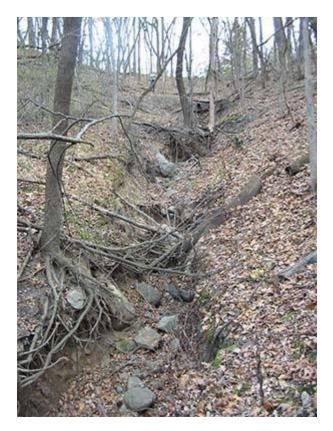
Location: Columbus Road

Top of gully, stormwater drain, deeply cut, bad erosion from points 1089-1092

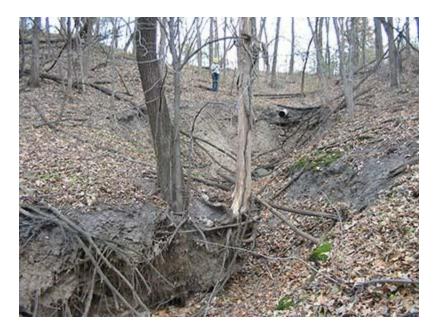
Top of gully, stormwater drain, deeply cut, bad erosion from points 1089-1092

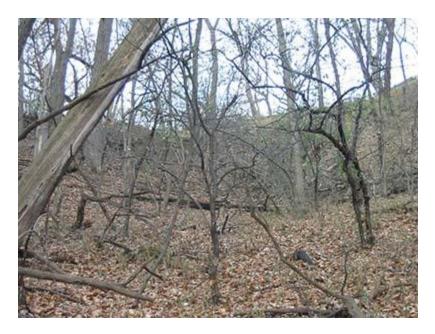
Location: City Property off Columbus Road

Top of gully

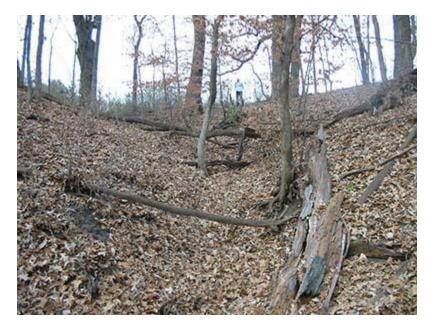
Location: City Property off Columbus Road

Trail/bike erosion on bank

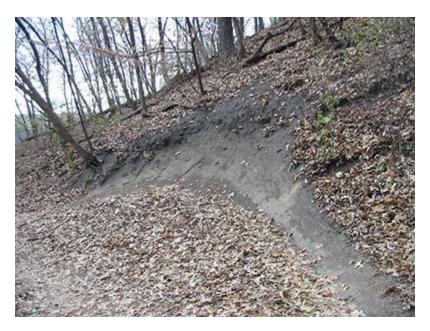
Location: City Property off Columbus Road

Trail crossing dry stream bed-bank erosion

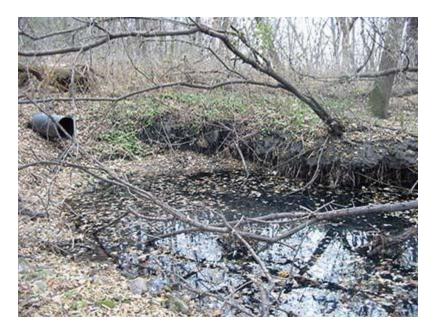
Location: City Property off Columbus Road

Pipe outfall, minimal erosion

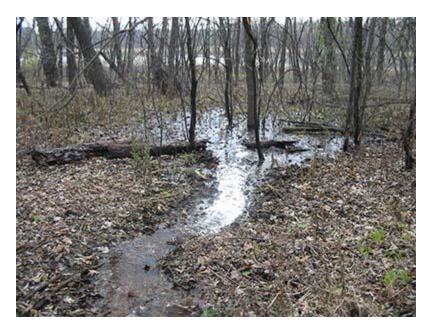
Water looks iron rich, orange "goo" buildup

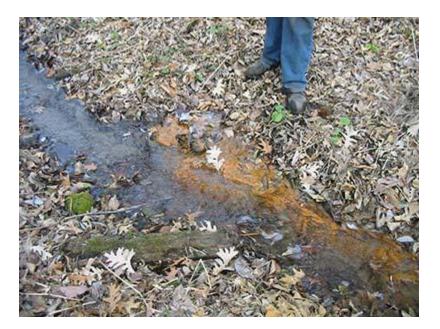
Location: City Property off Columbus Road

Stream confluence, bank erosion on east shore

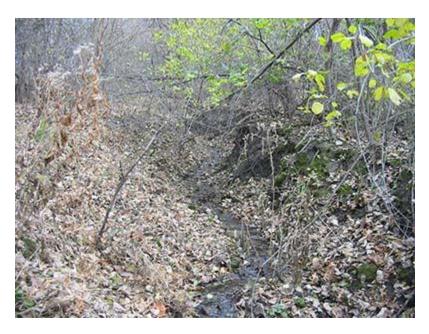
Location: 100249 Chicago

Top of gully/spring

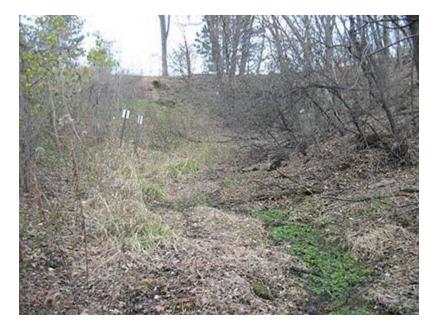
Location: 100249 Chicago

Spring

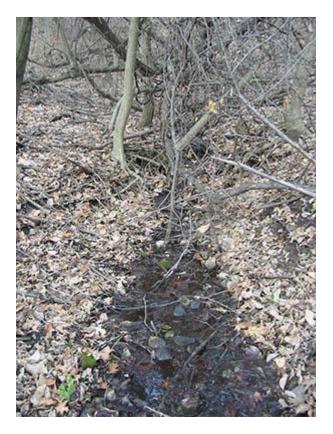
Location: 100249 Chicago

Spring that appears to recharge

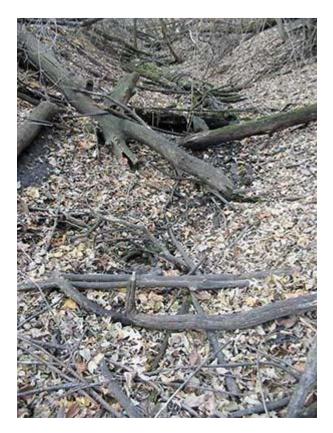
Location: 10331 Columbus Road

Top of gully, pretty steep banks, but looks o.k.

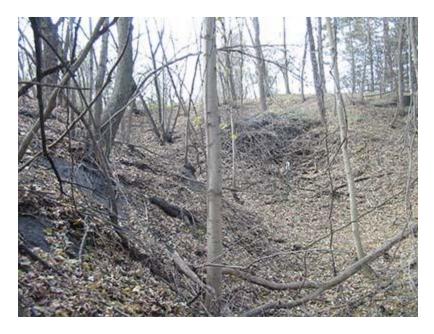
Location: 2901 E. Old Shakopee Road

Top of gully, lots of brush and brush piled up

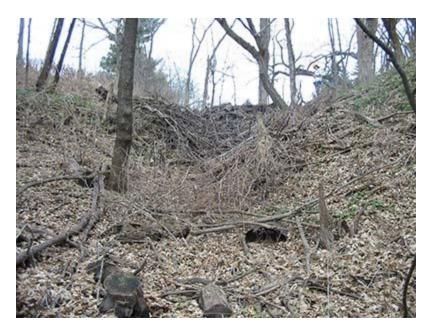
Location: 2901 E. Old Shakopee Road

Springs with eroding banks

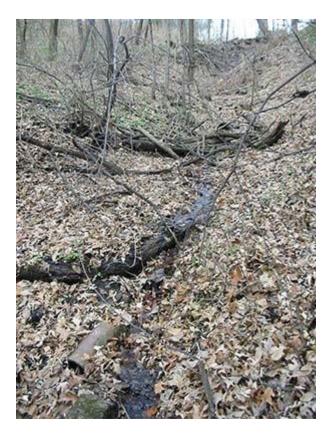
Springs with eroding banks

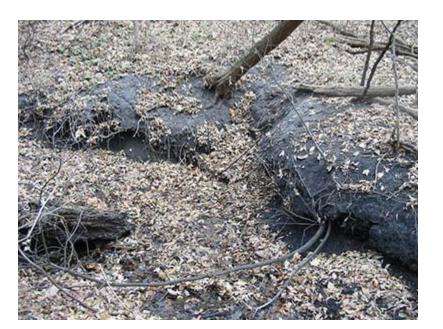
Springs with eroding banks

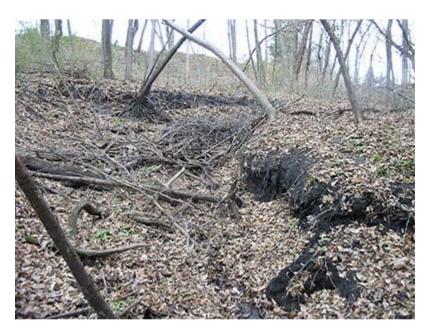
Location: 2901 E. Old Shakopee Road

Spring

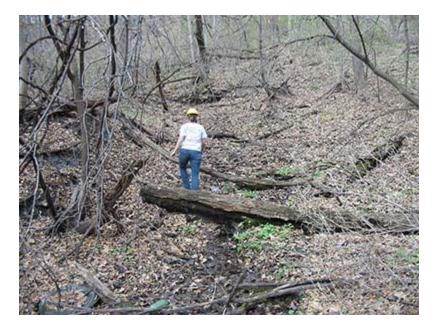
Location: 2901 E. Old Shakopee Road

Spring

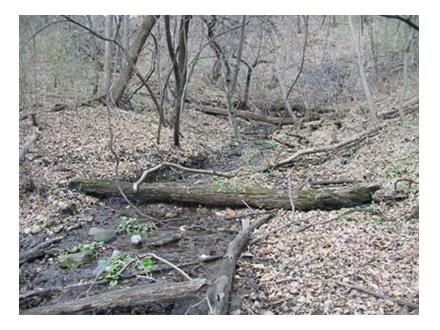
Location: 2901 E. Old Shakopee Road

More springs-top of gully huge complex of springs/grndwatr.

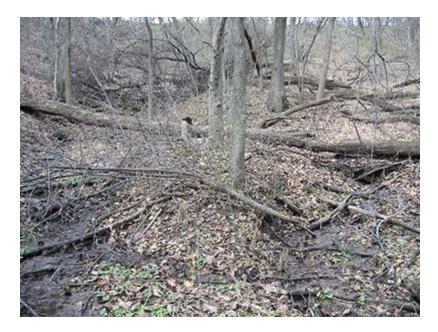
Location: 2901 E. Old Shakopee Road

Bank erosion along stream seepage

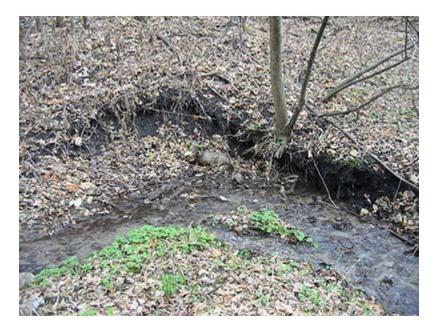
Steep gully side w/exposed roots and soil, spring flowing at base

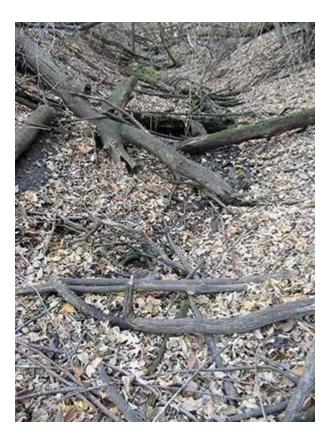
Location: 2901 E. Old Shakopee Road

Finger gully with spring

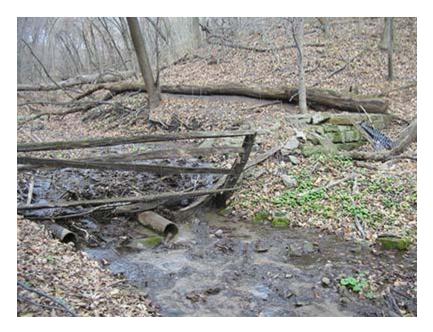
Location: 3055 Old Shakopee

Top of gully and spring; pretty steep banks along west side

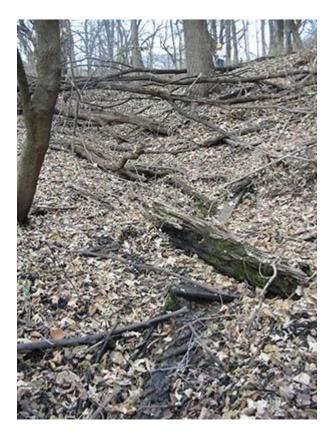
Location: 3055 Old Shakopee

Spring, very orange, two old pipes; pretty steep banks along west side

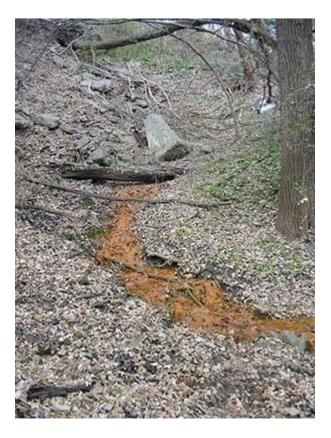
Location: 3055 Old Shakopee

Top of gully with spring and bank erosion; steep banks along west side.

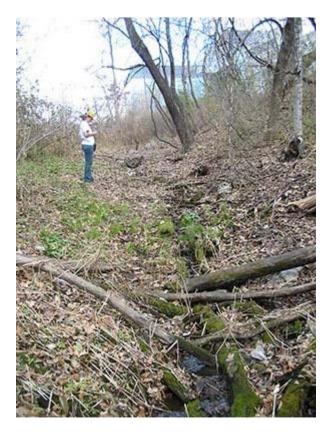
Top of gully with spring and bank erosion; steep banks along west side.

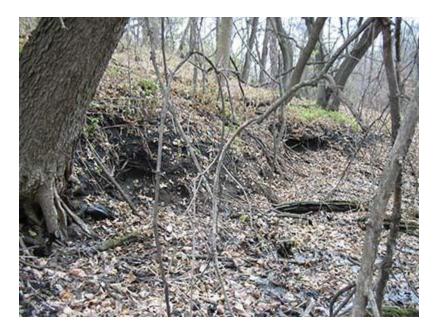
Location: 3055 Old Shakopee

Spring with some bank erosion; pretty steep banks along west side

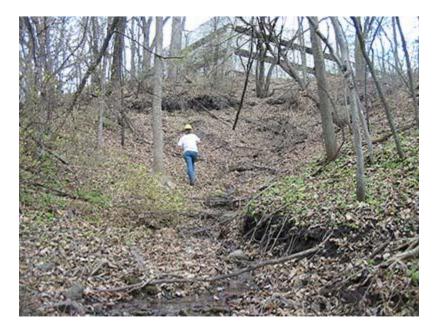
Location: 3055 Old Shakopee

Bank erosion; pretty steep banks along west side.

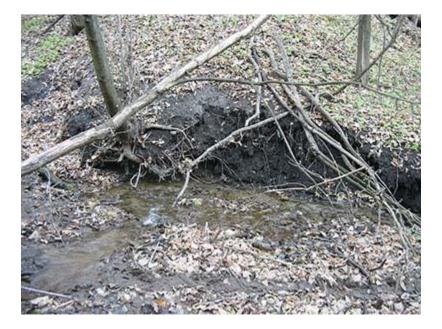
Location: 3055 Old Shakopee

Pipe and bank erosion; pretty steep banks along west side.

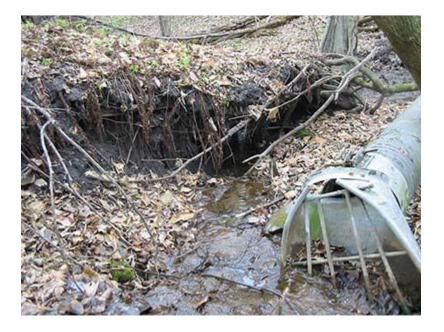
Location: 3055 Old Shakopee

Pipe with active water flow, some bank erosion; pretty steep banks along west side.

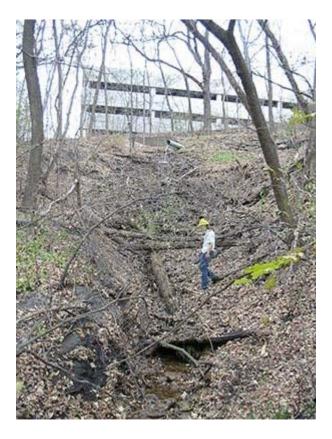
Location: 3055 Old Shakopee

Exposed dirt, looks like its from machinery next to walking path; pretty steep banks along west side.

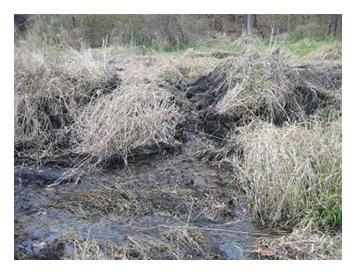
Location: 3055 Old Shakopee

Storm water outlet w/adjacent stream outlet; pretty steep banks along west side

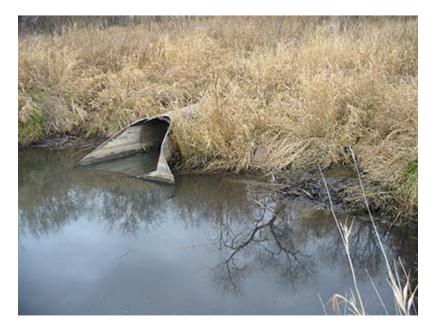
Location: 3055 Old Shakopee

Gully/spring - slight bank erosion; pretty steep banks along west side

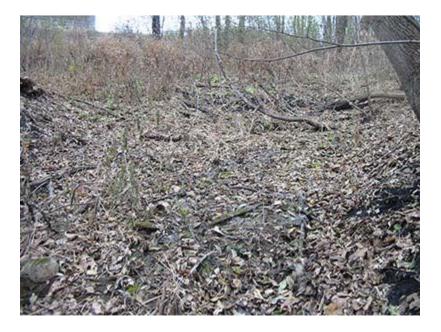
Location: 3055 Old Shakopee

Gully/spring - slight bank erosion; pretty steep banks along west side

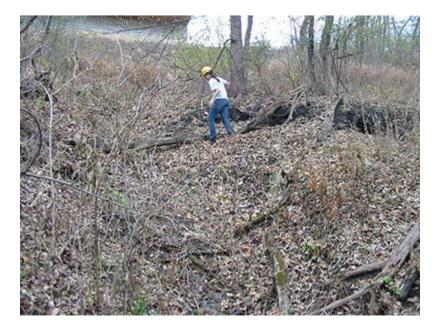
Location: 3055 Old Shakopee

Gully/spring; pretty steep banks along west side

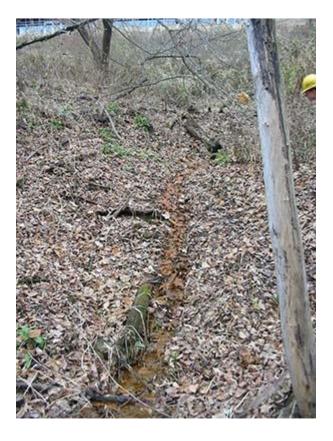
Location: 3055 Old Shakopee

Gully/spring, cut fairly deep w/steep banks along west side/loose soil

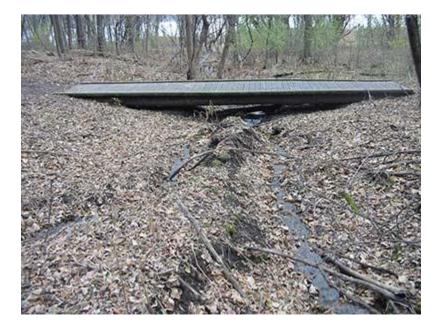
Location: USWFS - Near Visitor's Center

Top of gully-small broken retaining wall, top of gully looks fine, garbage, TV

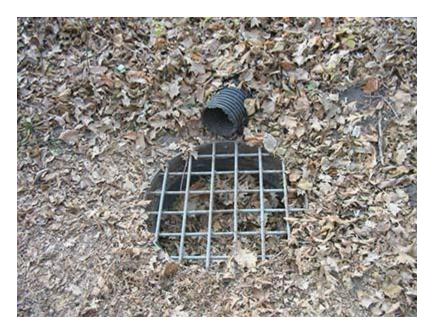
Location: USWFS - Near Visitor's Center

Storm water grate?
