Gully Inventory Map	Legend		\mathbf{T}
Area #1	LMRWD Boundary (not official)	FEMA Floodway	\mathbb{N}
Lower Minnesota River Watershed District	City/Township Boundary	100-Year FEMA Floodplain	T
Watershed Management Plan	Gully Inventory Locations	500-Year FEMA Floodplain	Not to Scale

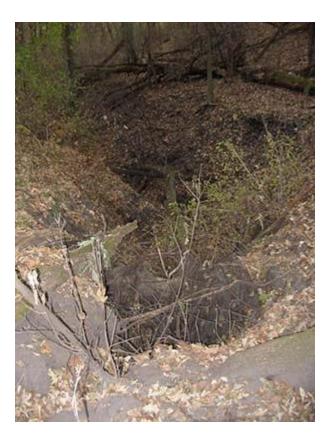
Erosion cut

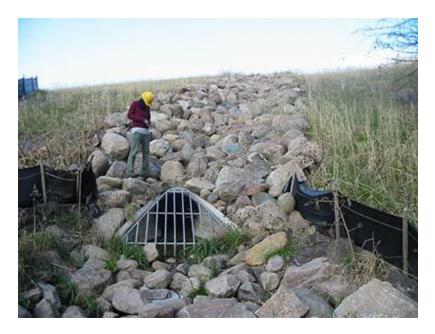
Location: USWFS - Near Visitor's Center

Storm water outlet from catchment pond in new development-top of gully

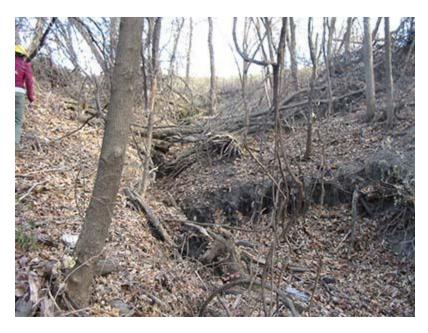
Location: USWFS - Near Visitor's Center

Finger, bad down cut and bank erosion, a little water wash, brush and mulch

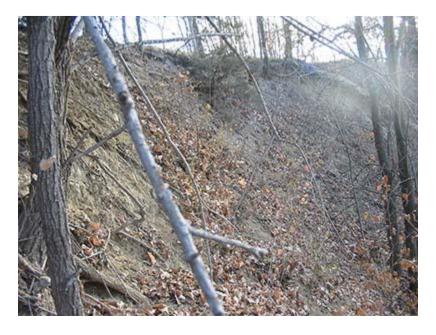
Location: USWFS - Near Visitor's Center

Bank erosion, slump/slide

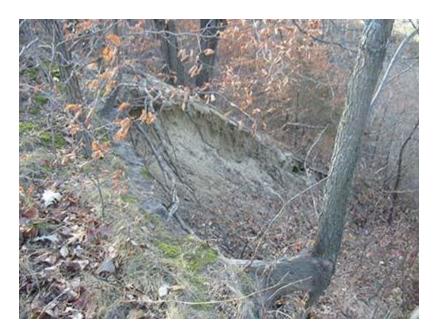
Bank erosion, slump/slide

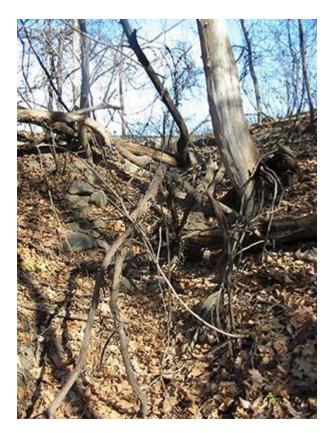
Location: USWFS - Near Visitor's Center

Finger, down cut at top, pretty bad

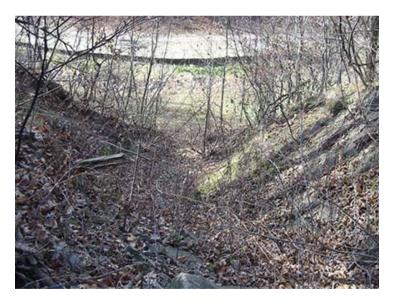
Location: USWFS - Near Visitor's Center

Finger, undercut banks, exposed roots, real bad, looks like an old path that channels water

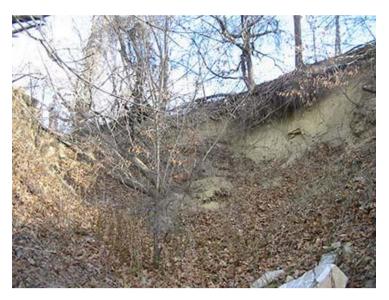
Finger, undercut banks, exposed roots, real bad, looks like an old path that channels water

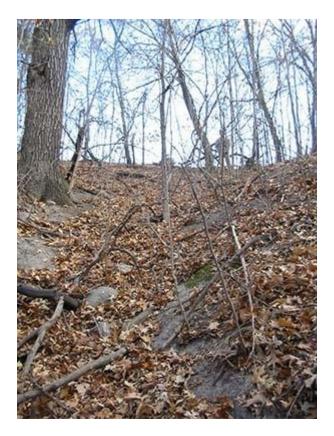
Location: USWFS - Near Visitor's Center

Finger, looks fine

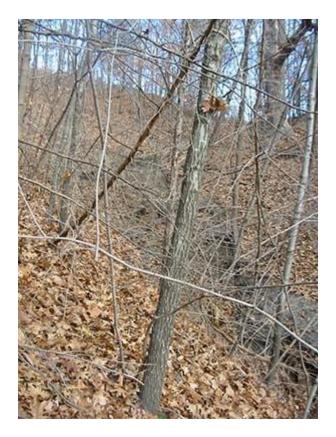
Location: USWFS - Near Visitor's Center

Top of gully/4596 cut deep with bad bank erosion

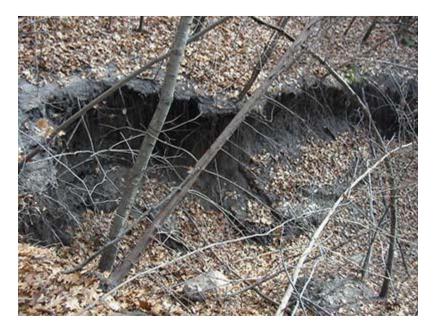
Location: USWFS - Near Visitor's Center

Half-way down to creek/4597 cut deep with bad erosion

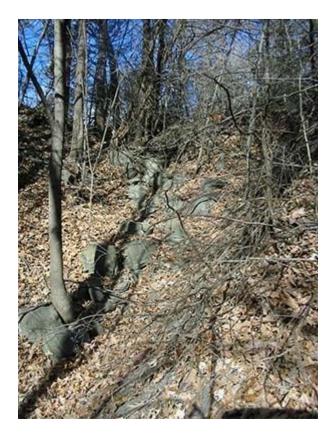
Location: USWFS - Near Visitor's Center

Finger, looks pretty good

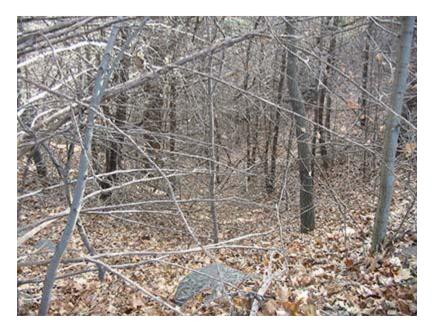
Location: USWFS - Near Visitor's Center

Finger, looks good

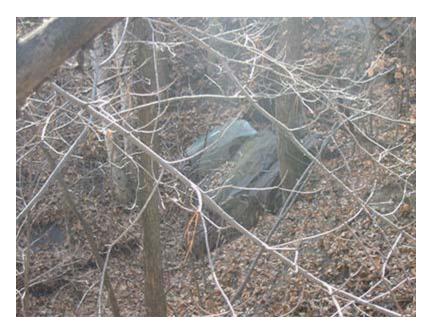
Location: USWFS - Near Visitor's Center

Finger, car frame, steep banks with bare soil

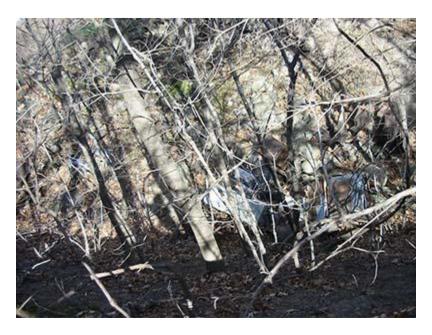
Location: USWFS - Near Visitor's Center

Finger, metal junk

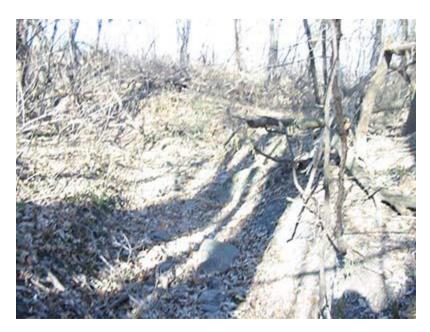
Location: USWFS - Near Visitor's Center

End of big finger, some garbage, looks pretty sad

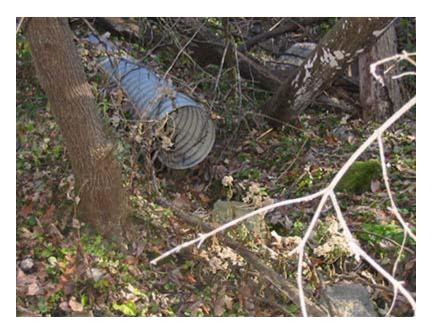
Location: USWFS - Near Visitor's Center

Drainage pipe, no flow

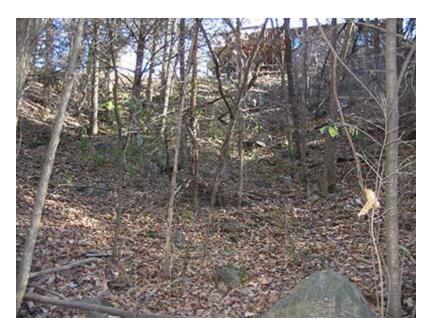
Location: USWFS - Near Visitor's Center

Resident confront about washout issues

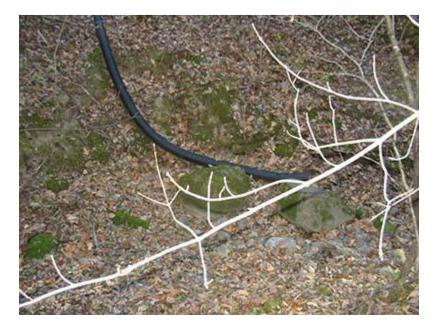
Location: USWFS - Near Visitor's Center

House runoff tile

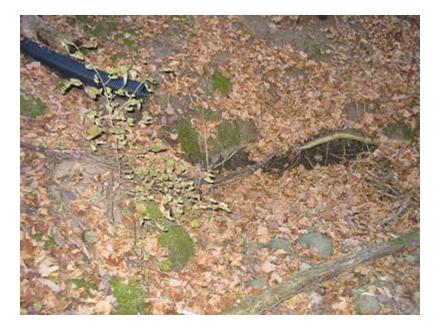
Location: USWFS - Near Visitor's Center

House runoff tile

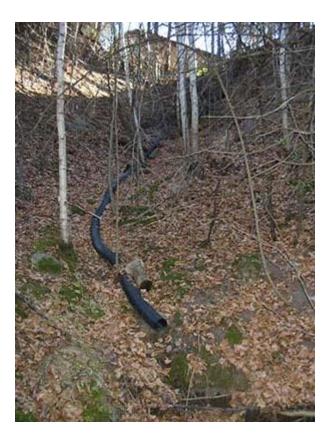
House runoff tile

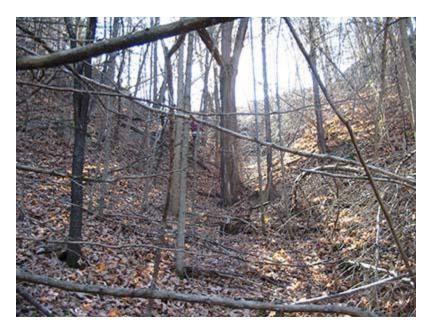
Location: USWFS - Near Visitor's Center

Finger, moderate erosion

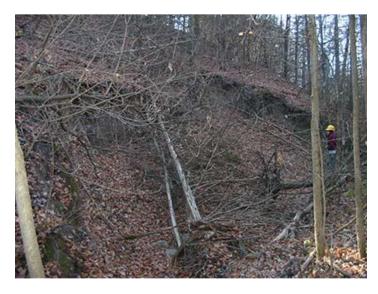
Location: USWFS - Near Visitor's Center

Bank erosion pretty bad; groundwater seepage starting here, seepage disappears just downstream

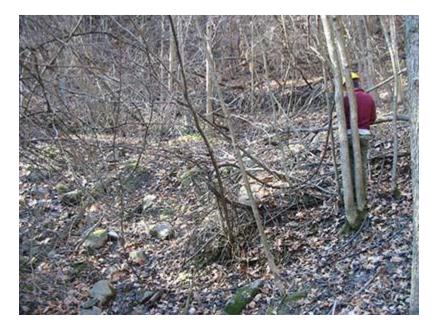
Location: USWFS - Near Visitor's Center

Spring w/solid flow - below 1146

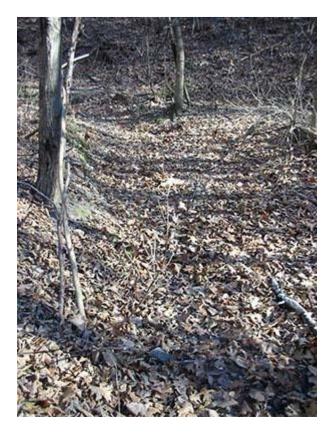
Location: USWFS - Near Visitor's Center

Both flows from water stop by house, spring water disappears right before house

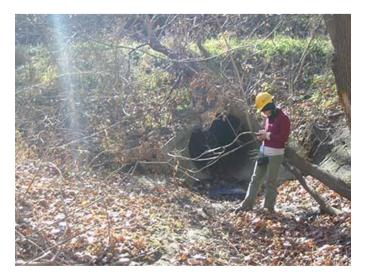
Location: USWFS - Near Visitor's Center

Culvert under driveway by house, finger to 212 NE, quite a bit of bank erosion along extent finger

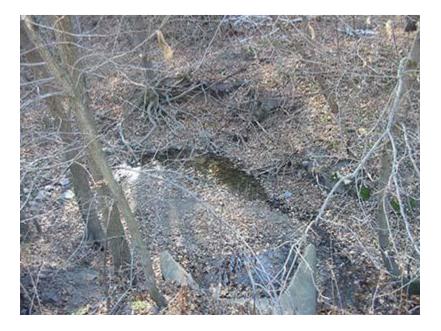
Location: USWFS - Near Visitor's Center

Other sides of culvert, erosion on bank directly adjacent

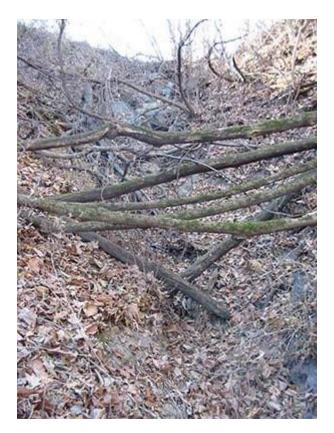
Location: USWFS - Near Visitor's Center

Water seepage and erosion

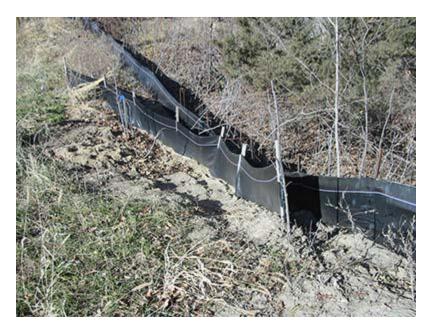
Location: USWFS - Near Visitor's Center

Top of gully erosion/construction erosion prevention

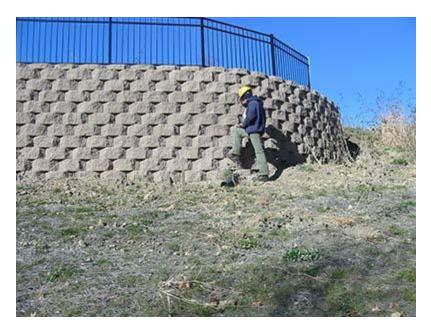
Location: USWFS - Near Visitor's Center

Runoff tile from construction

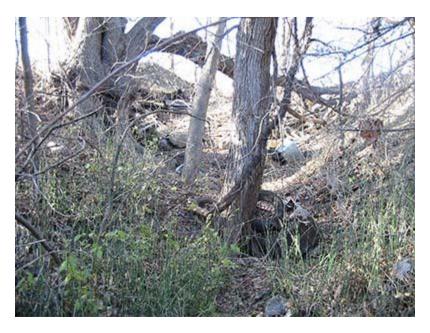
Location: USWFS - Near Visitor's Center

Finger gully top and garbage pile

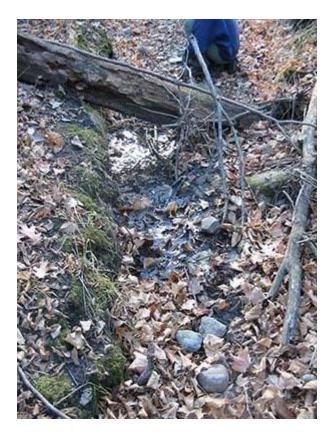
Location: USWFS - Near Visitor's Center

Spring water begins

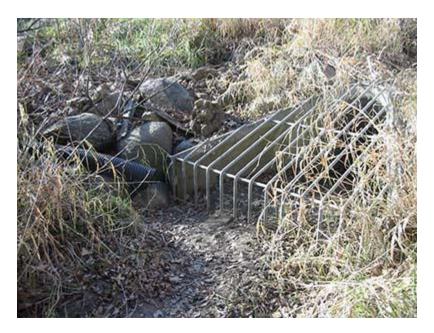
Location: USWFS - Near Visitor's Center

Culvert and finger gully tip and tile line

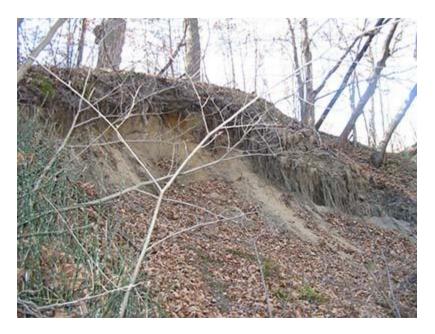
Location: USWFS - Near Visitor's Center

Extensive erosion

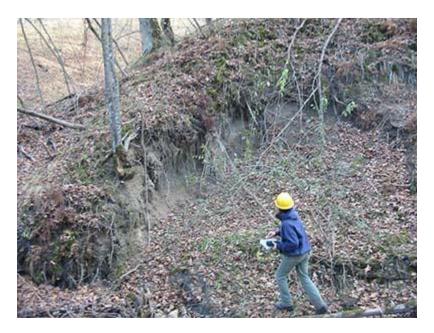
Location: USWFS - Near Visitor's Center

Steady water flow and extensive erosion

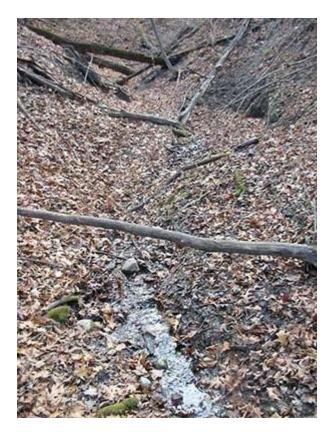
Location: USWFS - Near Visitor's Center

Spring water

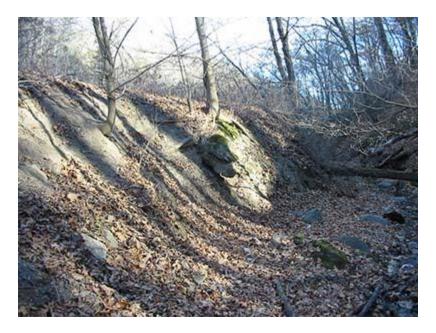
Entrance to finger erosion

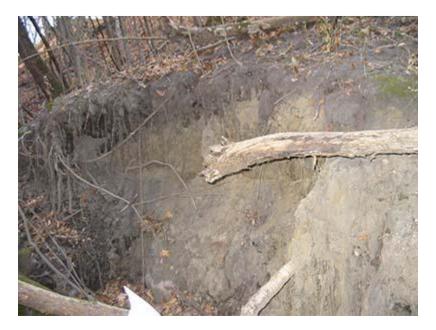
Extensive erosion

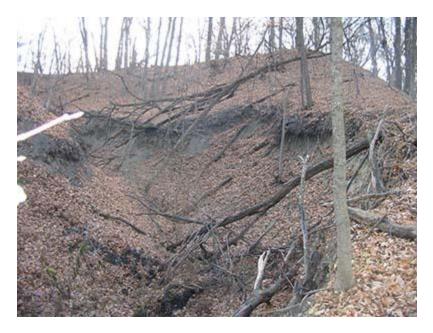
Waypoint 1171

Extensive erosion on southern gully

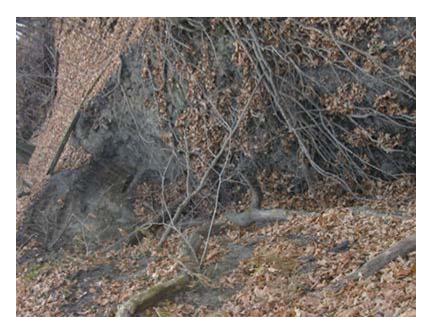
Waypoint 1172

Extensive and deep erosion

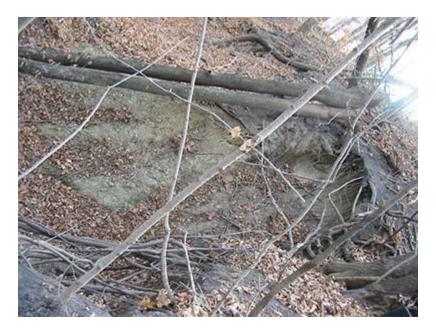
Extensive erosion

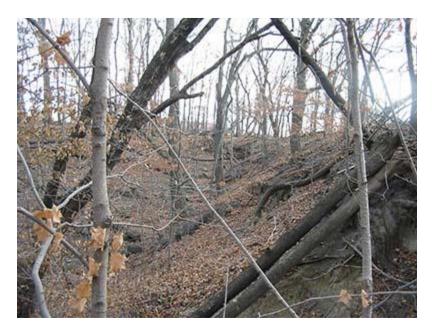
Finger tip and tile line w/mild erosion

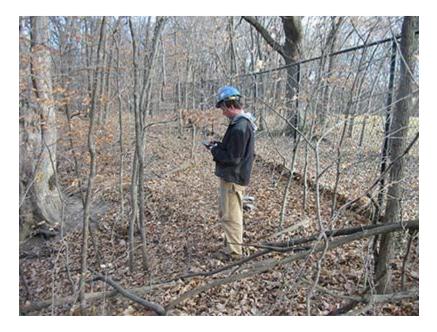
Erosion encroachment to llama fence

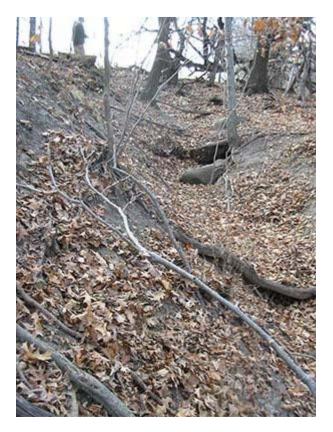
Finger tip looks good

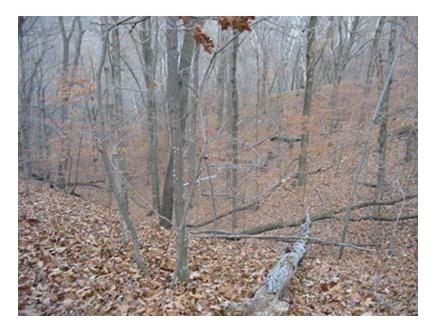
Finger tip looks good

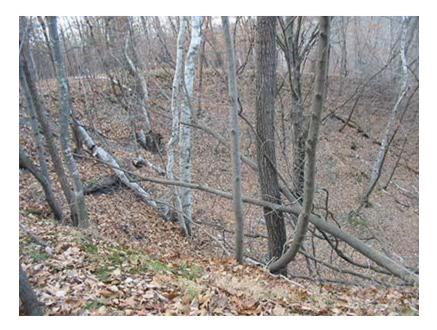
Bigger gully tip, looks alright

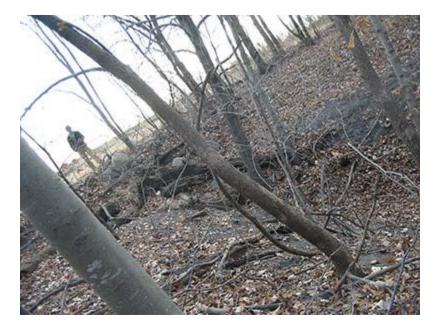
Finger tip, mild erosion, tip to spring water #1168

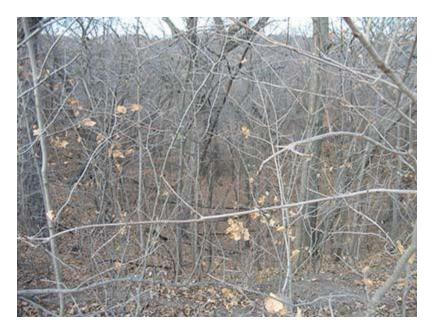
Finger tip/bowl, looks alright

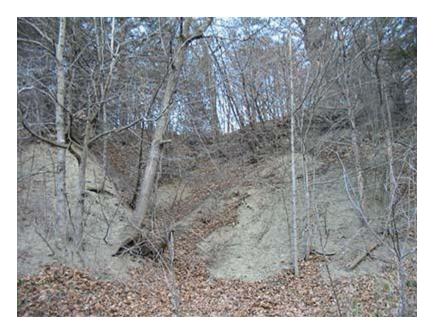
Deep cut erosion under trees and all up hillside, small finger

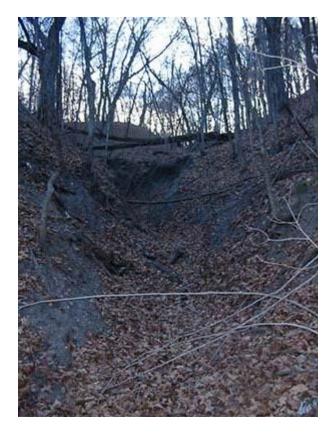
Deep cut erosion on finger

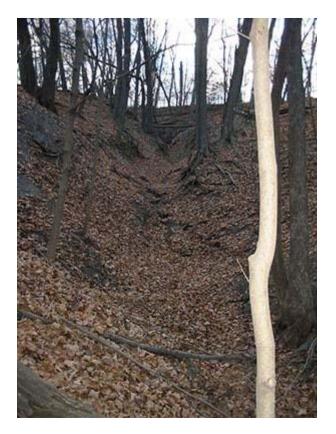
Finger tip, sizeable erosion whole finger

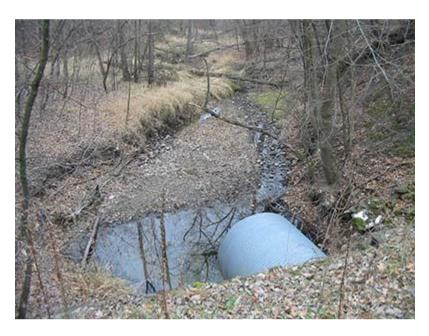
Large culvert w/some water flow -small spring, minor channel

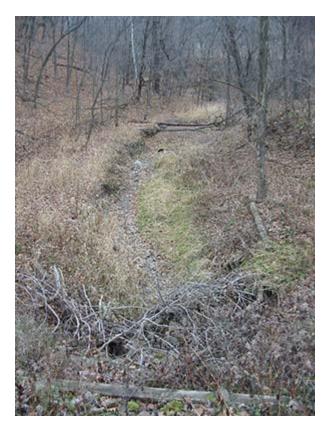
channel leading to culvert/some tree debris leading to culvert

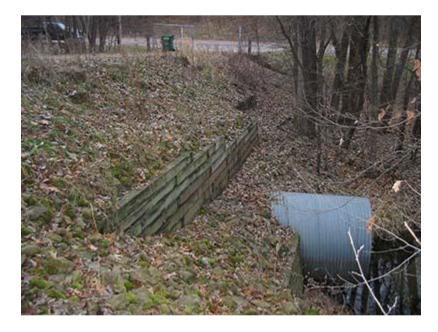
Erosion control on banks of culvert

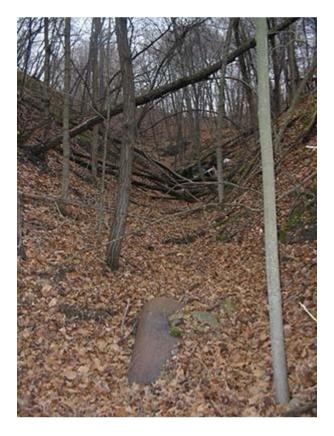
Deep channel outlet w/trash/significant

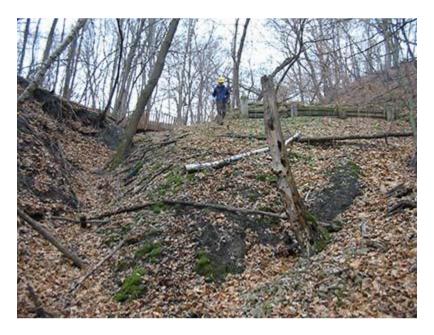
Erosion control/tile outlet

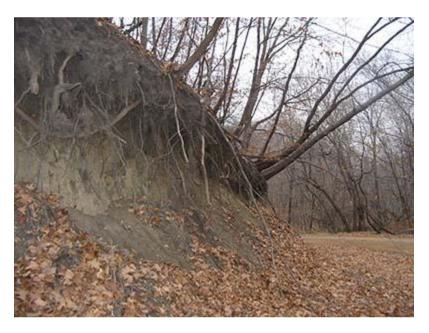
Under cut bank/erosion problem along entire driveway

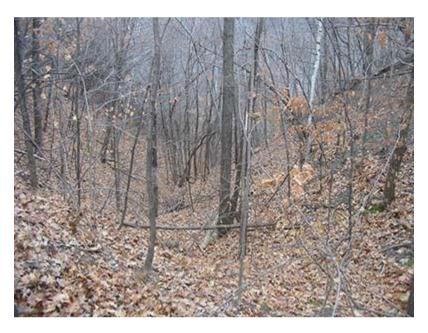
Minimal erosion along channel

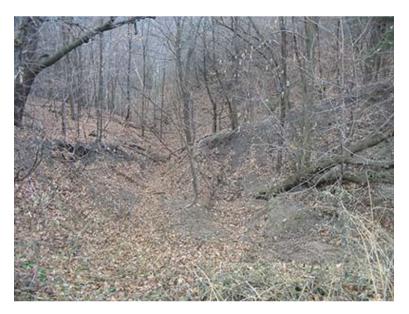
Deep cut channel, severe erosion/large amount of llama feces in channel from llama farm

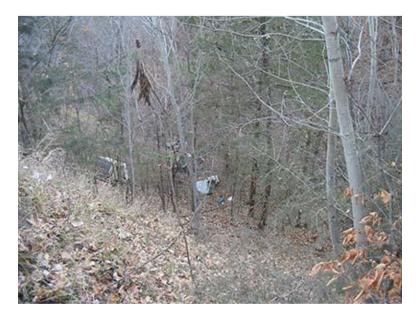
Deep channel w/severe erosion and copious amounts of feces/straw on hillside and trash

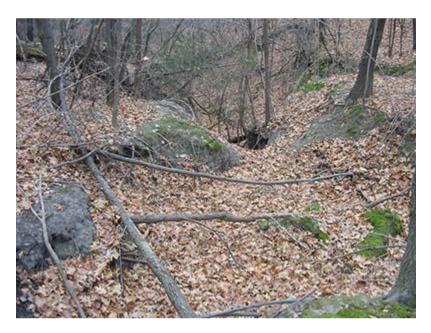
Deeply eroded finger

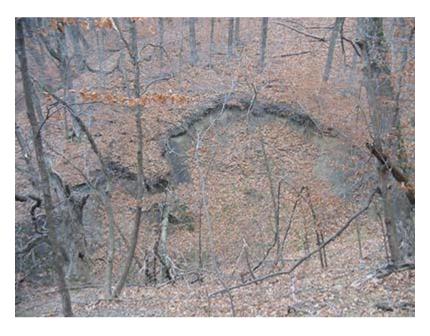
Eroded bank

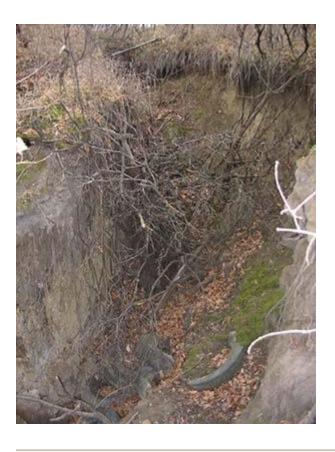
Extreme channel tires piled up in gully

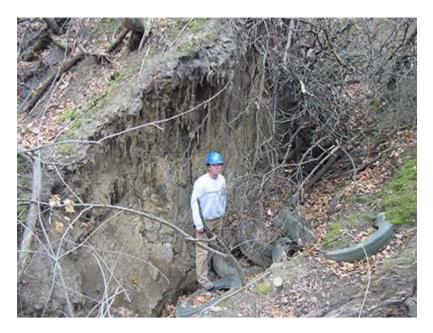
Extreme channel tires piled up in gully

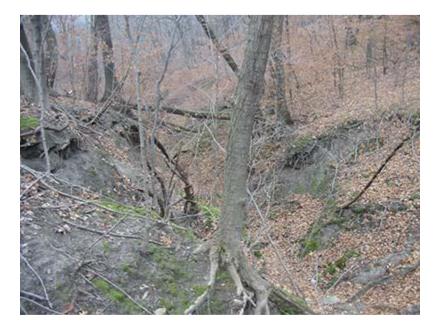
Eroded channel view from WP1192

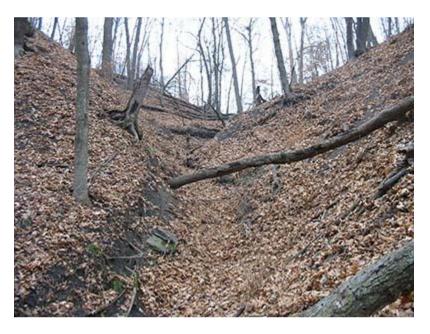
Some erosion along finger

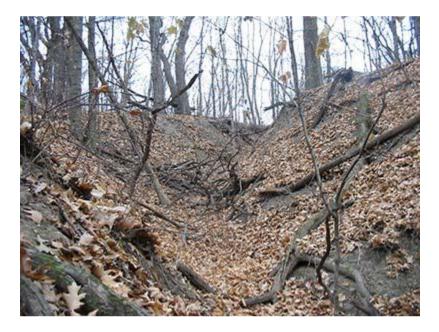
Finger strongly eroded banks

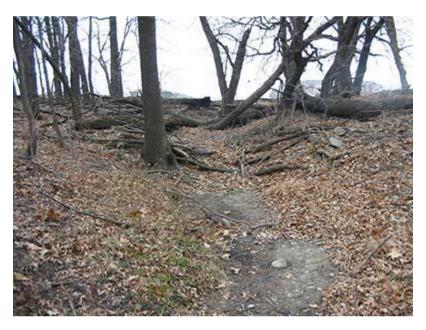
Beginning of long channel

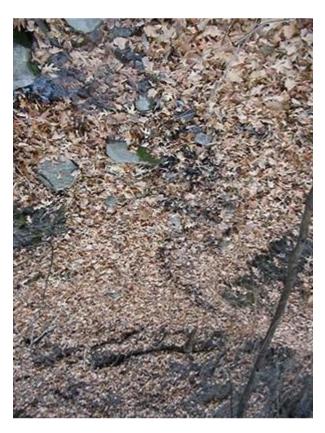
Beginning of spring

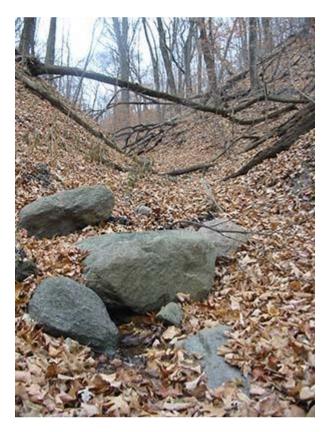
Waypoint 1198

End of spring

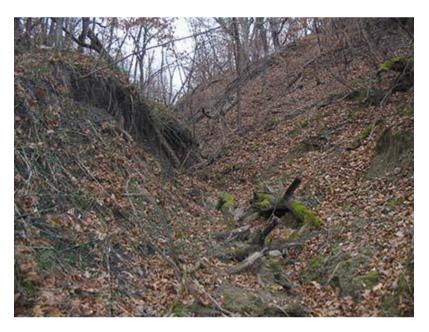
End of extremely eroded channel w/tires on top

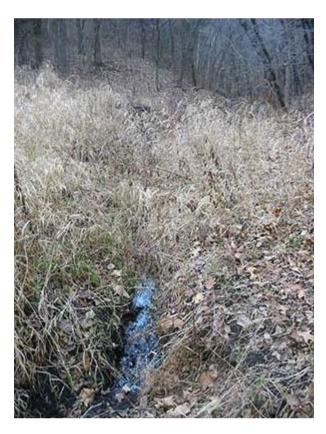
Spring at end of marsh

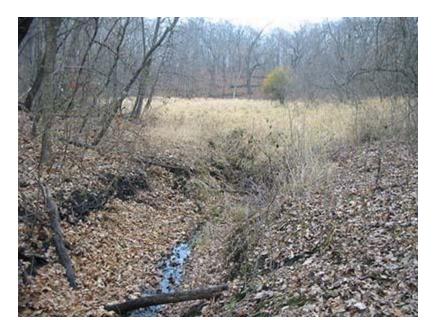
Spring at end of marsh

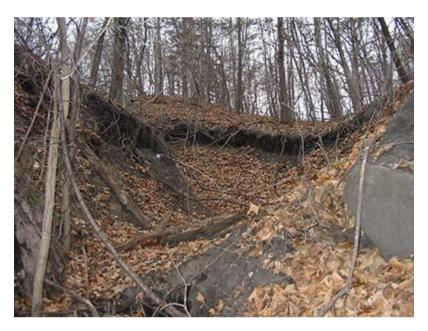
Severely undercut stream bank

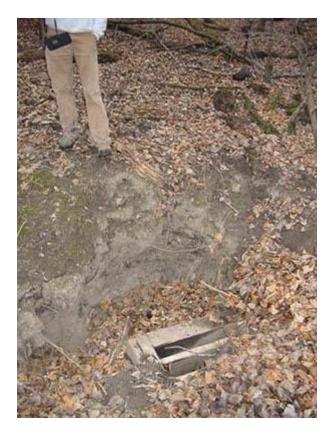
End of huge channel system/box culvert

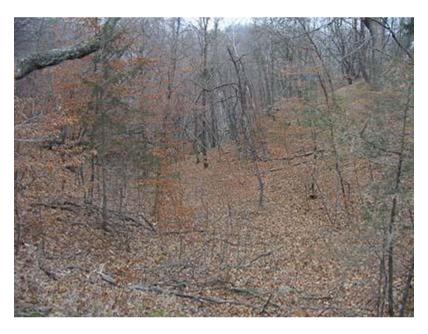
Gully with minor erosion

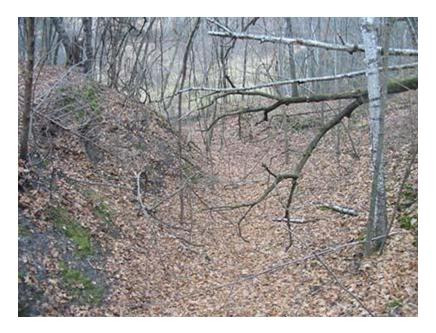
Start of severe erosion in gully

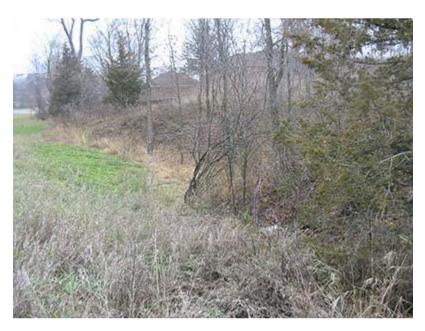
Location: Llama Farm

Old gully

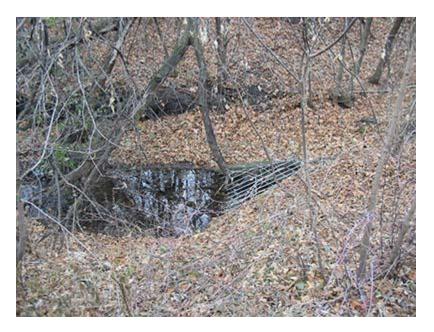
Location: Llama Farm

Culvert on side of road

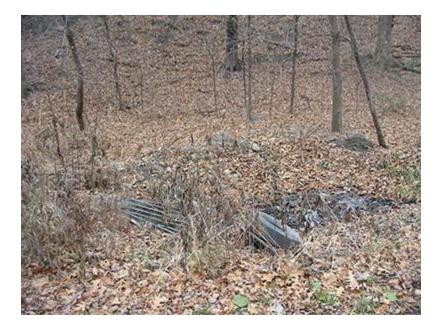
Location: Llama Farm

Culvert entrance on side of road

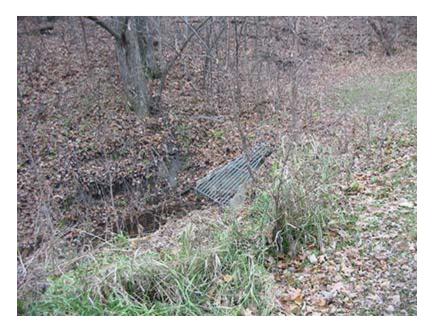
Location: Llama Farm

Culvert exit

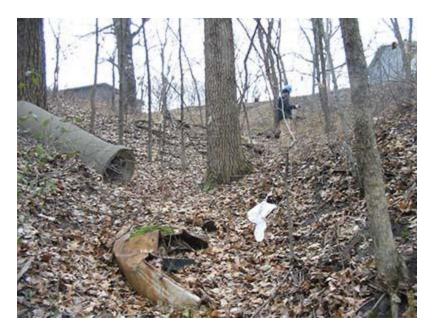
Location: Llama Farm

Gully w/minor erosion/trash

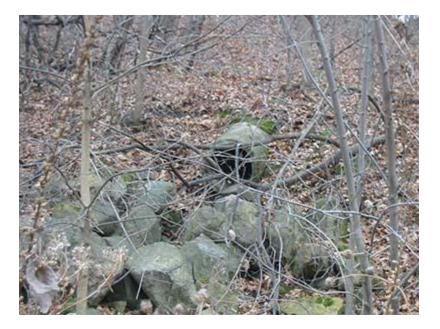
Location: Llama Farm

Drain pipe exit

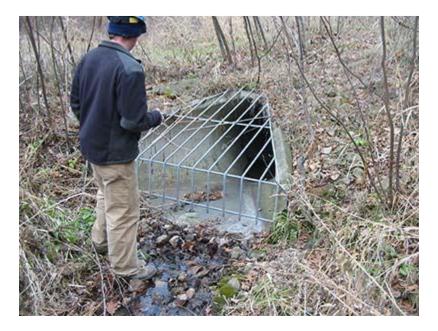
Location: Llama Farm

Culvert entrance on side of road

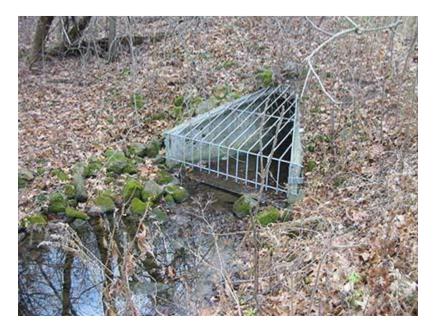
Location: Llama Farm

Culvert exit

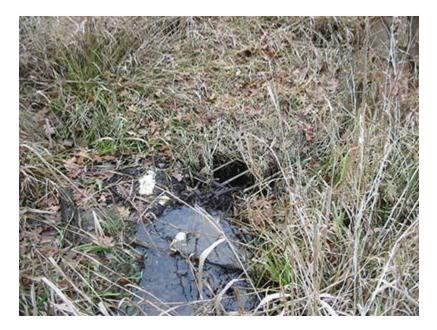
Location: Llama Farm

Culvert entrance on side of road

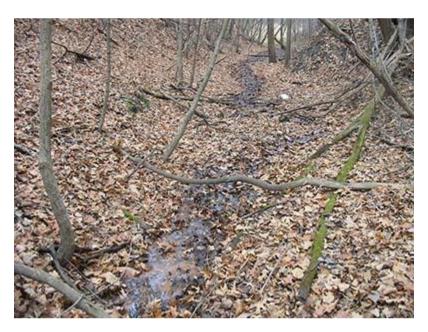
Location: Llama Farm

Spring at end of marsh

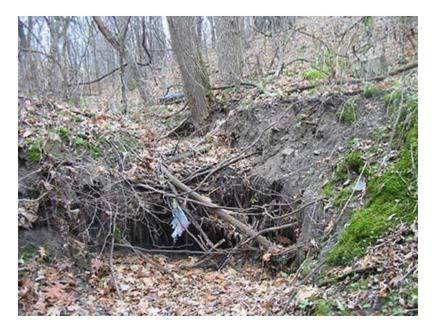
Location: Llama Farm

Washout area w/trash, tires, cans, etc.

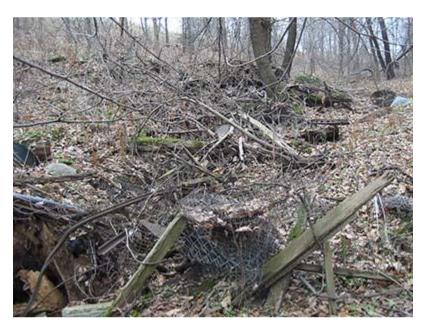
Location: Llama Farm

Scrap metal/trash

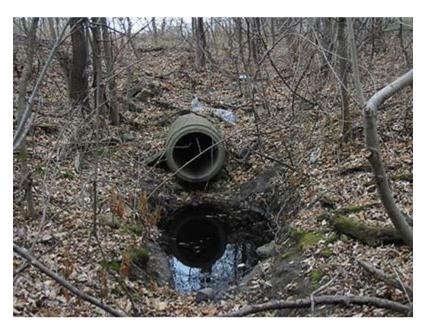
Location: Llama Farm

Drain pipe w/horribly black water/top of gully

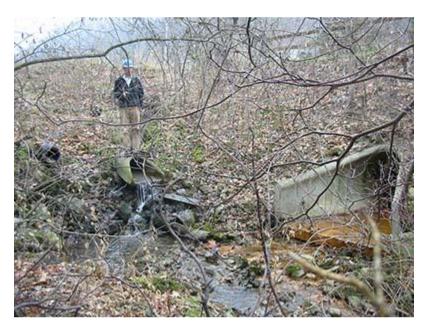
Location: Llama Farm

4 pipe outlets, lots of iron deposits

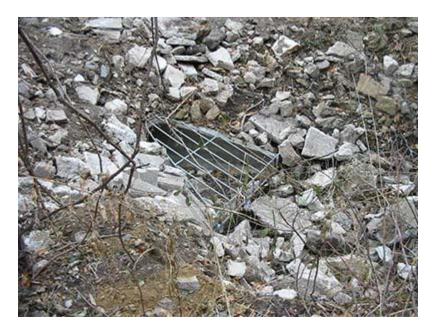
Location: Llama Farm

Culvert exit

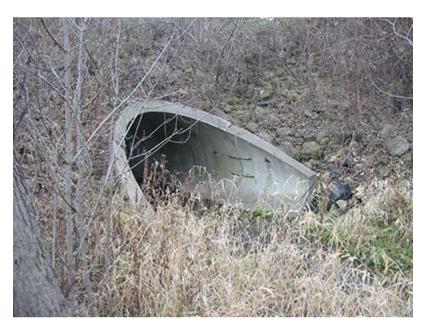
Location: Llama Farm

Entrance bridge tunnel

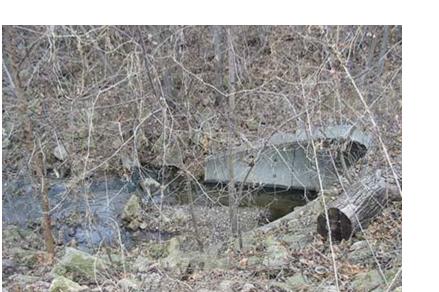
Exit

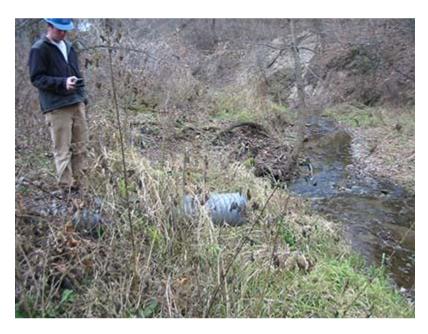
Location: Llama Farm

Drain pipe

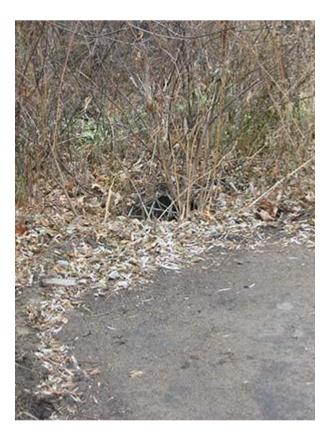
Drain pipe entrance at end of driveway

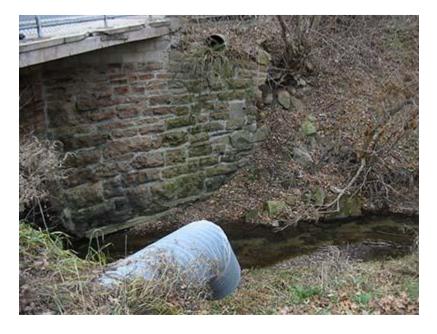
Location: Llama Farm

2 pipes draining from street into river

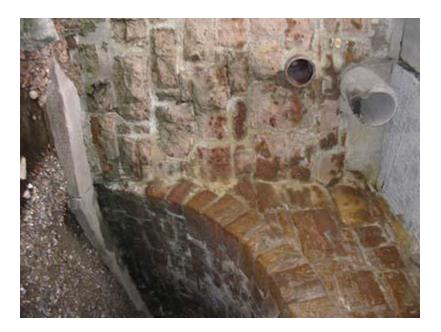
2 pipes draining into stream

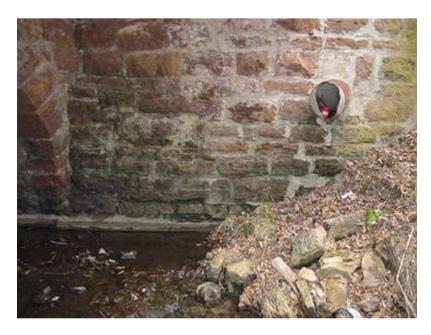
1 pipe draining into stream

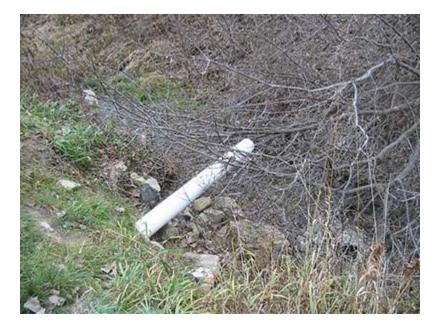
Location: Llama Farm

Runoff from roof drains onto ground going into this pipe

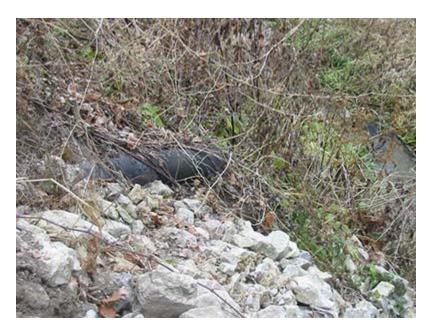
Location: Llama Farm

Pipe draining into stream

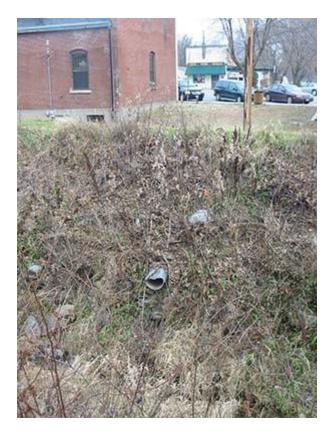
Location: Llama Farm

Pipe draining into stream

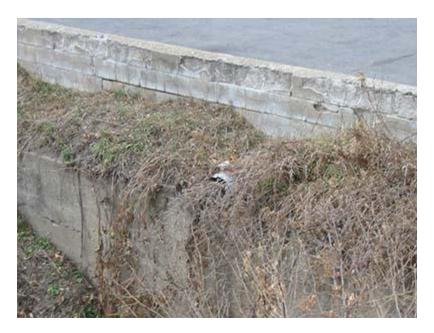
Location: Llama Farm

Pipe from street into disposal

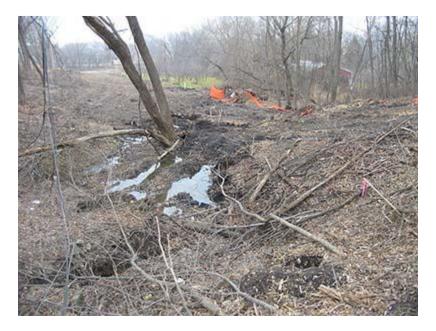
Location: Llama Farm

Pipe outlet/groundwater seepage

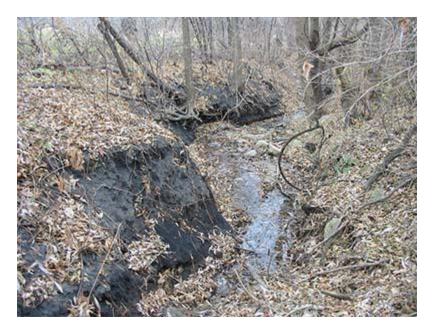
Location: Llama Farm

Stream bank erosion

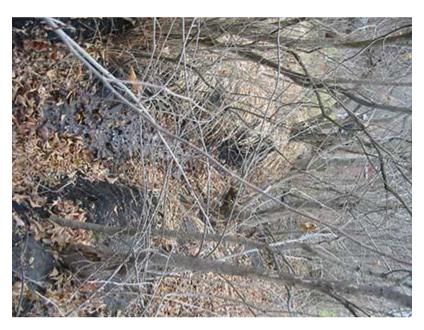
Location: Llama Farm

End of water in stream/banks lined w/honeysuckle/buckthorn, easily removable

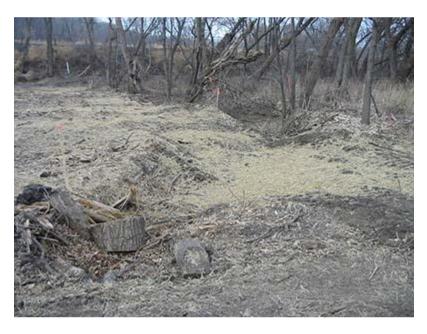
Location: Llama Farm

Gully filled in with soil from construction

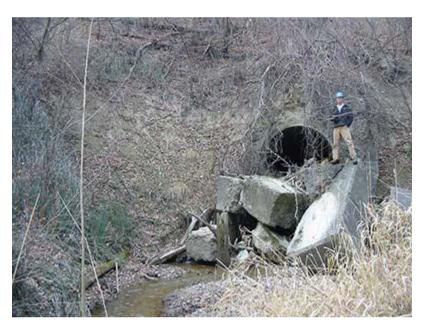
Location: Llama Farm

Culvert exit w/erosion on bank

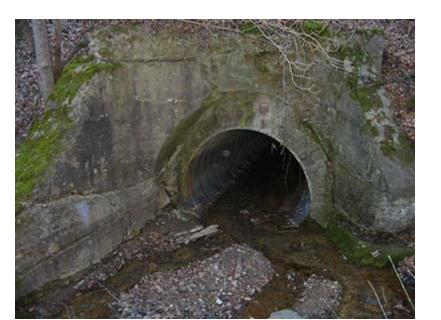
Culvert entrance

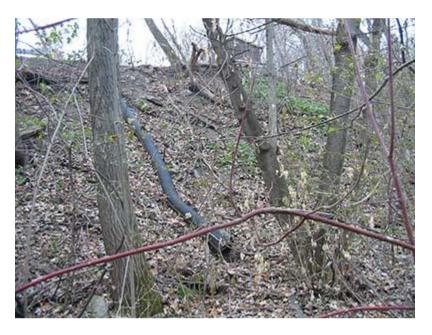
Location: Llama Farm

Drain pipe

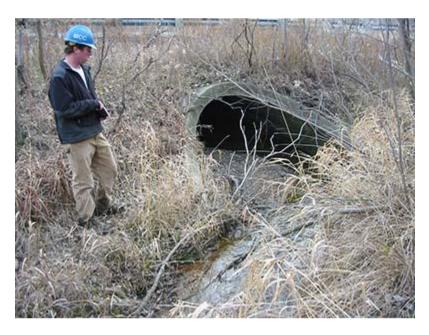
Location: Llama Farm

Culvert under #212

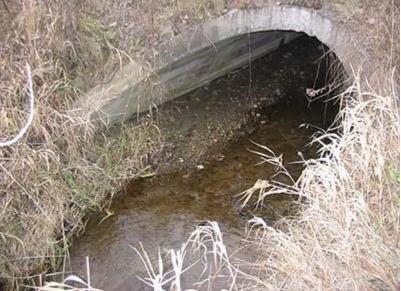
Culvert outlet under #212

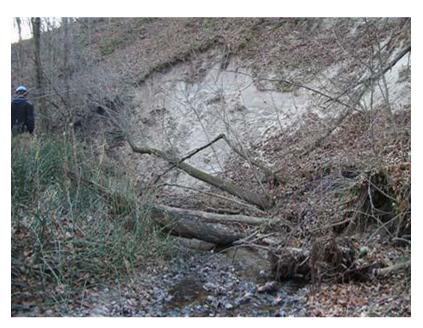
Location: Llama Farm

Eroded bank very sandy

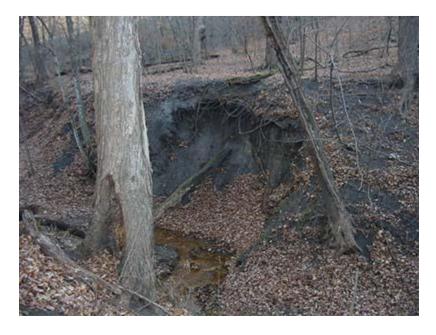
Location: Llama Farm

Eroded stream bank/very ferrous stream

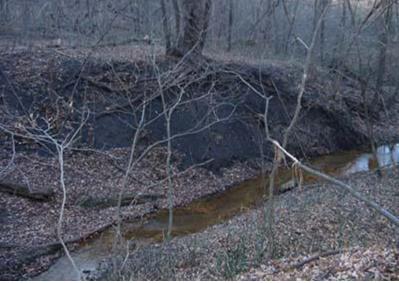
Eroded stream bank/very ferrous stream

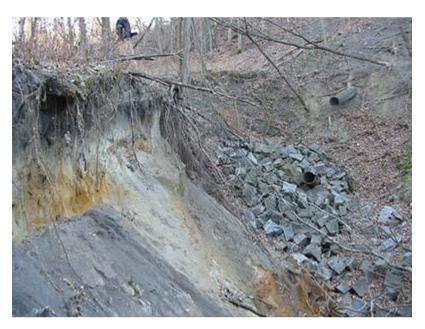
Outlet pipe/severe erosion

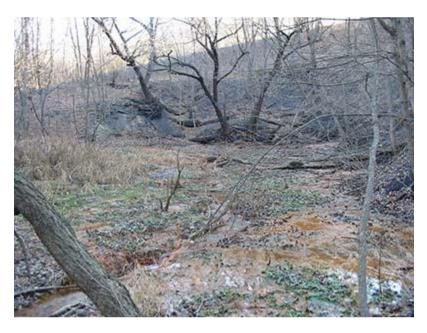
Spring of ferrous stream

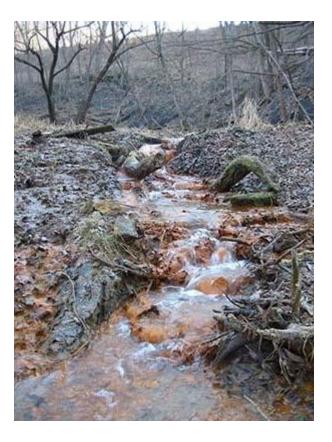
Sulfur smell

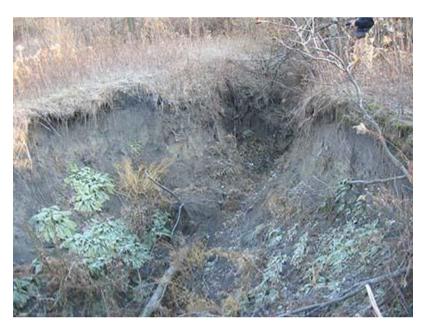
Gully extreme erosion

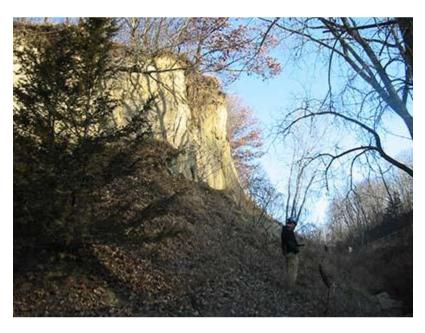
Eroded hillside glacial fill along trail severe

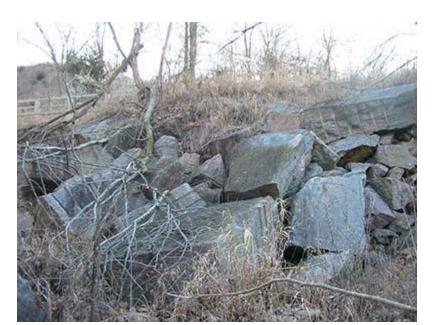
large boulders (from quarry?) to prevent erosion, beginning of gully

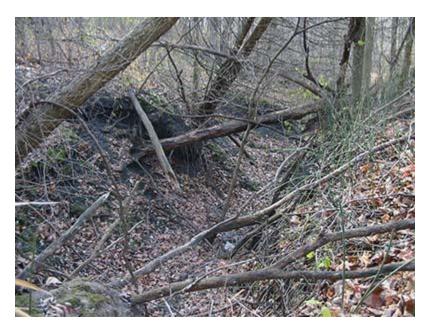
Eroded gully/small spring

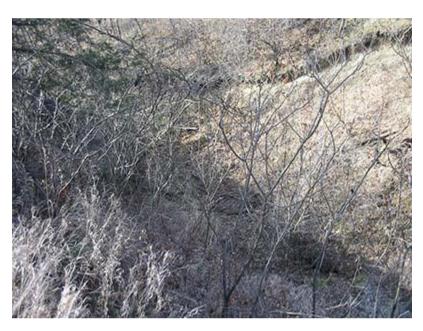
Eroded gully beginning at house

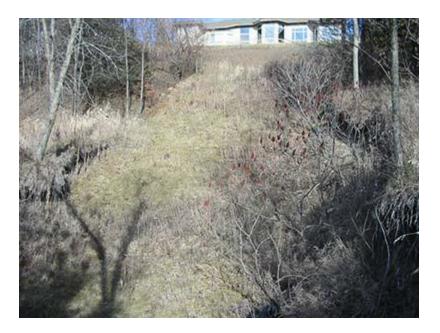
Some small erosion control-ineffective

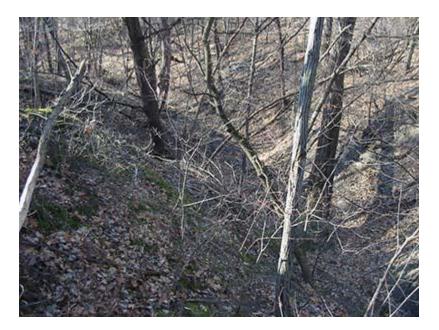
Beginning of gully/severe erosion by residnetial development

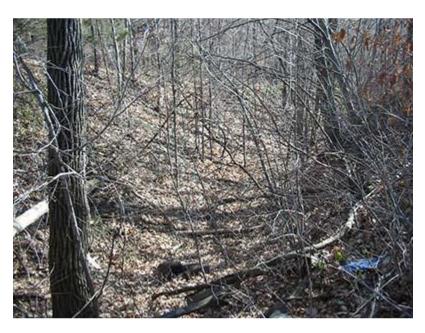
Strong erosion present

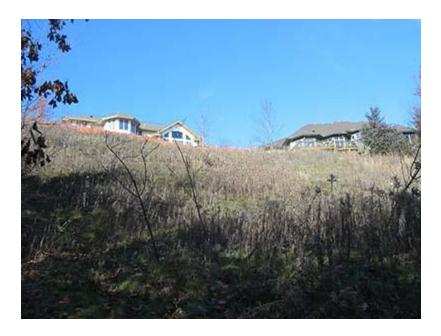
Waypoint 1245

Beginning of gully on edge of residential development

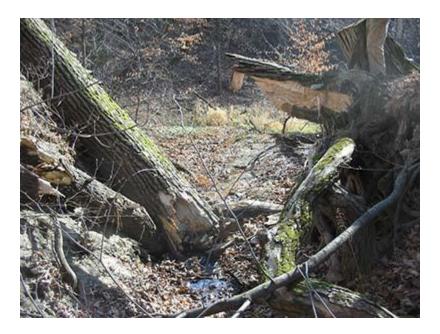
Spring/very ferrous, severe erosion, watercress

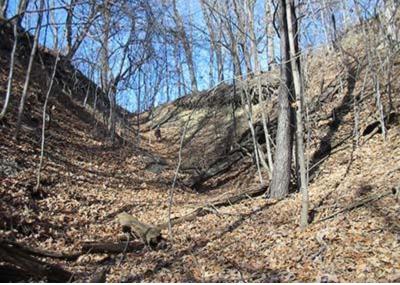
Severe erosion

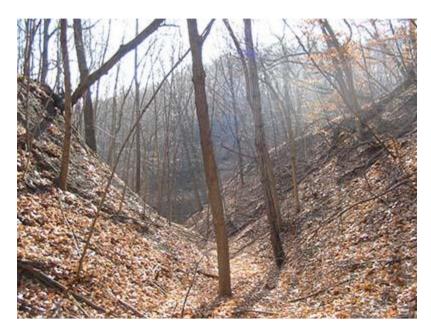
Erosion on rest of finger

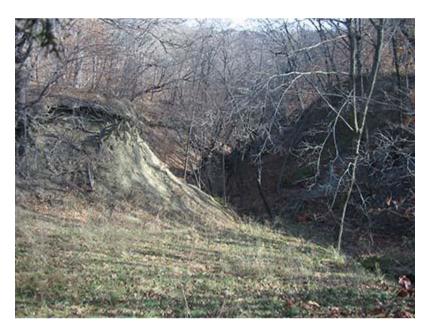
Extreme erosion next to development

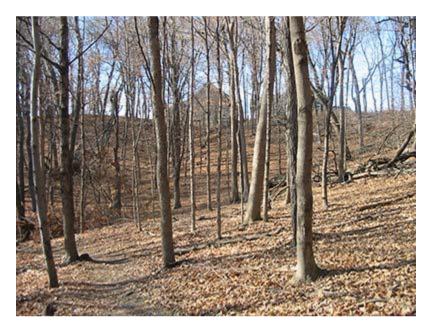
Little erosion/beginning of gully

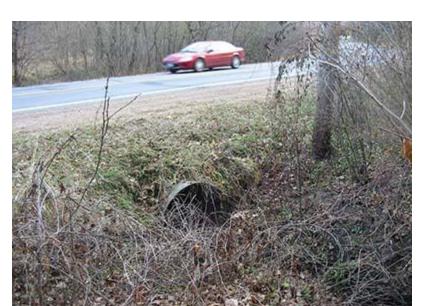
Extreme

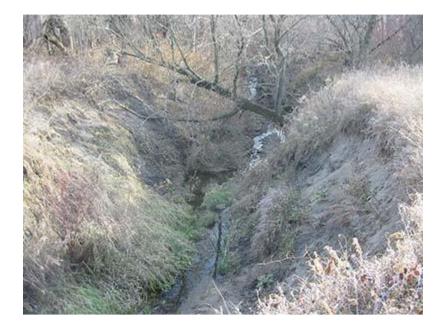
Severe erosion on banks after culvert

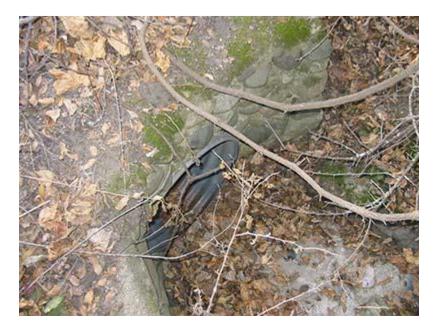
Entrance culvert, minor erosion in gully

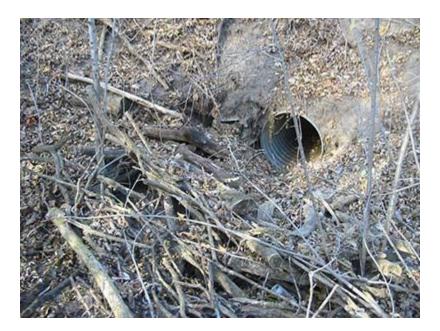
Exit

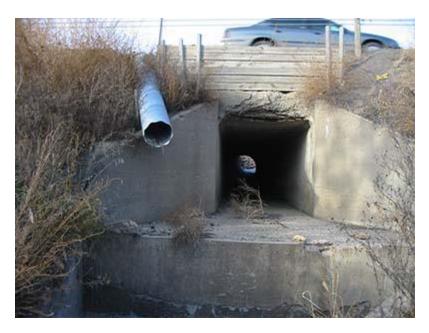
Culvert exit/culvert from #212 & culvert continues

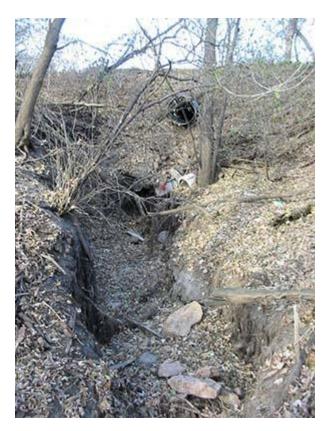
Culvert exit from WP1259, severe erosion & trash $% \left({{{\rm{T}}_{\rm{T}}}} \right) = 0$

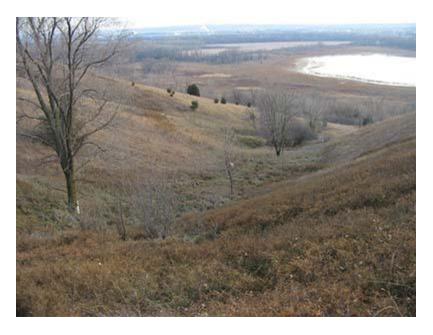
Gully, no erosion

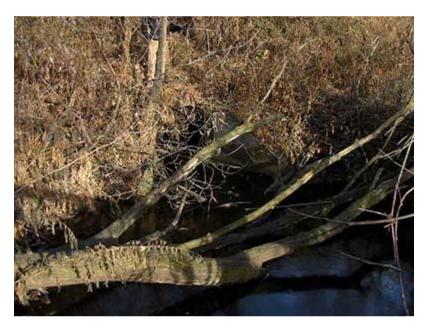
Culvert exit

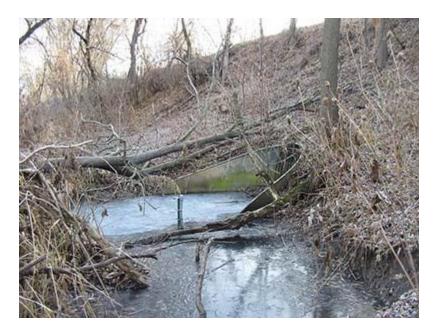
Culvert entrance

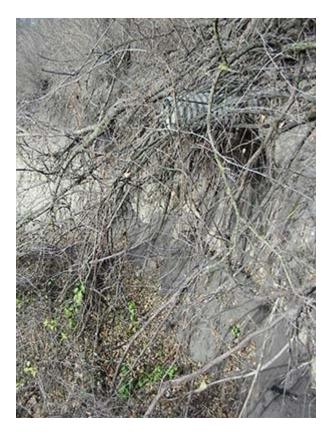
Pipe outlet along MN River/severe erosion

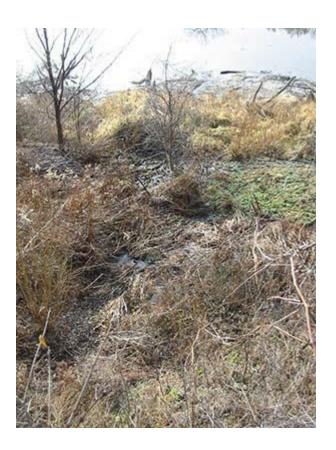
Spring 40 ft from river edge

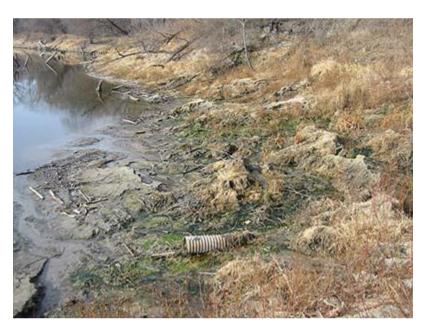
Pipe outlet/spring/pipe outlet plugged up with dirt

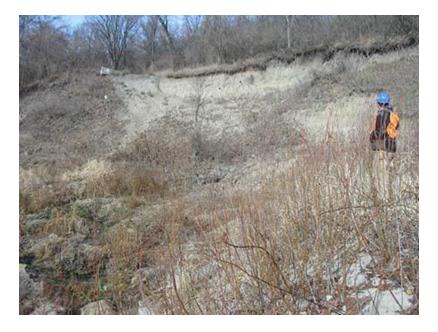
Erosion/severe on edge of river

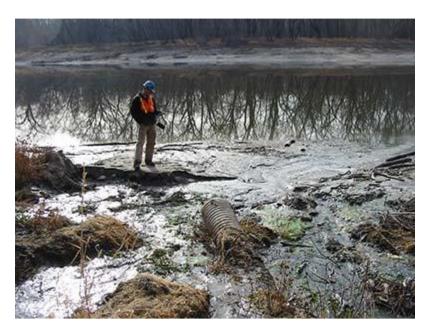
Shot of outlet facing river

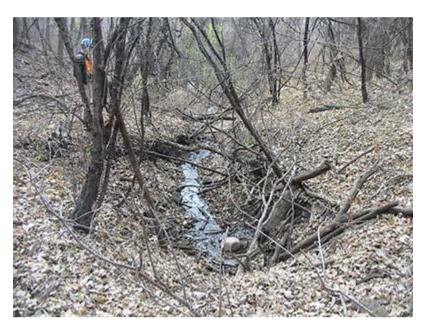
Spring/minor erosion

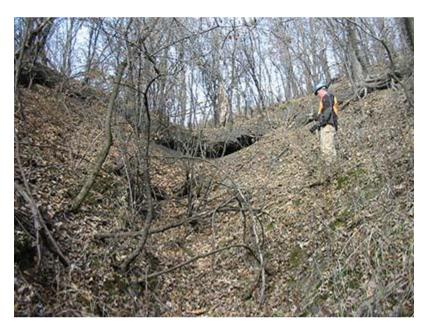
Beginning of gully/strong erosion
