Gully Inventory Map	Legend		\mathbf{T}
Area #1	LMRWD Boundary (not official)	FEMA Floodway	\mathbb{N}
Lower Minnesota River Watershed District	City/Township Boundary	100-Year FEMA Floodplain	T
Watershed Management Plan	Gully Inventory Locations	500-Year FEMA Floodplain	Not to Scale

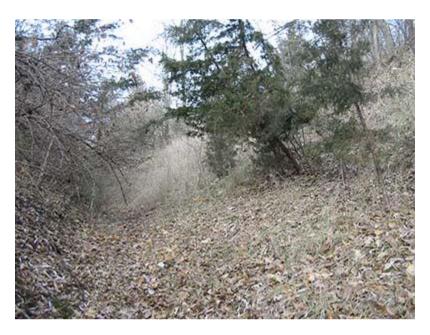
Gully w/some exposed soil on banks

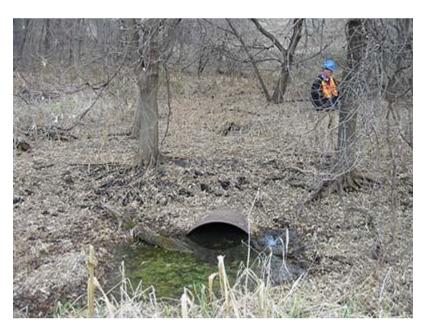
Culvert w/open manhole 20 ft. behind it; outlet from development straight above?

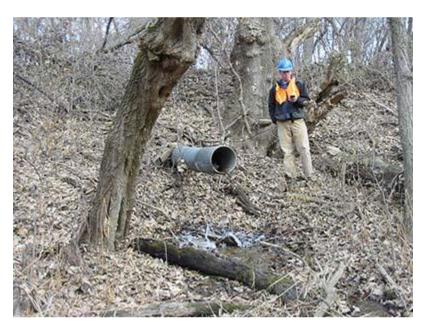
Drain pipe outlet

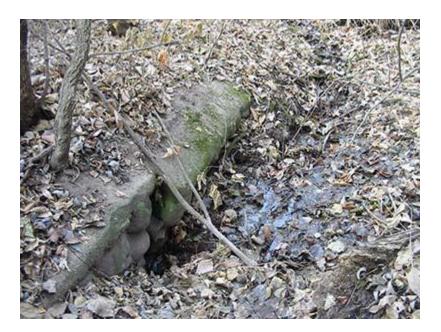
Drain pipe entrance

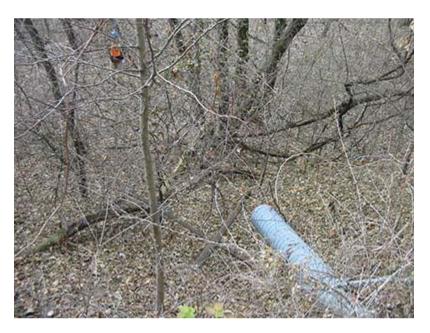
Drain pipe outlet

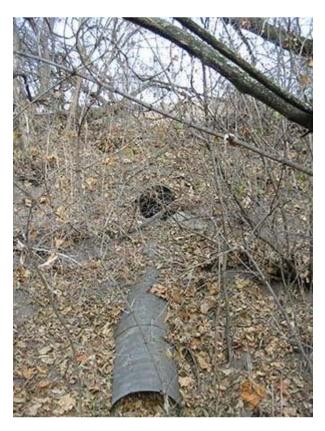
Culvert outlet

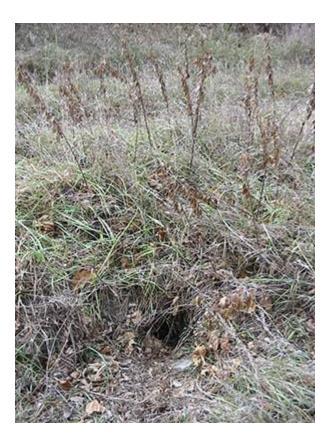
Culvert inlet

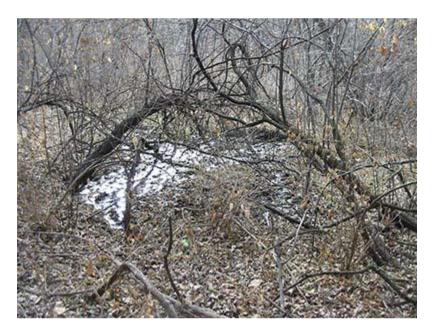
Spring

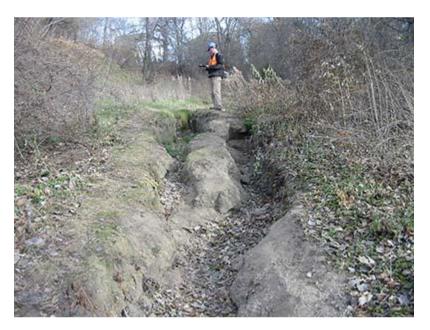
Eroded path/severe 100 yards from gate to w.p.

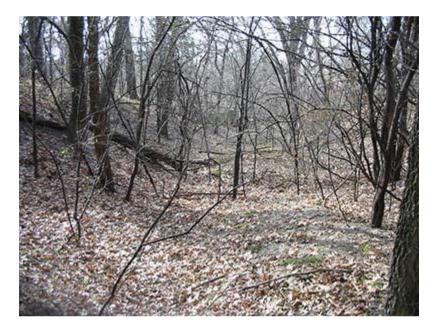
Top of gully/some erosion apparent

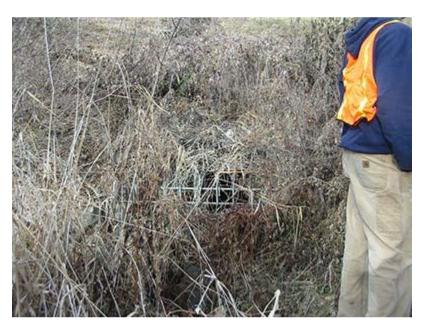
Culvert exit /spring

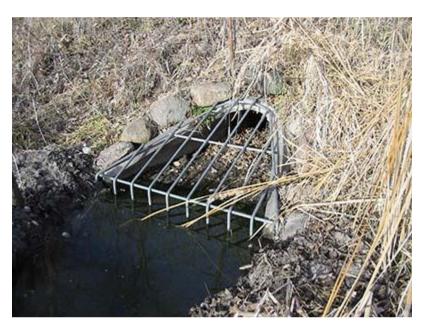
Culvert outlet

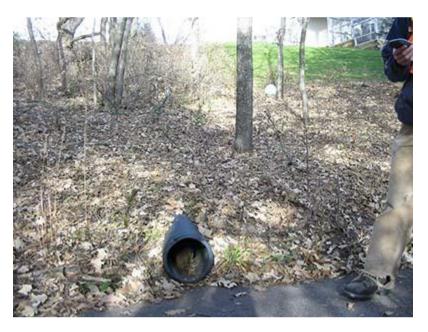
Residential pipe outlet

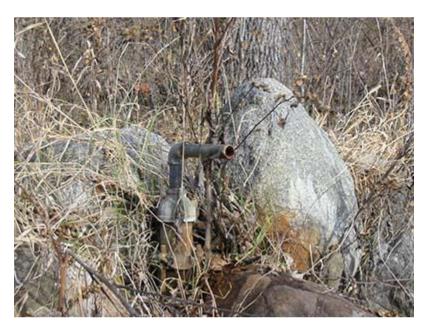
Small pipe outlet into pond

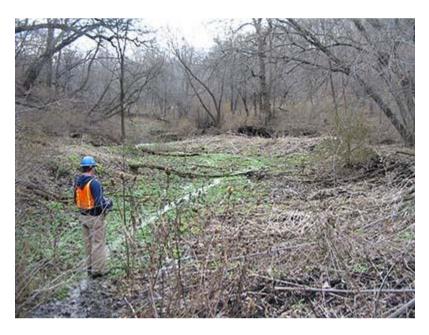
Large spring

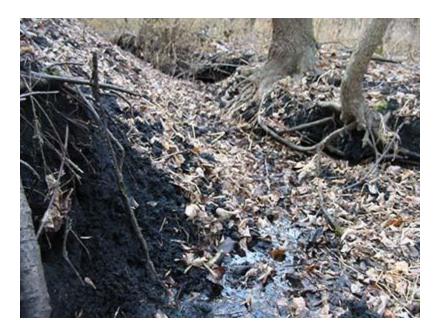
Small gully erosion

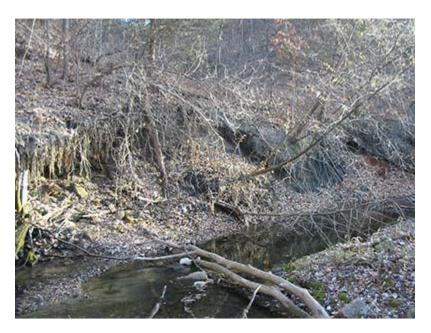
Severely eroded stream bank adjacent to tunnel

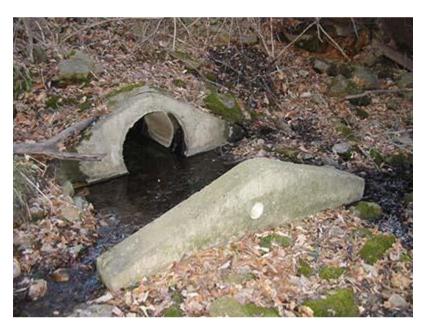
Culvert exit

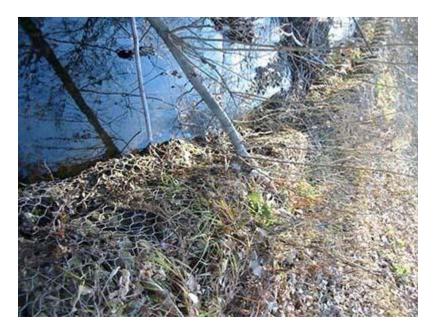
Caged riprap erosion control

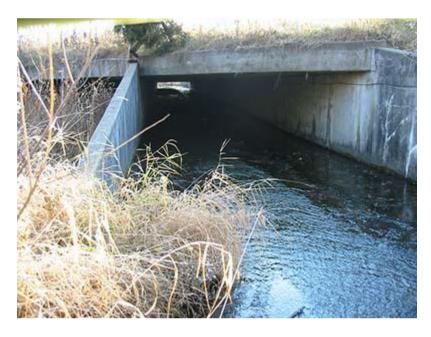
Culvert entrance

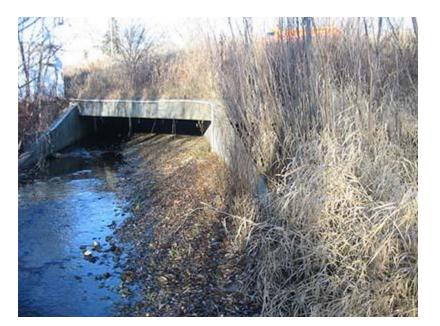
Culvert exit

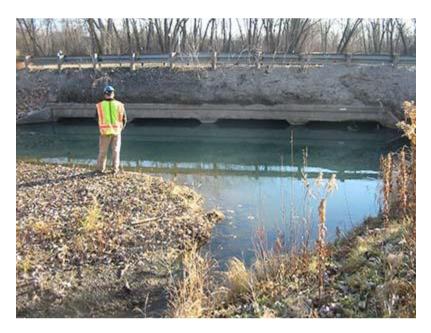
Culvert entrance

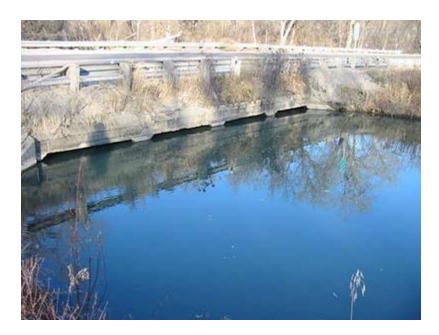
Culvert exit
