<b>Gully ID:</b> 07:15-11:41	<b>MAP</b>

<b>Date &amp; Time:</b> July 15, 2021 11:41 AM	
<b>Location:</b> Burnsville	
<b>Weather:</b> Sunny <b>Storm/Rainfall Event in the Past 24 Hours?</b> Yes-High Intensity	
<b>GULLY INFORMATION</b>	
<b>Calculated Erosion Potential:</b>	Low
<b>Approximate Depth:</b>	3-Medium (3'-15')
<b>Approximate Bottom Width:</b>	1-Wide (>5')
<b>Approximate Gully Length:</b>	3-Medium (50'-100')
<b>Condition of Gully Bottom:</b>	1-Heavy Vegetation
<b>Condition of Gully Banks:</b>	1-Heavy Vegetation
<b>Gully Bank Angles:</b>	3-Mid-Range (45 to 90 degrees)
<b>Gully Shape:</b>	1-Trapezoid
<b>Gully Material:</b>	Silt/Clay

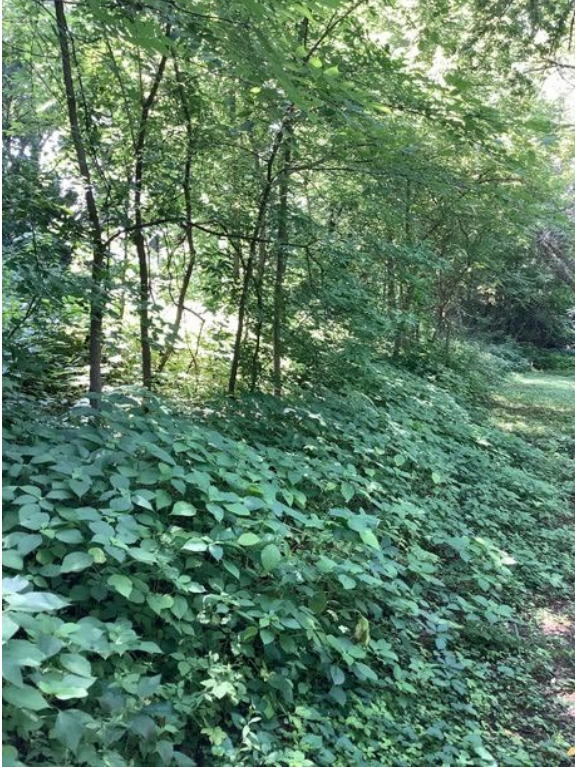
**Photo 1 Image**

Left bank

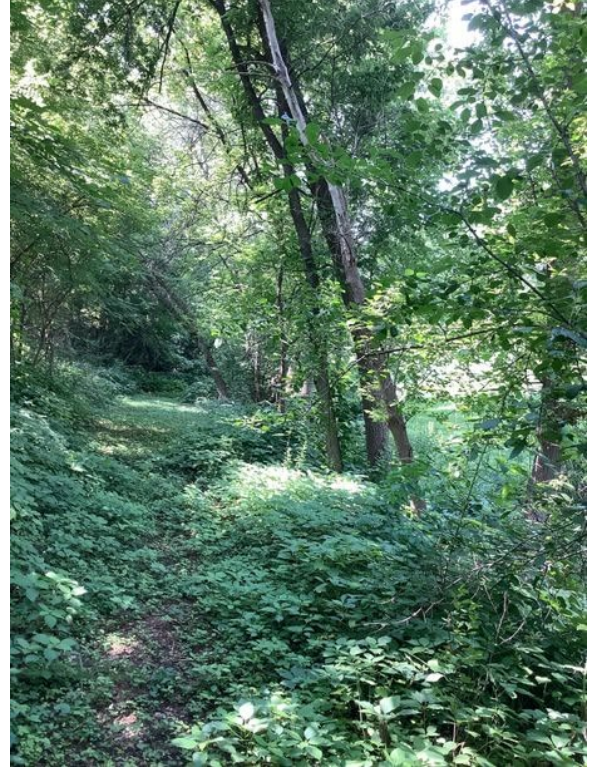
**Photo 2 Image**

Right bank

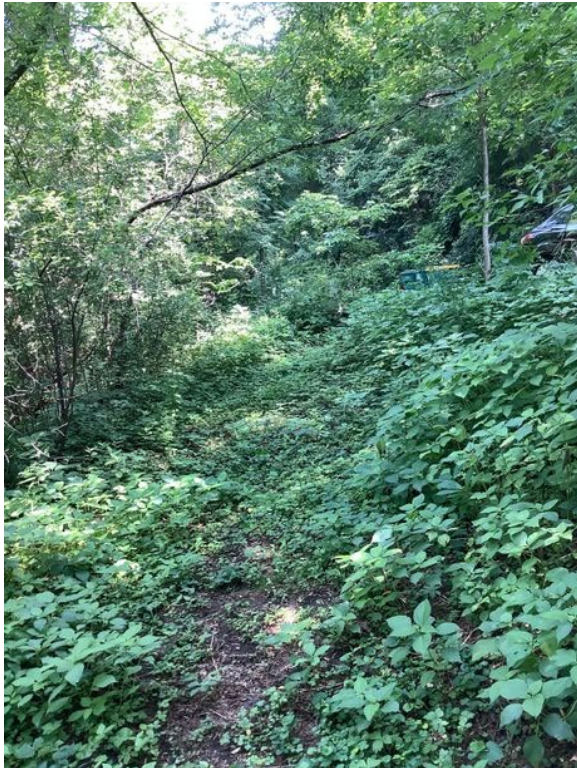
**Photo 3 Image**

Top of gully

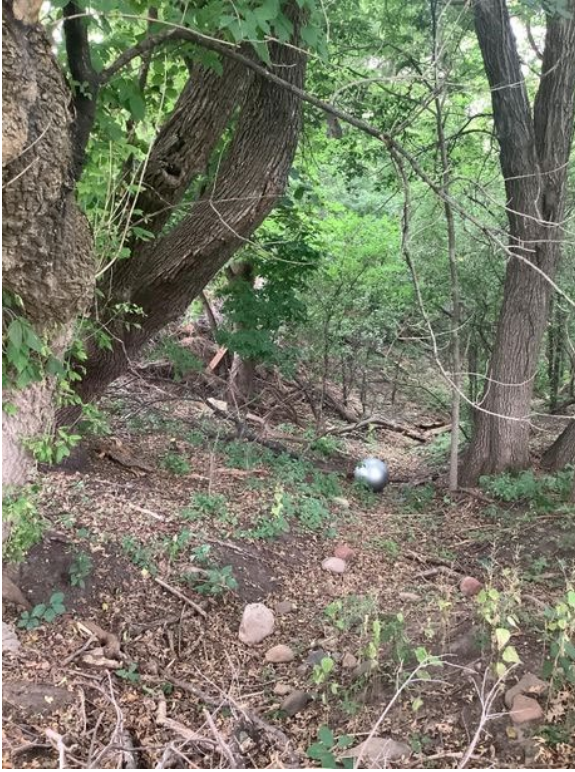
**Photo 1 Image**

**Photo 1 Caption**  
Downstream view of left bank with yard debris piling up behind tree.

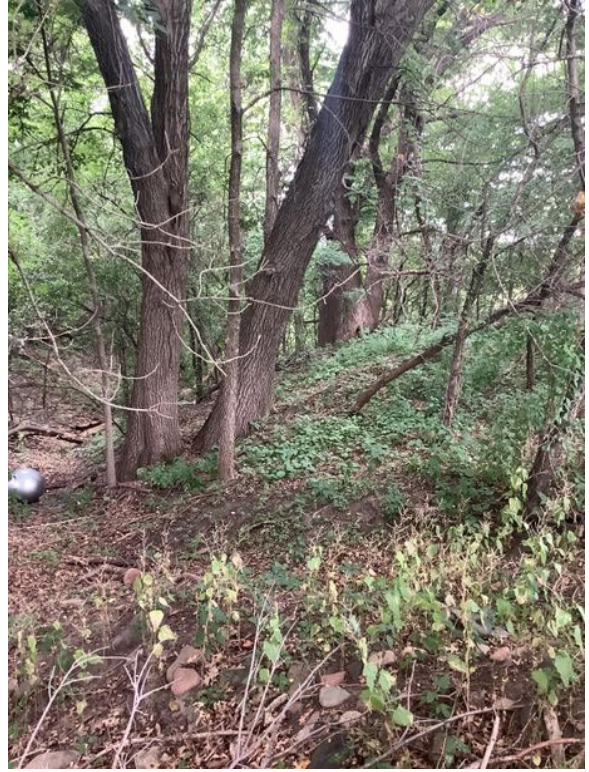
**Photo 2 Image**

**Photo 2 Caption**  
Downstream view of right bank.

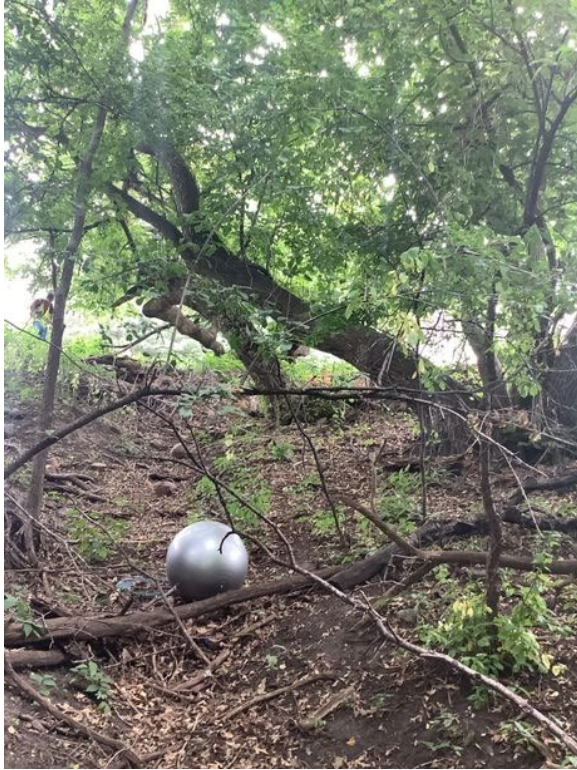
**Photo 3 Image**

Upstream view of left banks large leaning trees at the top of the gully.

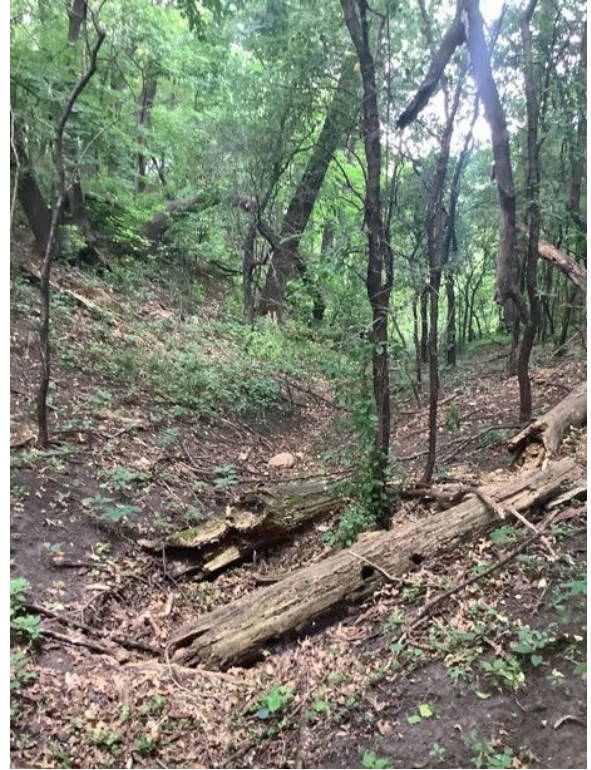
**Photo 4 Image**

Downstream view of area before it cuts down and worsens, another point was taken at that point.

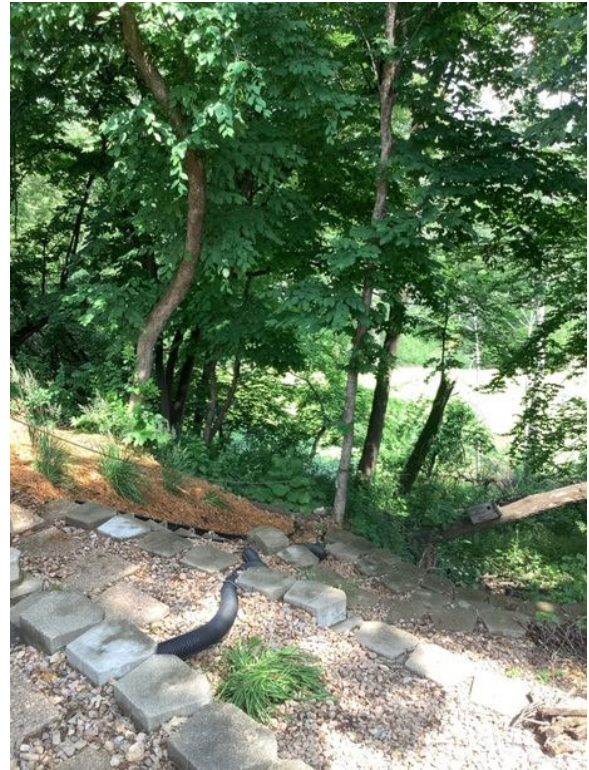
**Photo 2 Image**

Downstream view of left bank.

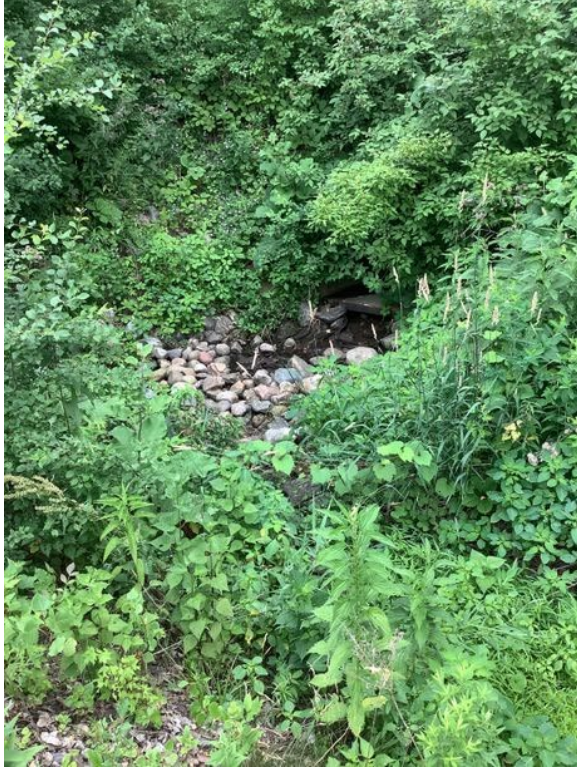
**Photo 1 Image**

Upstream view from railroad tracks.

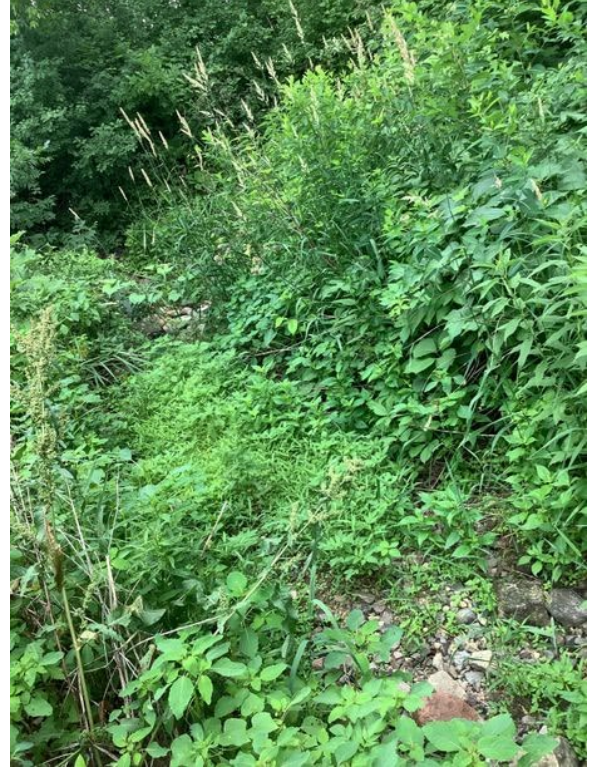
**Photo 2 Image**

Upstream view of channel from the bottom. The second and third metal pipe outfalls are on the left hidden behind vegetation.

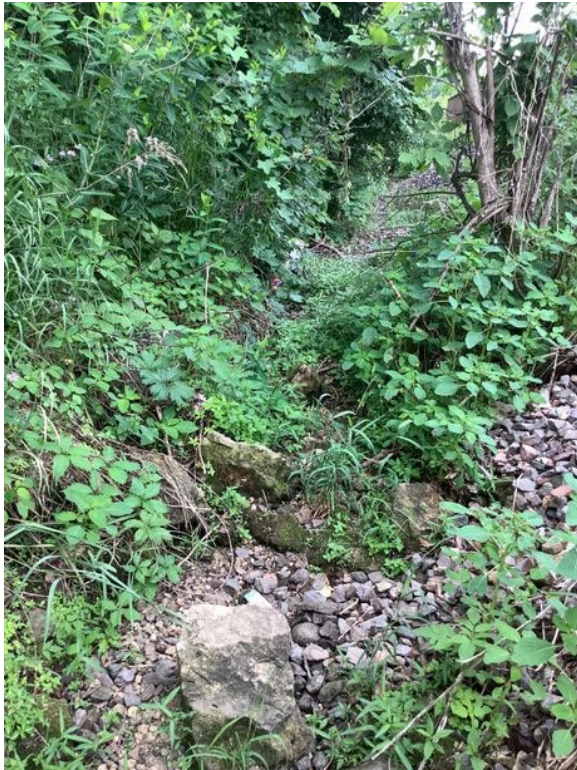
**Photo 3 Image**

Downstream view from bottom of gully. Some toys were throwing down here. This part of the channel is very dry.

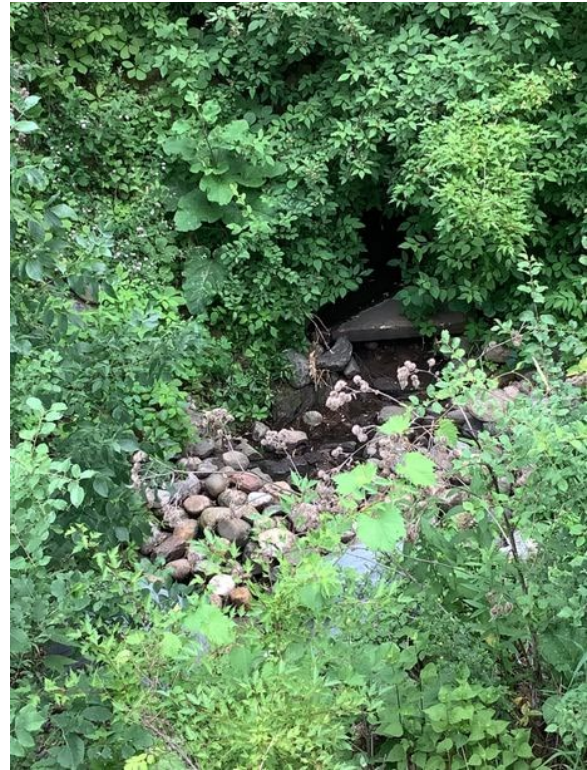
**Photo 4 Image**

Upstream view of the three pipes. Was hard to get picture with steep slope of loose rocks and heavy vegetation.

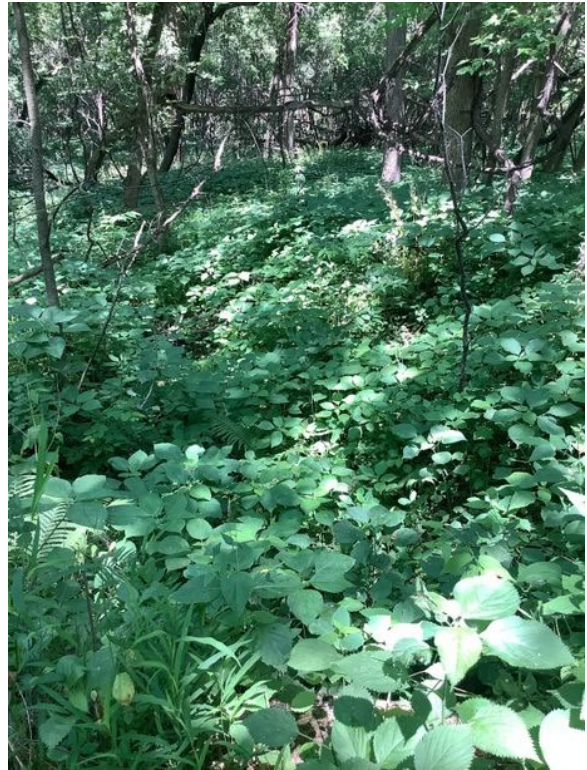
**Photo 2 Image**

Downstream view of gully from trail

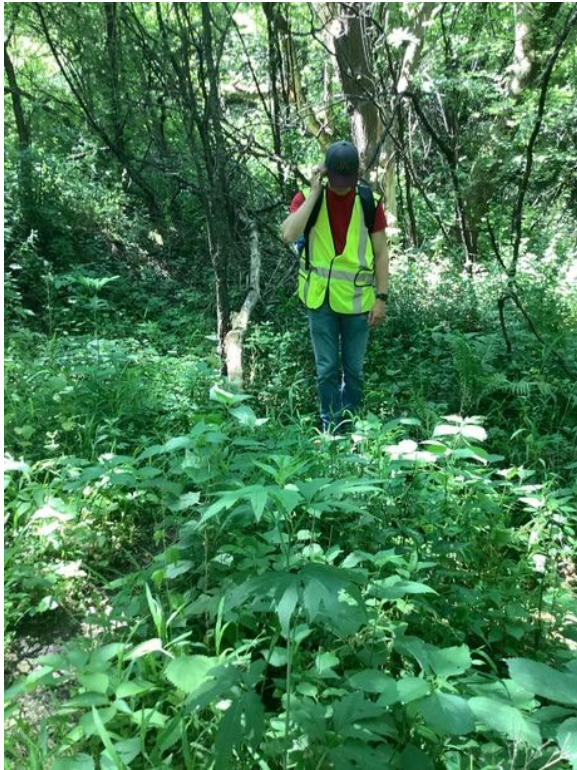
**Photo 3 Image**

View of left bank where gully runs through trail.

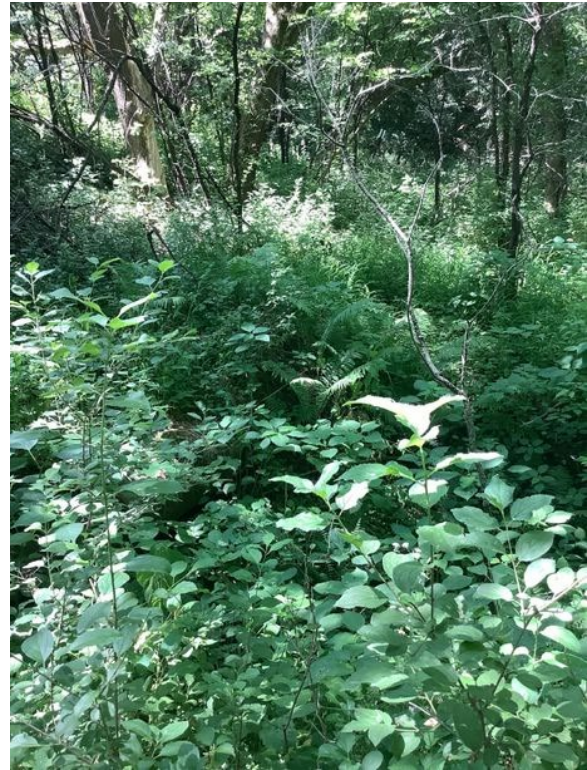
**Photo 4 Image**

Upstream from right bank where gully falls deeper after trail.

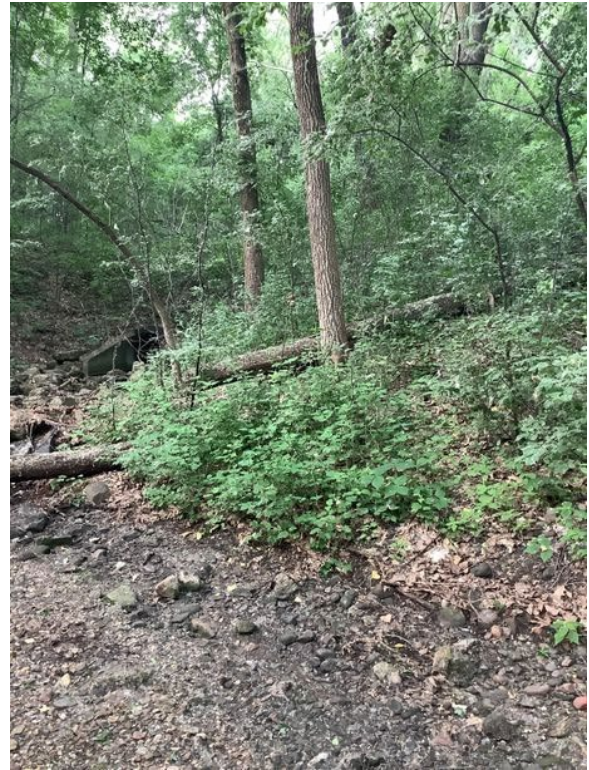
**Photo 2 Image**

Upstream view of left bank and pipe.

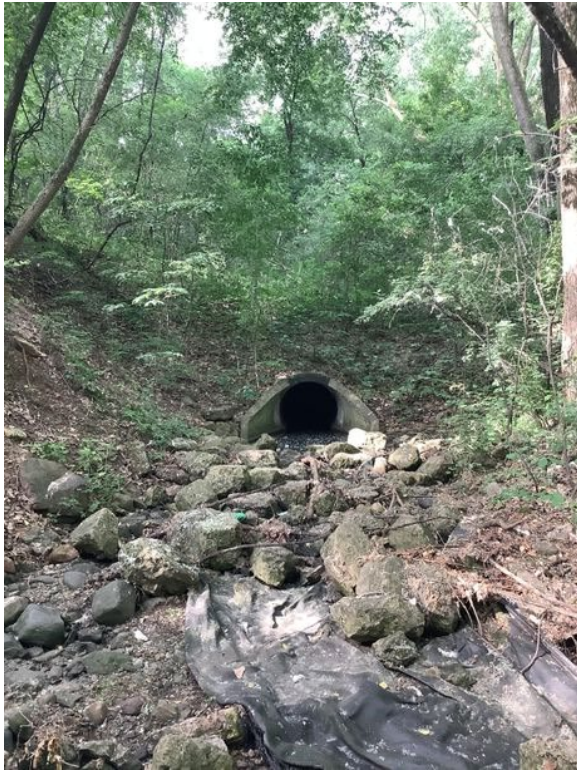
**Photo 3 Image**

Upstream view of pipe that is armored and has dripping water.

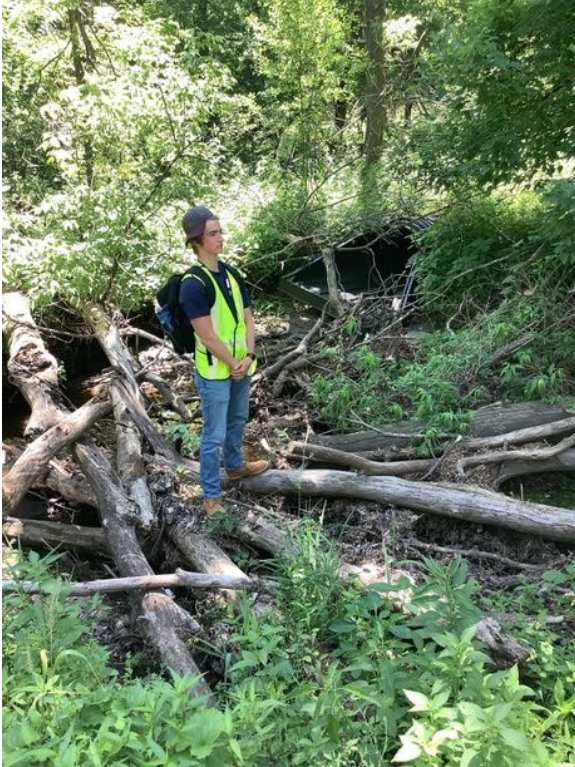
**Photo 1 Image**

Upstream view of pip from tracks.

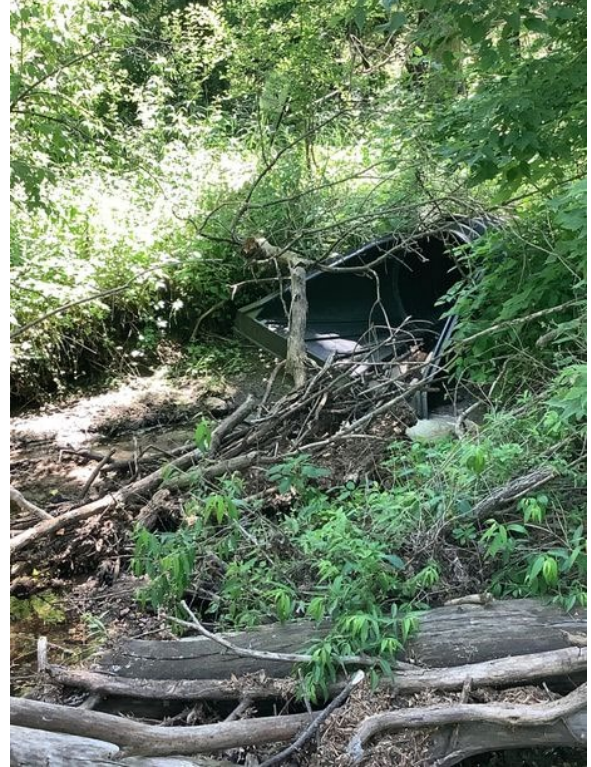
**Photo 2 Image**

Zoomed in view of pipe showing heavy degradation around it

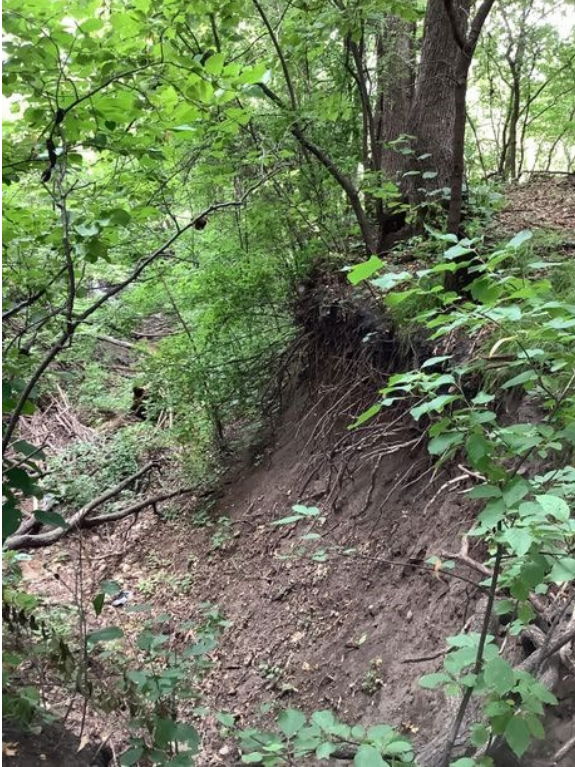
**Photo 1 Image**

Right bank

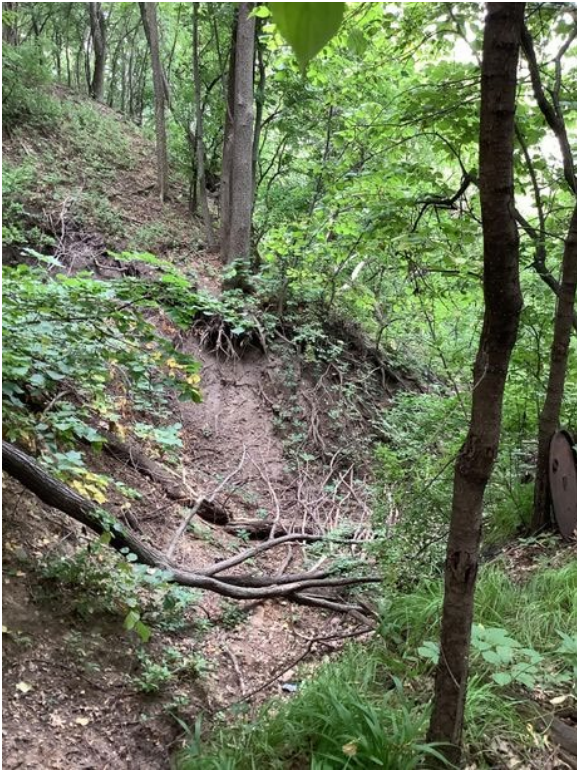
**Photo 3 Image**

Left bank

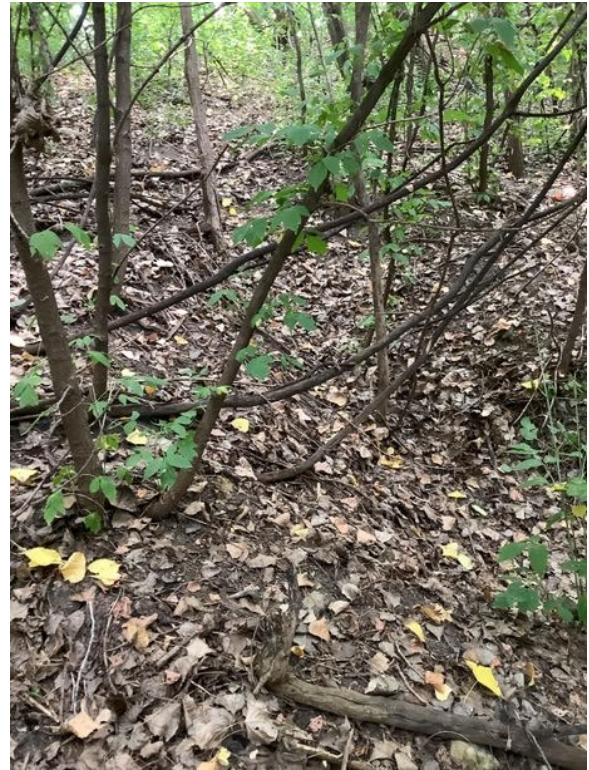
**Photo 2 Image**

Upstream view of gully.

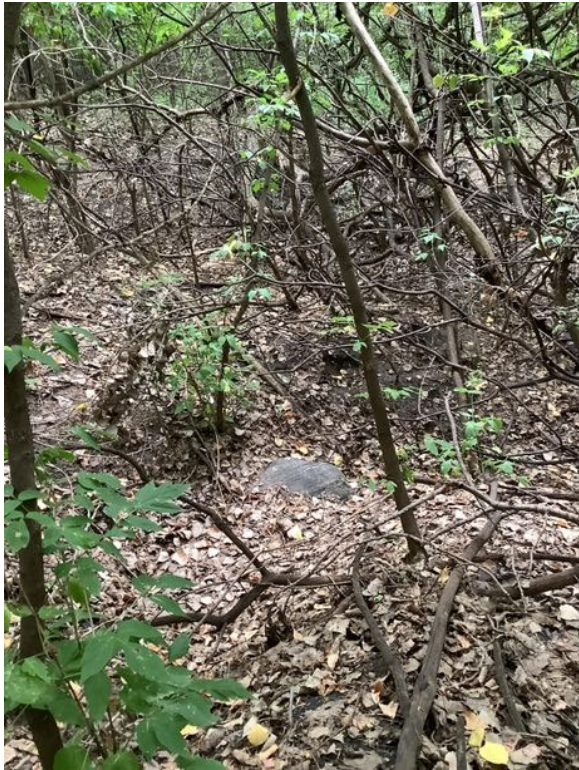
**Photo 3 Image**

Downstream view of further downstream in the channel.

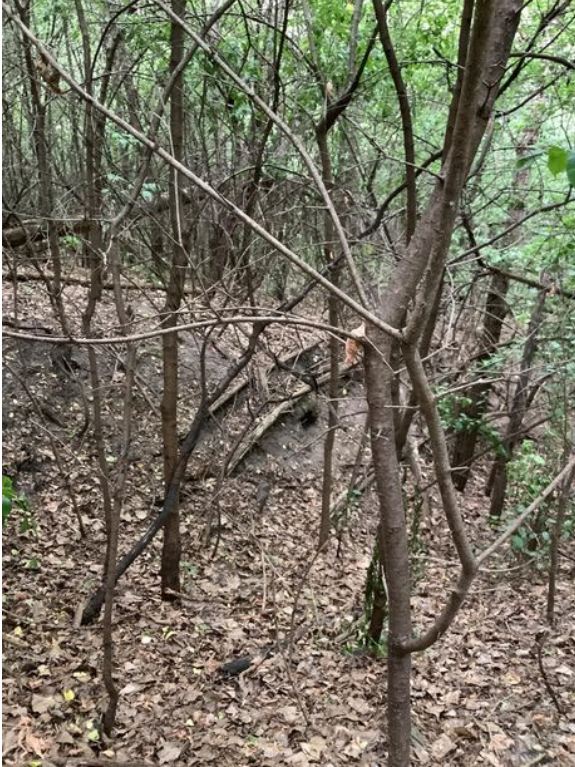
**Photo 1 Image**

Downstream view of gully. Severe degradation visible on left bank.

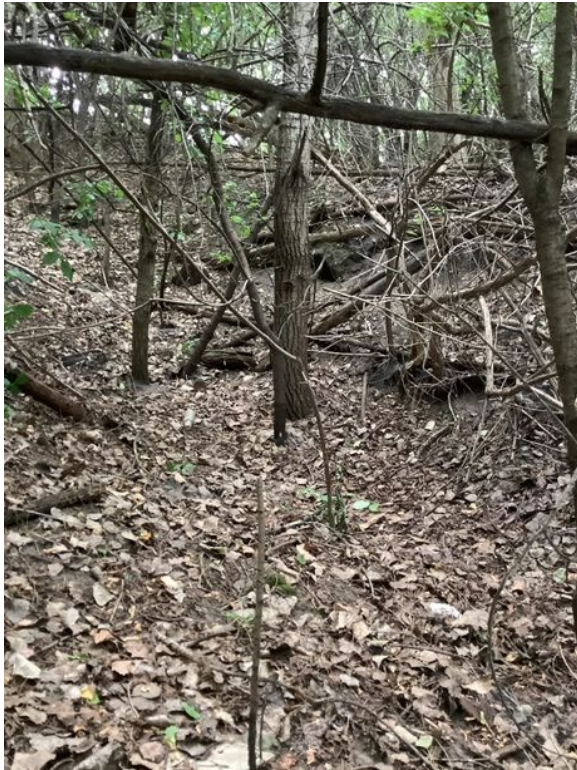
**Photo 3 Image**

Upstream view of gully.

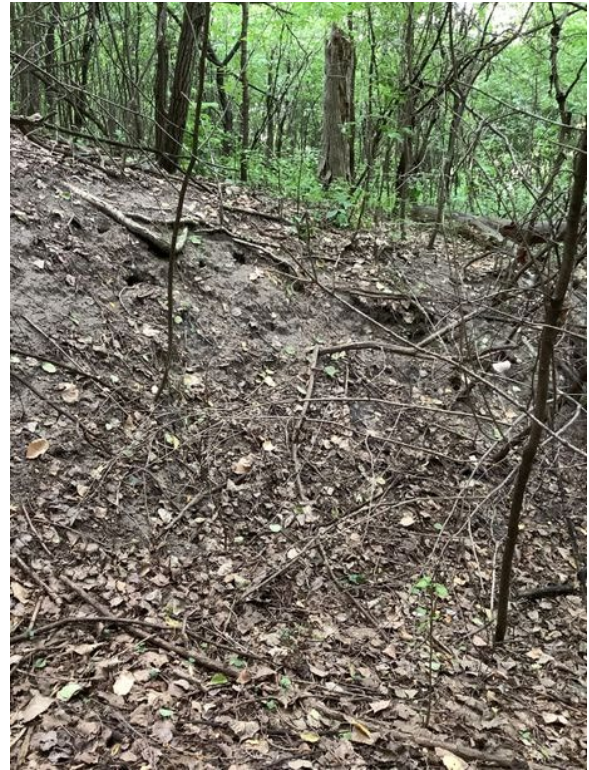
**Photo 4 Image**

View of left bank where there are tiny holes in the bank.

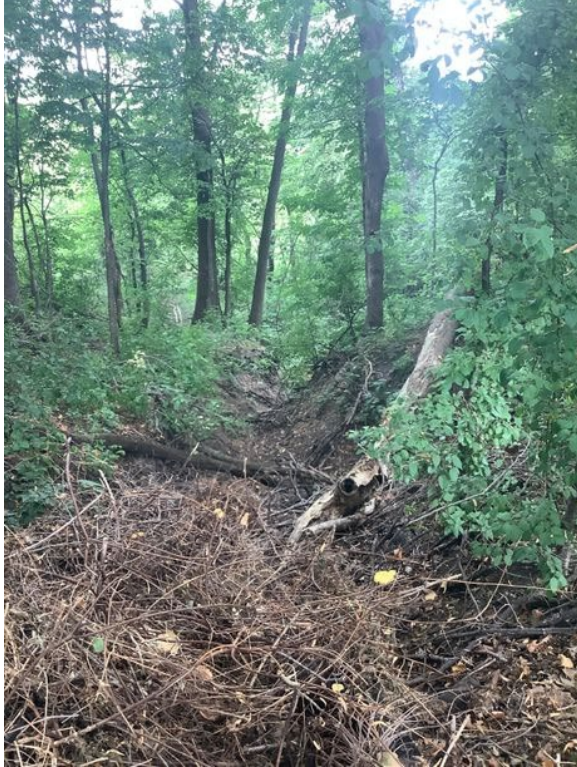
**Photo 1 Image**

Downstream view from top of gully.

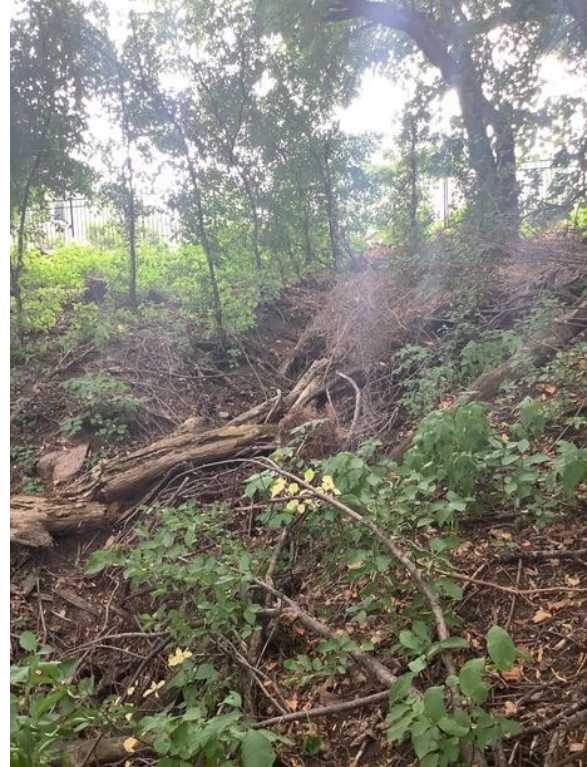
**Photo 2 Image**

Upstream, view of gully headcut.

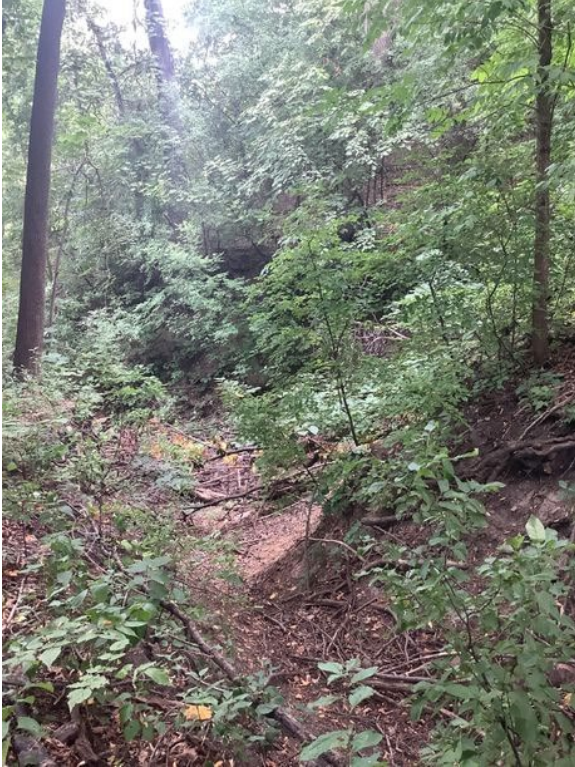
**Photo 3 Image**

Downstream, view of where this gully connects into the left bank of a large gully.

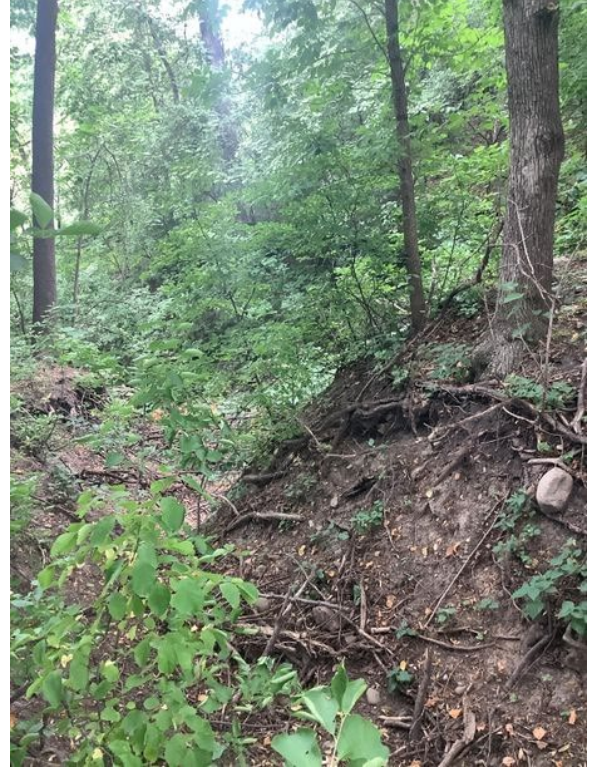
**Photo 4 Image**

Downstream view of severe degradation on the right bank.

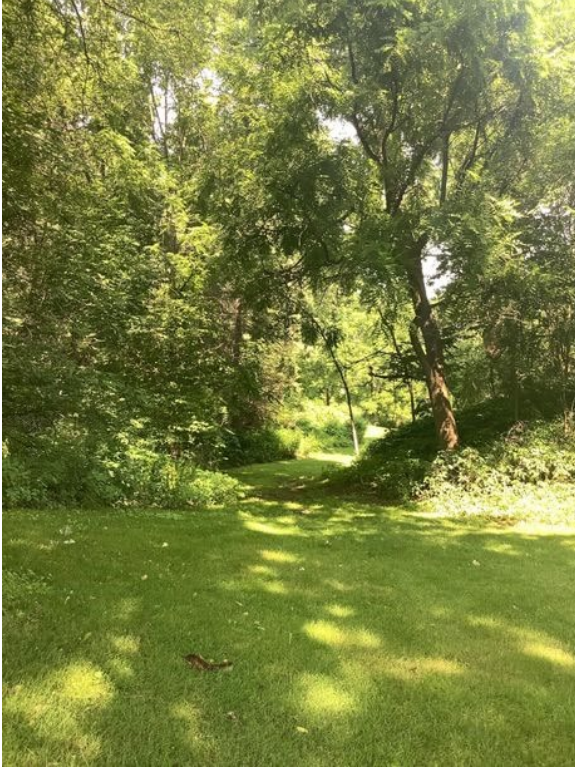
**Photo 1 Image**

Downstream view of gully. Can see some leaning trees.

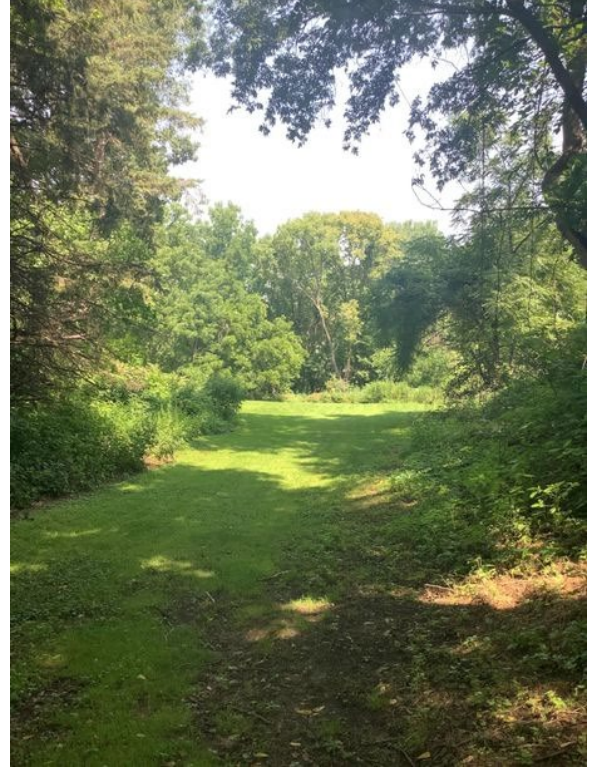
**Photo 2 Image**

Downstream view of end of gully where it drains into an open grassy area.

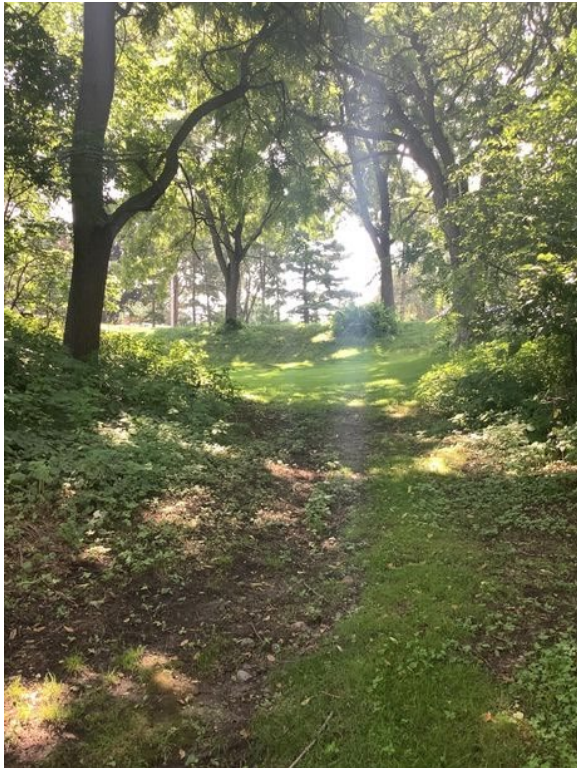
**Photo 3 Image**

Upstream view of open grassy area at beginning of gully.

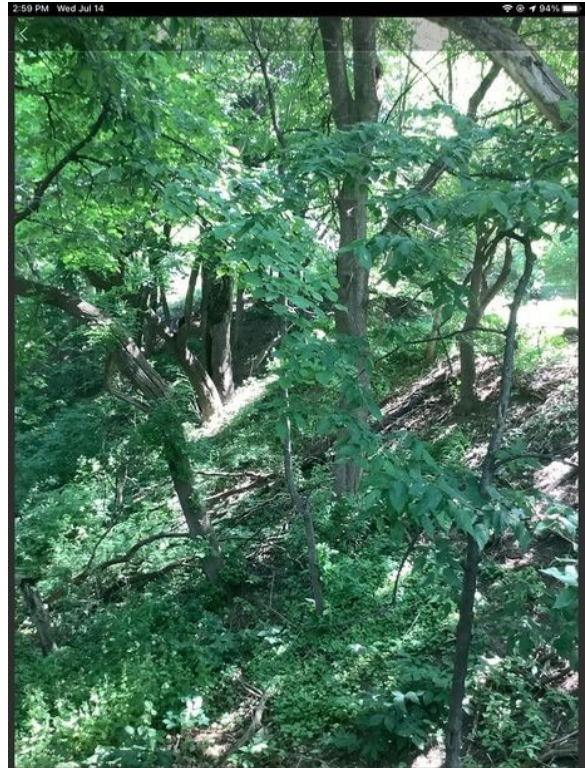
**Photo 2 Image**

View of left bank from top of gully.

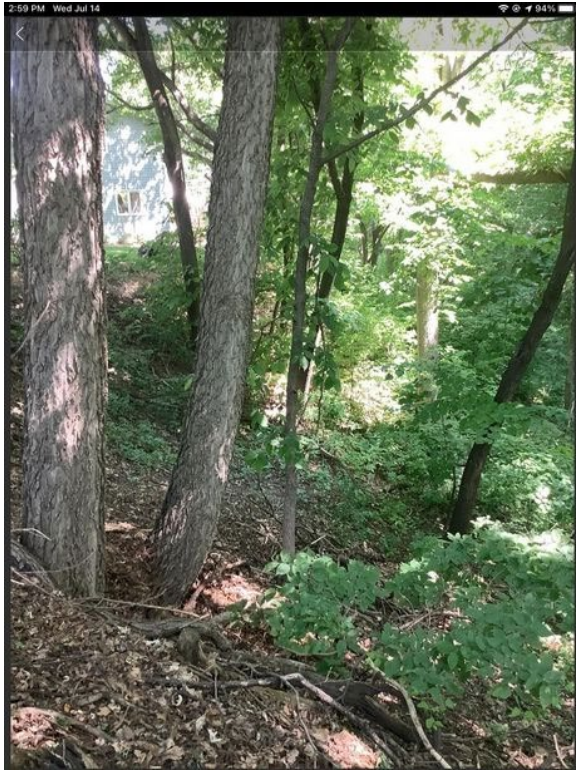
**Photo 3 Image**

View of right bank from top of gully. Can see fallen and slumping trees.

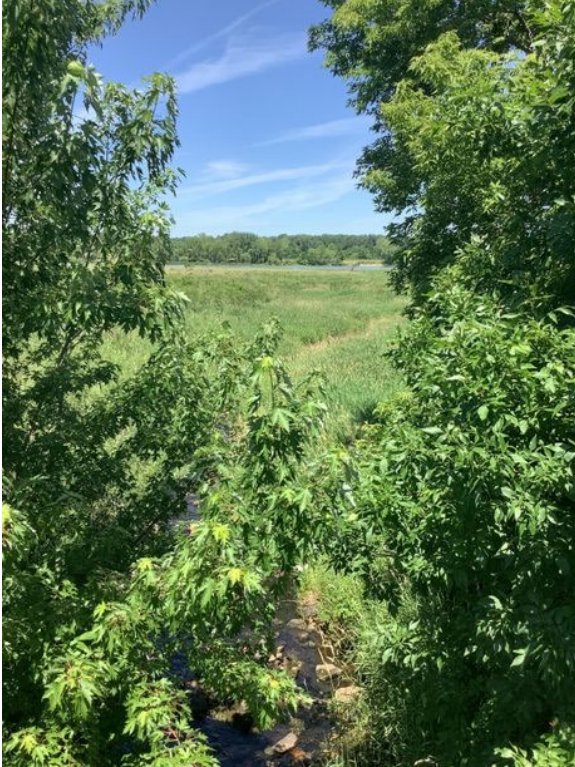
**Photo 1 Image**

Downstream view of gully winding through grass and showing its length and proximity to the river.

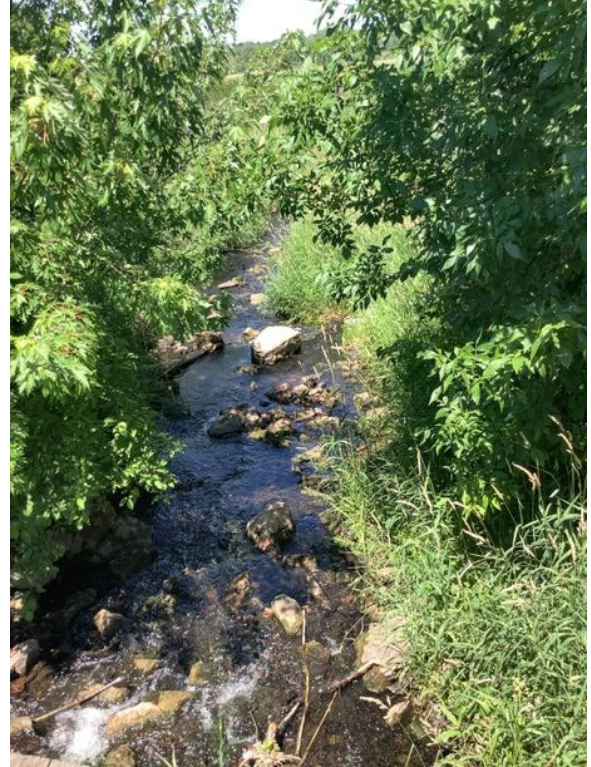
**Photo 2 Image**

Downstream view of beginning of gully with lots of water flowing through.

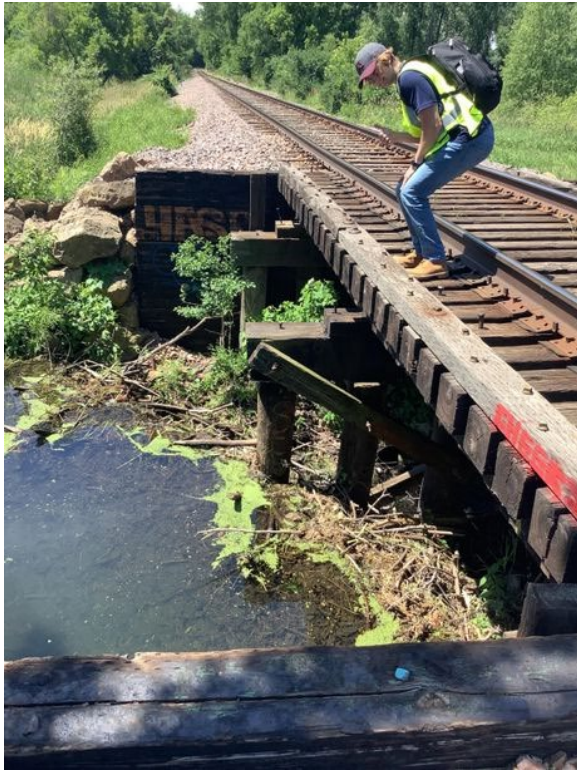
**Photo 3 Image**

View of left bank on south side of railroad tracks. Gully begins after dam which separates the pond from the gully.

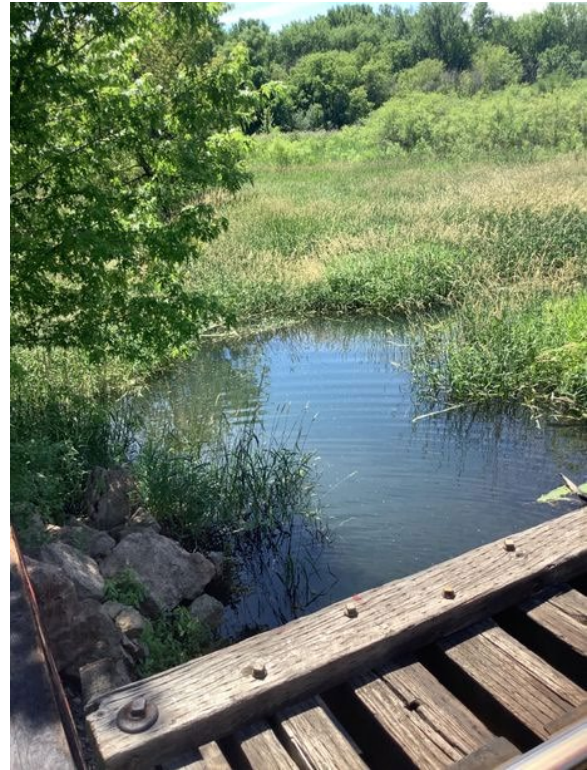
**Photo 4 Image**

Upstream view of pond south of railroad tracks which is the water source for the gully.

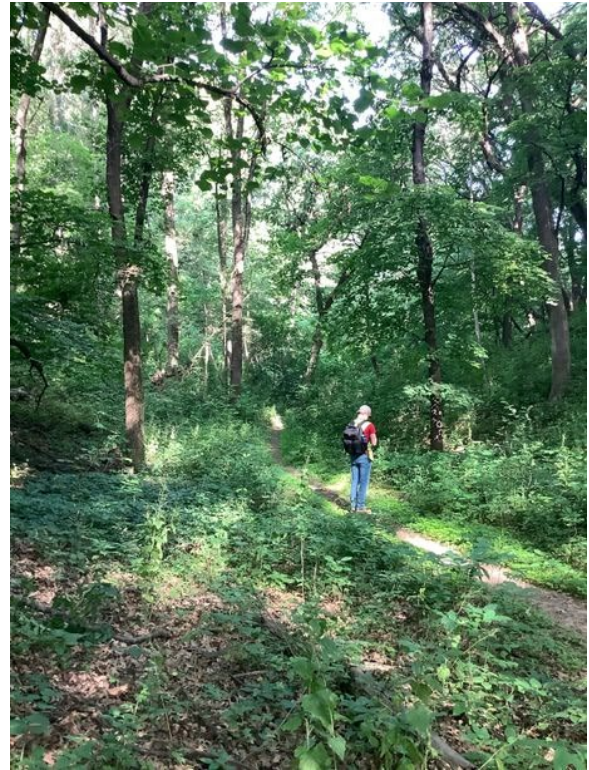
**Photo 2 Image**

Downstream view of gully with some leaning trees in the background.

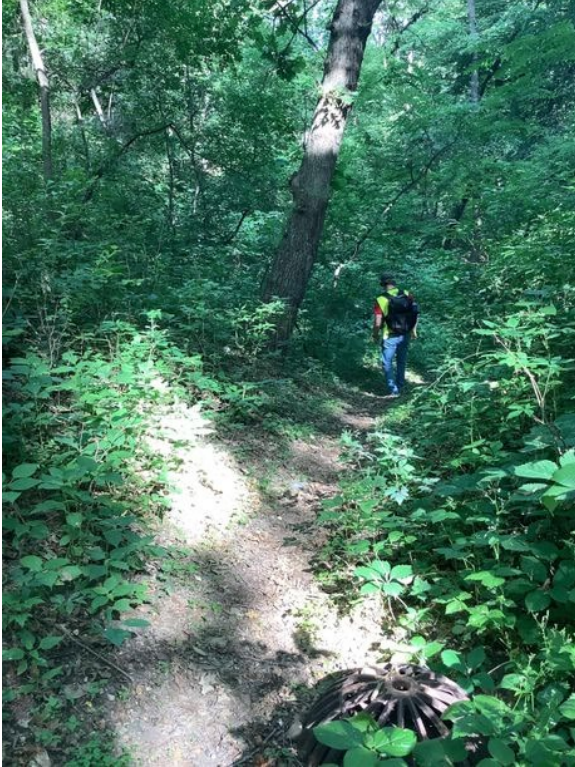
**Photo 3 Image**

Downstream view of gully. Sewer drain is located in the bottom right of the picture.

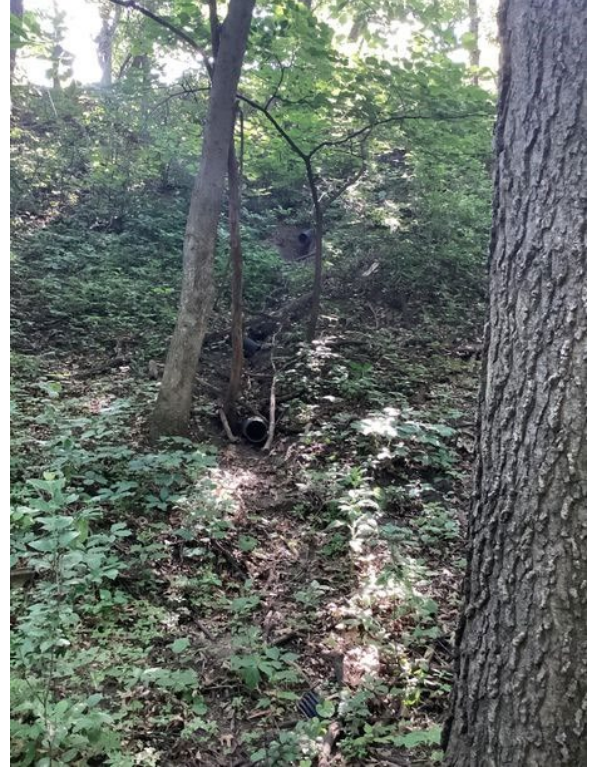
**Photo 4 Image**

With of right bank about 100 ft downstream from the beginning of the gully of residential run off pipes.

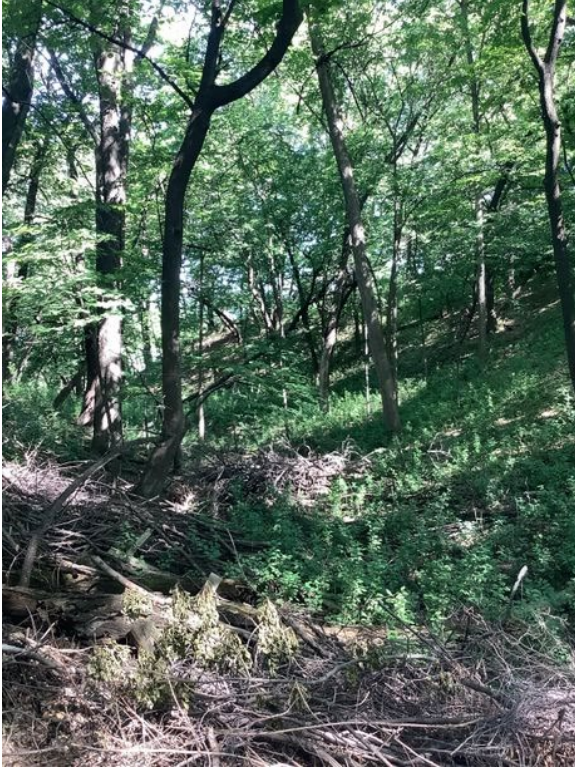
**Photo 1 Image**

Downstream view from left bank.

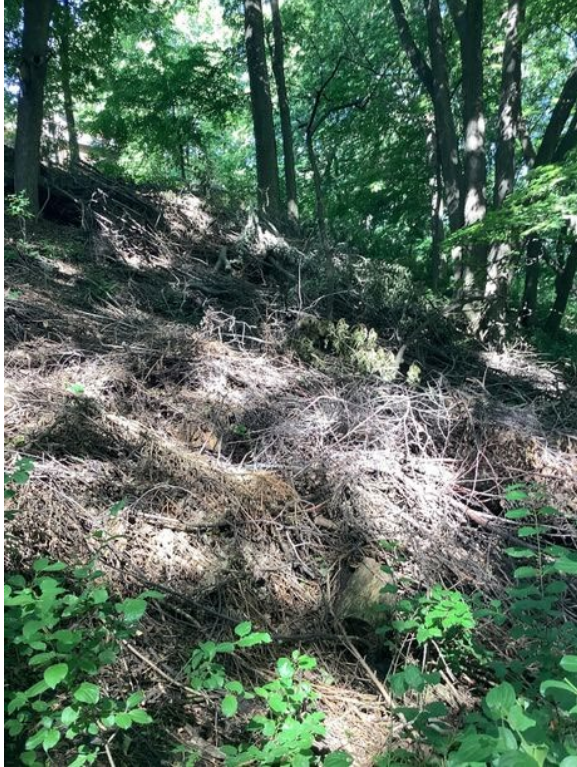
**Photo 3 Image**

View of left bank covered in yard waste.

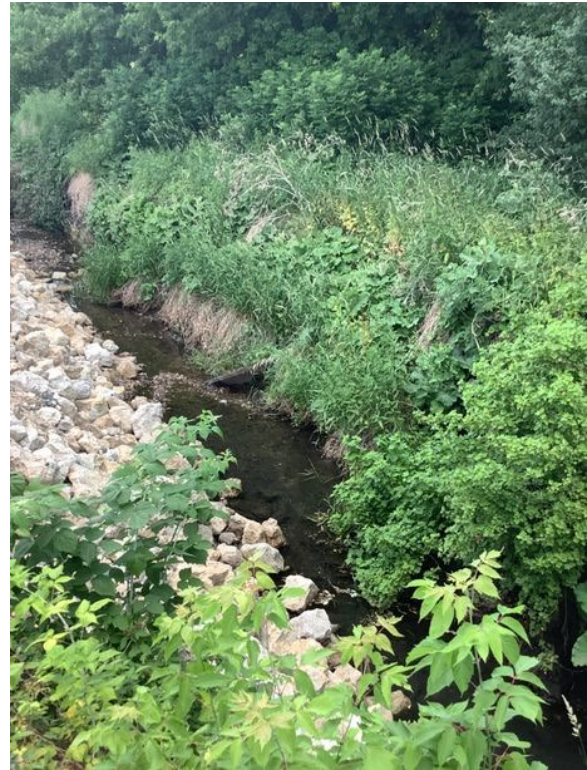
**Photo 2 Image**

View downstream from pipe. Left bank is armored but right bank has lots of slumping and degradation

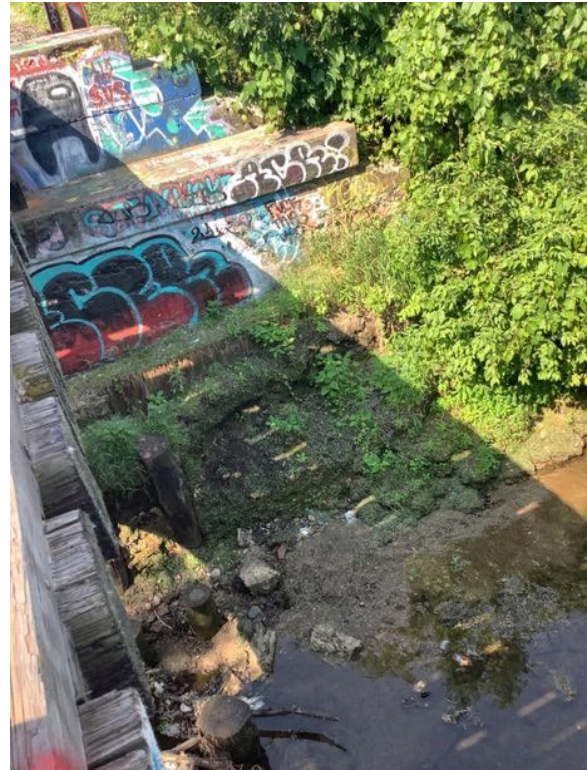
**Photo 2 Image**

Left bank view under railroad bridge showing signs of lots of degradation.

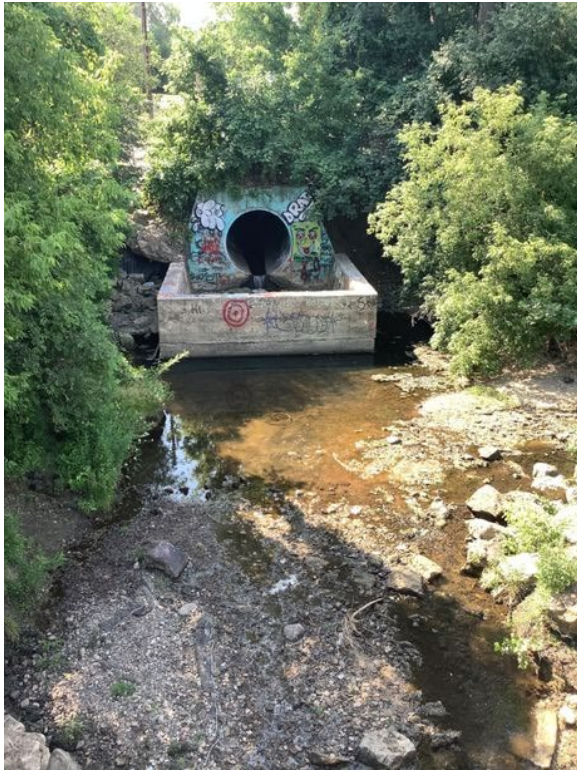
**Photo 3 Image**

Upstream view of pipe outfall in center and creek flowing into gully from its left bank near the pipe.

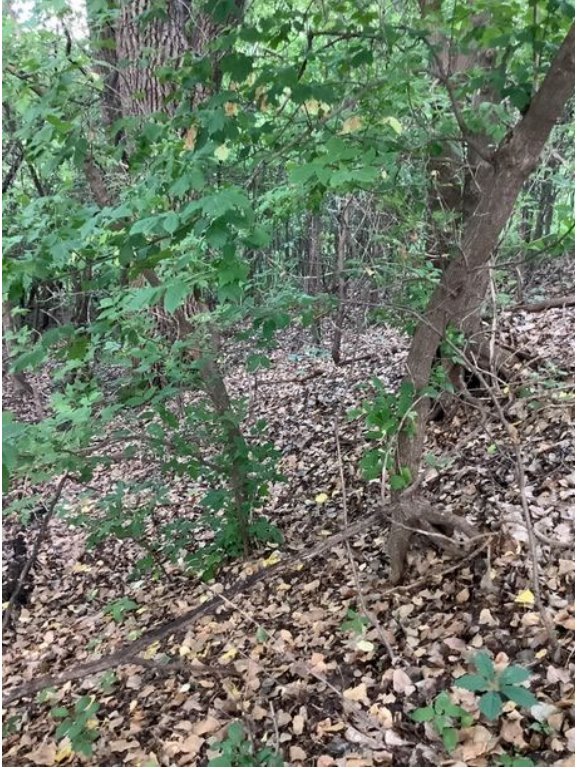
**Photo 1 Image**

Downstream view of right bank, lots of degradation around tree roots

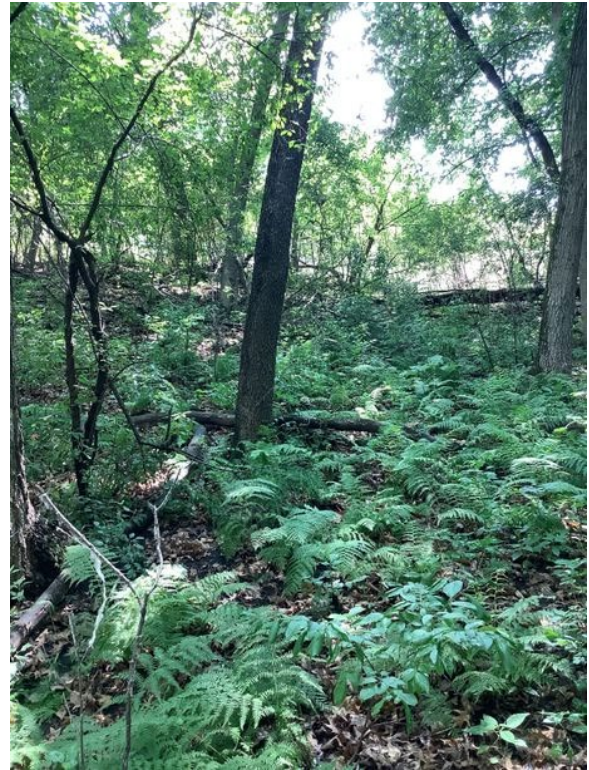
**Photo 2 Image**

Upstream view of right bank.
