<b>Gully ID:</b> 07:15-11:41	<b>MAP</b>

<b>Date &amp; Time:</b> July 15, 2021 11:41 AM	
<b>Location:</b> Burnsville	
<b>Weather:</b> Sunny <b>Storm/Rainfall Event in the Past 24 Hours?</b> Yes-High Intensity	
<b>GULLY INFORMATION</b>	
<b>Calculated Erosion Potential:</b>	Low
<b>Approximate Depth:</b>	3-Medium (3'-15')
<b>Approximate Bottom Width:</b>	1-Wide (>5')
<b>Approximate Gully Length:</b>	3-Medium (50'-100')
<b>Condition of Gully Bottom:</b>	1-Heavy Vegetation
<b>Condition of Gully Banks:</b>	1-Heavy Vegetation
<b>Gully Bank Angles:</b>	3-Mid-Range (45 to 90 degrees)
<b>Gully Shape:</b>	1-Trapezoid
<b>Gully Material:</b>	Silt/Clay

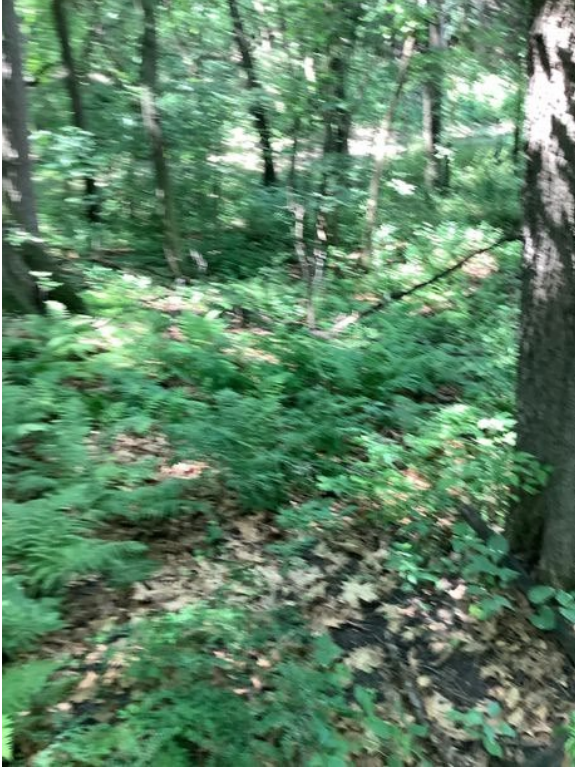
**Photo 3 Image**

Downstream view where gully flattens out and connects to other site.

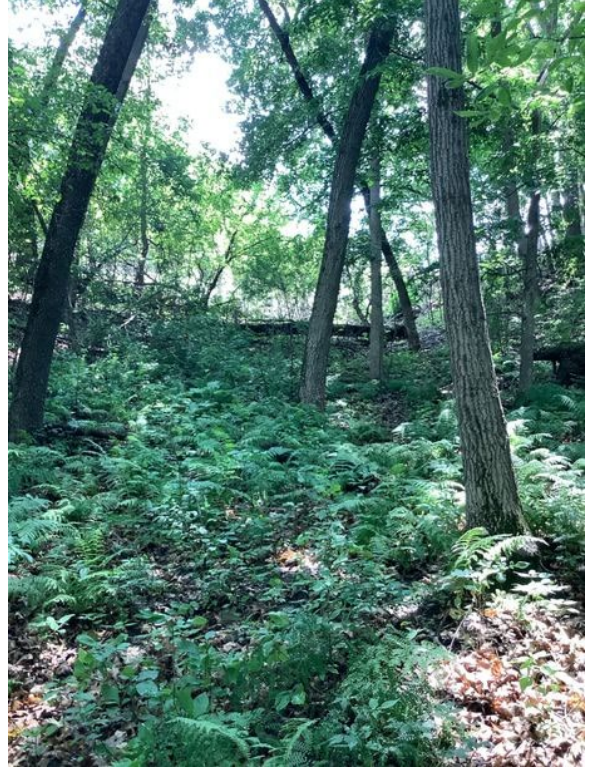
**Photo 4 Image**

Upstream view of center of gully showing leaning trees.

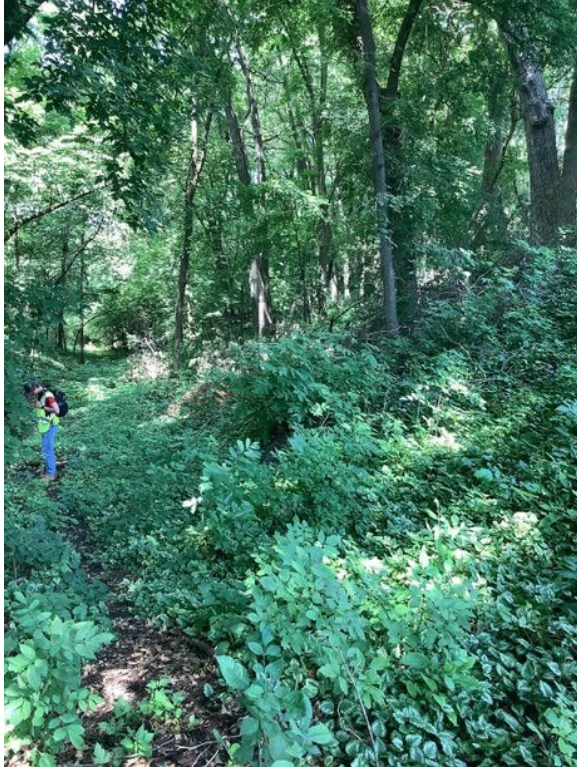
**Photo 1 Image**

Downstream view right bank.

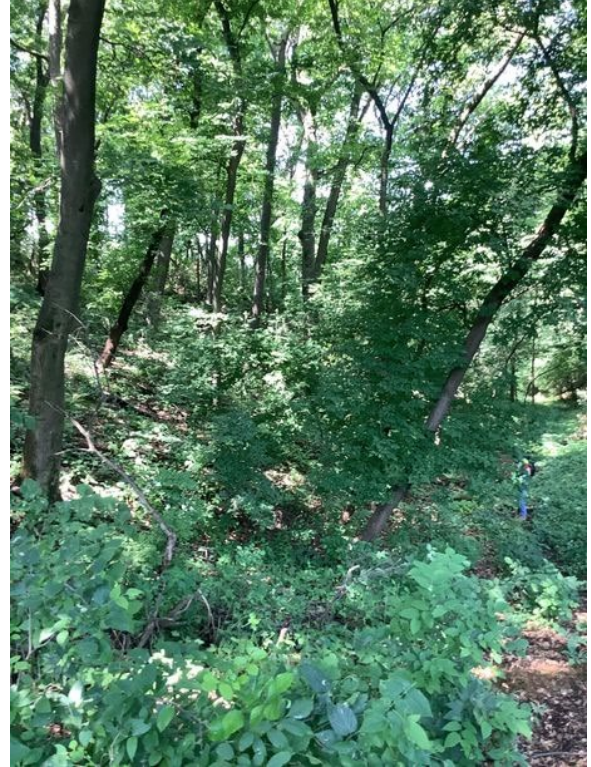
**Photo 2 Image**

Downstream view left bank.

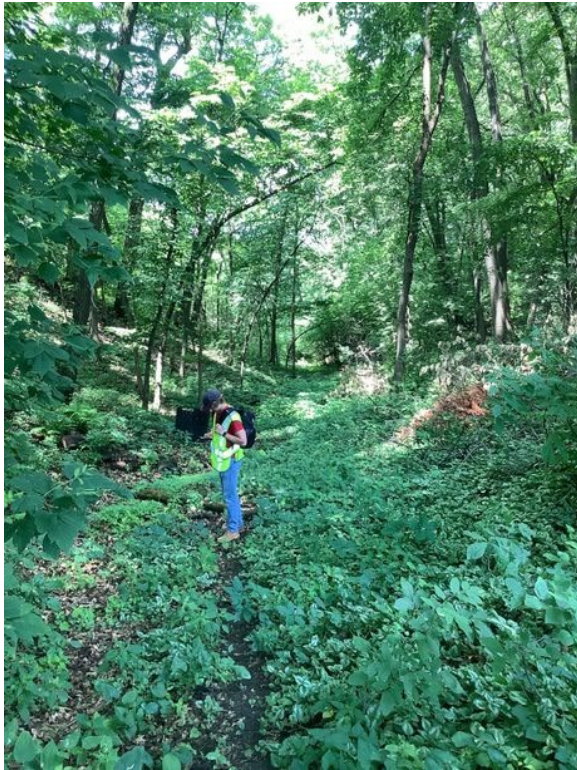
**Photo 3 Image**

Downstream view center

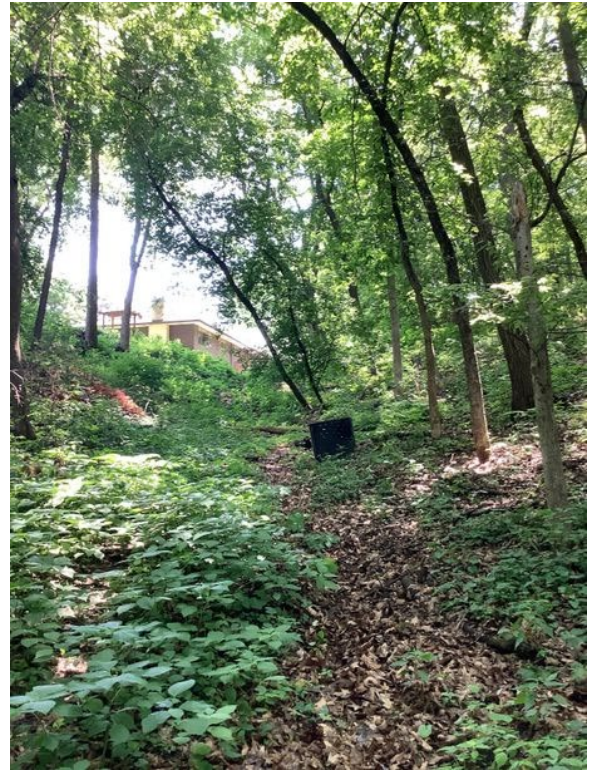
**Photo 4 Image**

Upstream view of gully.

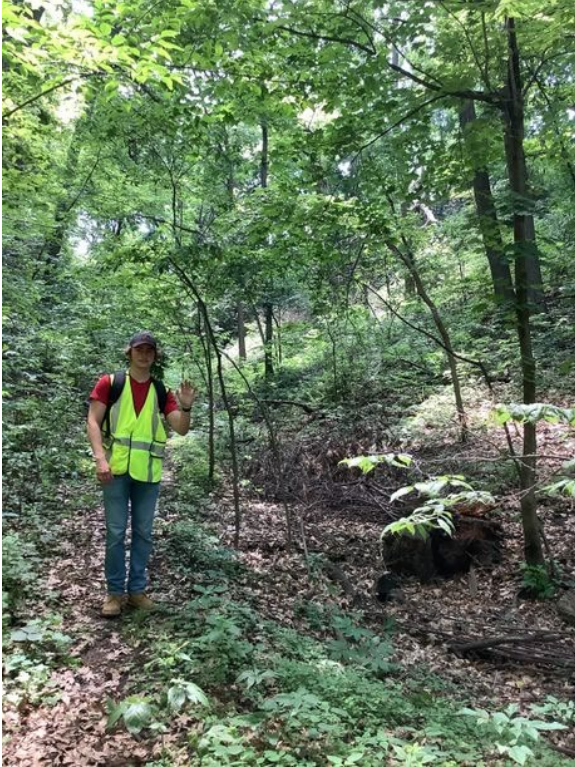
**Photo 1 Image**

View upstream of left bank.

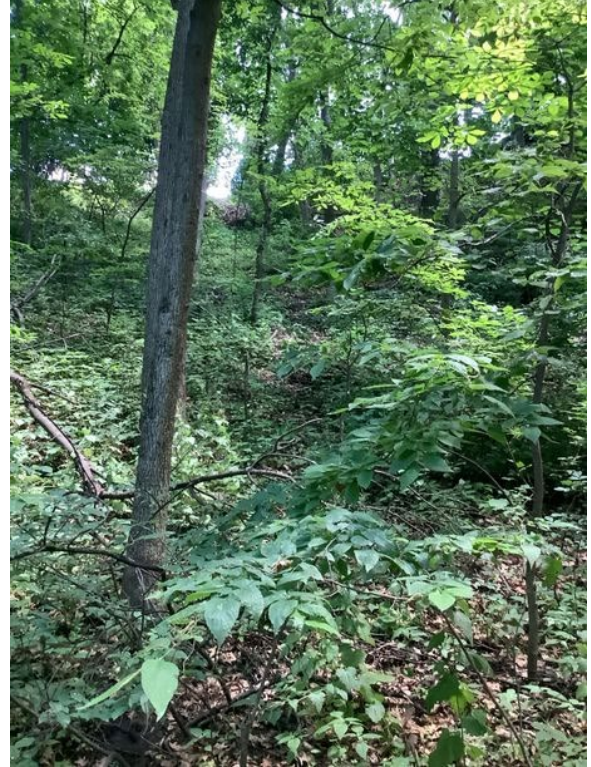
**Photo 2 Image**

Right bank view from bottom of gully.

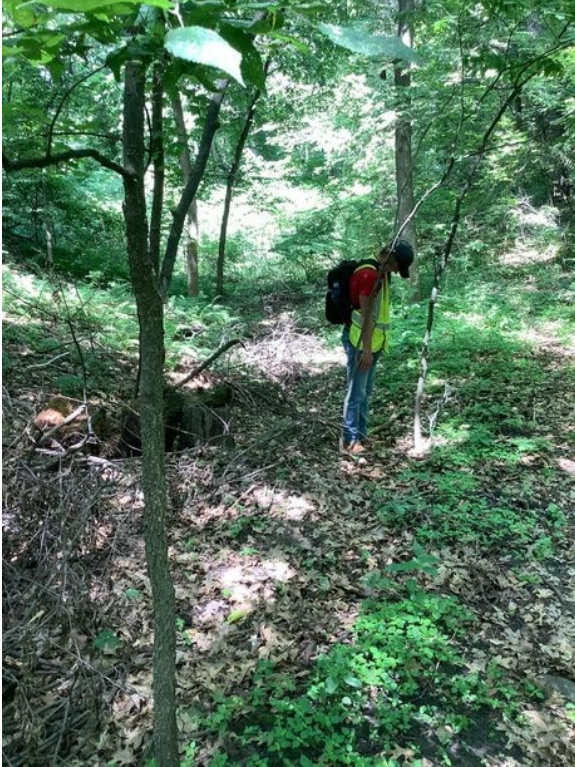
**Photo 3 Image**

Downstream view of center of gully, there is a mini gully running through the bottom but it is filled with a lot of branches which makes it hard to see

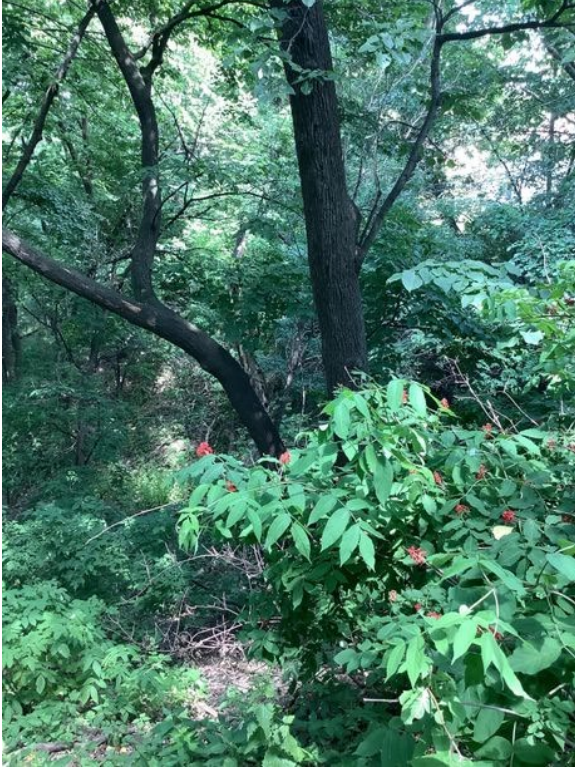
**Photo 1 Image**

Downstream view of right bank.

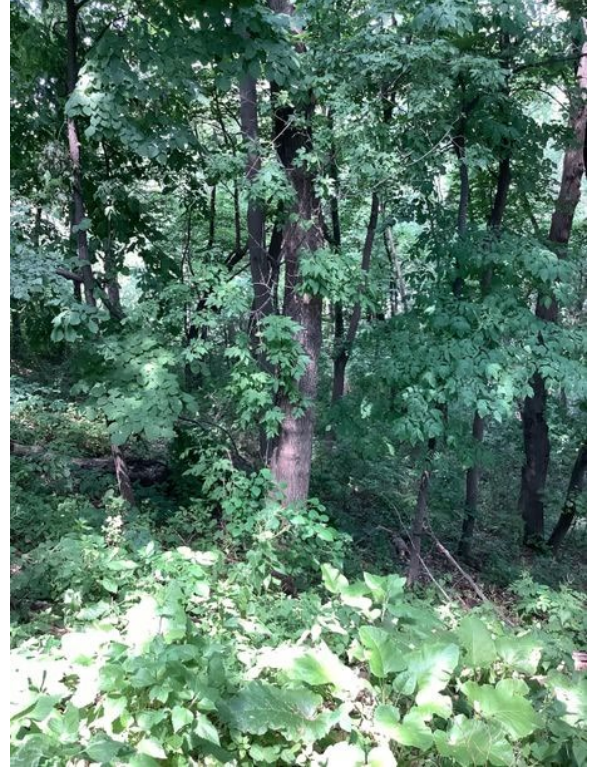
**Photo 2 Image**

Downstream view of left bank.

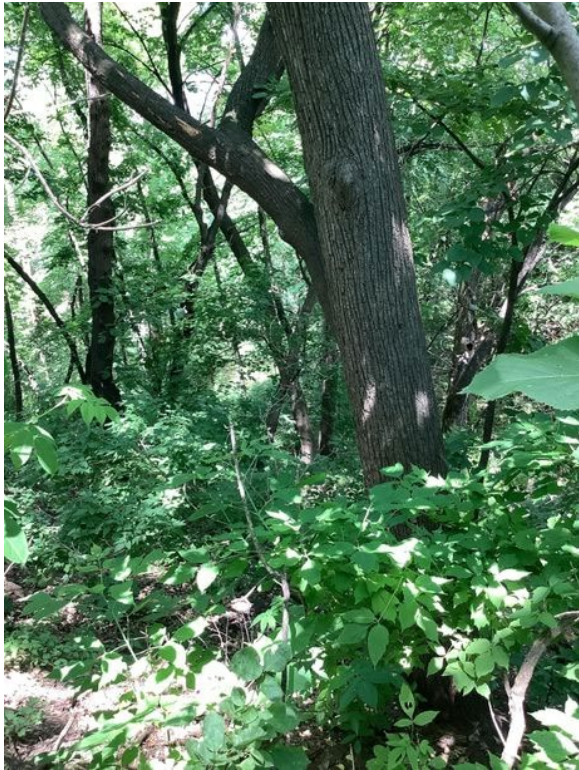
**Photo 3 Image**

More head on downstream pictures showing large trees that are leaning.

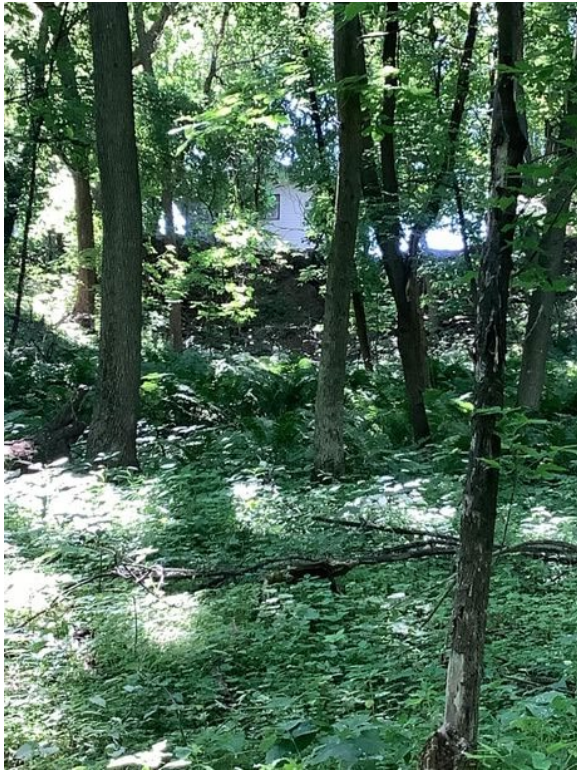
**Photo 1 Image**

Upstream view of gully from trail, located directly in front of the white shed.

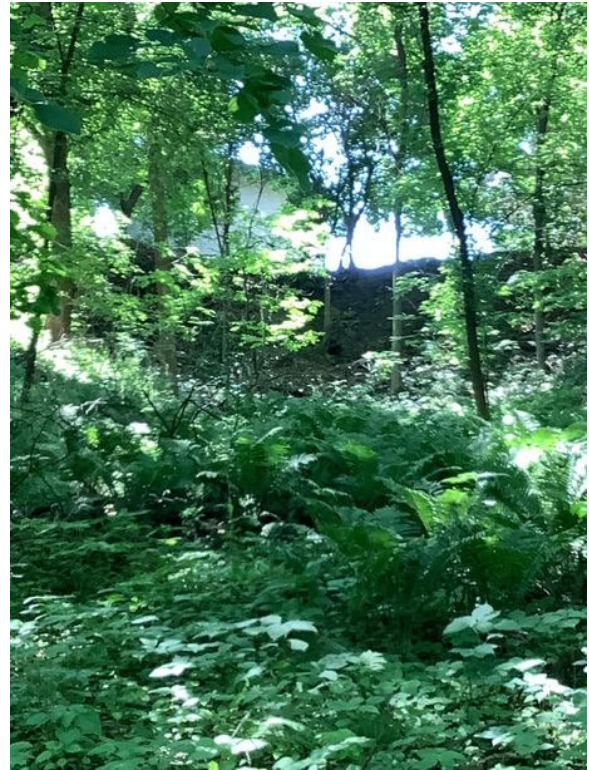
**Photo 2 Image**

Upstream view of gully from closer point.

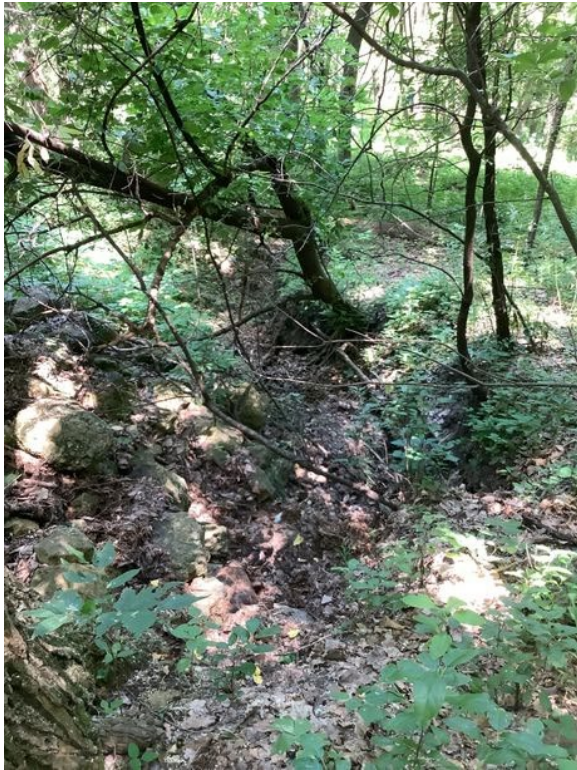
**Photo 1 Image**

Downstream view of gully about 50 feet downstream from pipe where armoring stops.

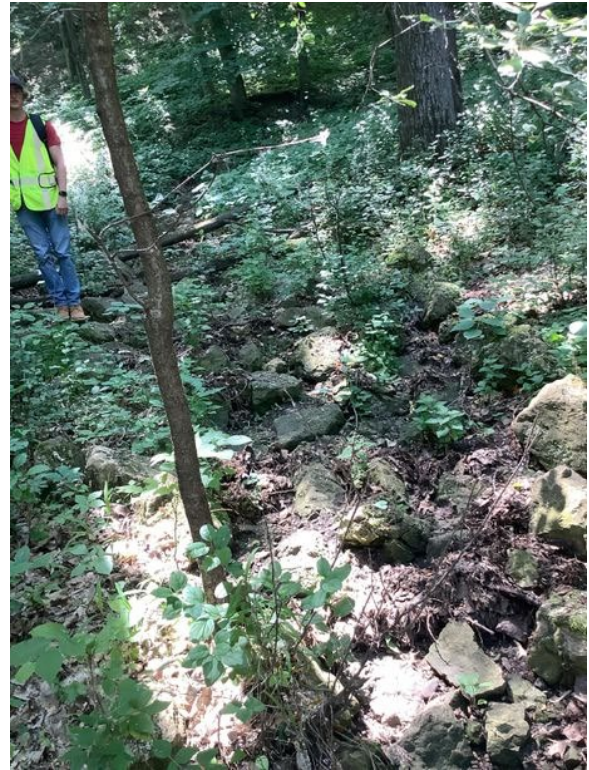
**Photo 2 Image**

Upstream view from end of rip rap

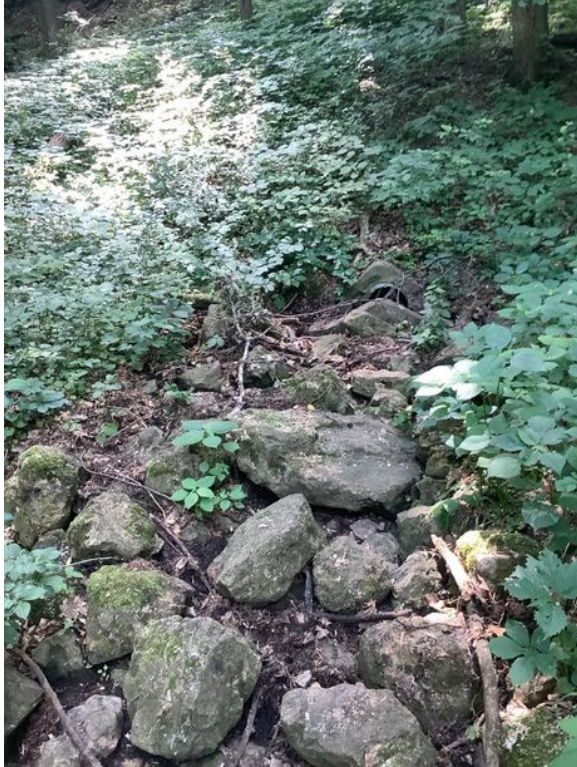
**Photo 3 Image**

Upstream view of pipe.

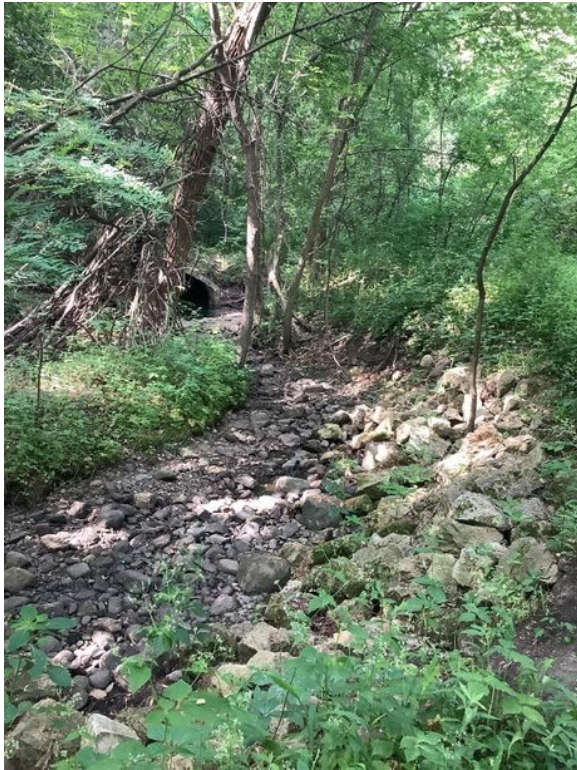
**Photo 1 Image**

Upstream view of left bank. There is an island in the middle of the gully.

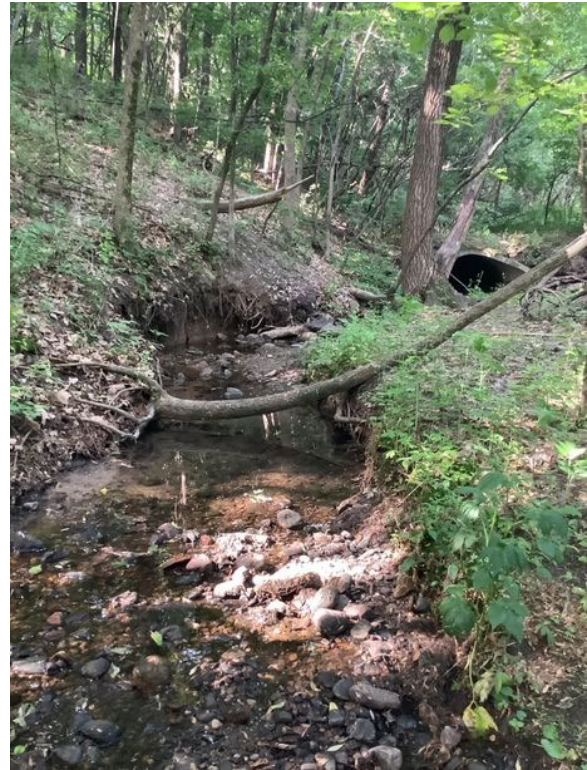
**Photo 2 Image**

Upstream view of right bank from end of island.

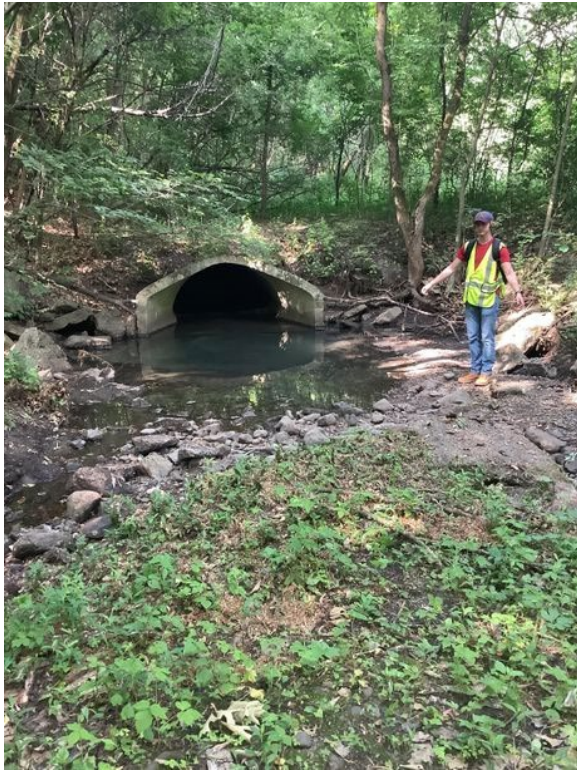
**Photo 3 Image**

Upstream view of the pipe outfall. Area around pipe is eroding.

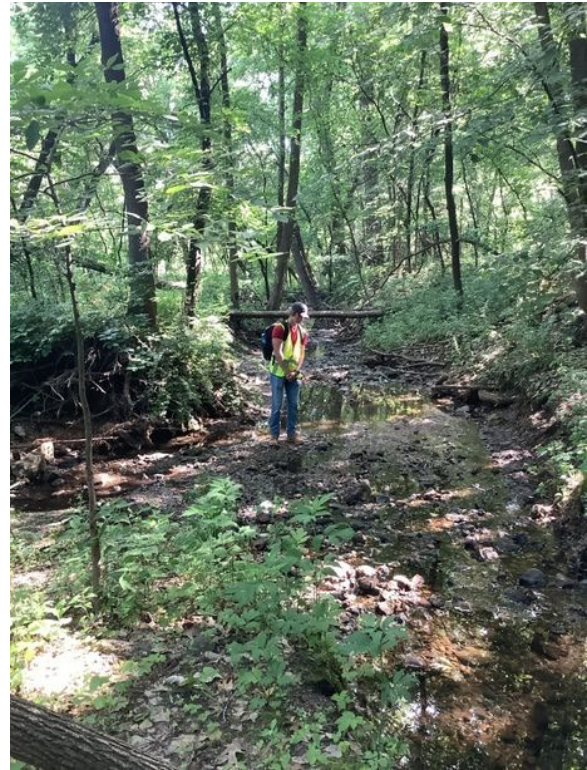
**Photo 4 Image**

Downstream view of where the two streams on the side of the gully connect. Lots of fallen and leaning trees.

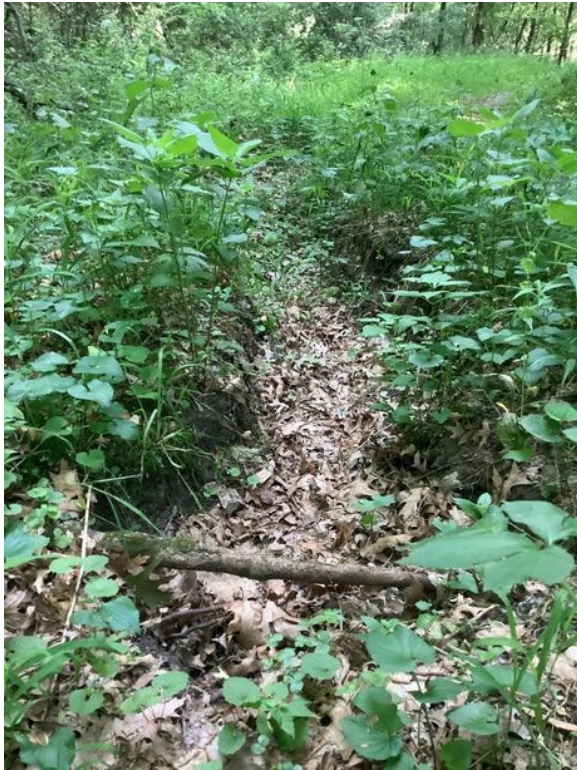
**Photo 1 Image**

Downstream view from above head cut.

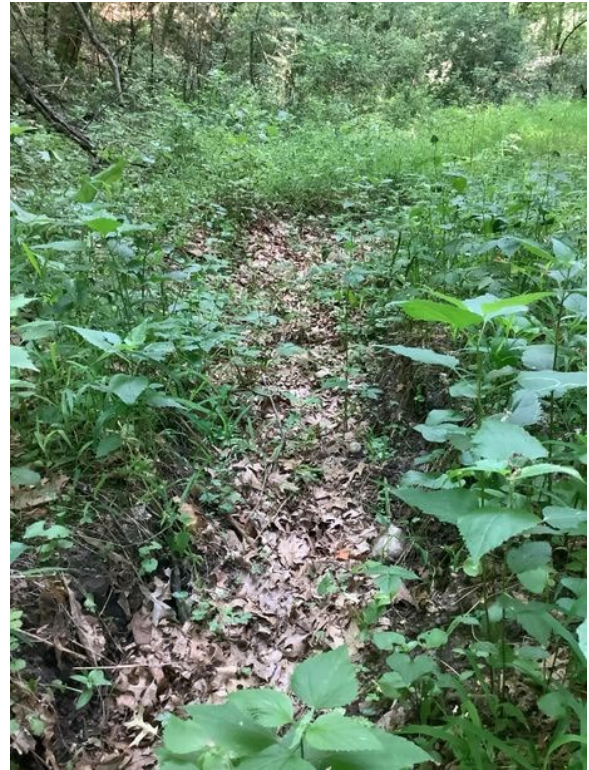
**Photo 2 Image**

Downstream view of gully. Showing moderate degradation on banks.

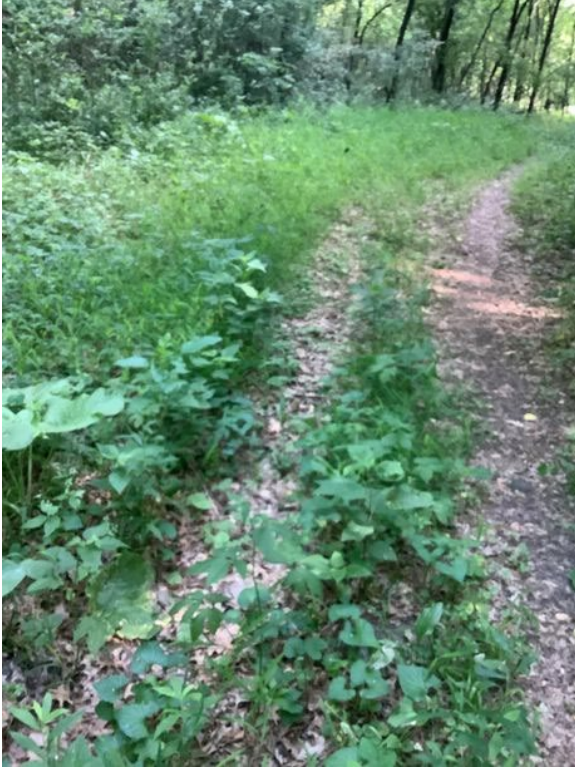
**Photo 3 Image**

Downstream view from end of gully showing where it flattens out and then about 40 feet downstream the other gully begins

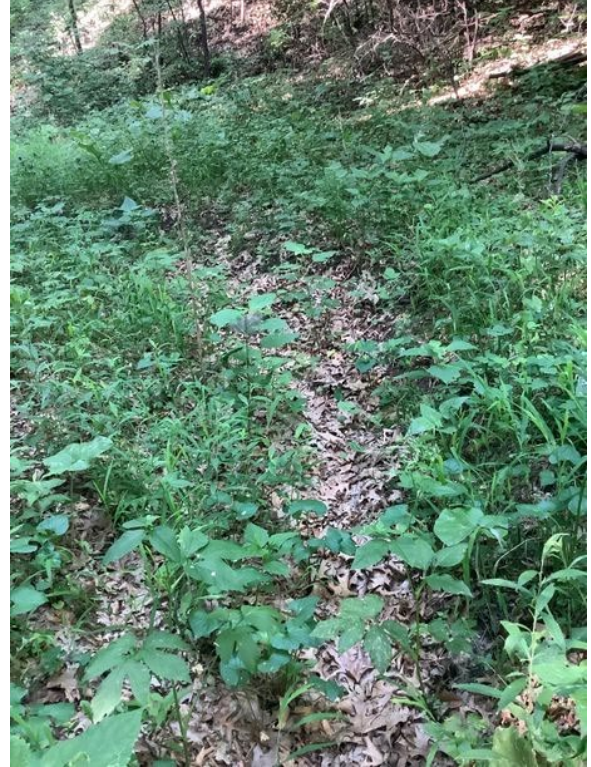
**Photo 4 Image**

Upstream view from bottom of gully.

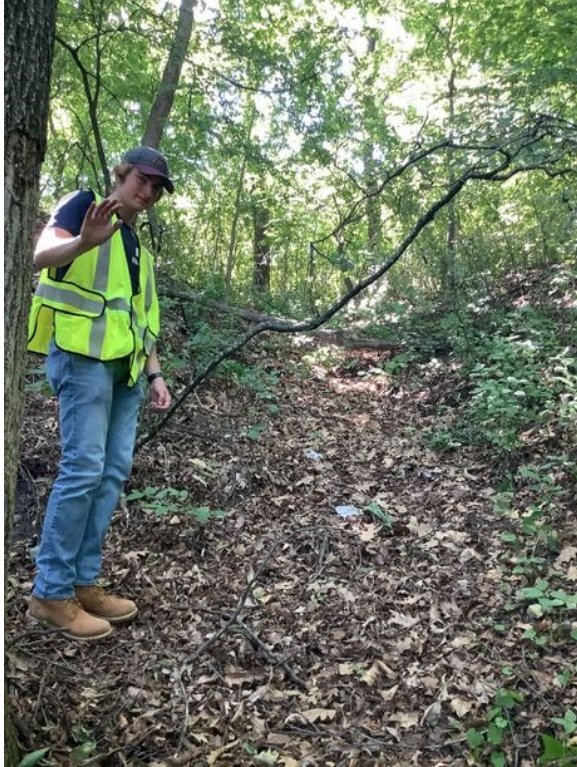
**Photo 1 Image**

Upstream view of steep gully.

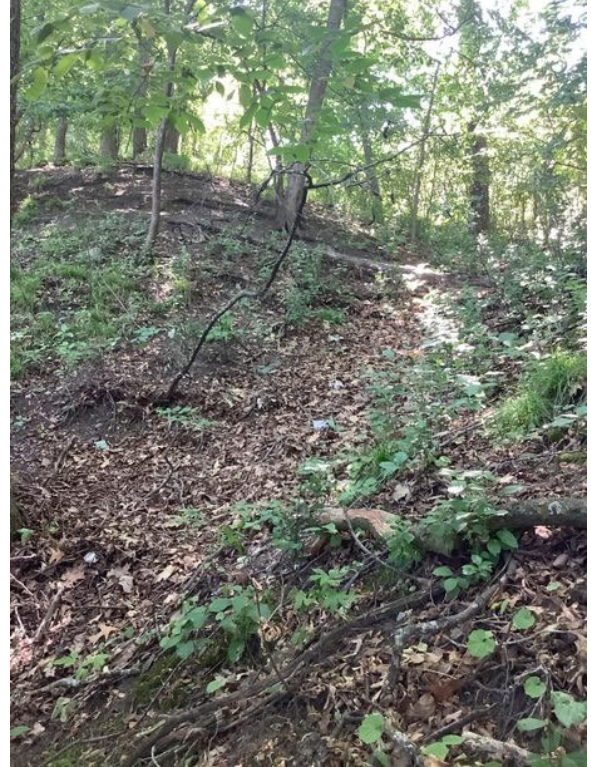
**Photo 2 Image**

Upstream view from left bank

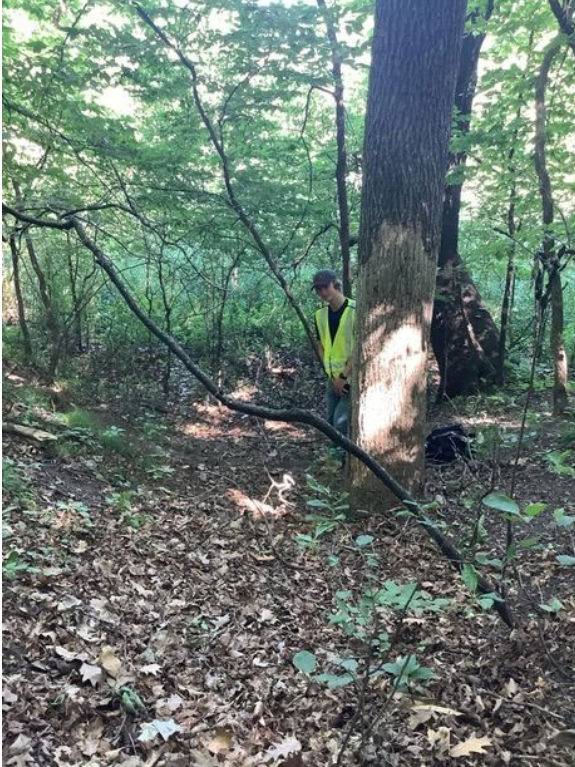
**Photo 3 Image**

Downstream view from center of gully

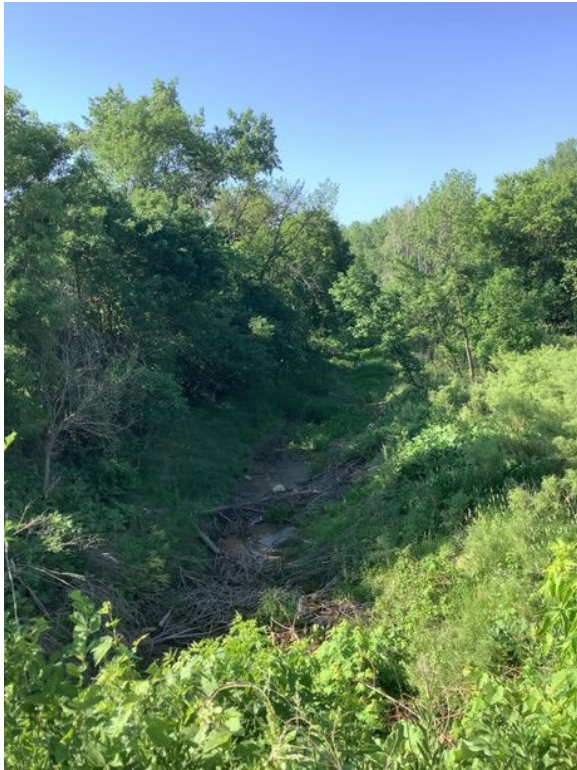
**Photo1**

**Upstream view of gully.**

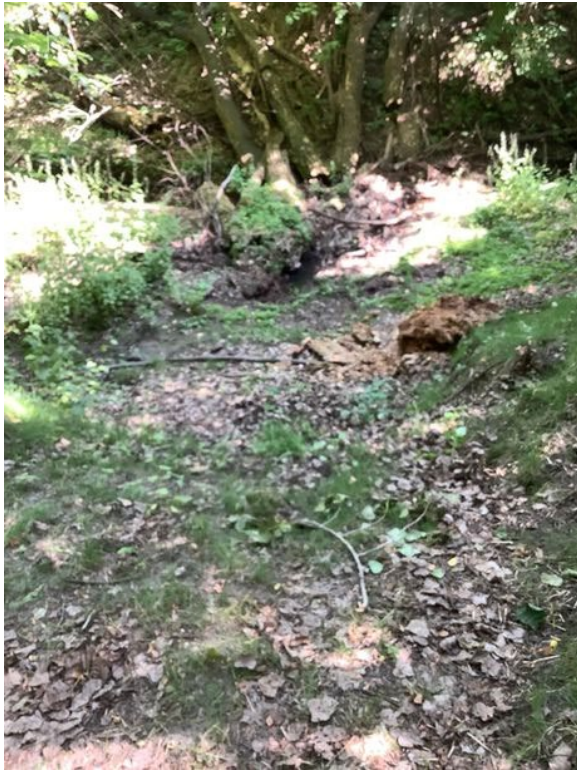
**Photo1**

<b>Seep:</b>	No
<b>Stormwater Inputs:</b>	0-Not present
<b>Fallen Trees:</b>	No
<b>Degradation:</b>	1-Low
<b>Aggradation:</b>	0-No aggradation
<b>Slumping:</b>	0-No slumping
<b>Additional Notes:</b>	<p>Classification? Low (4 - x)</p> <p>Notes/Comments: To the right of trail off Hayes Ave. small gully with lots of vegetation, but with no water flow. This gully runs into the large gully upstream of it, and is located on the left bank.</p>

**Downstream view from above gully on trail.**

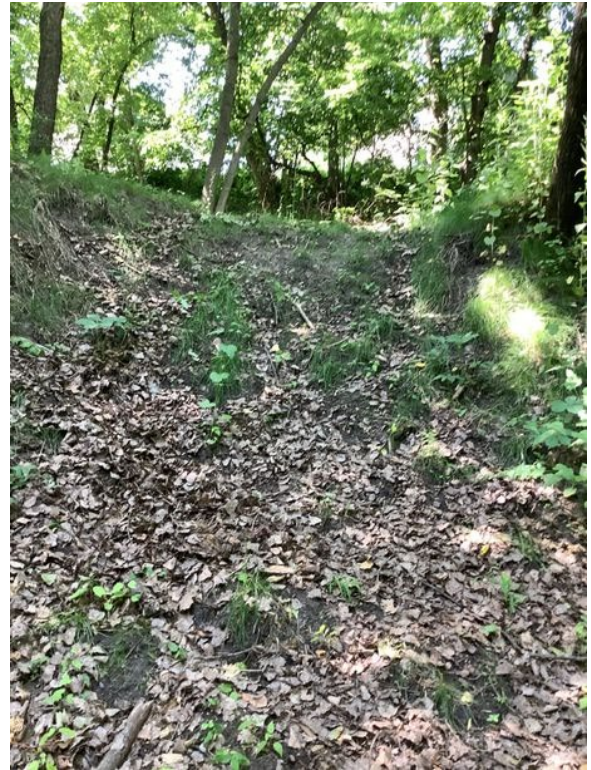
**Photo2**

**View from bottom of gully.**

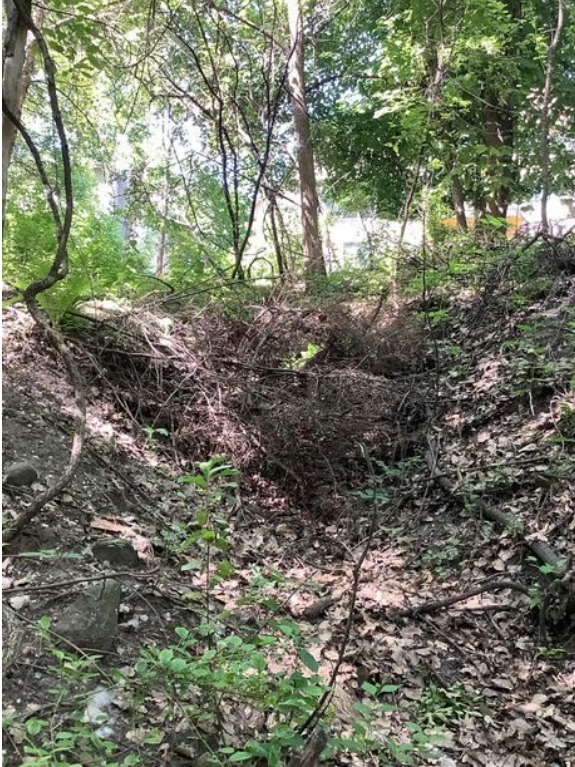
**Photo1**

<b>Seep:</b>	No	
<b>Stormwater Inputs:</b>	0-Not present	
<b>Fallen Trees:</b>	Yes	
<b>Degradation:</b>		3-Moderate
<b>Aggradation:</b>		0-No aggradation
<b>Slumping:</b>		3-Moderate
<b>Additional Notes:</b>	<p>Classification? Moderate (x - x)</p> <p>Notes/Comments: Gully appears to be filled with brush from residential area. Steep, with no vegetation on banks or bottom. Minor slumping</p>

**Upstream view of gully filled with brush.**

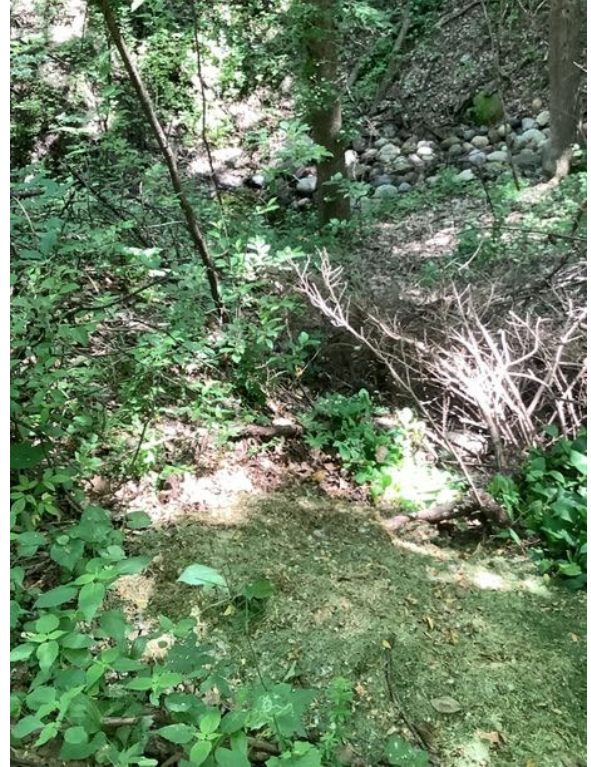
**Photo2**

**Downstream view of left bank.**

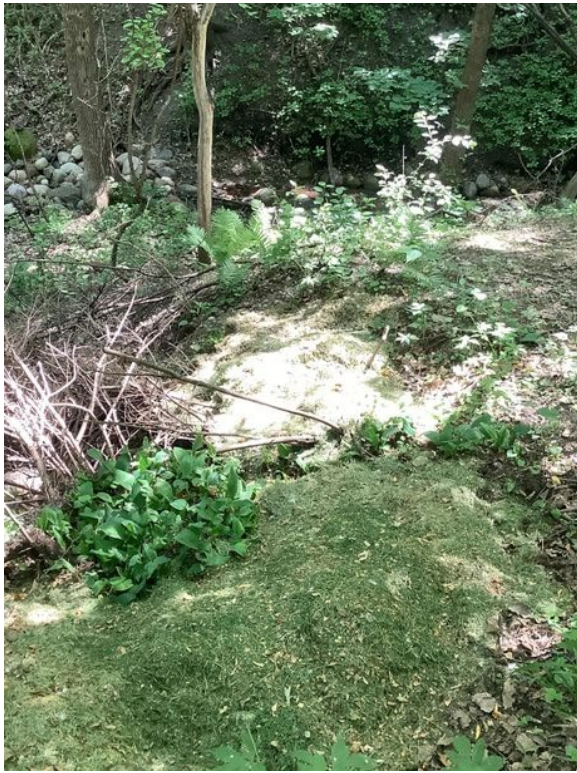
**Photo3**

**Downstream view of right bank filled with lawn clipping and brush.**

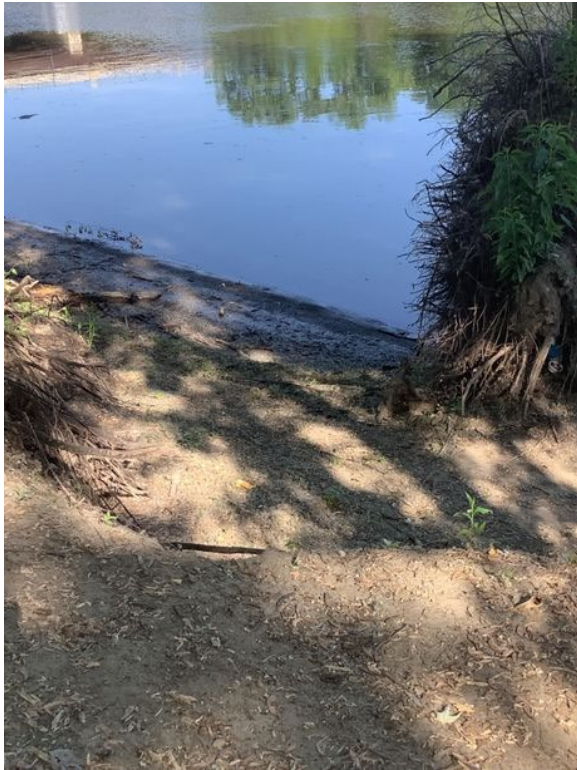
**Photo1**

<b>Seep:</b>	No	
<b>Stormwater Inputs:</b>	0-Not present	
<b>Fallen Trees:</b>	No	
<b>Degradation:</b>		5-Severe
<b>Aggradation:</b>		0-No aggradation
<b>Slumping:</b>		0-No slumping
<b>Additional Notes:</b>	<p>Classification? Moderate (x - x)</p> <p>Notes/Comments: Small gully off side of mn river. Has moderate potential due to is steepness and severe degradation, something to keep an eye on in the next few years.</p>

**View downstream from top of gully. Can see large tree that fell and potentially caused this erosion.**

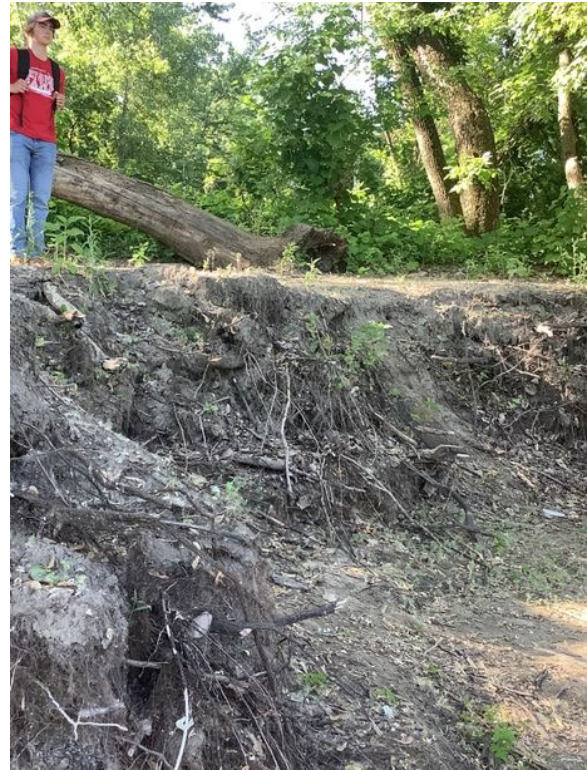
**Photo2**

**Upstream view from bottom of gully. Can see how steep the slope is and all the degradation through the exposed roots.**

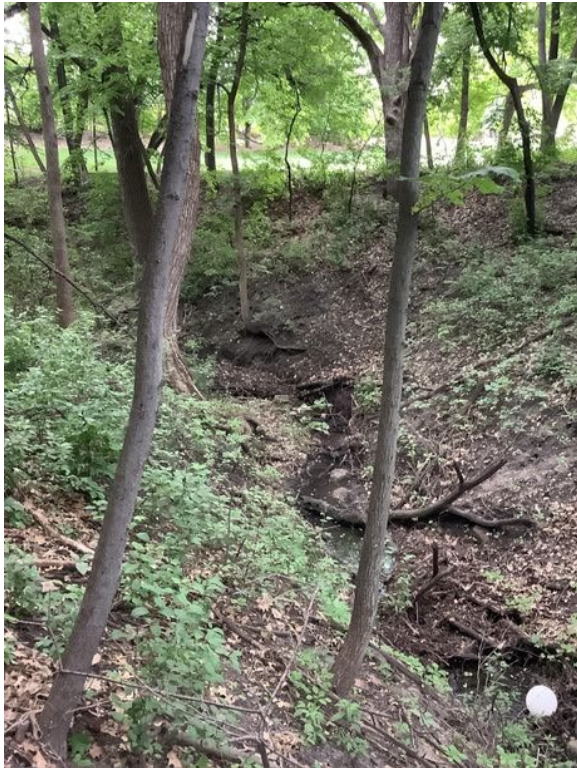
**Photo1**

<b>Seep:</b>	No	
<b>Stormwater Inputs:</b>	0-Not present	
<b>Fallen Trees:</b>	Yes	
<b>Degradation:</b>	5-Severe	
<b>Aggradation:</b>	1-Low	
<b>Slumping:</b>	3-Moderate	
<b>Additional Notes:</b>	<p>Classification? High (x - 49)</p> <p>Notes/Comments: Very large gully with water at bottom. Lots of visible degradation, moderate vegetation on banks, lots of pistol shaped trees, and decent slumping</p>

**Upstream view of gully.**

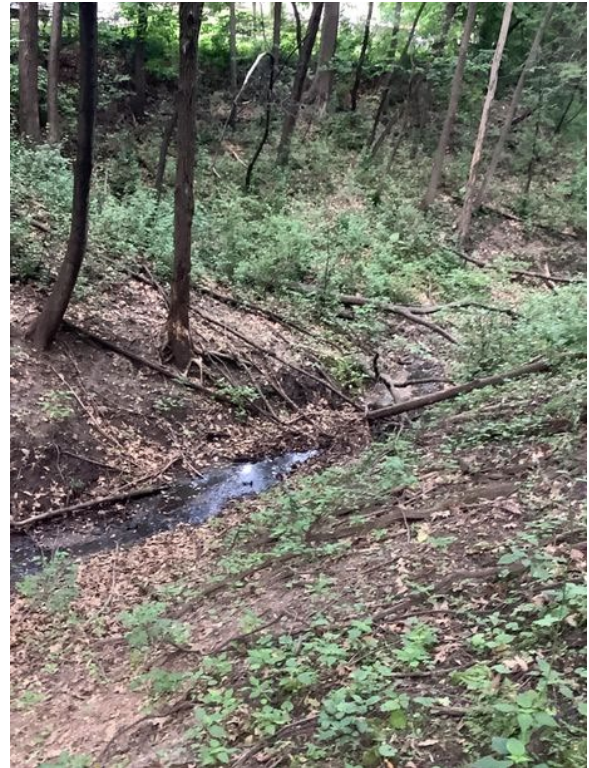
**Photo2**

**Downstream view of gully.**

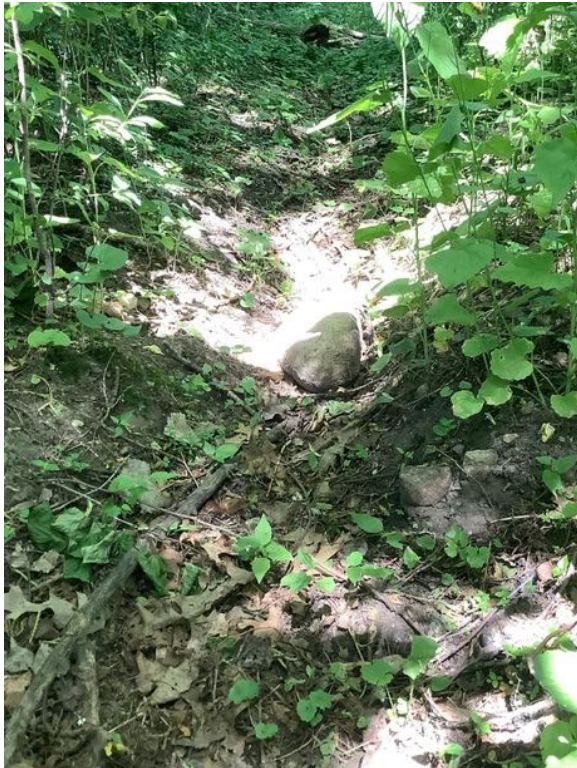
**Photo1**

<b>Seep:</b>	No	
<b>Stormwater Inputs:</b>	0-Not present	
<b>Fallen Trees:</b>	No	
<b>Degradation:</b>	1-Low	
<b>Aggradation:</b>	0-No aggradation	
<b>Slumping:</b>	0-No slumping	
<b>Additional Notes:</b>	Classification? Moderate (x - x) Notes/Comments: Small gully with a pipe like something at the top. Eroded in a v shape, with no vegetation in banks or bottom.

**Downstream view of gully.**

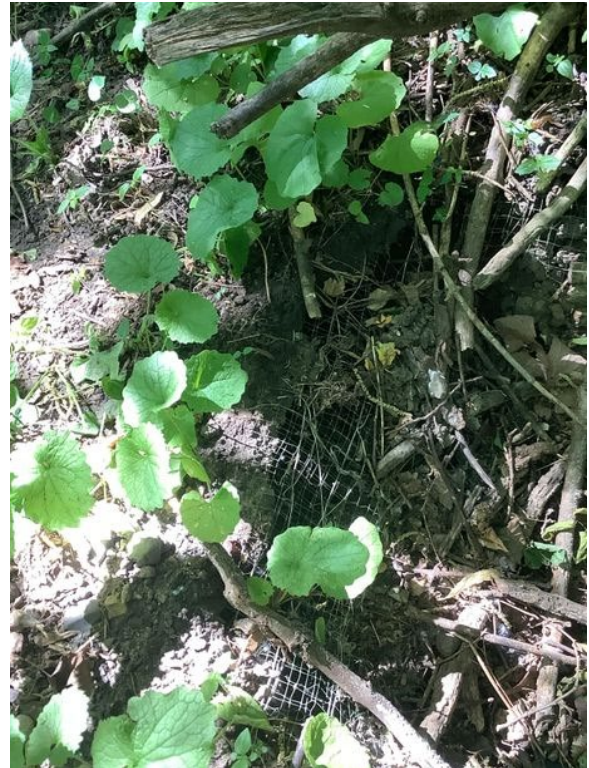
**Photo2**

**Upstream view of pipe in gully.**

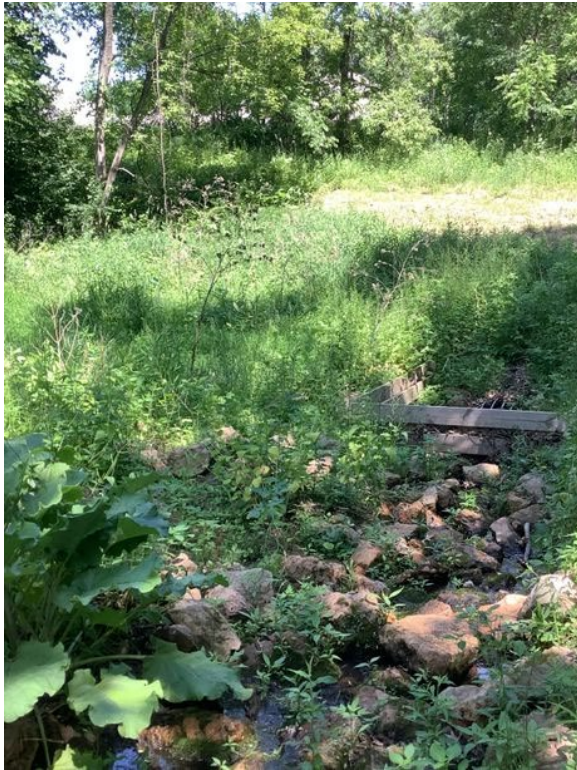
**Photo1**

<b>Seep:</b>	No
<b>Stormwater Inputs:</b>	2-Low flow
<b>Fallen Trees:</b>	No
<b>Degradation:</b>	1-Low
<b>Aggradation:</b>	1-Low
<b>Slumping:</b>	0-No slumping
<b>Additional Notes:</b>	<p>Classification? Low (4 - x)</p> <p>Notes/Comments: Water flowing over a bunch of boulders into pipe that leads to another gully across the street. Feeds from little stream. Low slumping, high bank vegetation</p>

**Downstream view of left bank.**

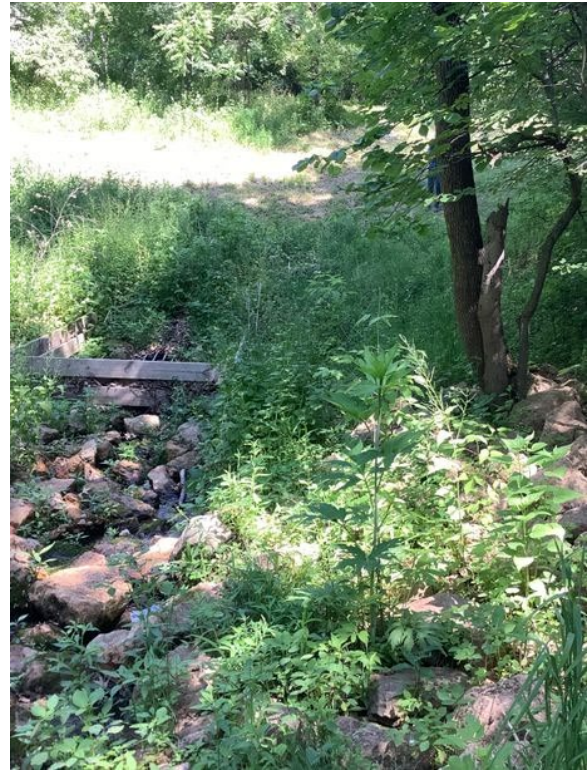
**Photo2**

**Downstream view of right bank.**

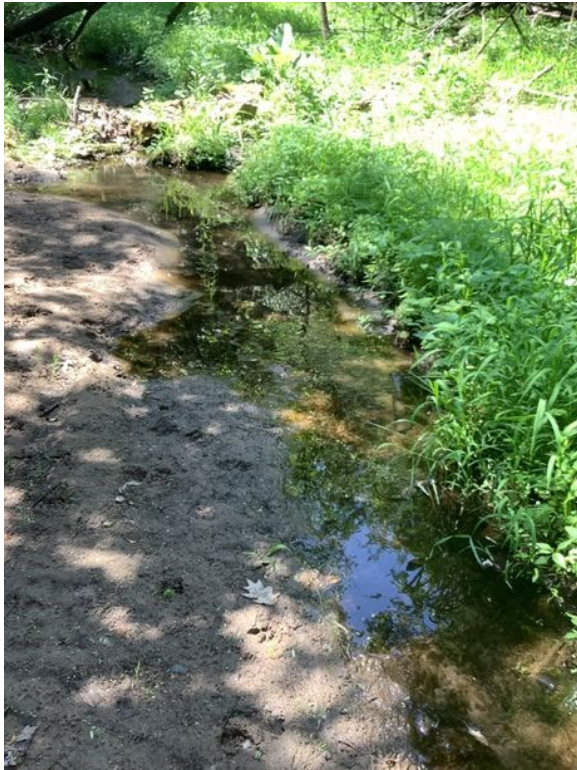
**Photo3**

**Upstream view of where the water is coming from.**

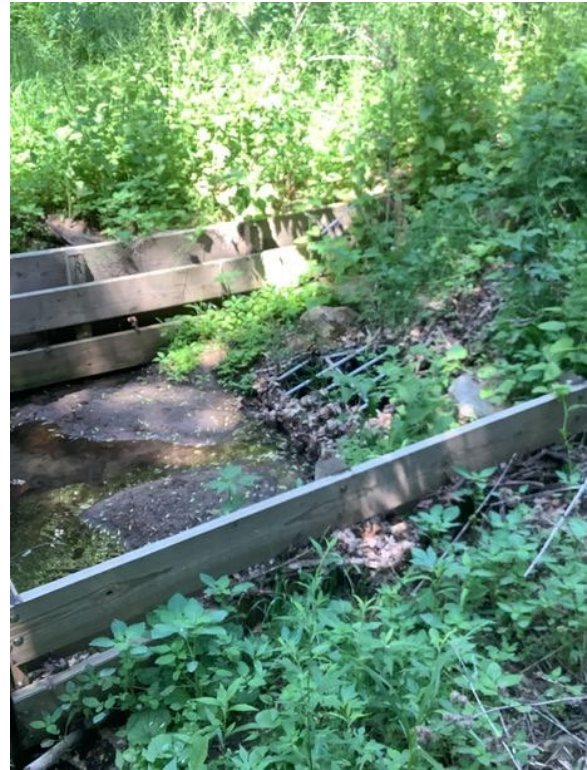
**Photo4**

**Downstream view of pipe where water feeds into**

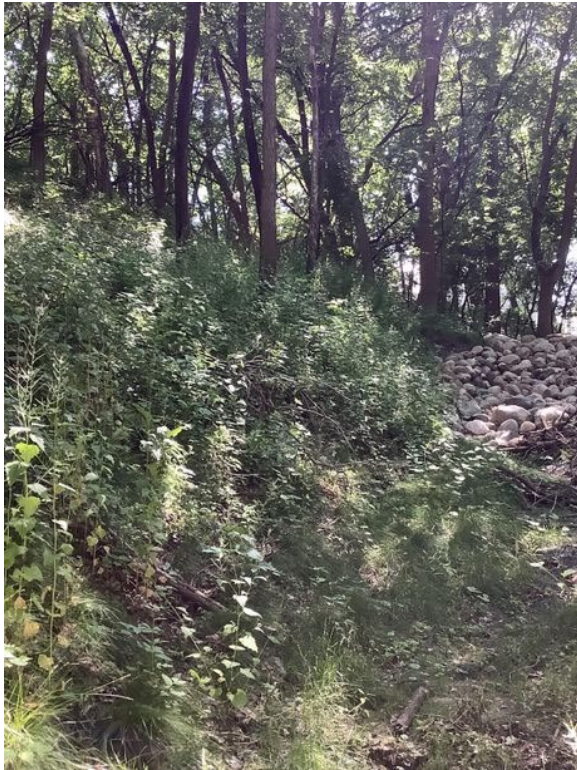
**Photo1**

<b>Seep:</b>	No	
<b>Stormwater Inputs:</b>	0-Not present	
<b>Fallen Trees:</b>	Yes	
<b>Degradation:</b>		1-Low
<b>Aggradation:</b>		0-No aggradation
<b>Slumping:</b>		1-Low
<b>Additional Notes:</b>	Classification? Low (4 - x) Notes/Comments: Looks like people dumped their brush in the gully, the top is armored with boulders, both banks and bottom have heavy vegetation.

**Upstream view of right bank.**

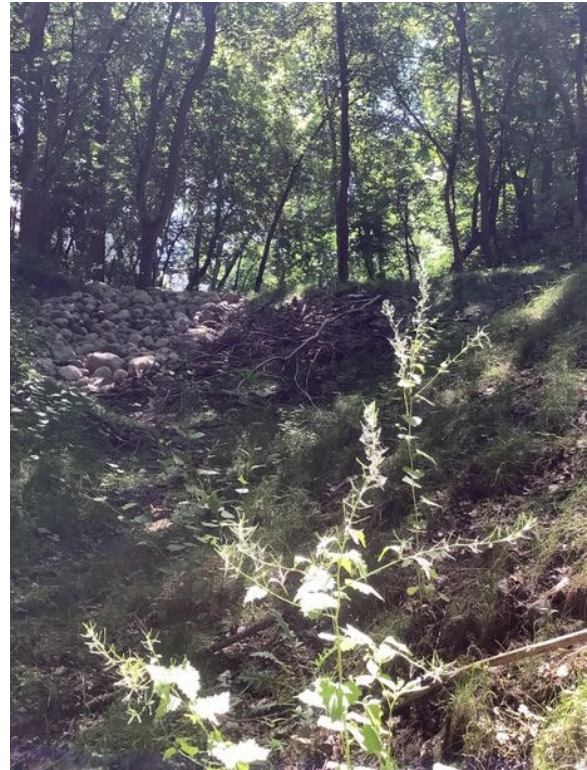
**Photo2**

**Upstream view of left bank.**

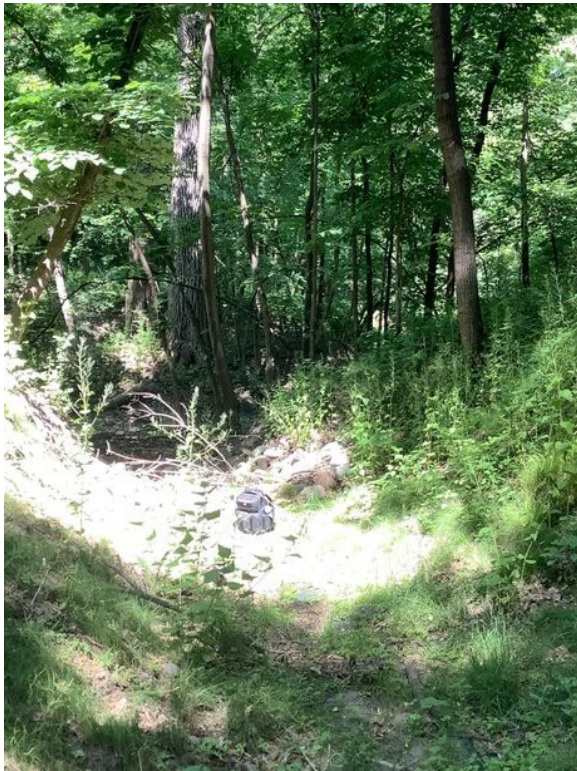
**Photo3**

**Downstream view of end of gully.**
