<b>Gully ID:</b> 07:15-11:41	<b>MAP</b>

<b>Date &amp; Time:</b> July 15, 2021 11:41 AM	
<b>Location:</b> Burnsville	
<b>Weather:</b> Sunny <b>Storm/Rainfall Event in the Past 24 Hours?</b> Yes-High Intensity	
<b>GULLY INFORMATION</b>	
<b>Calculated Erosion Potential:</b>	Low
<b>Approximate Depth:</b>	3-Medium (3'-15')
<b>Approximate Bottom Width:</b>	1-Wide (>5')
<b>Approximate Gully Length:</b>	3-Medium (50'-100')
<b>Condition of Gully Bottom:</b>	1-Heavy Vegetation
<b>Condition of Gully Banks:</b>	1-Heavy Vegetation
<b>Gully Bank Angles:</b>	3-Mid-Range (45 to 90 degrees)
<b>Gully Shape:</b>	1-Trapezoid
<b>Gully Material:</b>	Silt/Clay

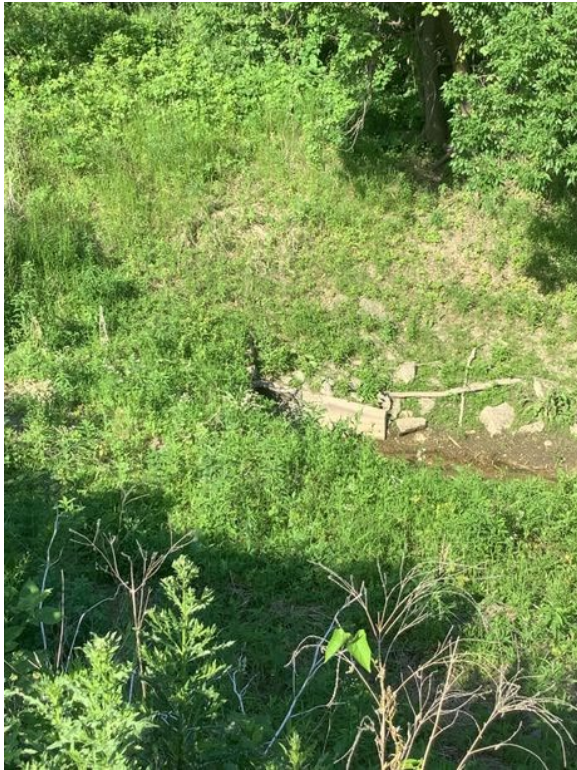
**Photo1**

<b>Seep:</b>	No
<b>Stormwater Inputs:</b>	1-Dripping
<b>Fallen Trees:</b>	No
<b>Degradation:</b>	1-Low
<b>Aggradation:</b>	0-No aggradation
<b>Slumping:</b>	1-Low
<b>Additional Notes:</b>	<p>Classification? Moderate (x - x)</p> <p>Notes/Comments: Gully off of black dog road near 35w. Runs from pipe into MN river. The pipe runs under the road and comes out the other side to another gully. Lots of vegetation and some large rocks are armoring the pipe.</p>

**Upstream view of pipe from right bank**

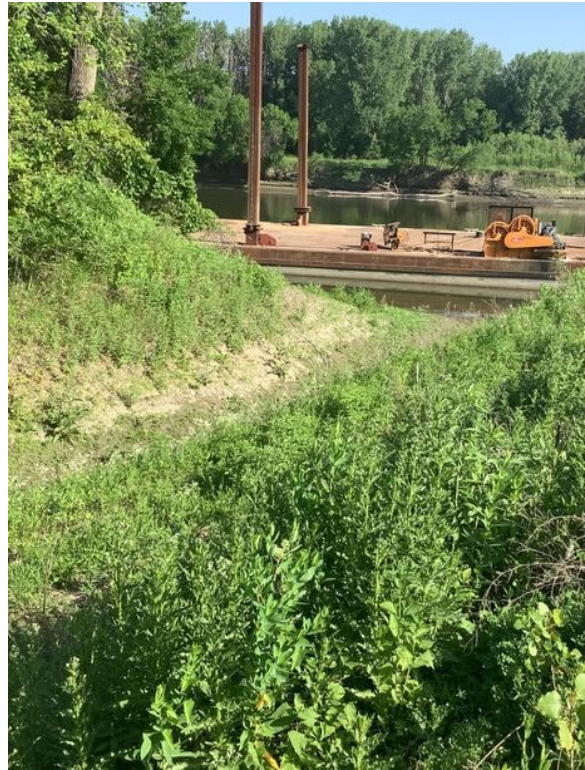
**Photo2**

**Downstream view from right bank.**

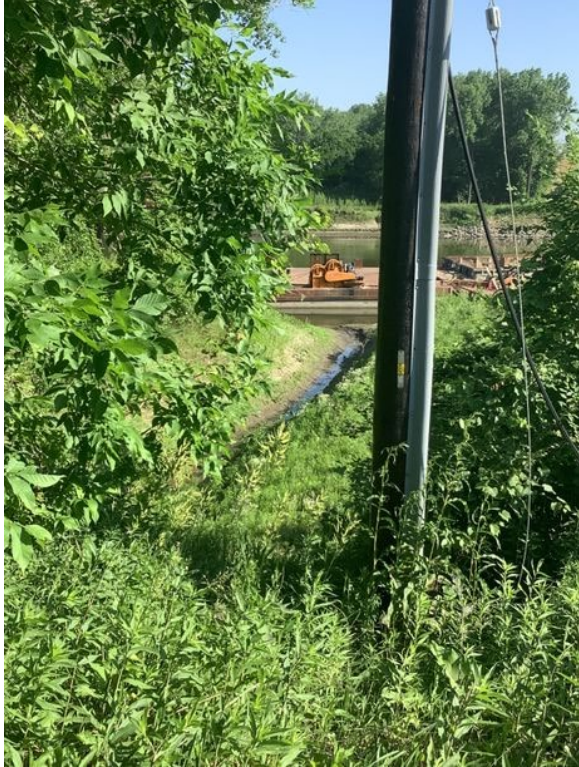
**Photo3**

**Downstream view of gully from road. Lots of vegetation made getting a clear picture difficult.**

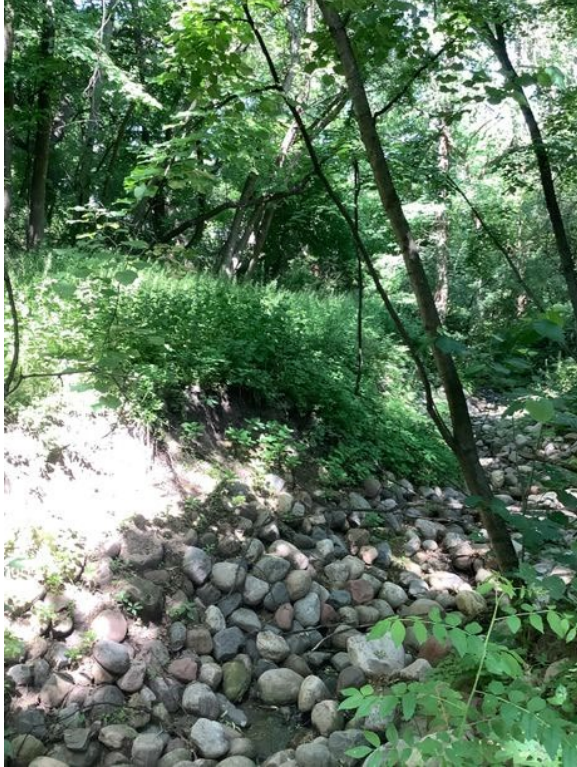
**Photo1**

<b>Seep:</b>	No
<b>Stormwater Inputs:</b>	2-Low flow
<b>Fallen Trees:</b>	Yes
<b>Degradation:</b>	5-Severe
<b>Aggradation:</b>	1-Low
<b>Slumping:</b>	3-Moderate
<b>Additional Notes:</b>	<p>Classification? High (x - 49)</p> <p>Notes/Comments: Boulders at bottom of gully, banks of gully are heavily eroding. Water flow is constant at bottom, decent slumping in the trees. Roots hanging from banks</p>

**Left bank**

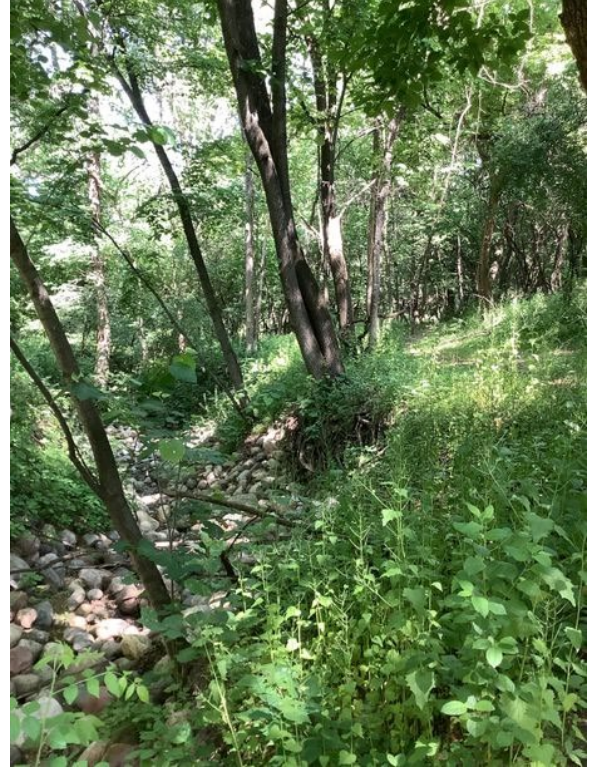
**Photo2**

**Right bank**

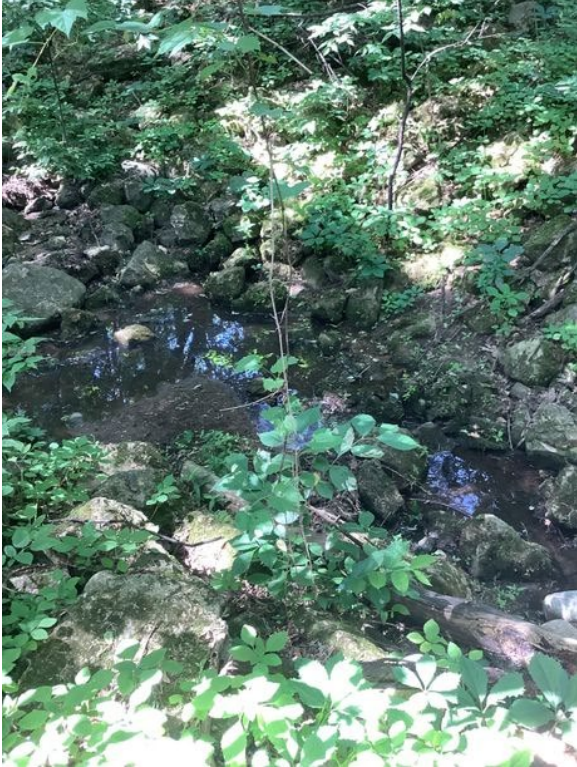
**Photo3**

**Confluence with another gully**

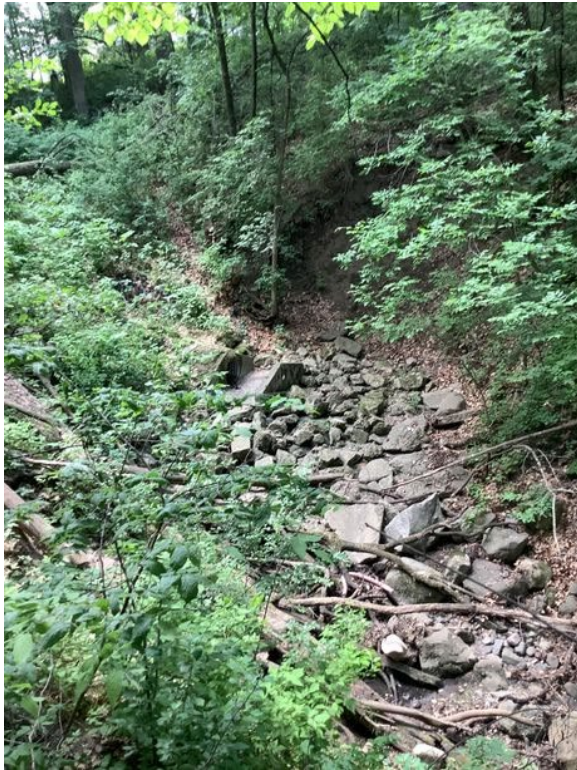
**Photo1**

<b>Seep:</b>	No	
<b>Stormwater Inputs:</b>	1-Dripping	
<b>Fallen Trees:</b>	Yes	
<b>Degradation:</b>	5-Severe	
<b>Aggradation:</b>	1-Low	
<b>Slumping:</b>	5-Severe	
<b>Additional Notes:</b>	<p>Classification? High (x - 49)</p> <p>Notes/Comments: Gully in cedar bridge park. Moderate vegetation on banks, mainly soil on bottom of gully with some boulders and larger rocks. The pipe is surrounded by concrete and rip rap.</p>

**View of pipe and Boulder and fallen trees in middle of gully from right bank.**

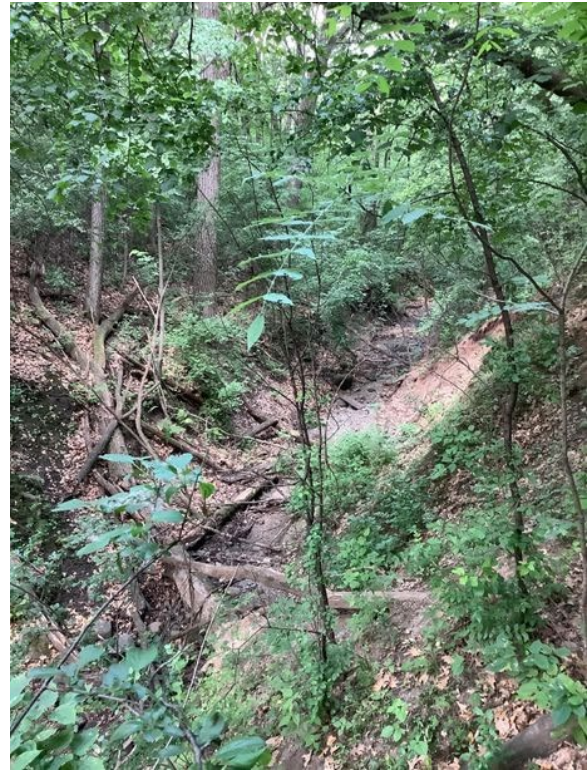
**Photo2**

**View downstream from right bank of gully**

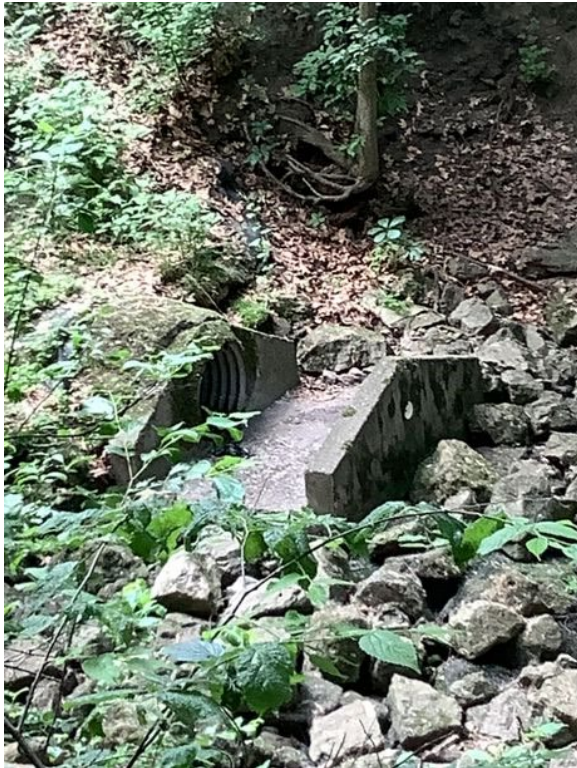
**Photo3**

**Zoomed in view of pipe.**

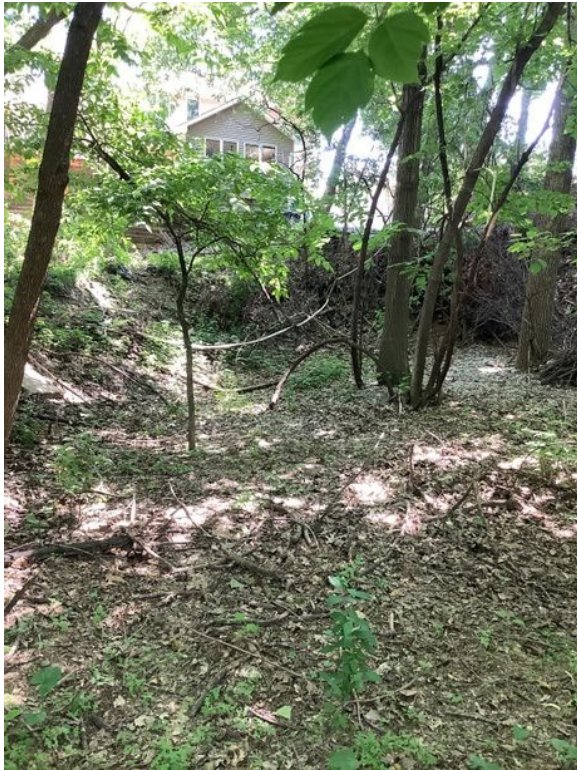
**Photo1**

<b>Seep:</b>	No	
<b>Stormwater Inputs:</b>	1-Dripping	
<b>Fallen Trees:</b>	Yes	
<b>Degradation:</b>	5-Severe	
<b>Aggradation:</b>	0-No aggradation	
<b>Slumping:</b>	3-Moderate	
<b>Additional Notes:</b>	<p>Classification? Moderate (x - x)</p> <p>Notes/Comments: Gully in wildlife refuge boundary behind houses. Has moderate vegetation and lots of dumped yard waste. Very wide gully.</p>

**View fro, bottom of gully. Can see fallen trees fro, left bank and there are two small drainage pipes from the residential property behind.**

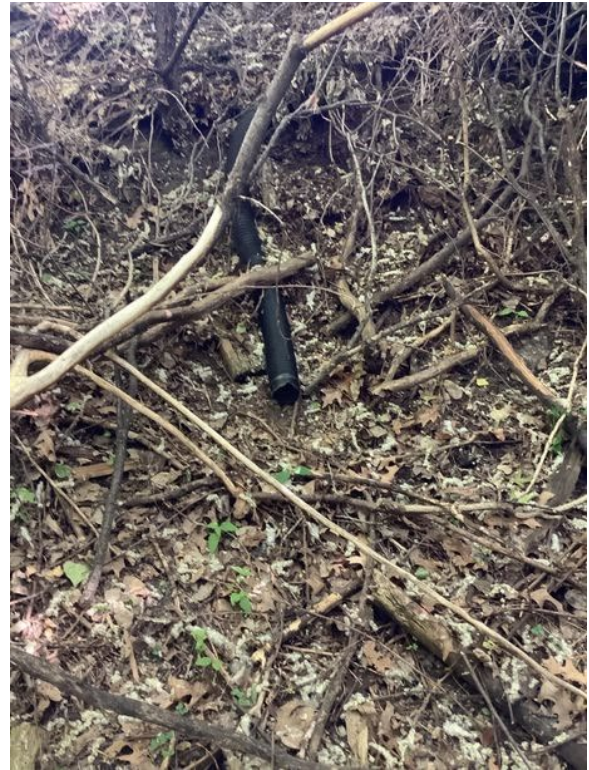
**Photo2**

**Left drainage pipe.**

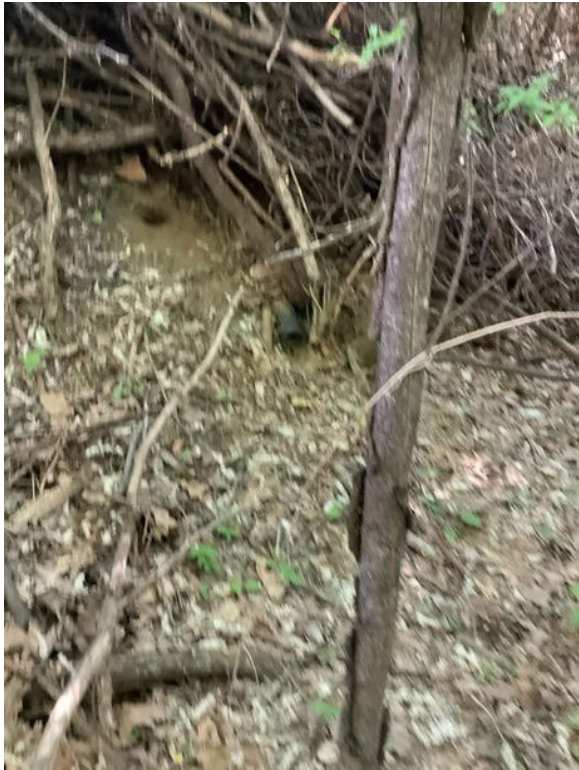
**Photo3**

**Right drainage pipe.**

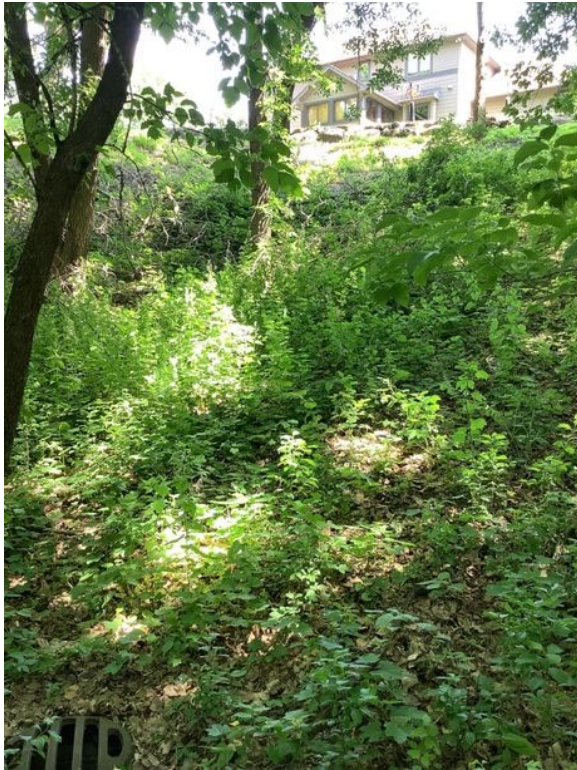
**Photo1**

<b>Seep:</b>	No
<b>Stormwater Inputs:</b>	0-Not present
<b>Fallen Trees:</b>	No
<b>Degradation:</b>	0-No degradation
<b>Aggradation:</b>	0-No aggradation
<b>Slumping:</b>	0-No slumping
<b>Additional Notes:</b>	<p>Classification? Low (4 - x)</p> <p>Notes/Comments: Gully behind neighborhood in wildlife refuge boundary. Looks like residents above drop their yard waste into the gully there is a sewer drain at the bottom. . A</p>

**View from base of gully**

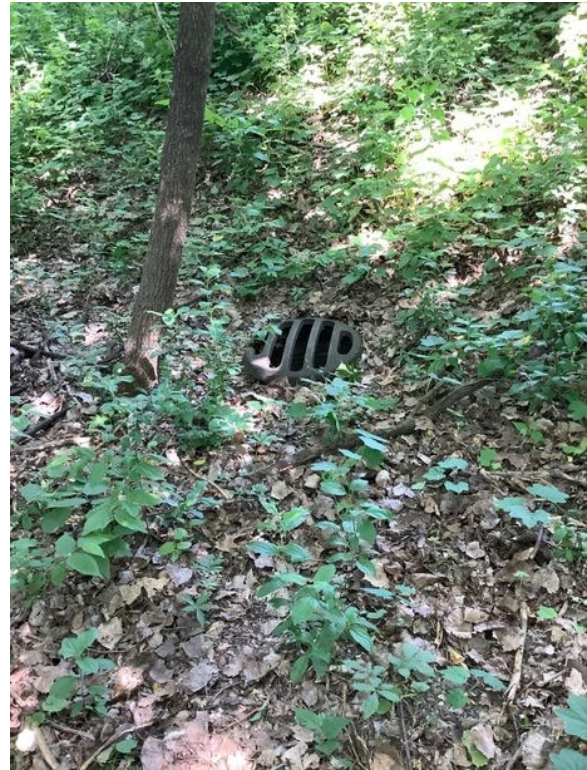
**Photo2**

**View of drain at bottom of gully**

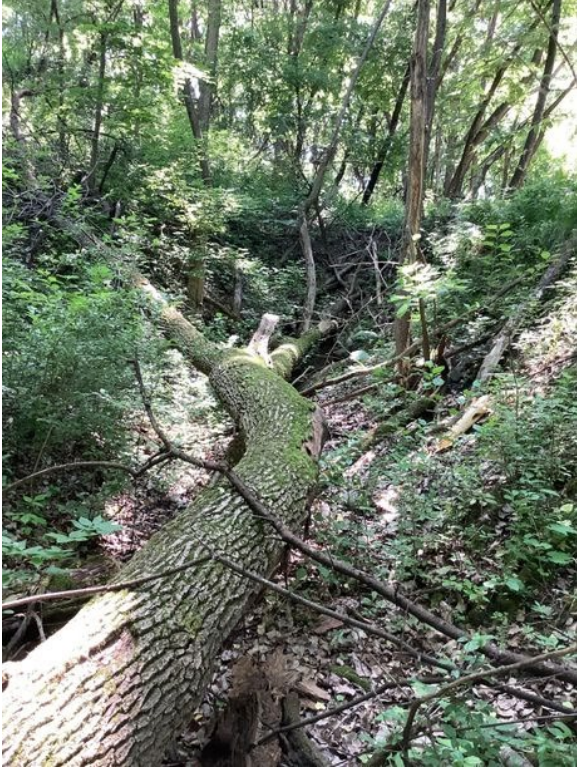
**Photo1**

<b>Seep:</b>	No	
<b>Stormwater Inputs:</b>	0-Not present	
<b>Fallen Trees:</b>	Yes	
<b>Degradation:</b>		3-Moderate
<b>Aggradation:</b>		0-No aggradation
<b>Slumping:</b>		3-Moderate
<b>Additional Notes:</b>	<p>Classification? Moderate (x - x)</p> <p>Notes/Comments: Short gully that runs into the main gully along the trail behind Hayes ave. Lots of branches and fallen trees are in this gully. The left and right bank have lots of vegetation but the bank area under the headcut does not.</p>

**View of gully from base by fallen tree. Couldn't get to top to get second picture.**

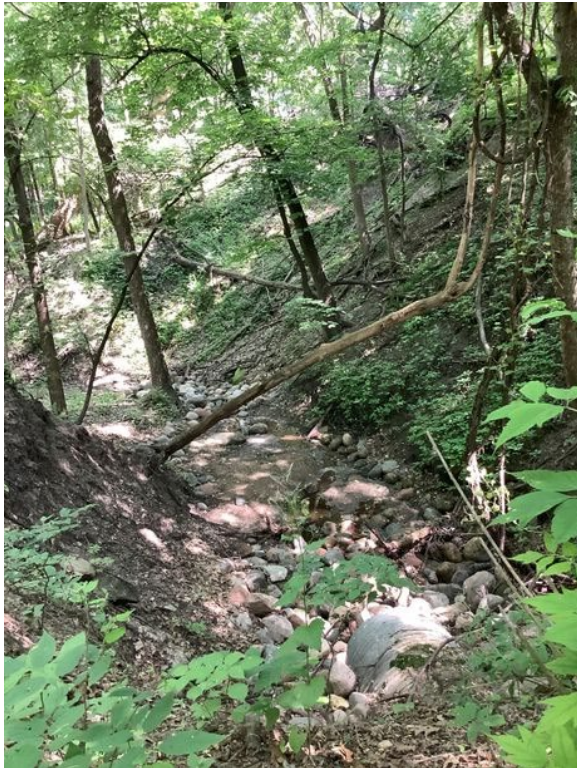
**Photo1**

<b>Seep:</b>	No	
<b>Stormwater Inputs:</b>	2-Low flow	
<b>Fallen Trees:</b>	Yes	
<b>Degradation:</b>		5-Severe
<b>Aggradation:</b>		3-Moderate
<b>Slumping:</b>		5-Severe
<b>Additional Notes:</b>	<p>Classification? High (x - 49)</p> <p>Notes/Comments: Gully downstream of previous gullies. Huge pipe which is severely eroded and is armored. The bottom is mainly silt but has some boulders downstream. Can see active erosion on banks and lots of slumping. another pipe downstream with no erosion.</p>

**Downstream view of gully from above pipe before gully drop off. Can see fallen tree on left bank and pistol trees on right bank.**

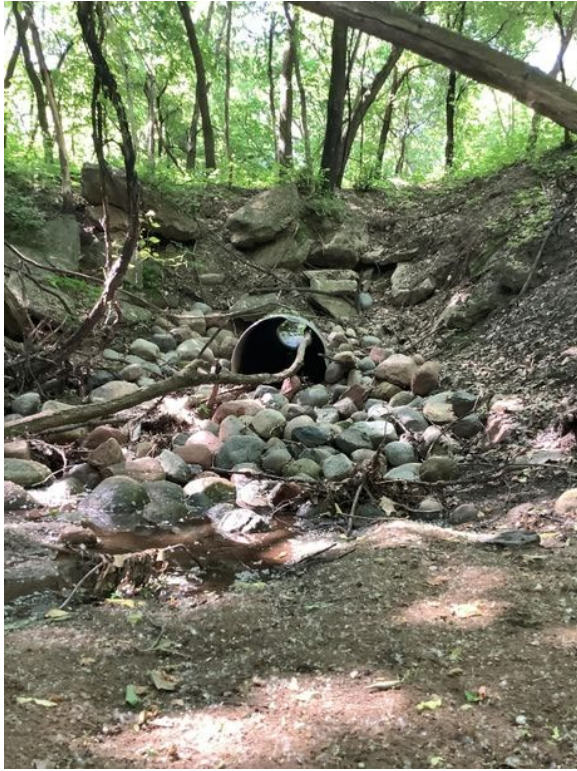
**Photo3**

**Upstream view of pipe from bottom of the gully.**

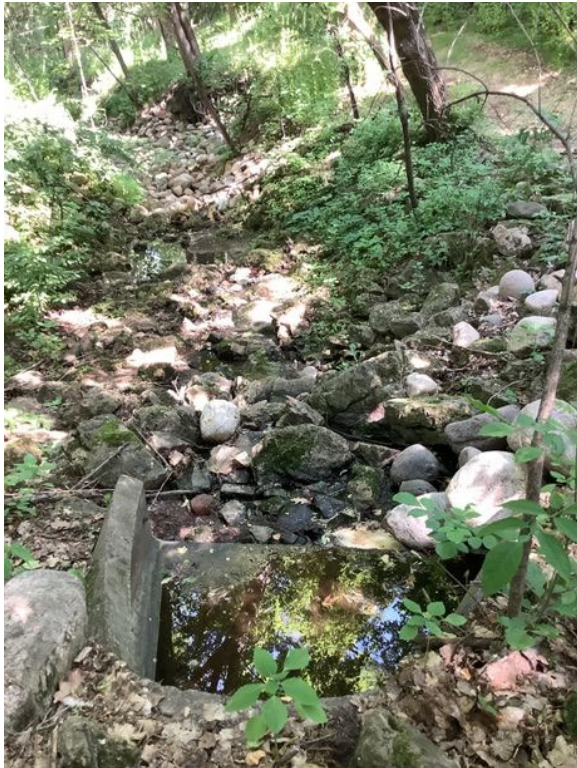
**Photo1**

<b>Seep:</b>	No	
<b>Stormwater Inputs:</b>	2-Low flow	
<b>Fallen Trees:</b>	No	
<b>Degradation:</b>	0-No degradation	
<b>Aggradation:</b>	0-No aggradation	
<b>Slumping:</b>	0-No slumping	
<b>Additional Notes:</b>	<p>Classification? Low (4 - x)</p> <p>Notes/Comments: Drain in wildlife refuge boundary area next to trail in a residential neighborhood. Gully is filled with large rocks and is armored on the sides with lots of vegetation. The water flow is constant, but slow moving. connects to severe gully downstream</p>

**View from above drain looking downstream at the gully.**

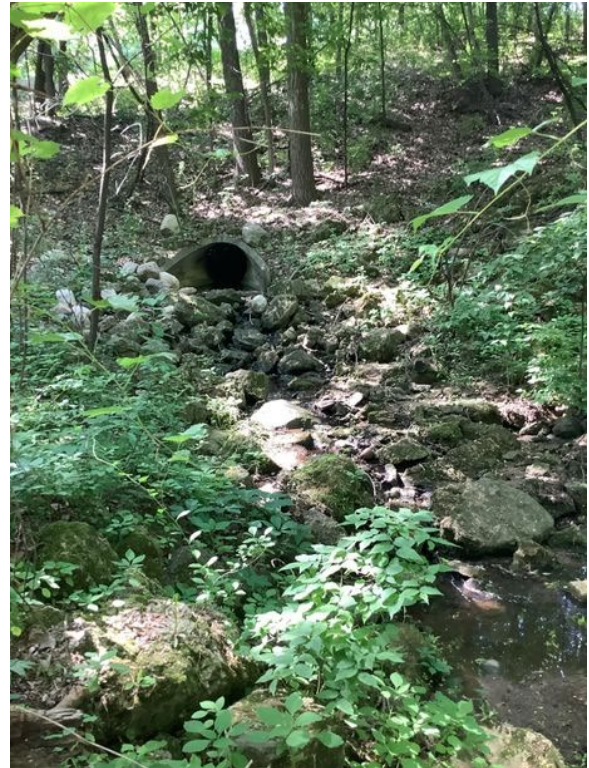
**Photo2**

**View upstream of pipe and gully from downstream on right bank trail.**

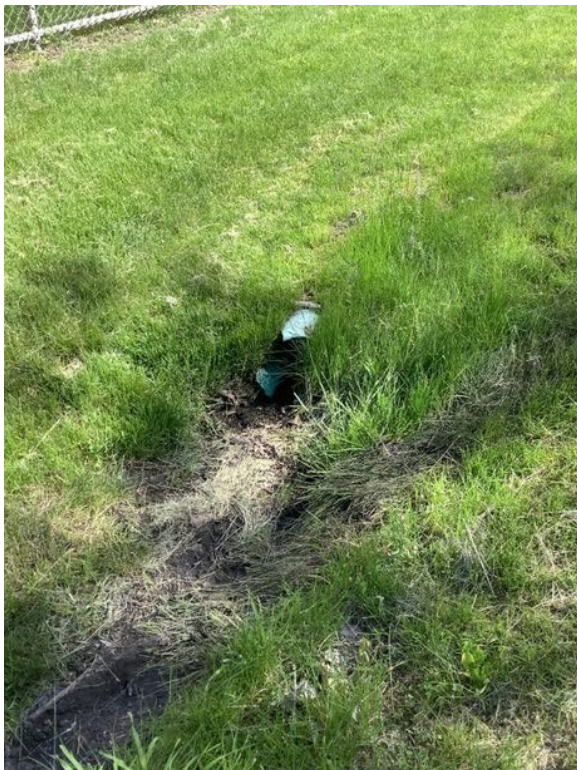
**Photo1**

<b>Seep:</b>	No	
<b>Stormwater Inputs:</b>	0-Not present	
<b>Fallen Trees:</b>	No	
<b>Degradation:</b>	1-Low	
<b>Aggradation:</b>	0-No aggradation	
<b>Slumping:</b>	0-No slumping	
<b>Additional Notes:</b>	Classification? Moderate (x - x) Notes/Comments: Pipe with water in it at bottom of v shape gully, no vegetation at bottom, but lots on the banks

**Entire gully and pipe, showing pool of water near pipe**

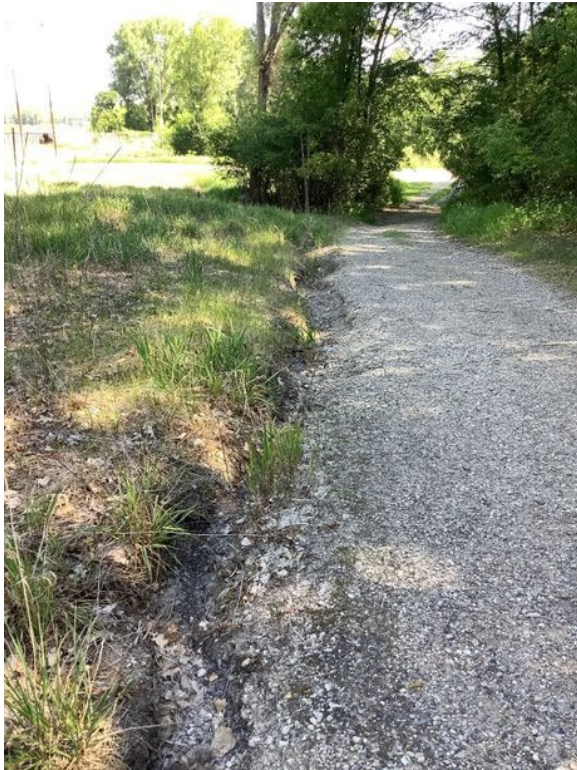
**Photo1**

<b>Gully Material:</b>	Gravel/Cobble/Boulders	
<b>Seep:</b>	No	
<b>Stormwater Inputs:</b>	0-Not present	
<b>Fallen Trees:</b>	No	
<b>Degradation:</b>		5-Severe
<b>Aggradation:</b>		0-No aggradation
<b>Slumping:</b>		1-Low
<b>Additional Notes:</b>	<p>Classification? High (x - 49)</p> <p>Notes/Comments: Ditch off side of gravel path looks like a place where water drains and heavy erosion occurs, could potentially erode the entire path in a few years.</p>

**View from headcut of small gully on trail. Can see eroding banks and lack of vegetation in gully. Lots of gravel and dirt make up gully material.**

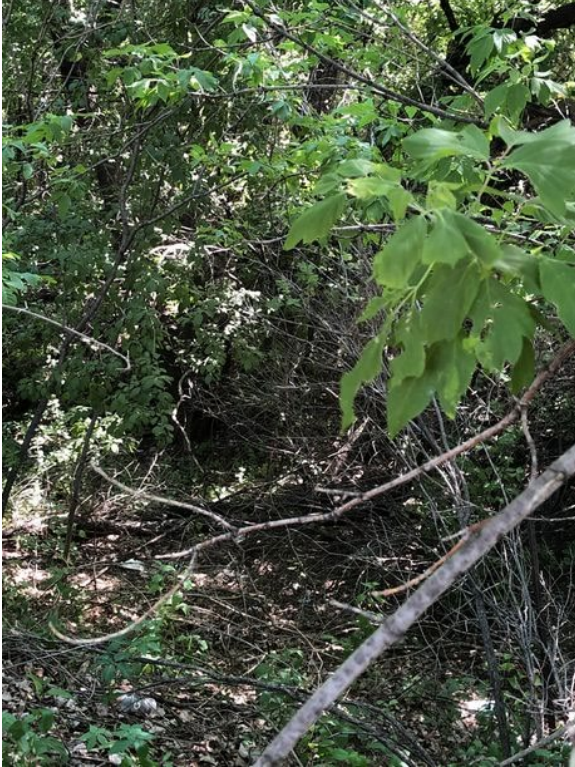
**Photo1**

<b>Seep:</b>	No	
<b>Stormwater Inputs:</b>	0-Not present	
<b>Fallen Trees:</b>	Yes	
<b>Degradation:</b>		1-Low
<b>Aggradation:</b>		1-Low
<b>Slumping:</b>		3-Moderate
<b>Additional Notes:</b>	Classification? Moderate (x - x) Notes/Comments: Steep gully with vegetation on the banks and bottom. Fallen trees throughout and slumping.

**Downstream view of right bank.**
