<p>Gully ID: 07:07-11:46</p>	<p style="text-align: center;">MAP</p>

<p>Date & Time: July 7, 2021 11:46 AM</p>	
<p>Location: Shakopee</p>	
<p>Weather: Cloudy</p> <p>Storm/Rainfall Event in the Past 24 Hours? Yes-Low Intensity</p>	
GULLY INFORMATION	
<p>Calculated Erosion Potential:</p>	<p>Moderate</p>
<p>Approximate Depth:</p>	<p>1-Shallow (<3')</p>
<p>Approximate Bottom Width:</p>	<p>3-Medium (1'-5')</p>
<p>Approximate Gully Length:</p>	<p>5-Long (>100')</p>
<p>Condition of Gully Bottom:</p>	<p>5-Bare Soil</p>
<p>Condition of Gully Banks:</p>	<p>1-Heavy Vegetation</p>
<p>Gully Bank Angles:</p>	<p>3-Mid-Range (45 to 90 degrees)</p>
<p>Gully Shape:</p>	<p>3-U-Shaped</p>
<p>Gully Material:</p>	<p>Gravel/Cobble/Boulders</p>

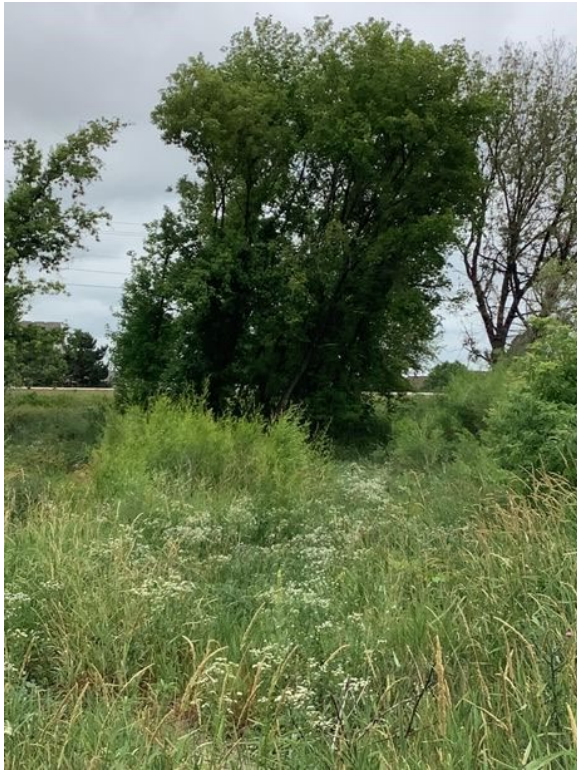
Photo 1 Image

Seep:	0-No	
Stormwater Runoff:	0-No	
Stormwater Inputs:		
Fallen Trees:	1-Yes	
Degradation:	1-Low	
Aggradation:	1-Low	
Slumping:	1-Yes	
Additional Notes:	<p>Classification? Moderate</p> <p>Presence of Water? Yes</p> <p>Quantity of Water? Trickle/Slow Moving</p> <p>Notes/Comments: This gully is a stream that runs through a grassy fie,d and under the road connecting to another gully. Upstream there are large trees leaning over the channel. couldnt reach area where stream drains into pipe under road due to heavy vegetation.</p>

Downstream view of large leaning trees.

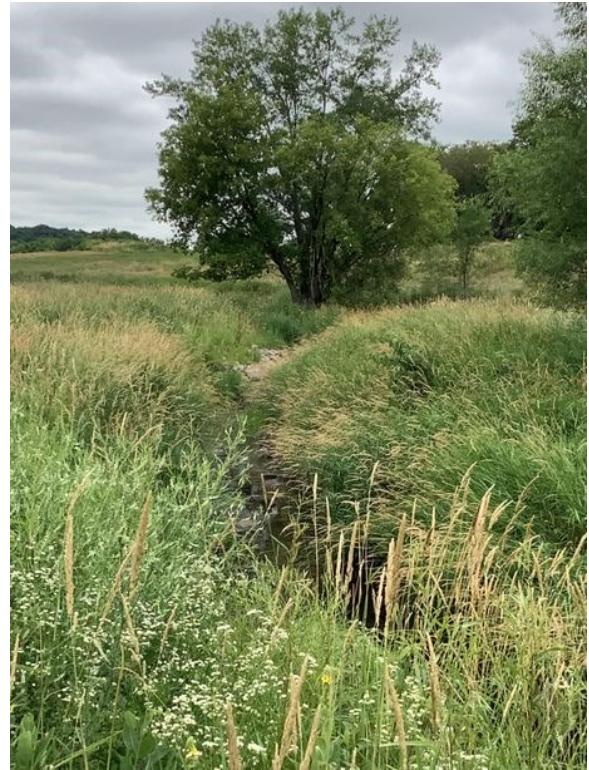
Photo 2 Image

Upstream view of gully.

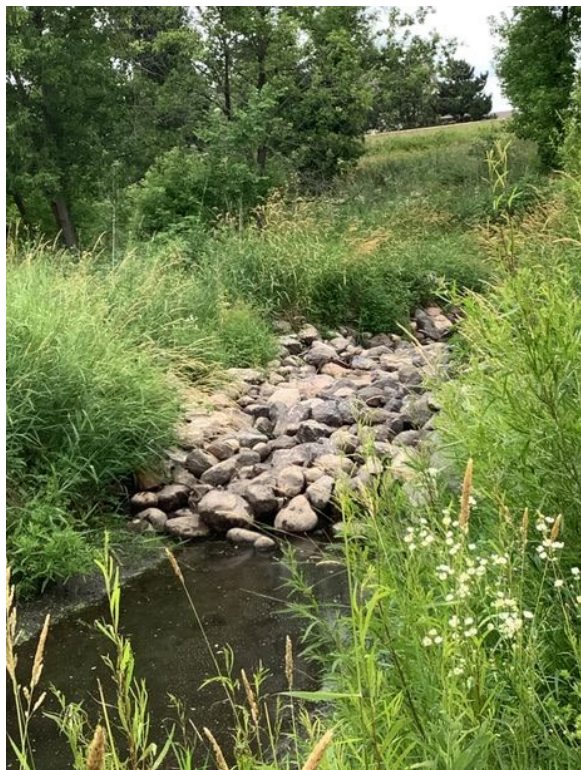
Photo 3 Image

Downstream view of gully.

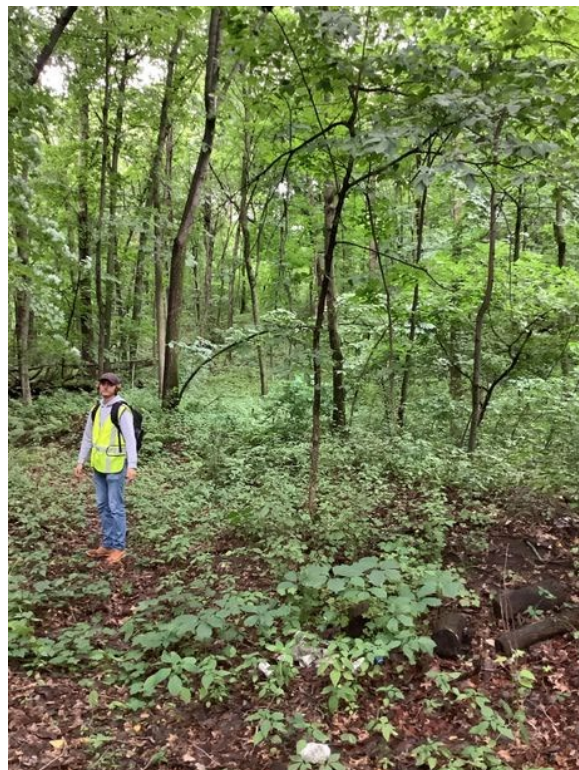
Photo 2 Image

Upstream view of left bank.

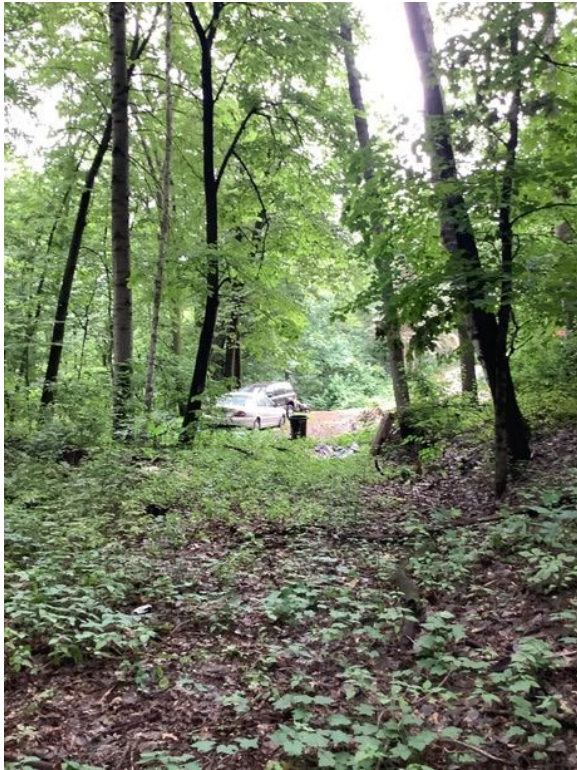
Photo 3 Image

Downstream view of end of gully which feed directly into private property.

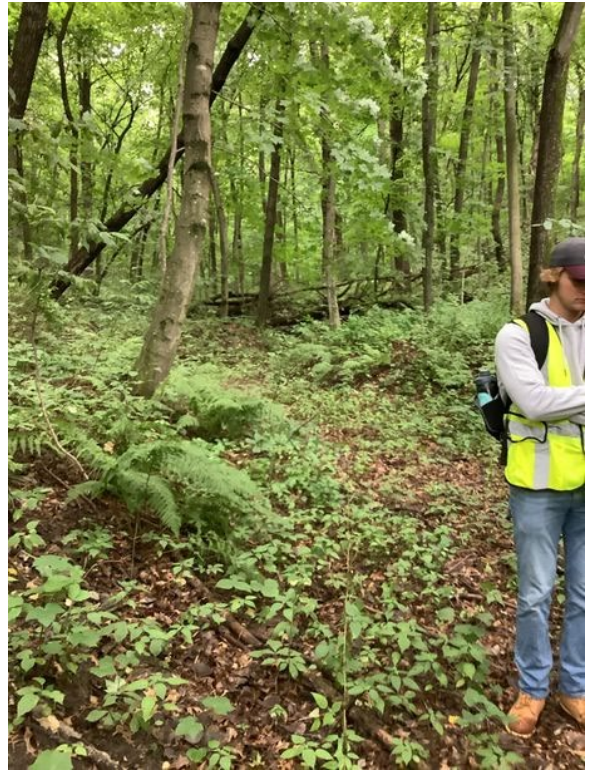
Photo 4 Image

Upstream view of area where a stream potentially runs through the gully.

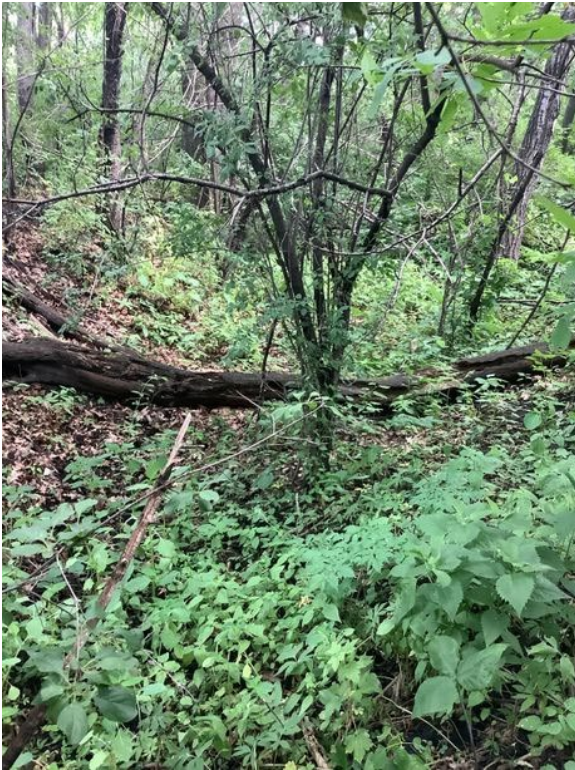
Photo 1 Image

Downstream view from right bank.

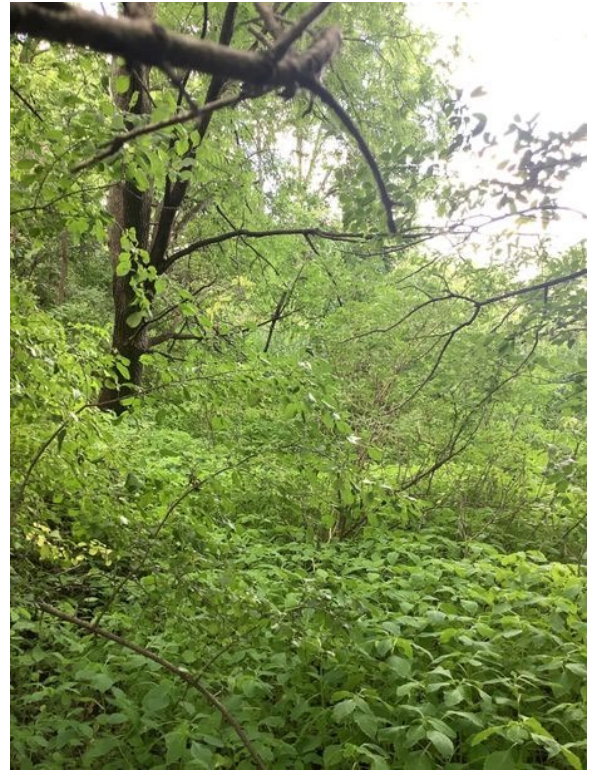
Photo 2 Image

Seep:	0-No	
Stormwater Runoff:	0-No	
Stormwater Inputs:		
Fallen Trees:	1-Yes	
Degradation:		3-Moderate
Aggradation:		0-None
Slumping:		1-Yes
Additional Notes:	<p>Classification? Low</p> <p>Presence of Water? No</p> <p>Quantity of Water?</p> <p>Notes/Comments: Gully in neighborhood next to eagle creek. Heavy vegetation and slumping with leaning trees.</p>

Upstream view from bottom of gully. Tree on right bank is leaning and slumping.

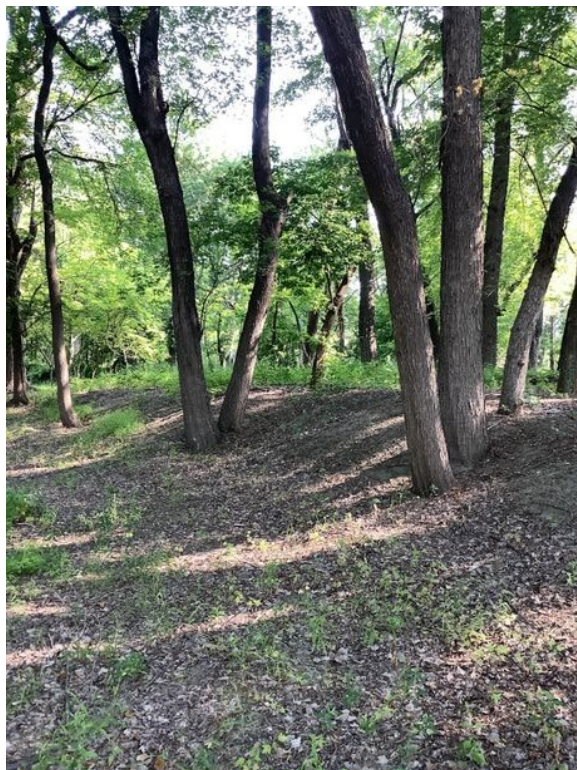
Photo 2 Image

Right bank

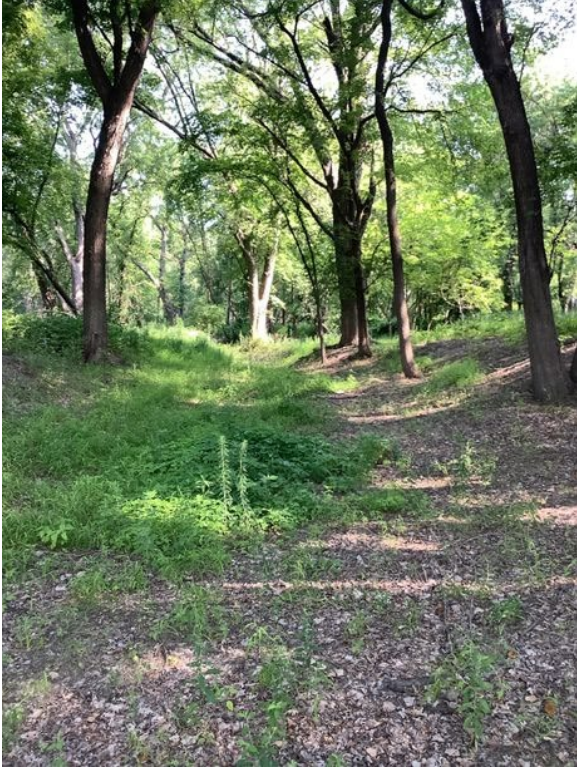
Photo 3 Image

Bottom

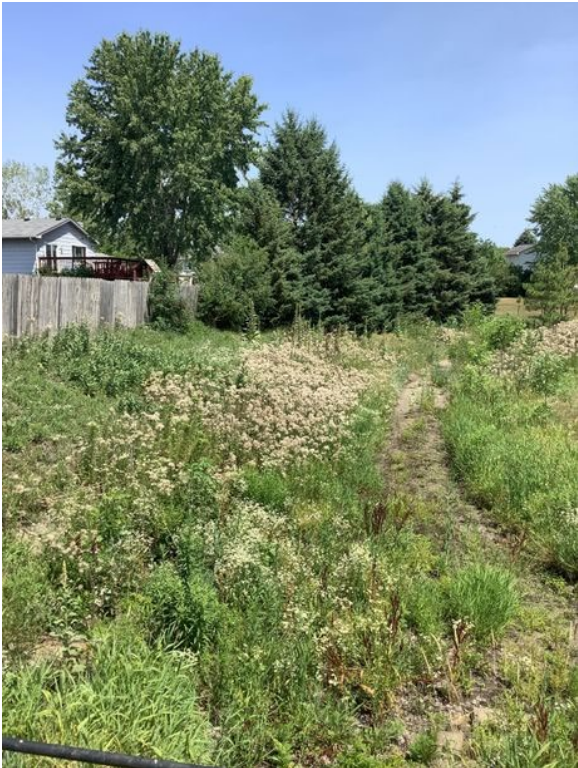
Photo 1 Image

Left bank

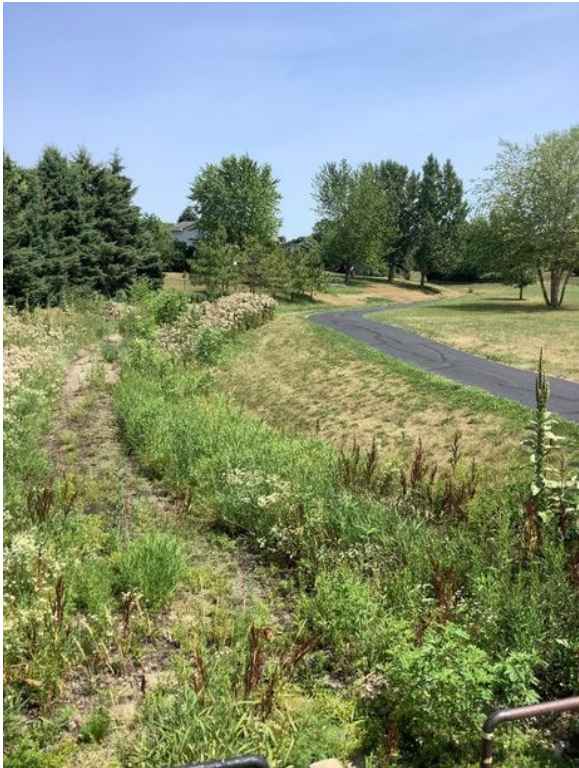
Photo 2 Image

Right bank

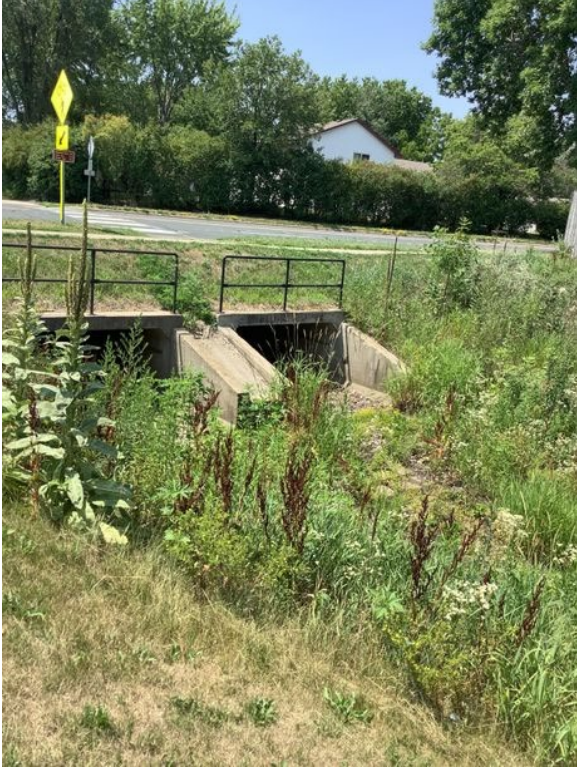
Photo 3 Image

Pipes

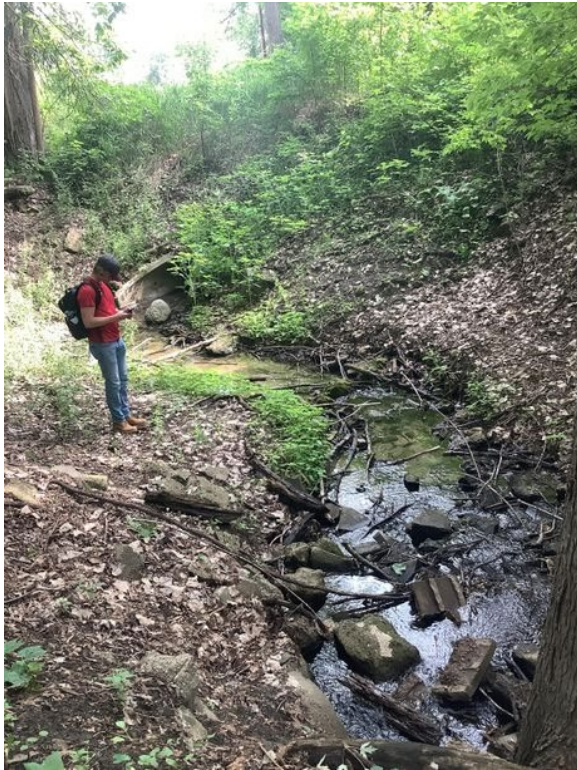
Photo 1 Image

Downstream view of gully, inflow and outflow pipes are visible.

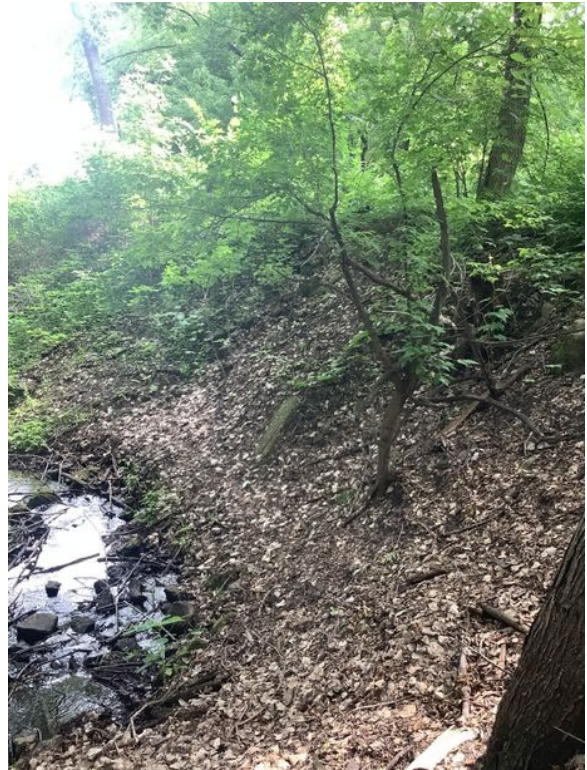
Photo 2 Image

Seep:	0-No	
Stormwater Runoff:	1-Yes	
Stormwater Inputs:	5-High Flow	
Fallen Trees:	1-Yes	
Degradation:	3-Moderate	
Aggradation:	1-Low	
Slumping:	0-No	
Additional Notes:	<p>Classification? High</p> <p>Presence of Water? Yes</p> <p>Quantity of Water? Torrent/Fast Moving</p> <p>Notes/Comments: Second part of gully connected through pipes leading into the river. The right bank is worse than the left bank for degradation.</p>

Downstream view of right bank which has worse degradation.

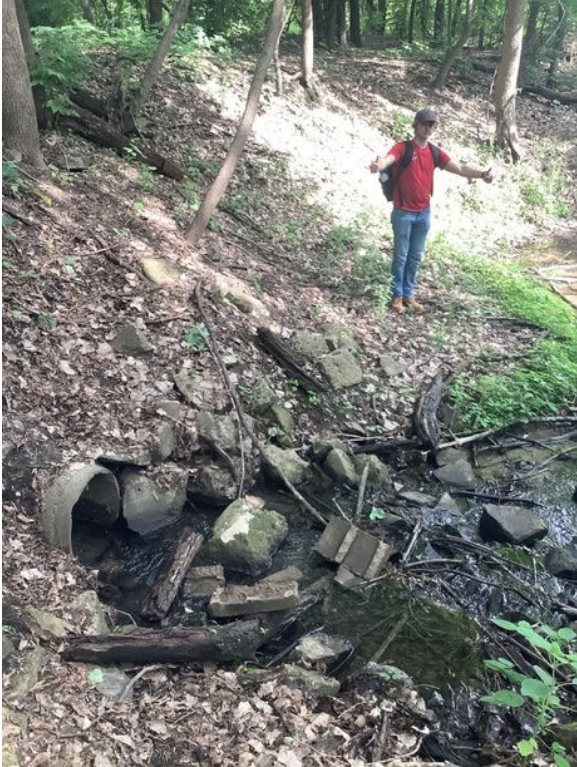
Photo 3 Image

Downstream view of inflow pipe and left bank.

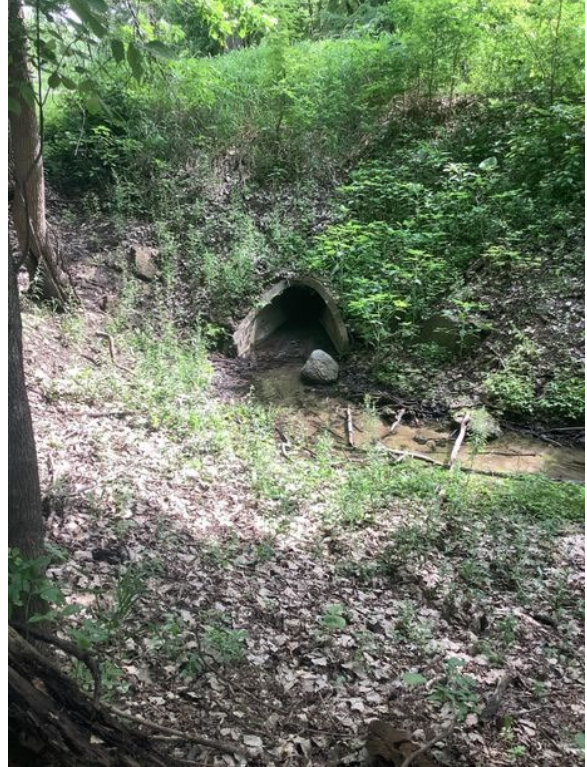
Photo 4 Image

Downstream view of outflow pipe.

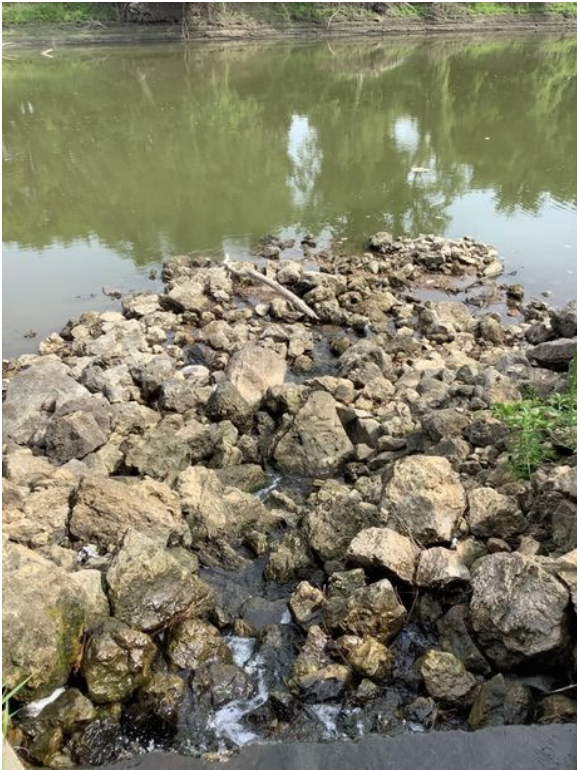
Photo 1 Image

Seep:	0-No	
Stormwater Runoff:	1-Yes	
Stormwater Inputs:	5-High Flow	
Fallen Trees:	0-No	
Degradation:		3-Moderate
Aggradation:		1-Low
Slumping:		0-No
Additional Notes:	<p>Classification? Moderate</p> <p>Presence of Water? Yes</p> <p>Quantity of Water? Torrent/Fast Moving</p> <p>Notes/Comments: Other side of pipe from previous gully, boulders armoring the gully, leads directly into river</p>

Full gully

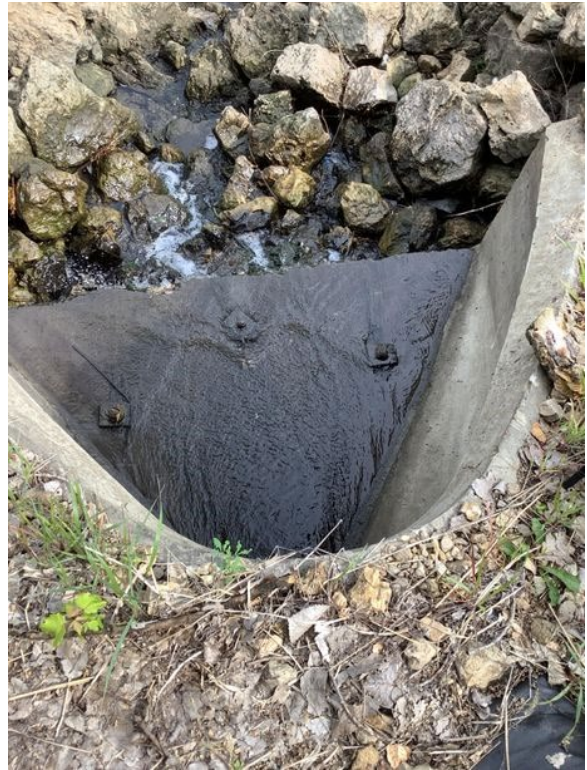
Photo 2 Image

Pipe

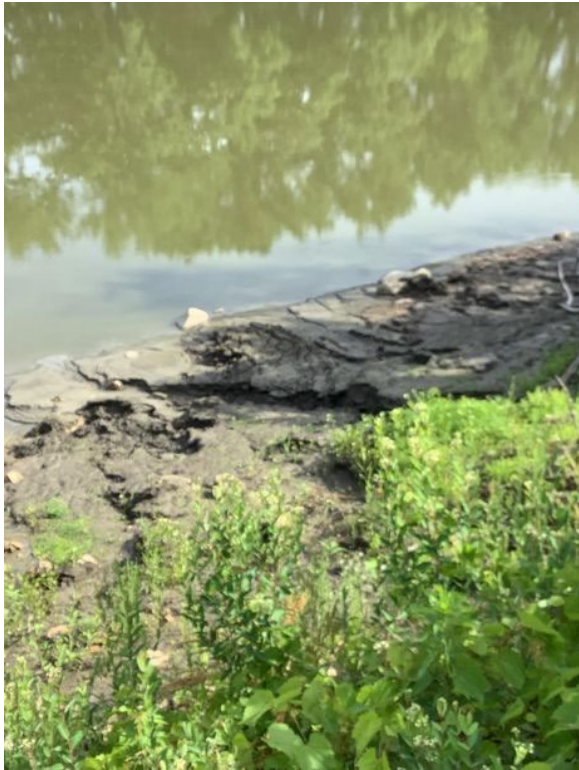
Photo 1 Image

Seep:	0-No	
Stormwater Runoff:	0-No	
Stormwater Inputs:		
Fallen Trees:	0-No	
Degradation:	5-Severe	
Aggradation:	3-Moderate	
Slumping:	0-No	
Additional Notes:	<p>Classification? High</p> <p>Presence of Water? Yes</p> <p>Quantity of Water? Trickle/Slow Moving</p> <p>Notes/Comments: Multiple very similar gullies all kind of connected, leads directly into river, high erosion, can see sediment deposit directly into river</p>

View of gully

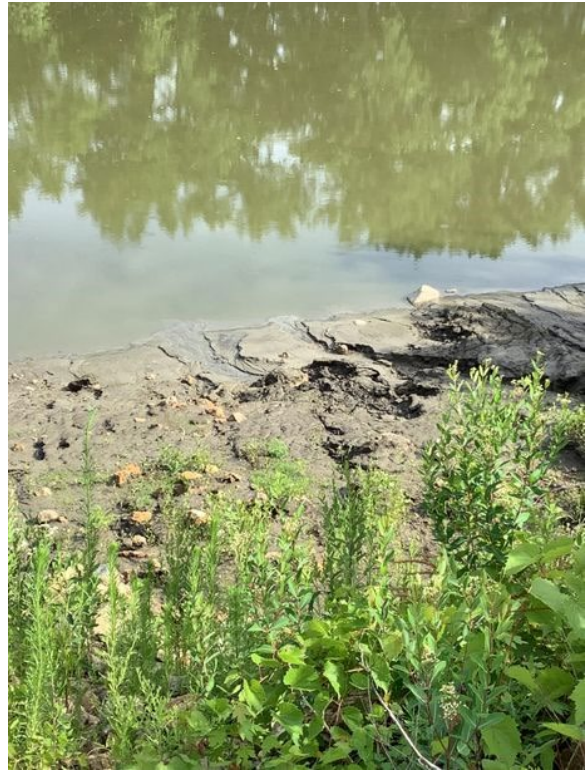
Photo 2 Image

Left side

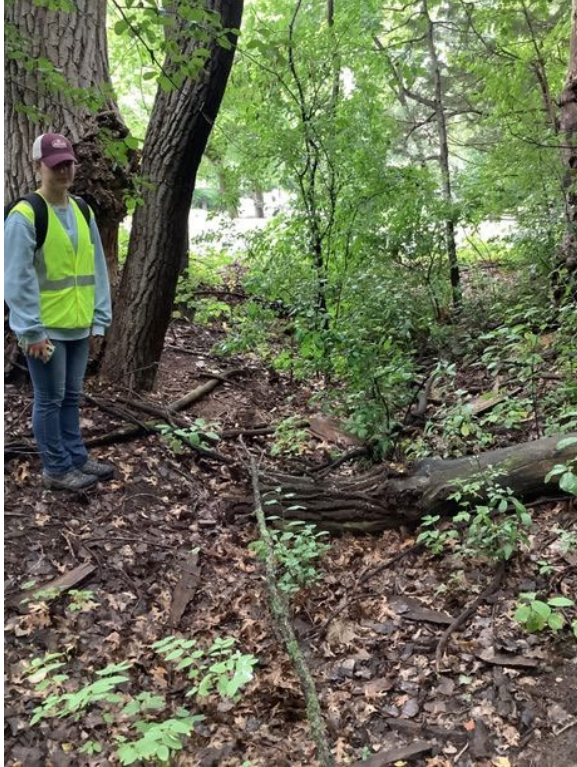
Photo 1 Image

End of gully

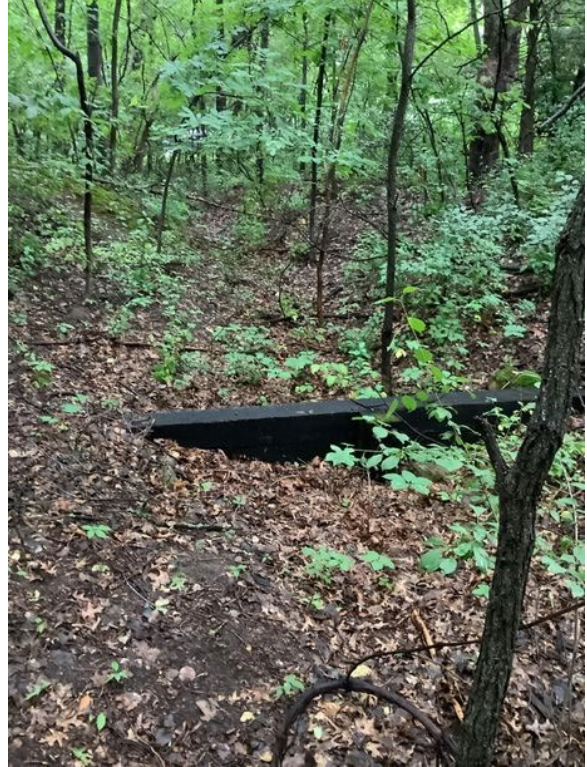
Photo 2 Image

Dam in middle

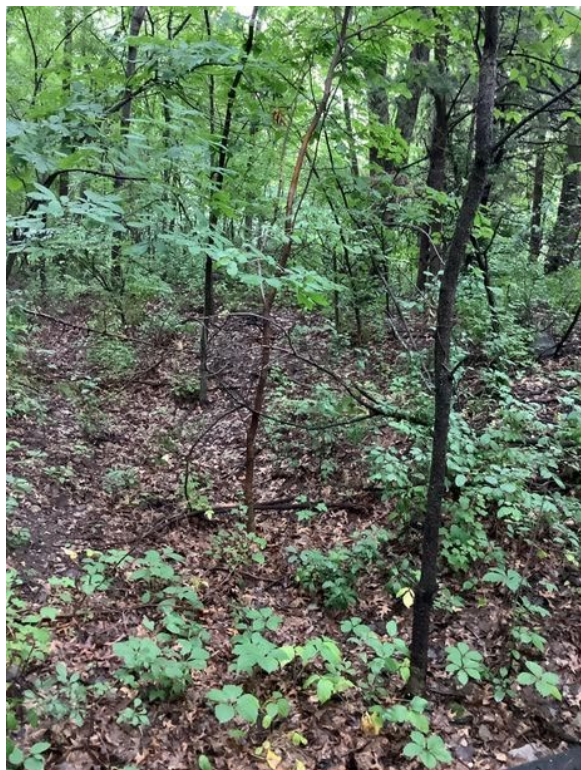
Photo 3 Image

Left bank

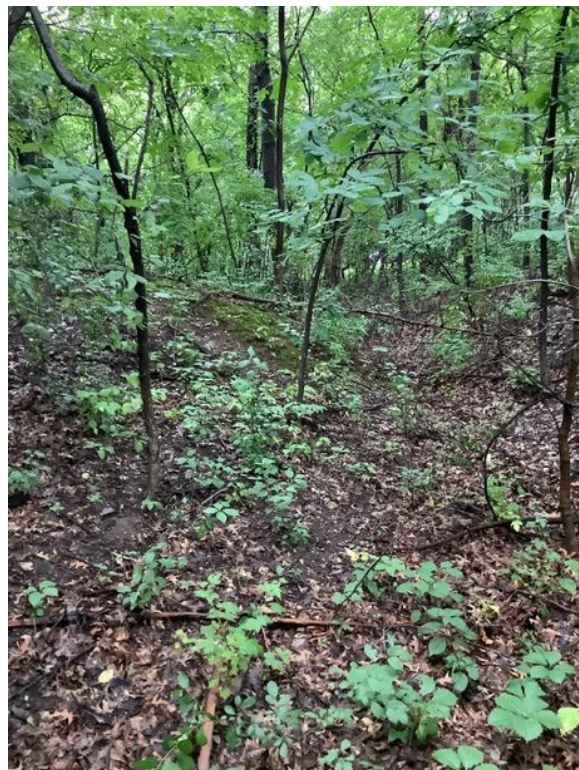
Photo 4 Image

Right bank

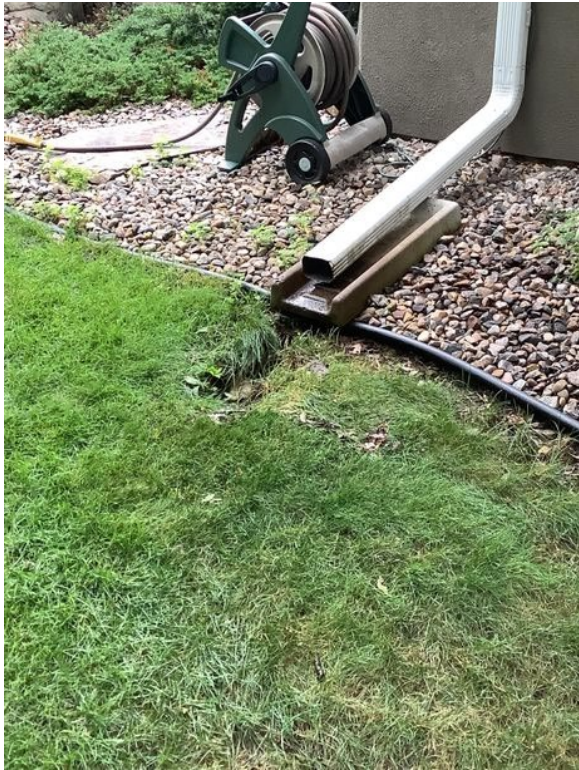
Photo 1 Image

Seep:	0-No	
Stormwater Runoff:	1-Yes	
Stormwater Inputs:	0-None	
Fallen Trees:	0-No	
Degradation:	5-Severe	
Aggradation:	3-Moderate	
Slumping:	0-No	
Additional Notes:	<p>Classification? High</p> <p>Presence of Water? No</p> <p>Quantity of Water?</p> <p>Notes/Comments: Gully likely formed from somebody's gutter, looks to run underground then cause erosion in hard. Kind of leads into previous site.</p>

Gutter and start

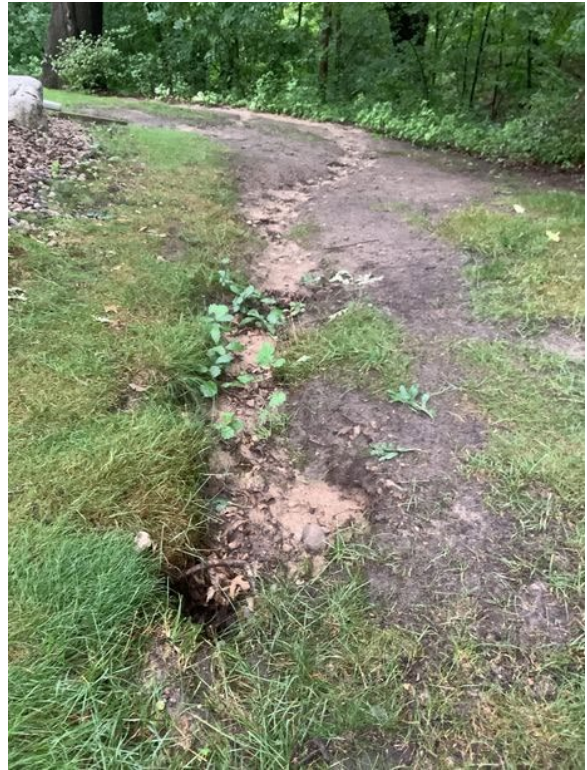
Photo 2 Image

Full gully

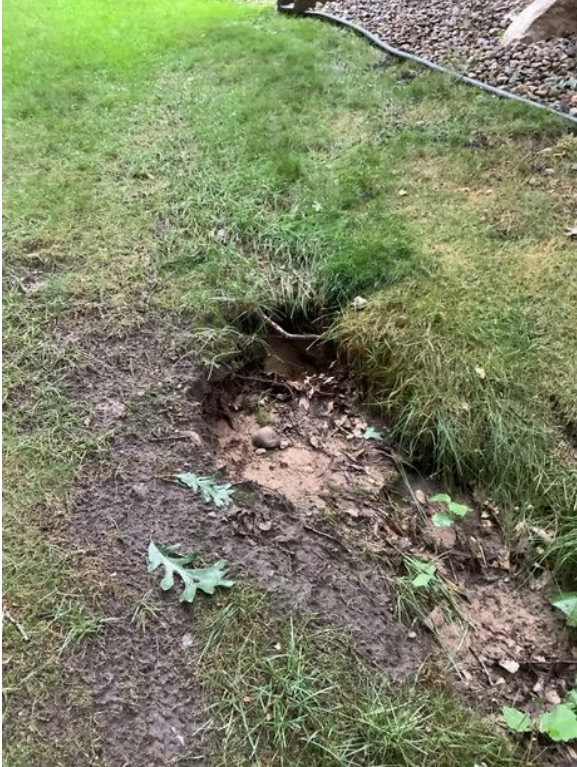
Photo 3 Image

Continuation

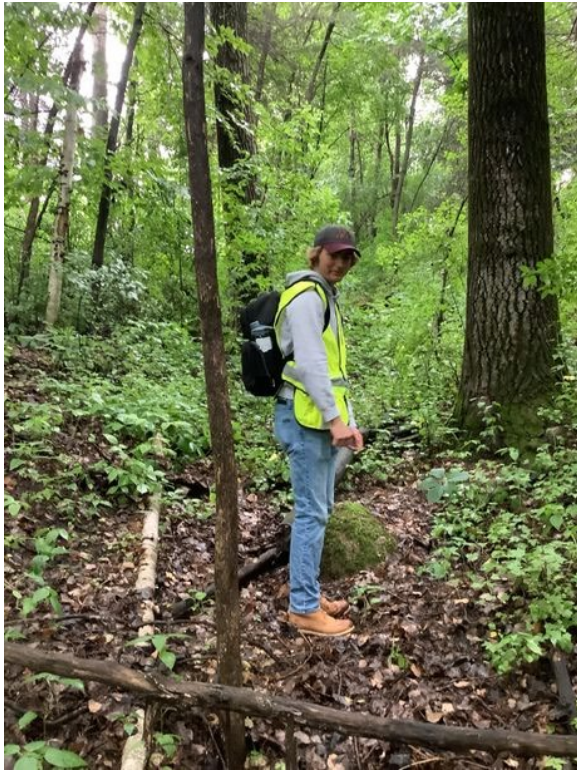
Photo 1 Image

Seep:	0-No	
Stormwater Runoff:	0-No	
Stormwater Inputs:		
Fallen Trees:	1-Yes	
Degradation:		3-Moderate
Aggradation:		1-Low
Slumping:		1-Yes
Additional Notes:	<p>Classification? High</p> <p>Presence of Water? No</p> <p>Quantity of Water?</p> <p>Notes/Comments: Gully running behind house in the woods. Begins with an obtuse u shape then cutes down and forms a narrow v shape. There are some fallen trees downstream.</p>

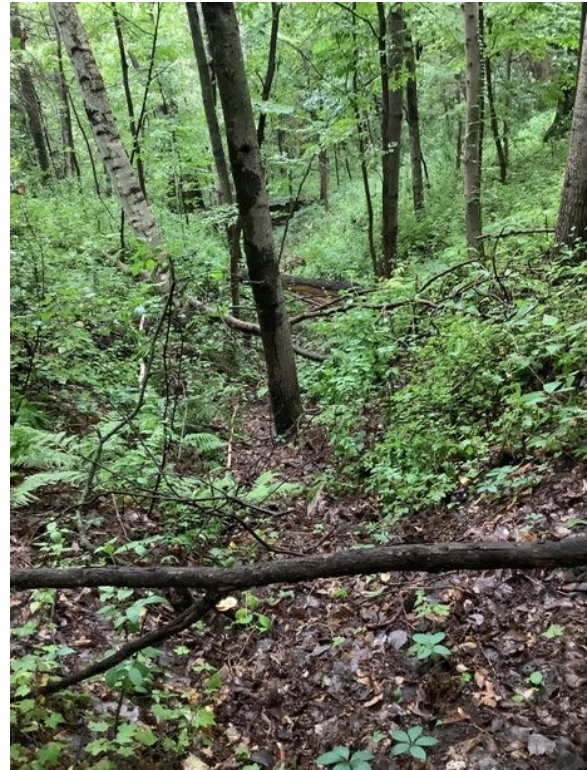
Photo 2 Image

Downstream view of gully, downstream there are fallen trees and a board walk running across the banks.

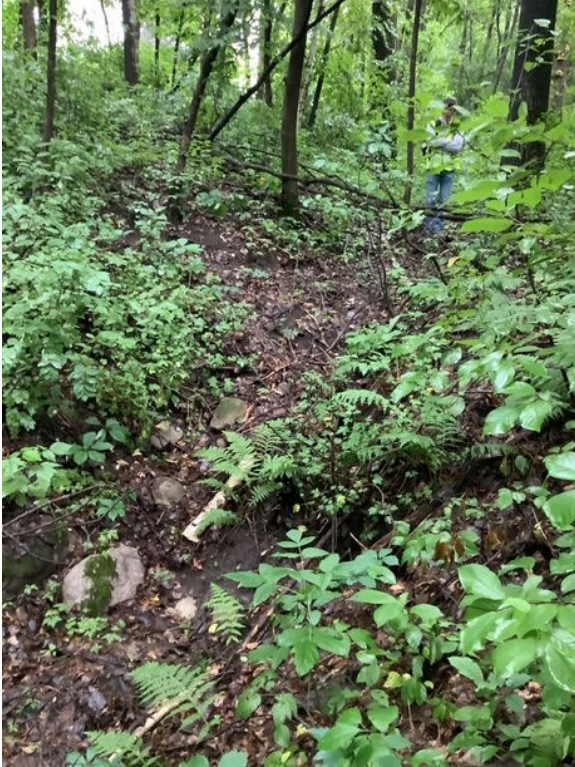
Photo 3 Image

Upstream view of area where slope drops off and gully becomes more severe.

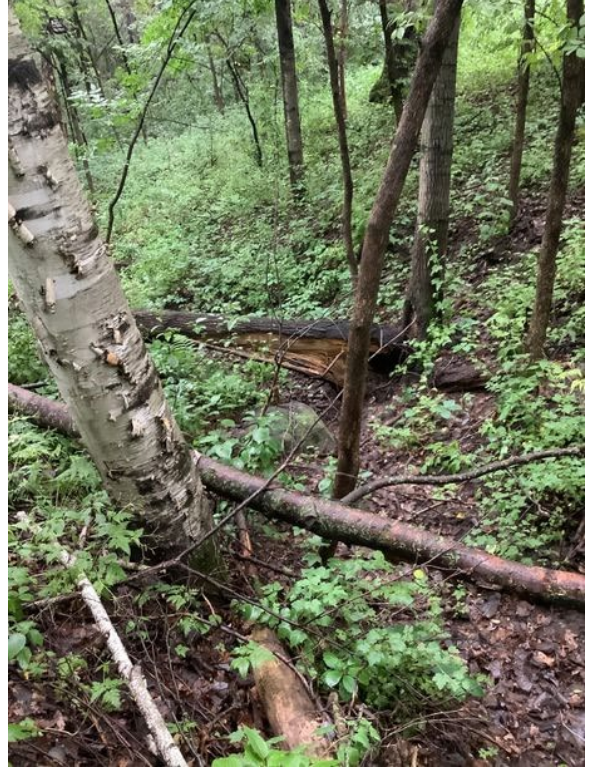
Photo 4 Image

Downstream view of fallen tree.

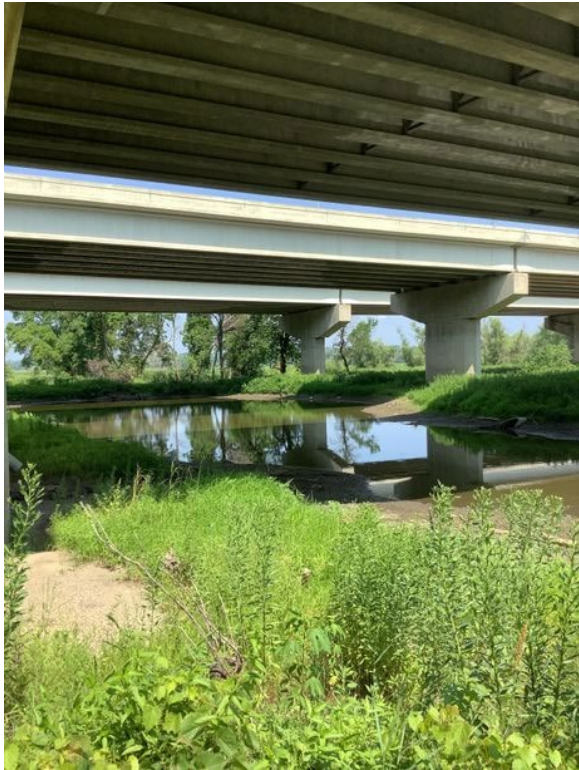
Photo 1 Image

Gully

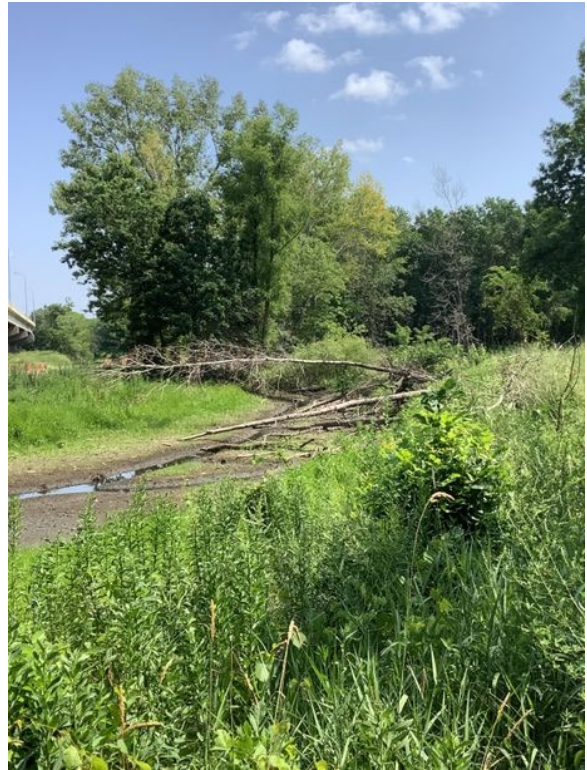
Photo 2 Image

Gully

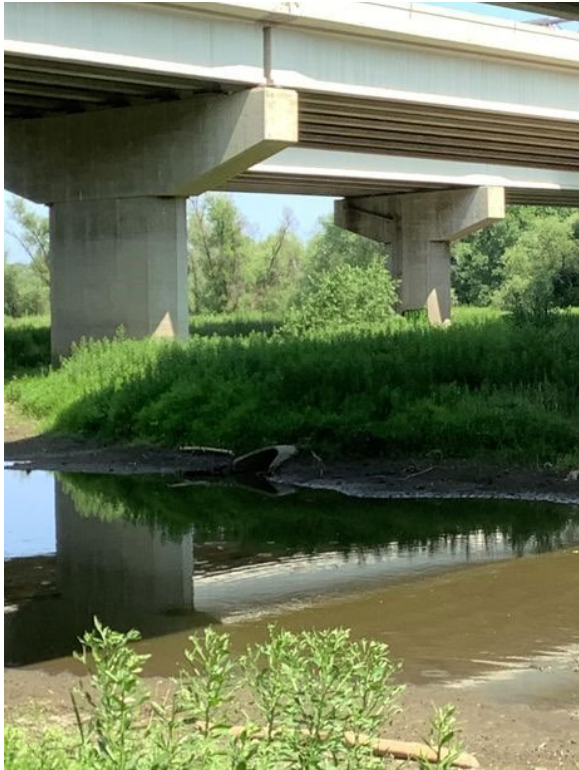
Photo 3 Image

Pipe

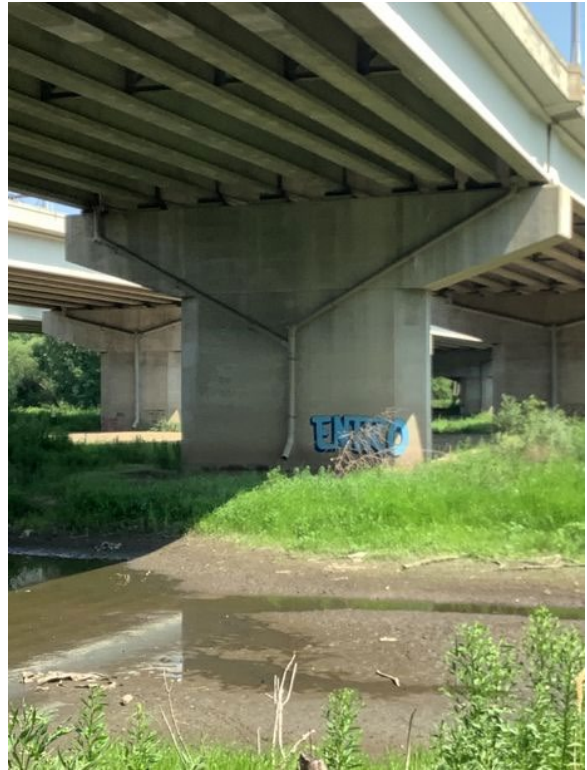
Photo 4 Image

Pipes from highway

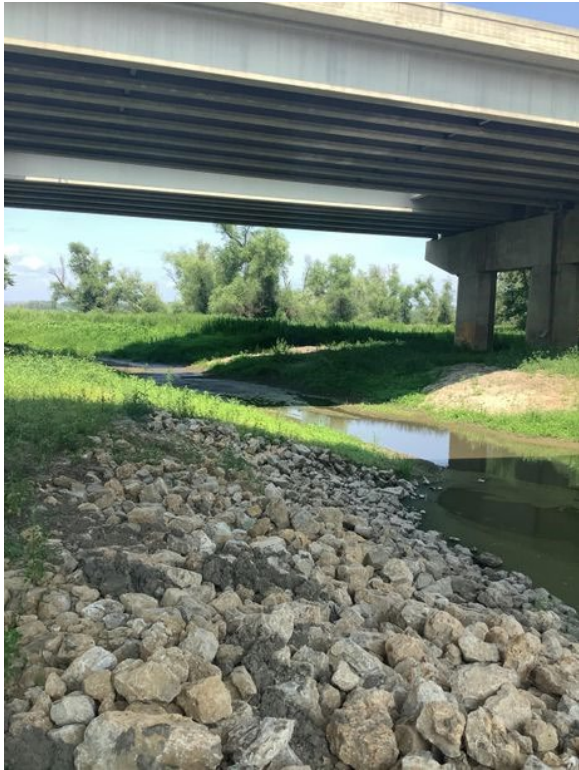
Photo 1 Image

Upstream view from right bank.

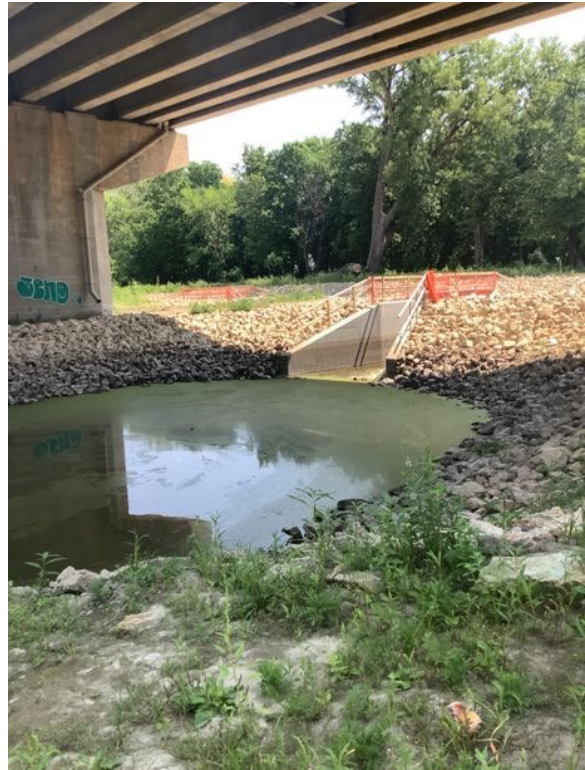
Photo 2 Image

Downstream view of dam.

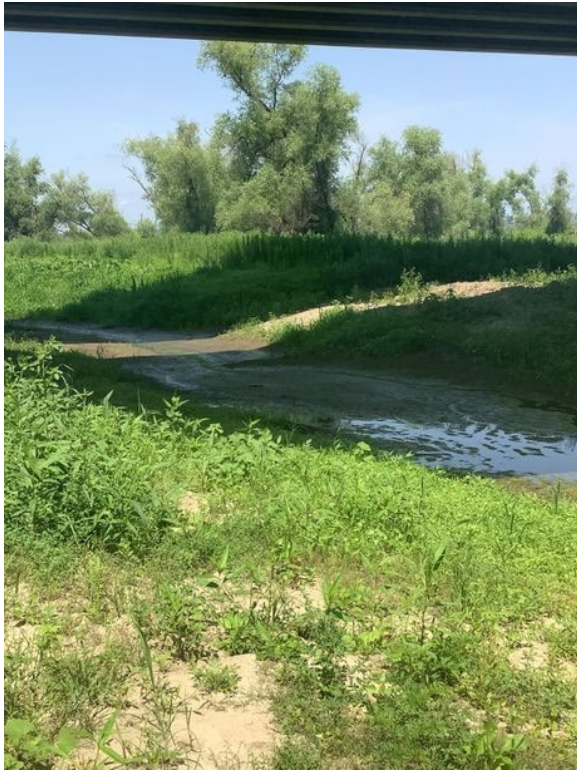
Photo 3 Image

Upstream view of gully bottom.

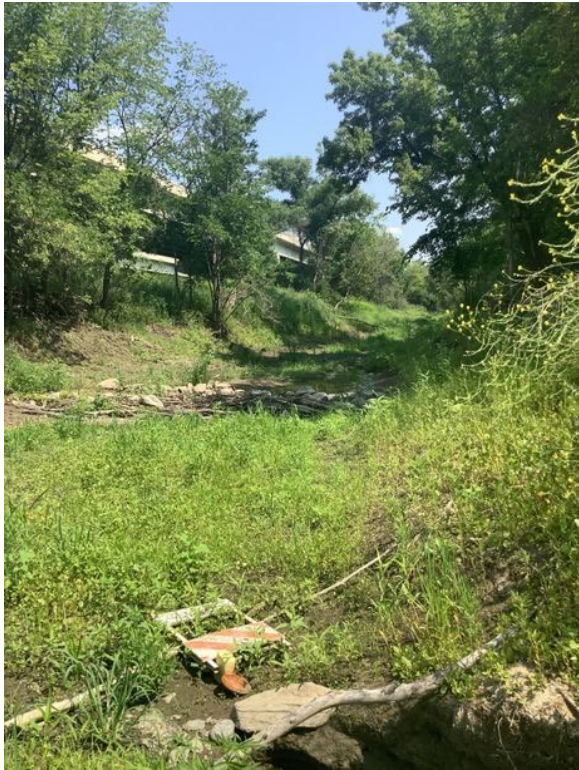
Photo 1 Image

Downstream view of gully.

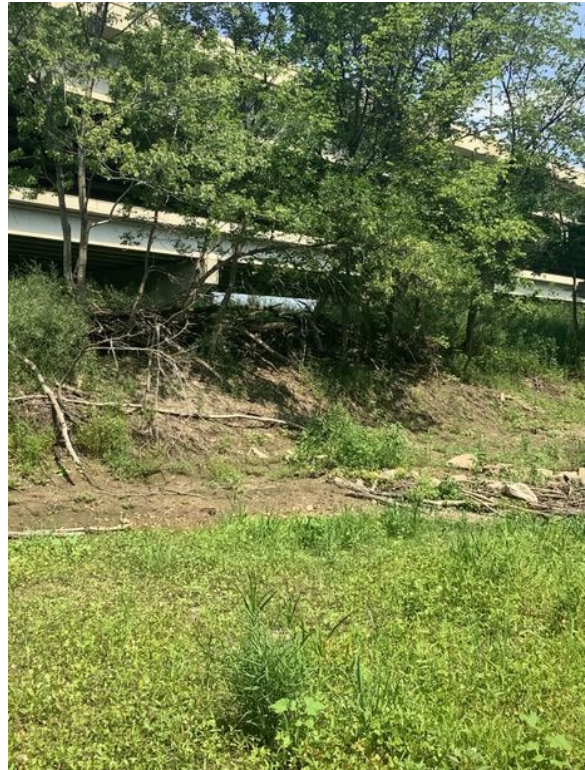
Photo 2 Image

Downstream view of severe degradation on left bank.

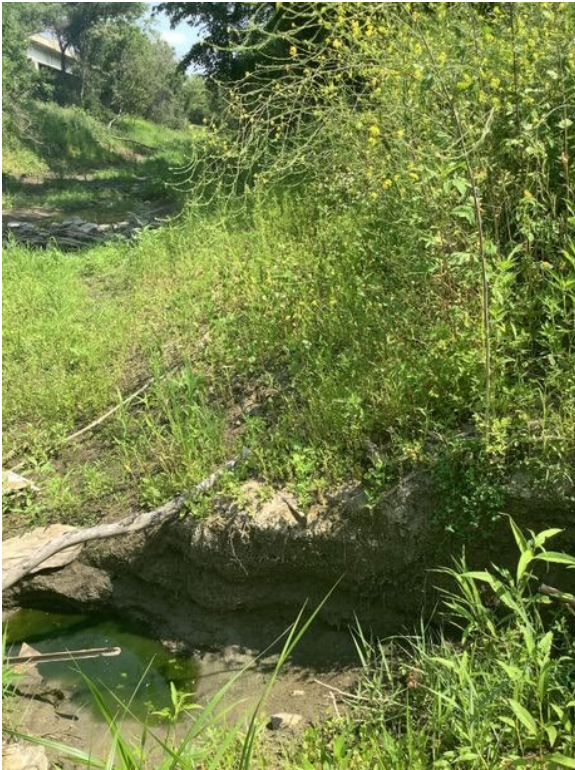
Photo 3 Image

Downstream view of severe degradation on right bank.

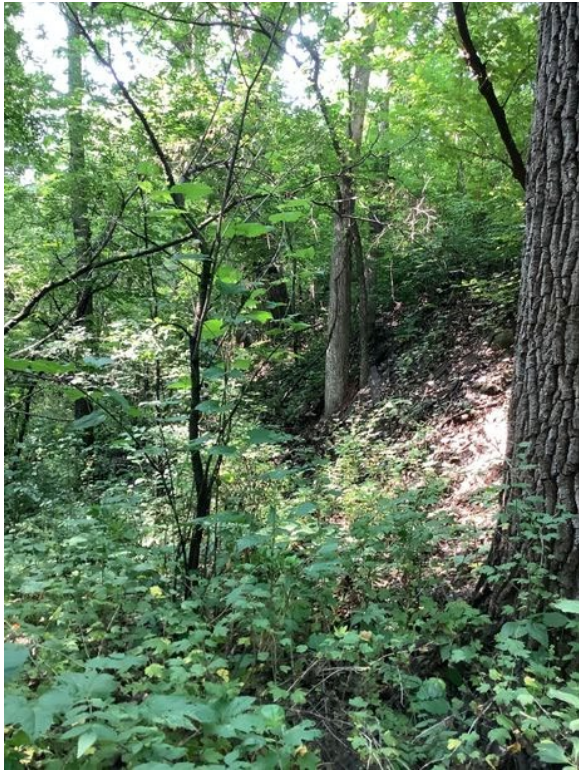
Photo 1 Image

Left bank

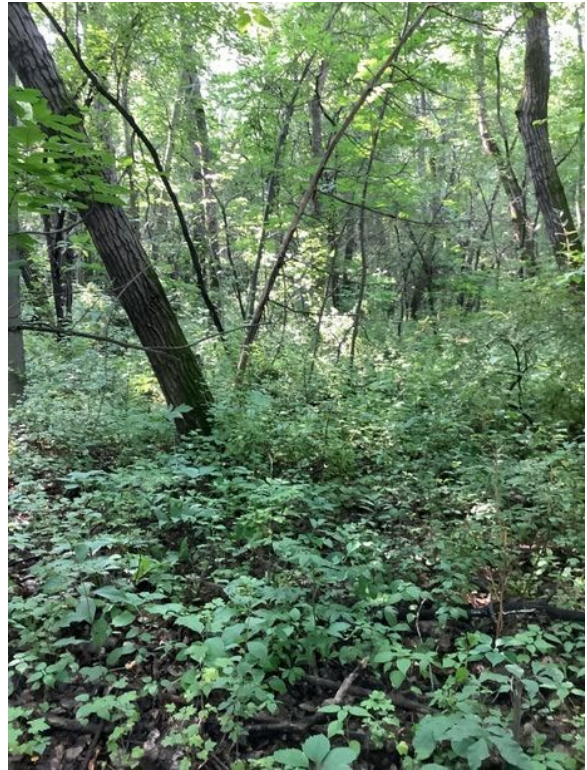
Photo 2 Image

Right bank

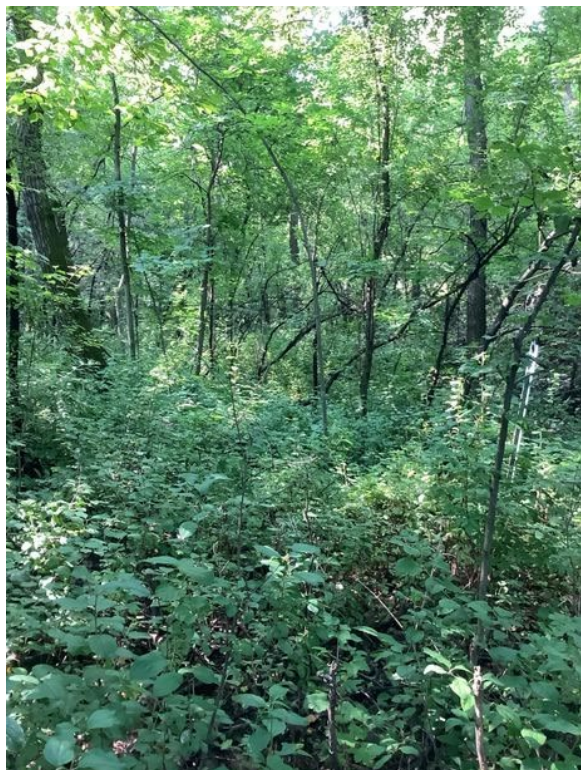
Photo 3 Image

Middle

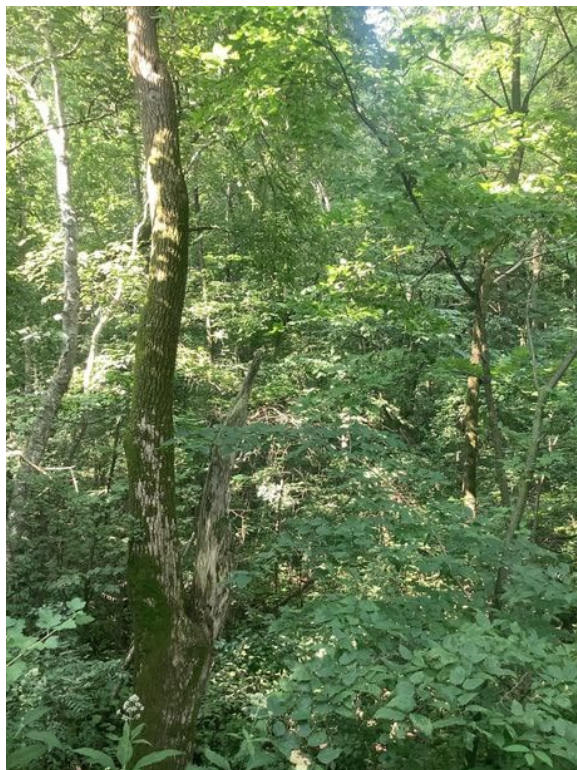
Photo 2 Image

Upstream view of left bank.

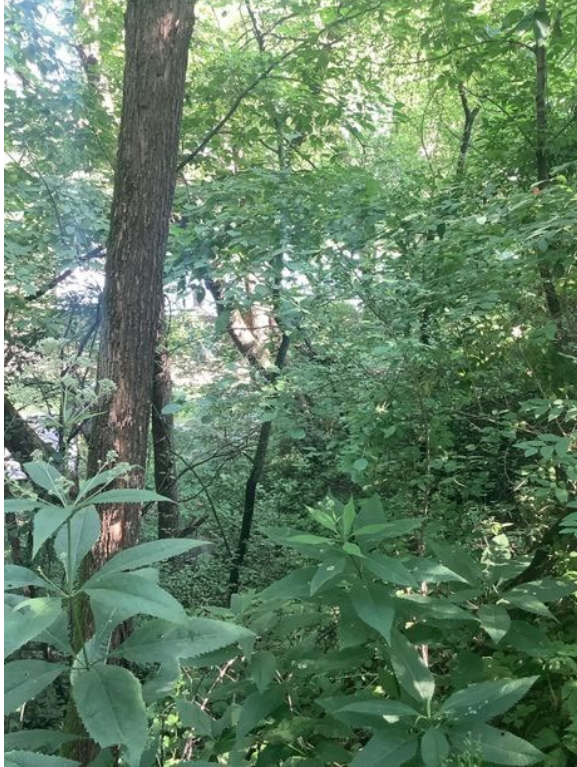
Photo 3 Image

Downstream view of right bank showing leaning trees and the private property in the background.

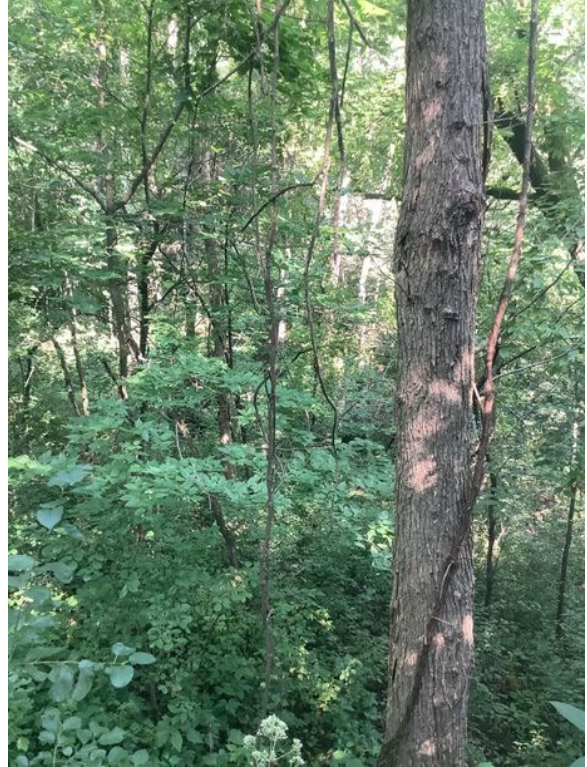
Photo 4 Image

Downstream view of left bank. This area is hard to see through all the trees, but some of these trees have some significant degradation around the roots.
