<p>Gully ID: 07:07-11:46</p>	<p style="text-align: center;">MAP</p>

<p>Date & Time: July 7, 2021 11:46 AM</p>	
<p>Location: Shakopee</p>	
<p>Weather: Cloudy</p> <p>Storm/Rainfall Event in the Past 24 Hours? Yes-Low Intensity</p>	
GULLY INFORMATION	
<p>Calculated Erosion Potential:</p>	<p>Moderate</p>
<p>Approximate Depth:</p>	<p>1-Shallow (<3')</p>
<p>Approximate Bottom Width:</p>	<p>3-Medium (1'-5')</p>
<p>Approximate Gully Length:</p>	<p>5-Long (>100')</p>
<p>Condition of Gully Bottom:</p>	<p>5-Bare Soil</p>
<p>Condition of Gully Banks:</p>	<p>1-Heavy Vegetation</p>
<p>Gully Bank Angles:</p>	<p>3-Mid-Range (45 to 90 degrees)</p>
<p>Gully Shape:</p>	<p>3-U-Shaped</p>
<p>Gully Material:</p>	<p>Gravel/Cobble/Boulders</p>

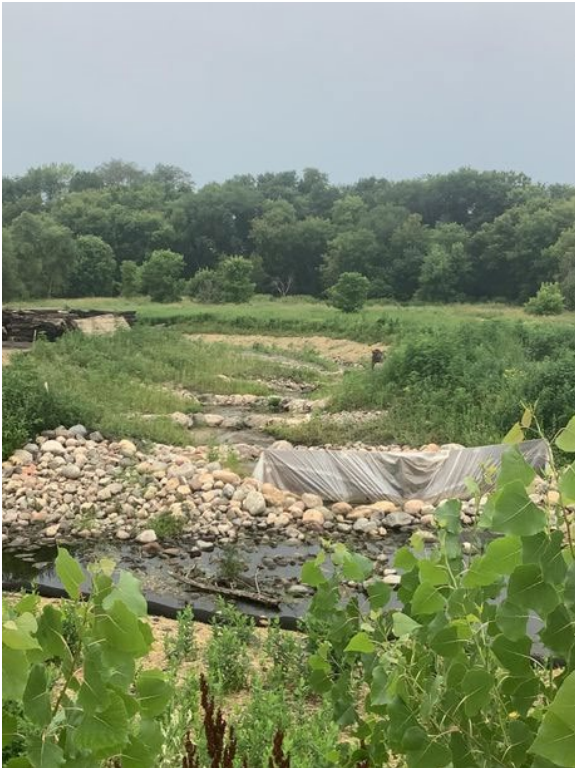
Photo 1 Image

Upstream view of gully from road. This is where the gully connects to the stream.

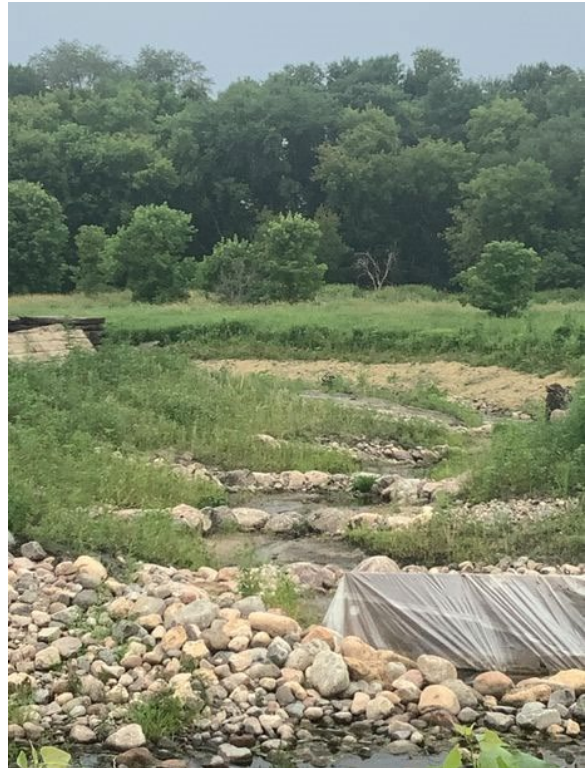
Photo 2 Image

Upstream view zoomed in showing small rock dams created.

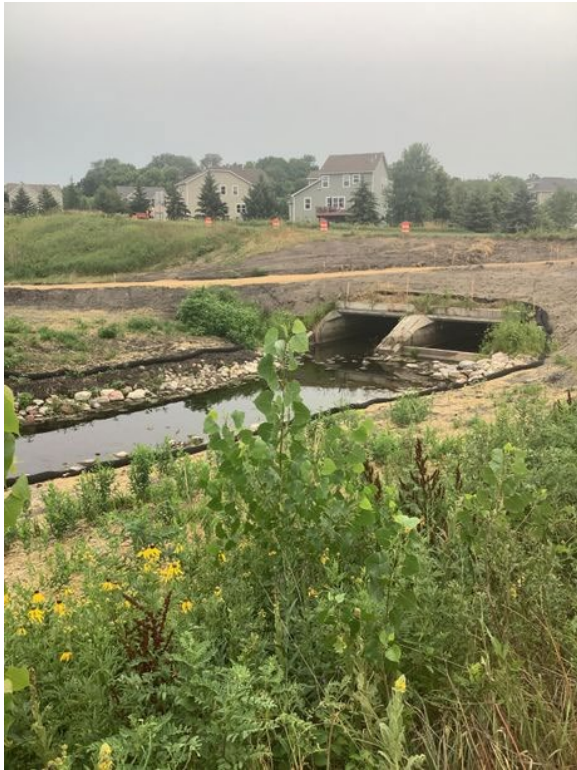
Photo 3 Image

Downstream view of where the stream the gully connects to drains under the road

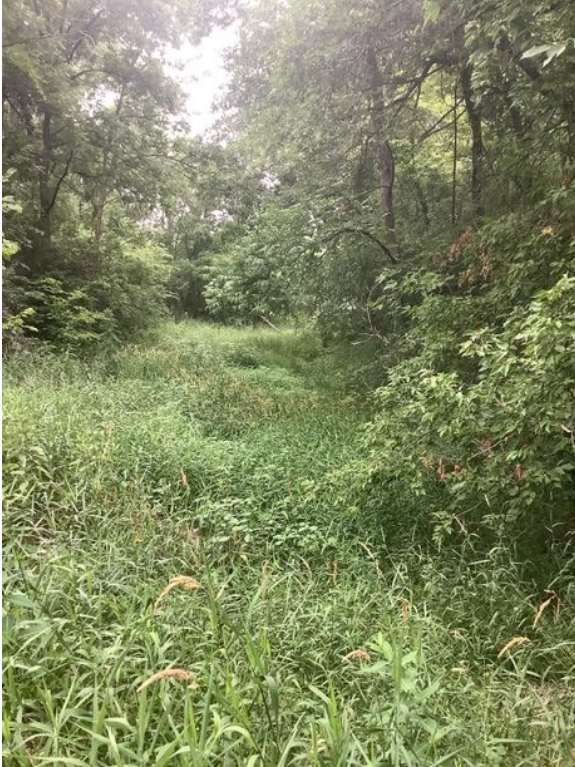
Photo 1 Image

Downstream view of gully. Hard to see channel due to high vegetation levels.

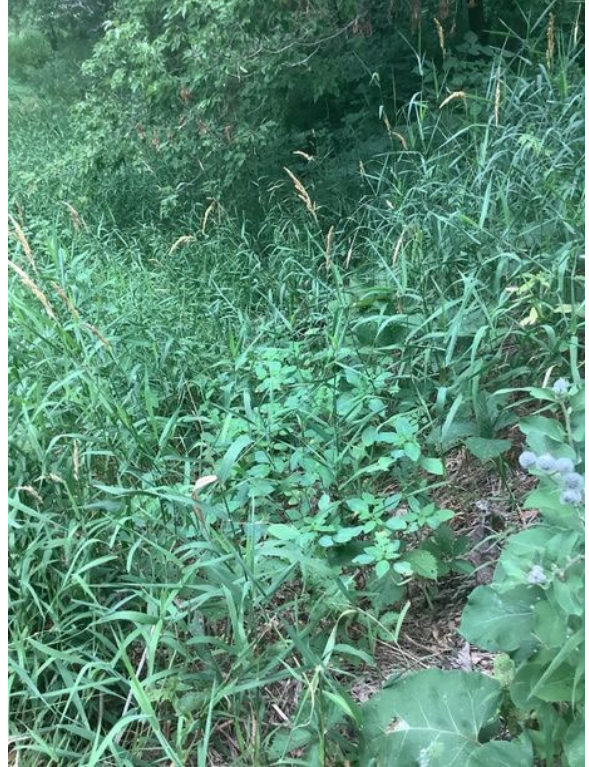
Photo 2 Image

Downstream view of headcut of gully right next to trail.

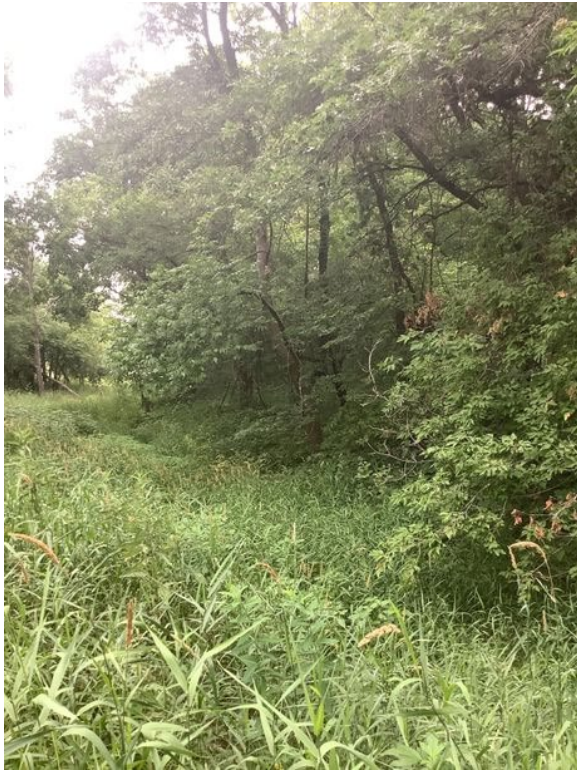
Photo 3 Image

Downstream view of trees leaning into channel

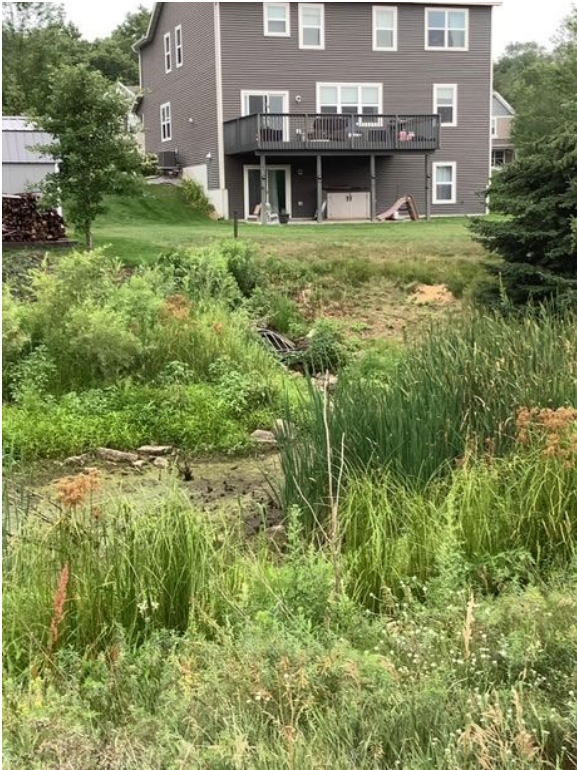
Photo 1 Image

Pipe

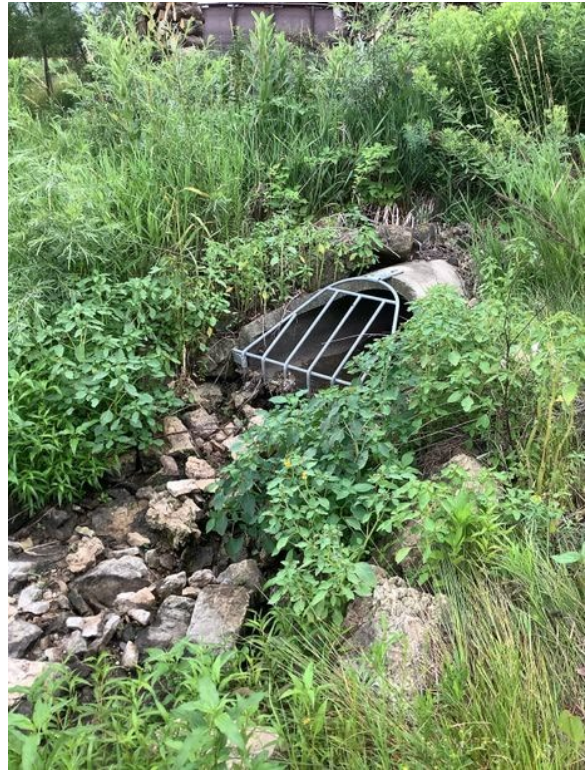
Photo 2 Image

Pipe again

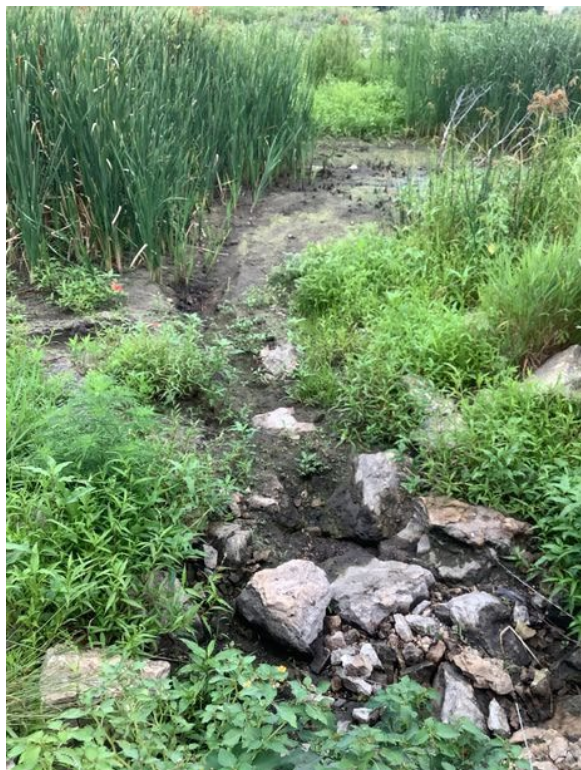
Photo 3 Image

Gully

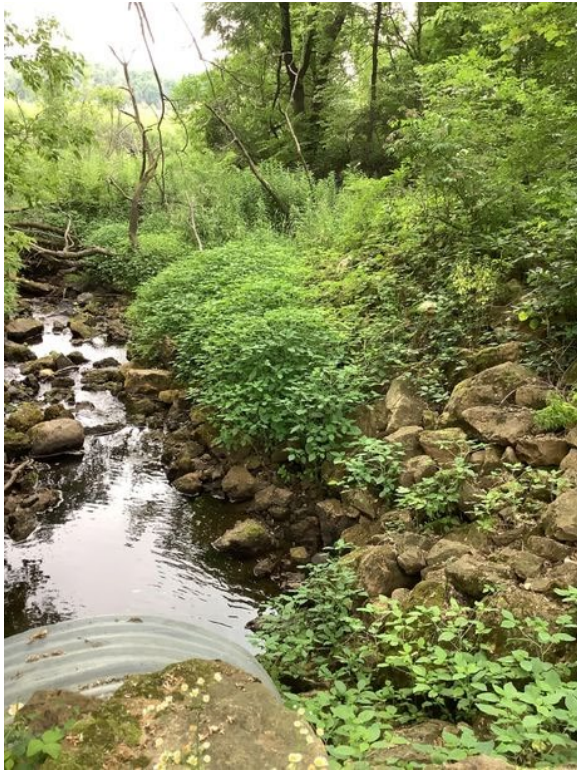
Photo 1 Image

Right bank

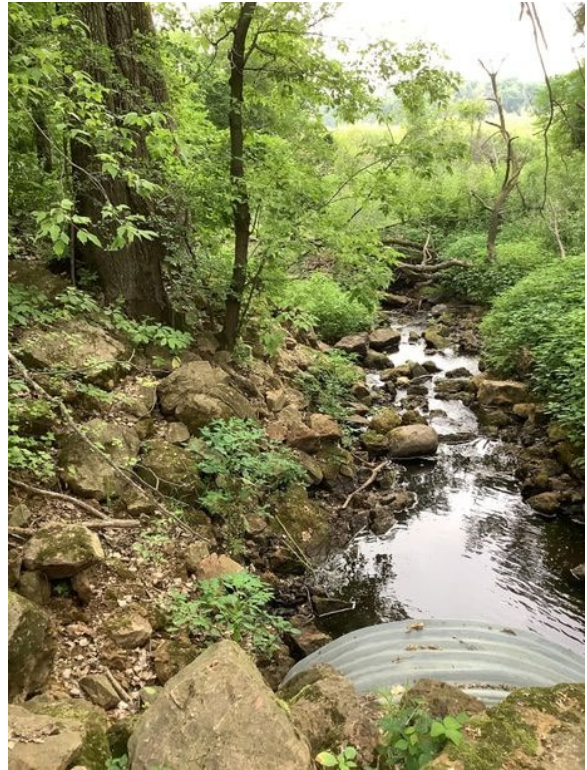
Photo 2 Image

Left bank

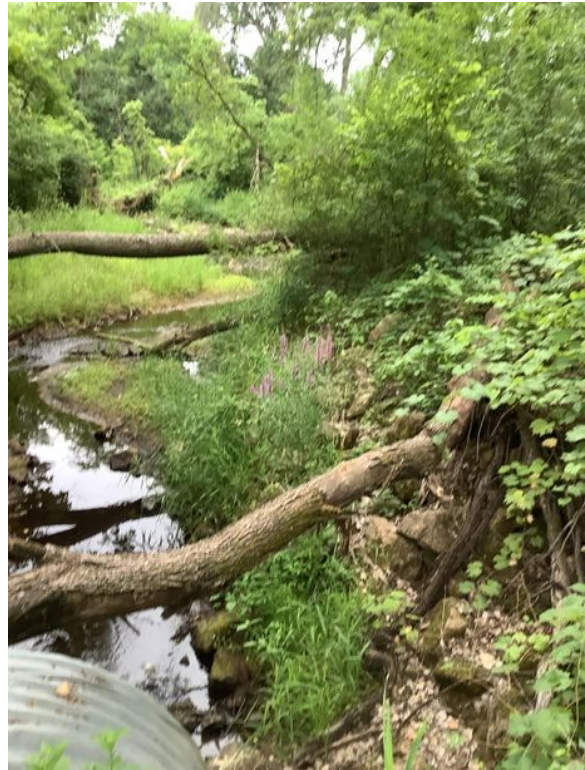
Photo 4 Image

Left bank

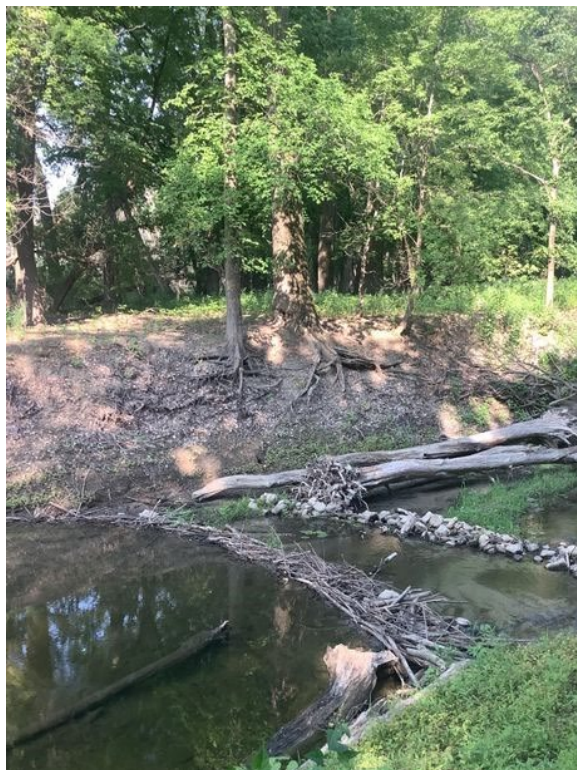
Photo 2 Image

View of left bank where severe degradation is occurring. This area is vey bare, but the bank downstream is heavily vegetated.

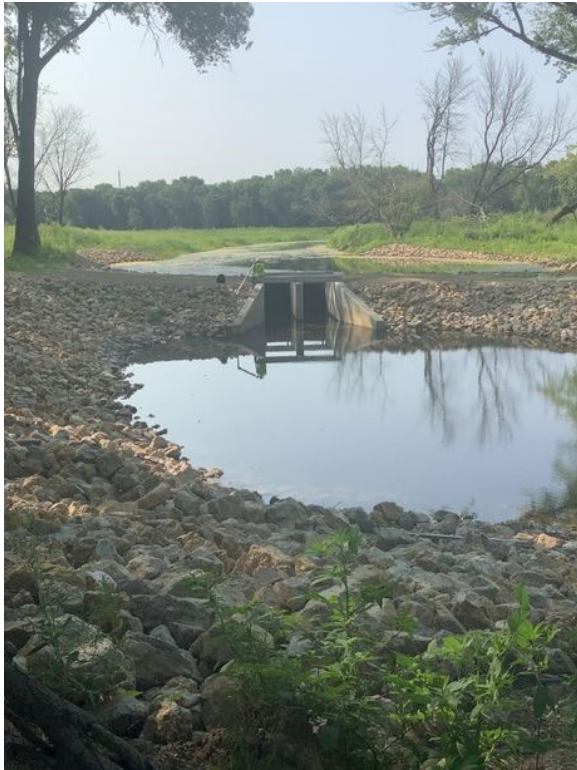
Photo 3 Image

Upstream view of dam.

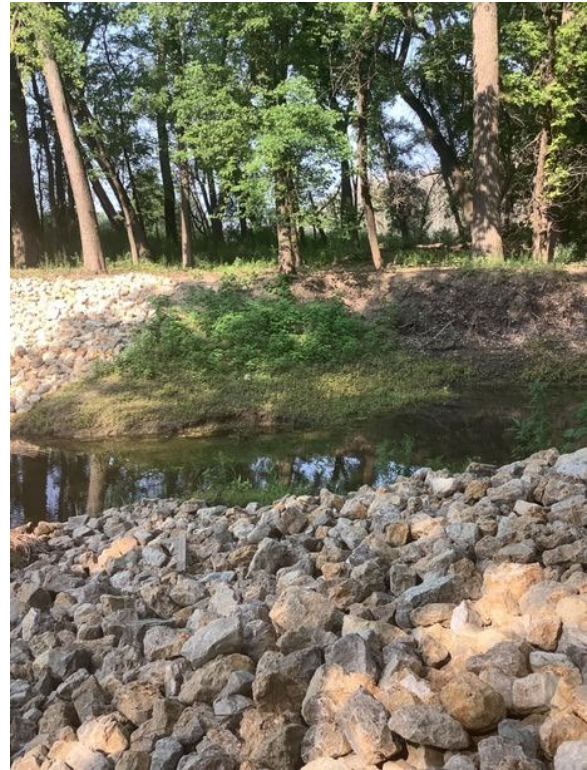
Photo 4 Image

Left bank view of where armoring transitions into severe degradation and a steep bank slope.

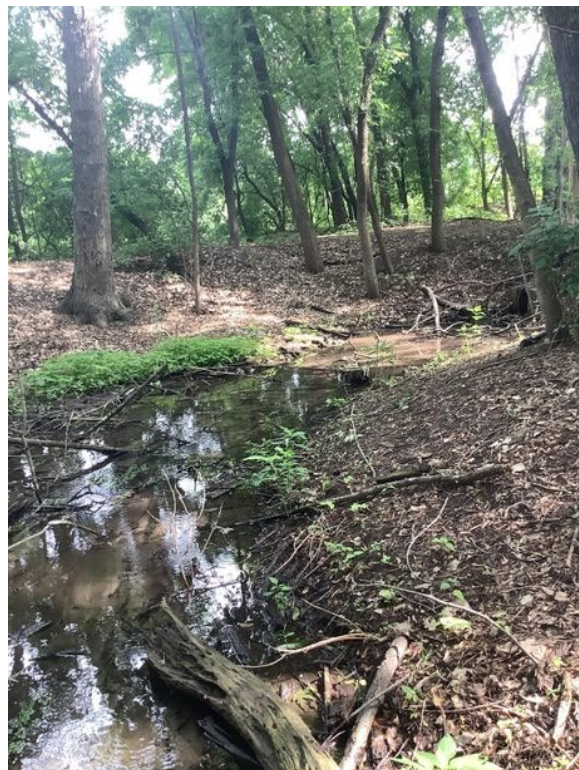
Photo 2 Image

Downstream view of gully, pipe drain is at the end.

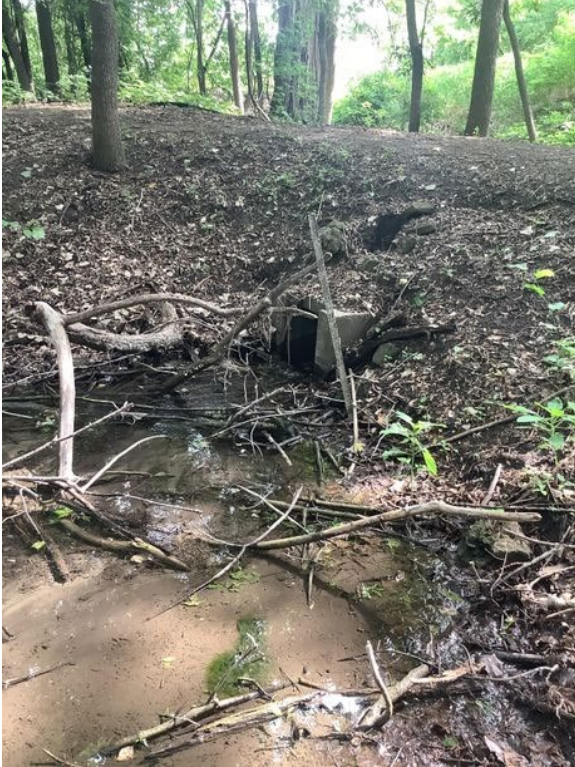
Photo 3 Image

Downstream view of pipe.

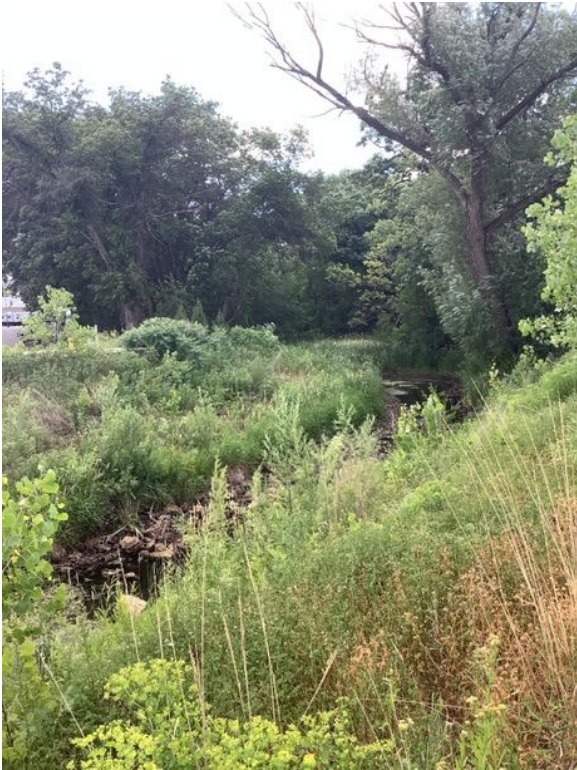
Photo 1 Image

Upstream view from left bank.

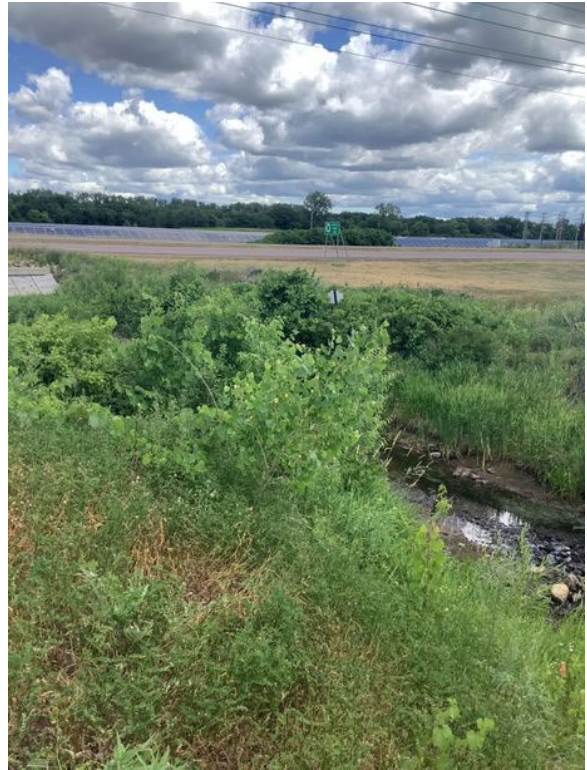
Photo 2 Image

Upstream view from left bank.

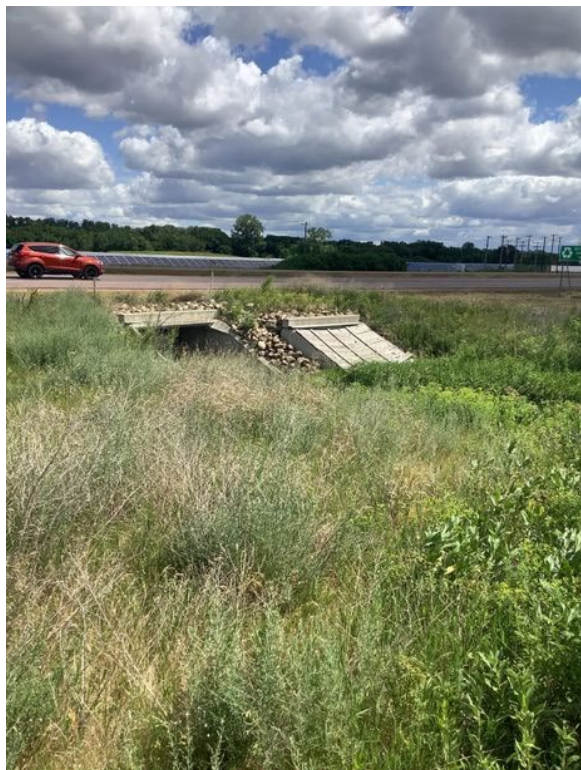
Photo 3 Image

Upstream view of pipes running under highway 101.

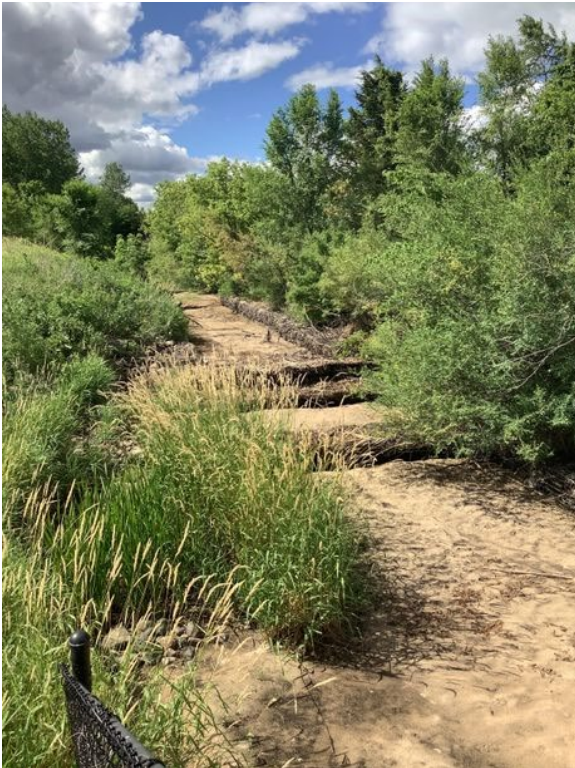
Photo 1 Image

Downstream view from next to pipes running under road on left bank side.

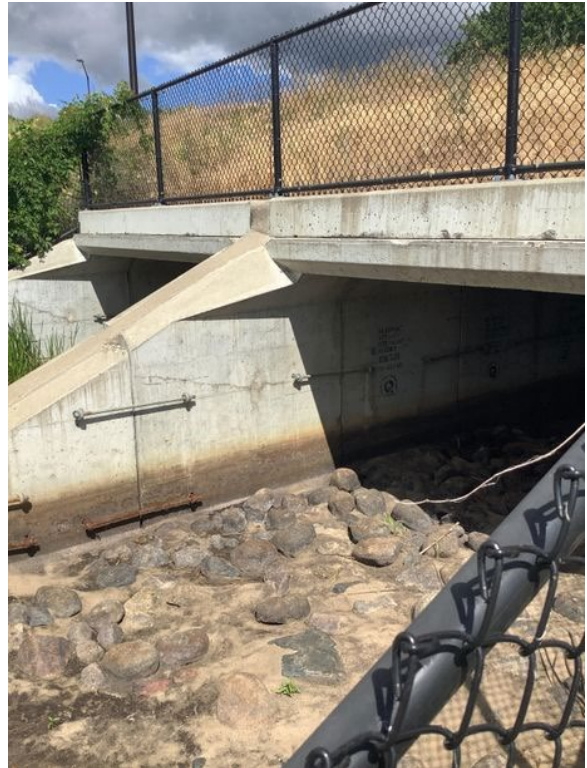
Photo 2 Image

Upstream view from left bank of pipes running under the road.

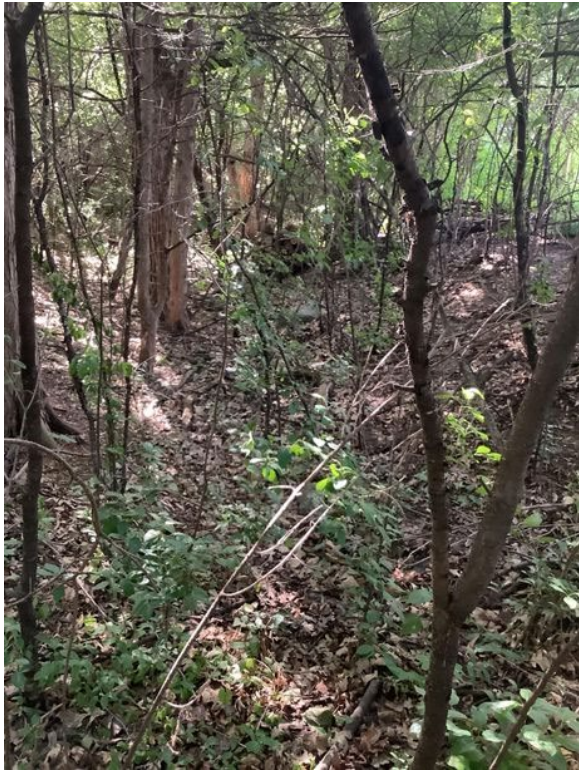
Photo 1 Image

Downstream view from top of gully.

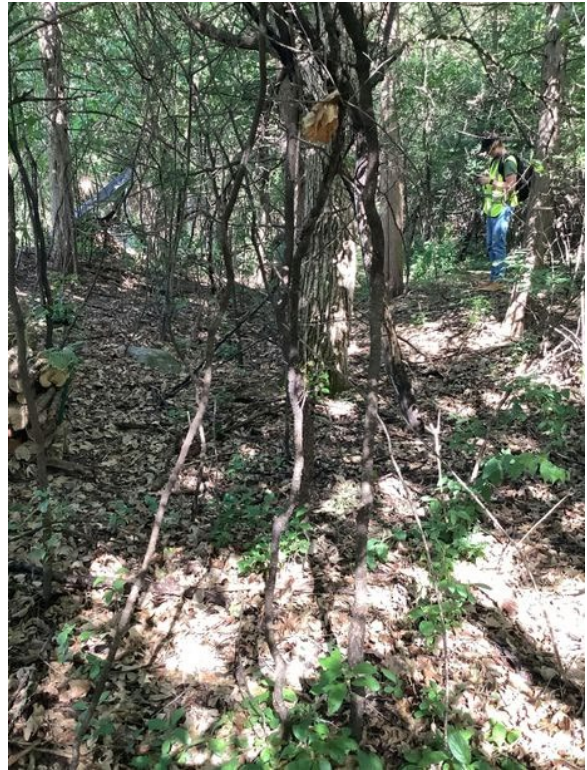
Photo 2 Image

Upstream view of gully showing some of the smaller trees leaning.

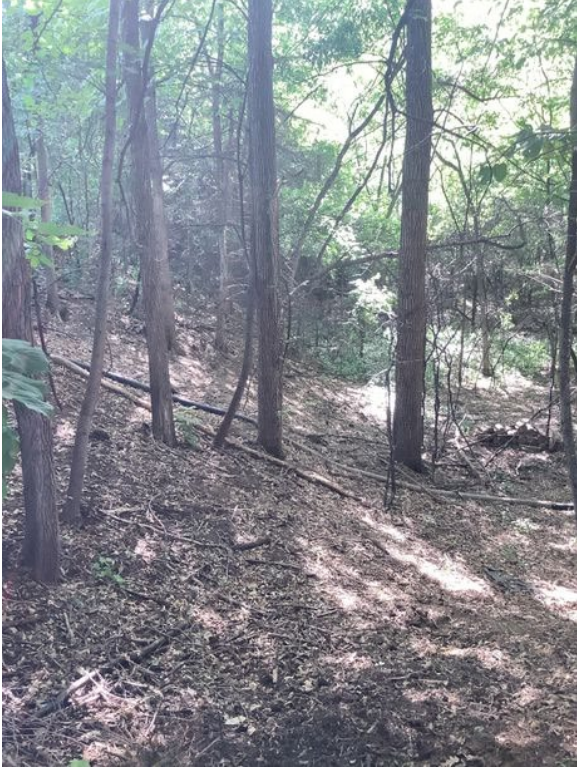
Photo 1 Image

Downstream view of left bank

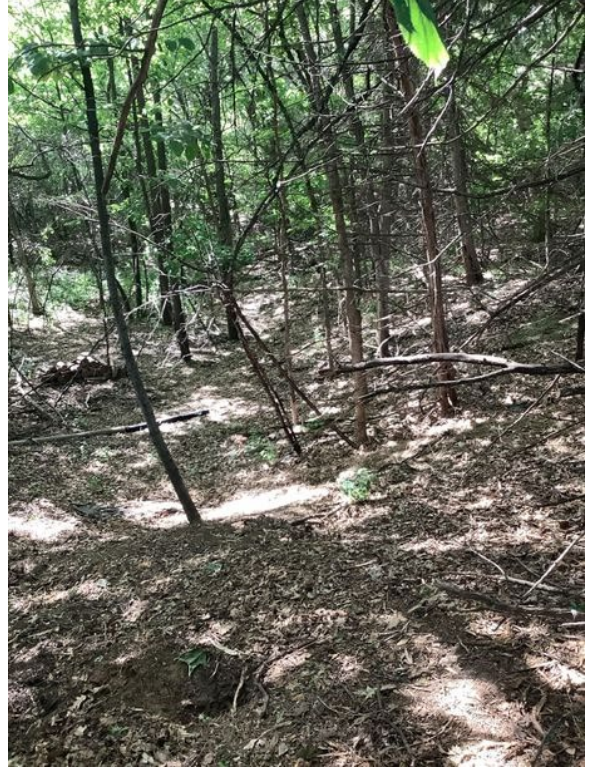
Photo 2 Image

Downstream view of right bank. Residential run off pipe visible in the middle, runs down left bank.

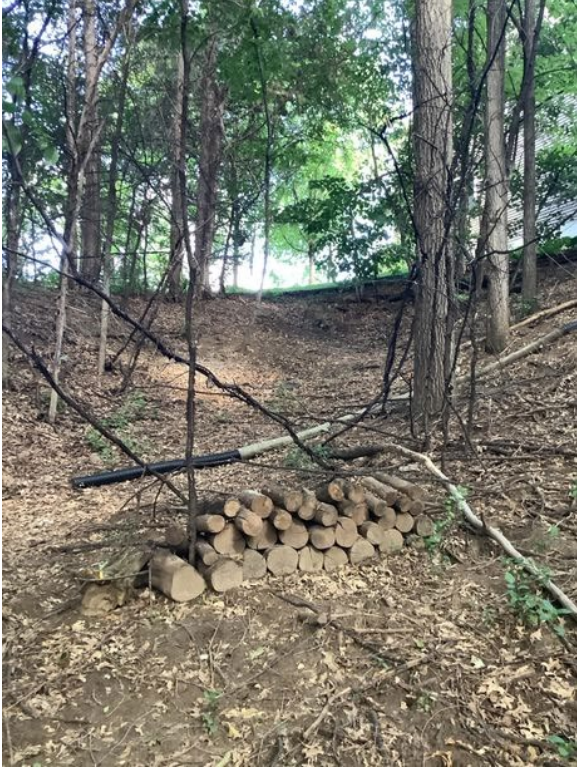
Photo 3 Image

Upstream view from bottom of gully.

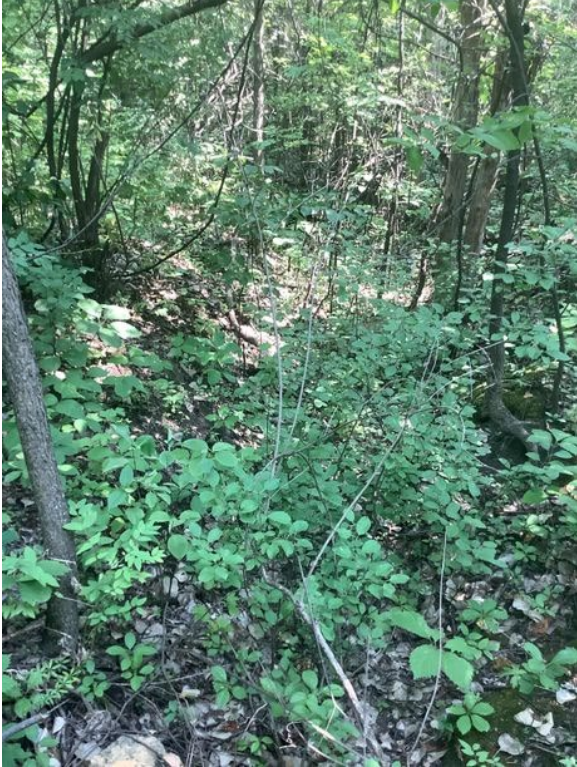
Photo 1 Image

Downstream view of gully. Lots of vegetation in the center, so pictures will not represent the site well

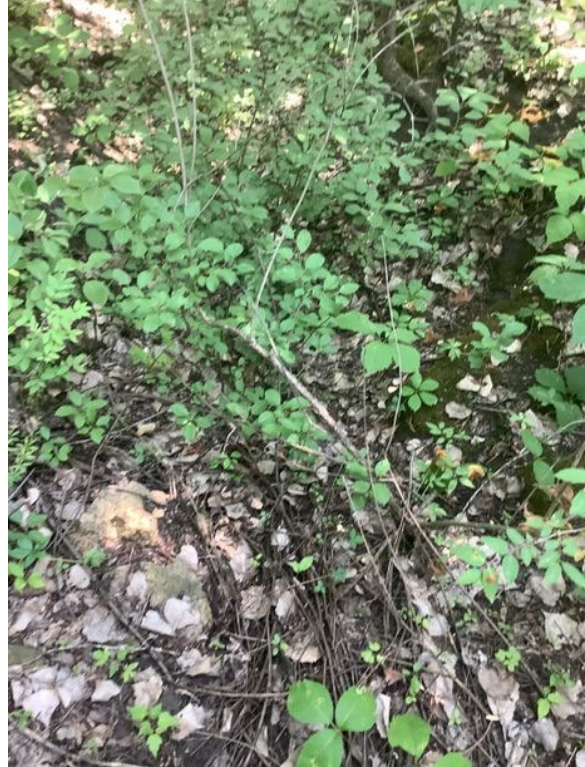
Photo 2 Image

View of the headcut of gully downstream.

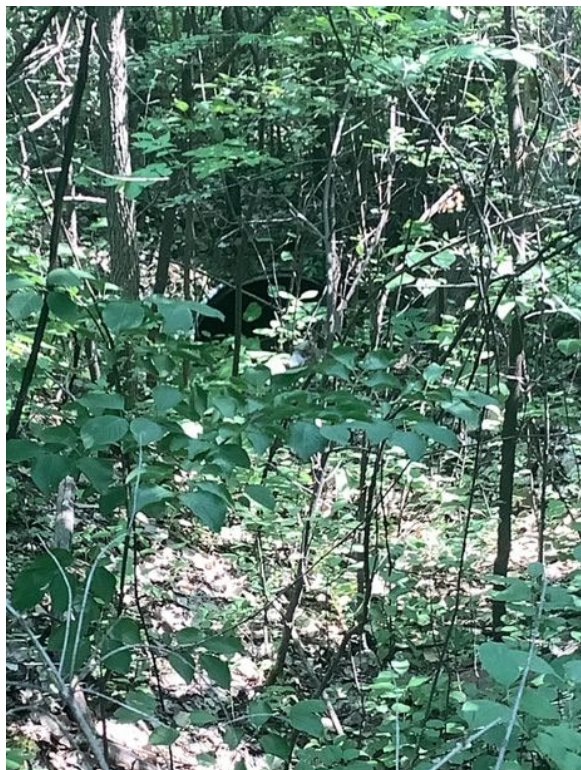
Photo 3 Image

Downstream view of pipe which doesn't have much degradation around it.

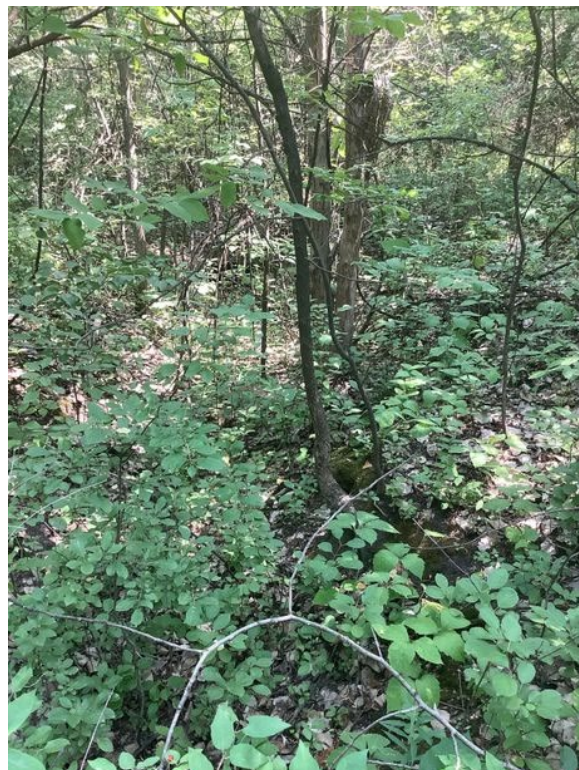
Photo 4 Image

Downstream view of pistol shaped tree on right bank.

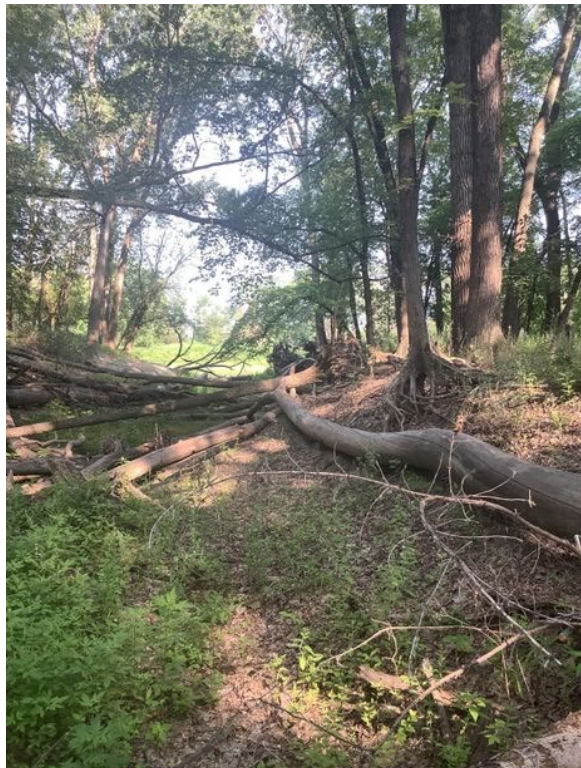
Photo 1 Image

Downstream view of right bank. Severe degradation is visible through the exposed roots around these trees.

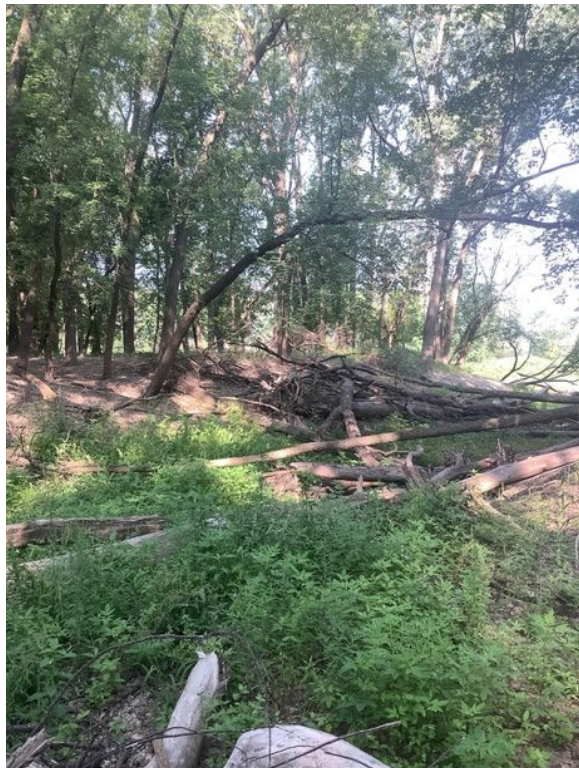
Photo 2 Image

Downstream view of left bank. Picture shows heavy vegetation on bottom, and very little on banks.

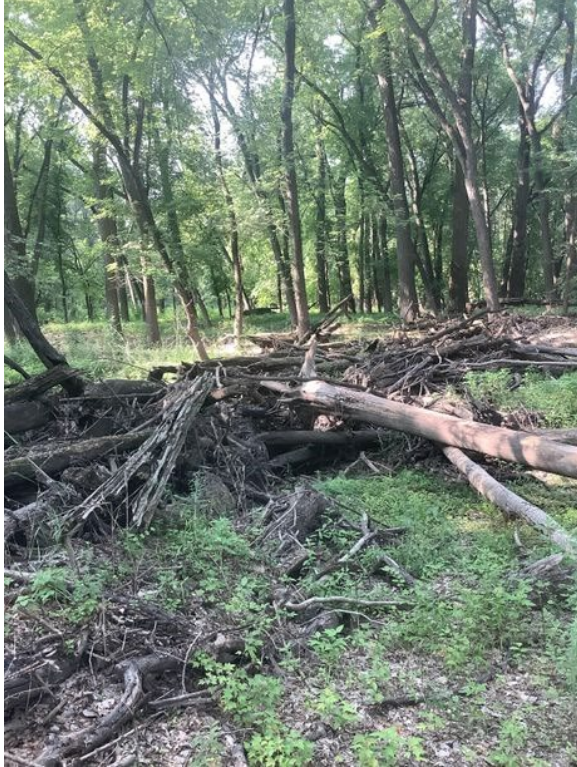
Photo 3 Image

Upstream view of tree dam from right bank. There is also a tire thrown in the middle of the stack.

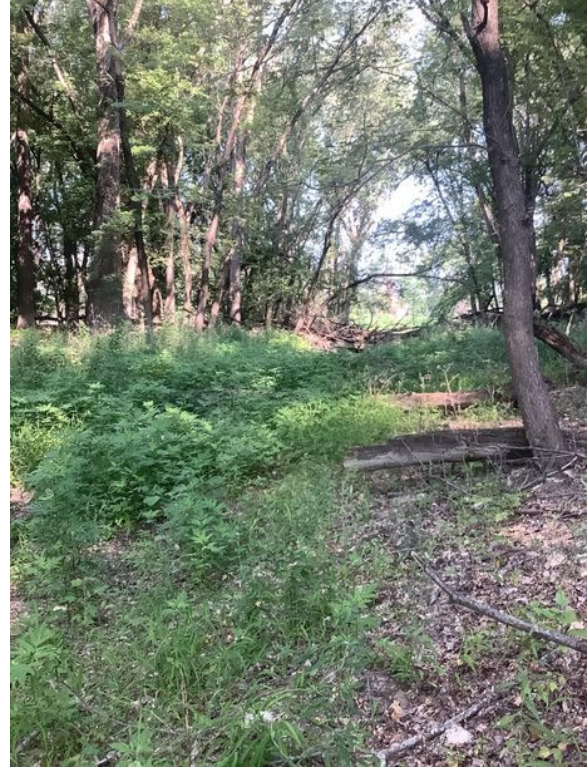
Photo 4 Image

Downstream view from beginning of gully there area is shallow and very grassy. The tree dam is visible in the background.

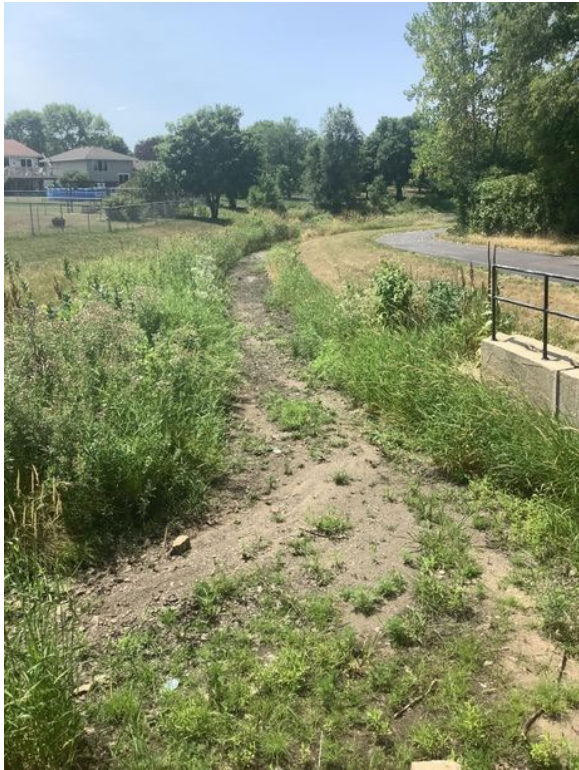
Photo 1 Image

Downstream view of gully from above large pipes.

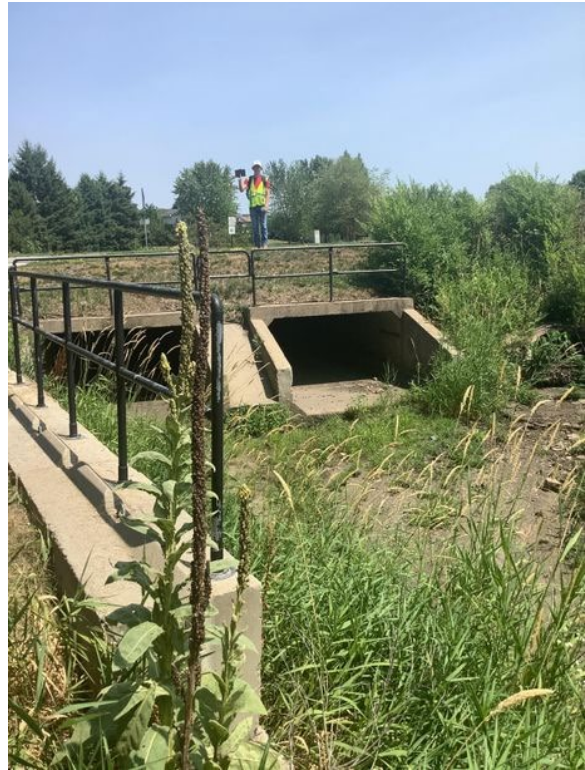
Photo 2 Image

Downstream view of pipes that run under the road.

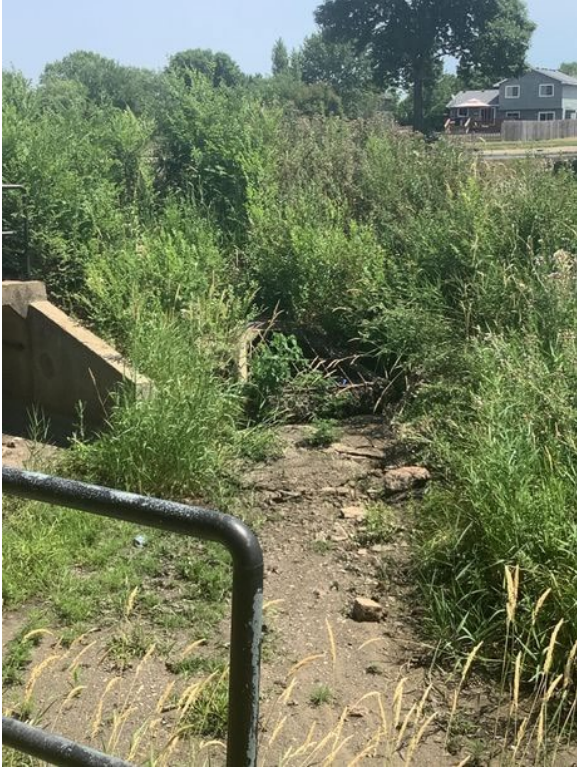
Photo 3 Image

Downstream view of smaller pipe

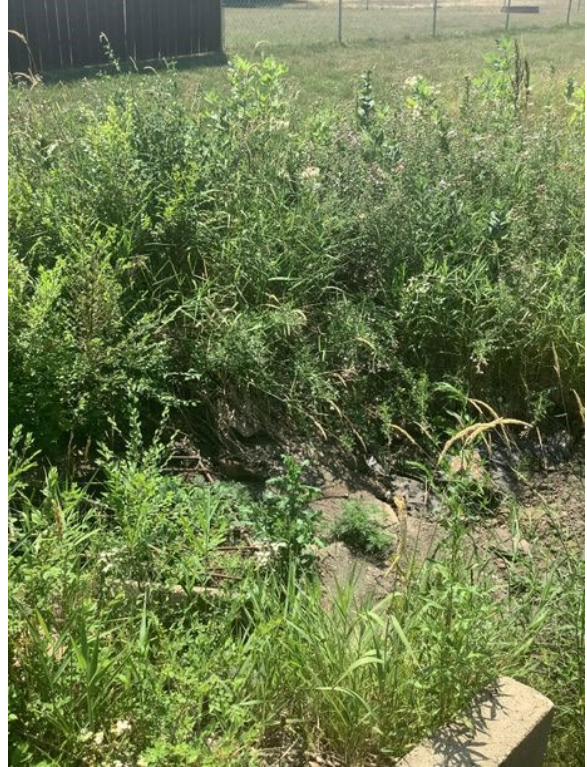
Photo 4 Image

View of right past bank area where moderate to severe erosion is happening near the smaller pipe.

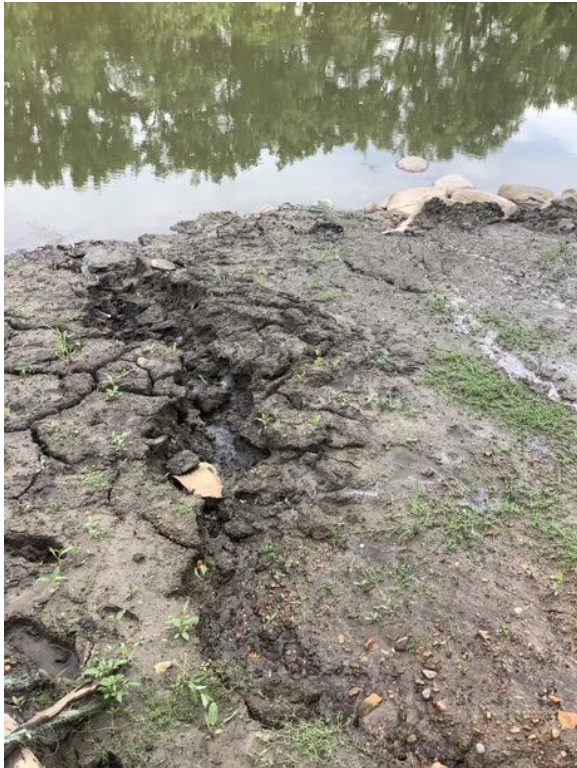
Photo 1 Image

Seep:	1-Yes	
Stormwater Runoff:	0-No	
Stormwater Inputs:		
Fallen Trees:	0-No	
Degradation:	5-Severe	
Aggradation:	3-Moderate	
Slumping:	1-Yes	
Additional Notes:	<p>Classification? High</p> <p>Presence of Water? Yes</p> <p>Quantity of Water? Trickle/Slow Moving</p> <p>Notes/Comments: Two seeps which created small gullies along the south bank of the mn river. These should be of concern as they are directly depositing sediment into the river and seem to be degrading quickly.</p>

Downstream view of small seep gully on the left.

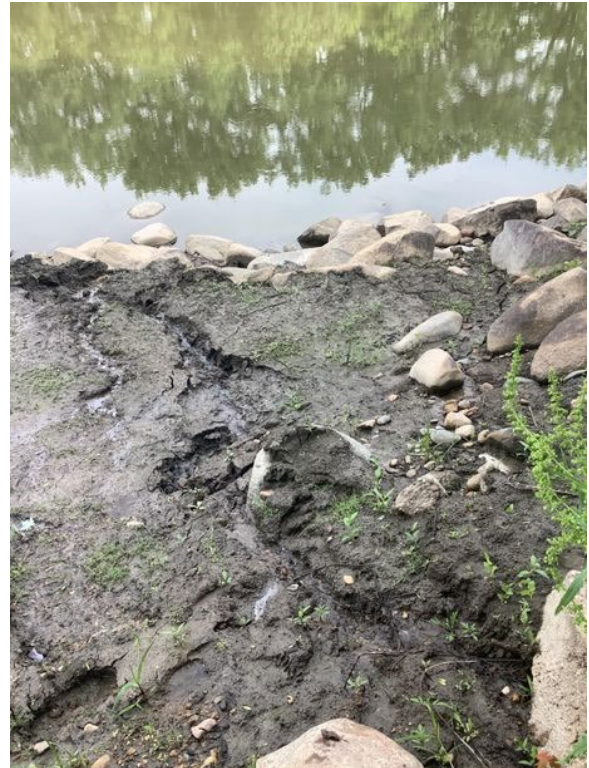
Photo 2 Image

Downstream view of small seep gully on the right.

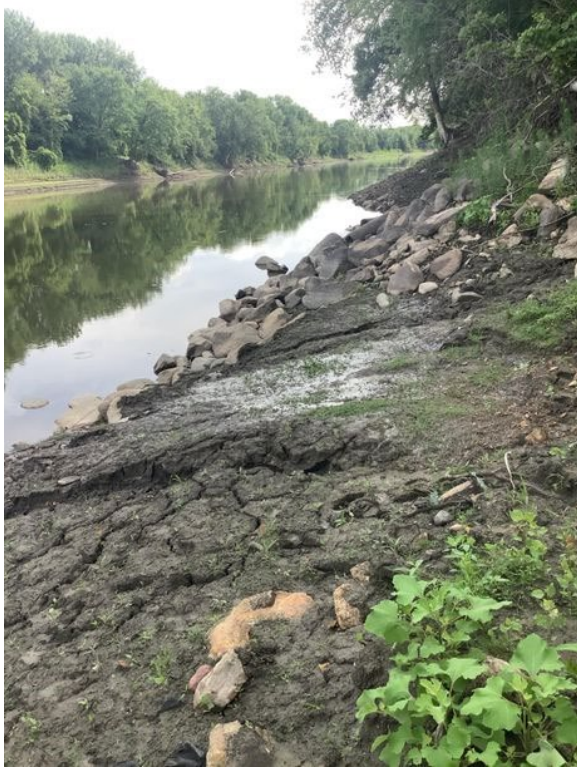
Photo 3 Image

Sidestream view of the right bank of both gullies. The left side gully is the closer of the two, and the right side gully is the farther one.

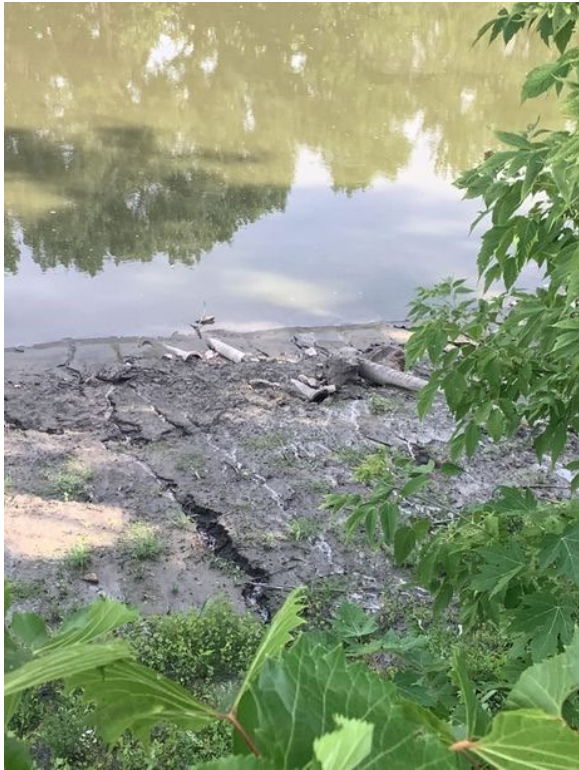
Photo 1 Image

Seep:	1-Yes	
Stormwater Runoff:	1-Yes	
Stormwater Inputs:	0-None	
Fallen Trees:	0-No	
Degradation:	5-Severe	
Aggradation:	3-Moderate	
Slumping:	1-Yes	
Additional Notes:	<p>Classification? High</p> <p>Presence of Water? No</p> <p>Quantity of Water?</p> <p>Notes/Comments: Small gully's running through clay/silt on bank of MN river. There is a broken pipe that appears to have drained straight into the river before it was broken but down drains ,UCB earlier and could be the cause of so,r of these mini gullies.</p>

Downstream view of mini gullies and broken pipe.

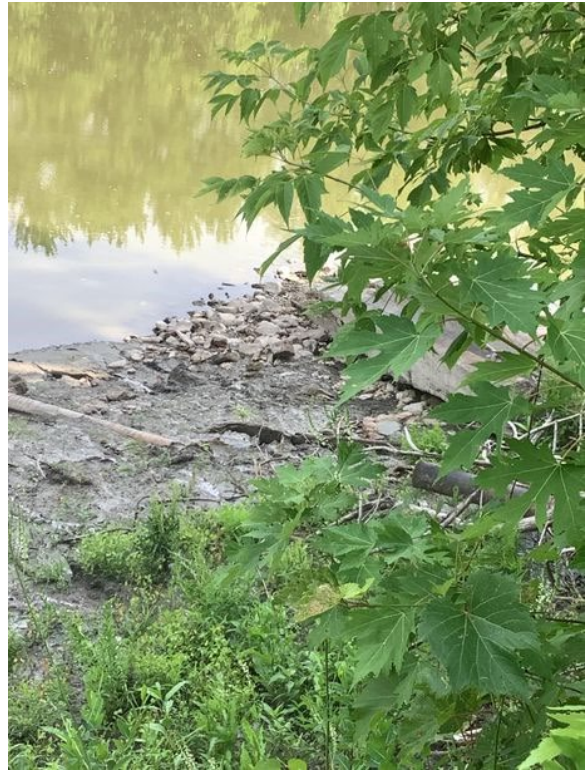
Photo 2 Image

Downstream view of where pipe outfall broke and now drains.

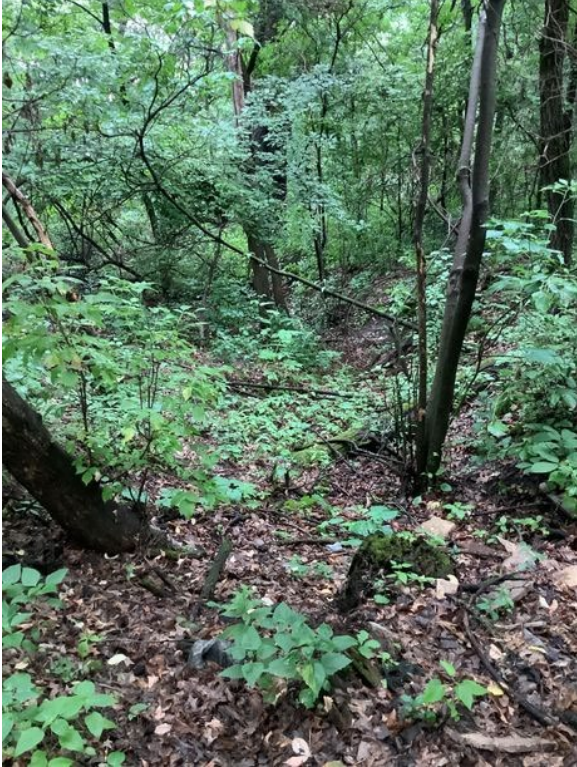
Photo 1 Image

Downstream view from trail.

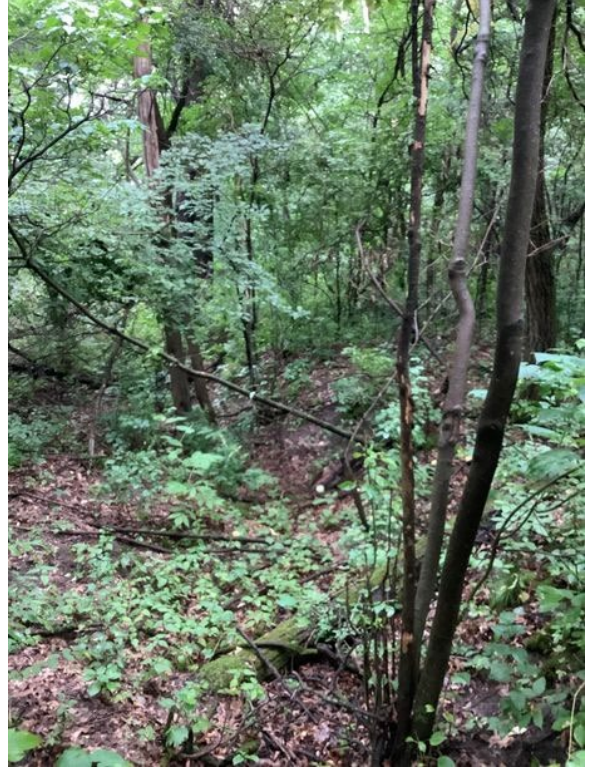
Photo 2 Image

Downstream view of fallen tree.

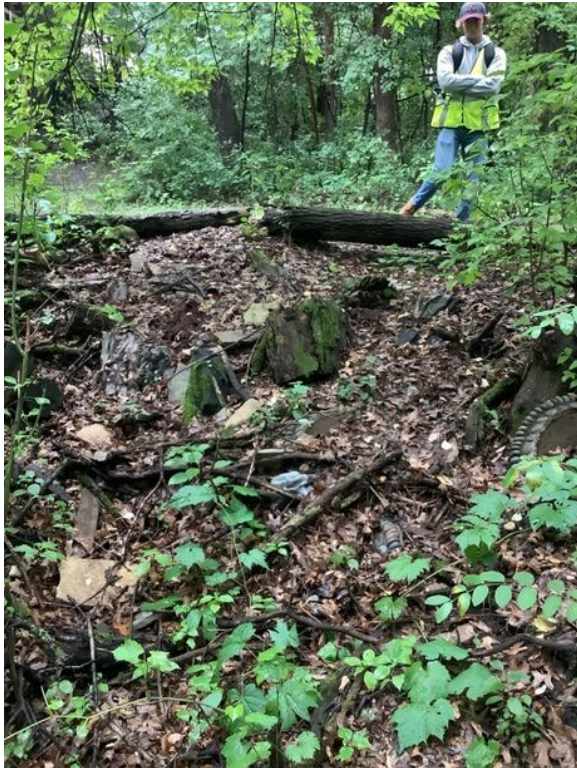
Photo 3 Image

Upstream view of slight armoring at headcut.

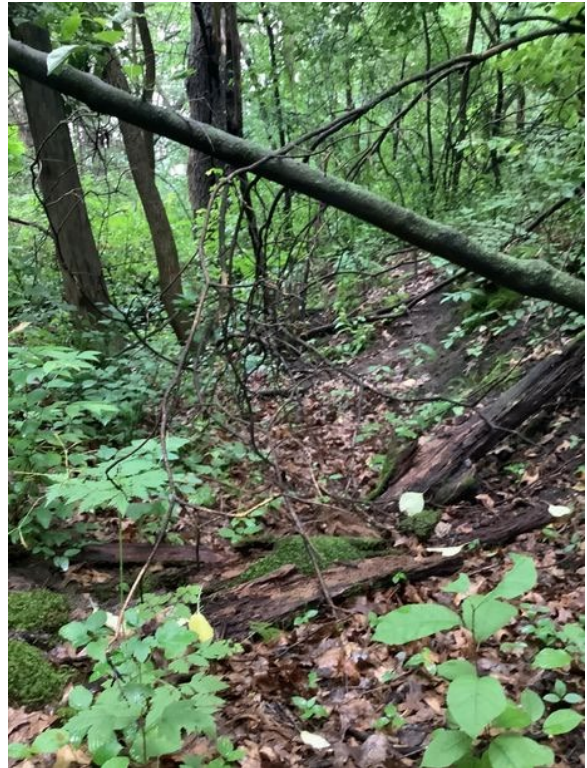
Photo 4 Image

Downstream view of bank angle.

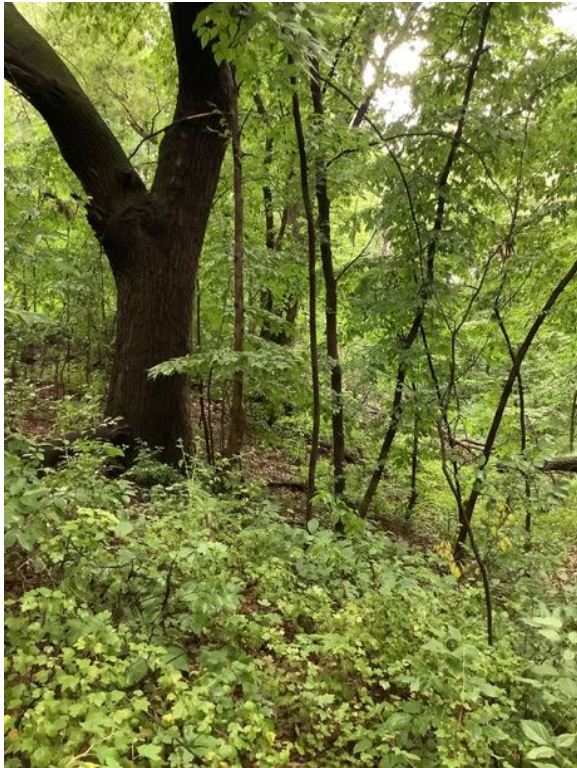
Photo 1 Image

Downstream left bank.
