<p>Gully ID: 07:07-11:46</p>	<p style="text-align: center;">MAP</p>

<p>Date & Time: July 7, 2021 11:46 AM</p>	
<p>Location: Shakopee</p>	
<p>Weather: Cloudy</p> <p>Storm/Rainfall Event in the Past 24 Hours? Yes-Low Intensity</p>	
GULLY INFORMATION	
<p>Calculated Erosion Potential:</p>	<p>Moderate</p>
<p>Approximate Depth:</p>	<p>1-Shallow (<3')</p>
<p>Approximate Bottom Width:</p>	<p>3-Medium (1'-5')</p>
<p>Approximate Gully Length:</p>	<p>5-Long (>100')</p>
<p>Condition of Gully Bottom:</p>	<p>5-Bare Soil</p>
<p>Condition of Gully Banks:</p>	<p>1-Heavy Vegetation</p>
<p>Gully Bank Angles:</p>	<p>3-Mid-Range (45 to 90 degrees)</p>
<p>Gully Shape:</p>	<p>3-U-Shaped</p>
<p>Gully Material:</p>	<p>Gravel/Cobble/Boulders</p>

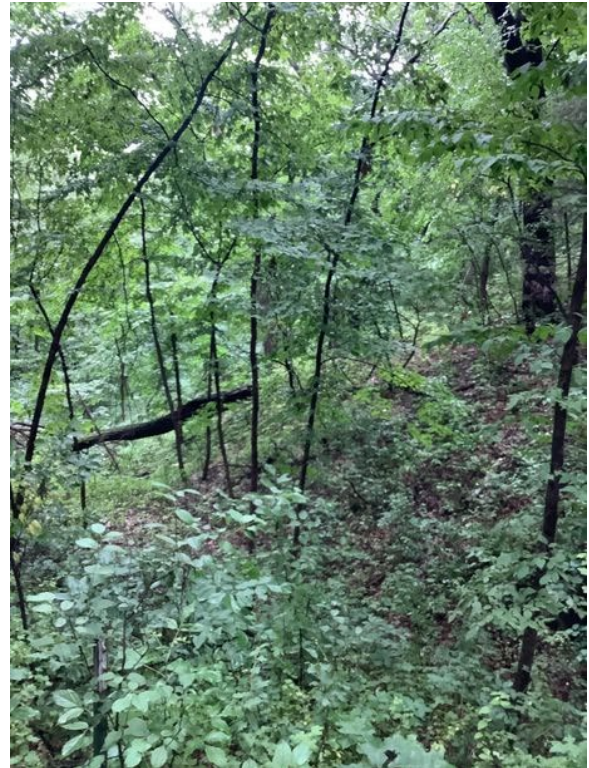
Photo 2 Image

Downstream right bank view.

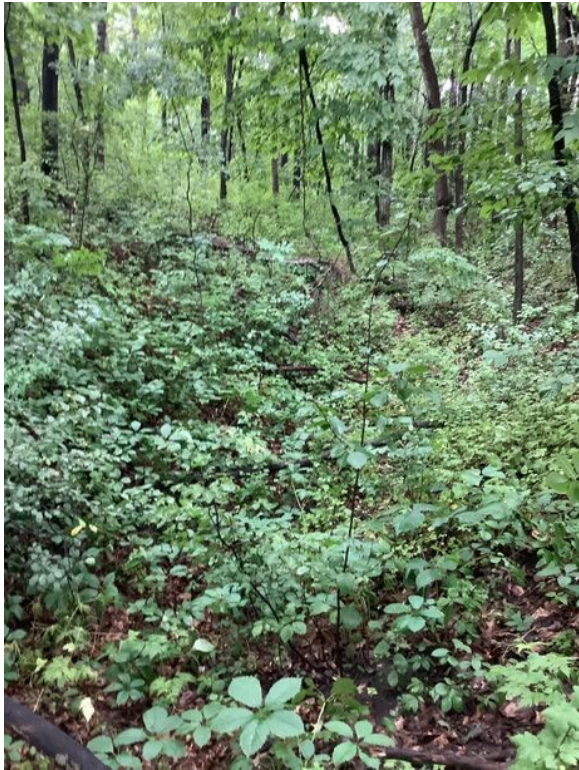
Photo 3 Image

Upstream view where gully begins and is less deep.

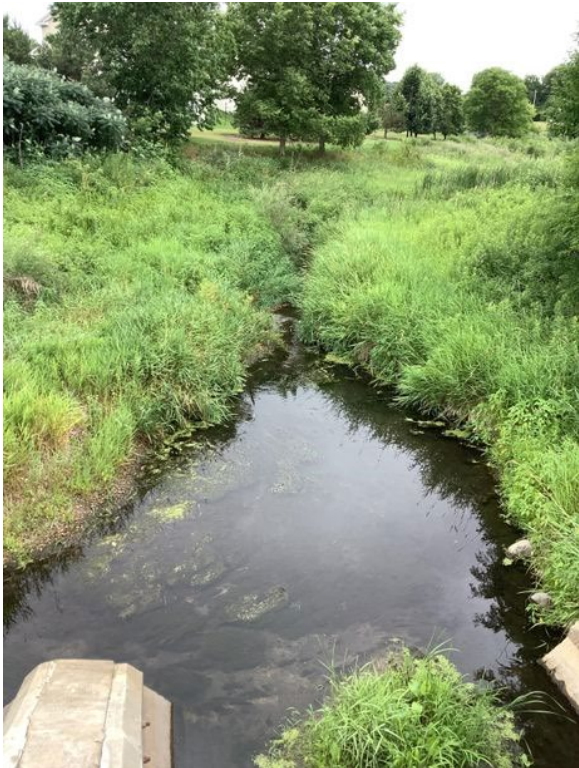
Photo 2 Image

Full gully

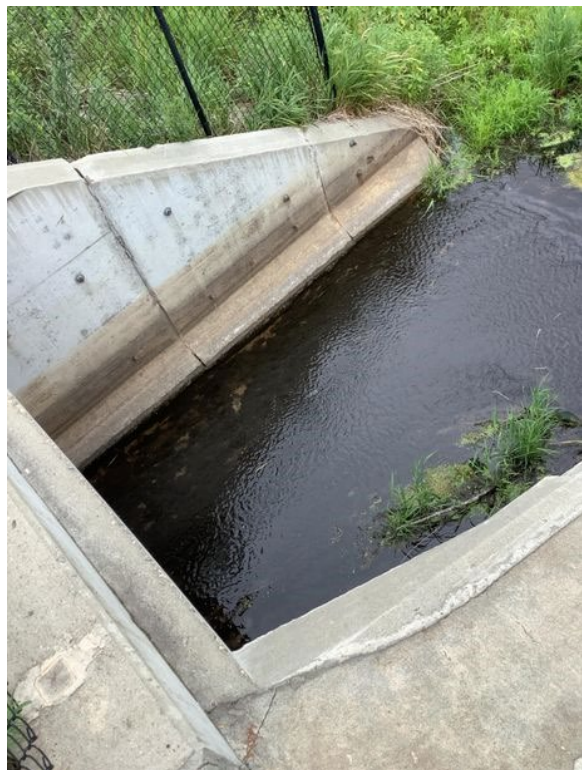
Photo 3 Image

Pipe under road

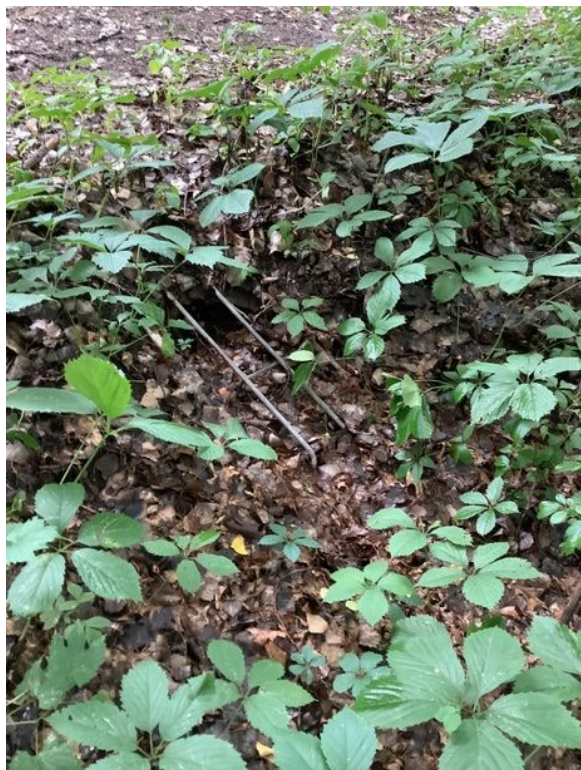
Photo 1 Image

Pipe on right bank

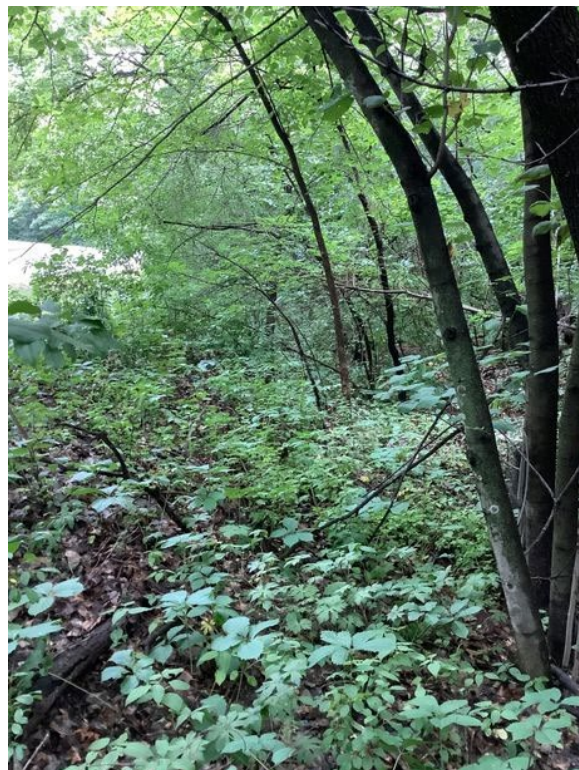
Photo 2 Image

Right bank

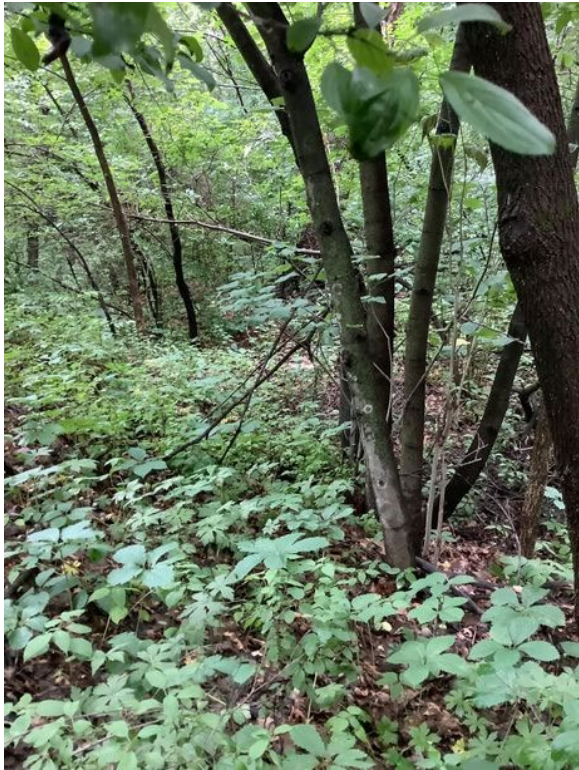
Photo 3 Image

Left bank

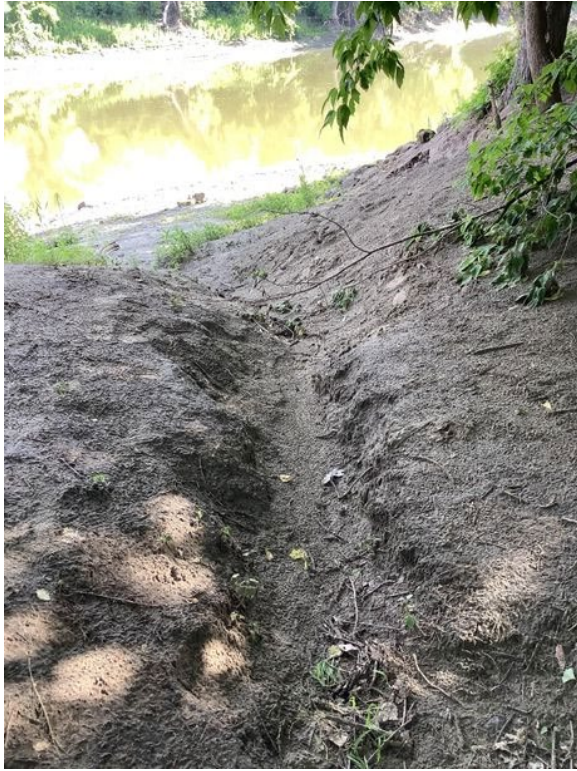
Photo 1 Image

Top of gully

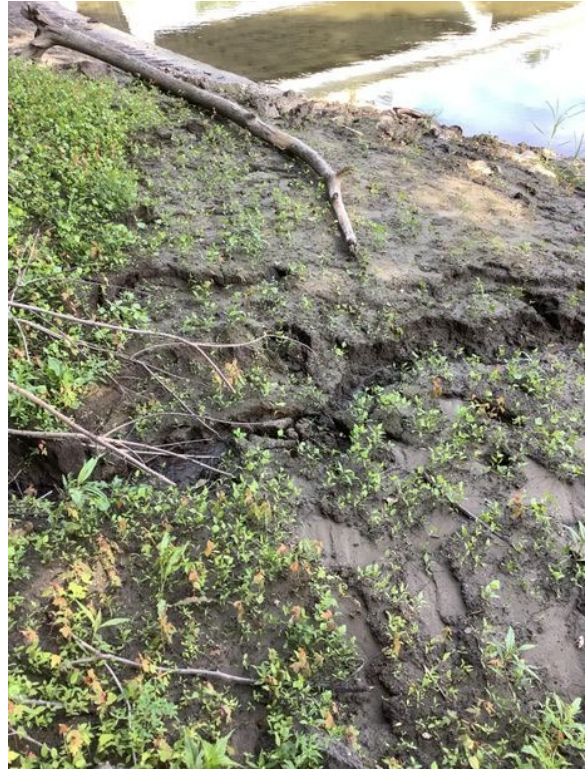
Photo 2 Image

Left bank

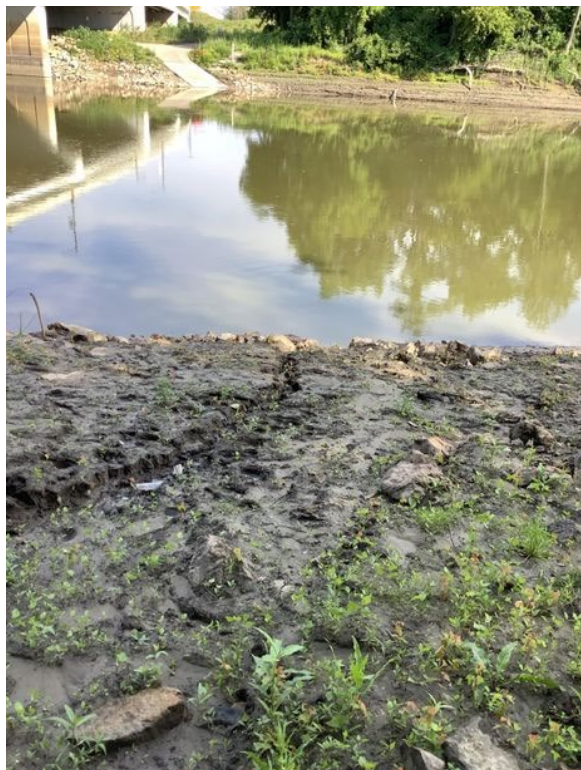
Photo 3 Image

Empties into river

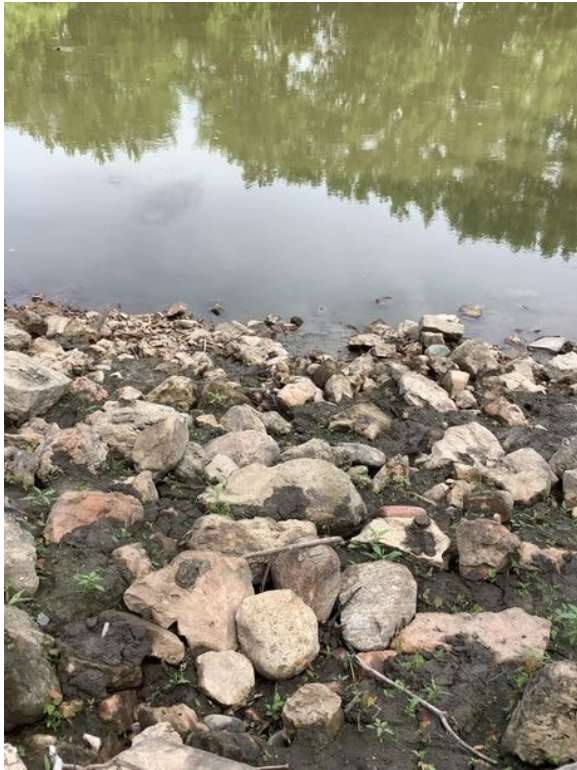
Photo 1 Image

Full gully

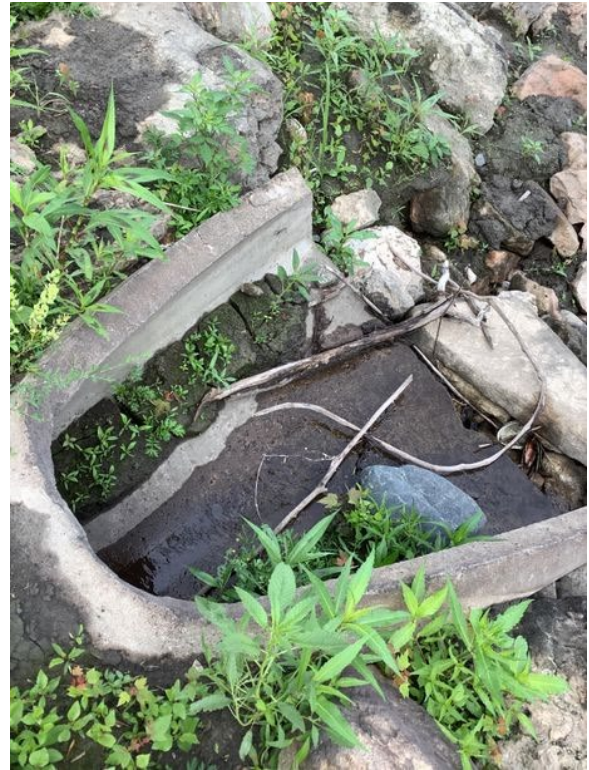
Photo 2 Image

Pipe with water trickling out

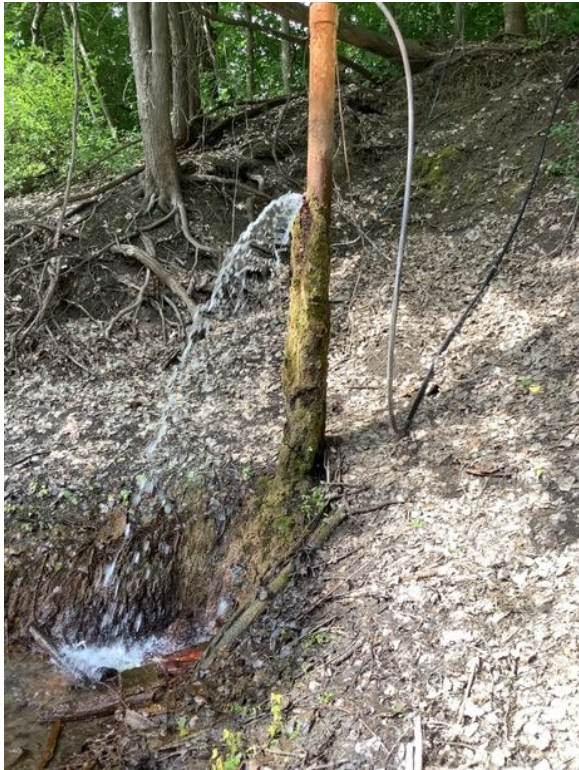
Photo 1 Image

Pipe exiting heavy flow of water

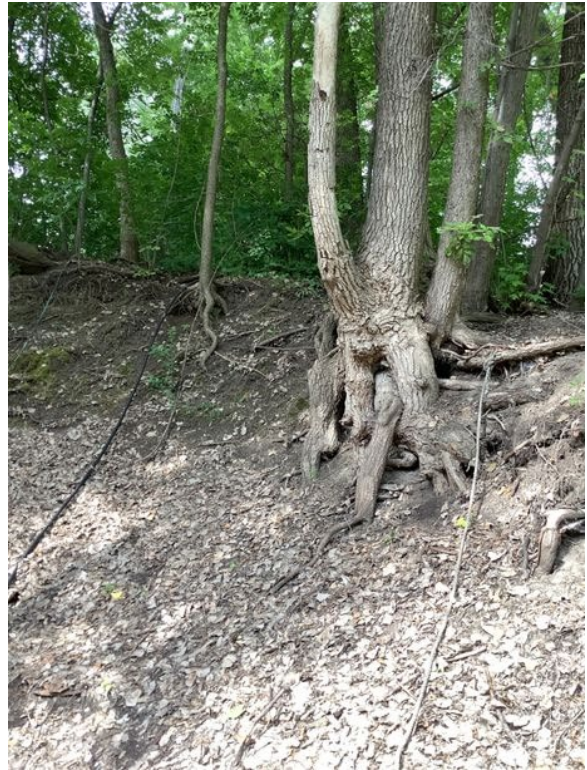
Photo 2 Image

Left bank

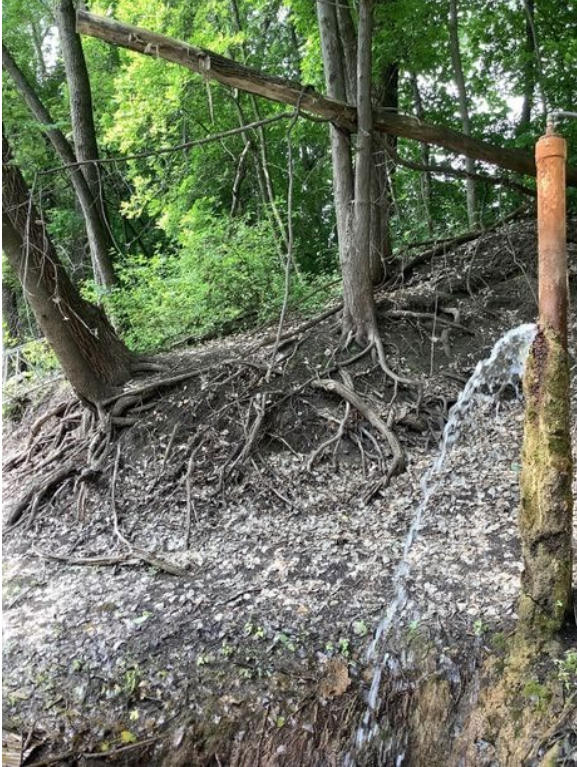
Photo 3 Image

Right bank

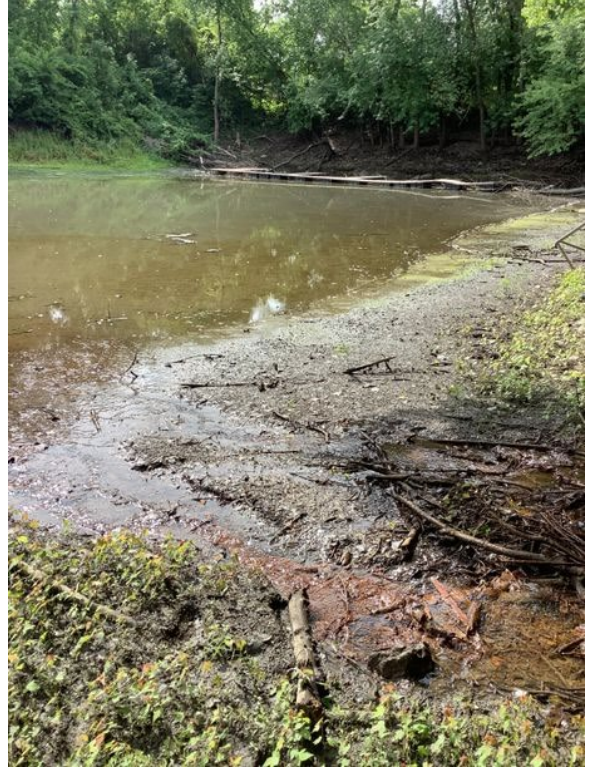
Photo 4 Image

Pond where water flows

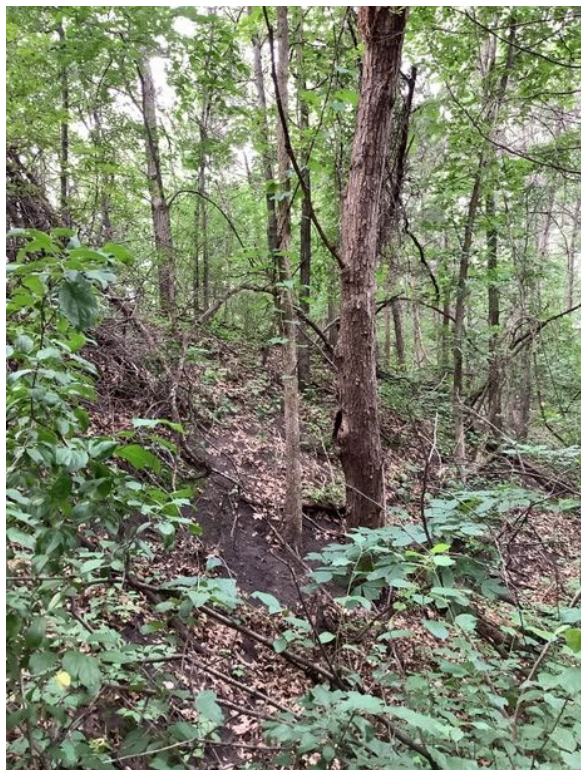
Photo 1 Image

Downstream view of left bank.

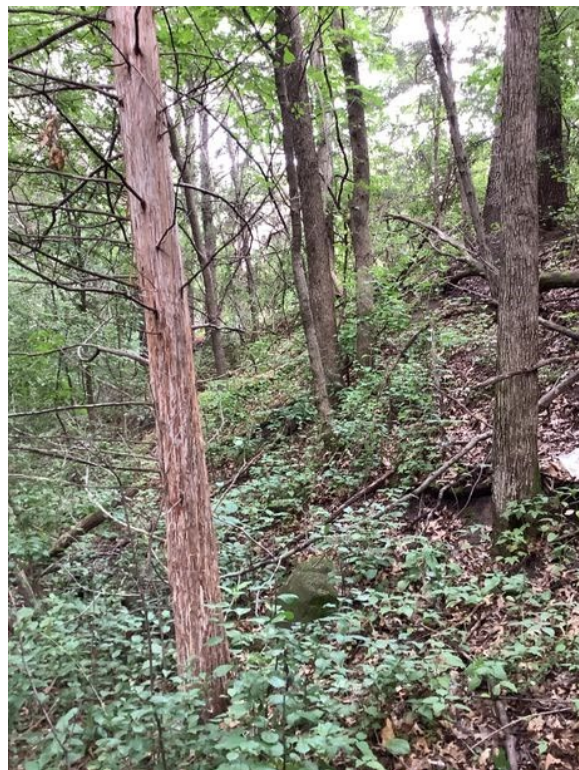
Photo 2 Image

Downstream view of right bank.

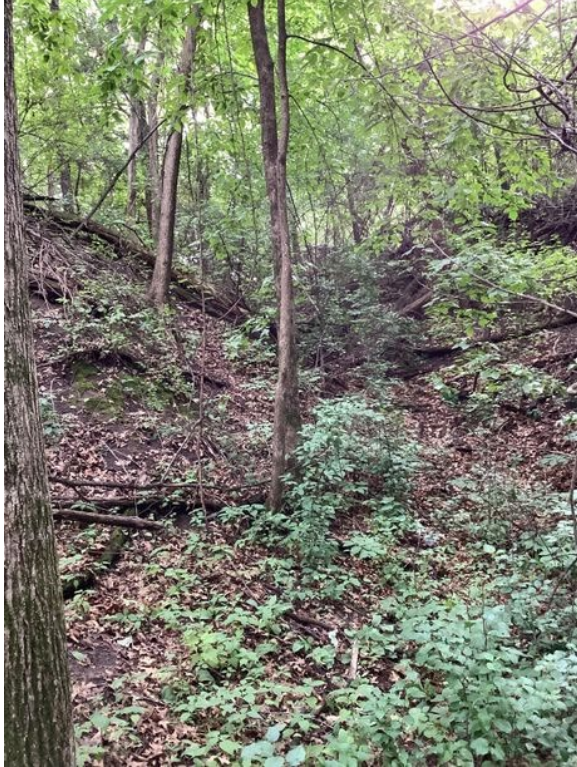
Photo 3 Image

Upstream view of area where the gully is narrower, the tree on the left edge of the photo is where the small gully connects to this larger one.

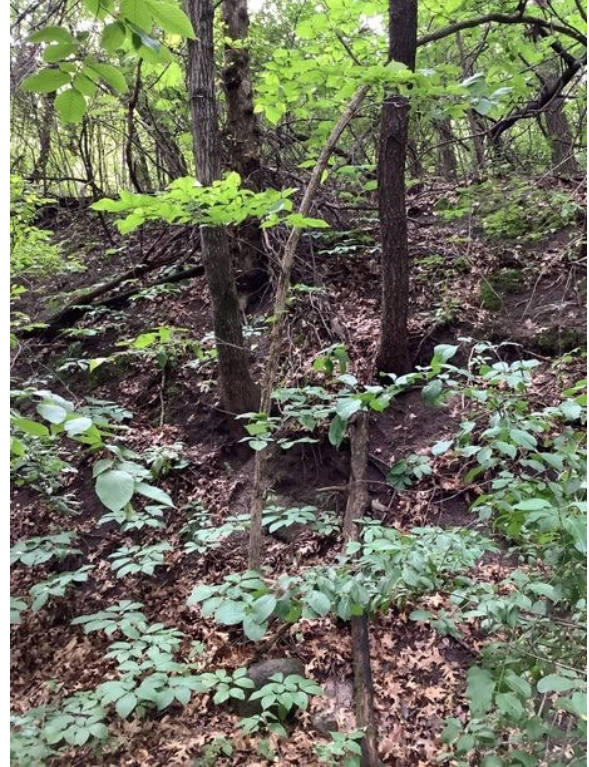
Photo 4 Image

Left bank view of degradation, slumping and pistol shaped trees.

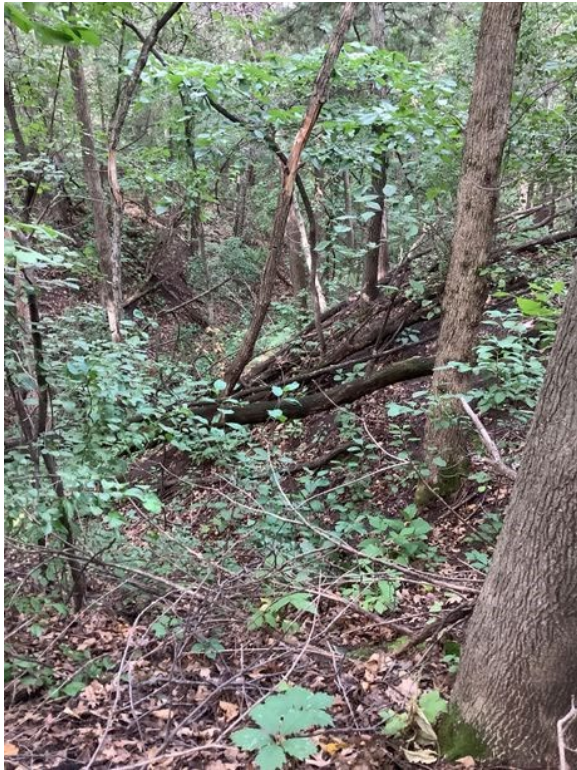
Photo 1 Image

Seep:	0-No	
Stormwater Runoff:	0-No	
Stormwater Inputs:		
Fallen Trees:	1-Yes	
Degradation:		3-Moderate
Aggradation:		1-Low
Slumping:		0-No
Additional Notes:	<p>Classification? Moderate</p> <p>Presence of Water? No</p> <p>Quantity of Water?</p> <p>Notes/Comments: Small gully which leads into the right bank of a larger gully. This area was hard to photograph with the vegetation present.</p>

Downstream view of right gully bank.

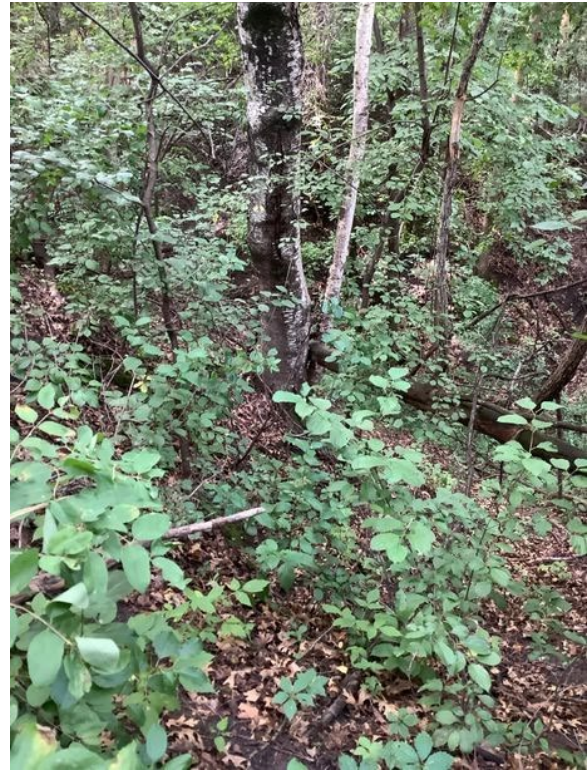
Photo 2 Image

Downstream view of left gully bank

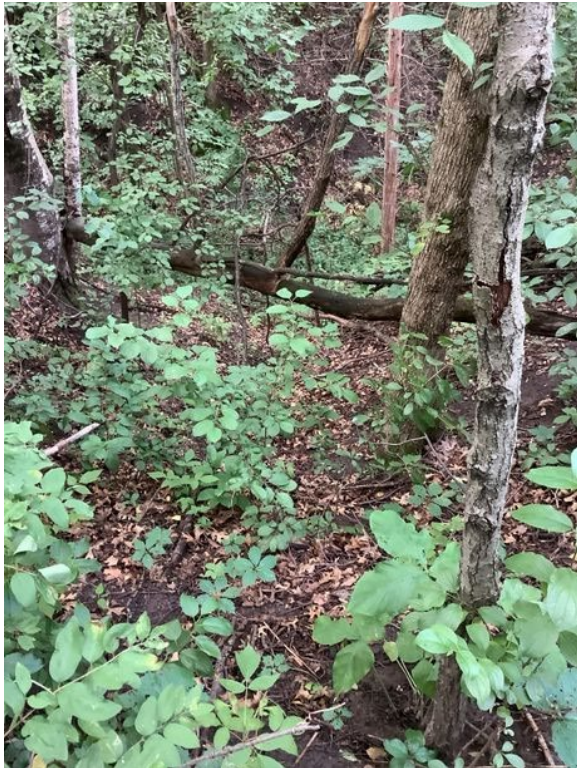
Photo 3 Image

Downstream view of center

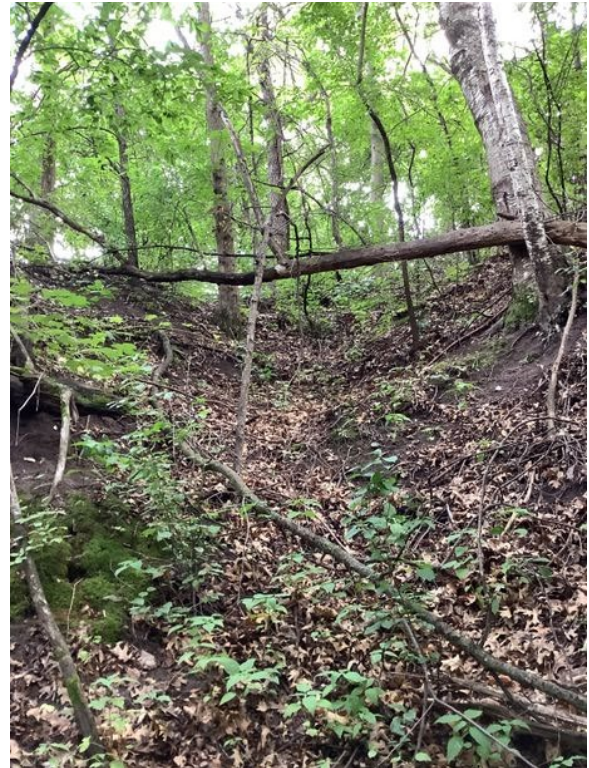
Photo 4 Image

Upstream view of small gully from bottom of large gully.

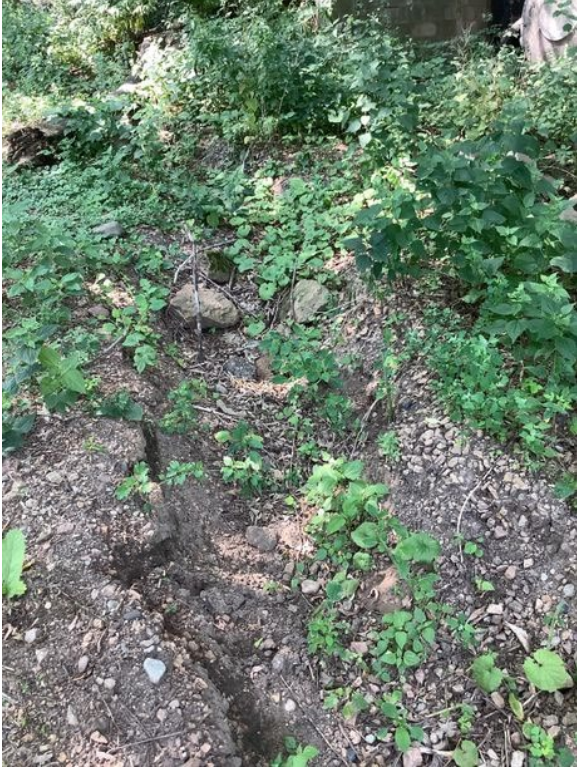
Photo 1 Image

Seep:	0-No	
Stormwater Runoff:	0-No	
Stormwater Inputs:		
Fallen Trees:	0-No	
Degradation:	5-Severe	
Aggradation:	1-Low	
Slumping:	1-Yes	
Additional Notes:	<p>Classification? High</p> <p>Presence of Water? No</p> <p>Quantity of Water?</p> <p>Notes/Comments: Long narrow gully, hanging roots and slumping vegetation, some small rocks along the banks but mostly soil, lots of wood and branches in the bottom</p>

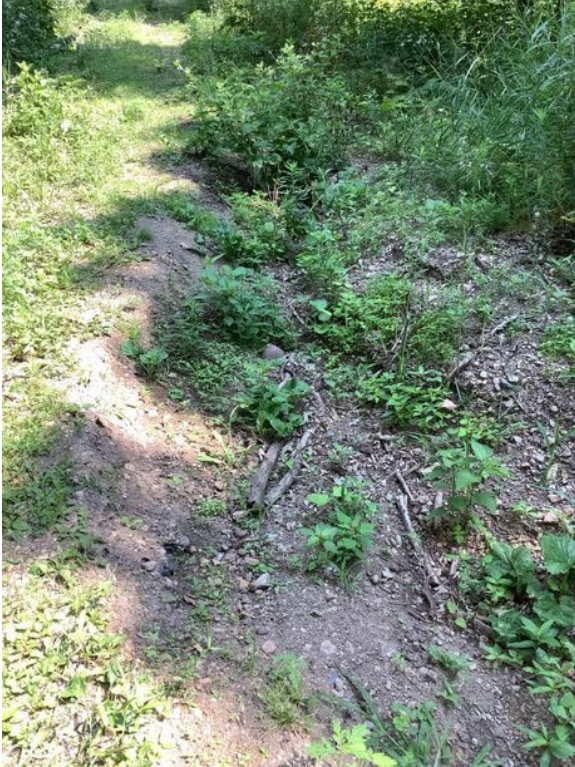
Photo 3 Image

Further downstream

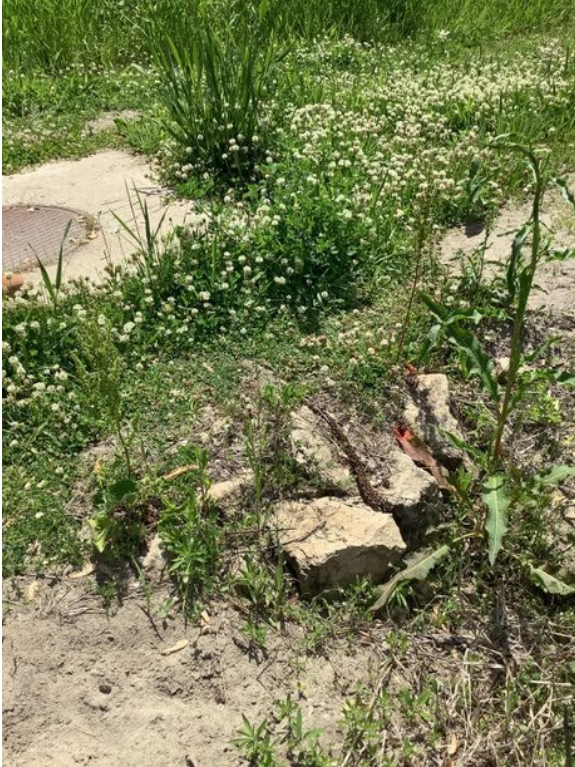
Photo1

Seep:	No	
Stormwater Inputs:	0-Not present	
Fallen Trees:	No	
Degradation:	0-No degradation	
Aggradation:	0-No aggradation	
Slumping:	0-No slumping	
Additional Notes:	Classification? Moderate (x - x) Notes/Comments: Small gully next to sewer hole.

View of small gully in front of sewer hole. Gully begins where rip rap is and is only a couple feet long.

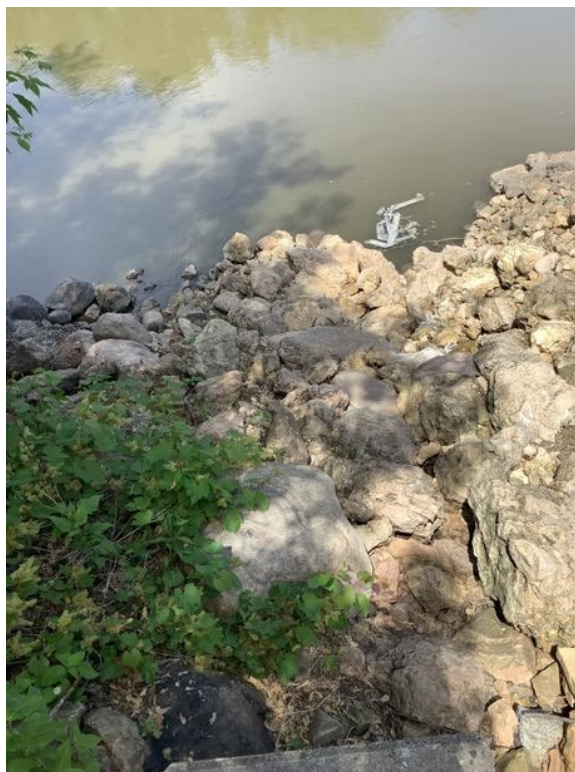
Photo2

Downstream view of left bank.

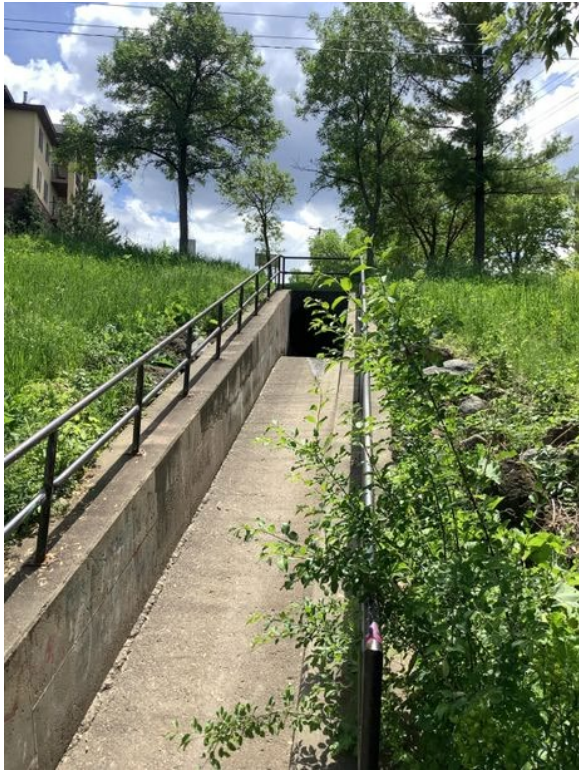
Photo3

Pipe and concrete area where the water flows from upstream.

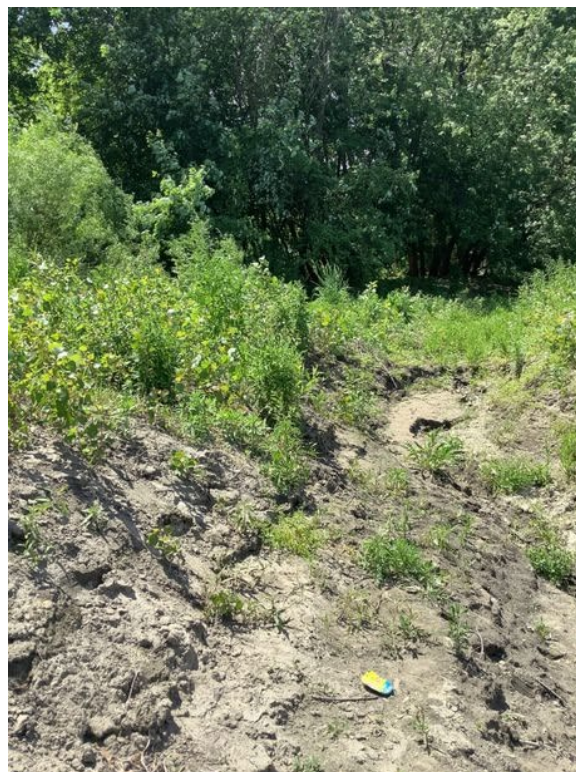
Photo2

Seep:	No	
Stormwater Inputs:	0-Not present	
Fallen Trees:	No	
Degradation:	3-Moderate	
Aggradation:	0-No aggradation	
Slumping:	0-No slumping	
Additional Notes:	Classification? Moderate (x - x) Notes/Comments: Very close to river, with some obvious erosion. Vegetation on banks, but little to none on bottom.

Upstream view of right bank.

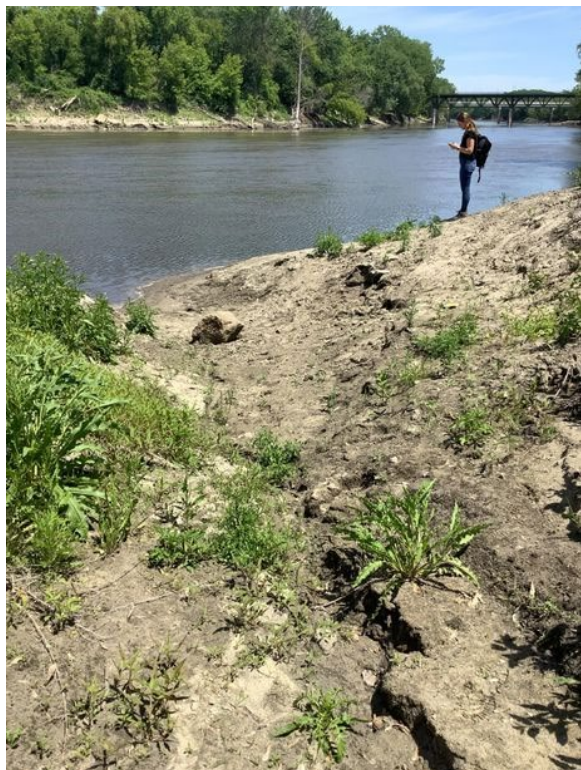
Photo3

View of downstream.

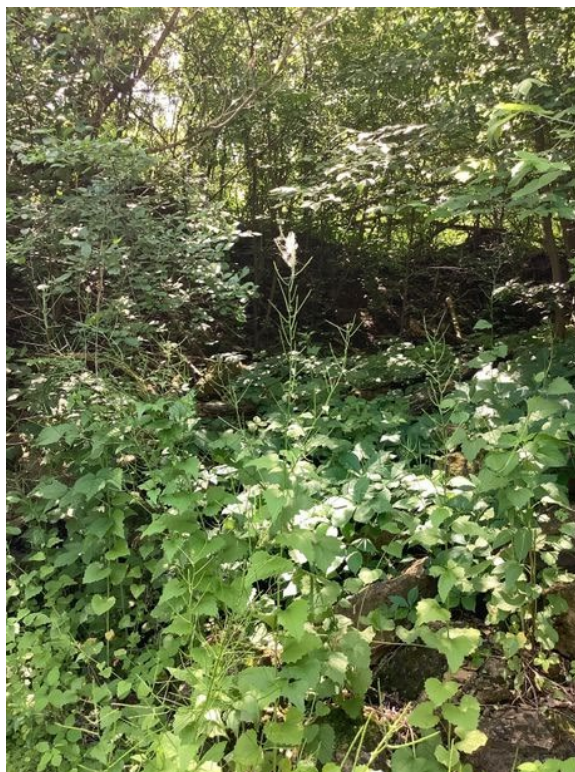
Photo2

Seep:	No	
Stormwater Inputs:	0-Not present	
Fallen Trees:	Yes	
Degradation:	3-Moderate	
Aggradation:	0-No aggradation	
Slumping:	1-Low	
Additional Notes:	Classification? Moderate (x - x) Notes/Comments: Other side of another gully across the trail, pipes downstream, steep slopes and bare soil on sides

Upstream view of right bank.

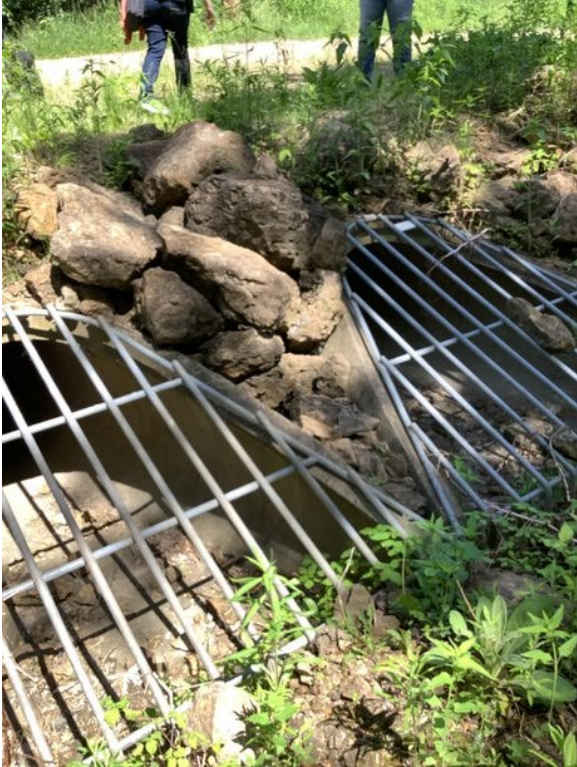
Photo3

Upstream view of pipes.

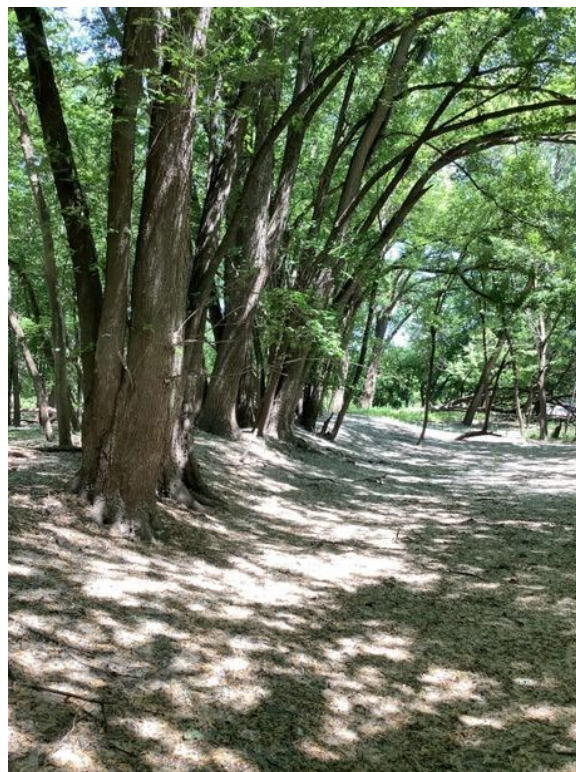
Photo2

Seep:	No	
Stormwater Inputs:	0-Not present	
Fallen Trees:	No	
Degradation:	0-No degradation	
Aggradation:	0-No aggradation	
Slumping:	1-Low	
Additional Notes:	Classification? Moderate (x - x) Notes/Comments: Very wide with no signs of water, but pipe at top. Minor slumping of trees, and close to other gullies found

Downstream view of left bank.

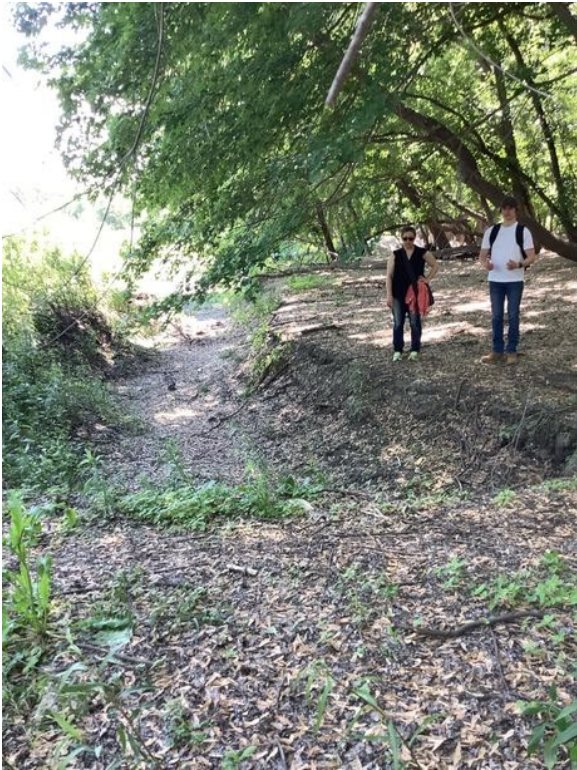
Photo1

Seep:	No	
Stormwater Inputs:	0-Not present	
Fallen Trees:	No	
Degradation:		5-Severe
Aggradation:		0-No aggradation
Slumping:		0-No slumping, 5-Severe
Additional Notes:	Classification? Moderate (x - x) Notes/Comments: Gully that is actively eroding, no traces of water or any pipe outfalls and some vegetation on banks and bottom.

View front on top of head cut, can see active erosion on banks.

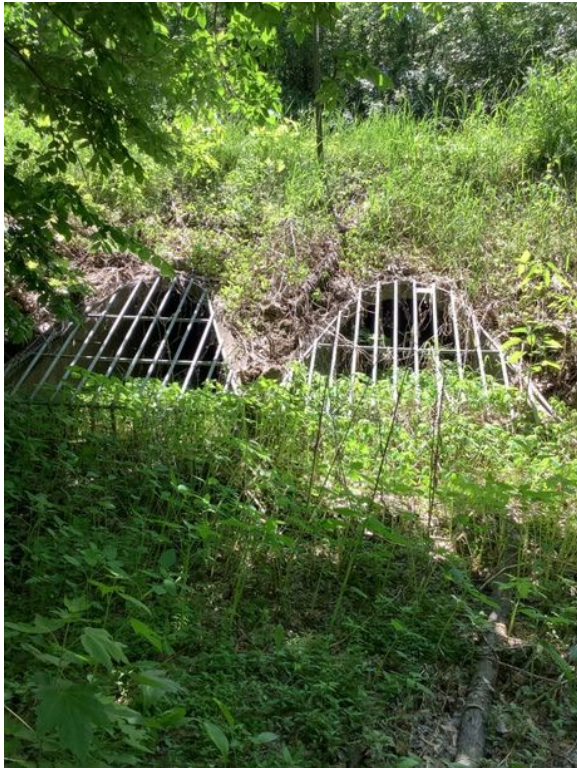
Photo1

Seep:	No
Stormwater Inputs:	0-Not present
Fallen Trees:	No
Degradation:	0-No degradation
Aggradation:	0-No aggradation
Slumping:	0-No slumping
Additional Notes:	<p>Classification? Low (4 - x)</p> <p>Notes/Comments: Two sewer pipes from right off trail, connects to gully downstream from pipe outfall with high water flow. No water flow, vegetation growing right in front of pipes and area seems very dry.</p>

Outfall pipes right under trail, heavy vegetation in front of outfall.

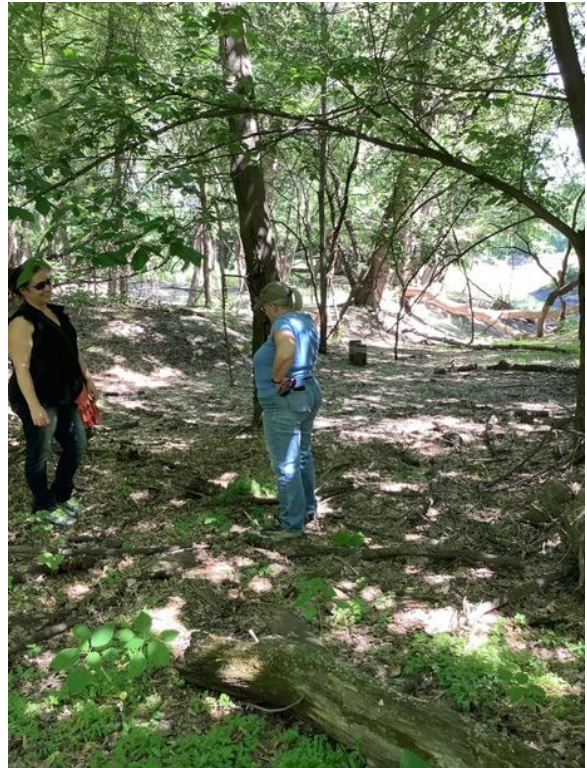
Photo2

View showing wide shallow banks with little vegetation.

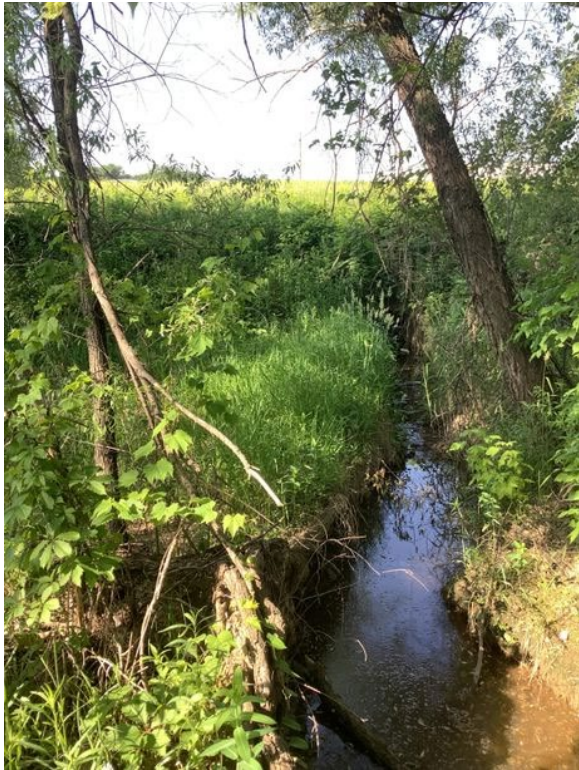
Photo1

Seep:	No	
Stormwater Inputs:	2-Low flow	
Fallen Trees:	No	
Degradation:		5-Severe
Aggradation:		1-Low
Slumping:		3-Moderate
Additional Notes:	<p>Classification? Moderate (x - x)</p> <p>Notes/Comments: Pipe outfall underneath hwy 101. Constant flow of water, and heavy degradation with grass roots hanging down. Moderate tree slumping. Downstream, another pipe goes under road and connects to other side, but was difficult to access</p>

Upstream view of right bank.

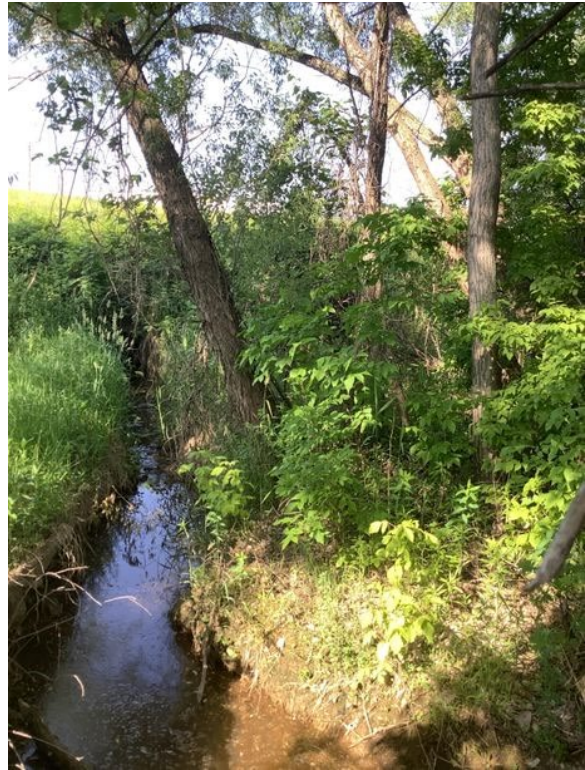
Photo2

Upstream view of left bank.

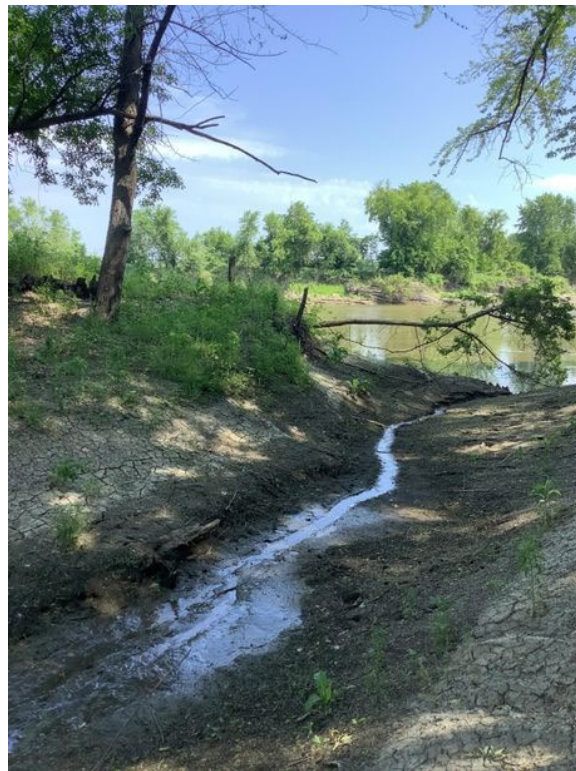
Photo2

Seep:	No	
Stormwater Inputs:	2-Low flow	
Fallen Trees:	Yes	
Degradation:	3-Moderate	
Aggradation:	1-Low	
Slumping:	1-Low	
Additional Notes:	Classification? Moderate (x - x) Notes/Comments: Pipe exits water, trees fallen into gully with constant stream leading directly into MN river. Not much vegetation on the banks

Downstream view of left bank.

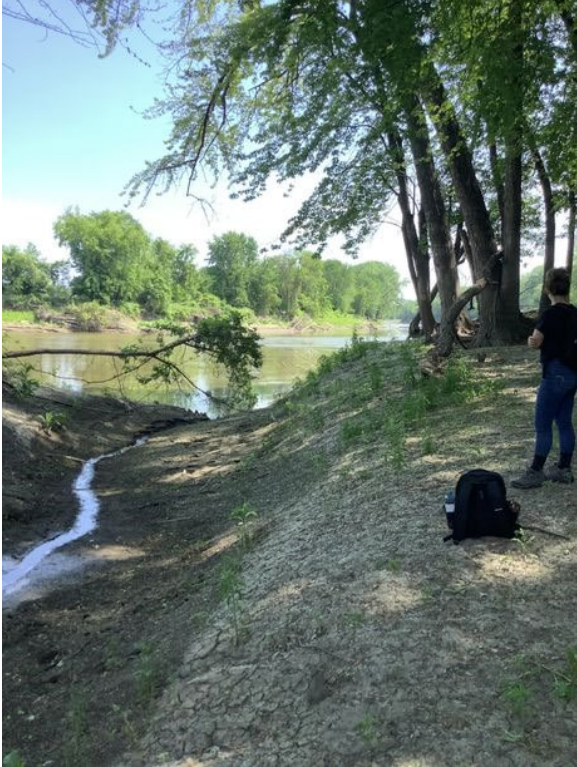
Photo3

Downstream view of right bank.

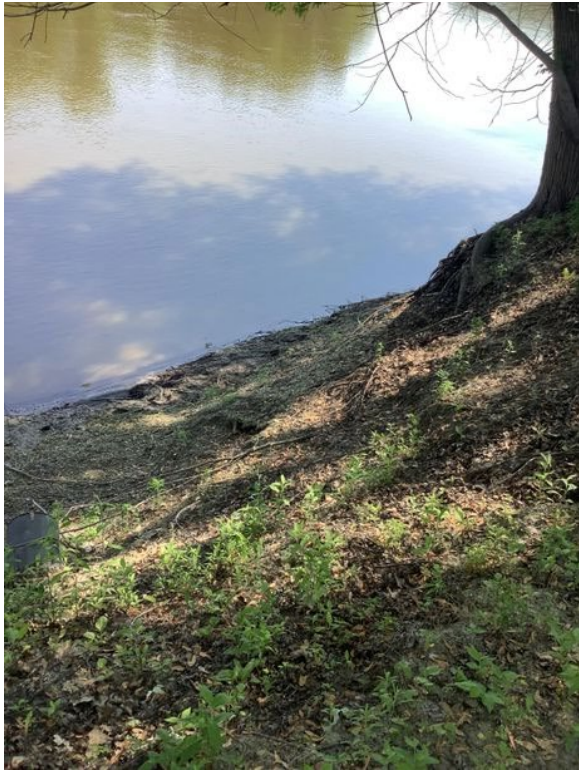
Photo1

Seep:	No	
Stormwater Inputs:	0-Not present	
Fallen Trees:	No	
Degradation:	1-Low	
Aggradation:	0-No aggradation	
Slumping:	0-No slumping	
Additional Notes:	Classification? Moderate (x - x) Notes/Comments: Hanging pipe, exits directly into the river, no vegetation on banks

Downstream view of right bank.

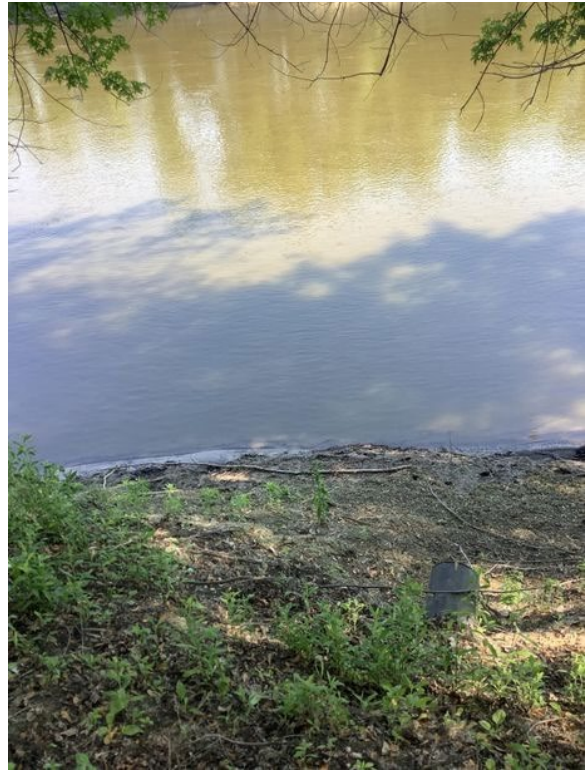
Photo2

Downstream view of left bank.

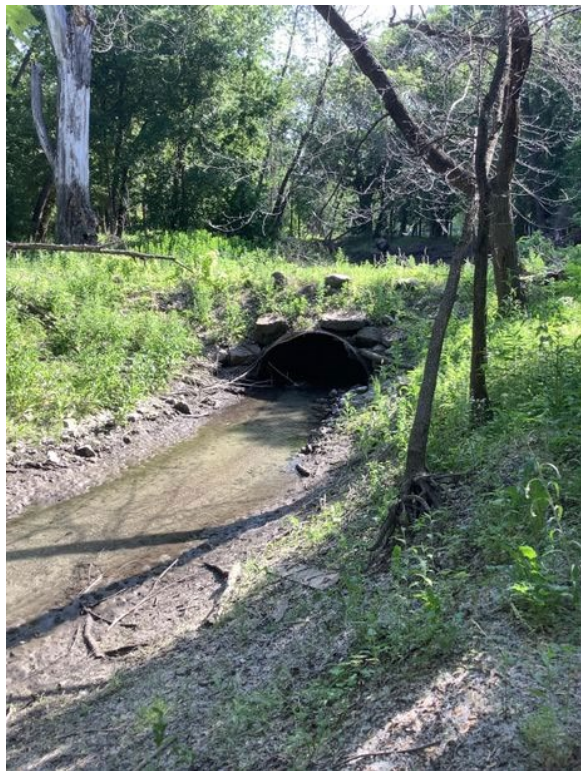
Photo1

Seep:	No	
Stormwater Inputs:	0-Not present	
Fallen Trees:	No	
Degradation:	0-No degradation	
Aggradation:	0-No aggradation	
Slumping:	1-Low	
Additional Notes:	Classification? Moderate (x - x) Notes/Comments: Further down area of gully with pipe outfall, big pipe at end connecting to other side. Water moving at decent pace.

Downstream view of entire gully and pipe connecting.

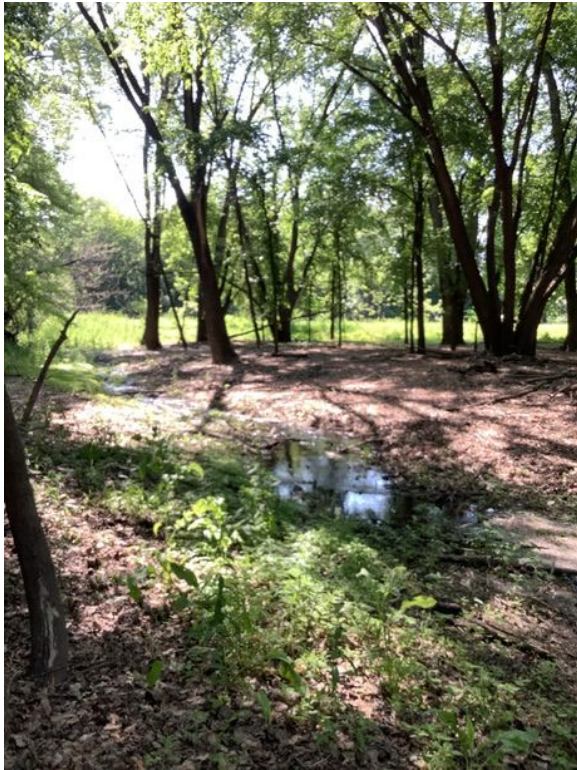
Photo1

Gully Material:	Silt and/or Clay	
Seep:	No	
Stormwater Inputs:	0-Not present	
Fallen Trees:	No	
Degradation:	0-No degradation	
Aggradation:	0-No aggradation	
Slumping:	0-No slumping	
Additional Notes:	<p>Classification? Moderate (x - x)</p> <p>Notes/Comments: Stream off of pond, we believe this stream connects to the gully downstream. Lots of vegetation upstream on the banks.</p>

View downstream from pond, can see lots of vegetation on the left bank and little on the right.

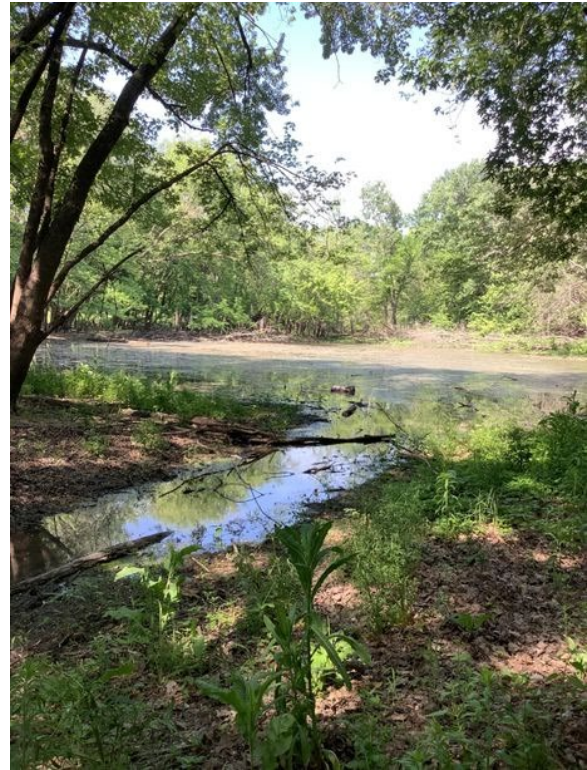
Photo2

Upstream view where stream connects to its source pond.

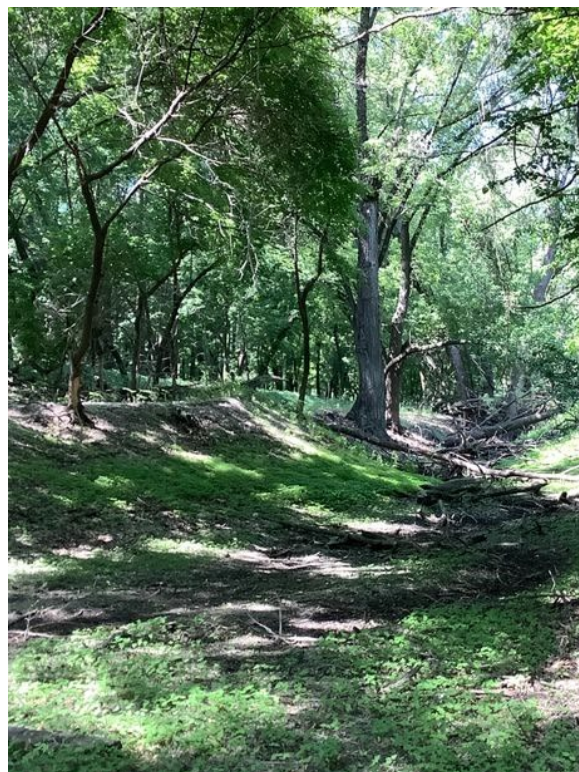
Photo2

Seep:	No	
Stormwater Inputs:	0-Not present	
Fallen Trees:	Yes	
Degradation:	1-Low	
Aggradation:	1-Low	
Slumping:	3-Moderate	
Additional Notes:	Classification? Moderate (x - x) Notes/Comments: Large gully with lots of fallen trees. Heavy vegetation on banks, light on bottom. Decent amount of slumping

Upstream view of right bank
