<p>Gully ID: 07:07-11:46</p>	<p style="text-align: center;">MAP</p>

<p>Date & Time: July 7, 2021 11:46 AM</p>	
<p>Location: Shakopee</p>	
<p>Weather: Cloudy</p> <p>Storm/Rainfall Event in the Past 24 Hours? Yes-Low Intensity</p>	
GULLY INFORMATION	
<p>Calculated Erosion Potential:</p>	<p>Moderate</p>
<p>Approximate Depth:</p>	<p>1-Shallow (<3')</p>
<p>Approximate Bottom Width:</p>	<p>3-Medium (1'-5')</p>
<p>Approximate Gully Length:</p>	<p>5-Long (>100')</p>
<p>Condition of Gully Bottom:</p>	<p>5-Bare Soil</p>
<p>Condition of Gully Banks:</p>	<p>1-Heavy Vegetation</p>
<p>Gully Bank Angles:</p>	<p>3-Mid-Range (45 to 90 degrees)</p>
<p>Gully Shape:</p>	<p>3-U-Shaped</p>
<p>Gully Material:</p>	<p>Gravel/Cobble/Boulders</p>

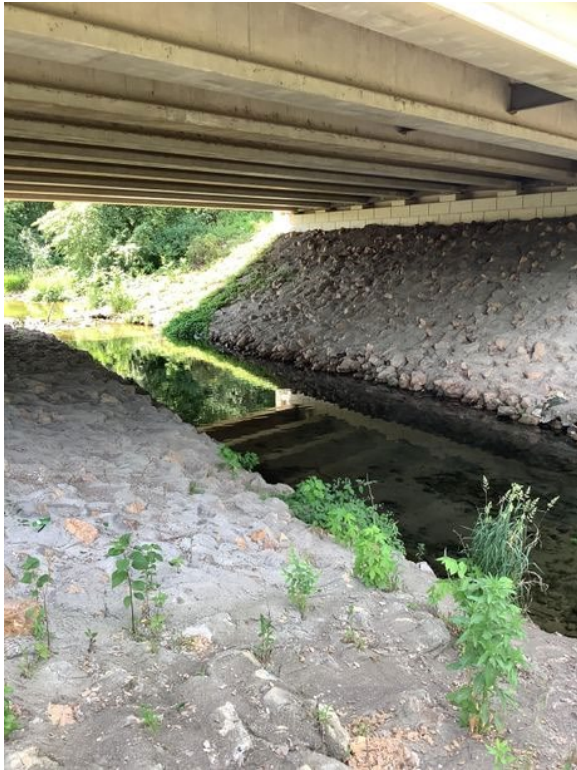
Photo1

Seep:	No
Stormwater Inputs:	2-Low flow
Fallen Trees:	No
Degradation:	0-No degradation
Aggradation:	0-No aggradation
Slumping:	0-No slumping
Additional Notes:	Classification? Low (4 - x) Notes/Comments: Armored gully under bridge. Very little vegetation.

Upstream view of gully, armored banks are visible.

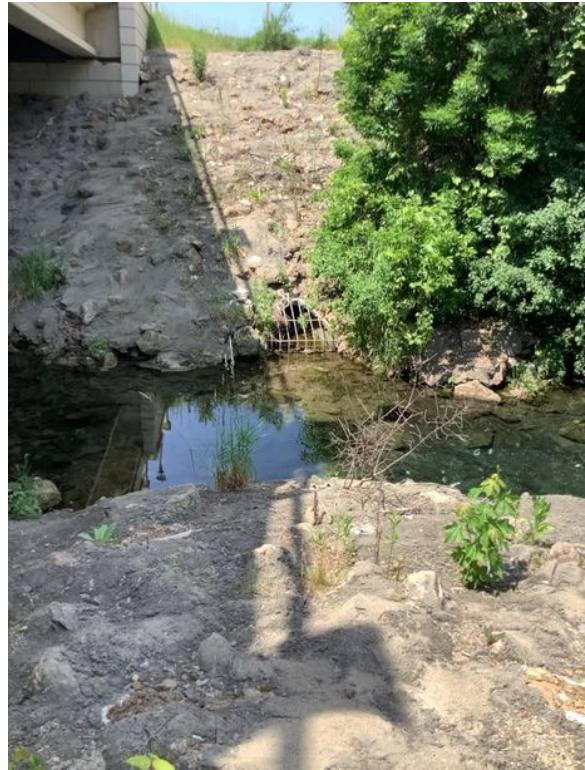
Photo2

Sewer drainage pipe leading into gully just downstream of the bridge on the left bank.

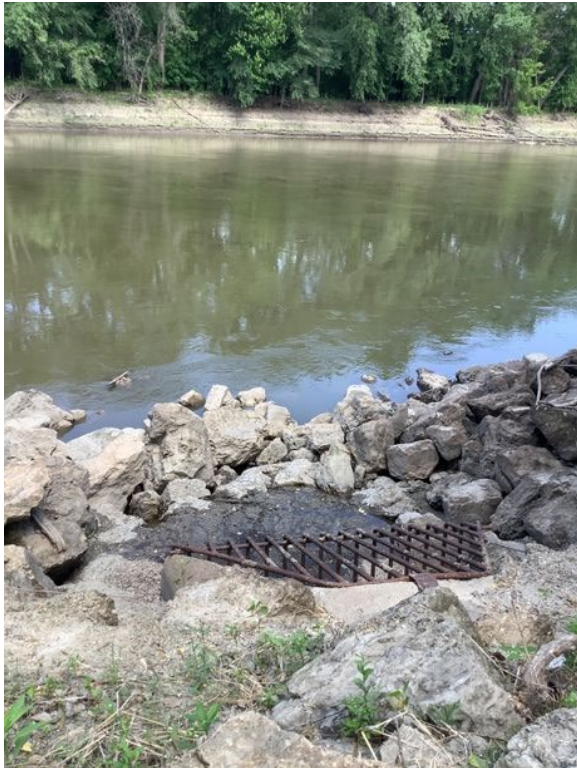
Photo1

Seep:	No	
Stormwater Inputs:	1-Dripping	
Fallen Trees:	No	
Degradation:	1-Low	
Aggradation:	3-Moderate	
Slumping:	0-No slumping	
Additional Notes:	<p>Classification? Low (4 - x)</p> <p>Notes/Comments: Sewer drainage pipe with very low flow and low degradation. Has some aggradation as the rocks in front of it are covered in dried dirt or clay that must've been carried through the sewer into the river on high flow days.</p>

View of sewer pipe from above pipe. Can see lots of armoring around pipe.

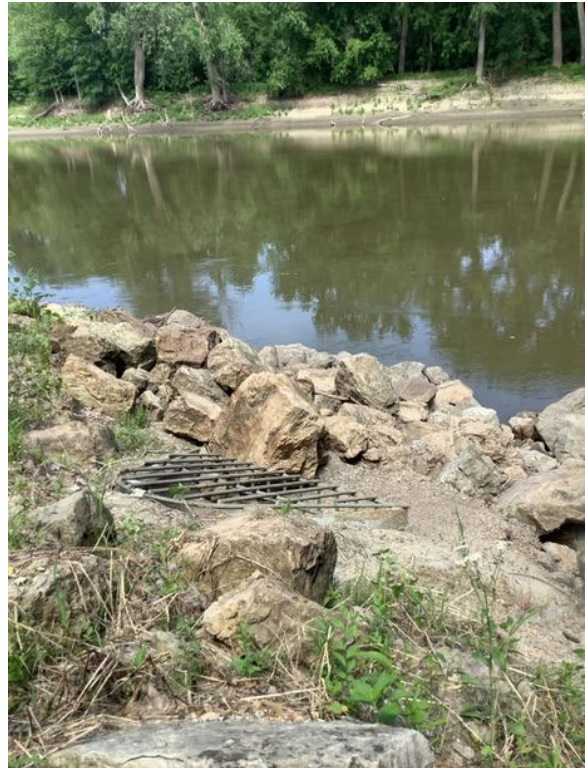
Photo2

Pipe to the left of other drainage pipe, with no erosion present and no noticeable flow.

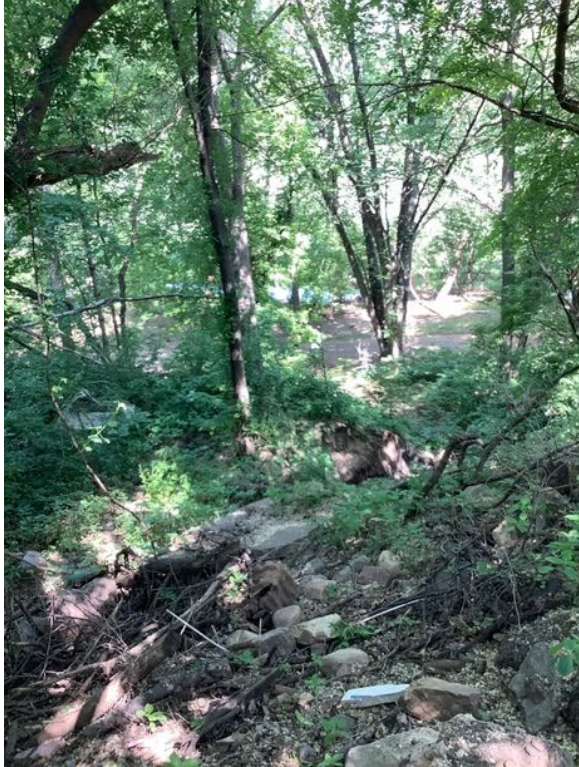
Photo1

Seep:	No	
Stormwater Inputs:	0-Not present	
Fallen Trees:	Yes	
Degradation:		5-Severe
Aggradation:		0-No aggradation, 5-Severe
Slumping:		5-Severe
Additional Notes:	<p>Classification? High (x - 49)</p> <p>Notes/Comments: Gully formed on land side of trail next to MN river, gully is eroding into a campsite/trailer park. Slabs of concrete and a tent were present on the gully</p>

View downstream of large gully it's lots of erosion and concrete slabs and rock.

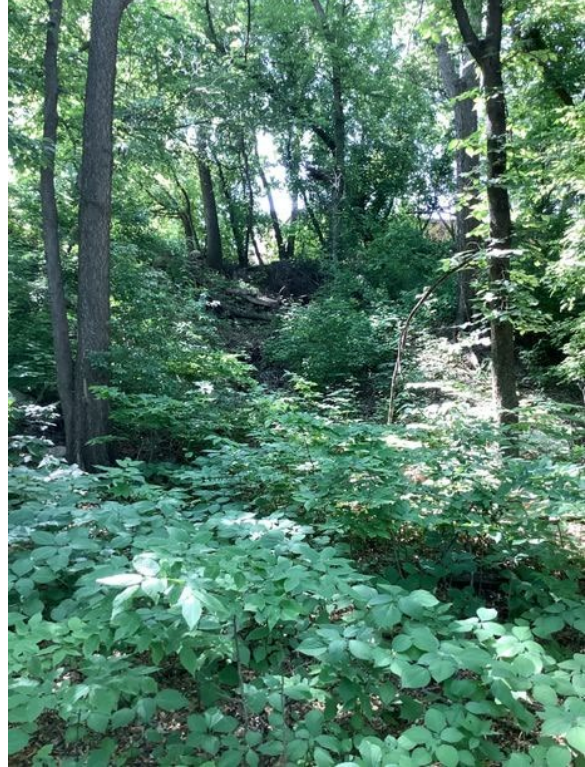
Photo2

View from trail looking up at the gully, moderate vegetation at the bottom, but the further up the gully the less vegetation there is and the more severe the erosion is

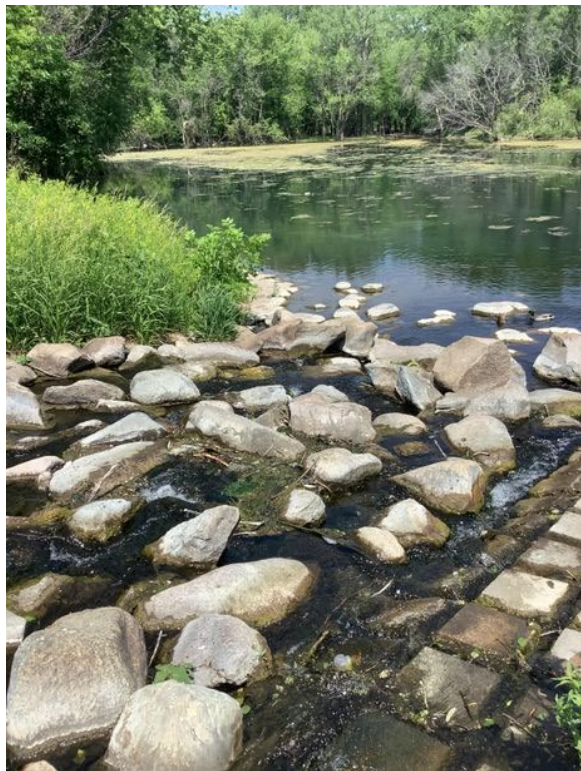
Photo1

Seep:	No	
Stormwater Inputs:	3-Constant high flow	
Fallen Trees:	No	
Degradation:	0-No degradation	
Aggradation:	0-No aggradation	
Slumping:	0-No slumping	
Additional Notes:	Classification? Low (4 - x) Notes/Comments: Armored all the way through, constant stream from one pond to another, some vegetation comes through the concrete armoring

Downstream view of gully covered in armoring.

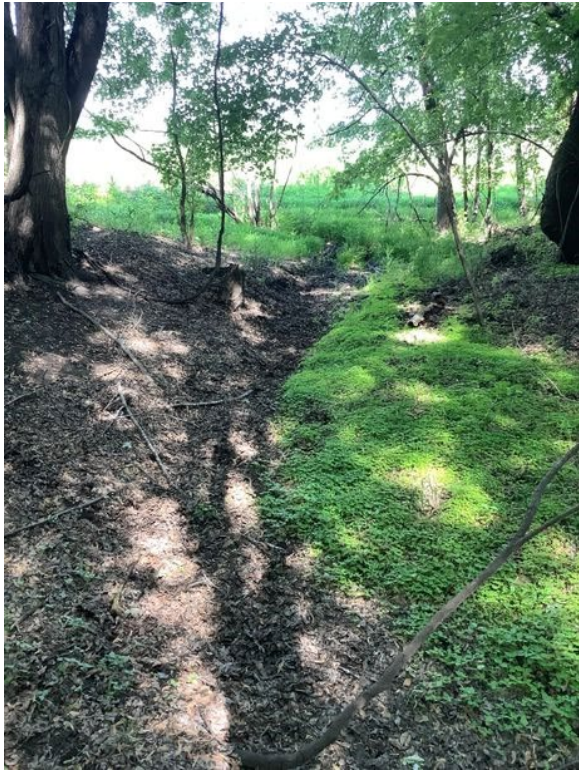
Photo1

Seep:	No	
Stormwater Inputs:	0-Not present	
Fallen Trees:	No	
Degradation:		1-Low
Aggradation:		0-No aggradation
Slumping:		1-Low
Additional Notes:	Classification? Low (4 - x) Notes/Comments: Pipe outfall, heavy vegetation on right bank, low on left bank, feeds into another creek/stream, smaller trees slumping

Both sides of gully downstream

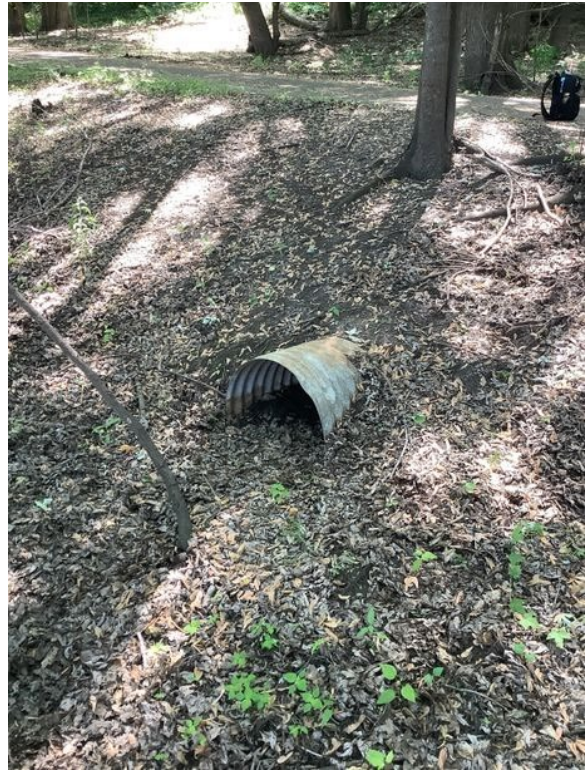
Photo2

Pipe at top of gully, likely feeds from nearby building

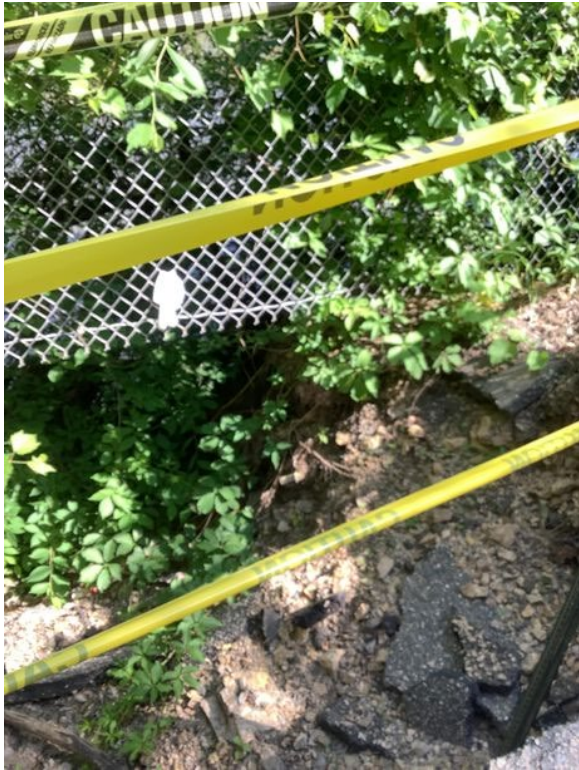
Photo1

Seep:	No	
Stormwater Inputs:	0-Not present	
Fallen Trees:	No	
Degradation:	5-Severe	
Aggradation:	0-No aggradation	
Slumping:	0-No slumping	
Additional Notes:	Classification? High (x - 49) Notes/Comments: Looks like part of the trail got heavily eroded, roots hanging off the side and very steep bank

Downstream view of right bank.

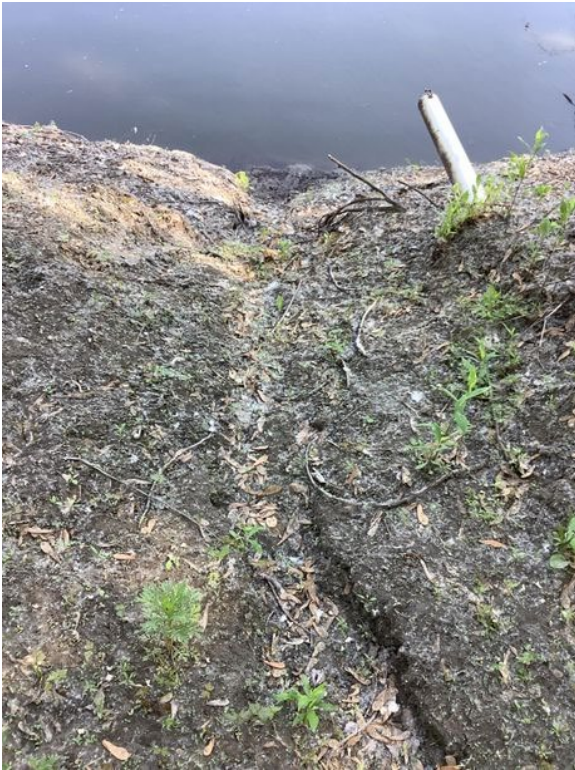
Photo1

Seep:	No	
Stormwater Inputs:	0-Not present	
Fallen Trees:	No	
Degradation:	3-Moderate	
Aggradation:	0-No aggradation	
Slumping:	0-No slumping	
Additional Notes:	<p>Classification? Moderate (x - x)</p> <p>Notes/Comments: Small gully leading into the Minnesota river, pipe outfall near gully but shows no sign of erosion, channel is pretty steep</p>

Gully in middle with decent erosion clearing path, pipe hanging to the right, but no indications of water exiting it

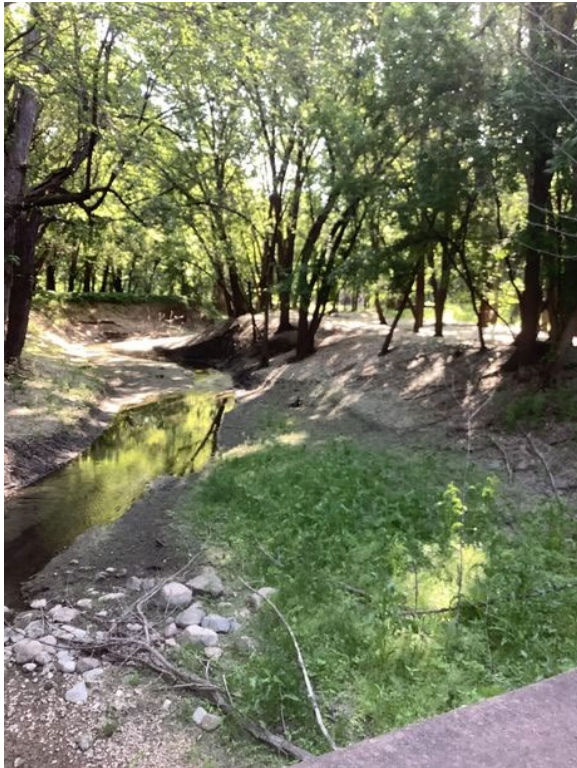
Photo1

Seep:	No	
Stormwater Inputs:	0-Not present	
Fallen Trees:	No	
Degradation:	0-No degradation	
Aggradation:	0-No aggradation	
Slumping:	3-Moderate	
Additional Notes:	Classification? Moderate (x - x) Notes/Comments: Fast moving water that meets the end of another gully found. Tree roots exposed on banks, and little vegetation

Downstream view of right bank.

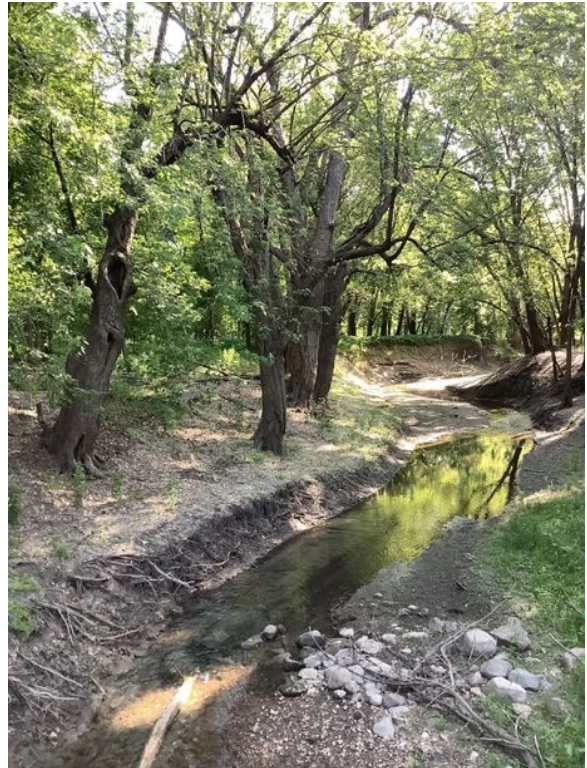
Photo2

Downstream view of left bank.

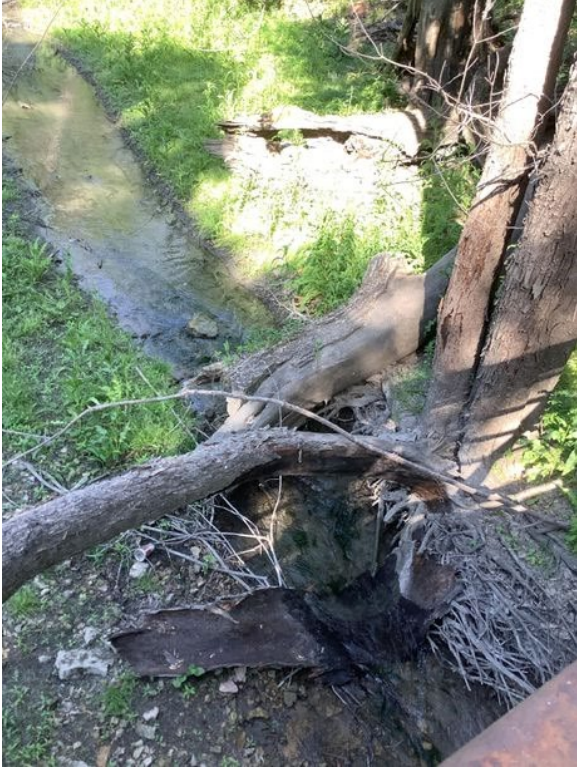
Photo3

View upstream with lots of fallen branches.

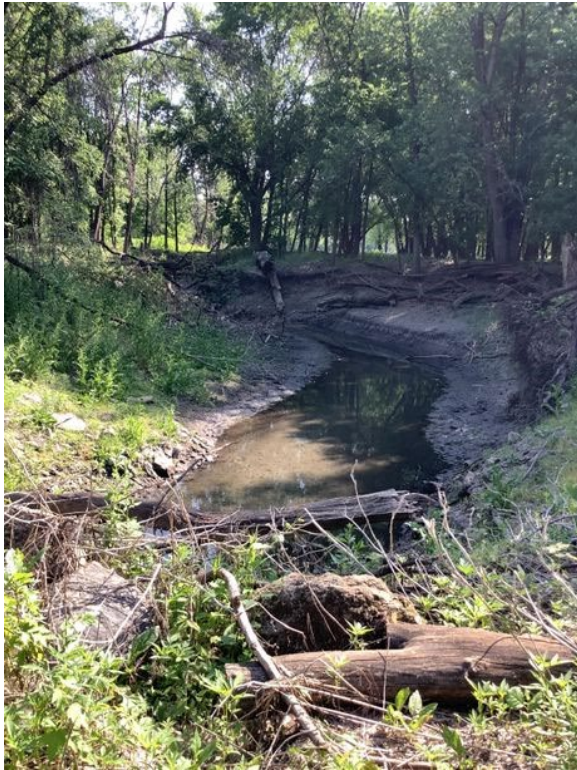
Photo1

Seep:	No	
Stormwater Inputs:	0-Not present	
Fallen Trees:	Yes	
Degradation:	3-Moderate, 5-Severe	
Aggradation:	0-No aggradation	
Slumping:	5-Severe	
Additional Notes:	Classification? High (x - 49) Notes/Comments: Lots of trees fallen further downstream, lots of exposed roots, has pipe connection on other side

View from on top of trail over pipe, showing lots of degradation through exposed roots on right bank, and lots of fallen trees further downstream

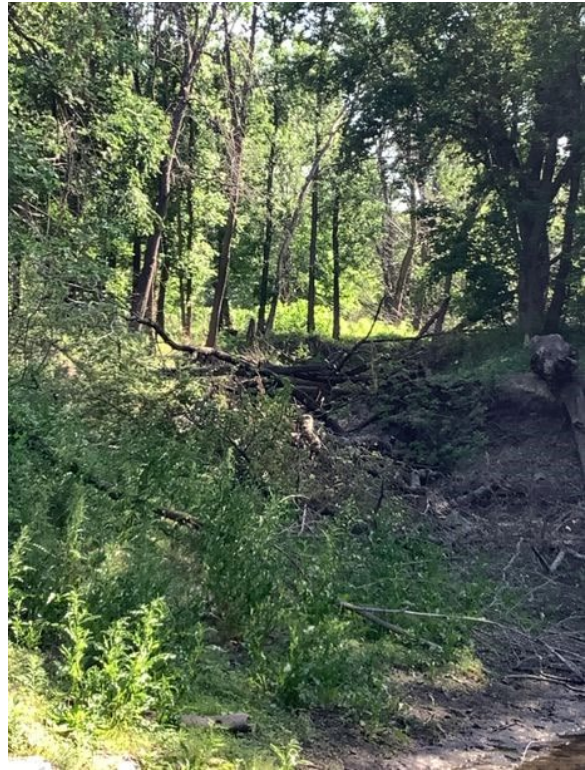
Photo2

Pile of fallen trees downstream.

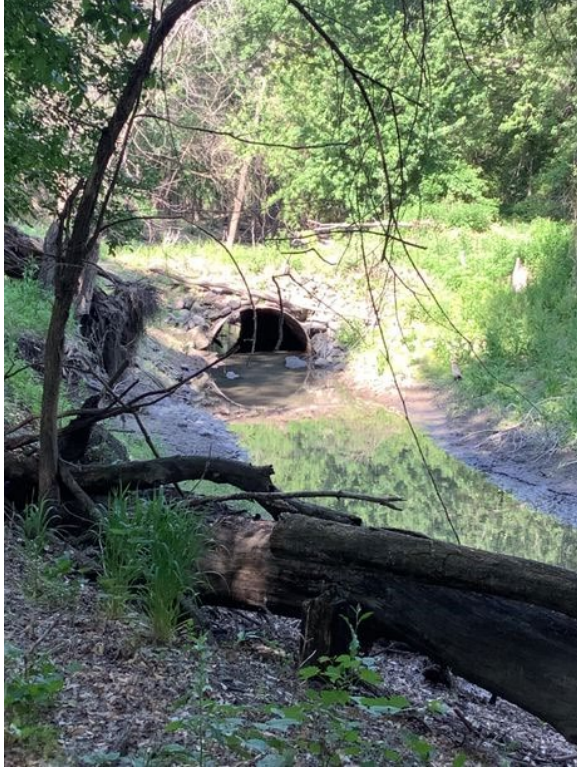
Photo3

Upstream view of pipe which is armored and doesn't show signs of erosion.

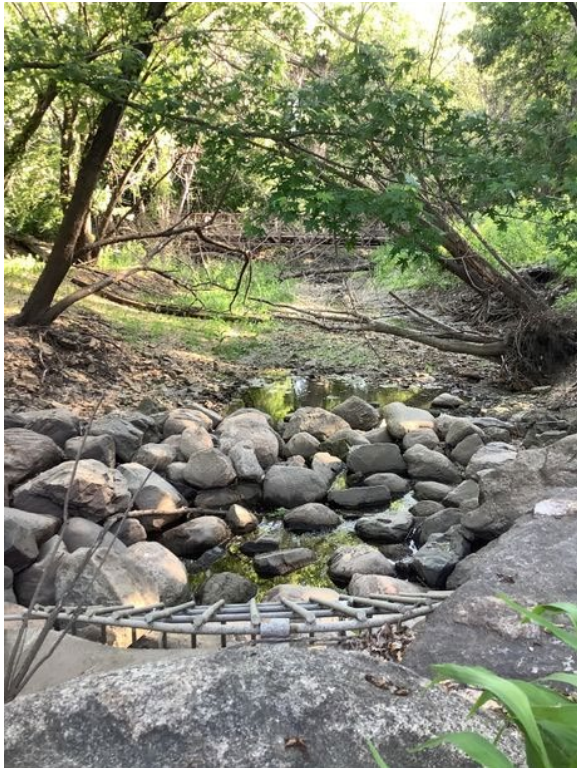
Photo1

Seep:	No
Stormwater Inputs:	0-Not present
Fallen Trees:	Yes
Degradation:	0-No degradation, 1-Low
Aggradation:	0-No aggradation
Slumping:	5-Severe
Additional Notes:	<p>Classification? Moderate (x - x)</p> <p>Notes/Comments: Pipe outfall armored with large rocks, there are some smaller rocks along part of the gully bank and bottom, but would not consider it armored. This gully leads into a creek. plarge pipe so area must get a lot of water</p>

View from above pipe outfall showing the armoring around the pipe. There is a fallen tree on the right bank and trees slumping on both banks.

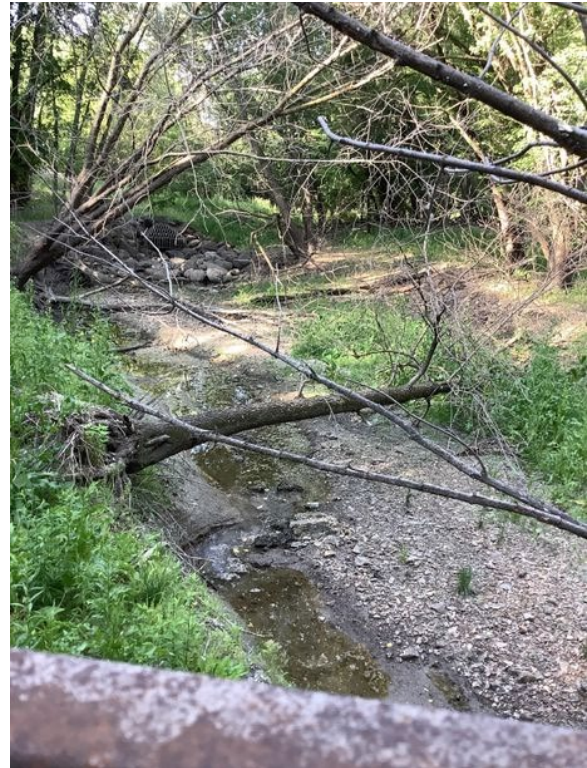
Photo2

View upstream from bridge over the gully, just downstream of the bridge this gully connects to the other gully/creek. Can see two ,ore fallen trees on the right bank.

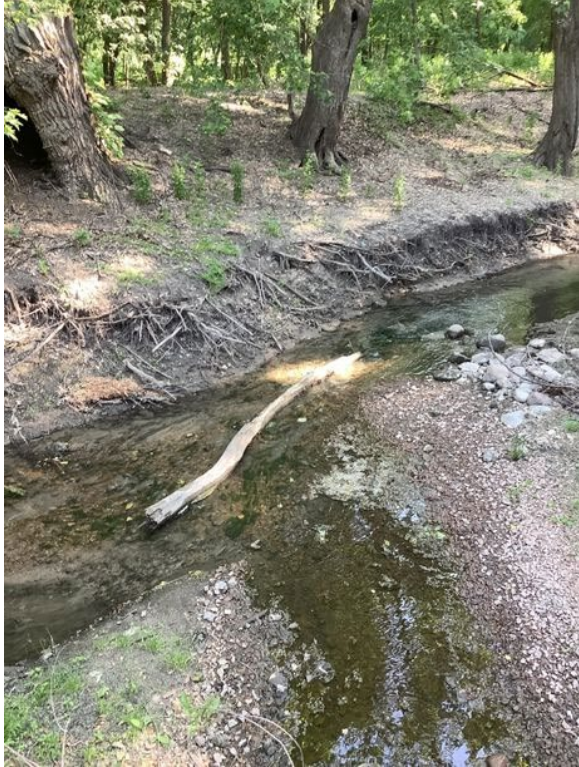
Photo3

Connection between gully from pipe and gully from creek. Gully from pipe is on the right side.

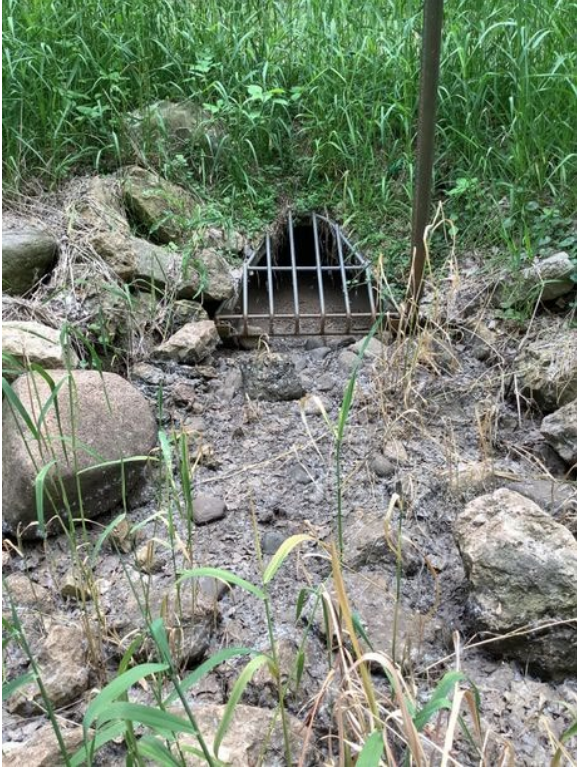
Photo1

Seep:	No
Stormwater Inputs:	0-Not present
Fallen Trees:	No
Degradation:	0-No degradation
Aggradation:	0-No aggradation
Slumping:	0-No slumping
Additional Notes:	<p>Classification? Low (4 - x)</p> <p>Notes/Comments: Drainage pipe right off trail. Surrounded by lots of riprap and some vegetation growing within.</p>

View from trail of drainage pipe, showing lots of rip rap and lack of vegetation.

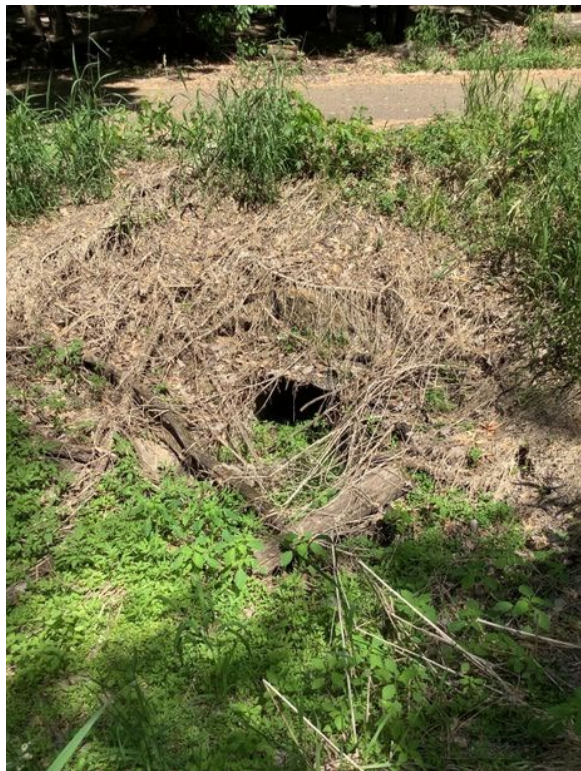
Photo1

Seep:	No	
Stormwater Inputs:	0-Not present	
Fallen Trees:	No	
Degradation:	0-No degradation, 1-Low	
Aggradation:	0-No aggradation	
Slumping:	0-No slumping	
Additional Notes:	Classification? Low (4 - x) Notes/Comments: Other side of drainage pipe under paved trail. Lots of vegetation and some logs and tree trunks, but doesn't look like the fell into the gully, may have been placed.

View of pipe from trail. Can see vegetation and dead branches. Rip rap around pipe opening.

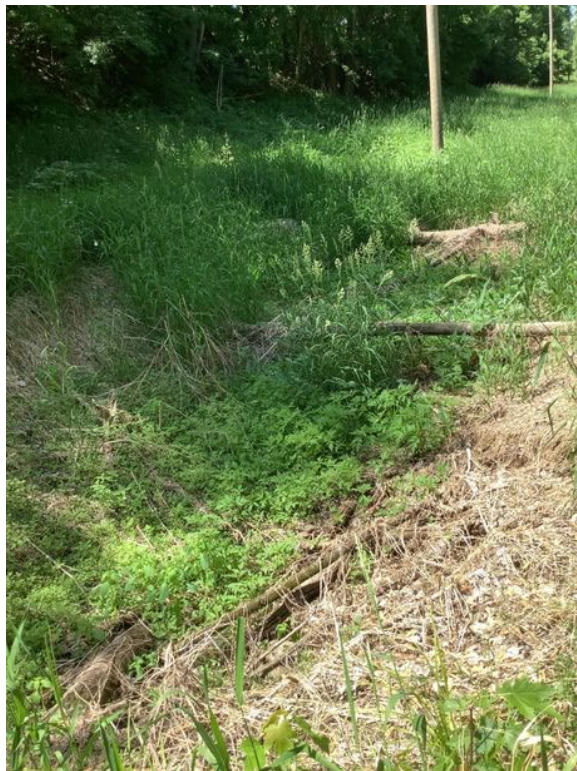
Photo2

View down from above pipe opening showing heavy vegetation.

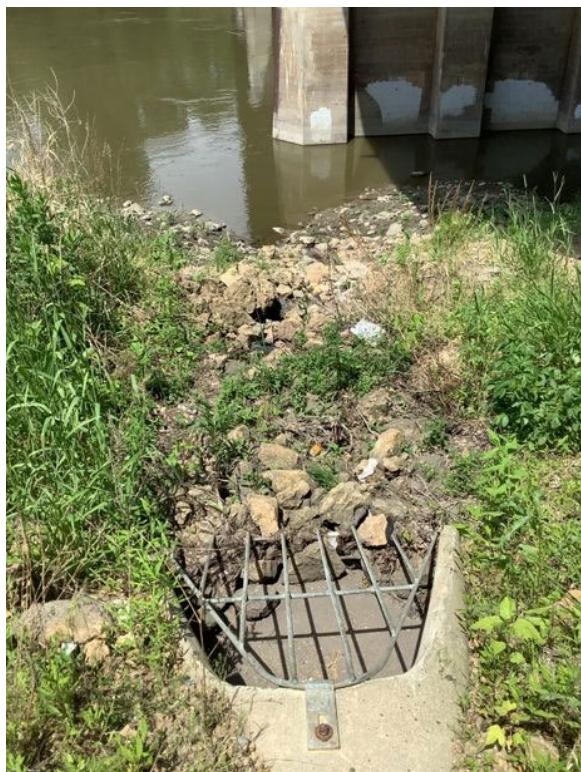
Photo1

Seep:	No	
Stormwater Inputs:	0-Not present	
Fallen Trees:	No	
Degradation:	0-No degradation	
Aggradation:	0-No aggradation	
Slumping:	0-No slumping	
Additional Notes:	Classification? Low (4 - x) Notes/Comments: Pipe comes out onto boulders, causing minor erosion on sides

Downstream view of armored banks of gully around pipe outfall

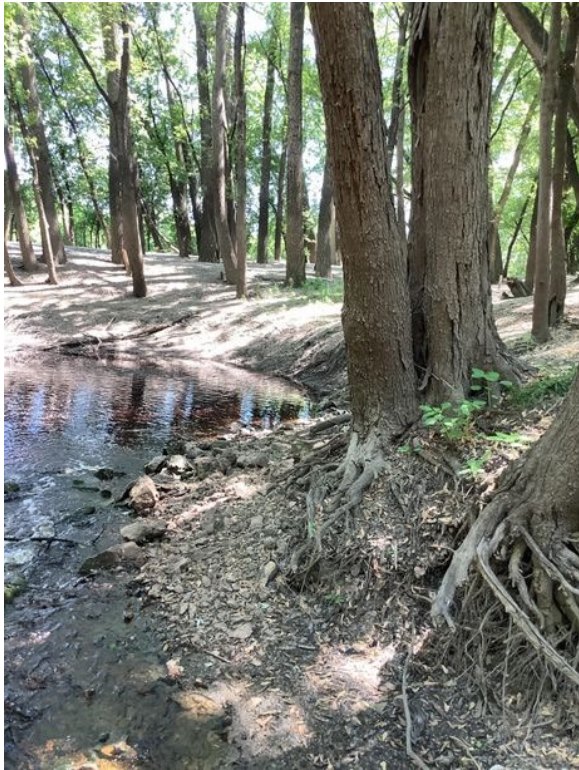
Photo1

Gully Material:	Silt and/or Clay	
Seep:	No	
Stormwater Inputs:	3-Constant high flow	
Fallen Trees:	Yes	
Degradation:		3-Moderate
Aggradation:		0-No aggradation
Slumping:		3-Moderate
Additional Notes:	Classification? High (x - 49) Notes/Comments: Pipe bringing lots of constant water flow into gully, trees fallen on side, low vegetation throughout

Downstream view of right bank of gully.

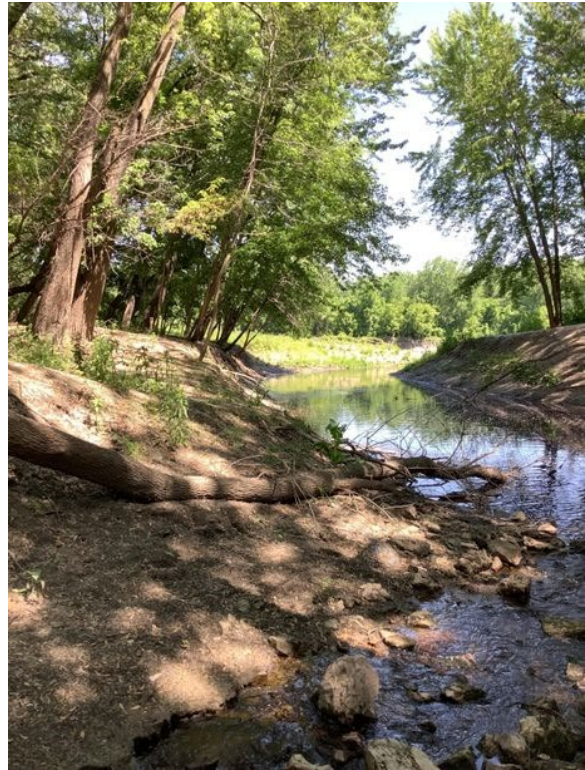
Photo2

Downstream view of left bank of gully.

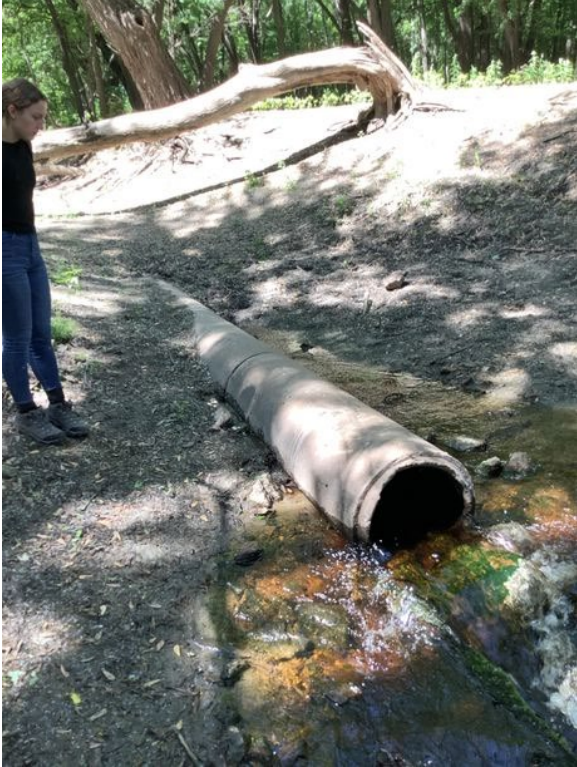
Photo3

Pipe with high flow of water coming out.
