Appendix K: Lower Minnesota River Watershed District: Gully Inventory

Gully Inventory Map
 Area #1
 Lower Minnesota River Watershed District
 Watershed Management Plan

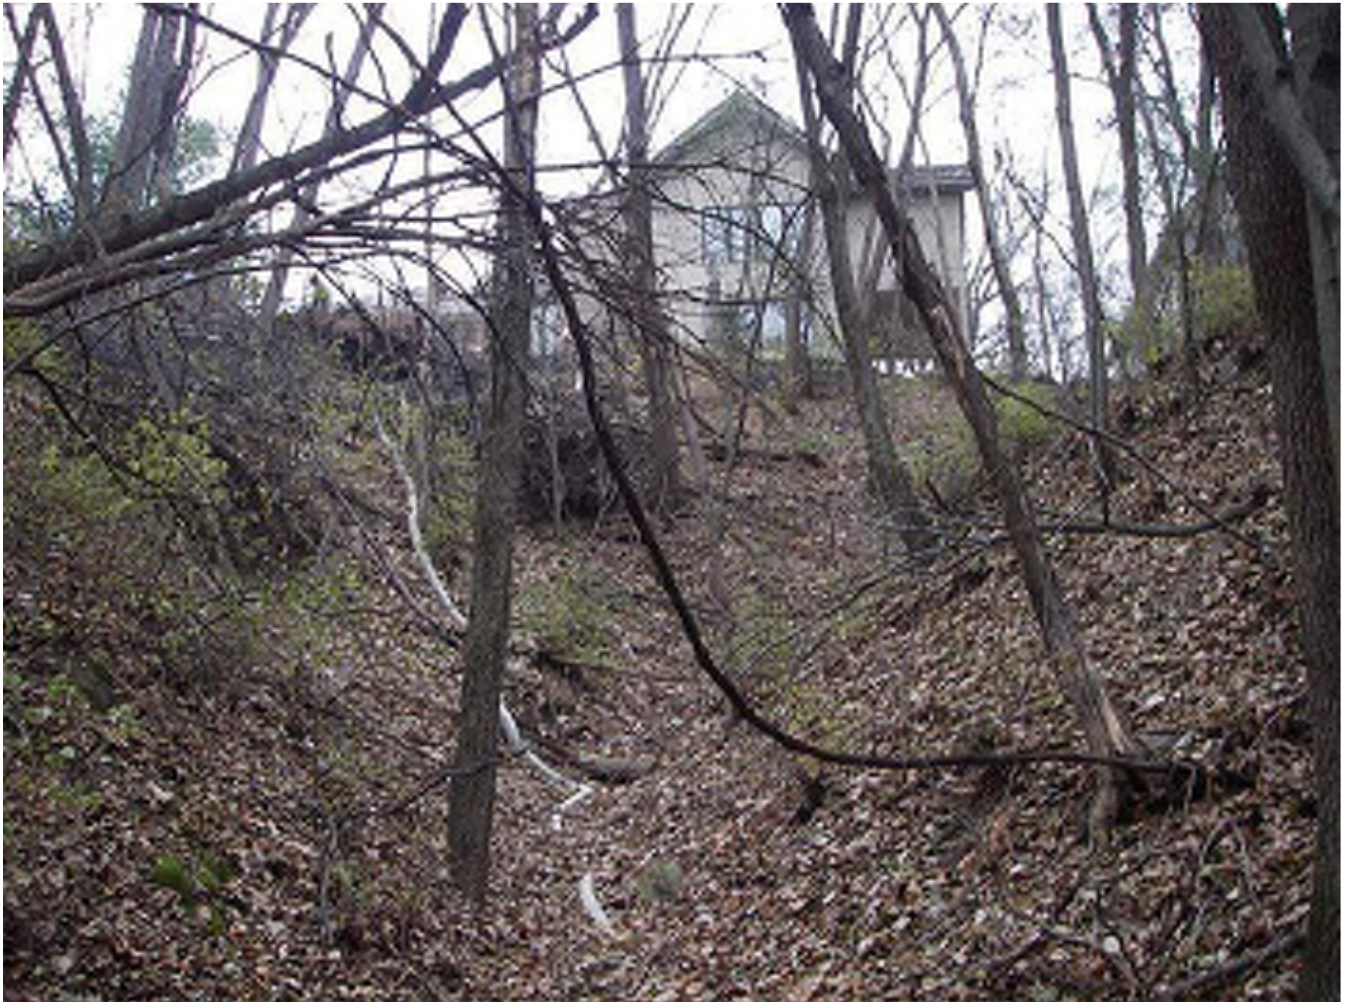
Waypoint 3

Tree debris; exposed soil.

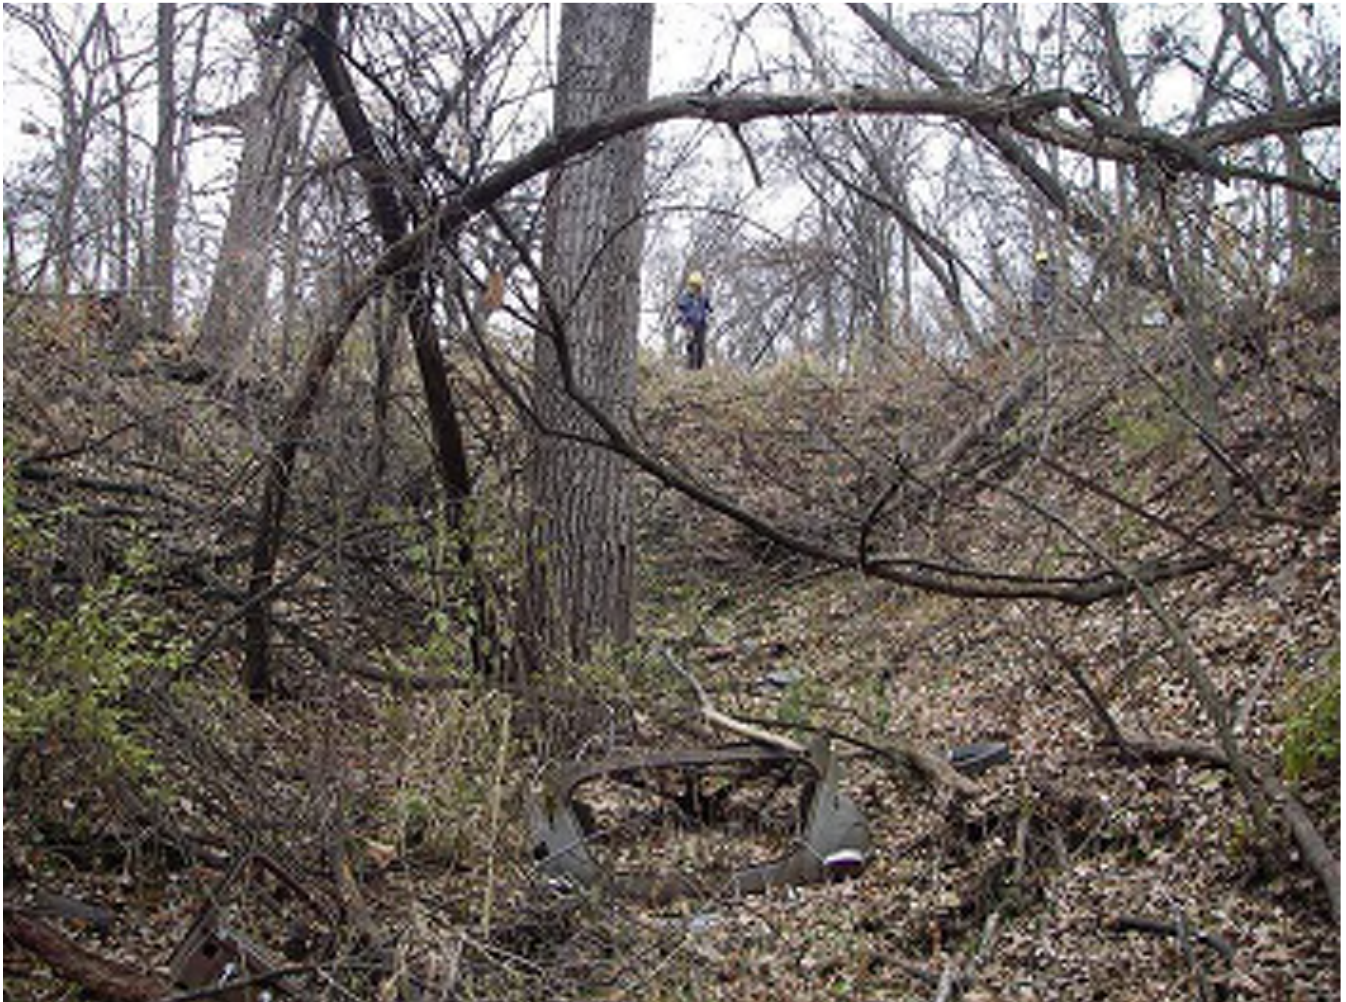
Waypoint 4

Trash, car, glass, cans

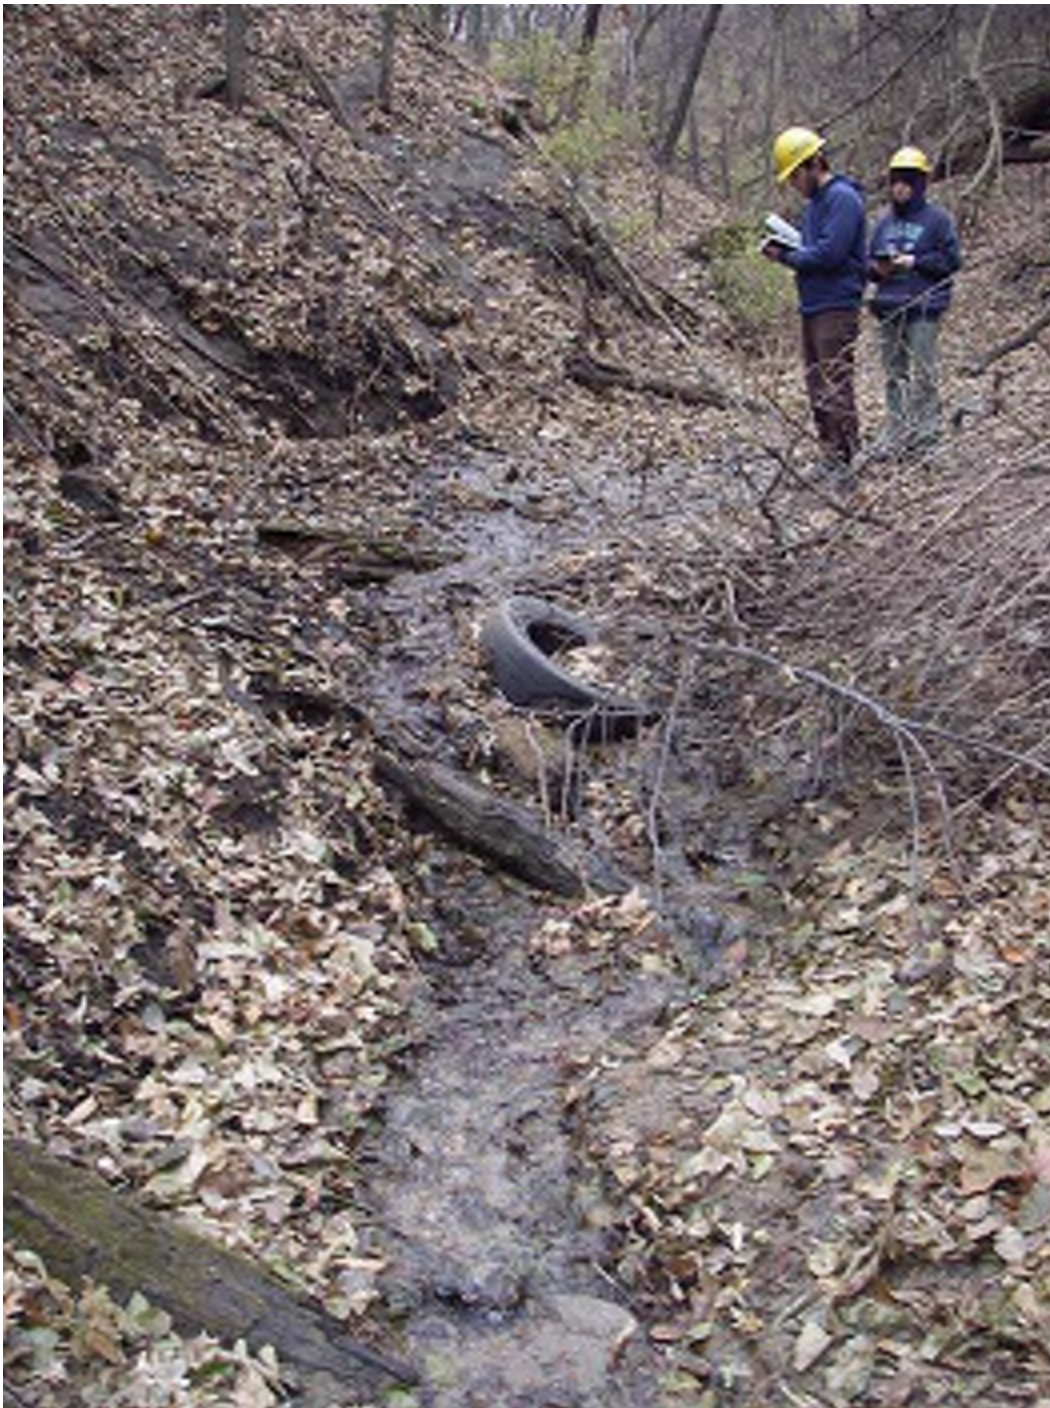
Waypoint 10

Drain pipe w/gardening weed barrier around pipe.

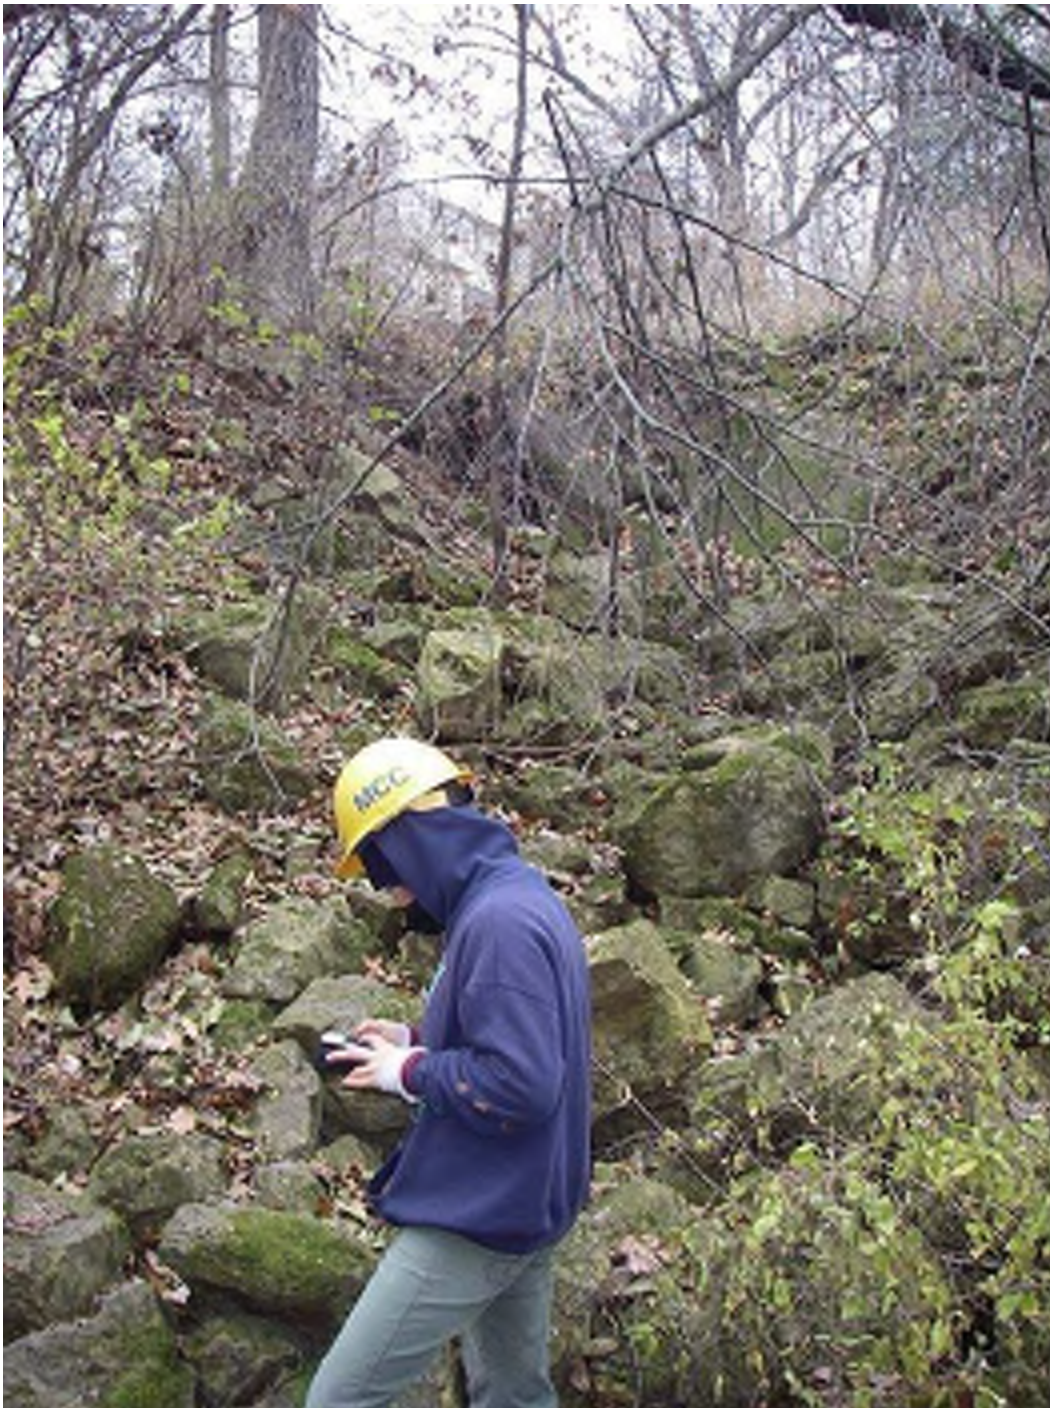
Eroded banks

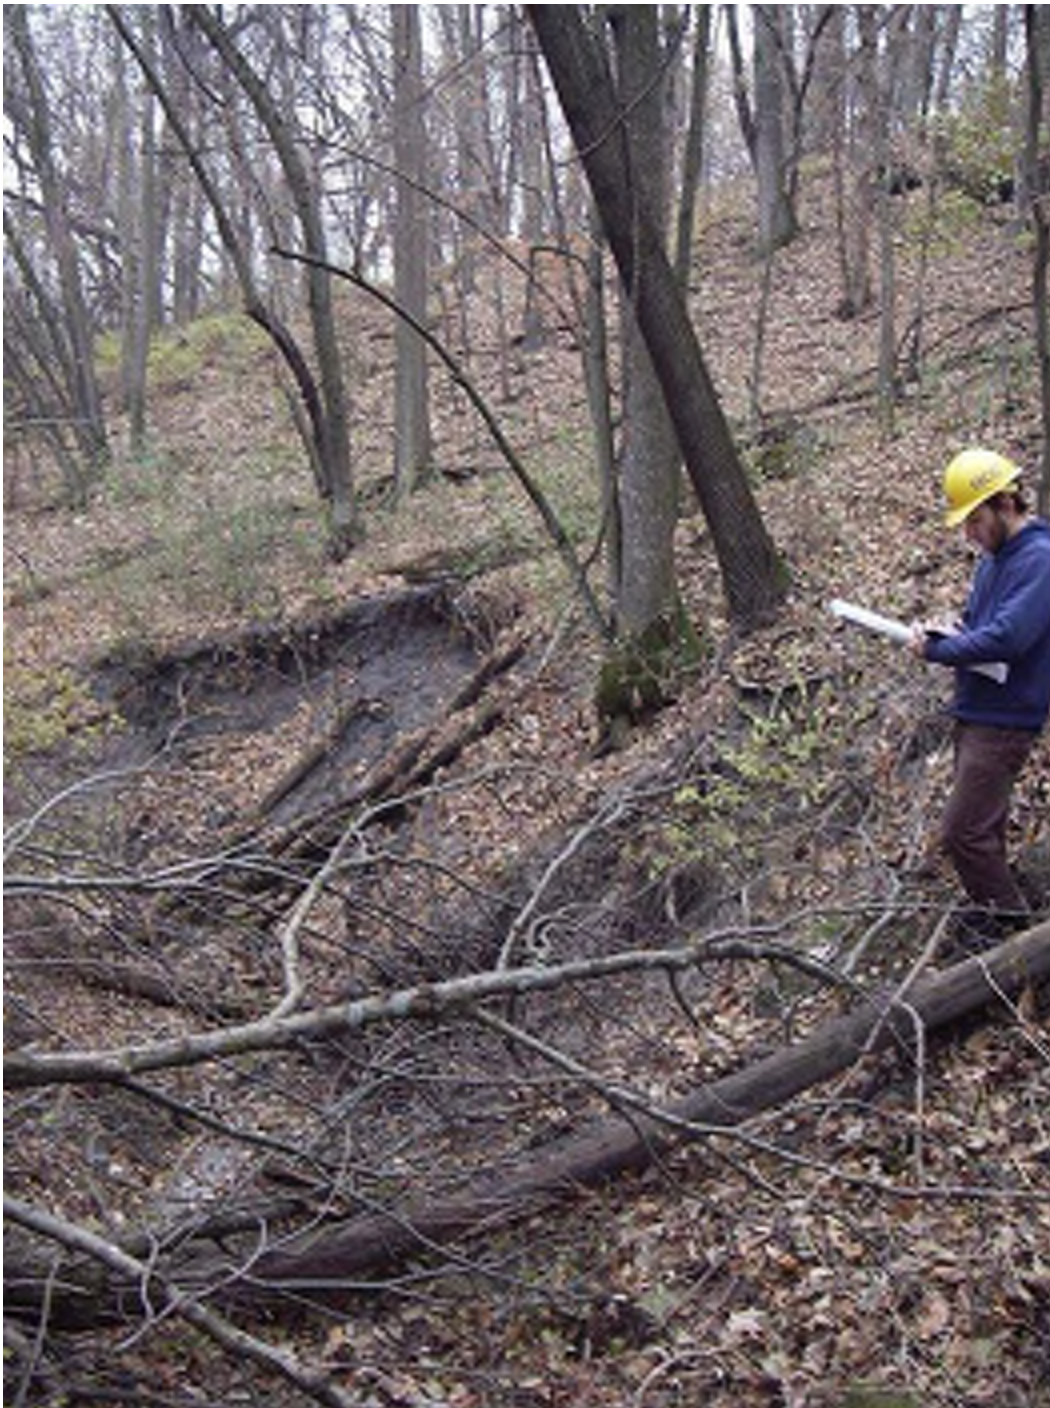
Waypoint 11

Drain pipe

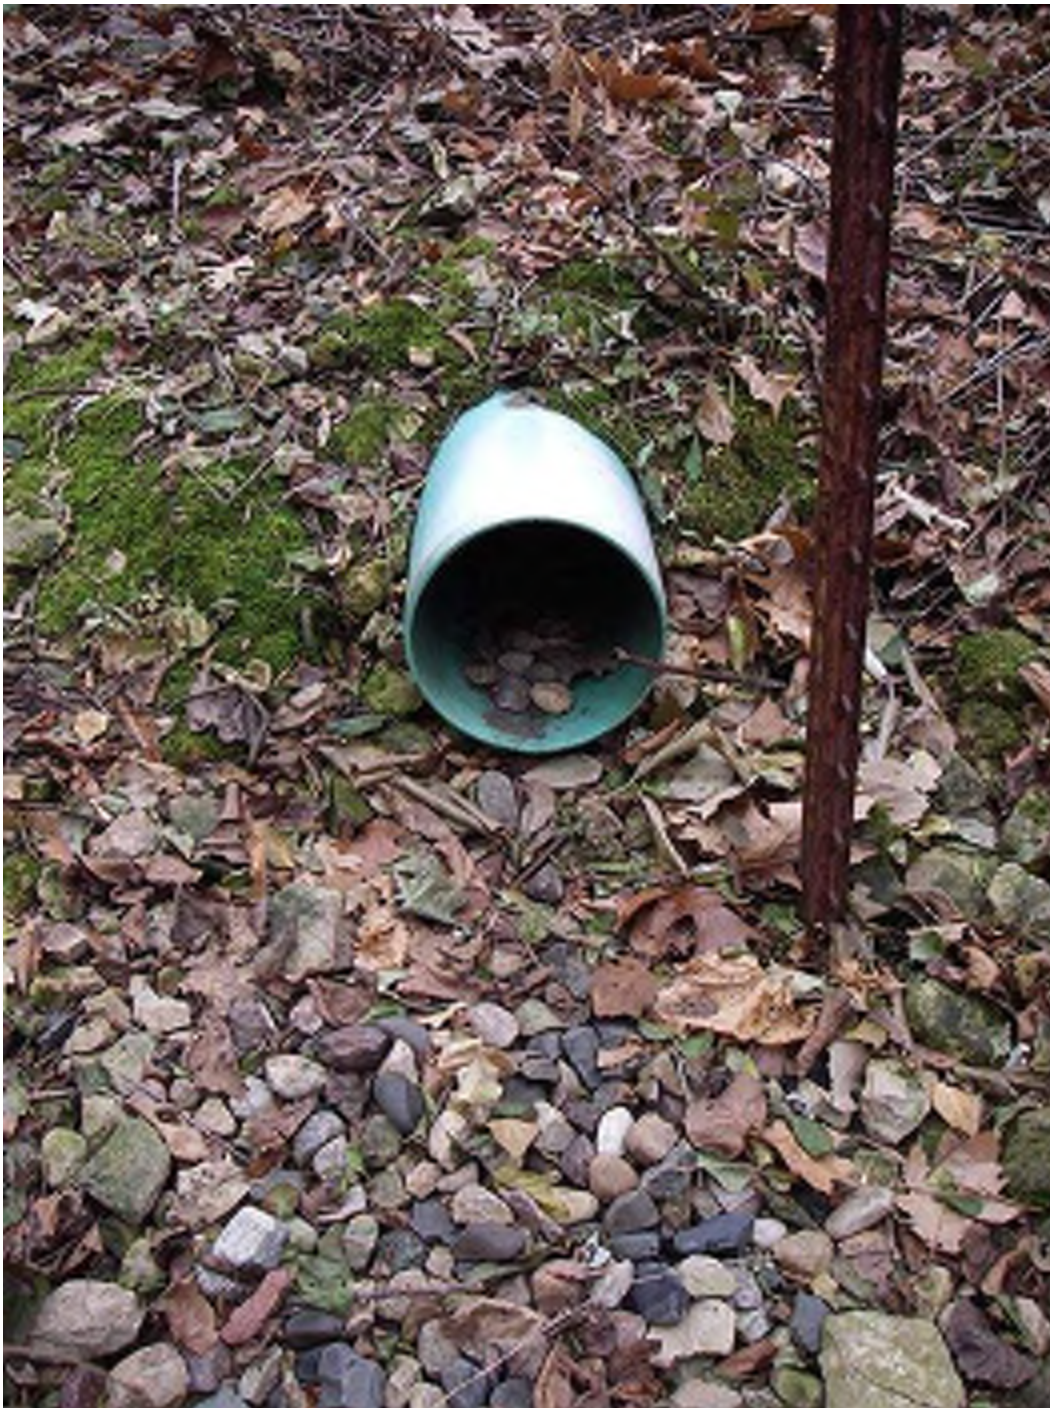
Waypoint 12

Drain pipe

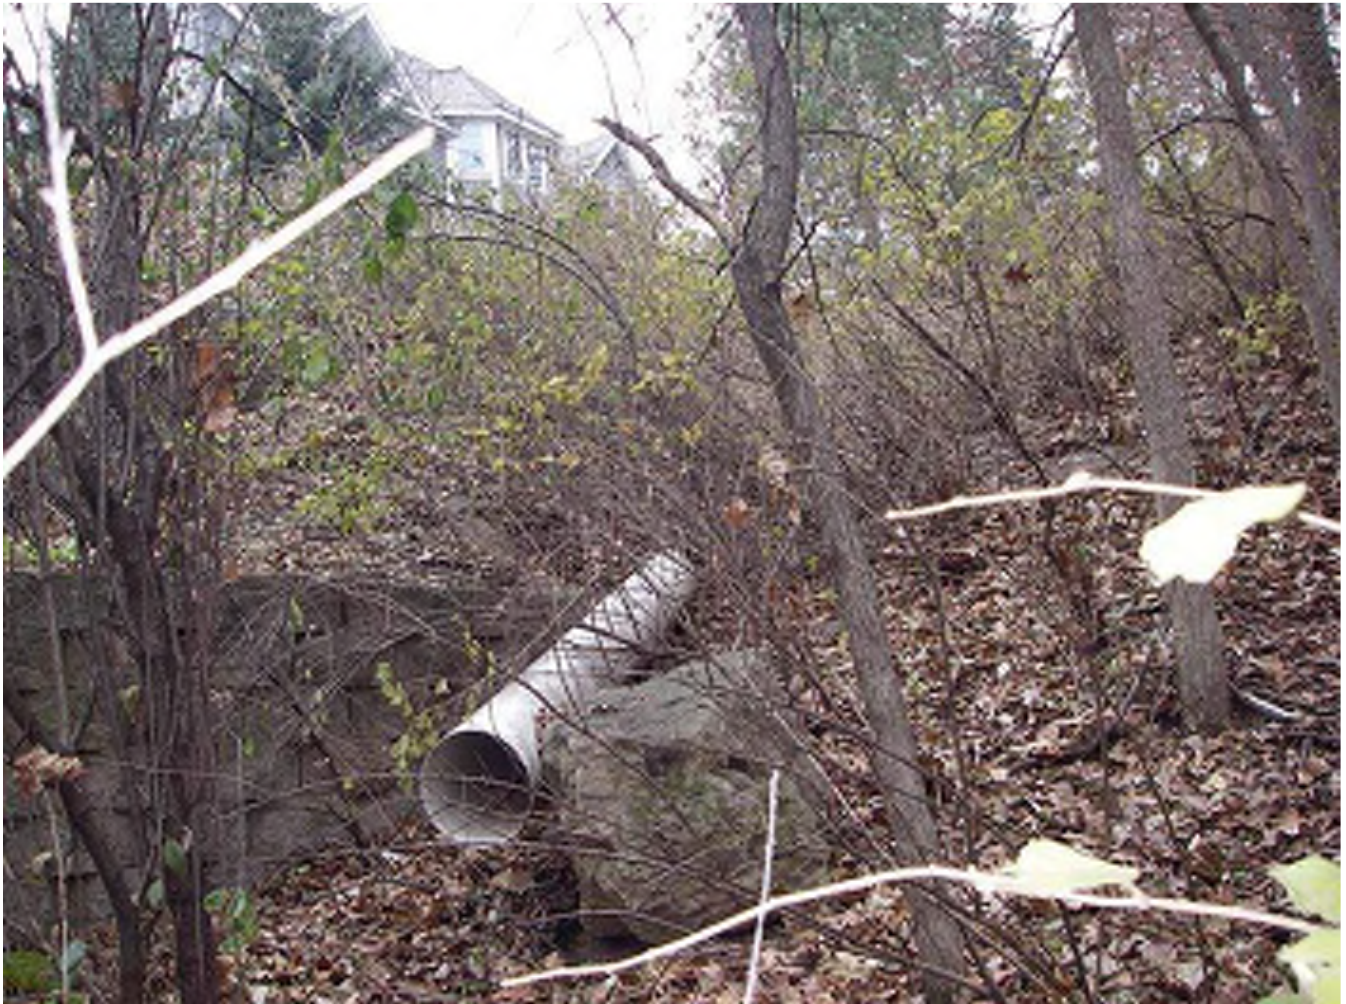
Waypoint 14

Minimal erosion; minor tree litter.

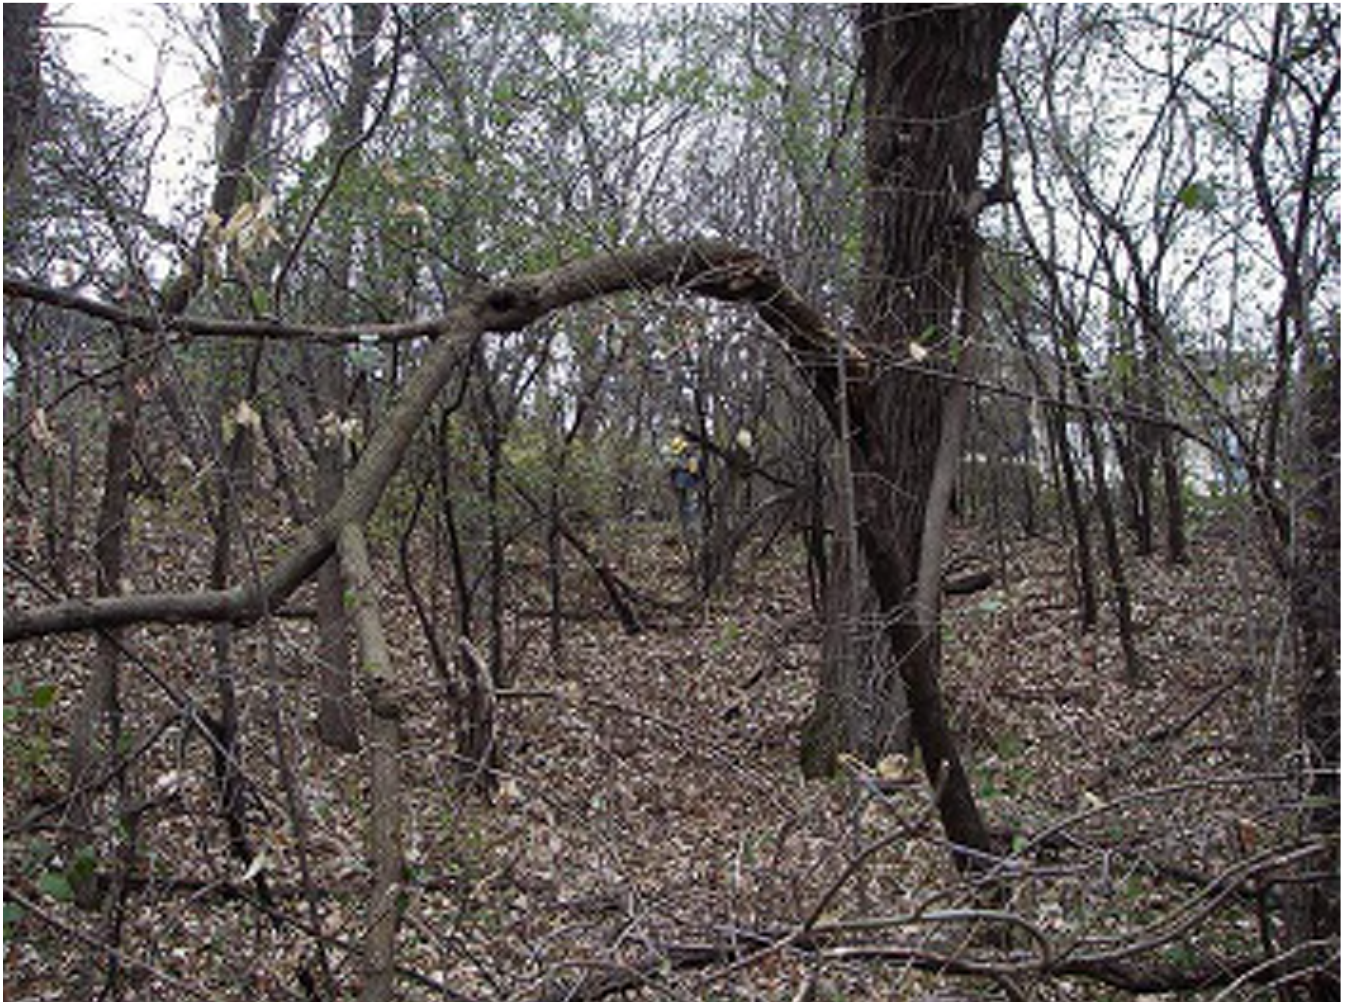
Waypoint 15

Minimal erosion.

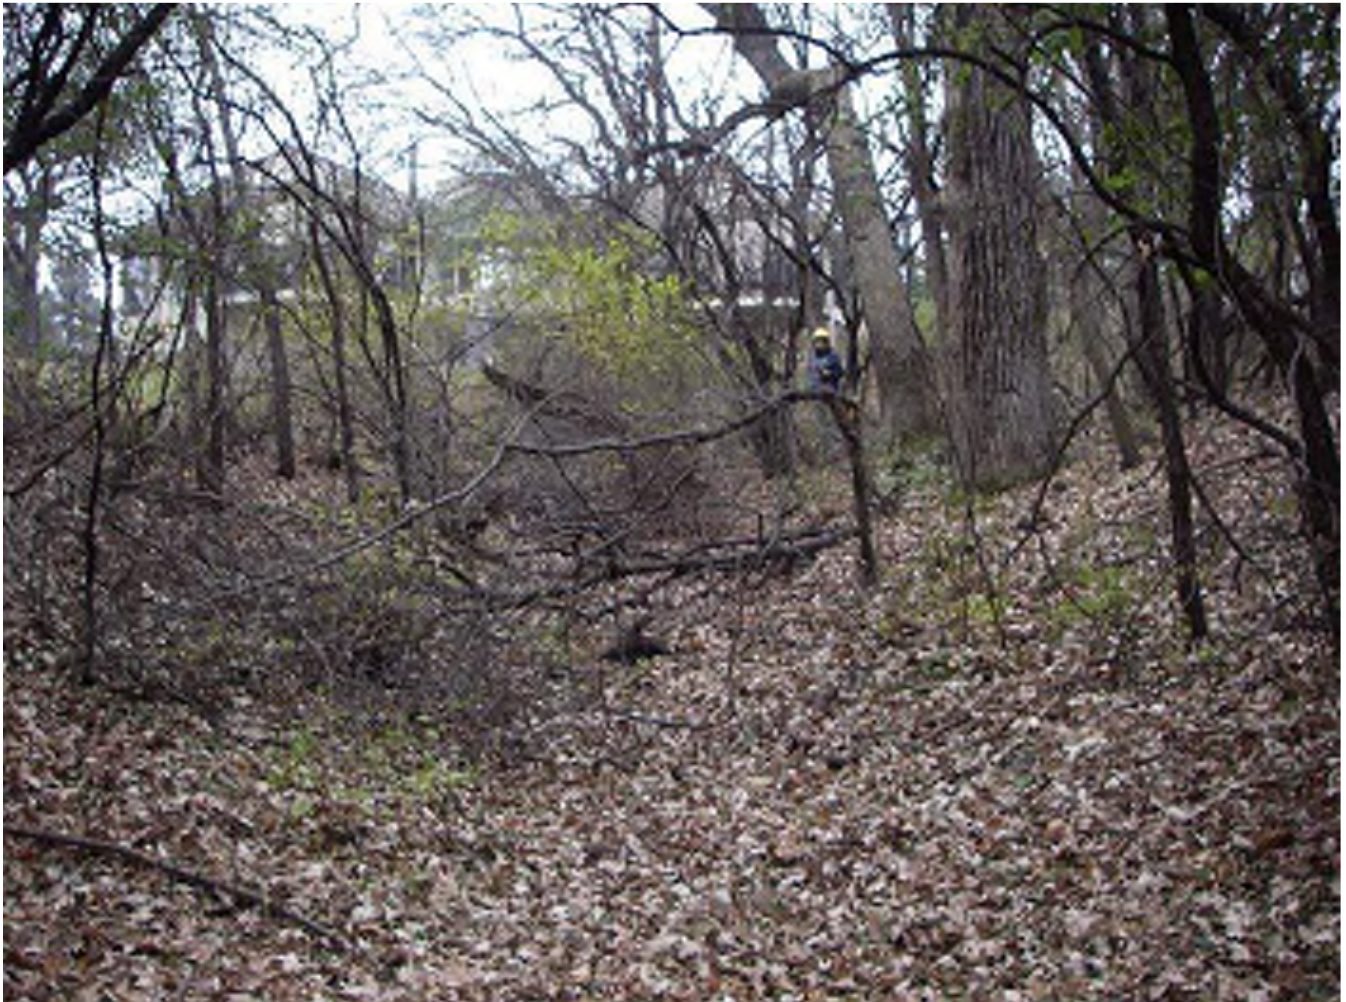
Waypoint 16

Minimal erosion.

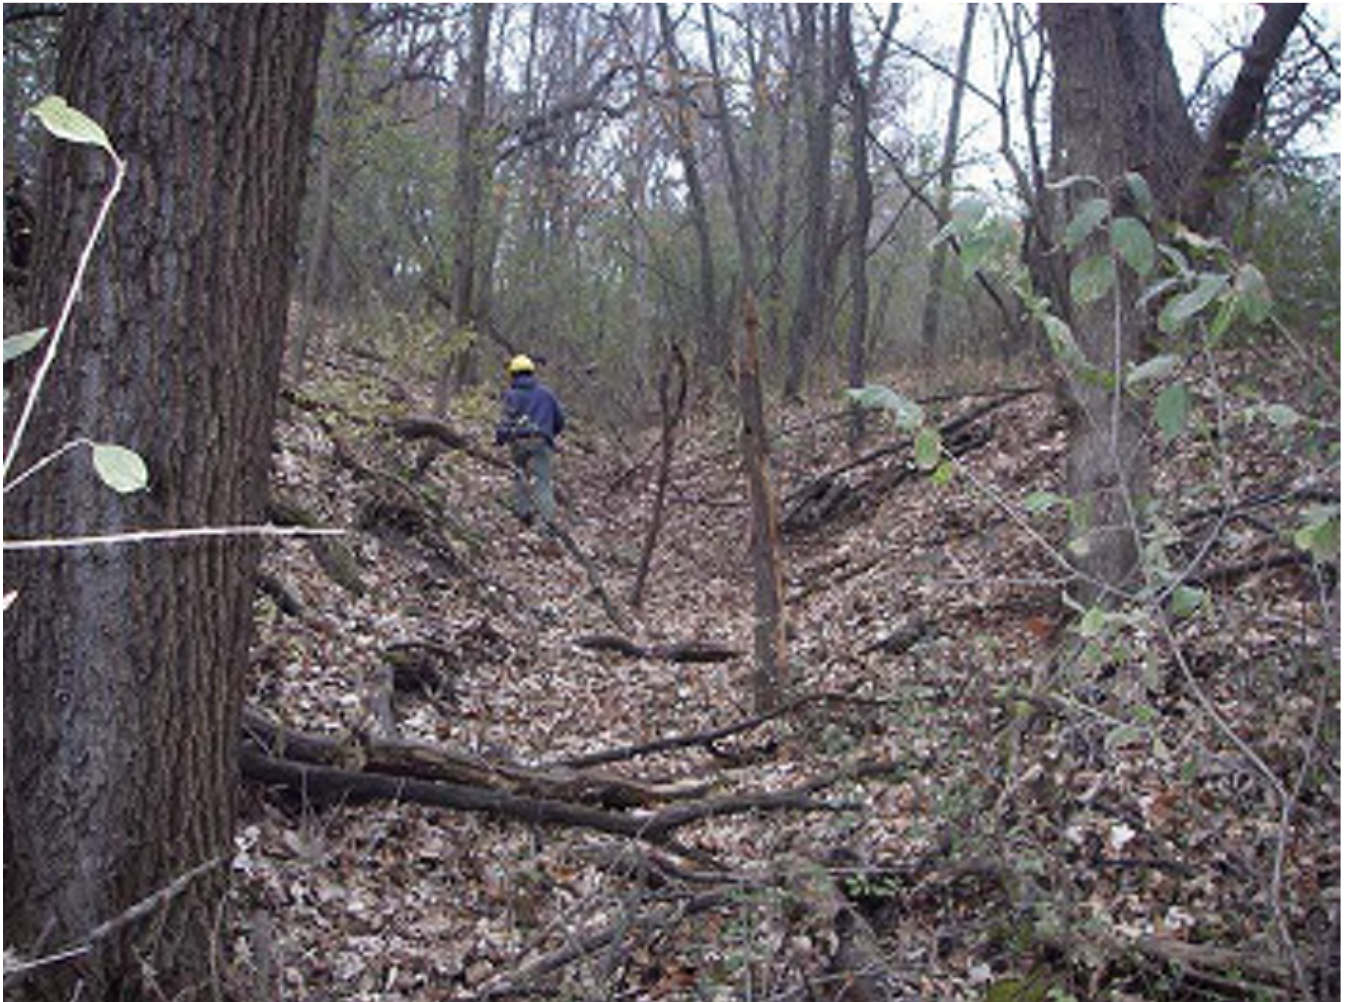
Waypoint 17

Minimal erosion.

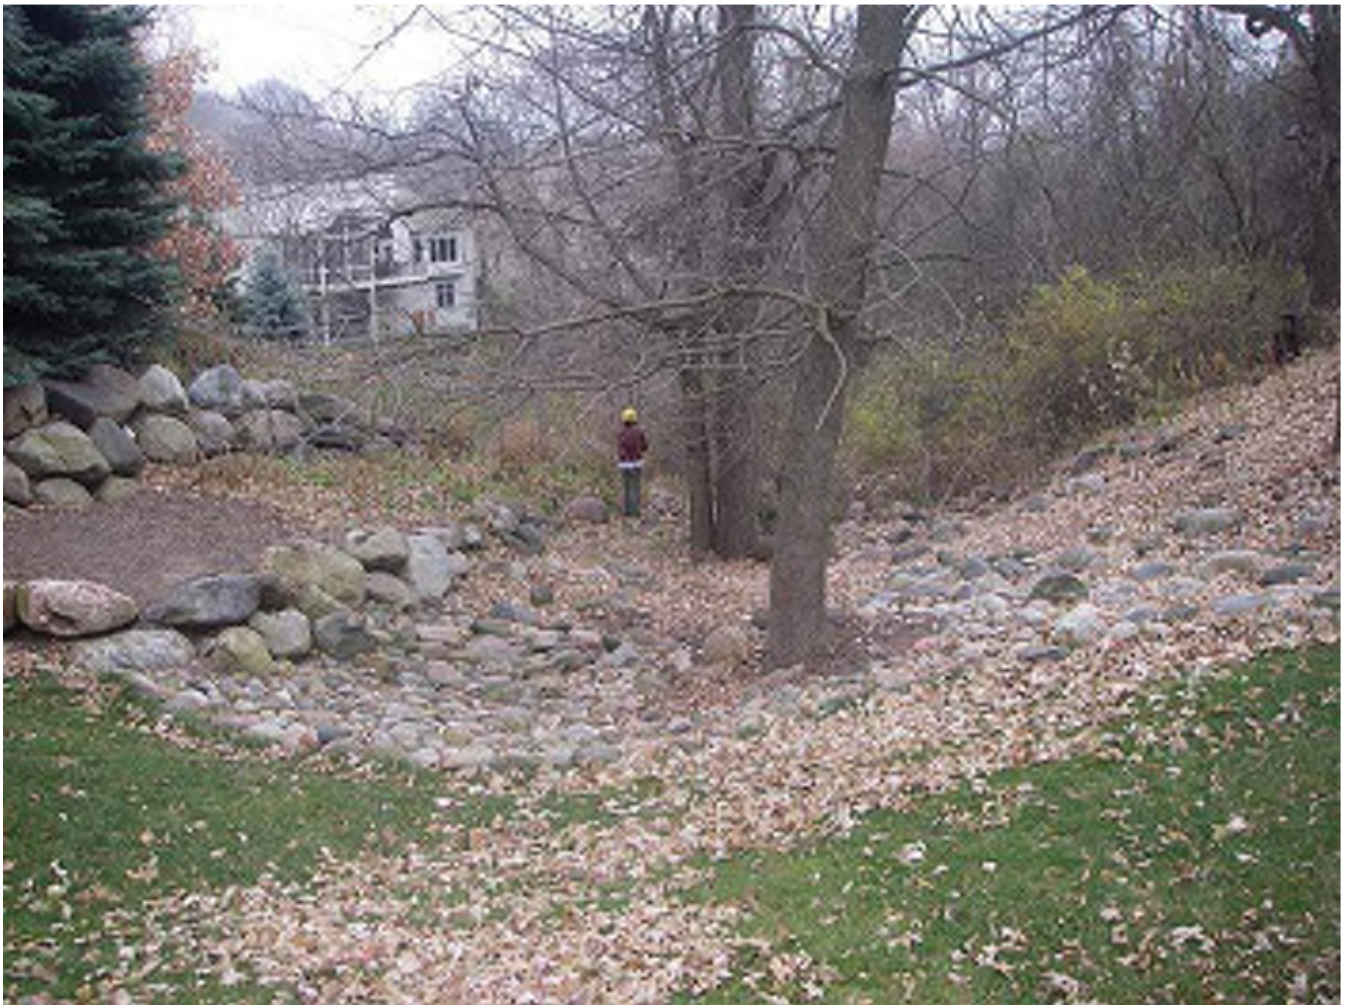
Waypoint 18

Erosion control; matting, stone drain field.

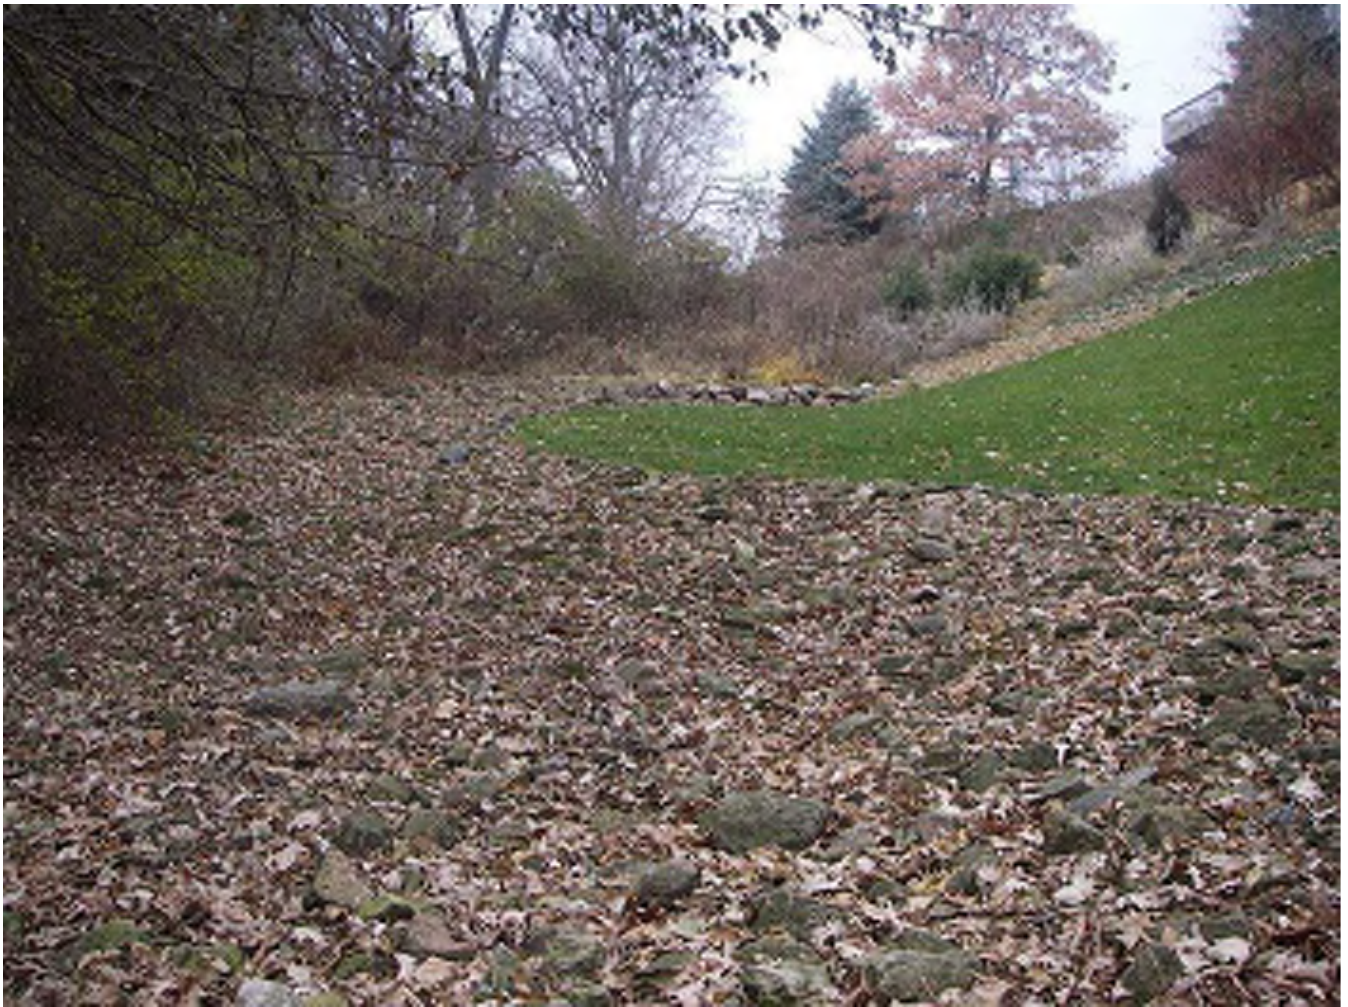
Erosion control; matting, stone drain field.

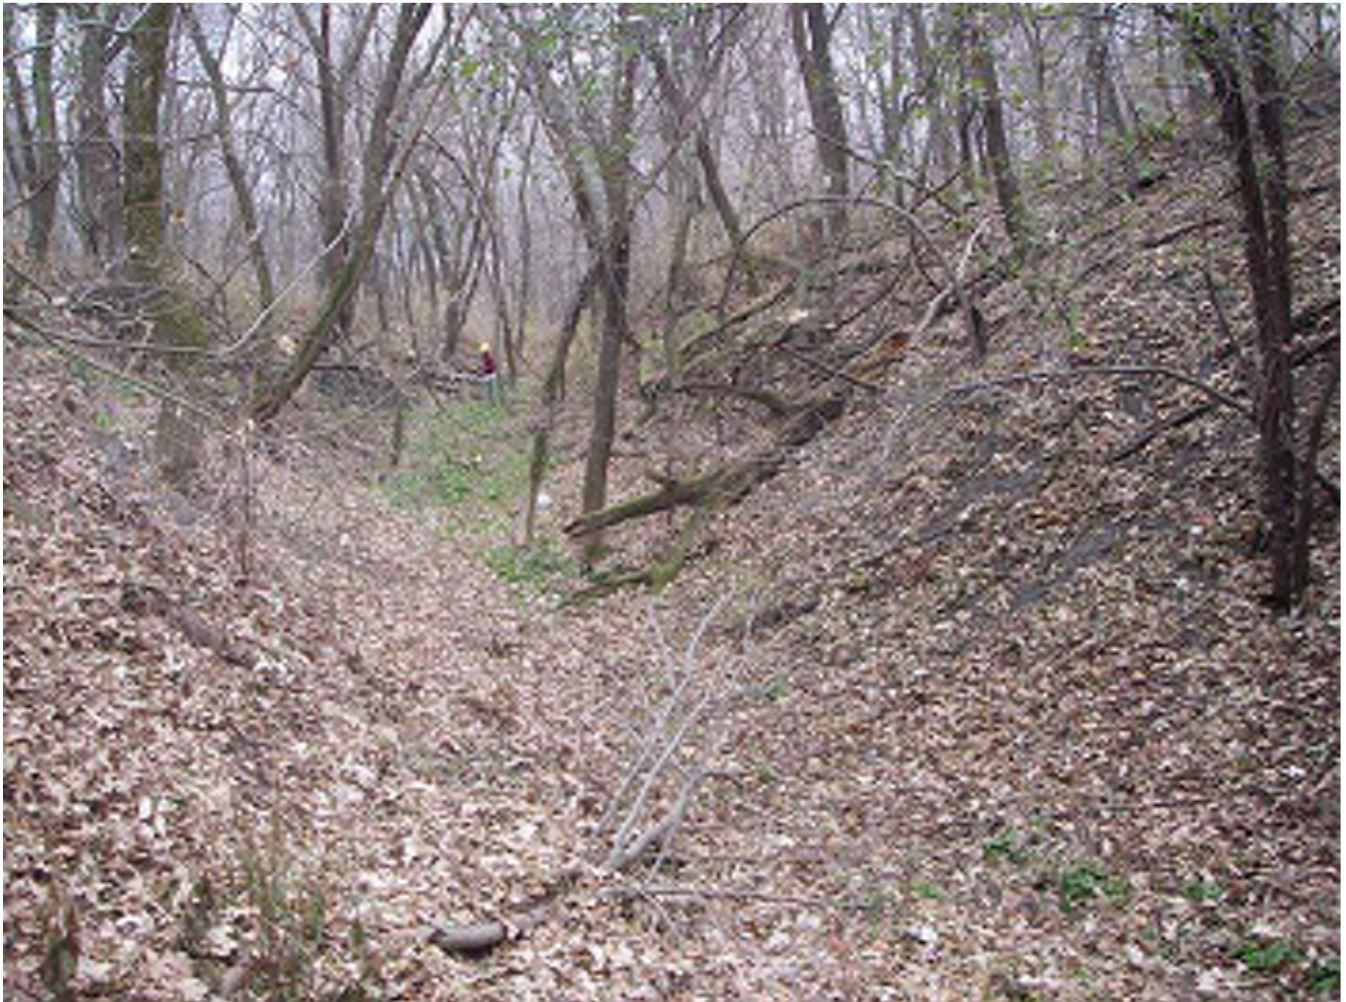
Waypoint 19

continuation of WP018 gully; med.erosion; tree litter.

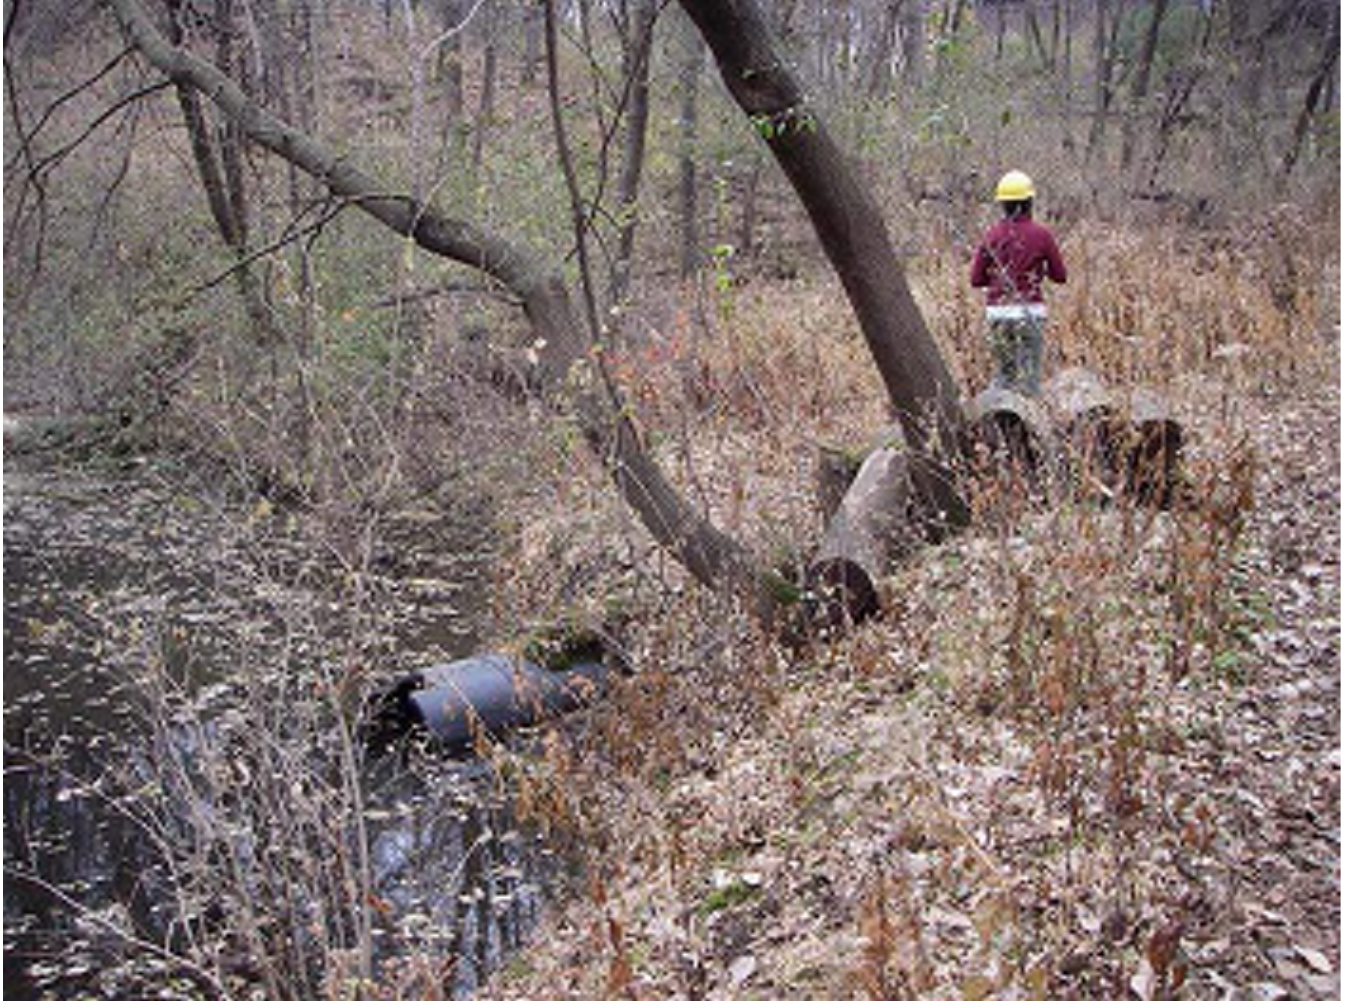
Waypoint 21

Drain pipe exit into pond

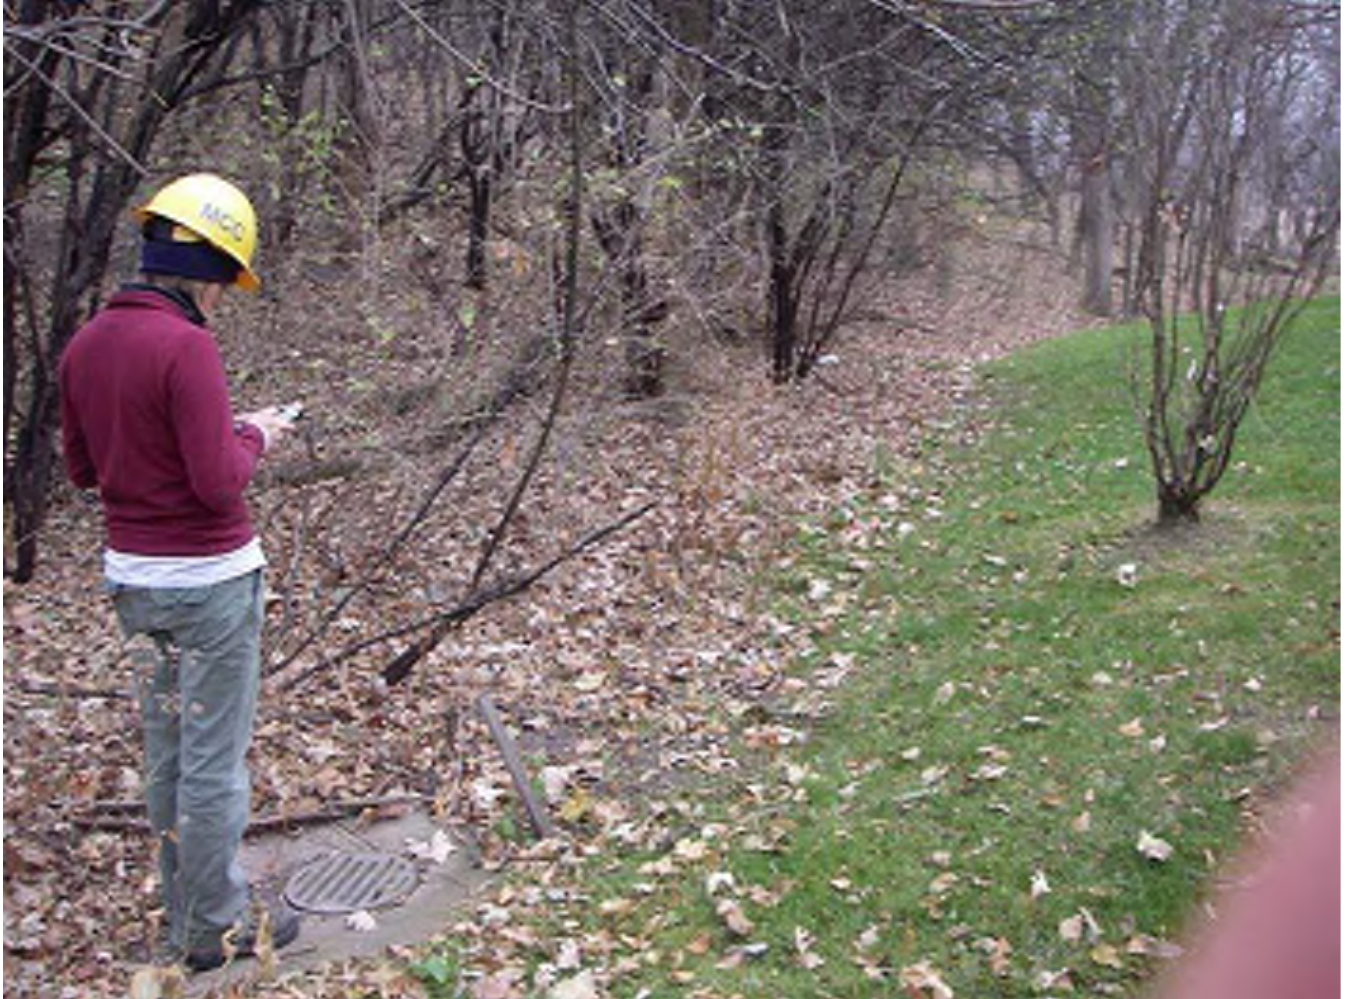
Waypoint 22

Storm drain

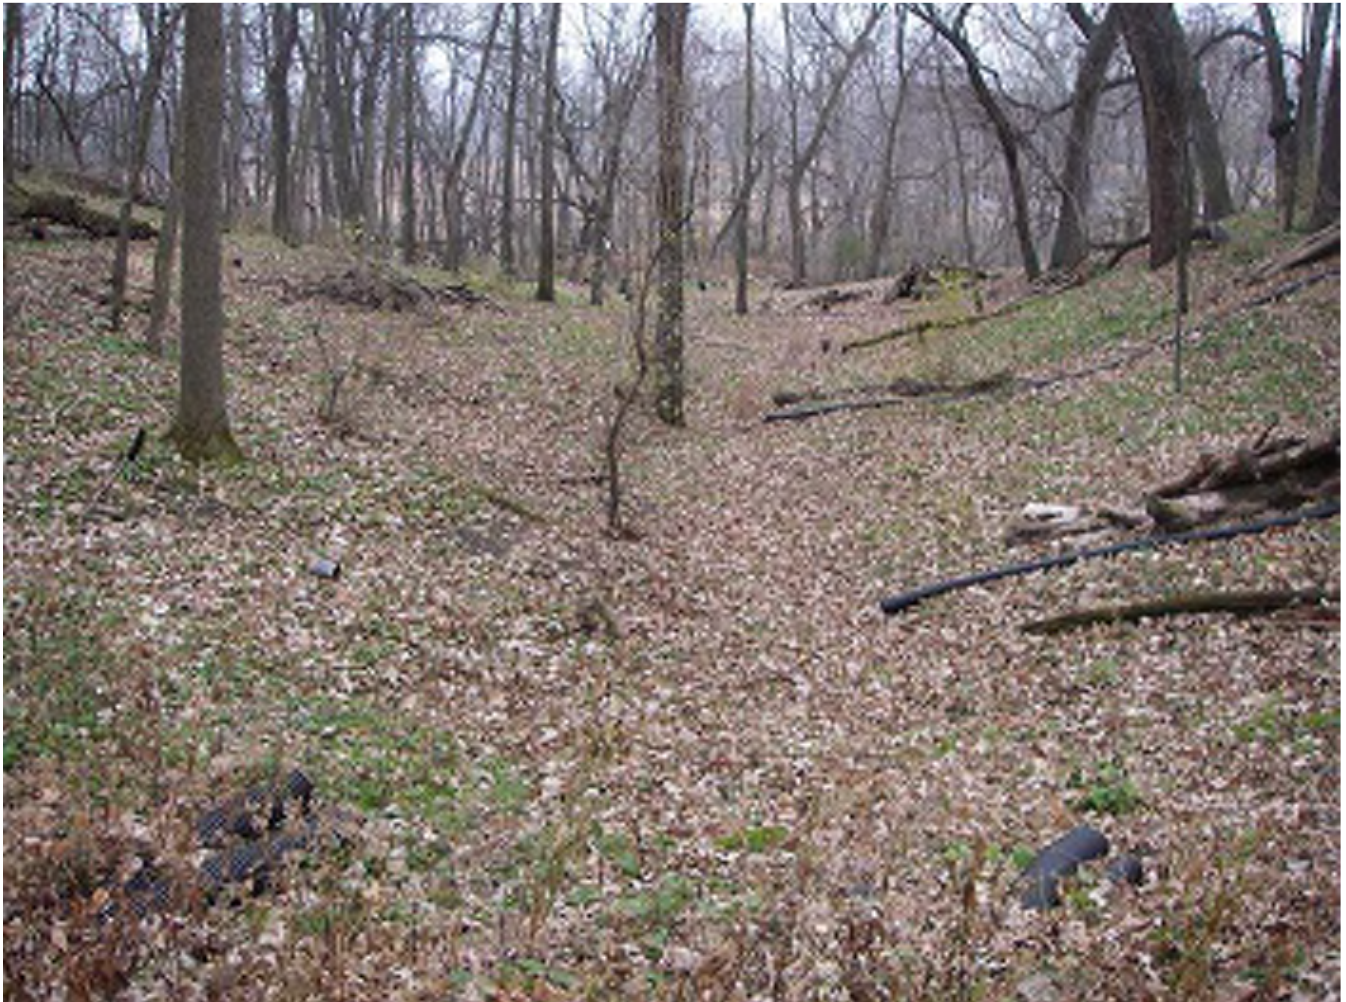
Waypoint 23

Minimal erosion, house gutter drain pipes
